April 14, 2026

Project No. US0039040.3990

**Re: MONTHLY STATUS UPDATE – ENGLEWOOD INTERMODAL YARD – REVISED INTERIM MEASURES  
WORK PLAN POST-CONSTRUCTION AND NAPL COLLECTION SYSTEM/CONCRETE CAP REPAIR  
INSPECTIONS  
UNION PACIFIC RAILROAD HOUSTON WOOD PRESERVING WORKS FACILITY  
4910 LIBERTY ROAD FACILITY, HOUSTON, TEXAS  
POST-CLOSURE CARE PERMIT NO. HW-50343; INDUSTRIAL SWR NO. 31547**

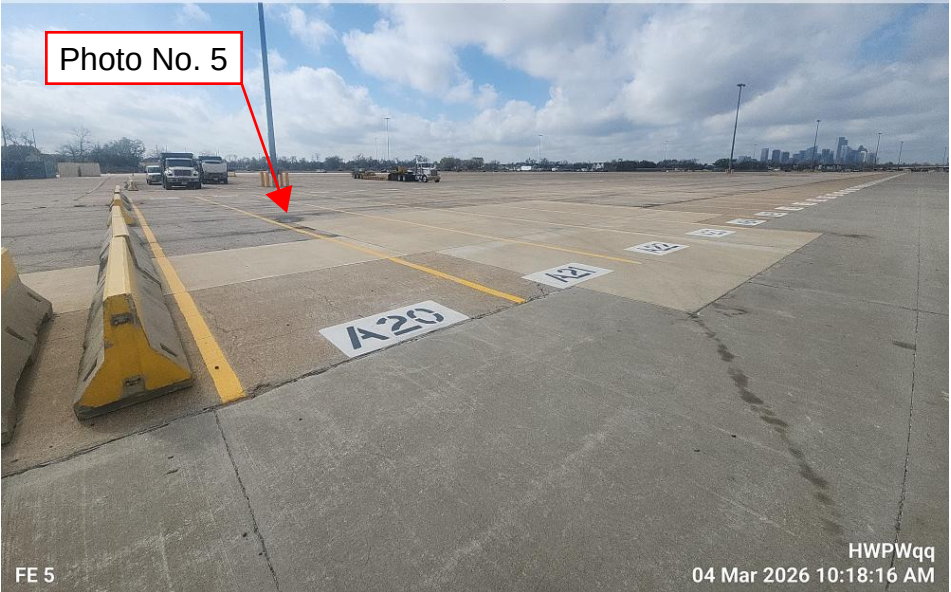
- Brown water staining was observed along the southern joint of the reconstructed concrete cap of FE-5 on March 4 (Photo No. 4 through 7) and March 11 (Photo No. 20 through 22). The brown water staining was not observed at this location during the March 18 and 25 inspections.

| <b>Photo No.</b><br>4 | <b>Inspection Date:</b><br>03/04/2026 | <b>S</b> <b>POS: 29.785449, -95.318619 ±13ft ALT: -36ft</b><br> |
| <b>Description:</b><br>FE-5 weekly inspection of concrete cap.<br>Reconstructed cap in good condition. No NAPL observed at FE location. Brown water staining along the southern joint of FE-5 observed. Facing south.<br><br>Lat: 29.78545<br>Long: -95.31862 | | |

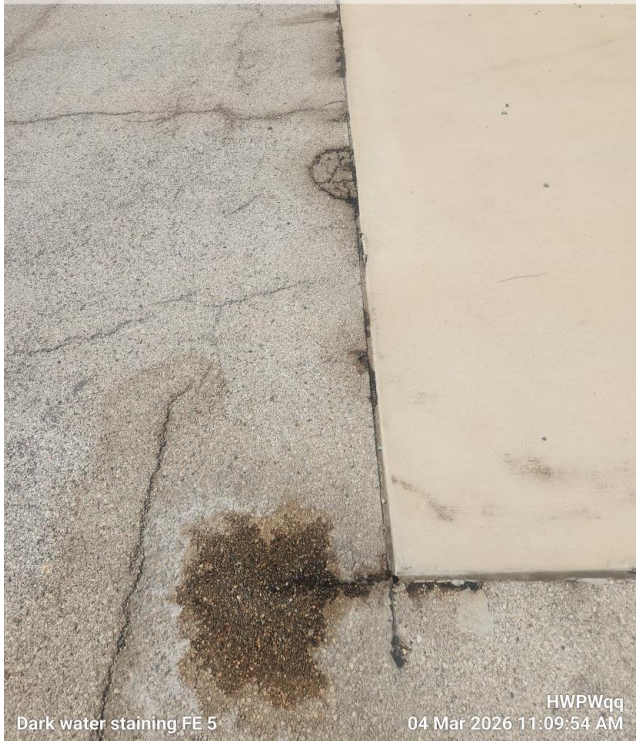
| <b>Description:</b><br>FE-5 brown water staining observed at the southeastern corner of the FE reconstructed cap, located with the red arrow on Photo No. 6. Facing southwest.<br><br>Lat: 29.78539<br>Long: -95.31851 | | |

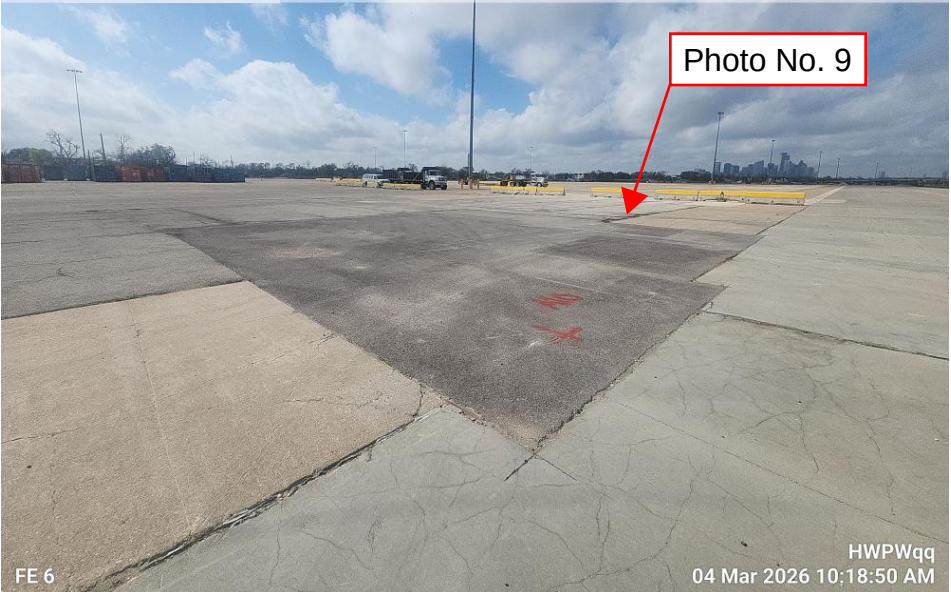
- On March 4, brown water staining and a small amount of standing water were observed along the western joint perpendicular to the reconstructed asphalt cap of FE-6 (Photo No. 8 and 9). On March 11, brown water staining and a small amount of standing water were observed along the southern joint of the reconstructed asphalt cap of FE-6 and along the western joint perpendicular to the reconstructed asphalt cap of FE-6 (Photo No. 23 and 24). The brown water staining was not observed at this location during the March 18 and 25 inspections.

| <b>Description:</b><br>FE-6 weekly inspection of asphalt cap. Reconstructed cap in good condition. No NAPL observed at FE location. Brown water staining along the western joint of FE-6 observed. Facing southwest.<br><br>Lat: 29.78556<br>Long: -95.31831 | | |

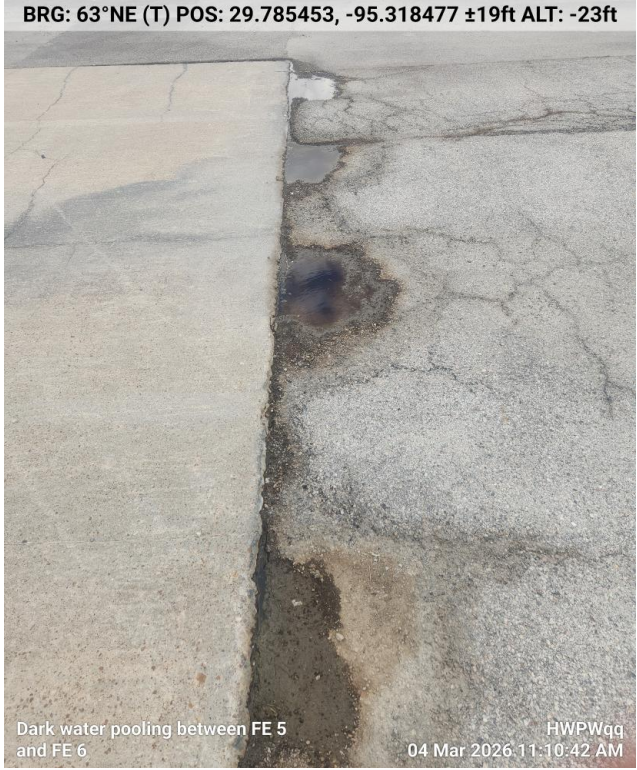
| <b>Description:</b><br>FE-6 brown water staining observed along the western joint of the FE reconstructed cap. Standing water was along the joint perpendicular to western edge of FE-6, located with the red arrow on Photo No. 8. Facing northeast.<br><br>Lat: 29.78545<br>Long: -95.31848 | | |

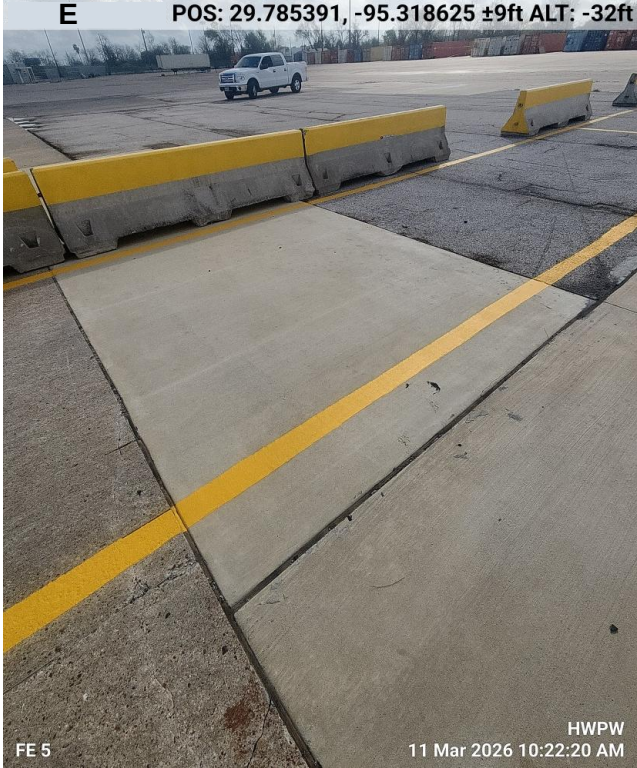
| <b>Description:</b><br>FE-5 weekly inspection of concrete cap. Reconstructed cap in good condition. No NAPL observed at FE location. Brown water staining along the southern joint of FE-5 observed. Facing east.<br><br>Lat: 29.78539<br>Long: -95.31863 | | |

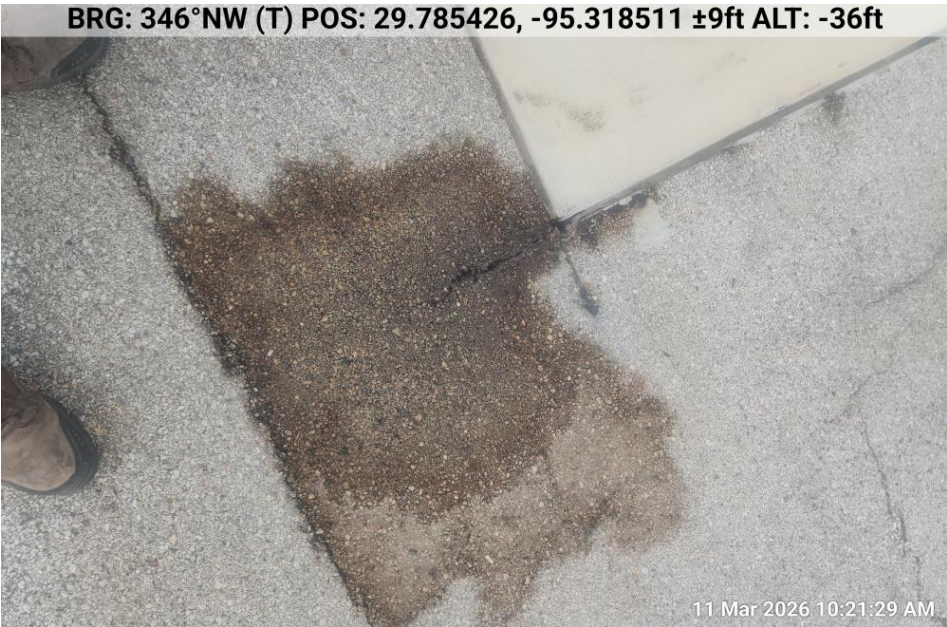
| <b>Description:</b><br>FE-5 brown water staining observed at the southeastern corner of the FE reconstructed cap.<br><br>Lat: 29.78543<br>Long: -95.31851 | | |

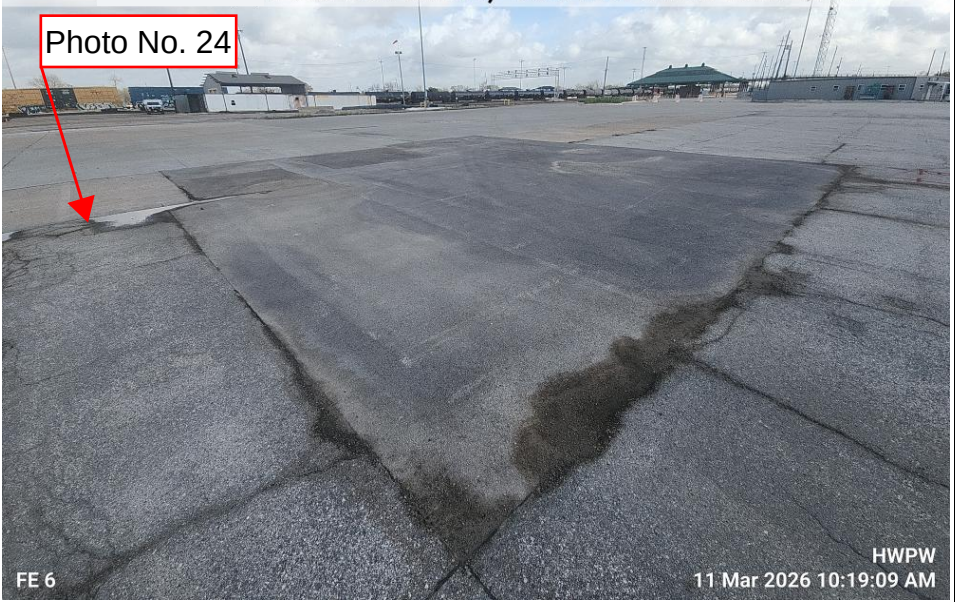
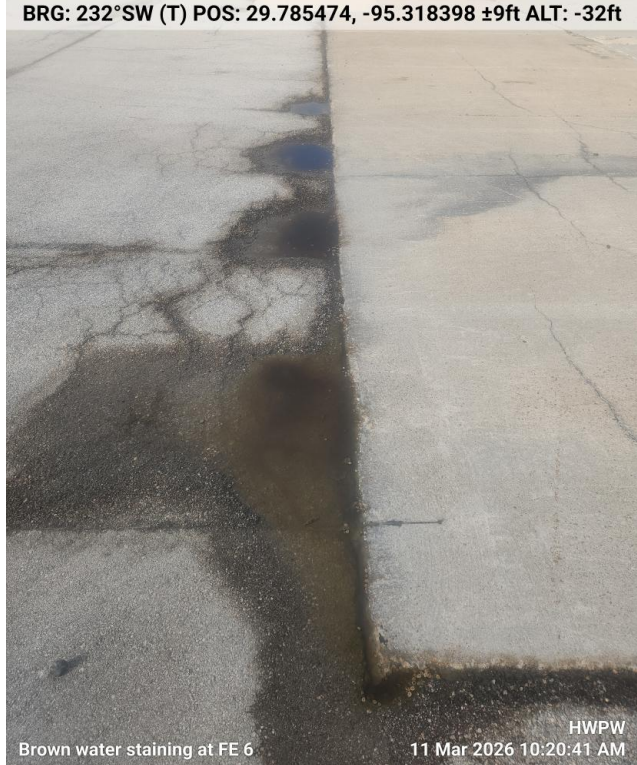
| <b>Description:</b><br>FE-6 weekly inspection of asphalt cap. Reconstructed cap in good condition. No NAPL observed at FE location. Brown water staining along the western and southern joint of FE-6 observed. Facing northeast.<br><br>Lat: 29.7854<br>Long: -95.31838 | | |

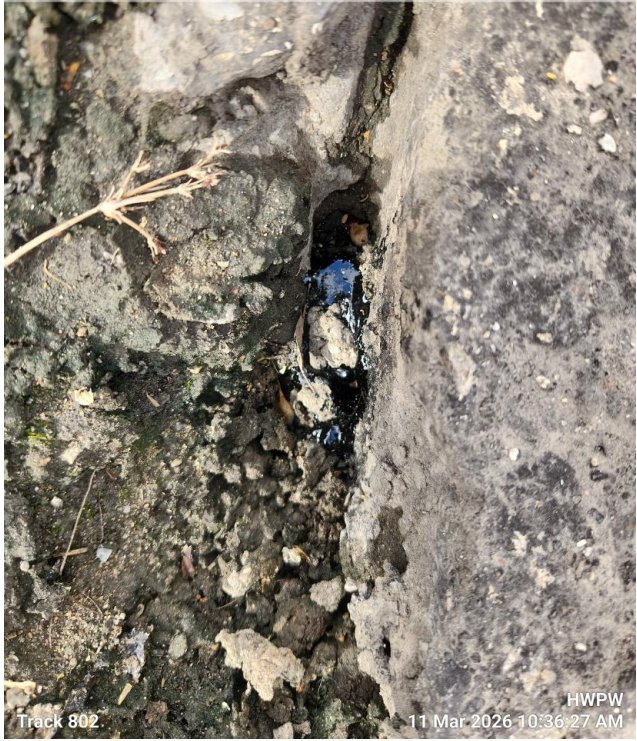
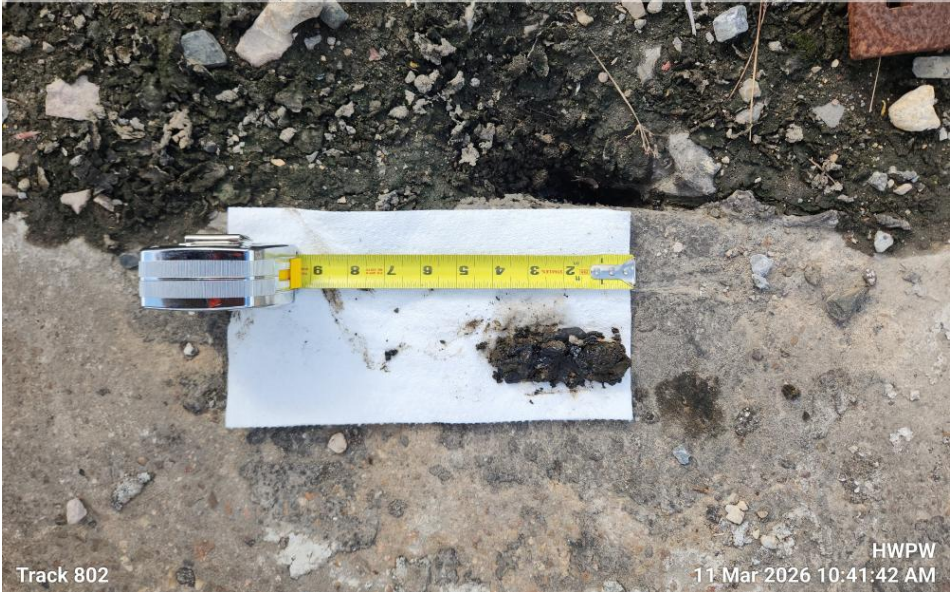
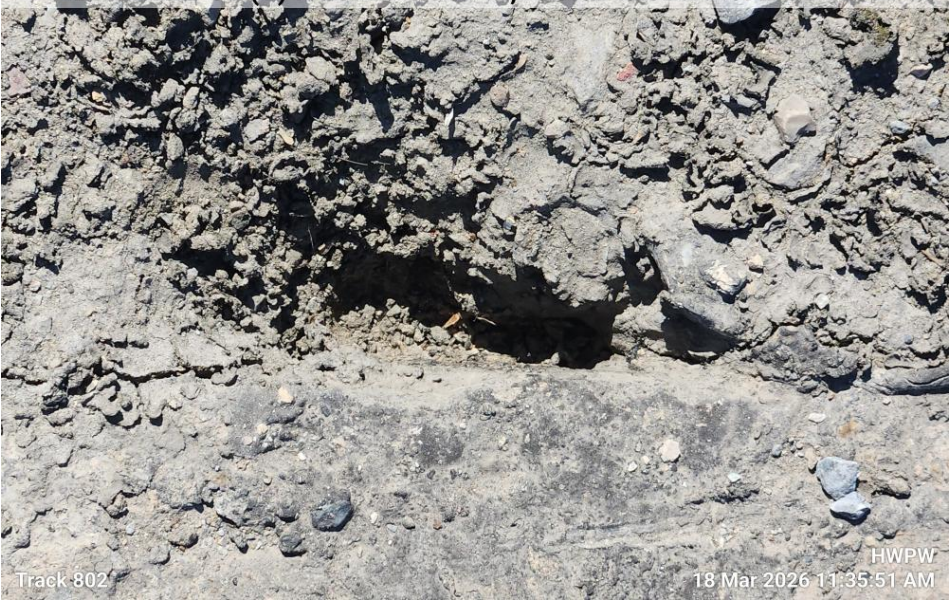
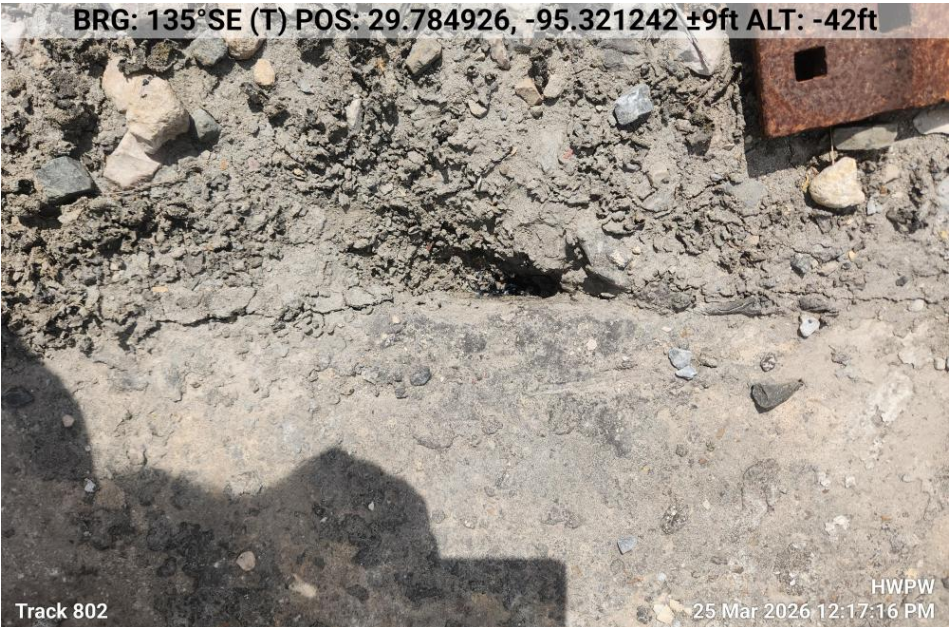
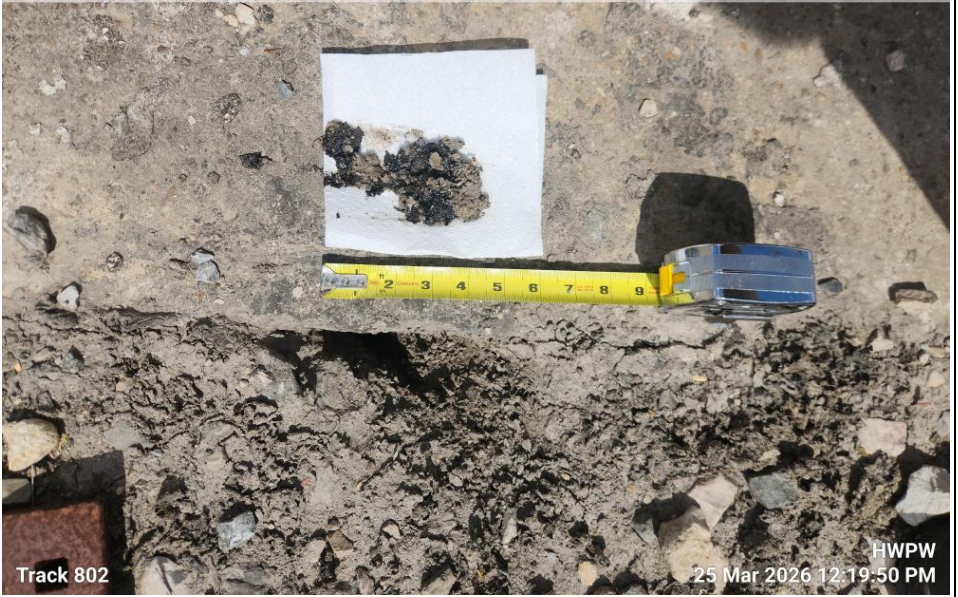
- Tar-like material seeps at the following two locations:
  - A tar-like material seep was observed at Track 802 on March 11 and March 25. Approximately 7.5 cubic inches (approximately 4.2 fluid ounces) of NAPL were recovered. No seep activity was noted at Track 802 during the other March weekly inspections (Photo Numbers 78 through 83).

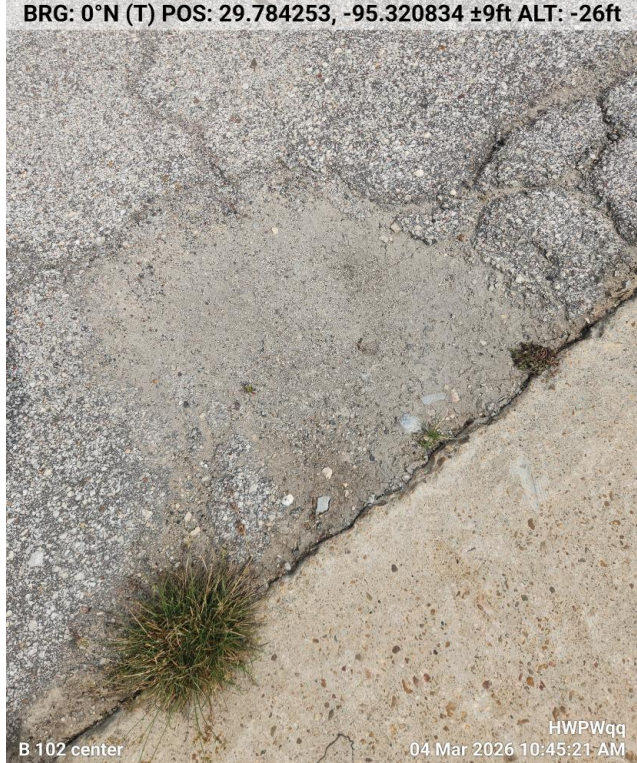
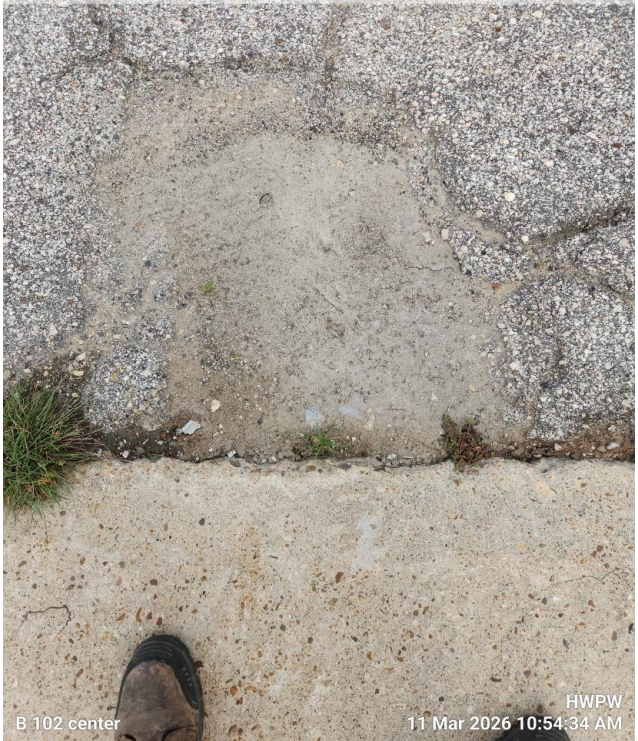
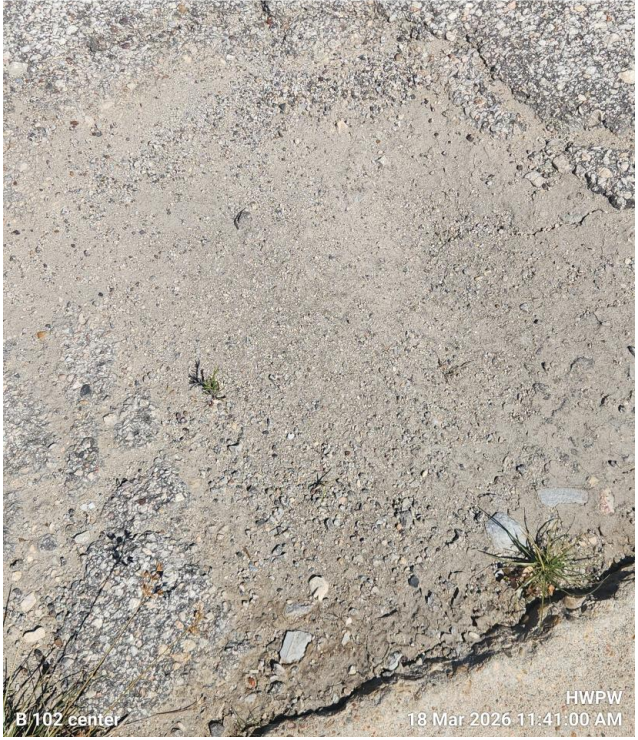
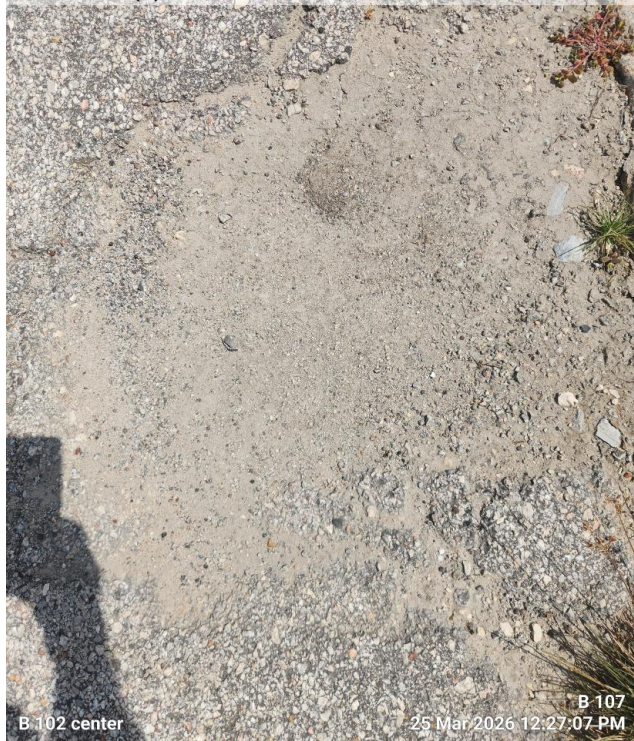
- No active seeps were noted at Stall B102 Center during the March weekly inspections (Photo Numbers 84 through 87).
- Overall, the volume of NAPL recovered from the surface seeps increased from February to March 2026 (approximately 2.9 fluid ounces in February compared to 5.3 fluid ounces in March). Annual increases in NAPL recovery volume are anticipated as ambient temperatures increase. In comparison, prior to implementing the Focused Excavations, approximately 14 fluid ounces (approximately 0.11 gallons) of NAPL were collected from the surface seeps during March 2024.
