May 14, 2026

Project No. US0039040.3990

**Re: MONTHLY STATUS UPDATE – ENGLEWOOD INTERMODAL YARD – REVISED INTERIM MEASURES  
WORK PLAN POST-CONSTRUCTION AND NAPL COLLECTION SYSTEM/CONCRETE CAP REPAIR  
INSPECTIONS  
UNION PACIFIC RAILROAD HOUSTON WOOD PRESERVING WORKS FACILITY  
4910 LIBERTY ROAD FACILITY, HOUSTON, TEXAS  
POST-CLOSURE CARE PERMIT NO. HW-50343; INDUSTRIAL SWR NO. 31547**

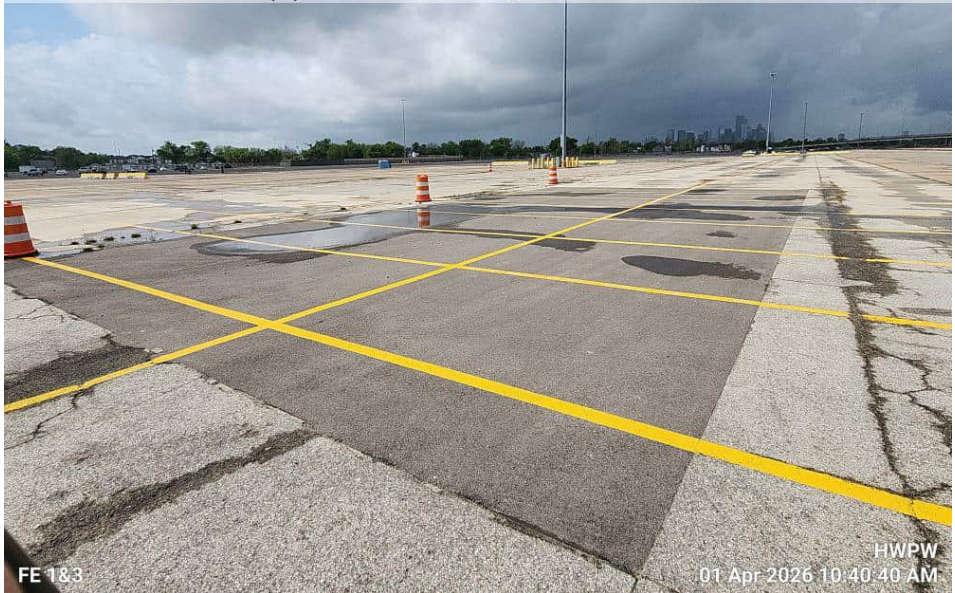
| <b>Description:</b><br>FE-1&3 weekly inspection of asphalt cap. Reconstructed cap in good condition. No NAPL observed at FE location. Standing water from recent rain event. Facing southwest.<br><br>Lat: 29.78439<br>Long: -95.32082 | | | |

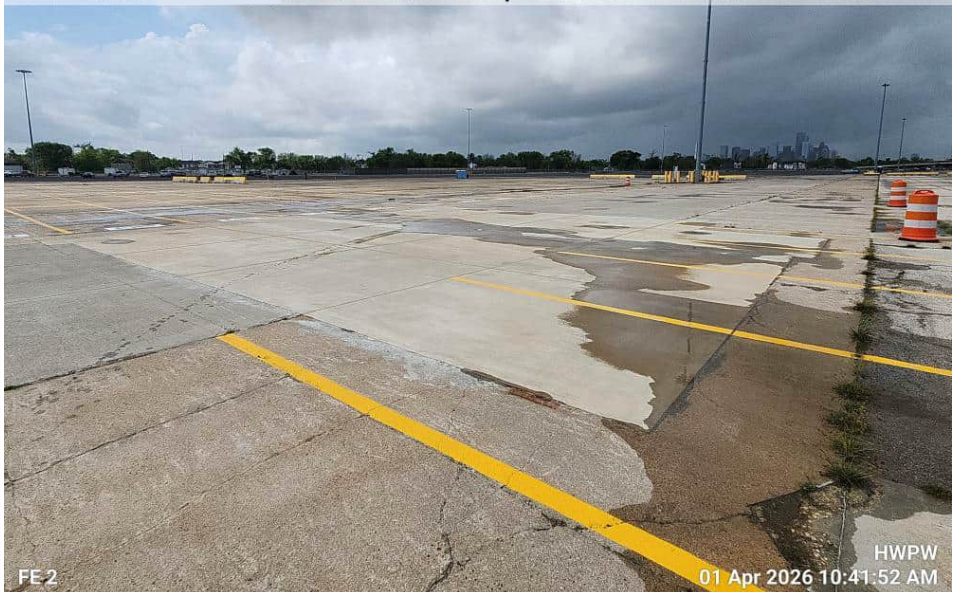
| <b>Description:</b><br>FE-2 weekly inspection of concrete cap. Reconstructed cap in good condition. No NAPL observed at FE location. Standing water from recent rain event. Facing southwest.<br><br>Lat: 29.78428<br>Long: -95.32074 | | | |

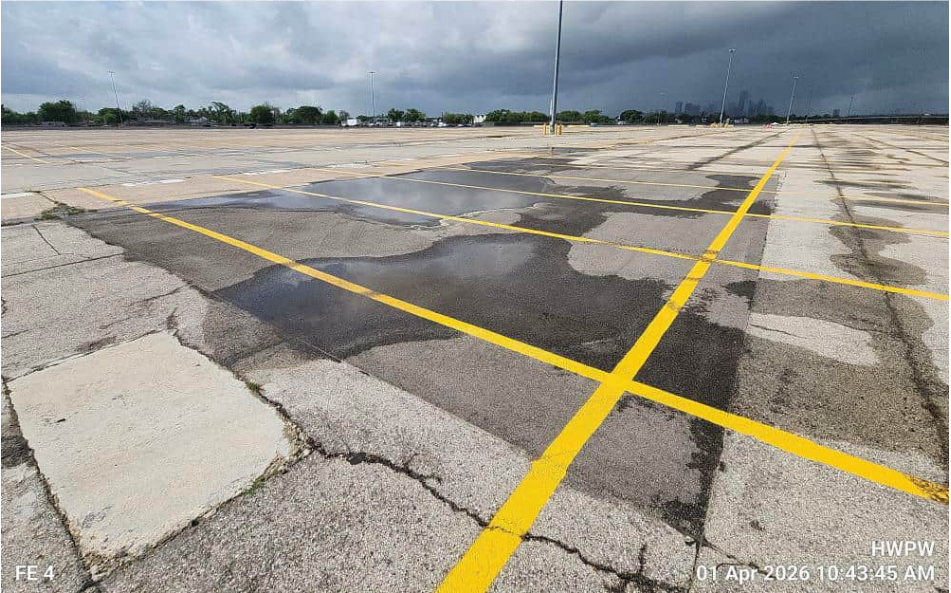
| <b>Description:</b><br>FE-4 weekly inspection of asphalt cap. Reconstructed cap in good condition. No NAPL observed at FE location. Standing water from recent rain event. Facing southwest.<br><br>Lat: 29.78492<br>Long: -95.31953 | | |

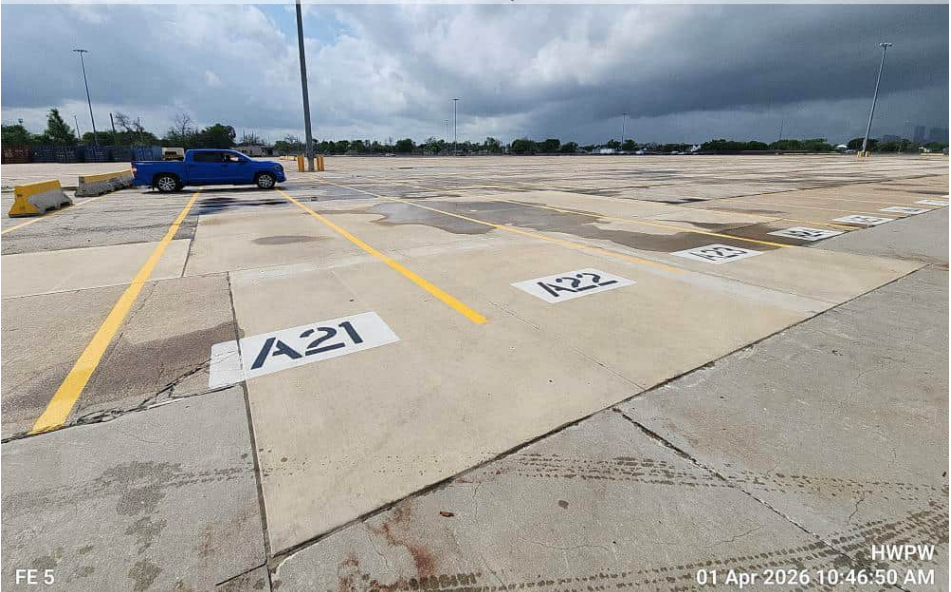
- Brown water staining was observed along the southern joint of the reconstructed concrete cap of FE-5 on April 1 (Photo Nos. 4 and 5), April 8 (Photo Nos. 21 through 23), April 15 (Photo Nos. 36 through 38), April 22 (Photo Nos. 52 through 54), and April 29 (Photo No. 66).

| <b>Description:</b><br>FE-5 weekly inspection of concrete cap. Reconstructed cap in good condition. No NAPL observed at FE location. Brown water staining along the southern joint of FE-5 observed. Standing water from recent rain event. Facing south.<br><br>Lat: 29.78544<br>Long: -95.31866 | | |

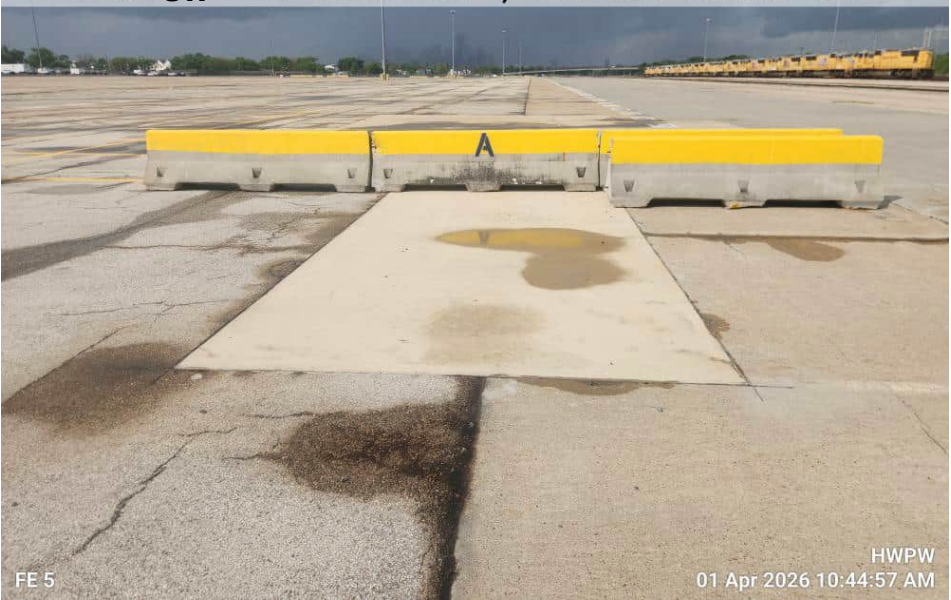
| <b>Description:</b><br>FE-5 weekly inspection of concrete cap. Reconstructed cap in good condition. No NAPL observed at FE location. Brown water staining along the southern joint of FE-5 observed. Standing water from recent rain event. Facing southwest.<br><br>Lat: 29.78542<br>Long: -95.31851 | | <div> FE 5 <span style="float: right;">HWPW<br/>01 Apr 2026 10:44:57 AM</span> </div> | |

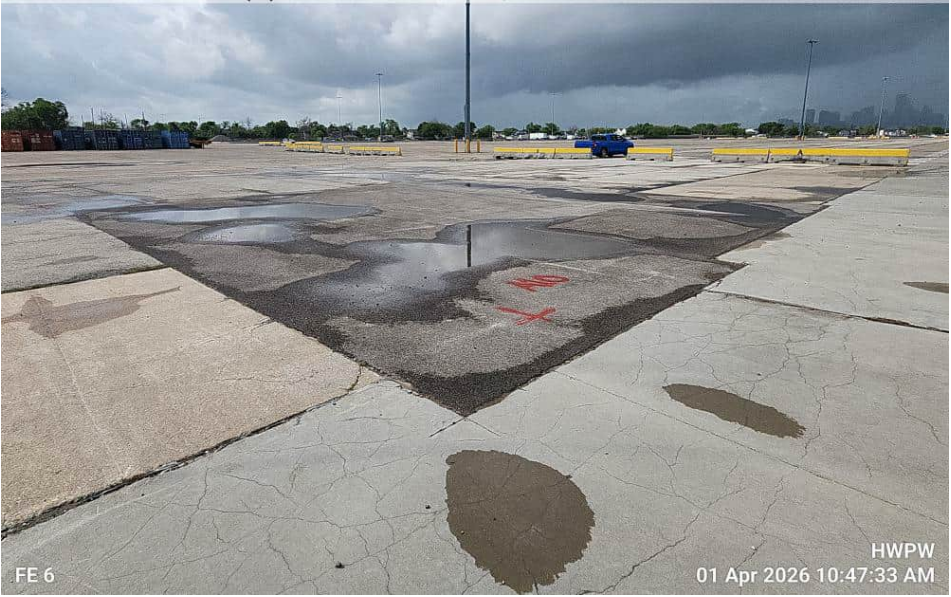
- Brown water staining and a small amount of standing water were observed along the western joint perpendicular to the reconstructed asphalt cap of FE-6 on April 1 (Photo Nos. 6 through 9), April 8 (Photo Nos. 24 and 25), April 15 (Photo Nos. 39 through 41), April 22 (Photo No. 55), and April 29 (Photo No. 67).

| <b>Description:</b><br>FE-6 weekly inspection of asphalt cap. Reconstructed cap in good condition. No NAPL observed at FE location. Brown standing water was along the joint perpendicular to western edge of FE-6. Other standing water from recent rain event. Facing south.<br><br>Lat: 29.78559<br>Long: -95.31831 | | <div> FE 6 <span style="float: right;">HWPW<br/>01 Apr 2026 10:47:33 AM</span> </div> | |

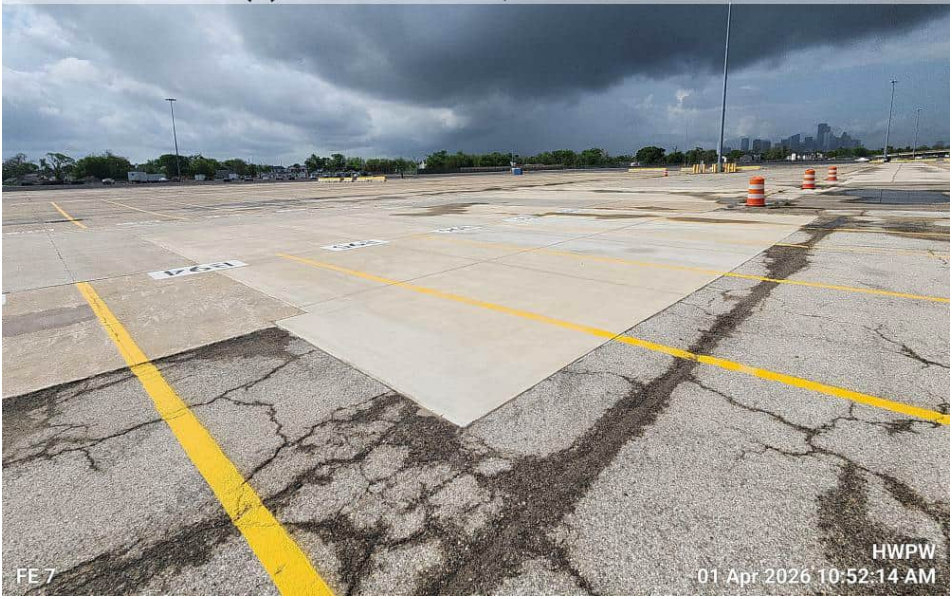
| <b>Description:</b><br>FE-7 weekly inspection of concrete cap. Reconstructed cap in good condition. No NAPL observed at FE location. Standing water from recent rain event. Facing south.<br><br>Lat: 29.78439<br>Long: -95.32062 | | |

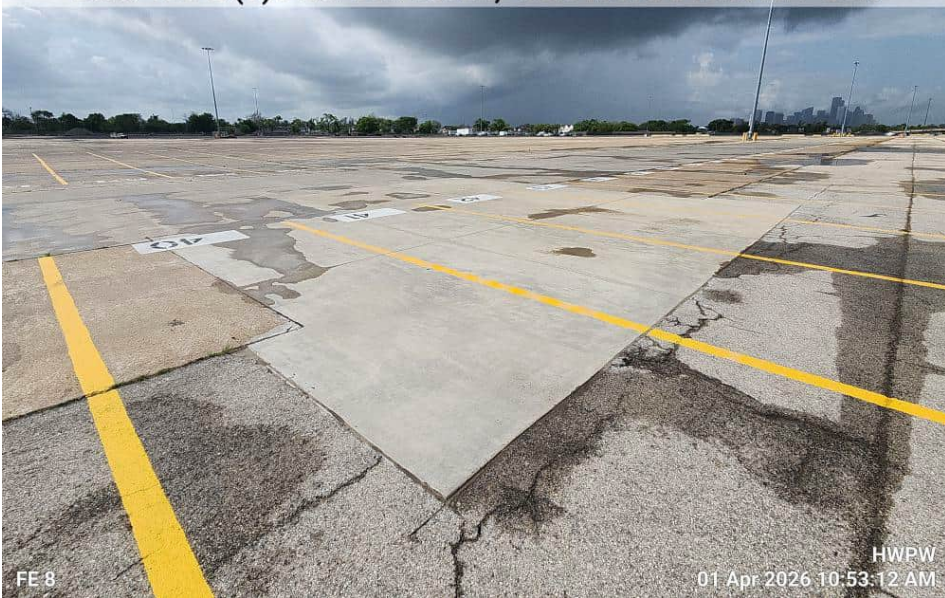
| <b>Description:</b><br>FE-8 weekly inspection of concrete cap.<br>Reconstructed cap in good condition. No NAPL observed at FE location. Standing water from recent rain event. Facing south.<br><br>Lat: 29.78502<br>Long: -95.31909 | | |

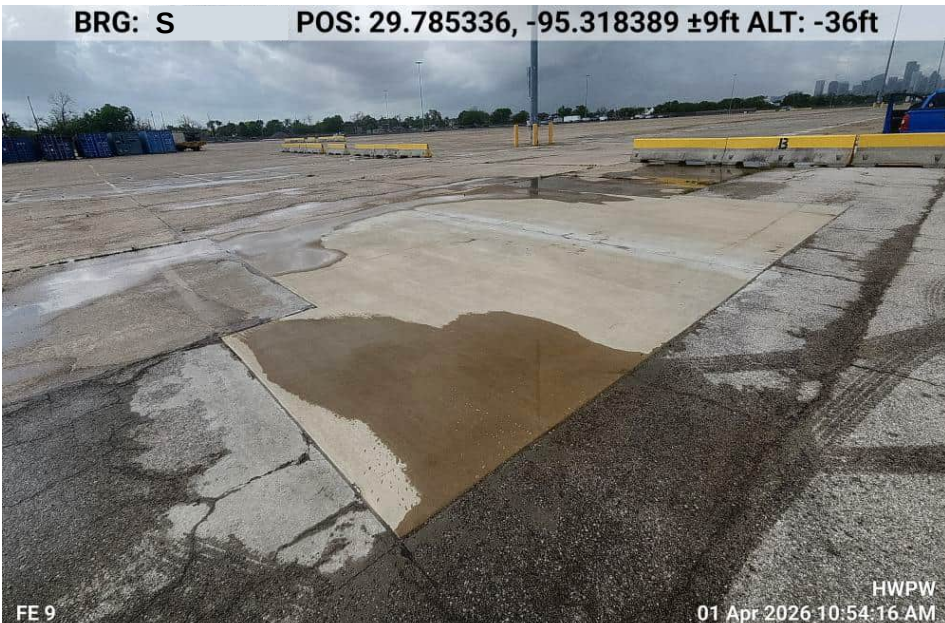
| <b>Description:</b><br>FE-9 weekly inspection of concrete cap.<br>Reconstructed cap in good condition. No NAPL observed at FE location. Standing water from recent rain event. Facing south.<br><br>Lat: 29.78534<br>Long: -95.31839 | | |

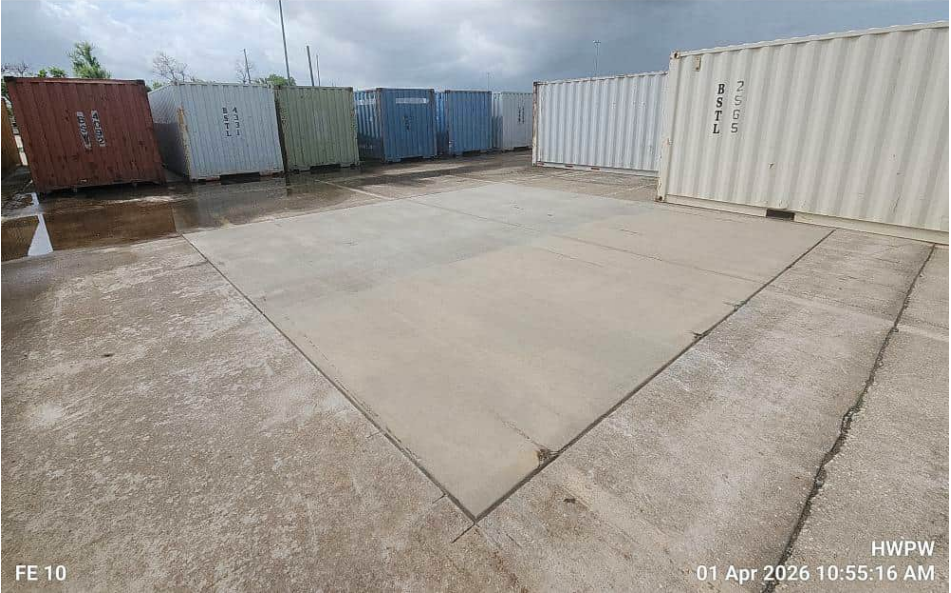
| <b>Description:</b><br>FE-10 weekly inspection of concrete cap. Reconstructed cap in good condition. No NAPL observed at FE location. Standing water from recent rain event. Facing southwest.<br>Lat: 29.78496<br>Long: -95.31771 | | |

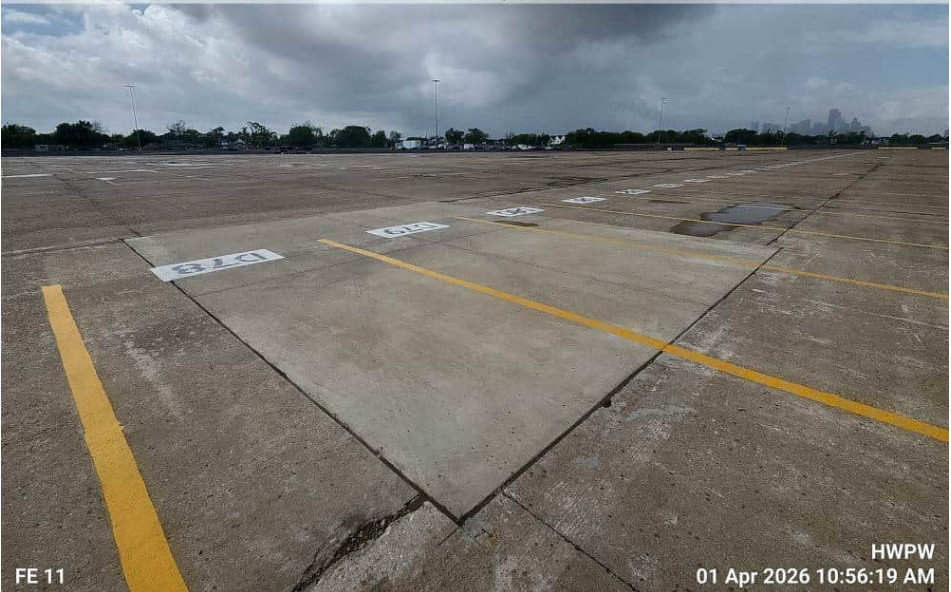
| <b>Description:</b><br>FE-11 weekly inspection of concrete cap. Reconstructed cap in good condition. No NAPL observed at FE location. Standing water from recent rain event. Facing southwest.<br>Lat: 29.7844<br>Long: -95.31958 | | |

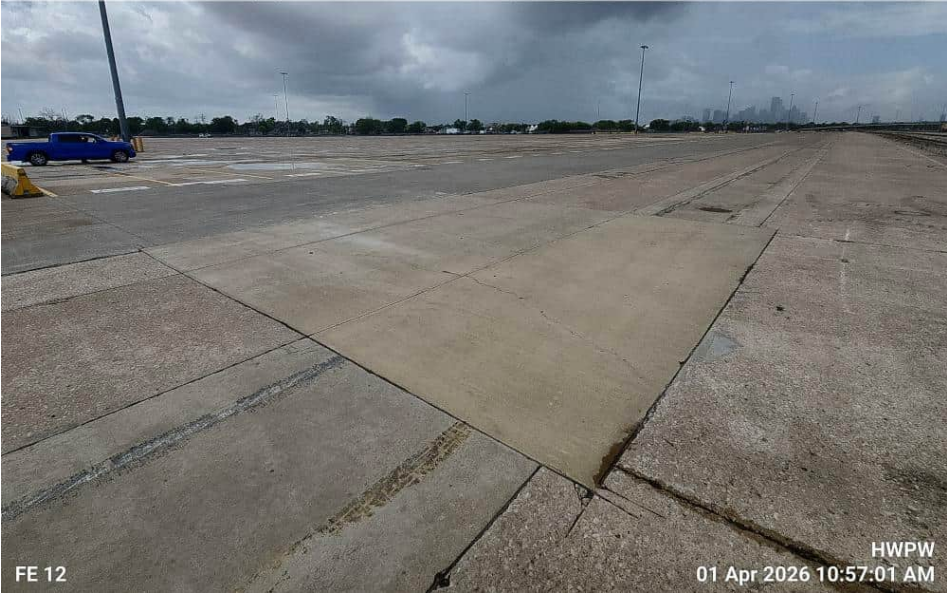
| <b>Description:</b><br>FE-12 weekly inspection of concrete cap.<br>Reconstructed cap in good condition. No NAPL observed at FE location. Standing water from recent rain event. Facing southwest.<br><br>Lat: 29.78557<br>Long: -95.31867 | | |

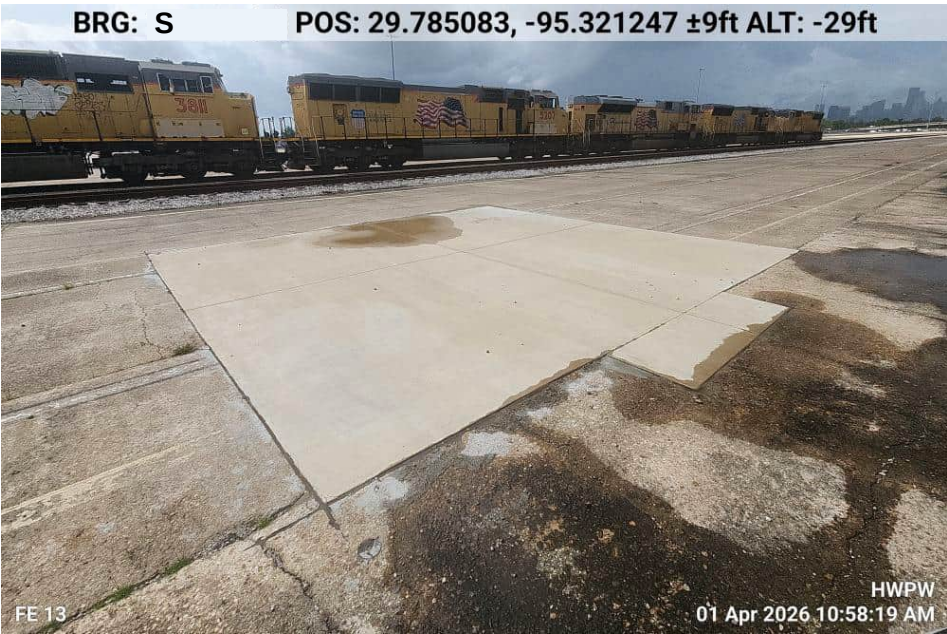
| <b>Description:</b><br>FE-13 weekly inspection of concrete cap.<br>Reconstructed cap in good condition. No NAPL observed at FE location. Standing water from recent rain event. Facing south.<br><br>Lat: 29.78508<br>Long: -95.32125 | | |

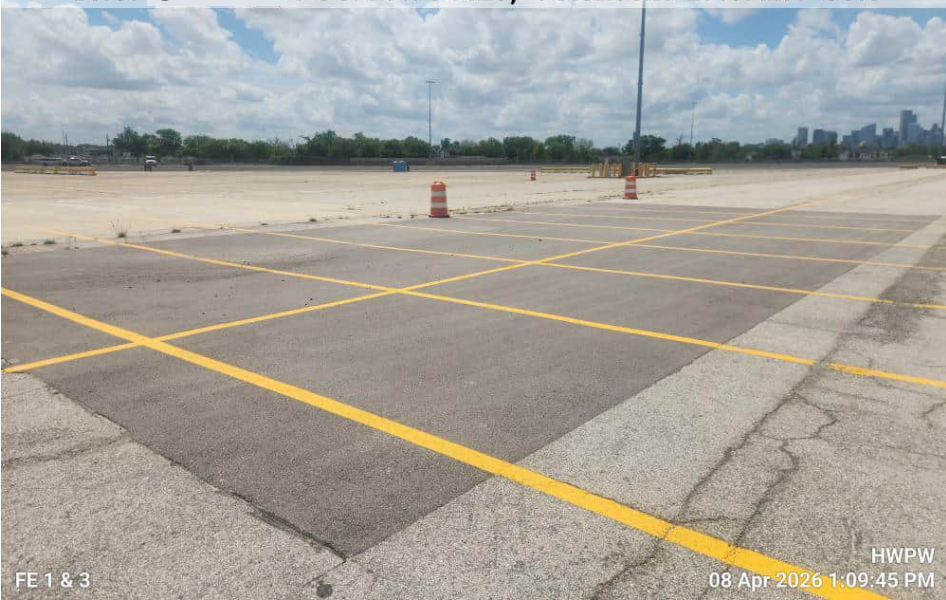
- Minor brown water staining was observed on the pavement north of the reconstructed concrete cap of FE-1&3 on April 8 (Attachment A, Photo Nos. 17 and 18). The brown water staining was not observed at this location during the other April inspections.

| <b>Photo No.</b><br>18 | <b>Inspection Date:</b><br>04/08/2026 | <b>Description:</b><br>FE-1&3 weekly inspection of asphalt cap. View of minor brown water staining observed on pavement to the north of the reconstructed cap. Cap in good condition. No NAPL observed at FE location. Facing west.<br>Lat: 29.7844<br>Long: -95.32099<br><br>WSP 2026 INSPECTION<br>Brown Water Staining FE1&3<br>04.08.2026 12:10 PM<br>29.78440 -95.32099 |

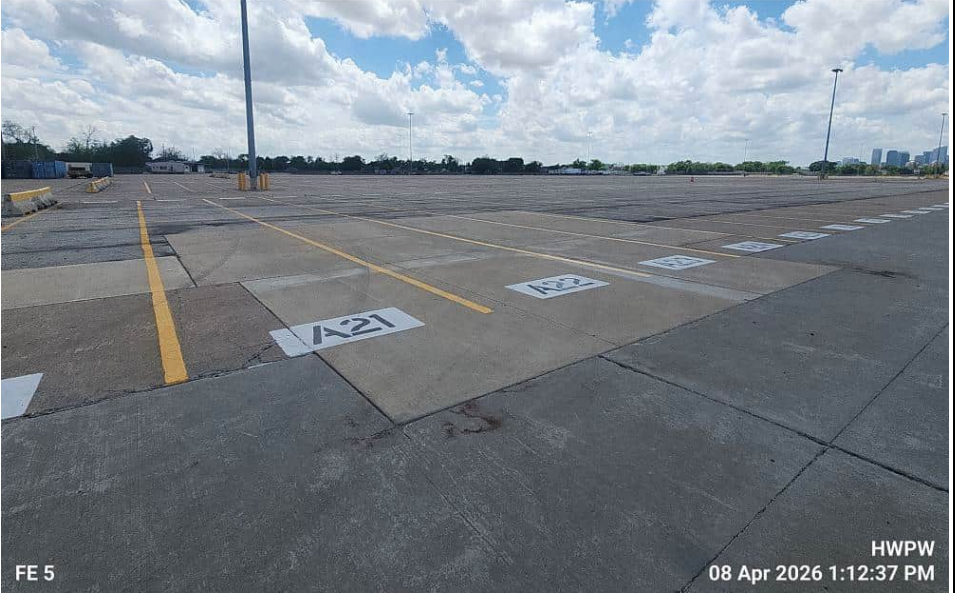
| <b>Description:</b><br>FE-5 weekly inspection of concrete cap. Reconstructed cap in good condition. No NAPL observed at FE location. Brown water staining along the southern joint of FE-5 observed. Facing south.<br><br>Lat: 29.78544<br>Long: -95.31868 | | |

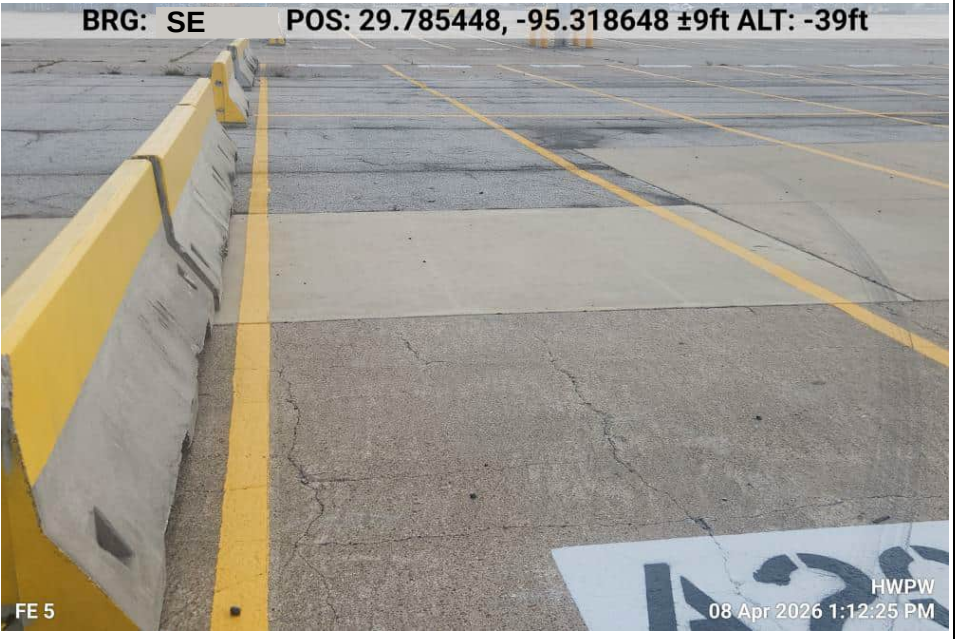
| <b>Description:</b><br>FE-5 weekly inspection of concrete cap. Reconstructed cap in good condition. No NAPL observed at FE location. Brown water staining along the southern joint of FE-5 observed. Facing southeast.<br><br>Lat: 29.78545<br>Long: -95.31865 | | |

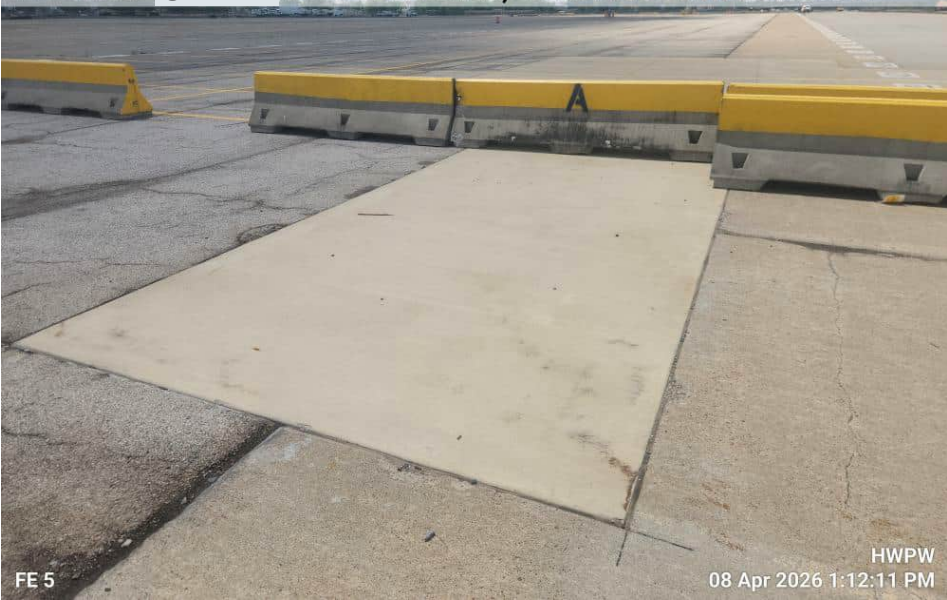
| <b>Description:</b><br>FE-5 weekly inspection of concrete cap. Reconstructed cap in good condition. No NAPL observed at FE location. Brown water staining along the southern joint of FE-5 observed. Facing southwest.<br><br>Lat: 29.78545<br>Long: -95.31854 | | |

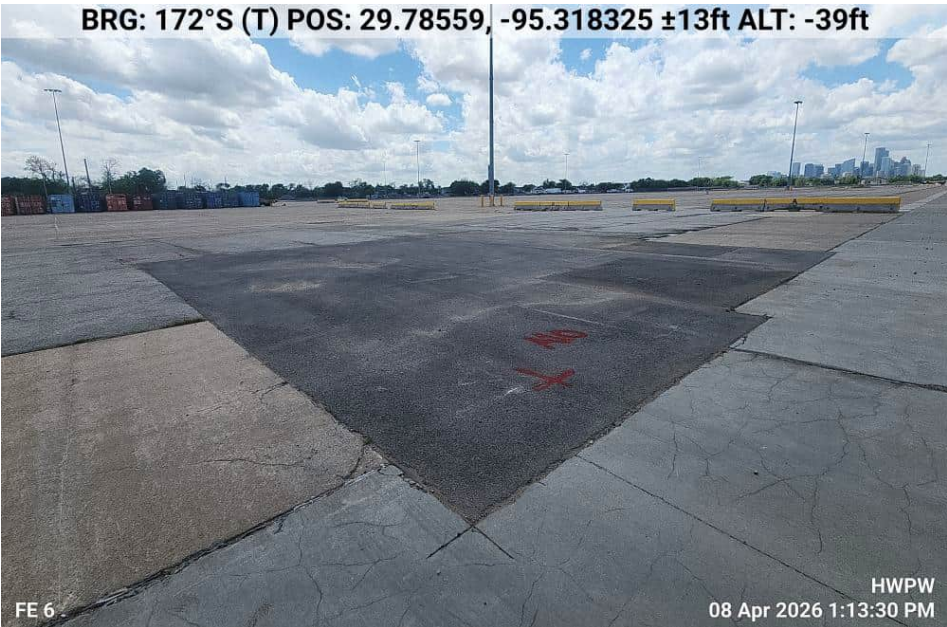
| <b>Description:</b><br>FE-6 weekly inspection of asphalt cap. Reconstructed cap in good condition. No NAPL observed at FE location. Brown standing water was along the joint perpendicular to western edge of FE-6. Facing south.<br><br>Lat: 29.78559<br>Long: -95.31833 | | |

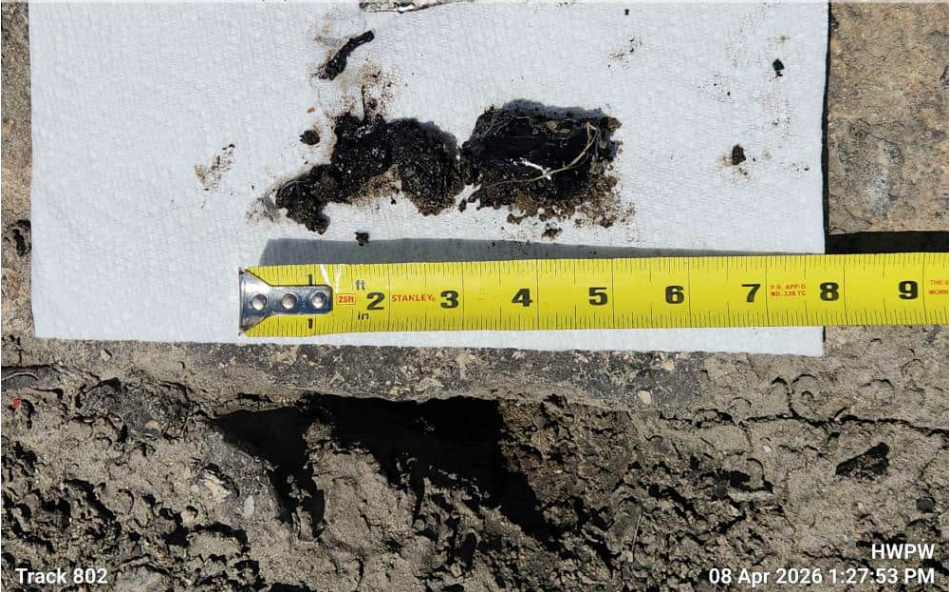
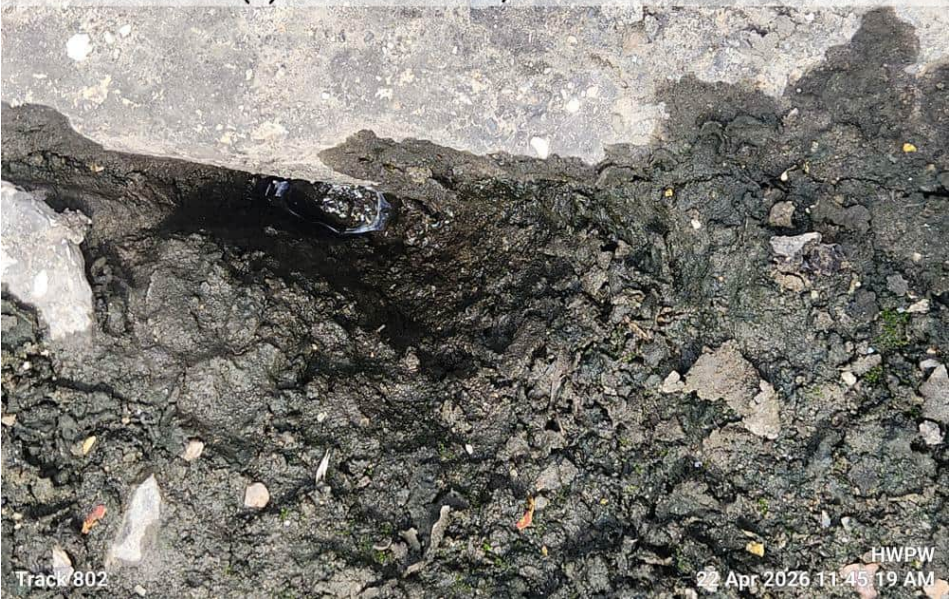
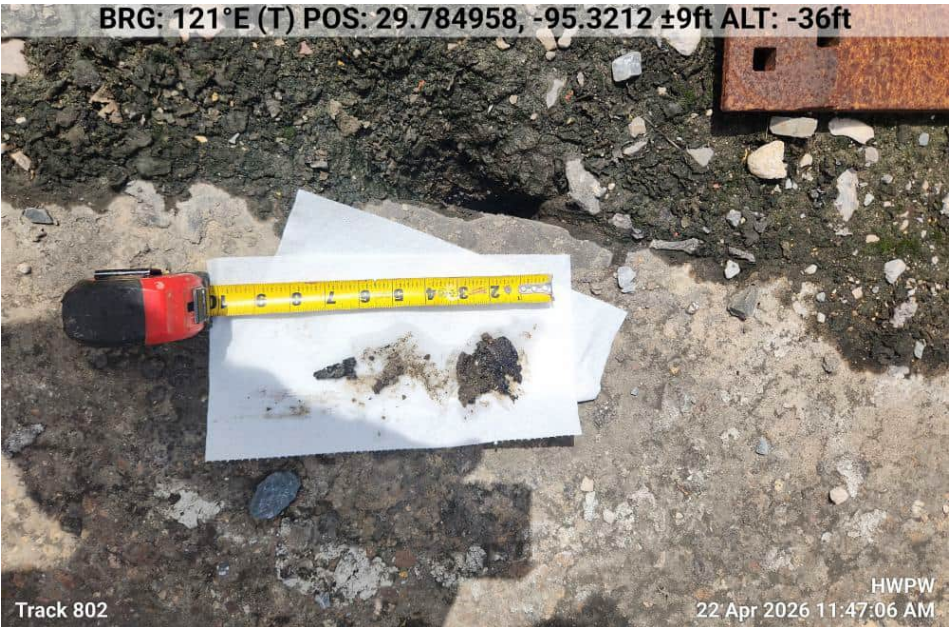
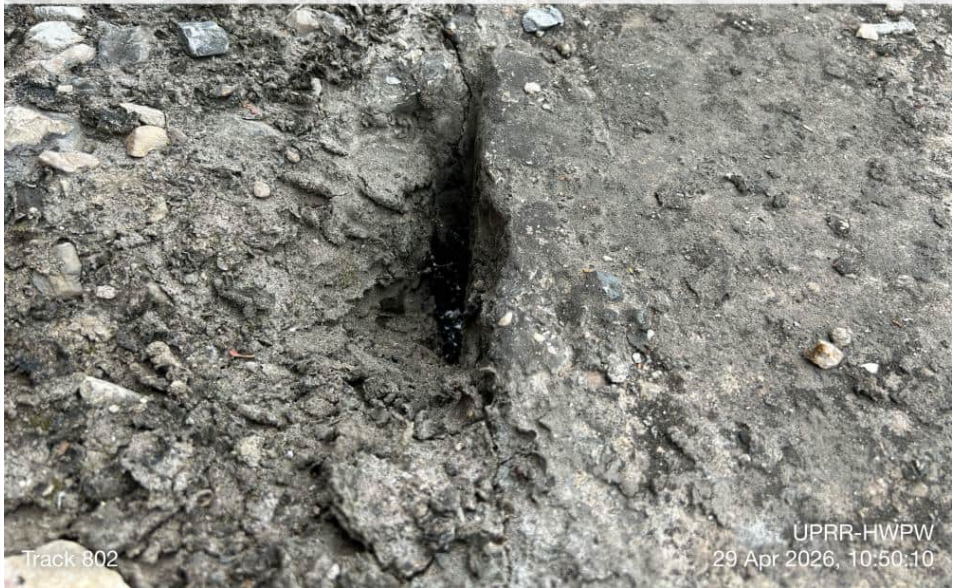
- Tar-like material seeps at the following two locations:
  - A tar-like material seep was observed at Track 802 on April 8, 15, and 22. Approximately 7 cubic inches (approximately 3.9 fluid ounces) of NAPL were recovered. No seep activity was noted at Track 802 during the other April weekly inspections (Photo Nos. 98 through 105).

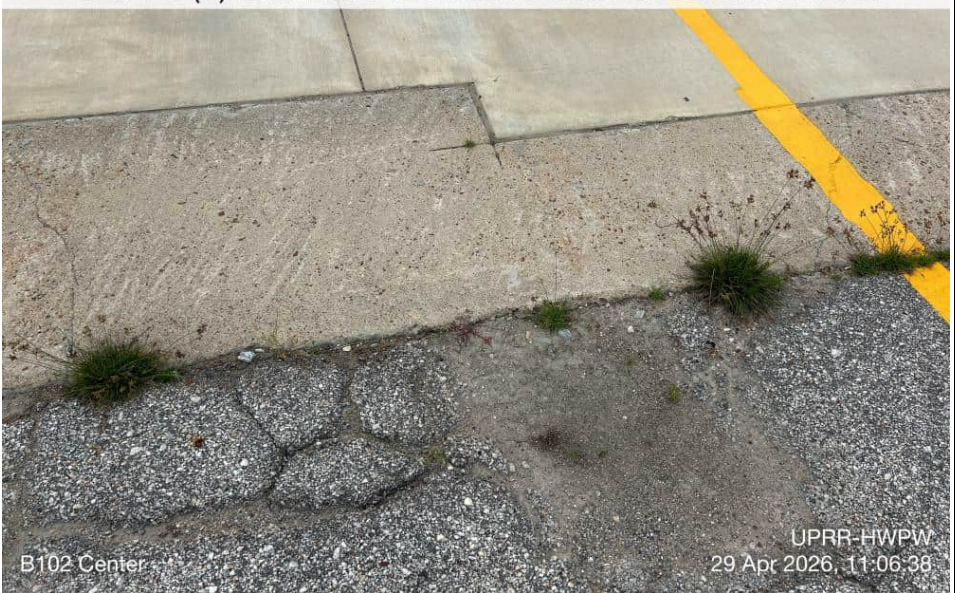
- No active seeps were noted at Stall B102 Center during the April weekly inspections (Photo Nos. 106 through 108).
- Overall, the volume of NAPL recovered from the surface seeps increased from March to April 2026 (approximately 5.3 fluid ounces in March compared to 7.2 fluid ounces in April). Annual increases in NAPL recovery volume are anticipated as ambient temperatures increase. In comparison, prior to implementing the Focused Excavations, approximately 32 fluid ounces (approximately 0.25 gallons) of NAPL were collected from the surface seeps during April 2024.
