June 15, 2026

Project No. US0039040.3990

**Re: MONTHLY STATUS UPDATE – ENGLEWOOD INTERMODAL YARD – REVISED INTERIM MEASURES  
WORK PLAN POST-CONSTRUCTION AND NAPL COLLECTION SYSTEM/CONCRETE CAP REPAIR  
INSPECTIONS  
UNION PACIFIC RAILROAD HOUSTON WOOD PRESERVING WORKS FACILITY  
4910 LIBERTY ROAD FACILITY, HOUSTON, TEXAS  
POST-CLOSURE CARE PERMIT NO. HW-50343; INDUSTRIAL SWR NO. 31547**

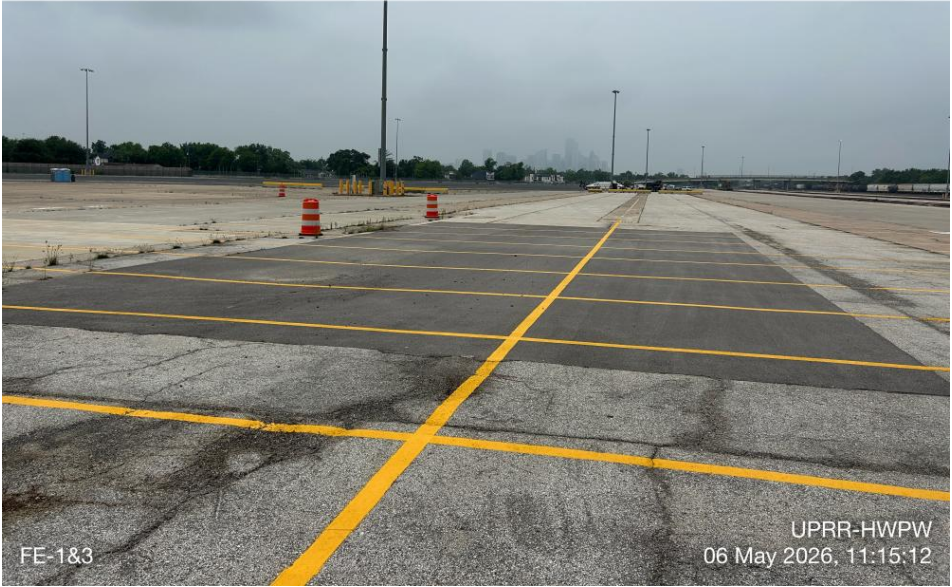
- Minor brown water staining was observed on the pavement north of the reconstructed concrete cap of FE-1&3 on May 6 (Attachment A, Photo No. 1). The brown water staining was not observed at this location during the other May inspections.

| <b>Description:</b><br>FE-1&3 weekly inspection of asphalt cap. Reconstructed cap in good condition. No NAPL observed at FE location. Minor brown water staining observed on pavement north of the reconstructed cap. Facing southwest.<br><br>Lat: 29.78439<br>Long: -95.32074 | | | |

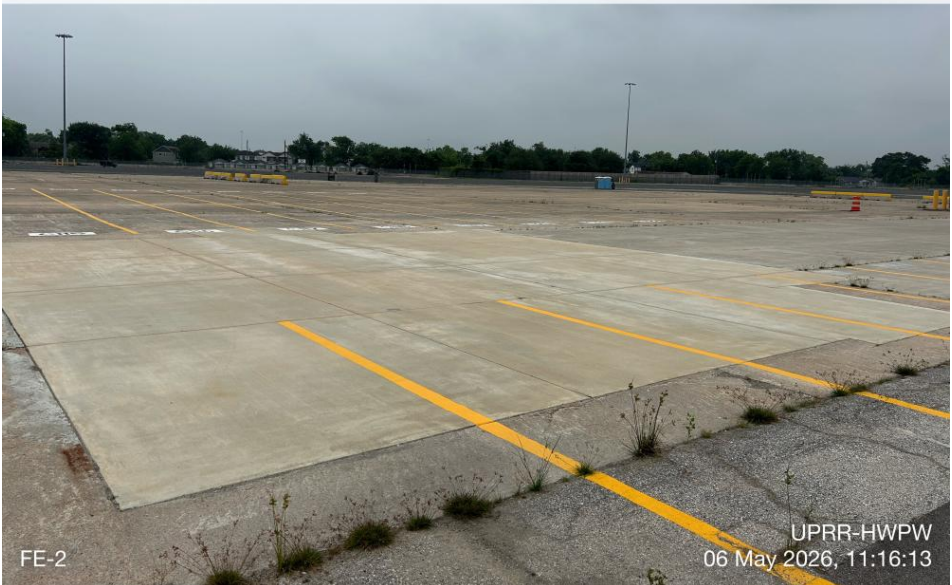
| <b>Description:</b><br>FE-2 weekly inspection of concrete cap. Reconstructed cap in good condition. No NAPL observed at FE location. Facing south.<br><br>Lat: 29.7843<br>Long: -95.3208 | | | |

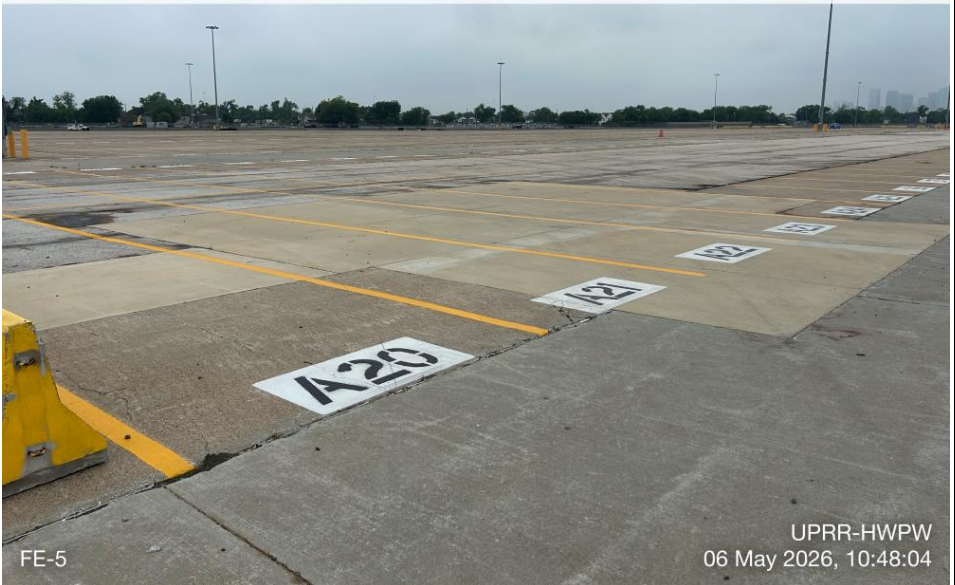
- Brown water staining was observed along the southern joint of the reconstructed concrete cap of FE-5 on May 6 (Photo No. 4), May 13 (Photo No. 17), May 20 (Photo Nos. 30 through 32), and May 27 (Photo No. 47). Brown water staining was observed at the southeastern corner of the reconstructed concrete cap of FE-5 on May 20 (Photo No. 33).

| <b>Description:</b><br>FE-4 weekly inspection of asphalt cap.<br>Reconstructed cap in good condition. No NAPL observed at FE location. Facing southwest.<br><br>Lat: 29.78492<br>Long: -95.31951 | | <b>Description:</b><br>FE-5 weekly inspection of concrete cap.<br>Reconstructed cap in good condition. No NAPL observed at FE location. Brown water staining along the southern joint of FE-5 observed. Facing southwest.<br><br>Lat: 29.78547<br>Long: -95.3186 | |

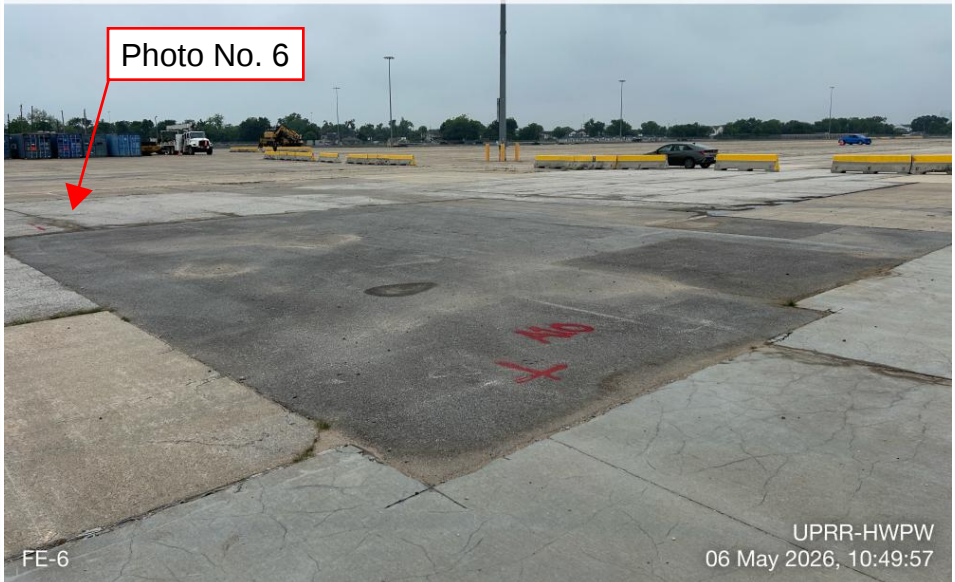
- Brown water staining and a small amount of standing water were observed along the western joint perpendicular to the reconstructed asphalt cap of FE-6 on May 6 (Photo No. 5), May 13 (Photo No. 18), May 20 (Photo Nos. 34 and 35), and May 27 (Photo Nos. 48 and 49). Brown water staining was observed along the southern joint of the reconstructed asphalt cap of FE-6 on May 6 (Photo No. 6), May 13 (Photo No. 19), May 20 (Photo No. 36), and May 27 (Photo No. 50).

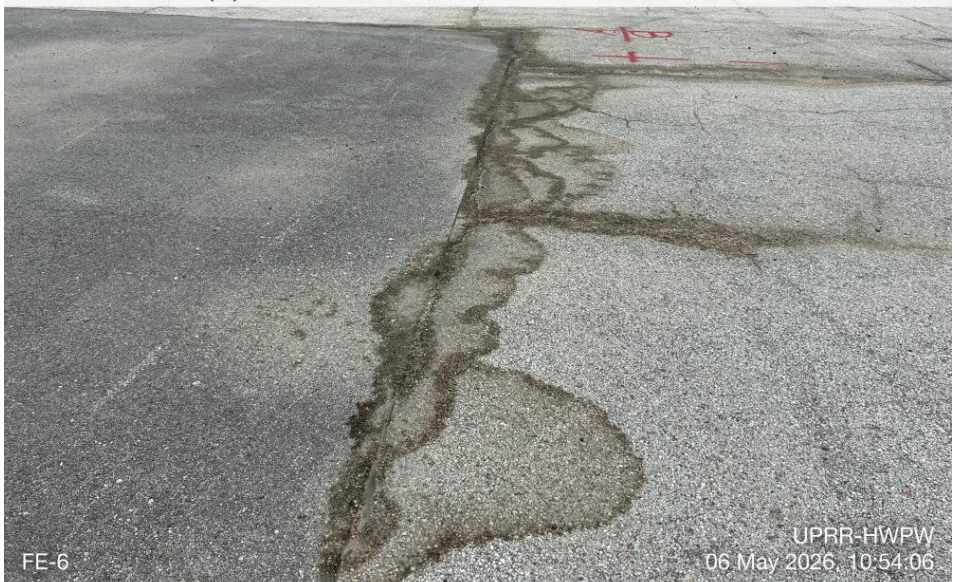
| <b>Description:</b><br>FE-6 weekly inspection of asphalt cap. Reconstructed cap in good condition. No NAPL observed at FE location. Brown water staining and a small amount of standing water were observed along the western joint perpendicular to the reconstructed asphalt cap of FE-6. Brown water staining was observed along the southern joint of the reconstructed asphalt cap of FE-6. Facing southwest.<br><br>Lat: 29.78558<br>Long: -95.31831 | | <b>Description:</b><br>FE-6 weekly inspection of asphalt cap. Reconstructed cap in good condition. No NAPL observed at FE location. Brown water staining was observed along the southern joint of the reconstructed asphalt cap of FE-6, located with the red arrow is Photo No. 5. Facing northeast.<br><br>Lat: 29.78542<br>Long: -95.31833 | | | |

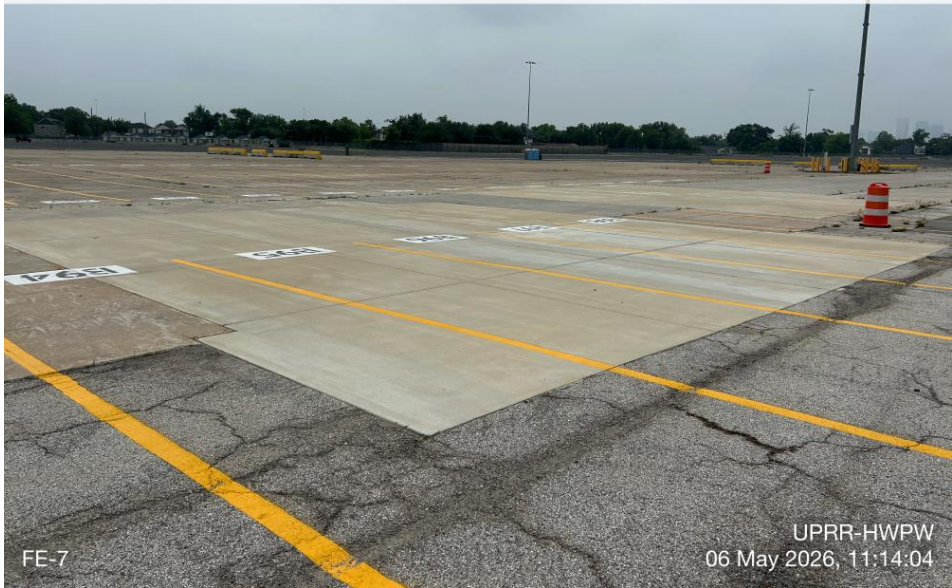
| <b>Description:</b><br>FE-7 weekly inspection of concrete cap.<br>Reconstructed cap in good condition. No NAPL observed at FE location. Facing south.<br><br>Lat: 29.78441<br>Long: -95.32063 | | | | | |

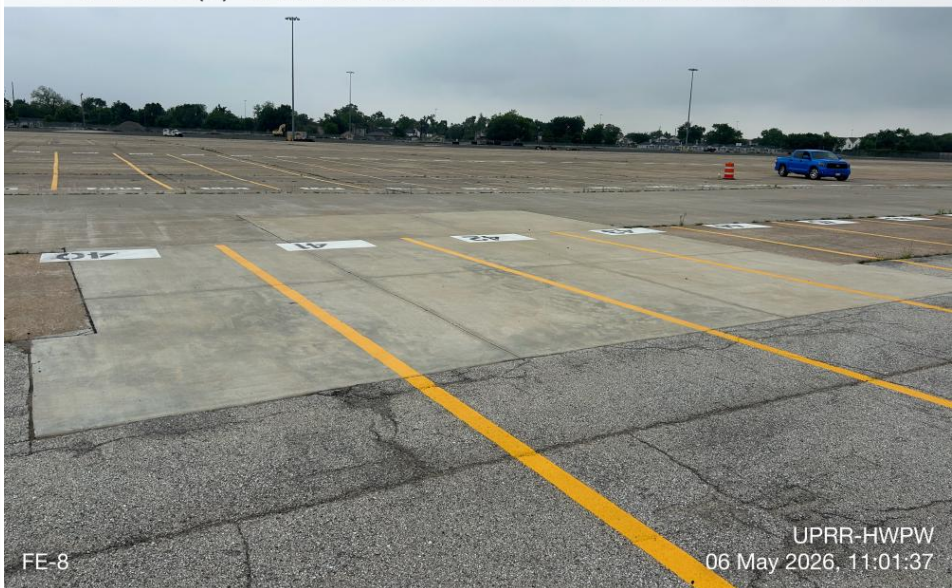
| <b>Description:</b><br>FE-8 weekly inspection of concrete cap.<br>Reconstructed cap in good condition. No NAPL observed at FE location. Facing south.<br><br>Lat: 29.78505<br>Long: -95.31911 | | | | | |

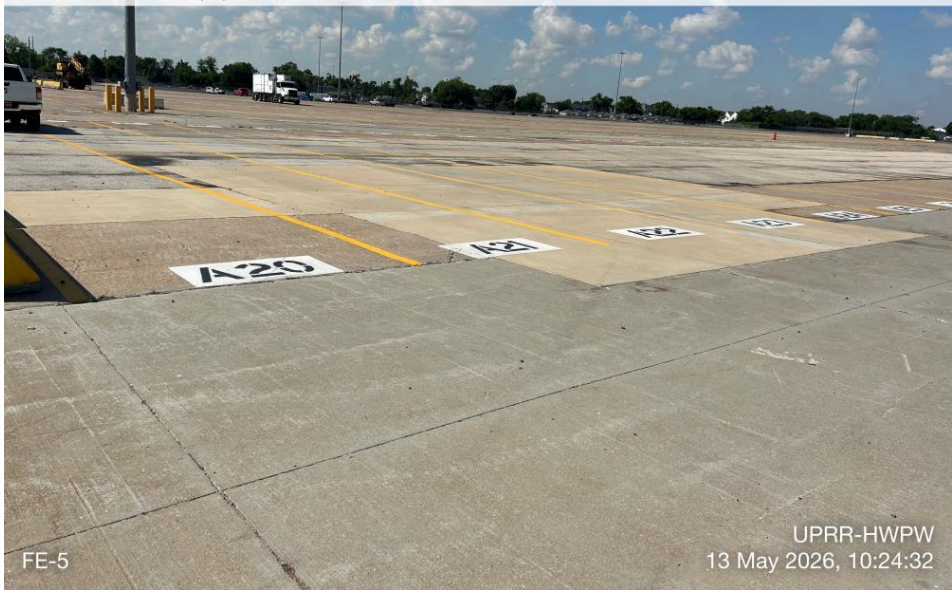
| <b>Description:</b><br>FE-5 weekly inspection of concrete cap. Reconstructed cap in good condition. No NAPL observed at FE location. Brown water staining along the southern joint of FE-5 observed. Facing south.<br><br>Lat: 29.78548<br>Long: -95.31865 | | | |

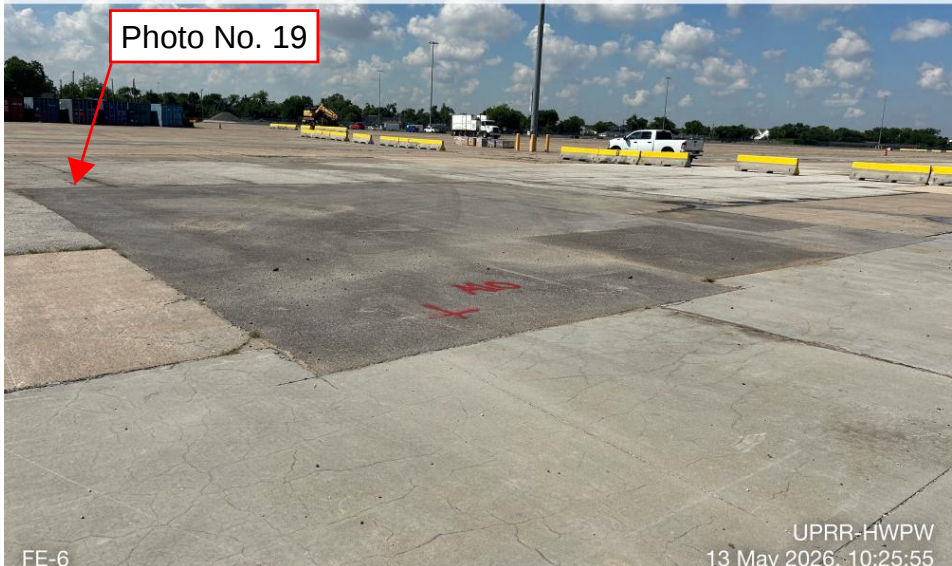
| <b>Description:</b><br>FE-6 weekly inspection of asphalt cap. Reconstructed cap in good condition. No NAPL observed at FE location. Brown water staining and a small amount of standing water were observed along the western joint perpendicular to the reconstructed asphalt cap of FE-6. Brown water staining was observed along the southern joint of the reconstructed asphalt cap of FE-6. Facing south.<br><br>Lat: 29.78559<br>Long: -95.31832 | | | |

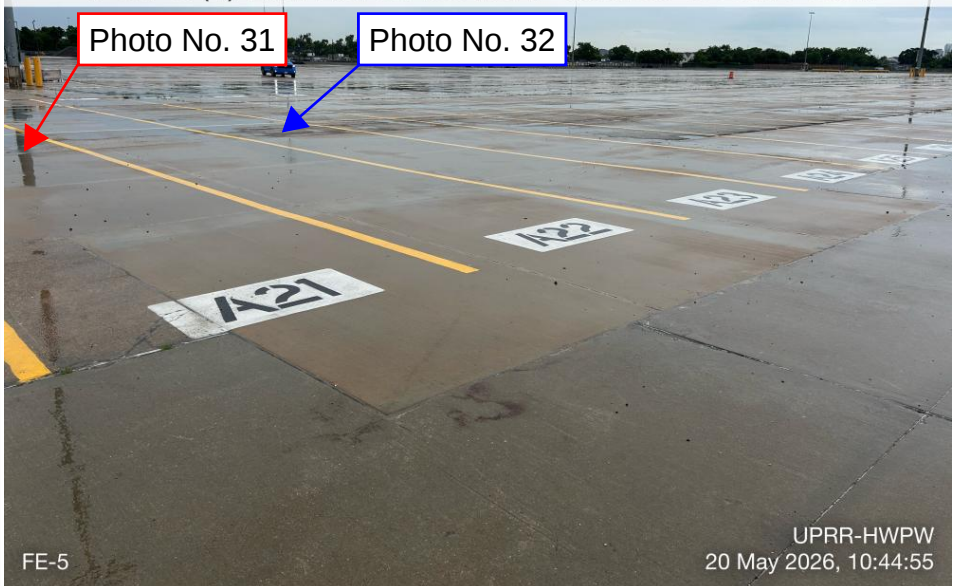
| <b>Description:</b><br>FE-5 weekly inspection of concrete cap. Reconstructed cap in good condition. No NAPL observed at FE location. Brown water staining along the southern joint and at the southeastern corner of FE-5 observed. Standing water from recent rain event. Facing south.<br><br>Lat: 29.78544<br>Long: -95.31865 | | | | | |

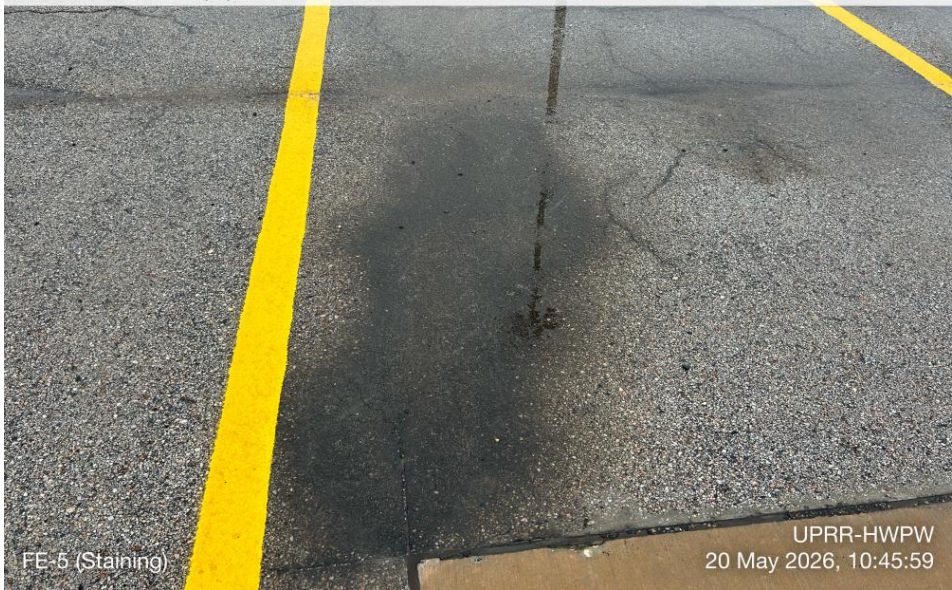
| <b>Description:</b><br>FE-5 weekly inspection of concrete cap. Reconstructed cap in good condition. No NAPL observed at FE location. Brown water staining along the southern joint of FE-5 observed, located with the red arrow is Photo No. 31. Standing water from recent rain event. Facing south.<br><br>Lat: 29.78532<br>Long: -95.3186 | | | | | |

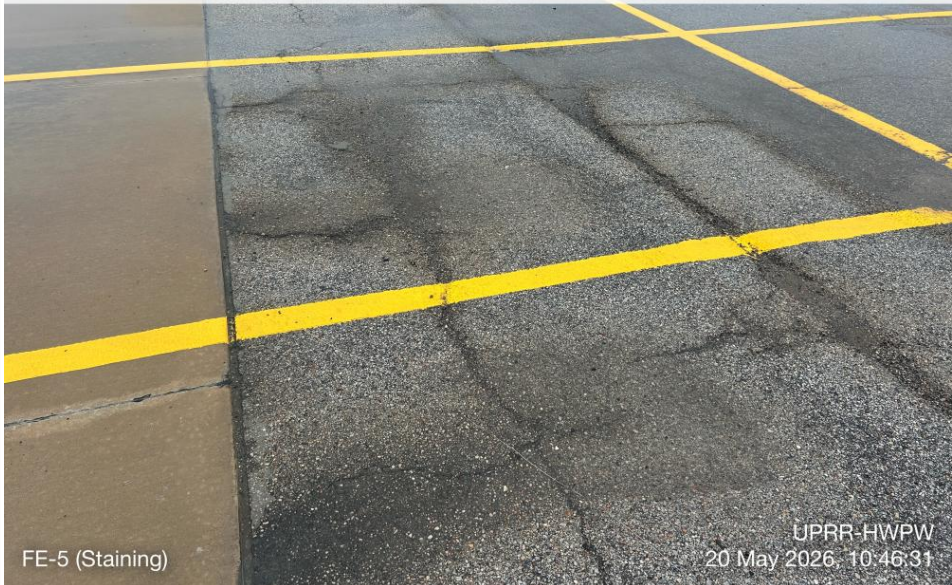
| <b>Description:</b><br>FE-5 weekly inspection of concrete cap. Reconstructed cap in good condition. No NAPL observed at FE location. Brown water staining along the southern joint of FE-5 observed, located with the blue arrow is Photo No. 32. Standing water from recent rain event. Facing east.<br><br>Lat: 29.78528<br>Long: -95.31868 | | | | | |

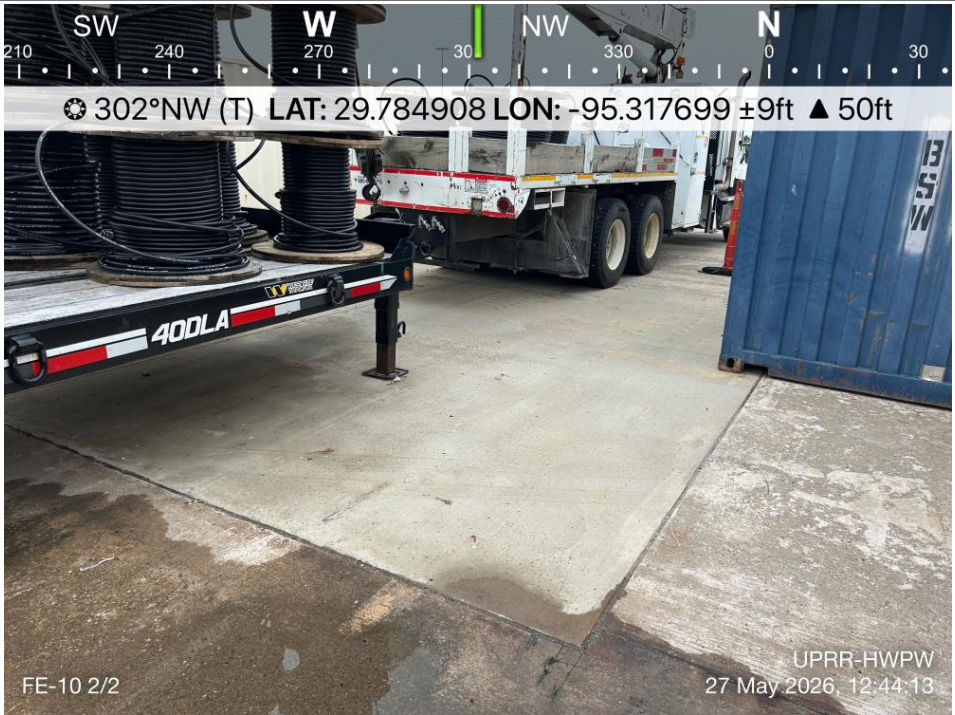
| <b>Description:</b><br>FE-10 weekly inspection of concrete cap. Reconstructed cap in good condition. No NAPL observed at FE location. Standing water from recent rain event. Facing northwest.<br><br>Lat: 29.78491<br>Long: -95.3177 | | | | | |

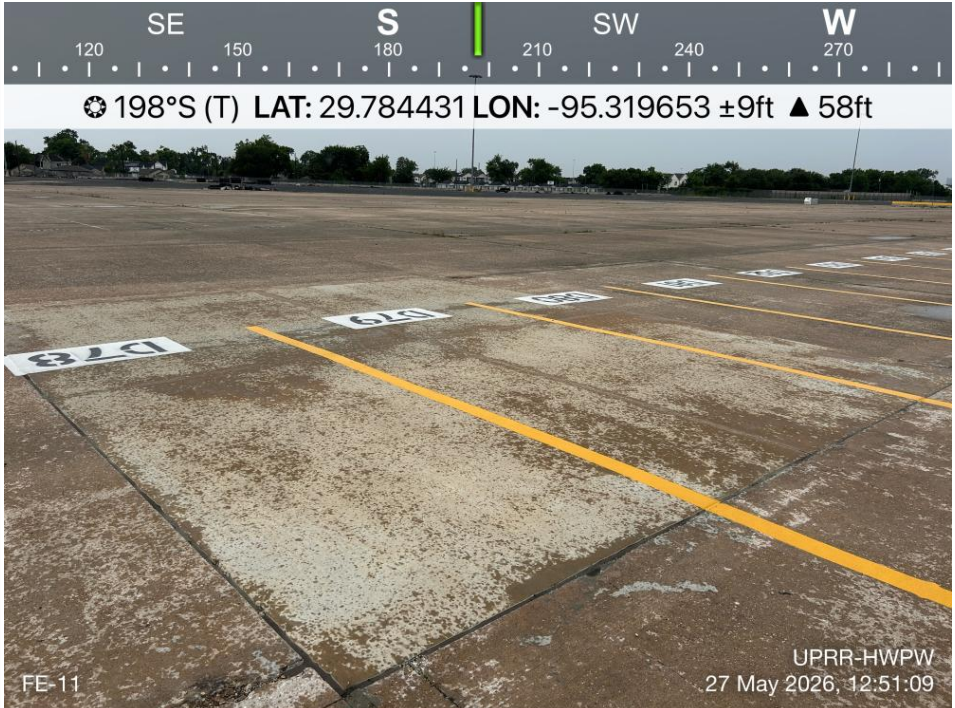
| <b>Description:</b><br>FE-11 weekly inspection of concrete cap. Reconstructed cap in good condition. No NAPL observed at FE location. Standing water from recent rain event. Facing south.<br><br>Lat: 29.78443<br>Long: -95.31965 | | | | | |

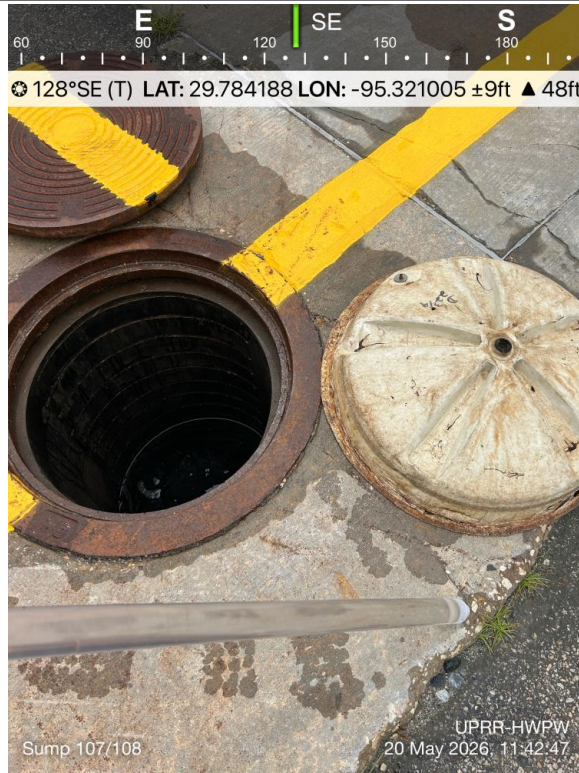
| <b>Description:</b><br>Sump 3 (B107/B108), 29.6 inches of freeboard in sump. Color is clear, and no sheen or odor was reported.<br><br>Lat: 29.78419<br>Long: -95.32101 | | <p>Sump 107/108</p> <p>UPRR-HWPW<br/>20 May 2026, 11:42:47</p> | |

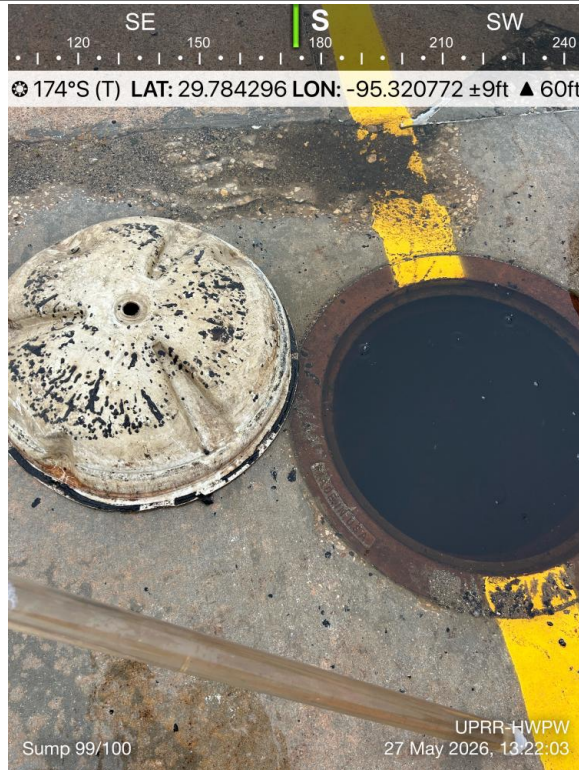
| <b>Description:</b><br>Sump 1 (B99/B100), freeboard could not be measured due to ponding. Standing water from recent and on-going rain event. Color is light brown, and a sheen was observed. No odor was reported.<br><br>Lat: 29.7843<br>Long: -95.32077 | | <p>Sump 99/100</p> <p>UPRR-HWPW<br/>27 May 2026, 13:22:03</p> | |

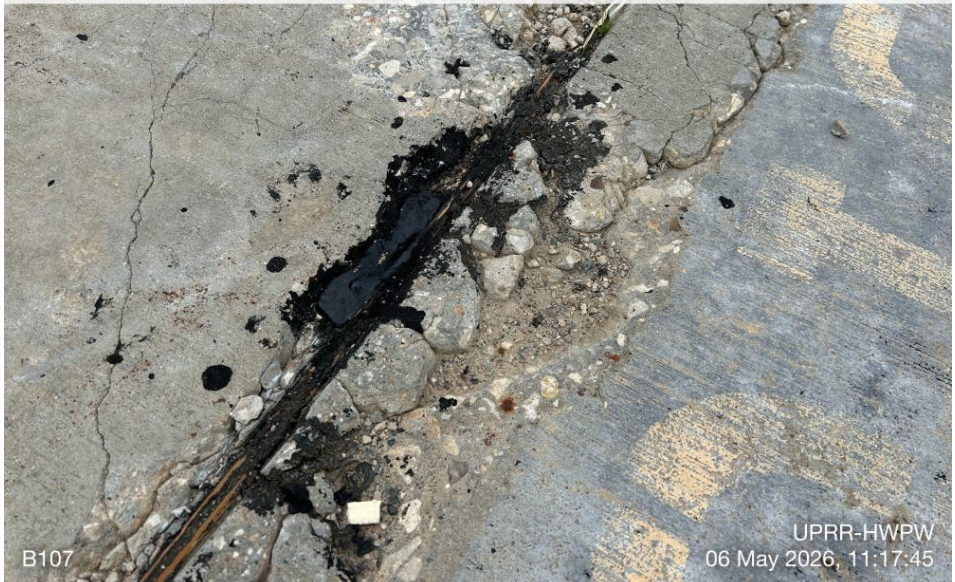
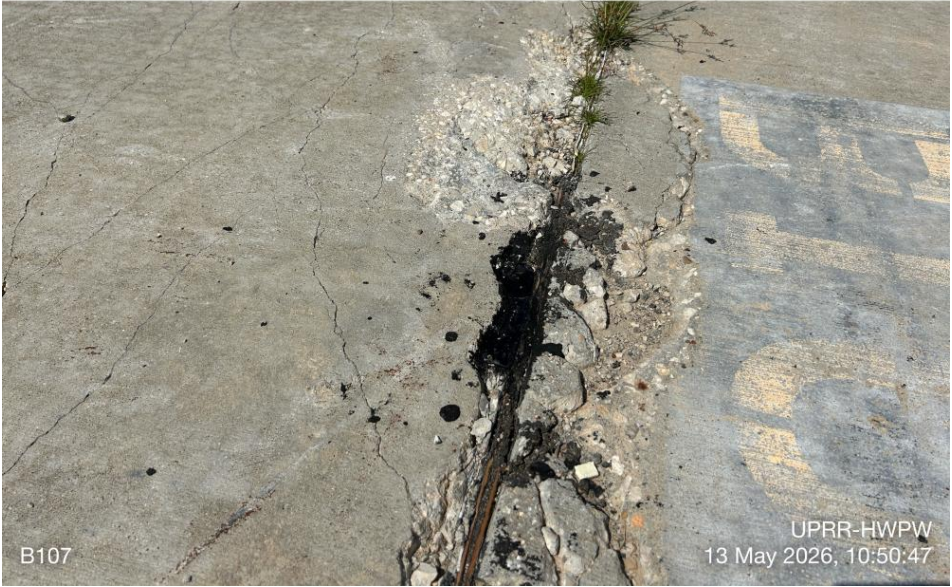
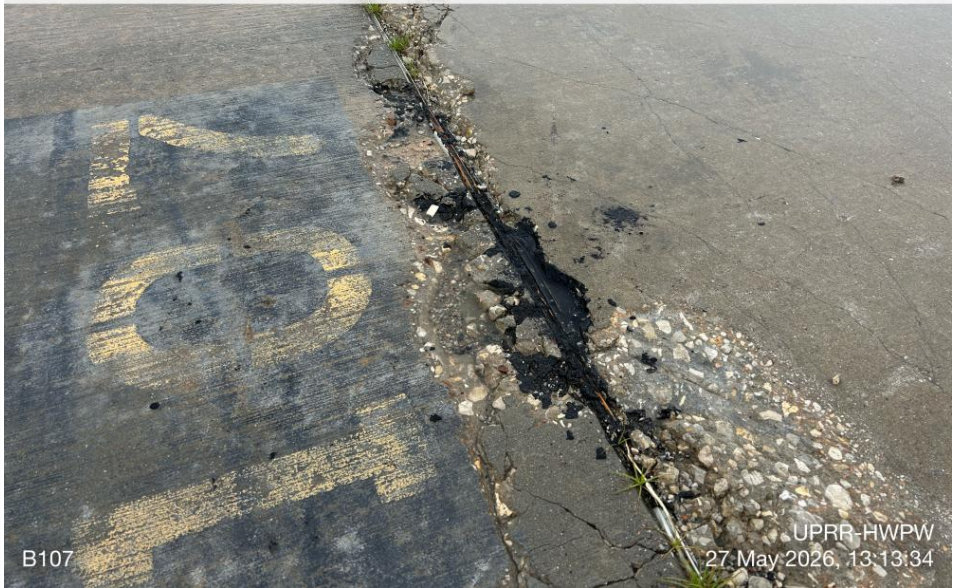
- A tar-like material seep was observed at a concrete joint at Stall B107 on May 6, 13, and 20 immediately adjacent to the NAPL Collection System. Approximately 9.2 cubic inches (approximately 5.1 fluid ounces) of NAPL were recovered. No NAPL seeps were observed along the concrete joints near the NAPL Collection System during the May 27 inspection (Photo Nos. 71 through 77).

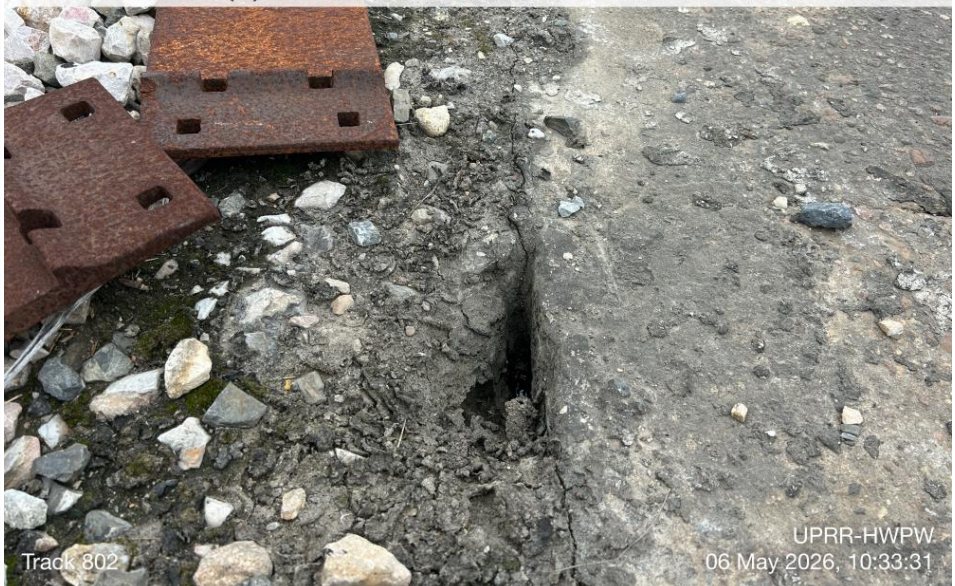
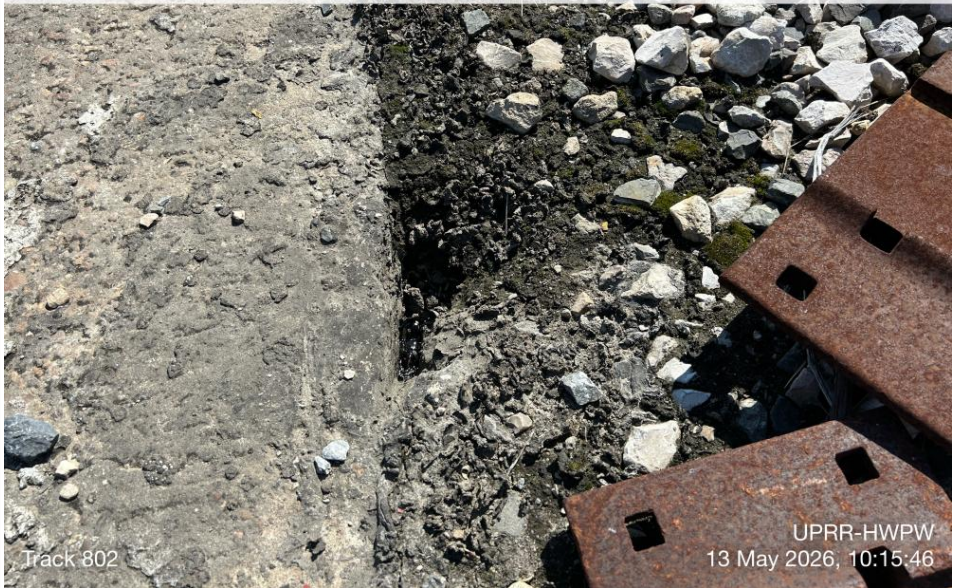
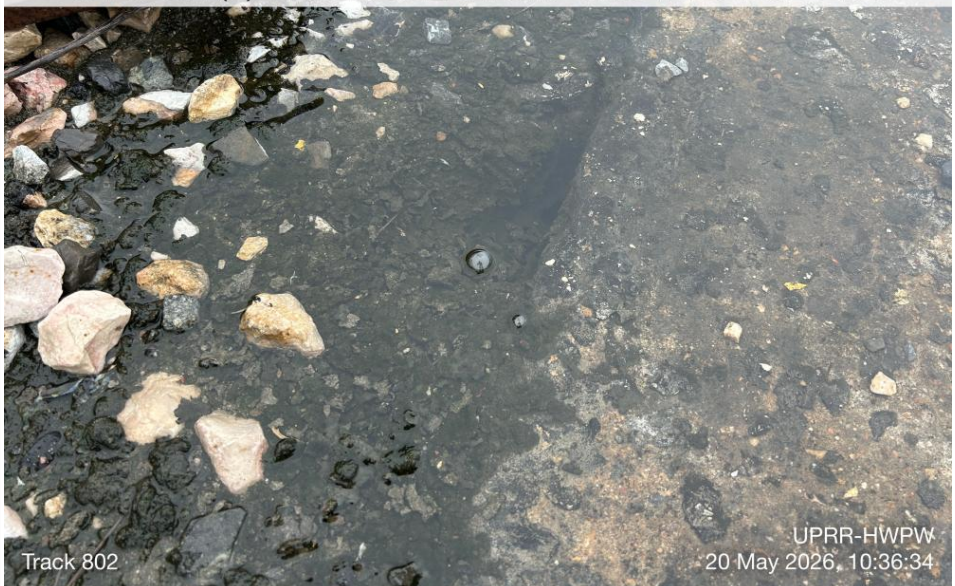
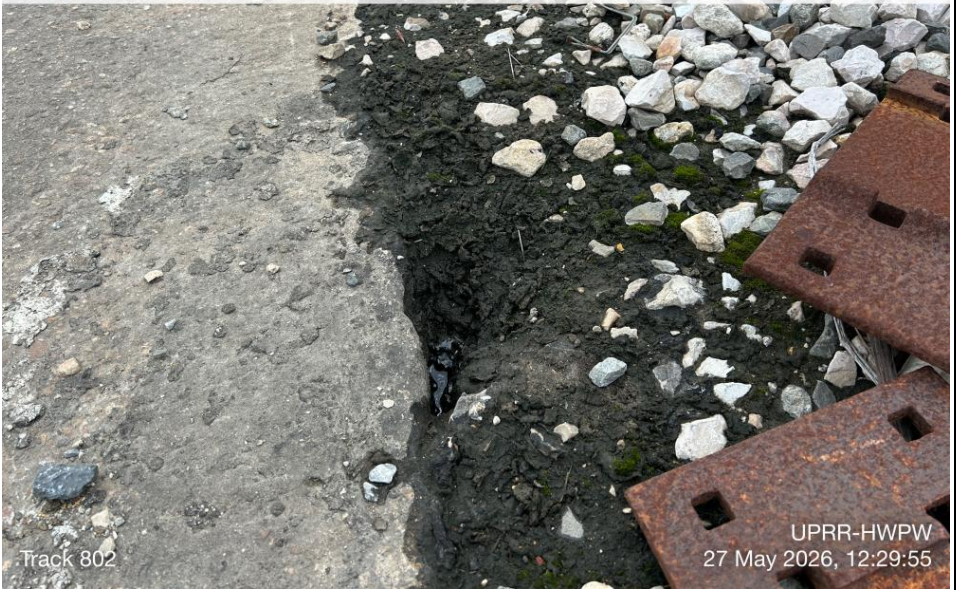
- No active seeps were noted at Track 802 during the May weekly inspections (Photo Nos. 78 through 81).
- No active seeps were noted at Stall B102 Center during the May weekly inspections (Photo Nos. 82 through 85).
- Overall, the volume of NAPL recovered from the surface seeps decreased from April to May 2026 (approximately 7.2 fluid ounces in April compared to 5.1 fluid ounces in May). In comparison, prior to implementing the Focused Excavations, approximately 24 fluid ounces (approximately 0.19 gallons) of NAPL were collected from the surface seeps during May 2023.

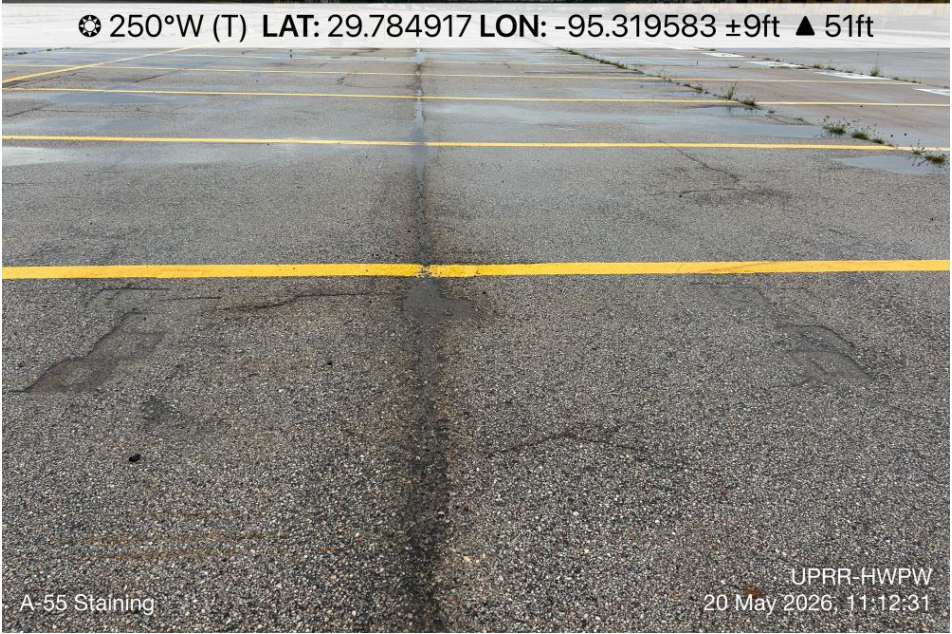
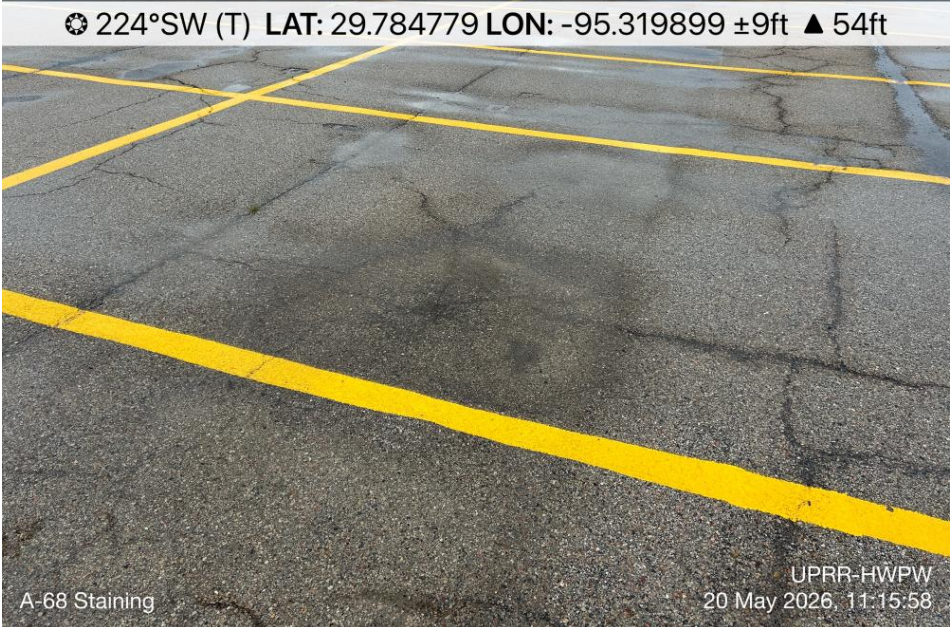
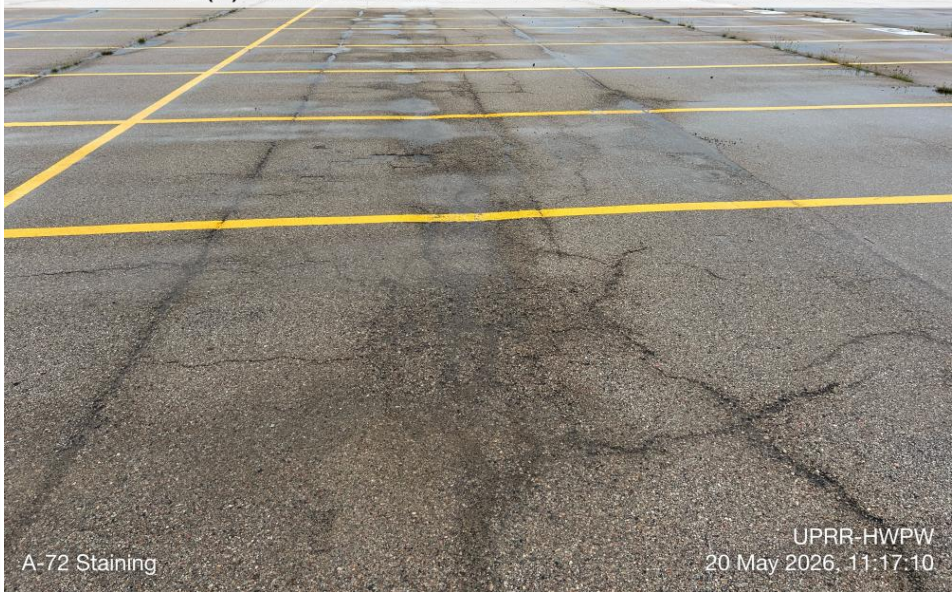
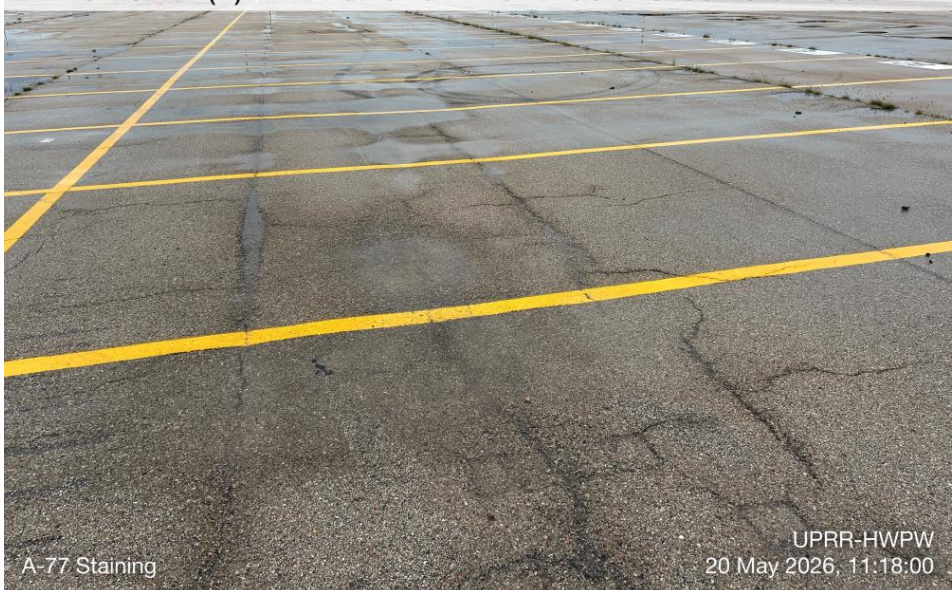
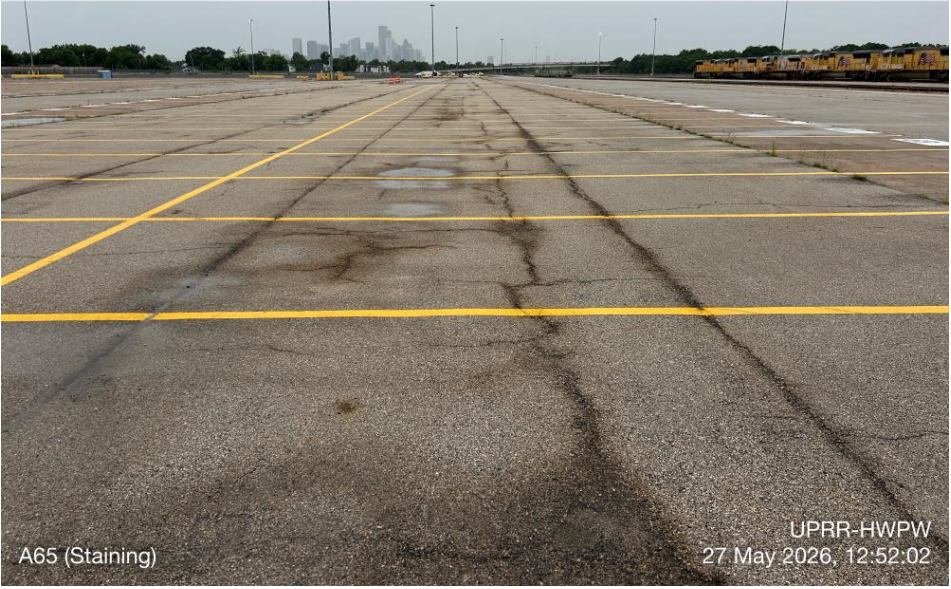
- The previously observed seeps at stalls B100/B101/B105 (FE-1&3), B102 (joint) (FE-2), B056/B057 (FE-4), A021/A022 (FE-5), A010/A011 (FE-6), B096 (FE-7), B042 (FE-8), B016 (FE-9), and RD-14 (FE-13) have been addressed through the Focused Excavation activities.
- During the May 2026 inspections, no NAPL seeps were observed at the remaining test pit locations that were not excavated as part of the Focused Excavations (Stalls A098 (TP-02), B013 (TP (B013)), B057 (TP-04), and B108 (TP (B108) and TP-01).
- Minor brown water staining was observed within the EIY in May along the asphalt joint between stall A050 and A080 on May 13 (Photo No. 86), between stall A055 and A077 on May 20 (Photo Nos. 87 through 90), and near stall A065 on May 27 (Photo No. 91).
