BUILDING AMERICA®

Re: Houston Wood Preserving Works Site

APPENDIX
VSI PHOTOGRAPHS

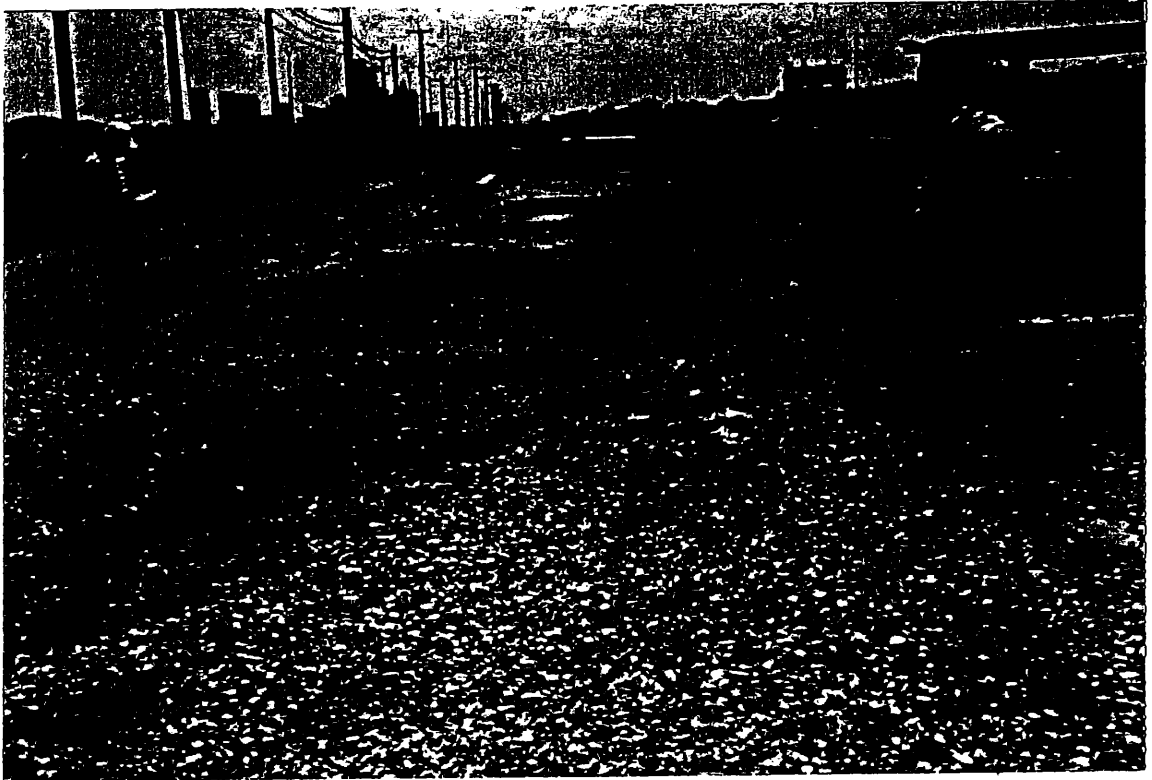
PHOTOGRAPH NO. 5

Date: 08/23/93 Picture Taken by: K. Matherne Direction Facing: Southwest
Picture Description: Location of Former UST no. 44-023-05 (SWMU No. 9), which is within the
original process area (SWMU No. 5)

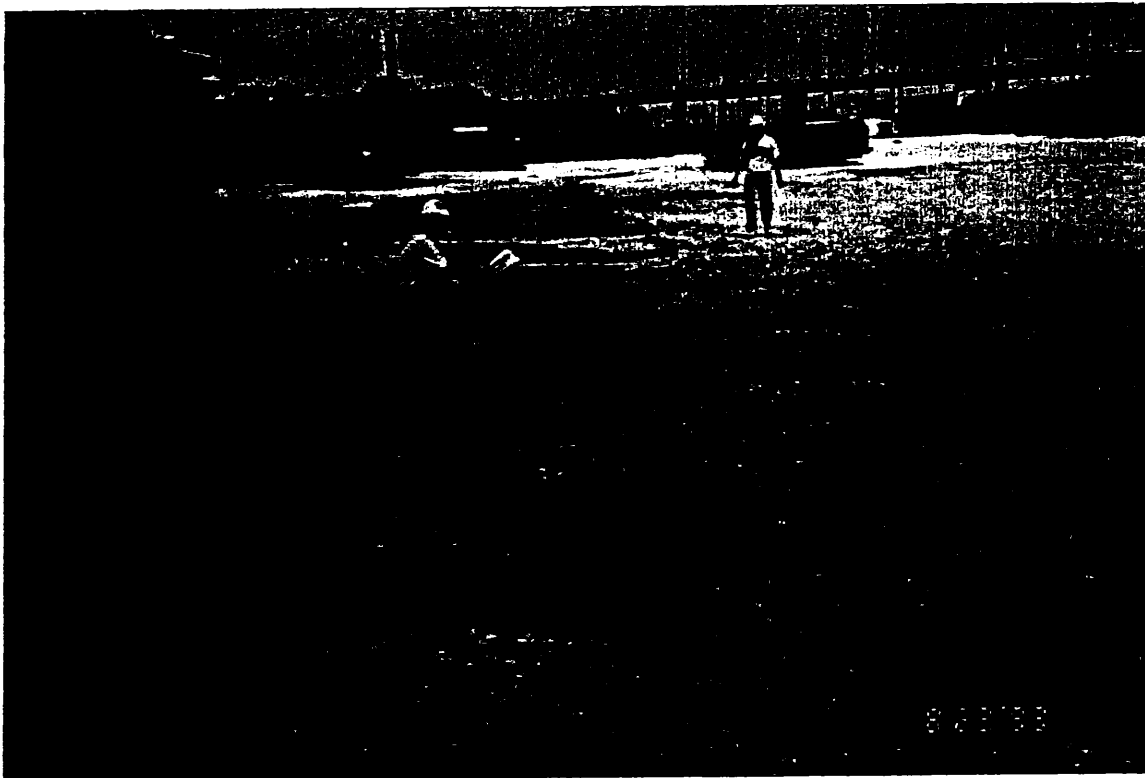
Date: 08/23/93 Picture Taken by: K. Matherne Direction Facing: East
Picture Description: Concrete pad, believed to have been the location of the boiler (SWMU No. 6);
the area is now used for material storage.

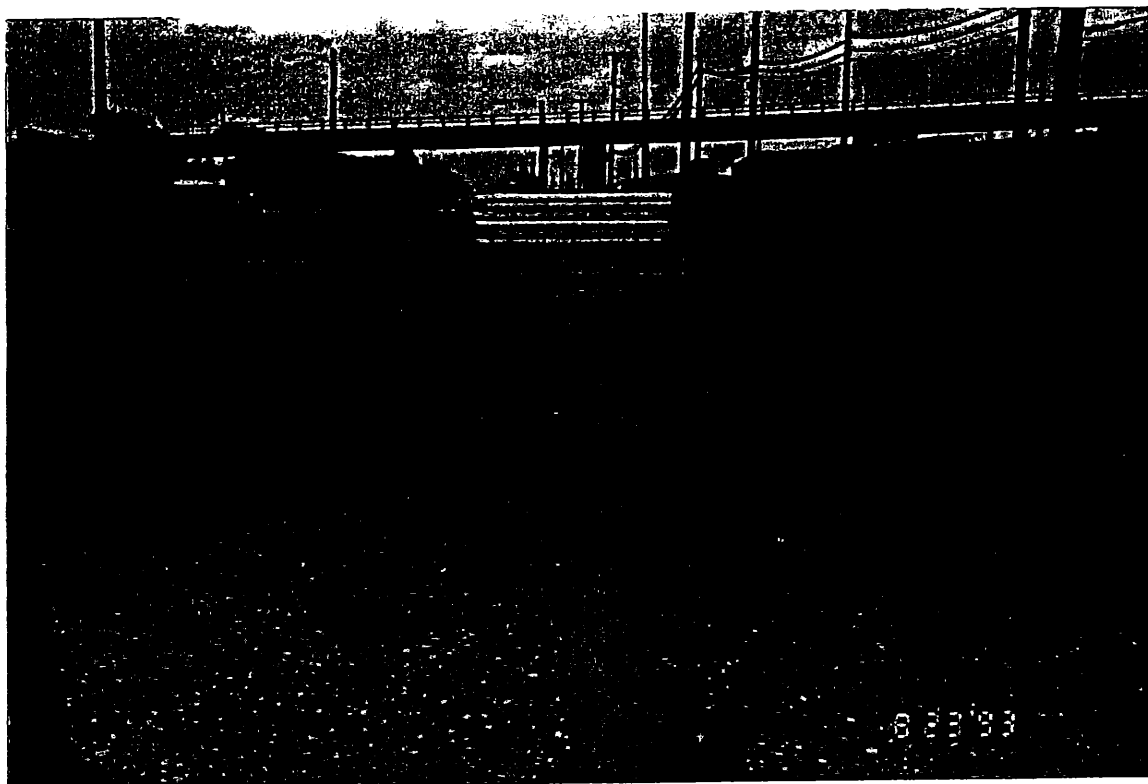
PHOTOGRAPH NO. 9

Date: 08/23/93 Picture Taken by: K. Matherne Direction Facing: East
Picture Description: Former aboveground storage tank (AST) area (SWMU No. 8); the base of a
former AST is visible in the bottom center of the photograph.

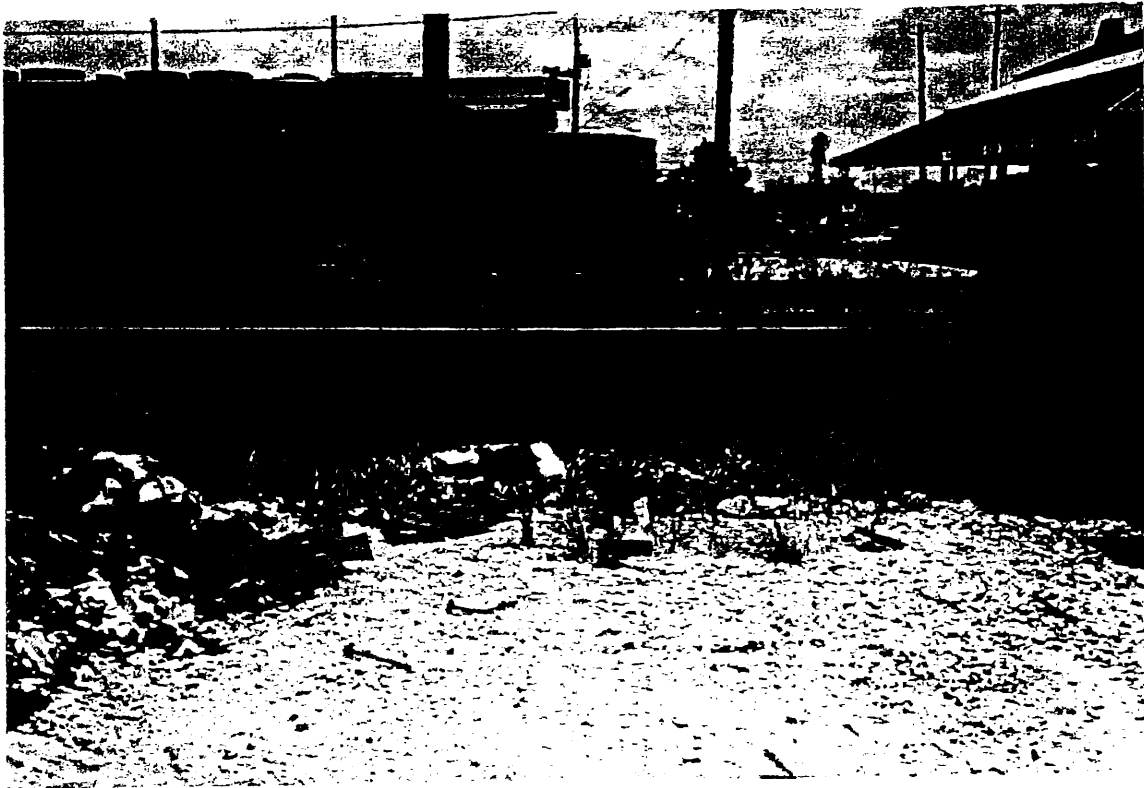
PHOTOGRAPH NO. 10

Date: 08/23/93 Picture Taken by: K. Matherne Direction Facing: Southeast
Picture Description: A portion of the retaining wall that originally surrounded the entire AST
(SWMU No. 8); wall is now limited to the southeast side of the SWMU.

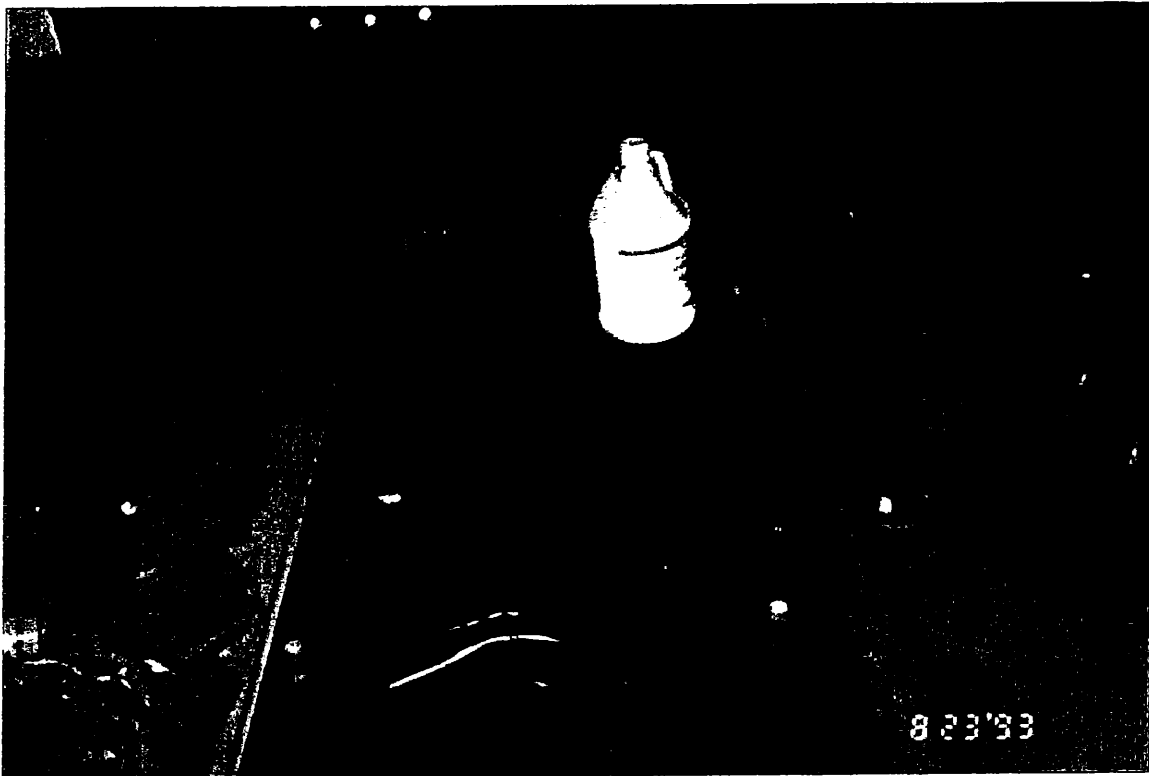
PHOTOGRAPH NO. 18

Date: 08/23/93 Picture Taken by: K. Matherne Direction Facing: Southeast
Picture Description: Inside the hose house (AOC No. 2); note recent oil staining (center) and floor
drain cap (upper right).

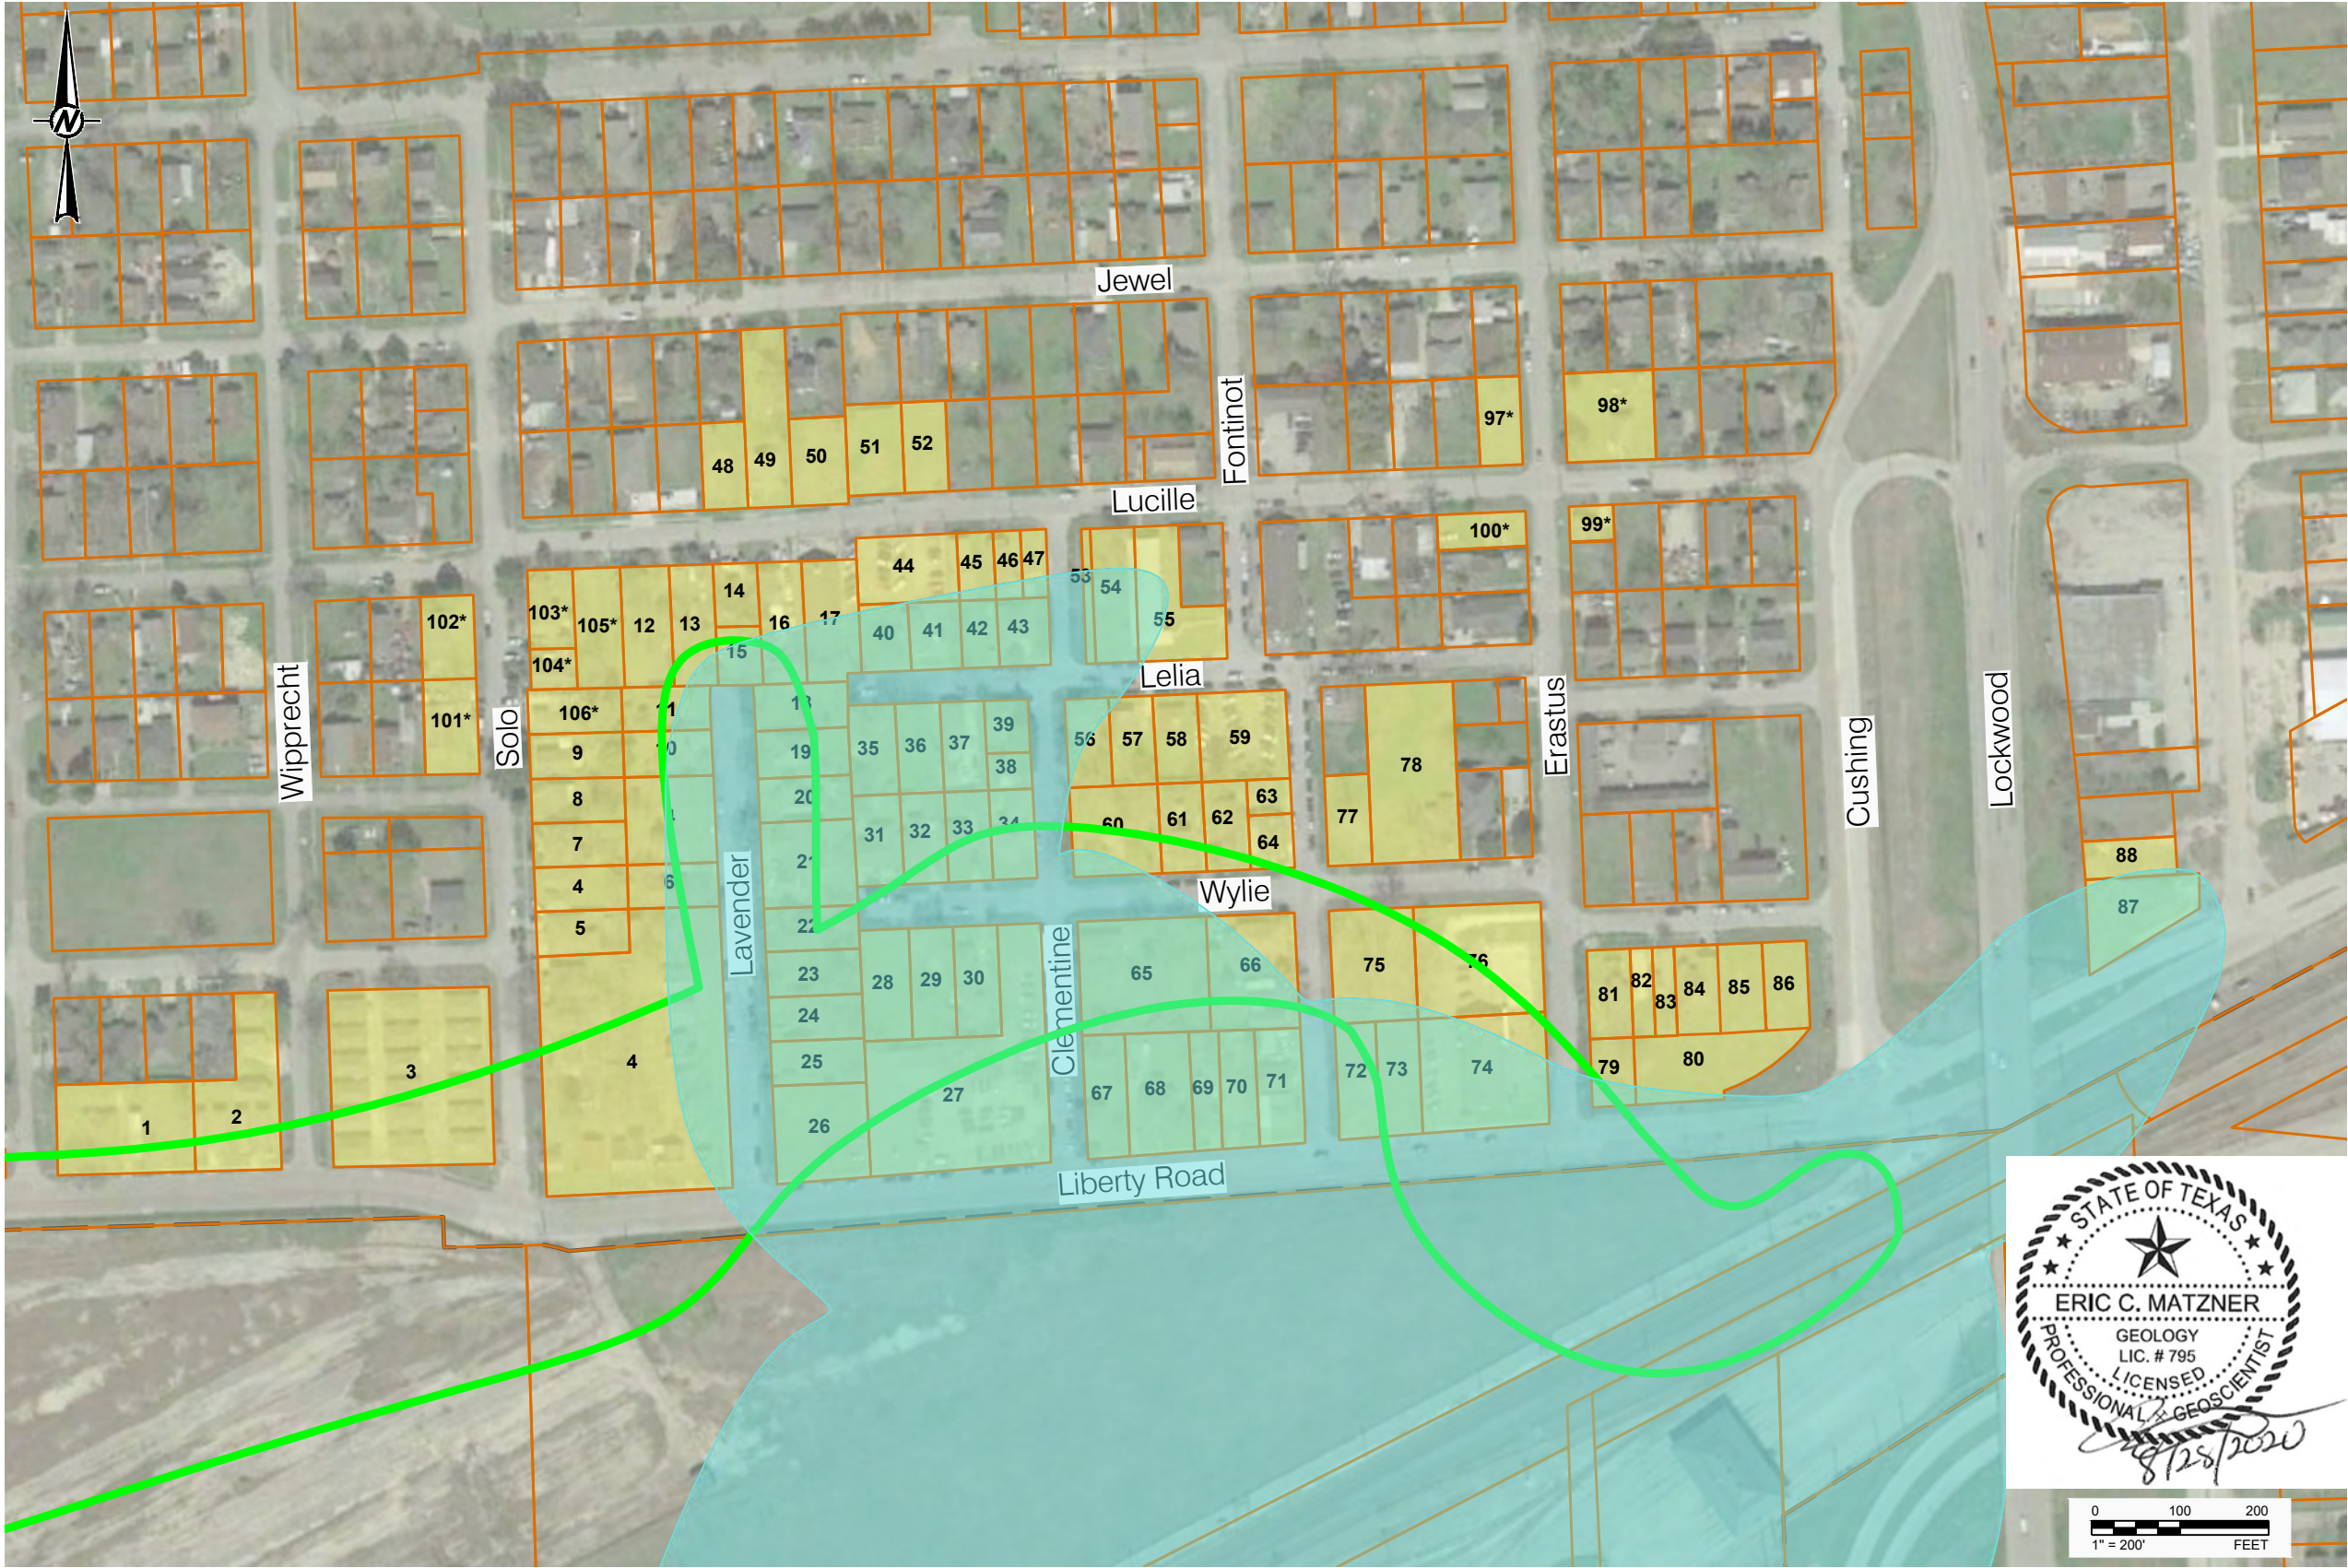
FIGURE
1A-2

Response: Details of the groundwater including directional flow are included as Figure 1A-2 (Off-Site Affected Properties [North]) and Figure 1A-3 (Off-Site Affected Properties [West]), attached as Appendices 4 and 5, respectively. Union Pacific has submitted several groundwater potentiometric surface maps in the Groundwater Monitoring Reports, APARs, and RAPs to the TCEQ or predecessor agencies. These reports are included on the USB drive submitted with these responses and can also be found at Union Pacific's public website (<https://hwpwinfo.com/>), as well as in the TCEQ records storage repository, see footnote 4.
