April 15, 2021

Project No. 19119232

**RE: MONTHLY STATUS UPDATE – ENGLEWOOD INTERMODAL YARD – NAPL COLLECTION SYSTEM/CONCRETE CAP REPAIRS
UNION PACIFIC RAILROAD HOUSTON WOOD PRESERVING WORKS FACILITY
4910 LIBERTY ROAD FACILITY, HOUSTON, TEXAS
POST-CLOSURE CARE PERMIT NO. HW-50343; INDUSTRIAL SWR NO. 31547**

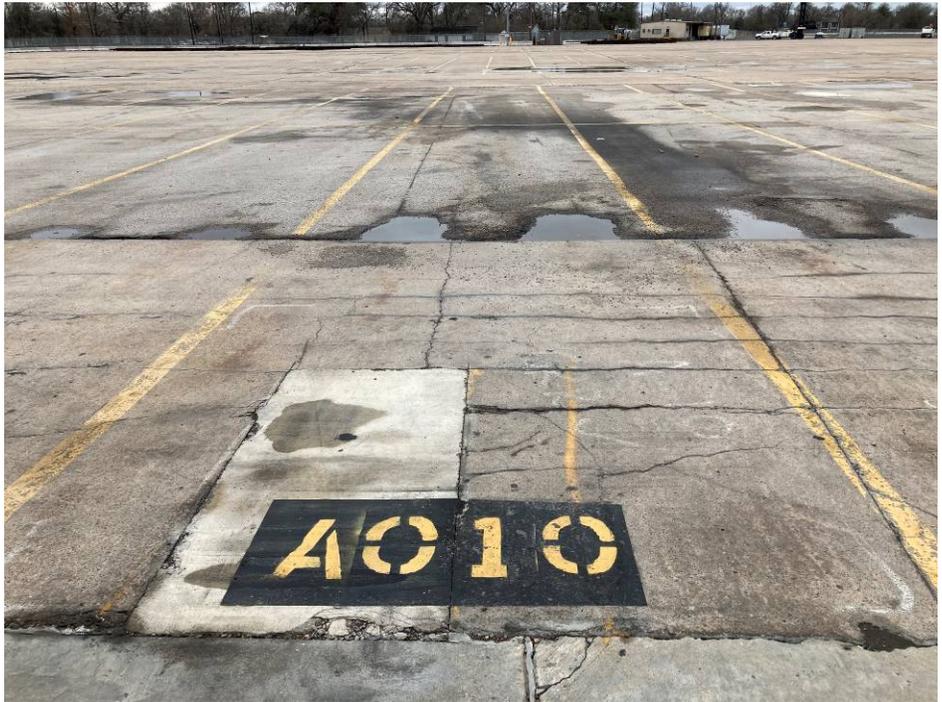
Photo No. 1	Date: 3/2/2021
Description: Slot A010, no tar-like material seeps observed where test pit conducted (July 2020), pavement wet from a recent rain event, looking southwest. Lat: 29.7855833, Long: -95.318375

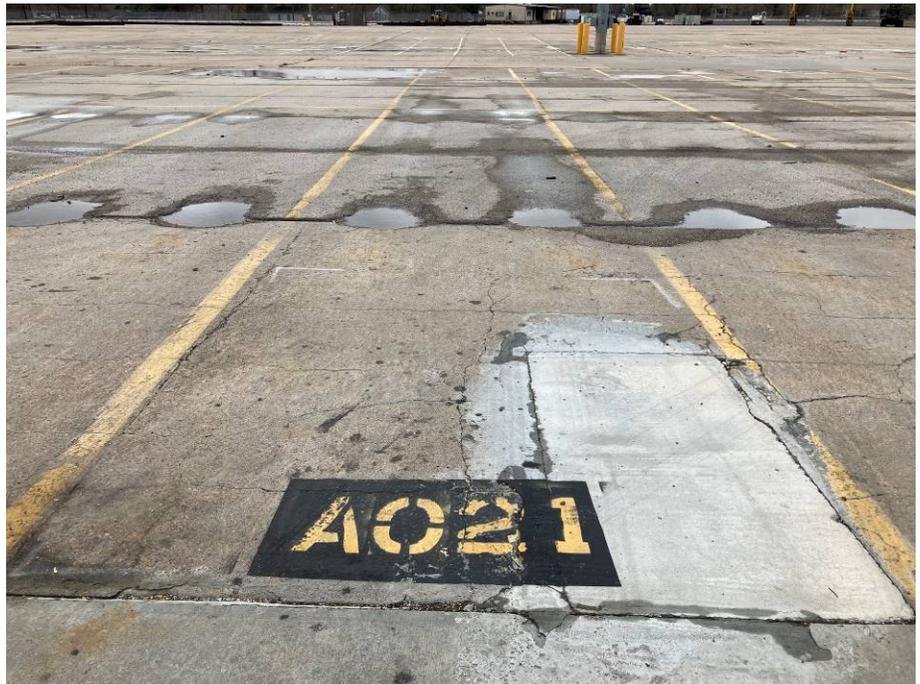
Photo No. 2	Date: 3/2/2021
-----------------------	--------------------------

Description: Slot A021, no tar-like material seeps observed where test pit conducted (July 2020), pavement wet from a recent rain event, looking south. Lat: 29.785392, Long: -95.318655	
--	--

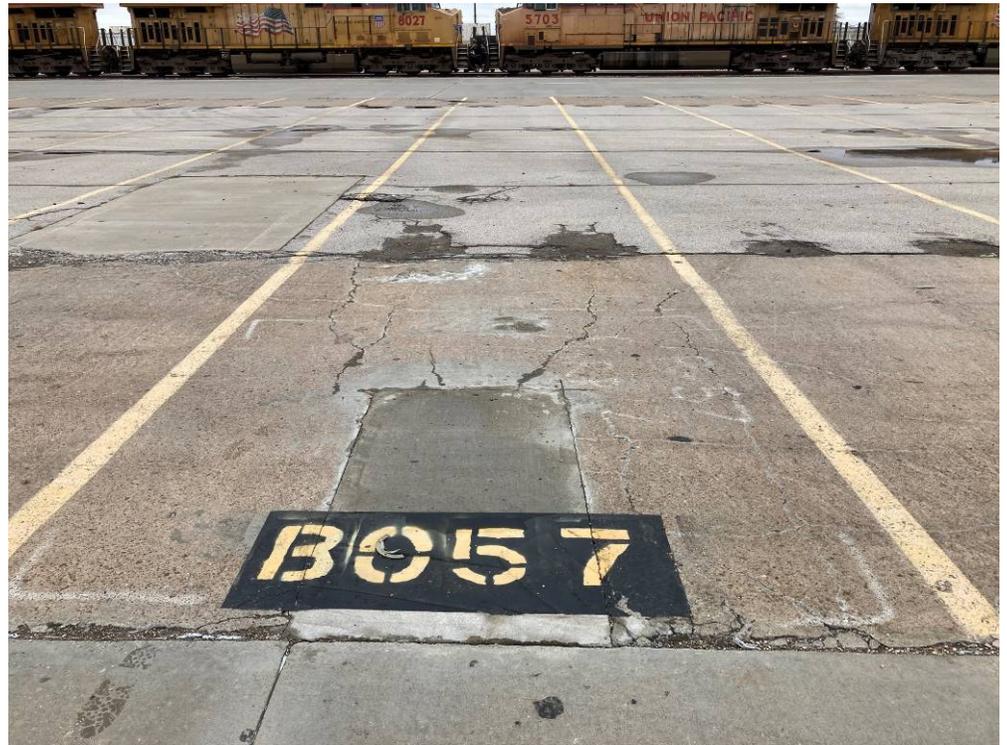
Photo No.
3

Slot B057, no tar-like material seeps observed where test pit conducted (July 2020), pavement wet from a recent rain event, looking northeast.

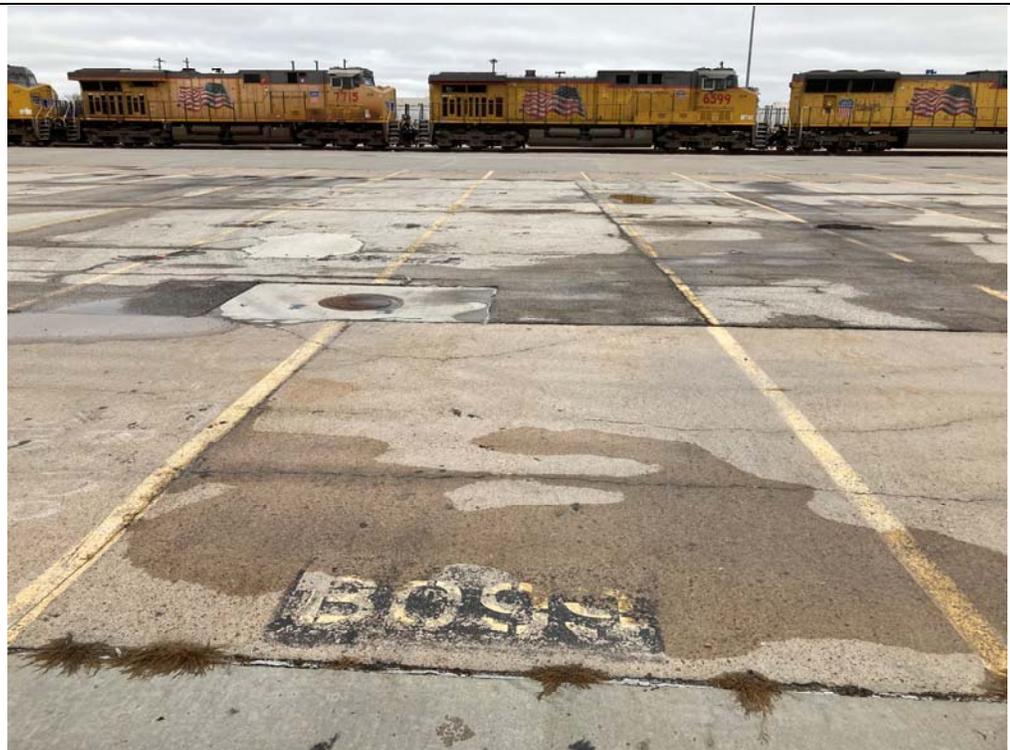
Photo No.
4

Sump 1 (B099/B100), pavement wet from a recent rain event, looking north.

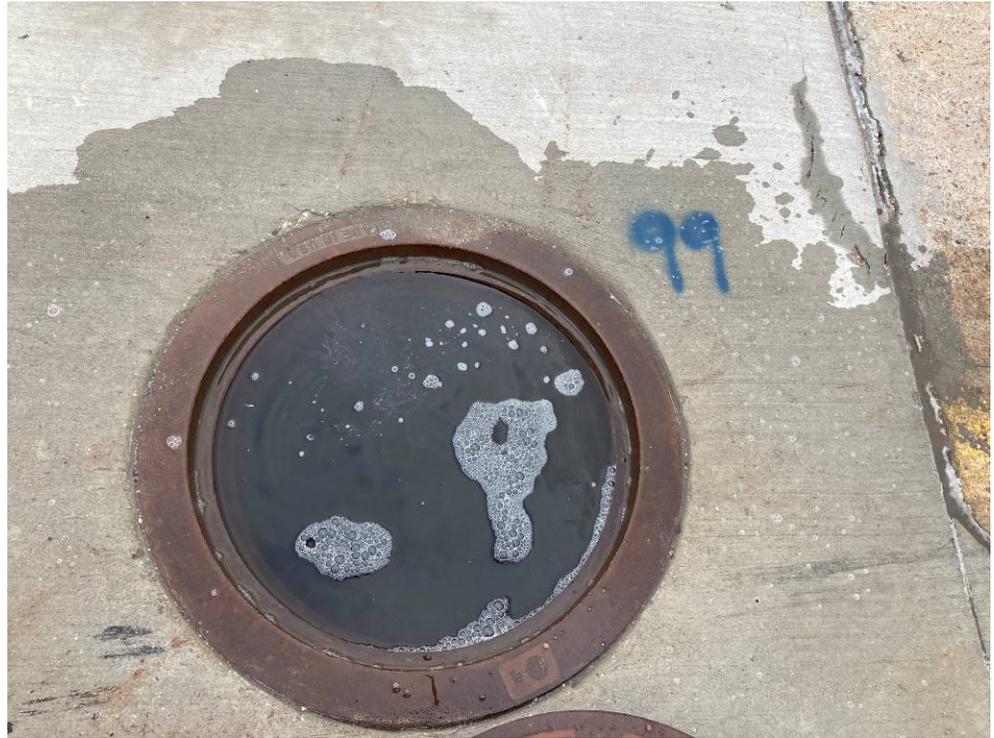
Photo No. 5	Date: 3/2/2021
Description: Sump 1 (B099/B100), 0 inches of freeboard in sump. No sheen, odor, or tar-like material observed. Lat: 29.7844000 Long: - 95.3205861

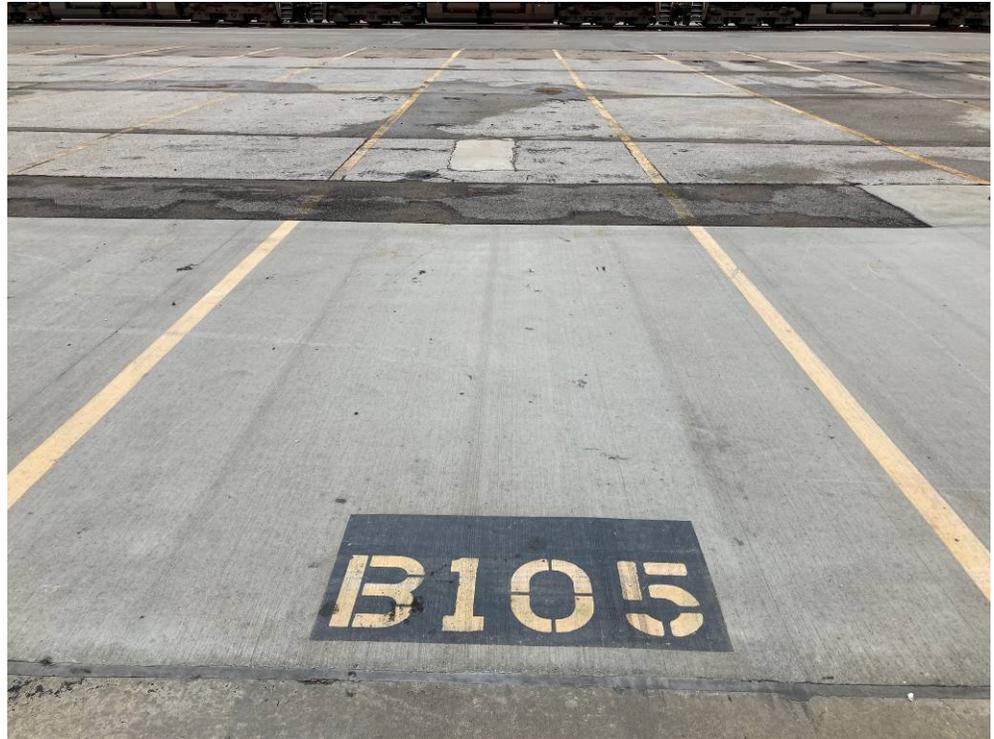
Photo No. 6	Date: 3/2/2021
Description: Slot B105, no tar-like material seeps observed, pavement wet from a recent rain event, looking northeast. Lat: 29.7841472 Long: - 95.3208777

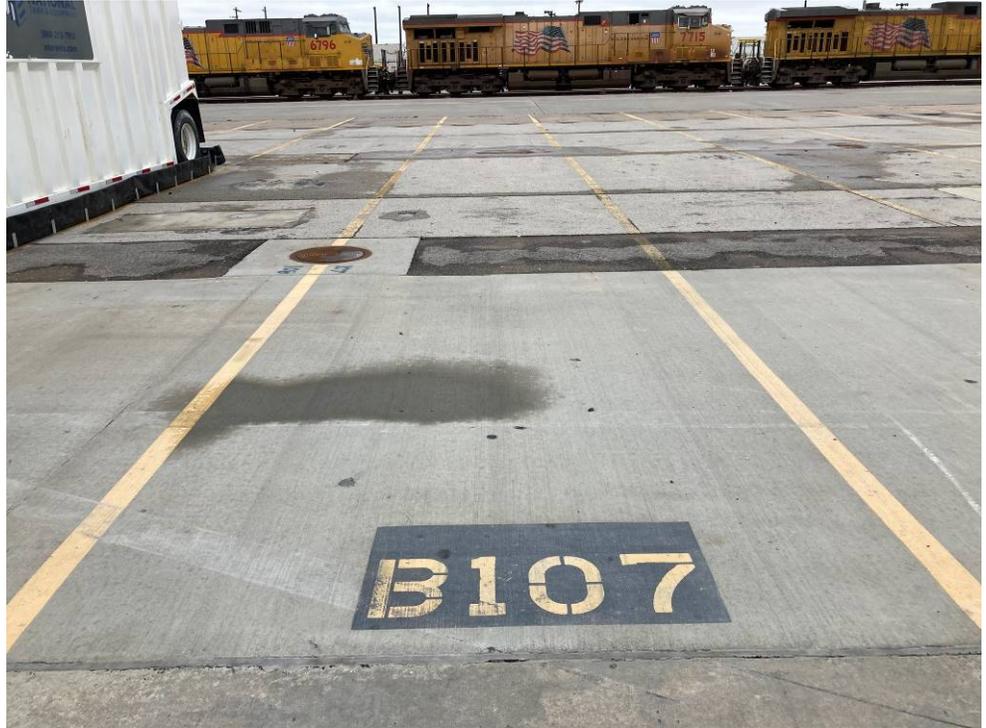
Photo No. 7	Date: 3/2/2021
Description: Slot B107, view of NAPL Collection System (Sump B107/B108 and test pit in background). No tar-like material seeps observed, pavement wet from a recent rain event, looking northeast. Lat: 29.784139 Long: -95.320964

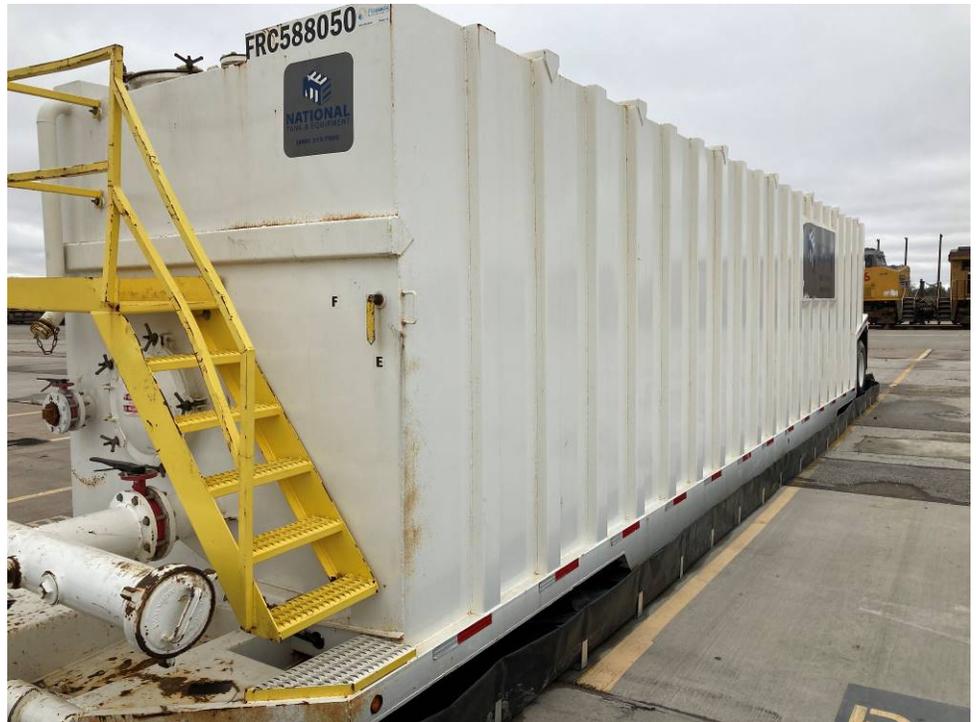
- Two frac tanks and a vacuum box (Photos 8 and 9) are staged at the Englewood Intermodal Yard that contain waste from UPRR activities not related to the Site. These wastes will be disposed of off-site in accordance with state and federal regulations.

Photo No. 8	Date: 3/2/2021
Description: Slot B109, frac tank staged for other UPRR activities and not related to Site activities. Lat: 29.7841028 Long: - 95.3209833

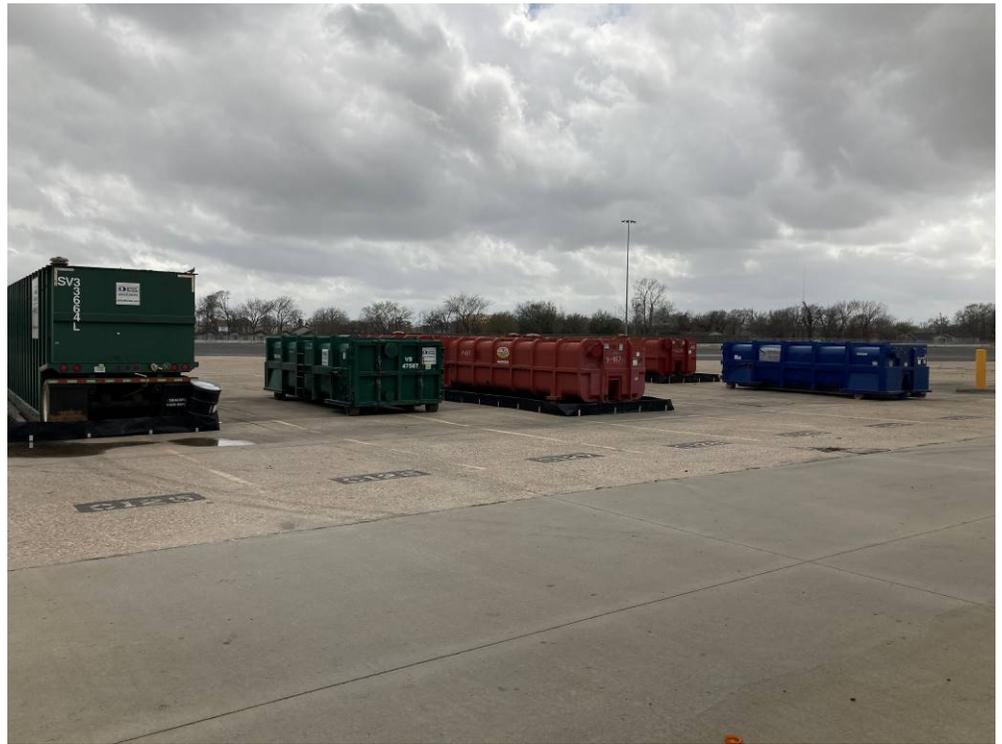
Photo No. 9	Date: 3/10/2021
------------------------------	---------------------------

Slots C125-C132, five vacuum boxes containing water from storm sewer obstruction removal activities, looking southwest. The green vacuum box and green frac tank contain waste not related to site activities (other UPRR activities).

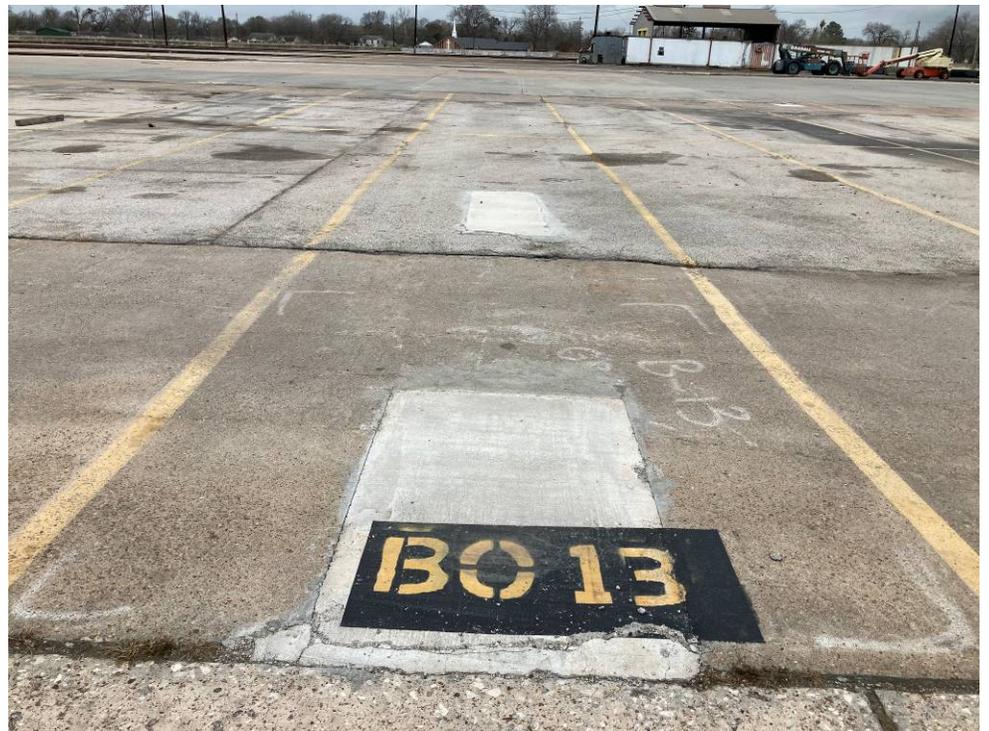
Photo No. 10	Date: 3/10/2021
-------------------------------	---------------------------

Slot B013, no tar-like material seeps observed where test pit conducted (July 2020), looking north.

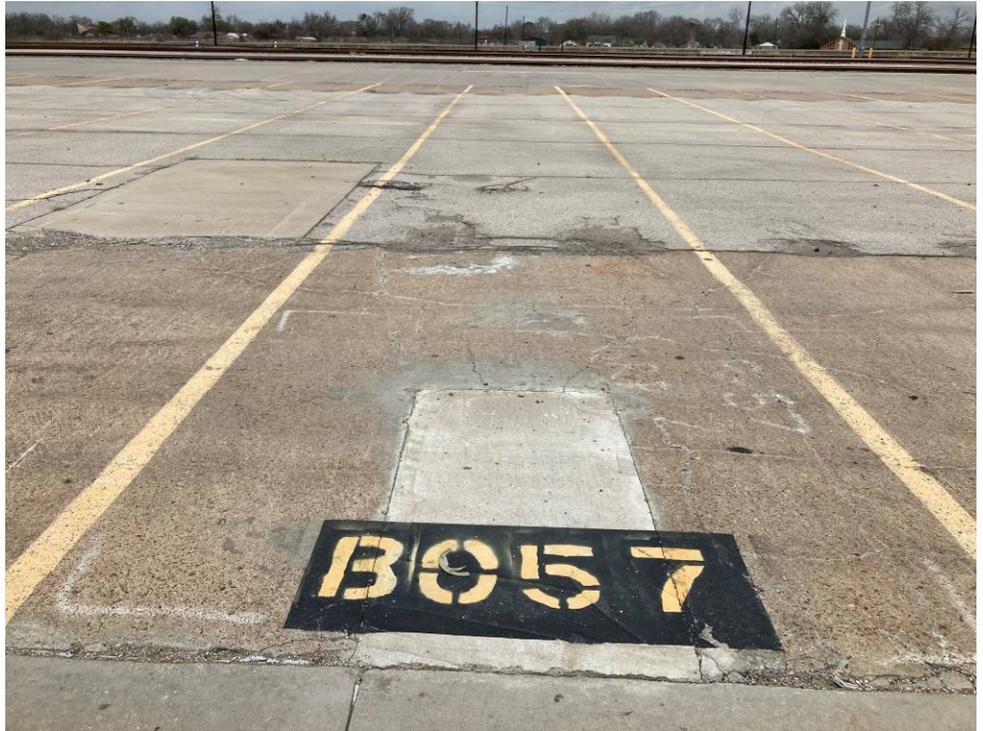
Photo No.
11

Slot B057, no tar-like material seeps observed where test pit conducted (July 2020), looking north.

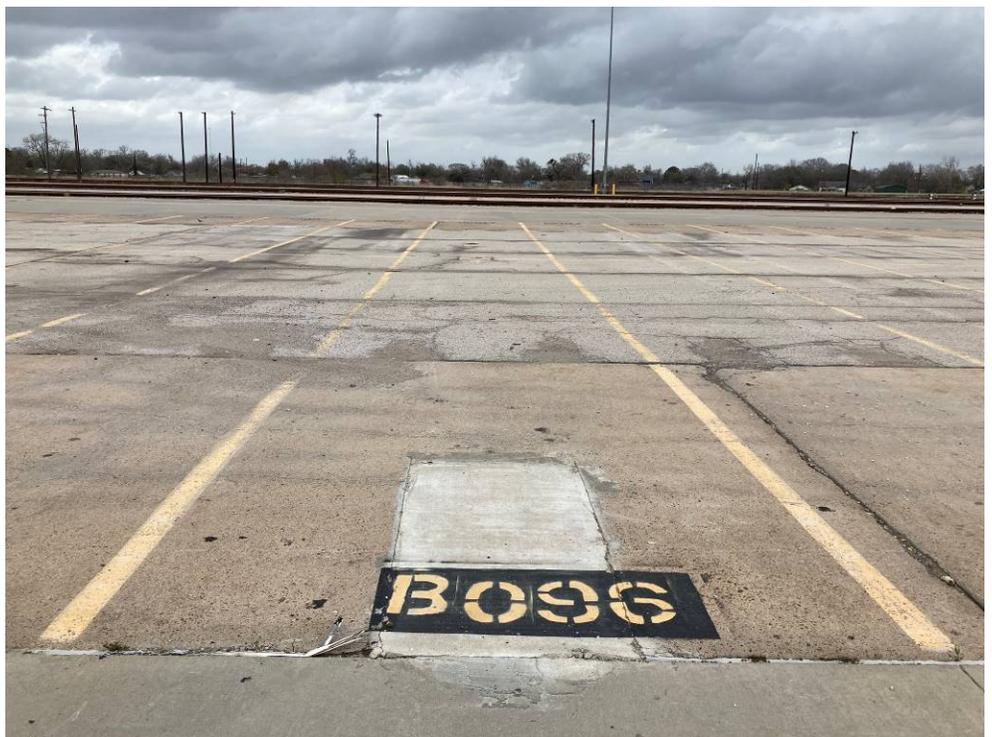
Photo No.
12

Slot B096, no tar-like material seeps observed where test pit conducted (July 2020), looking north.

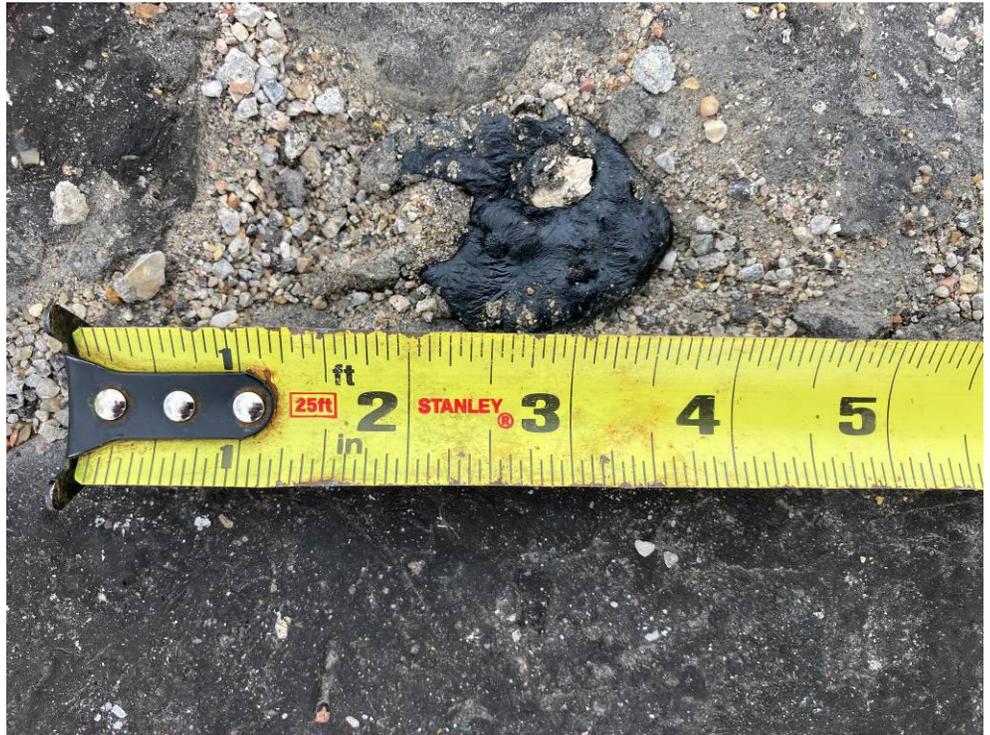
Photo No.
13

- No tar-like NAPL seeps were observed within the NAPL Collection System area during the month of March. For areas outside the NAPL Collection System, a very small amount of tar-like material was observed on the concrete surface in stalls A022, B013, B057, B101, and B105 during at least one weekly inspection event in March with more seeps observed during the last two inspections of the month (March 24, 2021 and March 31, 2021). Tar-like material observed during the inspection events was recovered upon its observation. While the number of tar-like material seeps observed during inspections increased through the month of March as daily temperatures increased, a total amount of less than 0.1 gallons was removed from the concrete surface.

Slot B101, very small amount of tar-like material seeping at asphalt crack, material was removed.

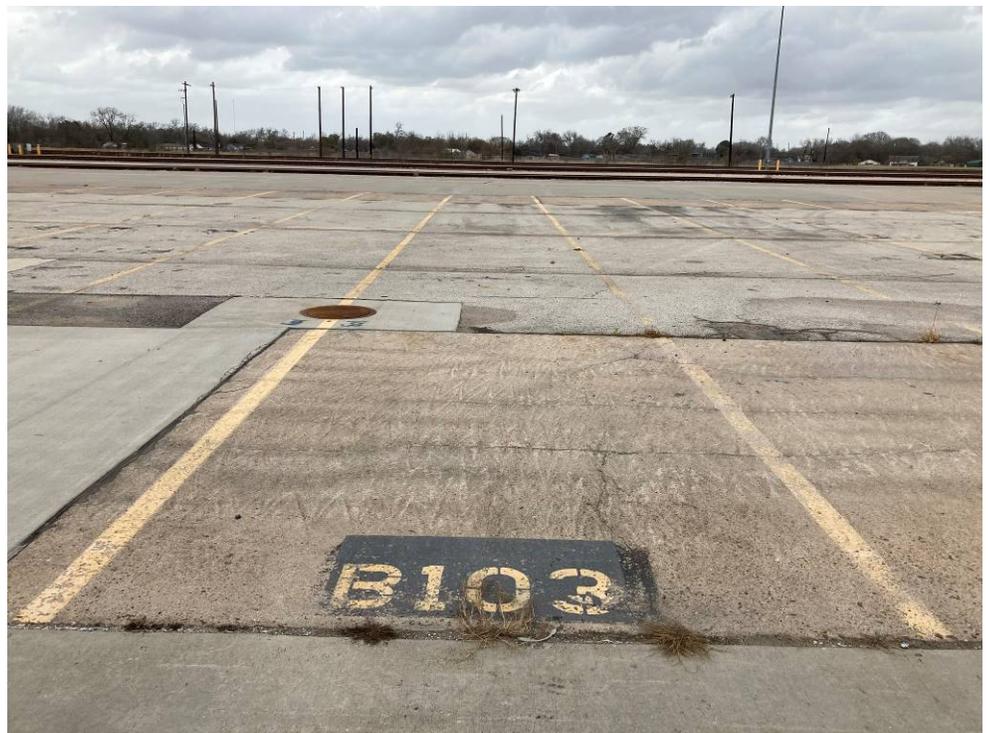
Photo No.
14

Slot B103, view of NAPL Collection System (Sump 103/104 on left). No tar-like material seeps observed, looking north.

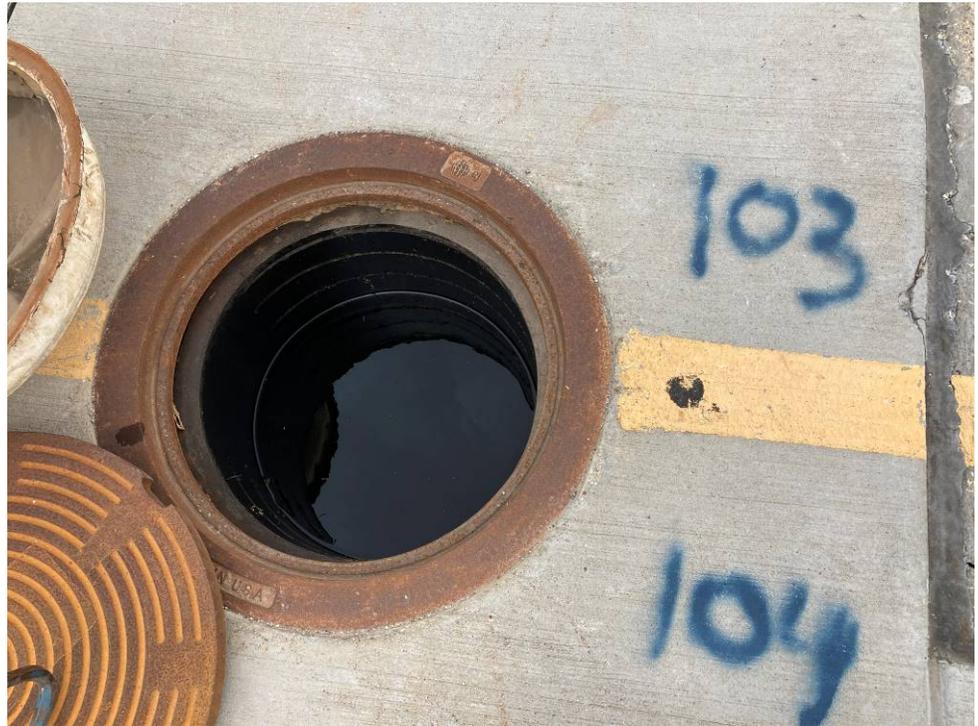
Photo No. 15	Date: 3/10/2021
-------------------------------	---------------------------

Sump 2 (B103/B104), 10 inches of freeboard in sump, no sheen or odors noted.

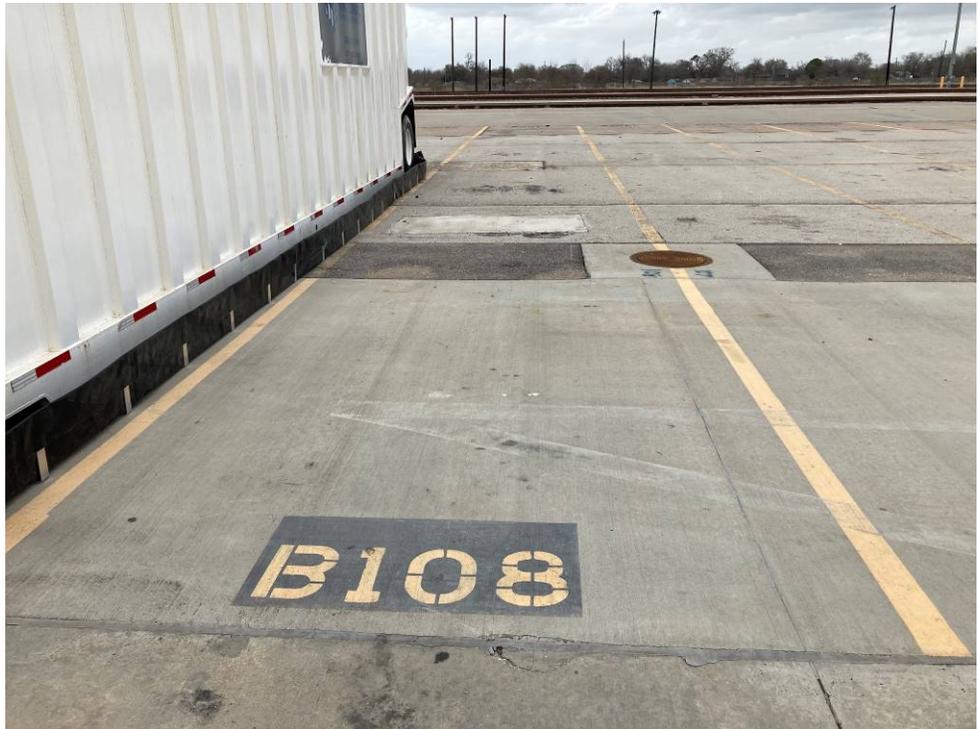
Photo No. 16	Date: 3/10/2021
-------------------------------	---------------------------

Slot B108, view of NAPL Collection System (Sump B107/B108 and test pit in background). No tar-like material seeps observed where test pit conducted (July 2020), looking north.

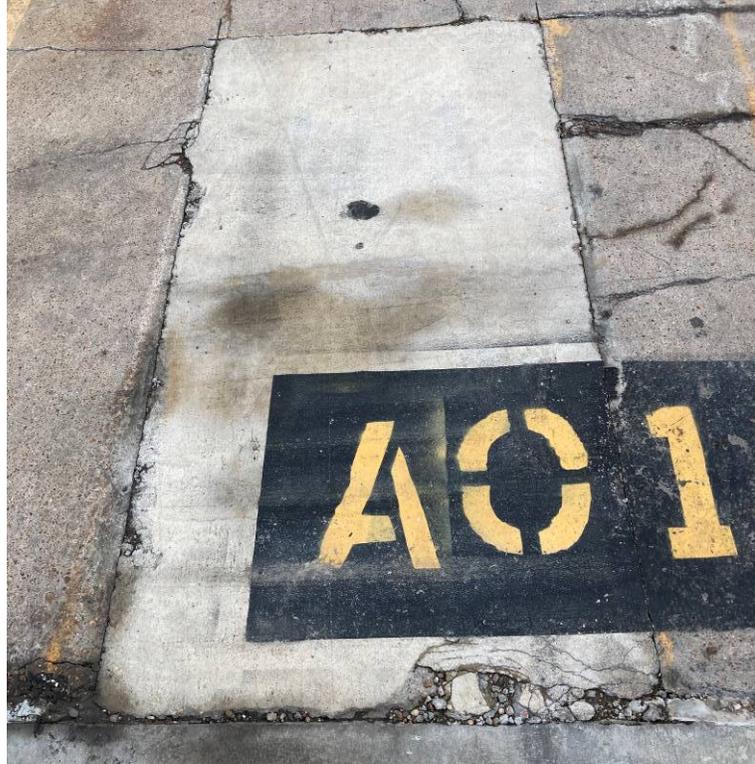
Photo No.
17

Slot A010, no tar-like material seeps observed where test pit conducted (July 2020), pavement wet from a recent rain event.

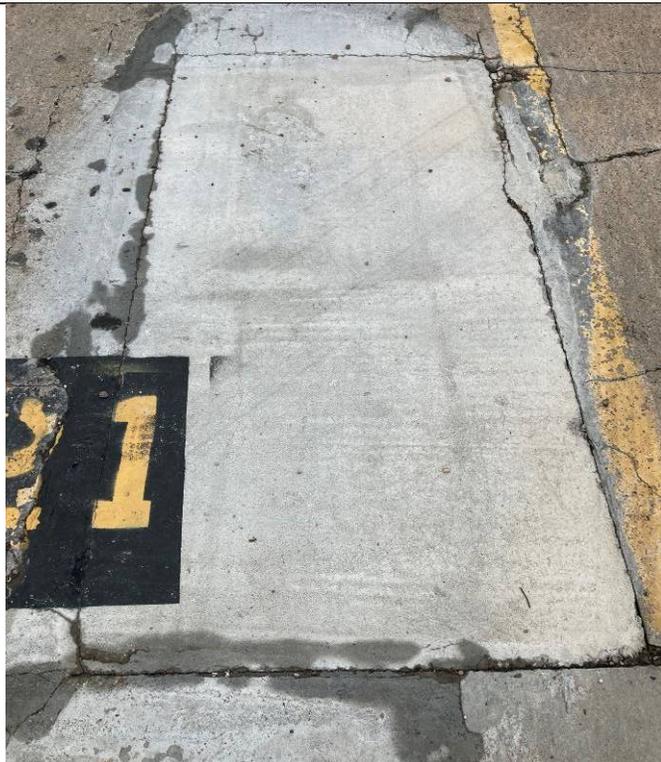
Photo No.
18

Slot A021, no tar-like material seeps observed where test pit conducted (July 2020), pavement wet from a recent rain event.

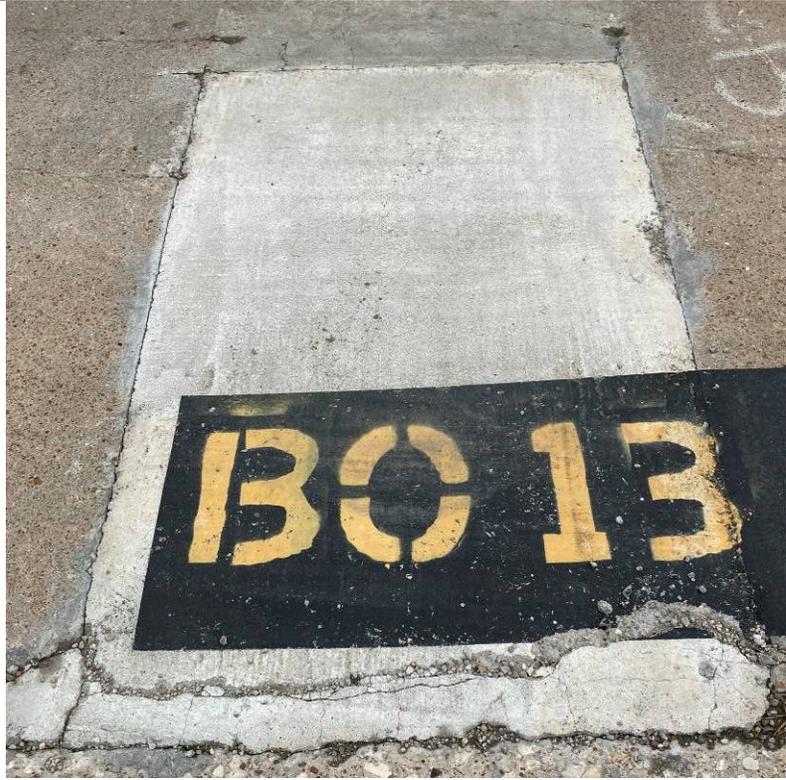
Photo No.
19

Slot B013, no tar-like material seeps observed where test pit conducted (July 2020).

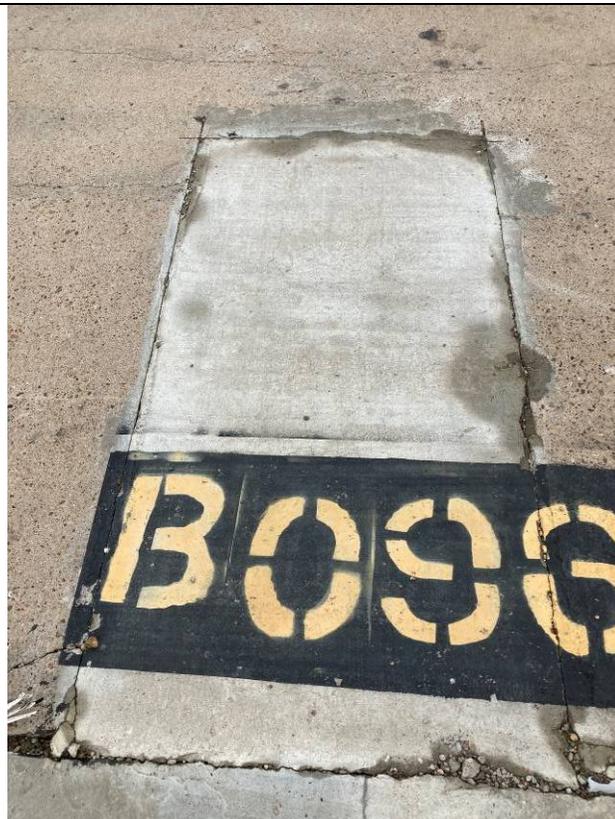
Photo No.
20

Slot B096, no tar-like material seeps observed where test pit conducted (July 2020), pavement wet from a recent rain event.

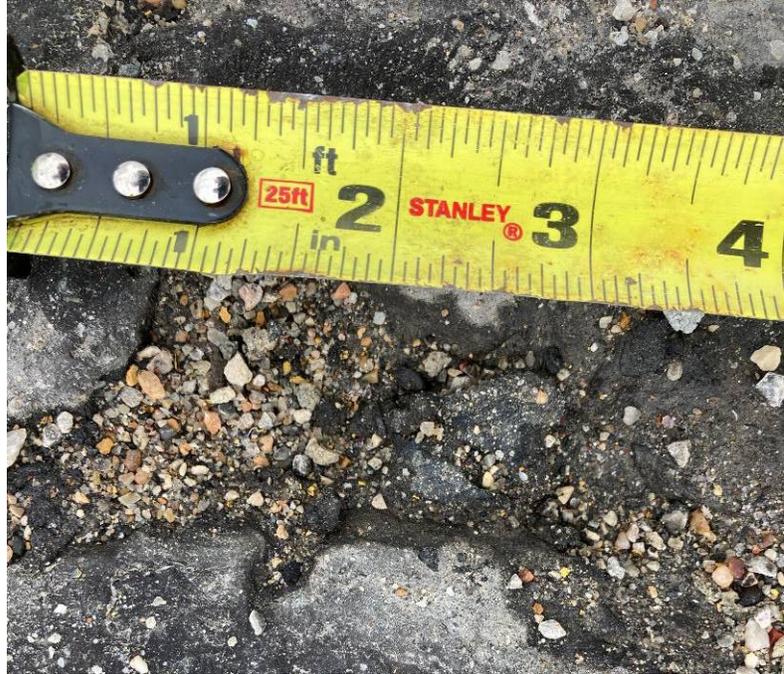
Photo No.: 21	Date: 3/17/2021
-------------------------	---------------------------

Slot B101, very small amount of tar-like material seeping at asphalt crack, material was removed.

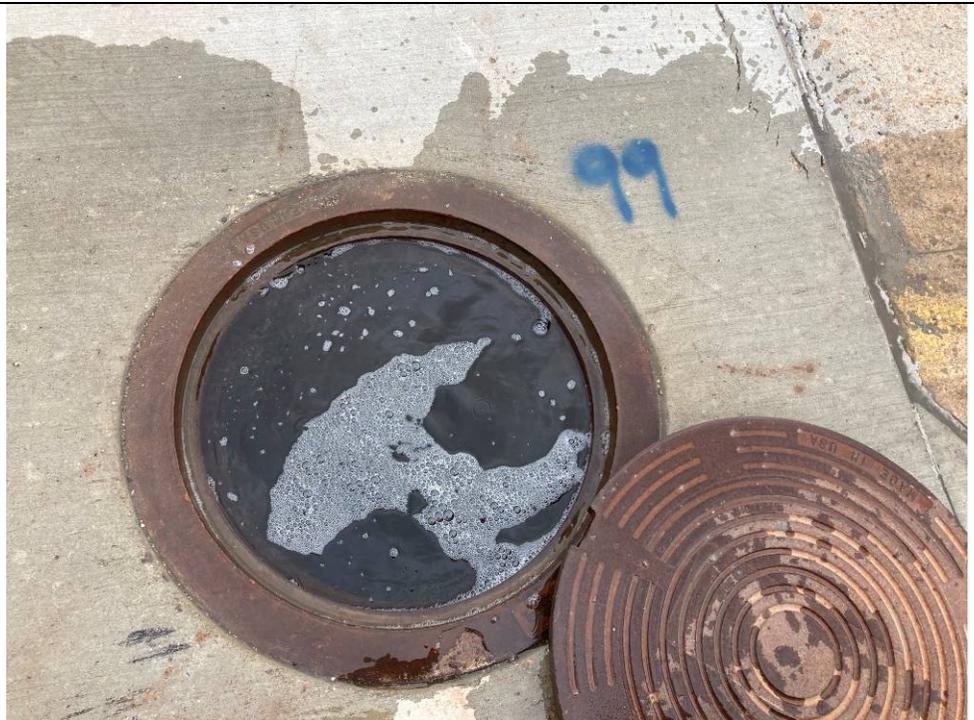
Photo No.: 22	Date: 3/17/2021
-------------------------	---------------------------

Sump 1 (B099/B100), 0 inches of freeboard in sump, no sheen or odor noted.

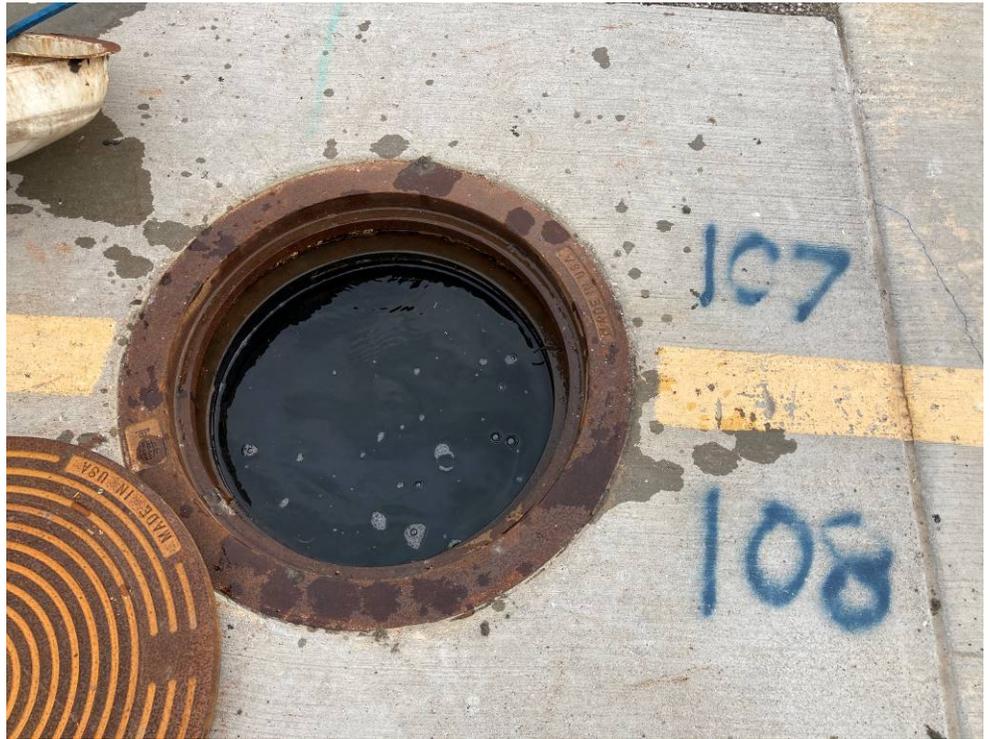
Photo No. 23	Date: 3/17/2021
Description: Sump 3 (B107/B108), 1 inch of freeboard in sump. No sheen, odor or tar-like material observed. Lat: 29.7842861 Long: - 95.3208611

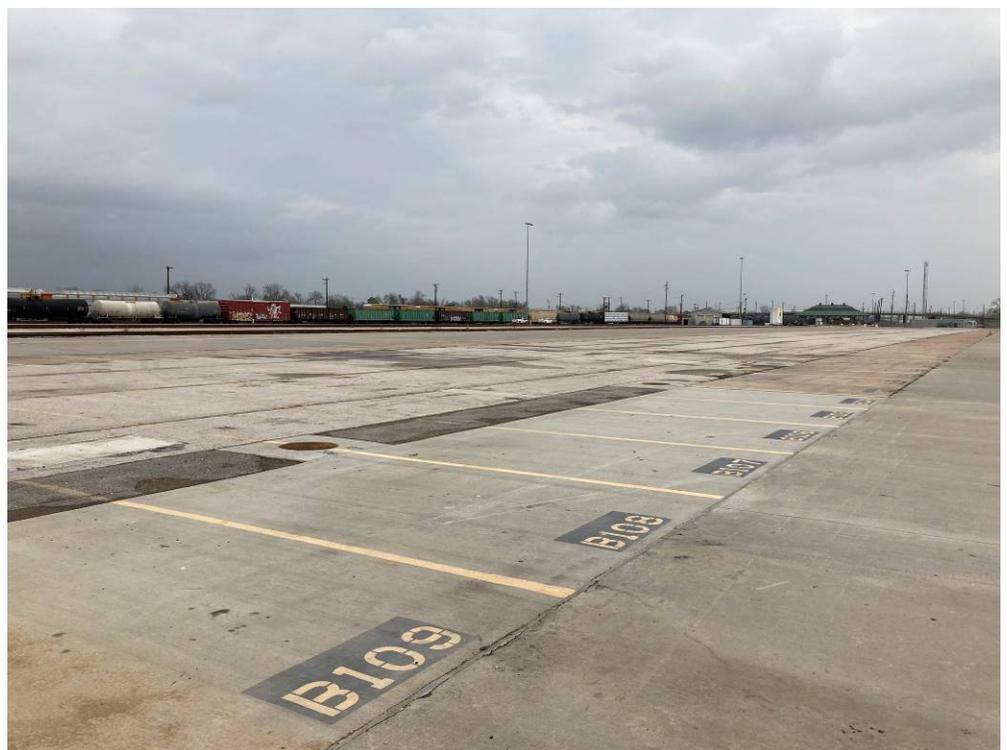
Photo No. 24	Date: 3/17/2021
Description: Slots B109-B097, NAPL collection system visible in background, looking northeast. Lat: 29.784116 Long: -95.321022

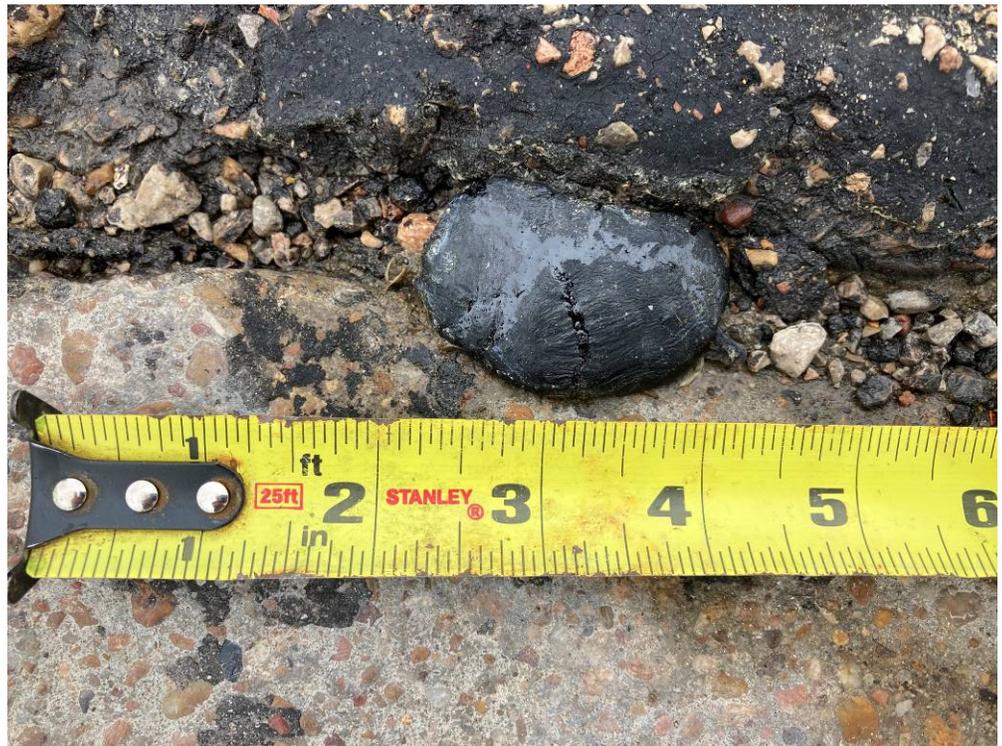
Photo No. 25	Date: 3/24/2021
Description Slot A022, very small amount of tar-like material seeping at asphalt crack, material was removed. Lat: 29.785392, Long: -95.318655

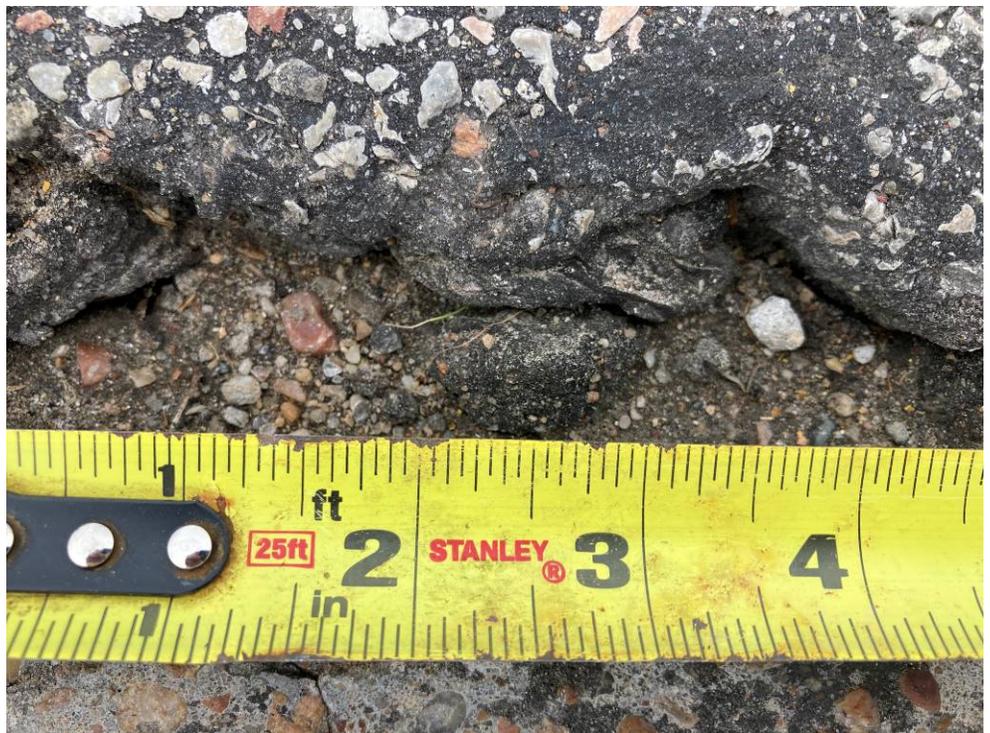
Photo No. 26	Date: 3/24/2021
Description: Slot B013, very small amount of tar-like material seeping at asphalt crack (not at July 2020 test pit), material was removed. Lat: 29.785217 Long: - 95.318261

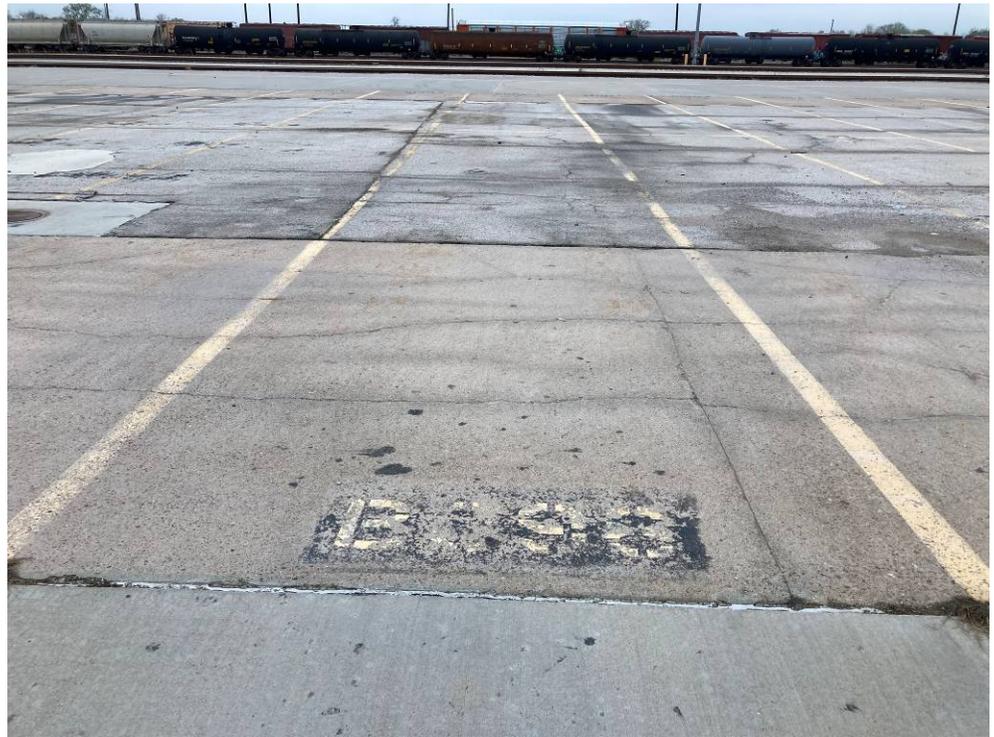
Photo No. 27	Date: 3/24/2021
Description: Slot B098, no tar-like material seeps observed, residual brown staining along asphalt cracks, looking north. Lat: 29.7842587 Long: - 95.3206699

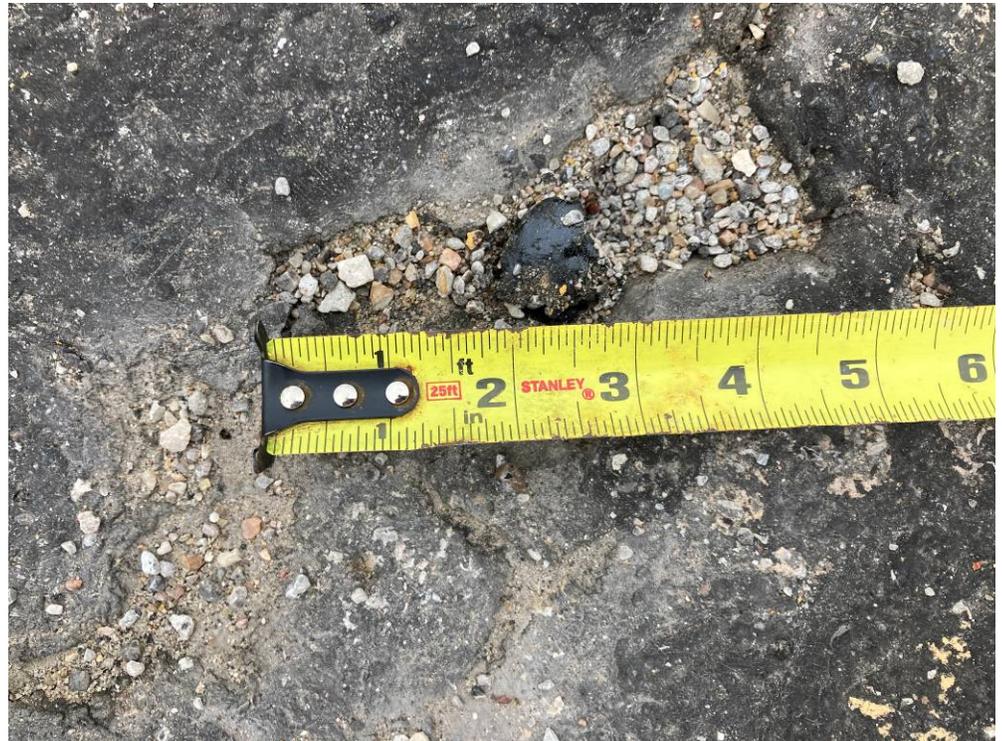
Photo No. 28	Date: 3/24/2021
Description: Slot B101, very small amount of tar-like material seeping at asphalt crack, material was removed. Lat: 29.784275 Long: - 95.320813

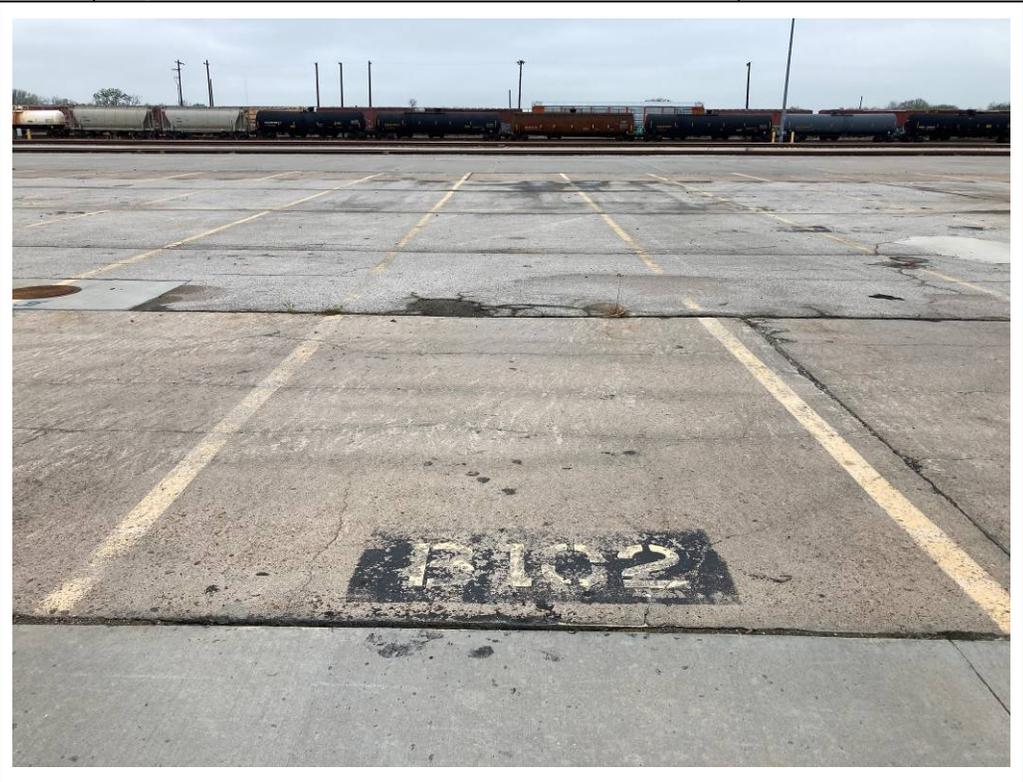
Photo No.: 29	Date: 3/24/2021
-------------------------	---------------------------

Slot B102, no tar-like material seeps observed, looking north.

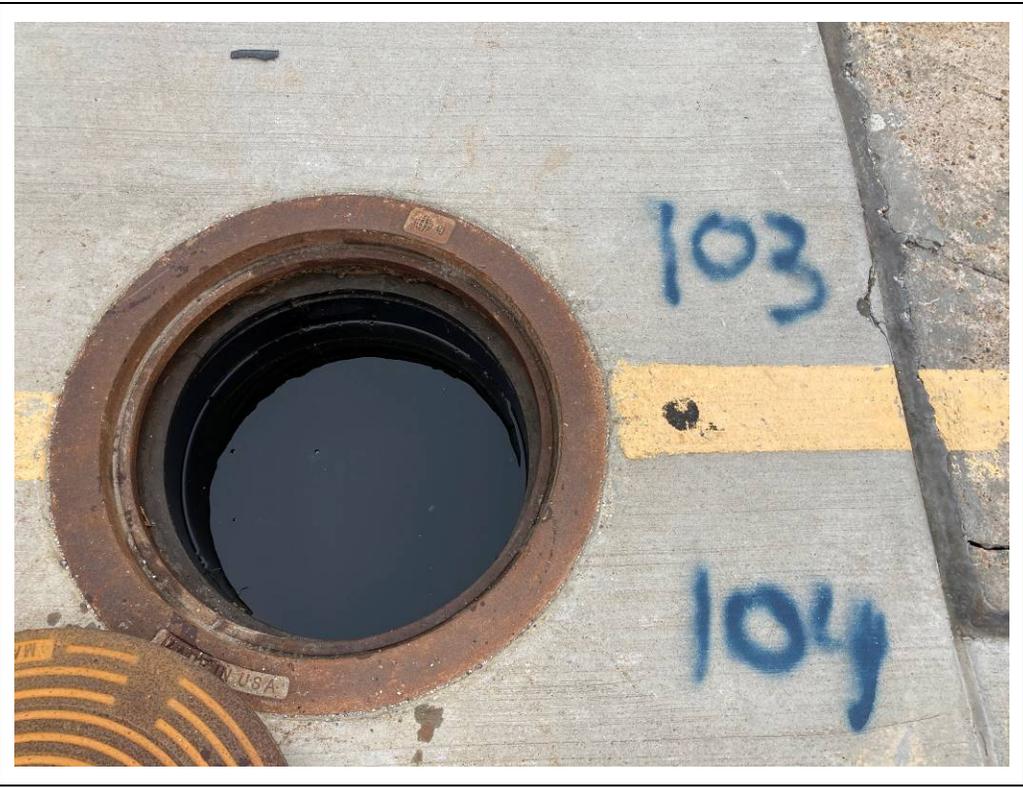
Photo No.: 30	Date: 3/24/2021
-------------------------	---------------------------

Sump 2 (B103/B104), 3.5 inches of freeboard in sump. No sheen or odor observed.
