April 15, 2021

Project No. 19119232

**RE: MONTHLY STATUS UPDATE – ENGLEWOOD INTERMODAL YARD – NAPL COLLECTION SYSTEM/CONCRETE CAP REPAIRS
UNION PACIFIC RAILROAD HOUSTON WOOD PRESERVING WORKS FACILITY
4910 LIBERTY ROAD FACILITY, HOUSTON, TEXAS
POST-CLOSURE CARE PERMIT NO. HW-50343; INDUSTRIAL SWR NO. 31547**

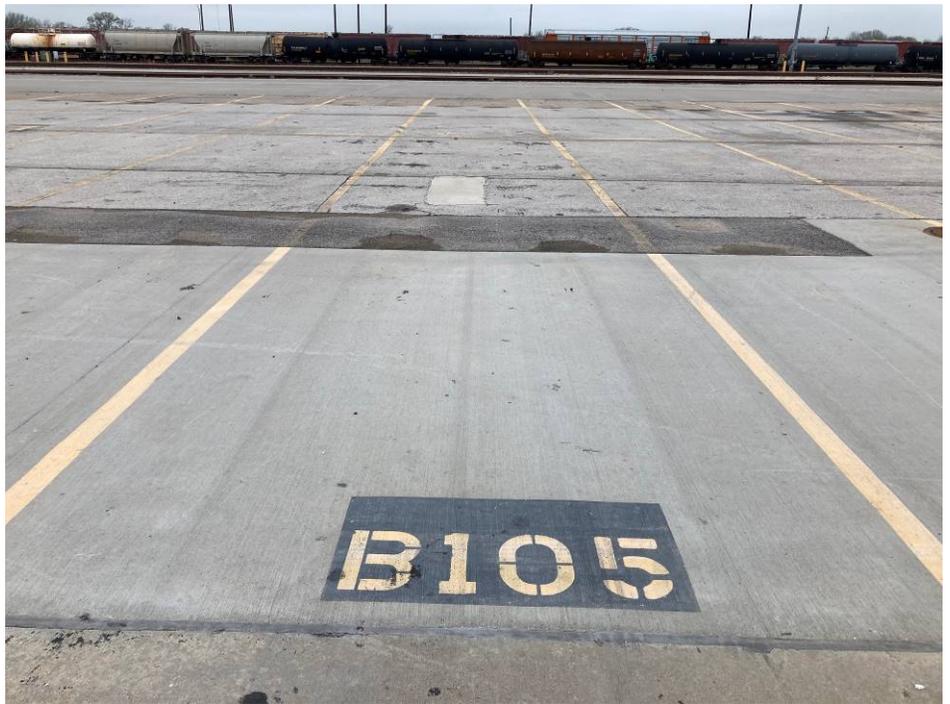
Photo No. 31	Date: 3/24/2021
Description: Slot B105, no tar-like material seeps observed, looking north. Lat: 29.7841472 Long: - 95.3208777

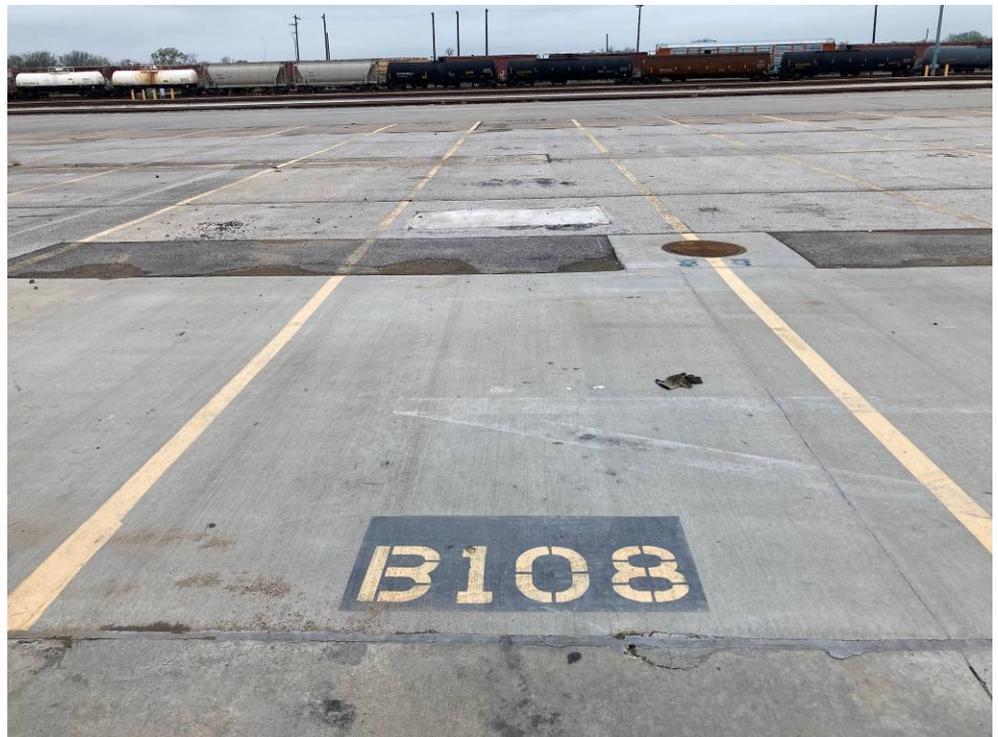
Photo No. 32	Date: 3/24/2021
Description: Slot B108, view of NAPL Collection System (Sump B107/B108 and test pit in background). No tar-like material seeps observed where test pit (July 2020) conducted, looking north. Lat: 29.784125 Long: - 95.320989

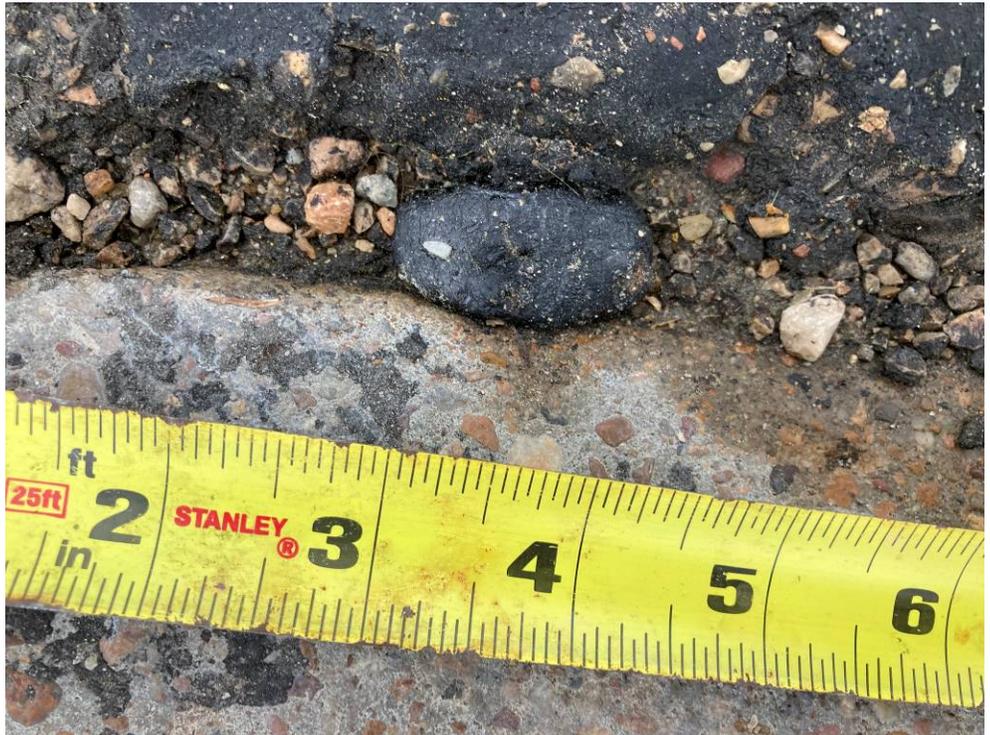
Photo No.: 33	Date: 3/31/2021
Description: Slot A022, very small amount of tar-like material seeping at asphalt crack, material was removed. Lat: 29.785392, Long: -95.318655

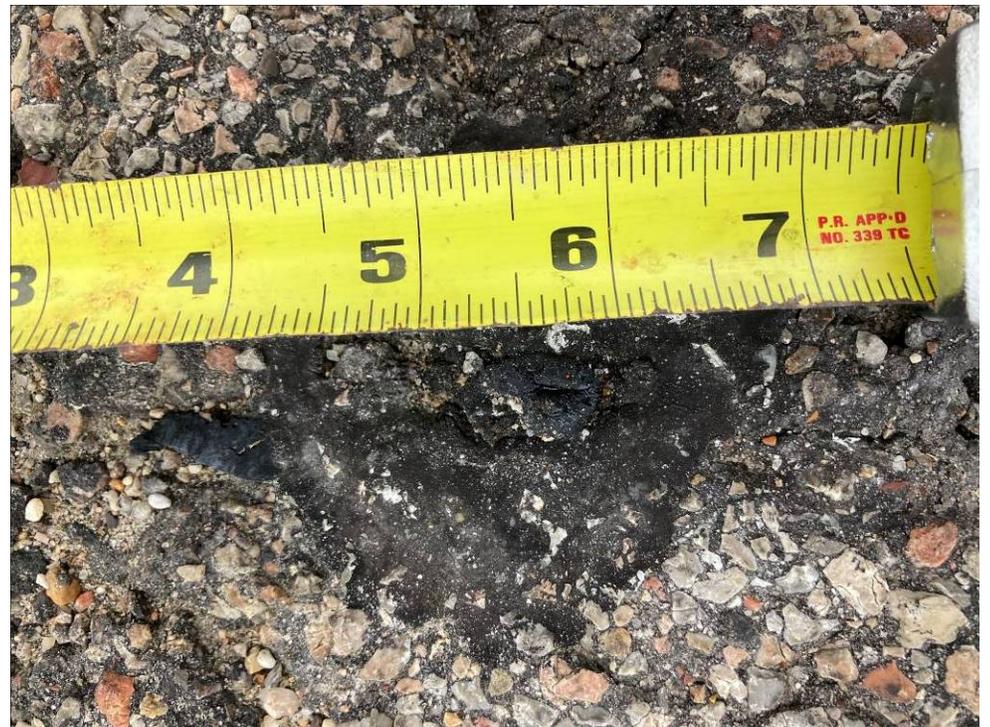
Photo No.: 34	Date: 3/31/2021
Description: Slot B057, very small amount of tar-like material seeping at asphalt crack (not at July 2020 test pit), material was removed, pavement wet from a recent rain event. Lat: 29.7847472 Long: - 95.3195417

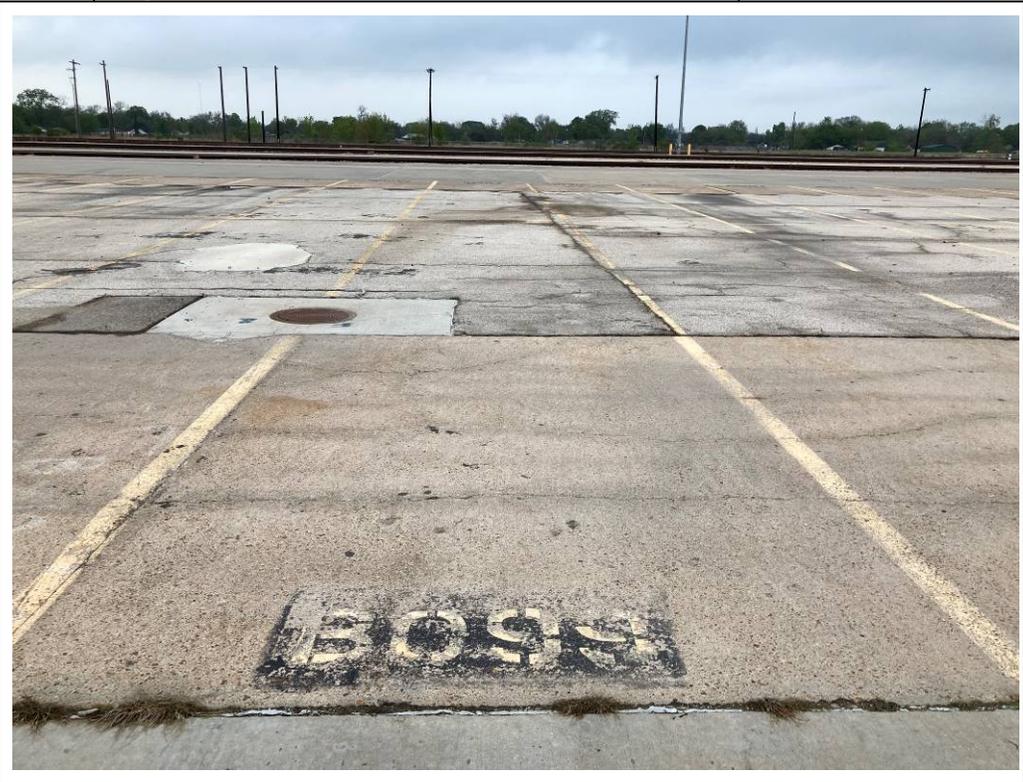
Photo No.: 35	Date: 3/31/2021
Description: Slot B099, view of NAPL Collection System (Sump 099/100 in background). No tar-like material seeps observed, looking north. Lat: 29.7842472 Long: - 95.3206944

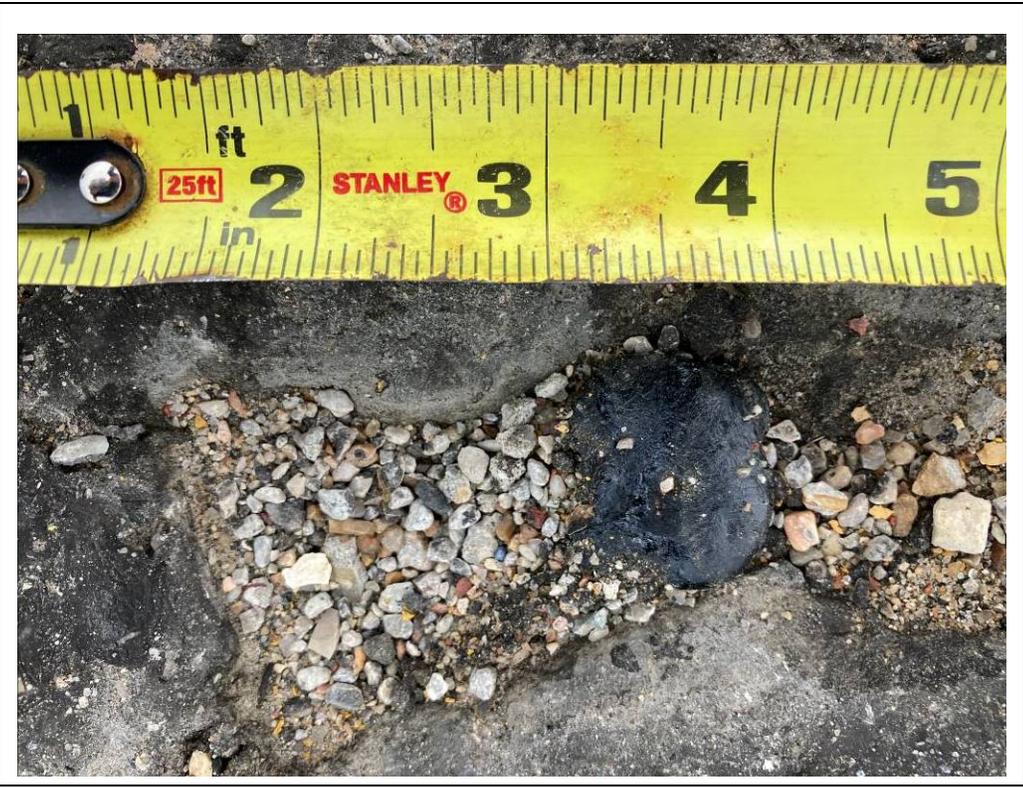
Photo No.: 36	Date: 3/31/2021
-------------------------	---------------------------

Description: Slot B101, very small amount of tar-like material seeping at asphalt crack, material was removed. Lat: 29.784275 Long: - 95.320813	
---	--

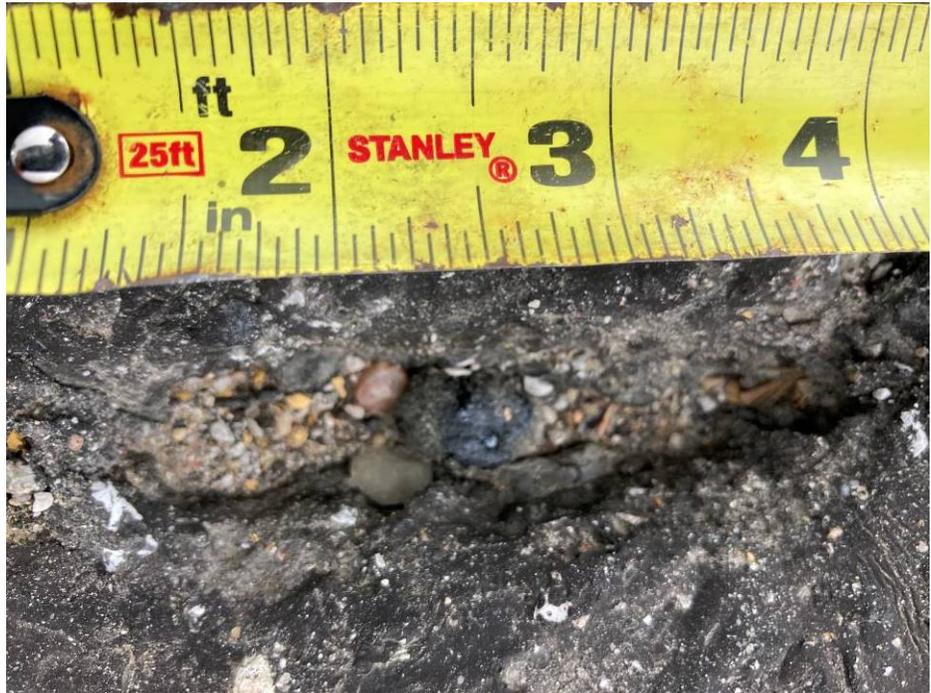
Photo No.: 37	Date: 3/31/2021
-------------------------	---------------------------

Slot B105, very small amount of tar-like material seeping at asphalt crack, material was removed.

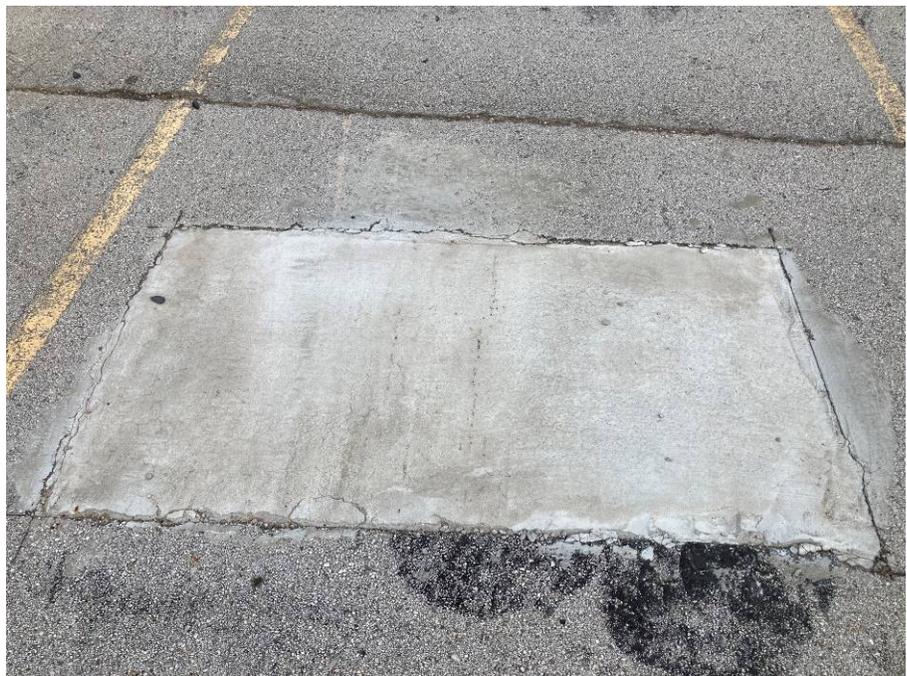
Photo No.: 38	Date: 3/31/2021
-------------------------	---------------------------

Slot B108, no tar-like material seeps observed where test pit (July 2020) conducted.

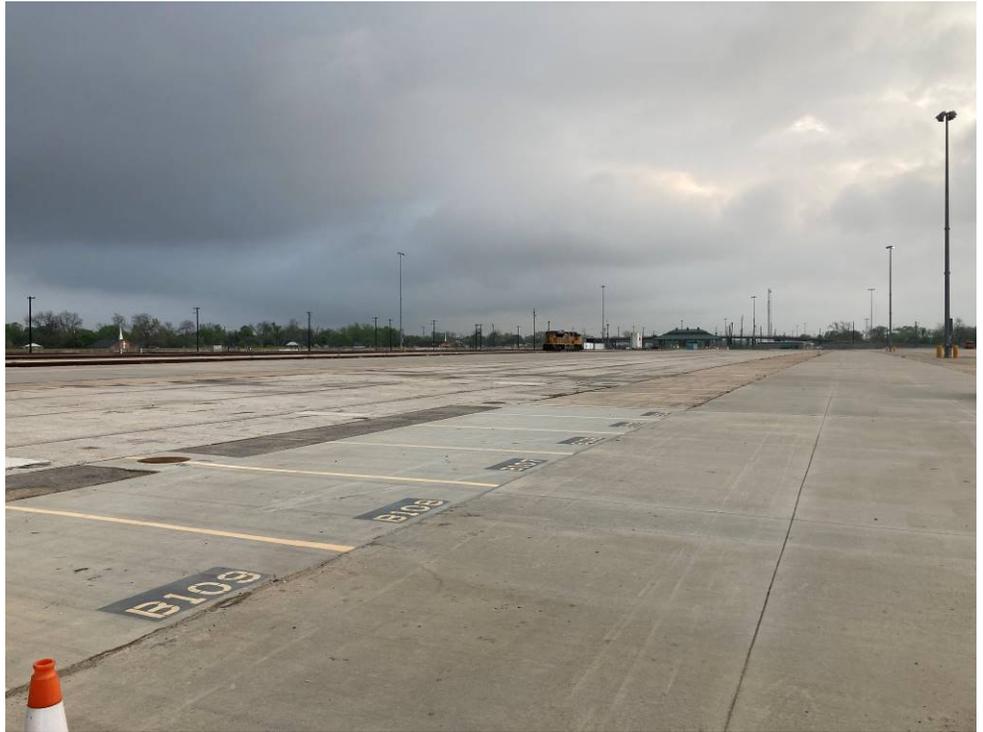
Photo No. 39	Date: 3/31/2021
Description: Slots B109-B097, NAPL collection system visible in background, looking northeast. Lat: 29.784116 Long: -95.321022

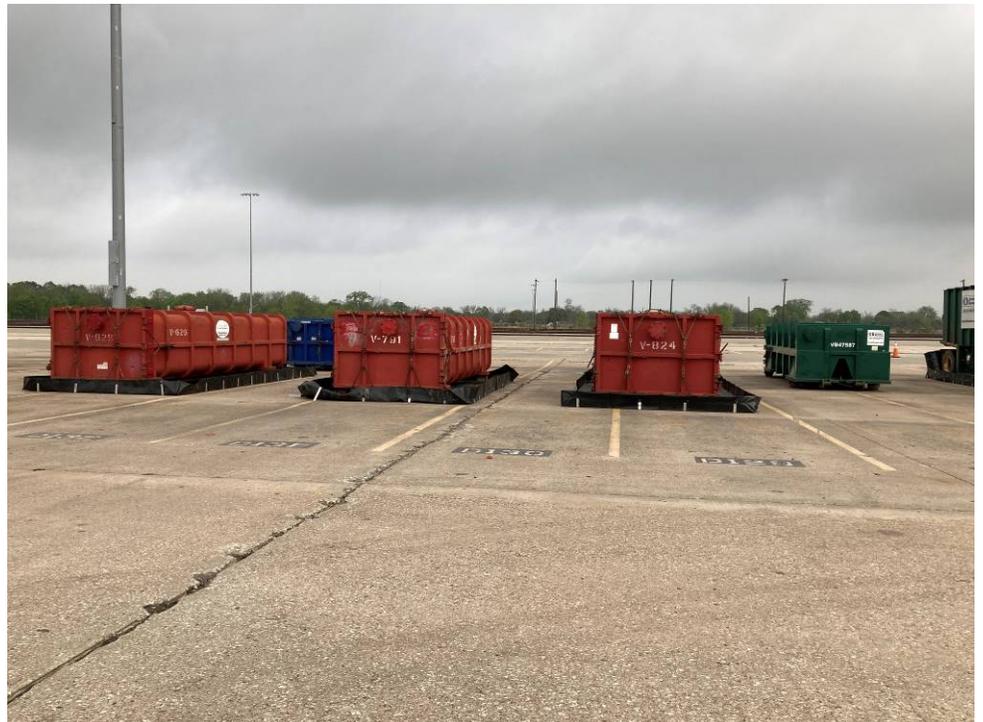
Photo No. 40	Date: 3/31/2021
Description: Slots D126-D134, five vacuum boxes containing water from storm sewer obstruction removal activities. The green vacuum box and green frac tank contain waste not related to site activities (other UPRR activities). Lat: 29.783922 Long: -95.321122
