February 12, 2021

Project No. 19119232

**RE: MONTHLY STATUS UPDATE – ENGLEWOOD INTERMODAL YARD – NAPL COLLECTION SYSTEM/CONCRETE CAP REPAIRS  
UNION PACIFIC RAILROAD HOUSTON WOOD PRESERVING WORKS FACILITY  
4910 LIBERTY ROAD FACILITY, HOUSTON, TEXAS  
POST-CLOSURE CARE PERMIT NO. HW-50343; INDUSTRIAL SWR NO. 31547**

# Weekly Inspection Photolog

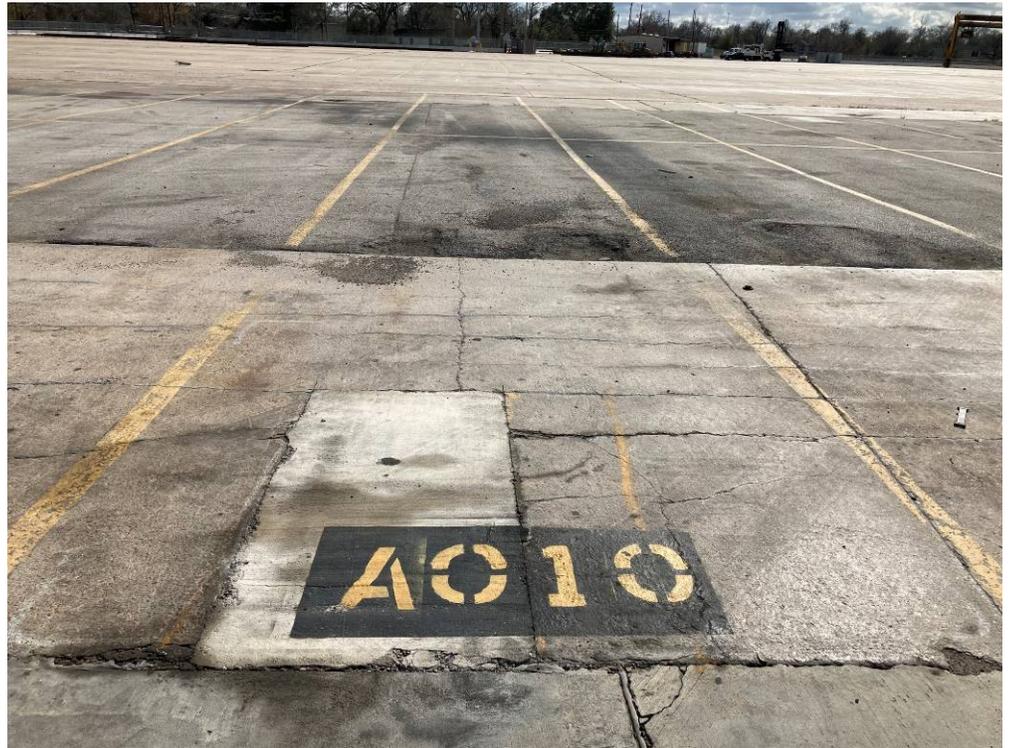
**Photo No.**  
**1**

Slot A010, no tar-like material seeps observed where test pit (July 2020) conducted, looking south.

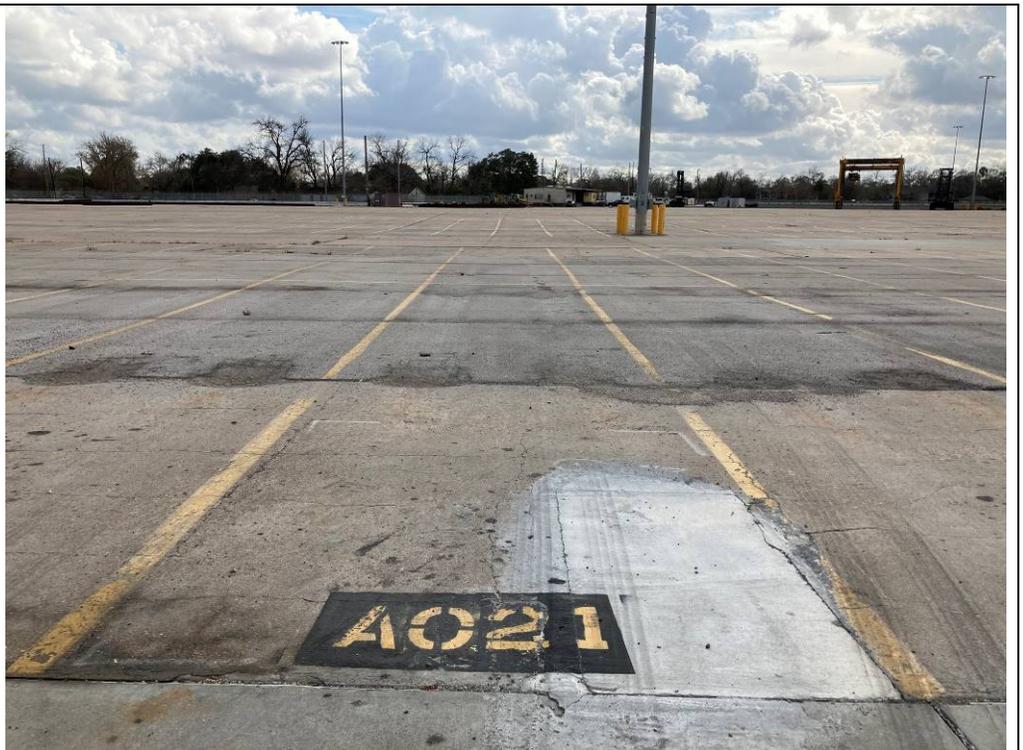
**Photo No.**  
**2**

Slot A021, no tar-like material seeps observed where test pit (July 2020) conducted, looking south.

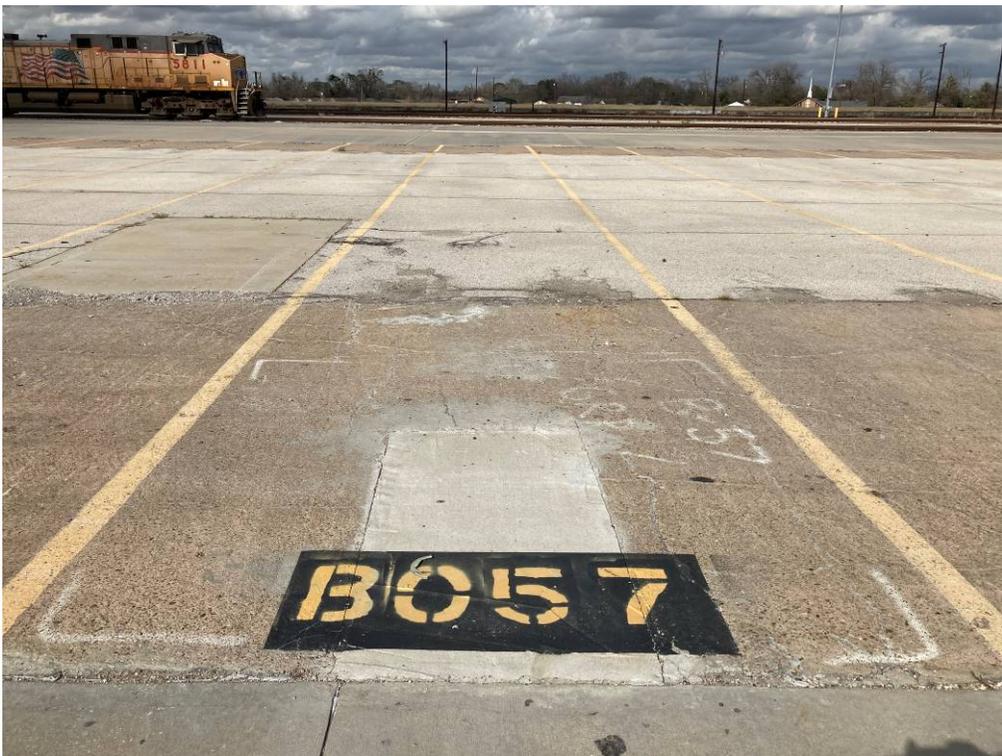
| <b>Photo No.:</b><br>3 | <b>Date:</b><br>1/6/2021 | | |

| <b>Description:</b><br><br>Slot B057, no tar-like material seeps observed where test pit (July 2020) conducted, looking north.<br><br>Lat: 29.7847472<br>Long: - 95.3195417 | | | |

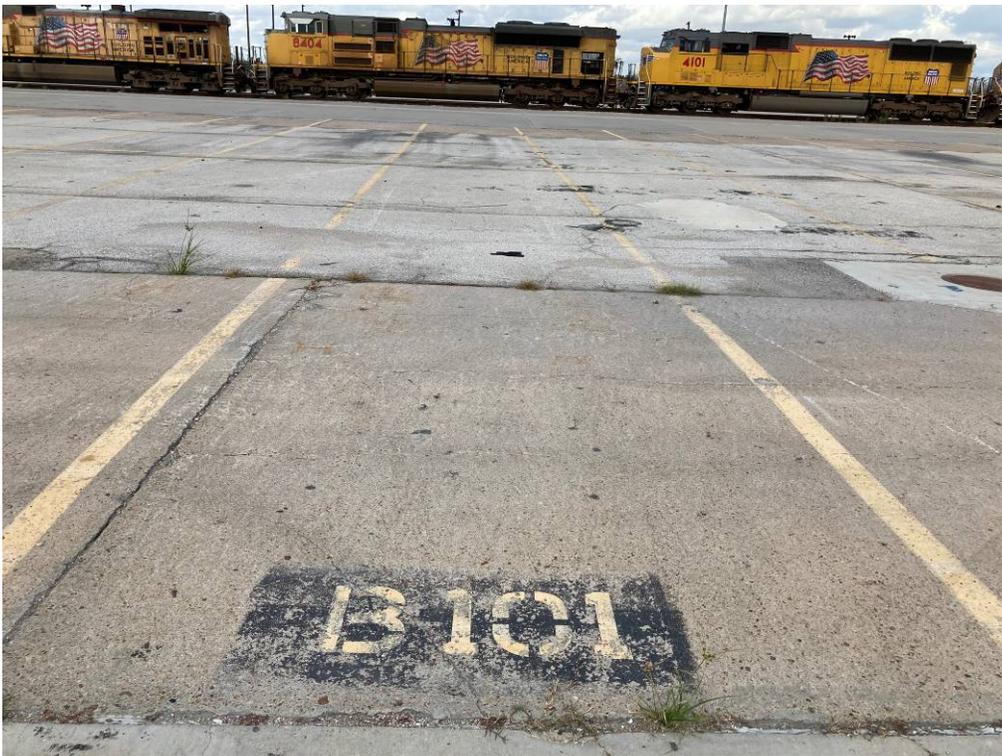
| <b>Photo No.:</b><br>4 | <b>Date:</b><br>1/6/2021 | | |

| <b>Description:</b><br><br>Slot B101, no tar-like material seeps observed, looking north.<br><br>Lat: 29.784275<br>Long: - 95.320813 | | | |

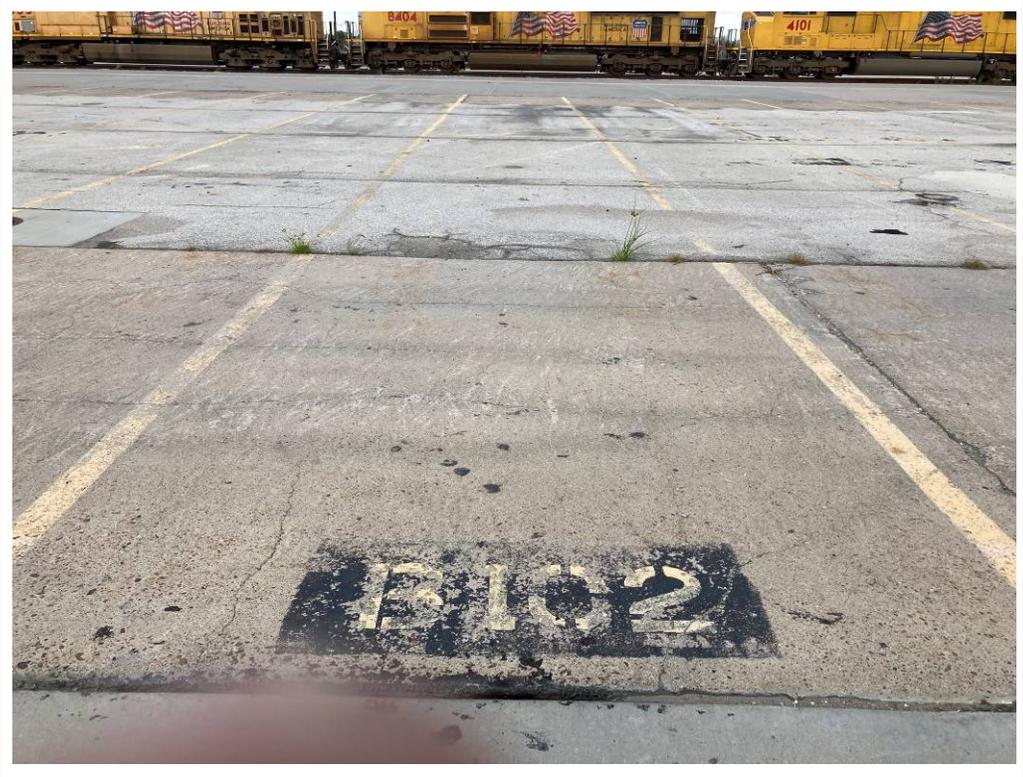
| <b>Photo No.</b><br>5 | <b>Date:</b><br>1/6/2021 |

| <b>Description:</b><br><br>Slot B102, no tar-like material seeps observed, looking north.<br><br>Lat: 29.7842203<br>Long: - 95.320827 | |

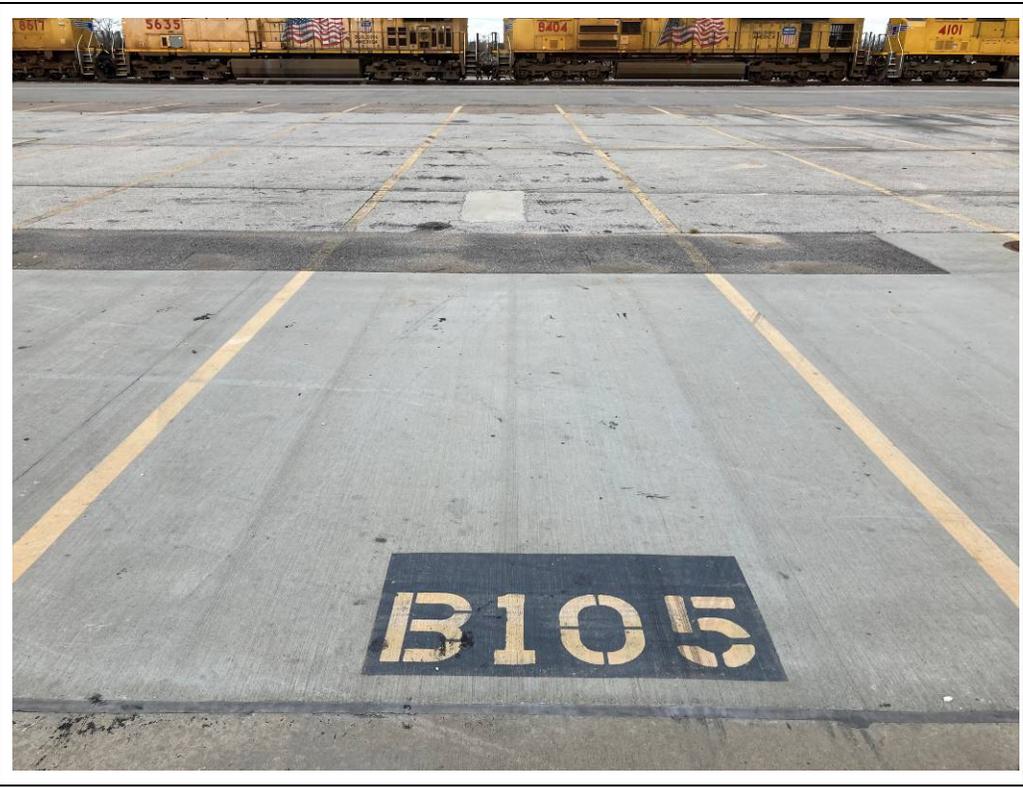
| <b>Photo No.</b><br>6 | <b>Date:</b><br>1/6/2021 |

| <b>Description:</b><br><br>Slot B105, no tar-like material seeps observed, looking north.<br><br>Lat: 29.7841472<br>Long: - 95.3208777 | |

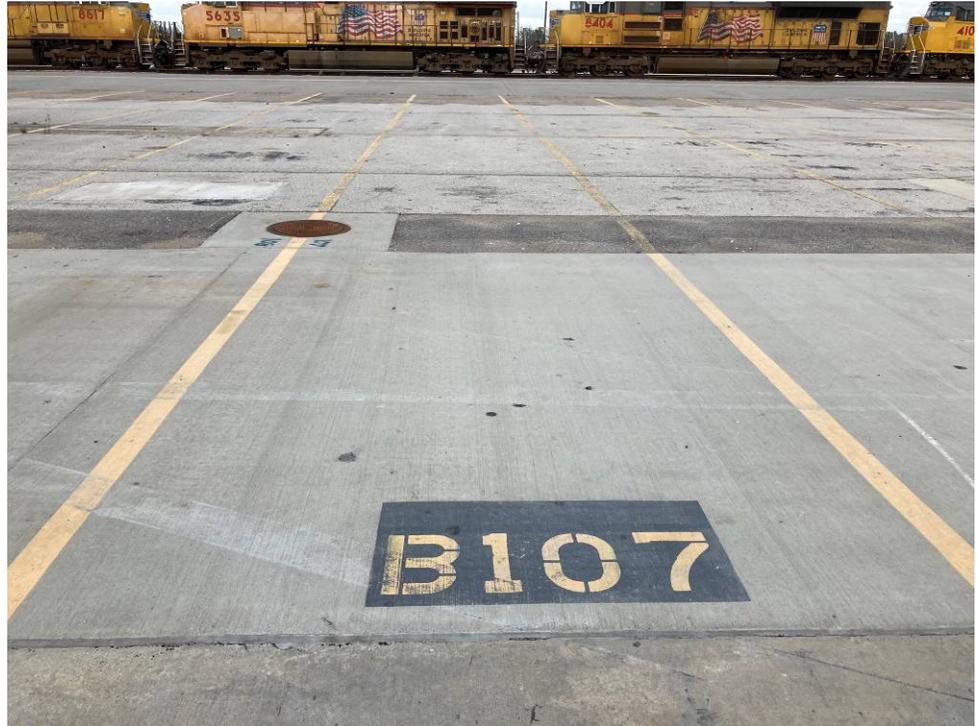
**Photo No.**  
**7**

Slot B107, view of NAPL Collection System (Sump B107/B108 and test pit in background). No tar-like material seeps observed, looking north.

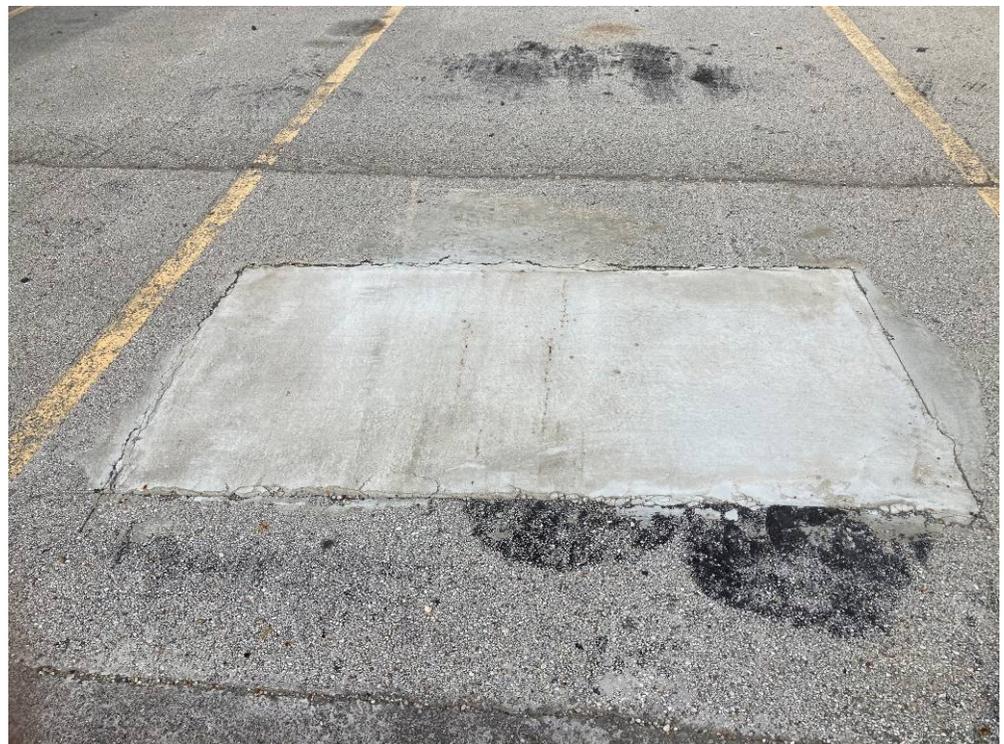
**Photo No.**  
**8**

Slot B108, no tar-like material seeps observed where test pit (July 2020) conducted, looking north.

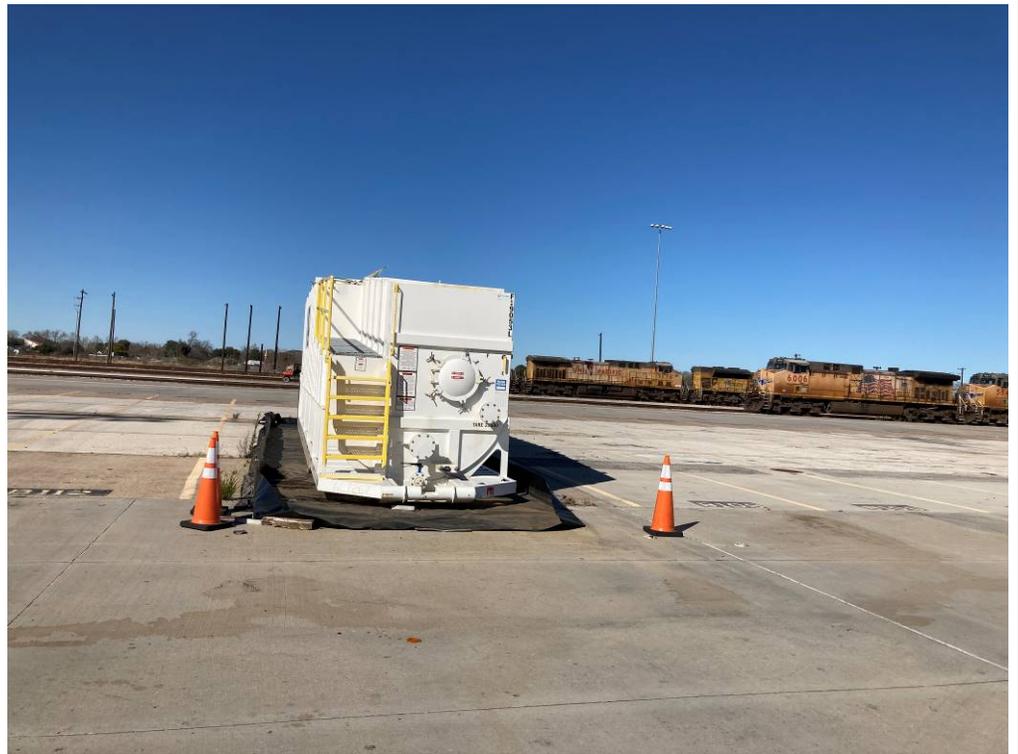
**Photo No.**  
**9**

Frac tank for storage of pumped down water from NAPL Collection Sumps (in Slot B110), looking north.

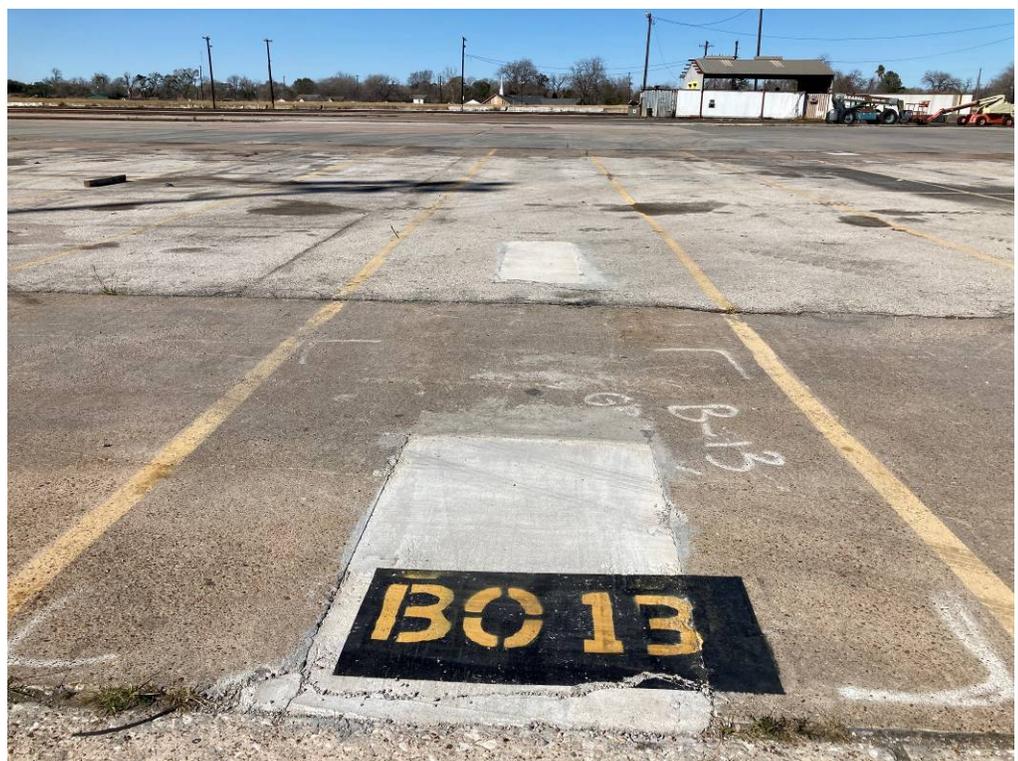
**Photo No.**  
**10**

Slot B013, no tar-like material seeps observed where test pit (July 2020) conducted, looking north.

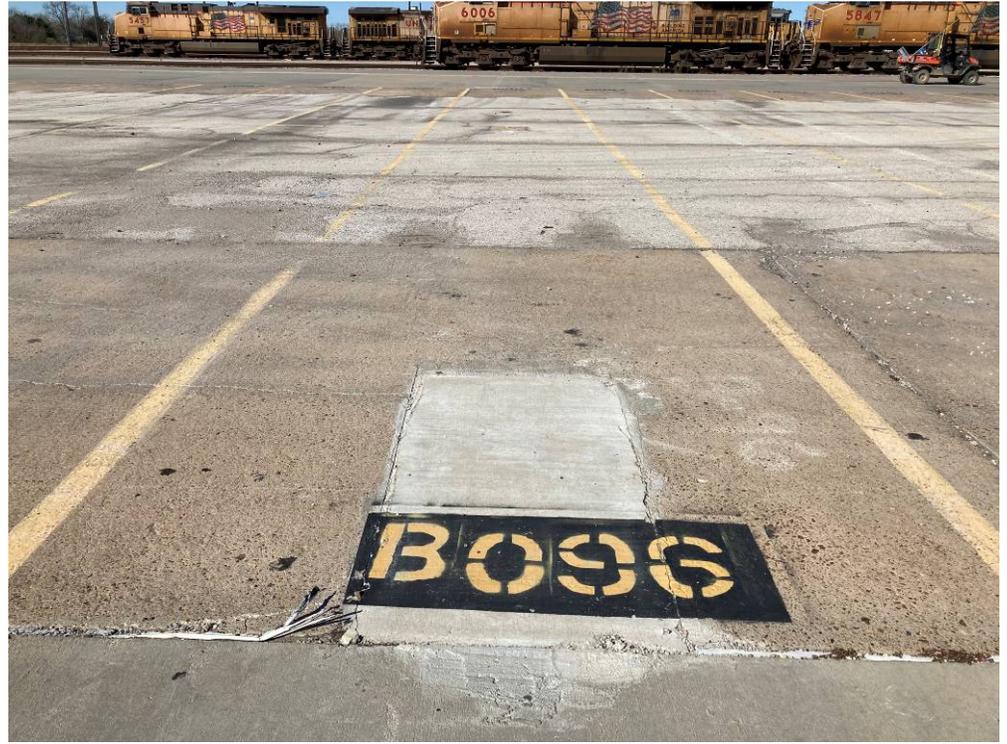
| <b>Photo No.</b><br>11 | <b>Date:</b><br>1/15/2021 |

| <b>Description:</b><br><br>Slot B096, no tar-like material seeps observed where test pit (July 2020) conducted, looking north.<br><br>Lat: 29.7842528<br>Long: - 95.3206250 | |

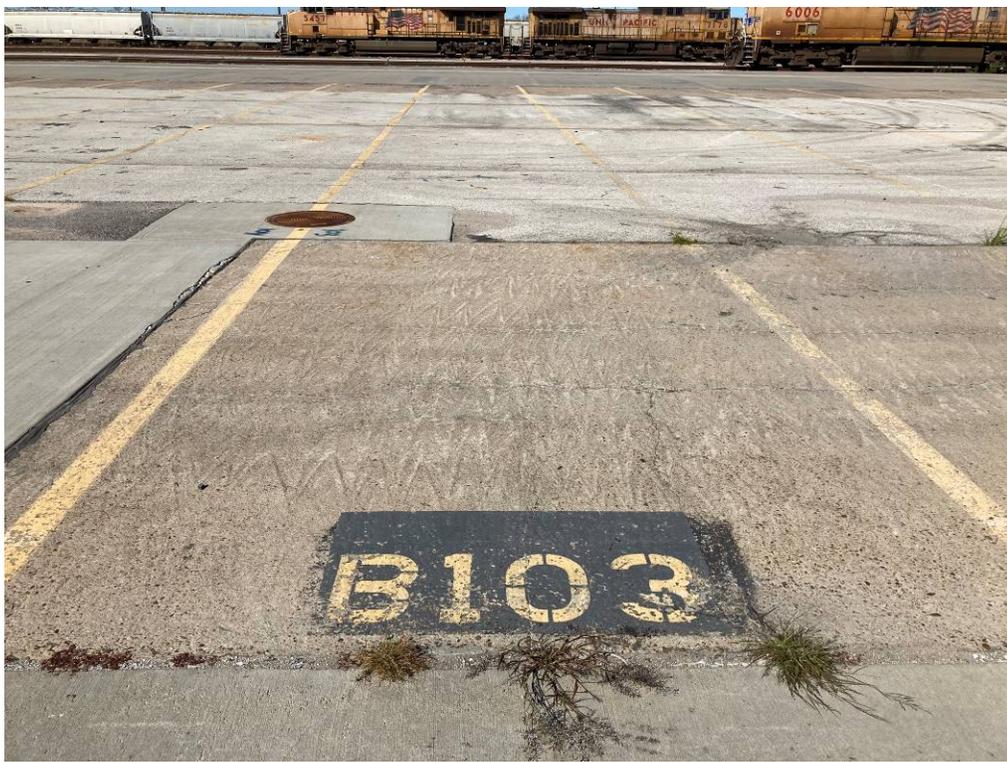
| <b>Photo No.</b><br>12 | <b>Date:</b><br>1/15/2021 |

| <b>Description:</b><br><br>Slot B103, view of NAPL Collection System (Sump 103/104 on left). No tar-like material seeps observed, looking north.<br><br>Lat: 29.7841639<br>Long: - 95.3208694 | |

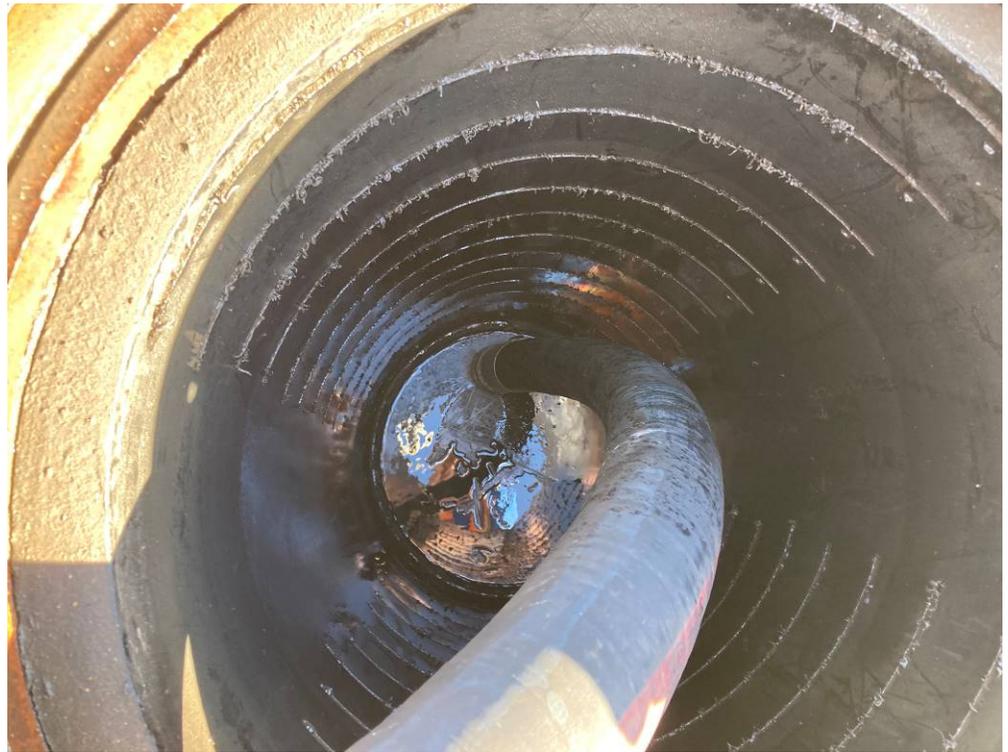
| <b>Photo No.</b><br><b>13</b> | <b>Date:</b><br>1/15/2021 |

Sump 1 (B099/B100), View of NAPL Collection Sump during a pump down. No NAPL noted in the sump. No sheen or odor noted on water recharge collected in the sump.

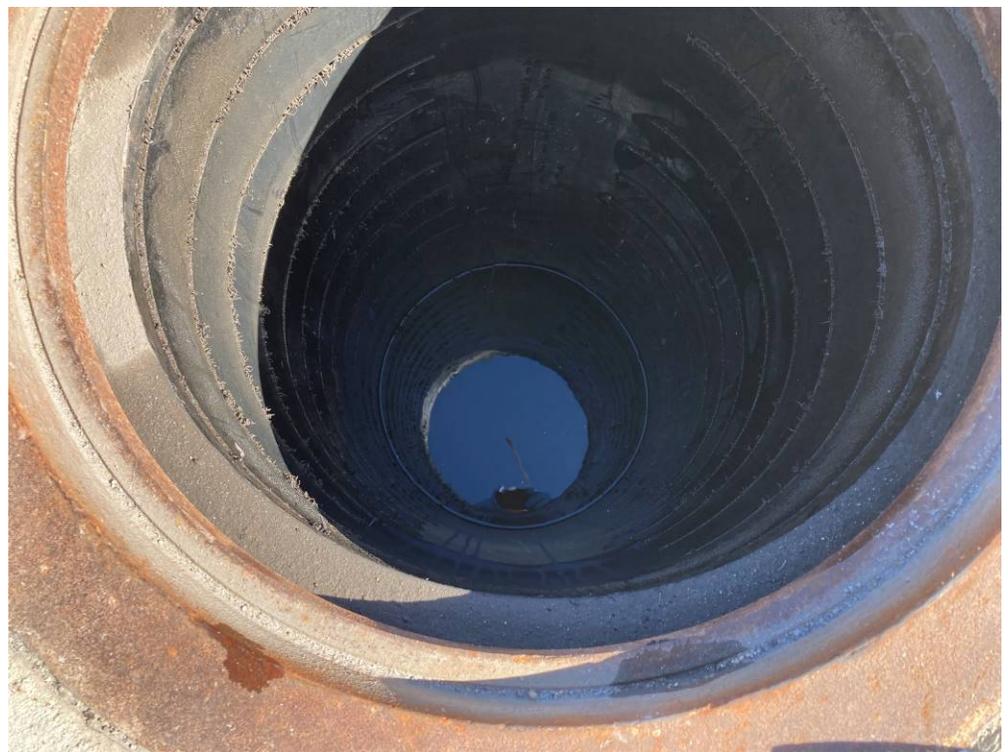
| <b>Photo No.</b><br><b>14</b> | <b>Date:</b><br>1/15/2021 |

Sump 1 (B099/B100), after pump down, 43 inches of freeboard in sump, no sheen or odor noted.

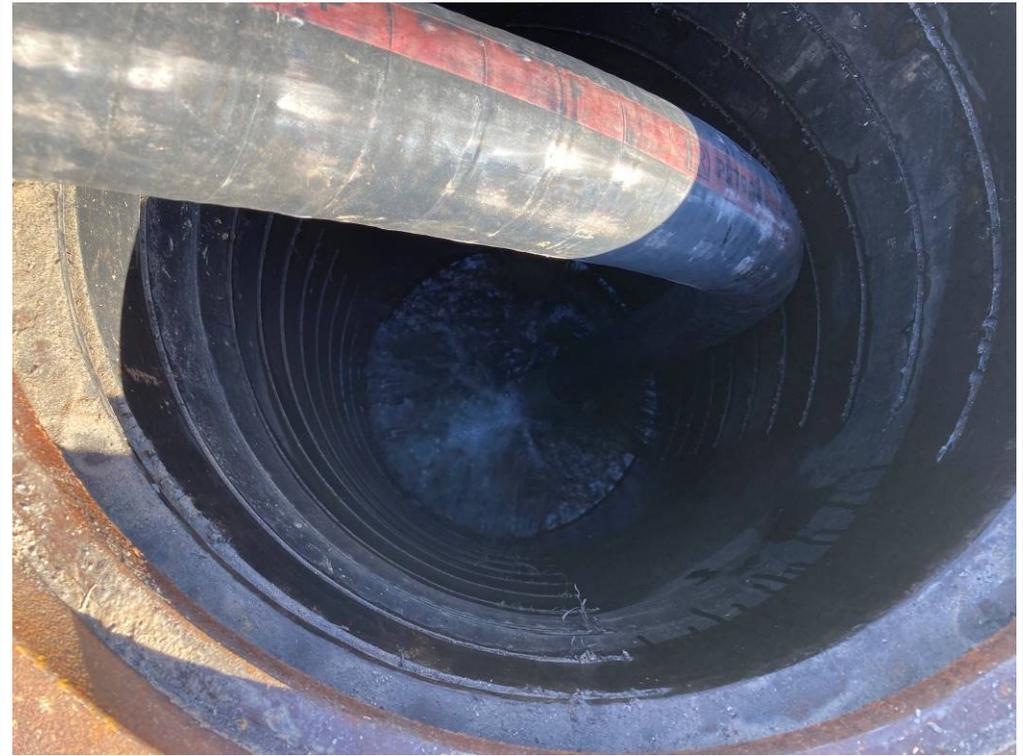
| <b>Photo No.</b><br><b>15</b> | <b>Date:</b><br>1/15/2021 |

Sump 2 (B103/B104), View of NAPL Collection Sump during a pump down. No NAPL noted in the sump. No sheen or odor noted on water recharge collected in the sump.

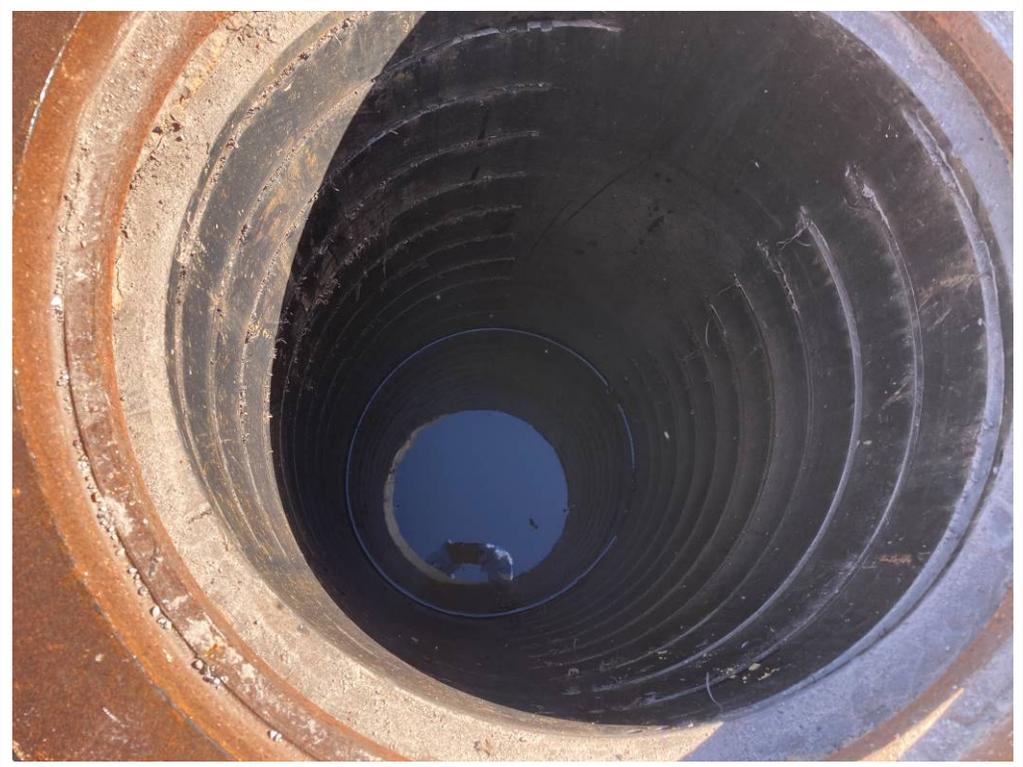
| <b>Photo No.</b><br><b>16</b> | <b>Date:</b><br>1/15/2021 |

Sump 2 (B103/B104), after pump down, 39 inches of freeboard in sump, no sheen or odors noted.

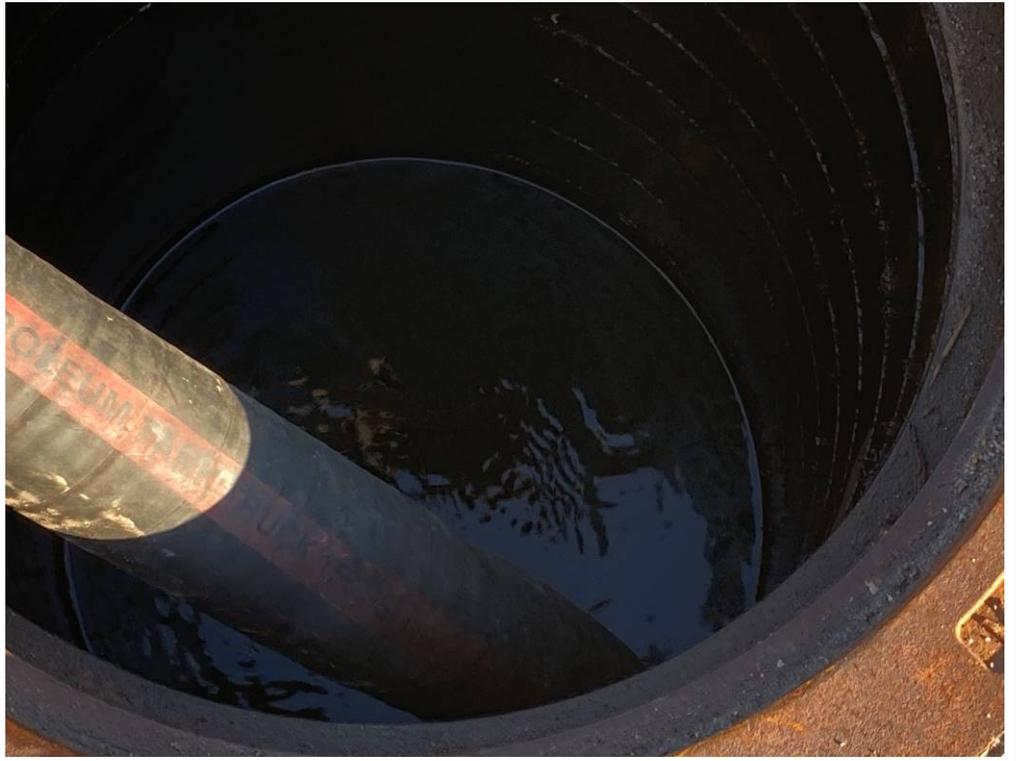
**Photo No.**  
**17**

Sump 3 (B107/B108), View of NAPL Collection Sump during a pump down. No NAPL noted in the sump. No sheen or odor noted on water recharge collected in the sump.

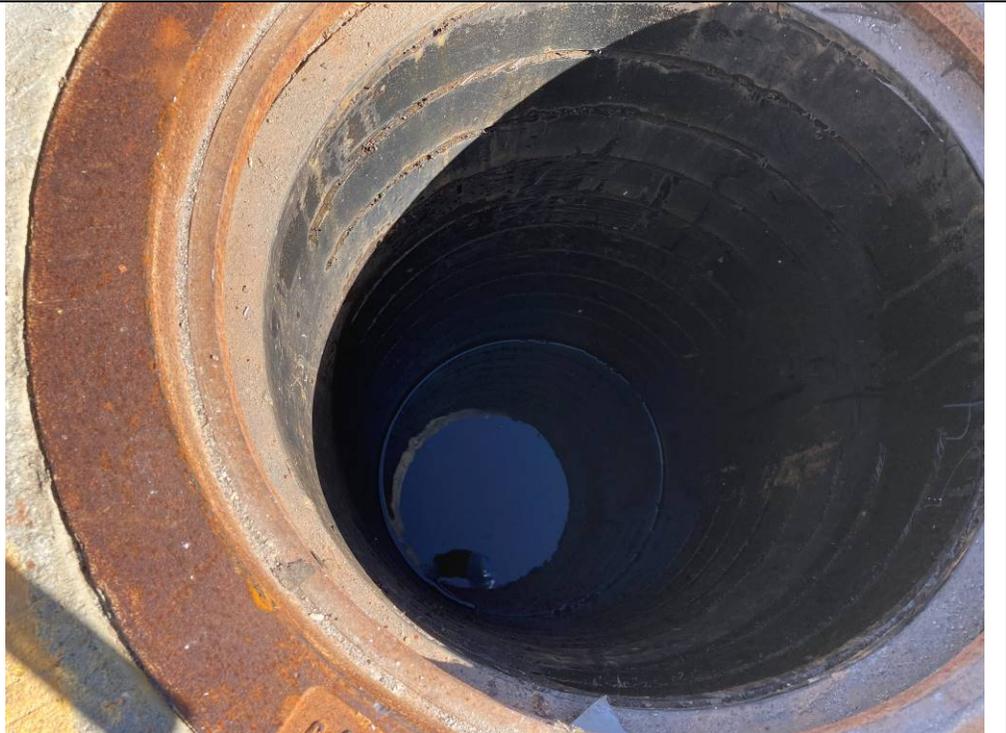
**Photo No.**  
**18**

Sump 3 (B107/B108), after pump down, 37.5 inches of freeboard in sump. No sheen, odor or tar-like material observed.

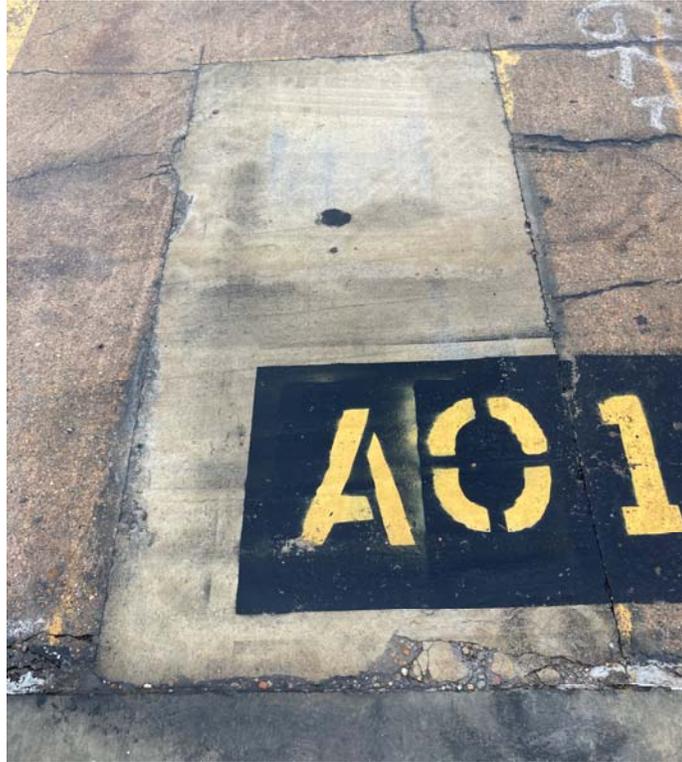
**Photo No.**  
**19**

Slot A010, no tar-like material seeps observed where test pit (July 2020) conducted, pavement wet from recent rain, looking south.

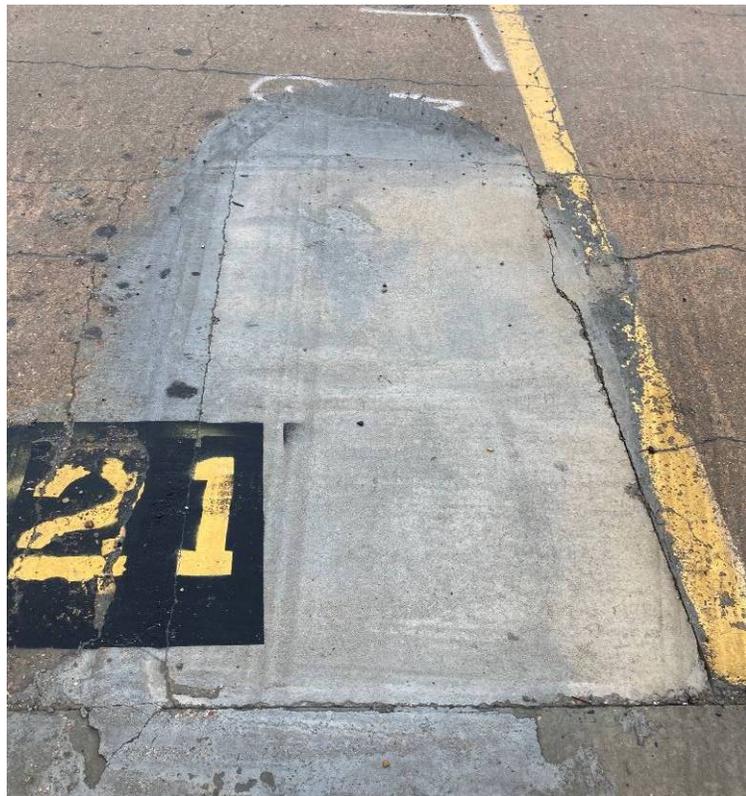
**Photo No.**  
**20**

Slot A021, no tar-like material seeps observed where test pit (July 2020) conducted, pavement wet from recent rain, looking south.

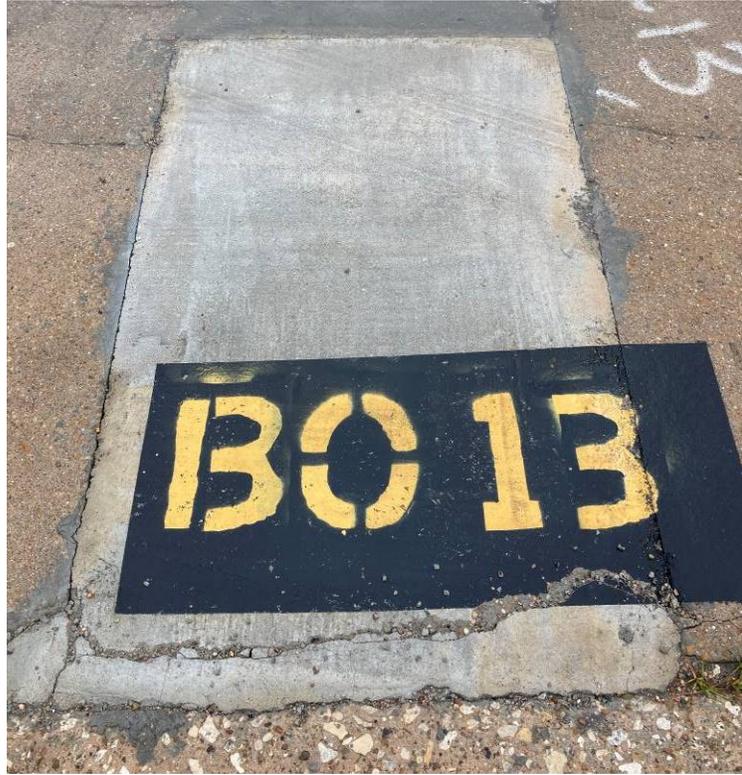
| <b>Photo No.</b><br><b>21</b> | <b>Date:</b><br>1/22/2021 |

| <b>Description:</b><br><br>Slot B013, no tar-like material seeps observed where test pit (July 2020) conducted, pavement wet from recent rain, looking north.<br><br>Lat: 29.785217<br>Long: - 95.318261 | |

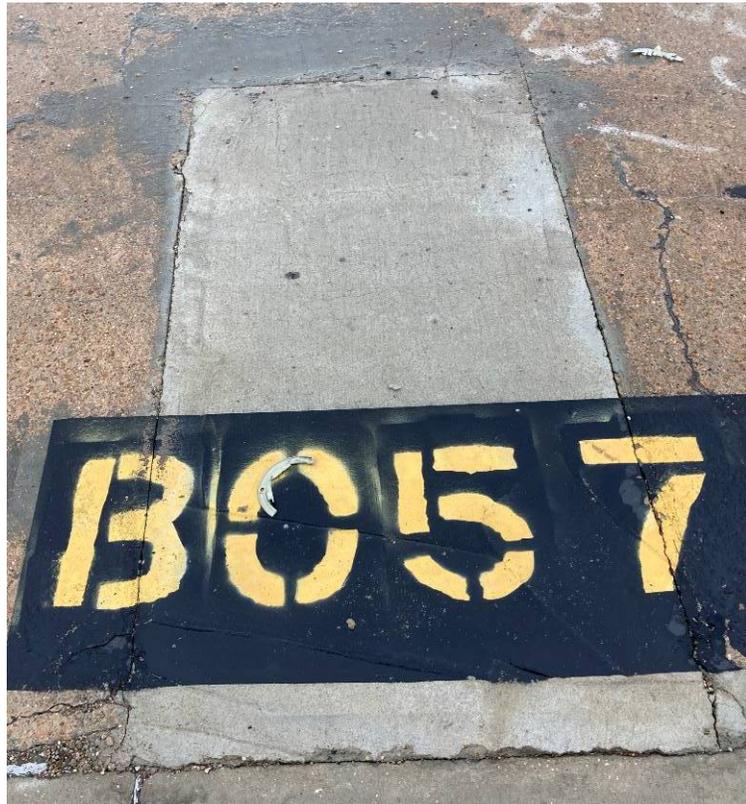
| <b>Photo No.</b><br><b>22</b> | <b>Date:</b><br>1/22/2021 |

| <b>Description:</b><br><br>Slot B057, no tar-like material seeps observed where test pit (July 2020) conducted, pavement wet from recent rain, looking north.<br><br>Lat: 29.7847472<br>Long: - 95.3195417 | |

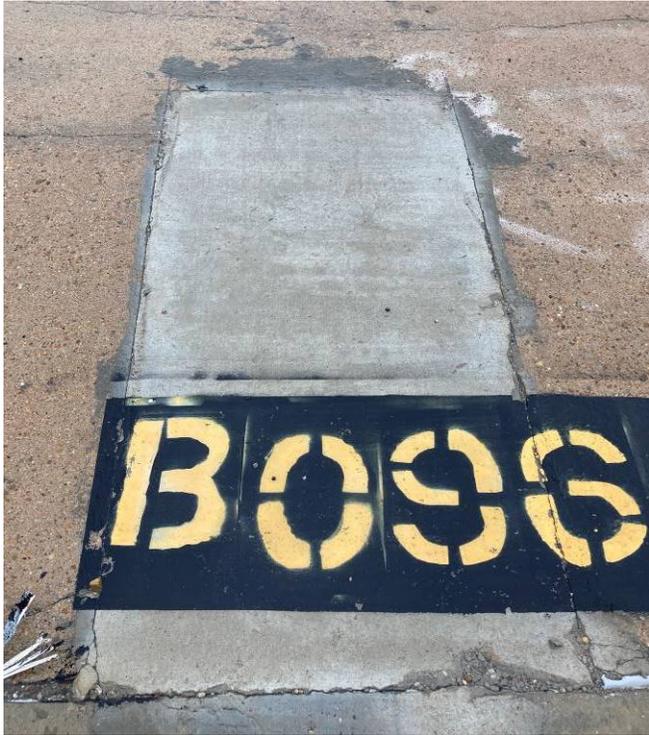
| <b>Photo No.:</b><br>23 | <b>Date:</b><br>1/22/2021 | | |

| <b>Description:</b><br><br>Slot B096, no tar-like material seeps observed where test pit (July 2020) conducted, pavement wet from recent rain, looking north.<br><br>Lat: 29.7842528<br>Long: - 95.3206250 | | | |

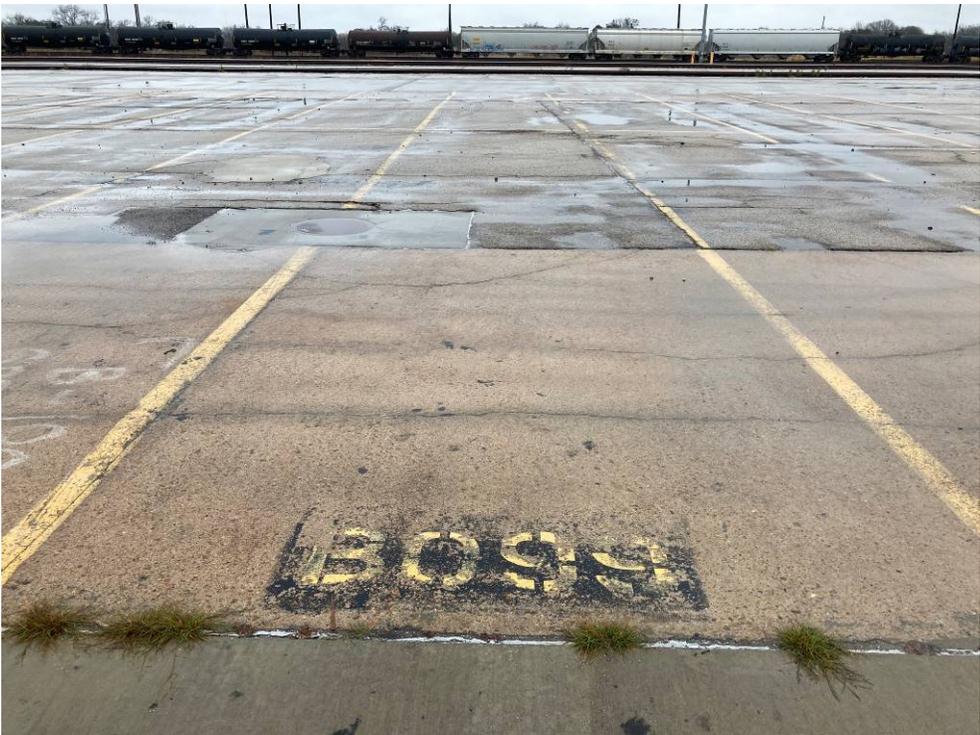
| <b>Photo No.:</b><br>24 | <b>Date:</b><br>1/22/2021 | | |

| <b>Description:</b><br><br>Slot B099, view of NAPL Collection System (Sump 099/100 in background). No tar-like material seeps observed, standing water on pavement from recent rain, looking north.<br><br>Lat: 29.7842472<br>Long: - 95.3206944 | | | |

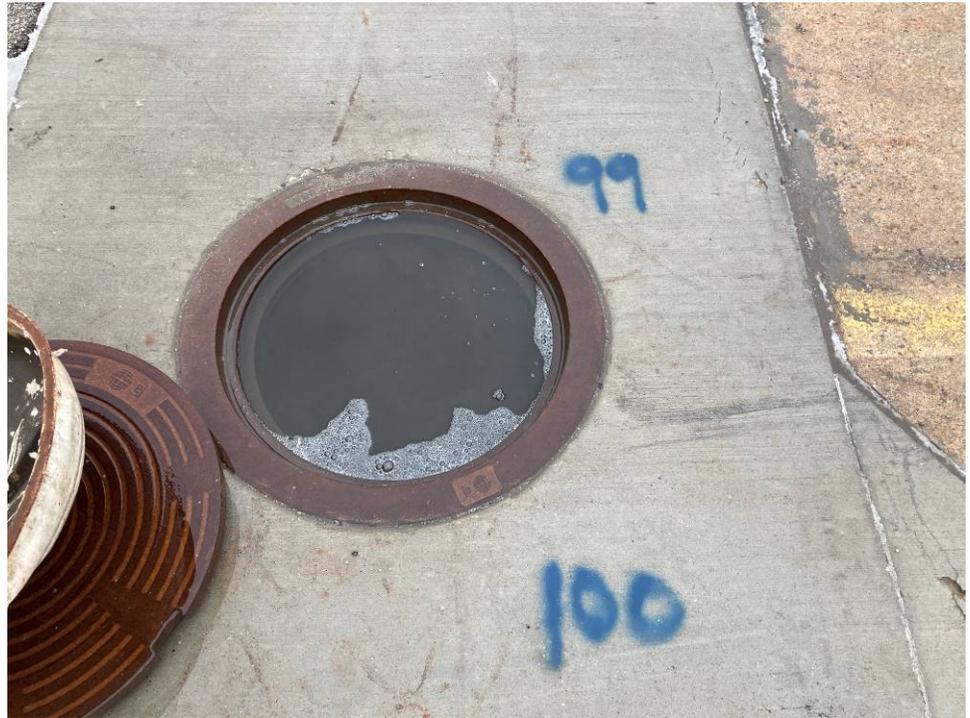
| <b>Photo No.:</b><br>25 | <b>Date:</b><br>1/22/2021 |

Sump 1 (B099/B100), 0 inches of freeboard in sump, no sheen or odor noted. Pavement wet from recent rain.

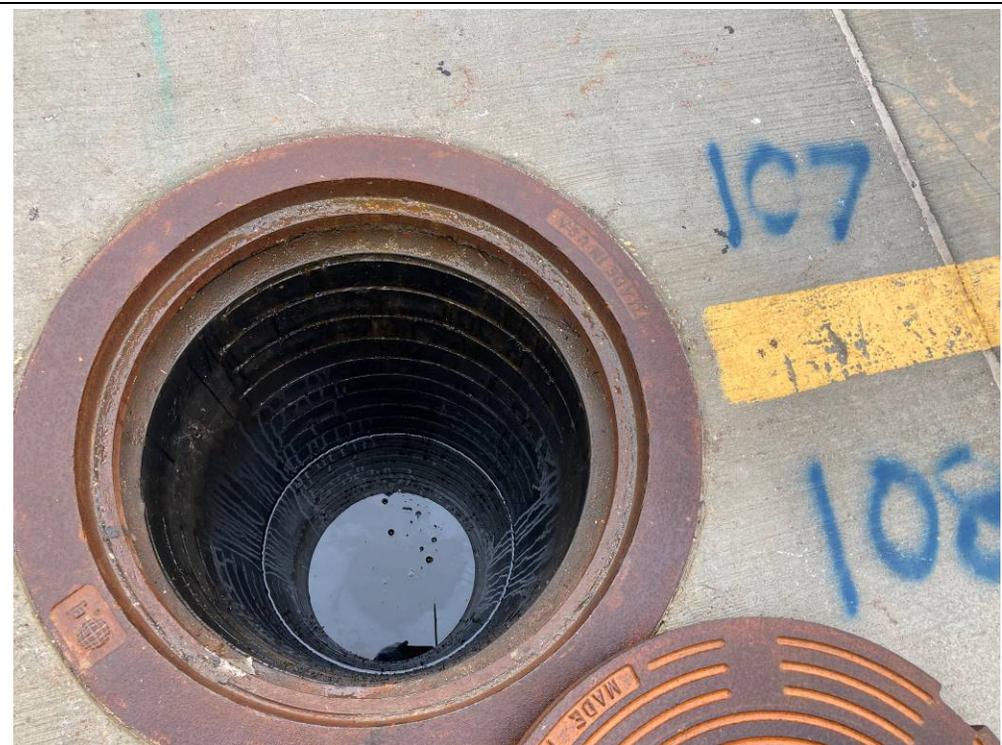
| <b>Photo No.:</b><br>26 | <b>Date:</b><br>1/22/2021 |

Sump 3 (B107/B108), 33 inches of freeboard in sump. Sheen noted on water in sump. No odor or tar-like material observed. Pavement wet from recent rain.

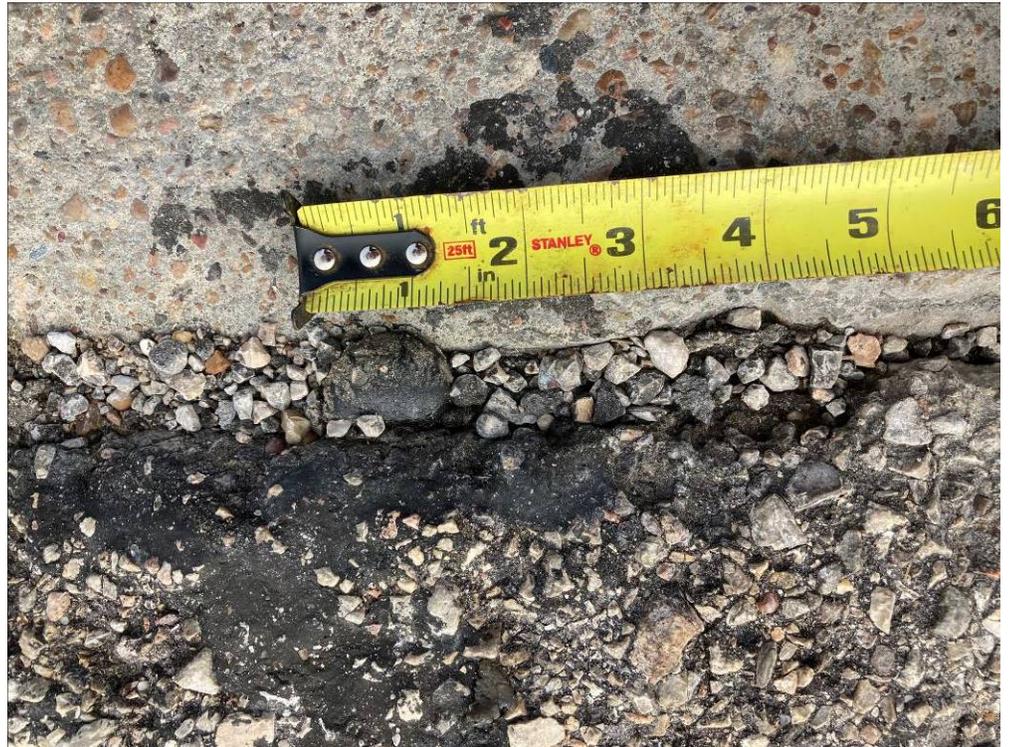
| <b>Photo No.</b><br><b>27</b> | <b>Date:</b><br>1/29/2021 |

- No tar-like NAPL seeps were observed within the NAPL Collection System area during the month of January. For areas outside the NAPL Collection System, a very small amount of tar-like material was observed on the concrete surface once in stalls A022 and B101 during the January 29, 2021 inspection. The overall amount of tar-like material removed from the concrete surface during January 2021 was less than 0.1 gallons.

| <b>Description:</b><br><br>Slot A022, very small amount of tar-like material seeping at asphalt crack, material was removed.<br><br>Lat: 29.785392,<br>Long: -95.318655 | |

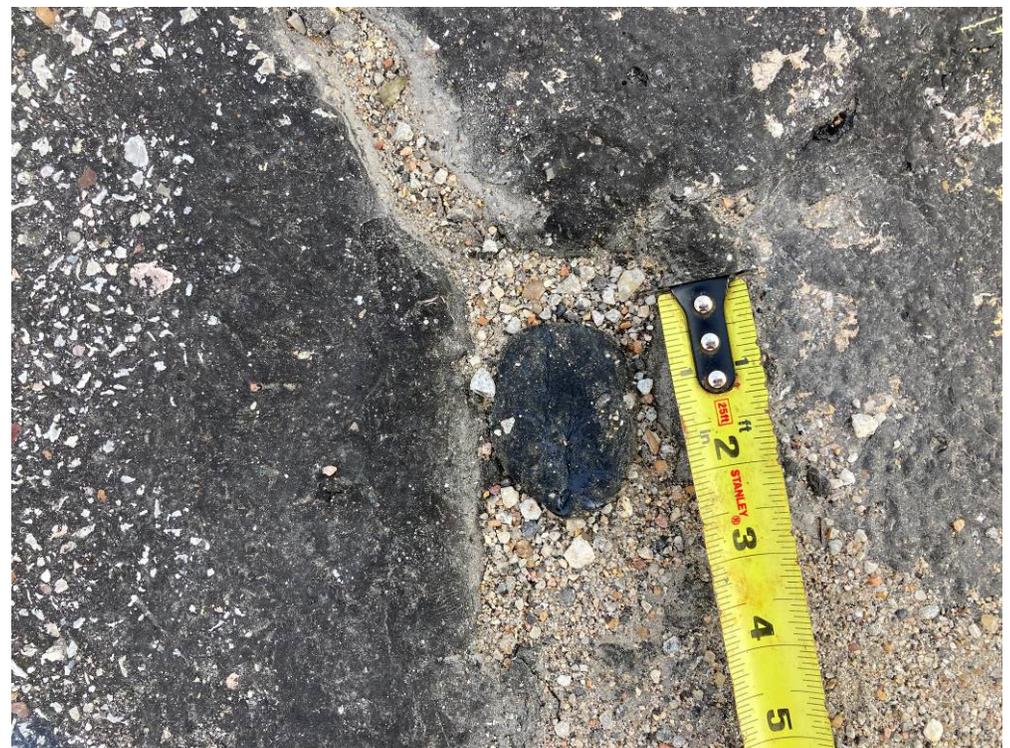
| <b>Photo No.</b><br><b>28</b> | <b>Date:</b><br>1/29/2021 |

| <b>Description:</b><br><br>Slot B101, very small amount of tar-like material seeping at asphalt crack, material was removed.<br><br>Lat: 29.784275<br>Long: - 95.320813 | |

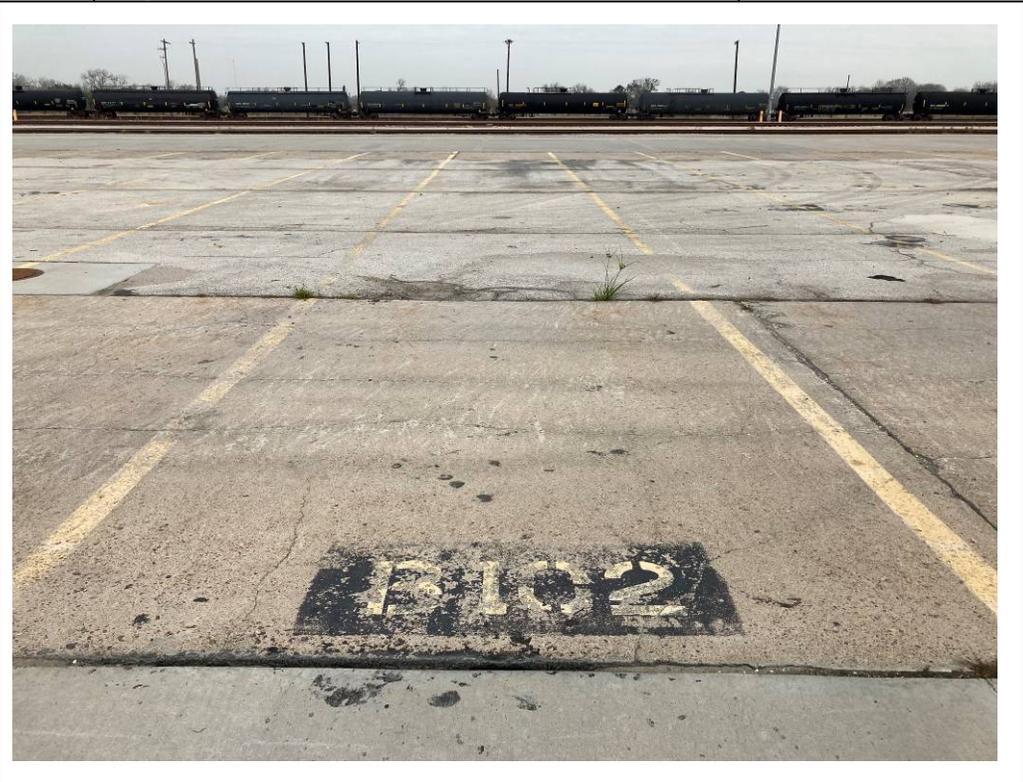
| <b>Photo No.</b><br><b>29</b> | <b>Date:</b><br>1/29/2021 |

| <b>Description:</b><br><br>Slot B102, no tar-like material seeps observed, looking north.<br><br>Lat: 29.7842203<br>Long: - 95.320827 | |
