February 12, 2021

Project No. 19119232

**RE: MONTHLY STATUS UPDATE – ENGLEWOOD INTERMODAL YARD – NAPL COLLECTION SYSTEM/CONCRETE CAP REPAIRS  
UNION PACIFIC RAILROAD HOUSTON WOOD PRESERVING WORKS FACILITY  
4910 LIBERTY ROAD FACILITY, HOUSTON, TEXAS  
POST-CLOSURE CARE PERMIT NO. HW-50343; INDUSTRIAL SWR NO. 31547**

# Weekly Inspection Photolog

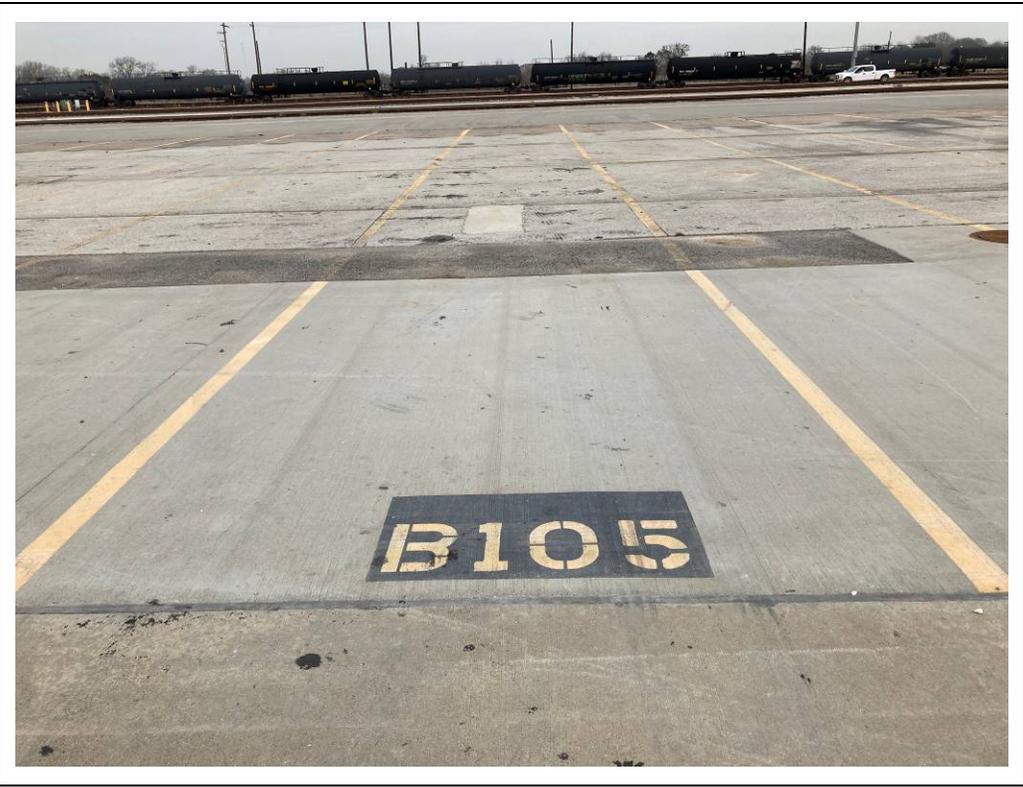
| <b>Photo No.</b><br><b>30</b> | <b>Date:</b><br>1/29/2021 |

| <b>Description:</b><br><br>Slot B105, no tar-like material seeps observed, looking north.<br><br>Lat: 29.7841472<br>Long: - 95.3208777 | |

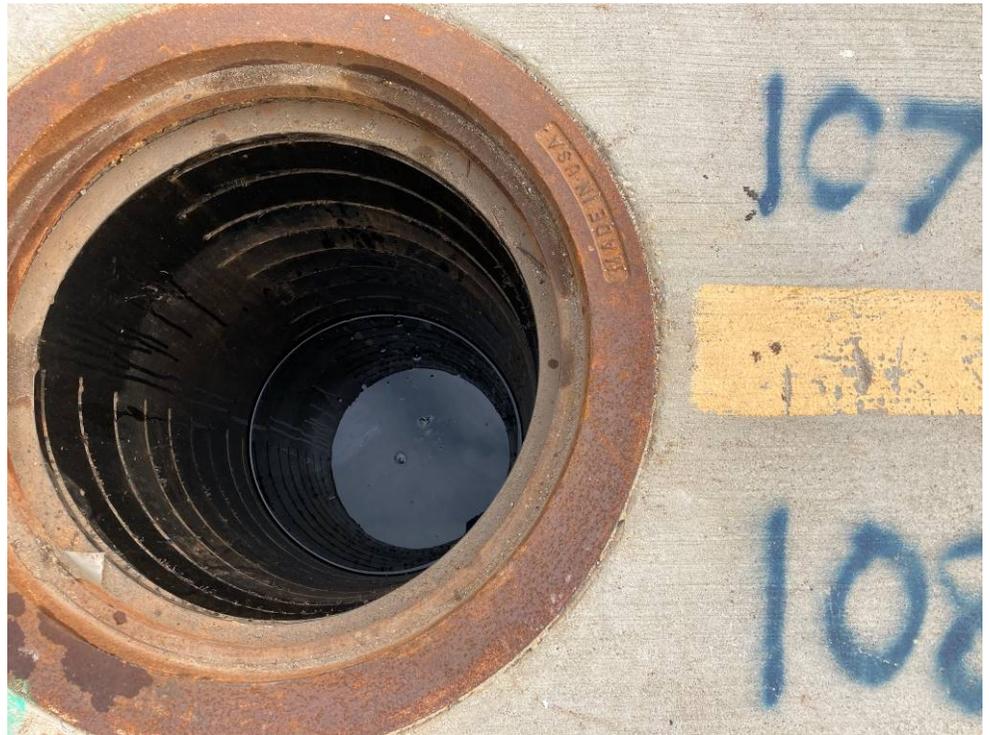
| <b>Photo No.</b><br><b>31</b> | <b>Date:</b><br>1/29/2021 |

| <b>Description:</b><br><br>Sump 3 (B107/B108), 30 inches of freeboard in sump. Sheen noted on water in sump. No odor or tar-like material observed.<br><br>Lat: 29.7842861<br>Long: - 95.3208611 | |

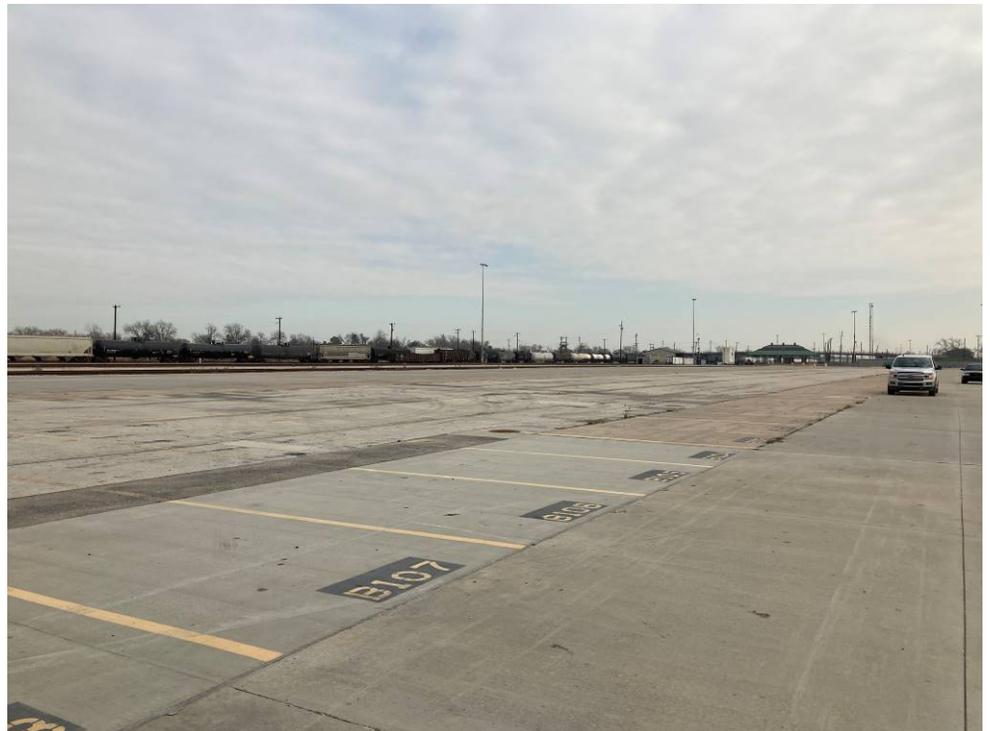
| <b>Photo No.</b><br><b>32</b> | <b>Date:</b><br>1/29/2021 |

| <b>Description:</b><br><br>Slots B108-B097, NAPL collection system visible in background, residual brown staining observed along the crack in the asphalt, looking northeast.<br><br>Lat: 29.784116<br>Long: -95.321022 | |

- No widespread seep water was observed in the paved areas during the January 2021 inspections. UPRR will continue to have USES pressure wash the areas where the brown staining and seeps are observed as needed.

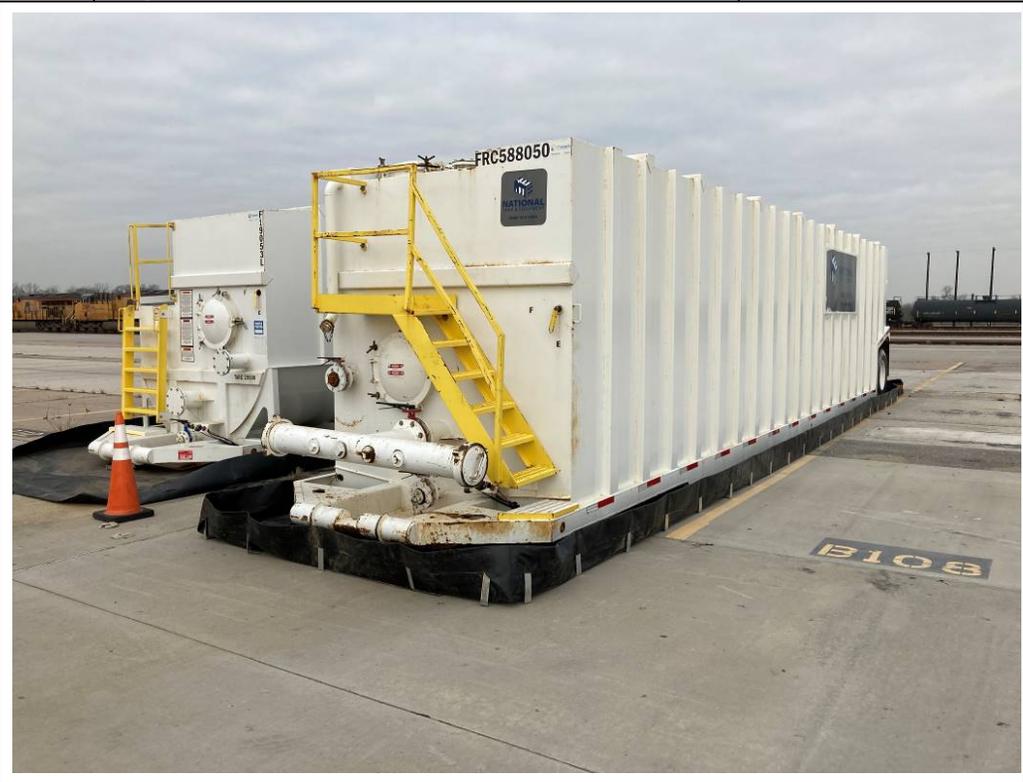
| <b>Photo No.:</b><br>33 | <b>Date:</b><br>1/29/2021 |

- During the last week of January, a second frac tank was staged at parking slot B109 (Photo 33) and a vacuum box was staged near stalls C129 and C131 (Photo 34) containing waste from UPRR activities not related to the Site. These wastes will be disposed of in accordance with state and federal regulations.

Frac tank for storage of pumped down water from NAPL Collection Sumps (in slot B110), looking northwest. Frac tank staged in slot B109 is from other UPRR activities and not related to Site activities.

Frac tank for storage of pumped down water from NAPL Collection Sumps was taken off-site on 1/29/2021 (after photo was taken).

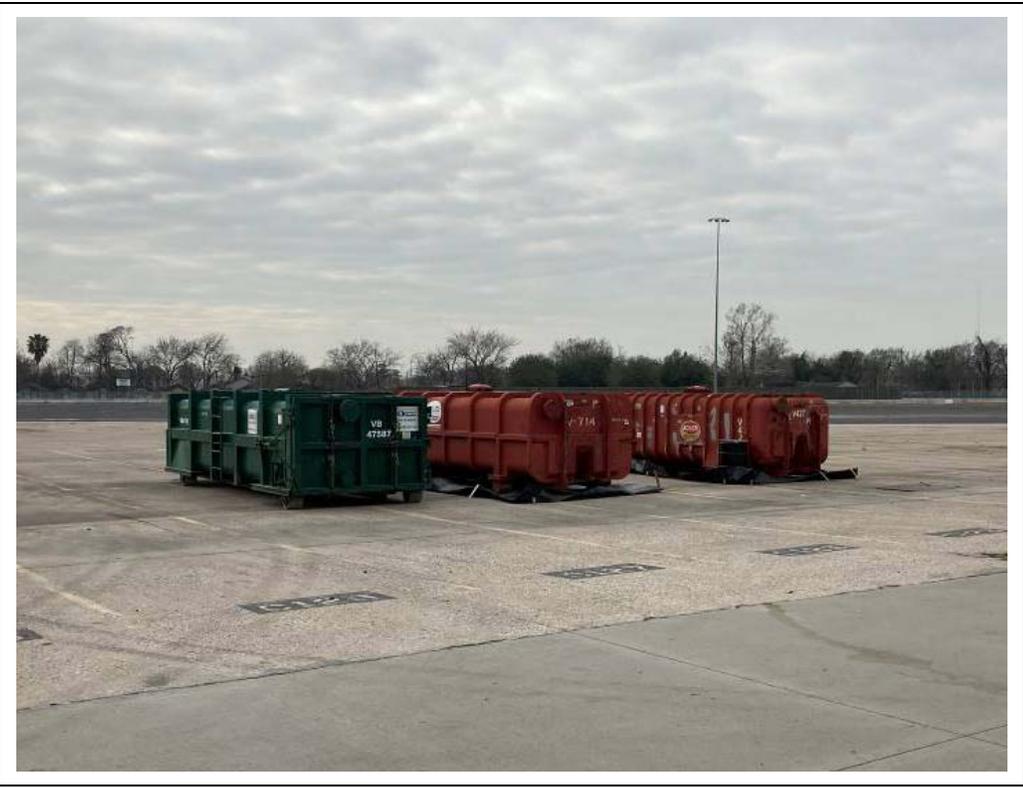
| <b>Photo No.:</b><br>34 | <b>Date:</b><br>1/29/2021 |

Slots C127-C131, the two red vacuum boxes containing water from storm sewer obstruction removal activities, looking south. The green vacuum box contains waste not related to site activities (other UPRR activities).
