July 15, 2021

Project No. 19119232

**RE: MONTHLY STATUS UPDATE – ENGLEWOOD INTERMODAL YARD – NAPL COLLECTION SYSTEM/CONCRETE CAP REPAIRS
UNION PACIFIC RAILROAD HOUSTON WOOD PRESERVING WORKS FACILITY
4910 LIBERTY ROAD FACILITY, HOUSTON, TEXAS
POST-CLOSURE CARE PERMIT NO. HW-50343; INDUSTRIAL SWR NO. 31547**

Weekly Inspection Photolog

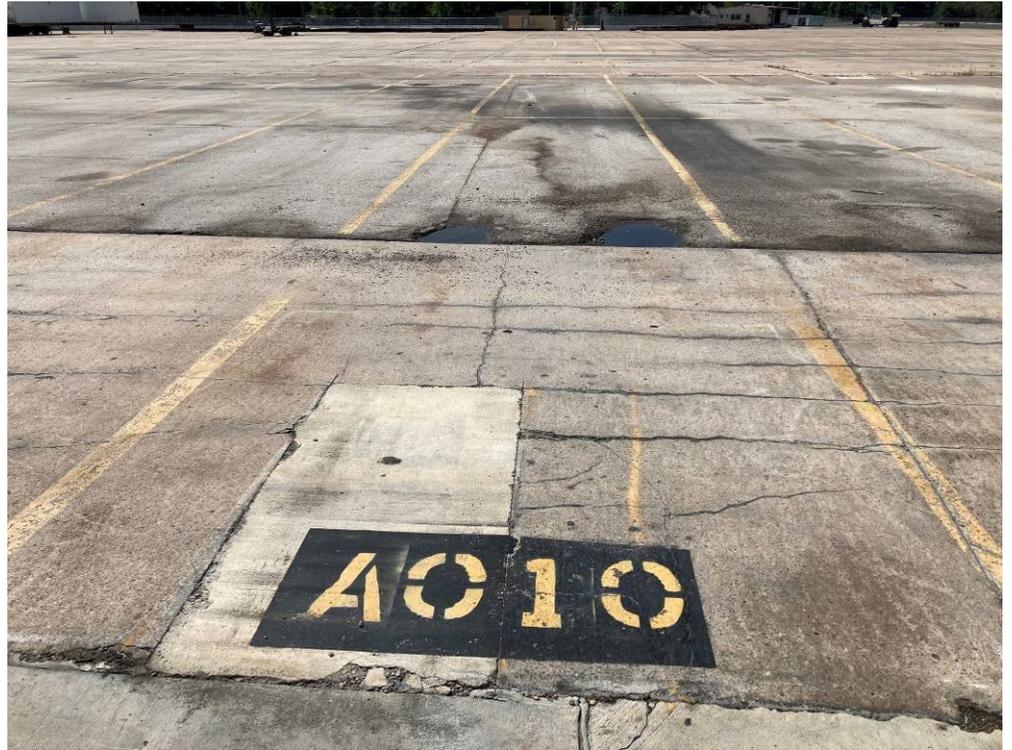
Photo No.
1

- Localized brown staining and seep water along cracks in the paved areas were observed during the inspections on June 2 and June 9, 2021 (Photo Nos. 1, 4, 10, 12, and 16). Widespread brown staining and water seeps that were observed in the A and B rows on June 16, 2021 (Photo Nos. 17 and 18). UPRR Contractor United States Environmental Service (USES) pressure washed the areas using pavement washing equipment and vacuumed the fluids (Photo No. 25 and 26), which were placed in the tote that was onsite holding wastewater from the cleanup event on June 16, 2021. The tote was disposed of on June 28, 2021. A copy of the waste manifest is provided in Attachment B. Following the pressure washing, no new seeping or staining was observed during the June 23 and June 30, 2021 inspections. UPRR will continue to have a remediation contractor pressure wash the areas where the brown staining and seeps are observed as needed.

Slot A010, no tar-like material seeps observed where test pit conducted (July 2020), brown staining observed along asphalt cracks, water from recent rain event, looking southeast.

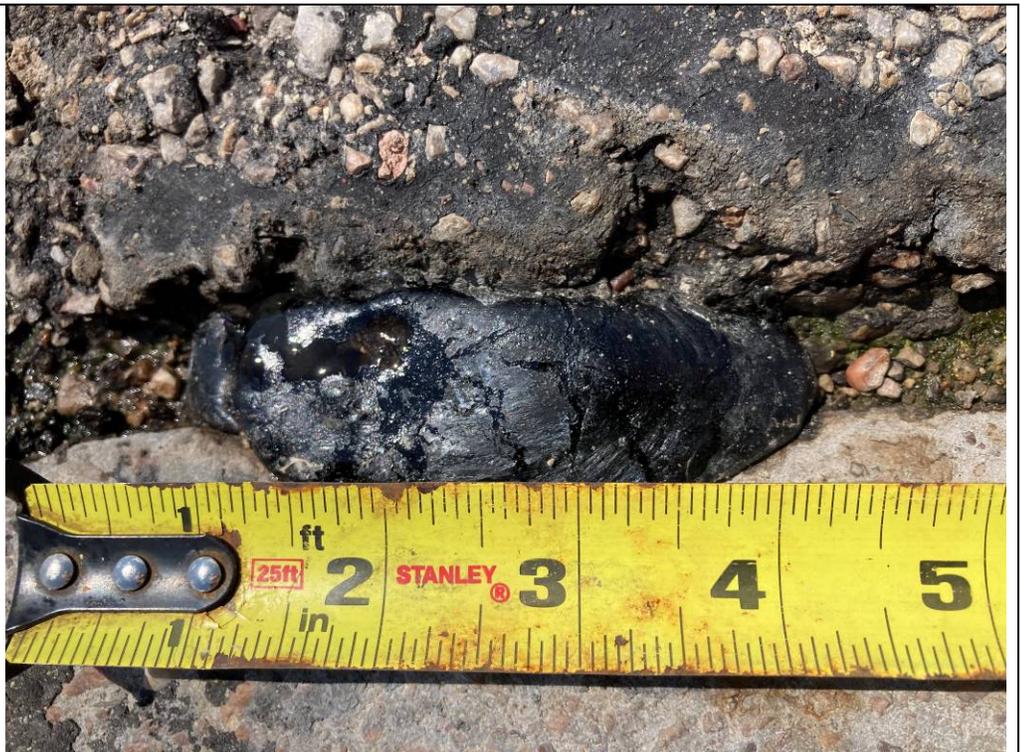
Photo No.
2

Slot A022, very small amount of tar-like material seeping at asphalt crack, material was removed.

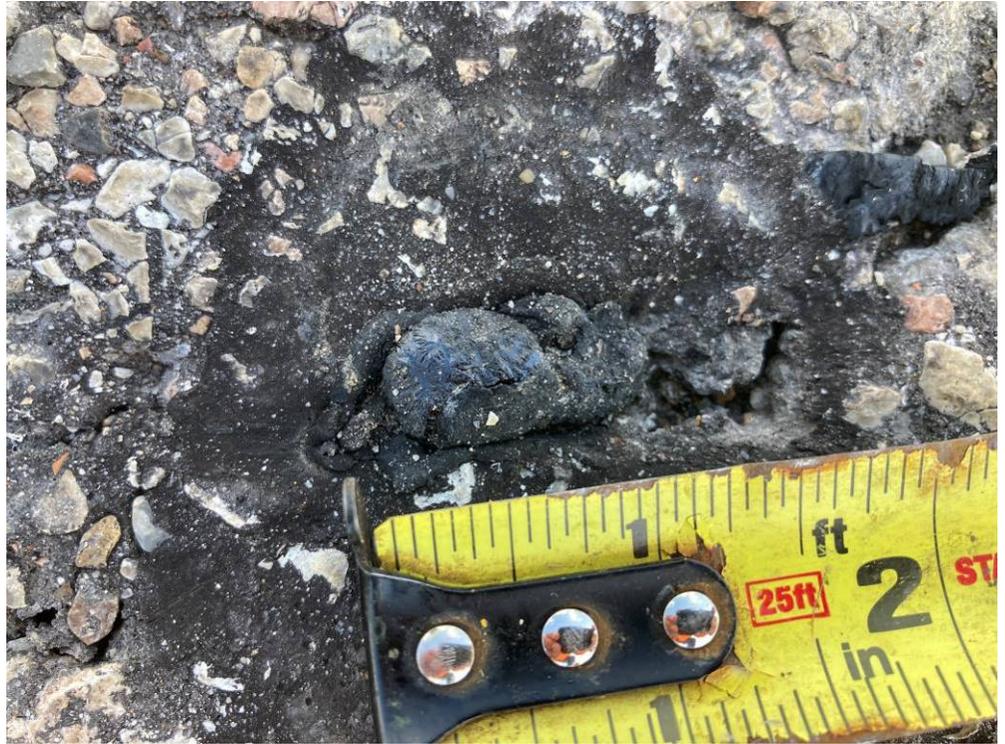
Photo No.
3

Slot B057, very small amount of tar-like material seeping at asphalt crack (not at July 2020 test pit), material was removed.

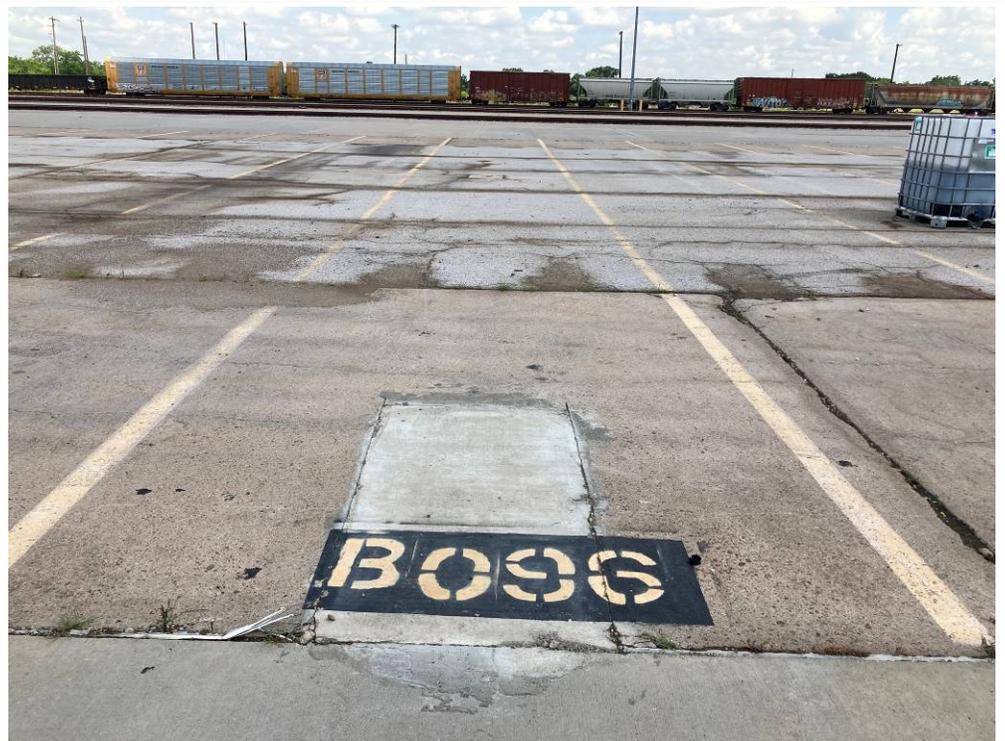
Photo No.
4

Slot B096, no tar-like material seeps observed where test pit conducted (July 2020), brown staining observed along asphalt cracks, looking northwest.

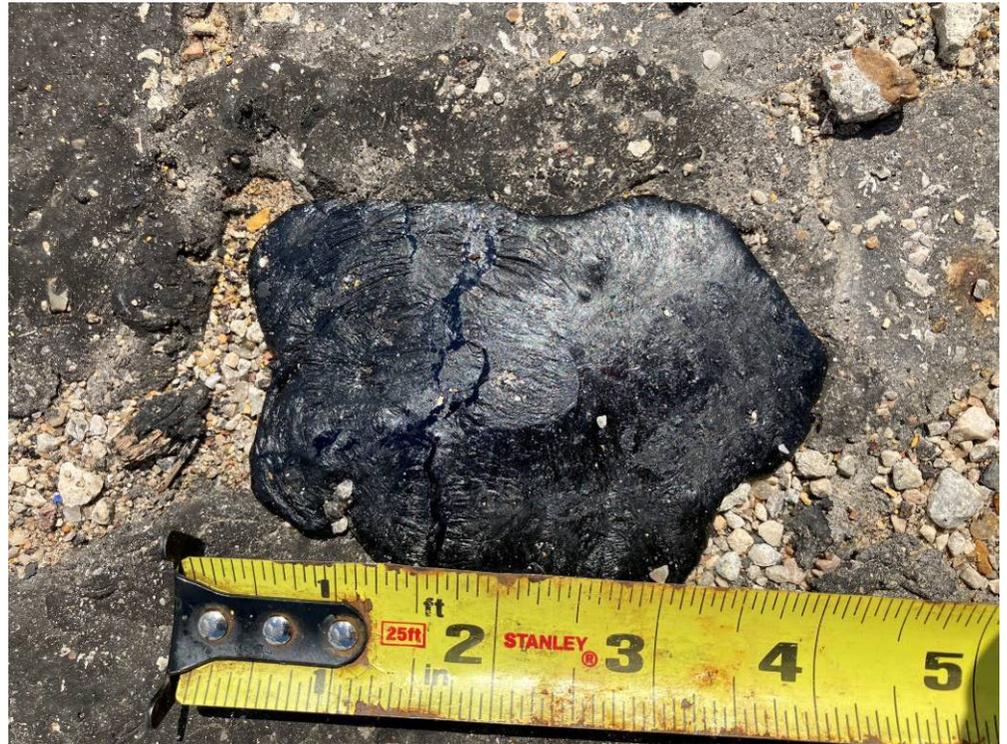
Photo No. 5	Date: 6/2/2021
-----------------------	--------------------------

Slot B101, small amount of tar-like material seeping at asphalt crack, material was removed.

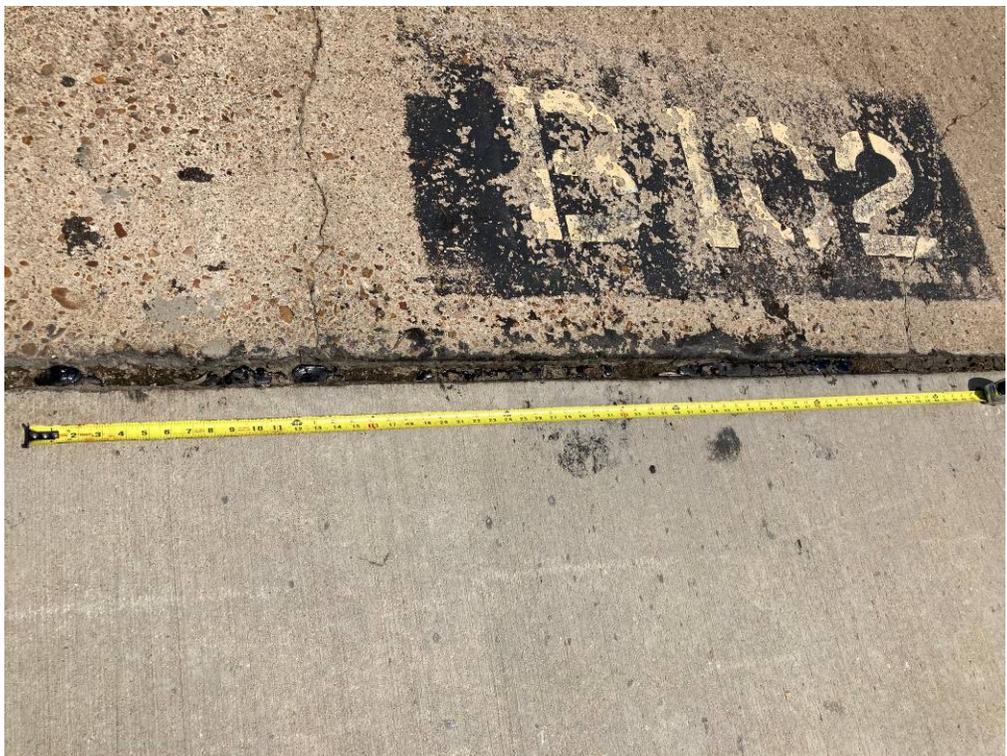
Photo No. 6	Date: 6/2/2021
-----------------------	--------------------------

Slot B102, small amount of tar-like material seeping at pavement joint, material was removed.

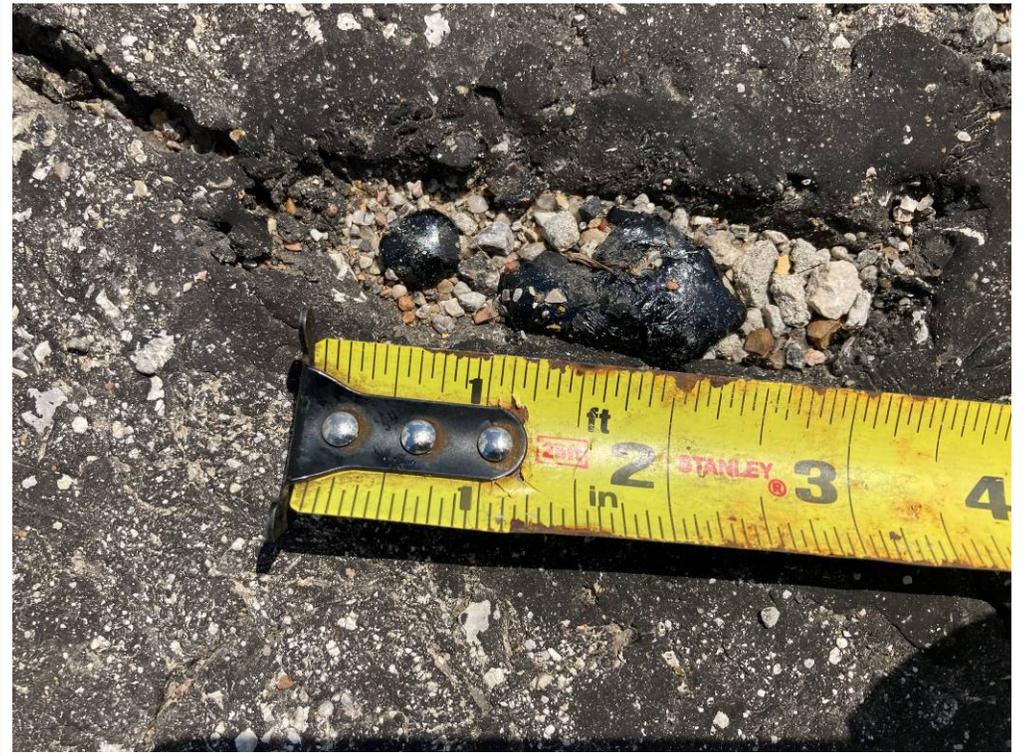
Photo No. 7	Date: 6/2/2021
-----------------------	--------------------------

- A very small tar-like NAPL surface seep was observed near the NAPL Collection System area in stall B105 during four of the five inspections in June (June 2nd, 9th, 16th, and 23rd) (Photo Nos. 7, 15, 24, and 33). One very small tar-like NAPL surface seep was observed near the NAPL Collection System area in stall B100 on June 16, 2021 (Photo No. 21). For areas outside the NAPL Collection System, small amounts of tar-like material were observed on the concrete surface in stalls A022, B057, B101, and at two locations within stall B102 during most weekly inspection events in June. Tar-like material observed during the inspection events was recovered using a hand tool to scrape up the material. During June, the number of tar-like material seeps observed during inspections and the total amount of material removed from the concrete surface increased compared to the May inspections as daily temperatures increased. A total of approximately 2 gallons of tar-like material was recovered for the month and placed in a drum for disposal. The drum is staged at the Container Storage Area (CSA).

Slot B105, very small amount of tar-like material seeping at asphalt crack, material was removed.

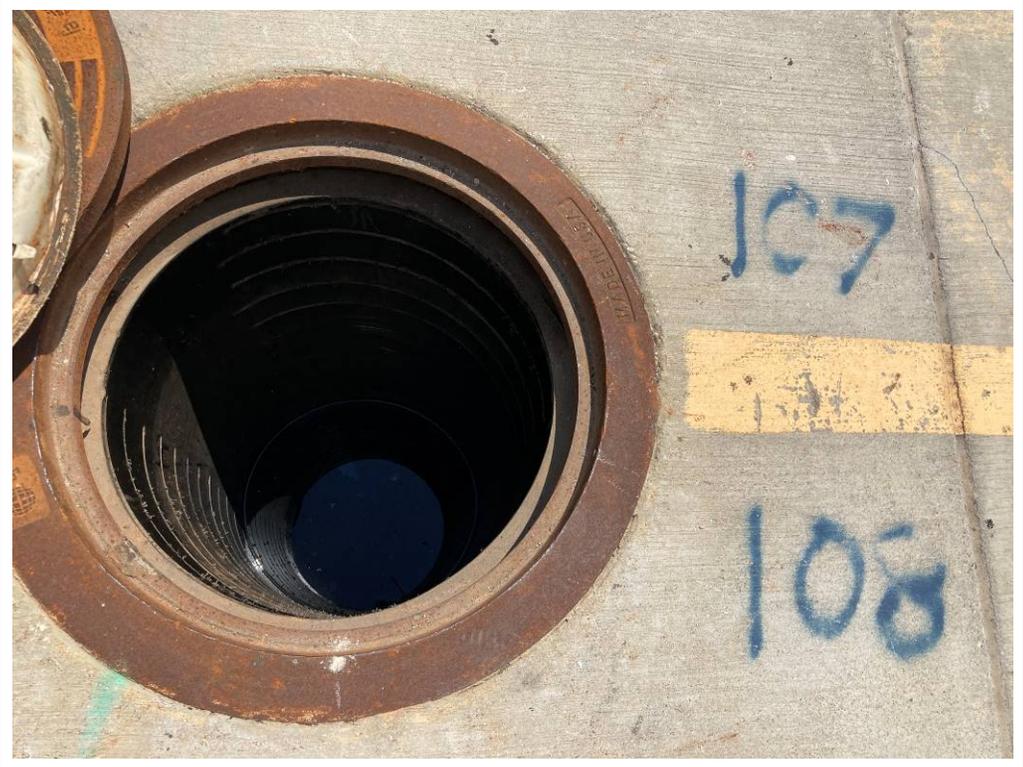
Photo No. 8	Date: 6/2/2021
-----------------------	--------------------------

- Water continues to accumulate in the NAPL collection sumps. The sumps were pumped down on May 27, 2021. The water level in Sump 1 (B099/B100 slots) returned to the top of the sump by the June 2nd weekly inspection and has remained at that level through June 30, 2021. Water levels in Sump 2 (B103/B104 slots) and Sump 3 (B107/B108 slots) continue to fluctuate between rainfall events. The water levels in Sumps 2 and 3 increased throughout the month of June and recovered to 3 inches and 1 inch, respectively, from the top of the sumps by June 30, 2021. Water level data for the sumps are available in Table 1. The water in the sumps was observed as being brown in color. A sheen was observed on the water within Sump 3 during the weekly inspection on June 2nd (Photo No. 8). No odors were reported during the June 2021 inspections.

Sump 3 (B107/B108), 38 inches of freeboard in sump. Sheen visible on water in sump. No odors noted. No tar-like material recovered.

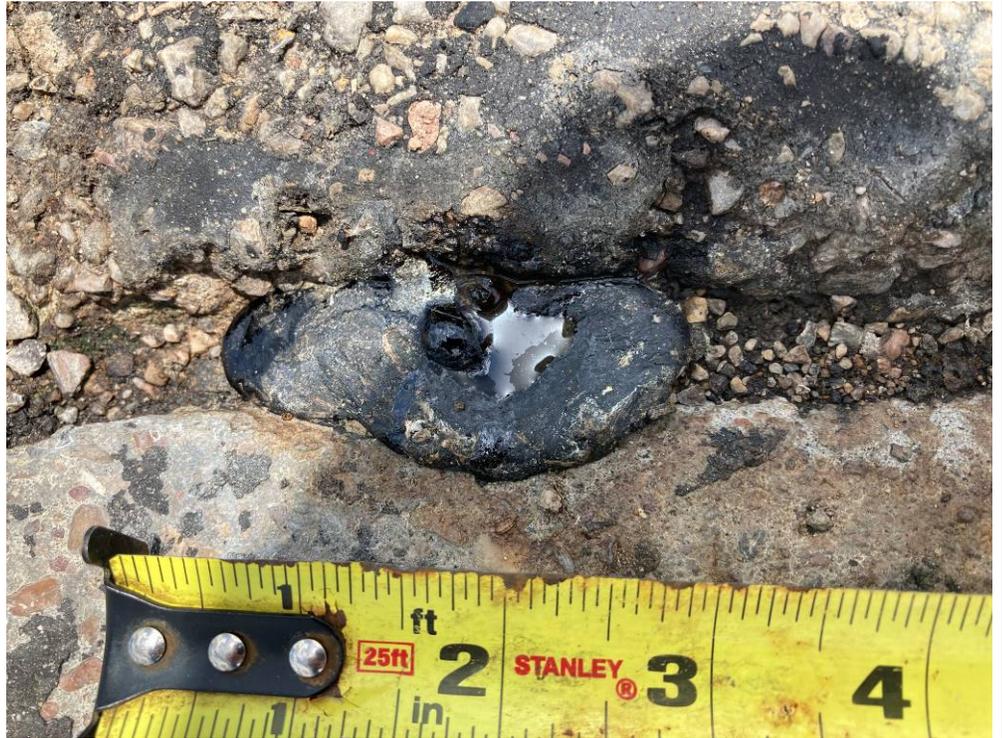
Photo No.
9

Slot A022, very small amount of tar-like material seeping at asphalt crack, material was removed.

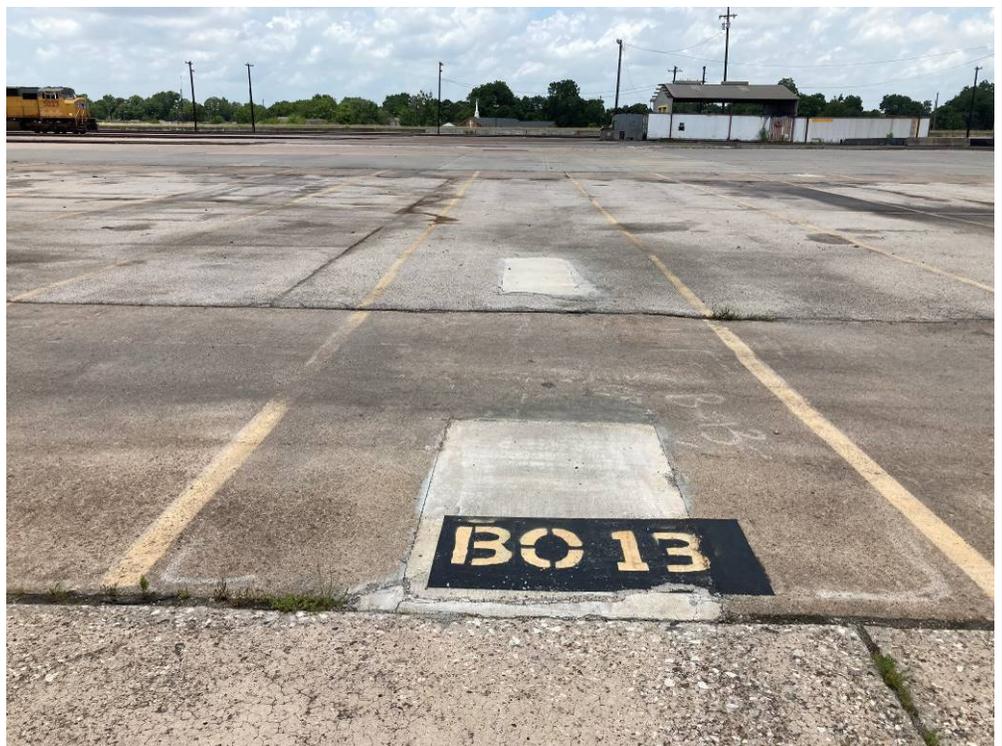
Photo No.
10

Slot B013, no tar-like material seeps observed where test pit conducted (July 2020), brown staining observed along asphalt cracks, looking northwest.

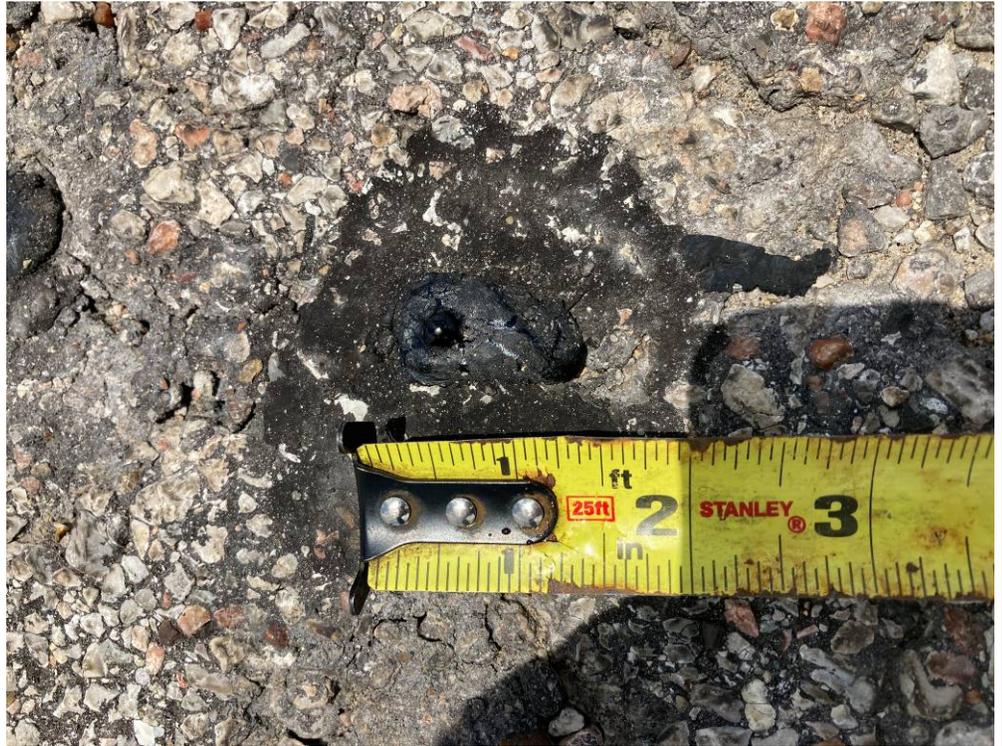
Photo No.
11

Slot B057, very small amount of tar-like material seeping at asphalt crack (not at July 2020 test pit), material was removed.

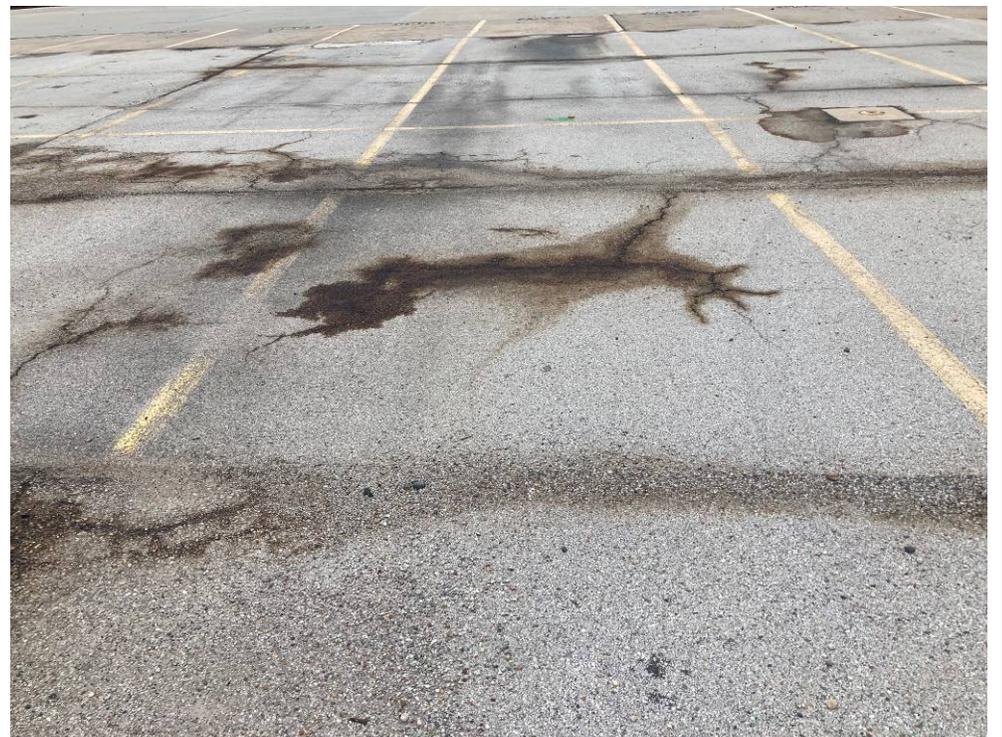
Photo No.
12

Slot B097, brown staining observed along asphalt cracks, looking northwest.

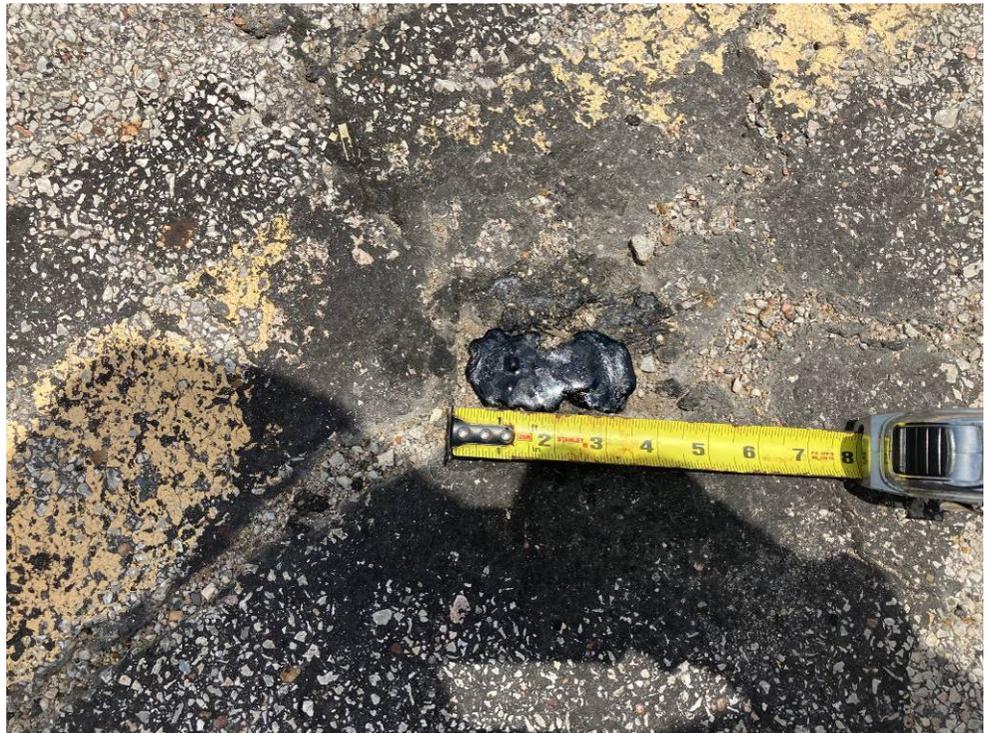
Photo No.
13

Slot B101, very small amount of tar-like material seeping at asphalt crack, material was removed.

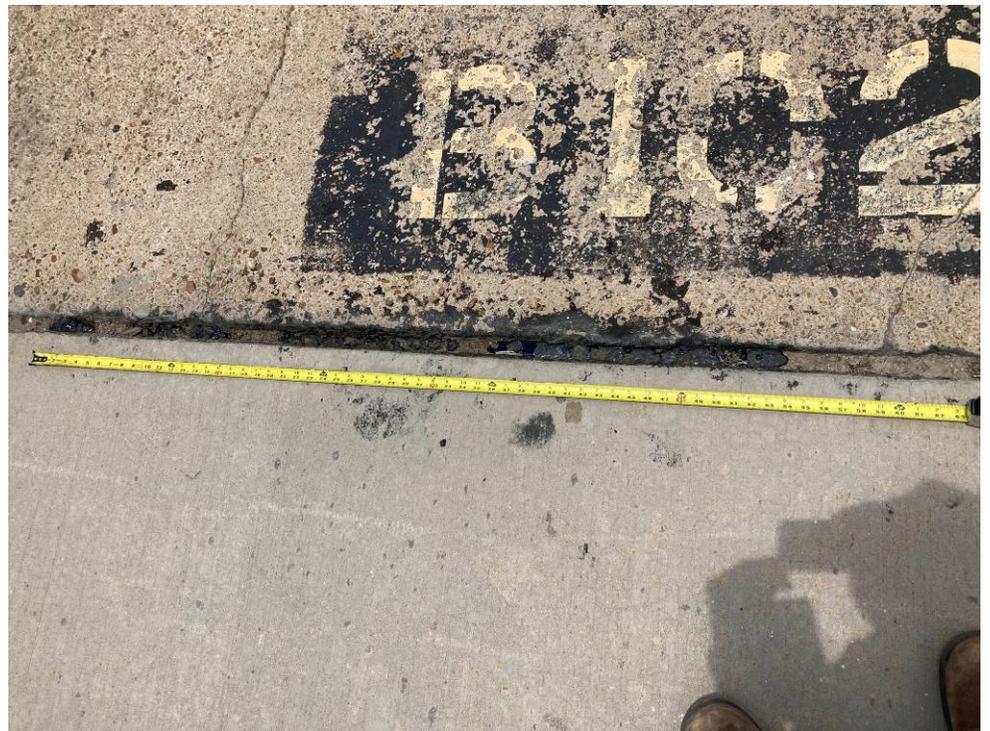
Photo No.
14

Slot B102, small amount of tar-like material seeping at pavement joint, material was removed.

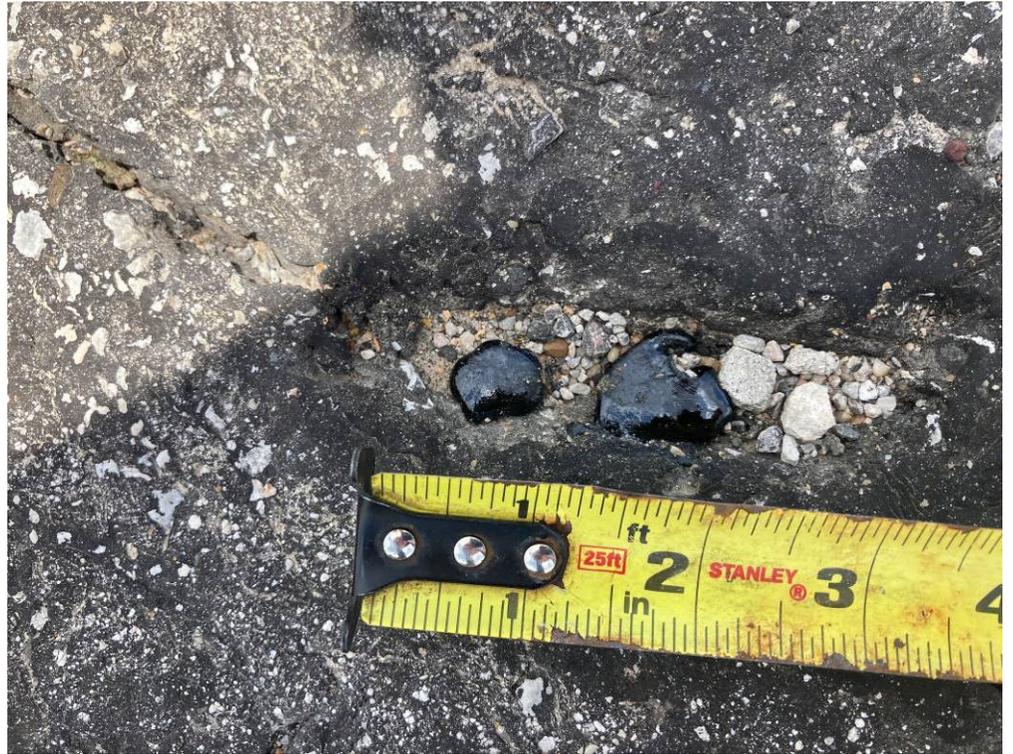
Photo No.
15

Slot B105, very small amount of tar-like material seeping at asphalt crack, material was removed.

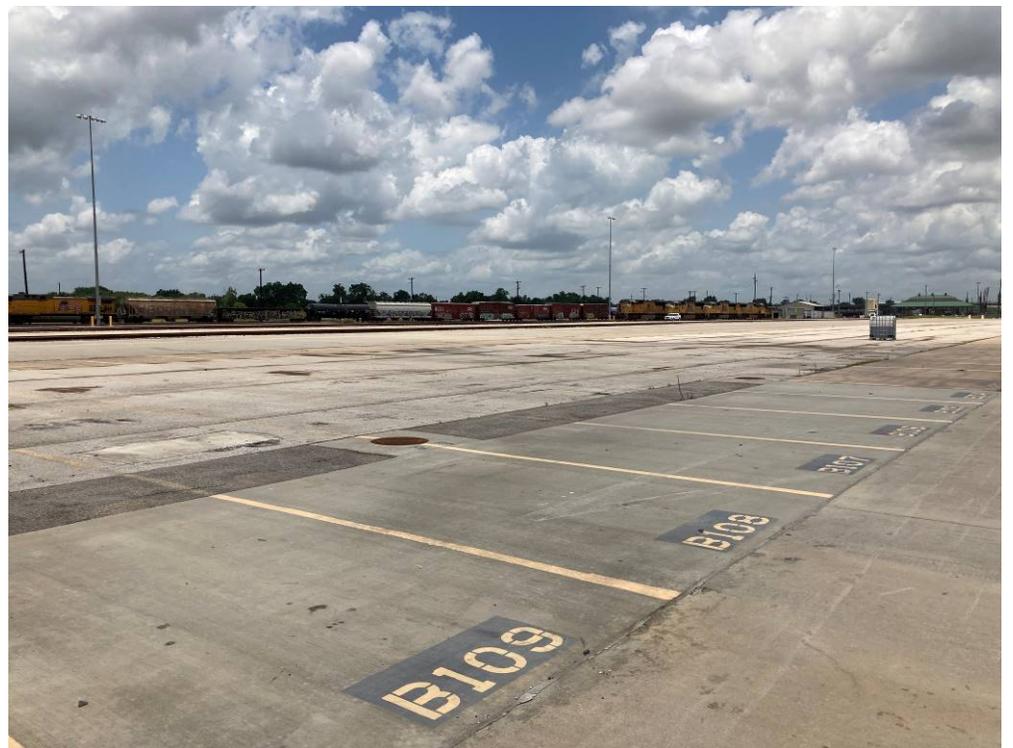
Photo No.
16

View of slots B109-B097, NAPL collection system visible in background, brown staining observed along asphalt cracks, looking northeast.

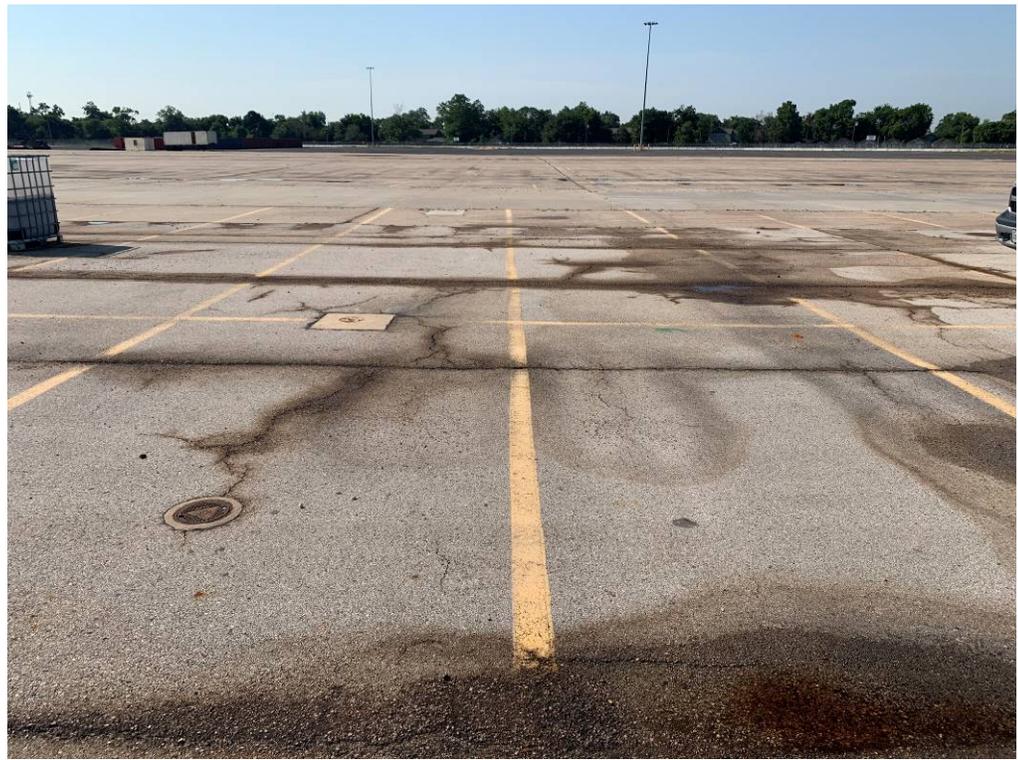
Photo No. 17	Date: 6/16/2021
Description: Slot A096, brown staining and water observed along asphalt cracks prior to cleaning by UPRR subcontractor USES, looking southeast. Lat: 29.784457 Long: -95.320770

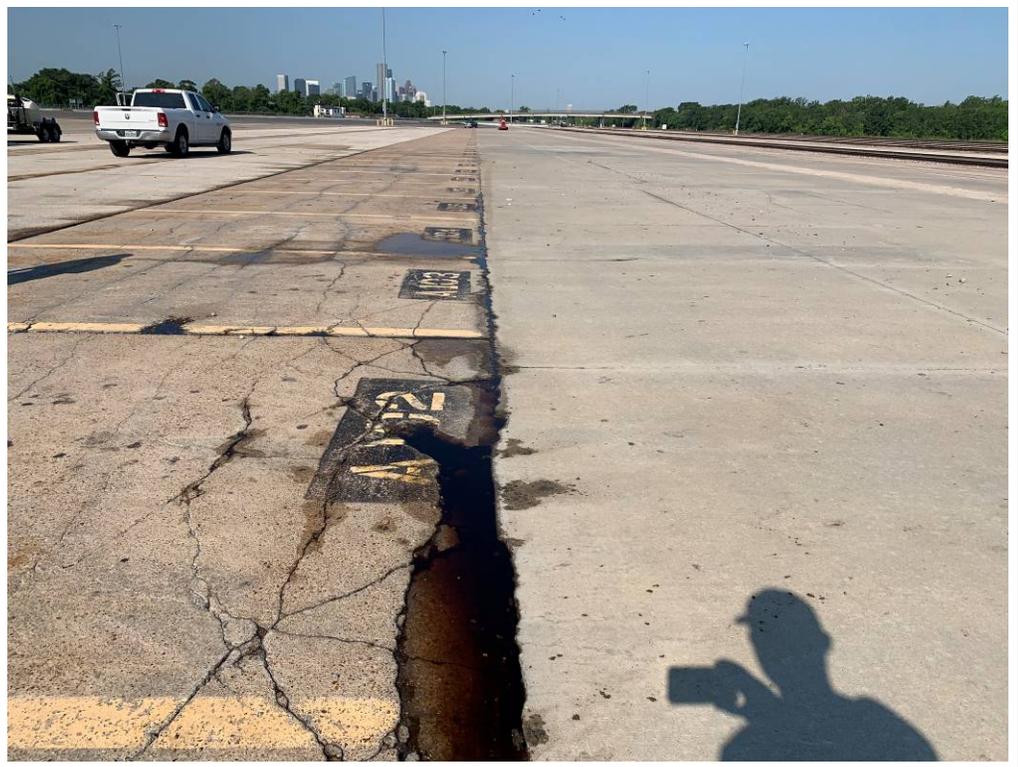
Photo No. 18	Date: 6/16/2021
Description: Slot A102, brown staining and water observed along asphalt cracks prior to cleaning by USES, looking west. Lat: 29.784408 Long: -95.320945

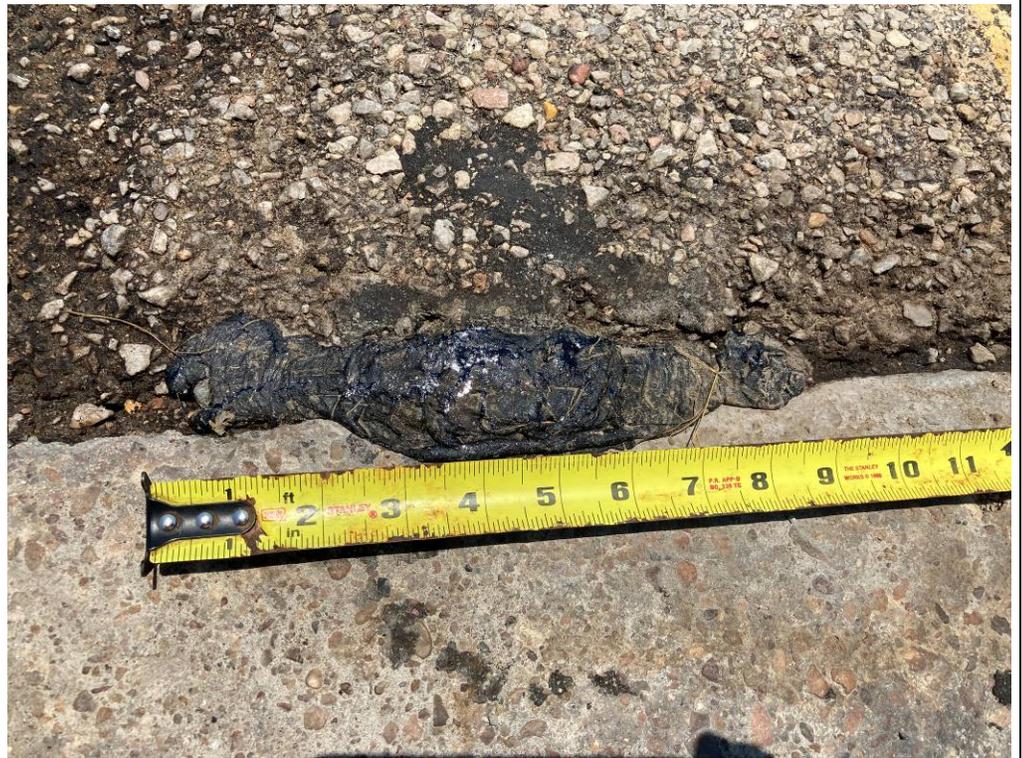
Photo No.
19

Slot A022, small amount of tar-like material seeping at asphalt crack, material was removed.

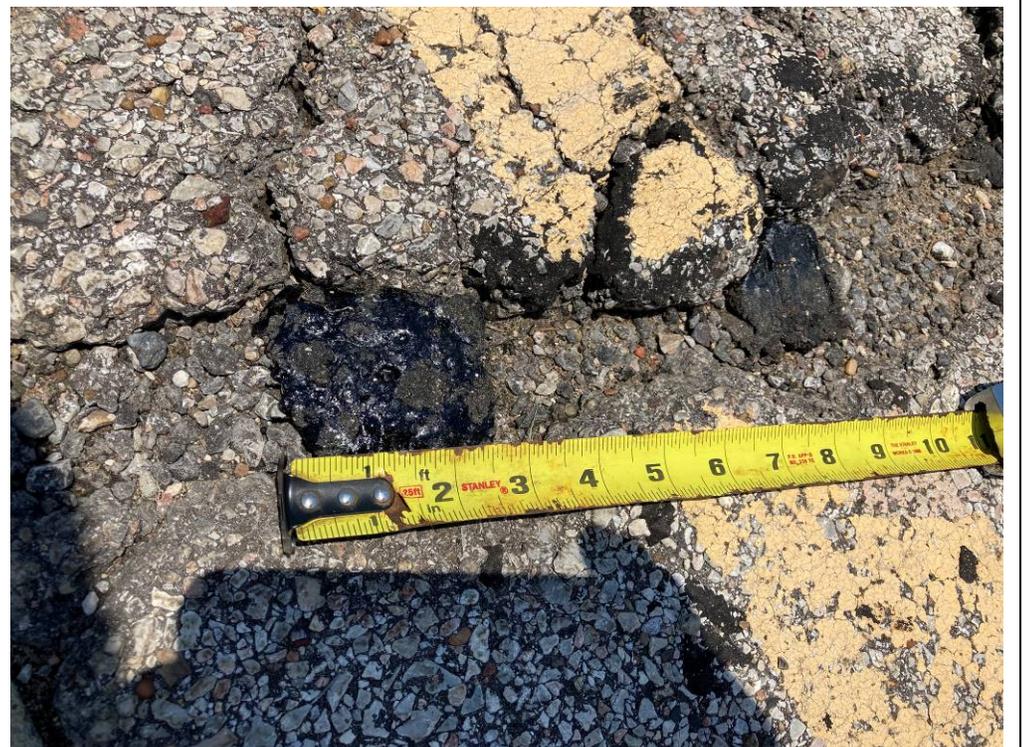
Photo No.
20

Slot B057, very small amount of tar-like material seeping at asphalt crack (not at July 2020 test pit), material was removed.

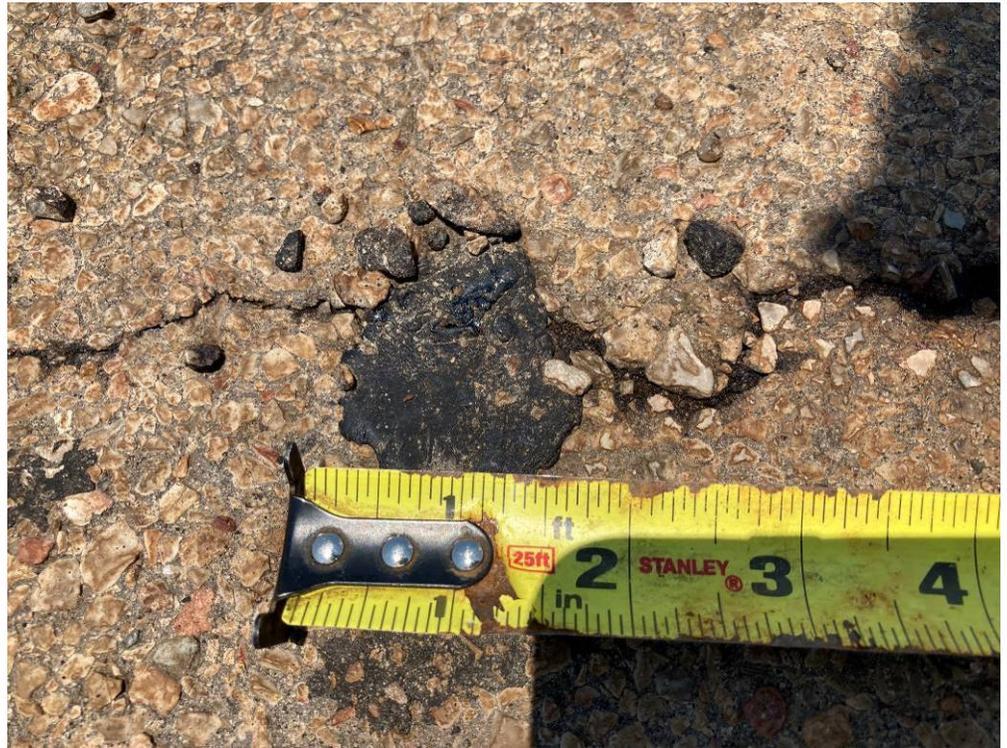
Photo No.: 21	Date: 6/16/2021
Description: Slot B100, very small amount of tar-like material seeping at asphalt crack, material was removed. Lat: 29.784315 Long: -95.320815

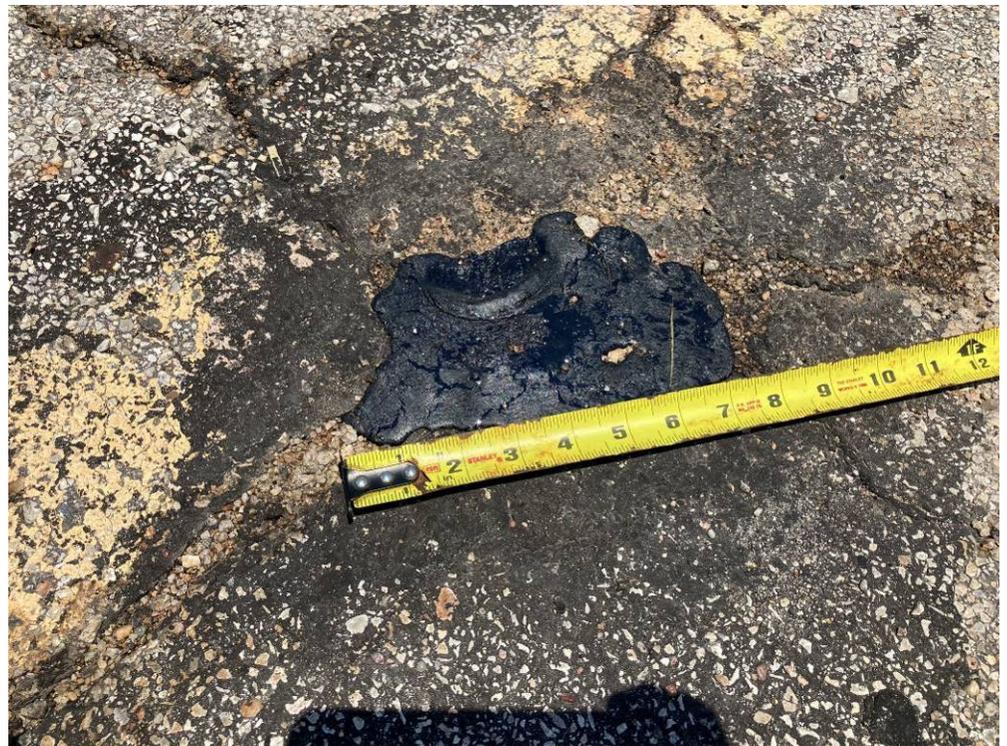
Photo No.: 22	Date: 6/16/2021
Description: Slot B101, small amount of tar-like material seeping at asphalt crack, material was removed. Lat: 29.784275 Long: -95.320813

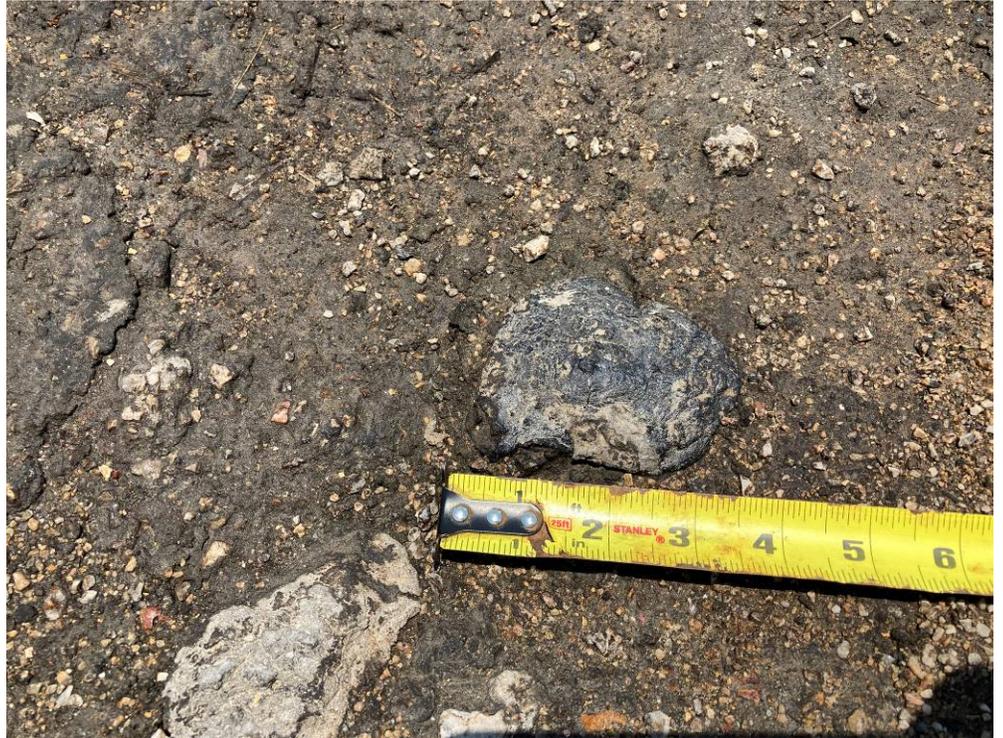
Photo No.
23

Slot B102, tar-like material seeping at two locations within the stall, small amount of at asphalt crack (pictured) as well as at the pavement joint (not-pictured), material was removed.

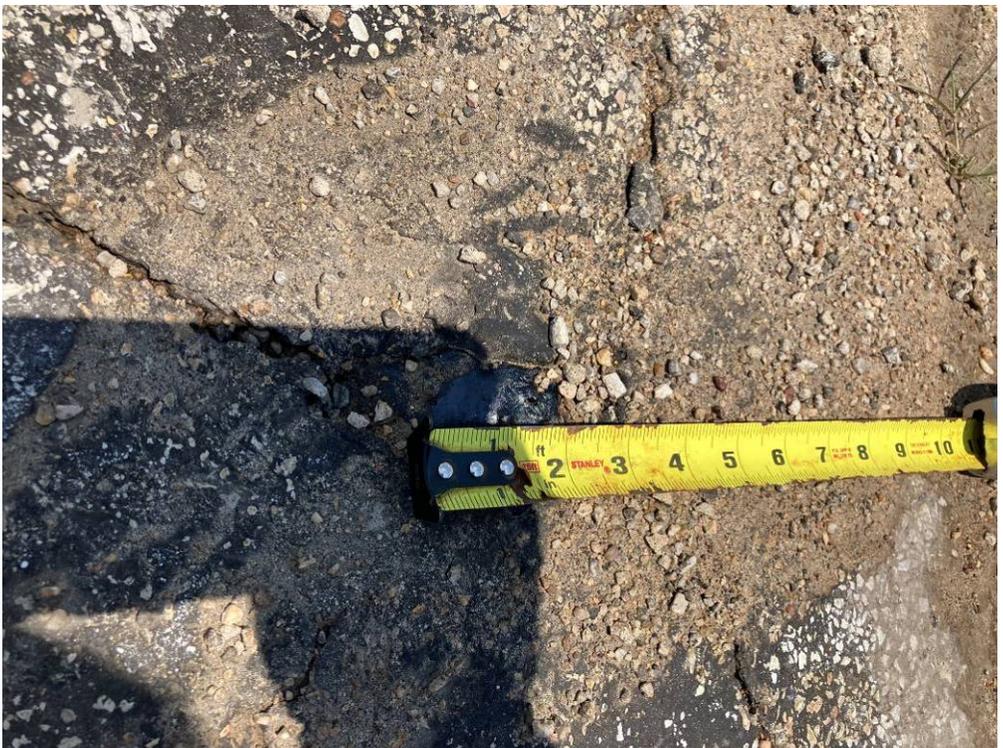
Photo No.
24

Slot B105, very small amount of tar-like material seeping at asphalt crack, material was removed.

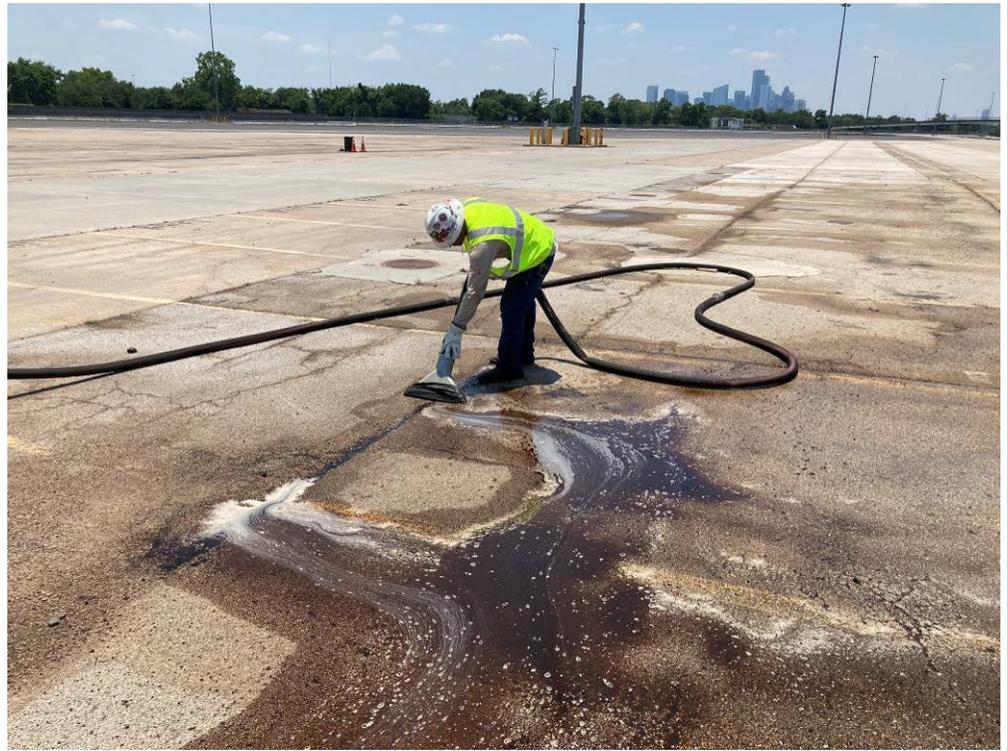
Photo No.
25

Slots B105-B098, USES pressure washing brown staining and vacuuming fluids in A and B rows, looking southwest.

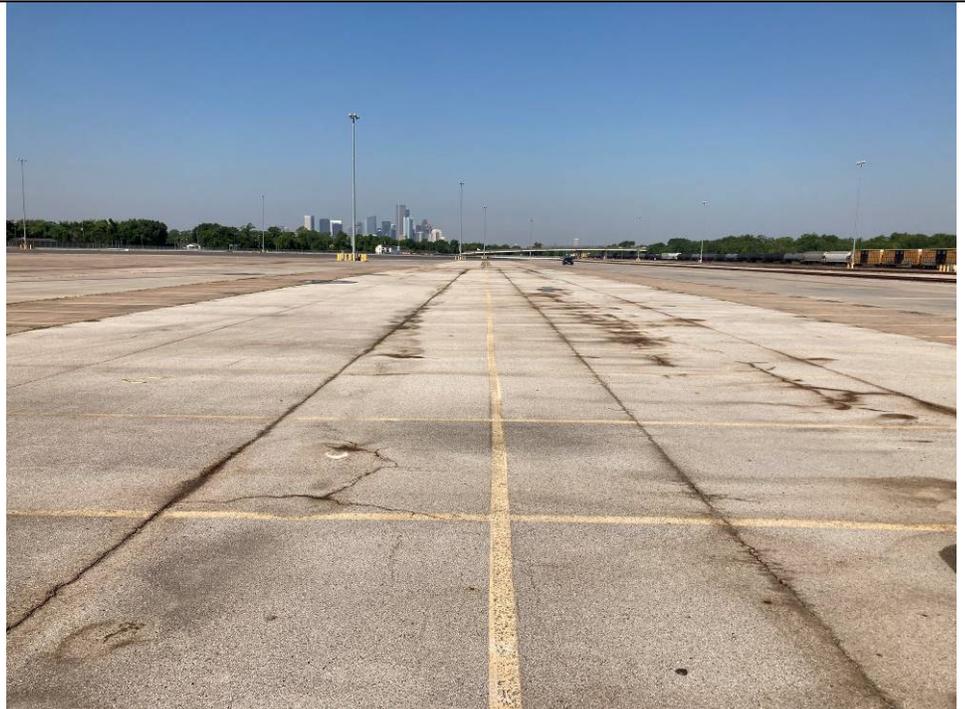
Photo No.
26

Residual brown staining after USES pressure washing activities in A and B rows, looking west.

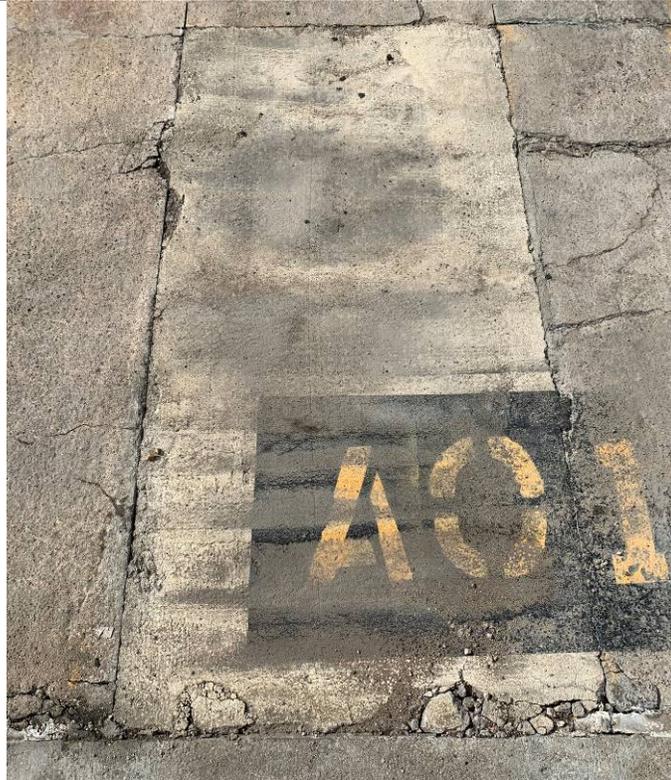
Photo No.
27

Slot A010, no tar-like material seeps observed where test pit conducted (July 2020).

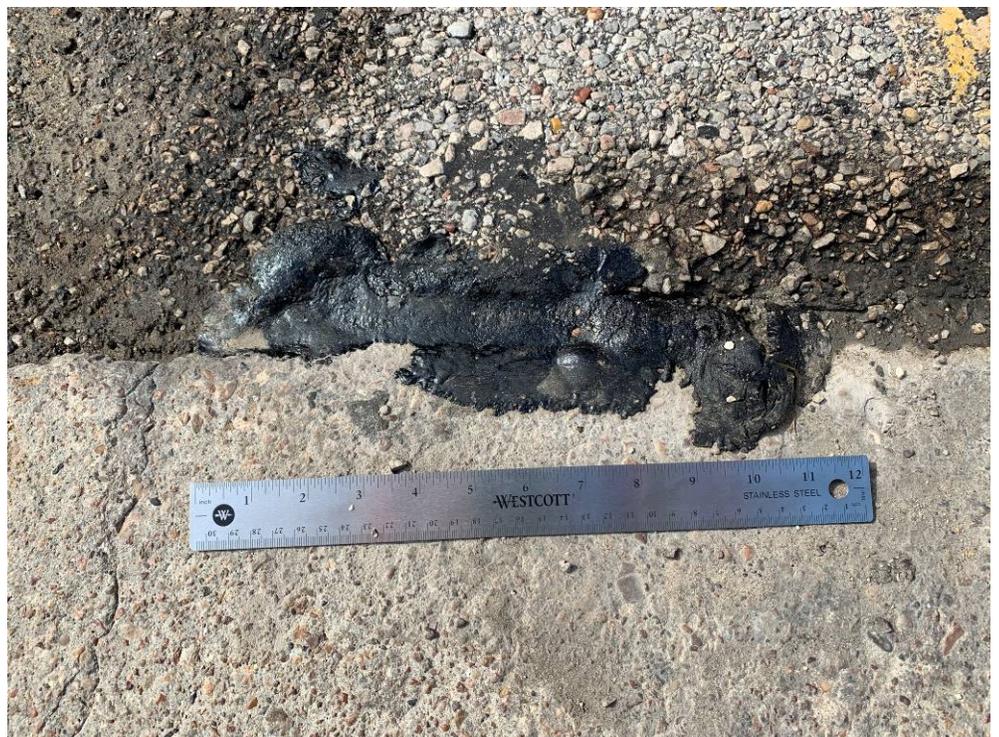
Photo No.
28

Slot A022, small amount of tar-like material seeping at asphalt crack, material was removed.
