July 15, 2021

Project No. 19119232

**RE: MONTHLY STATUS UPDATE – ENGLEWOOD INTERMODAL YARD – NAPL COLLECTION SYSTEM/CONCRETE CAP REPAIRS
UNION PACIFIC RAILROAD HOUSTON WOOD PRESERVING WORKS FACILITY
4910 LIBERTY ROAD FACILITY, HOUSTON, TEXAS
POST-CLOSURE CARE PERMIT NO. HW-50343; INDUSTRIAL SWR NO. 31547**

Weekly Inspection Photolog

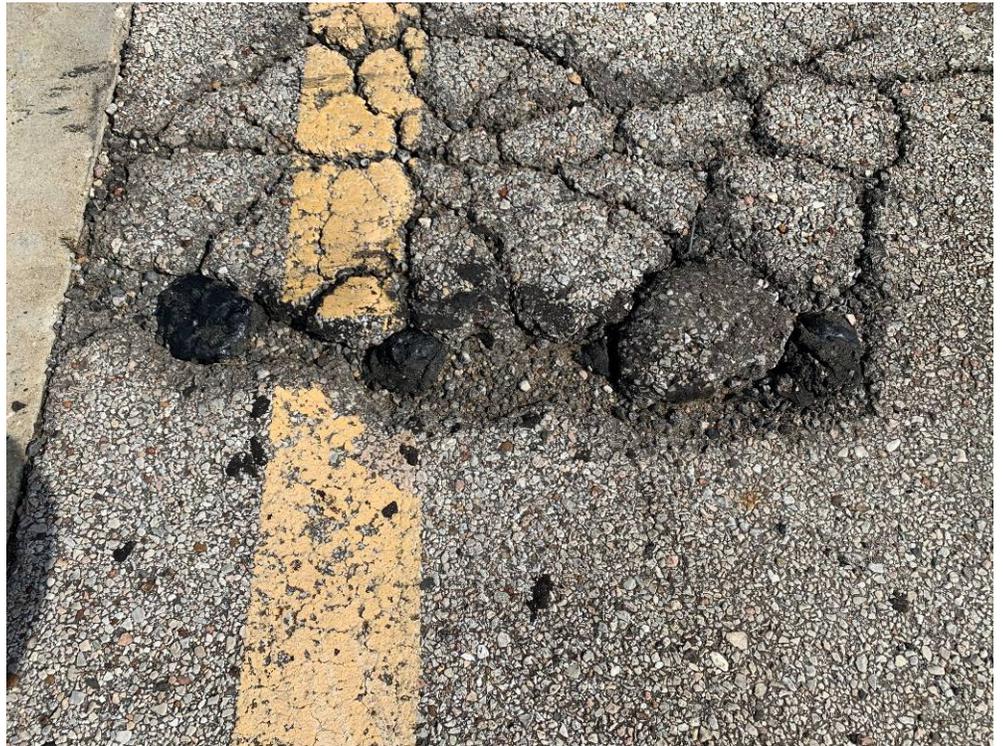
Slot B057, small amount of tar-like material seeping at asphalt crack (not at July 2020 test pit), material was removed.

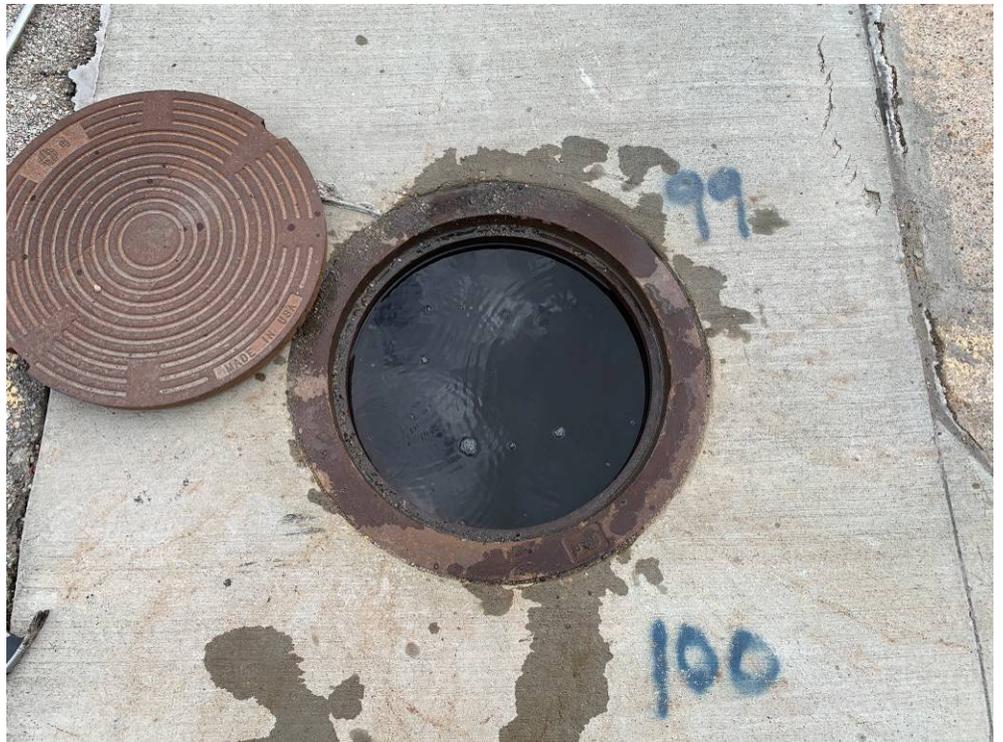
Sump 1 (B099/B100), 0 inches of freeboard in sump, no sheen or odor noted.

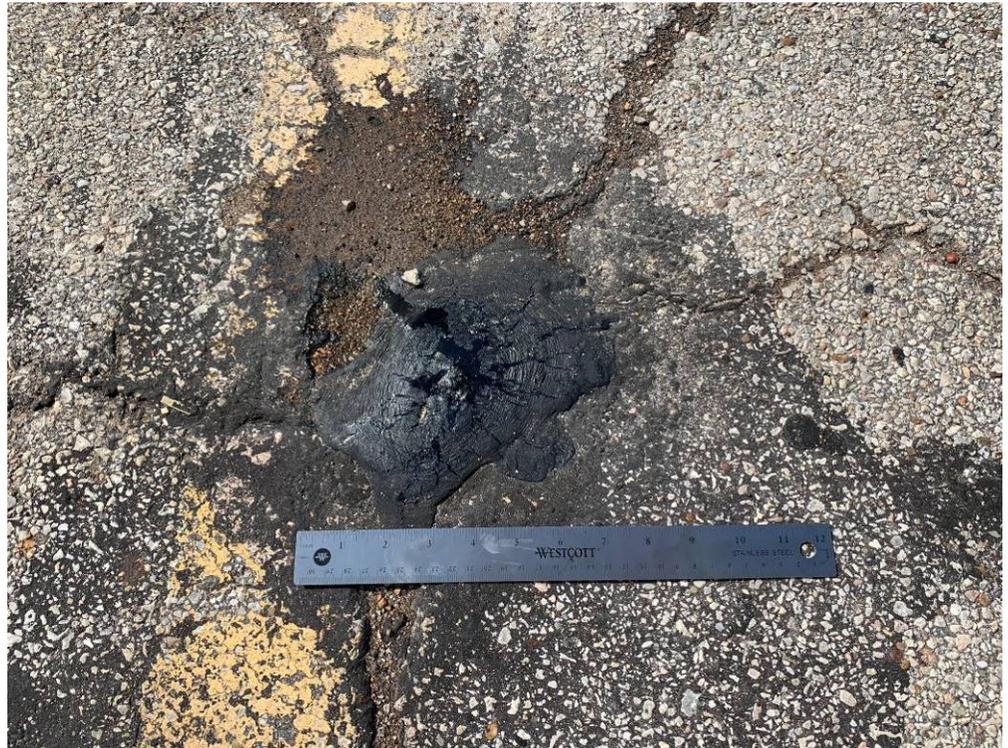
Photo No. 31	Date: 6/23/2021
Description: Slot B101, small amount of tar-like material seeping at asphalt crack, material was removed. Lat: 29.784275 Long: - 95.320813

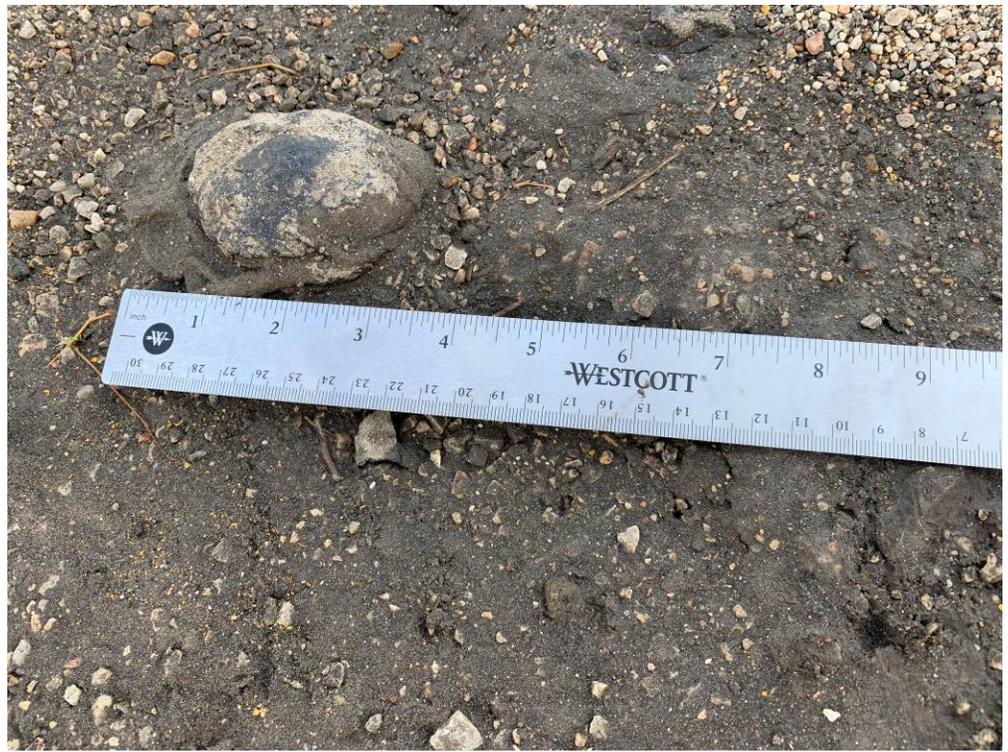
Photo No. 32	Date: 6/23/2021
Description: Slot B102, tar-like material seeping at two locations within the stall, small amount of at asphalt crack (pictured) as well as at the pavement joint (not-pictured), material was removed. Lat: 29.7842203 Long: - 95.320827

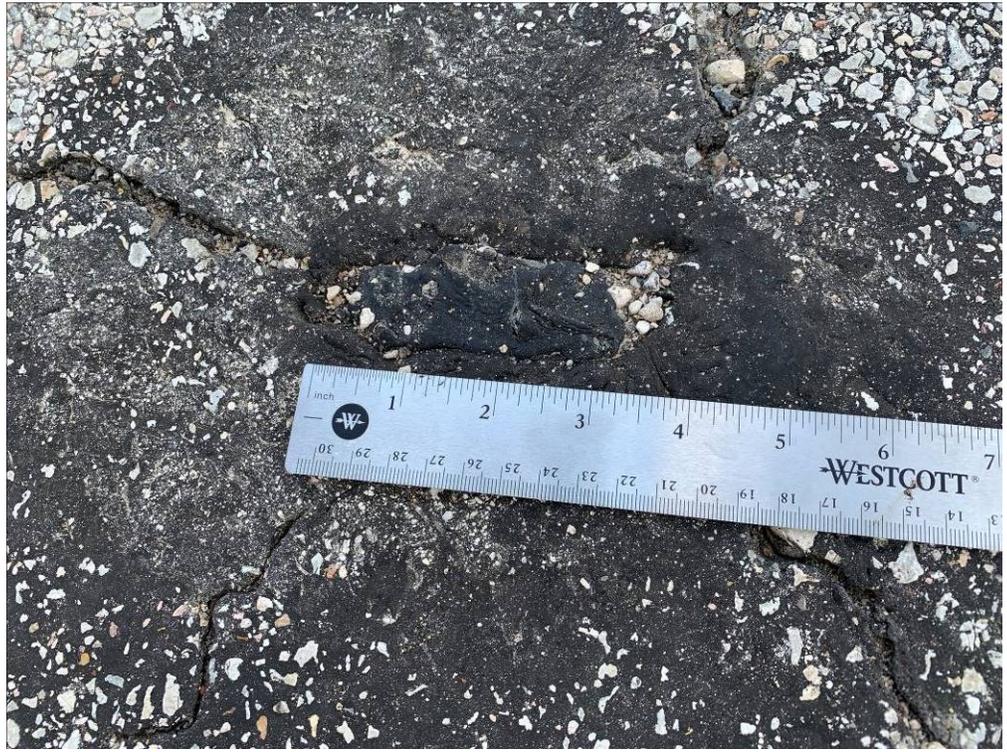
- A very small tar-like NAPL surface seep was observed near the NAPL Collection System area in stall B105 during four of the five inspections in June (June 2nd, 9th, 16th, and 23rd) (Photo Nos. 7, 15, 24, and 33). One very small tar-like NAPL surface seep was observed near the NAPL Collection System area in stall B100 on June 16, 2021 (Photo No. 21). For areas outside the NAPL Collection System, small amounts of tar-like material were observed on the concrete surface in stalls A022, B057, B101, and at two locations within stall B102 during most weekly inspection events in June. Tar-like material observed during the inspection events was recovered using a hand tool to scrape up the material. During June, the number of tar-like material seeps observed during inspections and the total amount of material removed from the concrete surface increased compared to the May inspections as daily temperatures increased. A total of approximately 2 gallons of tar-like material was recovered for the month and placed in a drum for disposal. The drum is staged at the Container Storage Area (CSA).

Photo No. 33	Date: 6/23/2021
Description Slot B105, very small amount of tar-like material seeping at asphalt crack, material was removed. Lat: 29.7841472 Long: - 95.3208777

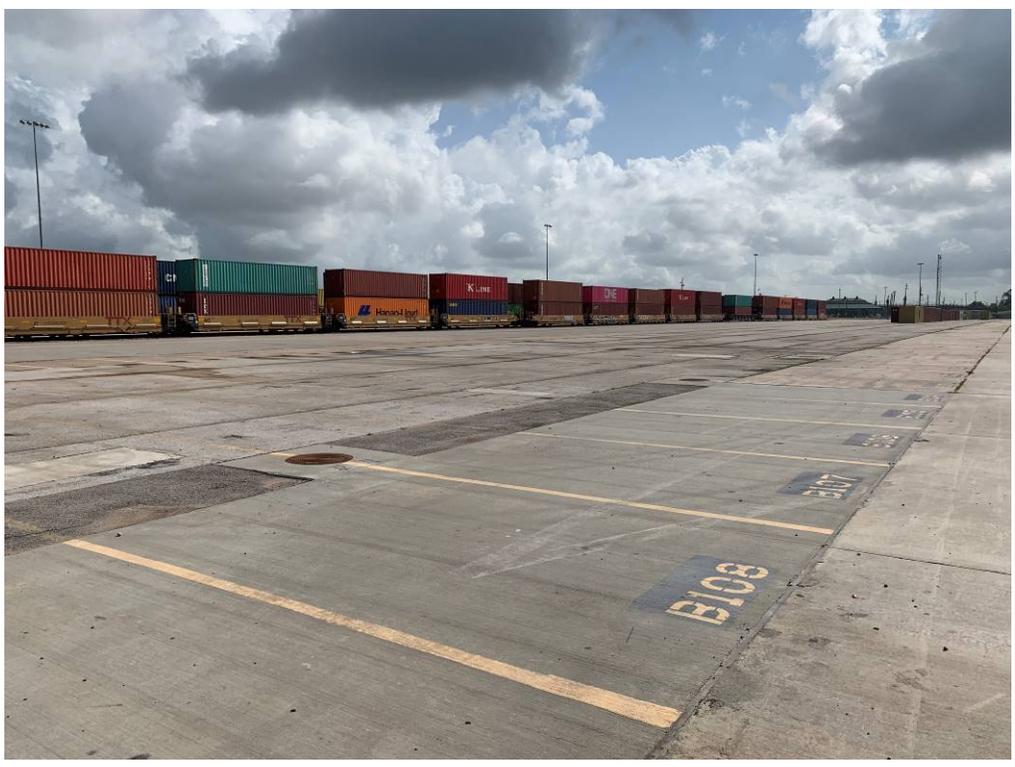
Photo No. 34	Date: 6/23/2021
Description: View of slots B109-B097, NAPL collection system visible in background, residual staining observed along asphalt cracks, looking northeast. Lat: 29.784116 Long: -95.321022

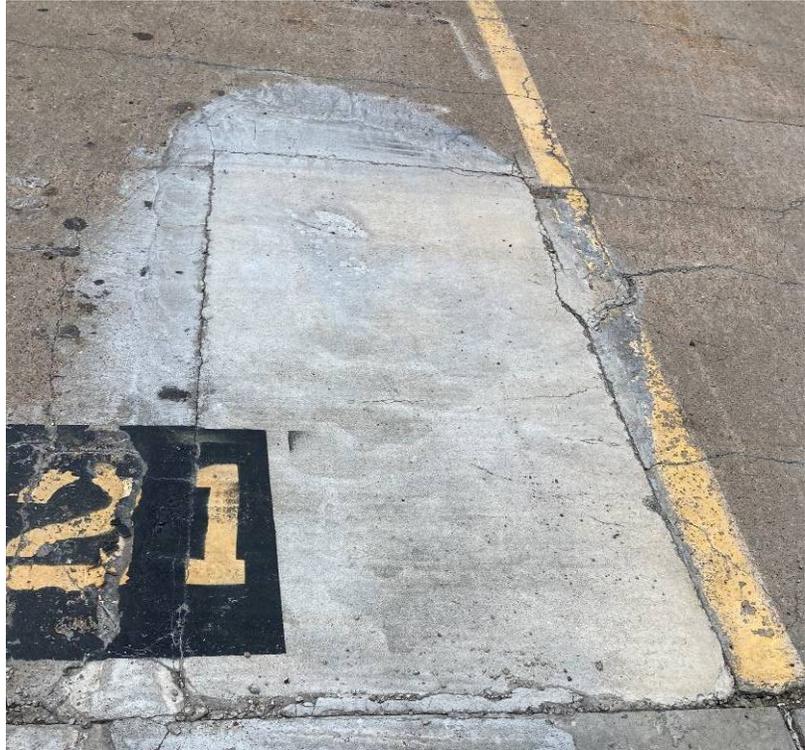
Photo No.
35

Slot A021, no tar-like material seeps observed where test pit conducted (July 2020).

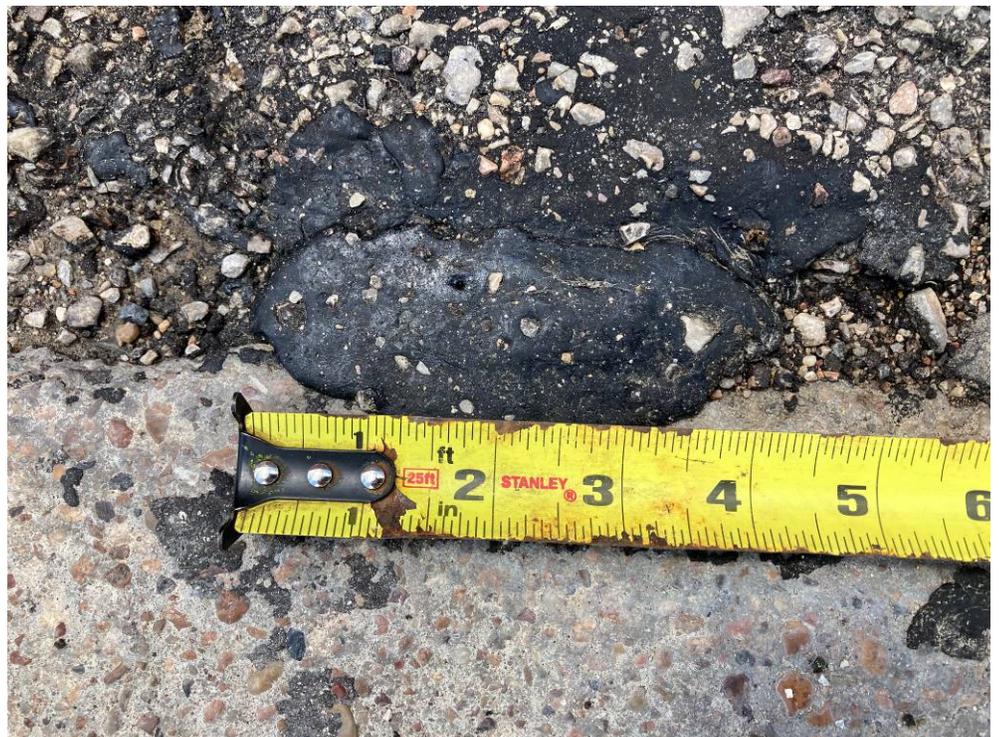
Photo No.
36

Slot A022, very small amount of tar-like material seeping at asphalt crack, material was removed.

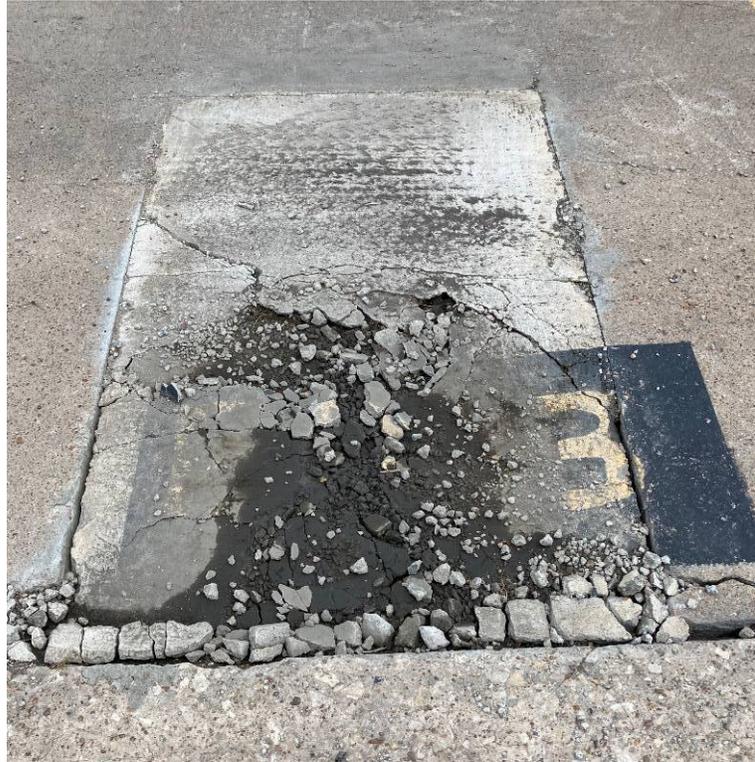
- Golder, on behalf of UPRR, submitted to the TCEQ the Englewood IM Yard Test Pit Evaluation Report dated June 2, 2021 summarizing the findings from the test pits installed in July 2020 including weekly inspections since the installation. During the weekly inspections through June 2021, no NAPL seeps have been observed at the seven test pit locations (slots A010, A021, A098, B013, B057, B096, and B108). The seep observed in slot B057 during each of the five June inspections is located at an asphalt crack near the western edge of the slot (Photo Nos. 3, 11, 20, 29, and 38). During the June 30, 2021 inspection, concrete patches covering test pits in slots B013 and B096 were observed to be damaged. UPRR will coordinate with a subcontractor to repair the concrete patches.

Photo No. 37	Date: 6/30/2021
Description: Slot B013, no tar-like material seeps observed where test pit conducted (July 2020), test pit pavement damaged. Lat: 29.785217 Long: - 95.318261

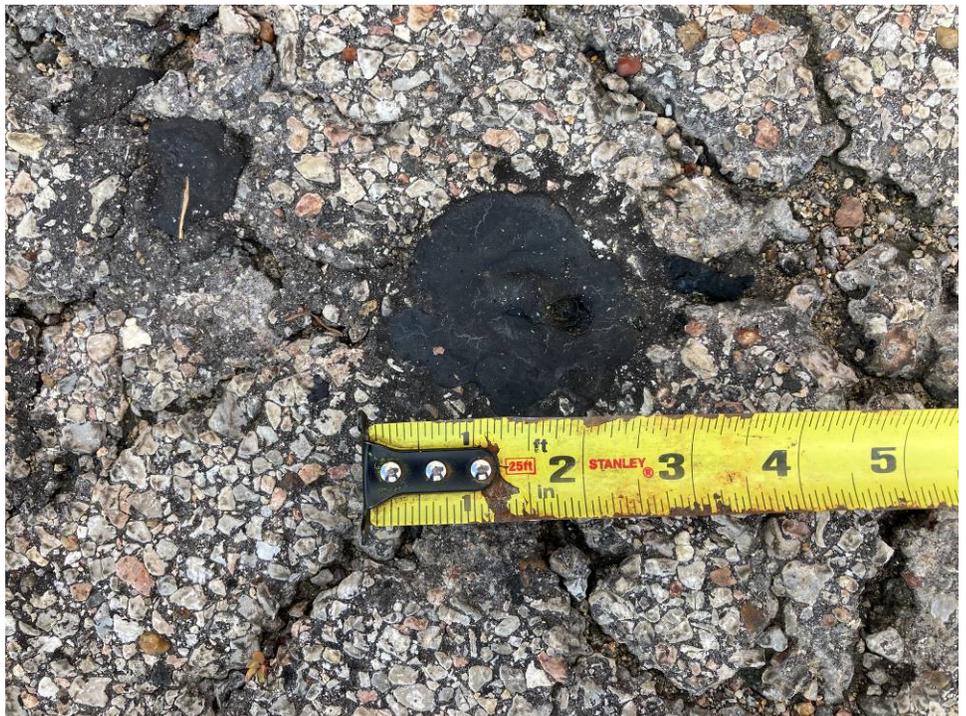
Photo No. 38	Date: 6/30/2021
Description: Slot B057, very small amount of tar-like material seeping at asphalt crack (not at July 2020 test pit), material was removed. Lat: 29.7847472 Long: - 95.3195417

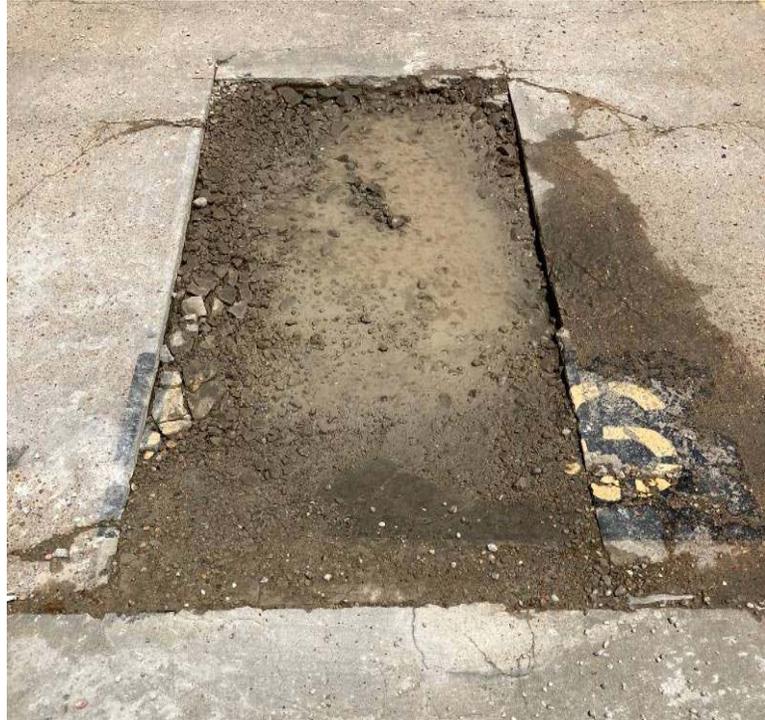
Photo No. 39	Date: 6/30/2021
Description: Slot B096, no tar-like material seeps observed where test pit conducted (July 2020), test pit pavement damaged. Lat: 29.7842528 Long: - 95.3206250

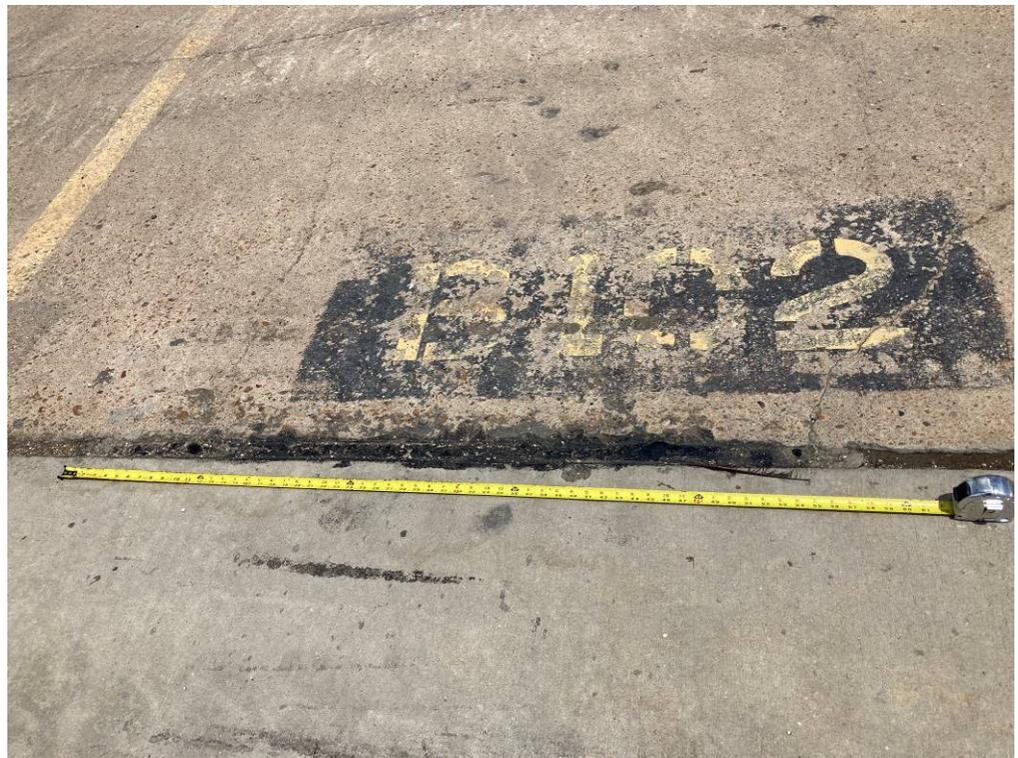
Photo No. 40	Date: 6/30/2021
Description: Slot B102, small amount of tar-like material seeping at pavement joint, material was removed. Lat: 29.7842203 Long: - 95.320827

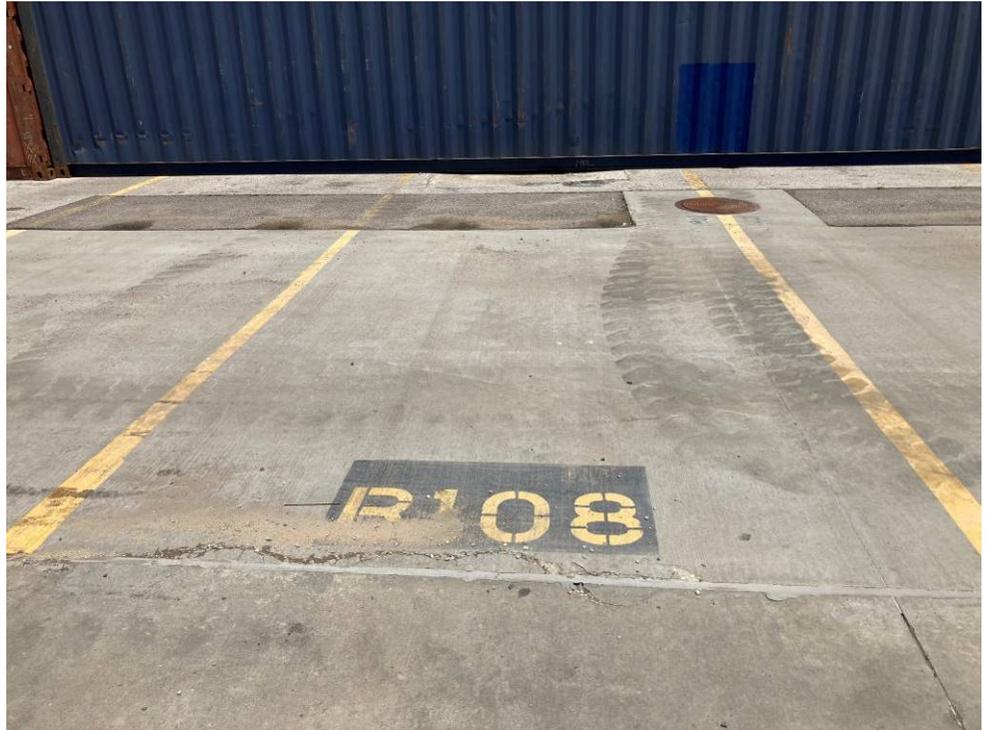
Photo No. 41	Date: 6/30/2021
Description: Slot B108, view of NAPL Collection System (Sump B107/B108 and test pit in background). No tar-like material seeps observed where test pit (July 2020) conducted, looking northwest. Lat: 29.784125 Long: - 95.320989

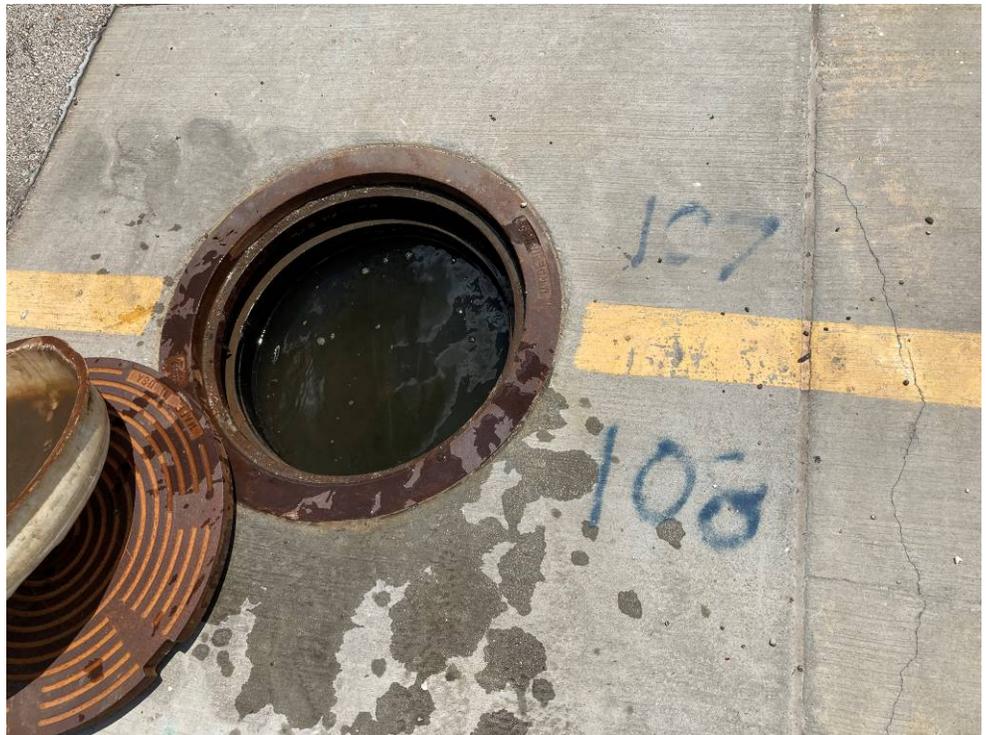
Photo No. 42	Date: 6/30/2021
Description: Sump 3 (B107/B108), 1 inch of freeboard in sump. No sheen or odors noted. No tar-like material recovered. Lat: 29.7842861 Long: - 95.3208611
