Project No. 19119232

**Re: MONTHLY STATUS UPDATE – ENGLEWOOD INTERMODAL YARD – NAPL COLLECTION
SYSTEM/CONCRETE CAP REPAIRS
UNION PACIFIC RAILROAD HOUSTON WOOD PRESERVING WORKS FACILITY
4910 LIBERTY ROAD FACILITY, HOUSTON, TEXAS
POST-CLOSURE CARE PERMIT NO. HW-50343; INDUSTRIAL SWR NO. 31547**

Weekly Inspection Photolog

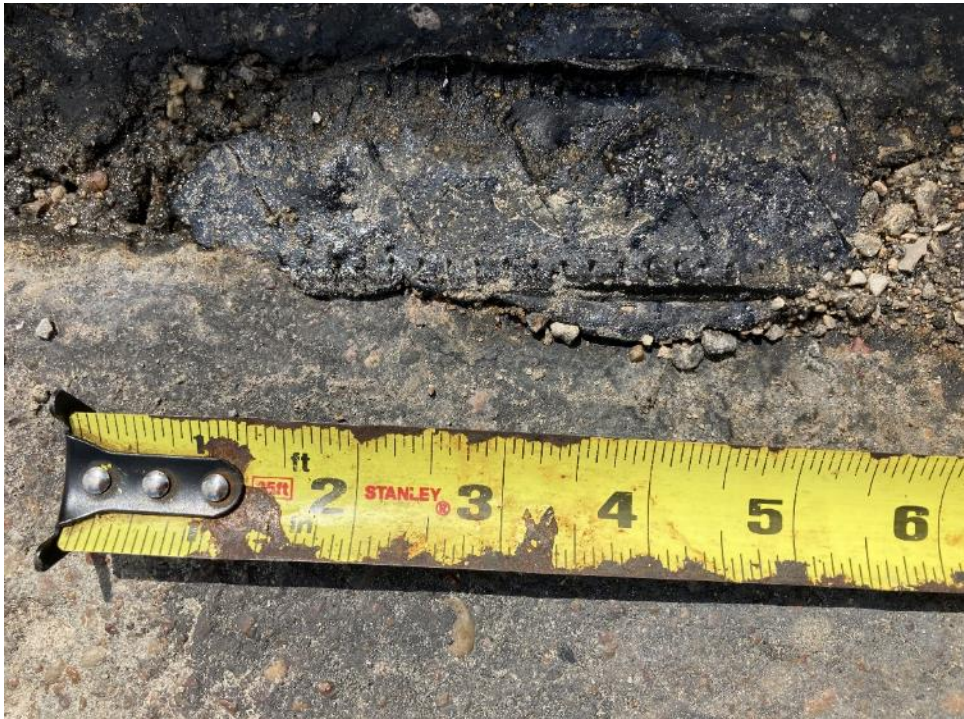
Description: Slot A022, small amount of tar-like material seeping at asphalt crack, material was removed. Lat: 29.785392, Long: -95.318655			
Photo No. 2	Date: 9/1/2021

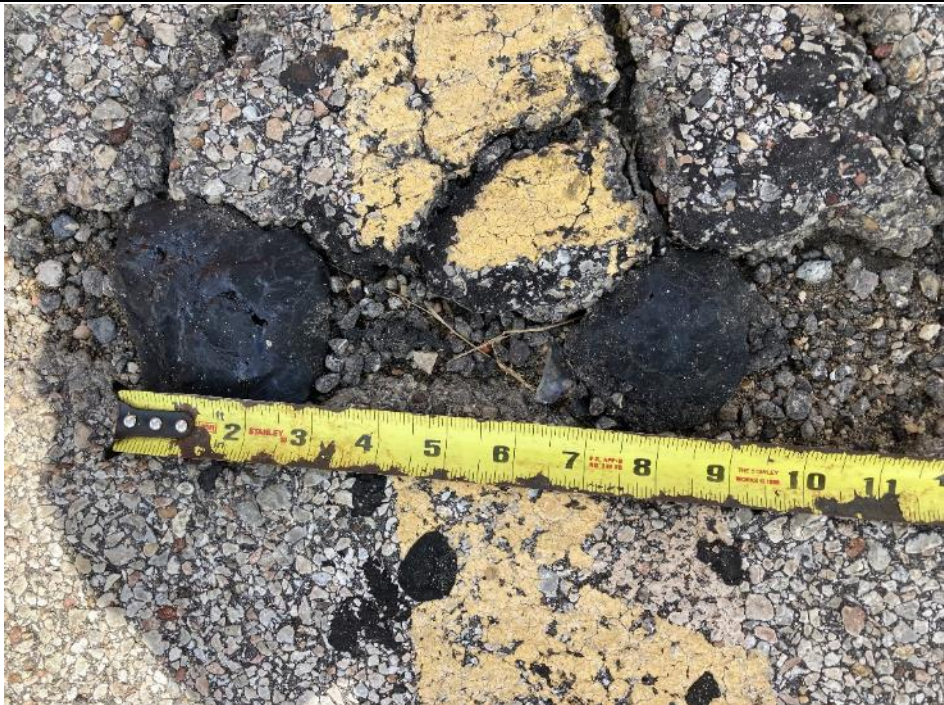
have been observed at the seven test pit locations (slots A010, A021, A098, B013, B057, B096, and B108). The seep observed in slot B057 during the inspection on September 1st, 15th, and 29th is located at an asphalt crack near the western edge of the slot (Photo Nos. 2, 14, and 32) and not at the test pit location. As discussed in the Test Pit Report, the test pit inspections were to continue through the warmer months (through September 2021). UPRR will prepare a Test Pit Evaluation Report Addendum summarizing the test pit inspections from June through September 2021. During the June 30, 2021 inspection, concrete patches covering test pits in slots B013 and B096 were observed to be damaged. During the July 7, 2021 inspection, concrete patches in slots A010 and B057 were observed to be damaged. The A021 concrete patch was observed to be damaged on July 29, 2021. UPRR is scheduling repairs to the test pit concrete patches and it is anticipated that those repairs will be conducted in October.

Description: Slot B057, small amount of tar-like material seeping at asphalt crack (not at July 2020 test pit location), material was removed. Lat: 29.7847472 Long: - 95.3195417

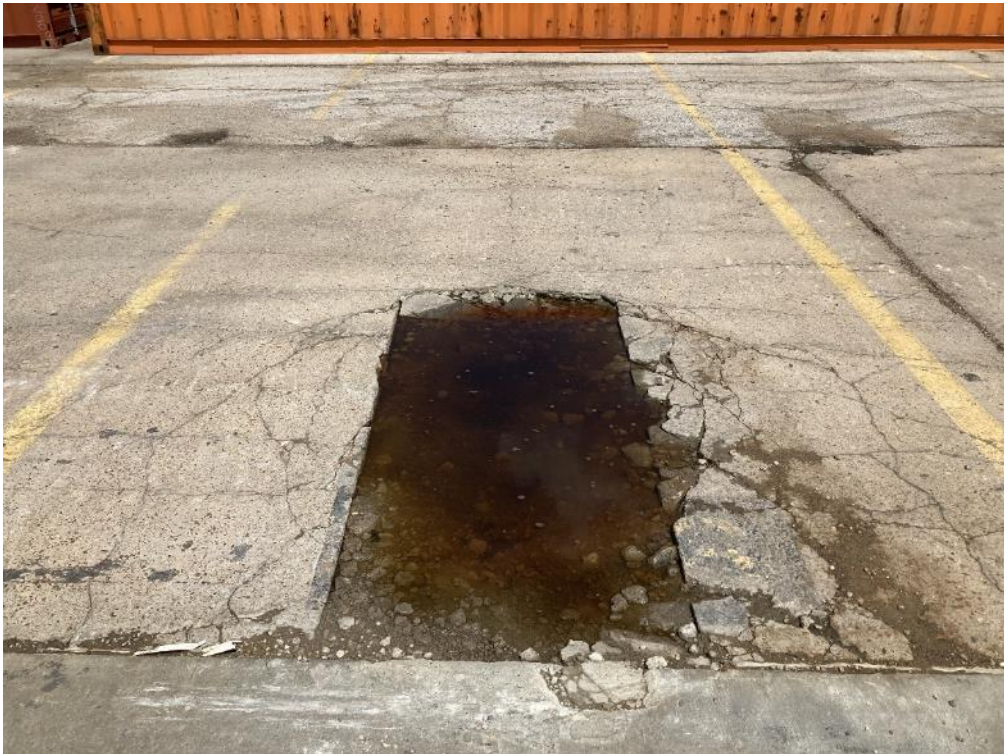
- No widespread brown water seeping or staining was observed during September. During the September 1st and 15th weekly inspections, brown stained water had collected within the damaged concrete area at the July 2020 test pit location in B096 slot (Photo Nos. 3 and 15). Sheen was also observed on standing water in a depression in the asphalt (not the July 2020 test pit location) in stall A010 during the September 15th inspection. After the September 1st inspection, the remediation contractor was called to mobilize to the Site and pressure wash the area; however, Golder personnel arrived on September 8th and no standing water or staining was present. As a result, there was no need to pressure wash the area and no water was recovered. UPRR will continue to have a remediation contractor pressure wash the areas where the brown staining and seeps are observed, as needed.

Description: Slot B096, no tar-like material seeps observed where test pit conducted (July 2020), brown stained water observed in damaged test pit pavement, looking northwest. Lat: 29.7842528 Long: - 95.3206250			
Photo No. 4	Date: 9/1/2021

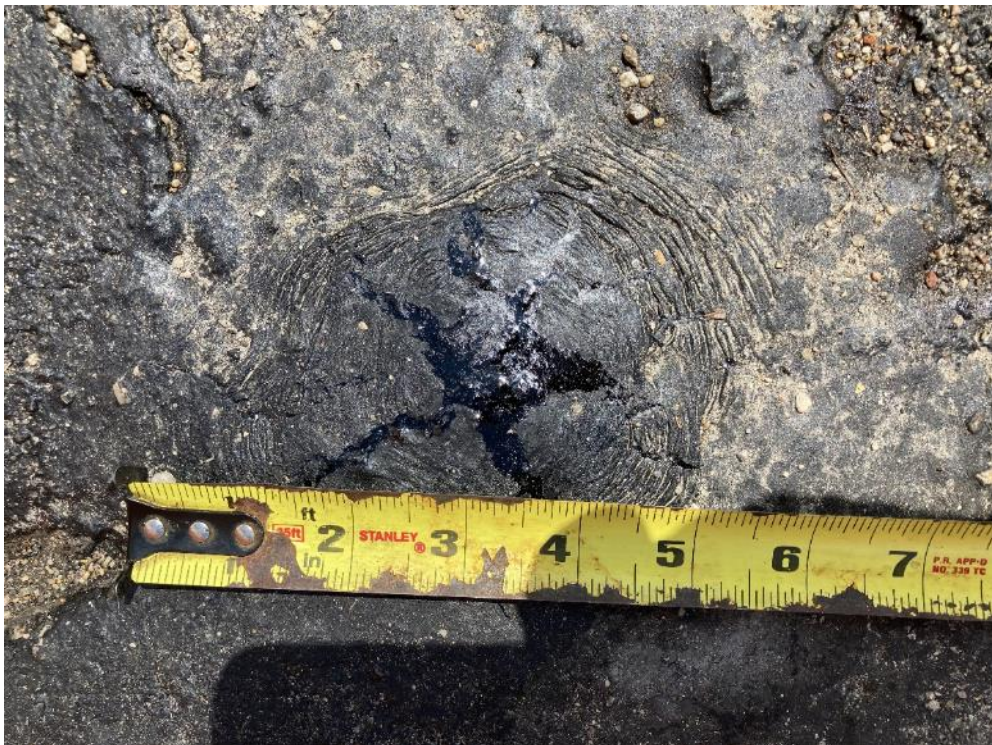
Description: Slot B101, small amount of tar-like material seeping at asphalt crack, material was removed. Lat: 29.784275 Long: - 95.320813

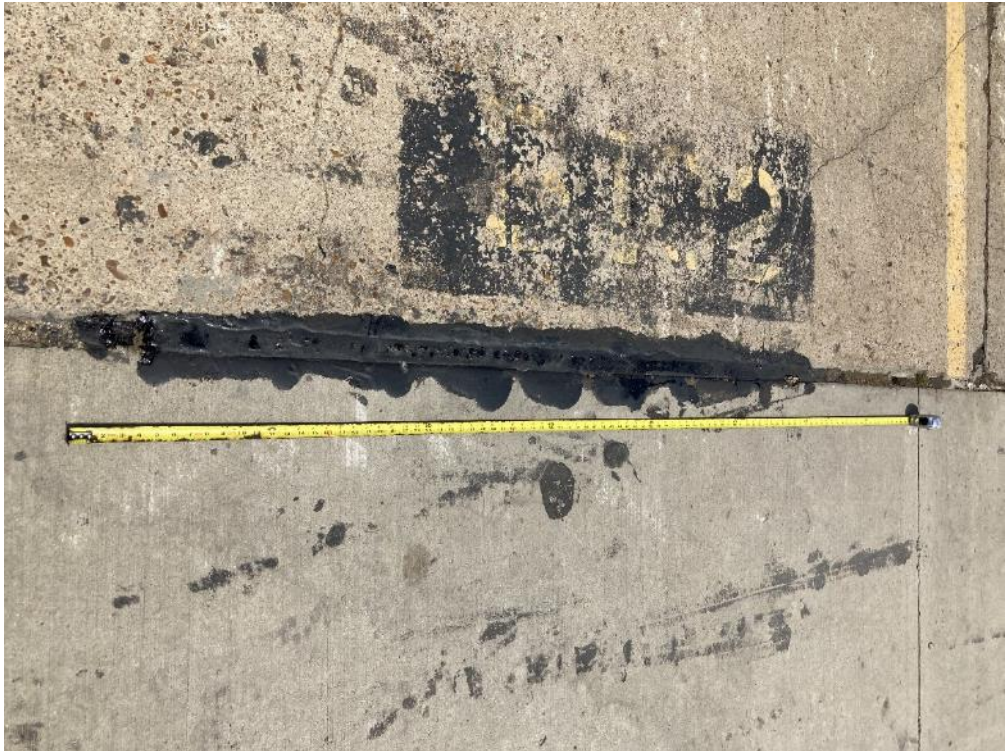
Description: Slot B102, small amount of tar-like material seeping at pavement joint, material was removed. Lat: 29.7842203 Long: - 95.320827			
Photo No. 6	Date: 9/1/2021

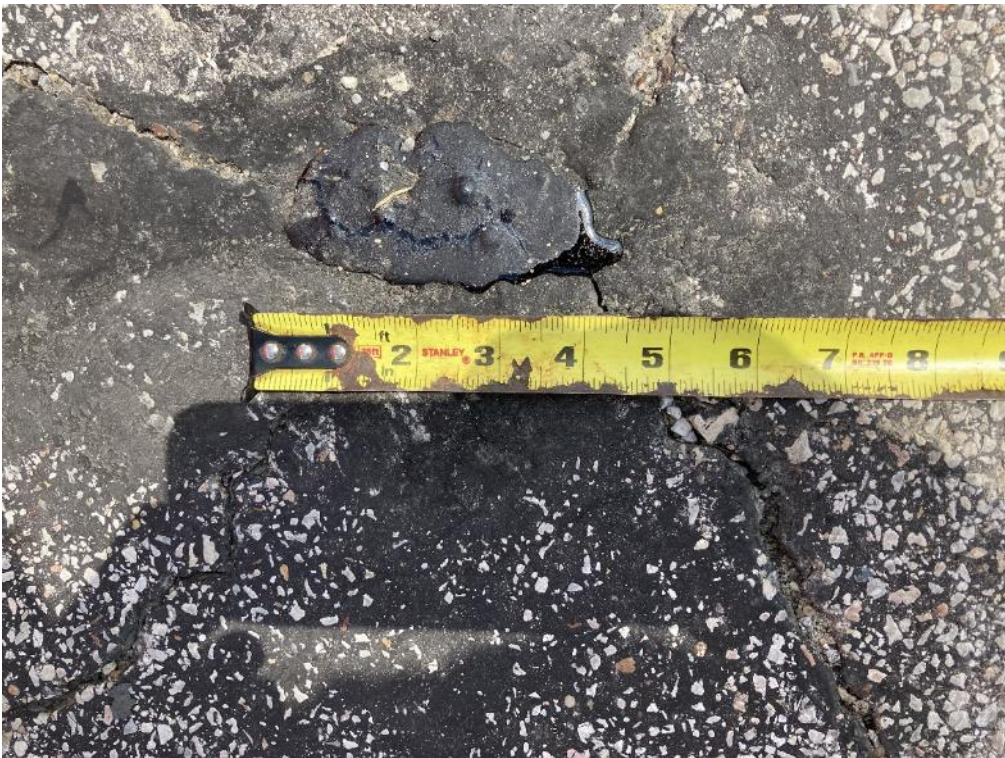
- A very small tar-like NAPL surface seep was observed in an asphalt crack approximately one foot outside of the edge of the NAPL Collection System in stall B105 during two of the five inspections in September (September 1st and 22nd) (Photo Nos. 6 and 29). For areas outside the NAPL Collection System, small amounts of tar-like material were observed on the concrete surface in the following locations during September:

Description: Slot B105, very small amount of tar-like material observed seeping observed at asphalt crack, material was removed. Lat: 29.7841472 Long: - 95.3208777

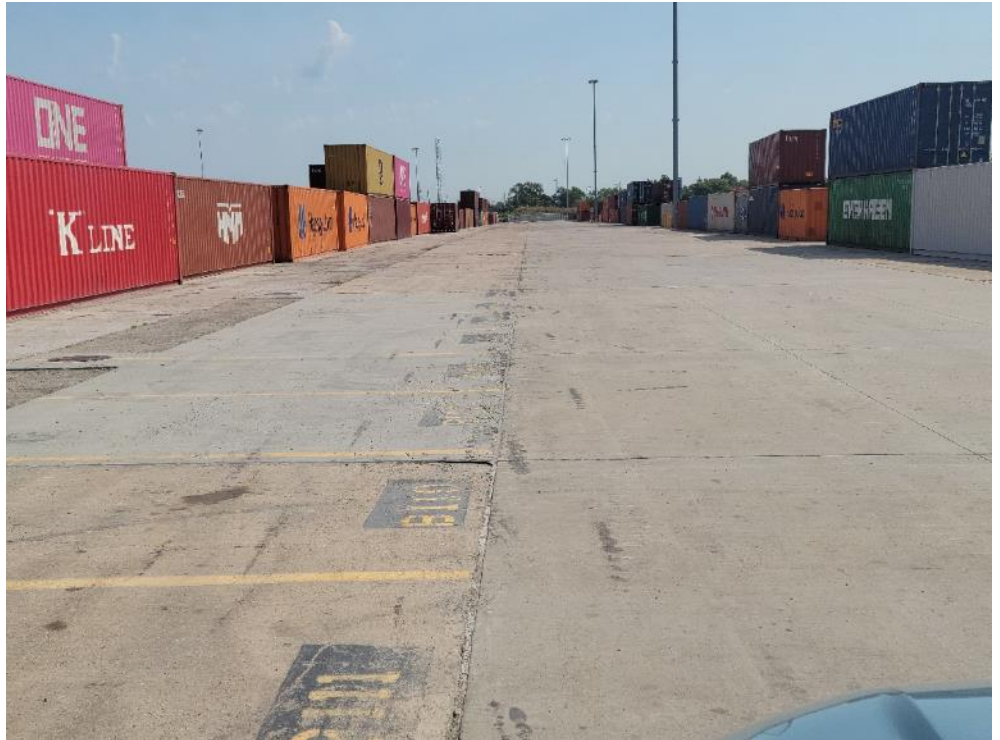
Photo No.
11

Tar-like material observed during the inspection events was recovered using a hand tool to scrape up the material. During the September 8th inspection, track marks from a container transport vehicle running over the seep in stall B102 were observed (Photo No. 11). The tracking was observed to run northeast to southwest and extended from Stall B090-B118. Barricades were set up surrounding the B102 seep location to prevent further tracking on September 10th (Photo No. 12). During September, the number of tar-like material seeps observed during inspections and the total amount of material removed from the concrete surface increased compared to the August inspections. A total of approximately 7 gallons of tar-like material was recovered for the month and placed in a drum for disposal. Approximately 5.5 gallons of the 7 total that were recovered came from the seep in stall B102. The drum is staged at the Container Storage Area (CSA).

View of slots B111-B090, NAPL collection system visible in background, tar-like material tracking from the B102 seep observed, looking northeast.

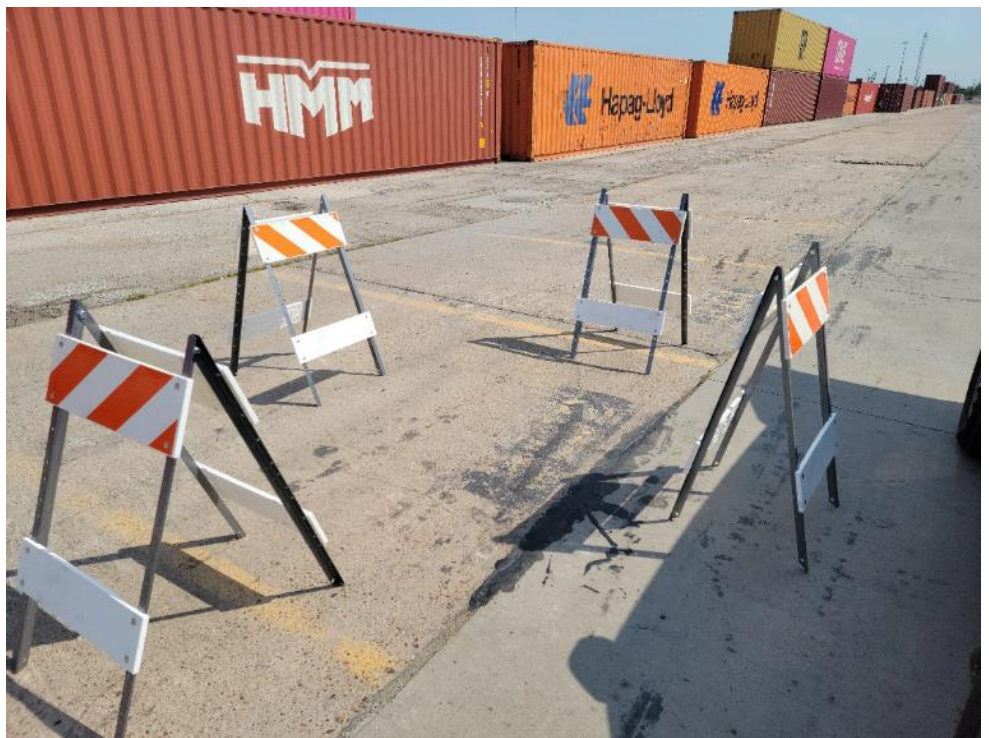
Photo No.
12

Slot B102, barricades placed around seep location to prevent material from tracking.

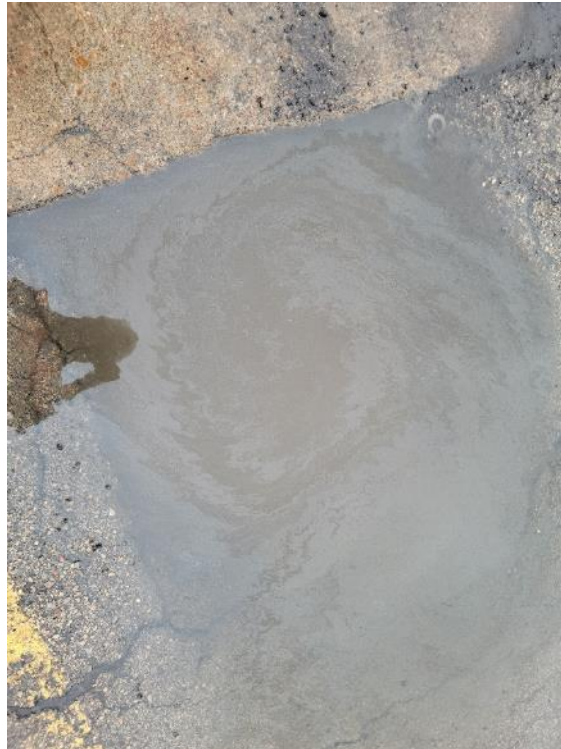
Photo No.
13

Slot A010, no tar-like material seeps observed where test pit conducted (July 2020), sheen observed on standing water from recent rain event in asphalt depression (not the test pit).

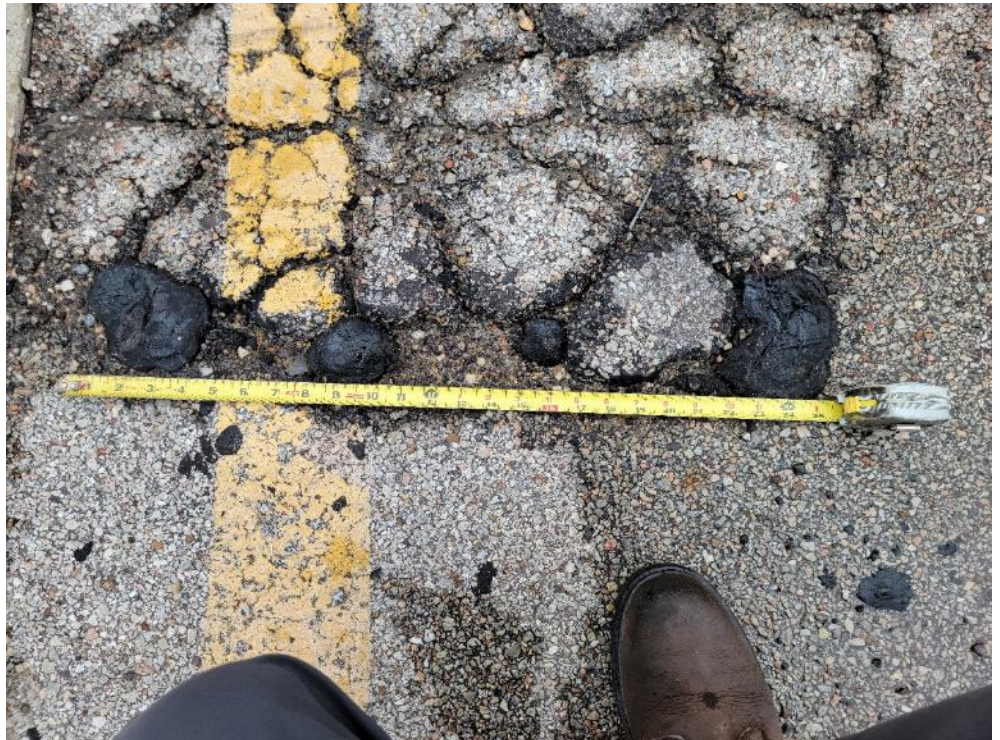
Photo No.
14

Slot B057, small amount of tar-like material seeping at asphalt crack (not at July 2020 test pit location), material was removed.

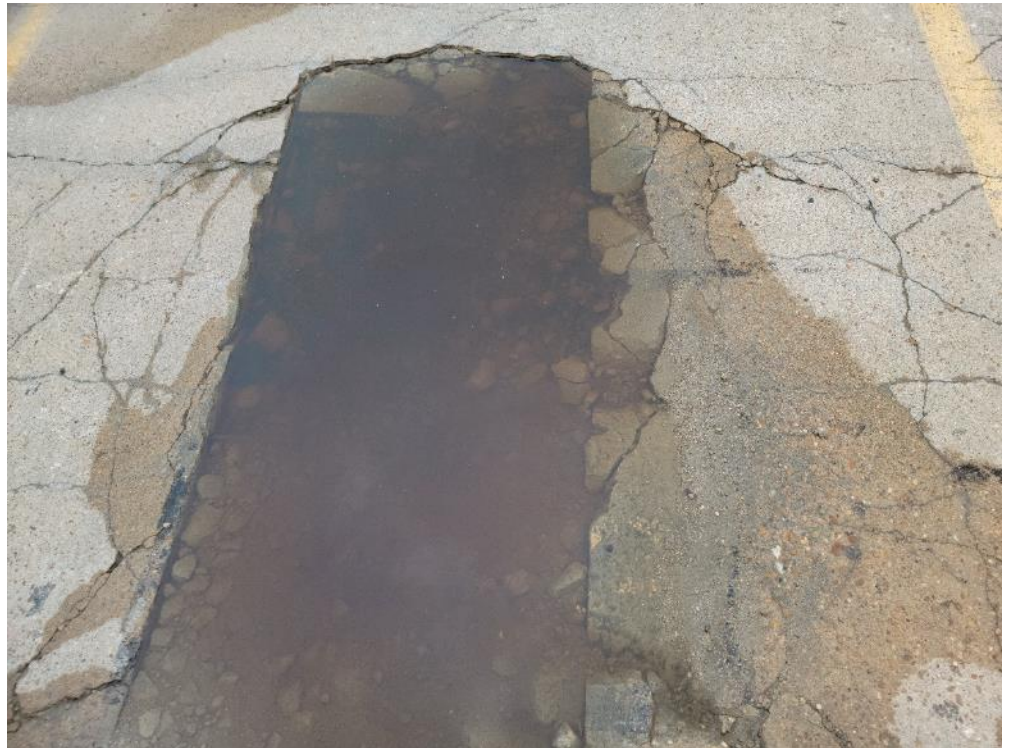
Photo No.
15

Slot B096, no tar-like material seeps observed where test pit conducted (July 2020), brown stained water from recent rain event observed in damaged test pit pavement.

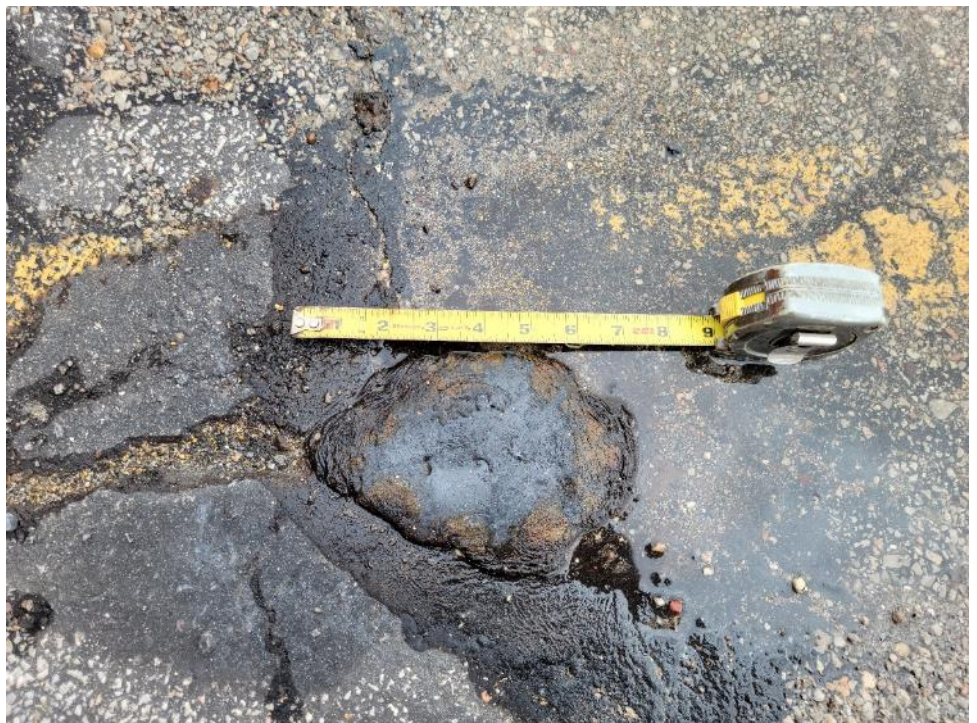
Photo No.
16

Slot B101, small amount of tar-like material seeping at asphalt crack, water on pavement from recent rain event, material was removed.

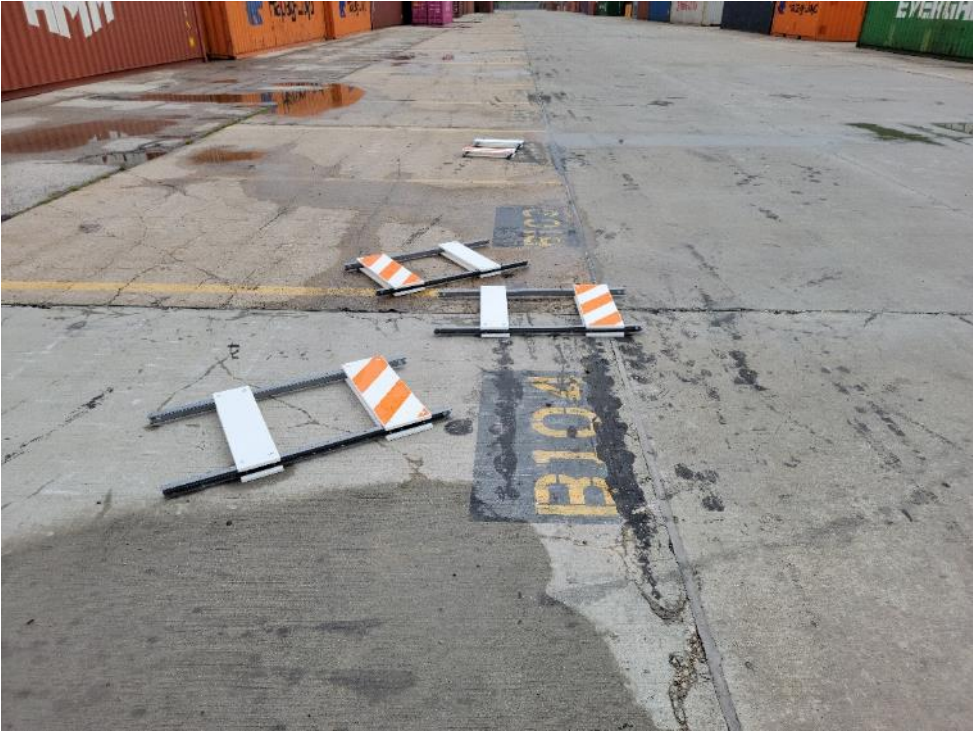
Description: Slots B104-B098, barricades placed around B102 seep location to prevent material from tracking were blown down, material tracking observed, pavement wet from recent rain event, looking east. Lat: 29.7842861 Long: - 95.3208611			
Photo No. 18	Date: 9/15/2021

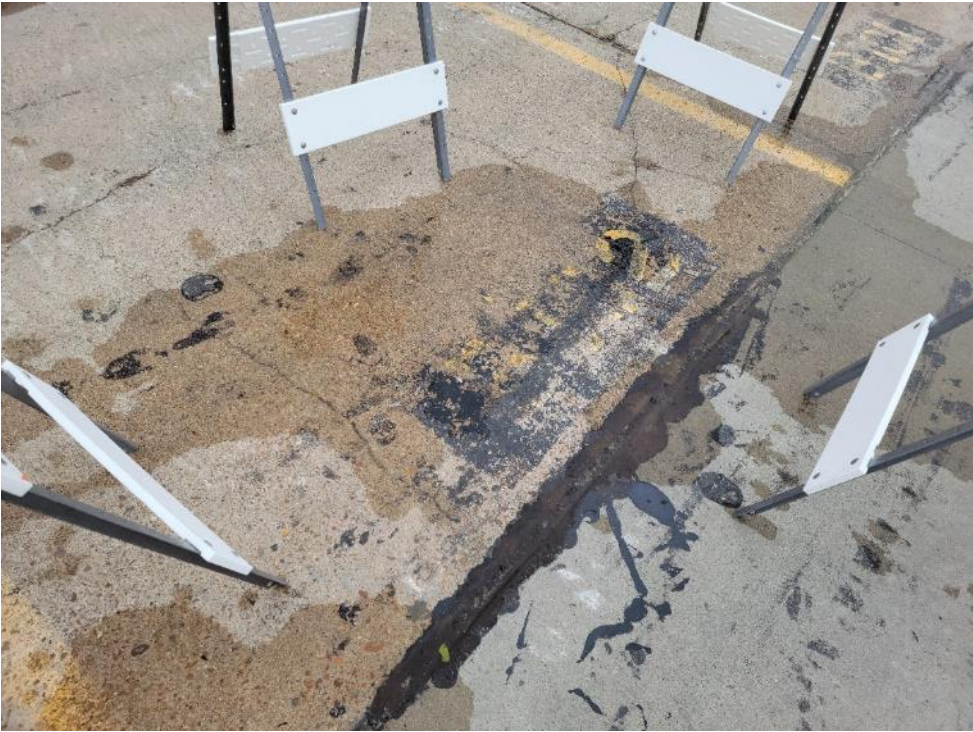
Description: Slot B102, tar-like material seeping at pavement joint, barricades set back up to prevent material tracking, pavement wet from recent rain event, material was removed. Lat: 29.7842203 Long: - 95.320827

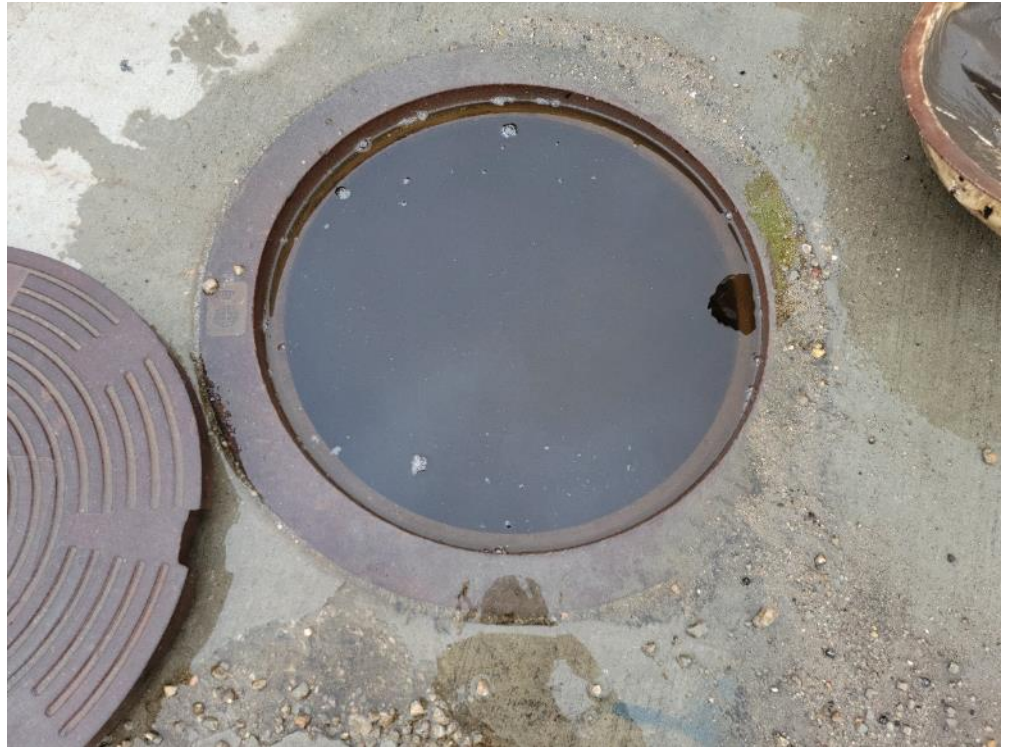
Photo No.
19

Sump 1 (B099/B100), 0 inches of freeboard in sump, no sheen or odor noted, water on pavement from recent rain event.

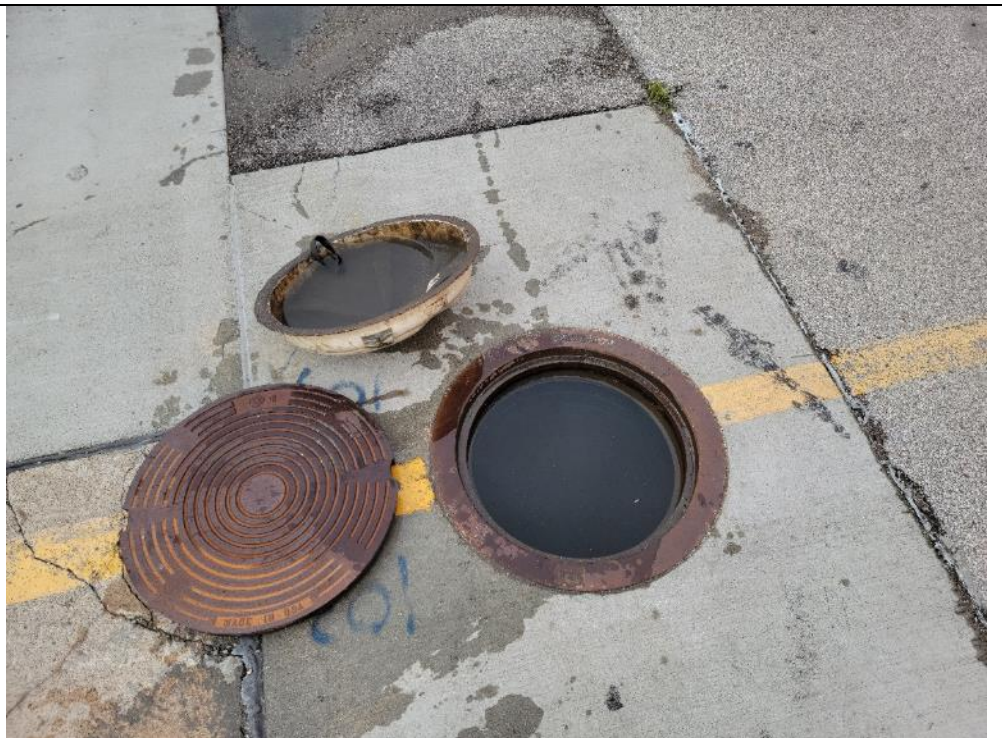
Photo No.
20

Sump 2 (B103/B104), 3 inches of freeboard in sump, no sheen or odor noted, water on pavement from recent rain event.

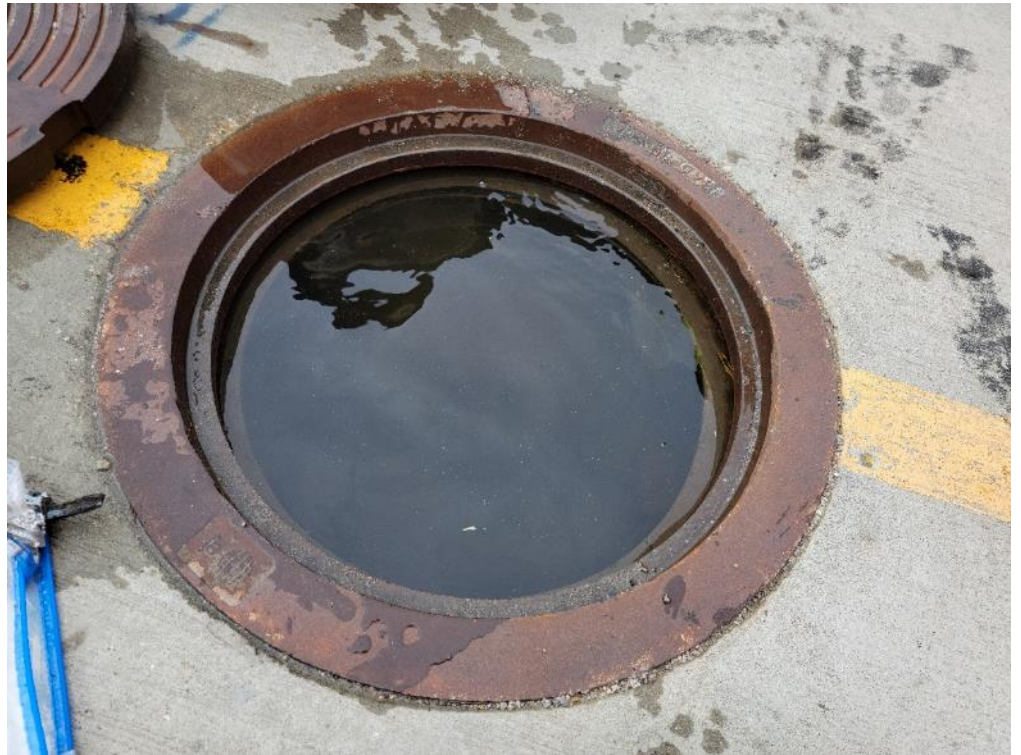
Photo No.
21

Sump 3 (B107/B108), 4 inches of freeboard in sump no sheen or odor noted. No tar-like material recovered.

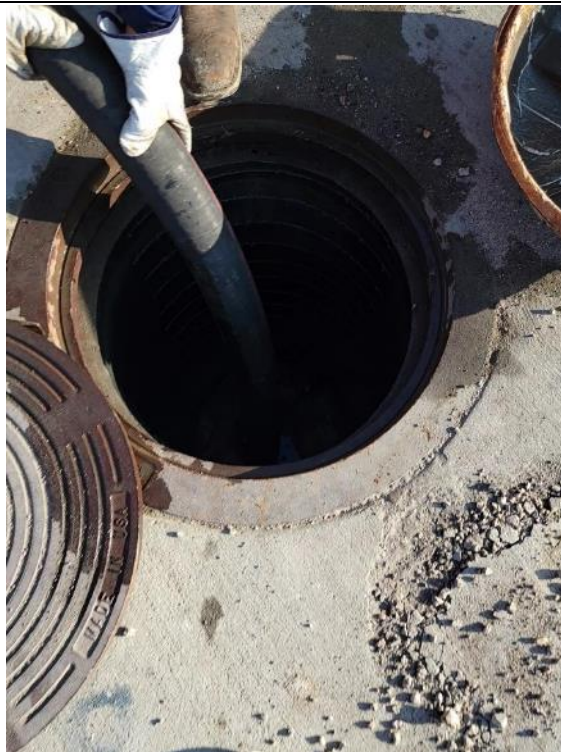
Photo No.
22

Sump 1 (B099/B100), emptied during pump down event, no sheen, odor, or tar-like material noted.

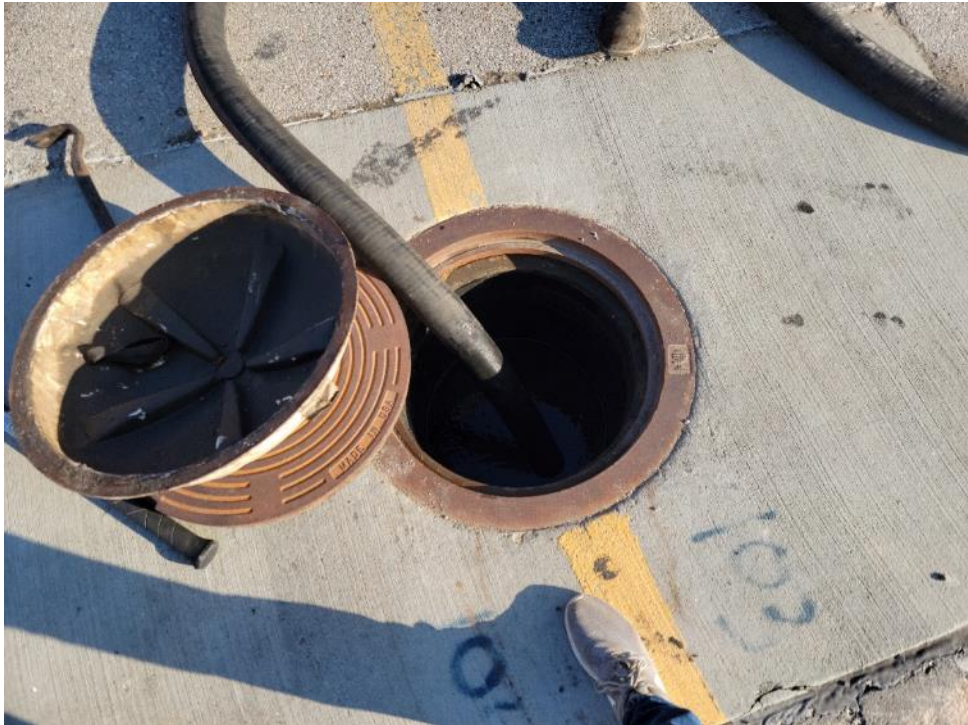
Description: Sump 2 (B103/B104), during pump down event, no sheen, odor, or tar-like material noted. Lat: 29.7842861 Long: - 95.3208611			
Photo No. 24	Date: 9/17/2021

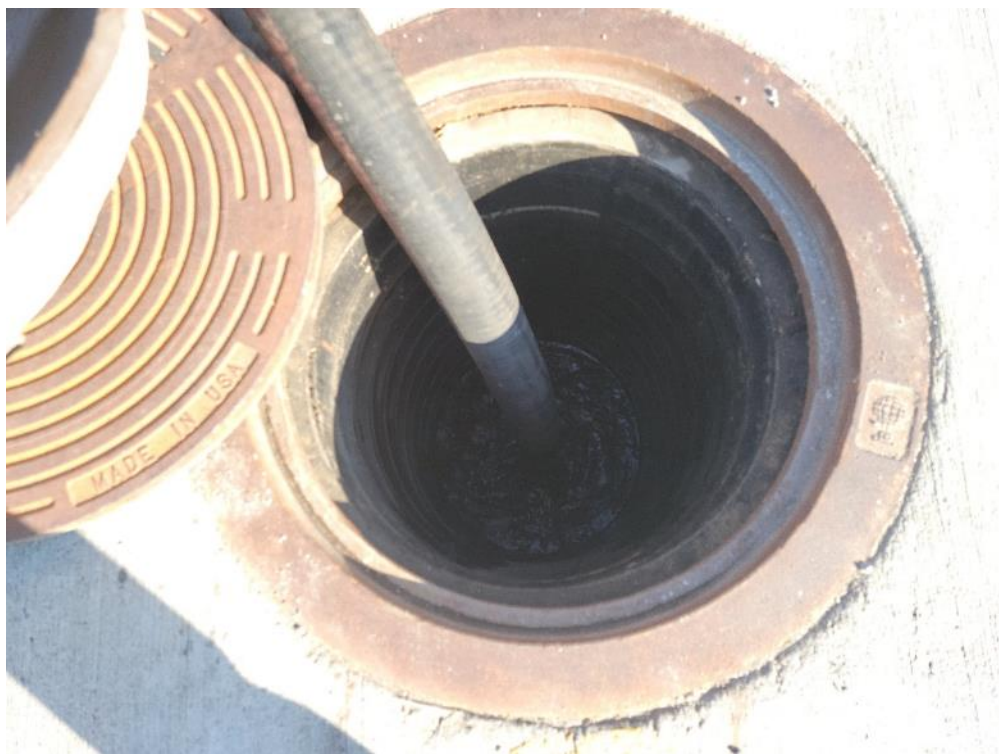
Description: Sump 3 (B107/B108), during pump down event, no sheen, odor, or tar-like material noted. Lat: 29.784172 Long: -95.320998

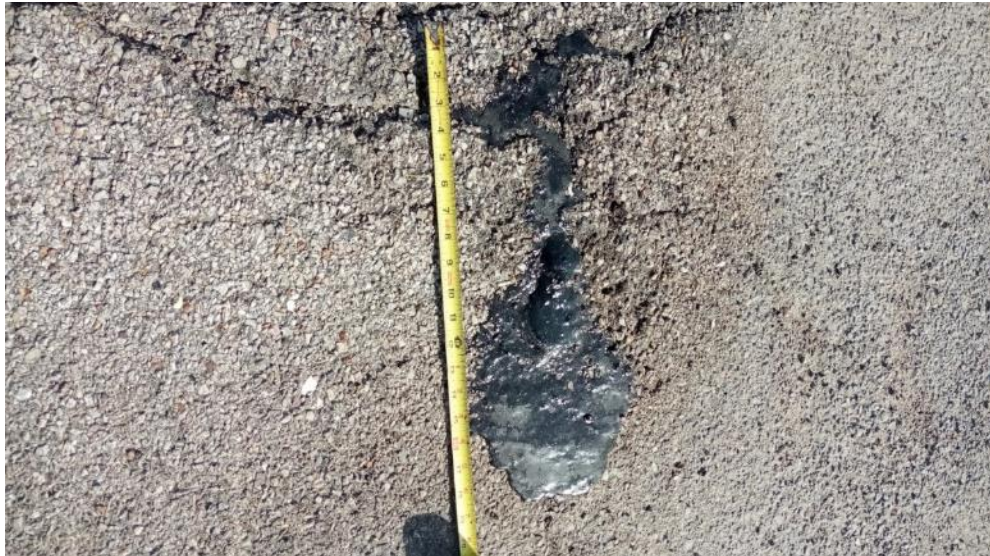
Description: Slot A011, small amount of tar-like material seeping at asphalt crack, material was removed. Lat: 29.785467 Long: -95.318347			
Photo No. 26	Date: 9/22/2021

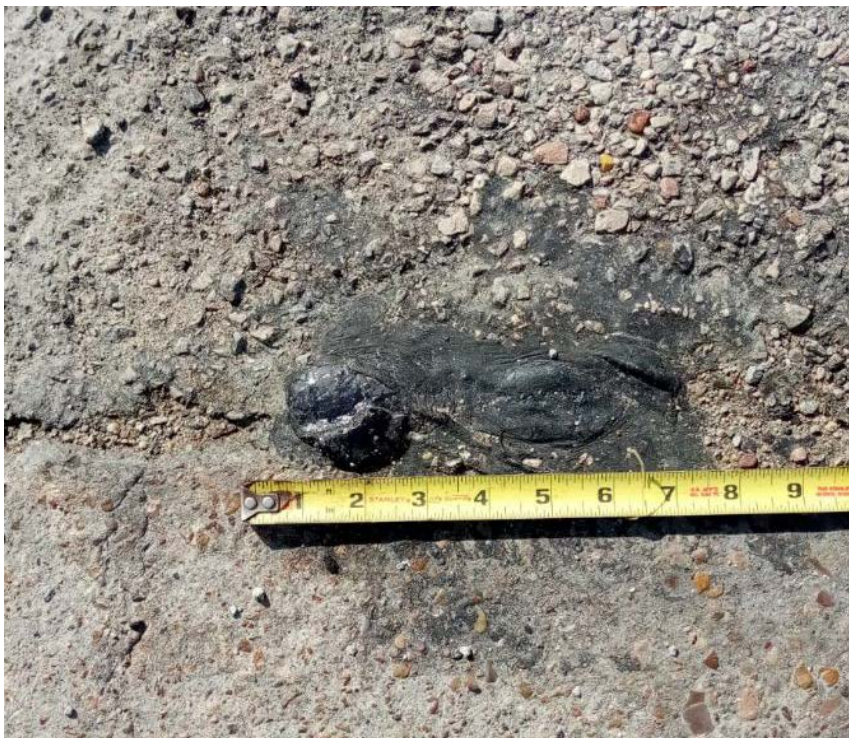
Description: Slot A022, very small amount of tar-like material seeping at asphalt crack, material was removed. Lat: 29.785392, Long: -95.318655

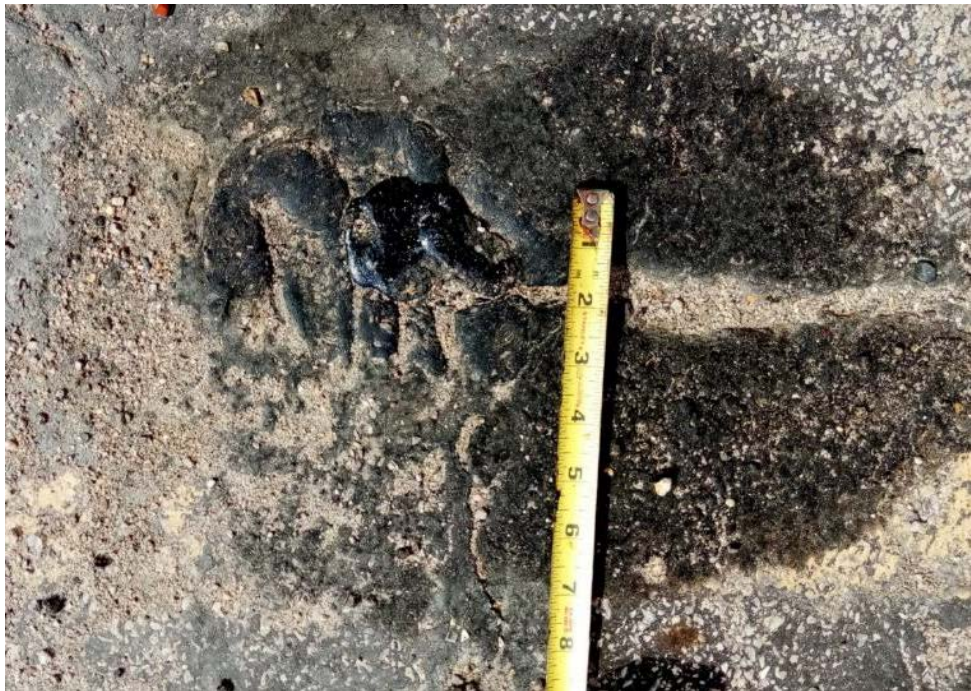
Description Slot B101, small amount of tar-like material seeping at asphalt crack, material was removed. Lat: 29.784275 Long: - 95.320813			
Photo No. 28	Date: 9/22/2021

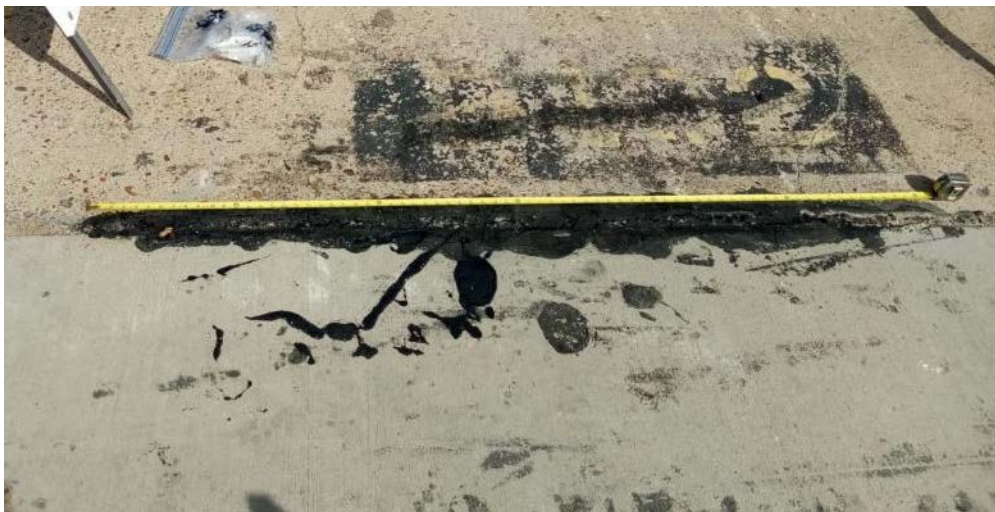
Description: Slot B102, tar-like material seeping at pavement joint, material was removed. Lat: 29.7842203 Long: - 95.320827

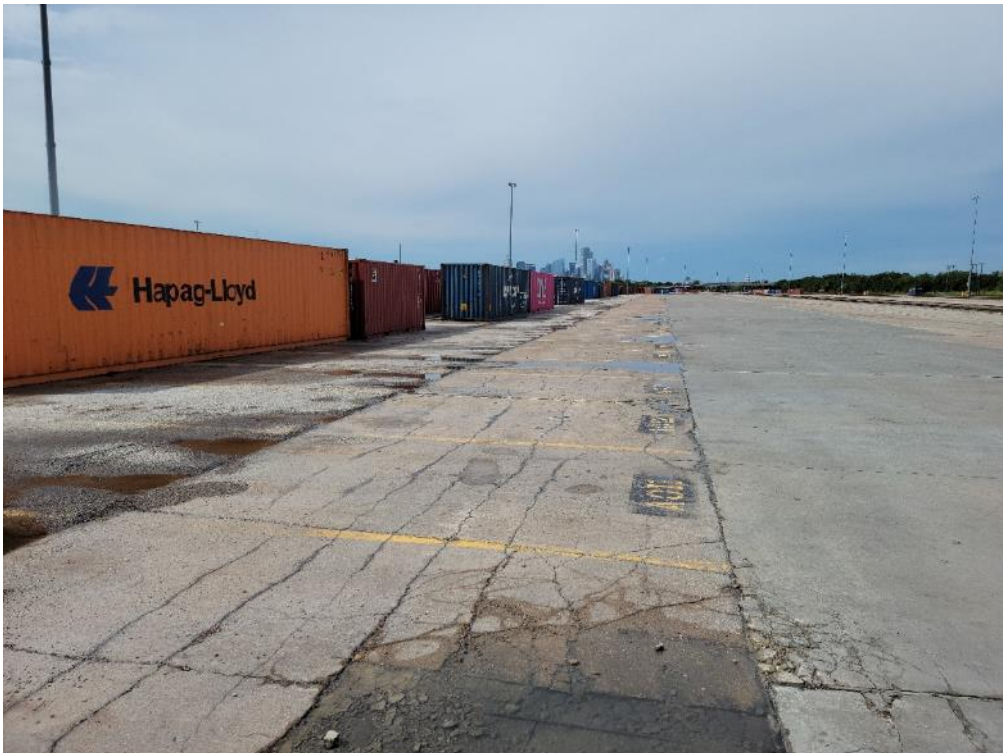
Description: Slots A010-A022, no tar-like material seeps observed test pit pavement damaged, standing water from recent rain event, no sheen or discoloration observed, looking southeast. Lat: 29.7855833, Long: -95.318375			
Photo No. 32	Date: 9/29/2021

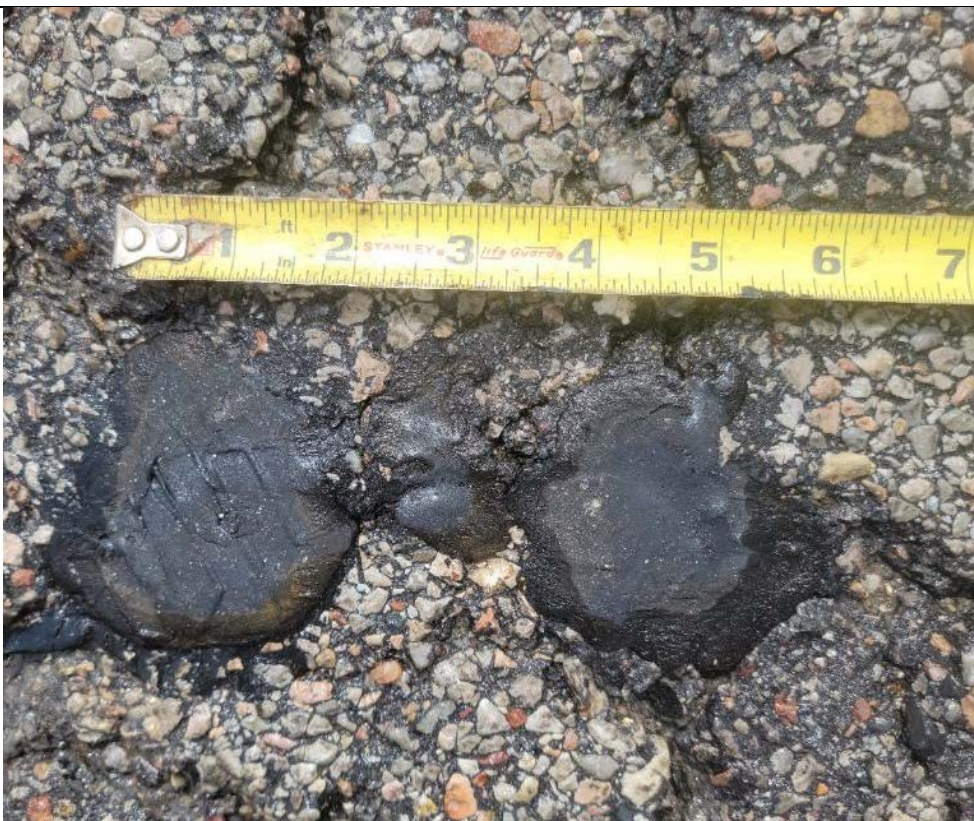
Description: Slot B057, small amount of tarlike material seeping at asphalt crack (not at July 2020 test pit location), material was removed. Lat: 29.7847472 Long: - 95.3195417

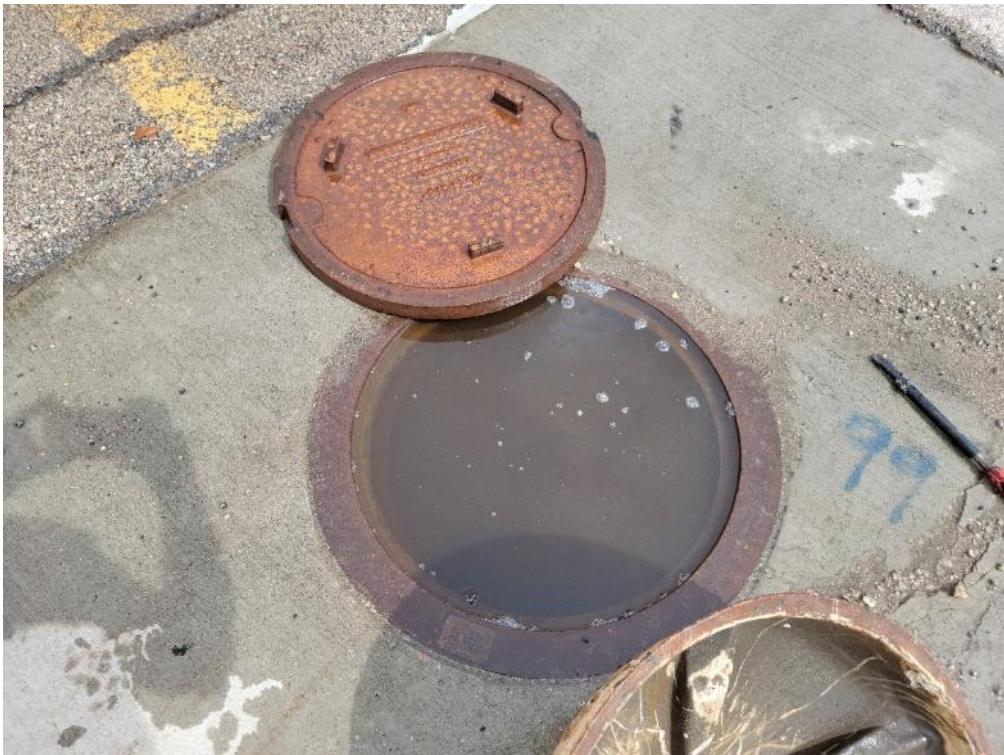
Description: Sump 1 (B099/B100), 0 inches of freeboard in sump, no sheen or odor noted, water on pavement from recent rain event. Lat: 29.7844000 Long: - 95.3205861			
Photo No. 34	Date: 9/29/2021

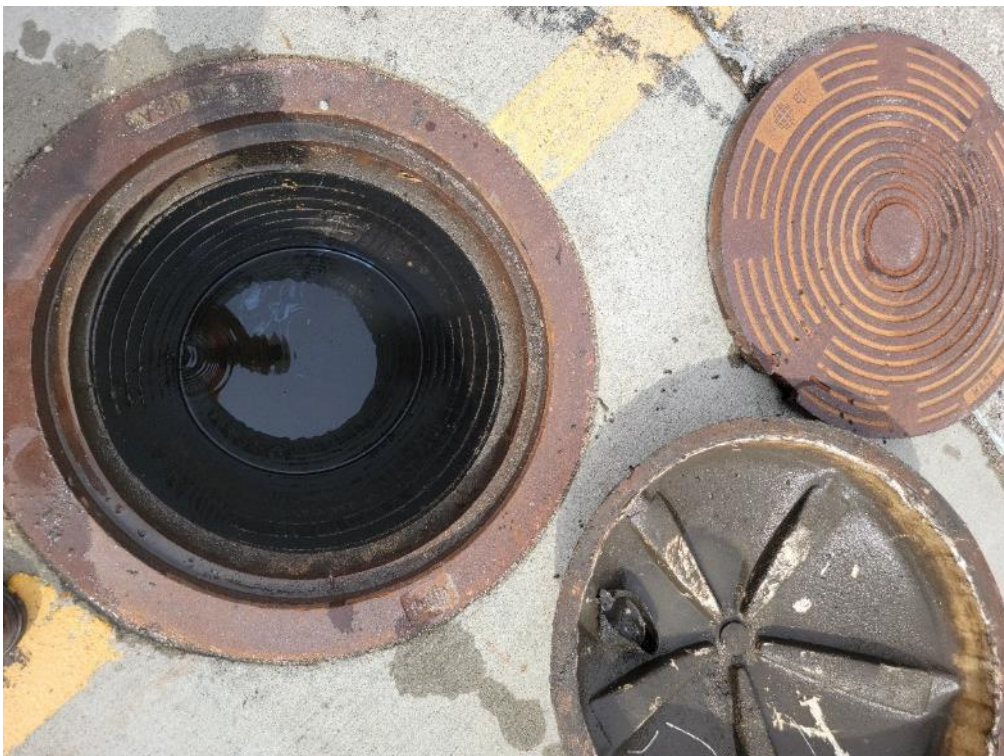
Description: Sump 2 (B103/B104), 29 inches of freeboard in sump. Sheen was observed on water in sump. No odors noted. Lat: 29.7842861 Long: - 95.3208611

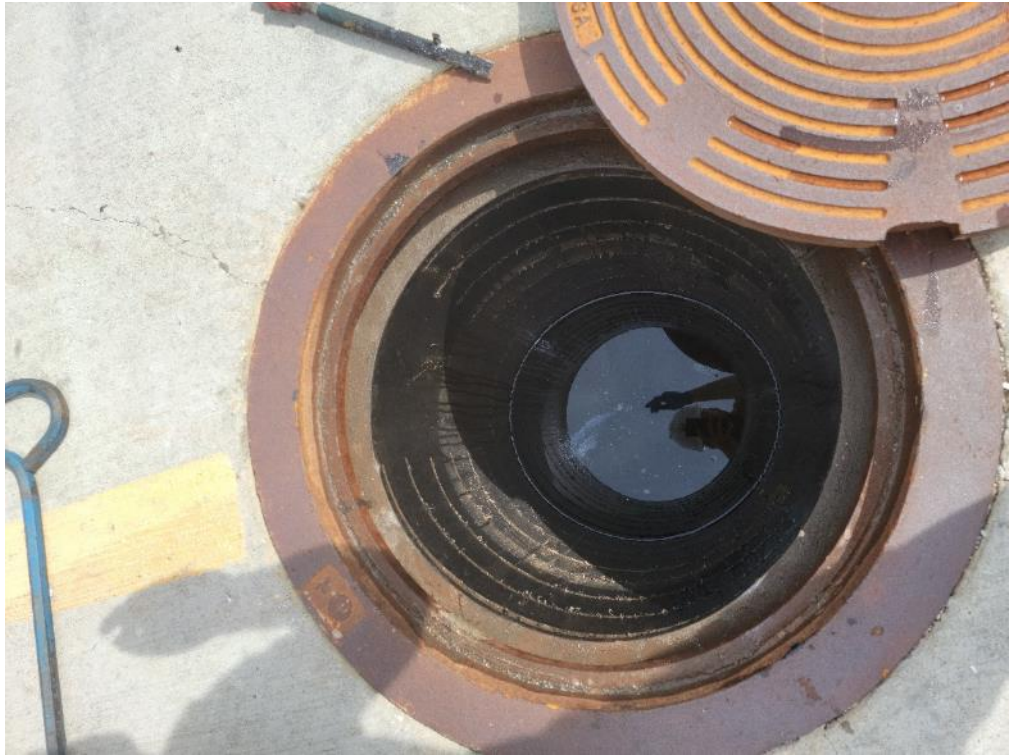
Description: Sump 3 (B107/B108), 30.75 inches of freeboard in sump. Sheen was observed on the water in the sump. No odors noted. No tar-like material recovered. Lat: 29.784172 Long: -95.320998			
Photo No. 36	Date: 9/29/2021
