Project No. 19119232

**Re: MONTHLY STATUS UPDATE – ENGLEWOOD INTERMODAL YARD – NAPL COLLECTION
SYSTEM/CONCRETE CAP REPAIRS
UNION PACIFIC RAILROAD HOUSTON WOOD PRESERVING WORKS FACILITY
4910 LIBERTY ROAD FACILITY, HOUSTON, TEXAS
POST-CLOSURE CARE PERMIT NO. HW-50343; INDUSTRIAL SWR NO. 31547**

Weekly Inspection Photolog

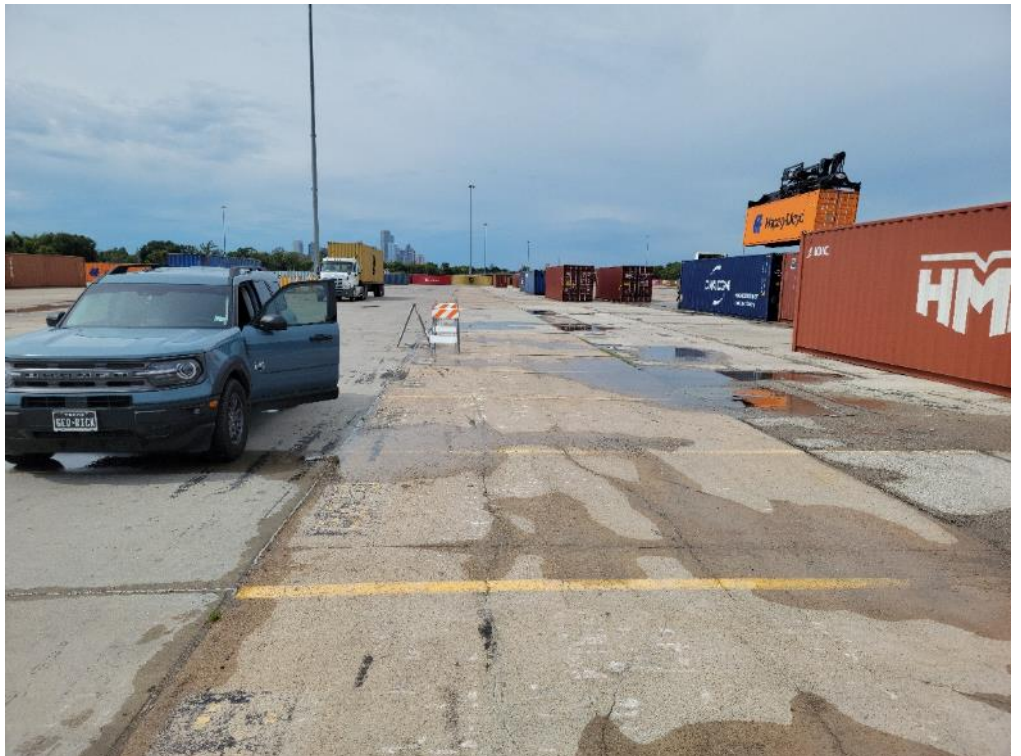
Description: View of slots B097-B109, NAPL collection system visible in background, barricades set up at B102 seep, standing water on pavement from recent rain event, looking northwest. Lat: 29.784300 Long: -95.320711
