January 15, 2022

Project No. 19119232

Re: **MONTHLY STATUS UPDATE – ENGLEWOOD INTERMODAL YARD – NAPL COLLECTION
SYSTEM/CONCRETE CAP REPAIRS
UNION PACIFIC RAILROAD HOUSTON WOOD PRESERVING WORKS FACILITY
4910 LIBERTY ROAD FACILITY, HOUSTON, TEXAS
POST-CLOSURE CARE PERMIT NO. HW-50343; INDUSTRIAL SWR NO. 31547**

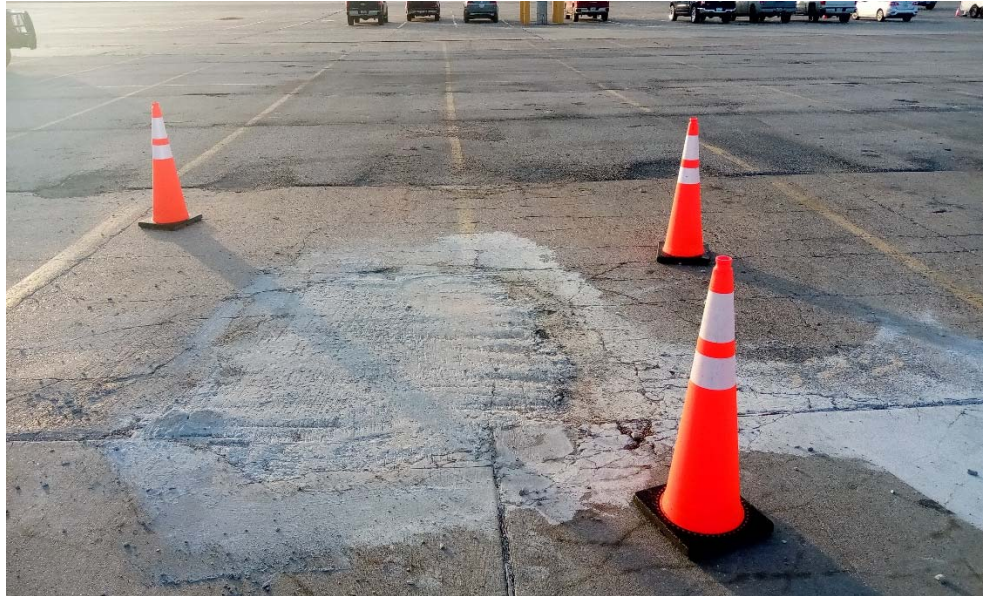
Photo No.
1

Slot A021, no tar-like material seeps observed where test pit conducted (July 2020), test pit pavement repaired, looking southwest.

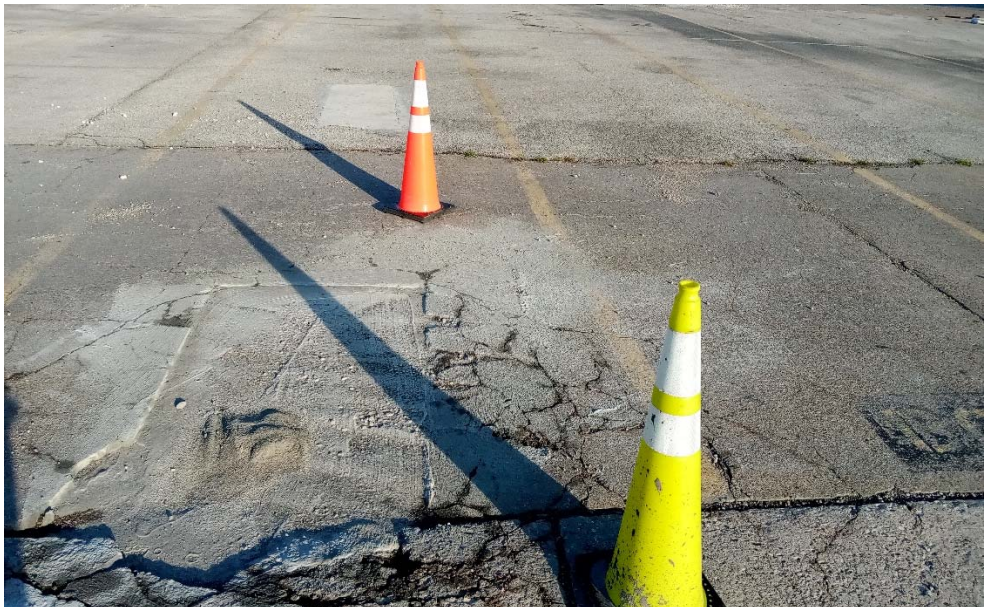
Photo No.
2

Slot B013, no tar-like material seeps observed where test pit conducted (July 2020), test pit pavement repaired, looking northeast.

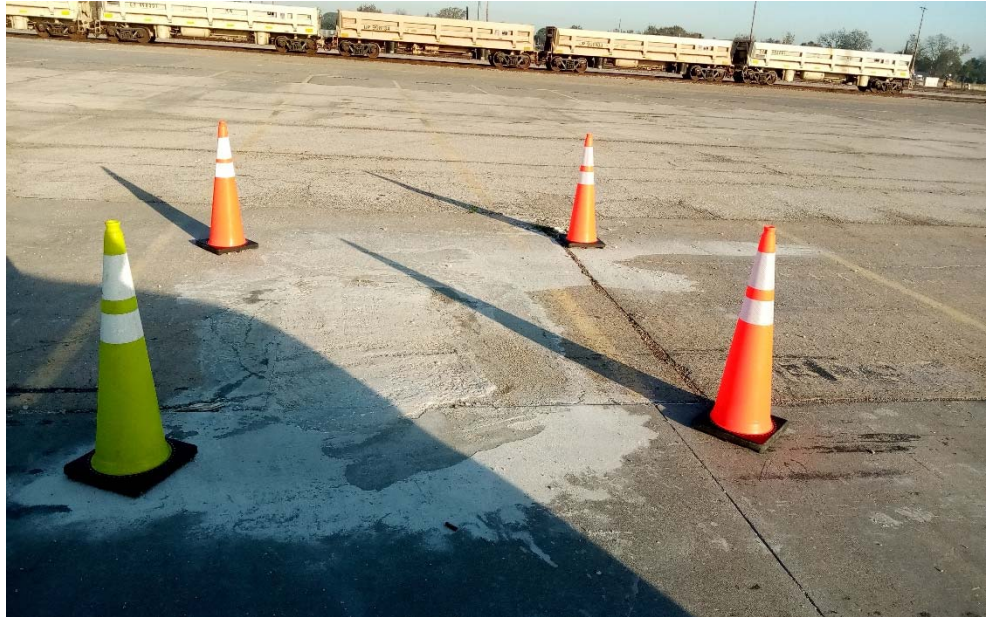
Photo No.
3

Slot B096, no tar-like material seeps observed where test pit conducted (July 2020), test pit pavement repaired, looking northwest.

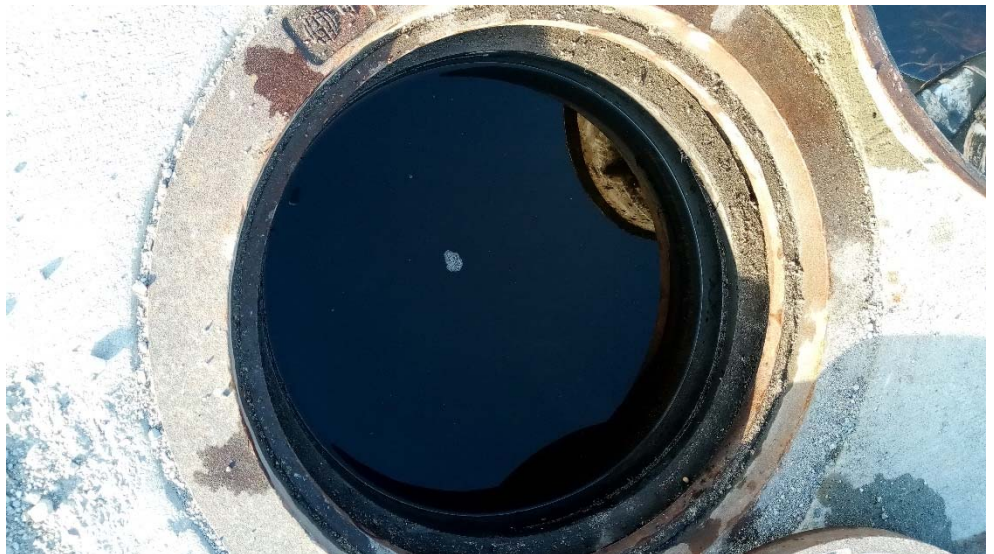
Photo No.
4

Sump 1 (B099/B100), 7 inches of freeboard in sump, no sheen or odor noted.

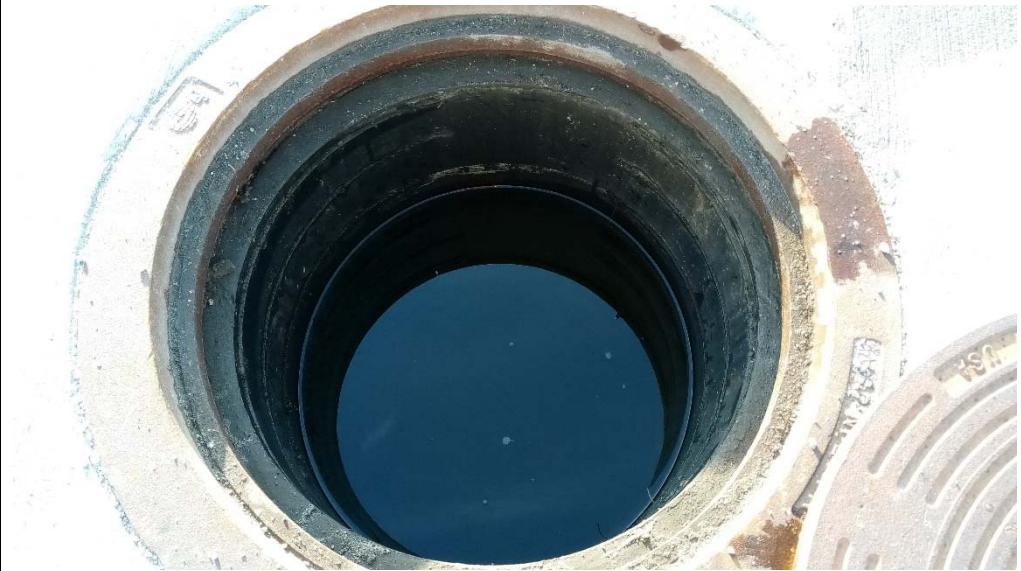
| Photo No. 5 | Inspection Date: 12/1/2021 | | |

| Description: Sump 2 (B103/B104), 15 inches of freeboard in sump. No sheen or odor noted. Lat: 29.7842861 Long: - 95.3208611 | | | |

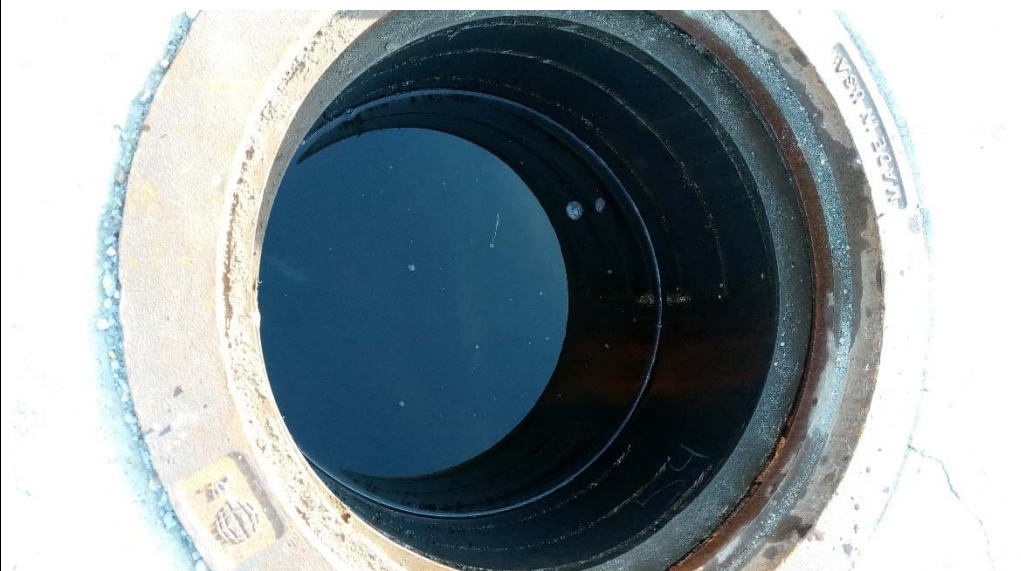
| Photo No. 6 | Inspection Date: 12/1/2021 | | |

| Description: Sump 3 (B107/B108), 21 inches of freeboard in sump. No sheen or odor noted. No tar-like material recovered. Lat: 29.784172 Long: -95.320998 | | | |

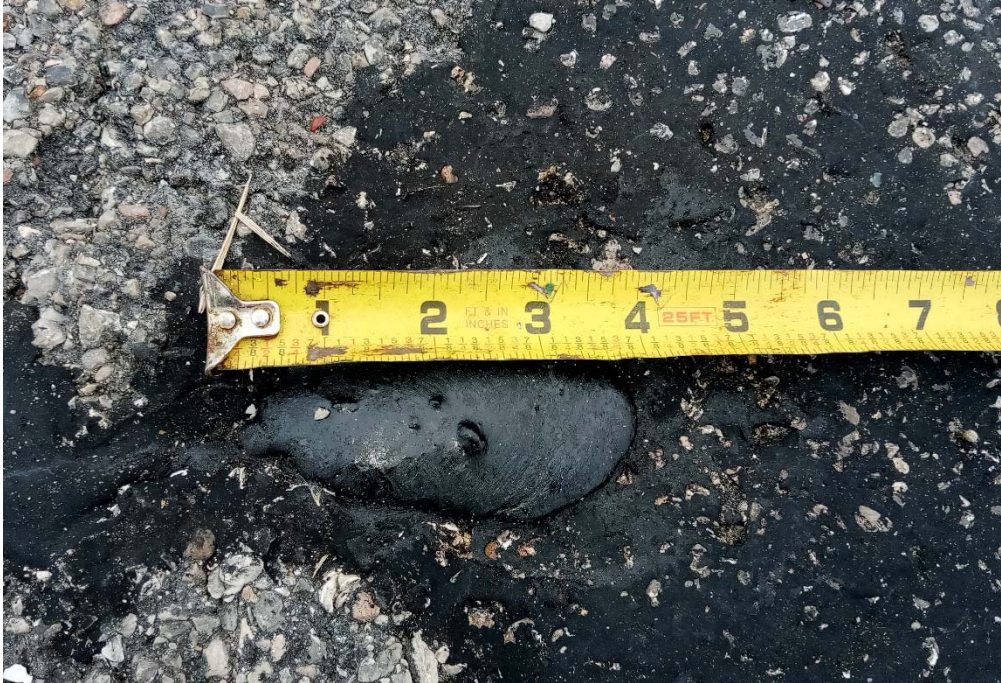
| Seep Observations Outside the NAPL Collection System Area | |
|---|---|
| A011 | December 8th (Photo No. 7) |

| Photo No. 7 | Inspection Date: 12/8/2021 | <p>Description:</p> <p>Slot A011, very small amount of tar-like material seeping at asphalt crack, material was removed.</p> <p>Lat: 29.785467 Long: -95.318347</p> | |

Tar-like material observed during the inspection event was recovered using a hand tool to scrape up the material. During September 2021, track marks from a container transport vehicle running over the seep in stall B102 were observed and barricades were set up surrounding the seep location to prevent further tracking. The barricades are checked and reset, as needed, during the weekly inspections. UPRR remediation contractor US Ecology pressure washed the tar-like material tracking in October 2021. Residual track marks were observed during the December inspections (Photo Nos. 11 and 22). No active seeps in Stall B102 or new track marks were observed during the month of December 2021. During December, the number of tar-like material seeps observed during inspections and the total amount of material removed from the concrete surface decreased compared to the November inspections. The only tar-like material seep observed during the December inspections was the small area at stall A011 during the December 8th inspection. Less than 0.1 gallons of tar-like material was recovered for the month and placed in a drum for disposal. The drum is staged at the Container Storage Area (CSA).

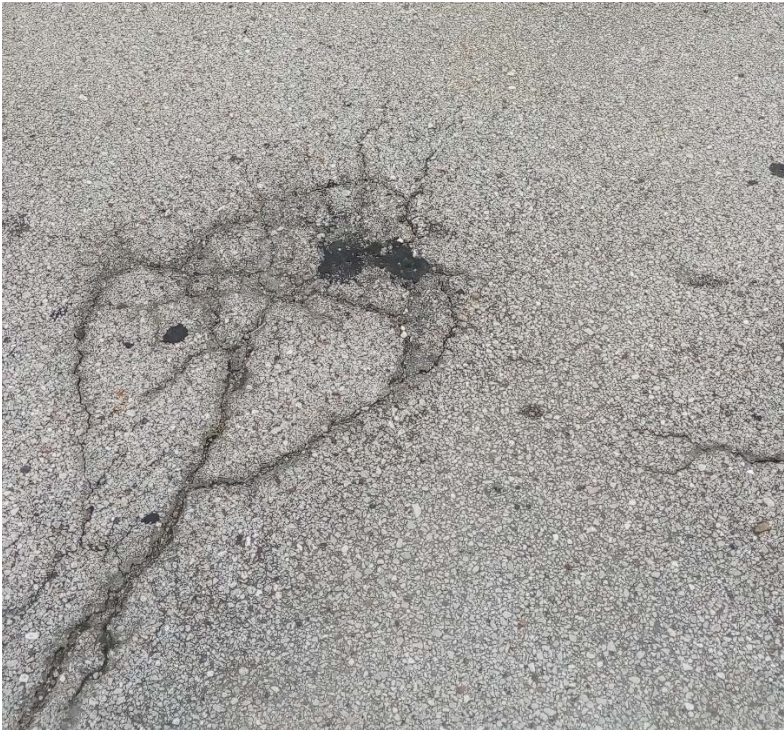
| Photo No. 8 | | Inspection Date: 12/8/2021 | <p>Description:</p> <p>Slot B057, no active tar-like material seeps observed at historical seep location or where test pit conducted (July 2020), residual staining noted.</p> <p>Lat: 29.7847472 Long: - 95.3195417</p> |

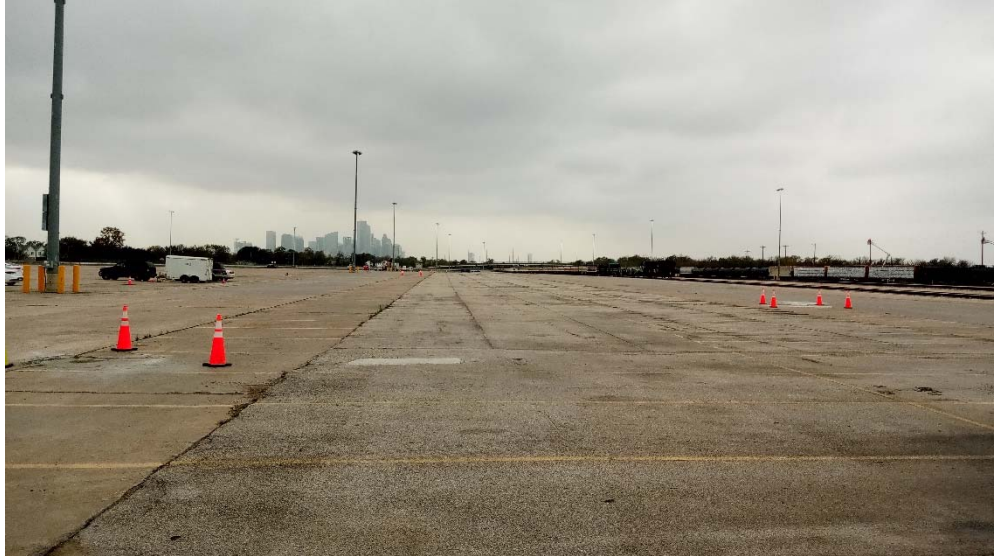
Photo No.
9

View of A and B rows, no new staining observed, residual staining visible, looking west.

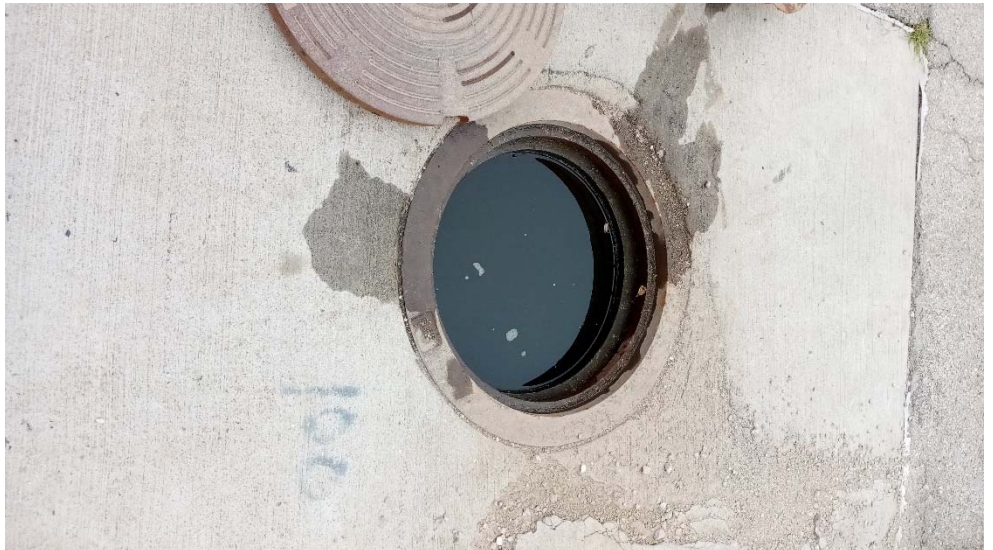
Photo No.
10

Sump 1 (B099/B100), 6 inches of freeboard in sump, no sheen or odor noted.

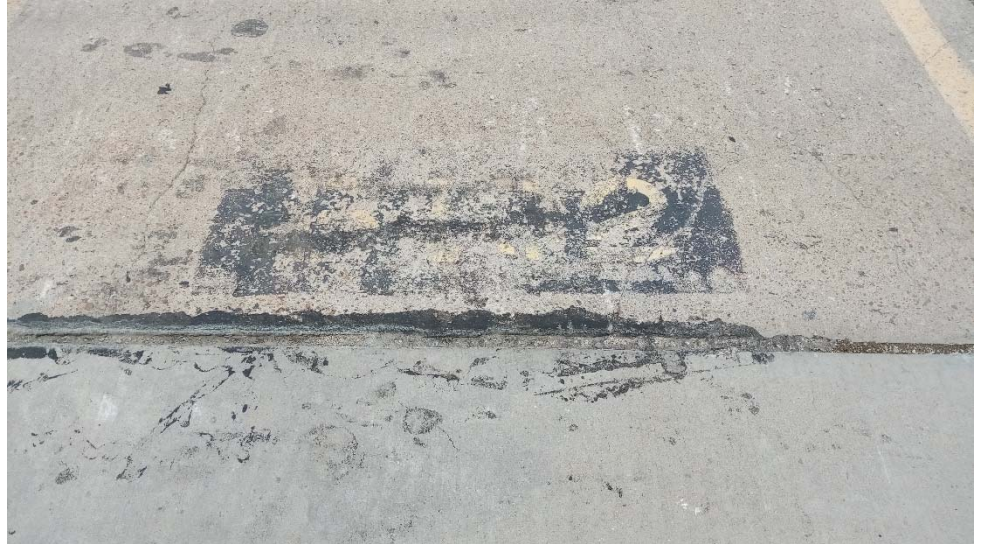
Photo No.
11

Slot B102, no active tar-like material seeps observed, residual staining noted.

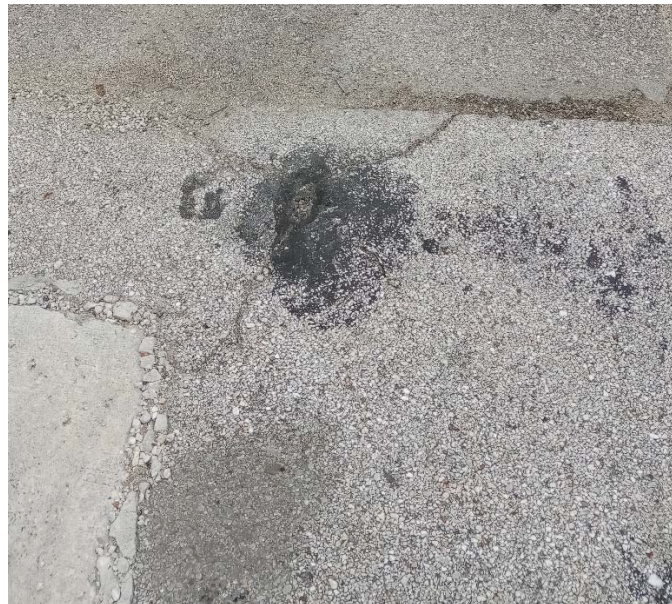
Photo No.
12

Slot B105, no active tar-like material seeps observed, residual staining noted.

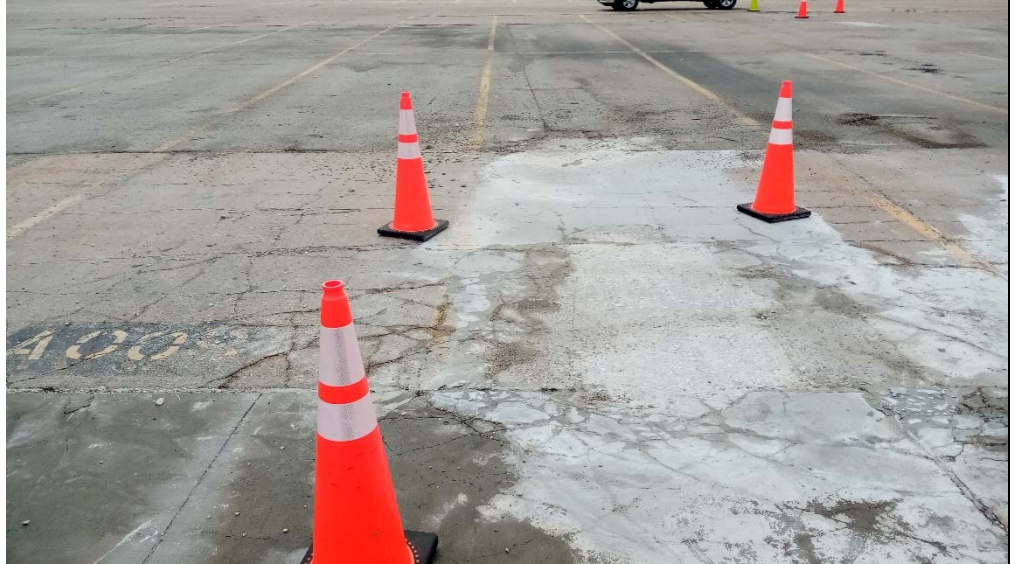
Photo No.
13

Slots A010, no tar-like material observed, July 2020 test pit pavement repaired, looking southwest.

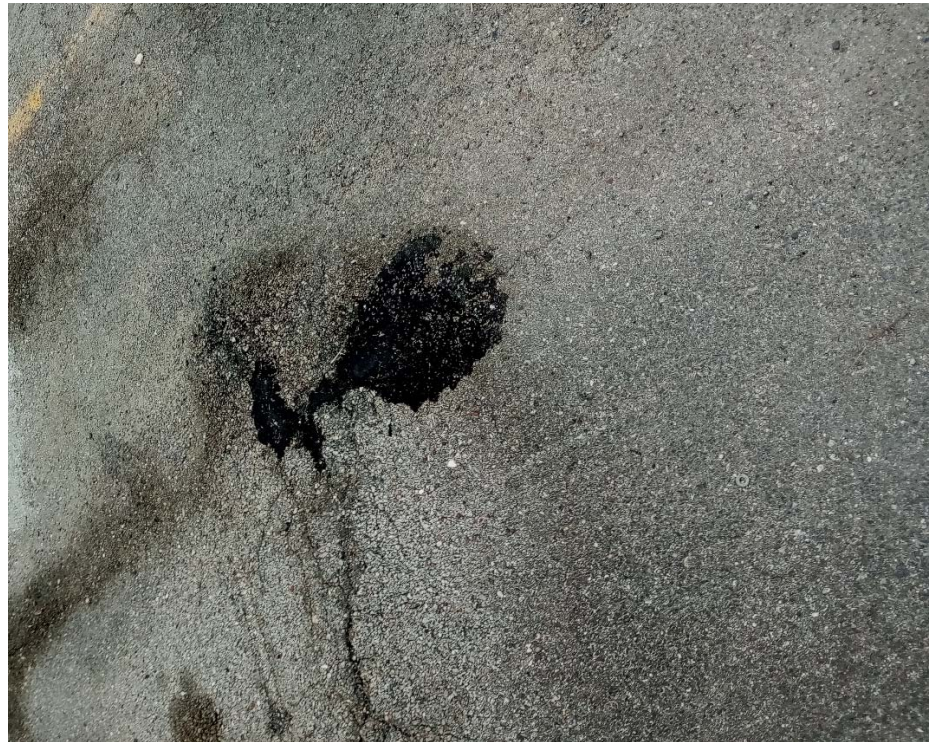
Photo No.
14

Slot A011, no active tar-like material seeps observed, residual staining noted.

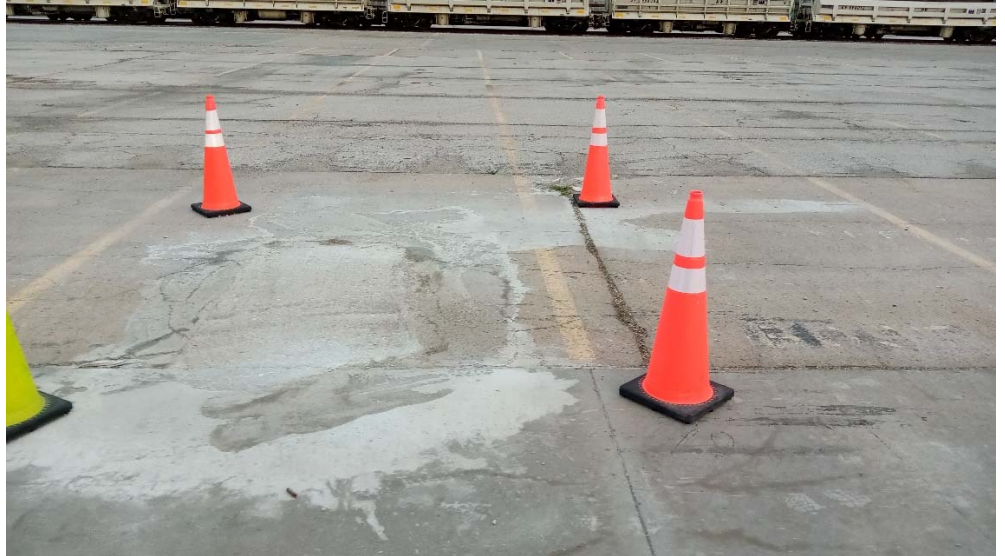
Photo No.
15

Slot B096, no tar-like material seeps observed where test pit conducted (July 2020), test pit pavement repaired, looking northwest.

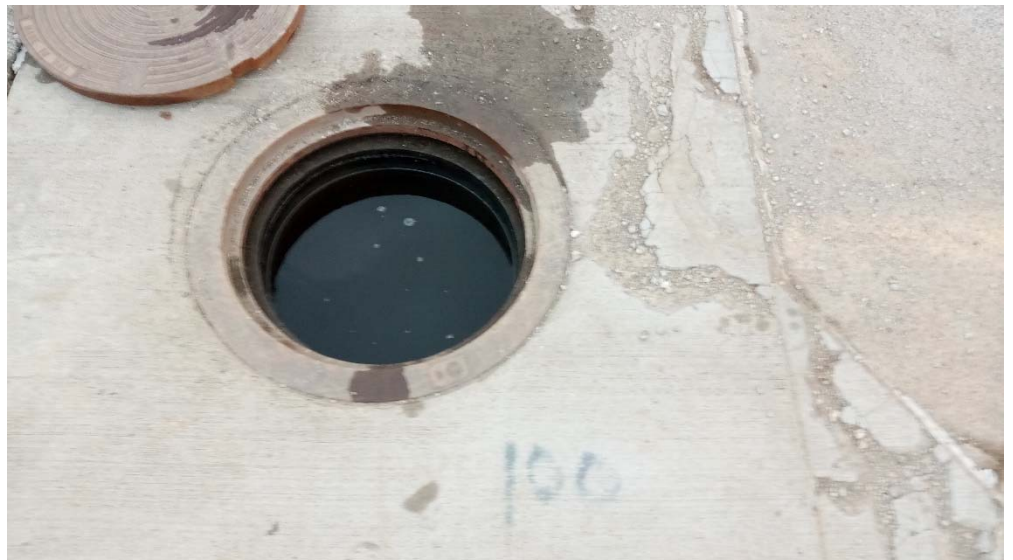
Photo No.
16

Sump 1 (B099/B100), 6 inches of freeboard in sump, no sheen or odor noted.

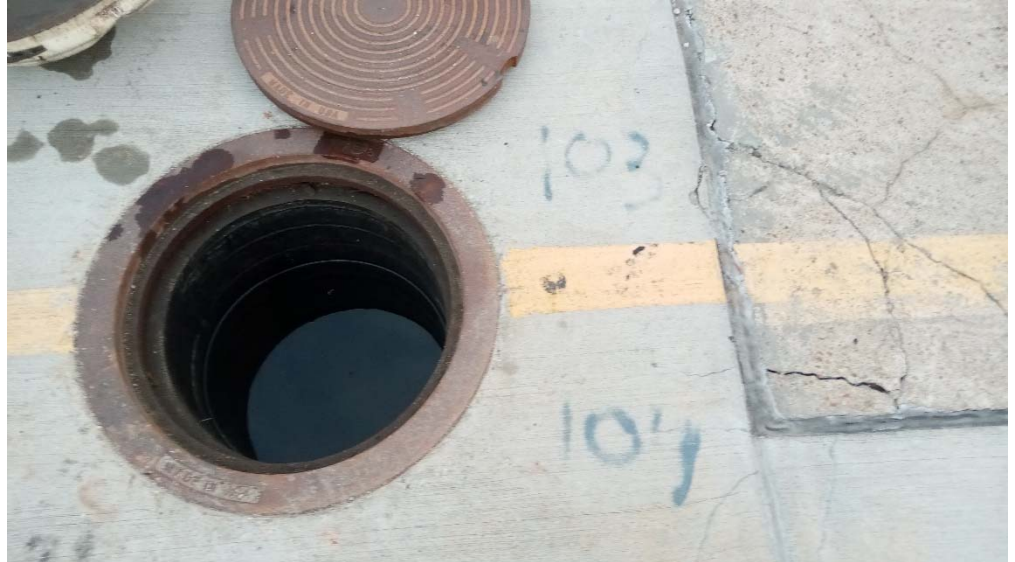
Photo No.
17

Sump 2 (B103/B104), 15 inches of freeboard in sump. No sheen or odor noted.

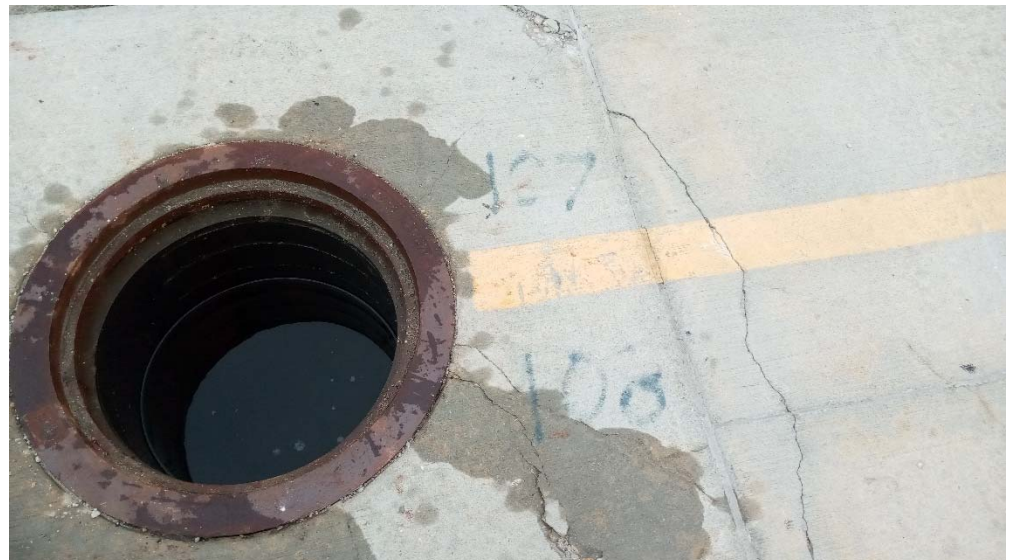
Photo No.
18

Sump 3 (B107/B108), 15 inches of freeboard in sump no sheen or odor noted. No tar-like material recovered.

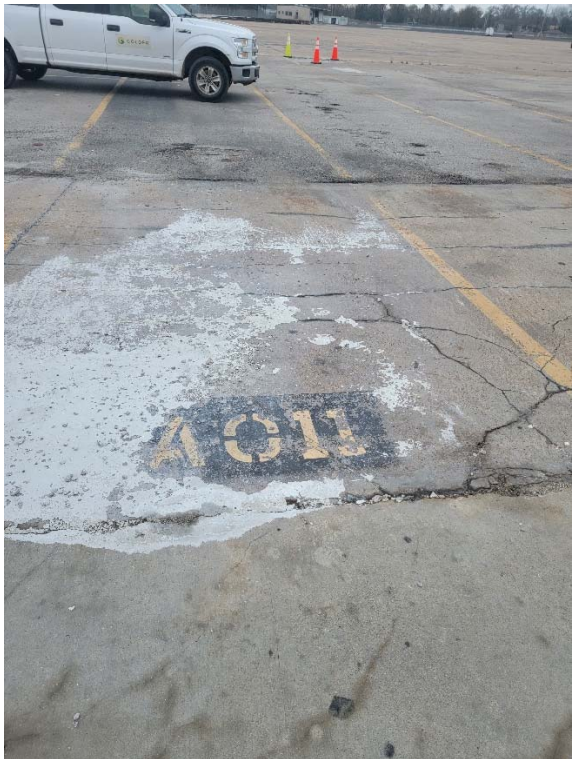
| Photo No. 19 | Inspection Date: 12/29/2021 | | |

| Description: Slot A011, no active tar-like material seeps observed, residual staining noted, looking south. Lat: 29.785467 Long: -95.318347 | | | |

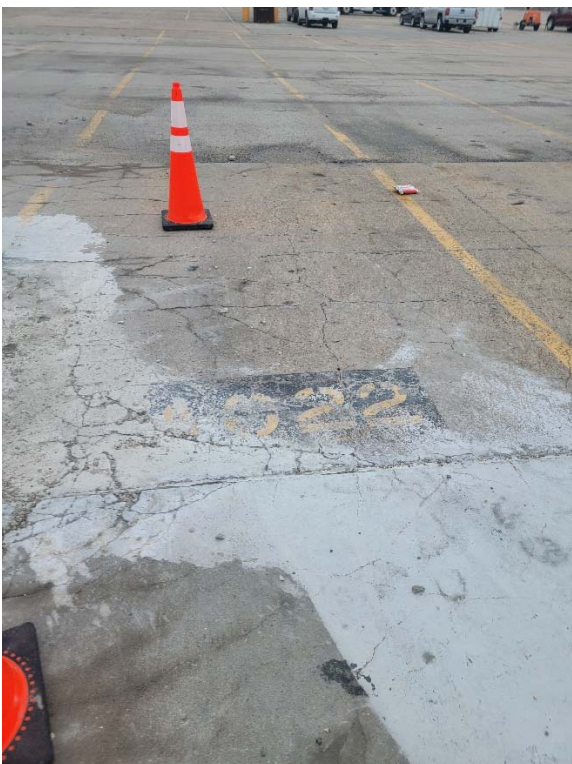
| Photo No. 20 | Inspection Date: 12/29/2021 | | |

| Description: Slot A022, no active tar-like material seeps observed, looking south. Lat: 29.785392, Long: -95.318655 | | | |

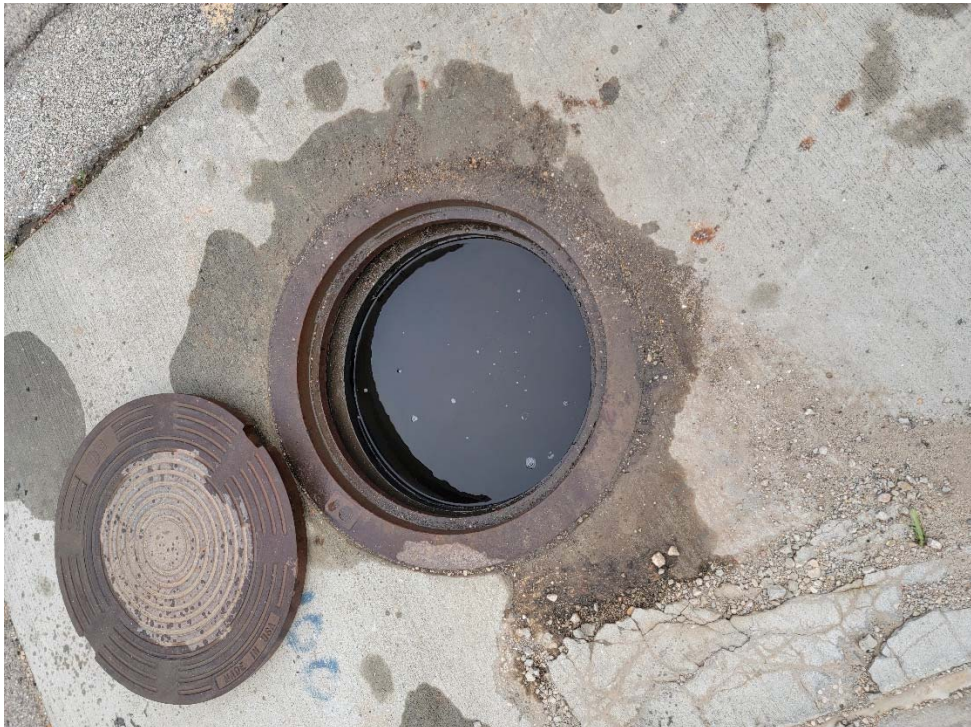
| Photo No. 21 | Inspection Date: 12/29/2021 | | |

| Description: Sump 1 (B099/B100), 0 inches of freeboard in sump, no sheen or odor noted. Lat: 29.7844000 Long: - 95.3205861 | | | |

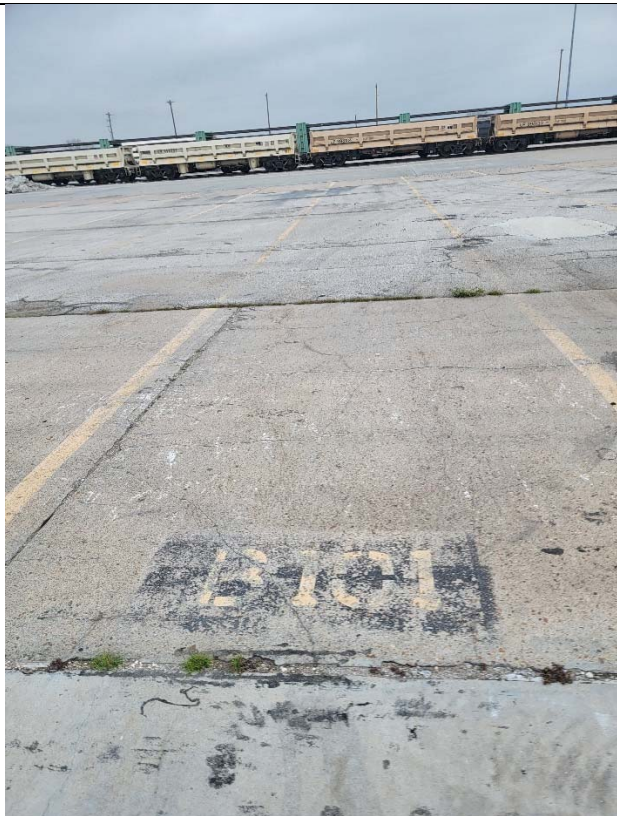
| Photo No. 22 | Inspection Date: 12/29/2021 | | |

| Description: Slot B101, no tar-like material seeps observed, residual staining noted, looking northwest. Lat: 29.784275 Long: - 95.320813 | | | |

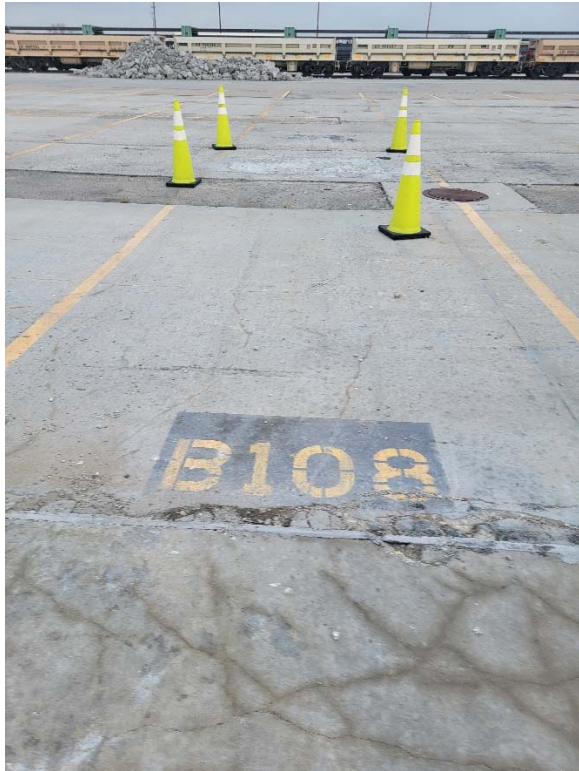
| Photo No. 23 | Inspection Date: 12/29/2021 | | |

| Description: Slot B108, view of NAPL Collection System (Sump B107/B108 and test pit in background). No tar-like material seeps observed where test pit (July 2020) conducted, test pit pavement repaired, looking northwest. Lat: 29.784125 Long: - 95.320989 | | | |

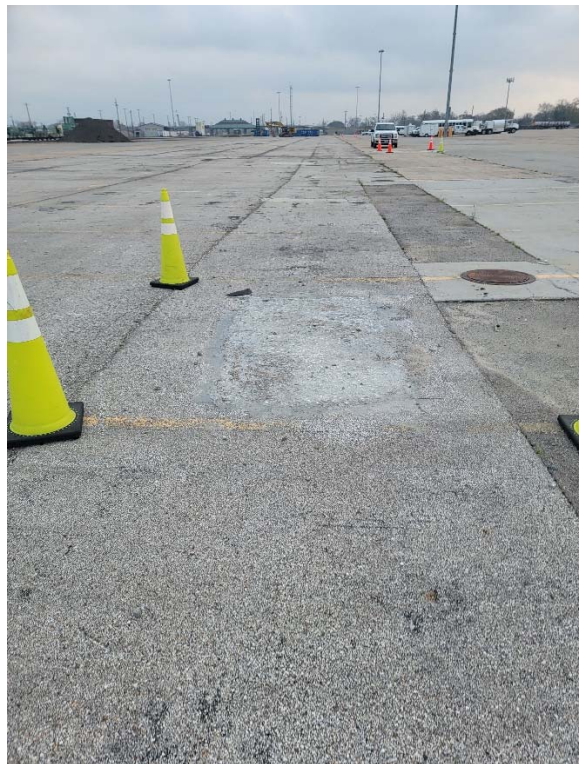
| Photo No. 24 | Inspection Date: 12/29/2021 | | |

| Description: View of slots B109-B090, NAPL collection system visible and B108 test pit (July 2020), looking east. Lat: 29.784358 Long: -95.320611 | | | |
