Project No. 19119232

**Re: MONTHLY STATUS UPDATE – ENGLEWOOD INTERMODAL YARD – NAPL COLLECTION  
SYSTEM/CONCRETE CAP REPAIRS  
UNION PACIFIC RAILROAD HOUSTON WOOD PRESERVING WORKS FACILITY  
4910 LIBERTY ROAD FACILITY, HOUSTON, TEXAS  
POST-CLOSURE CARE PERMIT NO. HW-50343; INDUSTRIAL SWR NO. 31547**

## Weekly Inspection Photolog

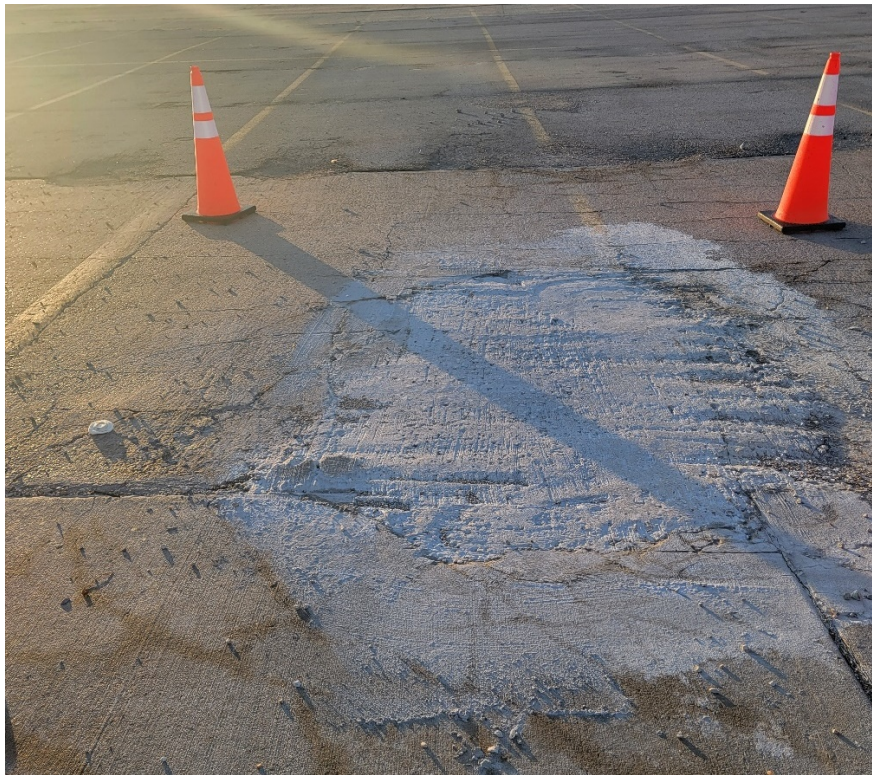
<b>Description:</b>  Slot A021, no tar-like material seeps observed where test pit conducted (July 2020), test pit pavement repaired, looking southwest.  Lat: 29.785392, Long: -95.318655			
<b>Photo No.</b> <b>2</b>	<b>Inspection Date:</b> 1/5/2022

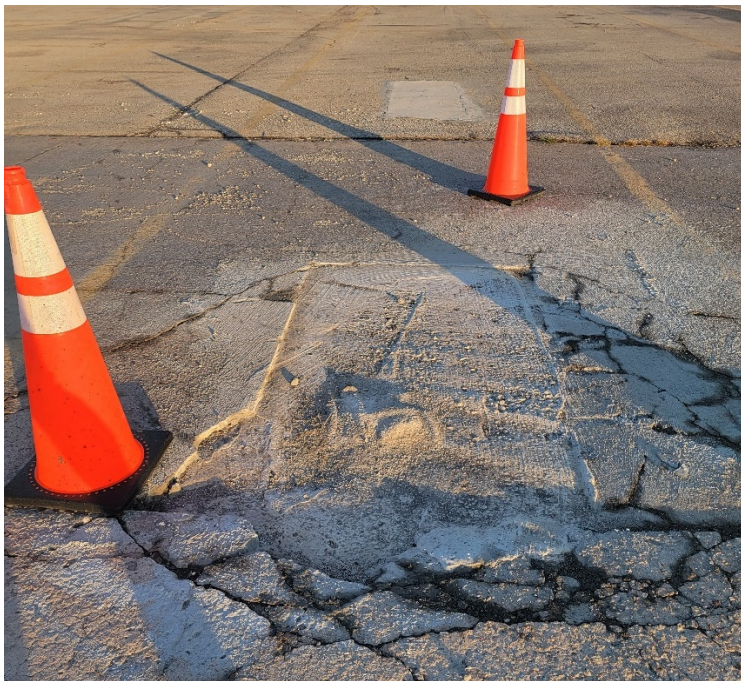
<b>Description:</b>  Slot B013, no tar-like material seeps observed where test pit conducted (July 2020), test pit pavement repaired, looking northeast.  Lat: 29.785217 Long: - 95.318261

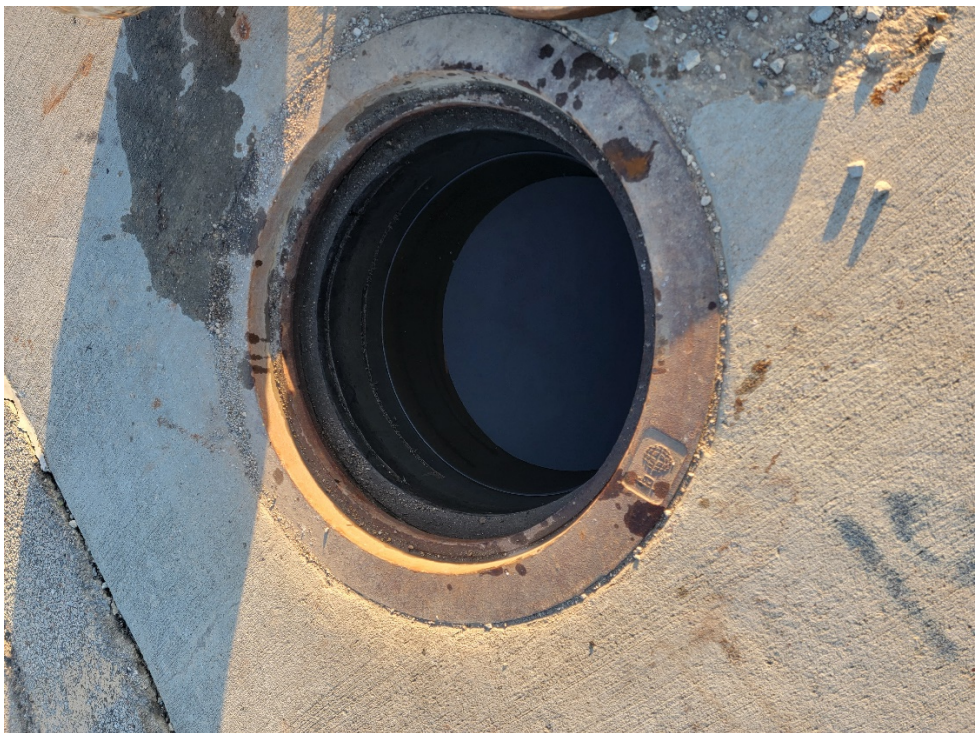
<b>Description:</b>  Sump 1 (B099/B100), 8.75 inches of freeboard in sump, no sheen or odor noted.  Lat: 29.7844000 Long: - 95.3205861

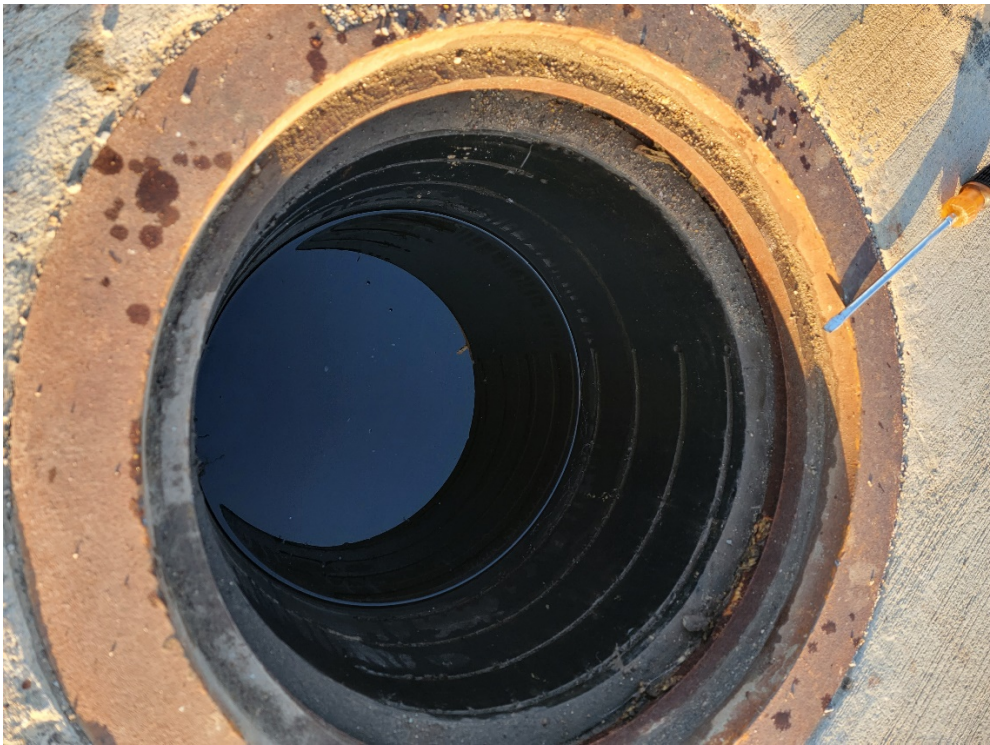
<b>Description:</b>  Sump 2 (B103/B104), 13.5 inches of freeboard in sump. No sheen or odor noted.  Lat: 29.7842861 Long: - 95.3208611			
<b>Photo No.</b> <b>6</b>	<b>Inspection Date:</b> 1/5/2022

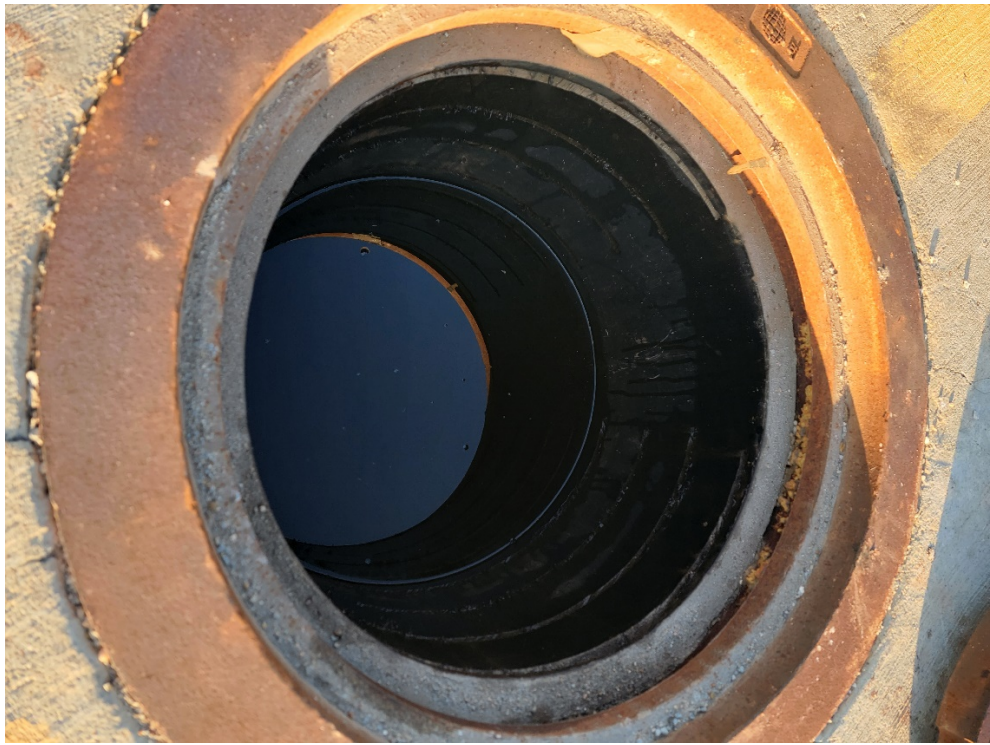
<b>Description:</b>  Sump 3 (B107/B108), 12.25 inches of freeboard in sump. No sheen or odor noted. No tar-like material recovered.  Lat: 29.784172 Long: -95.320998

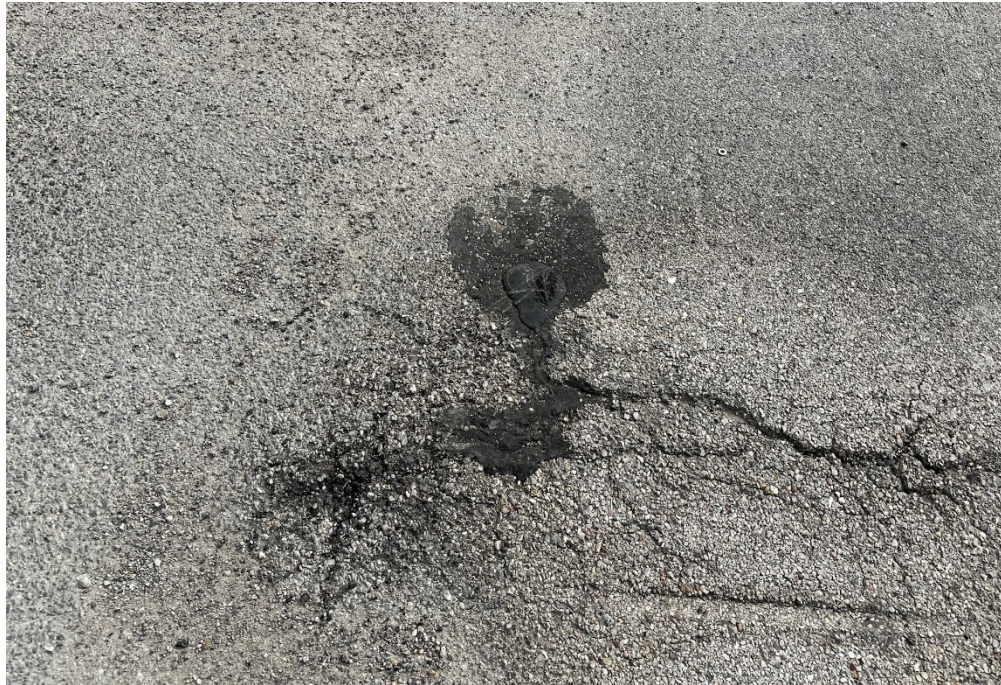
Seep Observations Outside the NAPL Collection System Area	
Stall Number	Observation Date(s)
A011	January 12 <sup>th</sup> and 19 <sup>th</sup> (Photo Nos. 7 and 14)
B102	January 19 <sup>th</sup> (Photo No. 16)

<b>Description:</b>  Slot A011, very small amount of tar-like material seeping at asphalt crack, material was removed.  Lat: 29.785467 Long: -95.318347			
<b>Photo No.</b> <b>8</b>	<b>Inspection Date:</b> 1/12/2022

The seep observed in Stall B102 on January 19<sup>th</sup>, 2022 was observed to be contained within the joint and below the concrete surface. Tar-like material observed during the inspection events was recovered using a hand tool to scrape up the material. During January, the number of tar-like material seeps observed during inspections and the total amount of material removed from the concrete surface slightly increased compared to the December weekly inspections. Less than 0.2 gallons of tar-like material was recovered for the month and placed in a drum for disposal. The drum is staged at the Container Storage Area (CSA).

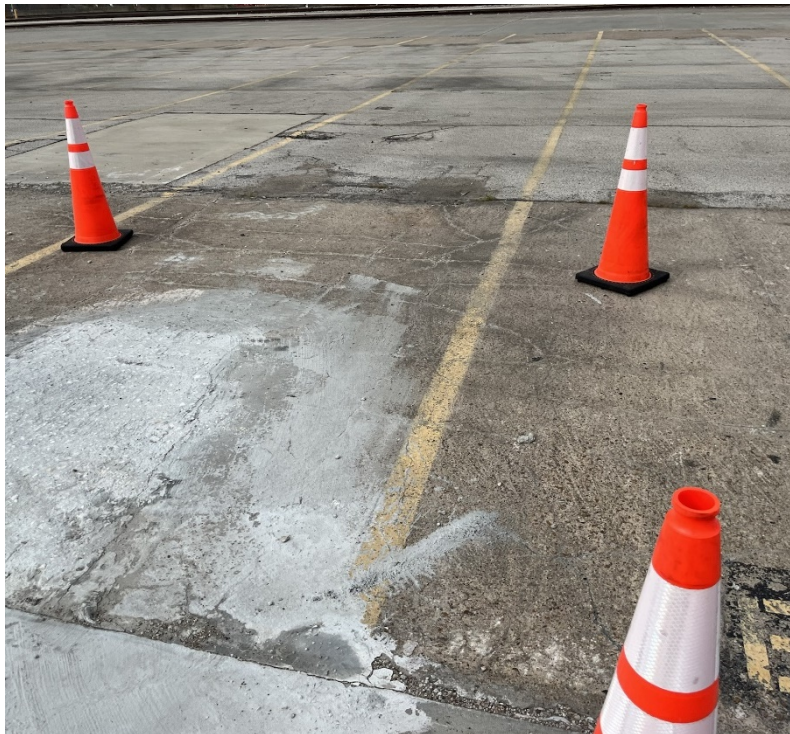
<b>Description:</b>  Slot B057, no active tar-like material seeps observed at historical seep location or where test pit conducted (July 2020), residual staining noted.  Lat: 29.7847472 Long: - 95.3195417

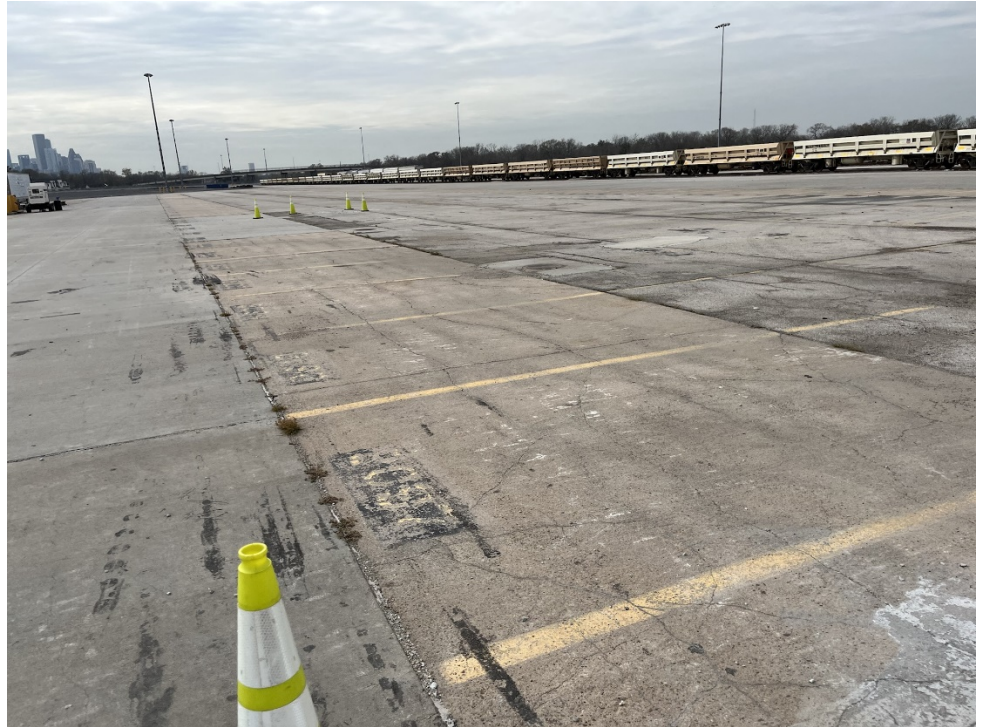
**Photo No.**  
**9**

During September 2021, track marks from a container transport vehicle running over the seep in stall B102 were observed and barricades were set up surrounding the seep location to prevent further tracking. The barricades are checked and reset, as needed, during the weekly inspections. UPRR remediation contractor US Ecology pressure washed the tar-like material tracking in October 2021. Residual track marks were observed during the January inspections (Photo No. 9); however, no new track marks were observed during the month of January 2022.

View of slots B097-B109, NAPL collection system visible, residual tracking from B102 seep visible, no active tar-like seeps noted, looking northwest.

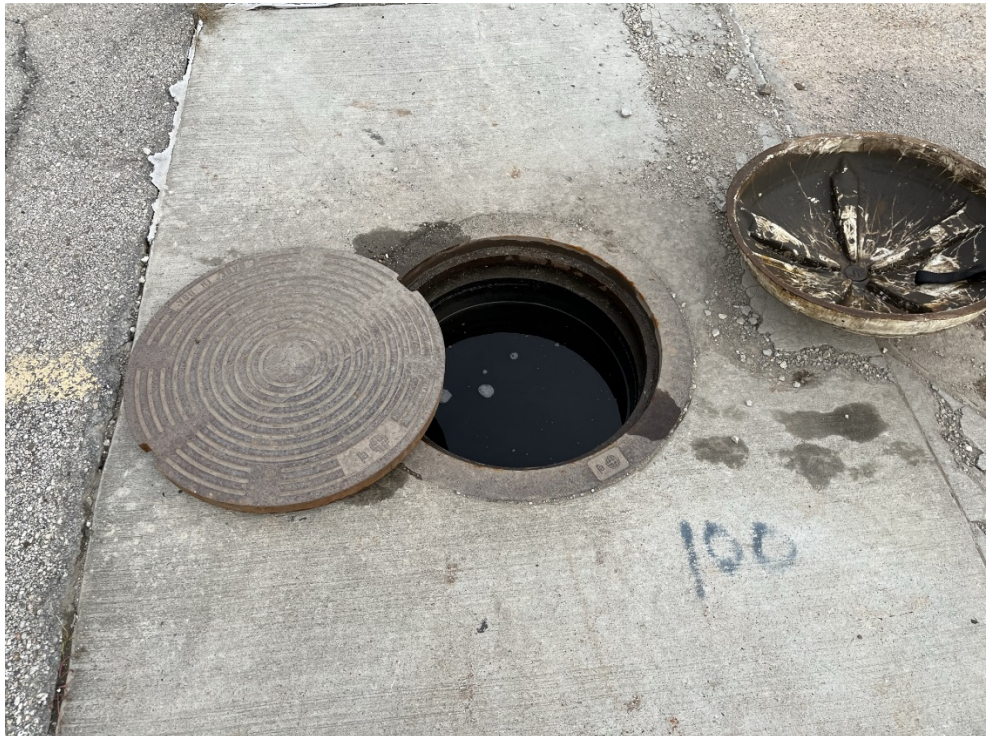
**Photo No.**  
**10**

Sump 1 (B099/B100), 6 inches of freeboard in sump, no sheen or odor noted.

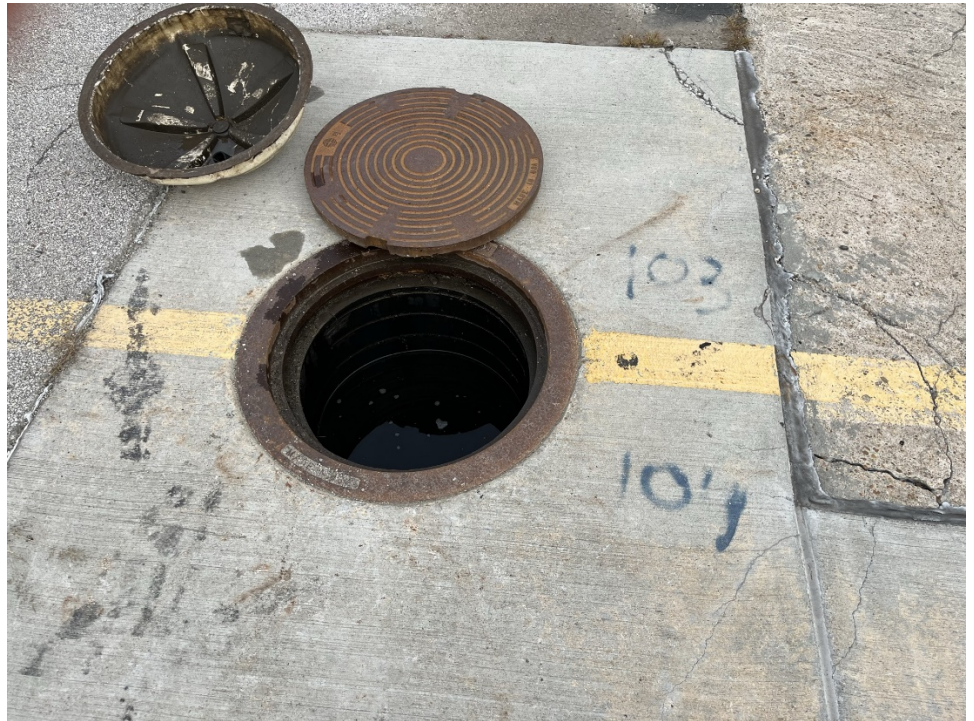
**Photo No.**  
**11**

Sump 2 (B103/B104), 12 inches of freeboard in sump. No sheen or odor noted.

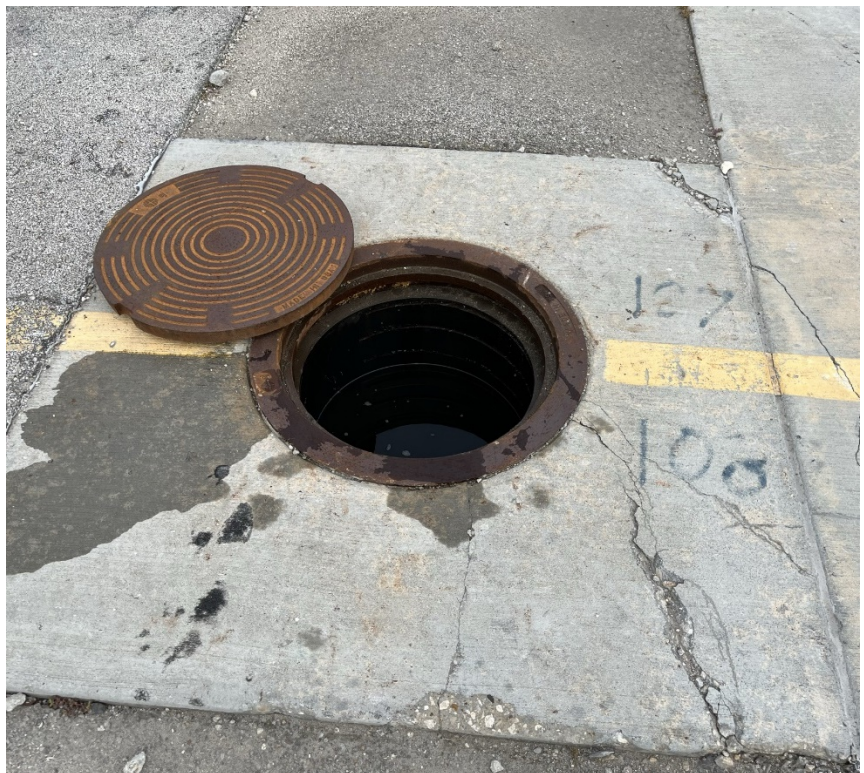
**Photo No.**  
**12**

Sump 3 (B107/B108), 12 inches of freeboard in sump. No sheen or odor noted. No tar-like material recovered.

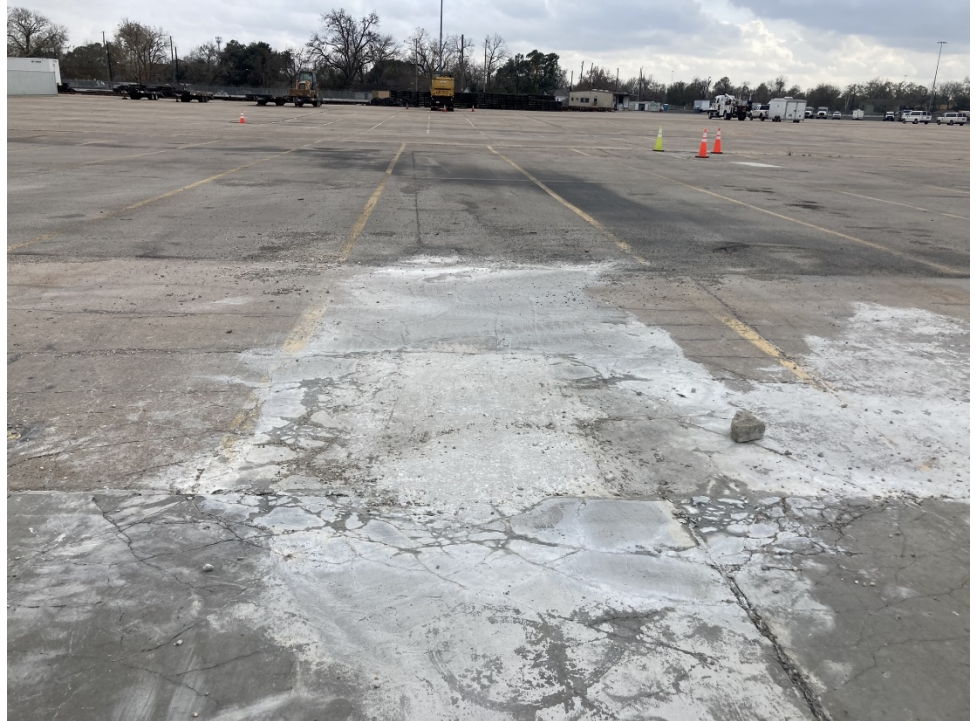
<b>Photo No.</b> <b>13</b>	<b>Inspection Date:</b> 1/19/2022
-------------------------------	--------------------------------------

Slots A010, no tar-like material observed, July 2020 test pit pavement repaired, looking southwest.

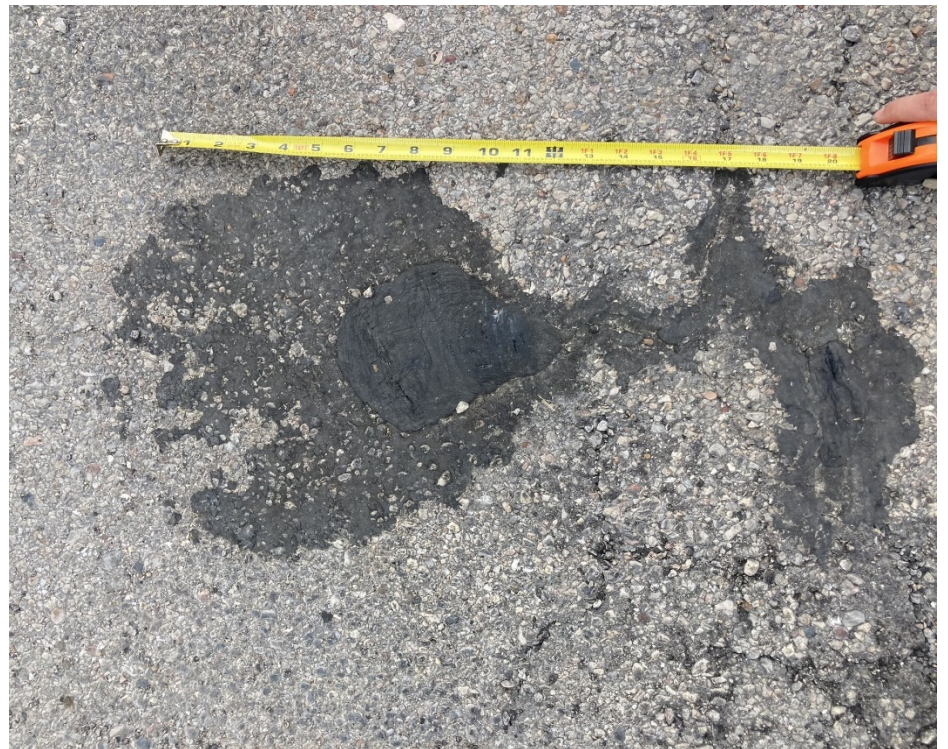
<b>Photo No.</b> <b>14</b>	<b>Inspection Date:</b> 1/19/2022
-------------------------------	--------------------------------------

Slot A011, very small amount of tar-like material seeping at asphalt crack, material was removed.

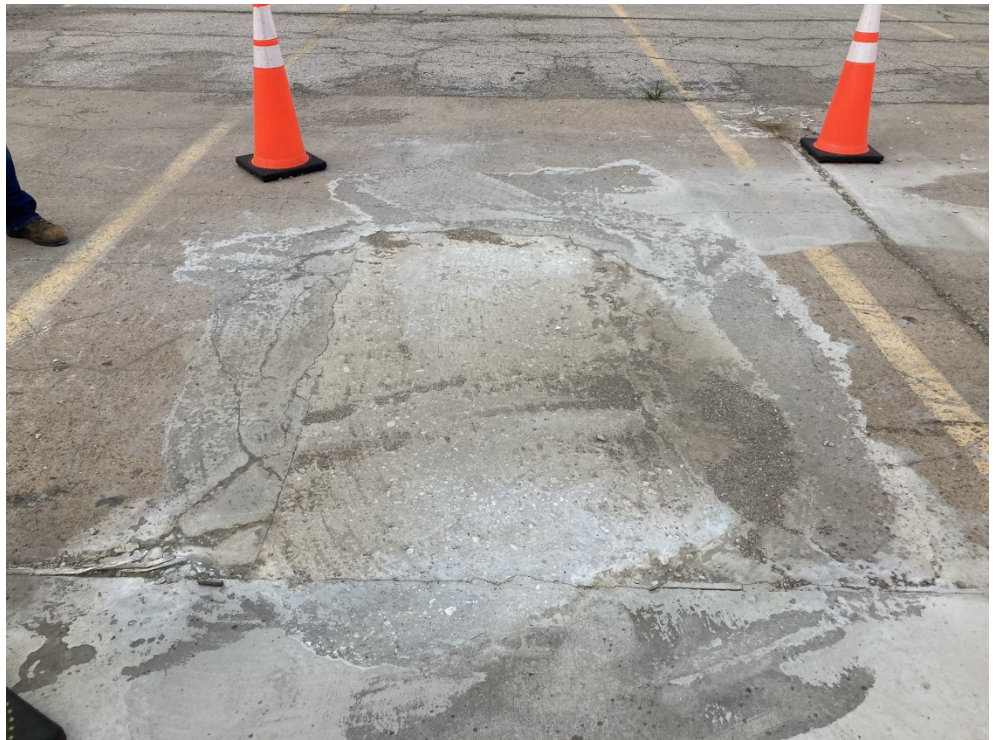
**Photo No.**  
**15**

Slot B096, no tar-like material seeps observed where test pit conducted (July 2020), test pit pavement repaired, looking northwest.

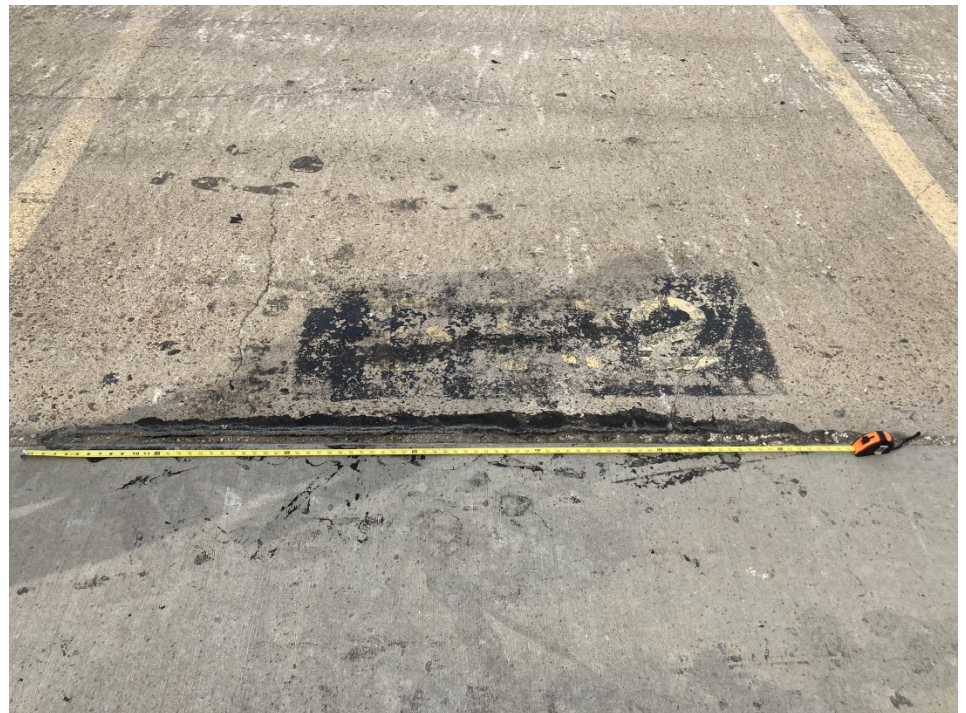
**Photo No.**  
**16**

Slot B102, small tar-like material seeping at joint, material was removed.

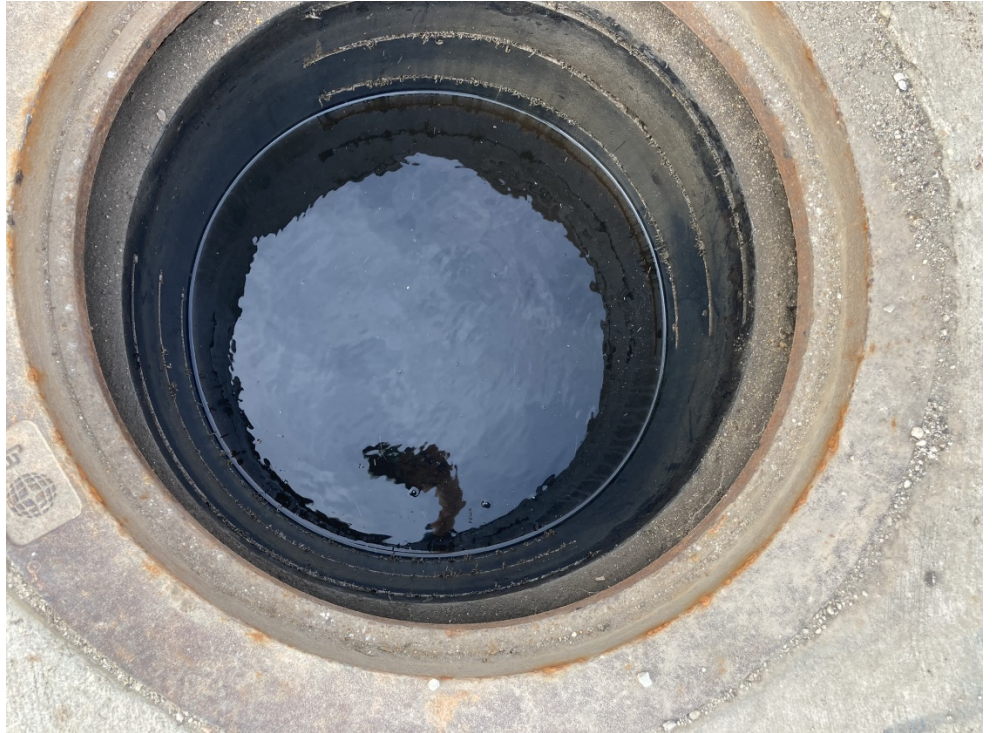
**Photo No.**  
**17**

Sump 1 (B099/B100), 13.5 inches of freeboard in sump, sheen observed on water in sump. No odor noted.

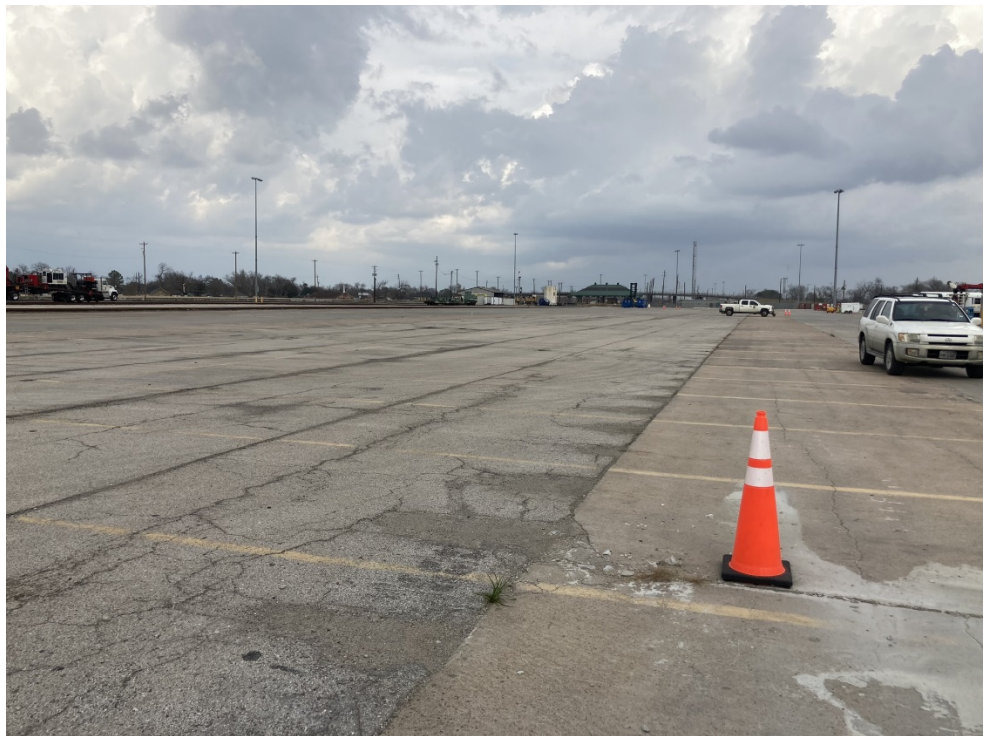
**Photo No.**  
**18**

View of A and B rows, no new staining observed, residual staining visible, looking northeast from Slot B096.

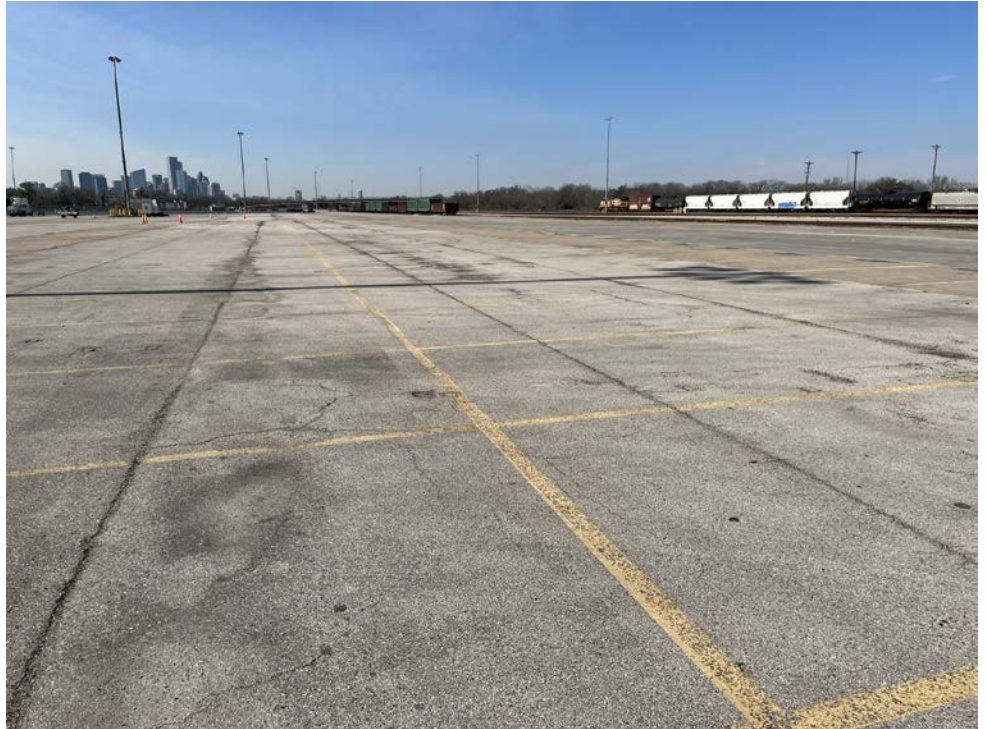
**Photo No.**  
**21**

View of A and B rows slots , no active tar-like material seeps observed, residual staining noted, looking west from B067.

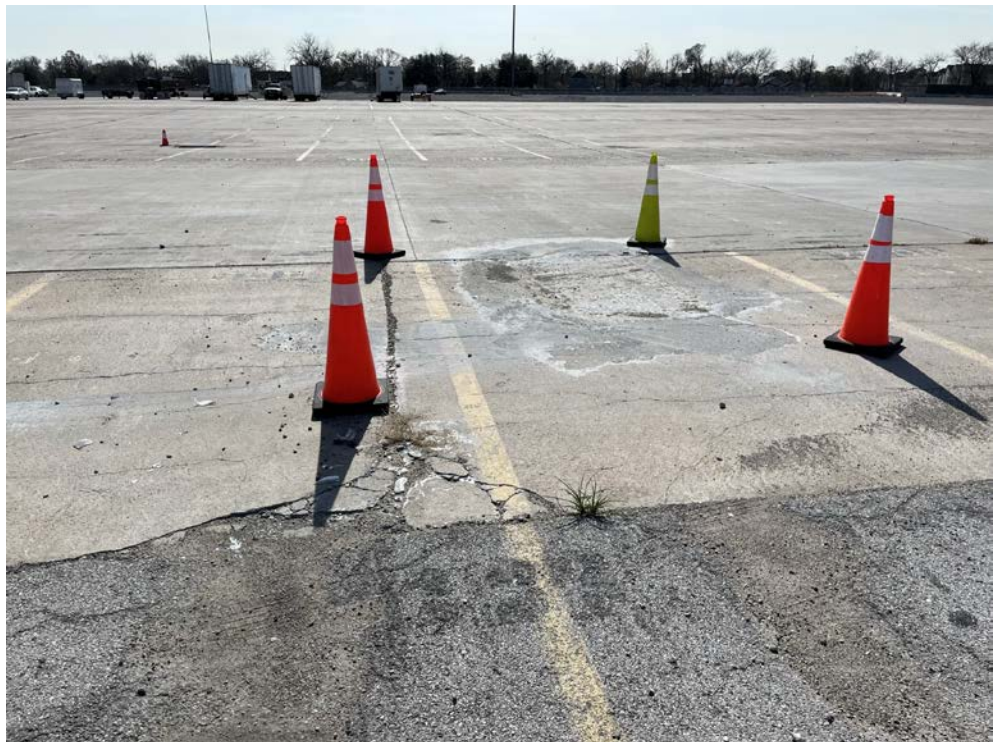
**Photo No.**  
**22**

Slot B096, no tar-like material seeps observed where test pit conducted (July 2020), test pit pavement repaired, looking southwest.

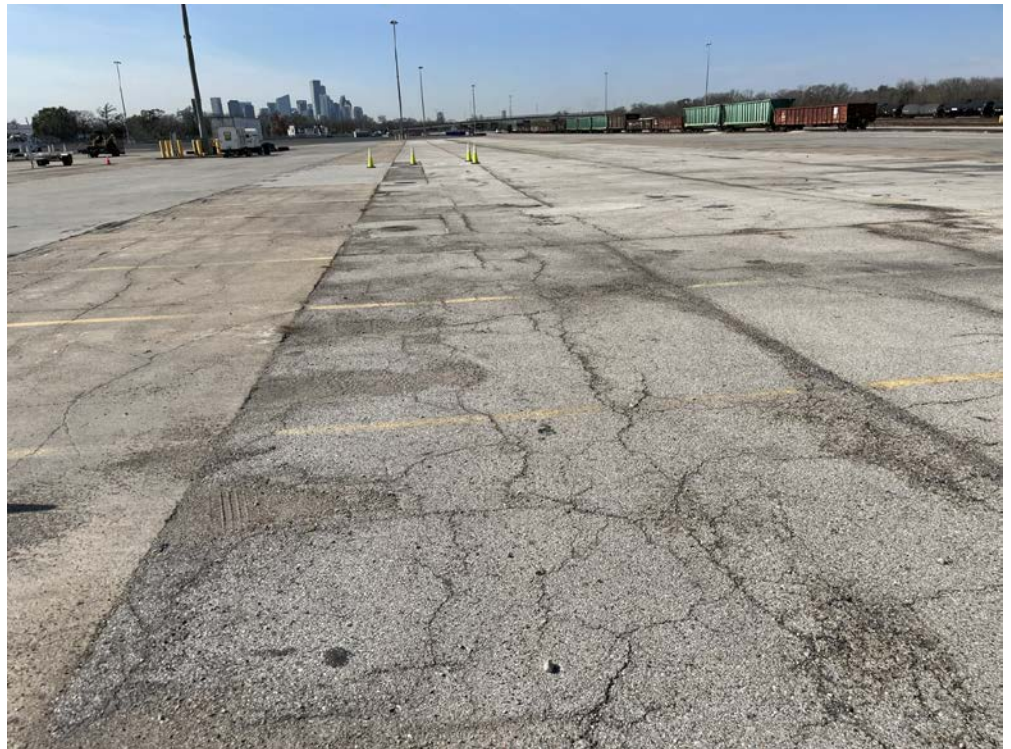
**Photo No.**  
**23**

Slots B096-B108, view of NAPL Collection System in background, no active tar-like material seeps observed, residual staining noted, looking west.

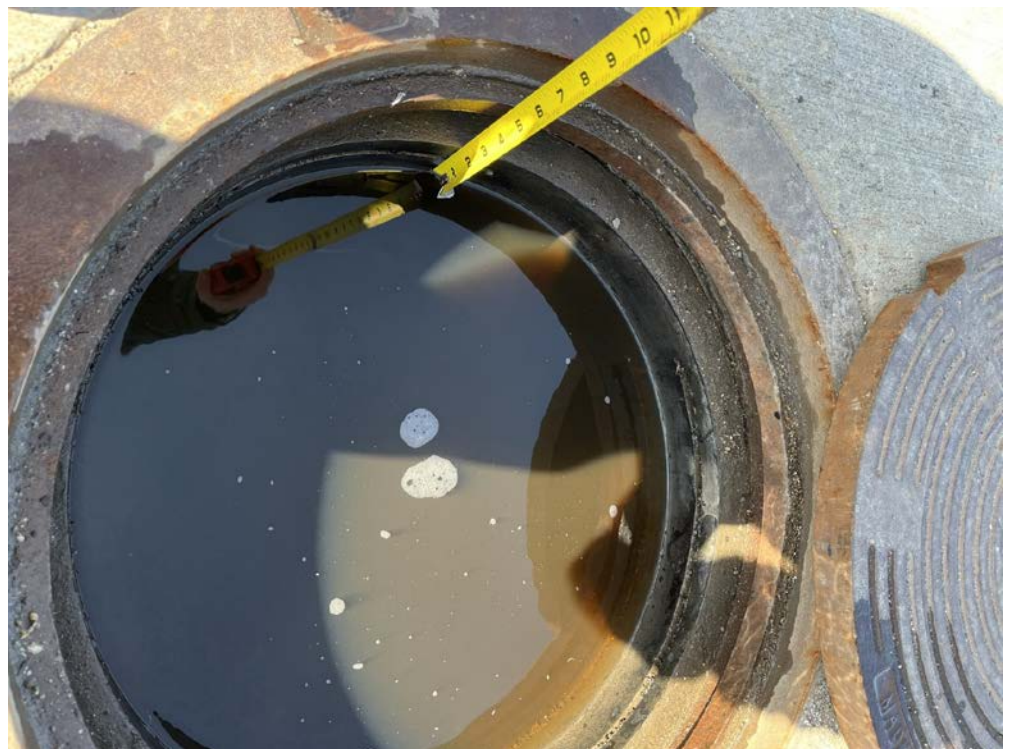
**Photo No.**  
**24**

Sump 1 (B099/B100), 3 inches of freeboard in sump, no sheen or odor noted.
