March 15, 2022

Project No. 19119232

**Re: MONTHLY STATUS UPDATE – ENGLEWOOD INTERMODAL YARD – NAPL COLLECTION
SYSTEM/CONCRETE CAP REPAIRS
UNION PACIFIC RAILROAD HOUSTON WOOD PRESERVING WORKS FACILITY
4910 LIBERTY ROAD FACILITY, HOUSTON, TEXAS
POST-CLOSURE CARE PERMIT NO. HW-50343; INDUSTRIAL SWR NO. 31547**

Weekly Inspection Photolog

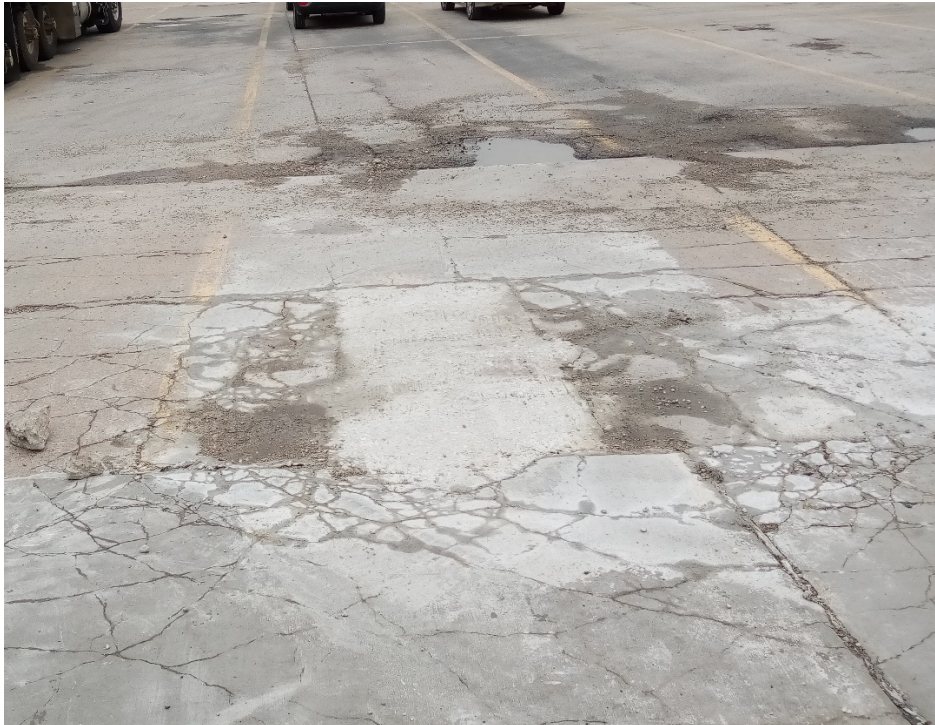
Description: Slots A010, no tar-like material observed, July 2020 test pit pavement repaired, pavement wet from recent rain event, looking southwest. Lat: 29.785392, Long: -95.318655			
Photo No. 2	Inspection Date: 2/2/2022

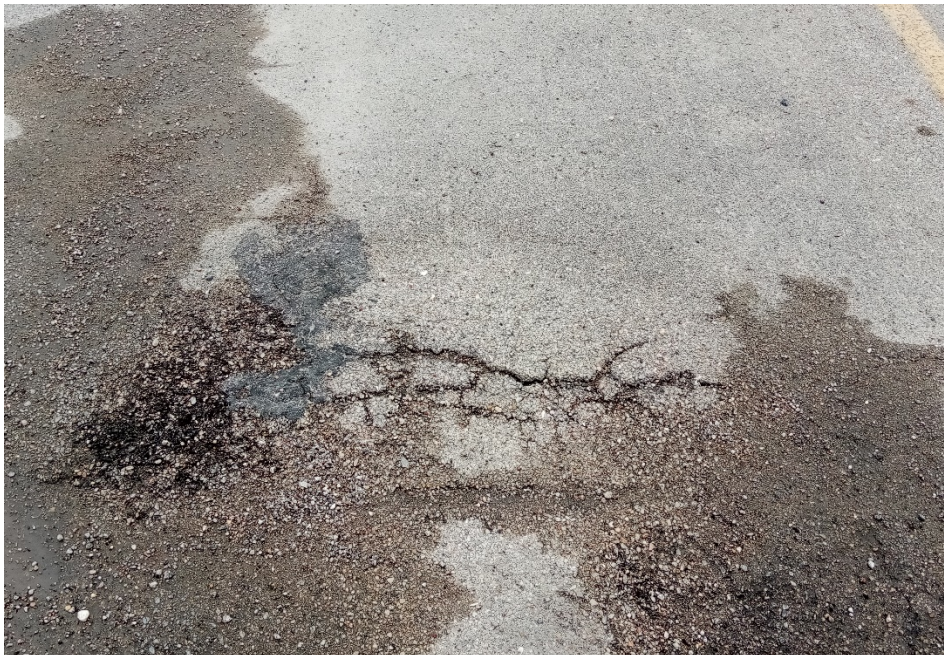
Description: Slot A011, no tar-like material seeps observed, pavement wet from recent rain event. Lat: 29.785467 Long: -95.318347

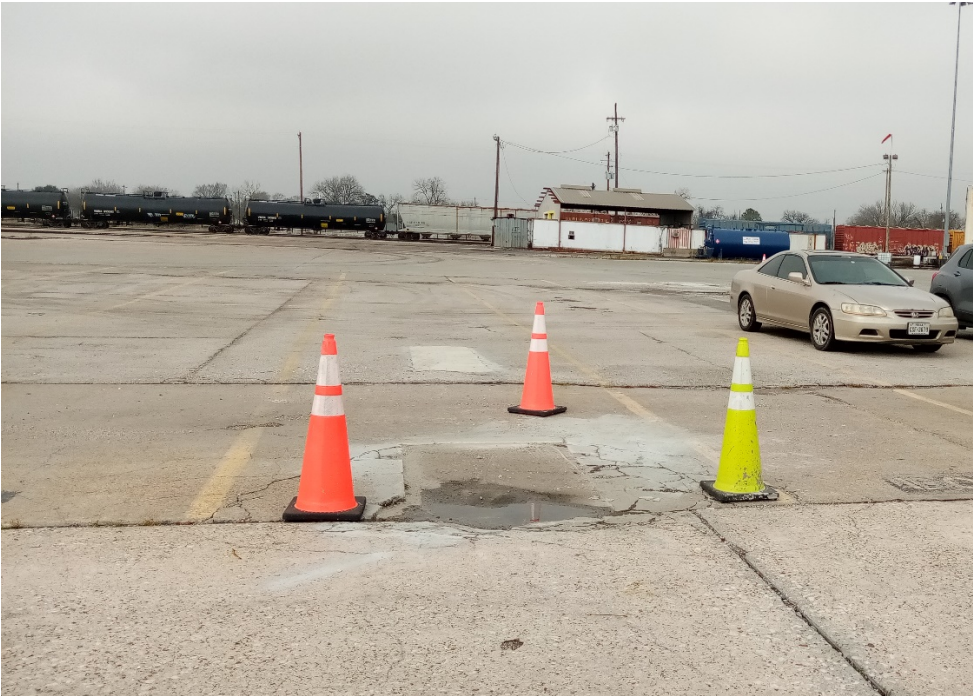
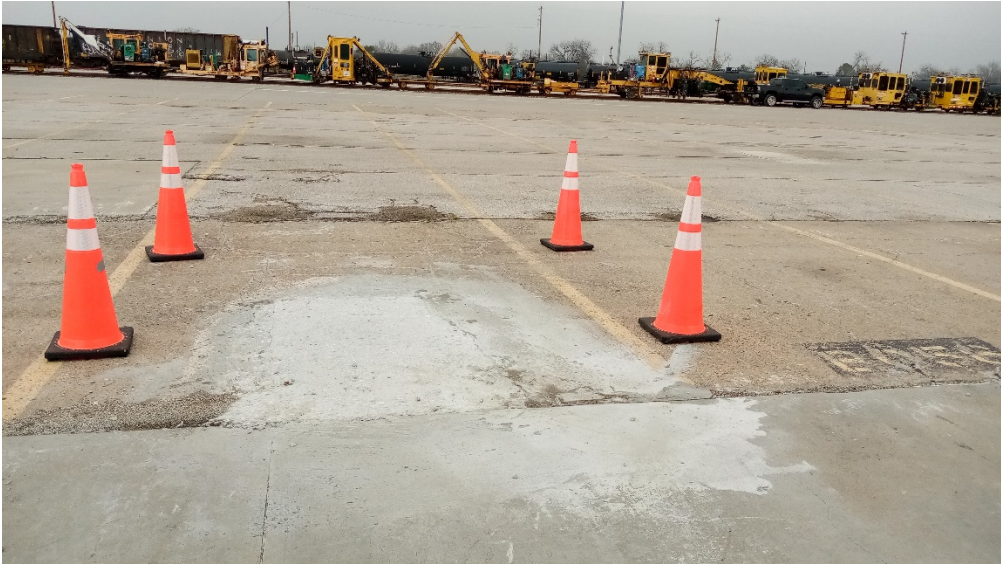
Client Name: Union Pacific Railroad		Site Location: Englewood Houston, Texas	Project No. 19119232
Photo No. 3	Inspection Date: 2/2/2022	<p>Description:</p> <p>Slot B013, no tar-like material seeps observed where test pit conducted (July 2020), test pit pavement repaired, standing water from recent rain event, looking northeast.</p> <p>Lat: 29.785217 Long: - 95.318261</p>	
<p>Photo No. 4</p> <p>Inspection Date: 2/2/2022</p> <p>Description:</p> <p>Slot B057, no active tar-like material seeps observed at historical seep location or where test pit conducted (July 2020).</p> <p>Lat: 29.7847472 Long: - 95.3195417</p>

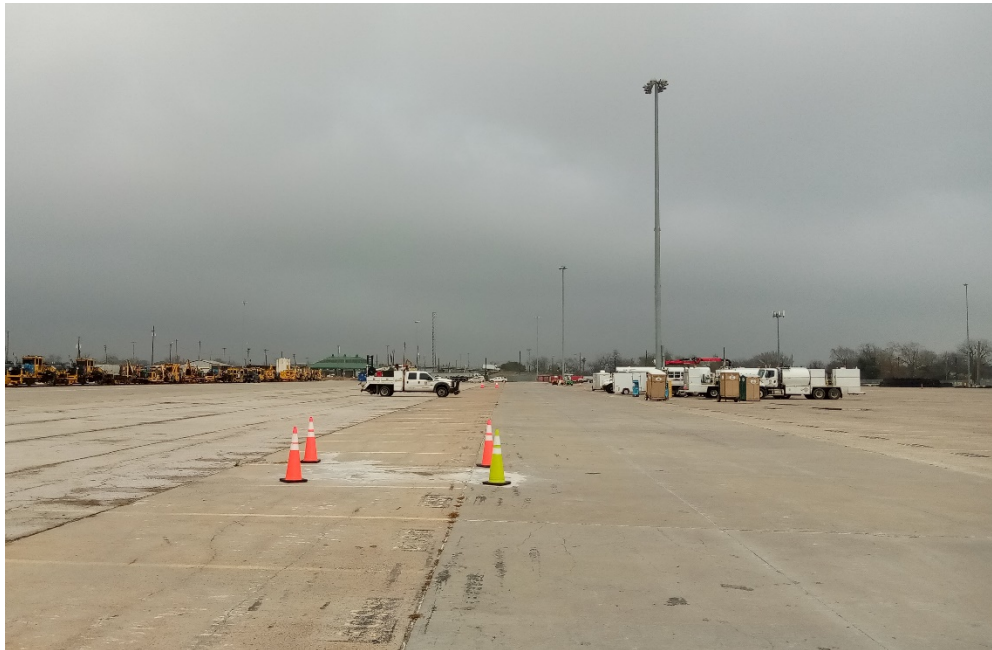
Photo No. 5	Inspection Date: 2/2/2022
Description:	
<p>View of A and B rows, no new staining observed, residual tracking from B102 seep visible, no active tar-like seeps noted, looking northeast from Slot B099.</p> <p>Lat: 29.7842528 Long: - 95.3206250</p>

During September 2021, track marks from a container transport vehicle running over the seep in stall B102 were observed and barricades were set up surrounding the seep location to prevent further tracking. The barricades are checked and reset, as needed, during the weekly inspections. UPRR remediation contractor US Ecology pressure washed the tar-like material tracking in October 2021. Residual track marks were observed during the February inspections (Photos No. 5, 6, and 16); however, no new track marks were observed during the month of February 2022.

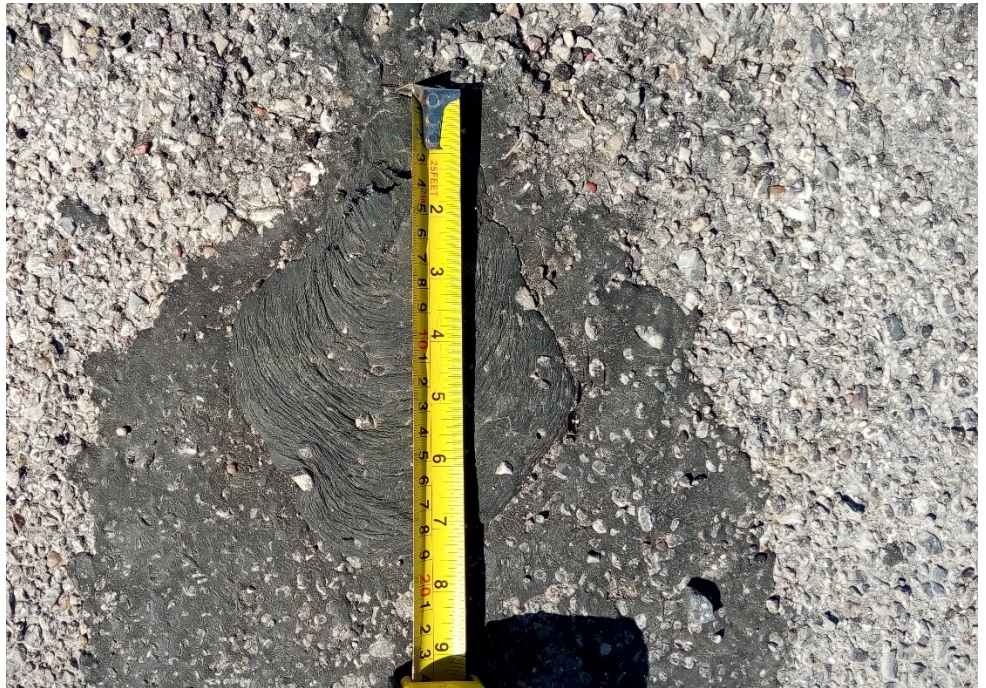
Photo No. 7	Inspection Date: 2/9/2022
------------------------------	-------------------------------------

Seep Observations Outside the NAPL Collection System Area	
Stall Number	Observation Date(s)
A011	February 9 th (Photo No. 7)

Slot A011, very small amount of tar-like material seeping at asphalt crack, material was removed.

Tar-like material observed during the inspection events was recovered using a hand tool to scrape up the material. During February, the number of tar-like material seeps observed during inspections and the total amount of material removed from the concrete surface decreased compared to the January weekly inspections. The only active seep location observed during February was the one in stall A011 on February 9, 2022. Less than 0.1 gallons of tar-like material was recovered for the month and placed in a drum for disposal. The drum is staged at the Container Storage Area (CSA).

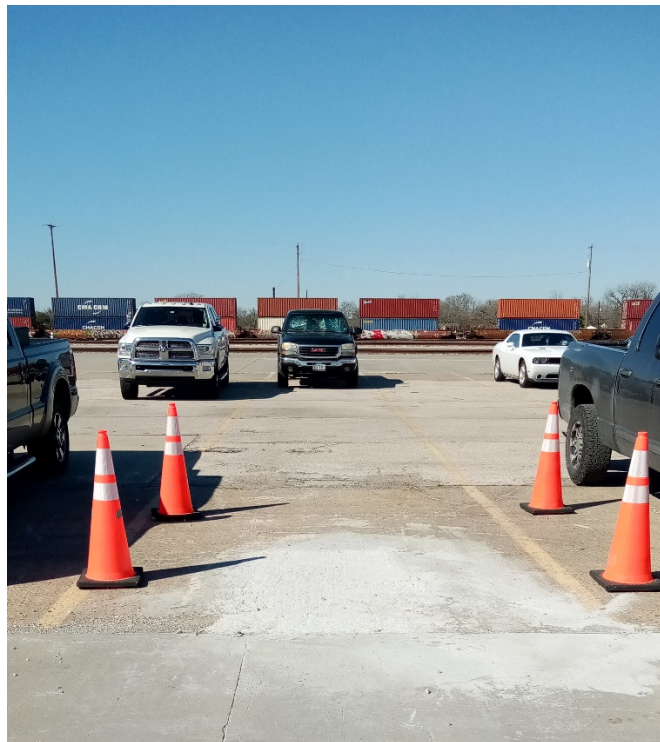
Photo No. 8	Inspection Date: 2/9/2022
------------------------------	-------------------------------------

Slot B057, no active tar-like material seeps observed at historical seep location or where test pit conducted (July 2020).

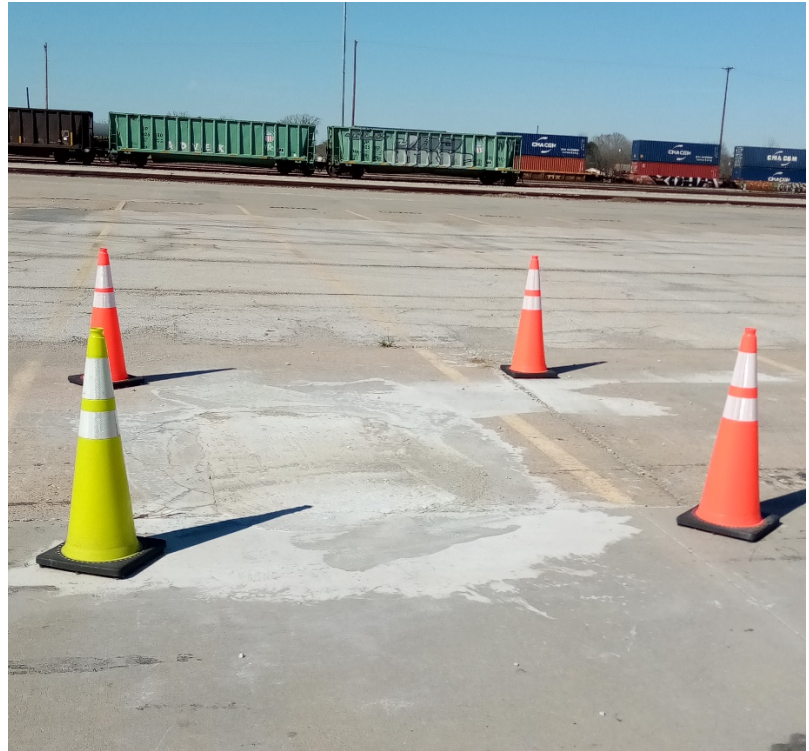
Photo No. 9	Inspection Date: 2/9/2022
------------------------------	-------------------------------------

Slot B096, no tar-like material seeps observed where test pit conducted (July 2020), test pit pavement repaired, looking northwest.

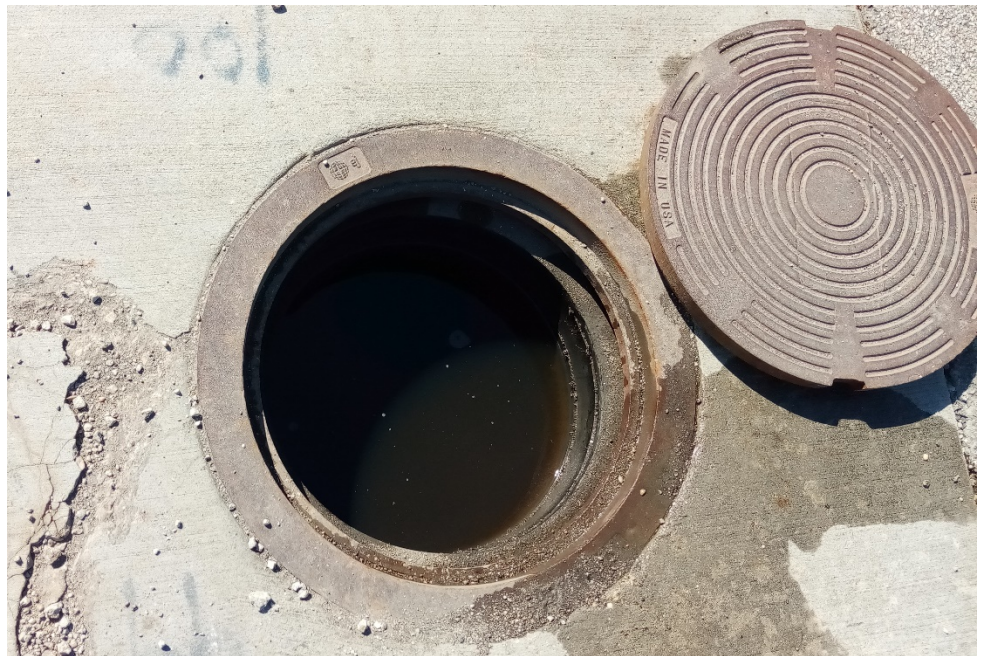
Photo No. 10	Inspection Date: 2/9/2022
-------------------------------	-------------------------------------

Sump 1 (B099/B100), 9 inches of freeboard in sump, no sheen or odor noted.

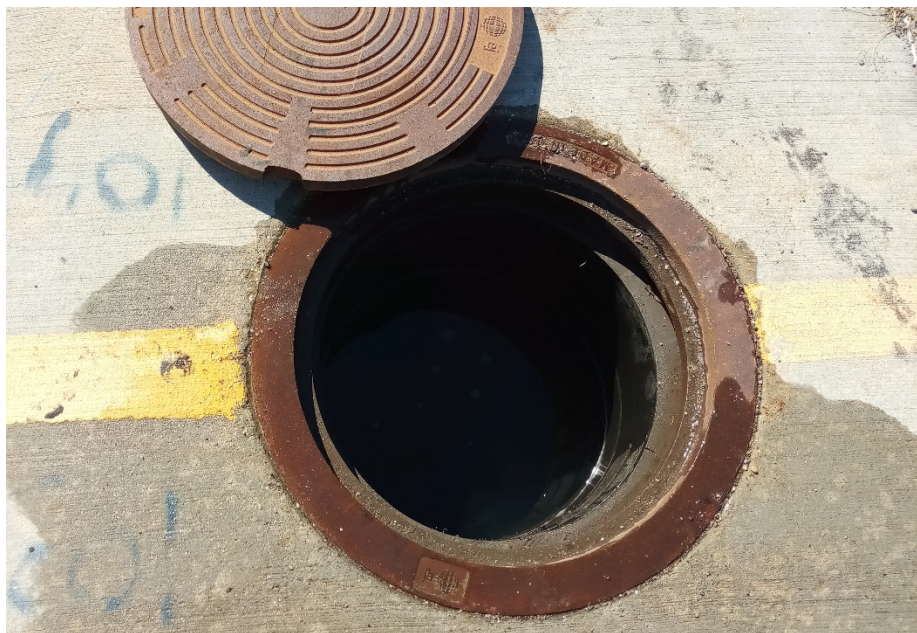
Description: Sump 2 (B103/B104), 15 inches of freeboard in sump. No sheen or odor noted. Lat: 29.7842861 Long: - 95.3208611			
Photo No. 12	Inspection Date: 2/9/2022

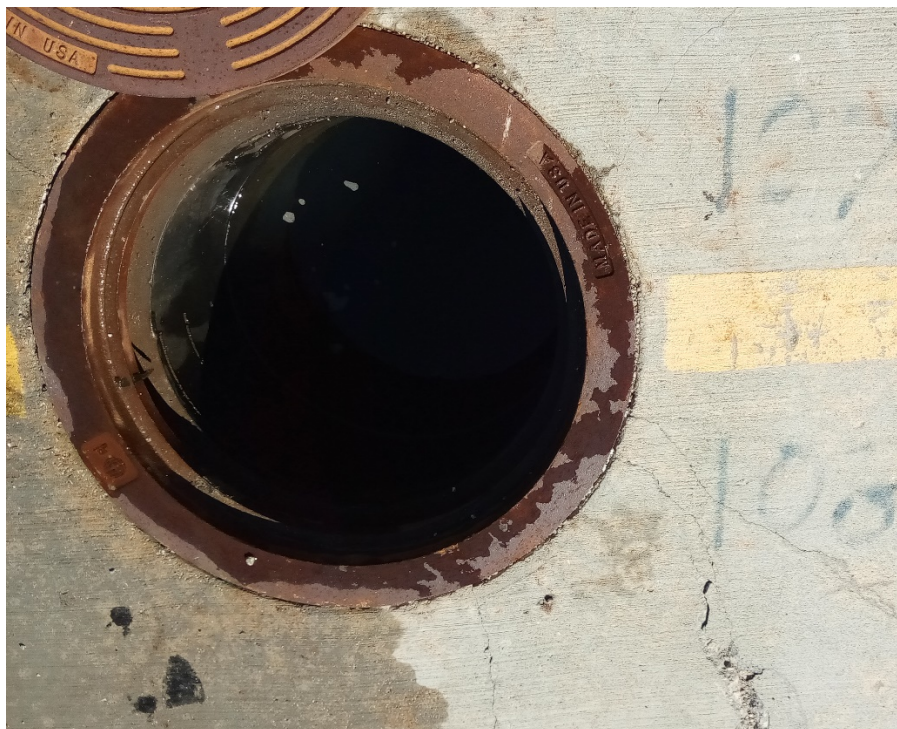
Description: Sump 3 (B107/B108), 15 inches of freeboard in sump. No sheen or odor noted. No tar-like material recovered. Lat: 29.784172 Long: -95.320998

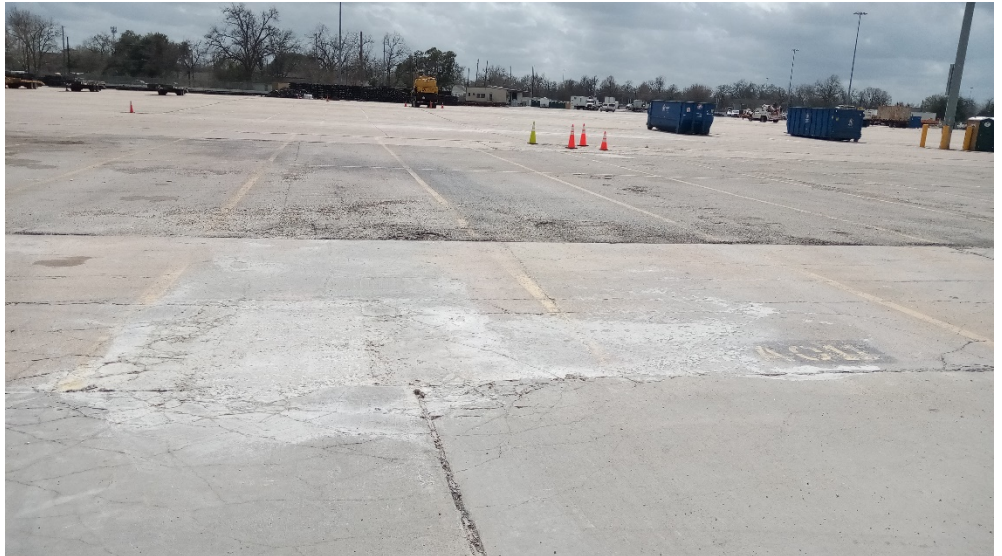
Description: Slots A010, no tar-like material observed, July 2020 test pit pavement repaired, looking southwest. Lat: 29.785392, Long: -95.318655			
Photo No. 14	Inspection Date: 2/16/2022

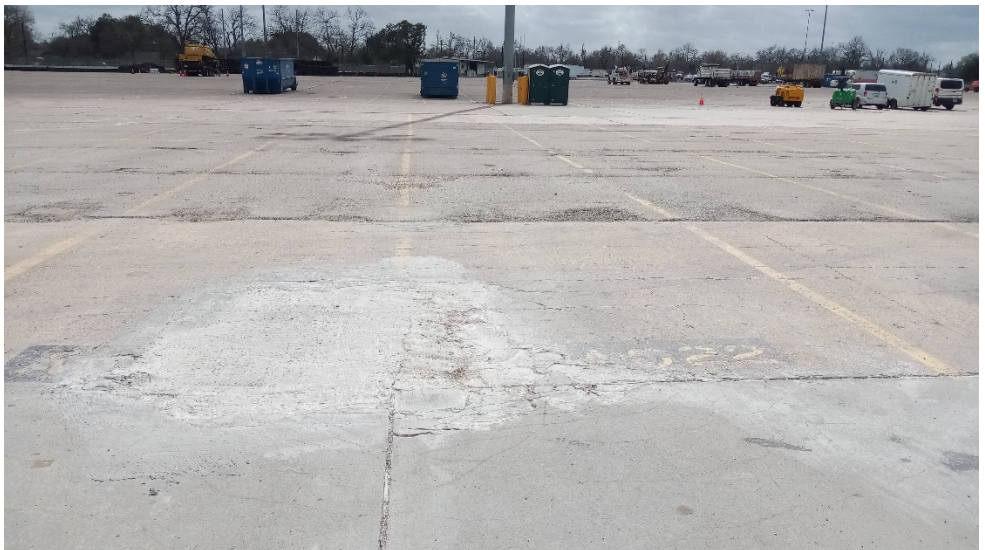
Description: Slot A021, no tar-like material seeps observed where test pit conducted (July 2020), test pit pavement repaired, looking southwest. Lat: 29.785392, Long: -95.318655

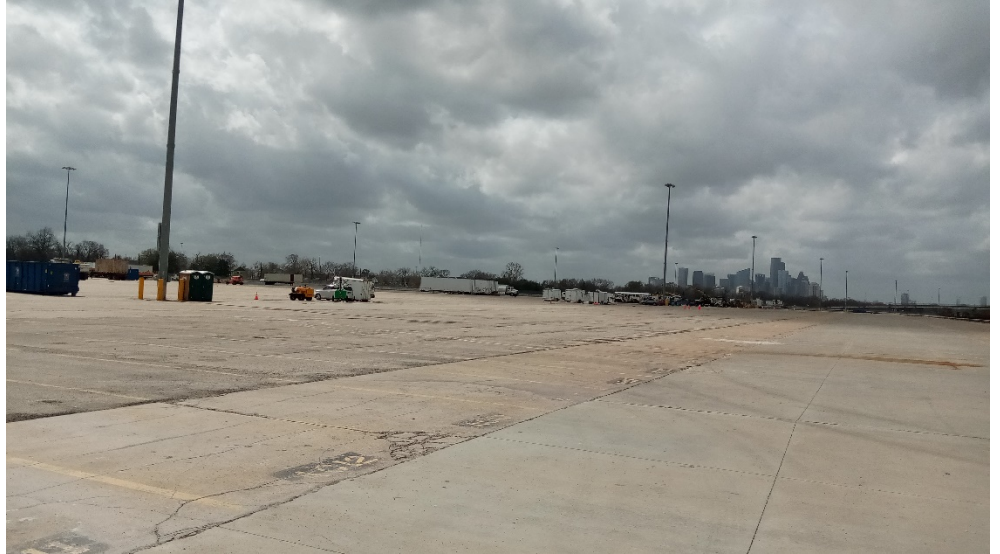
Photo No. 15	Inspection Date: 2/16/2022
-------------------------------	--------------------------------------

View of A and B rows from slot A011, no new staining or active tar-like material seeps observed, residual staining noted, looking southwest.

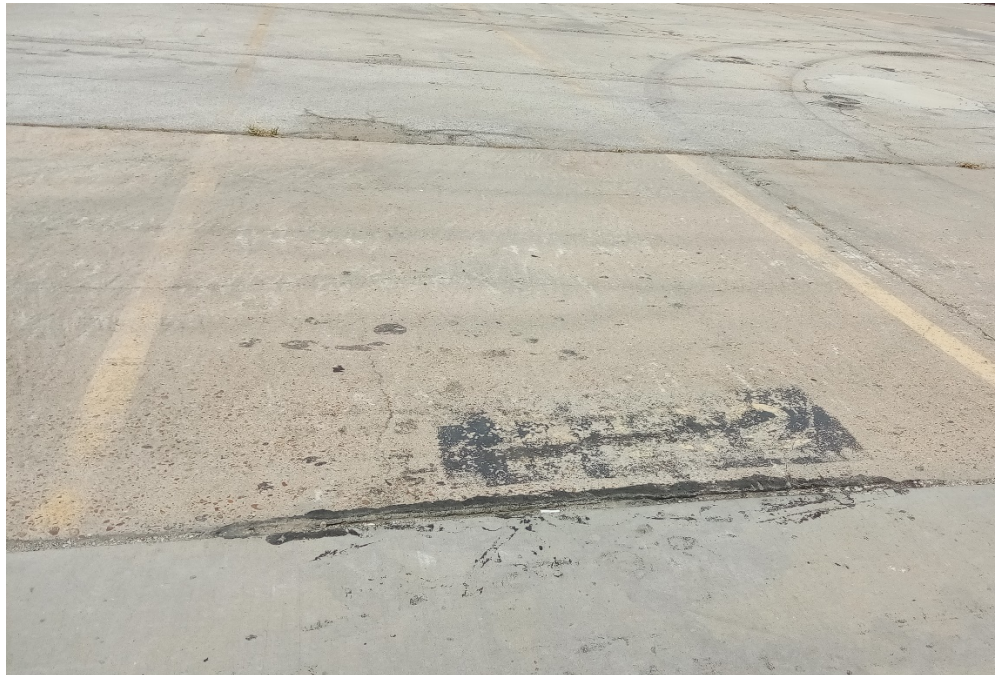
Photo No. 16	Inspection Date: 2/16/2022
-------------------------------	--------------------------------------

Slot B102, no active tar-like material seeps observed, residual staining noted.

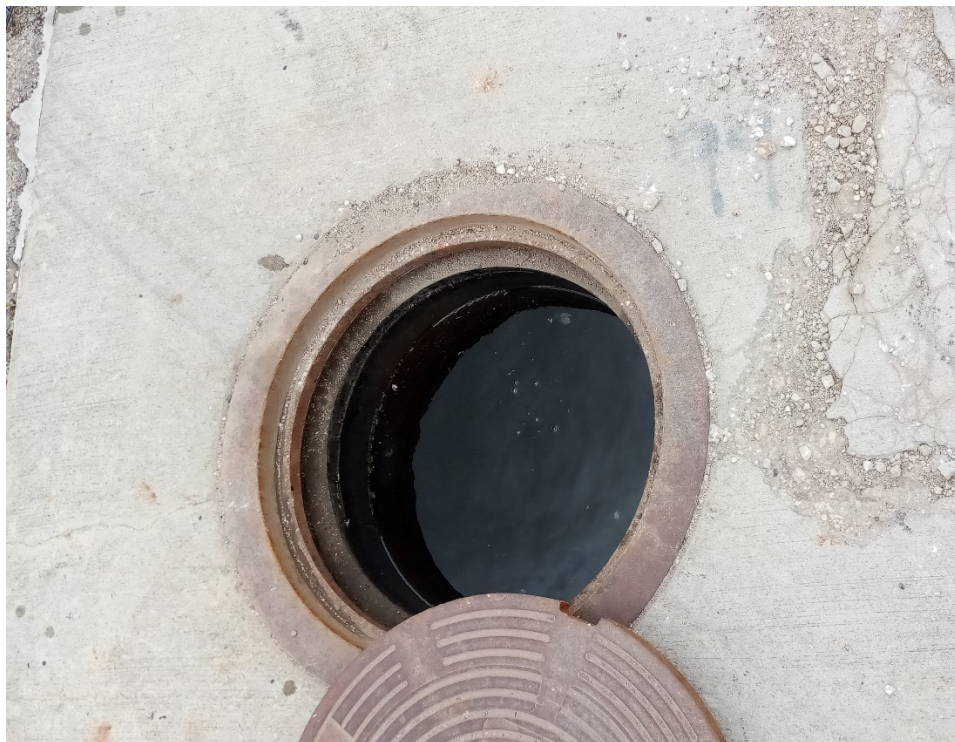
Photo No. 17	Inspection Date: 2/16/2022
-------------------------------	--------------------------------------

Sump 1 (B099/B100), 8.5 inches of freeboard in sump. No sheen or odor noted.

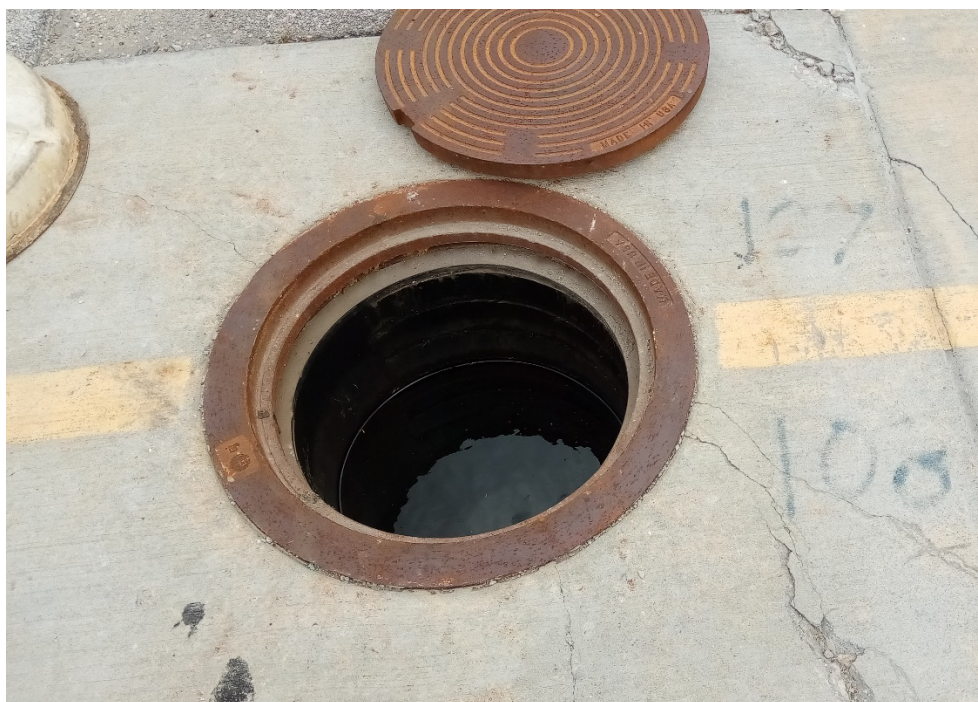
Photo No. 18	Inspection Date: 2/16/2022
-------------------------------	--------------------------------------

Sump 3 (B107/B108), 16 inches of freeboard in sump. No sheen or odor noted. No tar-like material recovered.

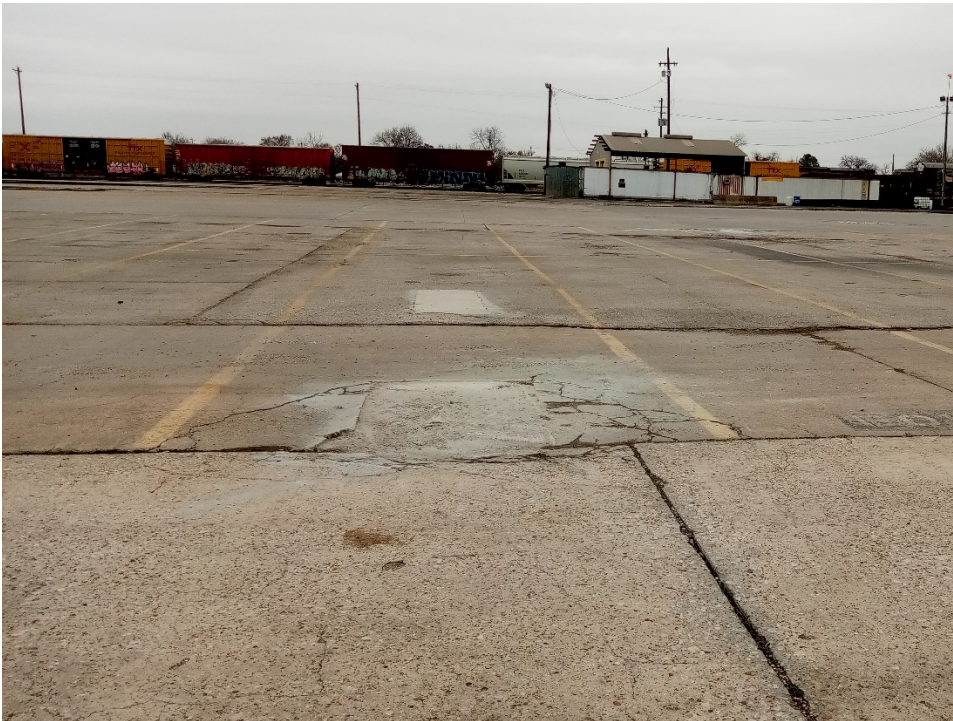
Description: Slot B013, no tar-like material seeps observed where test pit conducted (July 2020), test pit pavement repaired, looking northeast. Lat: 29.785217 Long: - 95.318261			
Photo No. 20	Inspection Date: 2/23/2022

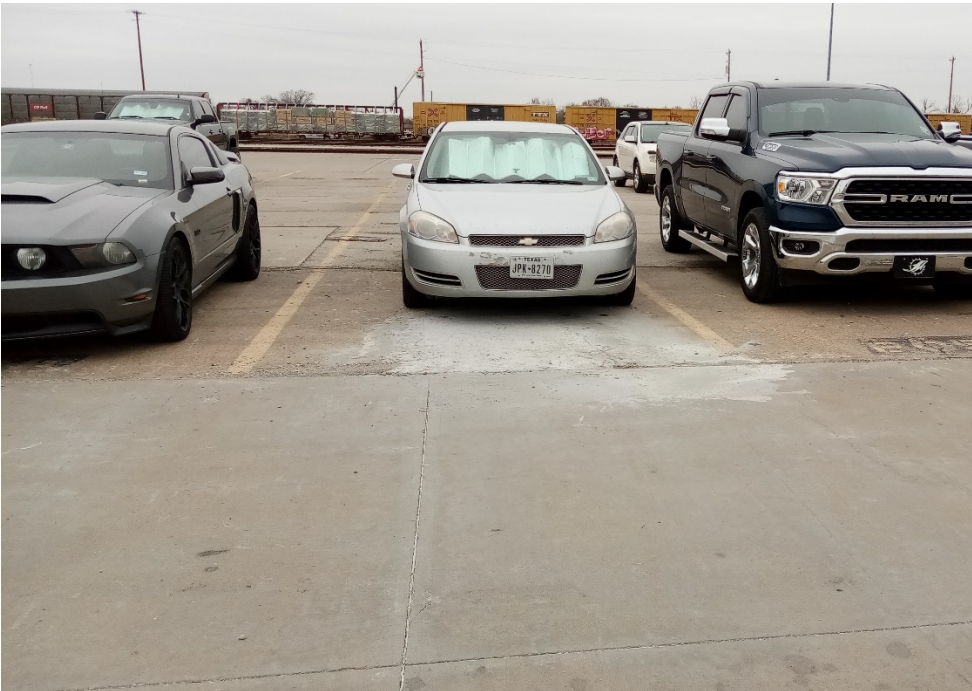
Description: Slot B057, no active tar-like material seeps observed at historical seep location or where test pit conducted (July 2020). Lat: 29.7847472 Long: - 95.3195417

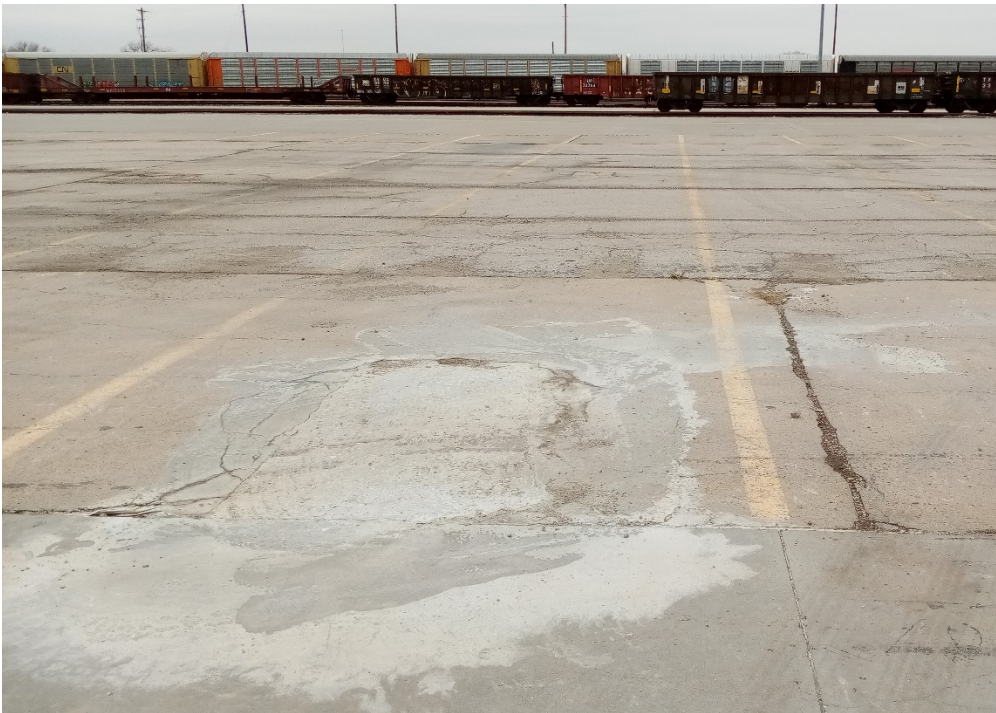
Description: Slot B096, no tar-like material seeps observed where test pit conducted (July 2020), test pit pavement repaired, looking southwest. Lat: 29.7842528 Long: - 95.3206250			
Photo No. 22	Inspection Date: 2/23/2022

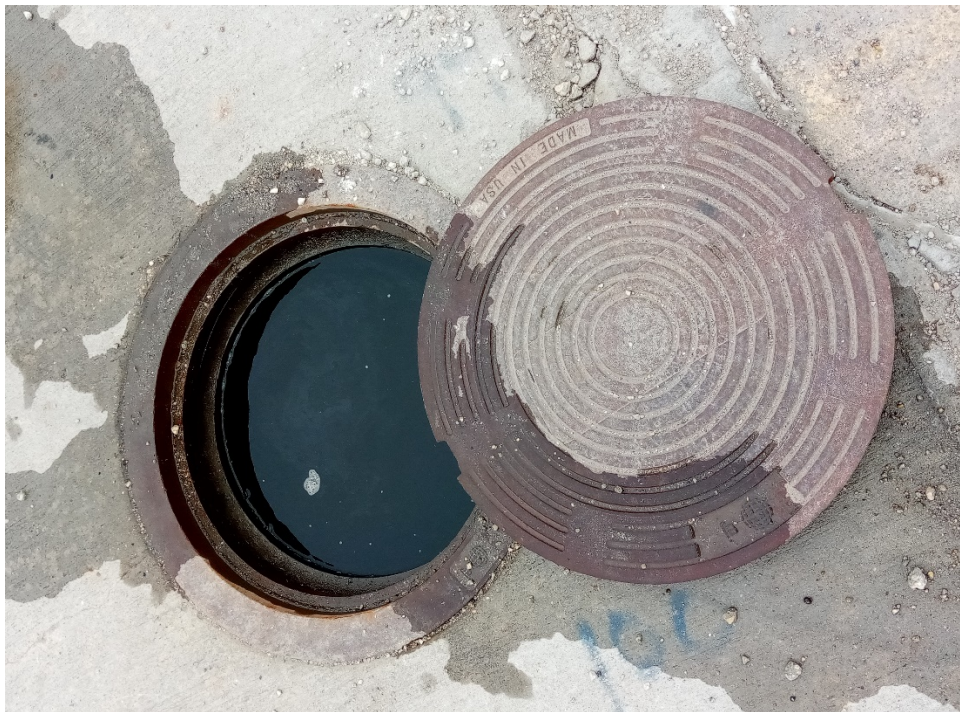
Description: Sump 1 (B099/B100), 5.5 inches of freeboard in sump. No sheen or odor noted. Lat: 29.7844000 Long: - 95.3205861

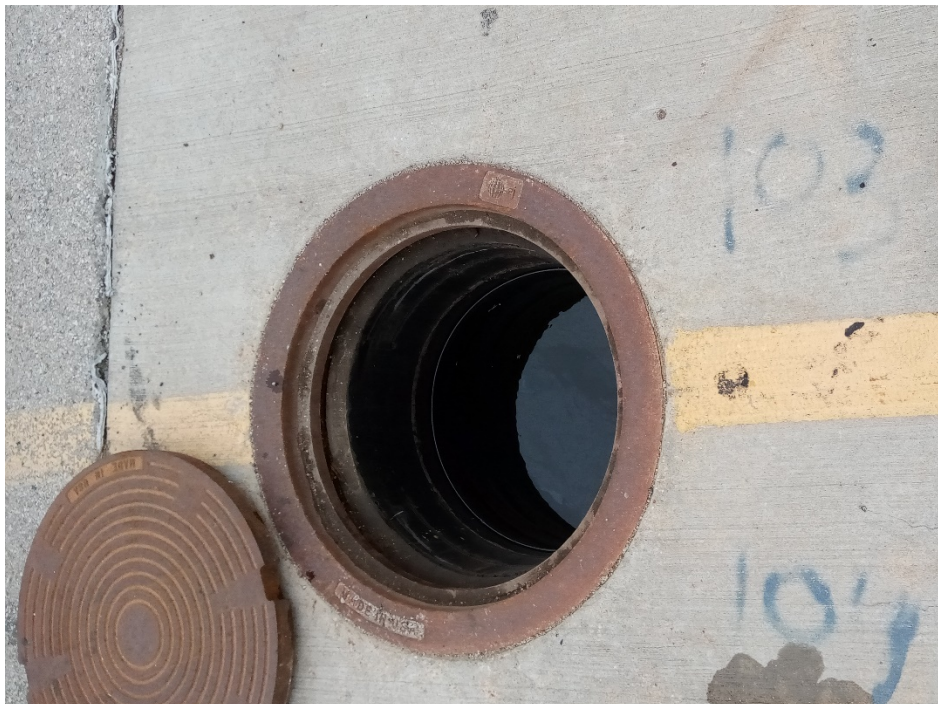
Description: Sump 2 (B103/B104), 14 inches of freeboard in sump. No sheen or odor noted. Lat: 29.7842861 Long: - 95.3208611			
Photo No. 24	Inspection Date: 2/23/2022

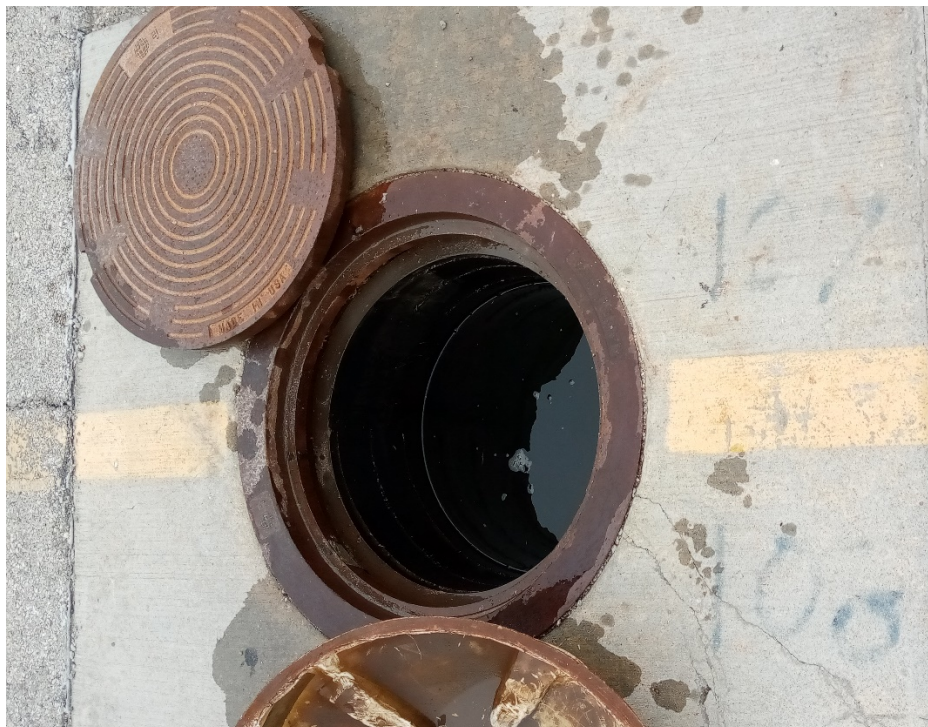
Description: Sump 3 (B107/B108), 13.5 inches of freeboard in sump. No sheen or odor noted. No tar-like material recovered. Lat: 29.784172 Long: -95.320998
