April 13, 2022

Project No. 19119232

**Re: MONTHLY STATUS UPDATE – ENGLEWOOD INTERMODAL YARD – NAPL COLLECTION  
SYSTEM/CONCRETE CAP REPAIRS  
UNION PACIFIC RAILROAD HOUSTON WOOD PRESERVING WORKS FACILITY  
4910 LIBERTY ROAD FACILITY, HOUSTON, TEXAS  
POST-CLOSURE CARE PERMIT NO. HW-50343; INDUSTRIAL SWR NO. 31547**

## Weekly Inspection Photolog

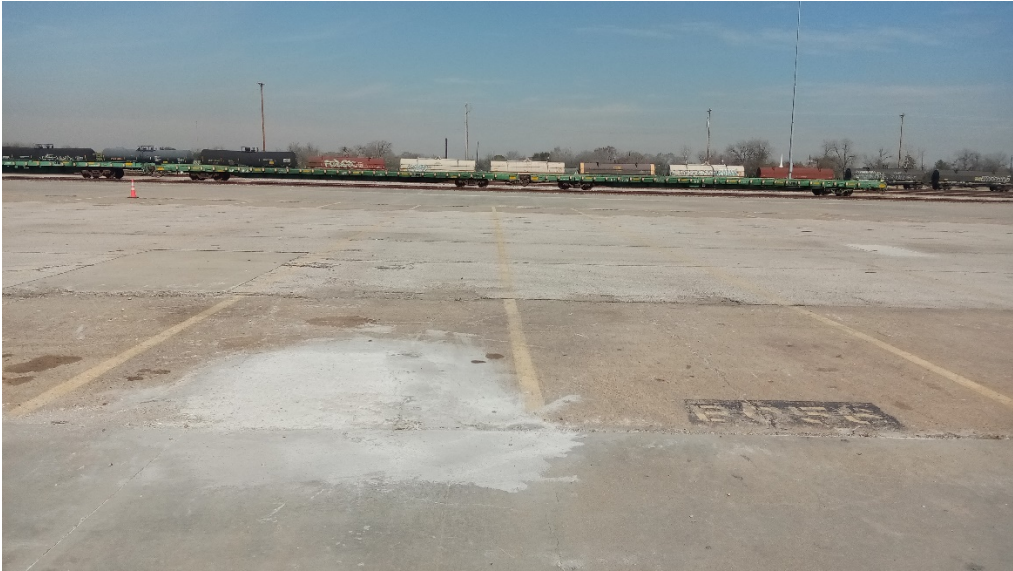
<b>Client Name:</b> Union Pacific Railroad		<b>Site Location:</b> Englewood Houston, Texas	<b>Project No.</b> 19119232
<b>Photo No.</b> 3	<b>Inspection Date:</b> 3/2/2022	<div> <div> <b>Description:</b>   Slot B057, no active tar-like material seeps observed at historical seep location or where test pit conducted (July 2020), looking north.   Lat: 29.7847472  Long: - 95.3195417 </div>

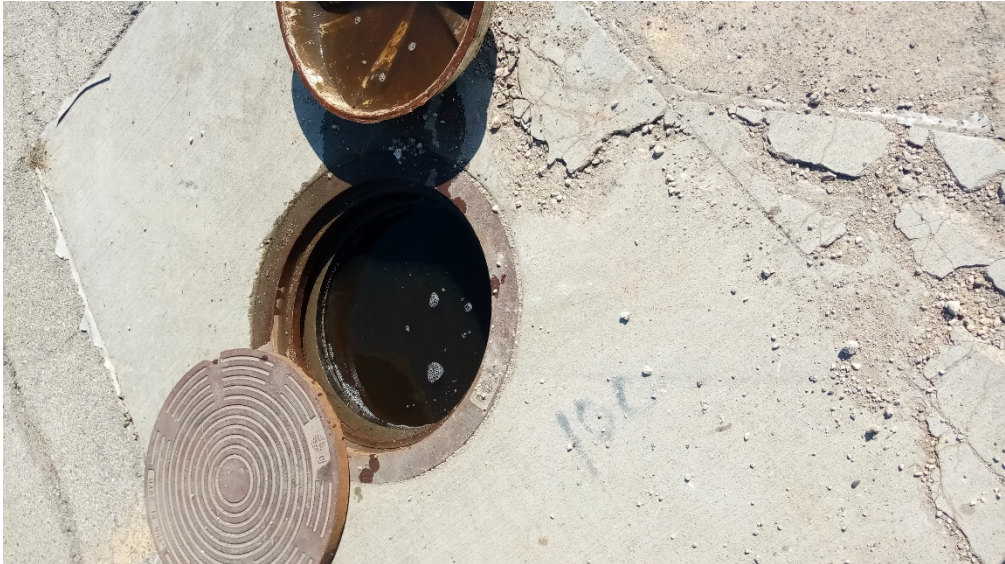
</div>	
<b>Photo No.</b> 4	<b>Inspection Date:</b> 3/2/2022	<div> <div> <b>Description:</b>   Sump 1 (B099/B100), 5.5 inches of freeboard in sump, no sheen or odor noted.   Lat: 29.7844000  Long: - 95.3205861 </div>

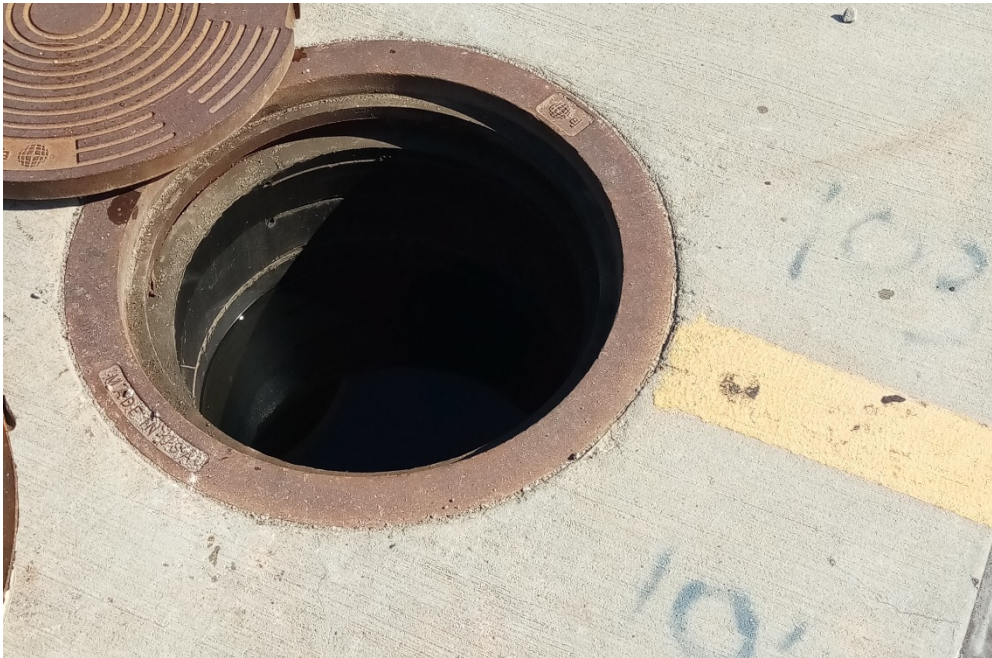
<b>Client Name:</b> <b>Union Pacific Railroad</b>		<b>Site Location:</b> Englewood Houston, Texas	<b>Project No.</b> 19119232
<b>Photo No.</b> <b>5</b>	<b>Inspection Date:</b> 3/2/2022	<div> <p><b>Description:</b></p> <p>Sump 2 (B103/B104), 15 inches of freeboard in sump. No sheen or odor noted.</p> <p>Lat: 29.7842861 Long: - 95.3208611</p> </div>

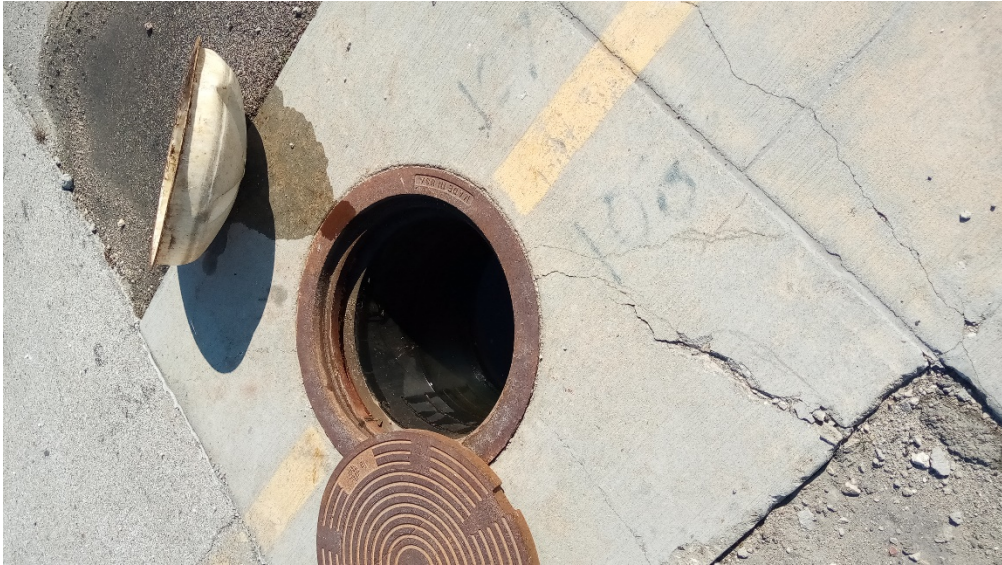
<b>Photo No.</b> <b>6</b>	<b>Inspection Date:</b> 3/2/2022	<div> <p><b>Description:</b></p> <p>Sump 3 (B107/B108), 14 inches of freeboard in sump. No sheen or odor noted. No tar-like material recovered.</p> <p>Lat: 29.784172 Long: -95.320998</p> </div>

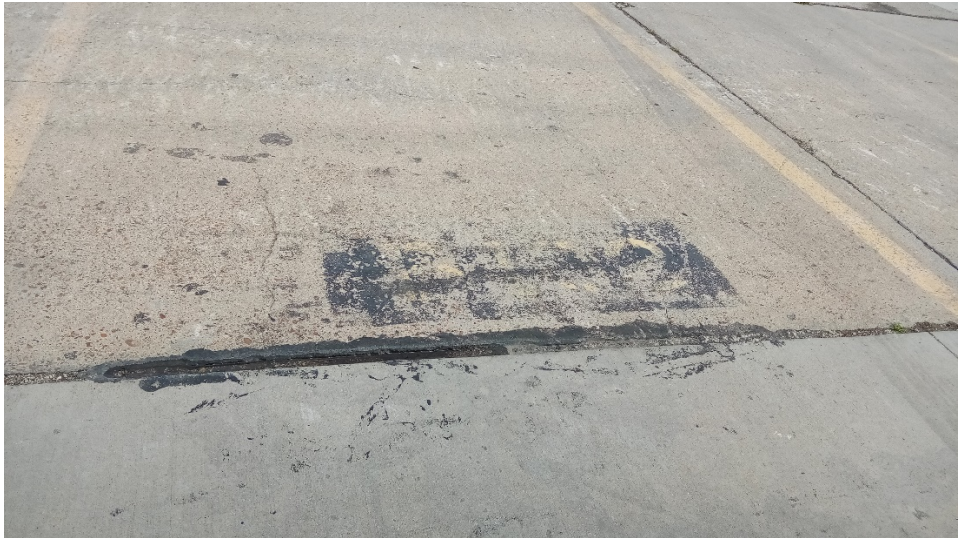
<b>Client Name:</b> <b>Union Pacific Railroad</b>		<b>Site Location:</b> Englewood Houston, Texas	<b>Project No.</b> 19119232
<b>Photo No.</b> <b>9</b>	<b>Inspection Date:</b> 3/9/2022

<b>Description:</b>  Slot B102, small amount of tar-like material observed within concrete join, residual staining on concrete surface noted.  Lat: 29.7842203 Long: - 95.320827			
<b>Photo No.</b> <b>10</b>	<b>Inspection Date:</b> 3/9/2022

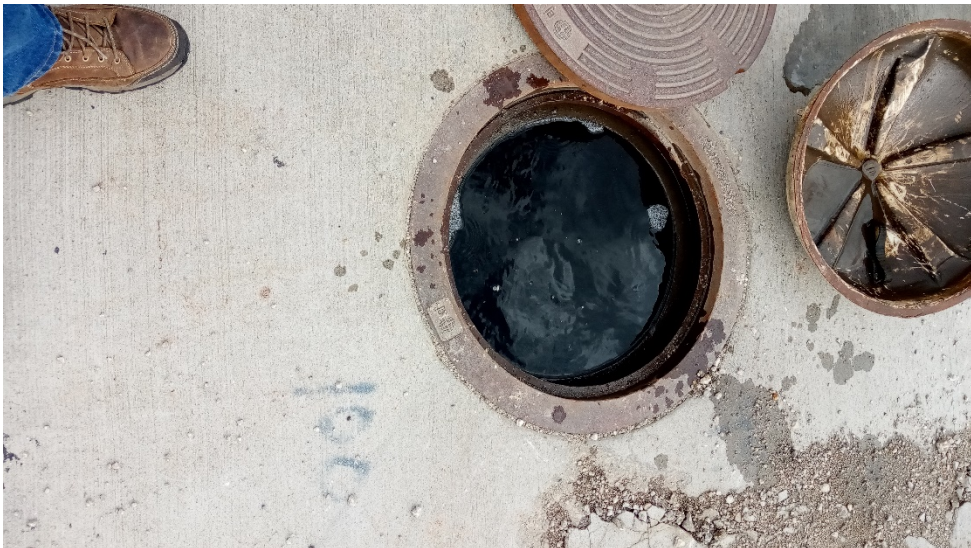
<b>Description:</b>  Sump 1 (B099/B100), 4.5 inches of freeboard in sump, no sheen or odor noted.  Lat: 29.7844000 Long: - 95.3205861

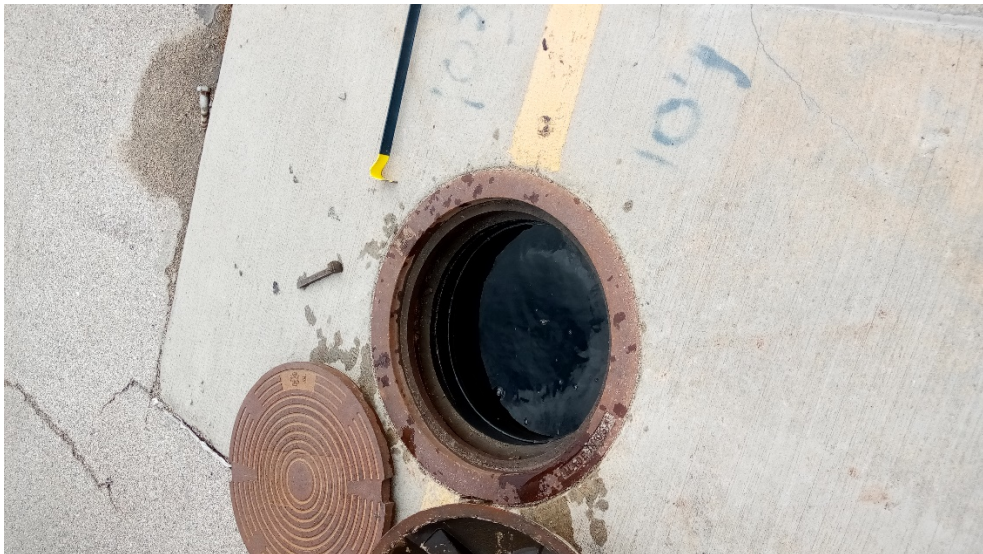
Client Name: Union Pacific Railroad		Site Location: Englewood Houston, Texas	Project No. 19119232
Photo No. 11	Inspection Date: 3/9/2022

Description:  Sump 2 (B103/B104), 7 inches of freeboard in sump. No sheen or odor noted.  Lat: 29.7842861 Long: - 95.3208611			
Photo No. 12	Inspection Date: 3/9/2022

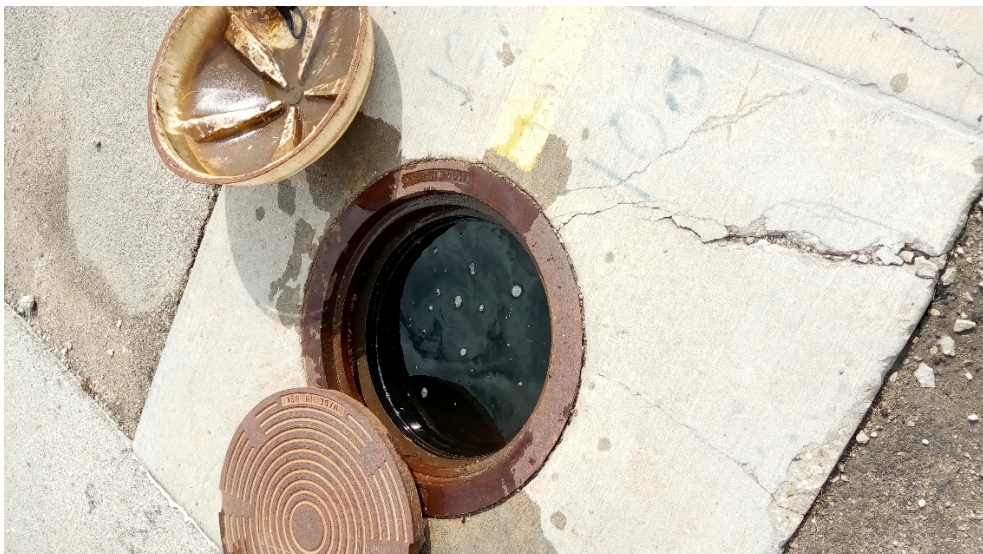
Description:  Sump 3 (B107/B108), 6 inches of freeboard in sump. No sheen or odor noted. No tar-like material recovered.  Lat: 29.784172 Long: -95.320998

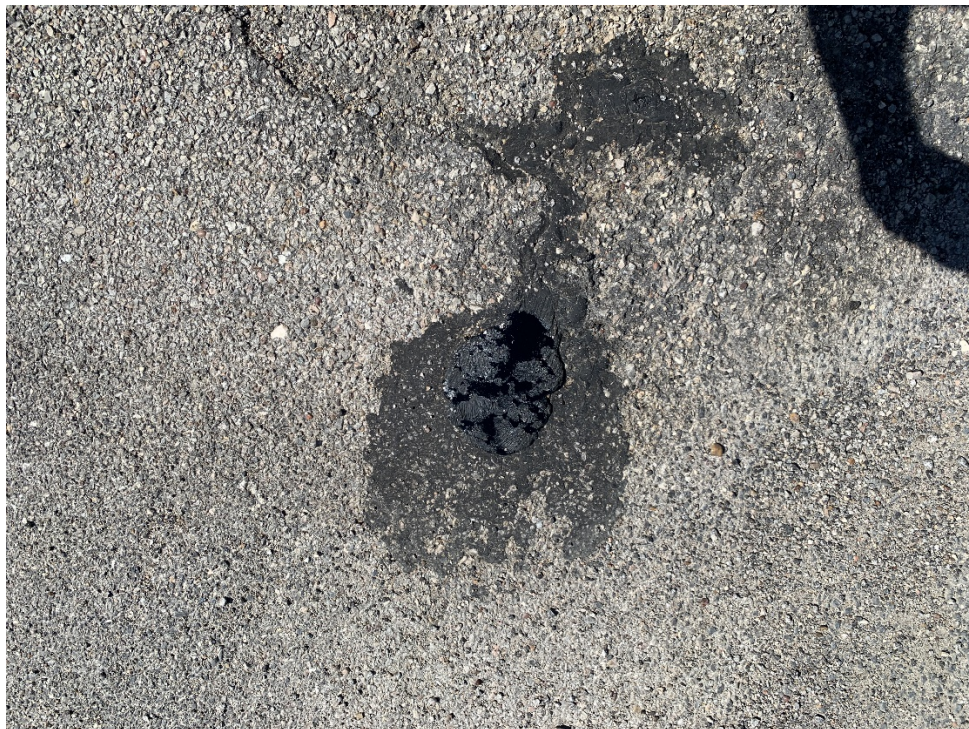
<b>Photo No.</b> <b>13</b>	<b>Inspection Date:</b> 3/16/2022
-------------------------------	--------------------------------------

Slot A011, very small amount of tar-like material seeping at asphalt crack, material was removed.

Tar-like material observed during the inspection events was recovered using a hand tool to scrape up the material. During March, the number of tar-like material seeps observed during inspections and the total amount of material removed from the concrete surface increased compared to the February weekly inspections. Less than 0.75 gallons of tar-like material was recovered for the month and placed in a drum for disposal. The drum is staged at the Container Storage Area (CSA).

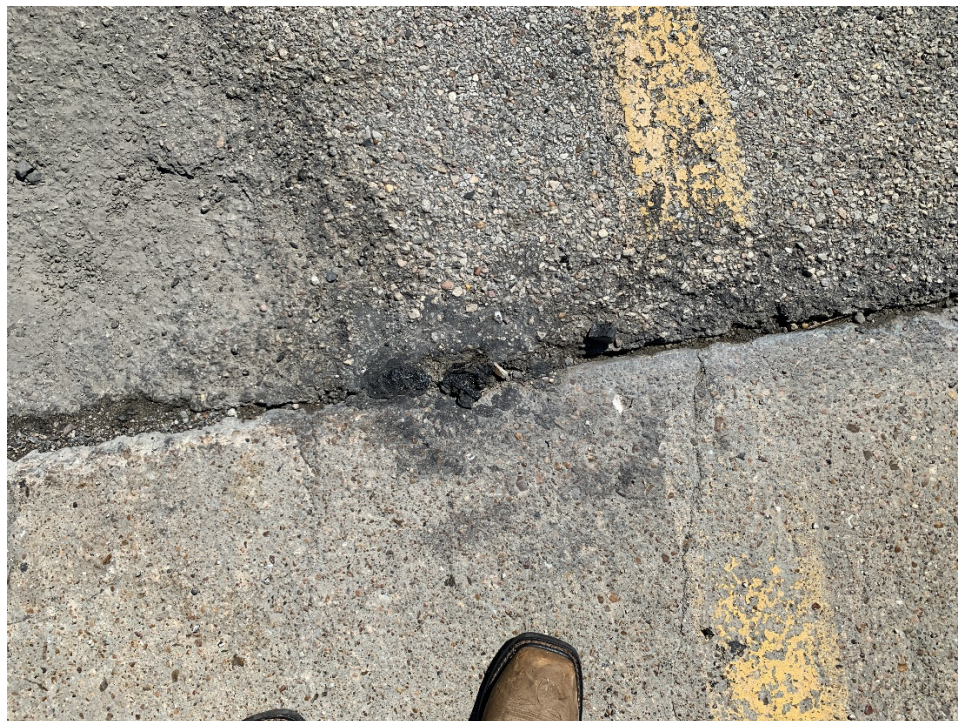
<b>Photo No.</b> <b>14</b>	<b>Inspection Date:</b> 3/16/2022
-------------------------------	--------------------------------------

Slot A022, very small amount of tar-like material seeping at asphalt crack, material was removed.

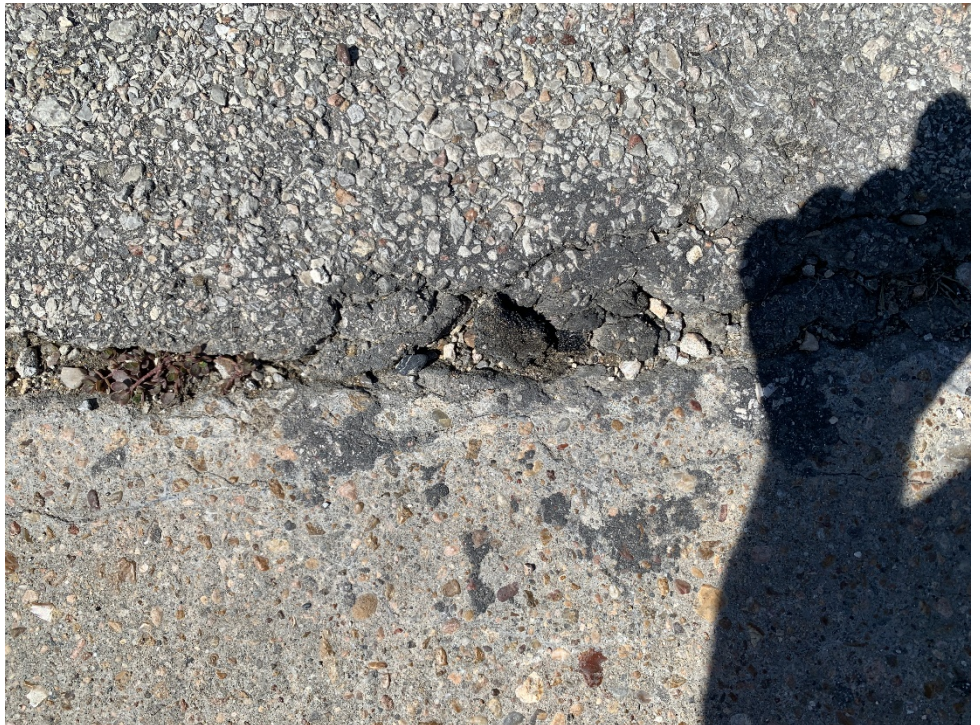
<b>Client Name:</b> <b>Union Pacific Railroad</b>		<b>Site Location:</b> Englewood Houston, Texas	<b>Project No.</b> 19119232
<b>Photo No.</b> <b>15</b>	<b>Inspection Date:</b> 3/16/2022

<b>Description:</b>  Slot B013, very small amount of tar-like material seeping at historical seep location in asphalt crack, no seeps observed where test pit conducted (July 2020), material was removed.  Lat: 29.785217 Long: - 95.318261			
<b>Photo No.</b> <b>16</b>	<b>Inspection Date:</b> 3/16/2022

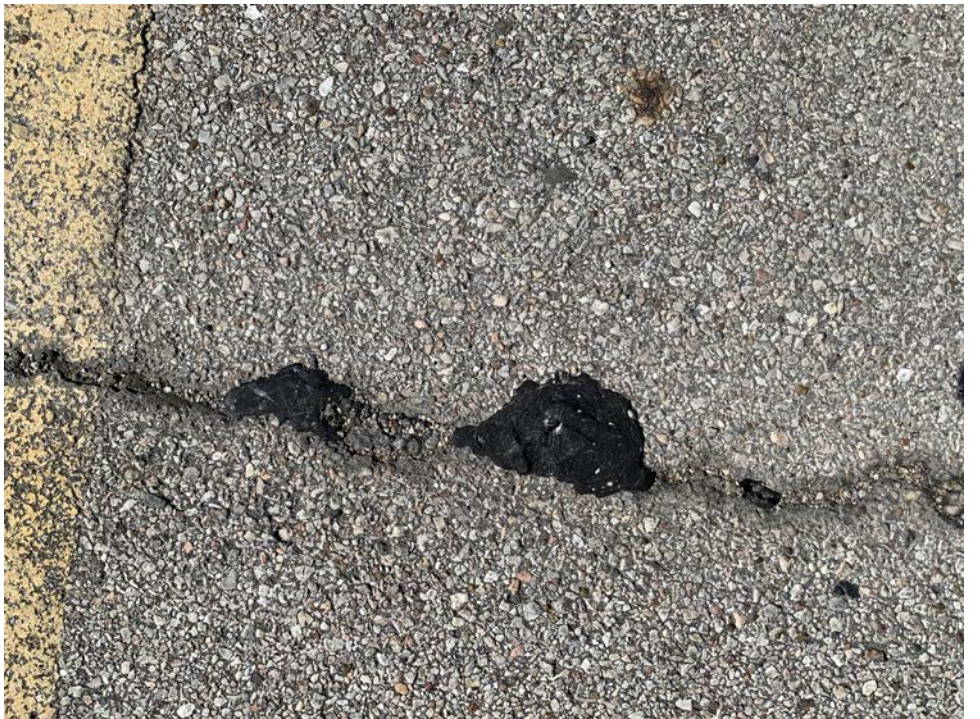
<b>Description:</b>  Slot B056, very small amount of tar-like material seeping at asphalt crack, material was removed.  Lat: 29.784784 Long: -95.319620

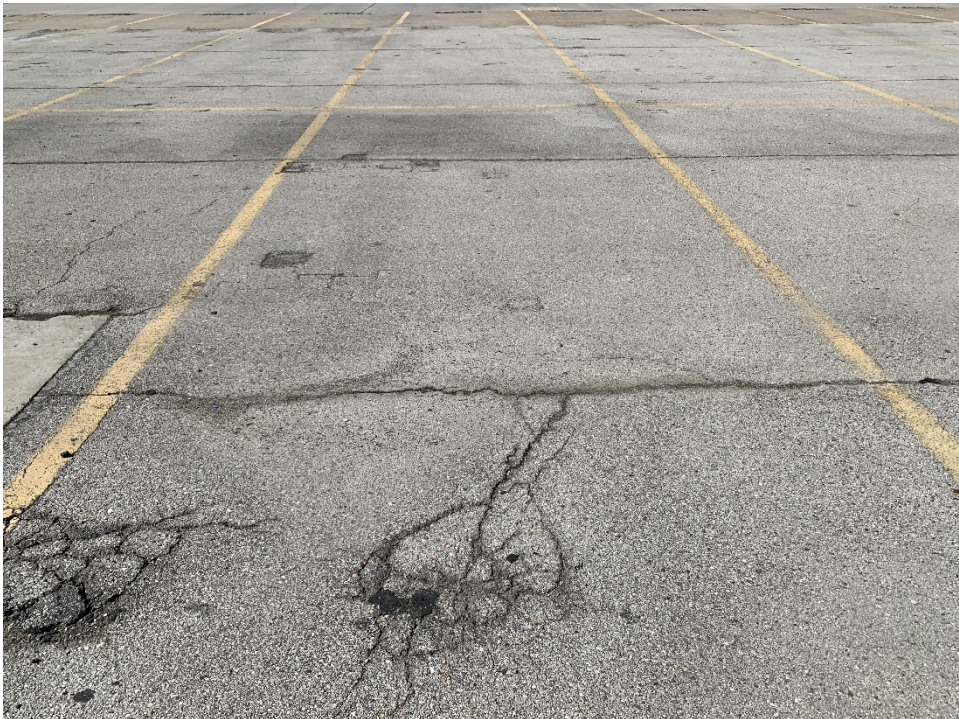
<b>Client Name:</b> <b>Union Pacific Railroad</b>		<b>Site Location:</b> Englewood Houston, Texas	<b>Project No.</b> 19119232
<b>Photo No.</b> <b>17</b>	<b>Inspection Date:</b> 3/16/2022

<b>Description:</b>  Slot B057, very small amount of tar-like material seeping at historical seep location in asphalt cracks, no seeps observed where test pit conducted (July 2020), material was removed.  Lat: 29.7847472 Long: - 95.3195417			
<b>Photo No.</b> <b>18</b>	<b>Inspection Date:</b> 3/16/2022

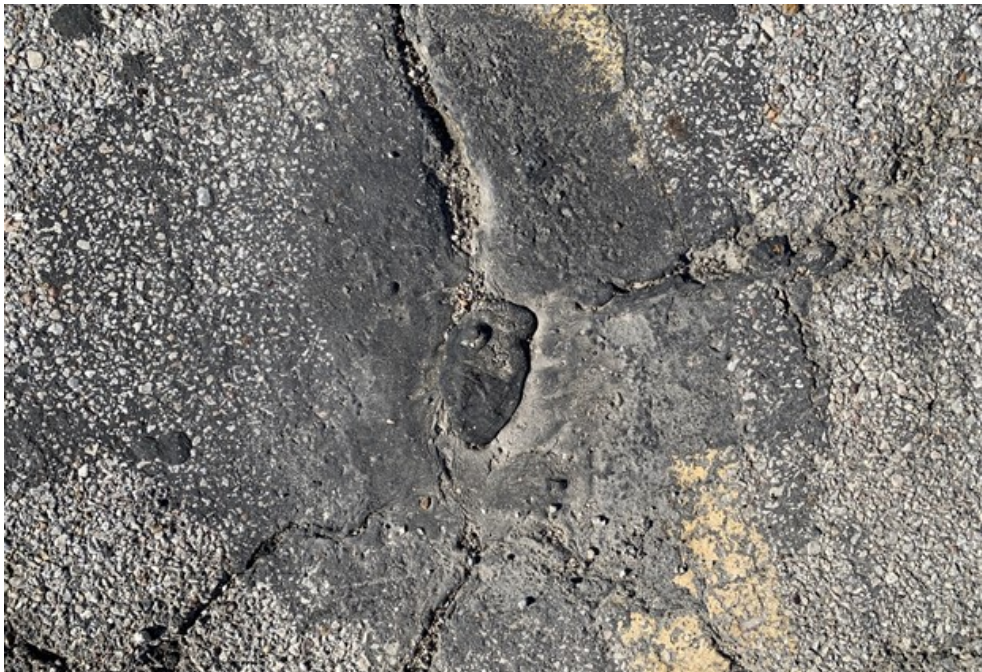
<b>Description:</b>  Slot B101, very small amount of tar-like material seeping at asphalt crack, material was removed.  Lat: 29.784275 Long: - 95.320813

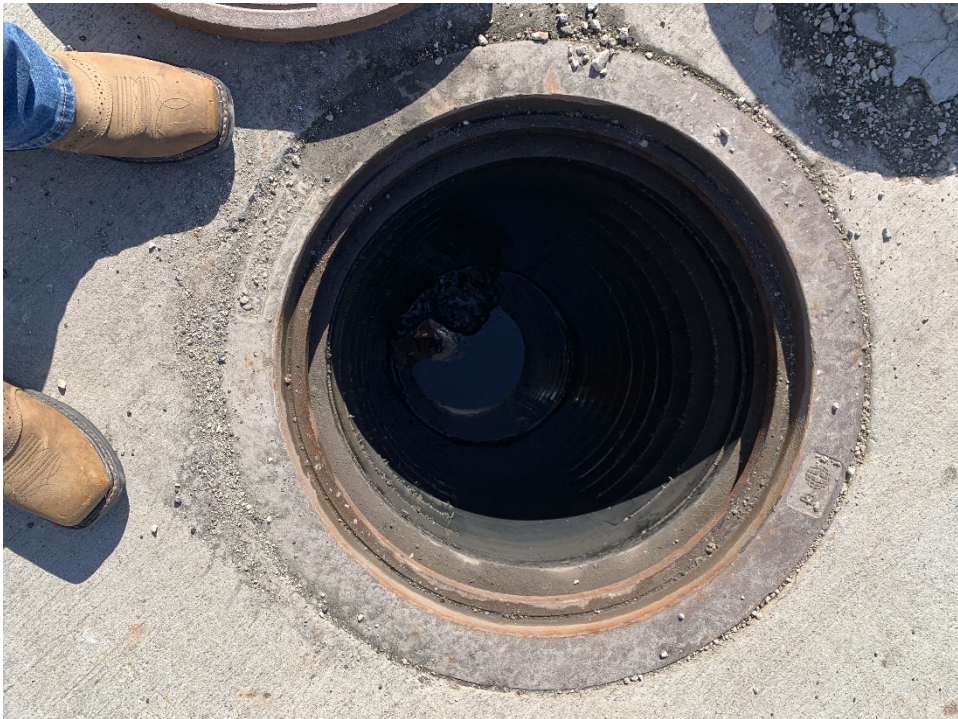
<b>Client Name:</b> <b>Union Pacific Railroad</b>		<b>Site Location:</b> Englewood Houston, Texas	<b>Project No.</b> 19119232
<b>Photo No.</b> <b>21</b>	<b>Inspection Date:</b> 3/16/2022

<b>Description:</b>  Sump 1 (B099/B100), after pump down event; 48 inches of freeboard in sump. No sheen or odor noted.  Lat: 29.7844000 Long: - 95.3205861			
<b>Photo No.</b> <b>22</b>	<b>Inspection Date:</b> 3/16/2022

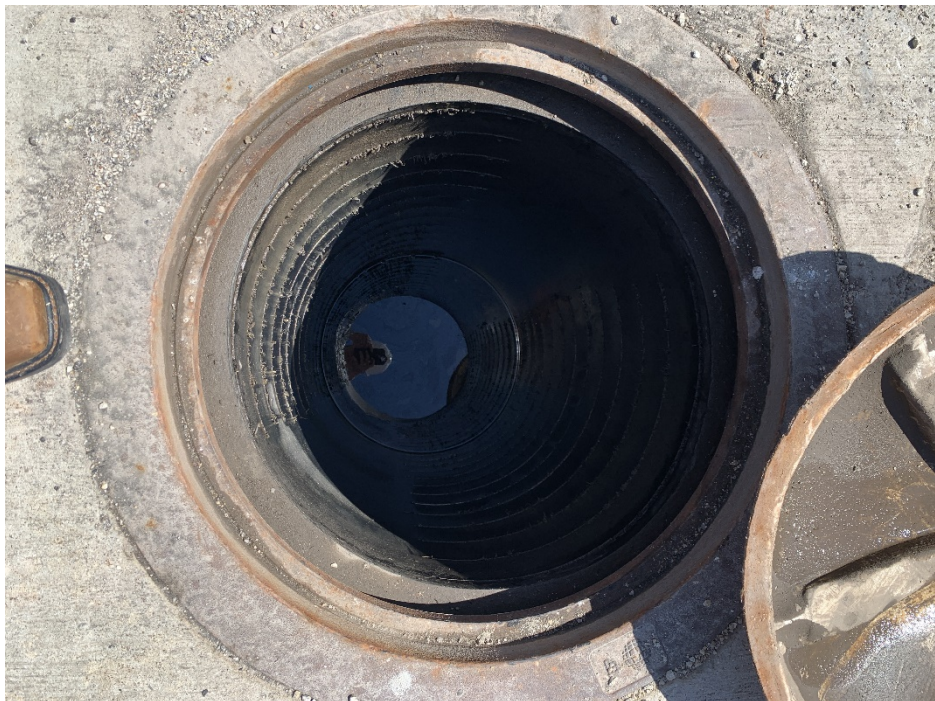
<b>Description:</b>  Sump 2 (B103/B104), after pump down event; 36 inches of freeboard in sump. No sheen or odor noted.  Lat: 29.7842861 Long: - 95.3208611

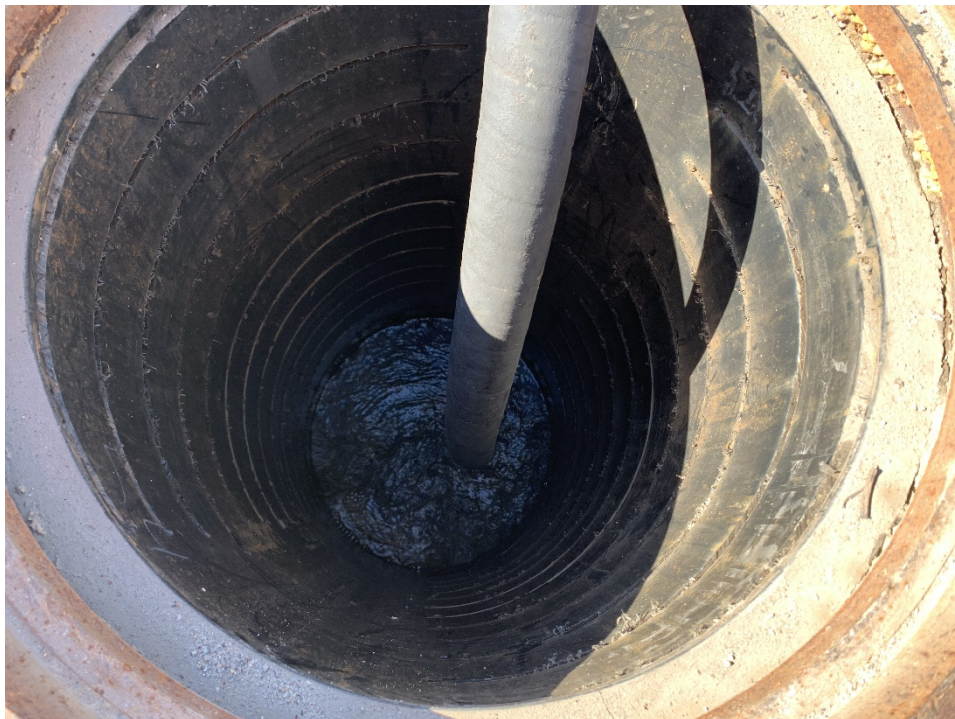
<b>Photo No.</b> <b>23</b>	<b>Inspection Date:</b> 3/16/2022
-------------------------------	--------------------------------------

Sump 3 (B107/B108), after pump down event; 48 inches of freeboard in sump. No sheen or odor noted. Approximately 0.5 gallons of tar-like material recovered.

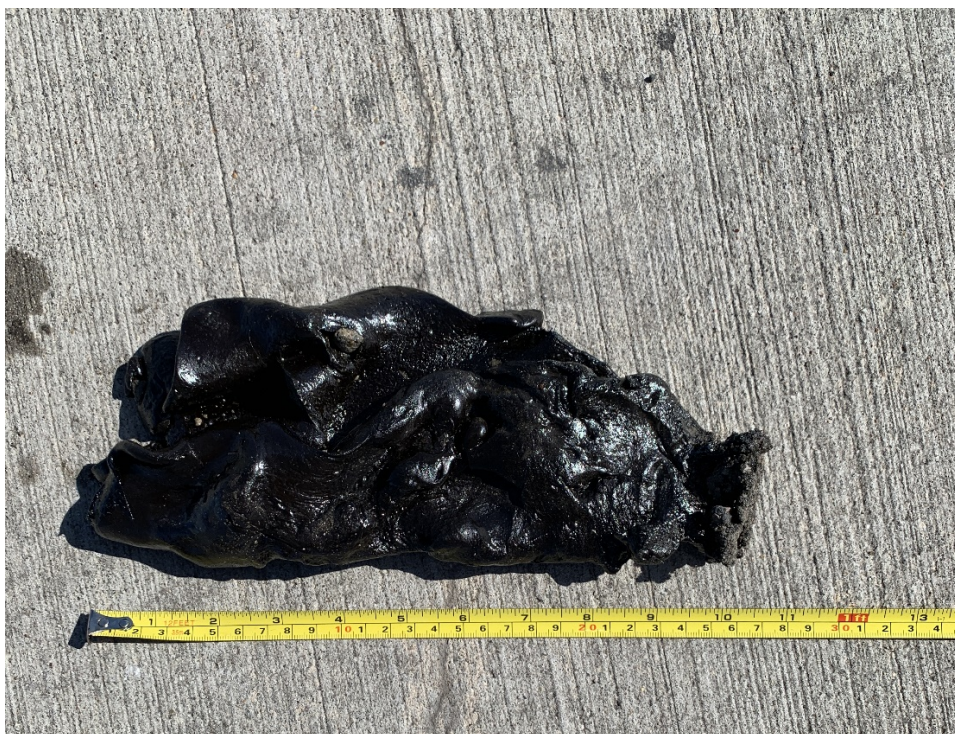
<b>Photo No.</b> <b>24</b>	<b>Inspection Date:</b> 3/16/2022
-------------------------------	--------------------------------------

Sump 3 (B107/B108), Approximately 0.45 gallons of tar-like material recovered during pump down event.

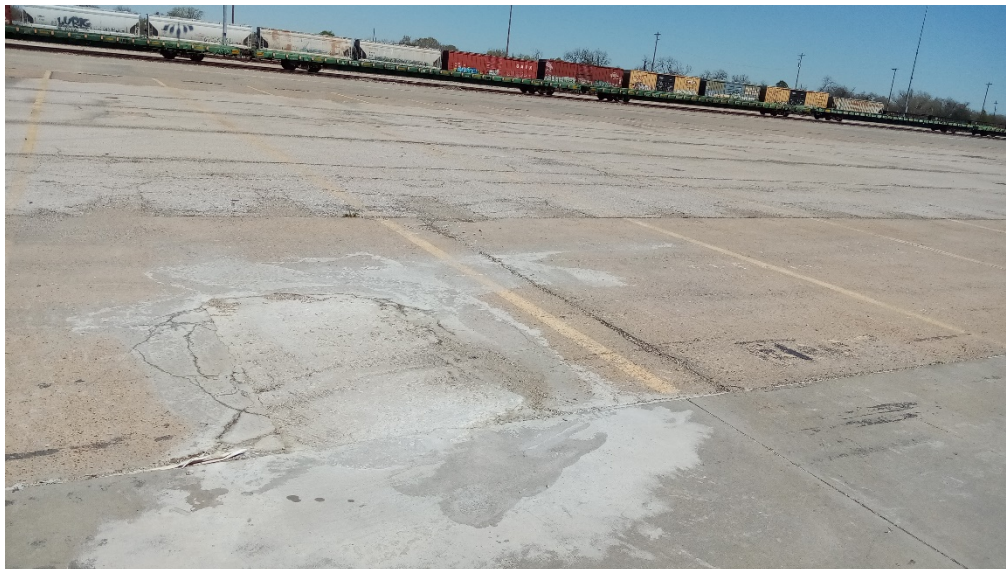
<b>Photo No.</b> <b>27</b>	<b>Inspection Date:</b> 3/23/2022
-------------------------------	--------------------------------------

Slot B096, no tar-like material seeps observed where test pit conducted (July 2020), looking northeast.

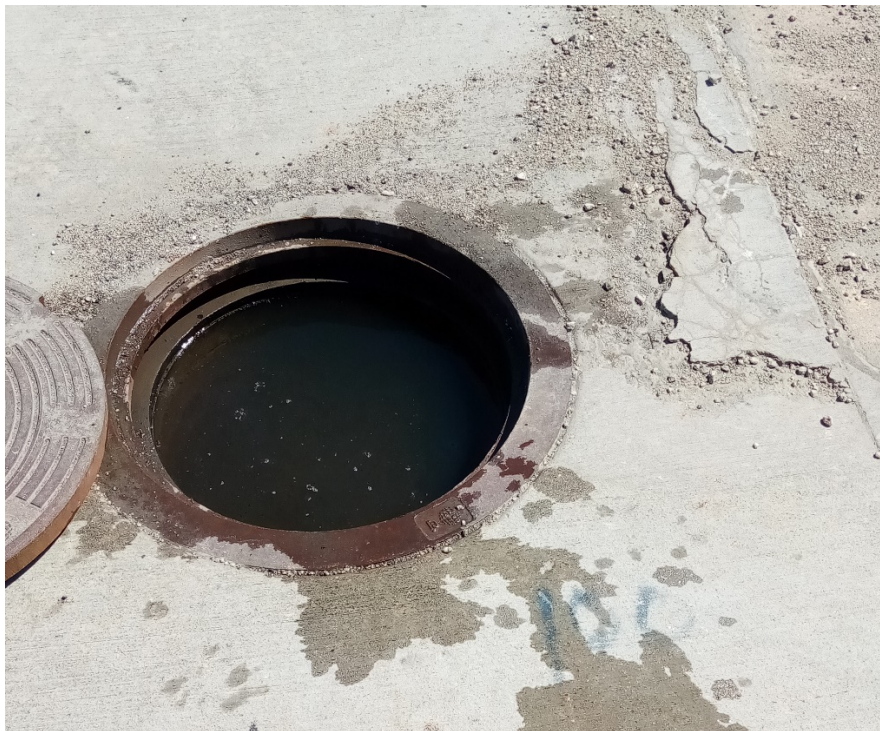
<b>Photo No.</b> <b>28</b>	<b>Inspection Date:</b> 3/23/2022
-------------------------------	--------------------------------------

Sump 1 (B099/B100), 6 inches of freeboard in sump. No sheen or odor noted.

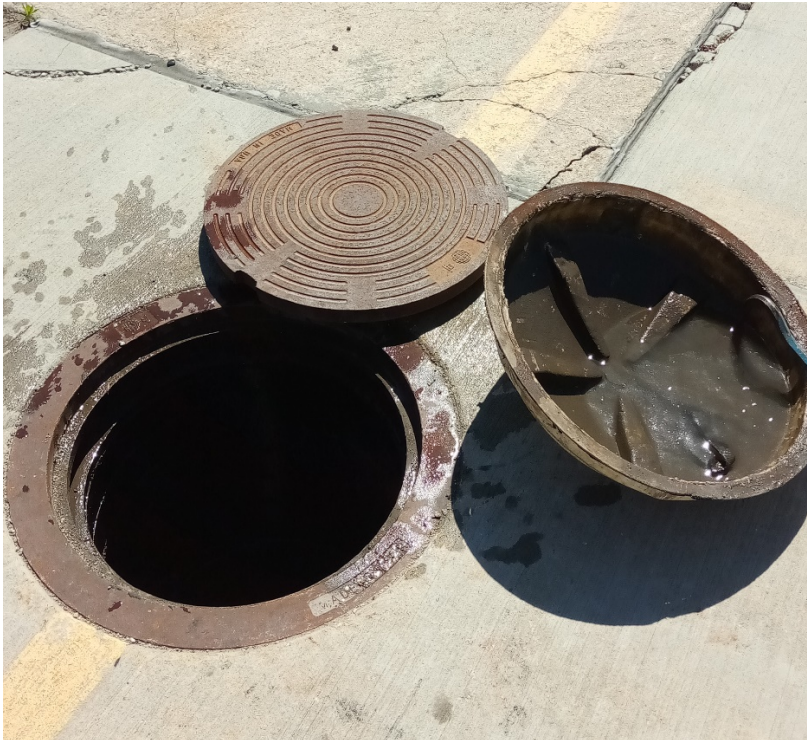
Client Name: Union Pacific Railroad		Site Location: Englewood Houston, Texas	Project No. 19119232
Photo No. 29	Inspection Date: 3/23/2022

Description:  Sump 2 (B103/B104), 29 inches of freeboard in sump. No sheen or odor noted.  Lat: 29.7842861 Long: - 95.3208611			
Photo No. 30	Inspection Date: 3/23/2022

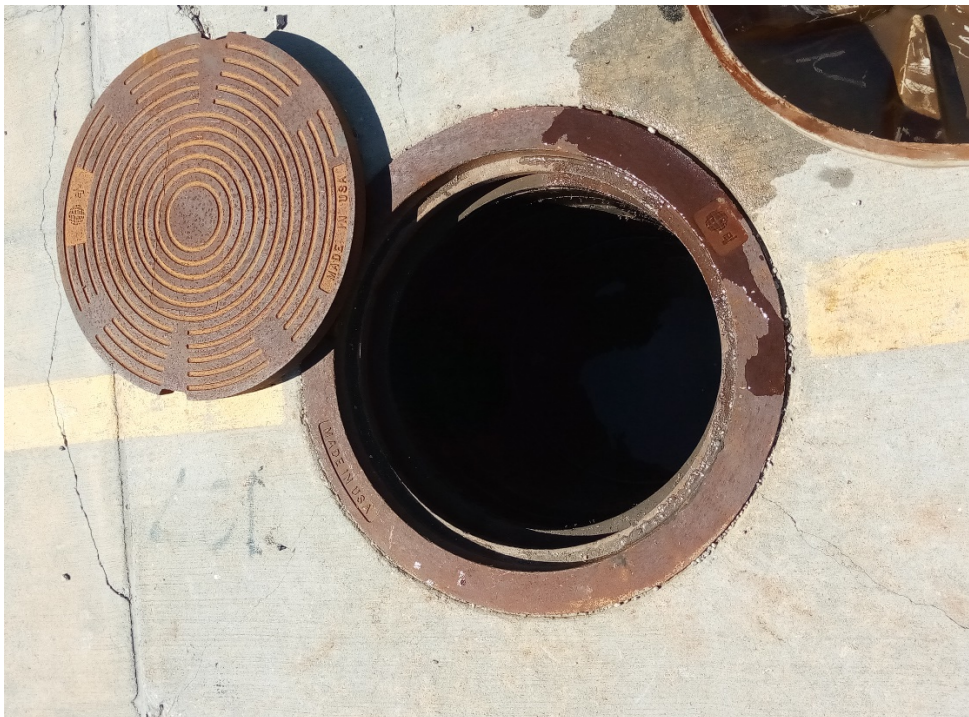
Description:  Sump 3 (B107/B108), 28 inches of freeboard in sump. No sheen or odor noted. No tar-like material recovered.  Lat: 29.784172 Long: -95.320998

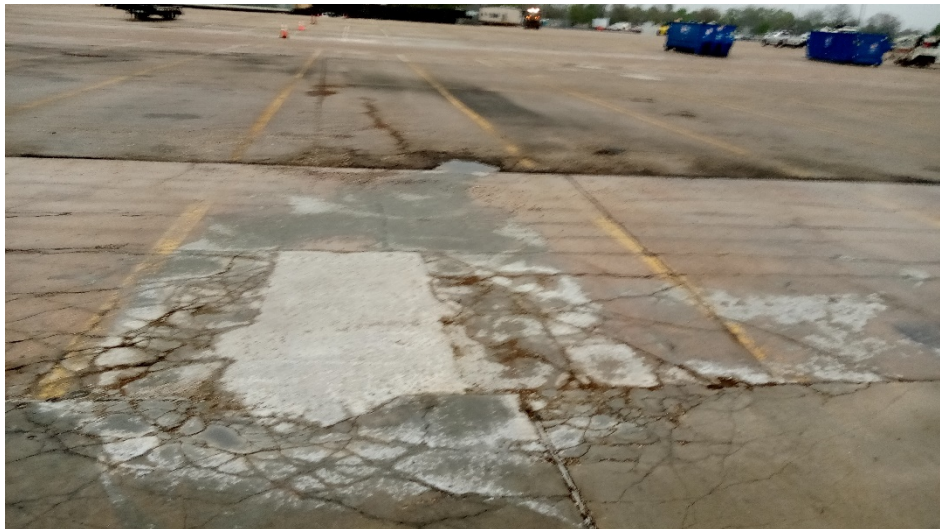
<b>Client Name:</b> <b>Union Pacific Railroad</b>		<b>Site Location:</b> Englewood Houston, Texas	<b>Project No.</b> 19119232
<b>Photo No.</b> <b>31</b>	<b>Inspection Date:</b> 3/30/2022

<b>Description:</b>  Slots A010, no tar-like material seeps observed where test pit conducted (July 2020), pavement wet from ongoing rain event, looking southwest.  Lat: 29.785392, Long: -95.318655			
<b>Photo No.</b> <b>32</b>	<b>Inspection Date:</b> 3/30/2022

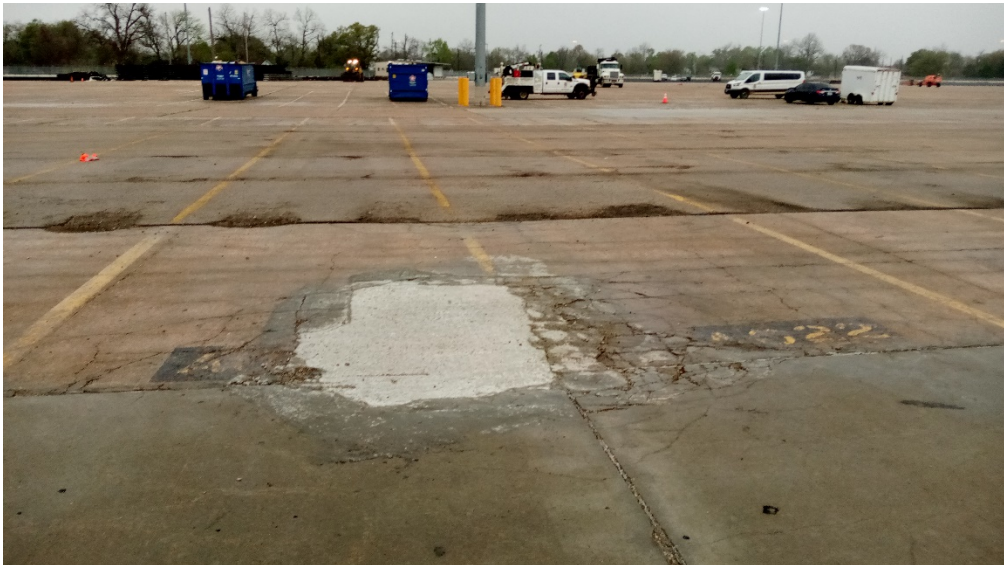
<b>Description:</b>  Slot A021, no tar-like material seeps observed where test pit conducted (July 2020), pavement wet from ongoing rain event, looking southwest.  Lat: 29.785392, Long: -95.318655

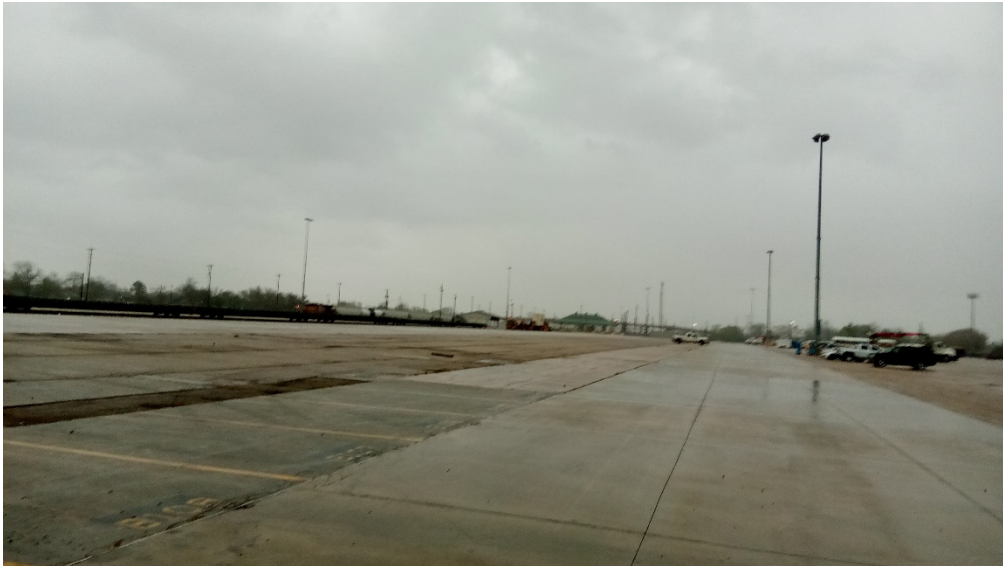
Client Name: Union Pacific Railroad		Site Location: Englewood Houston, Texas	Project No. 19119232
Photo No. 33	Inspection Date: 3/30/2022

Description:  View of slots B109-B097, no tar-like material seeps observed NAPL collection system visible in background, pavement wet from ongoing rain event, looking east.  Lat: 29.784358 Long: -95.320611			
Photo No. 34	Inspection Date: 3/30/2022

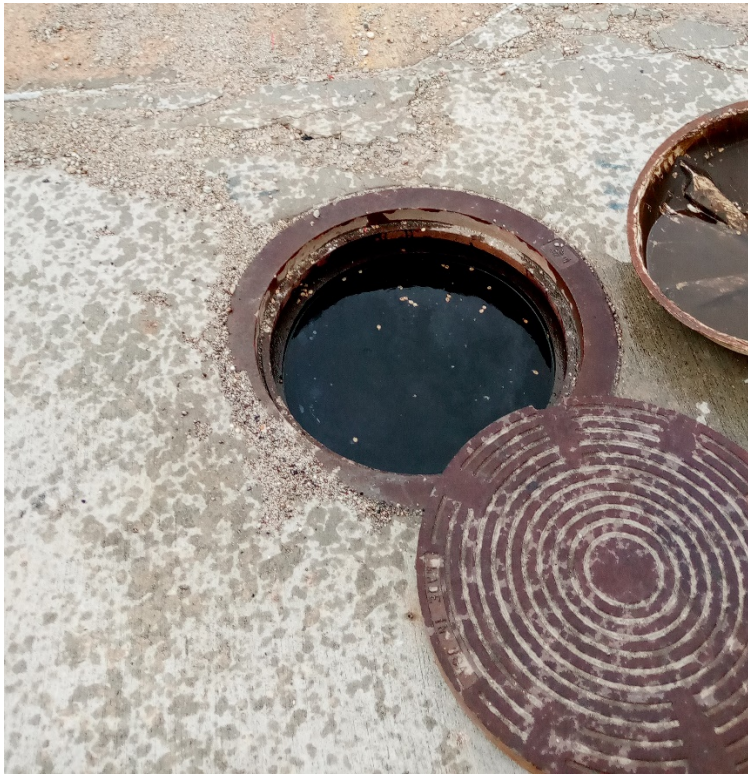
Description:  Sump 1 (B099/B100), 5.5 inches of freeboard in sump. No sheen or odor noted. Pavement wet from ongoing rain event.  Lat: 29.7844000 Long: - 95.3205861

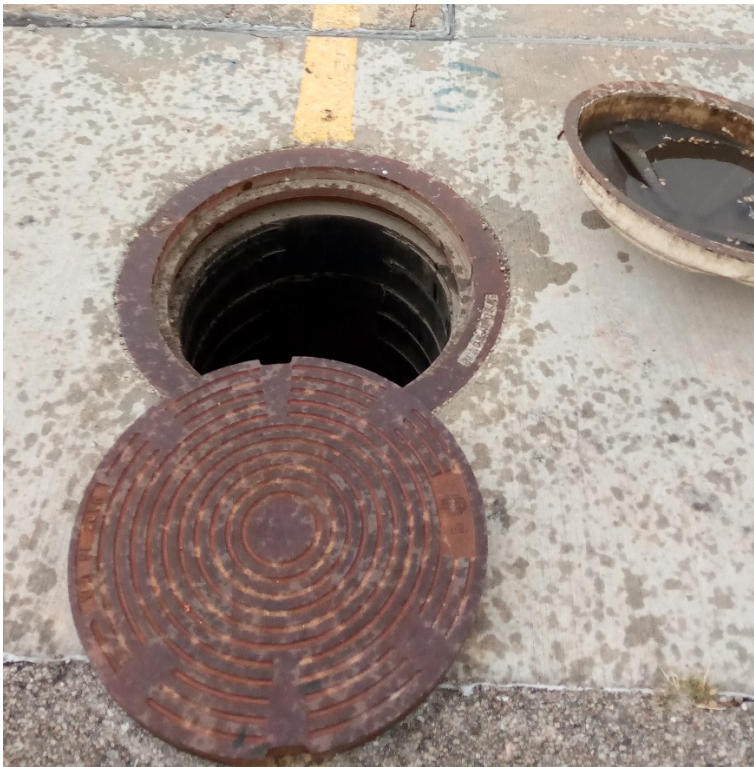
Client Name: Union Pacific Railroad		Site Location: Englewood Houston, Texas	Project No. 19119232
Photo No. 35	Inspection Date: 3/30/2022

Description:  Sump 2 (B103/B104), 28 inches of freeboard in sump. No sheen or odor noted. Pavement wet from ongoing rain event.  Lat: 29.7842861 Long: - 95.3208611			
Photo No. 36	Inspection Date: 3/30/2022

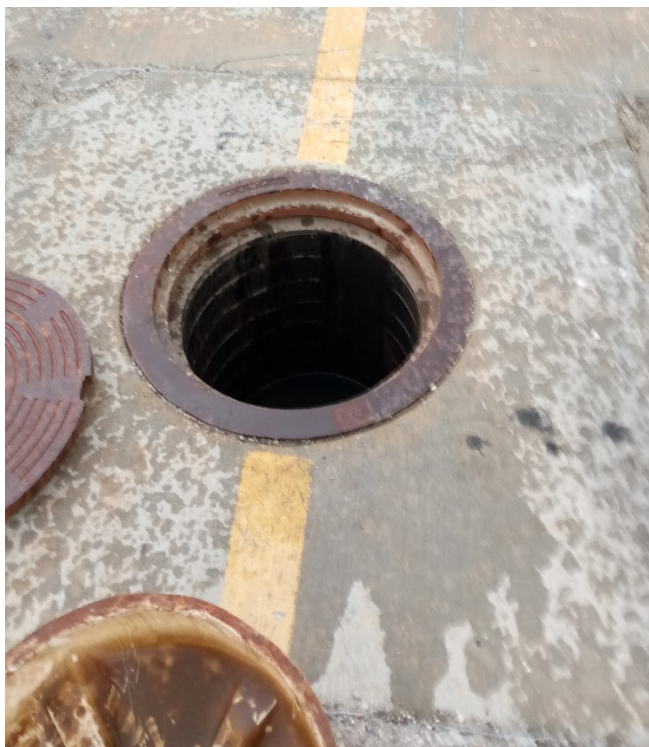
Description:  Sump 3 (B107/B108), 28 inches of freeboard in sump. No sheen or odor noted. No tar-like material recovered. Pavement wet from ongoing rain event.  Lat: 29.784172 Long: -95.320998
