**RE: WEEKLY STATUS UPDATE – ENGLEWOOD YARD NORTH BYPASS PROJECT  
UNION PACIFIC RAILROAD HOUSTON WOOD PRESERVING WORKS SITE  
4910 LIBERTY ROAD FACILITY, HOUSTON, TEXAS  
POST-CLOSURE CARE PERMIT NO. 50343, INDUSTRIAL SWR NO. 31547**

**Week Period:** *February 27 through March 5, 2023*

### Union Pacific Railroad North Bypass Construction Project

For Period from 2023-02-27 to 2023-03-05

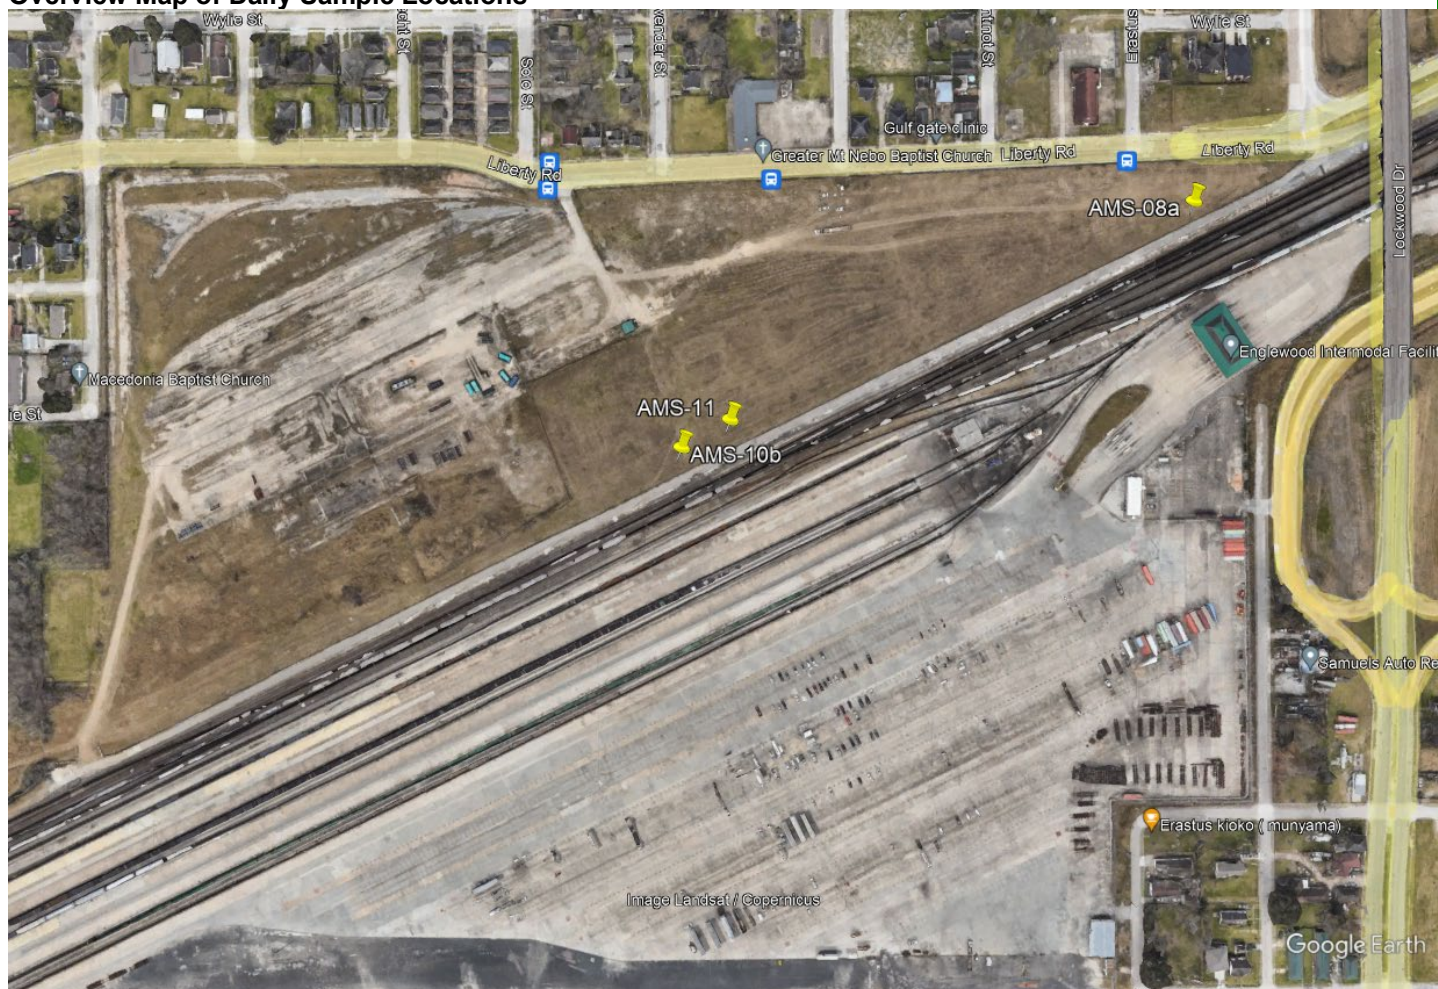
### Overview Map of Daily Sample Locations

Work in the capped area consisted of excavation, old asphalt removal and surface prep in discrete areas of damaged asphalt near signal turnouts on North Bypass access road, south side of the capped area, near the east-west center and eastern end of the capped area. Work hours were from approximately 08:00 – 17:05.

Station ID	Location Description	Start	Stop	Latitude	Longitude	Overall Average PM 2.5	Overall Average PM 10
AMS-08a	HWPW - Erastus	08:05	13:00	29.78734	-95.31717	15.2 ug/m3	47.5 ug/m3
AMS-10b	HWPW - Lavender South	08:13	17:22	29.78602	-95.32033	11 ug/m3	29.7 ug/m3
AMS-11	HWPW - Lavender South	08:10	14:23	29.78617	-95.32003	15.8 ug/m3	52.6 ug/m3

**Note:** Stations AMS-08a and AMS-11 lost network communication between approximately 13:00 and 14:23. AMS-10b, in immediate proximity to the work area, remained up for the entire duration of the work.

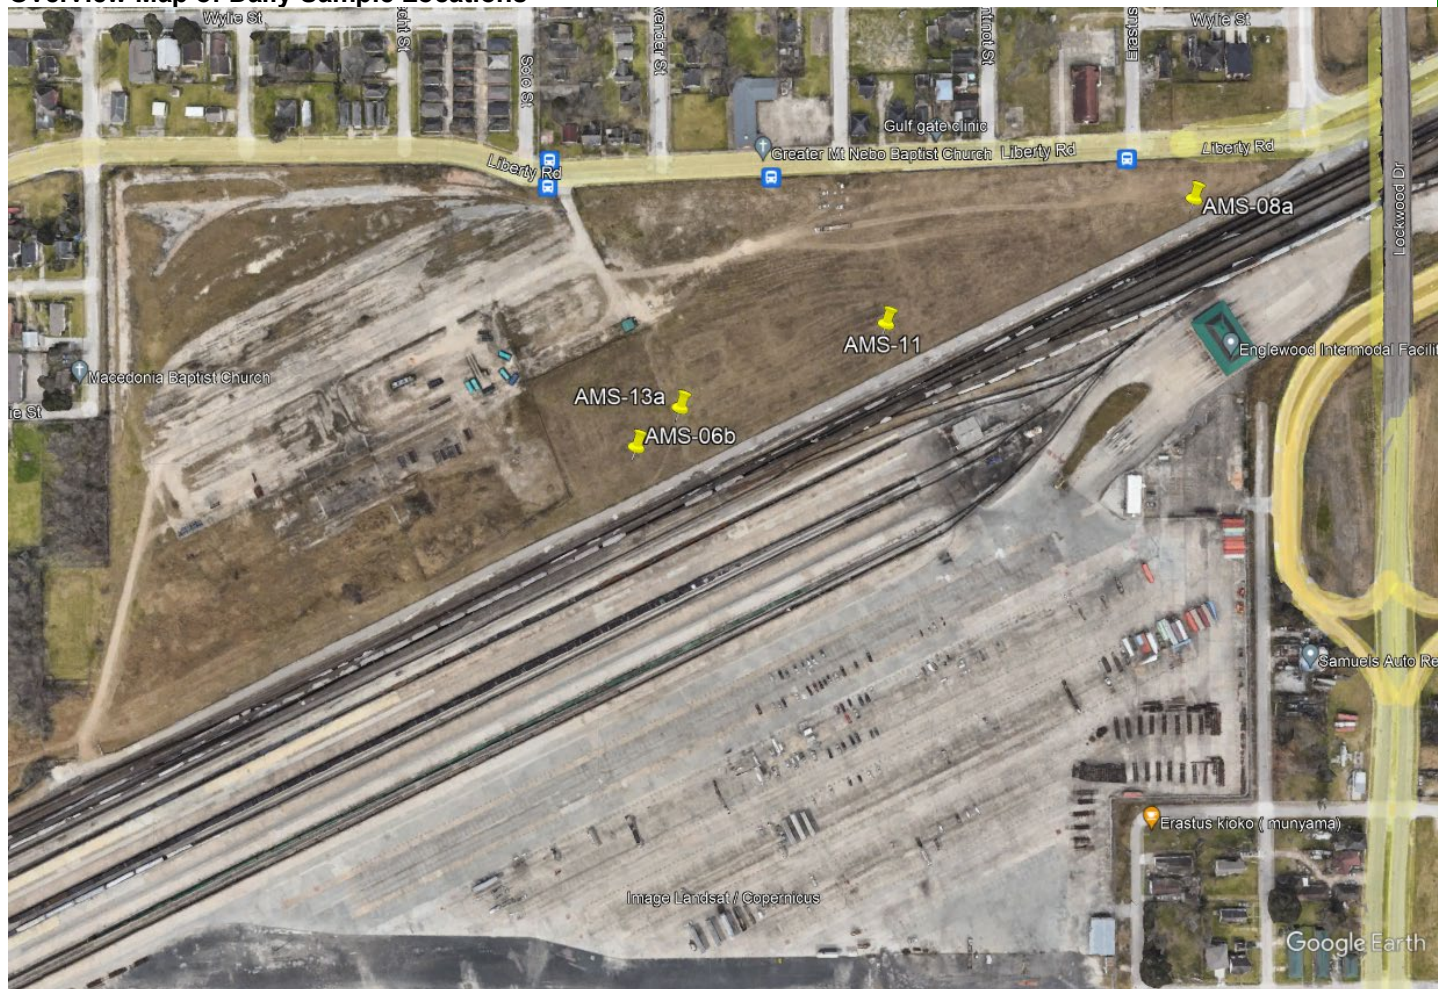
### Overview Map of Daily Sample Locations

Work in the capped area consisted of excavation, old asphalt removal and surface prep in discrete areas of damaged asphalt near signal turnouts on the North Bypass access road, south side of the capped area, near the east-west center and eastern end of the capped area. Work hours were from approximately 08:00 – 16:40.

Station ID	Location Description	Start	Stop	Latitude	Longitude	Overall Average PM 2.5	Overall Average PM 10
AMS-06b	HWPW - Solo South	08:02	14:46	29.78601	-95.32061	17.6 ug/m3	47.2 ug/m3
AMS-08a	HWPW - Erastus	09:45	16:40	29.78734	-95.31717	19.2 ug/m3	48.5 ug/m3
AMS-11	HWPW - Clementine South	08:07	17:04	29.78667	-95.31907	19.5 ug/m3	50.1 ug/m3
AMS-13a	HWPW - Lavender South	10:09	16:57	29.78622	-95.32034	20.6 ug/m3	51.6 ug/m3

**Note:** Stations AMS-06b lost network communication at approximate 14:46. All other stations remained up for the entire duration of the work.
