**RE: POST-RESPONSE ACTION COMPLETION REPORT – 2022  
UNION PACIFIC RAILROAD HOUSTON WOOD PRESERVING WORKS, HOUSTON, TEXAS  
4910 LIBERTY ROAD, HOUSTON, HARRIS COUNTY, TEXAS  
TCEQ SWR NO. 31547; TCEQ PERMIT/COMPLIANCE PLAN NO. 50343 EPA ID NO. TXD000820266  
CUSTOMER NO. CN600131098; REGULATED ENTITY NO. RN100674613**

# TEXAS COMMISSION ON ENVIRONMENTAL QUALITY Post-Response Action Care Report (PRACR)

**SECOND QUARTER 2022 (APRIL 27<sup>th</sup>) INSPECTION RECORD AND PHOTOGRAPHIC LOG**

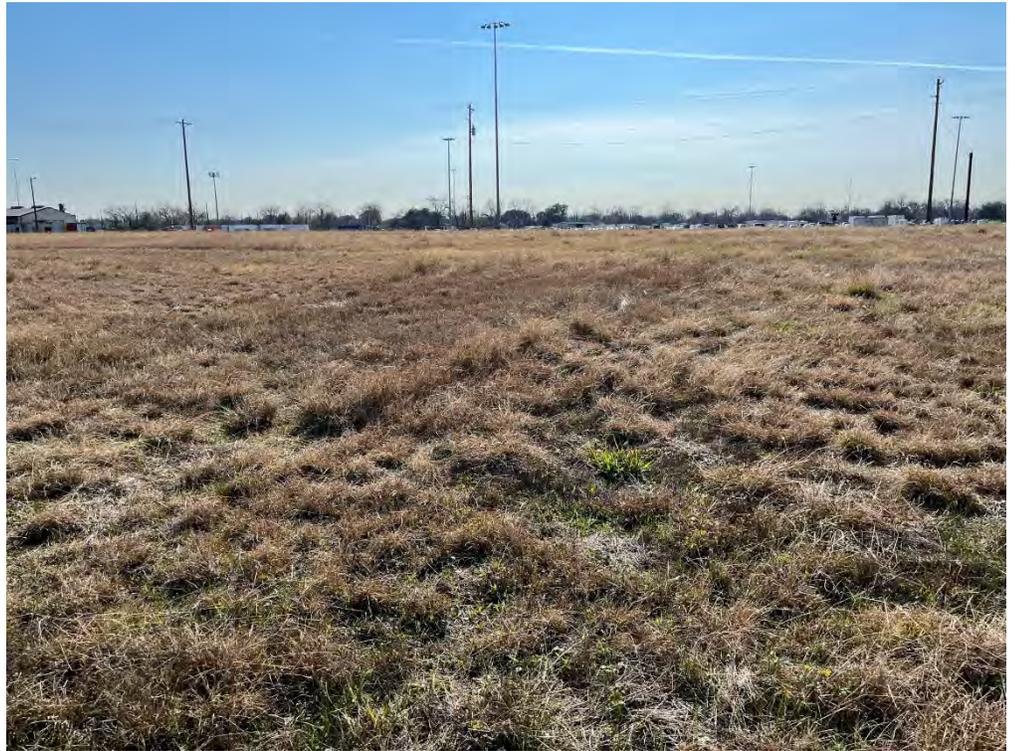
Soil cap well-vegetated in most areas with a low risk of erosion. No major rills observed during inspection. Facing south.

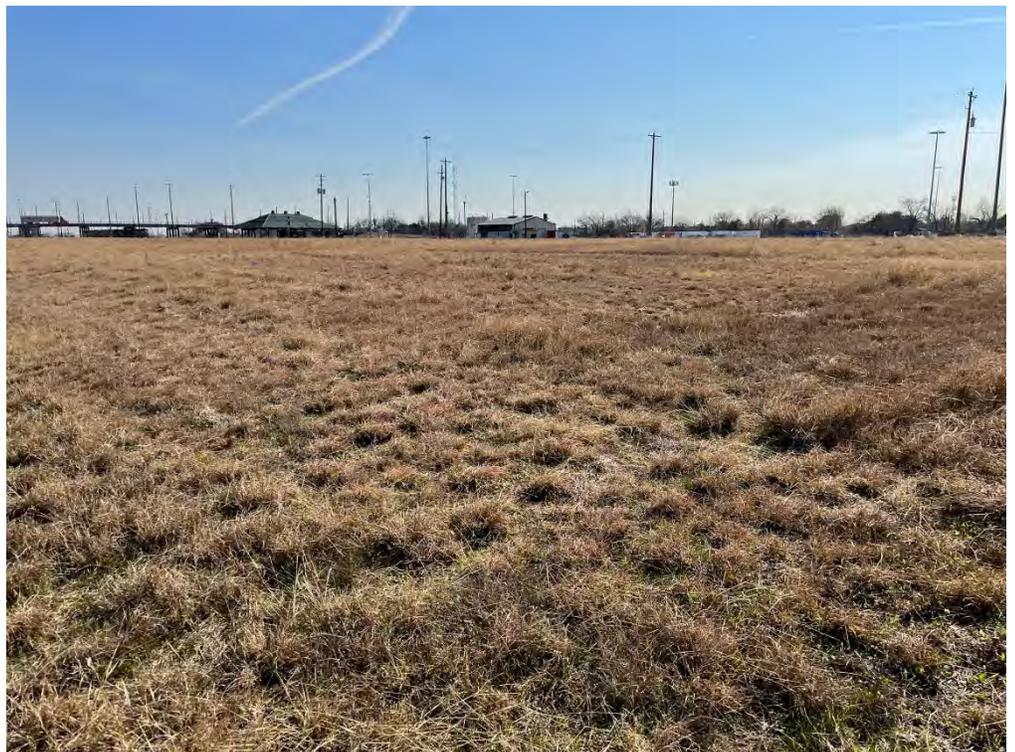
**Photo No.**  
**2**

Vegetative growth can be observed along the length of the soil cap, preventing future erosion. Facing southeast.

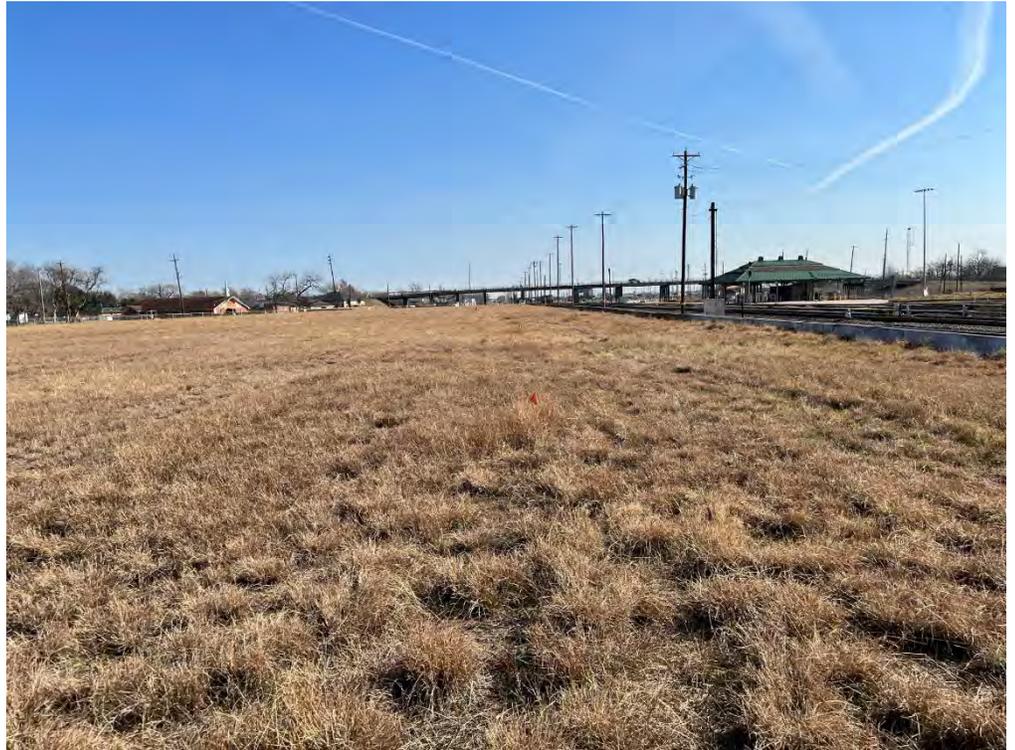
Soil cap well-vegetated in most areas with a low risk of erosion. Some areas of exposed soil noted. Facing east.

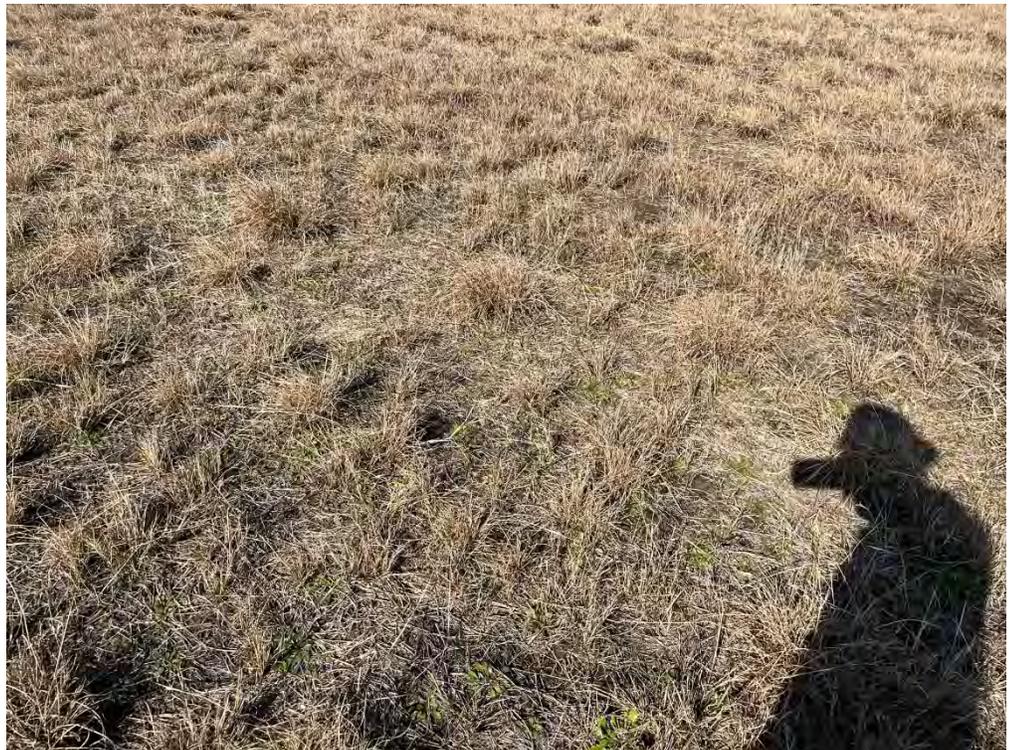
**Photo No.**  
**4**

Soil cap well-vegetated in most areas with a low risk of erosion. Some minor bald patches and exposed soil noted. Vegetation is mostly dormant. Facing east.

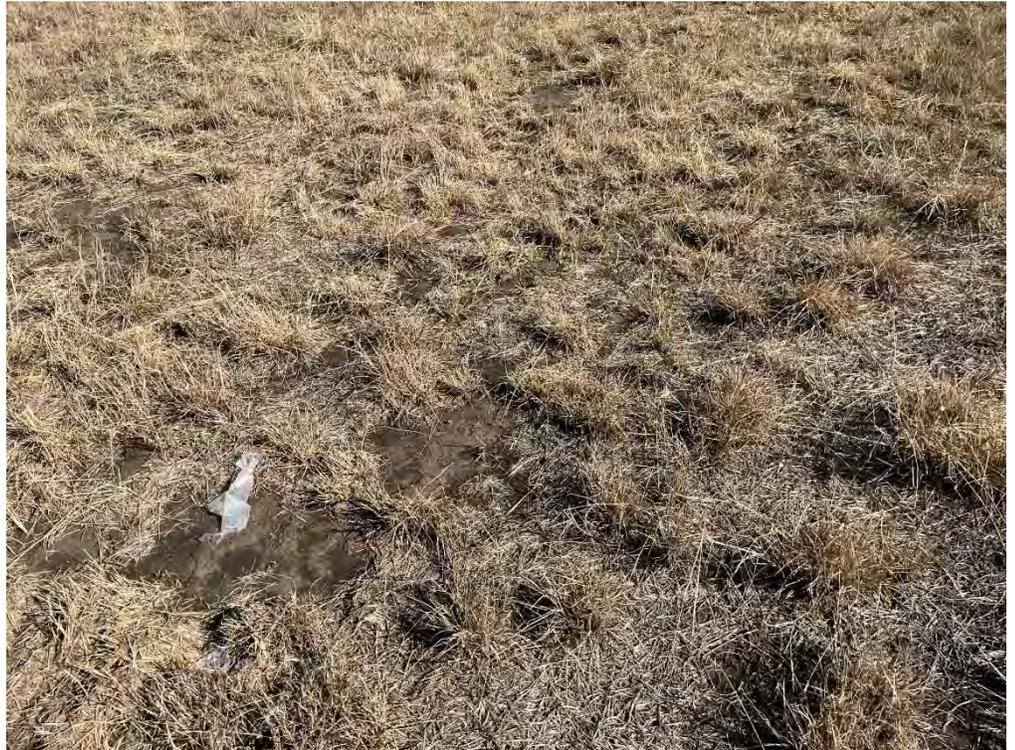
Soil cap well-vegetated in most areas with a low risk of erosion. Some minor bald patches and exposed soil noted. Vegetation is mostly dormant. Facing northeast.

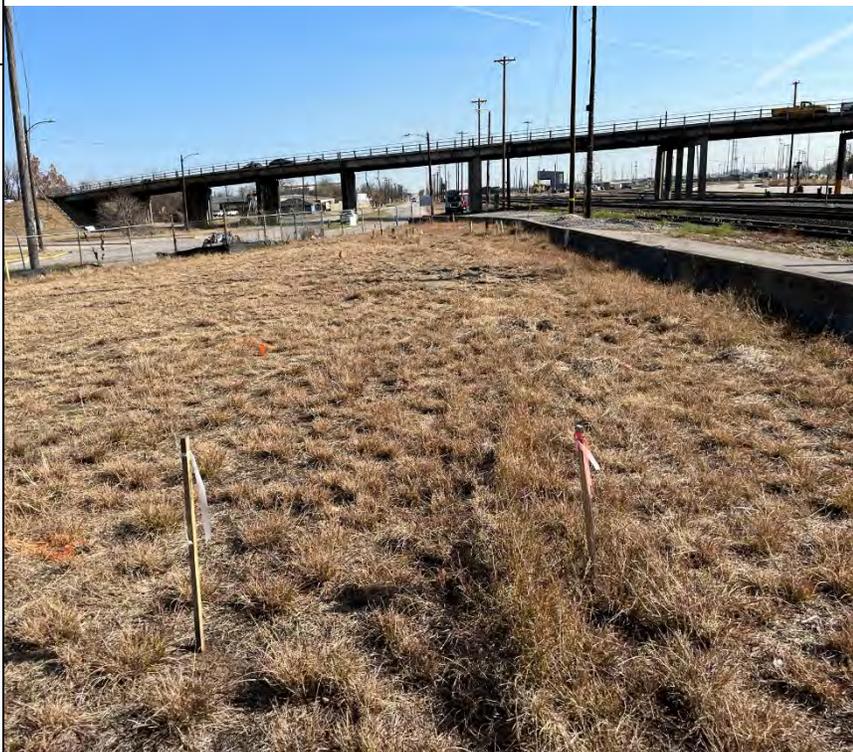
**Photo No.**  
**6**

Soil cap well-vegetated in most areas with a low risk of erosion. Facing east.

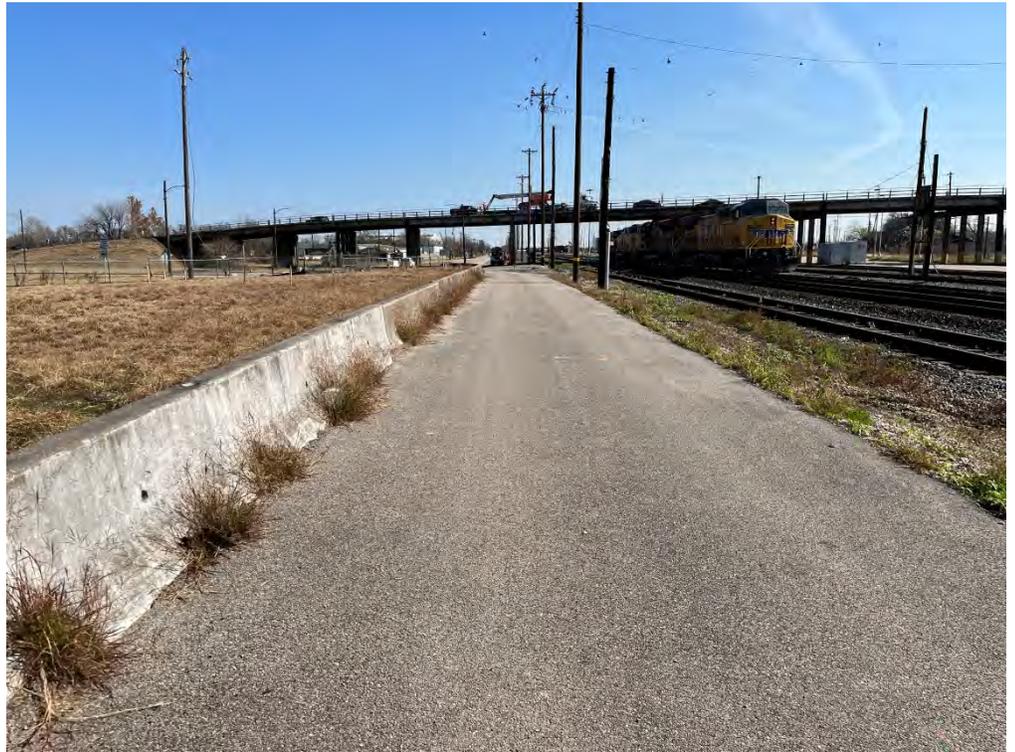
Asphalt roadway in good condition, free of major cracking/damage. Some vegetation can be noted growing within the ballast cap and under the concrete barriers. Facing east.

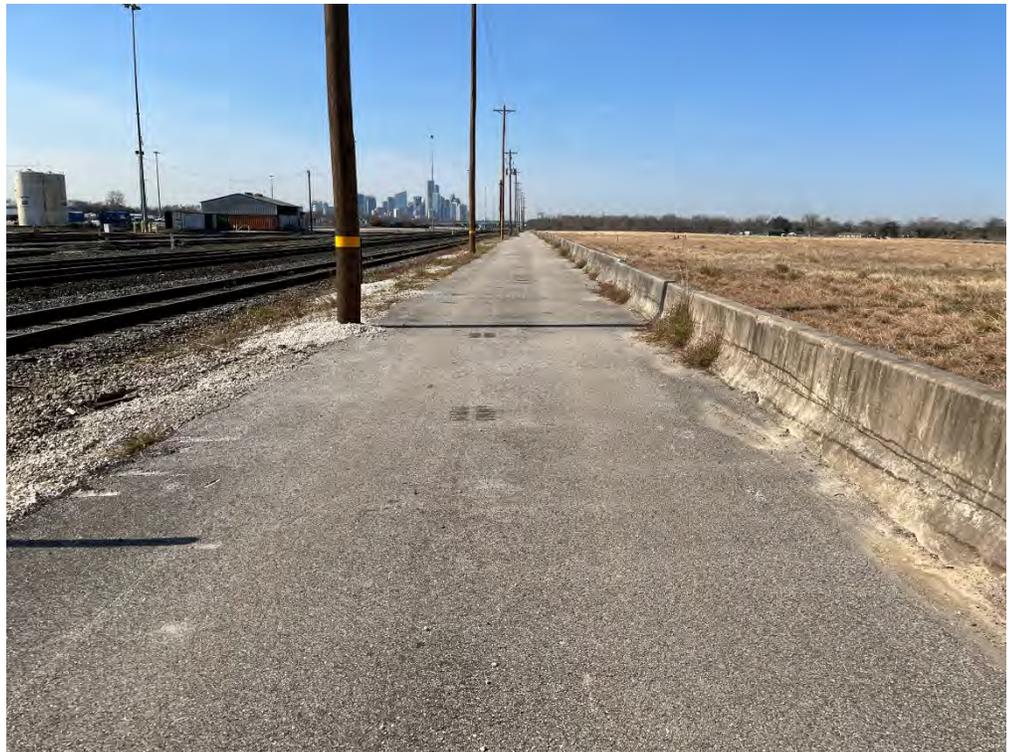
**Photo No.**  
**8**

Asphalt roadway in good condition, free of major cracking/damage. Some vegetation can be noted growing within the ballast cap and under the concrete barriers. Facing west.

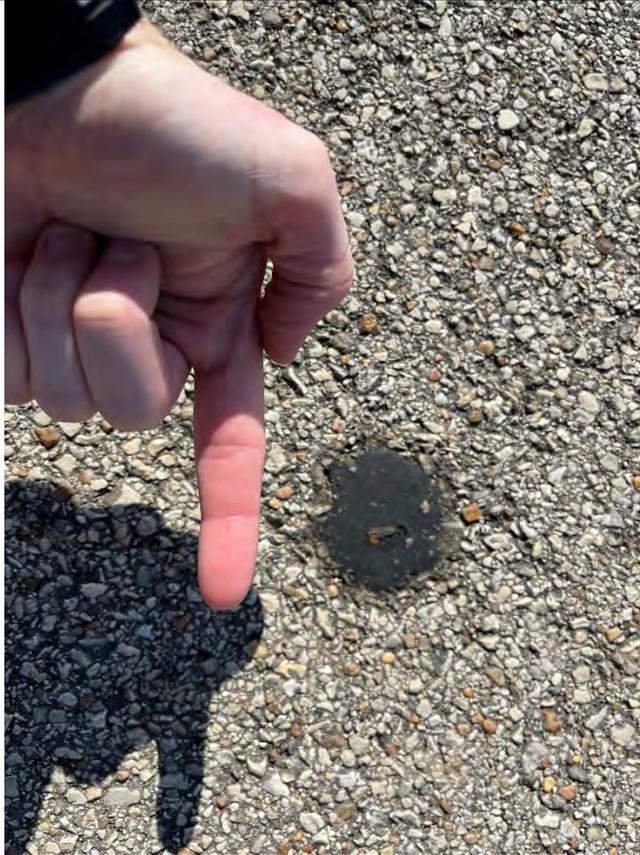
Asphalt roadway in good condition, free of major cracking/damage. Tar-like marks on road do not appear to have changed in size (approximately 2 inches wide). Facing northwest.

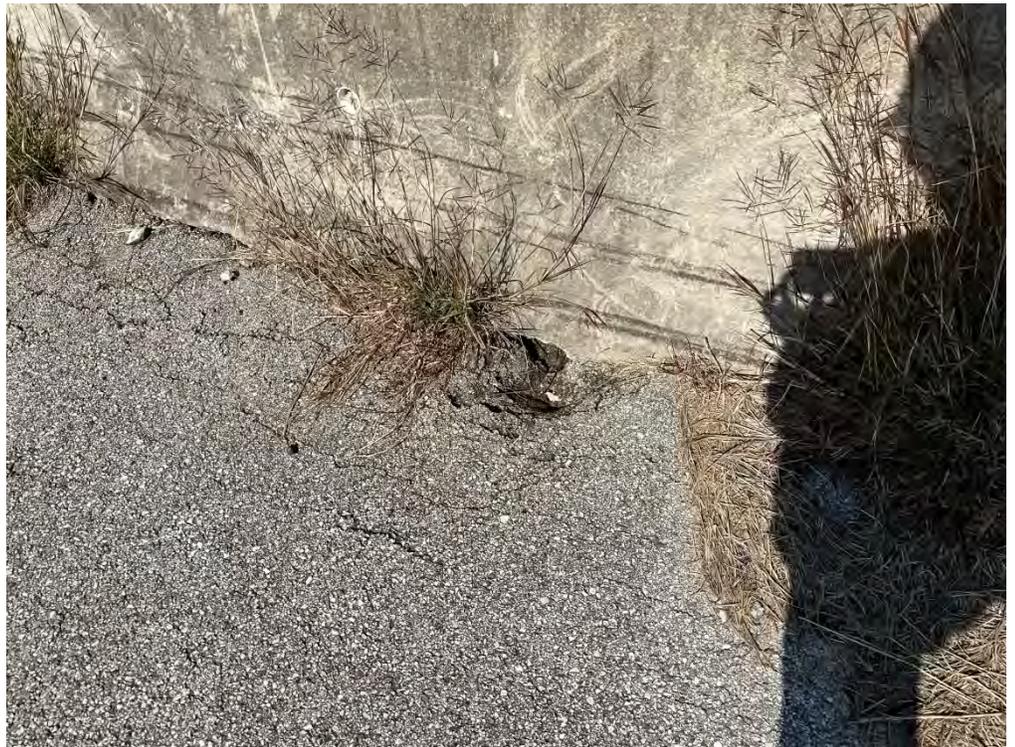
**Photo No.**  
**10**

Small area of erosion under concrete barriers on the north side of asphalt road.

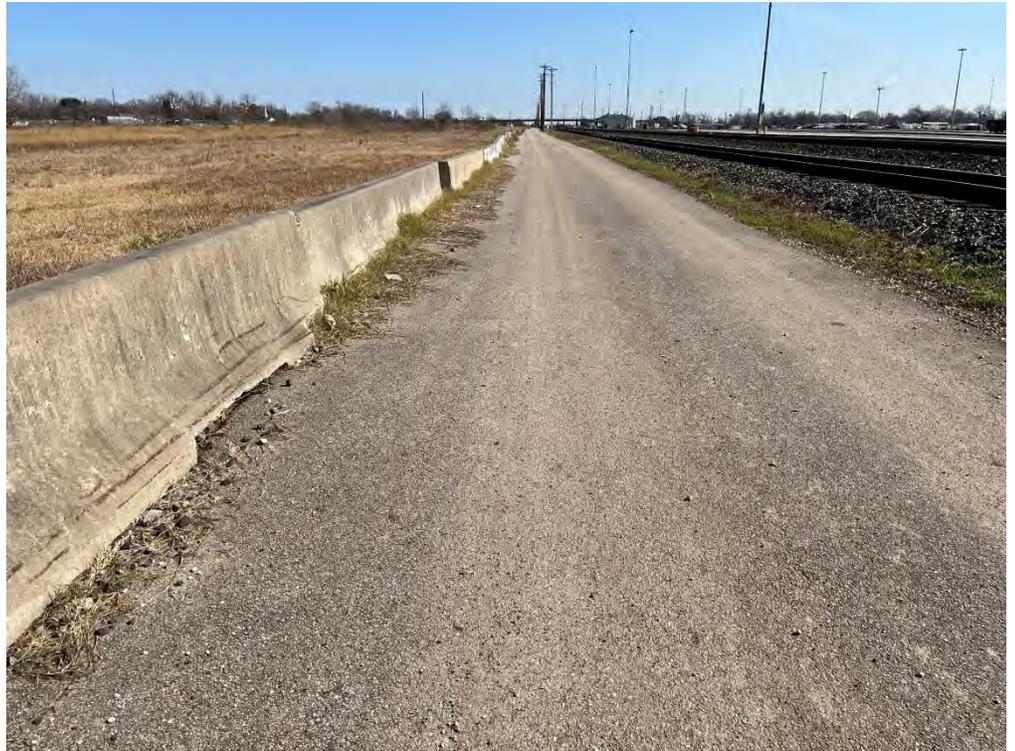
Asphalt roadway in good condition, free of major cracking/damage. Some vegetation can be noted growing within the ballast cap and under the concrete barriers. Facing east.

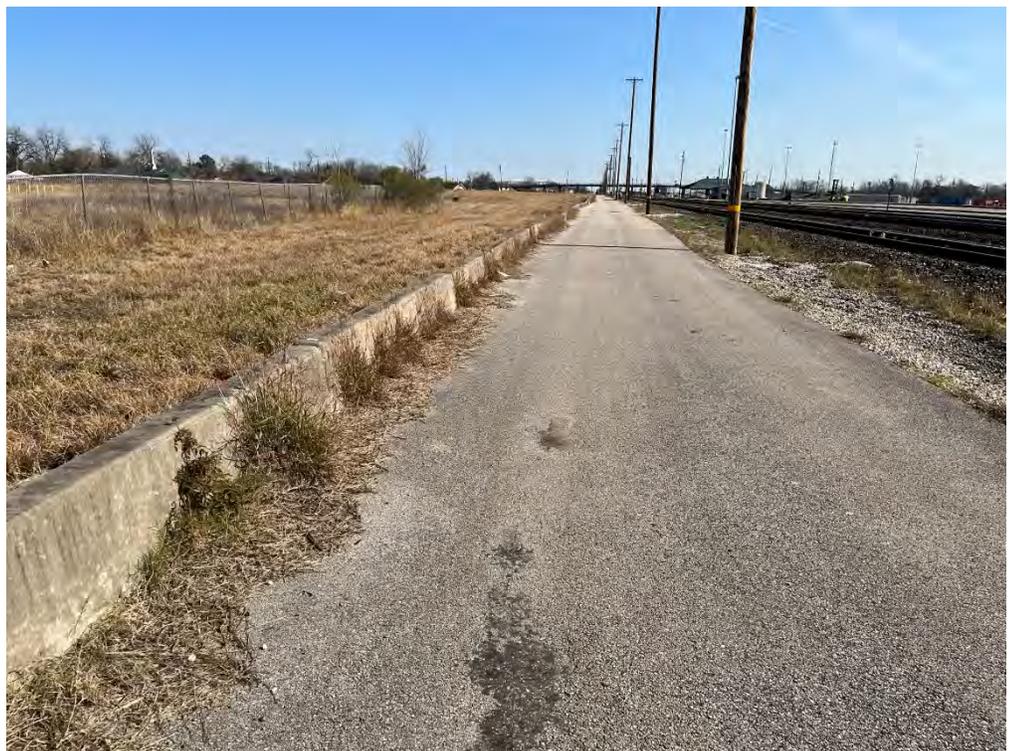
**Photo No.**  
**12**

Weeds and vegetation can be observed growing under the concrete barriers. Some anthills can be seen on the edge of the concrete barriers. Tar-like marks do not appear to have changed in size Facing east.

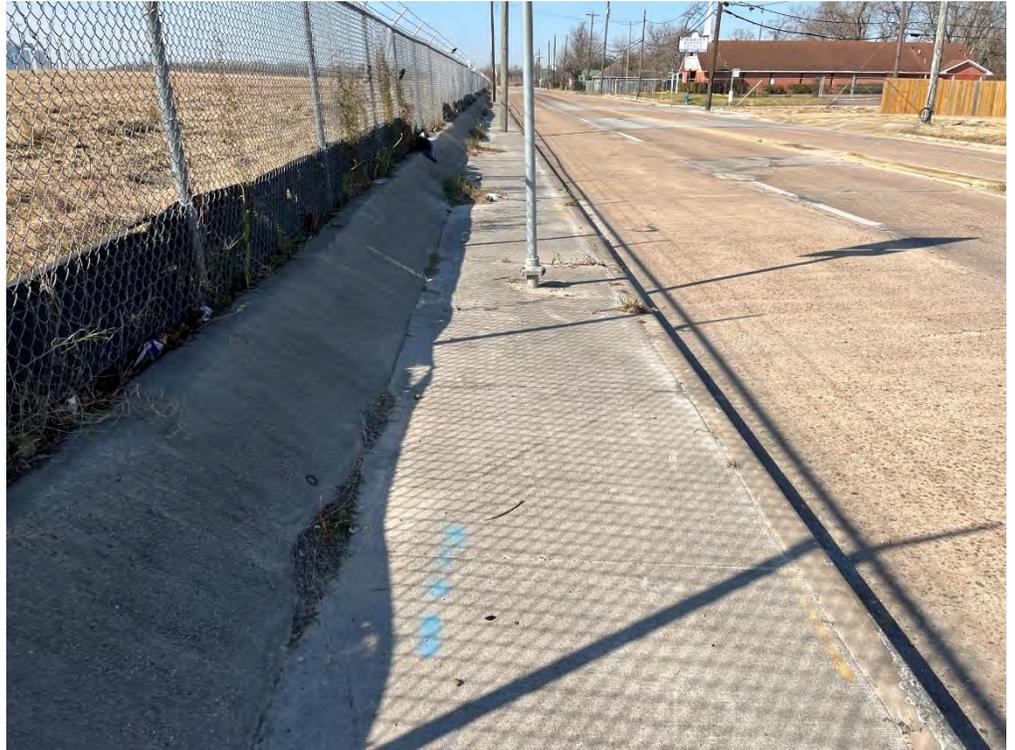
Sidewalk outside security fence in good condition. Some areas have minor vegetative growth. Minor damage and erosion under the security fence observed at the end of the sidewalk. Facing west.

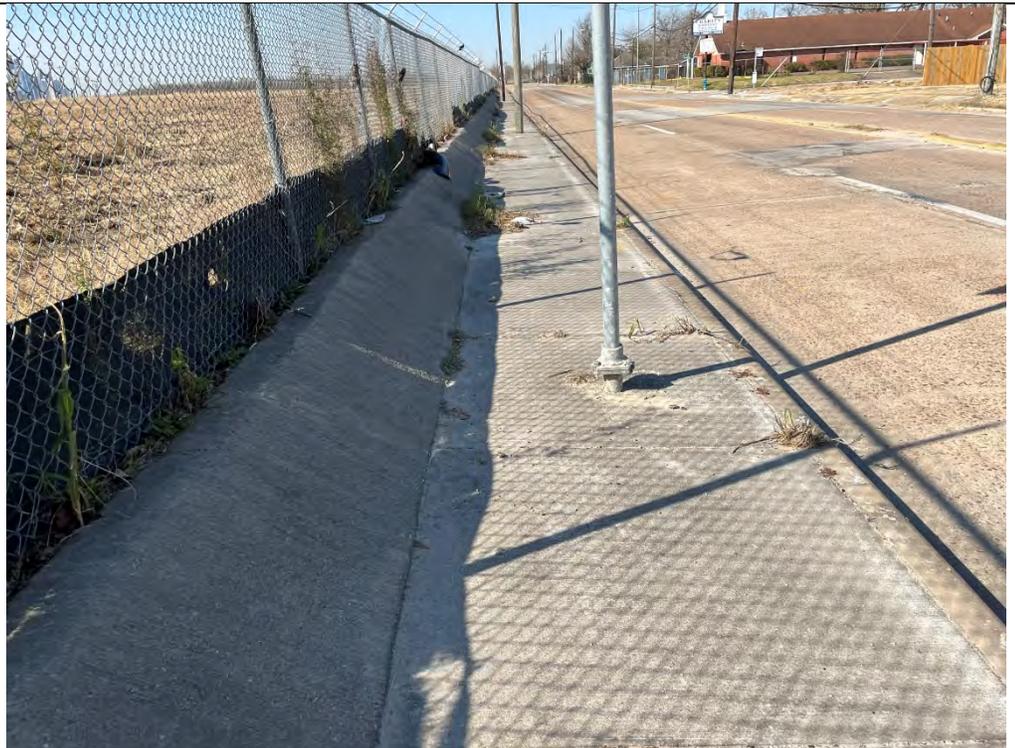
**Photo No.**  
**14**

Sidewalk outside security fence in good condition. Some areas of minor vegetative growth. Facing west.

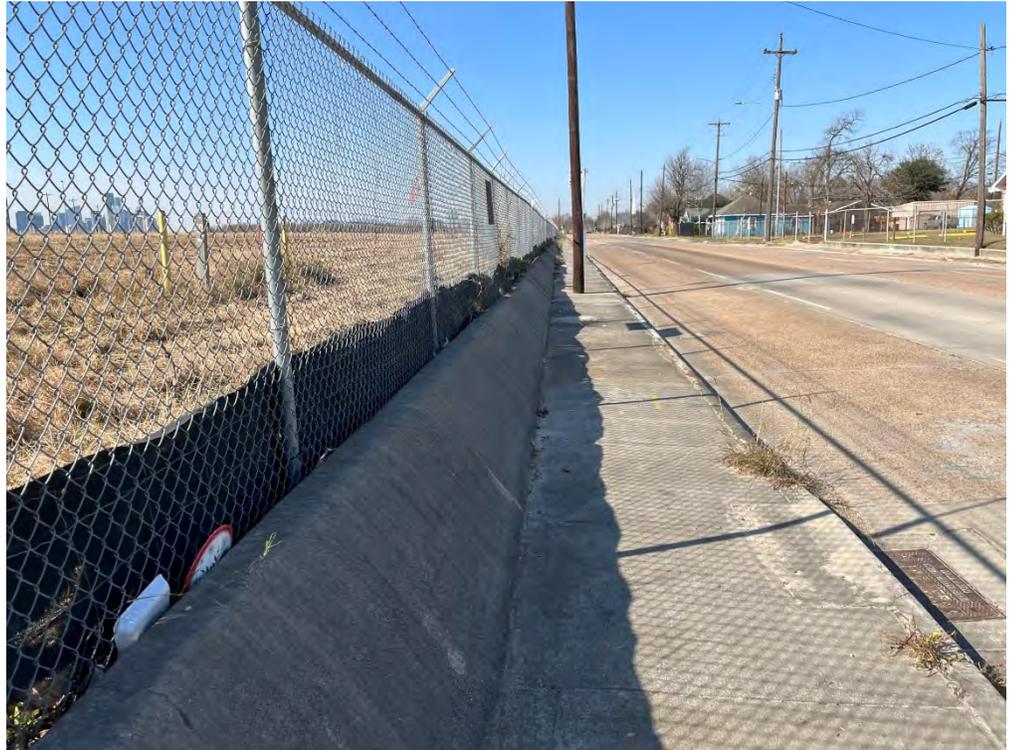
Sidewalk outside security fence in good condition. Some areas of minor vegetative growth. Facing west.

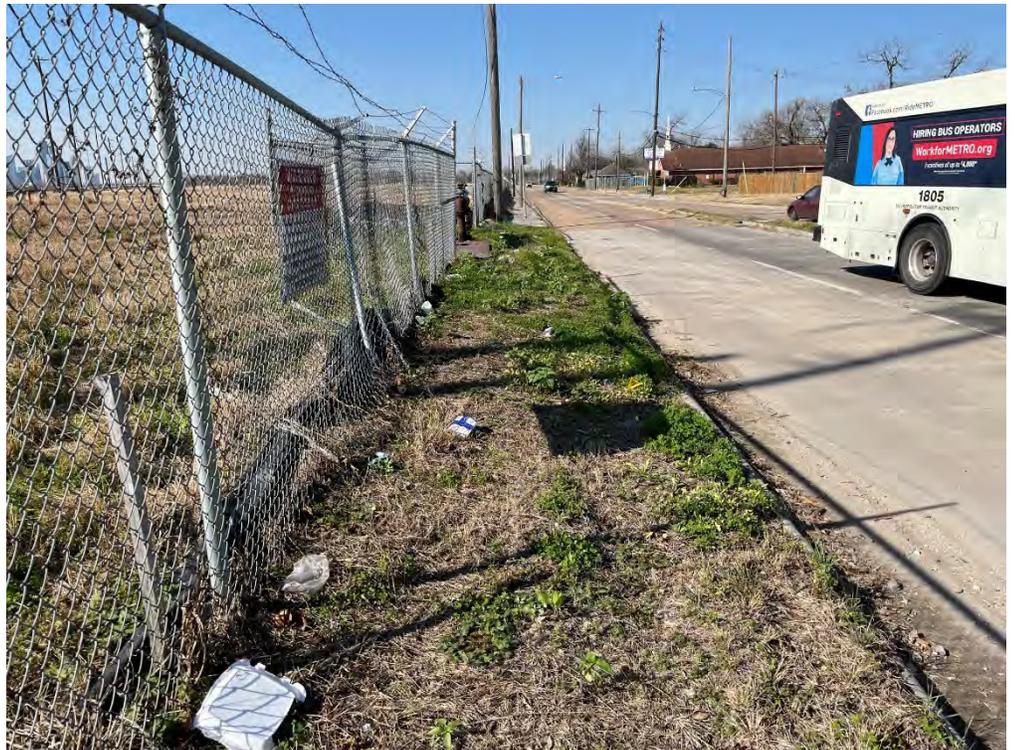
**Photo No.**  
**16**

Sidewalk area outside security fence in good condition. Some garbage and debris can be observed in sidewalk area. Facing west.

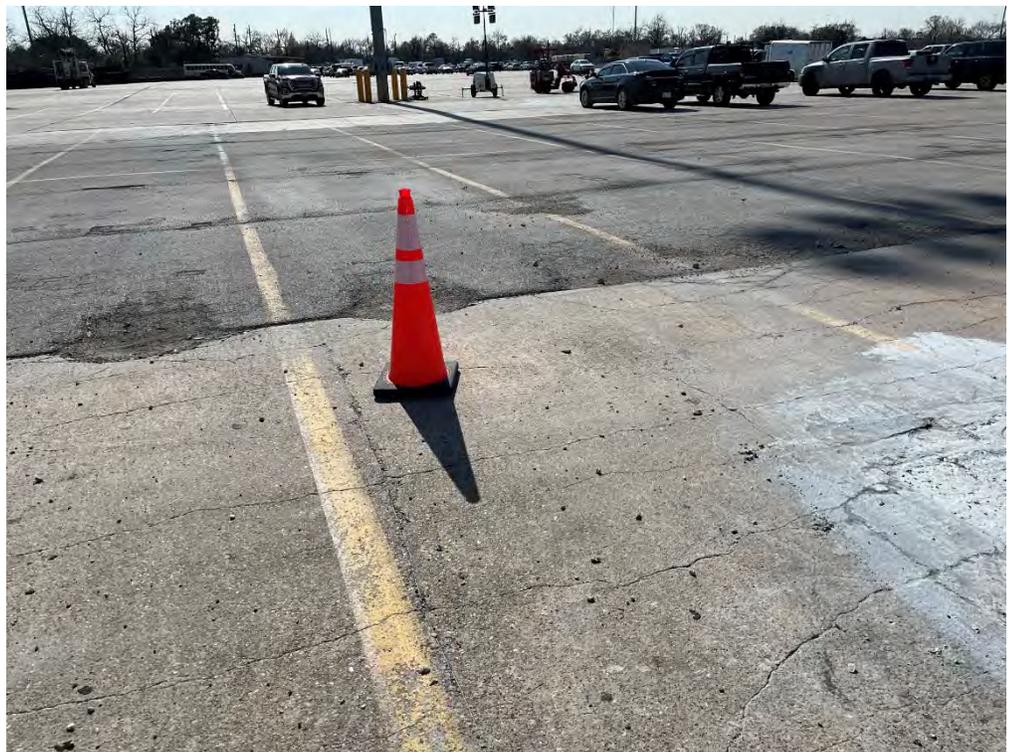
Stall A012. Evidence of cracking evident in multiple spots (particularly along the edge) in A and B rows. Facing southeast.

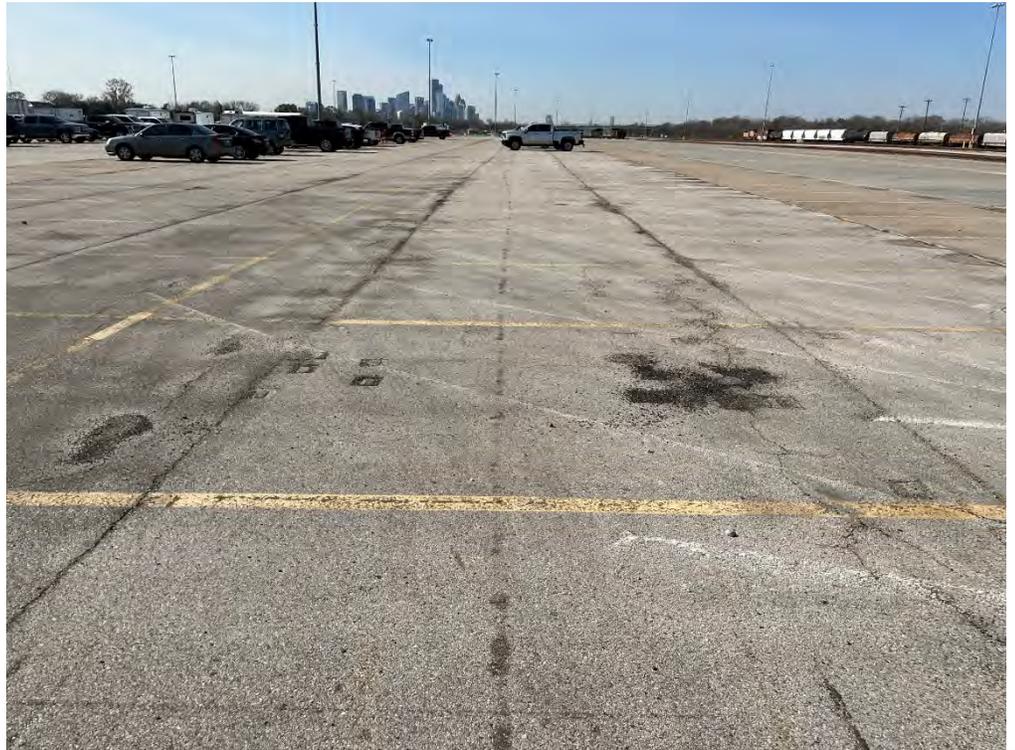
**Description:**  
**Concrete Cap Area**  
**(Englewood Yard):**  
A096 stall. Localized brown staining along asphalt cracks and joints. Facing west.

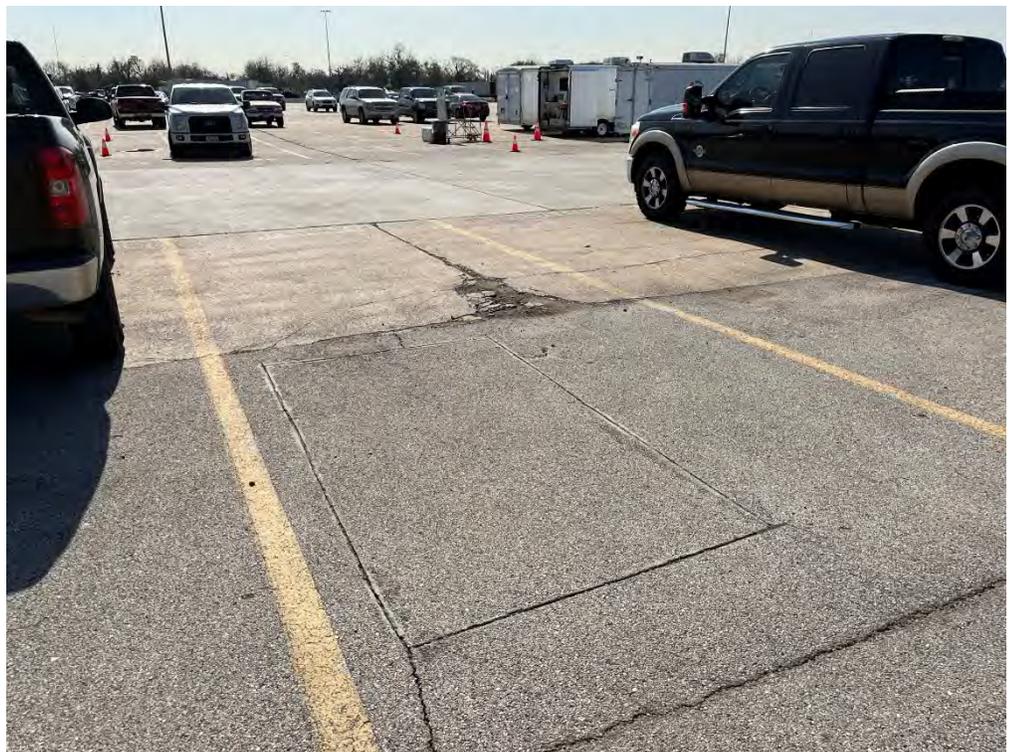
**Photo No.**  
**20**

**Description:**  
**Concrete Cap Area**  
**(Englewood Yard):**  
Some cracking in concrete along joints near stall B054.

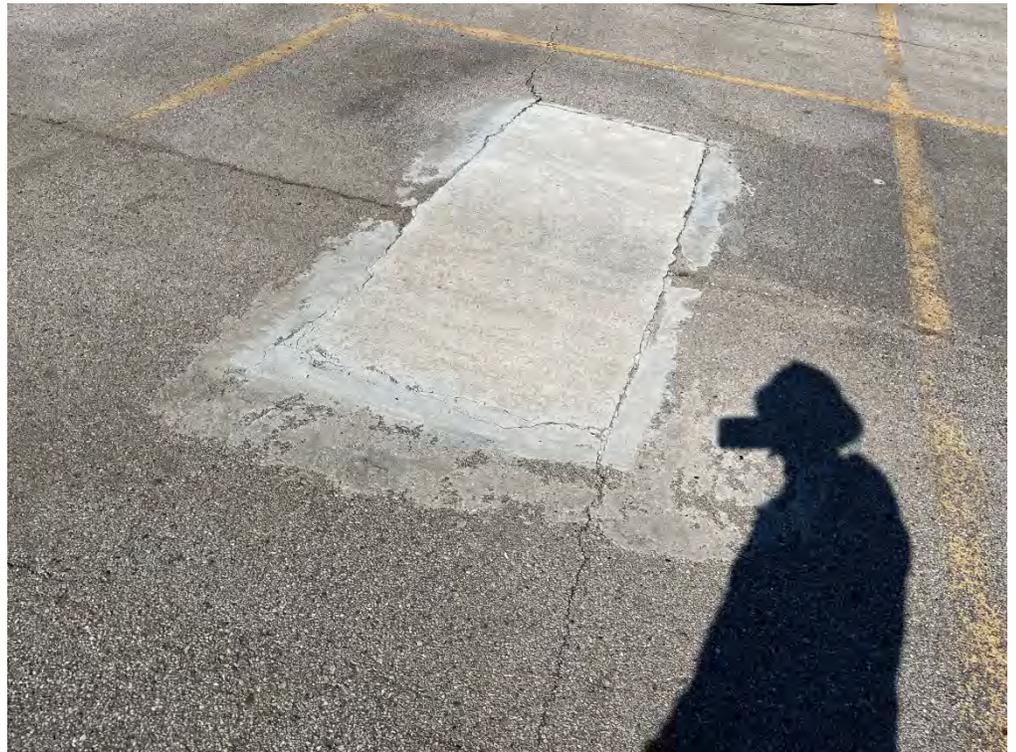
B096 Stall. Pavement patch showing signs of minor cracking from previous quarter repair.

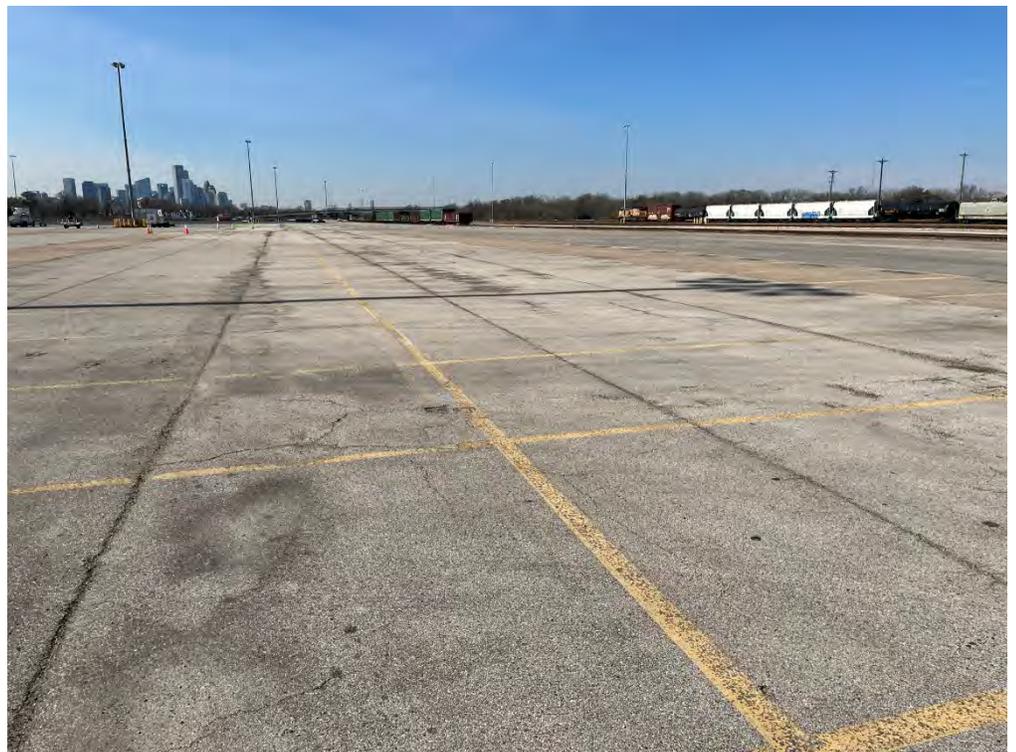
**Photo No.**  
**22**

A and B Rows showing general signs of minor cracking and staining.

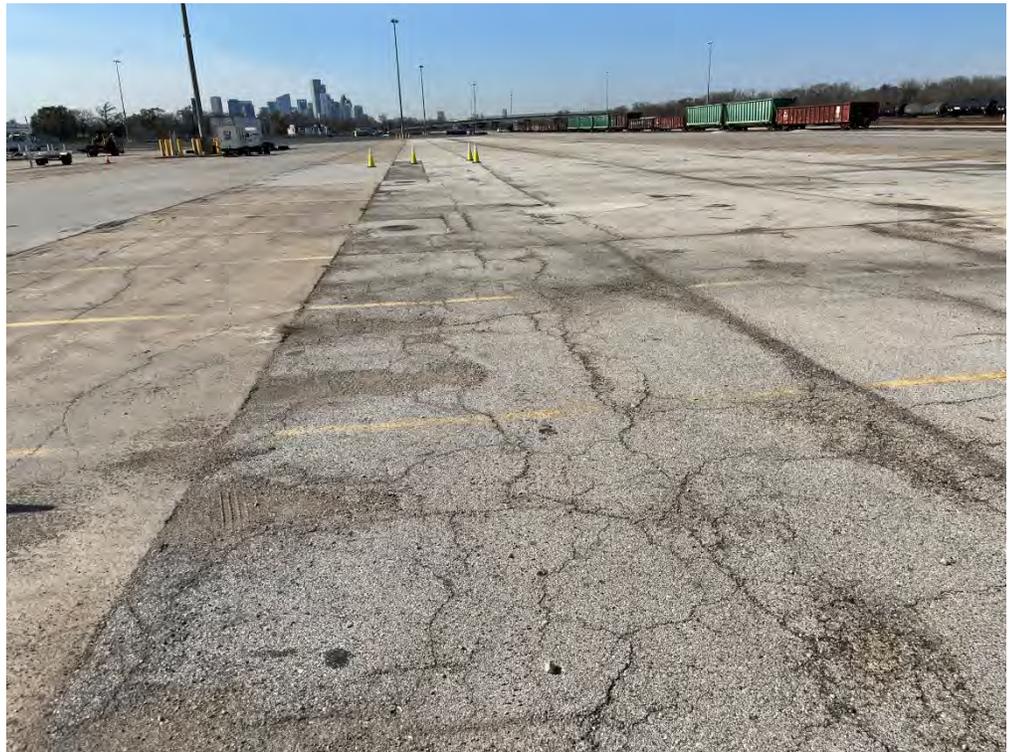
NAPL Collection System in stalls B099-B110 in good condition with little evidence of cracking, stains, etc. Facing west.

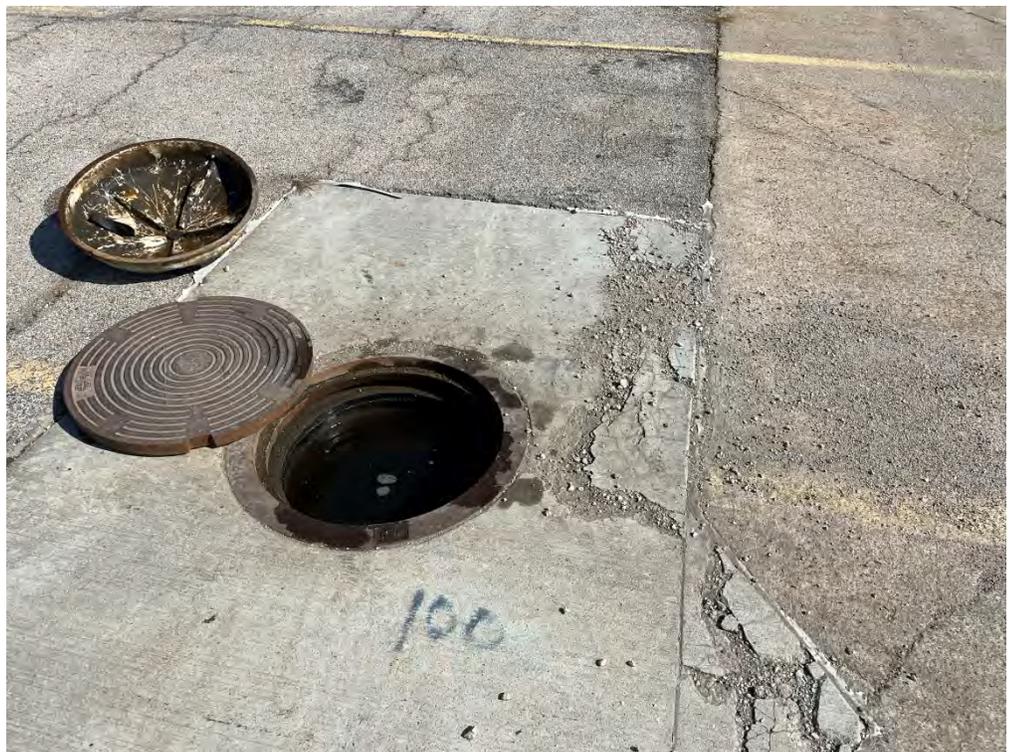
**Photo No.**  
**24**

Sump B099/B100. Sump has 3 inches of freeboard. This sump has historically exhibited higher water levels and has not produced any DNAPL. Water is brown in color, but no odor or sheen observed.

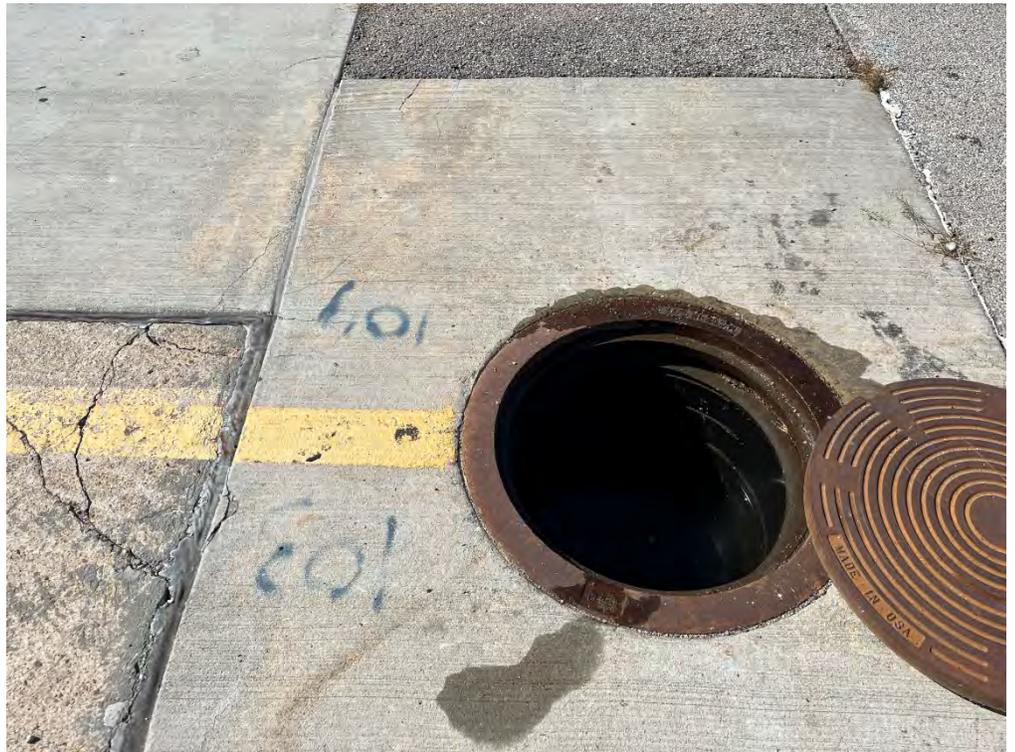
Sump B103/B104. Sump has 9 inches of freeboard. This sump has historically not produced any DNAPL. Water is brown in color, but no odor or sheen observed.

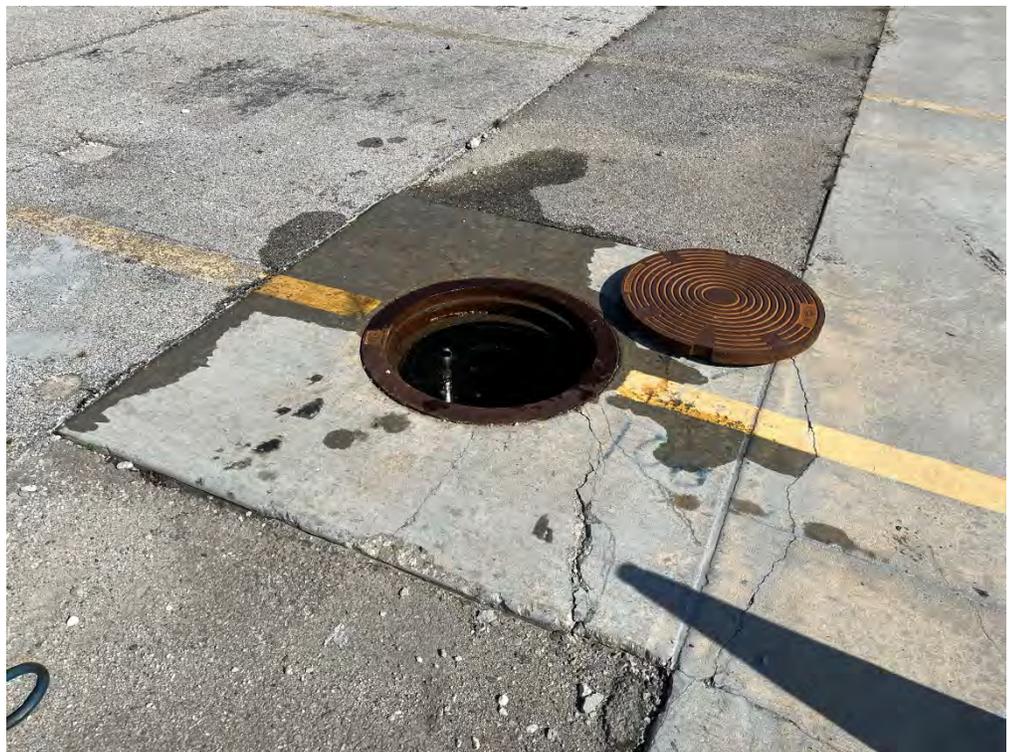
**Photo No.**  
**26**

Sump B107/B108. Sump has 9 inches of freeboard. This sump has occasionally produced small quantities of DNAPL, which is removed weekly if observed. Water is brown in color, but no odor or sheen observed. Water surrounding manhole is rainwater accumulated during recent rainfall in sump cap.

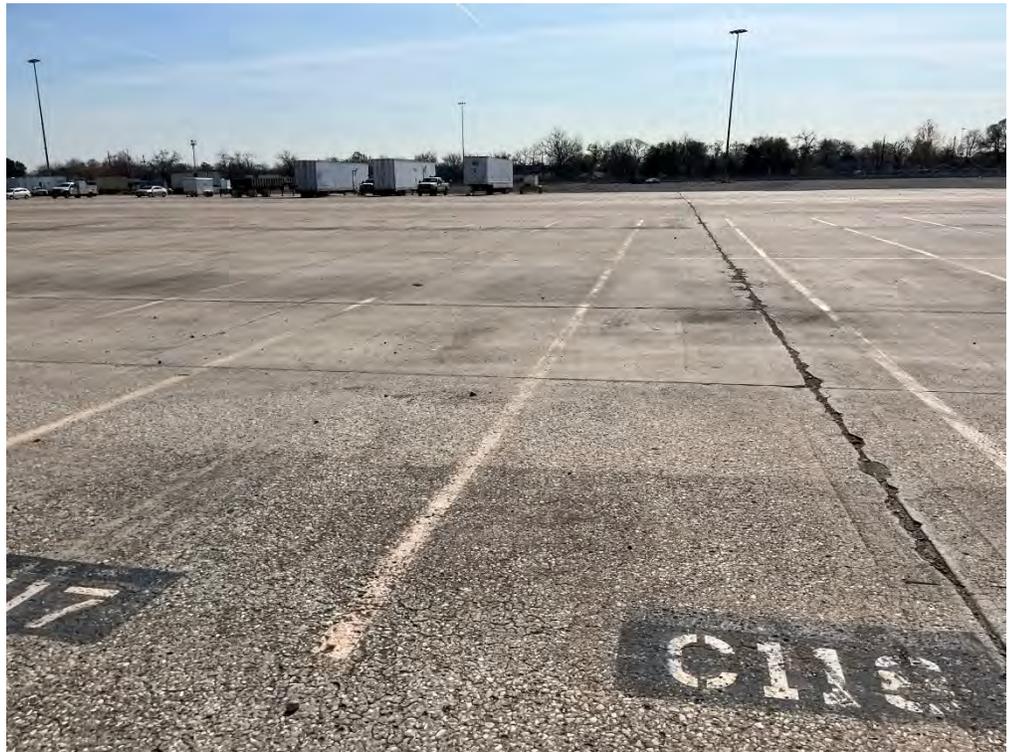
Concrete cap within yard in good condition. Some cracking evident, particularly on edges of rows, with minimal vegetative growth. Facing northeast.

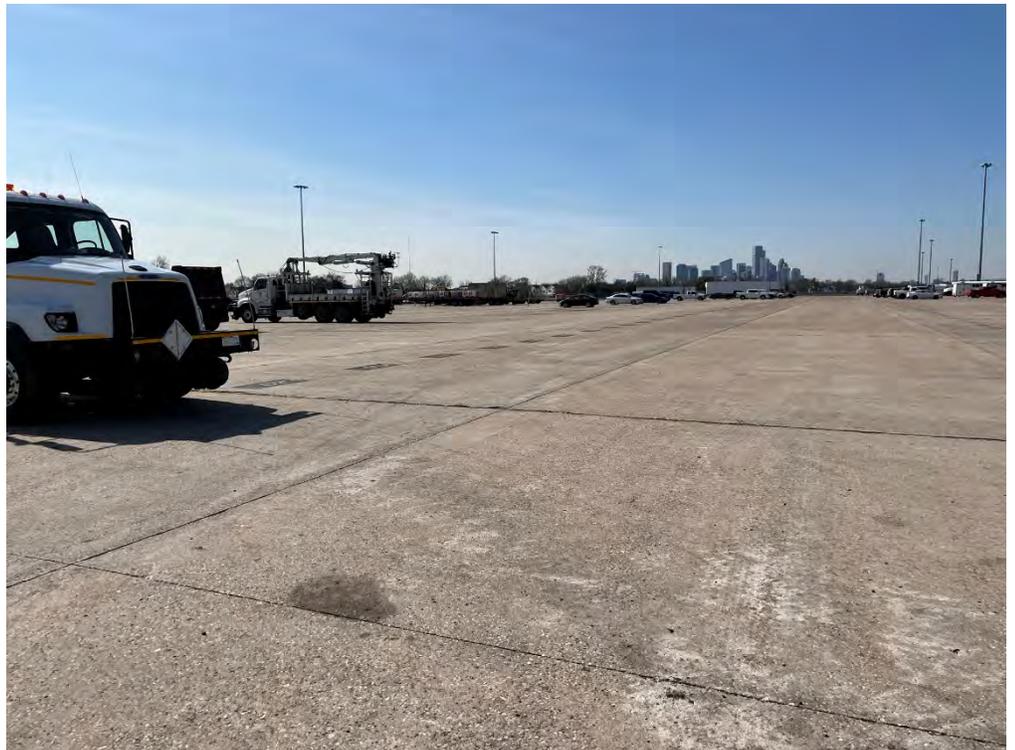
**Photo No.**  
**28**

Concrete cap within yard in good condition. Some cracking evident, particularly on edges of rows, with minimal vegetative growth. Facing southwest.

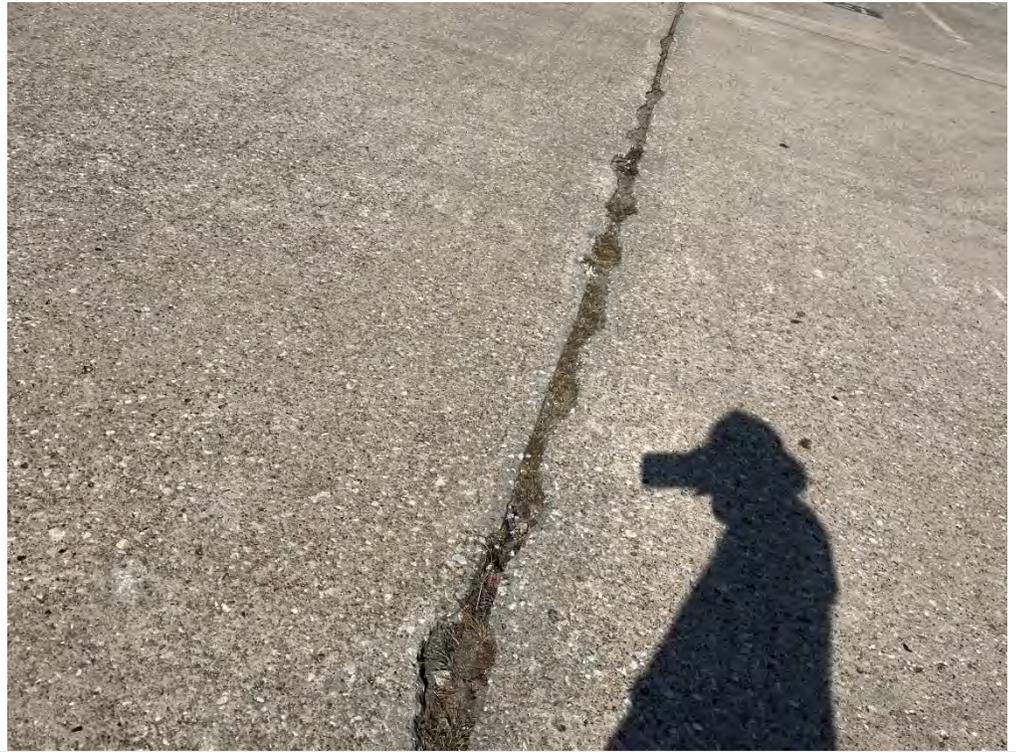
Small gaps in concrete joints, photo representative of locations in C and D rows expressing such separation ranging between 1 and 2 inches.

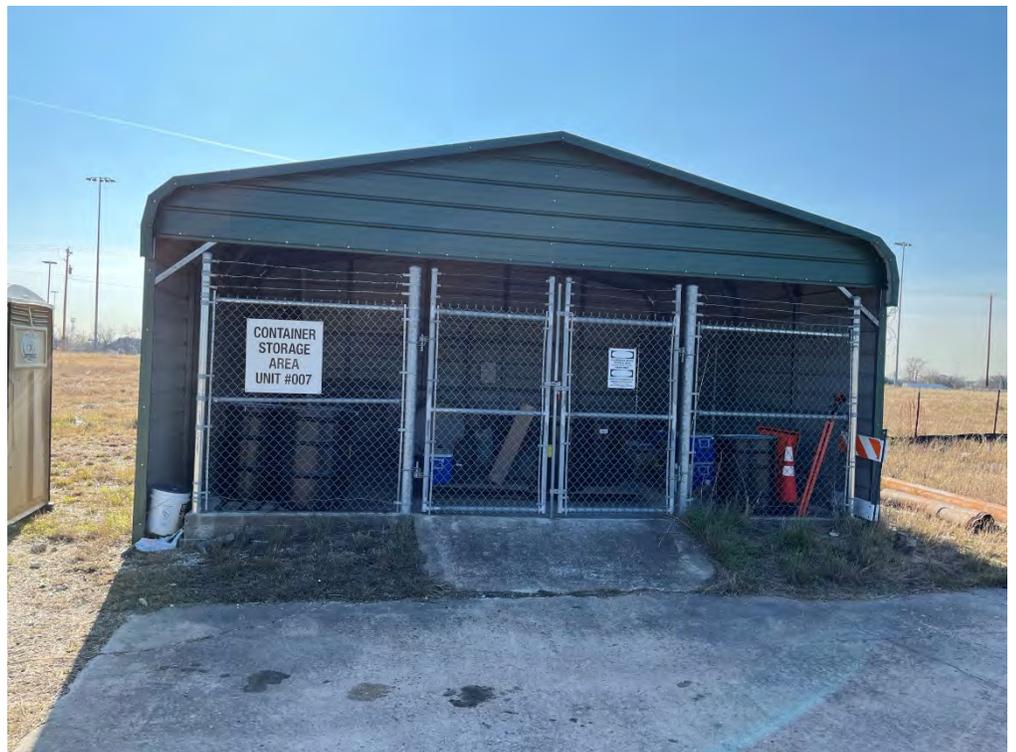
**Photo No.**  
**30**

Valve in closed position and functioning within the container storage area. CSA in good condition, free of major dents and other damage. No water observed on floor. Facing south.
