**RE: POST-RESPONSE ACTION COMPLETION REPORT – 2022  
UNION PACIFIC RAILROAD HOUSTON WOOD PRESERVING WORKS, HOUSTON, TEXAS  
4910 LIBERTY ROAD, HOUSTON, HARRIS COUNTY, TEXAS  
TCEQ SWR NO. 31547; TCEQ PERMIT/COMPLIANCE PLAN NO. 50343 EPA ID NO. TXD000820266  
CUSTOMER NO. CN600131098; REGULATED ENTITY NO. RN100674613**

# TEXAS COMMISSION ON ENVIRONMENTAL QUALITY Post-Response Action Care Report (PRACR)

**SECOND QUARTER 2022 (APRIL 27<sup>th</sup>) INSPECTION RECORD AND PHOTOGRAPHIC LOG**

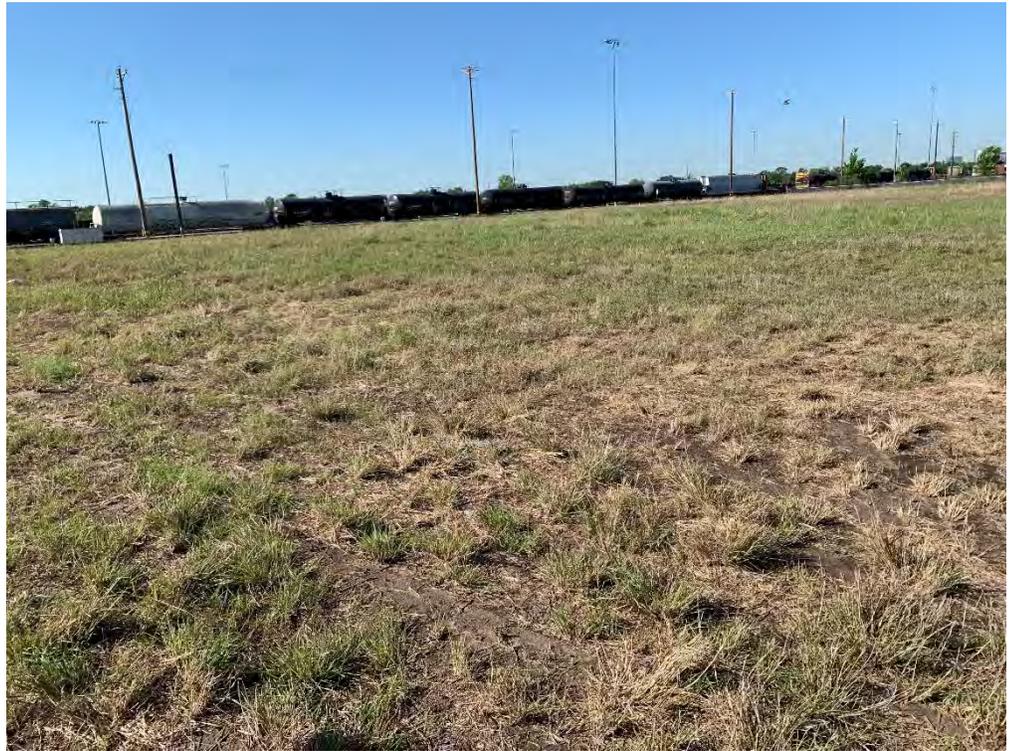
Soil cap well-vegetated in most areas with a low risk of erosion. No major rills observed during inspection. Facing south.

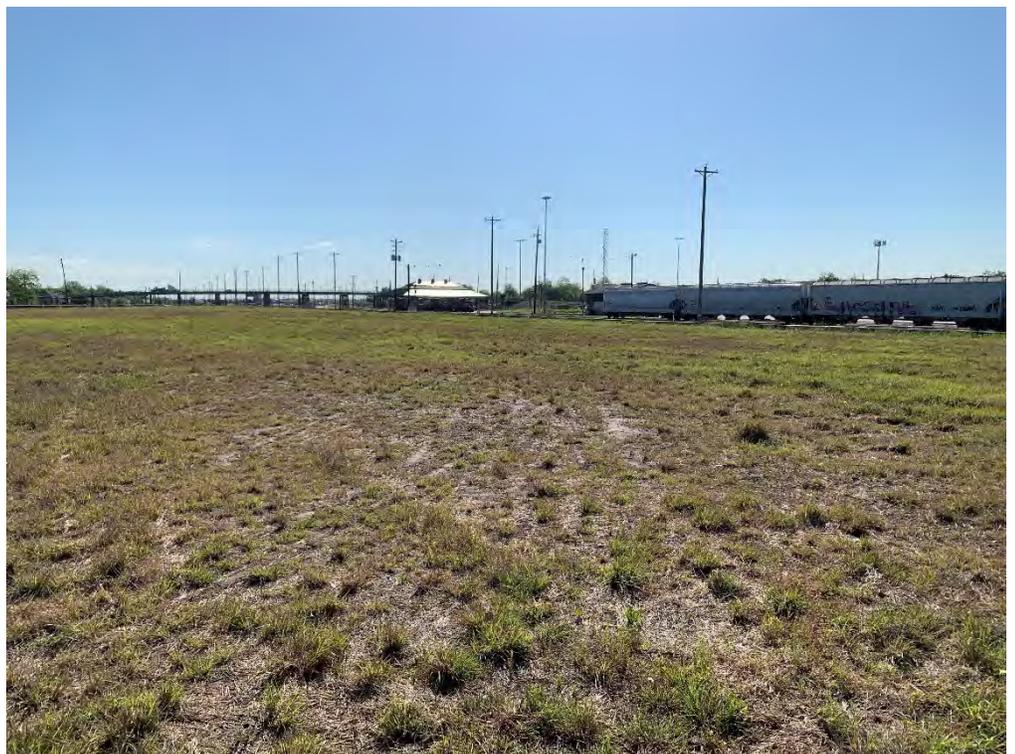
**Photo No.**  
**2**

Vegetative growth can be observed along the length of the soil cap, some bald spots observed. Facing southeast.

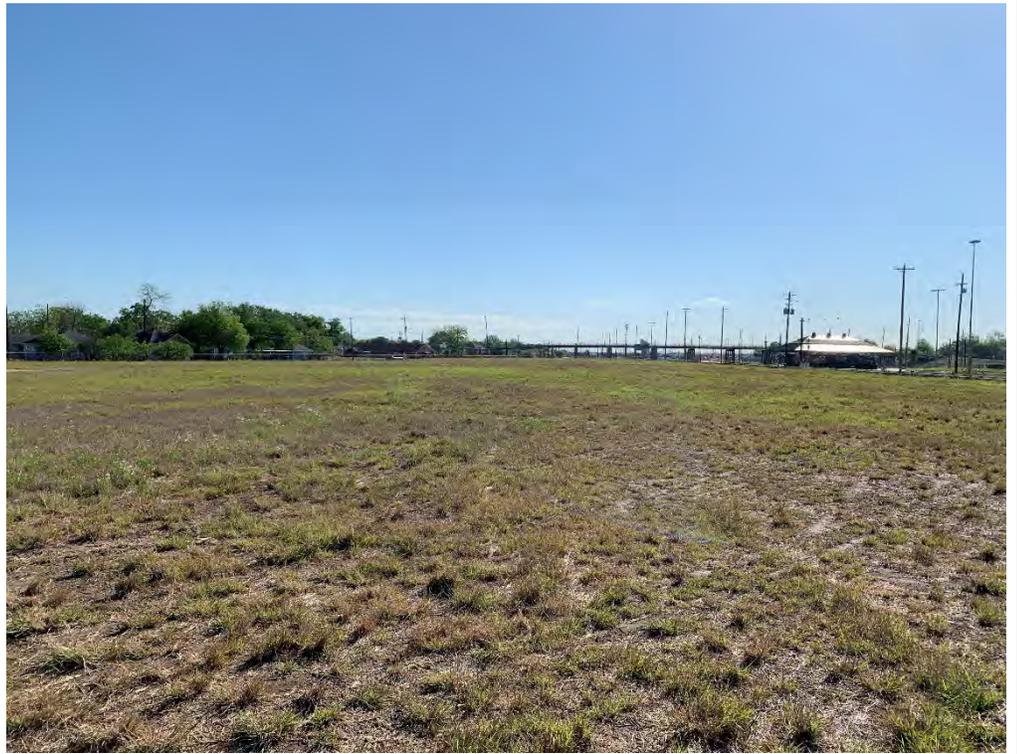
<b>Photo No.</b> 3	<b>Date:</b> 04/27/2022
<b>Description:</b>  <b><u>HWPW Yard Area and Soil Cap:</u></b> Soil cap well-vegetated in most areas with a low risk of erosion. Some areas of exposed soil noted. Facing east.  Lat: 29.786411 Long: -95.320214

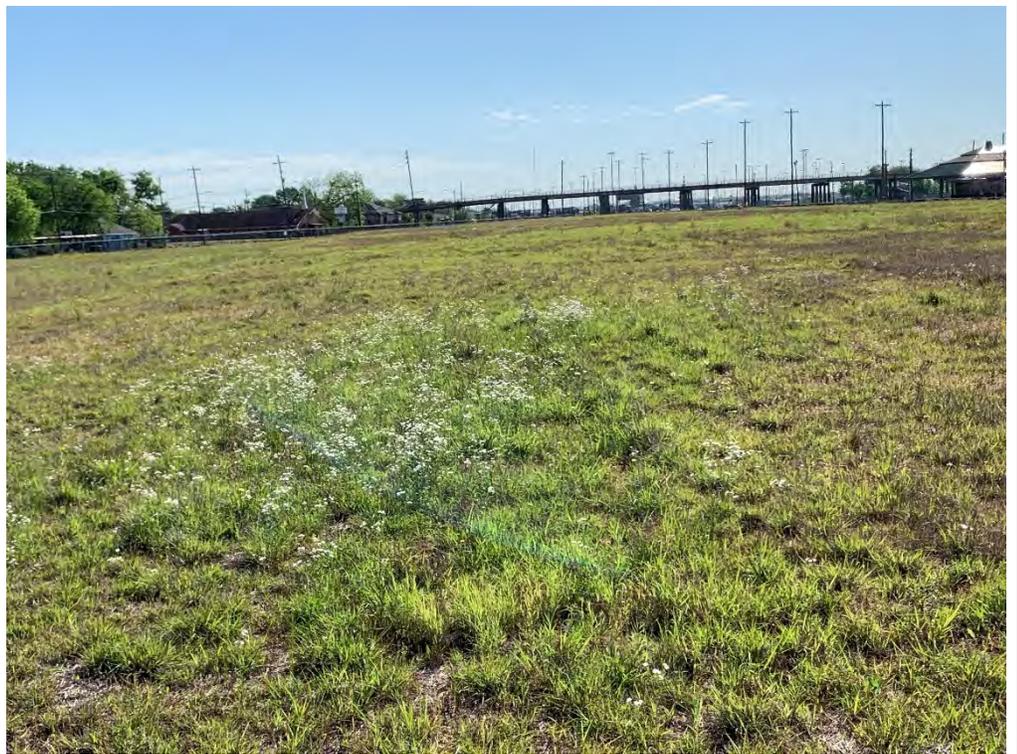
<b>Photo No.</b> 4	<b>Date:</b> 04/27/2022
<b>Description:</b>  <b><u>HWPW Yard Area and Soil Cap:</u></b> Soil cap well-vegetated in most areas with a low risk of erosion.. Facing east.  Lat: 29.786564 Long: -95.320350

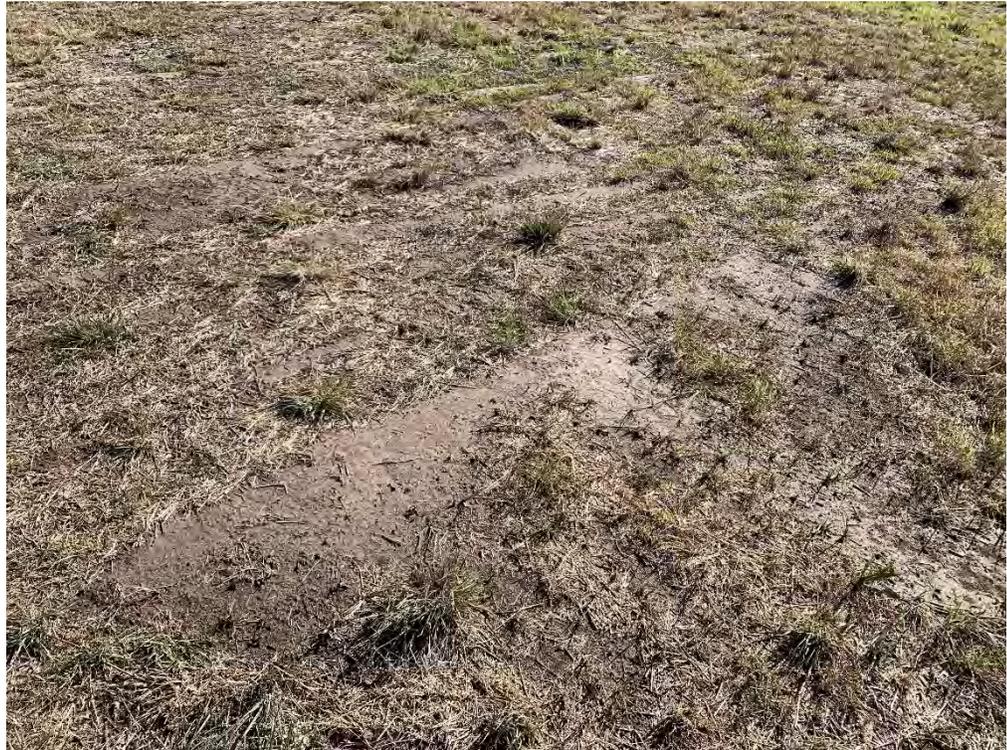
<b>Photo No.</b> 5	<b>Date:</b> 04/27/2022

<b>Description:</b>  <b><u>HWPW Yard Area and Soil Cap:</u></b> Soil cap well-vegetated in most areas with new growth observed and a low risk of erosion. Some minor bald patches and exposed soil noted.  Lat: 29.786383 Long: -95.320122

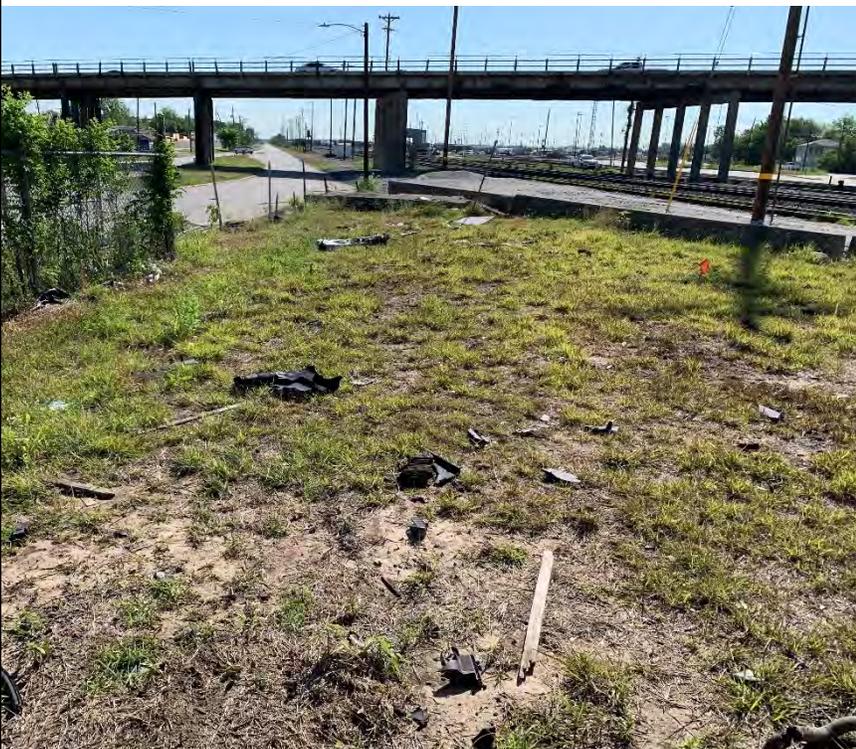
<b>Photo No.</b> 6	<b>Date:</b> 04/27/2022

<b>Description:</b>  <b><u>HWPW Yard Area and Soil Cap:</u></b> Soil cap well-vegetated in most areas with new growth observed and a low risk of erosion. Some minor bald patches and exposed soil noted. Fence and barrier damaged from a car wreck. Car parts observed near wreck location. Facing east.  Lat: 29.787594 Long: -95.316681

**Additional Comments or Observations:** Fence is good overall but, has damaged or no wire in some areas. Also there's one hole in the fence. Posts and wire are missing on the far end where car wreck occurred.

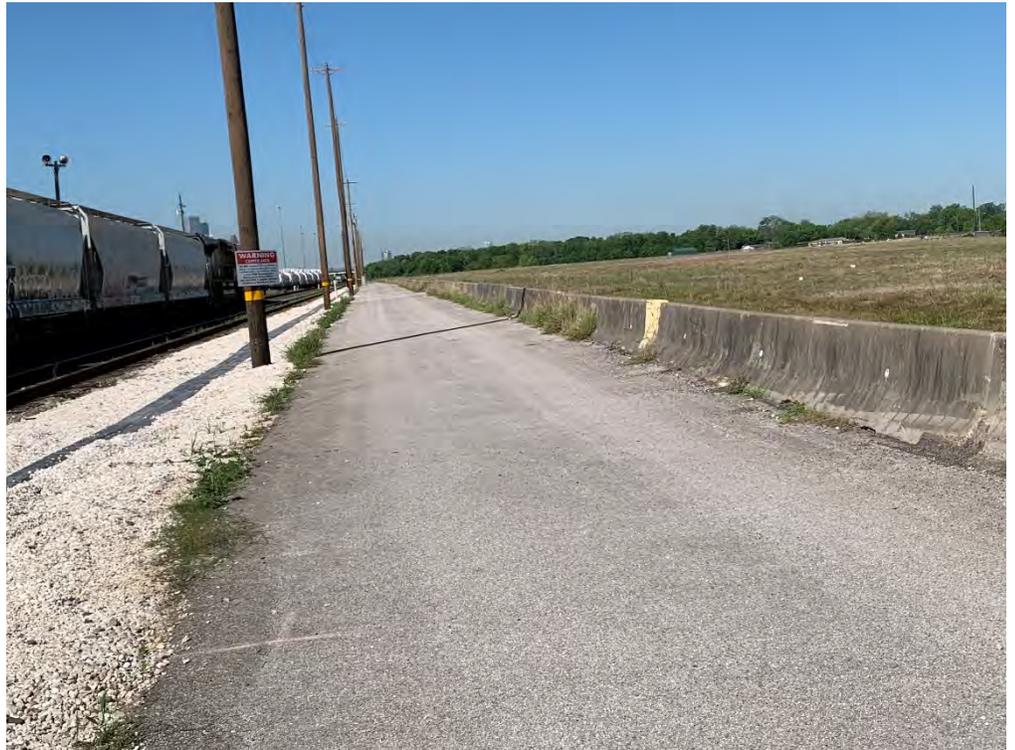
Asphalt roadway in good condition, free of major cracking/damage. Some vegetation can be noted growing within the ballast cap and under the concrete barriers. Facing west.

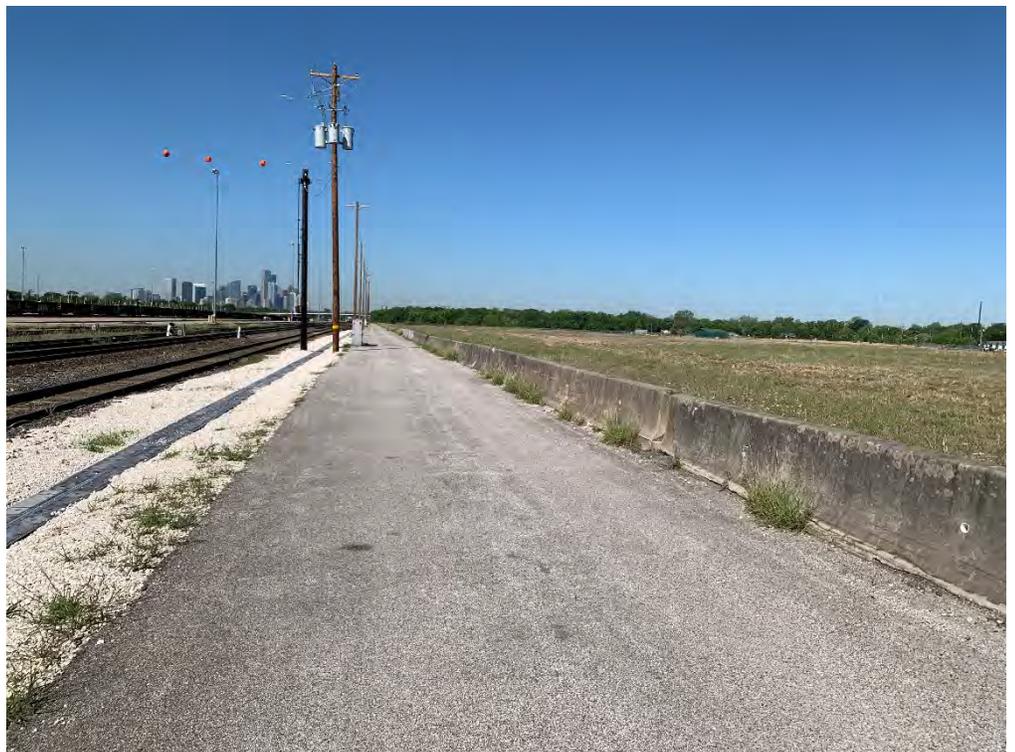
**Photo No.**  
8

Asphalt roadway in good condition, free of major cracking/damage. Some vegetation can be noted growing within the ballast cap and under the concrete barriers. Facing west.

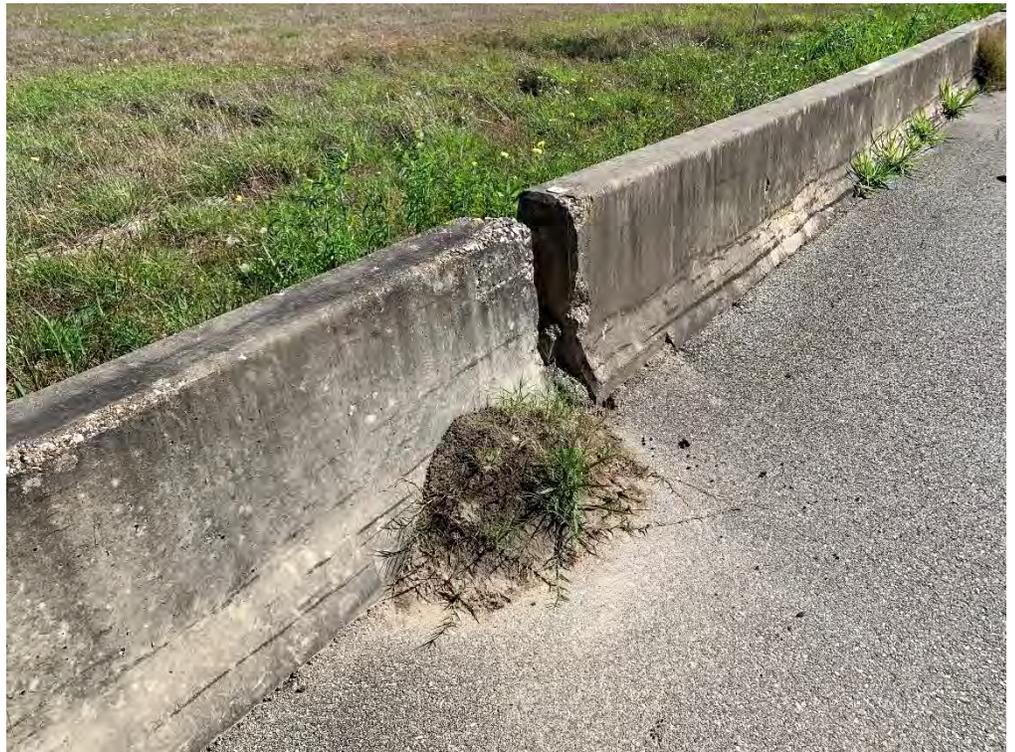
Asphalt roadway in good condition, free of major cracking/damage. Fire ant mound between concrete barrier and asphalt road. Facing southwest.

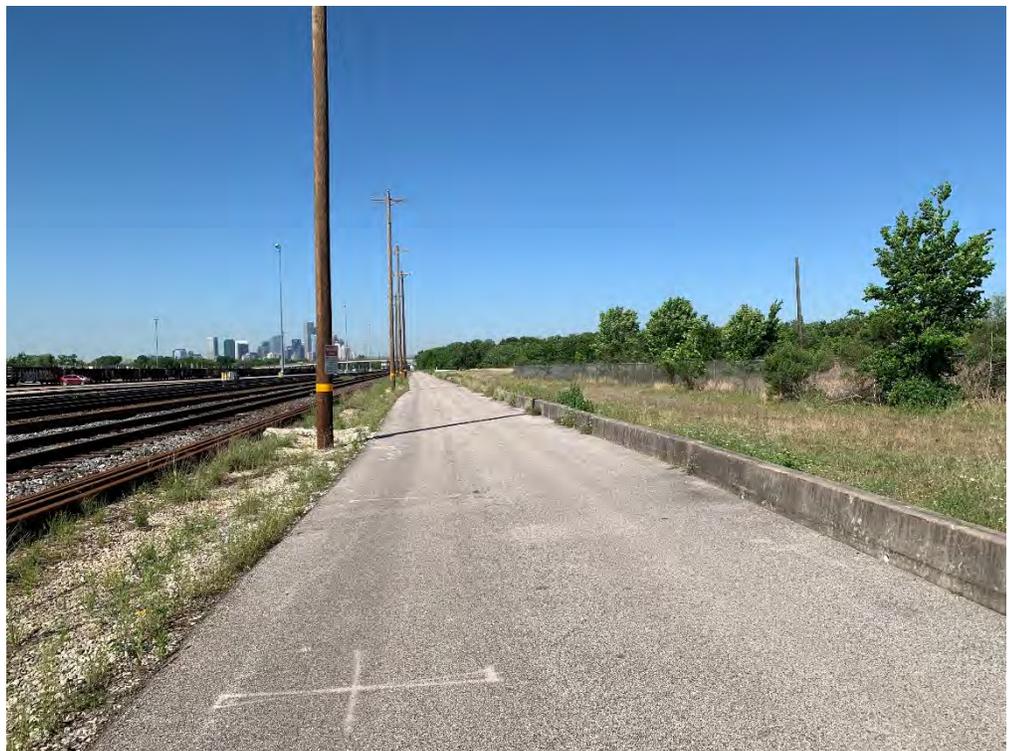
**Photo No.**  
10

Asphalt roadway in good condition, free of major cracking/damage. Some vegetation can be noted growing within the ballast cap and under the concrete barriers. Facing west.

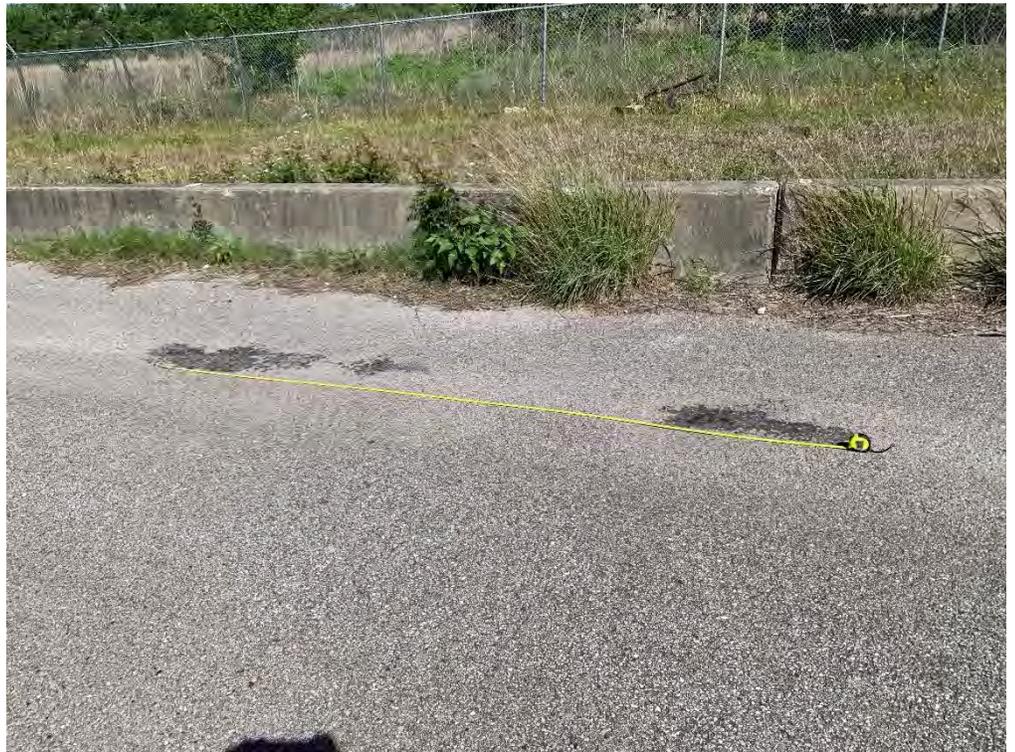
Asphalt roadway in good condition, free of major cracking/damage, tar-like marks on road do not appear to have changed in size. Some vegetation can be noted under the concrete barriers. Facing south.

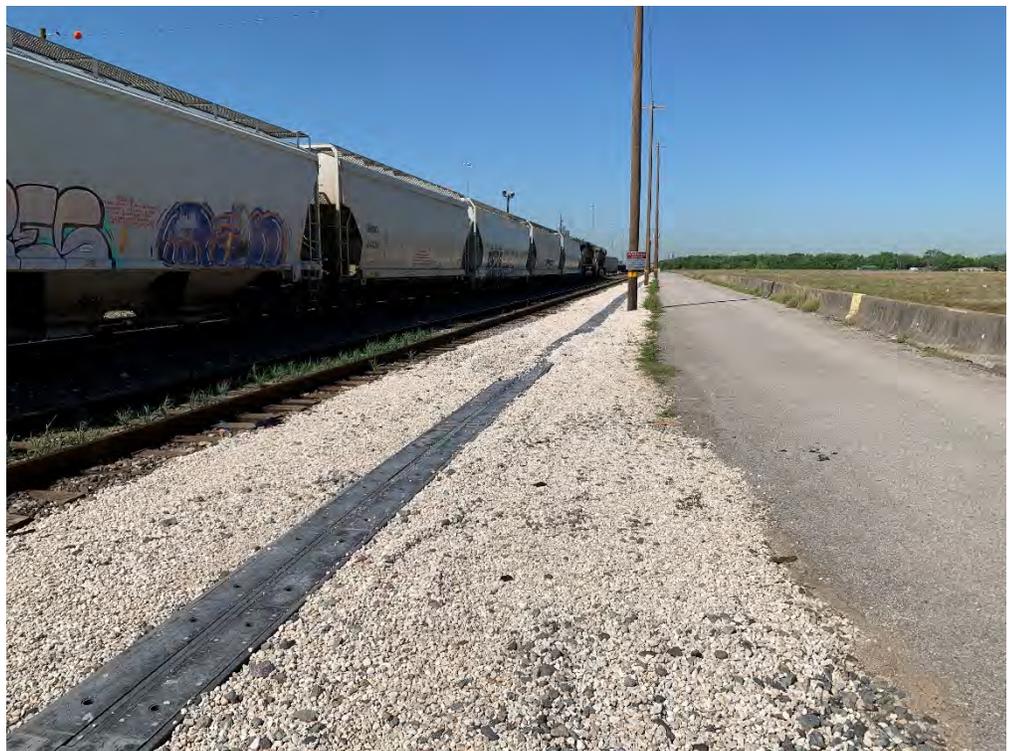
**Photo No.**  
12

Weeds and vegetation can be observed growing in the ballast cap and under the concrete barriers. Facing west.

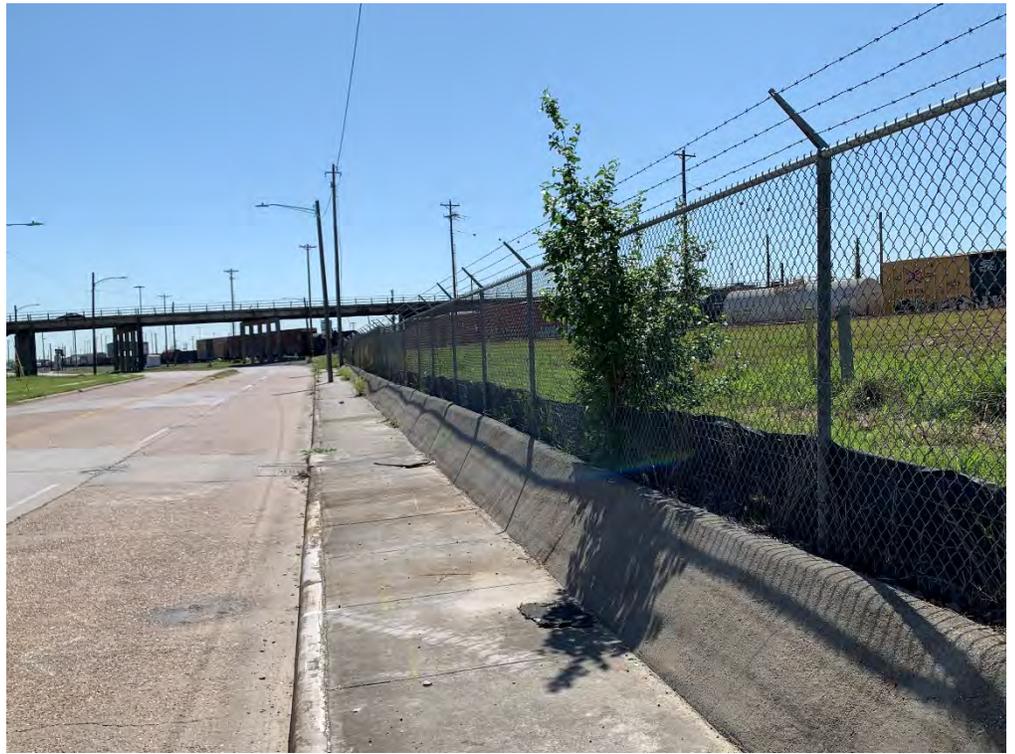
Sidewalk outside security fence in good condition. Some areas have vegetative growth. Facing east.

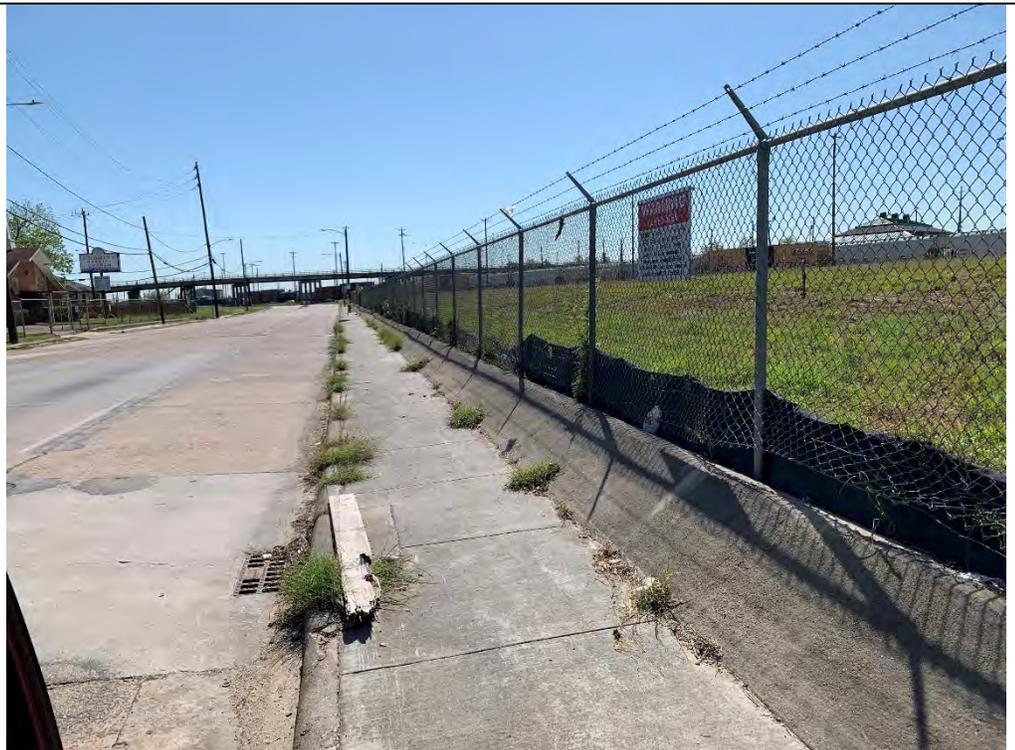
**Photo No.**  
14

Sidewalk outside security fence in good condition. Some areas have vegetative growth. Facing east.

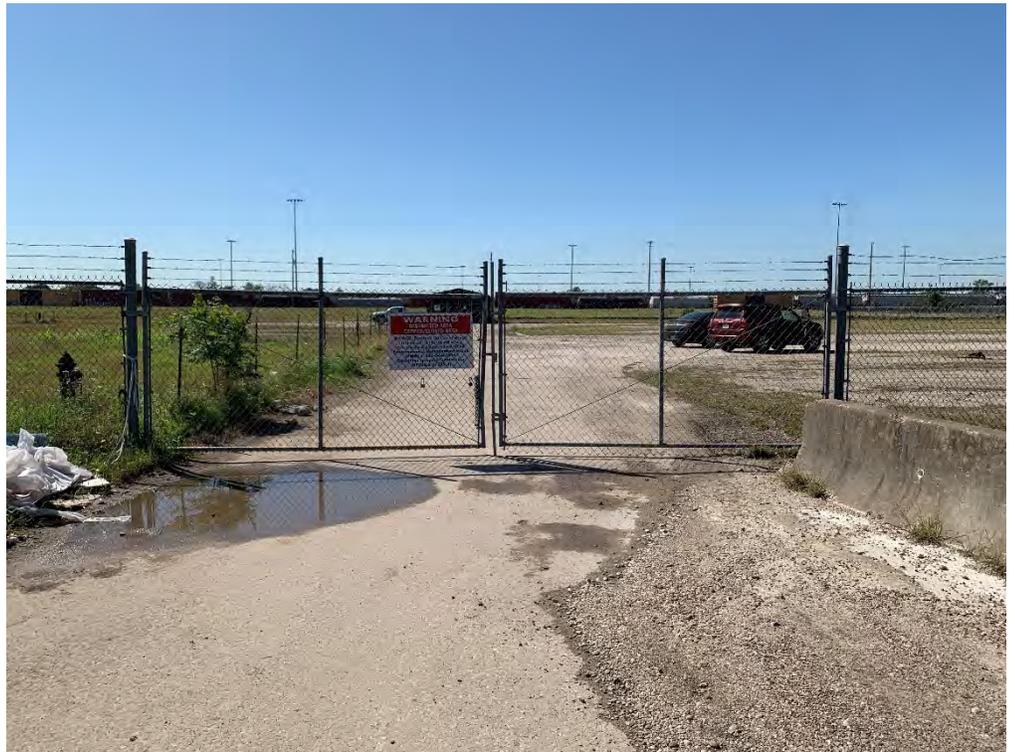
Main gate and security fence in good condition. Some areas of minor vegetative growth. Facing North.

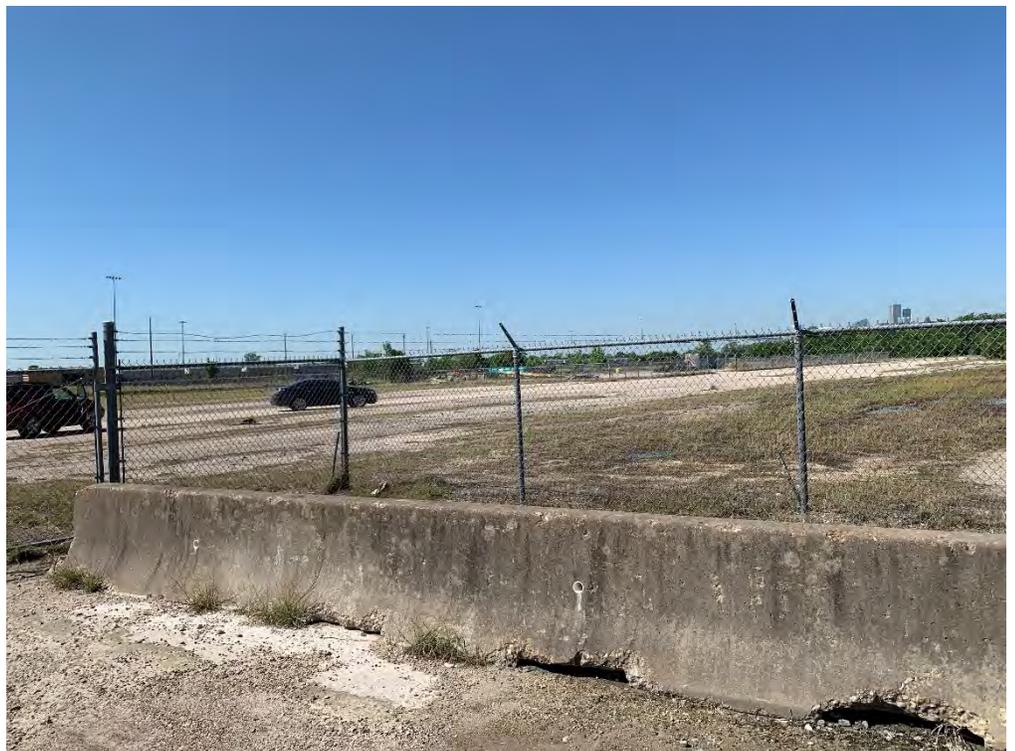
**Photo No.**  
16

Security fence in good condition, small section of barb wire is missing or disconnect next to the main gate. Facing northwest.

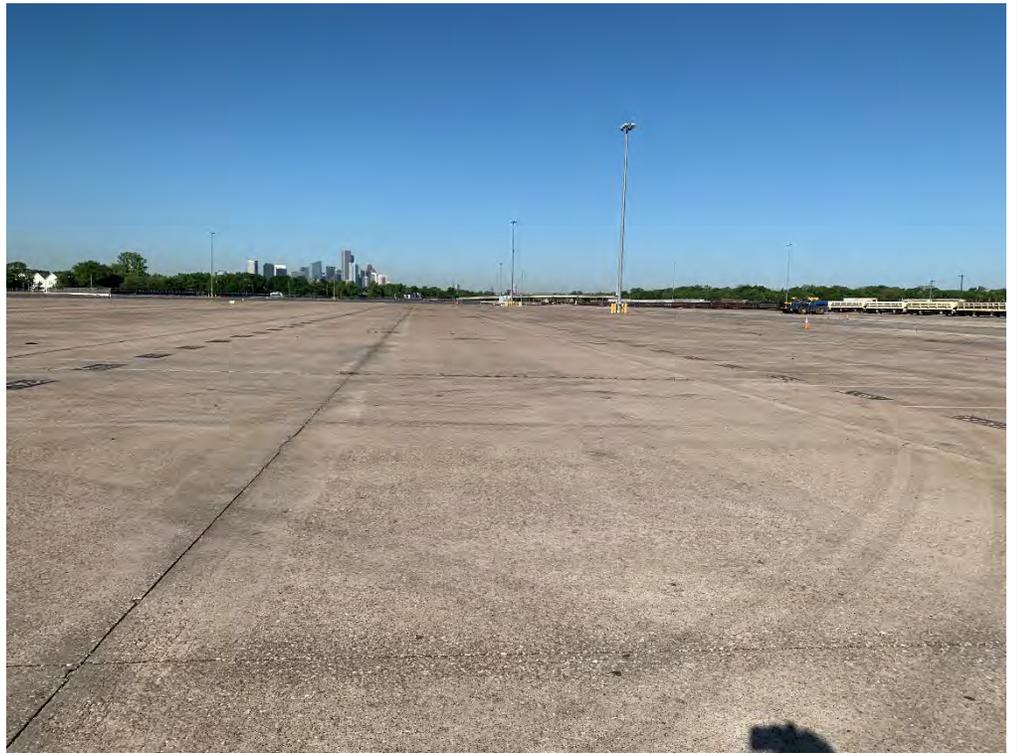
<b>Photo No.</b> 17	<b>Date:</b> 04/27/2022
<b>Description:</b> <b><u>Concrete Cap Area</u></b> <b><u>(Englewood Yard):</u></b> Concrete cap within yard in good condition. Some cracking evident, particularly on edges of rows, with minimal vegetative growth. Facing west.  Lat: 29.784419 Long: -95.324319

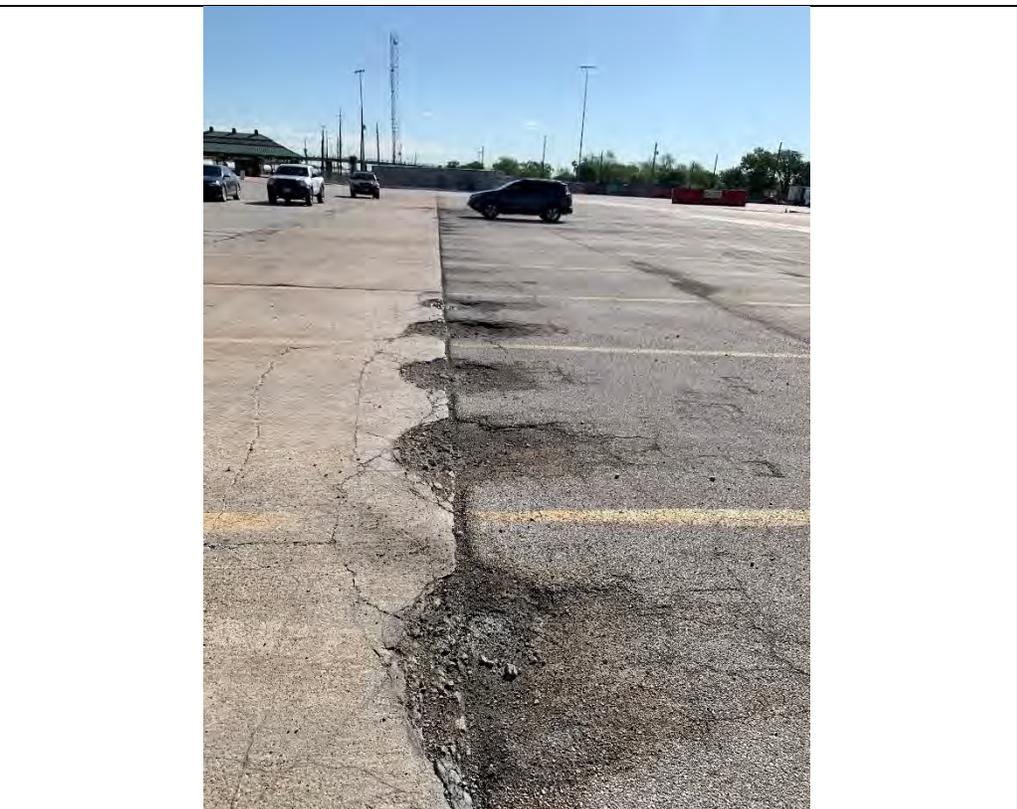
<b>Photo No.</b> 18	<b>Date:</b> 04/27/2022
<b>Description:</b> <b><u>Concrete Cap Area</u></b> <b><u>(Englewood Yard):</u></b> Stall A012. Evidence of cracking/potholes in multiple spots (particularly along the edge) in A and B rows. Facing east.  Lat: 29.785331 Long: -95.318803

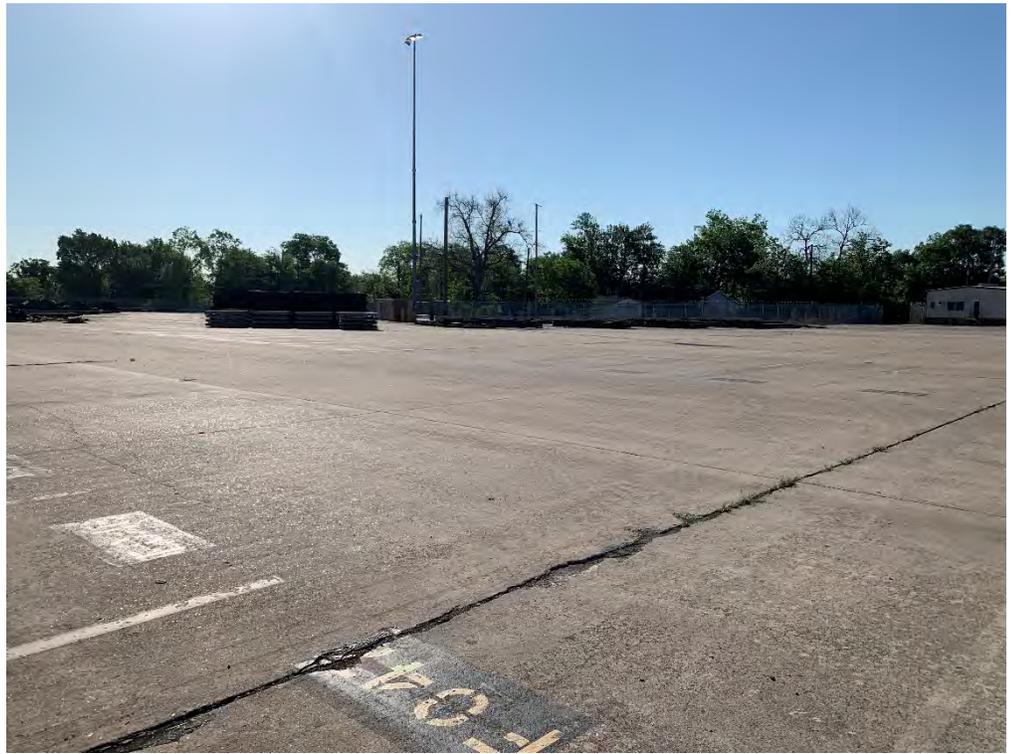
**Description:**  
**Concrete Cap Area**  
**(Englewood Yard):**  
F047 stall. Localized cracks and  
vegetation along joints. Facing  
northeast.

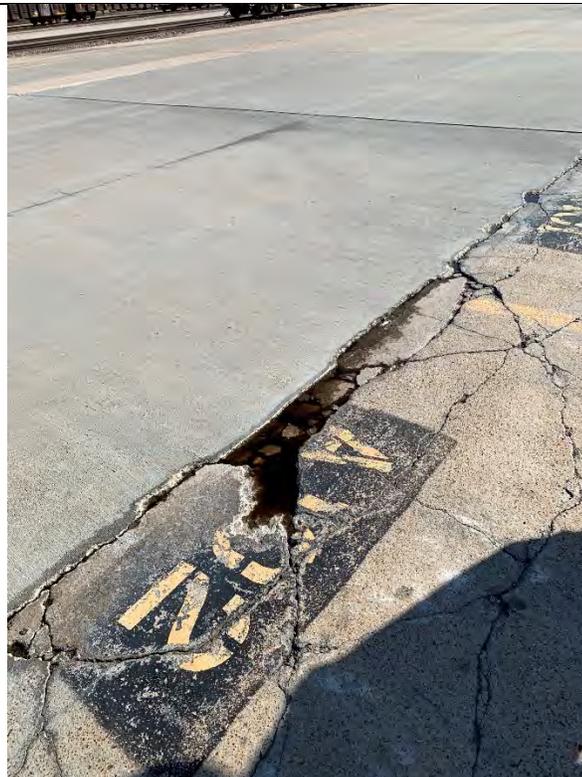
**Photo No.**  
20

**Description:**  
**Concrete Cap Area**  
**(Englewood Yard):**  
Cracking in concrete in stall  
A102 with water from rain  
pooling within crack. Facing  
southeast

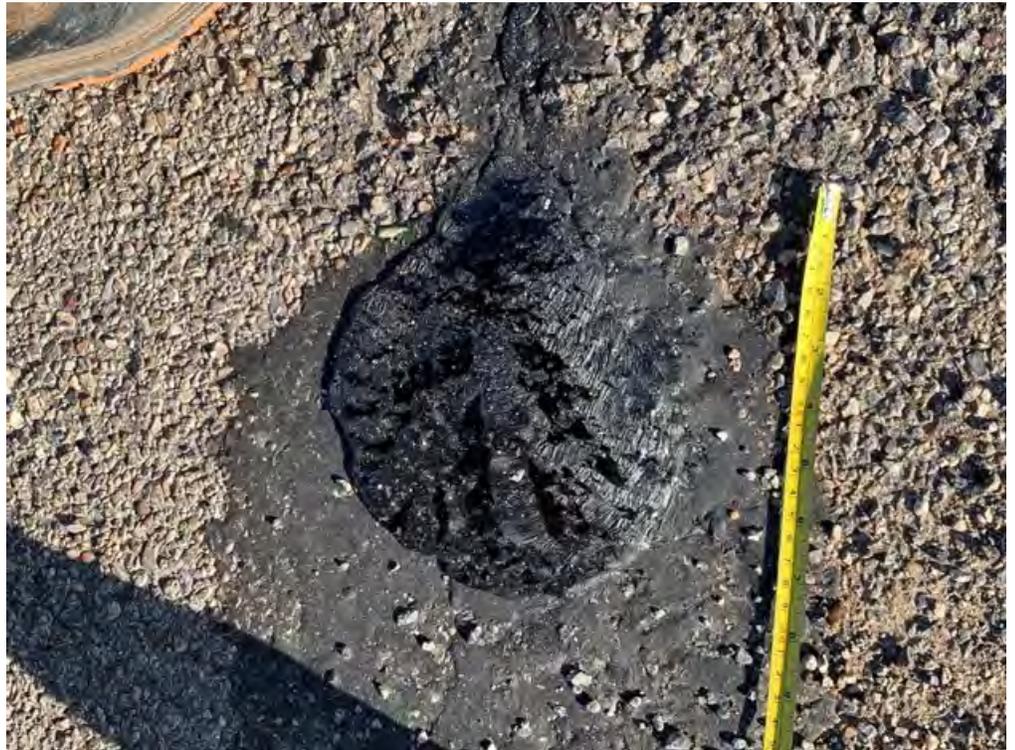
Stall A011, small amount of tar-like material seeping at asphalt crack, material was removed.

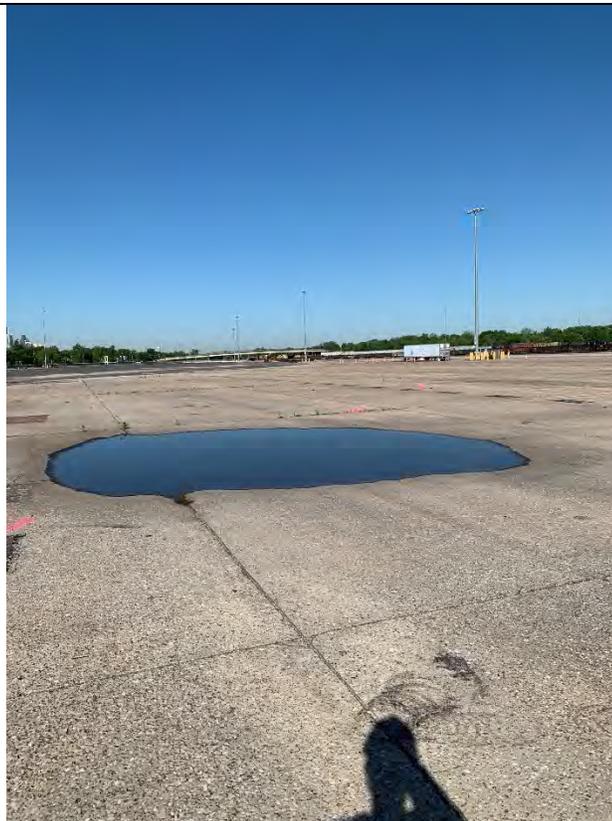
**Photo No.**  
22

Western end of the G row, cap showing large pooling of water from previous rain event. Minor vegetation in cracks and joints. Facing southwest

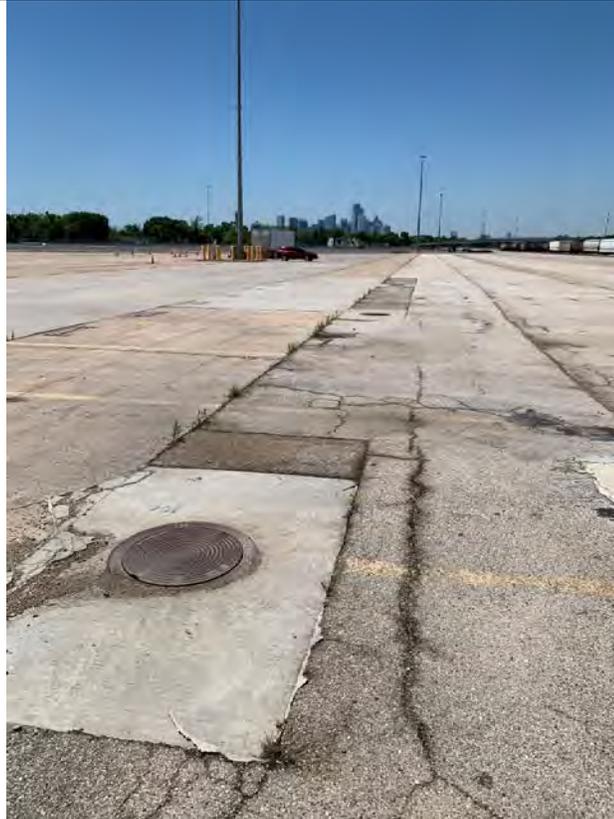
**Description:**  
**Concrete Cap Area**  
**(Englewood Yard)/NAPL**  
**Collection System:**  
NAPL Collection System in stalls  
B099-B110 in functional  
condition with evidence of  
cracking, stains, vegetation, etc.  
Facing west.

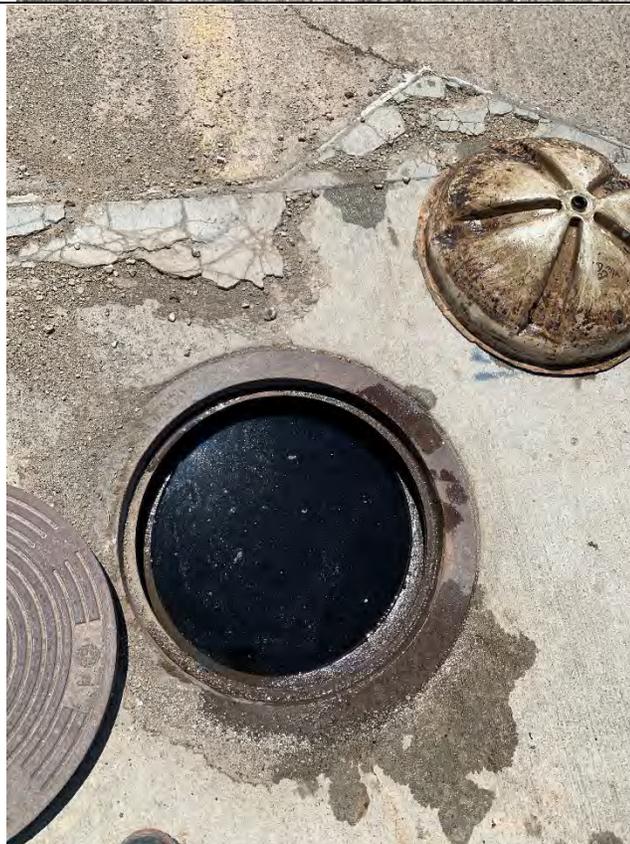
**Photo No.**  
24

**Description:**  
**Concrete Cap Area**  
**(Englewood Yard)/NAPL**  
**Collection System:**  
Sump B099/B100. Sump has 4.5  
inches of freeboard. This sump  
has historically exhibited higher  
water levels and has not  
produced any DNAPL. Water is  
brown in color, but no odor or  
sheen observed.

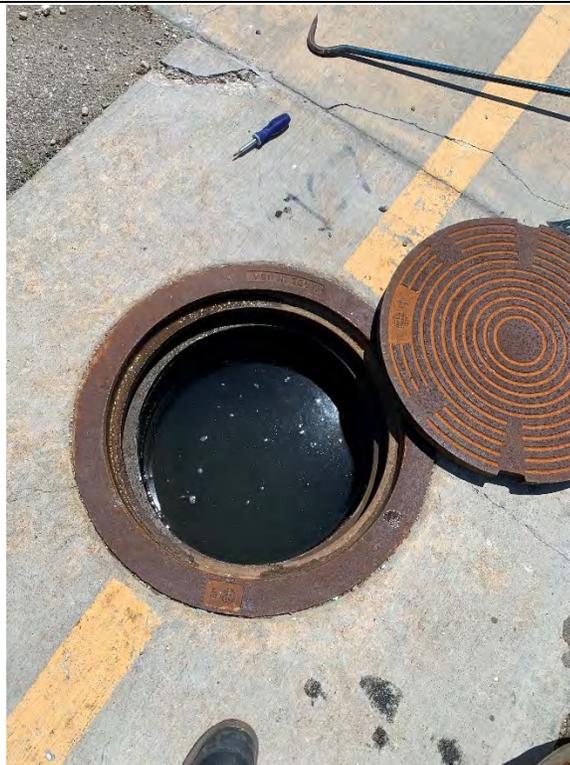
**Description:**  
**Concrete Cap Area**  
**(Englewood Yard)/NAPL**  
**Collection System:**  
Sump B107/B108. Sump has 8.5 inches of freeboard. This sump has occasionally produced small quantities of DNAPL, which is removed weekly if observed. Water is brown in color, but no odor or sheen observed.

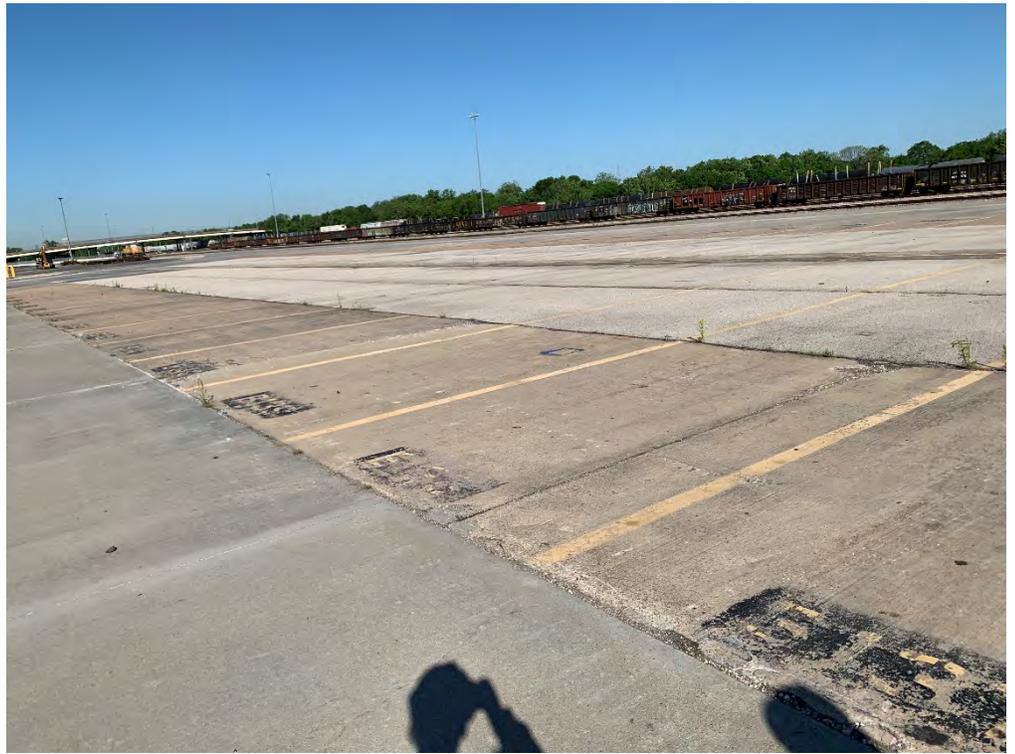
Concrete cap within yard in good condition. Some cracking evident, particularly on edges of rows, with minimal vegetative growth. Facing southwest.

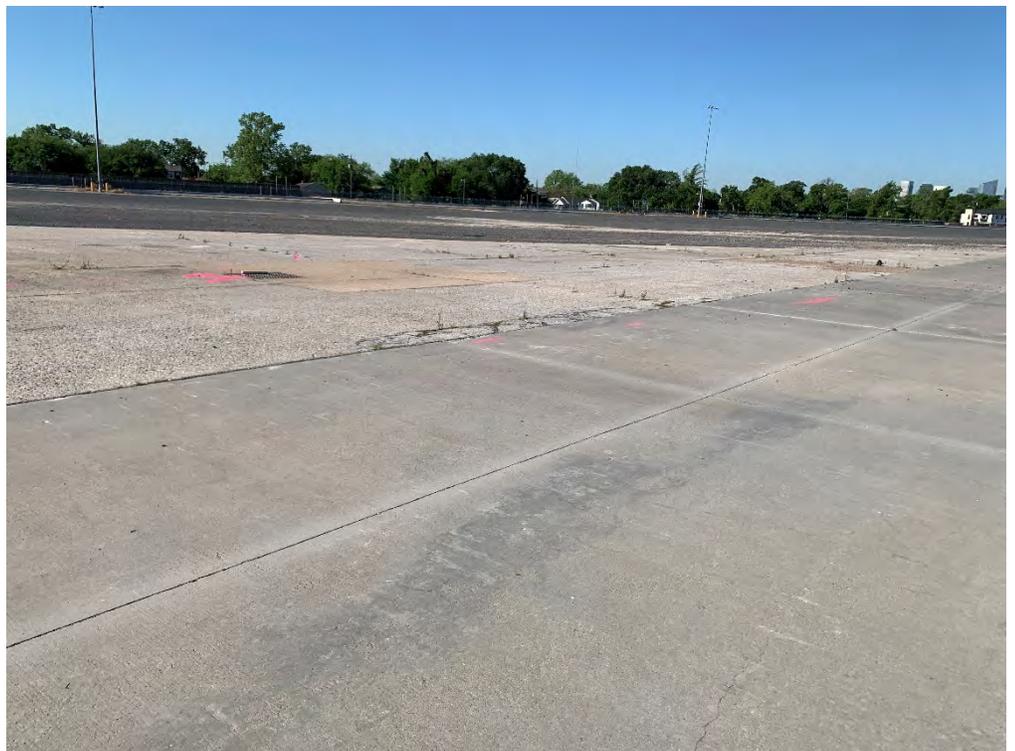
**Photo No.**  
28

Concrete cap within yard in good condition. Some cracking evident, particularly on edges of rows, with minimal vegetative growth. Facing northwest.

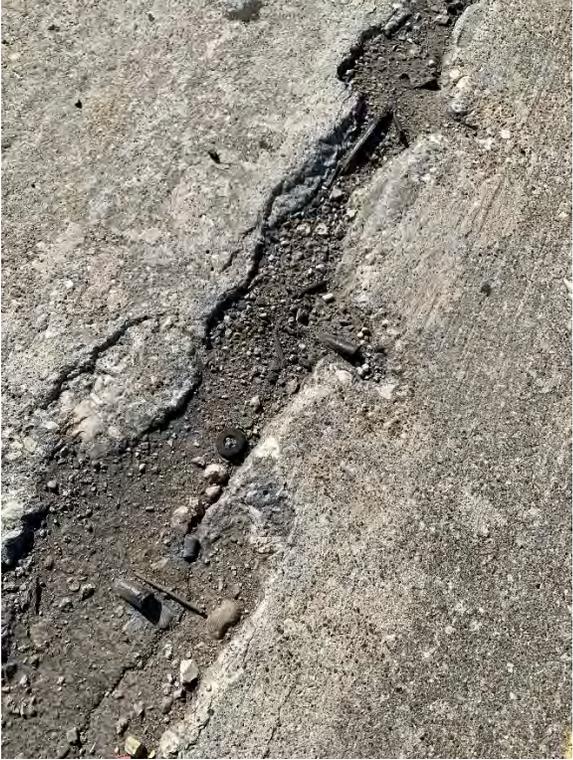
<b>Photo No.</b> 29	<b>Date:</b> 04/27/2022

<b>Description:</b>  <b>Concrete Cap Area (Englewood Yard):</b> Western end of D row, gap in concrete joint, very small amount of rebar becoming exposed.  Lat: 29.783797 Long: -95.321022

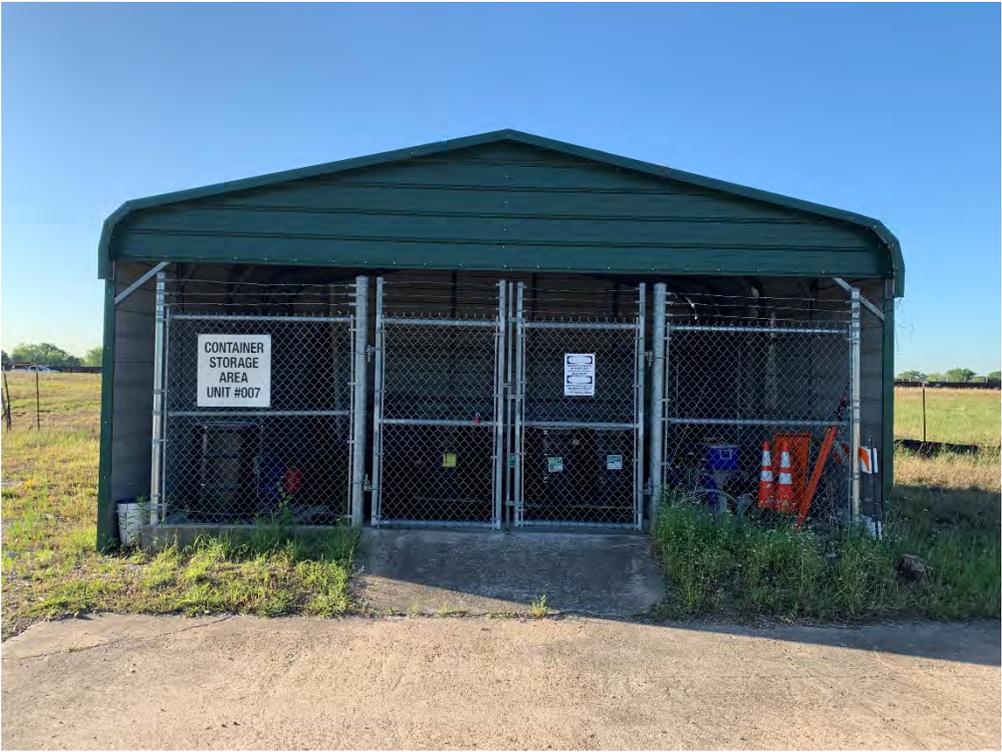
<b>Photo No.</b> 30	<b>Date:</b> 04/27/2022

<b>Description:</b>  <b>Container Storage Area:</b> Valve in closed position and functioning within the container storage area. CSA in good condition, free of major dents and other damage. No water observed on floor. Facing south.  Lat: 29.786813 Long: -95.320612

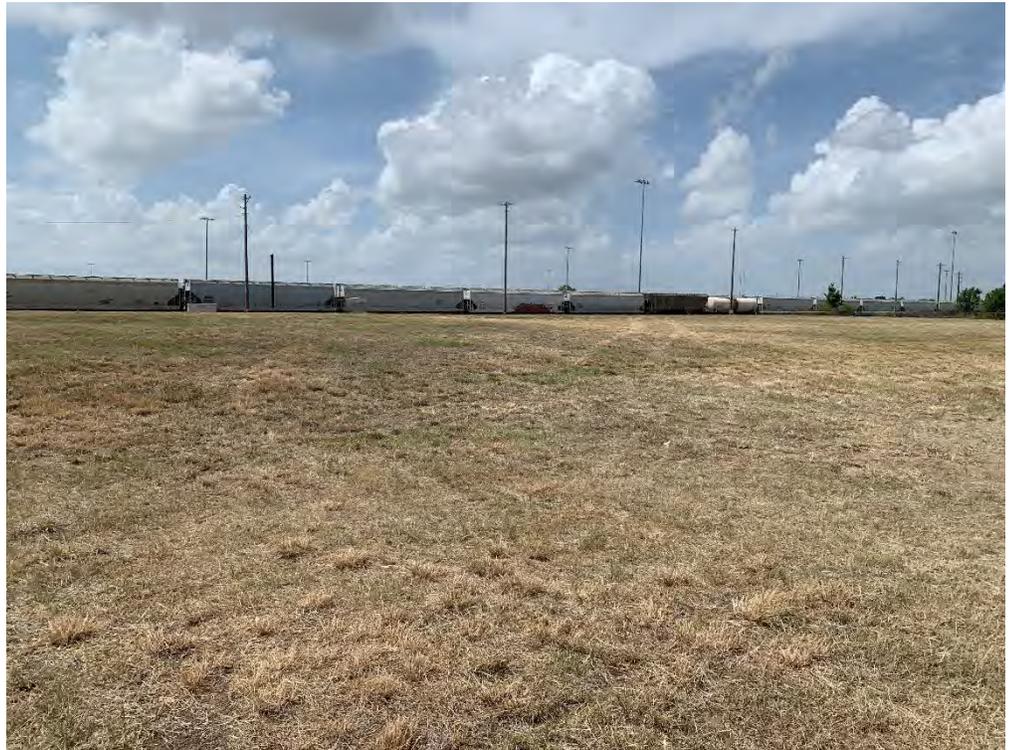
Soil cap well-vegetated in most areas with some stressed areas due to lack of rain and a low risk of erosion. No major ruts observed during inspection. Facing southwest.
