**RE: POST-RESPONSE ACTION COMPLETION REPORT – 2022  
UNION PACIFIC RAILROAD HOUSTON WOOD PRESERVING WORKS, HOUSTON, TEXAS  
4910 LIBERTY ROAD, HOUSTON, HARRIS COUNTY, TEXAS  
TCEQ SWR NO. 31547; TCEQ PERMIT/COMPLIANCE PLAN NO. 50343 EPA ID NO. TXD000820266  
CUSTOMER NO. CN600131098; REGULATED ENTITY NO. RN100674613**

# TEXAS COMMISSION ON ENVIRONMENTAL QUALITY Post-Response Action Care Report (PRACR)

**SECOND QUARTER 2022 (APRIL 27<sup>th</sup>) INSPECTION RECORD AND PHOTOGRAPHIC LOG**

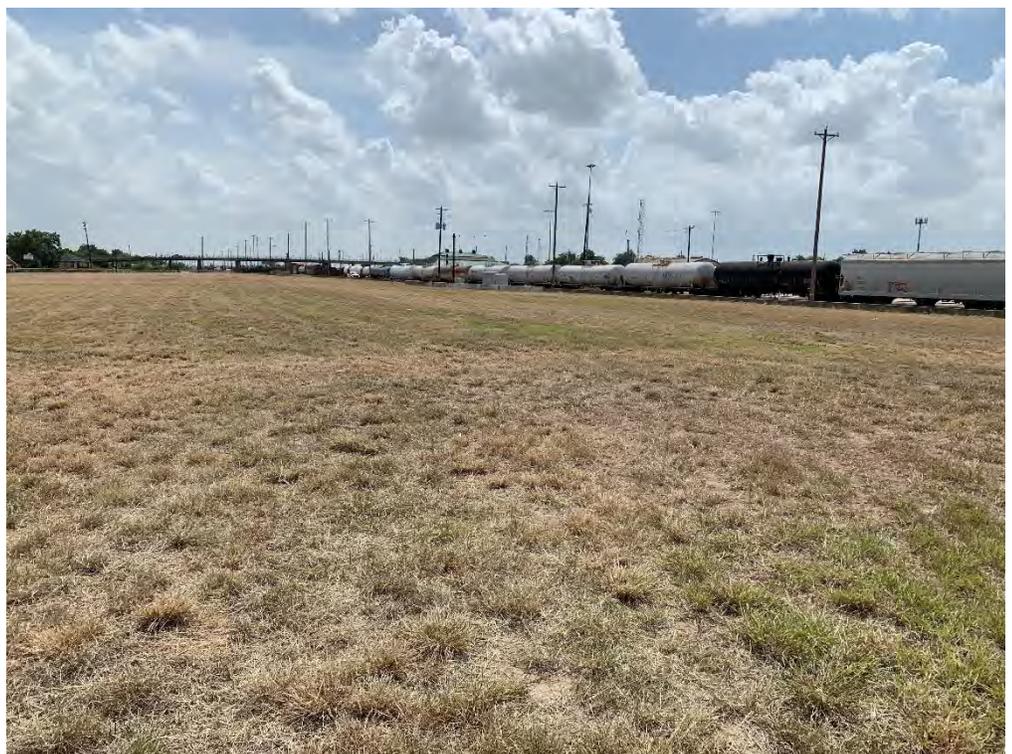
**Photo No.**  
 2

Vegetative growth can be observed along the length of the soil cap, however, some areas are stressed due to lack of rain, some bald patches observed. Facing southeast.

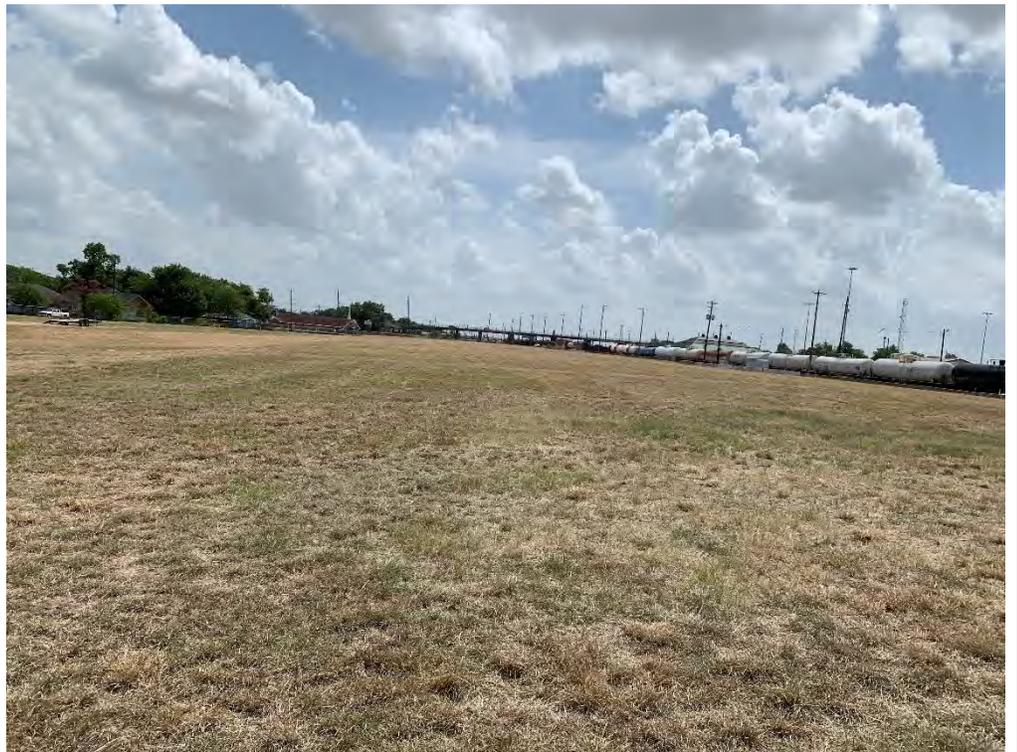
<b>Photo No.</b> 3	<b>Date:</b> 07/22/2022
<b>Description:</b>  <u><b>HWPW Yard Area and Soil Cap:</b></u> Soil cap well-vegetated in most areas with a low risk of erosion. Some areas of stressed vegetation due to lack of rain noted. Facing northeast.  Lat: 29.786522 Long: -95.320472

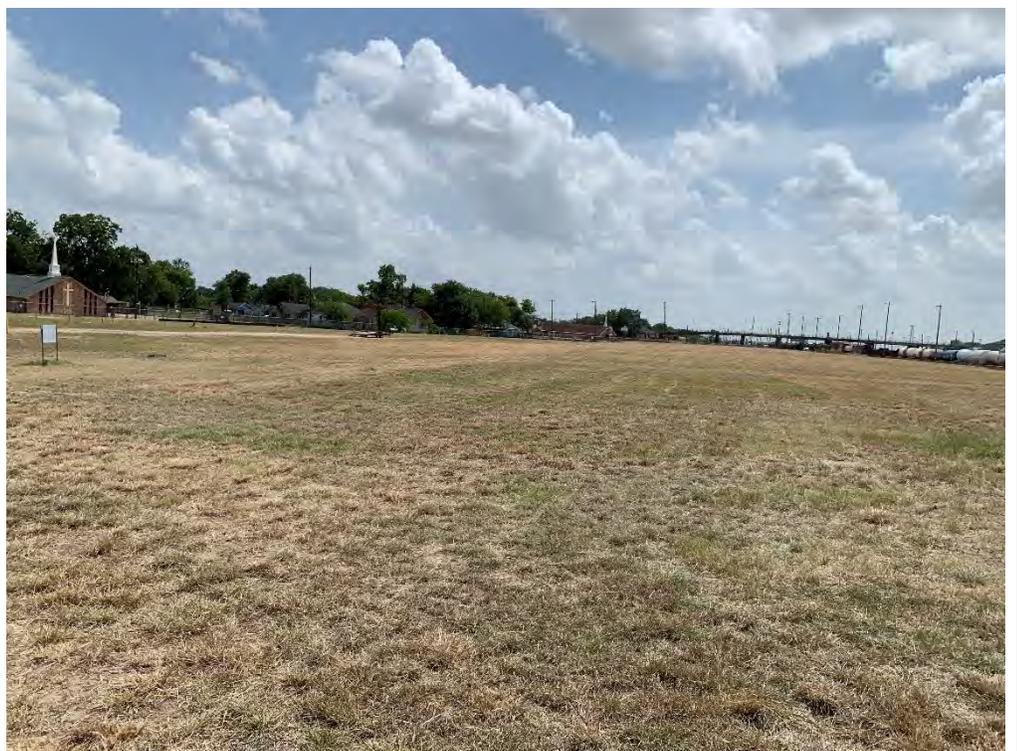
<b>Photo No.</b> 4	<b>Date:</b> 07/22/2022
<b>Description:</b>  <u><b>HWPW Yard Area and Soil Cap:</b></u> Soil cap well-vegetated in most areas with a low risk of erosion. Some minor areas of stressed vegetation due to lack of rain noted. Facing northeast.  Lat: 29.786522 Long: -95.320472

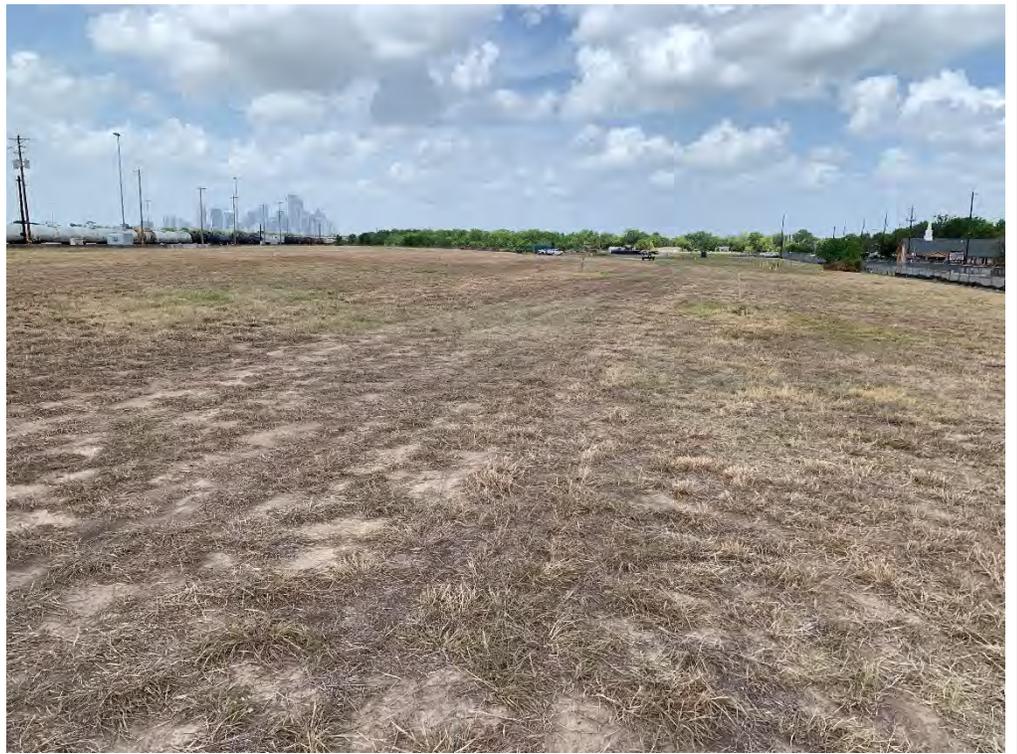
<b>Photo No.</b> 5	<b>Date:</b> 07/22/2022
<b>Description:</b>  <b><u>HWPW Yard Area and Soil Cap:</u></b> Soil cap well-vegetated in most areas with a low risk of erosion. Some minor bald patches, exposed soil, and areas of stressed vegetation due to lack of rain noted. Facing west.  Lat: 29.787469 Long: -95.317872

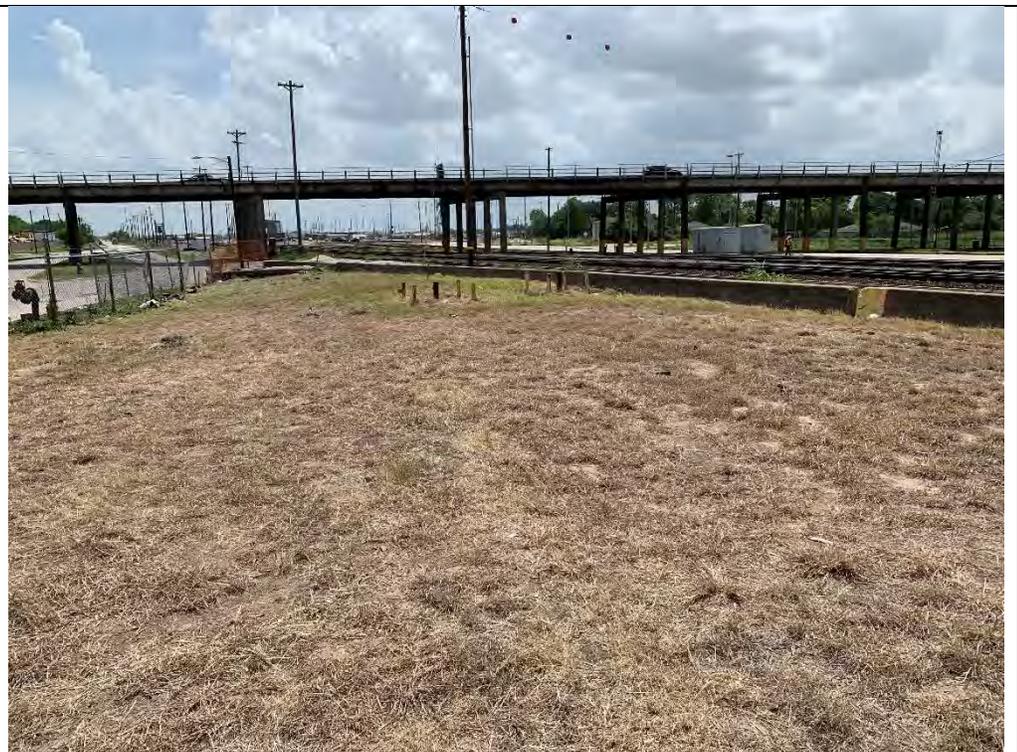
<b>Photo No.</b> 6	<b>Date:</b> 07/22/2022
<b>Description:</b>  <b><u>HWPW Yard Area and Soil Cap:</u></b> Soil cap well-vegetated in most areas with a low risk of erosion. Small patches of exposed soil and areas of stressed vegetation due to lack of rain noted. Fence damaged due to a car wreck. Facing east.  Lat: 29.787564 Long: -95.316903

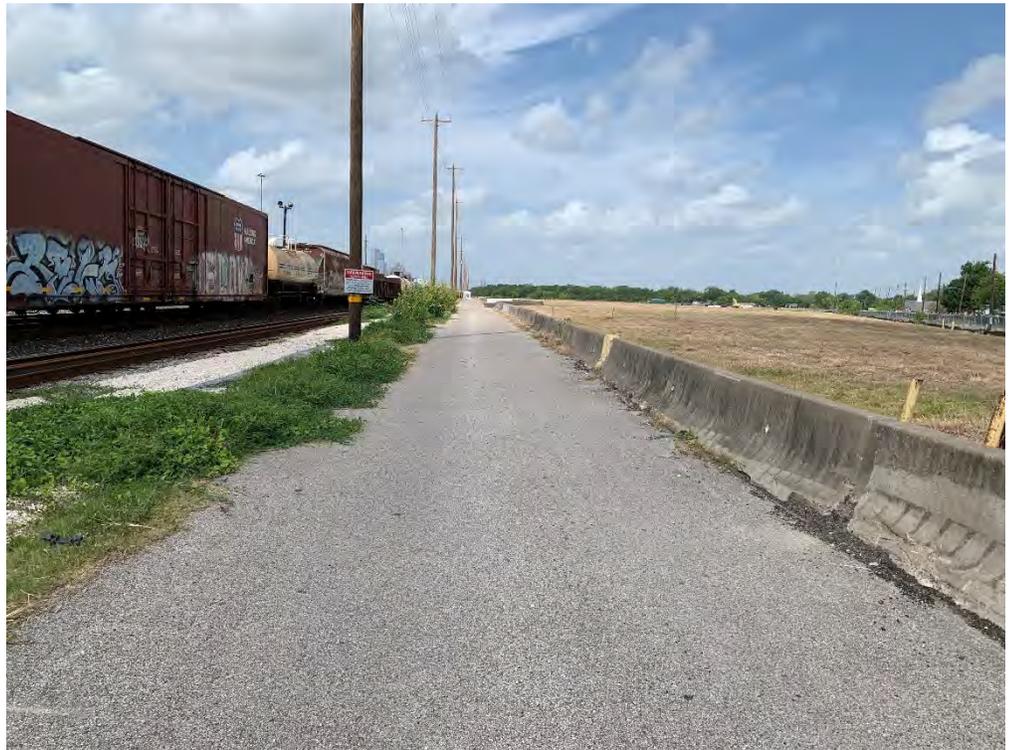
Asphalt roadway in good condition, free of major cracking/damage. Vegetation growth noted within the ballast cap and under the concrete barriers. Facing west.

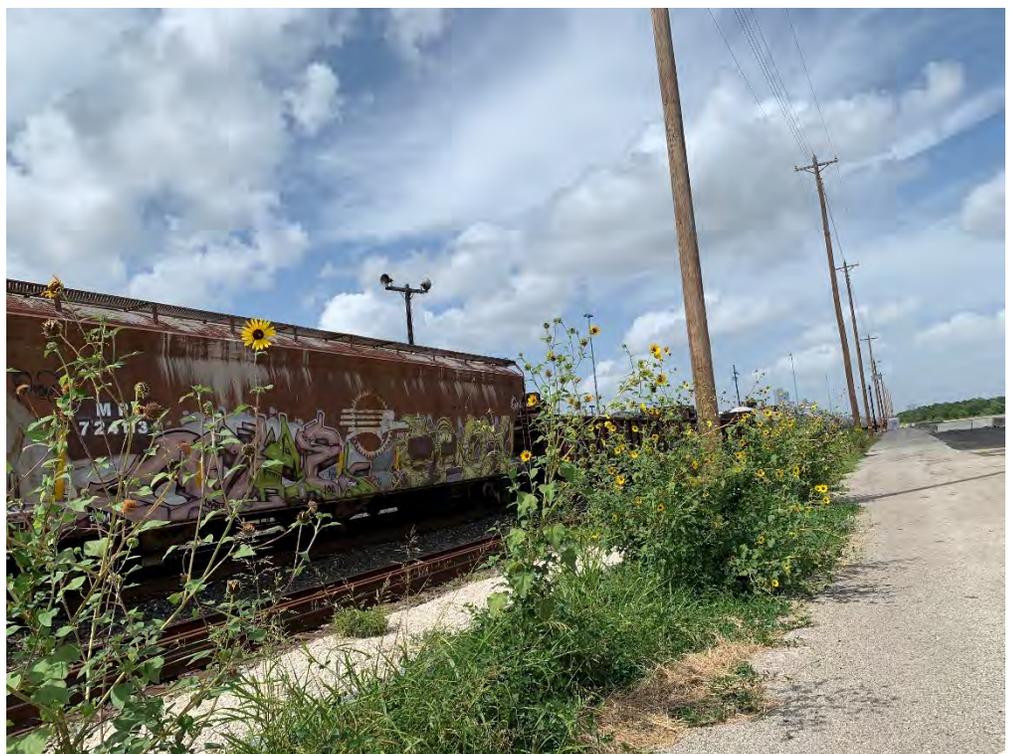
**Photo No.**  
8

Asphalt roadway in good condition, free of major cracking/damage. Vegetation growth noted within the ballast cap. Facing southwest.

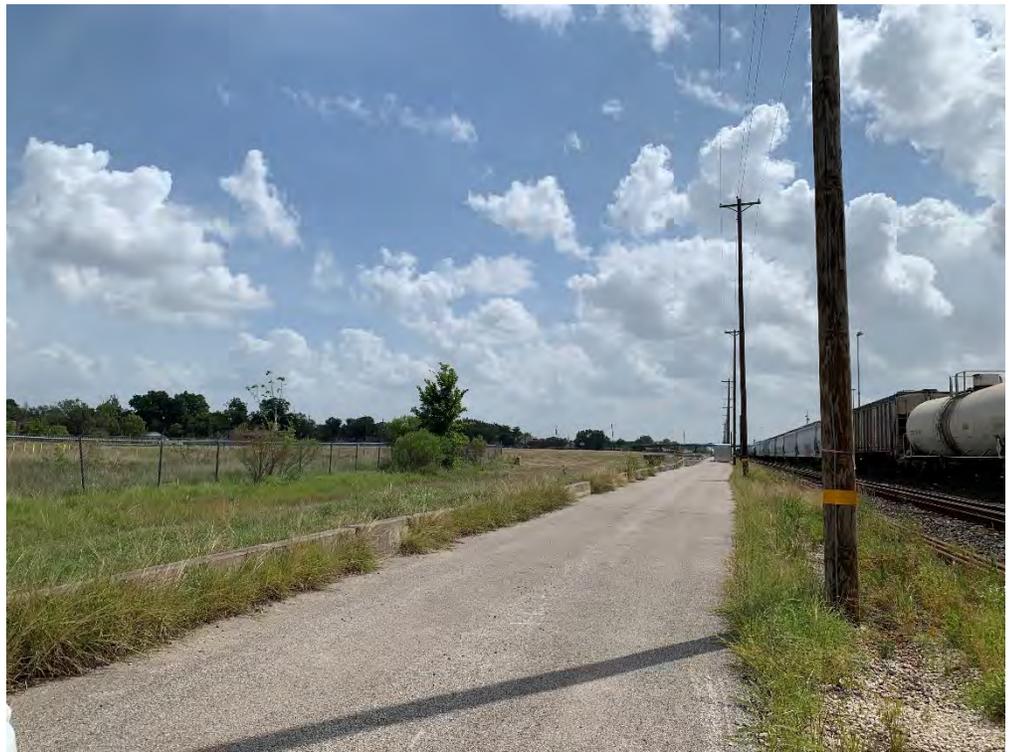
Asphalt roadway in good condition, free of major cracking/damage. Vegetation growth noted within the ballast cap and under the concrete barriers. Facing southeast.

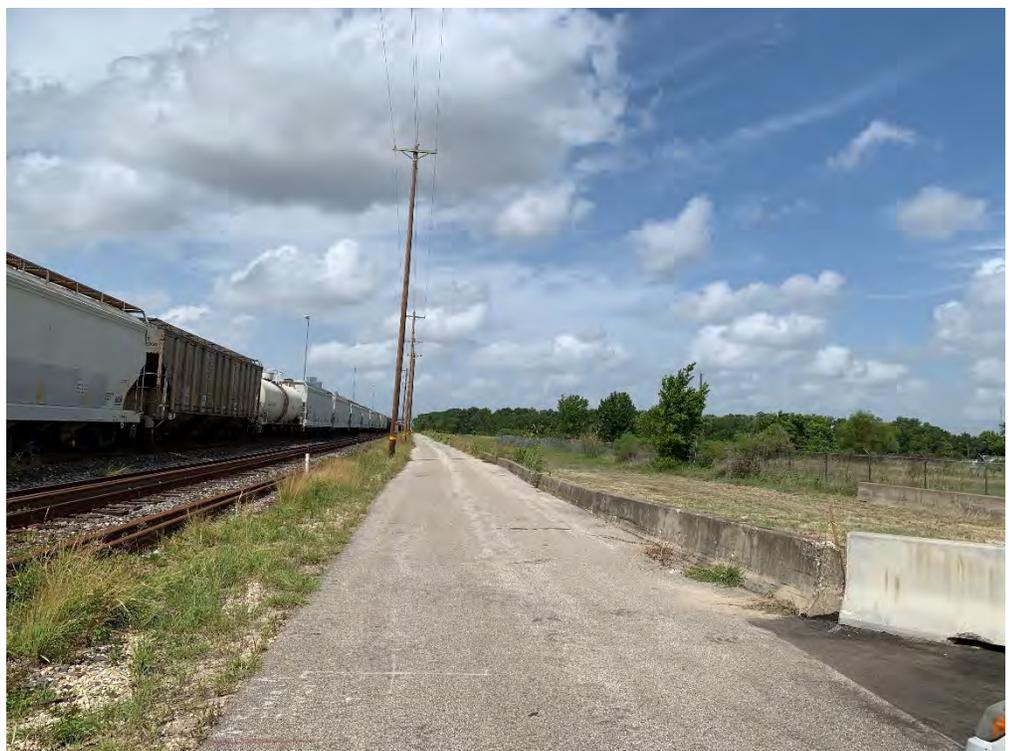
**Photo No.**  
 10

Asphalt roadway in good condition, free of major cracking/damage. Vegetation growth noted within the ballast cap and under the concrete barriers. Facing west.

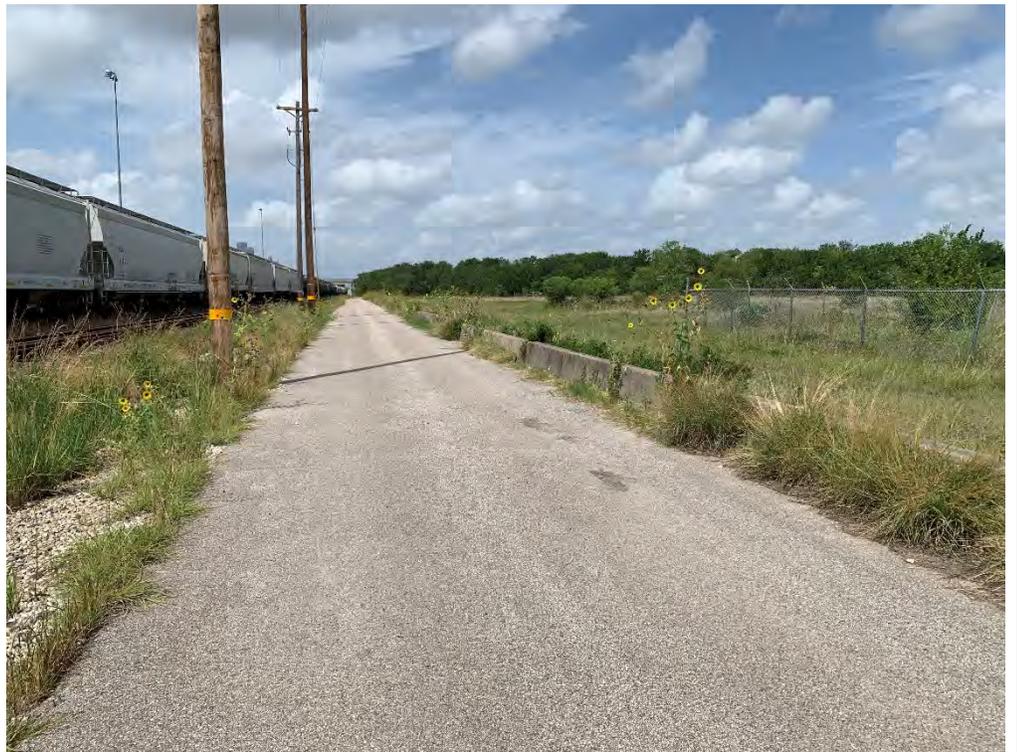
<b>Photo No.</b> 11	<b>Date:</b> 07/22/2022
<b>Description:</b>  <b>Asphalt Roadway:</b> Asphalt roadway in good condition, free of major cracking/damage. Small tar-like marks do not appear to have expanded in size. Vegetation growth noted within the ballast cap and under the concrete barriers. Facing west.  Lat: 29.785372 Long: -95.321572

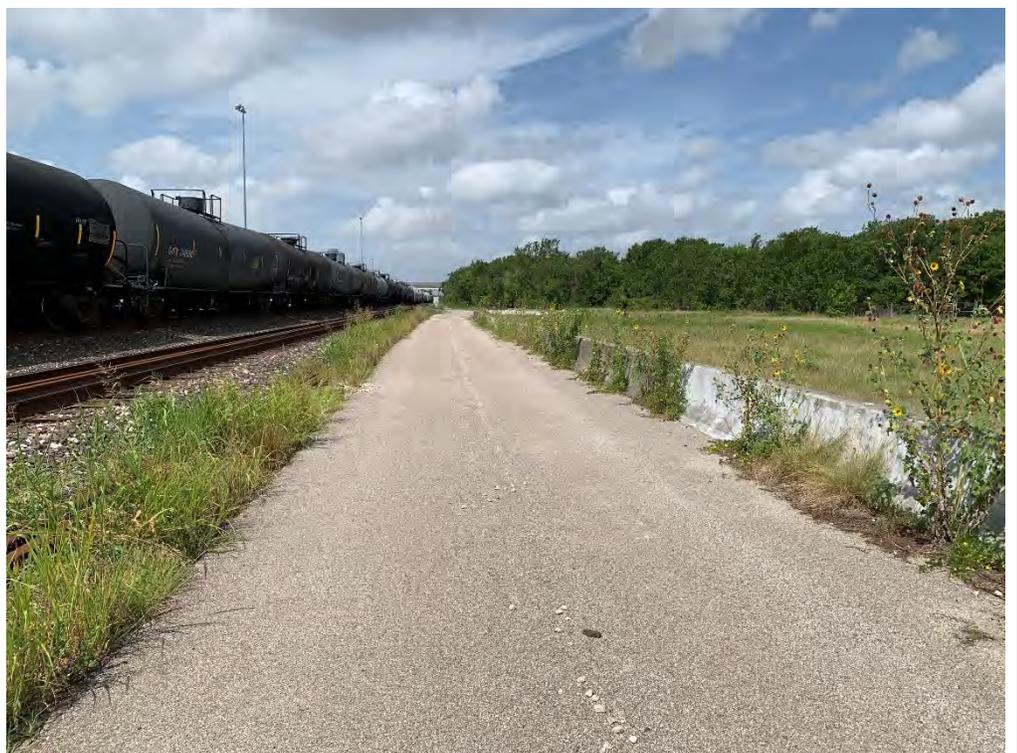
<b>Photo No.</b> 12	<b>Date:</b> 07/22/2022
<b>Description:</b>  <b>Ballast Cap, Asphalt Roadway and Soil Cap Vegetative Cover:</b> Asphalt roadway in good condition. Vegetation growth noted within the ballast cap and under the concrete barriers. Facing west.  Lat: 29.784775 Long: -95.322983

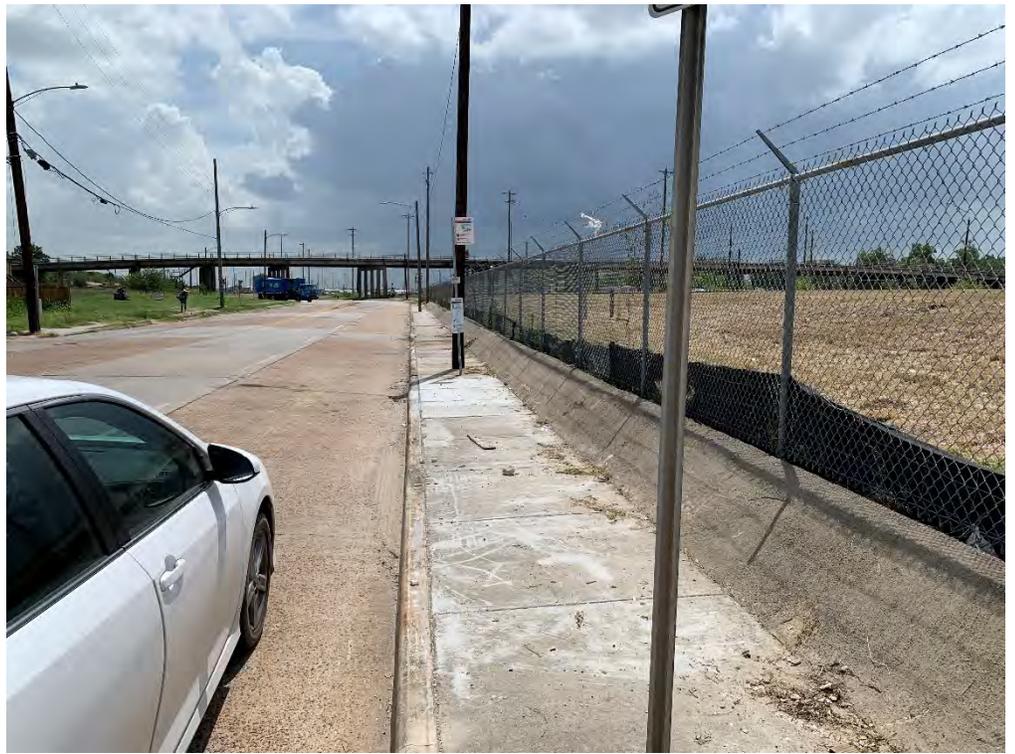
**Security Fence/Sidewalk Area:**  
Sidewalk outside security fence in good condition. Facing east.

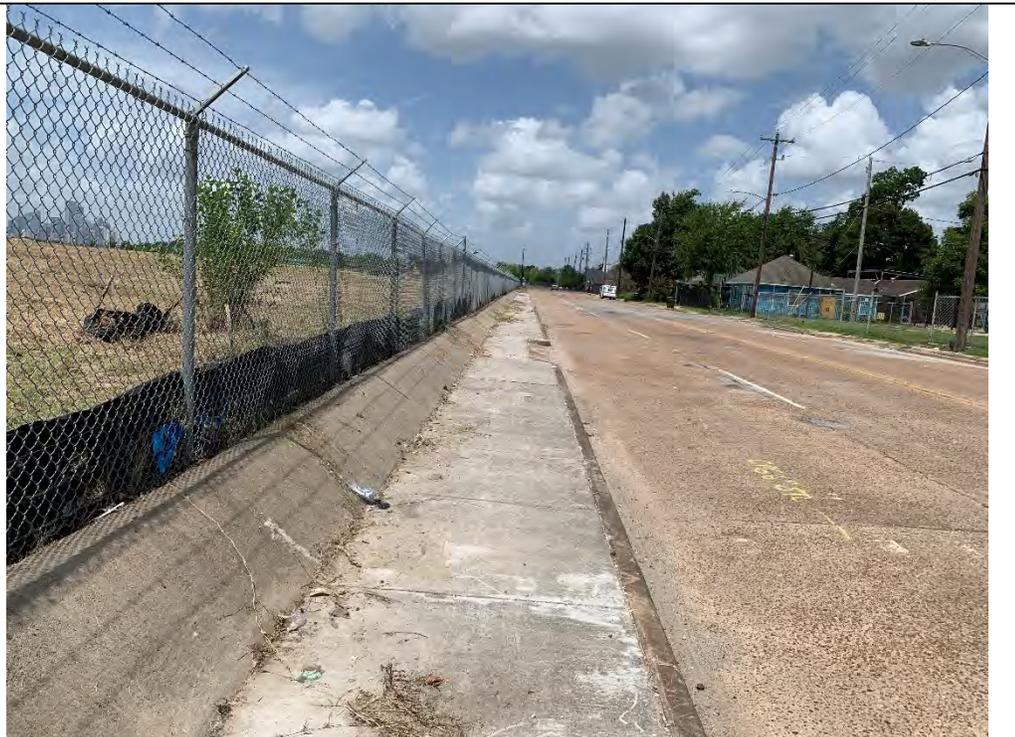
**Photo No.**  
14

**Security Fence/Sidewalk Area:**  
Sidewalk outside security fence in good condition. Facing west.

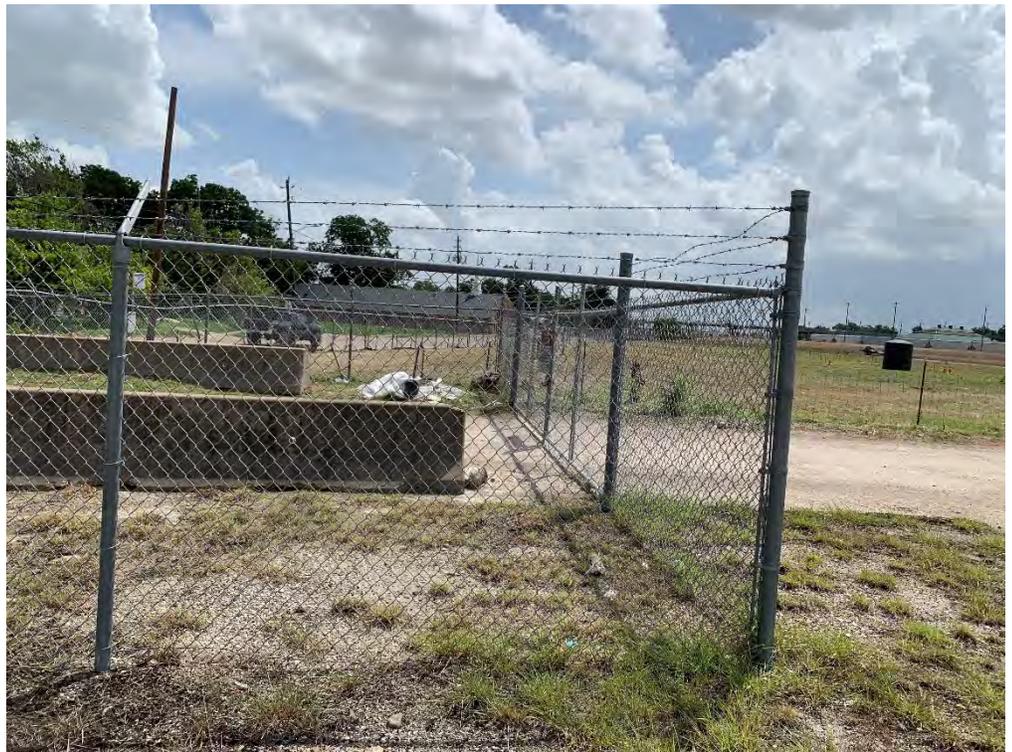
Main gate and security fence in good condition. Some areas have sagging or missing wire. Facing east.

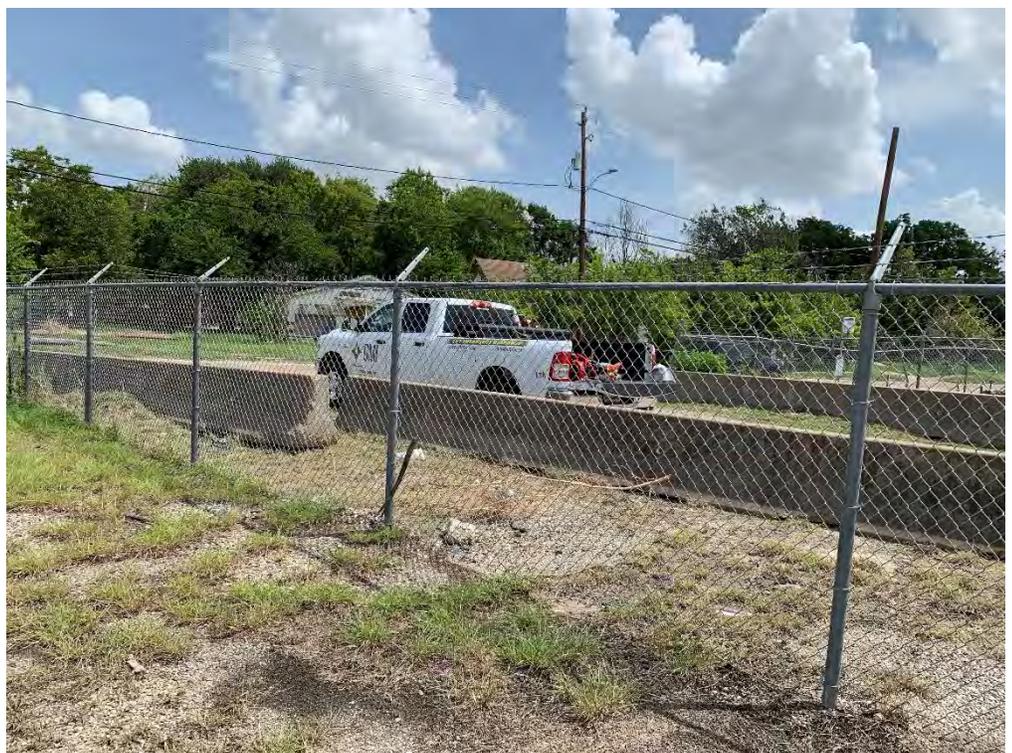
**Photo No.**  
16

Security fence in good condition, some sections have missing or sagging barbwire next to the main gate. Facing northeast.

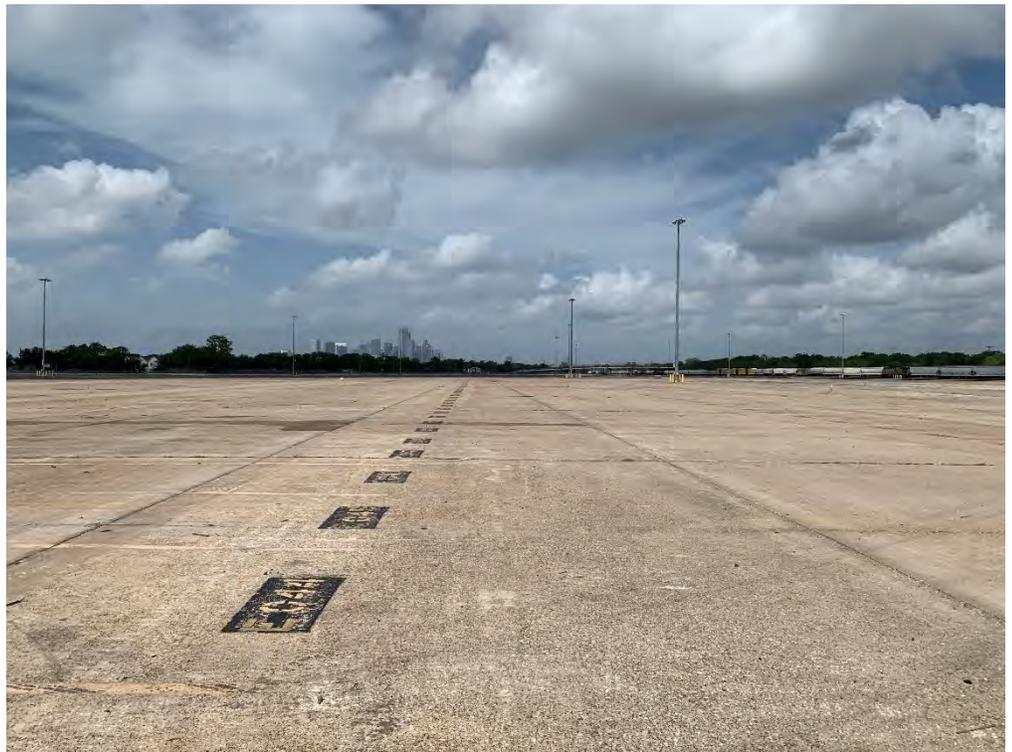
**Description:**  
**Concrete Cap Area (Englewood Yard):**  
Concrete cap within yard in good condition. Some cracking evident, particularly on edges of rows, with minimal vegetative growth. Facing west.

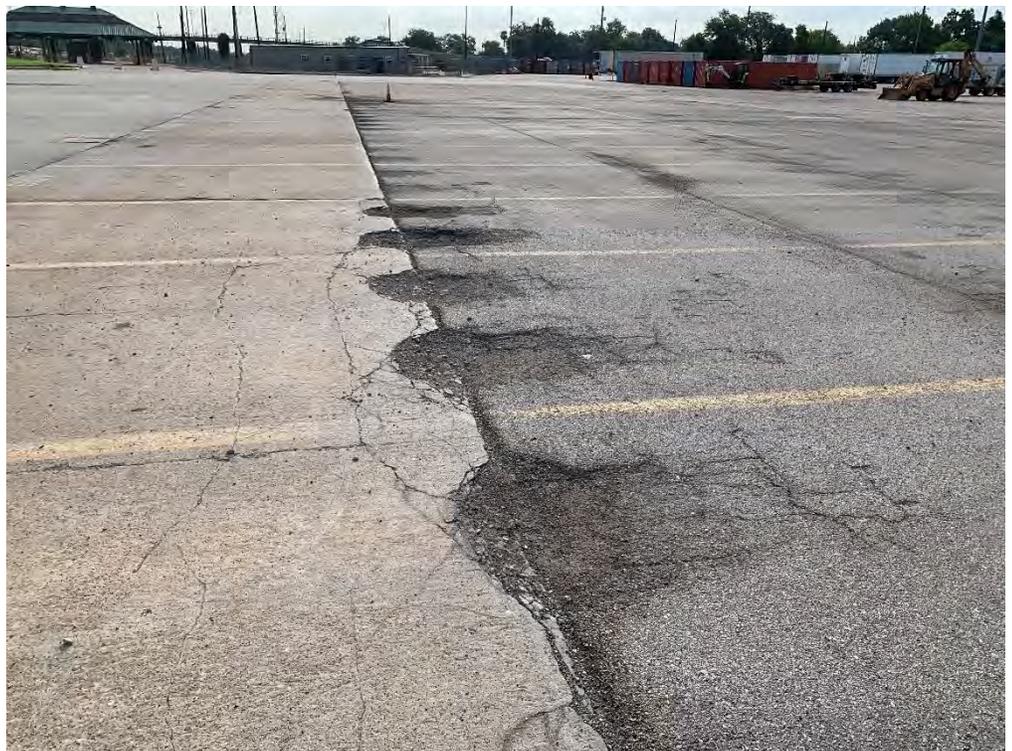
**Photo No.**  
18

**Description:**  
**Concrete Cap Area (Englewood Yard):**  
Stall A012. Evidence of cracking/potholes in multiple spots (particularly along the edge) in A and B rows. Facing east.

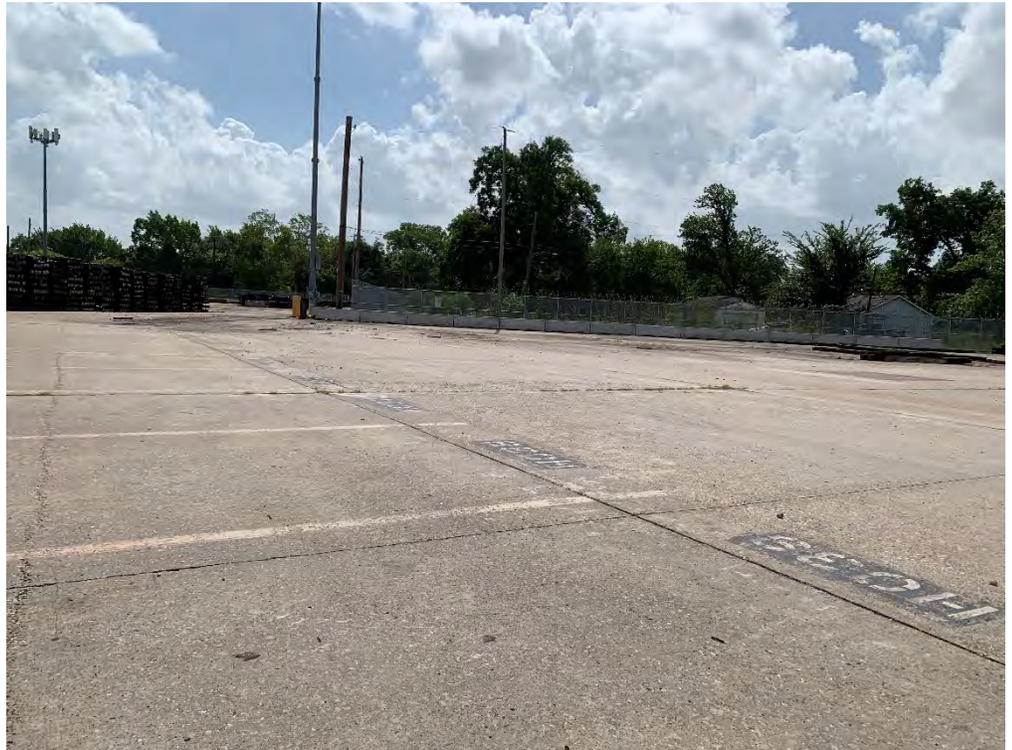
**Description:**  
**Concrete Cap Area**  
**(Englewood Yard):**  
H039 stall. Localized cracks and vegetation along joints. Facing southeast.

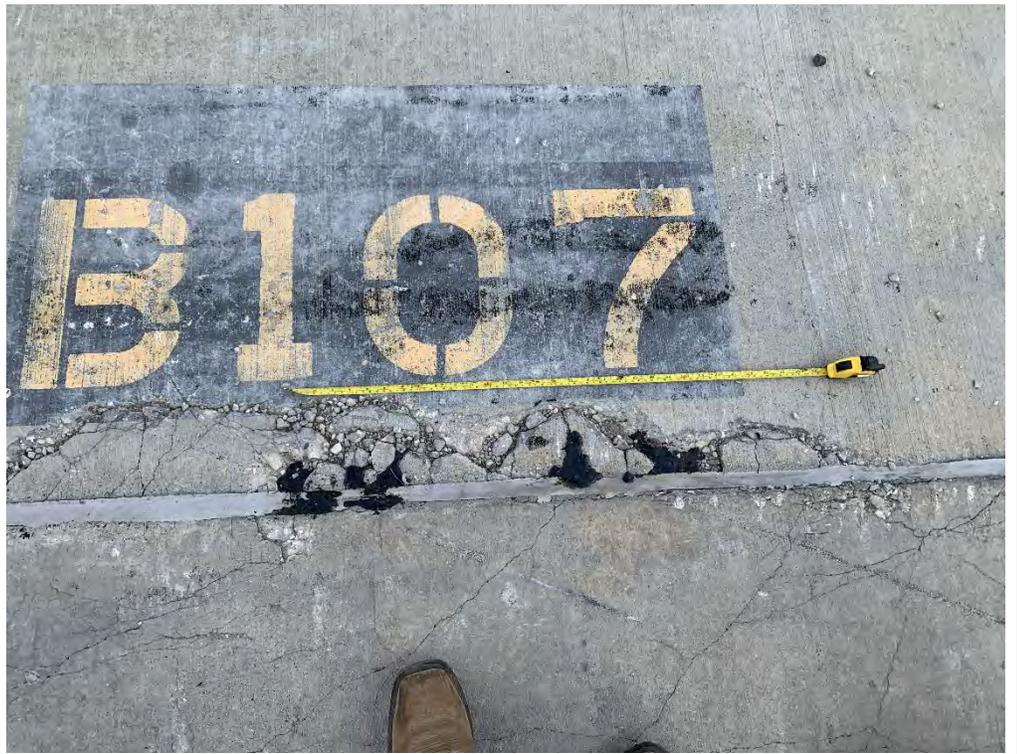
- A small tar-like material seep was observed July 6, 2022 along the southern edge of the NAPL Collection System in cracks in the cement at the joint of Stall B107, as noted in the Monthly Status Update dated August 15, 2022. This was the first occurrence of the tar-like material seeps being observed at this location since installation of the NAPL Collection System.

<b>Photo No.</b> 21	<b>Date:</b> 07/22/2022
<b>Description:</b> <b>Concrete Cap Area (Englewood Yard):</b> Slot B107, a small seep of tar-like material in concrete cracks within the NAPL Collection Area. Material was removed.  Lat: 29.784156 Long: -95.320953

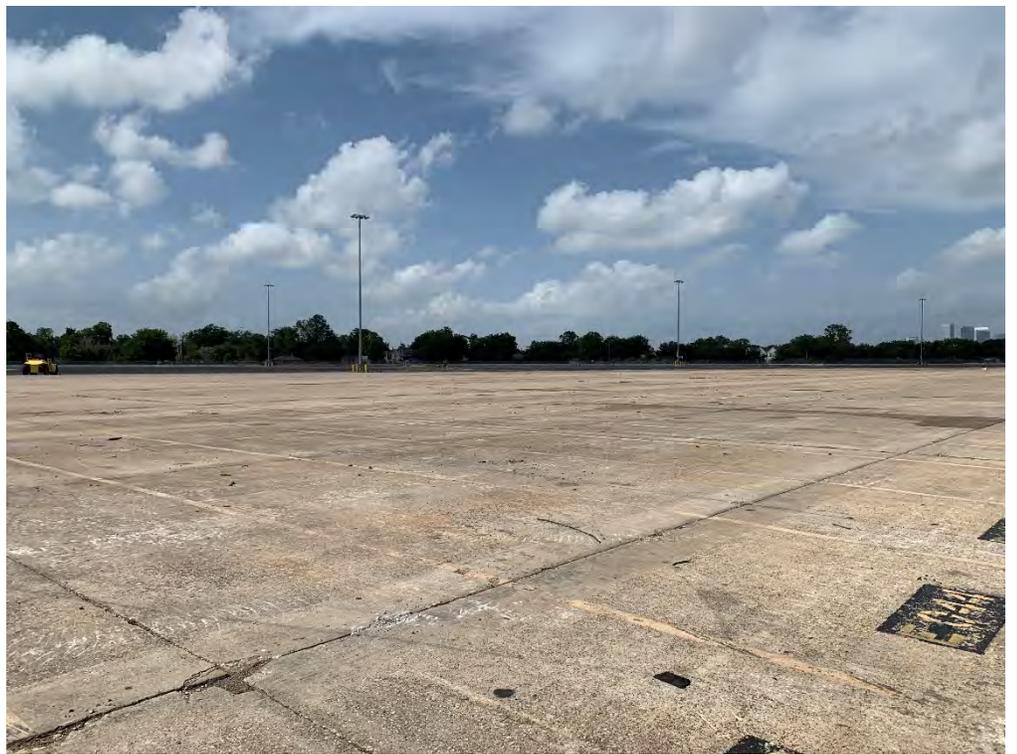
<b>Photo No.</b> 22	<b>Date:</b> 07/22/2022
<b>Description:</b> <b>Concrete Cap Area (Englewood Yard):</b> Concrete cap within yard in good condition. Some cracking evident, particularly on edges of rows, with minimal vegetative growth. Facing southwest.  Lat: 29.784714 Long: -95.318419

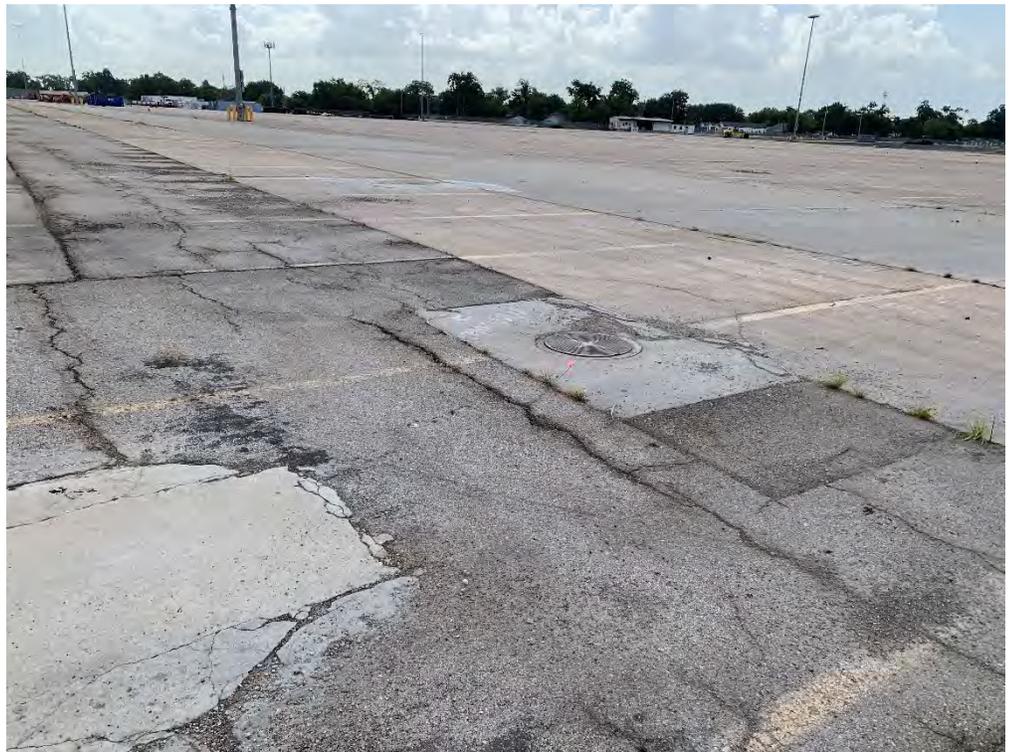
**Description:**  
**Concrete Cap Area (Englewood Yard)/NAPL Collection System:**  
NAPL Collection System in stalls B099-B110 in functional condition with evidence of cracking, residual stains, and minor vegetation growth. Facing southeast.

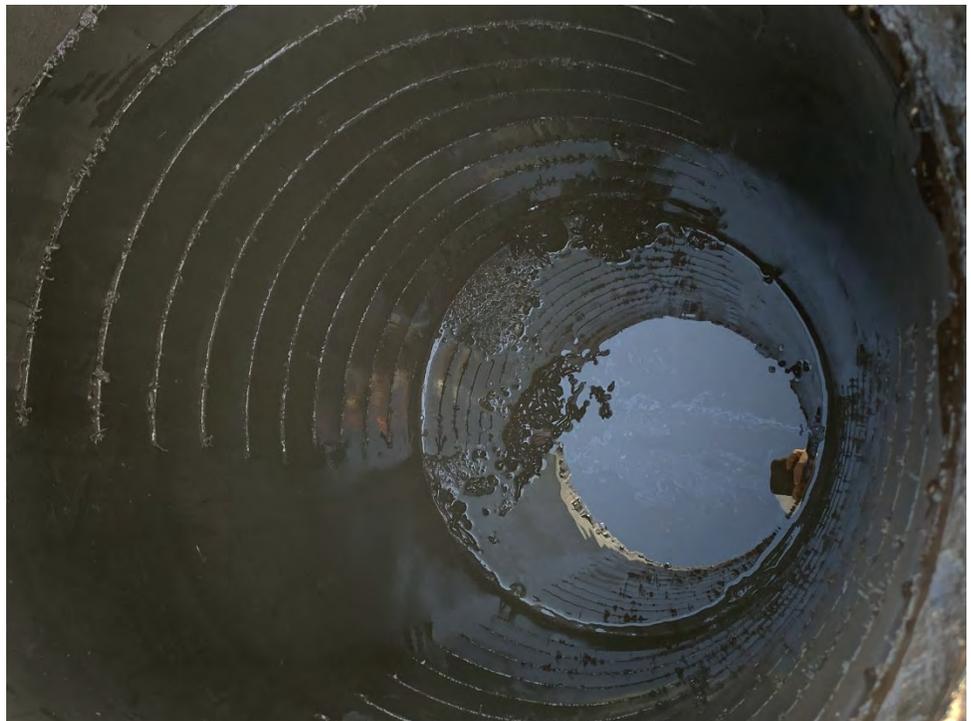
**Photo No.**  
24

**Description:**  
**Concrete Cap Area (Englewood Yard)/NAPL Collection System:**  
Sump B099/B100 following pump down event. This sump has historically exhibited higher water levels. A small amount of DNAPL (less than 0.1 gal) was recovered for the first time from this sump during the pumpdown. Water is brown in color, with sheen visible on recharge water.

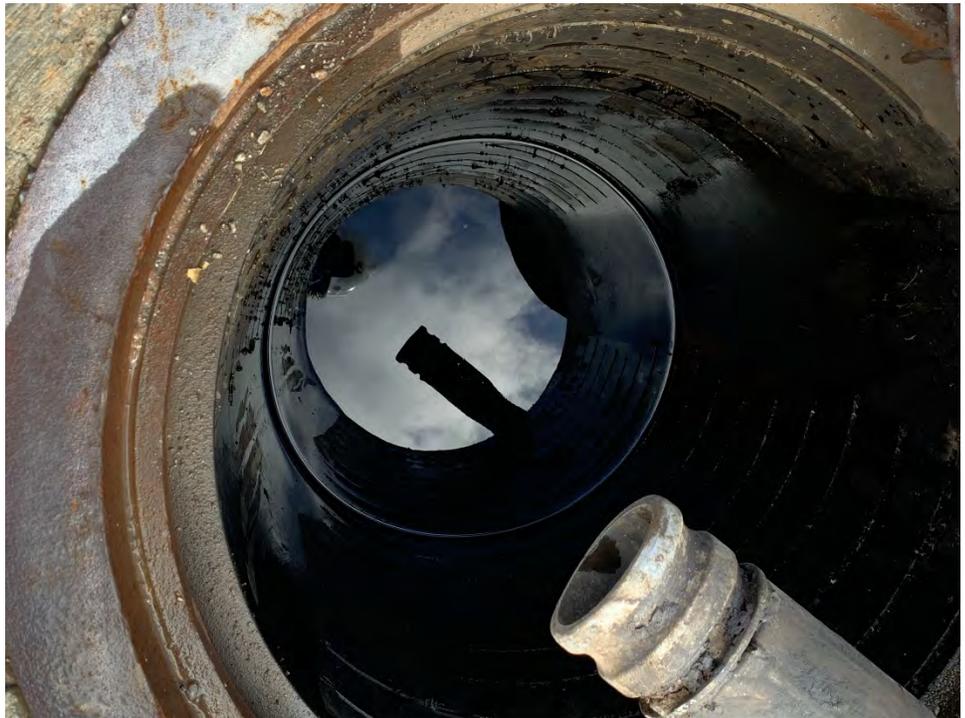
**Description:**  
**Concrete Cap Area**  
**(Englewood Yard)/NAPL**  
**Collection System:**  
Sump B103/B104, following pump down event. This sump has historically not produced any DNAPL. Water is brown in color, but no odor or sheen observed.

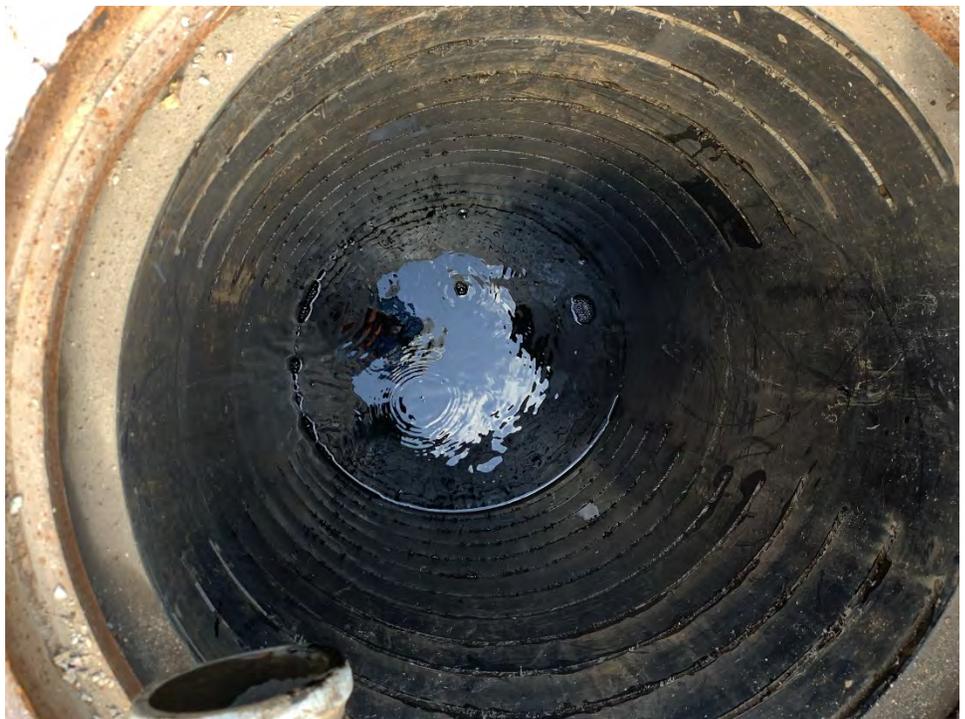
**Photo No.**  
26

**Description:**  
**Concrete Cap Area**  
**(Englewood Yard)/NAPL**  
**Collection System:**  
Sump B107/B108, following pump down event. This sump has occasionally produced small quantities of DNAPL, which is removed weekly if observed. Water is brown in color, but no odor or sheen observed.

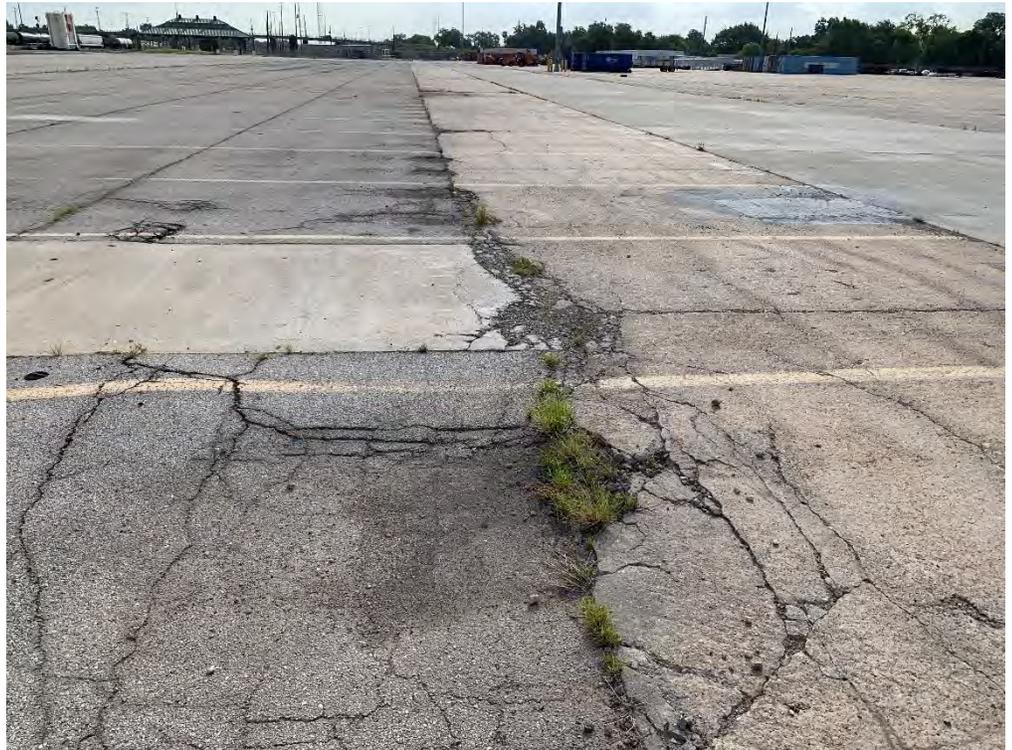
Concrete cap within yard in good condition. Some cracking evident, particularly on edges of rows, with minor vegetative growth. Facing east.

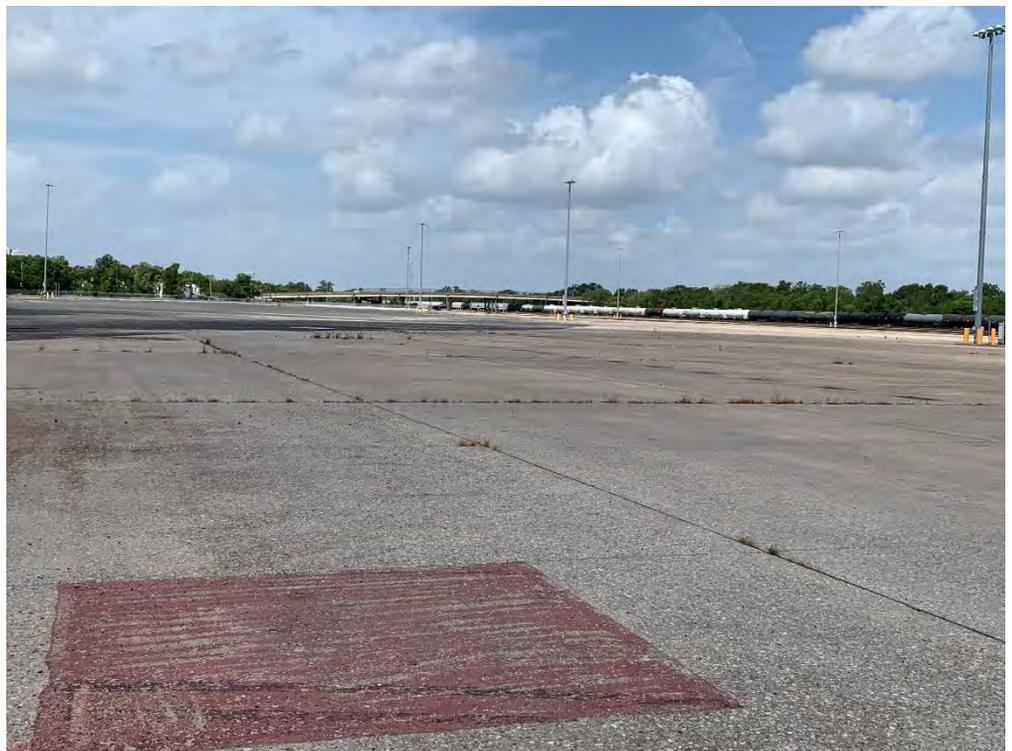
**Photo No.**  
28

Concrete cap within yard in good condition. Some cracking evident, particularly on edges of rows, with minimal vegetative growth. Facing southwest.

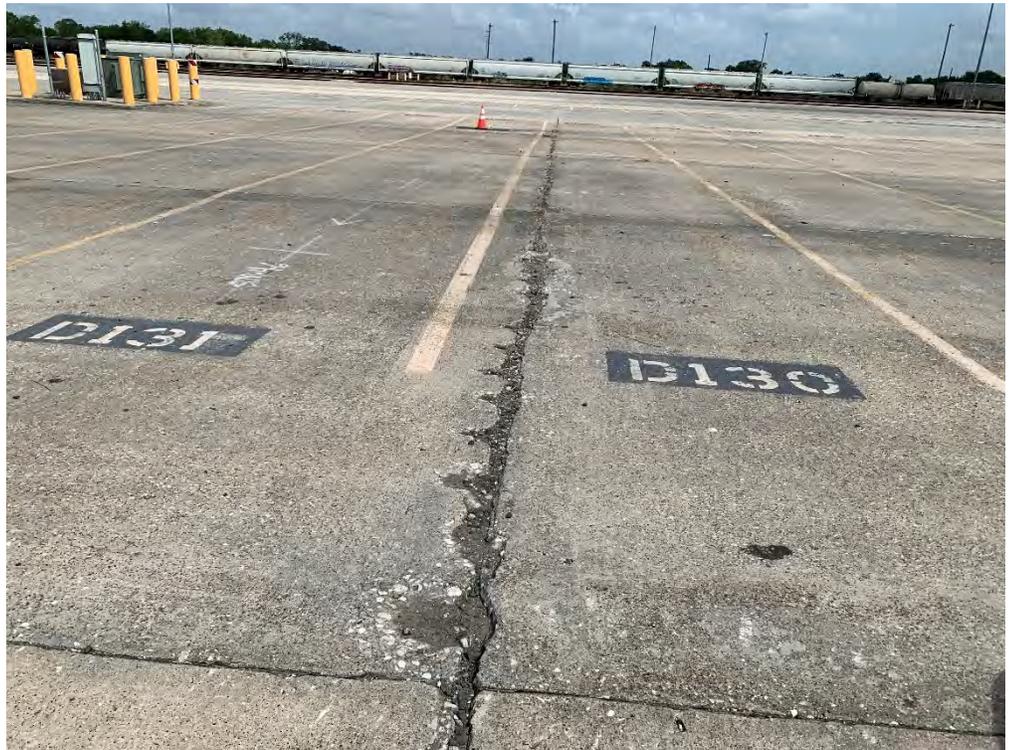
Stalls D130-D131, gapping and concrete wear along joint.

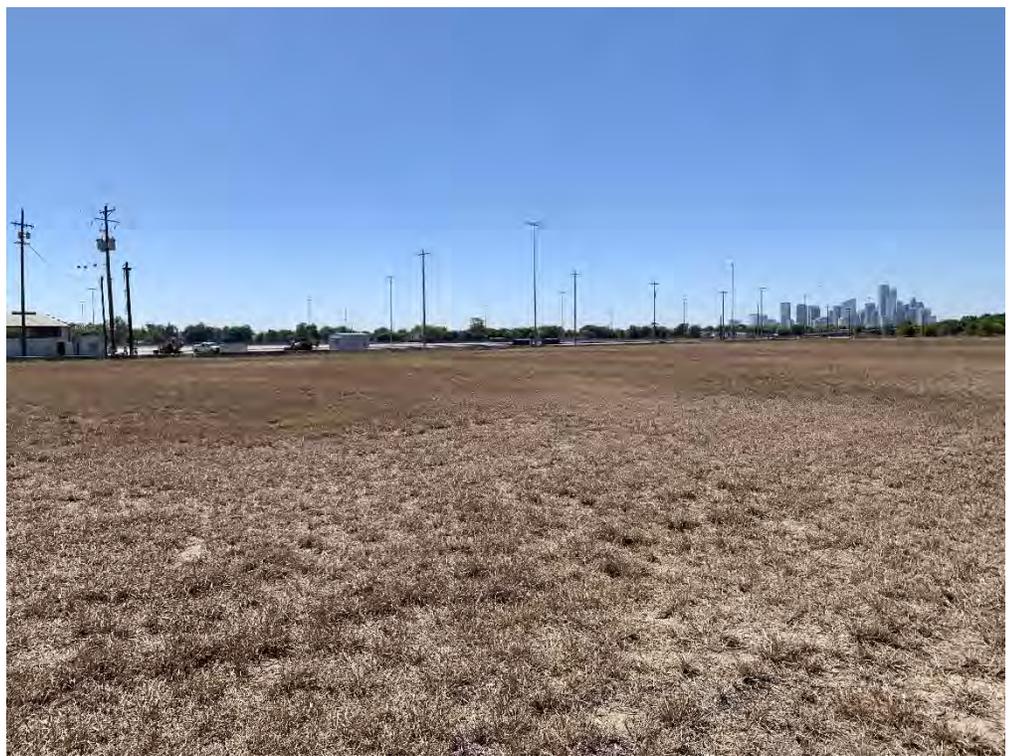
Soil cap well-vegetated in most areas with some stressed areas due to lack of rain and a low risk of erosion. Most vegetation is dormant, with some areas of new growth. No major erosion or ruts observed during inspection. Facing southwest.
