**RE: POST-RESPONSE ACTION COMPLETION REPORT – 2022  
UNION PACIFIC RAILROAD HOUSTON WOOD PRESERVING WORKS, HOUSTON, TEXAS  
4910 LIBERTY ROAD, HOUSTON, HARRIS COUNTY, TEXAS  
TCEQ SWR NO. 31547; TCEQ PERMIT/COMPLIANCE PLAN NO. 50343 EPA ID NO. TXD000820266  
CUSTOMER NO. CN600131098; REGULATED ENTITY NO. RN100674613**

# TEXAS COMMISSION ON ENVIRONMENTAL QUALITY Post-Response Action Care Report (PRACR)

**SECOND QUARTER 2022 (APRIL 27<sup>th</sup>) INSPECTION RECORD AND PHOTOGRAPHIC LOG**

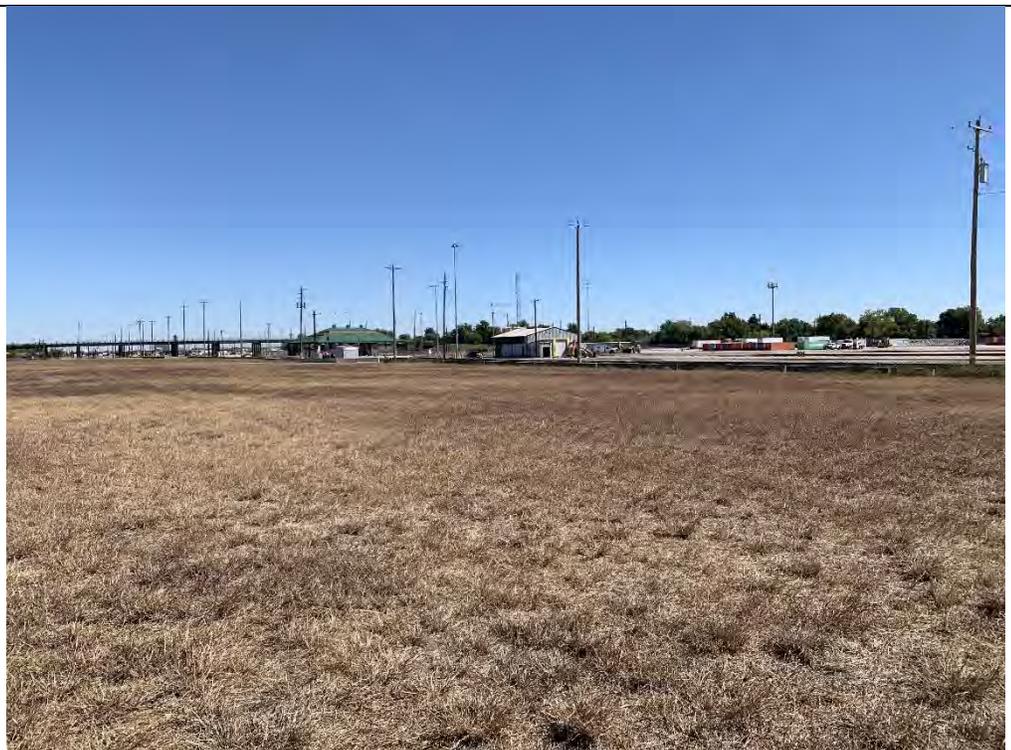
<b>Photo No.</b> <b>2</b>	<b>Date:</b> 10/19/2022
------------------------------	----------------------------

Soil cap well-vegetated in most areas with some stressed areas due to lack of rain and a low risk of erosion. Most vegetation is dormant. No major erosion or ruts observed during inspection. Facing southeast.

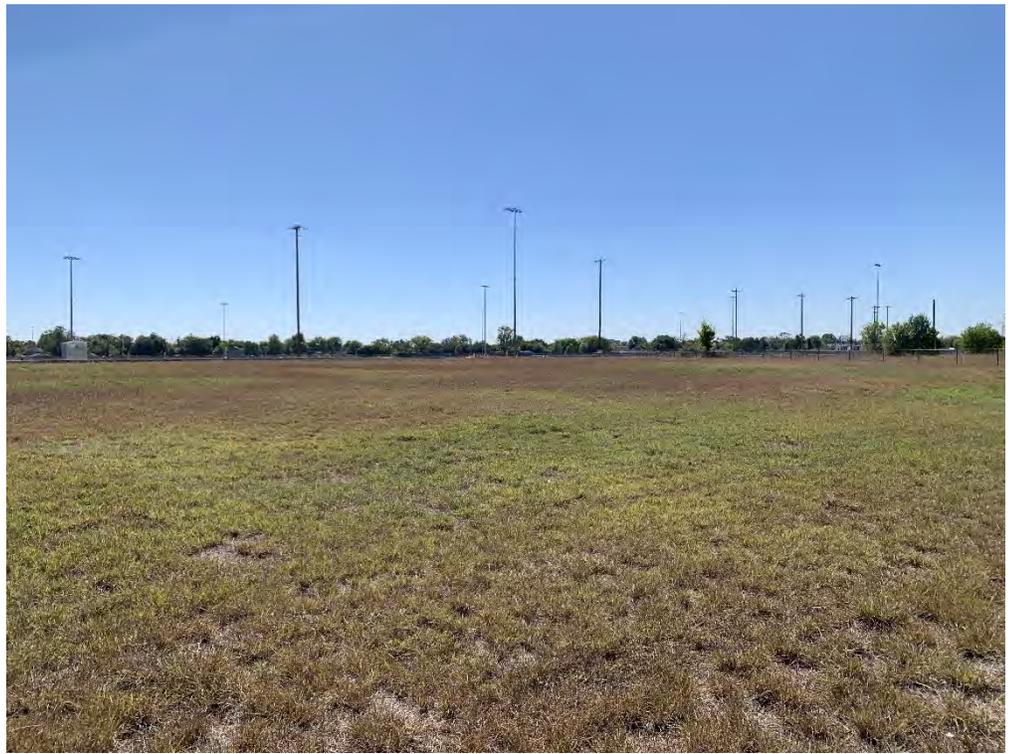
<b>Photo No.</b> 3	<b>Date:</b> 10/19/2022
<b>Description:</b>  <u><b>HWPW Yard Area and Soil Cap:</b></u>  Soil cap well-vegetated in most areas with a low risk of erosion, minor bald patches observed. Most vegetation is dormant with some areas of new growth. Facing southwest.  Lat: 29.786678 Long: -95.320647

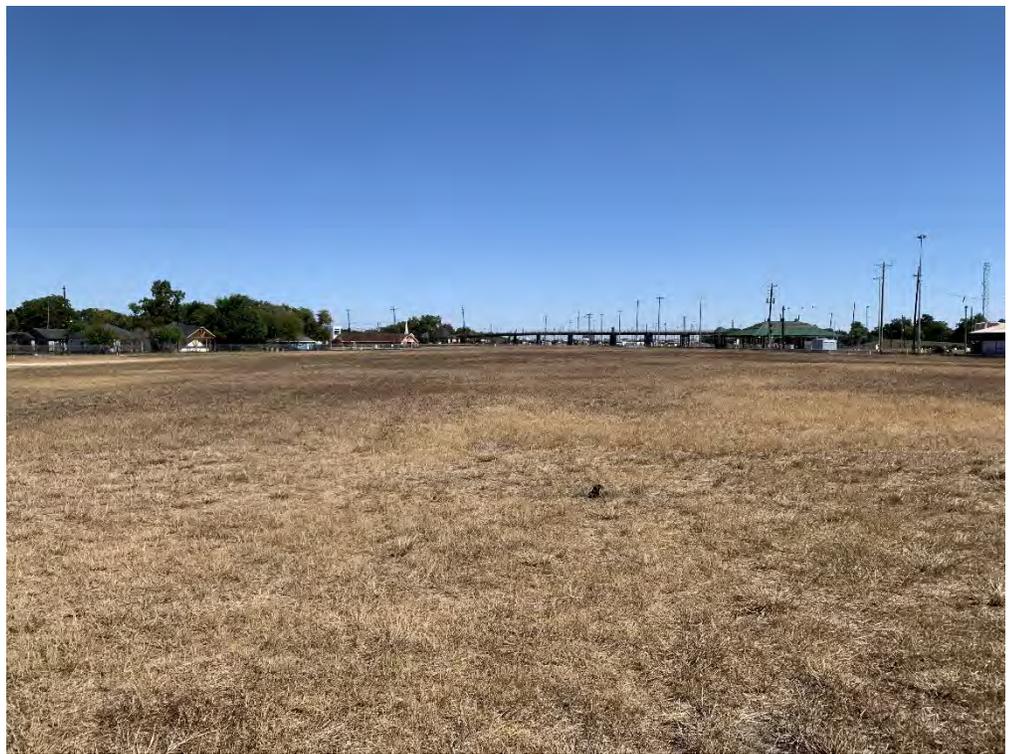
<b>Photo No.</b> 4	<b>Date:</b> 10/19/2022
<b>Description:</b>  <u><b>HWPW Yard Area and Soil Cap:</b></u>  Soil cap well-vegetated in most areas with a low risk of erosion. Most vegetation is dormant, some minor areas of stressed vegetation due to lack of rain noted. Facing east.  Lat: 29.786953 Long: -95.320297

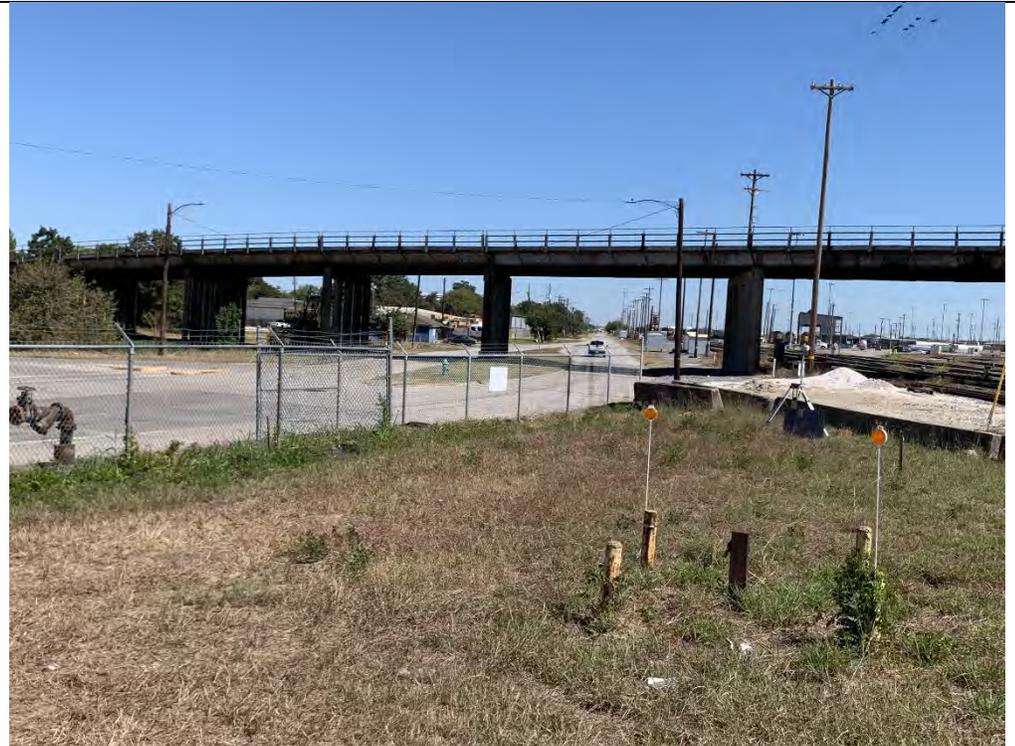
**Photo No.**  
6

Soil cap well-vegetated in most areas with a low risk of erosion. Fence and barrier damage from car wreck has been repaired. Facing east.

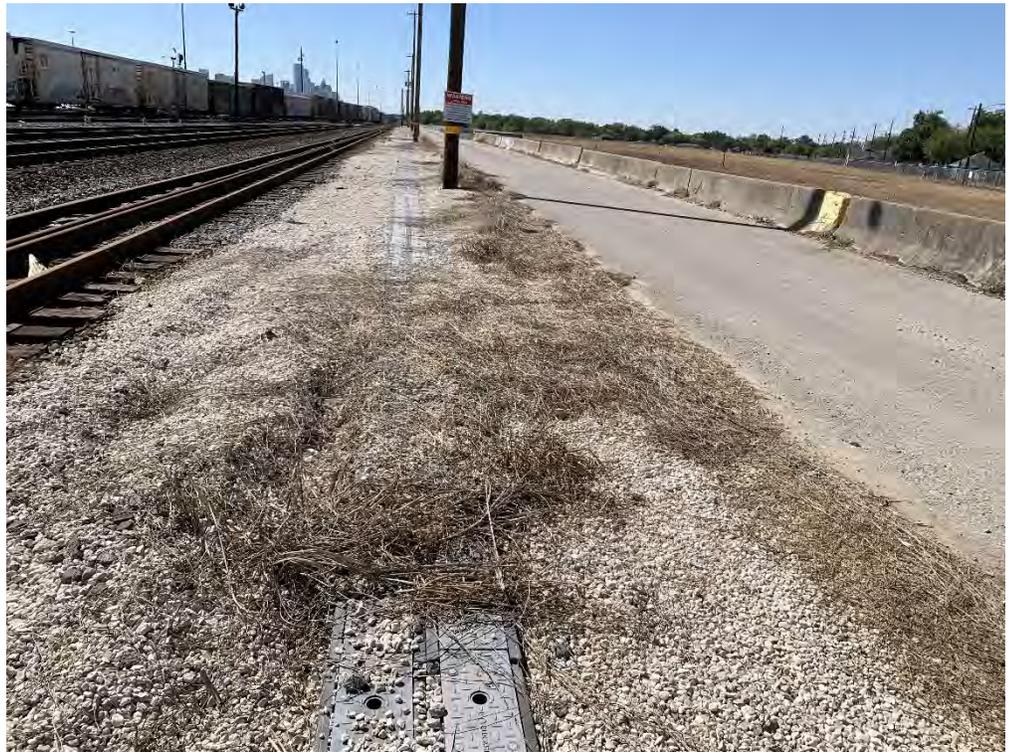
Asphalt roadway in good condition, free of major cracking/damage. Dead vegetation within the ballast cap. Minor vegetation growth under concrete barrier. Facing west.

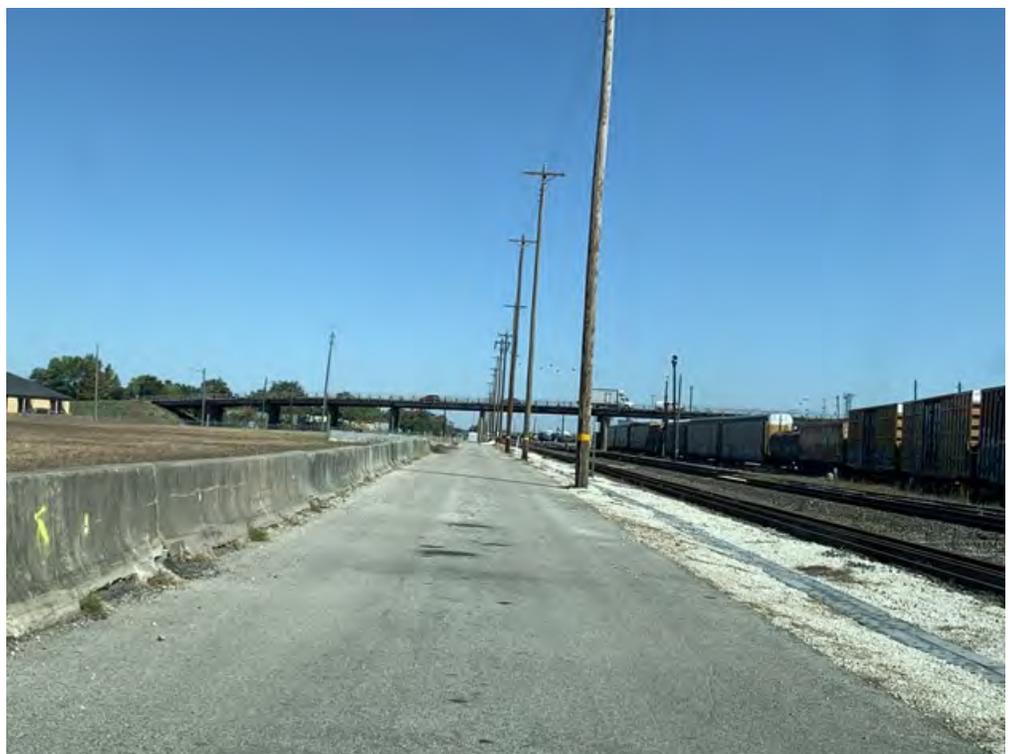
**Photo No.**  
8

Asphalt roadway in good condition, free of major cracking/damage. Residual oil staining noted from ongoing construction project. Minor vegetation noted growing within the ballast cap and under concrete barrier. Facing east.

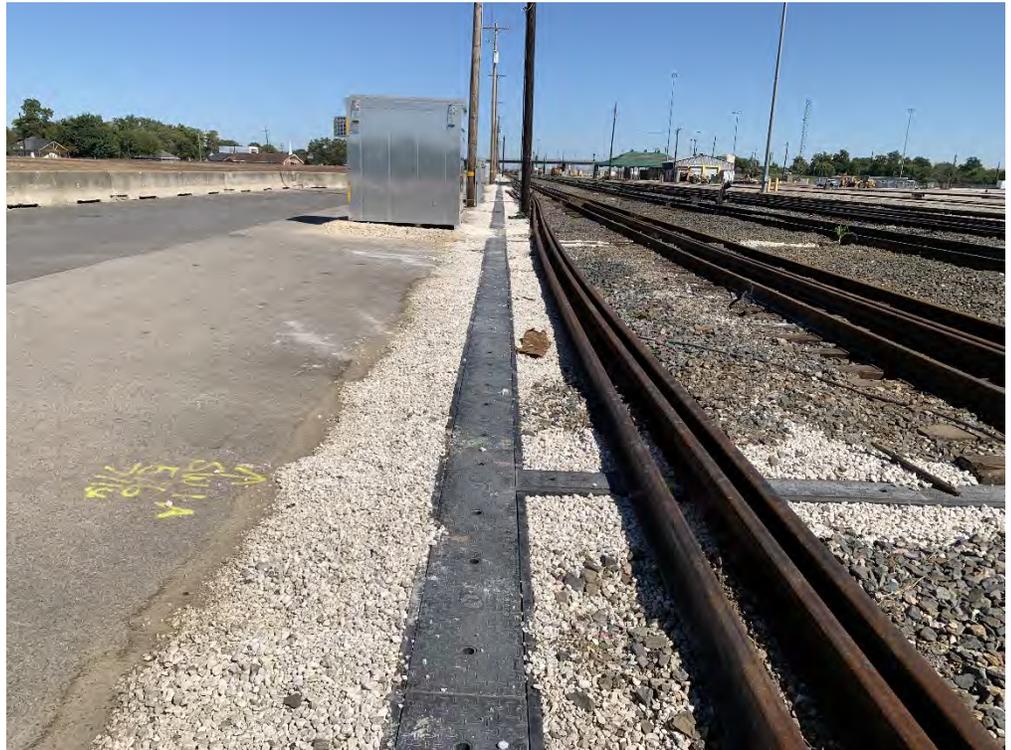
<b>Photo No.</b> 9	<b>Date:</b> 10/19/2022
<b>Description:</b>  <u><b>Asphalt Roadway:</b></u>  Asphalt roadway in good condition, free of major cracking/damage. Ballast cap in good condition. Facing northeast.  Lat: 29.785786 Long: -95.320528

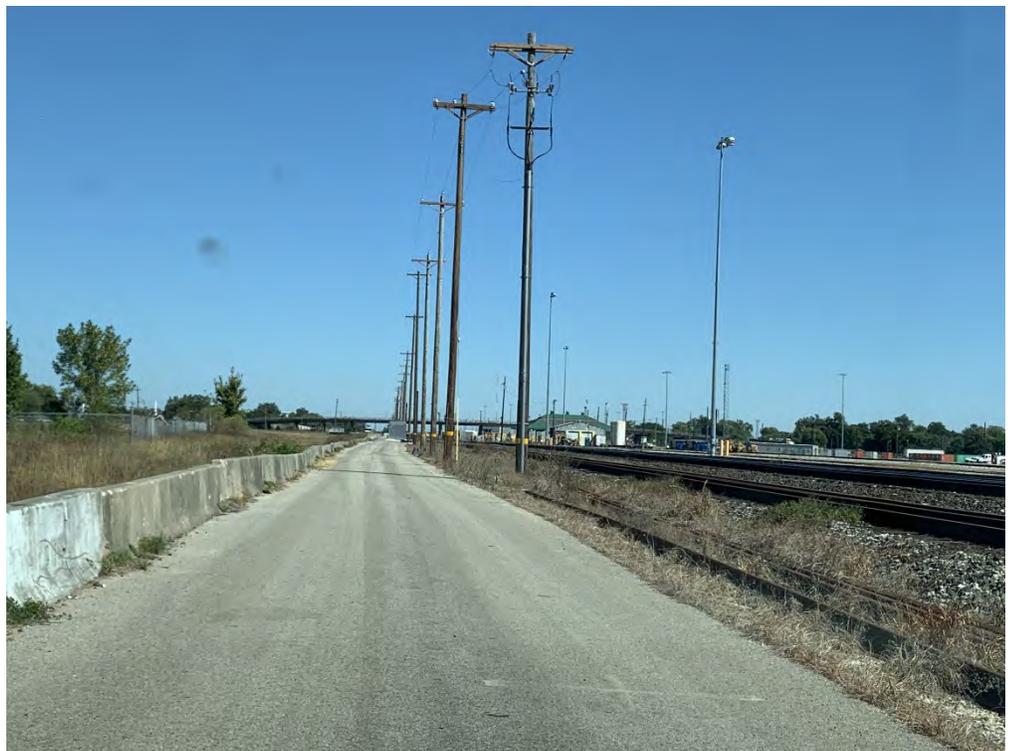
<b>Photo No.</b> 10	<b>Date:</b> 10/19/2022
<b>Description:</b>  <u><b>Ballast Cap, Soil Cap Vegetative Cover, and Asphalt Roadway:</b></u>  Asphalt roadway in good condition, free of major cracking/damage. Vegetation growing under barriers and ballast cap. Facing east.  Lat: 29.785383 Long: -95.321539

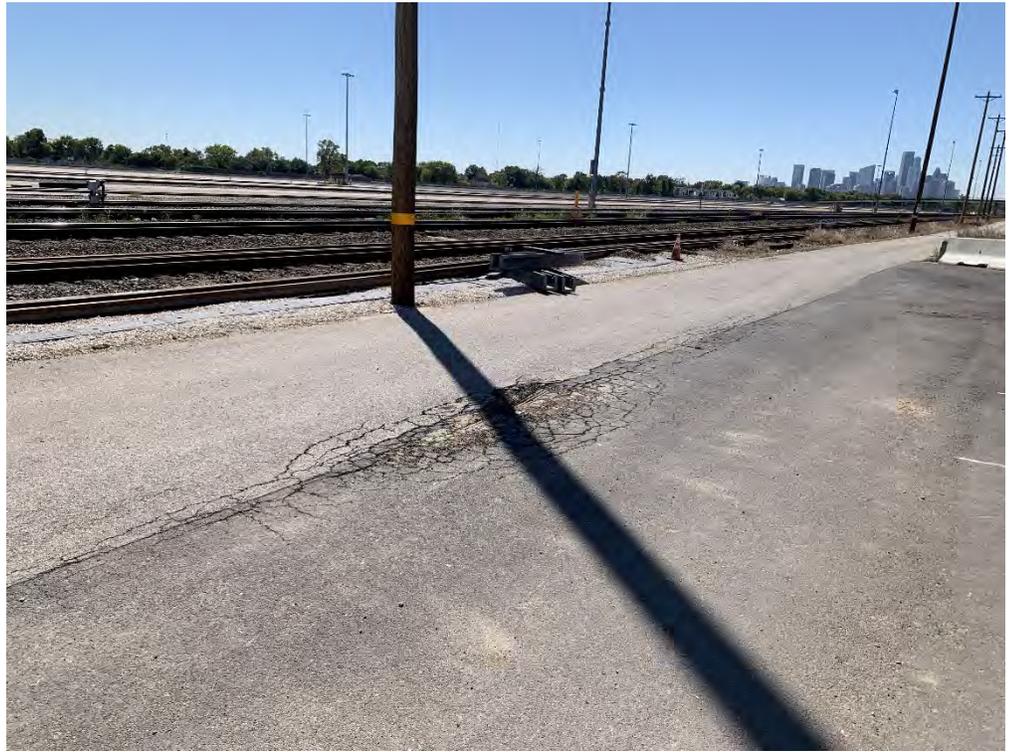
Minor cracking in asphalt where the asphalt roadway meets the new asphalt pull out section. Facing southwest.

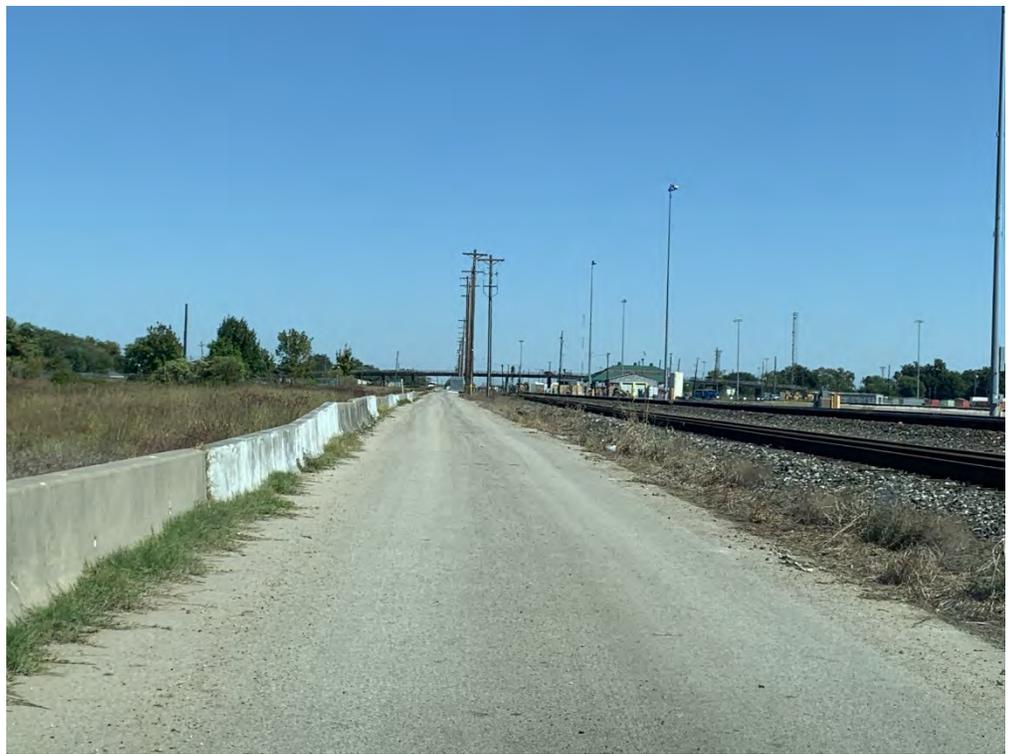
**Photo No.**  
 12

Asphalt roadway in good condition, free of major cracking/damage. Some vegetation can be noted under the concrete barriers and ballast cap. Facing west.

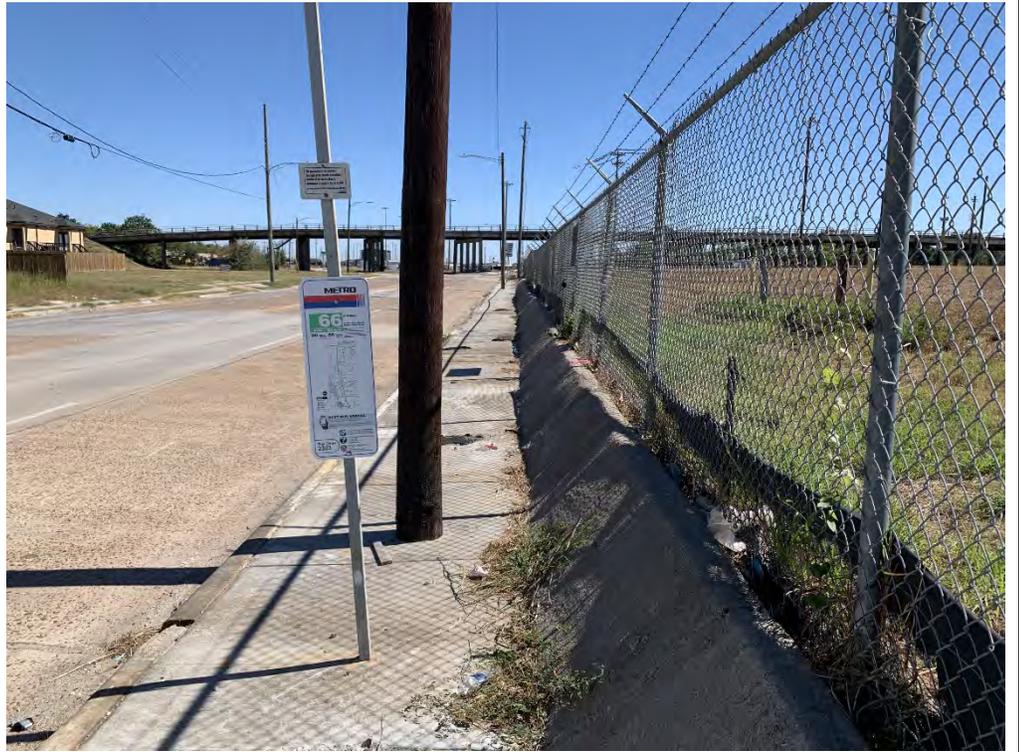
<b>Photo No.</b> 13	<b>Date:</b> 10/19/2022
<b>Description:</b>  <b><u>Security Fence/Sidewalk Area:</u></b>  Sidewalk outside security fence in good condition. Minor vegetation growth in joints. Facing east.  Lat: 29.787681 Long: -95.317747

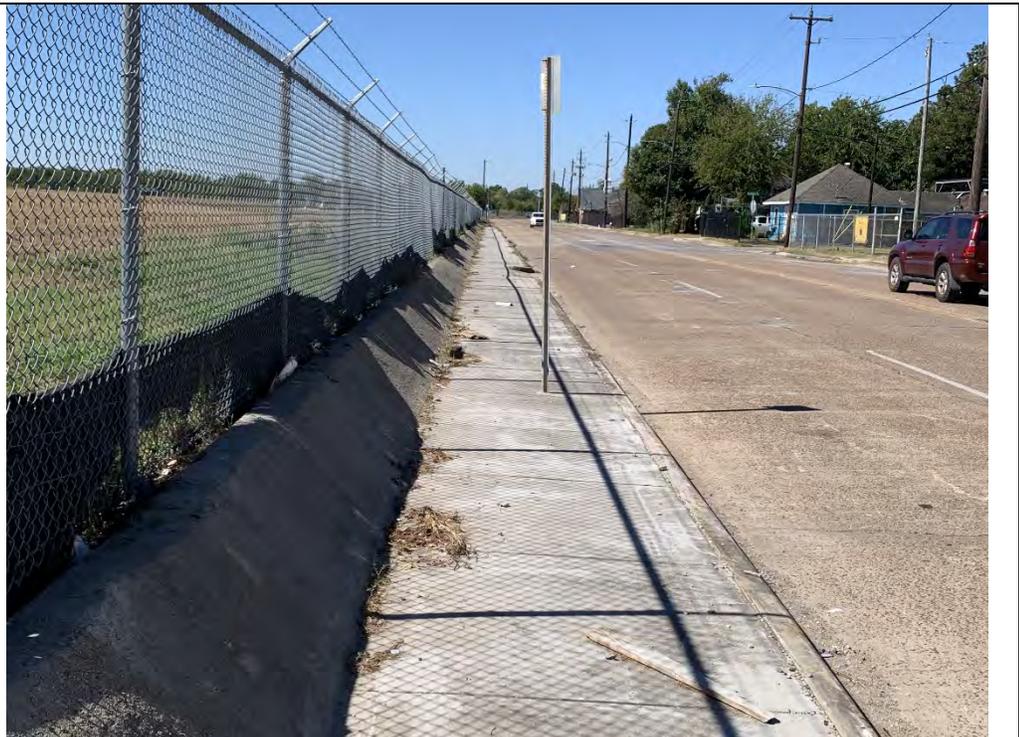
<b>Photo No.</b> 14	<b>Date:</b> 10/19/2022
<b>Description:</b>  <b><u>Security Fence/Sidewalk Area:</u></b>  Sidewalk outside security fence in good condition. Minor vegetation growth in joints. Facing west.  Lat: 29.787681 Long: -95.317747

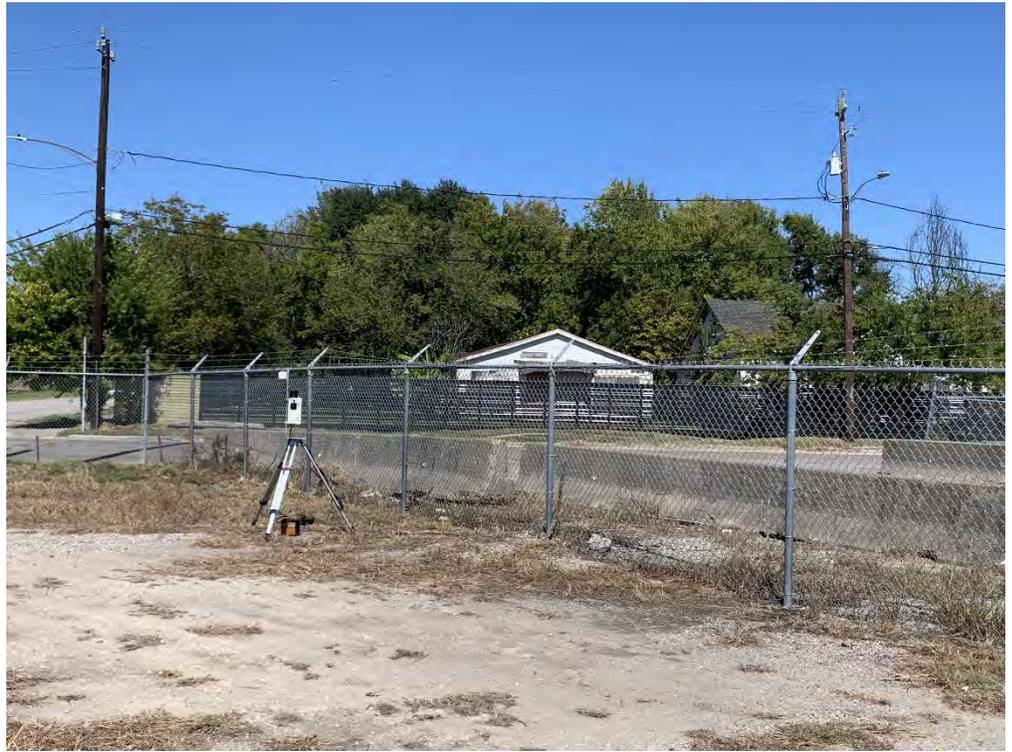
Main gate and security fence in good condition. Some areas have sagging or missing wire. Facing northeast.

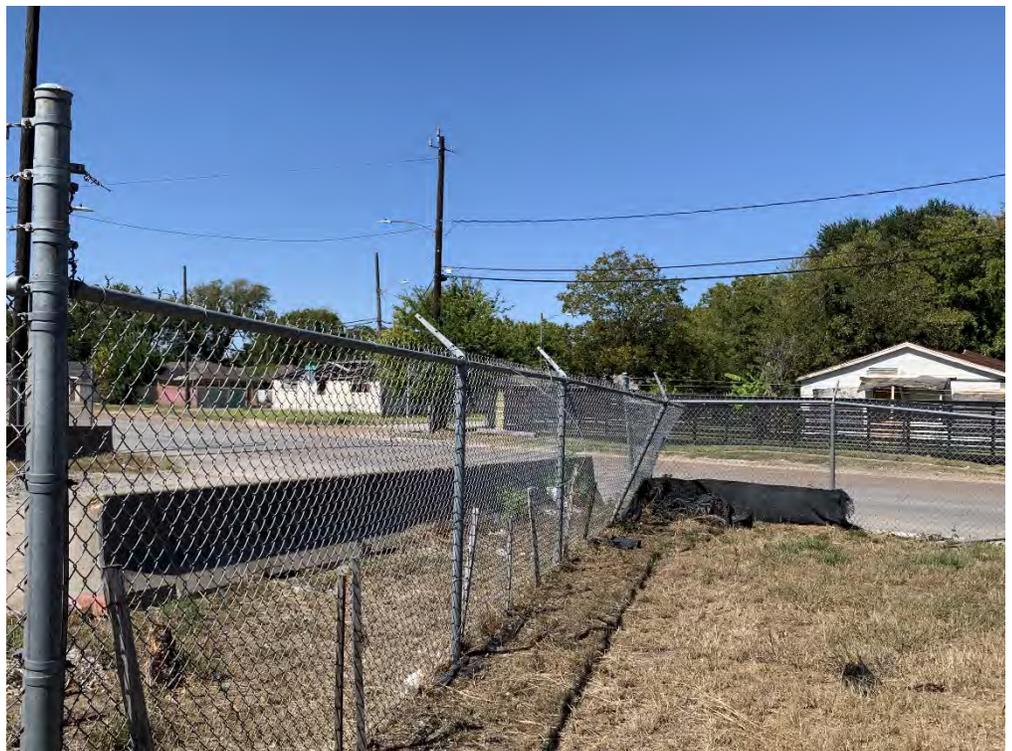
**Photo No.**  
 16

Minor damage to security fence and missing wire next to the main gate, fence is still functional. Facing northwest.

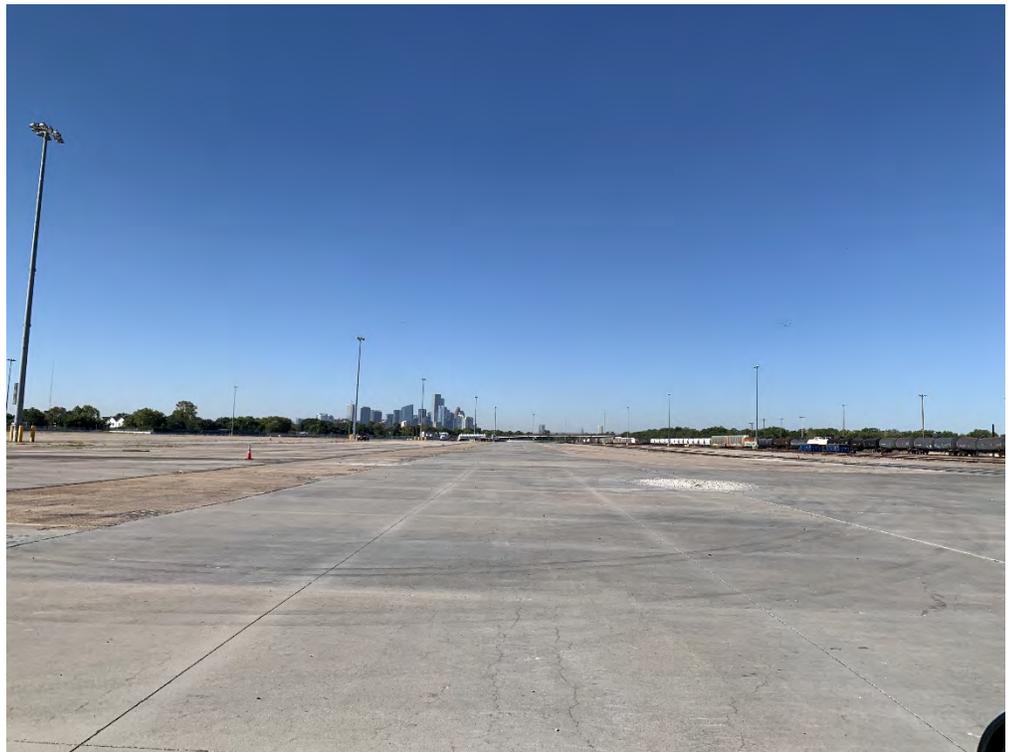
Concrete cap within yard in good condition. Some cracking and potholes, with minimal vegetative growth. Facing west.

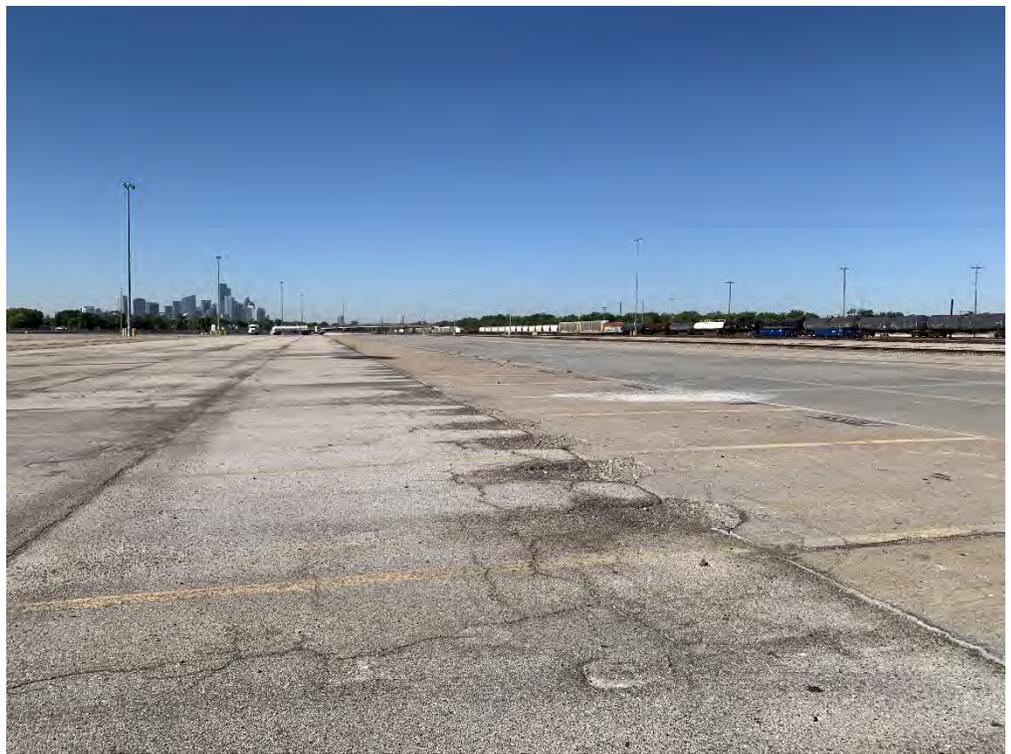
**Photo No.**  
 18

A and B rows. Evidence of cracking/potholes in multiple spots (particularly along the asphalt concrete joint). Facing west.

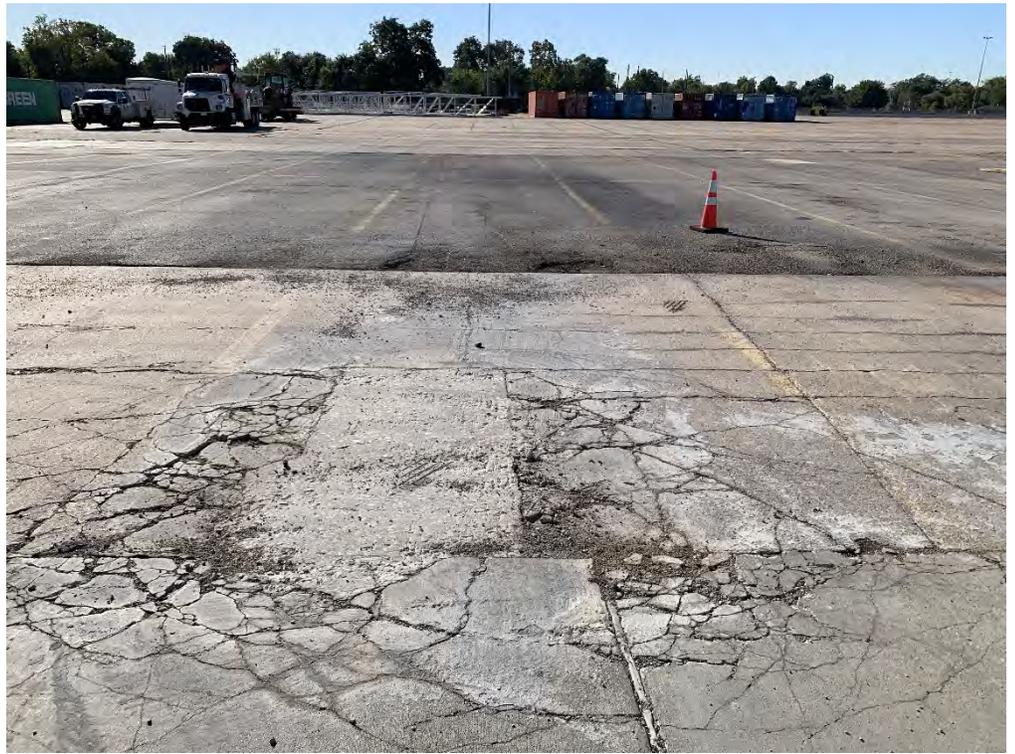
Cracking in concrete surrounding test pit patch in stall A010. Facing south.

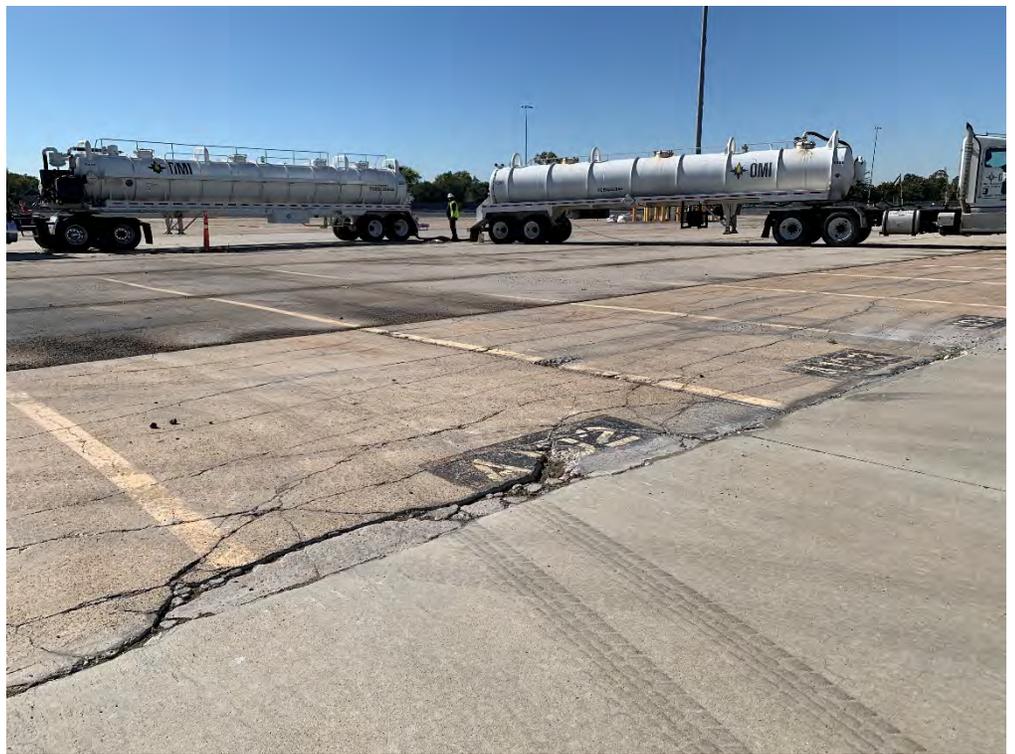
**Photo No.**  
20

Cracking in concrete in stall A102. Facing southwest.

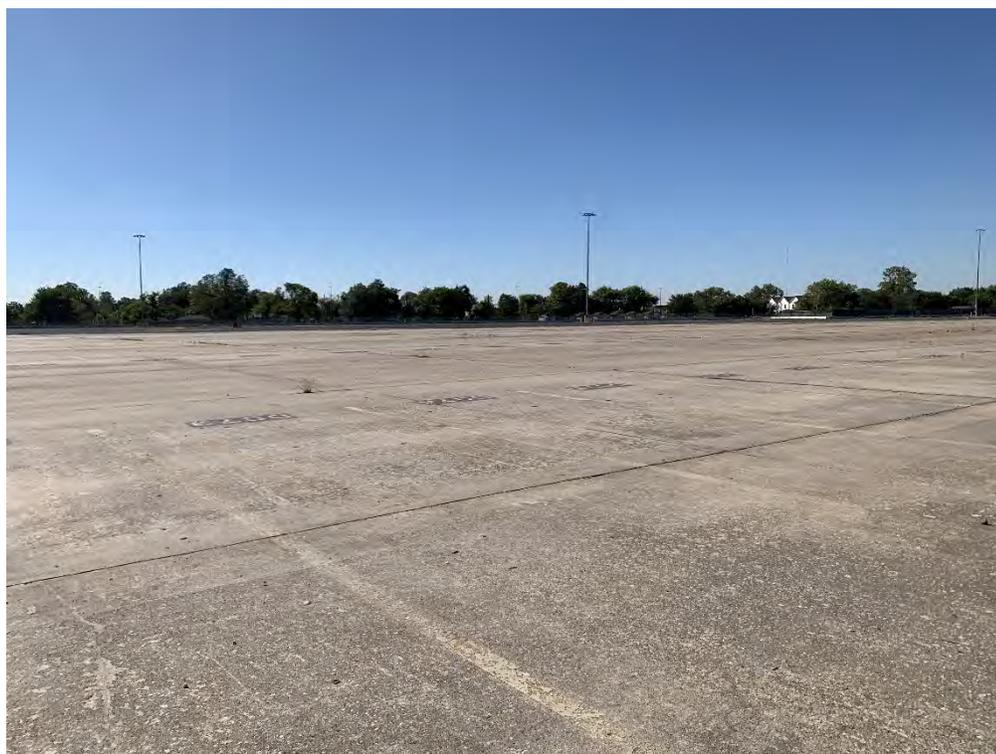
Western end of D row, concrete cap in good condition, localized vegetation along joints. Facing southwest.

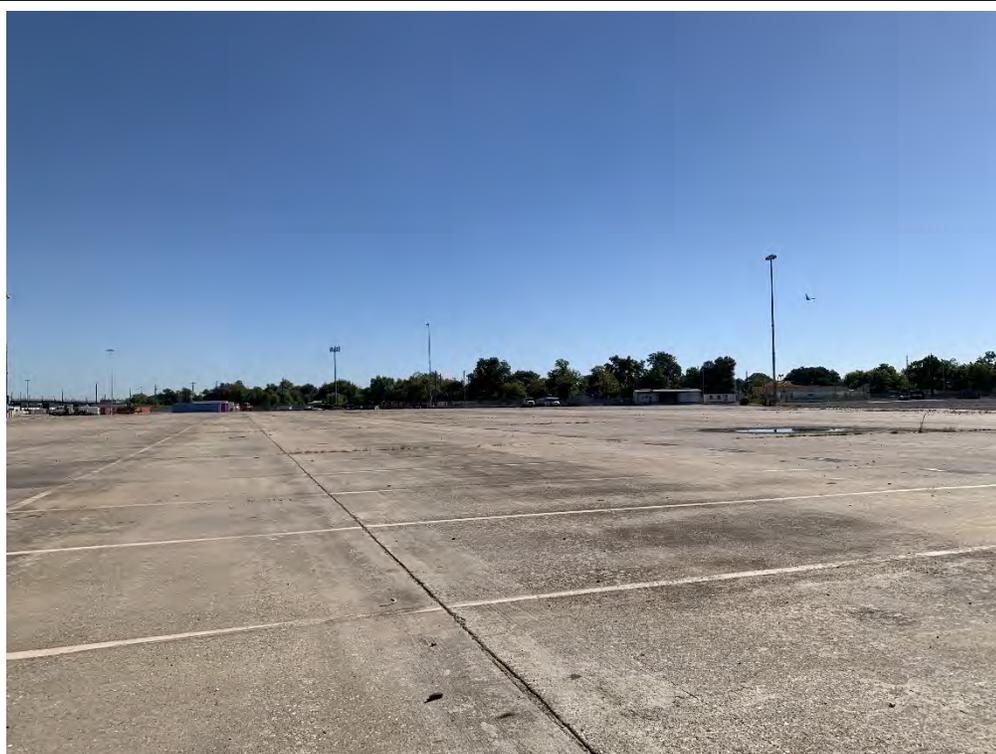
**Photo No.**  
 22

Western end of E and F rows. Concrete cap in good condition, small area of rainwater pooling, localized vegetation along joints. Facing east.

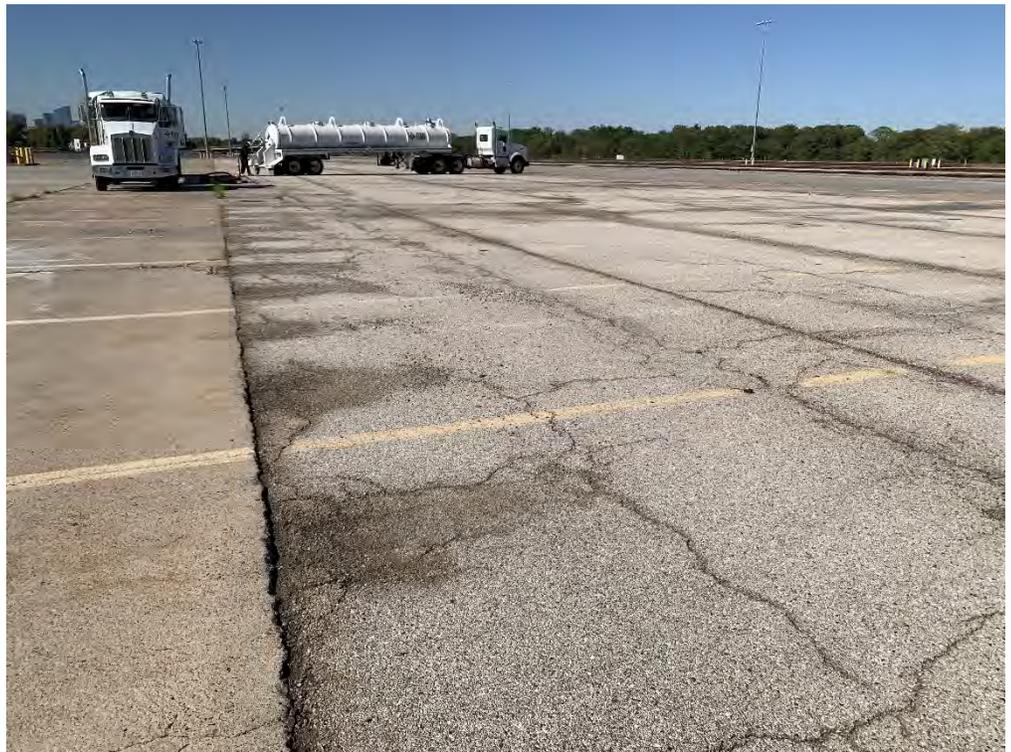
NAPL Collection System (stalls B099-B110) area, cracking in asphalt, residual staining. NAPL Collection system pump down in progress. Facing west.

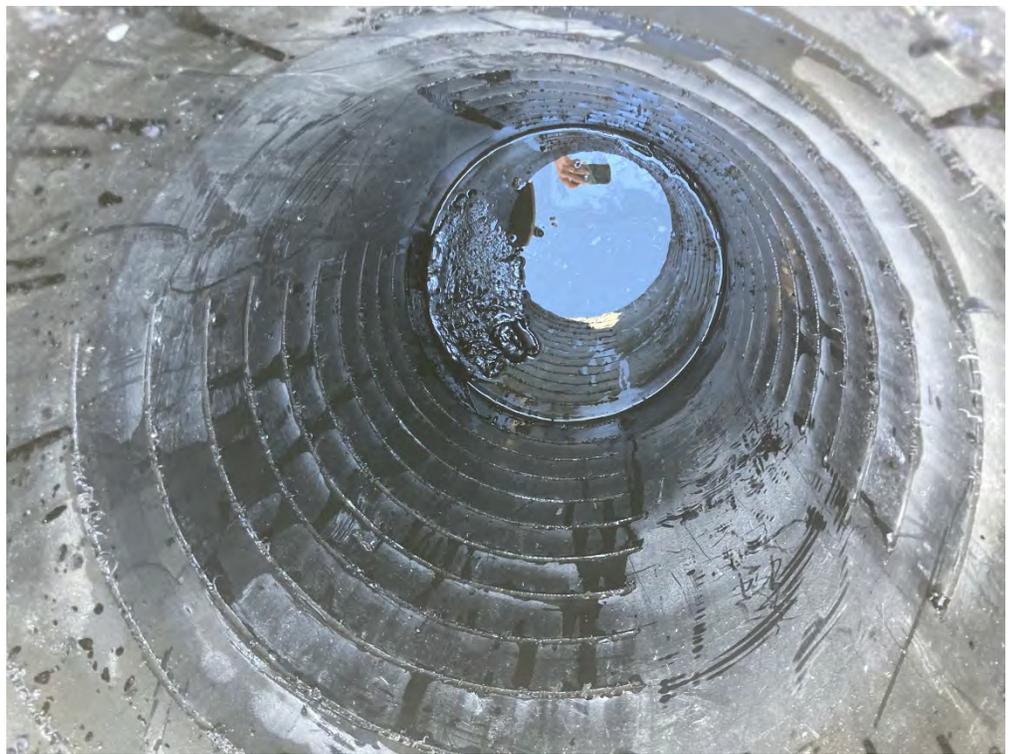
**Photo No.**  
24

Sump B099/B100, empty immediately following pump down. This sump has historically exhibited higher water levels and occasionally produced small amounts of DNAPL in 2022, which is removed weekly if observed. Sheen noted on thin layer of recharge water.

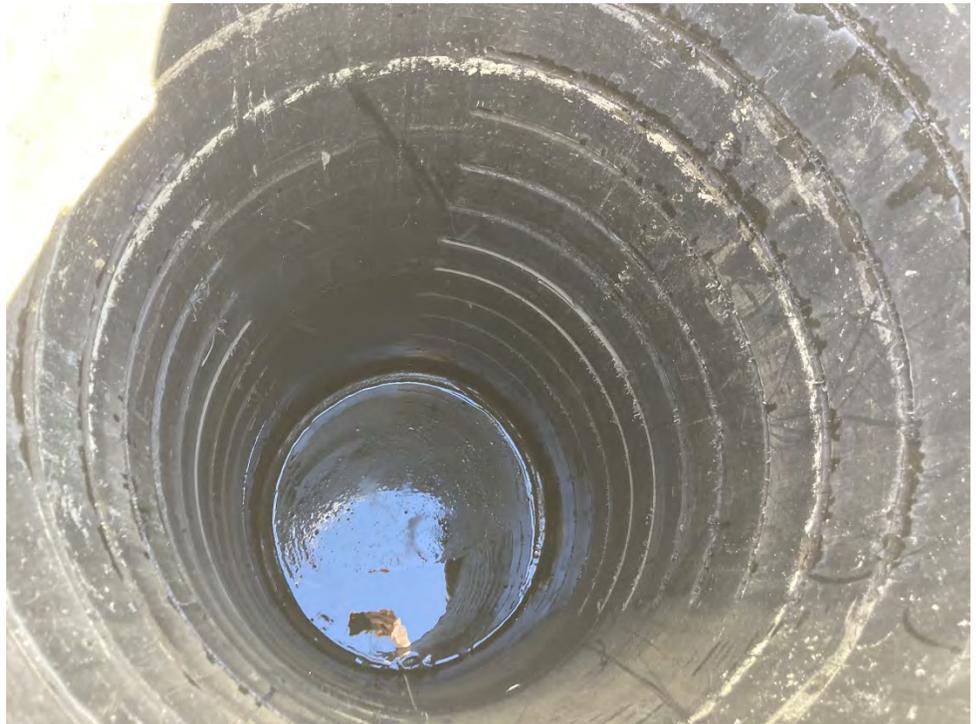
<b>Photo No.</b> 25	<b>Date:</b> 10/19/2022
<b>Description:</b>	
<b><u>Concrete Cap Area (Englewood Yard)/NAPL Collection System:</u></b>	
Sump B103/B104, empty immediately following pump down. This sump has historically not produced any DNAPL.	
Lat: 29.782336 Long: -95.324678

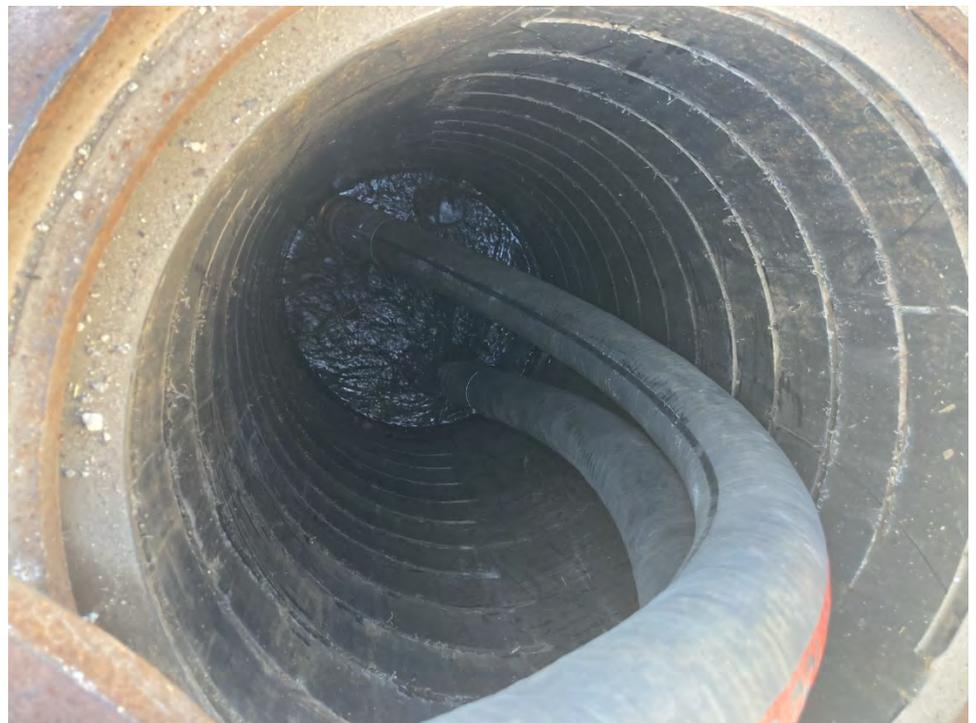
<b>Photo No.</b> 26	<b>Date:</b> 10/19/2022
<b>Description:</b>	
<b><u>Concrete Cap Area (Englewood Yard)/NAPL Collection System:</u></b>	
Sump B107/B108, water continued to flow into the sump during pump down. This sump has occasionally produced small quantities of DNAPL, which is removed weekly if observed. Water is brown in color, but no odor or sheen observed.	
Lat: 29.782331 Long: -95.324692

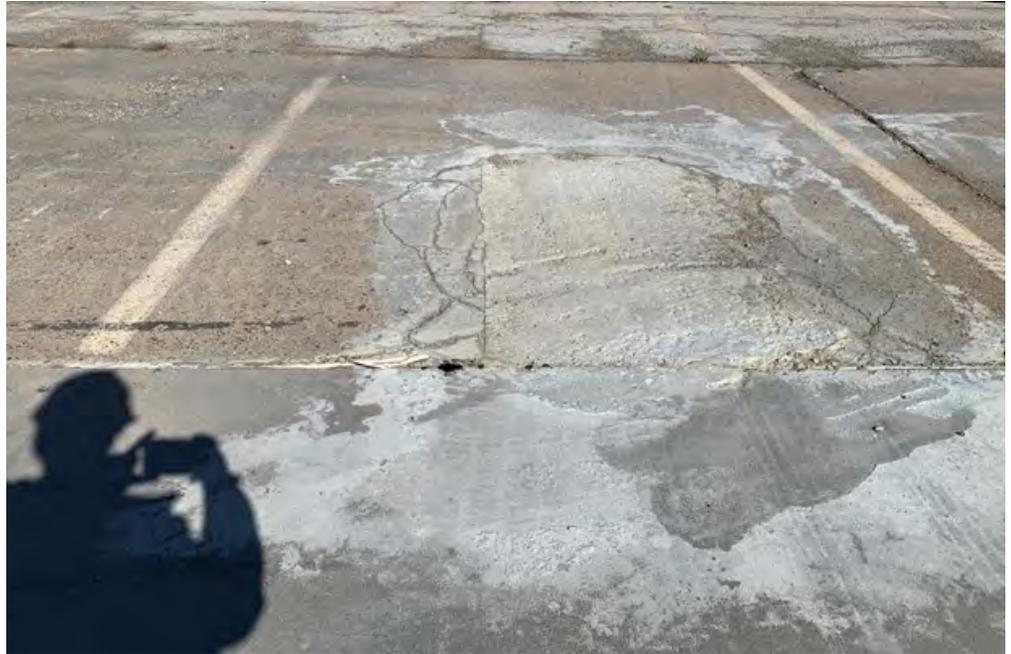
Stall B096, small amount of tar-like material observed near historical seep location along concrete joint adjacent to July 2020 test pit.

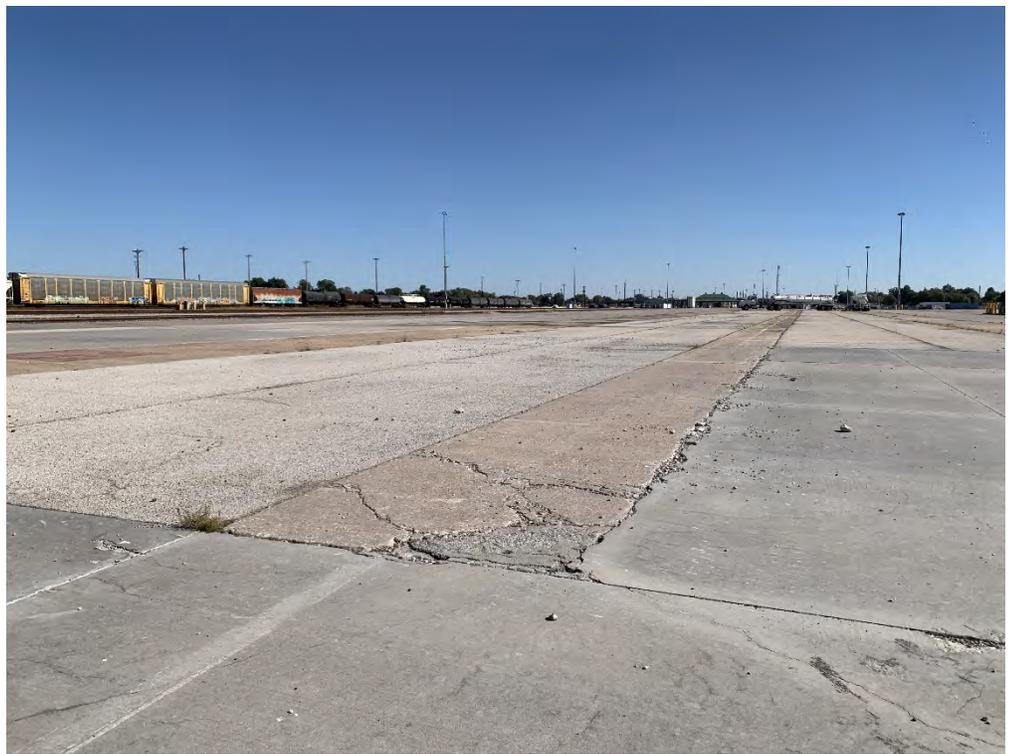
**Photo No.**  
28

Western end of concrete cap, minor cracking, gapping and concrete wear along joint, similar wear can be observed several locations throughout the yard.

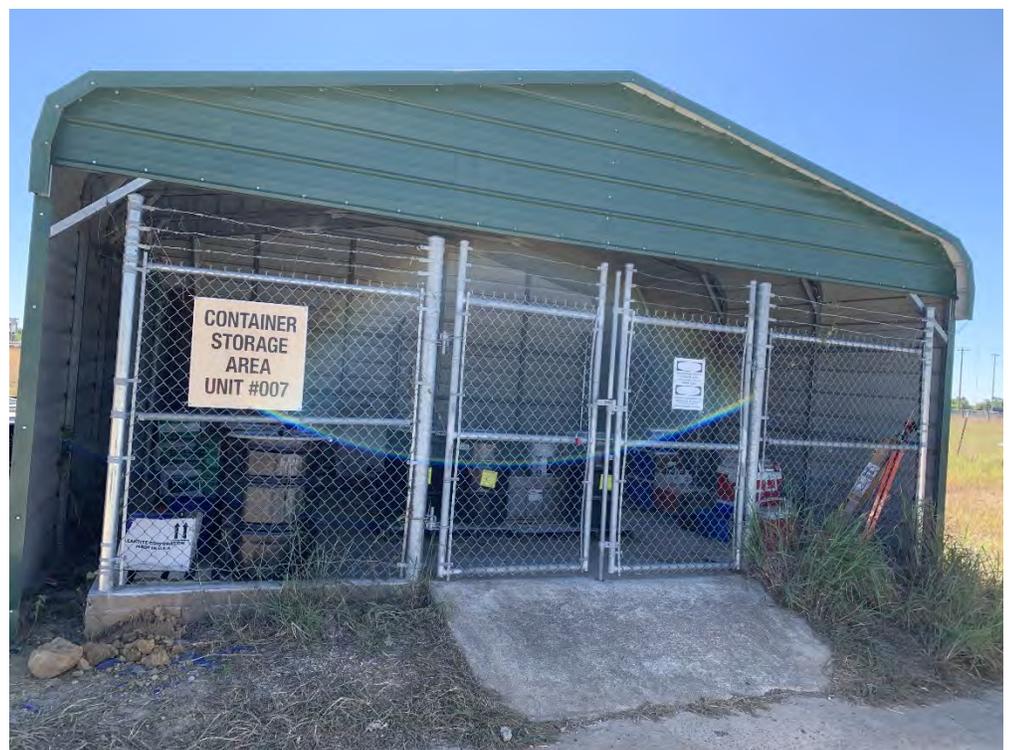
Valve in closed position and functioning within the container storage area. CSA in good condition, free of major dents and other damage. No water observed on floor.
