RE: WEEKLY STATUS UPDATE – ENGLEWOOD YARD NORTH BYPASS PROJECT UNION PACIFIC RAILROAD HOUSTON WOOD PRESERVING WORKS SITE 4910 LIBERTY ROAD FACILITY, HOUSTON, TEXAS POST-CLOSURE CARE PERMIT NO. 50343, INDUSTRIAL SWR NO. 31547

Week Period: May 15 through 21, 2023

# **Weekly Report of Air Monitoring**

For Period from 2023-05-15 to 2023-05-21

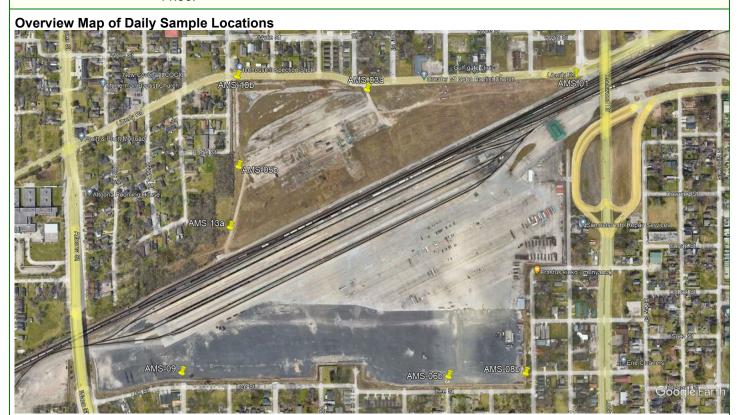
May 16, 2023

Work plan for the day included hydro-vacuuming, excavation and backfilling for signal tower foundations near the east end of the North Bypass Service Road of the former Houston Wood Preserving Works site, and also on the south side of the railroad tracks in the intermodal yard. Work occurred near the Lockwood overpass. Work hours were from approximately 08:00 – 11:00.

Station ID	Location Description	Start	Stop	Latitude	Longitude	Overall Average PM 2.5	Overall Average PM 10
AMS-01	HWPW - Erastus	08:57	11:47	29.78759	-95.31662	9 ug/m3	21.8 ug/m3
AMS-03a	HWPW - Solo North	08:32	11:10	29.78732	-95.32103	9.6 ug/m3	26 ug/m3
AMS-05b	HWPW - Eddie and Amboy	08:41	11:23	29.7859	-95.32376	8.2 ug/m3	20.5 ug/m3
AMS-06b	IMY South - Gagne	08:01	18:42	29.78203	-95.3193	5.8 ug/m3	16.6 ug/m3
AMS-08b	IMY SE - Fontinot	08:00	12:04	29.78209	-95.31766	9.4 ug/m3	25.5 ug/m3
AMS-09	IMY South - Waco and Lee	08:08	12:50	29.7821	-95.32497	8.3 ug/m3	20 ug/m3
AMS-10b	HWPW - Kashmere and Liberty	08:36	11:14	29.78756	-95.32379	8.2 ug/m3	20 ug/m3
AMS-13a	HWPW - Quitman East	08:46	11:34	29.78478	-95.32394	9.5 ug/m3	23.1 ug/m3

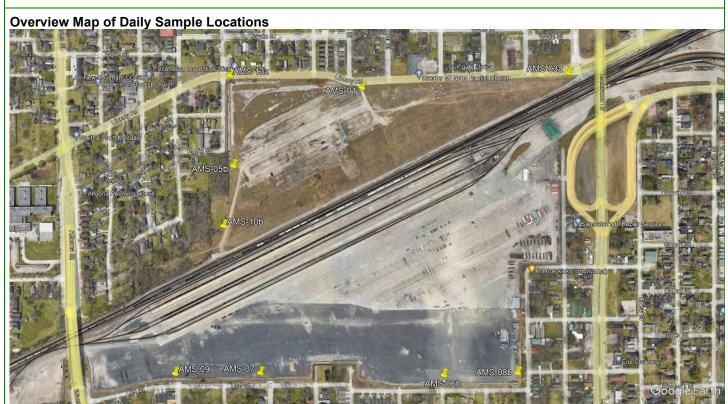
May 17, 2023

Work plan for the day included hydro-vacuuming, excavation and backfilling for signal tower foundations near the east end of the North Bypass Service Road of the former Houston Wood Preserving Works site, and also on the south side of the railroad tracks in the intermodal yard. Work occurred near the Lockwood overpass. Work hours were from approximately 07:45 -16:30.

Station ID	Location Description	Start	Stop	Latitude	Longitude	Overall Average PM 2.5	Overall Average PM 10
AMS-01	HWPW - Solo North	08:21	17:26	29.78734	-95.32103	7.9 ug/m3	16.9 ug/m3
AMS-03a	HWPW - Erastus	08:49	17:07	29.78761	-95.31664	7.9 ug/m3	17.9 ug/m3
AMS-05b	HWPW - Eddie and Amboy	08:32	17:18	29.7859	-95.32376	6.9 ug/m3	15.1 ug/m3
AMS-06b	IMY South - Gagne	09:50	16:56	29.78204	-95.31929	6.2 ug/m3	14.7 ug/m3
AMS-07	IMY South - Yates	12:37	17:01	29.78208	-95.32319	7.4 ug/m3	15.3 ug/m3
AMS-08b	IMY SE - Fontinot	07:47	16:55	29.78208	-95.31772	7.3 ug/m3	16 ug/m3
AMS-09	IMY South - Waco and Lee	07:51	17:01	29.78207	-95.325	6.9 ug/m3	15.4 ug/m3
AMS-10b	HWPW - Quitman East	08:39	17:14	29.78479	-95.32397	6.6 ug/m3	13.9 ug/m3
AMS-13a	HWPW - Kashmere and Liberty	08:27	17:23	29.78756	-95.32384	8.1 ug/m3	17.1 ug/m3

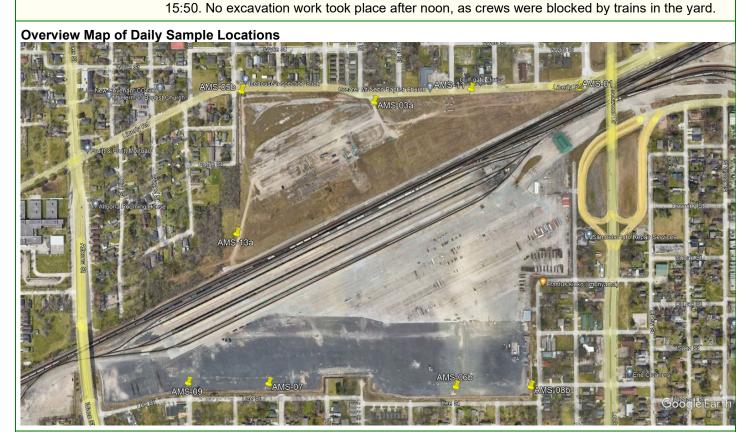
Station ID	Location Description	Start	Stop	Latitude	Longitude	Overall Average PM 2.5	Overall Average PM 10
AMS-01	HWPW - Erastus	08:17	16:05	29.78757	-95.31666	20.7 ug/m3	52.1 ug/m3
AMS-03a	HWPW - Solo North	08:35	16:19	29.78731	-95.32101	19.4 ug/m3	50.9 ug/m3
AMS-05b	HWPW - Kashmere and Liberty	08:30	16:16	29.78751	-95.32383	18.6 ug/m3	46.7 ug/m3
AMS-06b	IMY SE - Clementine	08:00	16:48	29.78206	-95.31927	15.5 ug/m3	45.5 ug/m3
AMS-07	IMY South - Yates	07:58	16:44	29.78212	-95.32325	19.2 ug/m3	52.8 ug/m3
AMS-08b	IMY SE - Fontinot	08:01	16:55	29.78206	-95.31768	19.8 ug/m3	51.9 ug/m3
AMS-09	IMY South - Waco and Lee	07:56	16:42	29.78213	-95.32496	1.2 ug/m3	1.2 ug/m3
AMS-11	HWPW - Clementine North	08:45	16:25	29.78755	-95.31895	19.8 ug/m3	52.3 ug/m3
AMS-13a	HWPW - Quitman East	08:21	16:10	29.78488	-95.32393	19.8 ug/m3	49.5 ug/m3

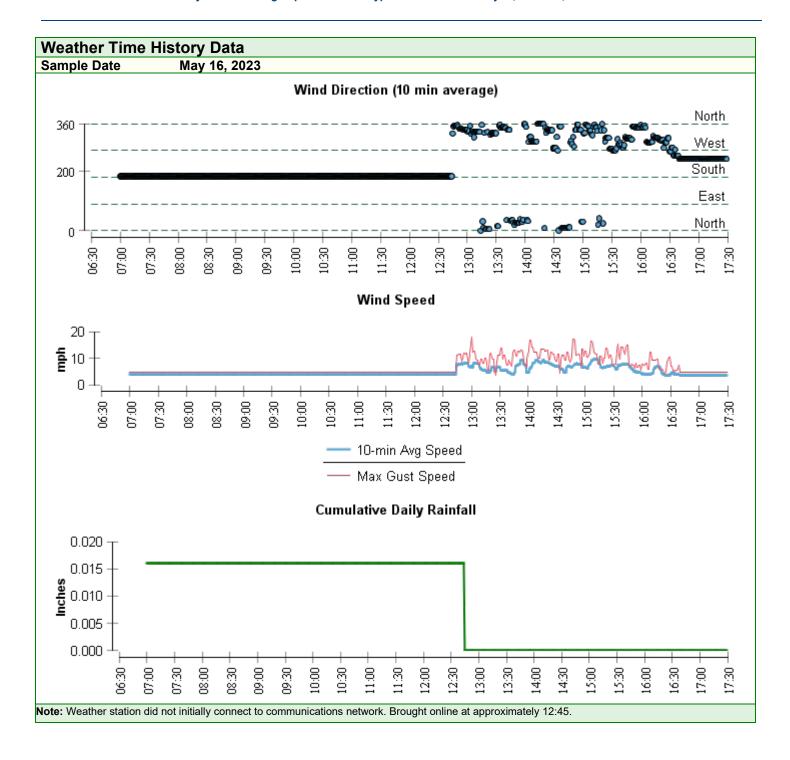
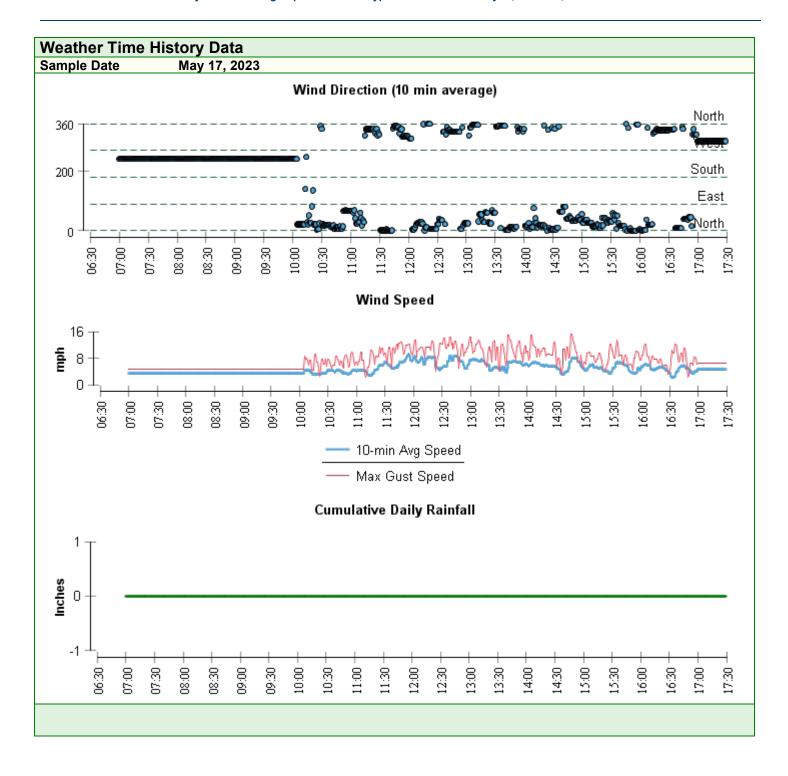
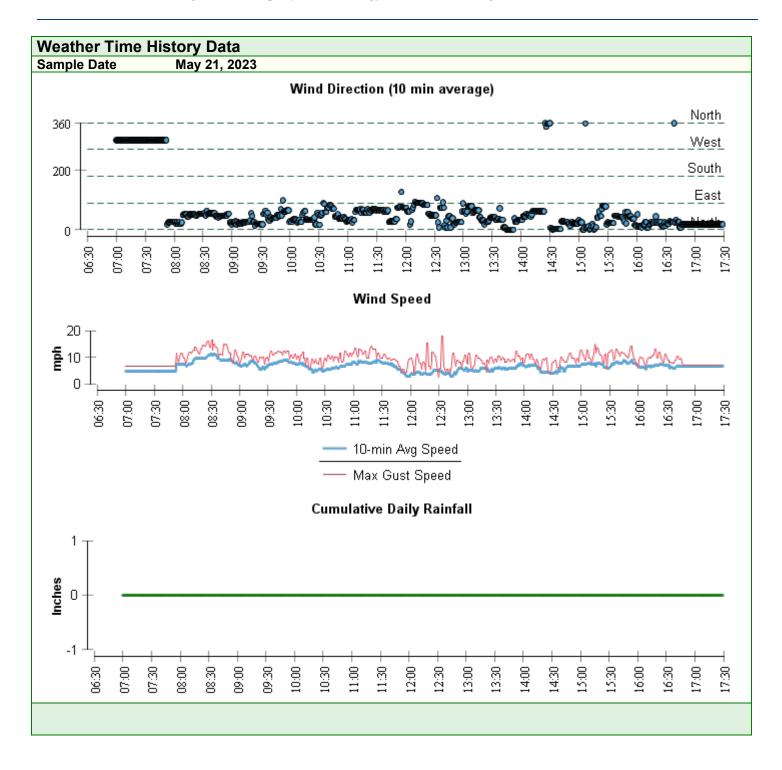
# **Summary Results of Daily Weather Conditions**

This section provides charts showing wind speed, wind direction and rainfall during each day of sampling during the specified week.

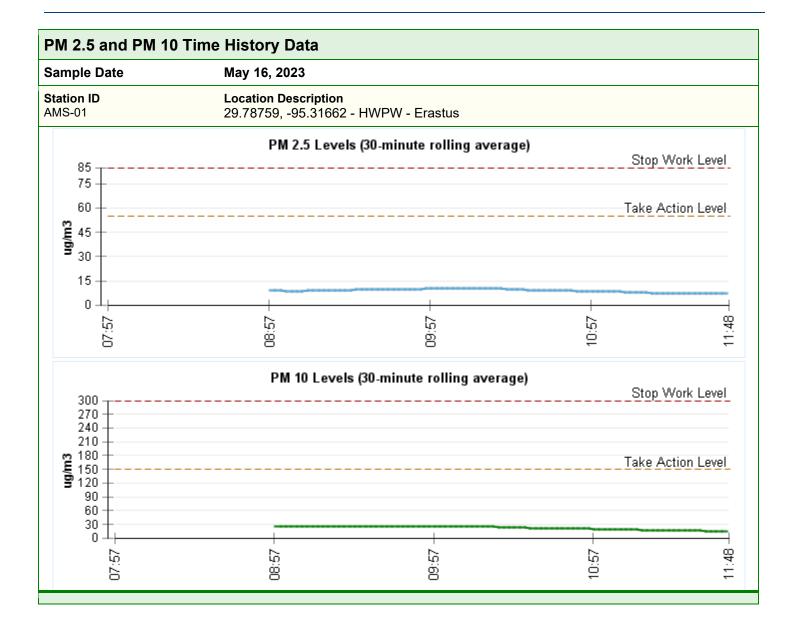
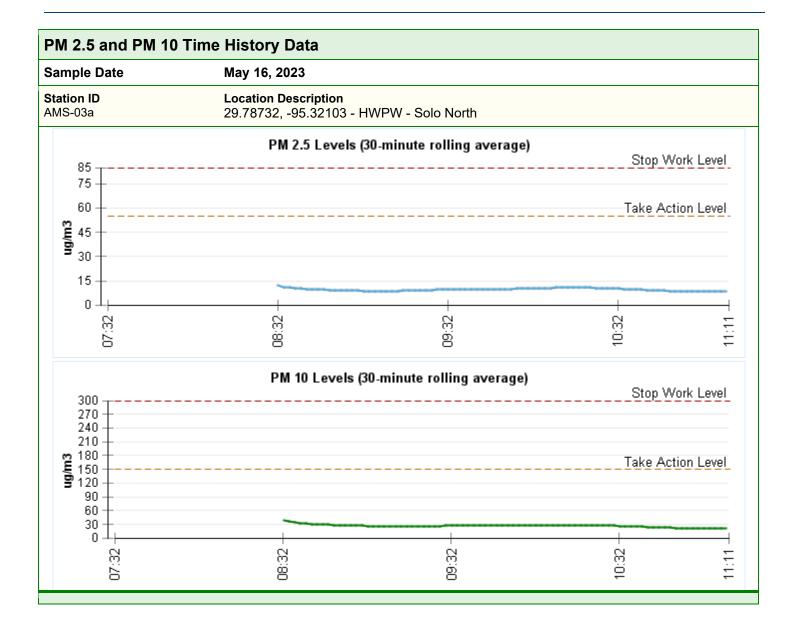
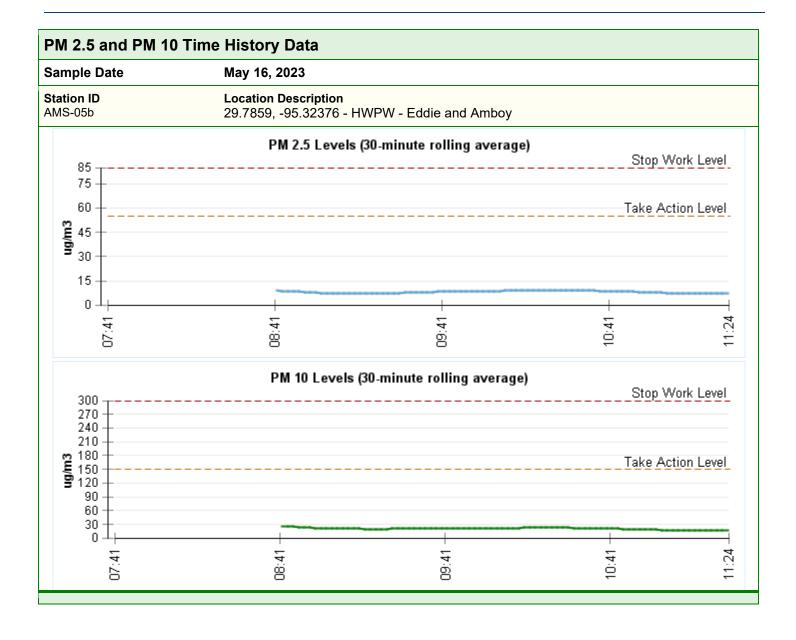
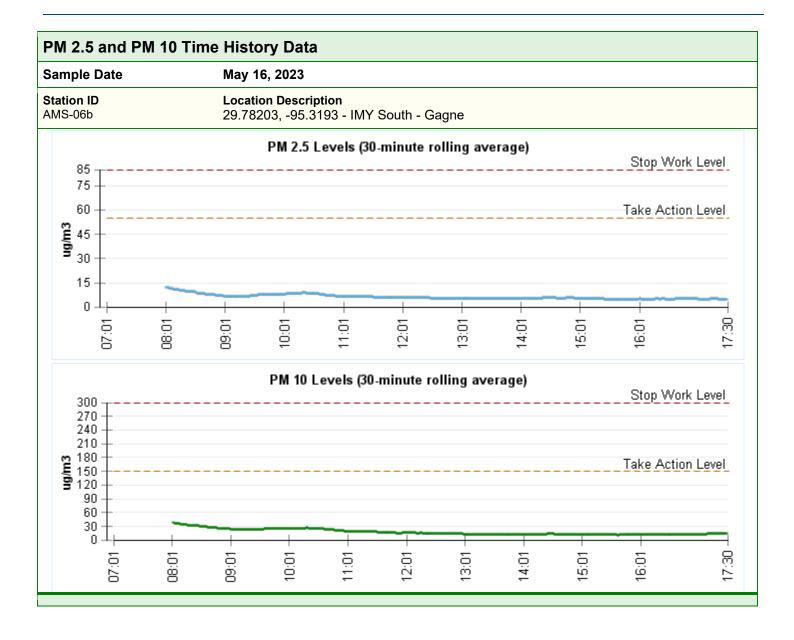
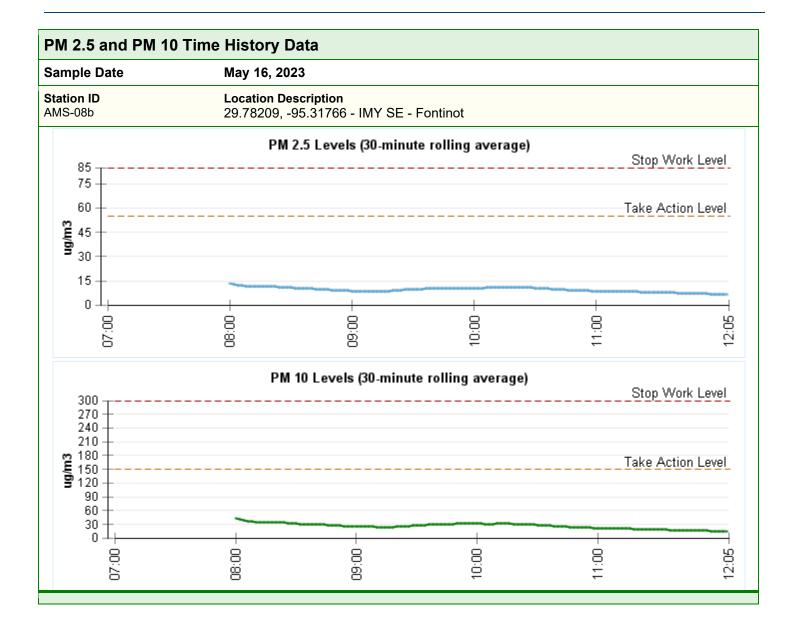
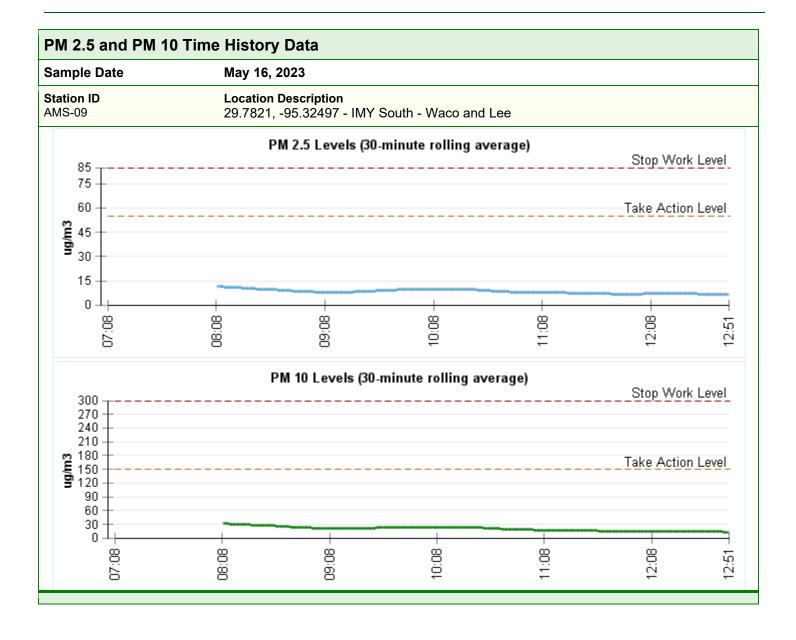
# Daily Time History Detail for PM 2.5 and PM 10 Dust Levels

This section provides charts showing the rolling thirty-minute average concentrations of PM 2.5 and PM 10 particulates measured at each location on each sample day during the specified week.

PM 2.5 and PM 10 airborne particulate levels are measured every two minutes during the active sampling period. The charts track the average particulate concentrations over the past 30 minutes at the time of the measurement.

- Take-Action Level 30-minute average dust concentrations >55 ug/m3 (PM 2.5) or >150 ug/m3 (PM 10)
   Additional dust control measures, as outlined in the site dust control plan, will be promptly implemented to reduce levels below the Take-Action Level.
- Stop-Work Level 30-minute average dust concentrations >85 ug/m3 (PM 2.5) or >300 ug/m3 (PM 10)
  Work will be stopped immediately, as outlined in the site dust control plan, and UPRR will evaluate dust control
  measures. Work will not resume until UPRR has implemented additional controls that will effectively prevent
  generation of dust levels above the Stop-Work Level.

Air monitoring stations may exhibit higher than actual readings during the first 5 - 10 minutes after startup, before the instrumentation has fully warmed up. This is a known and expected behavior of the instrumentation.
