June 17, 2024

Project No. 31406585.016

**Re: MONTHLY STATUS UPDATE – ENGLEWOOD INTERMODAL YARD – NAPL COLLECTION
SYSTEM/CONCRETE CAP REPAIRS AND REVISED INTERIM MEASURES WORK PLAN
CONSTRUCTION ACTIVITIES
UNION PACIFIC RAILROAD HOUSTON WOOD PRESERVING WORKS FACILITY
4910 LIBERTY ROAD FACILITY, HOUSTON, TEXAS
POST-CLOSURE CARE PERMIT NO. HW-50343; INDUSTRIAL SWR NO. 31547**

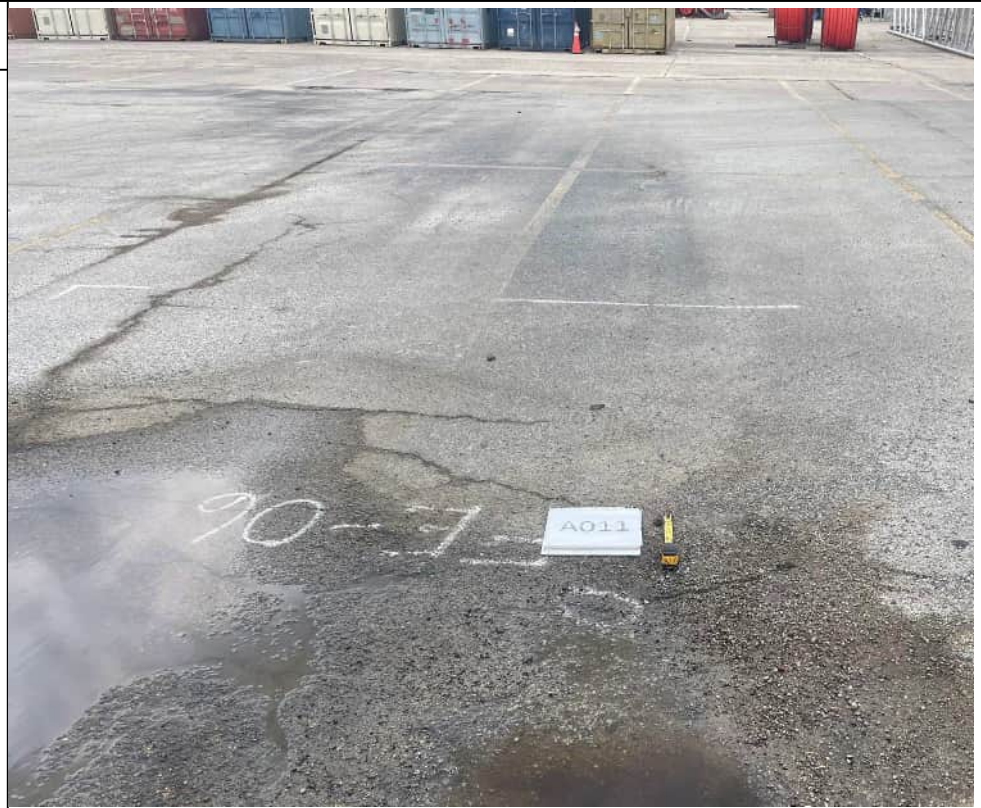
Stall A011. Some tar-like material observed at Test Pit A011 location, material removed. Area where Focused Excavation FE-06 is planned.

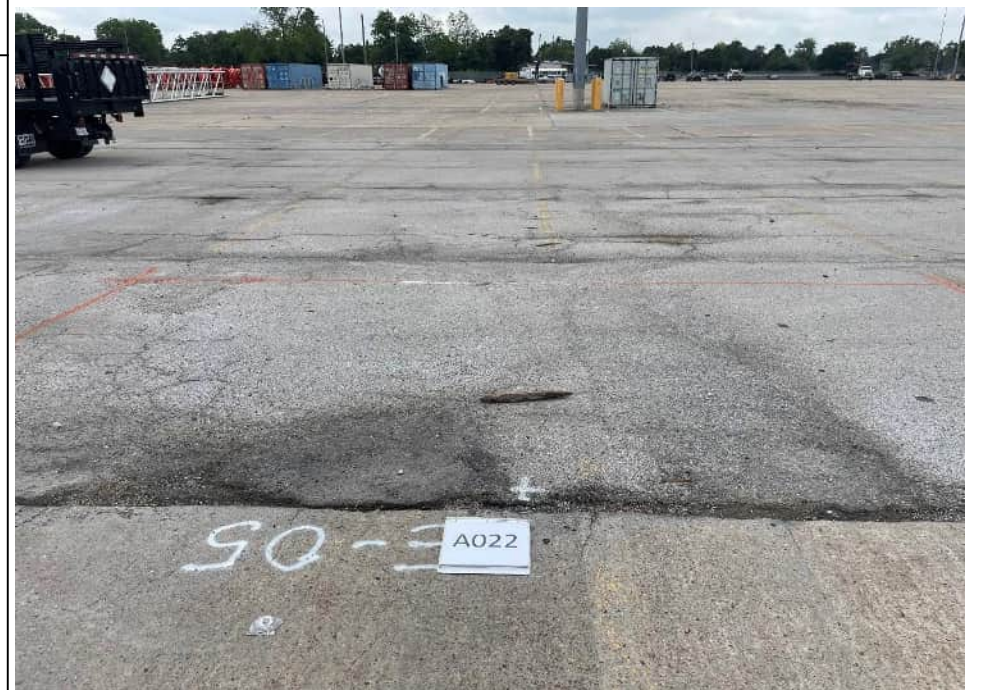
Photo No.
4

Stall A022, some tar-like material observed at the seep location along the edge, material removed. Area where Focused Excavation FE-05 is planned.

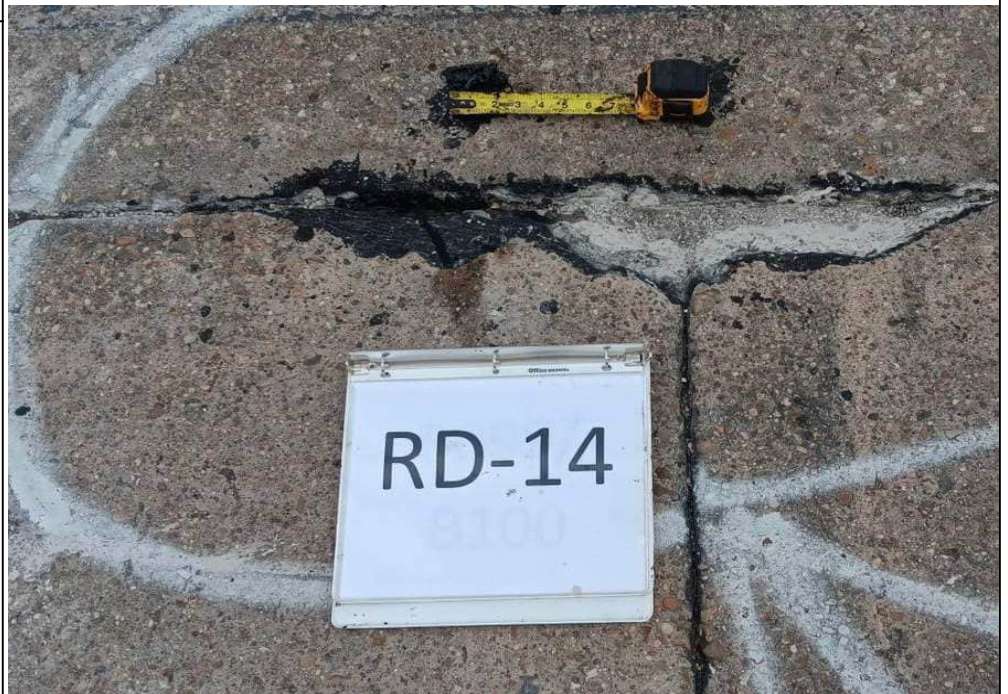
RD-14 Seep location observed within the concrete road area (RD-14) north of Track 802 (east of existing Track 802 seep location), some new tar-like material observed along a concrete joint, material removed.

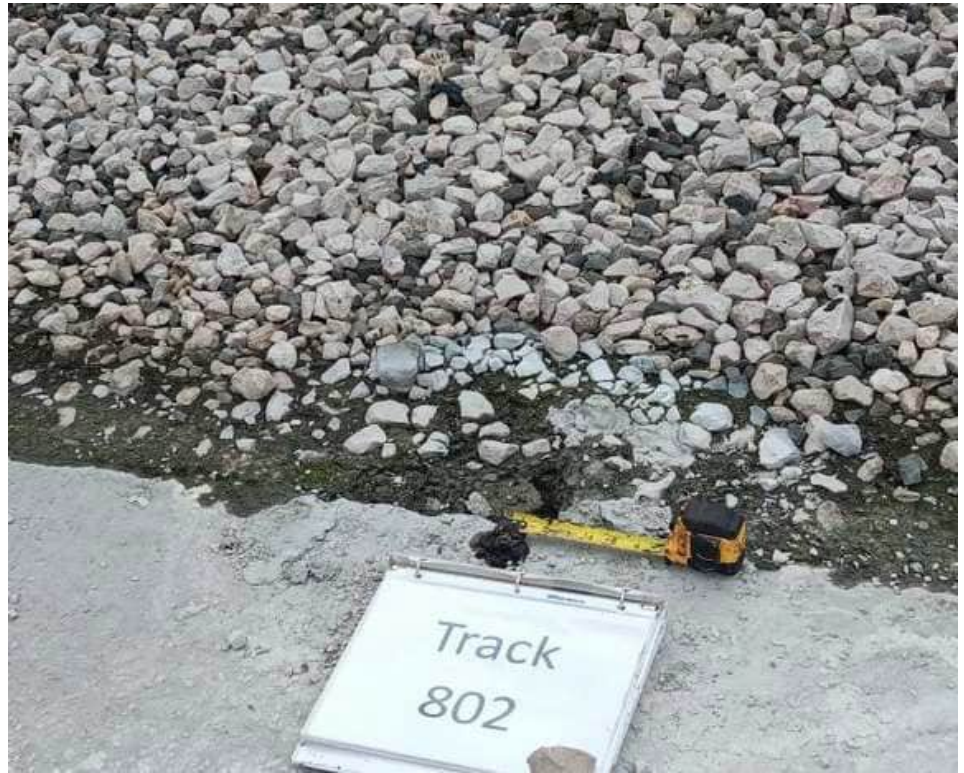
North side of Track 802, some tar-like material observed at seep location near the edge of the ballast, material removed.

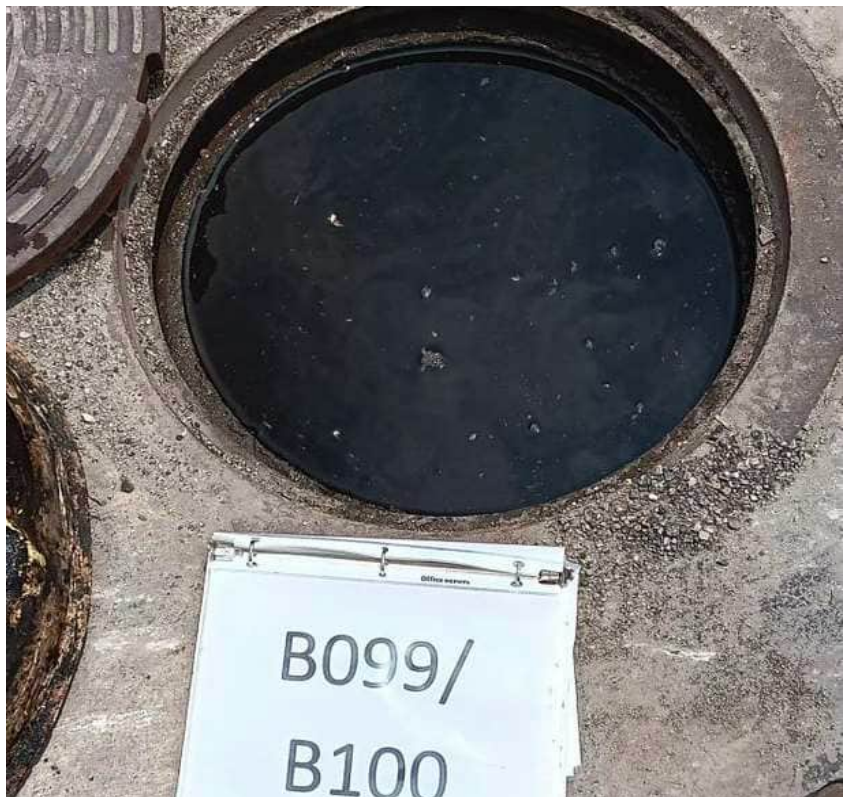
Photo No.
18

Sump 1 (B099/B100), 1 inch of freeboard in sump, sheen observed, water color noted as brown.

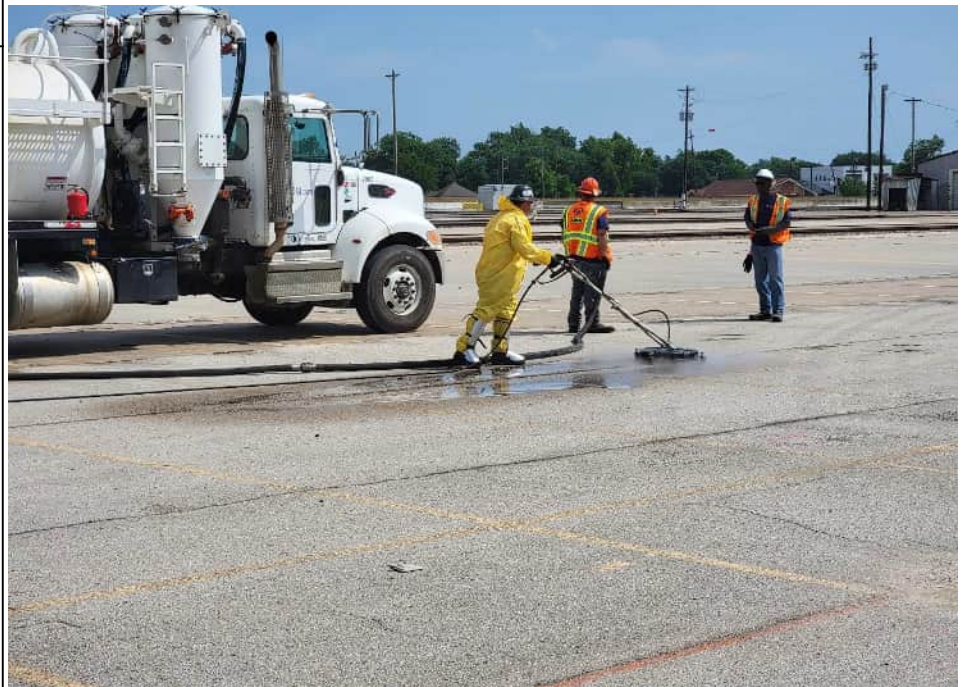
E3 pressure washing staining in rows A060 to A074.

- UPRR remediation contractor E3 was mobilized to the site on May 10th to pressure wash areas of brown staining/residue present in cracks in the pavement in stalls A060 -A074 (Photo No. 22). The brown staining was again observed in cracks in the pavement in stalls B060-B070 during the May 22nd inspection. A small amount of seep water was also present in the depressions in the joint between the asphalt and concrete pavement in stall A010 and A011 during the May 22nd inspection (Photo No. 34). E3 returned to the site on May 28, 2024, to recover this seep water and pressure wash the brown staining (Photo No. 40). Wash water from the clean-up events was recovered and is staged in a tote onsite pending transportation and disposal. UPRR will continue to have a remediation contractor pressure wash and collect the water in the areas where the brown staining and seeps are observed, as needed.

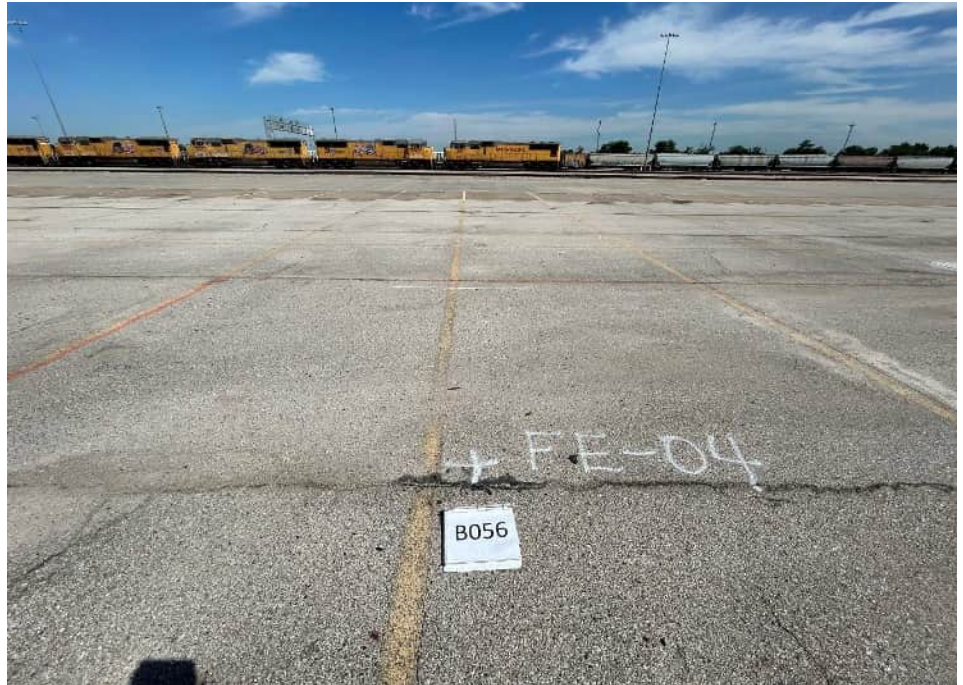
Stall B056. Some tar-like material observed at historical seep location along asphalt crack, material removed. Area where Focused Excavation FE-04 is planned.

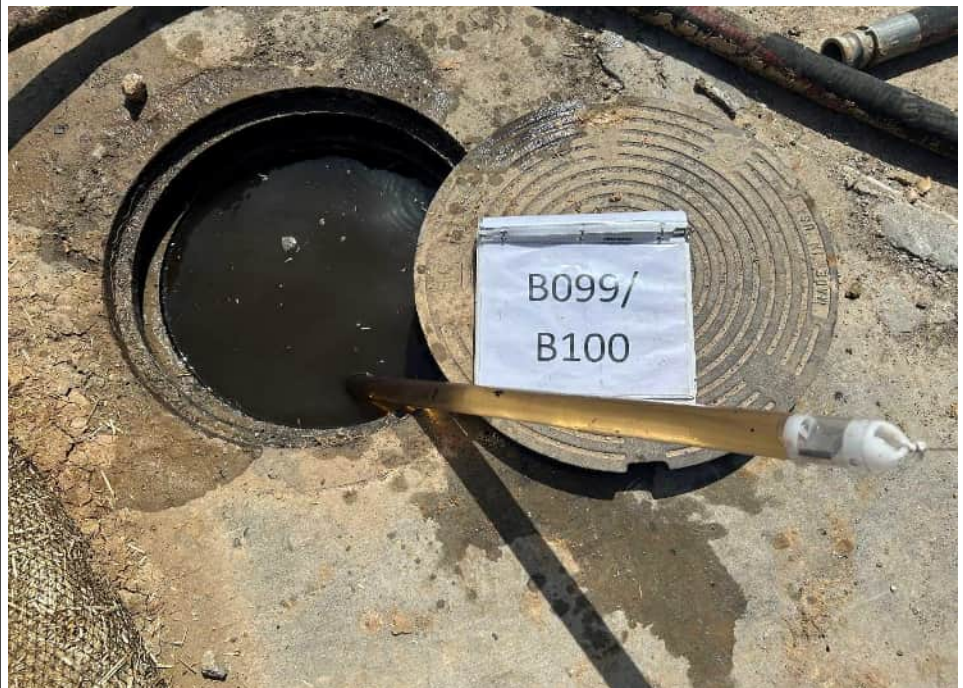
Photo No.
26

Sump 1 (B099/B100), 0 inches of freeboard in sump, no sheen observed, water color noted as light brown.

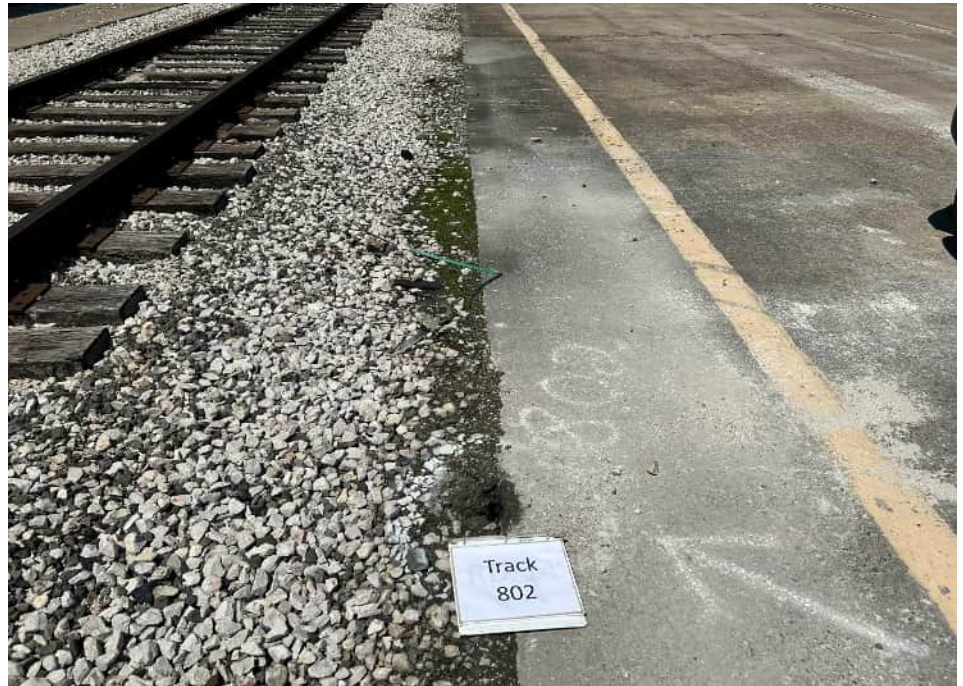
North side of Track 802, some tar-like material observed at seep location near the edge of the ballast, material removed.

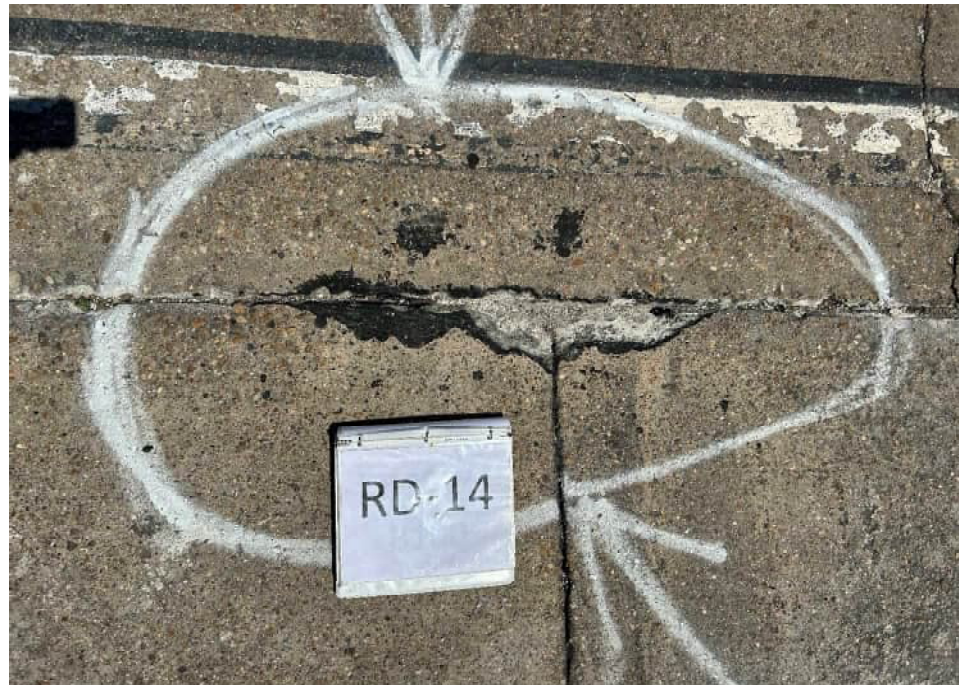
Photo No.
30

RD-14 Seep location observed within the concrete road area (RD-14) north of Track 802 (east of existing Track 802 seep location), some new tar-like material observed along a concrete joint, material removed.

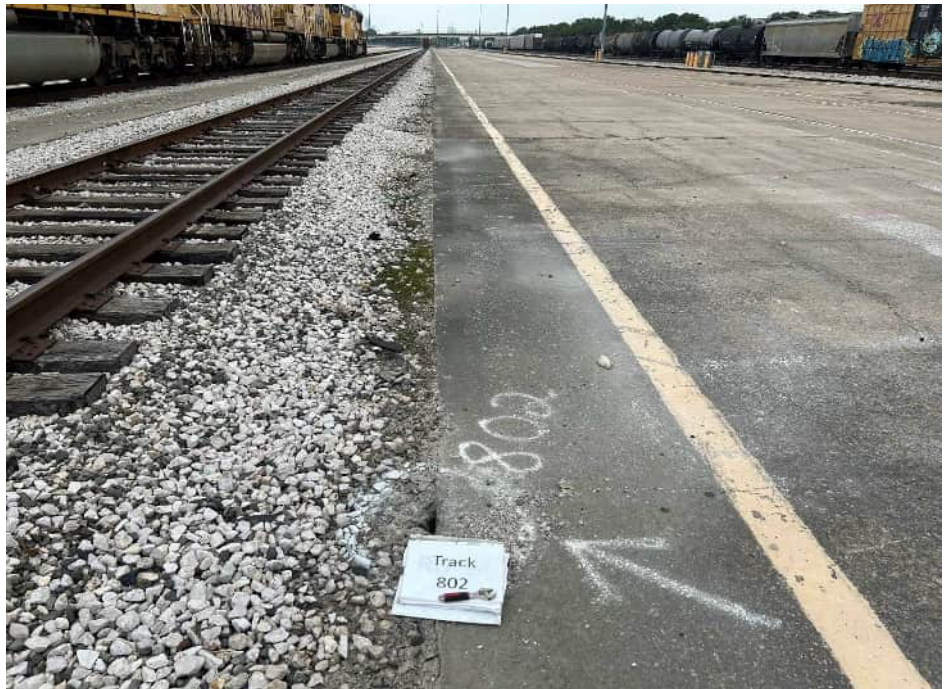
North side of Track 802, some tar-like material observed at seep location near the edge of the ballast, material removed.

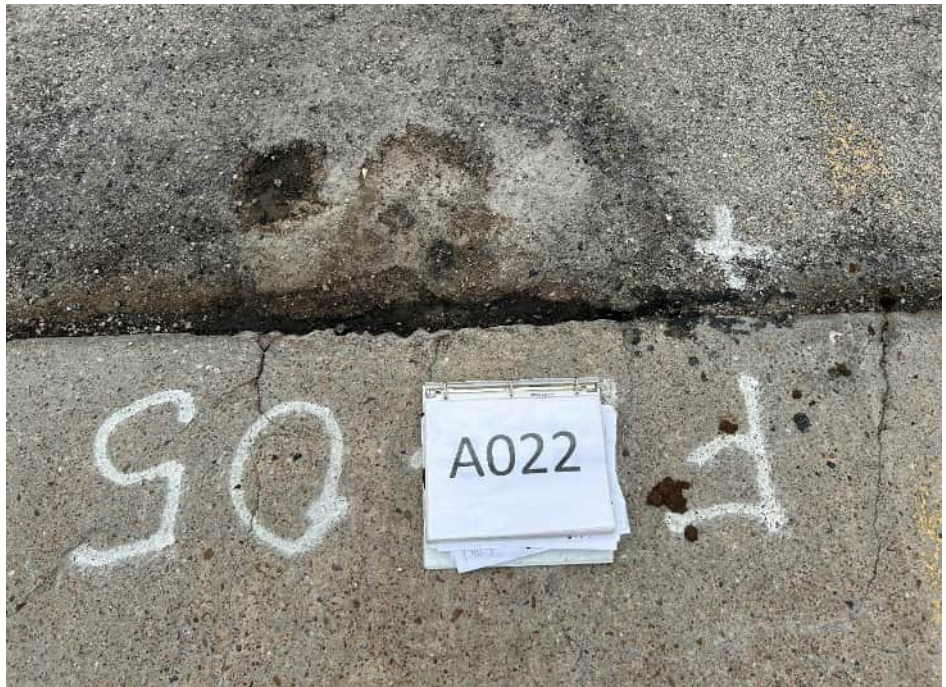
Photo No.
36

Stall A022, some tar-like material observed at the seep location along the edge, material removed. Area where Focused Excavation FE-05 is planned.

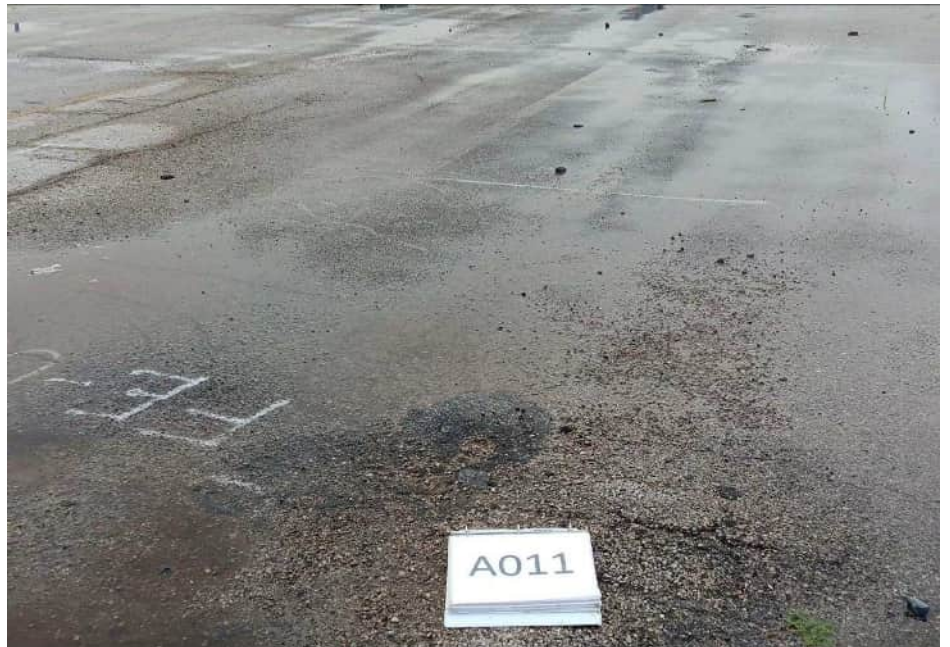
Stall A011. Some new tar-like material observed at historical seep location along asphalt crack, material removed. Area where Focused Excavation FE-06 is planned.

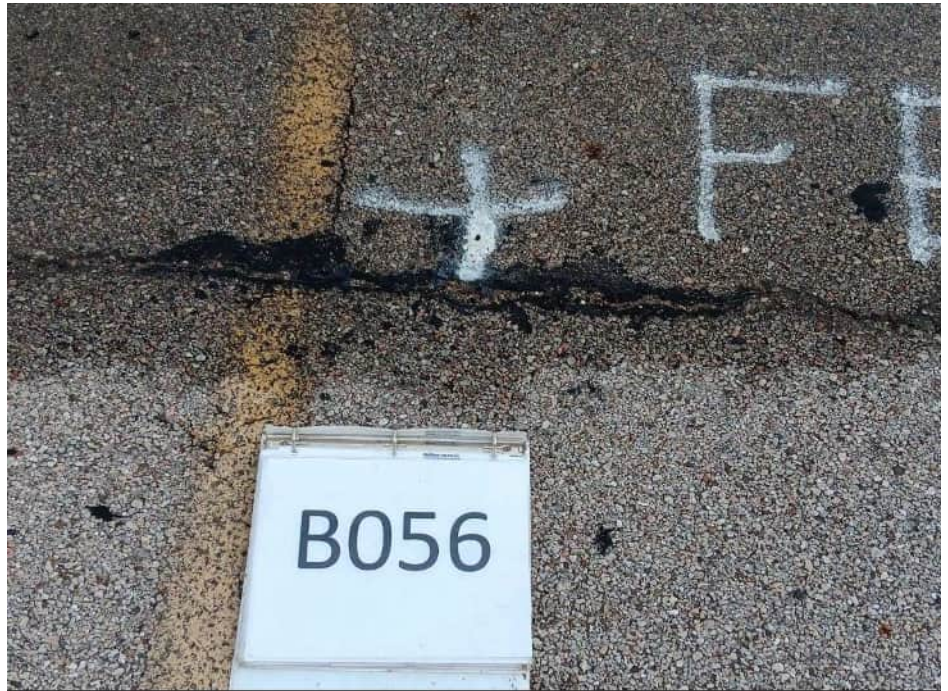
Stall B056. Some new tar-like material observed at historical seep location along asphalt crack, material removed. Area where Focused Excavation FE-04 is planned.
