July 11, 2024

Project No. 31406585.016

**Re: MONTHLY STATUS UPDATE – ENGLEWOOD INTERMODAL YARD – NAPL COLLECTION  
SYSTEM/CONCRETE CAP REPAIRS AND REVISED INTERIM MEASURES WORK PLAN  
CONSTRUCTION ACTIVITIES  
UNION PACIFIC RAILROAD HOUSTON WOOD PRESERVING WORKS FACILITY  
4910 LIBERTY ROAD FACILITY, HOUSTON, TEXAS  
POST-CLOSURE CARE PERMIT NO. HW-50343; INDUSTRIAL SWR NO. 31547**

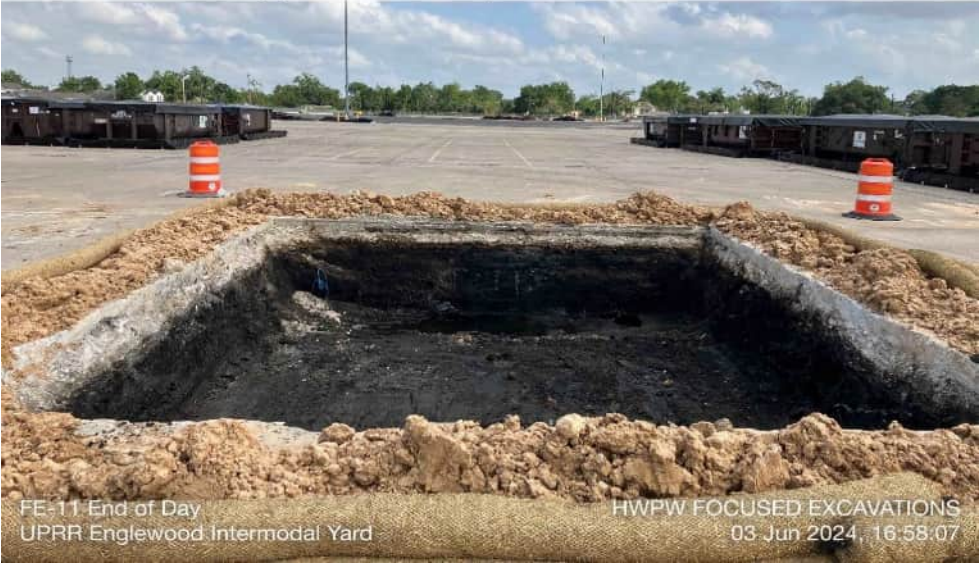
- Continued and completed initial excavation at FE-11. Began and completed floor extension at FE-11 (Photo 1).
  - Began and completed North, North-East, and North-West extensions at FE-4 (Photo 2).

| <b>Description:</b><br>The end of day excavation progress of FE-11.<br><br>Lat: 29.784167<br>Long: -95.319444 | | | |

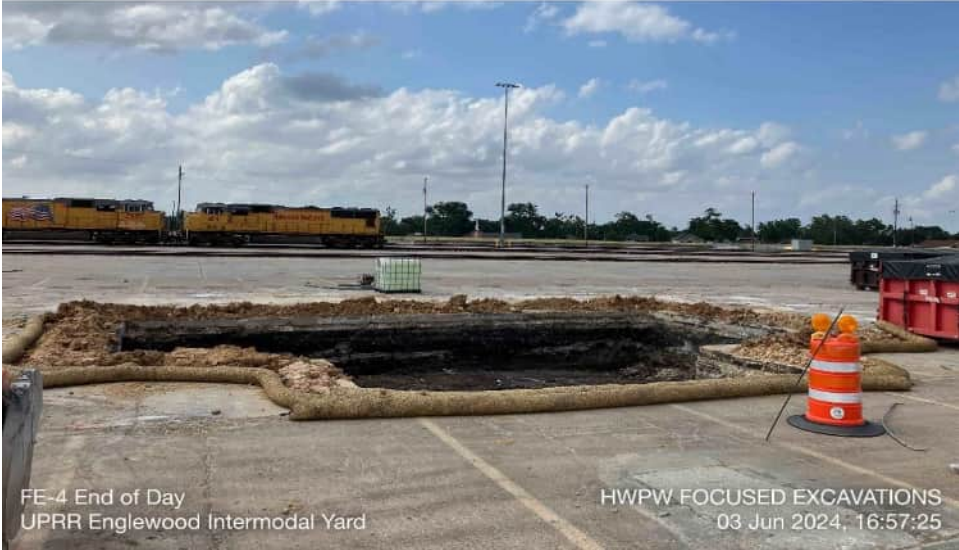
| <b>Description:</b><br>The end of day excavation progress of FE-4<br><br>Lat: 29.784722<br>Long: -95.319444 | | | |

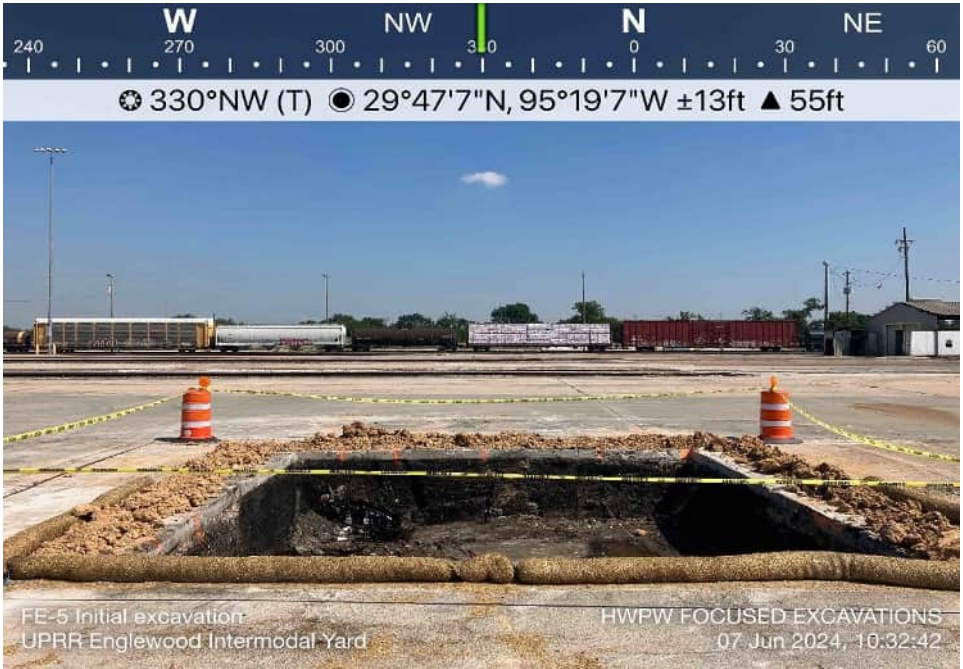
| <b>Description:</b><br><br>The initial excavation of FE-5.<br><br><br><br><br><br>Lat: 29.785278<br>Long: - 95.318611 | | <div style="display: flex; justify-content: space-between; margin-top: 10px;"> <span>FE-5 Initial excavation<br/>UPRR Englewood Intermodal Yard</span> <span>HWPW FOCUSED EXCAVATIONS<br/>07 Jun 2024, 10:32:42</span> </div> | |

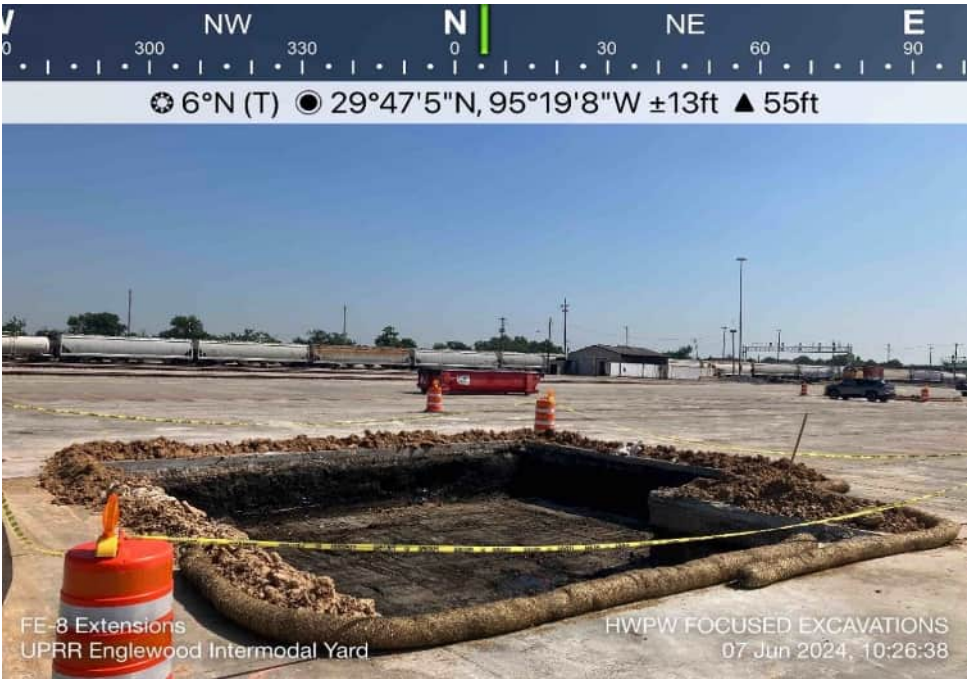
| <b>Photo No.</b><br><b>5</b> | <b>Inspection Date:</b><br>6/7/2024 | | |

| <b>Description:</b><br><br>The extension of the excavation at FE-8.<br><br><br><br><br><br>Lat: 29.784722<br>Long: -95.318889 | | | |

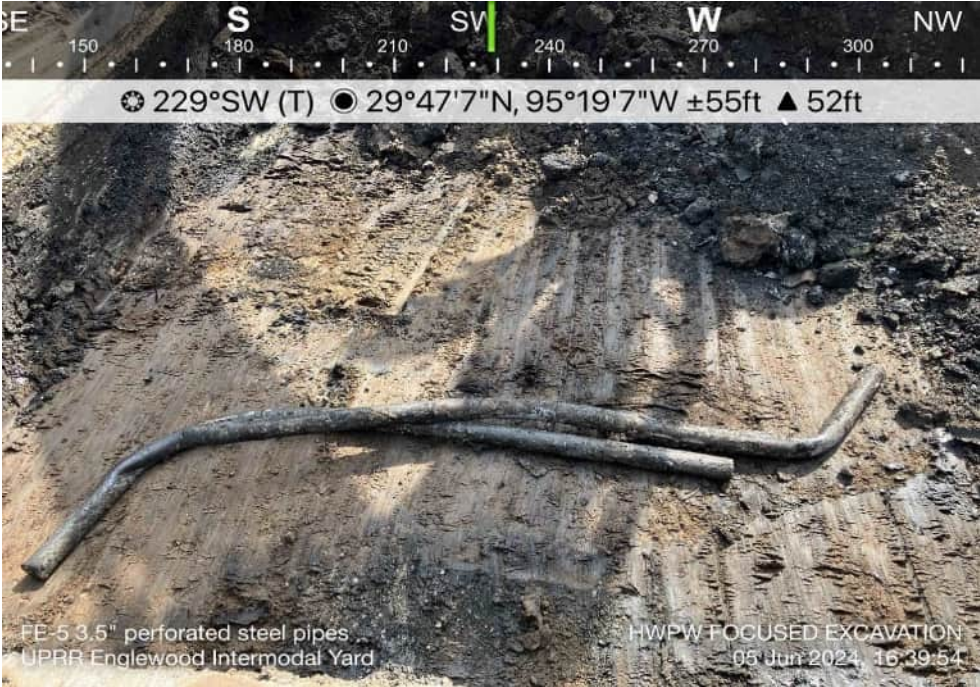
| <b>Description:</b><br><br>3.5' perforated, threaded steel pipes recovered from FE-5.<br><br><br><br><br><br>Lat: 29.785278<br>Long: -95.318611 | | | |

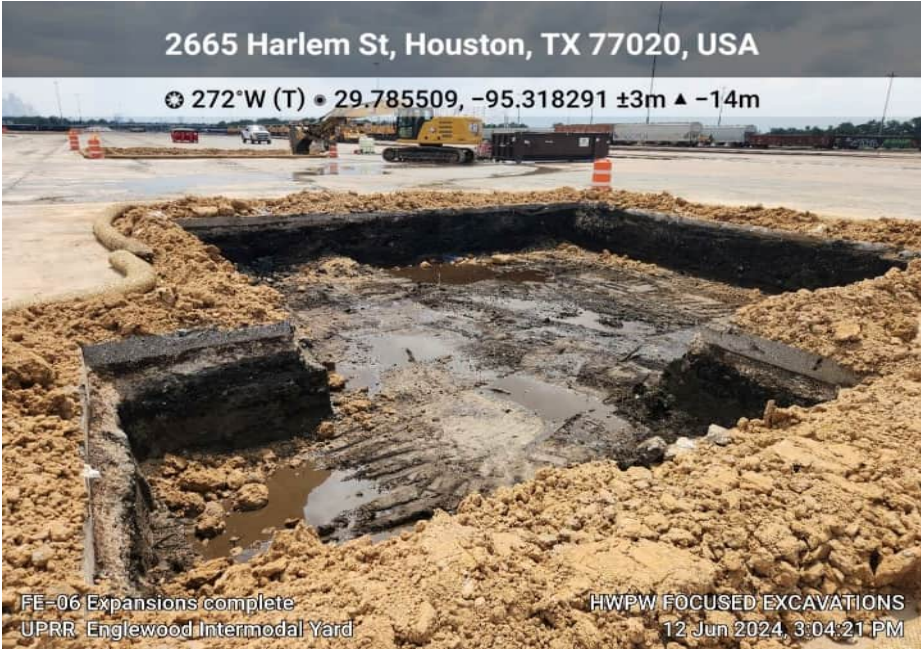
| <b>Photo No.</b><br><b>7</b> | <b>Inspection Date:</b><br>6/12/2024 | | |

| <b>Description:</b><br><br>The completed expansion of the FE-06.<br><br><br><br><br><br>Lat: 29.785509<br>Long: - 95.318291 | | | |

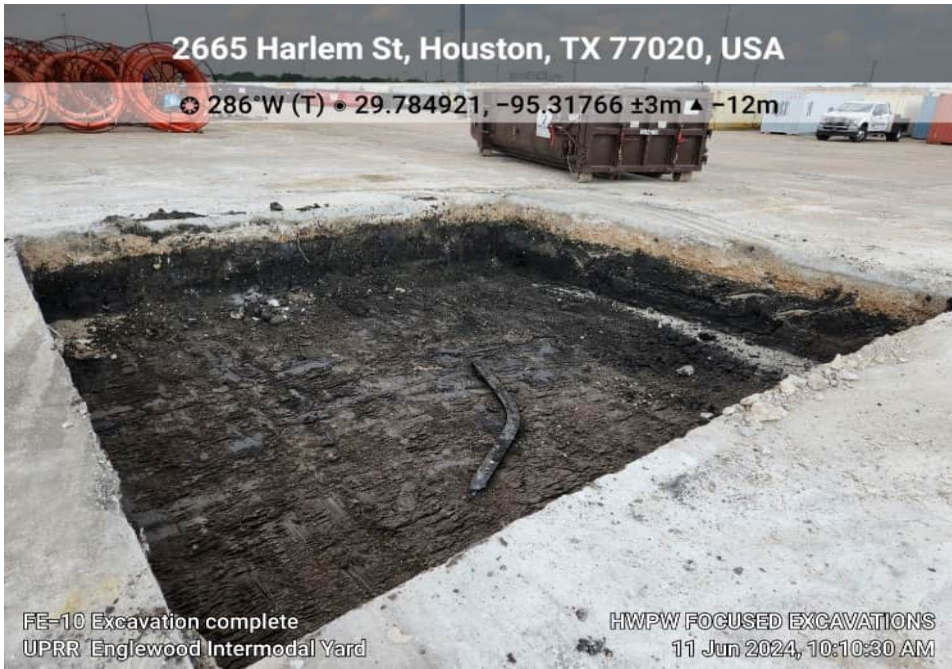
| <b>Photo No.</b><br><b>8</b> | <b>Inspection Date:</b><br>6/11/2024 | | |

| <b>Description:</b><br><br>The completed excavation of FE-10.<br><br><br><br><br><br>Lat: 29.784921<br>Long: - 95.31766 | | | |

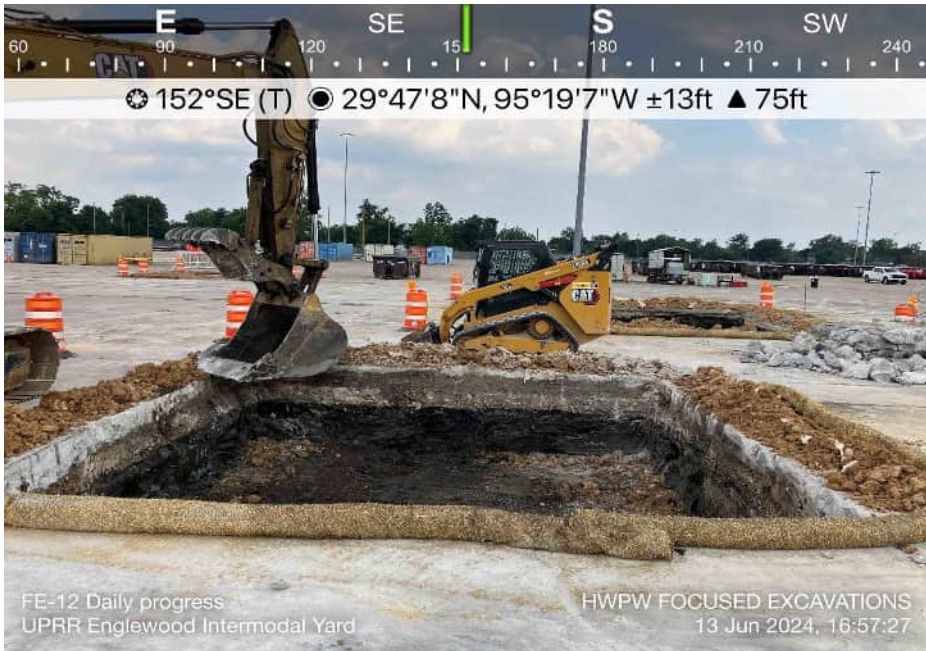
| Description:<br><br>The process of the excavation at FE-12.<br><br><br><br><br><br><br><br><br>Lat: 29.785556<br>Long: -95.318611 | | | |

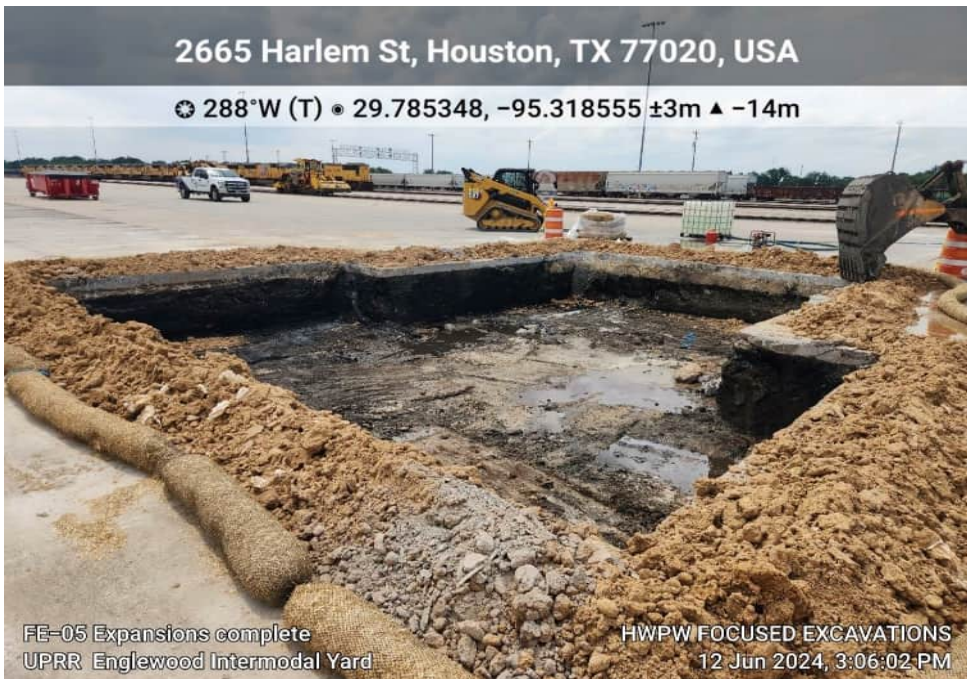
| Description:<br><br>The completed expansion of the FE-05.<br><br><br><br><br><br><br><br><br>Lat: 29.785348<br>Long: - 95.318555 | | | |

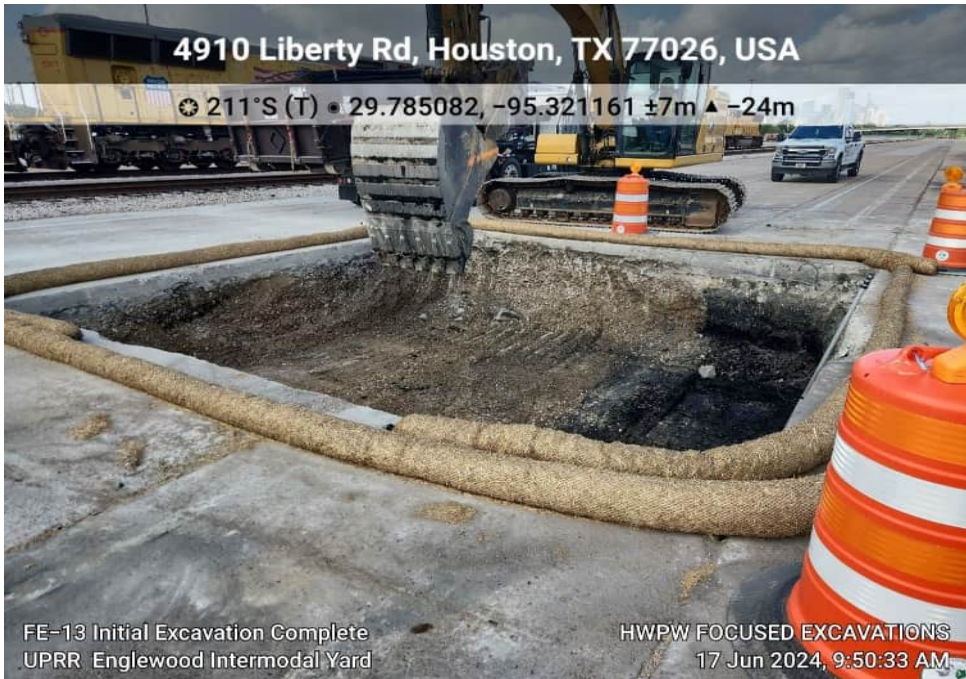
| Photo No.<br>12 | Inspection Date:<br>6/17/2024 | | |

| Description:<br><br>The completed initial excavation at FE-13.<br><br><br><br><br><br><br><br><br><br>Lat: 29.785082<br>Long: -95.321161 | | | |

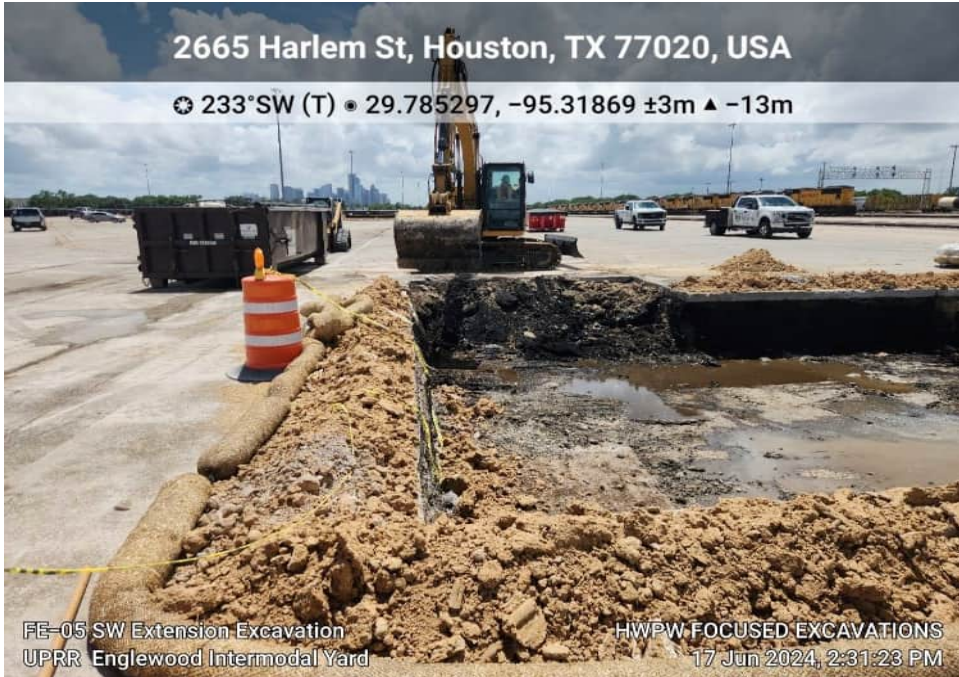
| Description:<br><br>The SW extension excavation of FE-05.<br><br>Lat: 29.785297<br>Long: -95.31869 | | | |

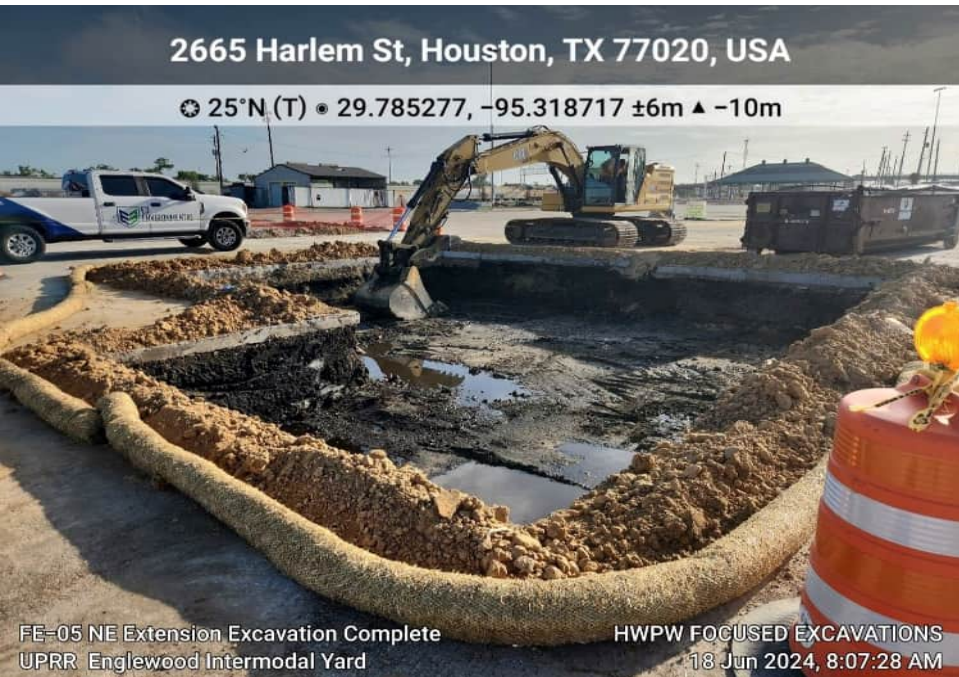
| Description:<br><br>The completed extension excavation at FE-05.<br><br>Lat: 29.785277<br>Long: -95.318717 | | | |

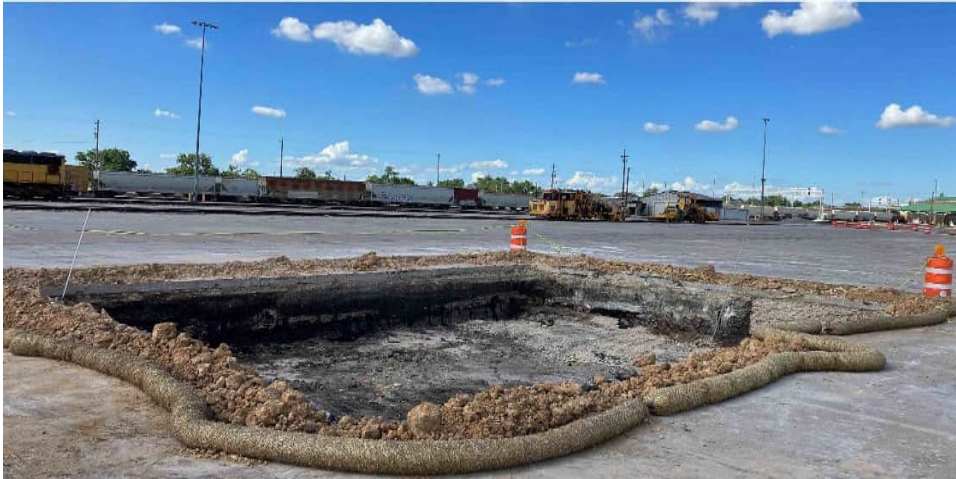
| <b>Description:</b><br><br>The completed excavation of FE-4.<br><br><br><br><br><br><br><br><br><br>Lat: 29.784722<br>Long: -95.319444 | | | |

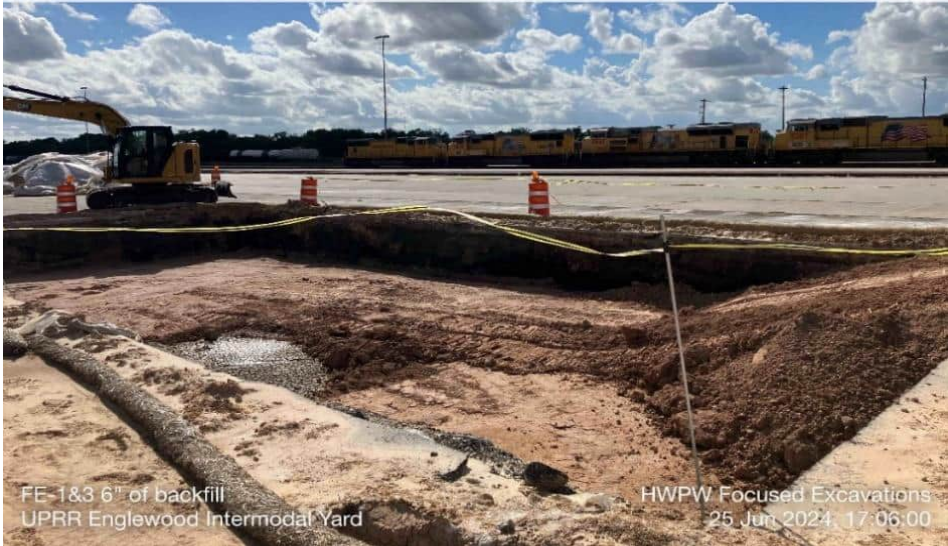
| <b>Description:</b><br><br>The backfill process of FE-1/3.<br><br><br><br><br><br><br><br><br><br>Lat: 29.784167<br>Long: -95.320556 | | | |

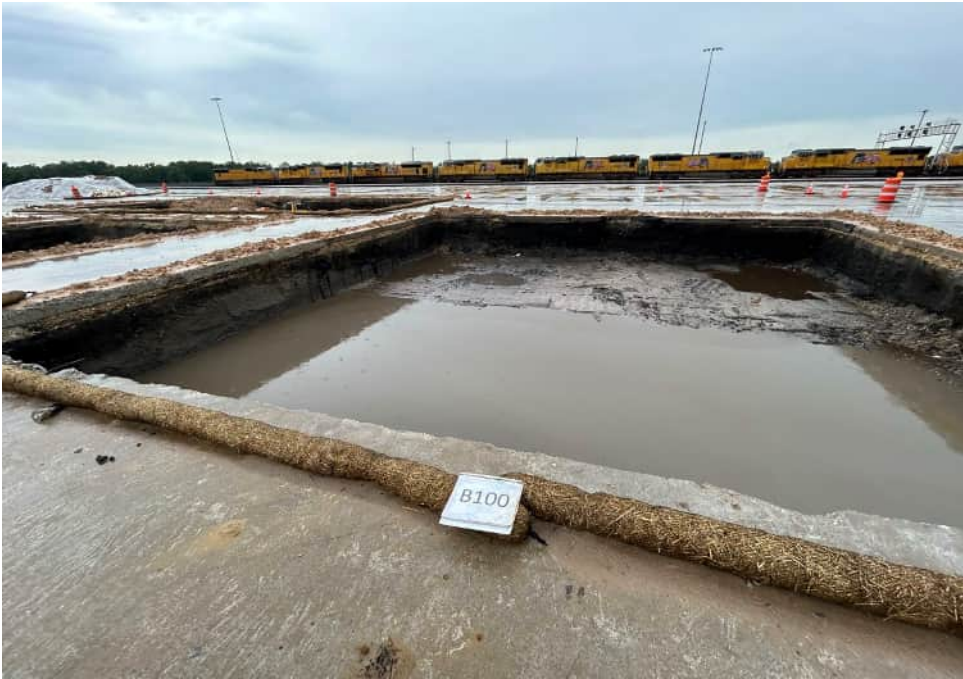
| <b>Photo No.</b><br><b>19</b> | <b>Inspection Date:</b><br>6/7/2024 | | |

| Measured Date | Sump 1<br>(B099/B100)<br>Freeboard (in) | Sump 2<br>(B103/B104)<br>Freeboard (in) | Sump 3<br>(B107/B108)<br>Freeboard (in) | Depth to DNAPL (in) | Comments |
|---|---|---|---|---|---|
| 6/5/2024 | Not measurable | Not measurable | 13 | Not measurable | Sumps B099/B100 and B103/B104 could not be opened due to ongoing excavation. No sheen observed in any of the sumps. Water color was clear to cloudy by B107/B108. |

| <b>Description:</b><br><br>Sump 1 (B099/B100), not accessible due to excavations.<br><br><br>Lat: 29.784236<br>Long: -95.320786 | | | |

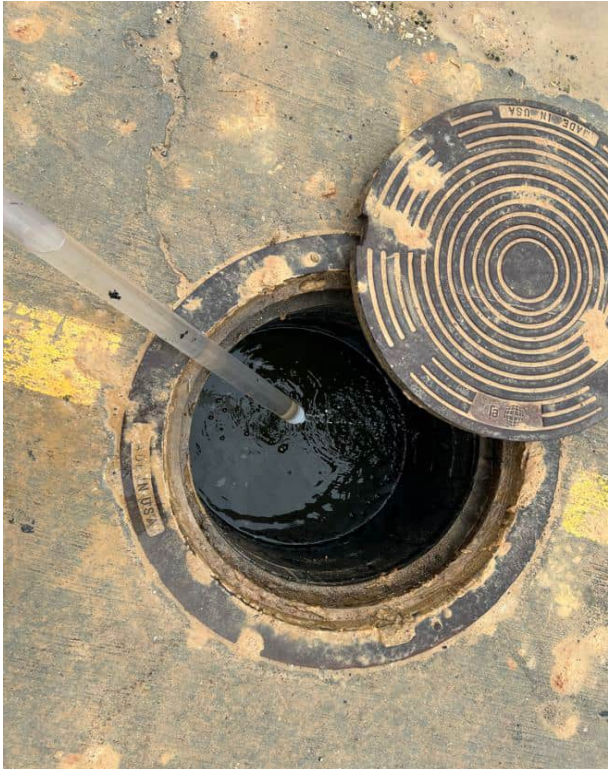
| <b>Photo No.</b><br><b>20</b> | <b>Inspection Date:</b><br>6/7/2024 | | |

| <b>Description:</b><br><br>Sump 3 (B107/B108), 13 inches of freeboard in sump, no sheen observed, water color noted as cloudy to clear.<br><br><br>Lat: 29.7844000<br>Long: -95.3205861 | | | |

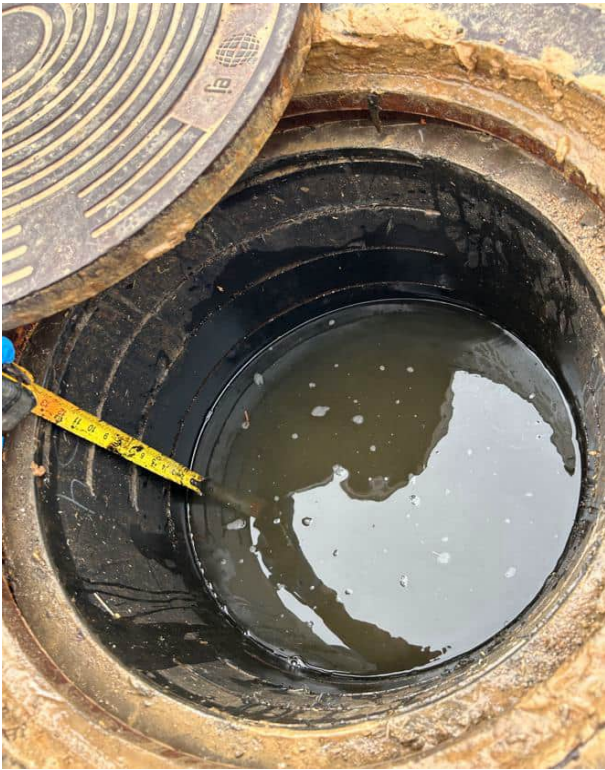
| <b>Photo No.</b><br><b>21</b> | <b>Inspection Date:</b><br>6/7/2024 | | |

| <b>Description:</b><br><br>Sump 3 (B107/B108), 13 inches of freeboard in sump, no sheen observed, water color noted as cloudy to clear.<br><br>Lat: 29.7844000<br>Long: -95.3205861 | | | |

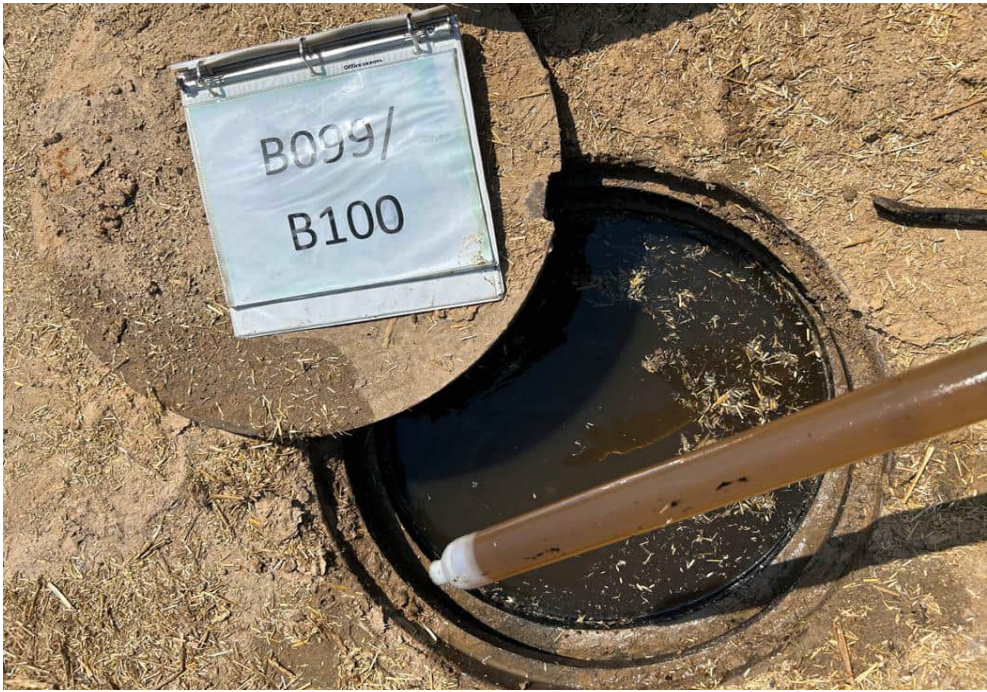
| <b>Photo No.</b><br><b>22</b> | <b>Inspection Date:</b><br>6/12/2024 | | |

| <b>Description:</b><br><br>Sump 1 (B090/B100), 0 inches of freeboard in sump, no sheen observed, water color noted as brown to cloudy.<br><br>Lat: 29.7844000<br>Long: -95.3205861 | | | |

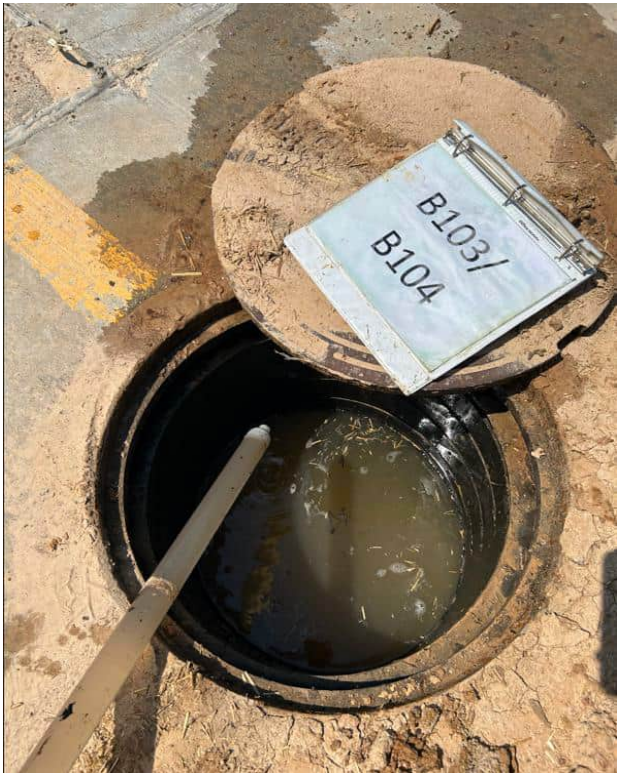
| <b>Photo No.</b><br><b>23</b> | <b>Inspection Date:</b><br>6/12/2024 | | |

| <b>Description:</b><br><br>Sump 2 (B103/B104), 13 inches of freeboard in sump. No odor or sheen observed, color noted as clear to cloudy.<br><br>Lat: 29.7842861<br>Long: -95.3208611 | | | |

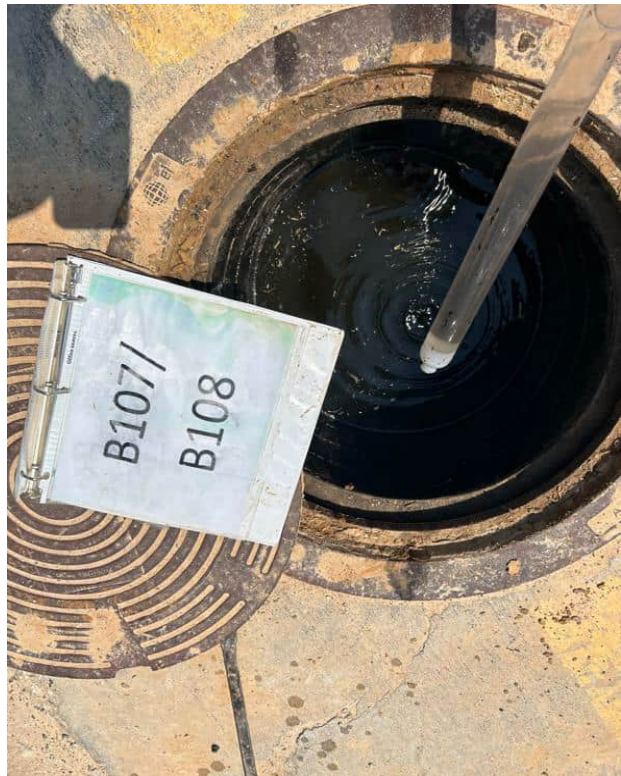
| <b>Photo No.</b><br><b>24</b> | <b>Inspection Date:</b><br>6/12/2024 | | |

| <b>Description:</b><br><br>Sump 3 (B107/B108), 13 inches of freeboard in sump, no sheen observed, water color noted as clear.<br><br>Lat: 29.7844000<br>Long: -95.3205861 | | | |

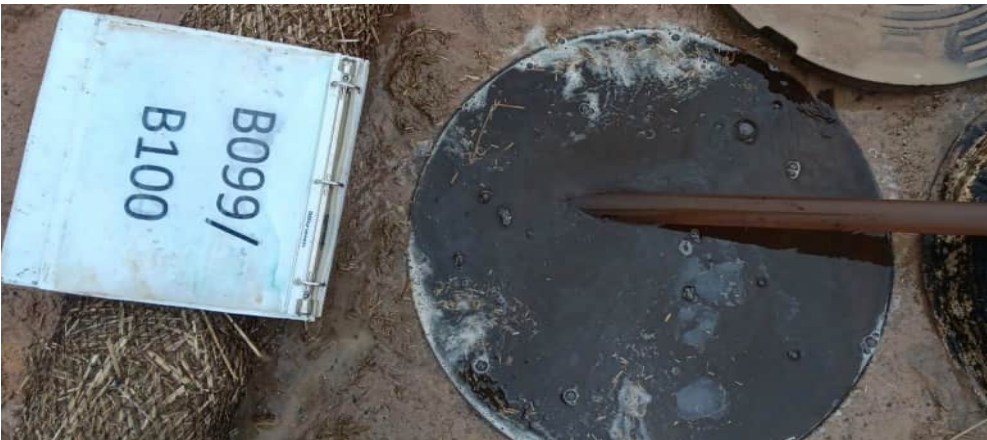
| <b>Photo No.</b><br><b>25</b> | <b>Inspection Date:</b><br>6/19/2024 | | |

- During the June 2024 inspections, the water in Sump 1 was observed to be cloudy or dark brown in color, and the water in Sump 2 and Sump 3 were observed to be cloudy or clear. A sheen was observed at Sump 1 and Sump 3 during the June 19, 2024 inspection and Sump 1 during the June 26, 2024 inspection (Photo 25, 27, and 28). No odors were reported during the June inspections.

| <b>Description:</b><br><br>Sump 1 (B090/B100), 0 inches of freeboard in sump, sheen observed, water color noted as dark brown.<br><br>Lat: 29.7844000<br>Long: -95.3205861 | | | |

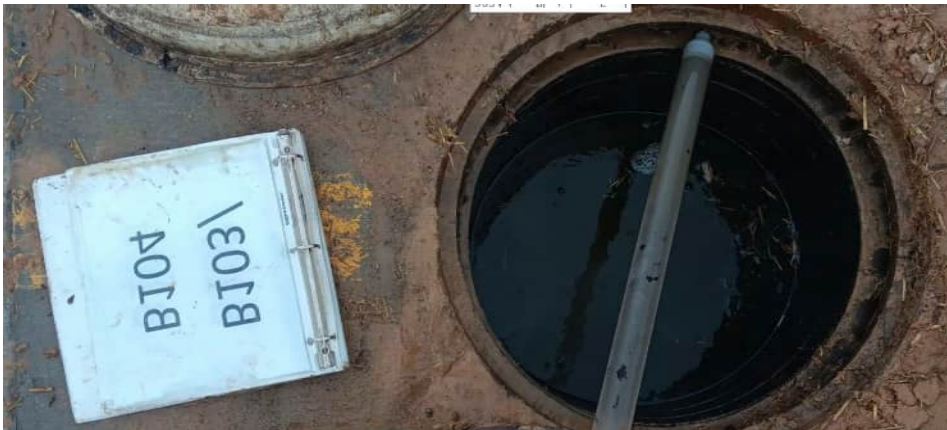
| <b>Photo No.</b><br><b>26</b> | <b>Inspection Date:</b><br>6/19/2024 | | |

| <b>Description:</b><br><br>Sump 2 (B103/B104), 13 inches of freeboard in sump. No odor or sheen observed, color noted as clear.<br><br>Lat: 29.7842861<br>Long: -95.3208611 | | | |

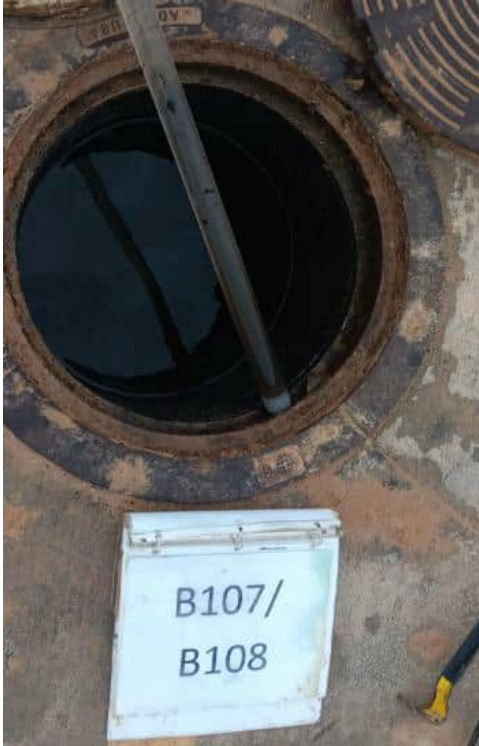
| <b>Photo No.</b><br><b>27</b> | <b>Inspection Date:</b><br>6/19/2024 | | |

| <b>Description:</b><br><br>Sump 3 (B107/B108), 13 inches of freeboard in sump, sheen observed, water color noted as clear.<br><br><br>Lat: 29.7844000<br>Long: -95.3205861 | | | |

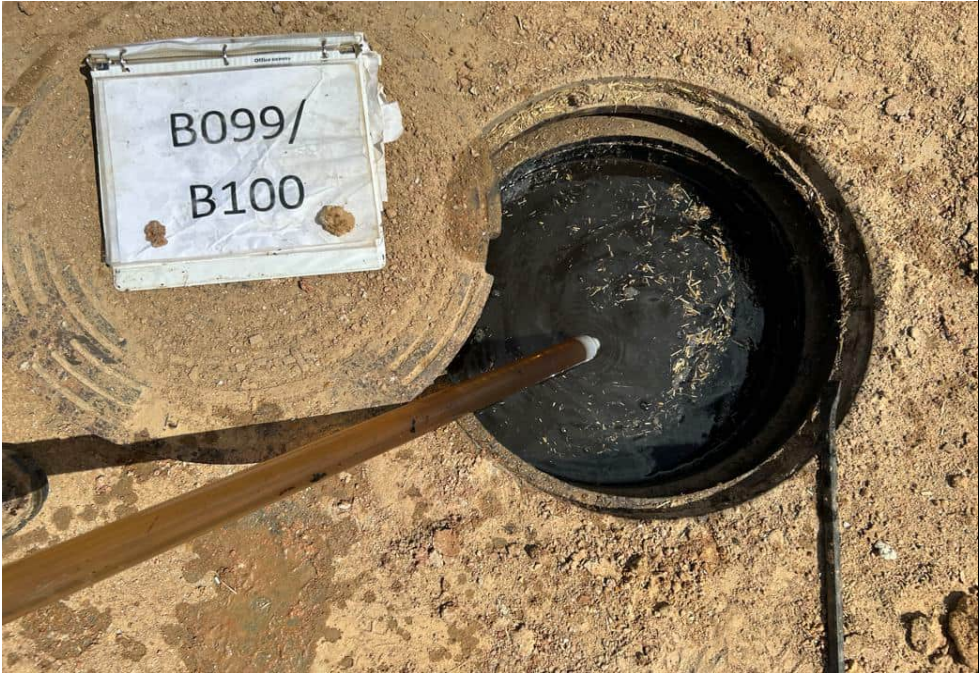
| <b>Photo No.</b><br><b>28</b> | <b>Inspection Date:</b><br>6/26/2024 | | |

| <b>Description:</b><br><br>Sump 1 (B009/B100), 2.5 inches of freeboard in sump, sheen observed, water color noted as brown to cloudy.<br><br><br>Lat: 29.7844000<br>Long: -95.3205861 | | | |

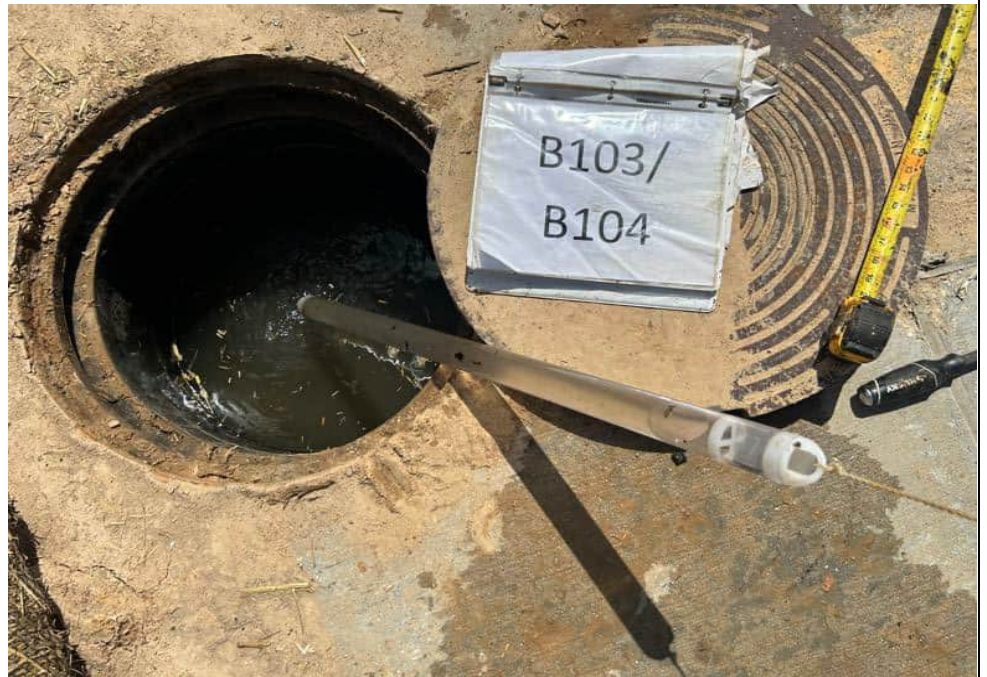
Sump 2 (B103/B104), 10.5 inches of freeboard in sump. No odor or sheen observed, color noted as clear.

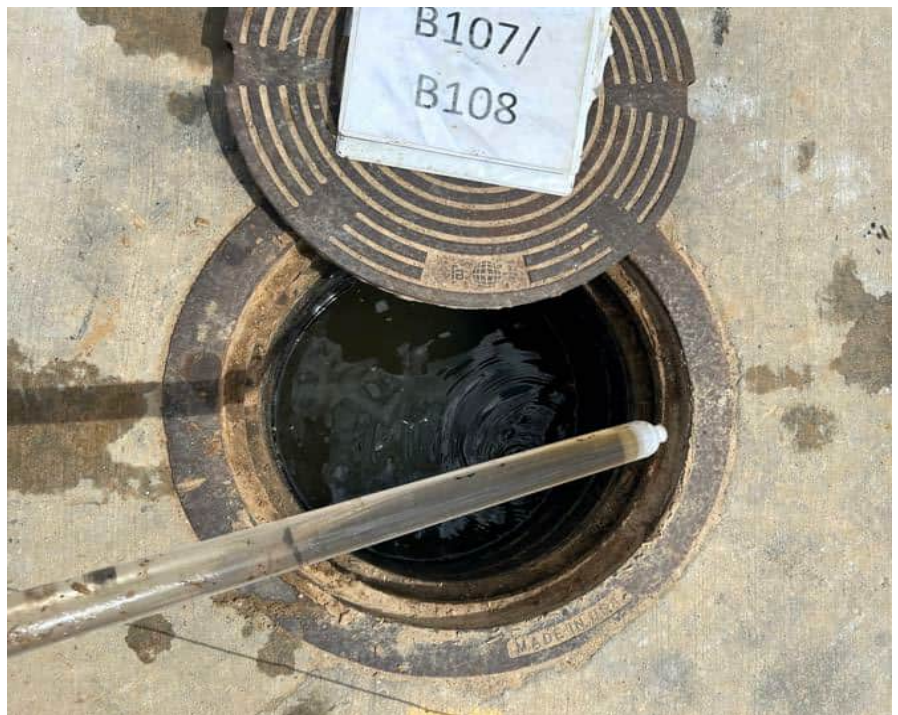
**Photo No.**  
**30**

Sump 3 (B107/B108), 10 inches of freeboard in sump, no sheen observed, water color noted as clear.

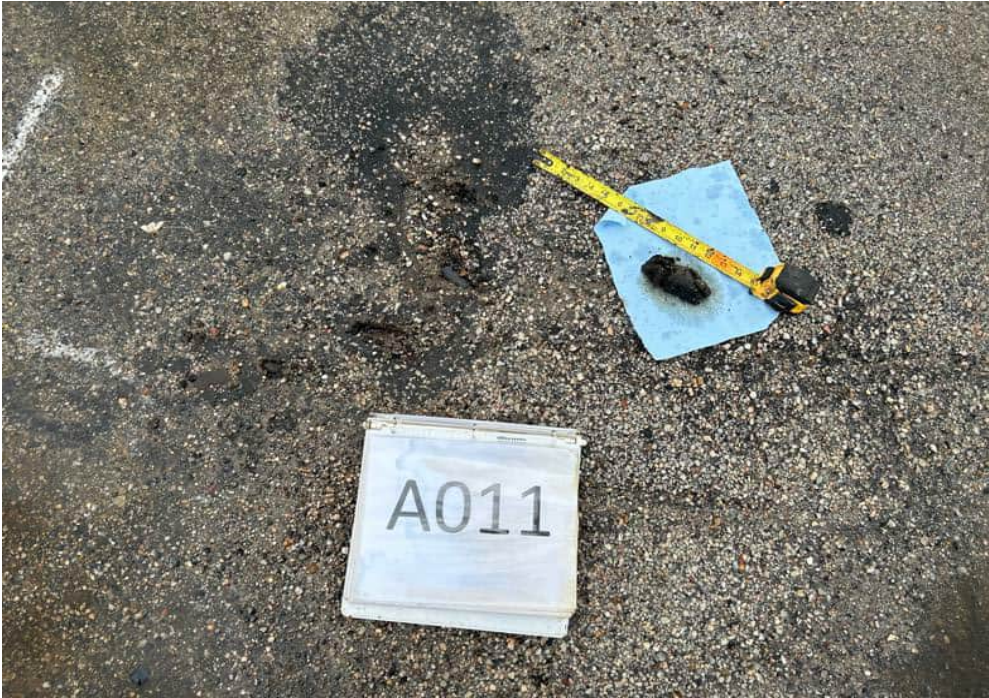
| <b>Photo No.</b><br><b>31</b> | <b>Inspection Date:</b><br>6/5/2024 | | |

| <b>Description:</b><br><br>4 cubic inches of NAPL found at A011.<br><br><br><br><br><br>Lat: 29.785467<br>Long: -95.318341 | | | |

- Tar-like material observed during the weekly inspection events was removed and recovered using a hand tool to scrap up the material. The number of tar-like material seeps observed, and total volume of material recovered during the month of June was significantly less than during the May inspections. The collection volume reduced from 0.19 gallons to 0.08 gallons due to the quantity of excavations at the seep locations. The material recovered was placed in a drum staged at the CSA for disposal.
- During the June 2024 inspections, no NAPL seeps were observed at the seven July 2020 test pit locations (stalls A010, A021, A098, B013, B057, B096 and B108) or three other stall numbers B042, B056, and B102 Joint.
- As of the end of June 2024, seeps A010, A022, B042, B056, B057, B096, B100, B102, B105, and RD-14 have been excavated.

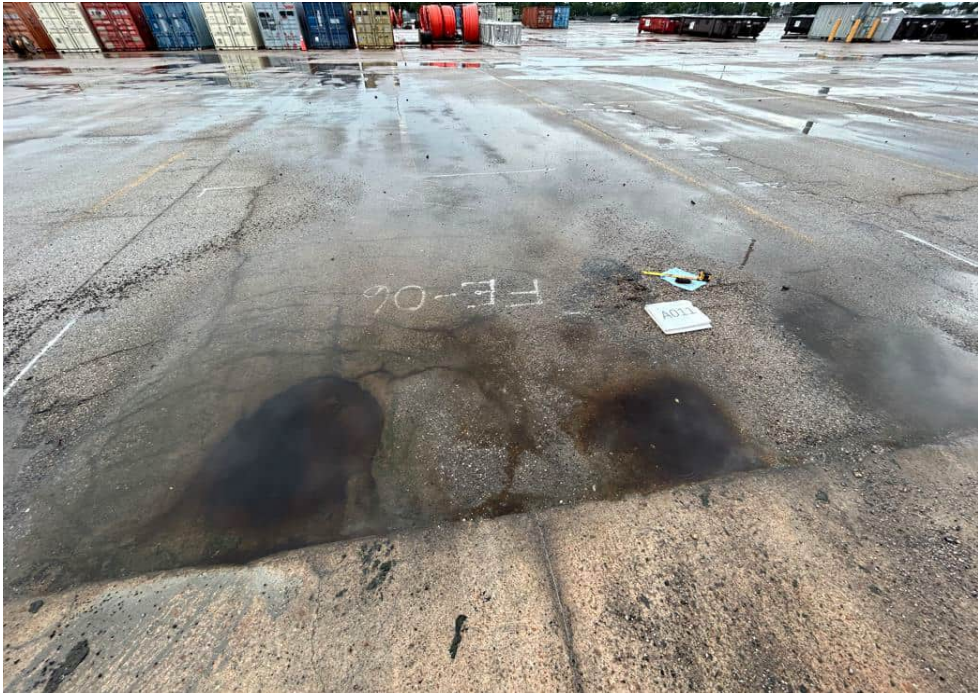
| <b>Photo No.</b><br><b>32</b> | <b>Inspection Date:</b><br>6/5/2024 | | |

| <b>Description:</b><br><br>4 cubic inches of NAPL found at A011.<br><br><br><br><br><br>Lat: 29.785467<br>Long: -95.318341 | | | |

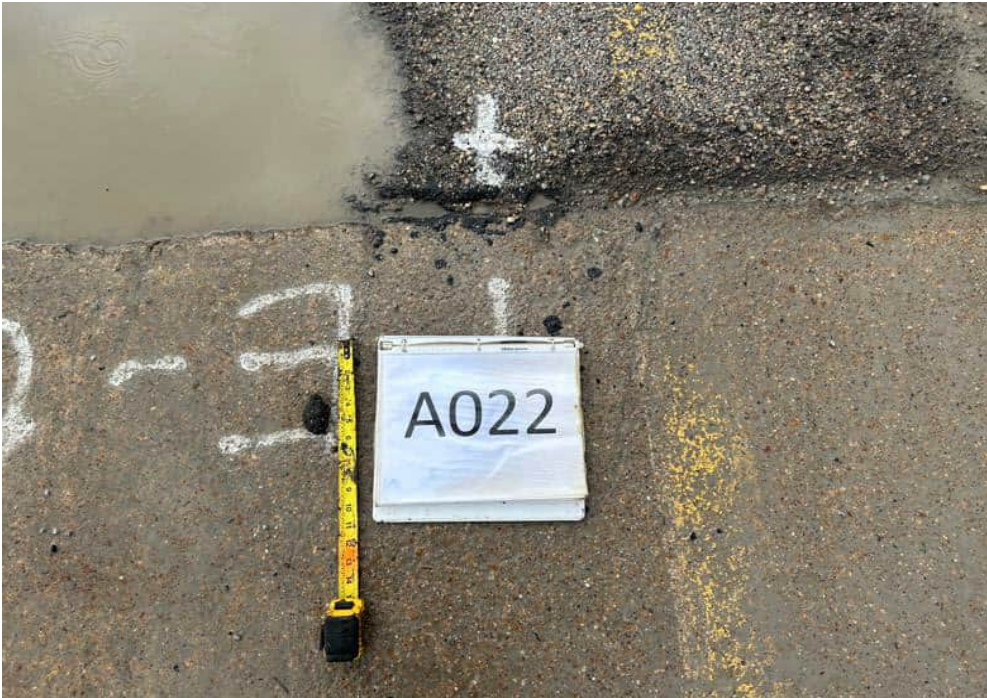
| <b>Photo No.</b><br><b>33</b> | <b>Inspection Date:</b><br>6/5/2024 | | |

| <b>Description:</b><br><br>2 cubic inches of NAPL found at A022.<br><br><br>Lat: 29.785378<br>Long: -95.318694 | | | |

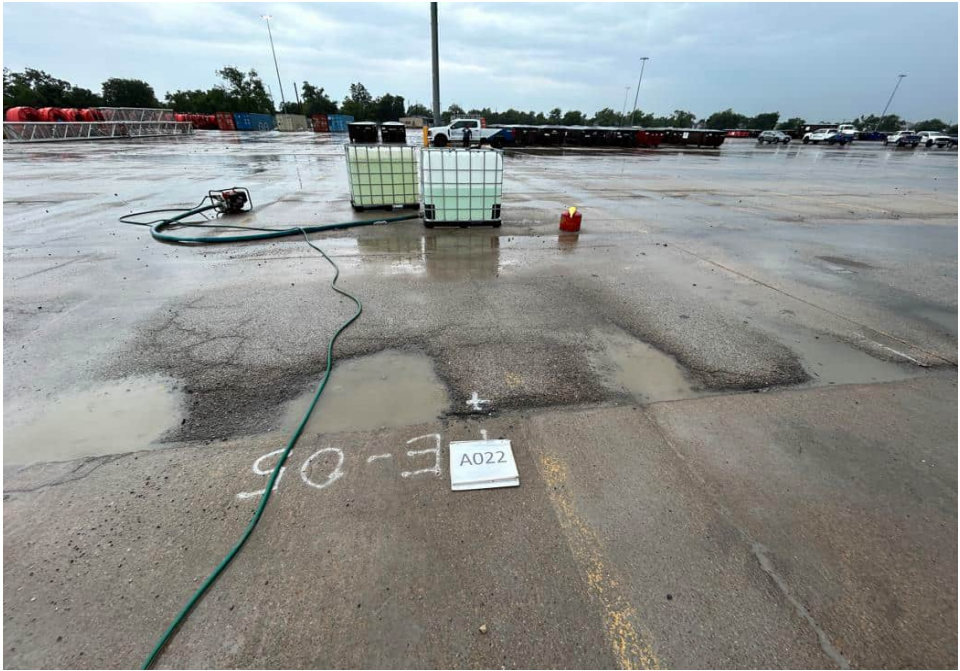
| <b>Photo No.</b><br><b>34</b> | <b>Inspection Date:</b><br>6/5/2024 | | |

| <b>Description:</b><br><br>2 cubic inches of NAPL found at A022.<br><br><br>Lat: 29.785378<br>Long: -95.318694 | | | |

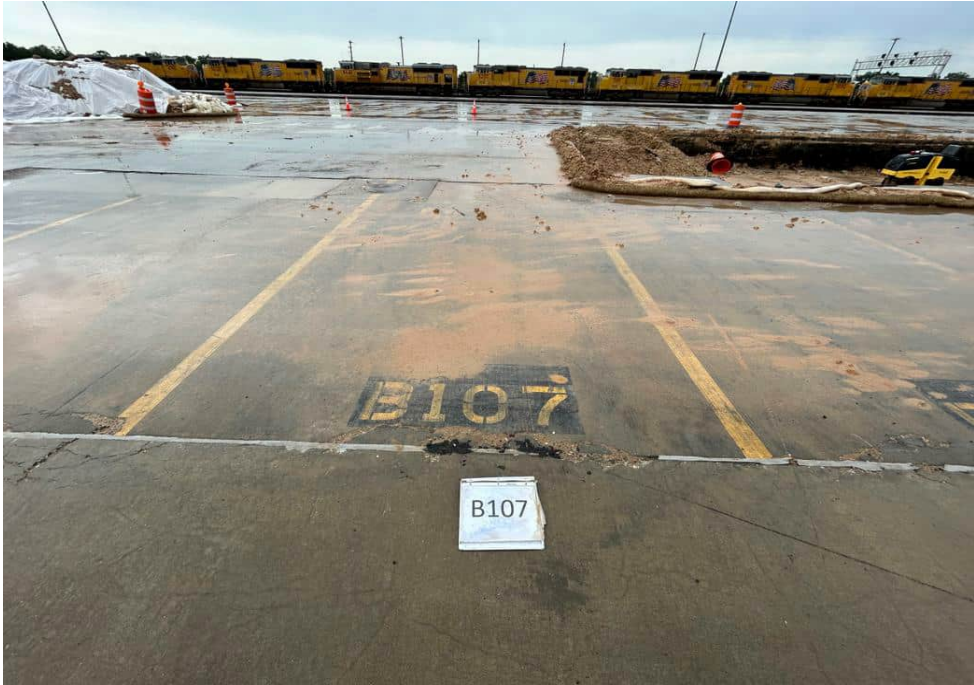
| <b>Photo No.</b><br><b>35</b> | <b>Inspection Date:</b><br>6/5/2024 | | |

| <b>Description:</b><br><br>2.5 cubic inches of NAPL found at B107.<br><br><br><br><br>Lat: 29.784137<br>Long: -95.32096 | | | |

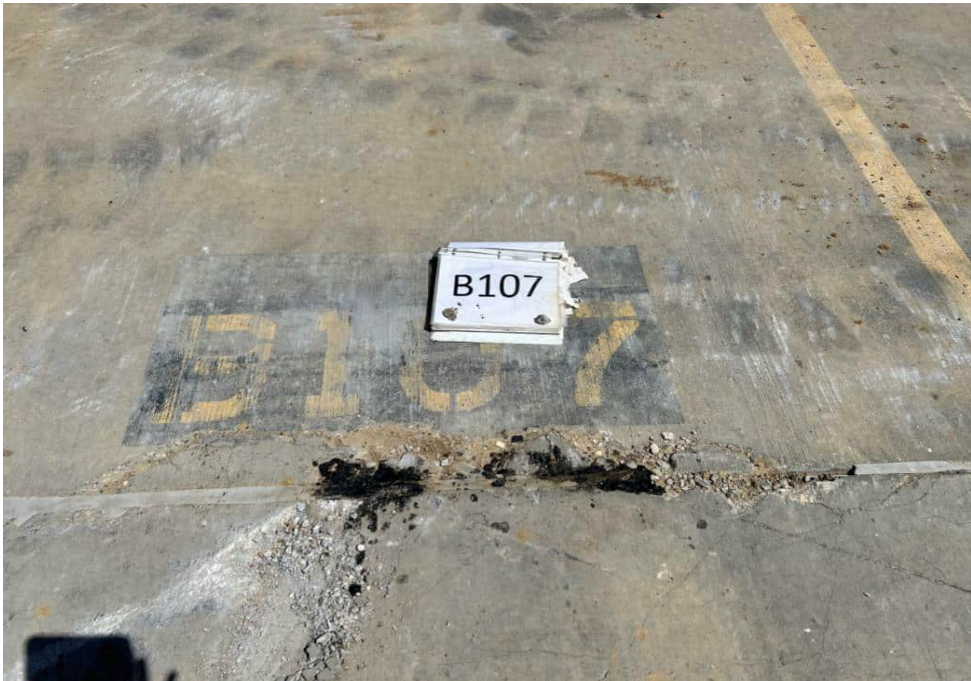
| <b>Photo No.</b><br><b>37</b> | <b>Inspection Date:</b><br>6/24/2024 | | |

| <b>Description:</b><br><br>2 cubic inches of NAPL found at B107.<br><br><br>Lat: 29.784137<br>Long: -95.32096 | | | |

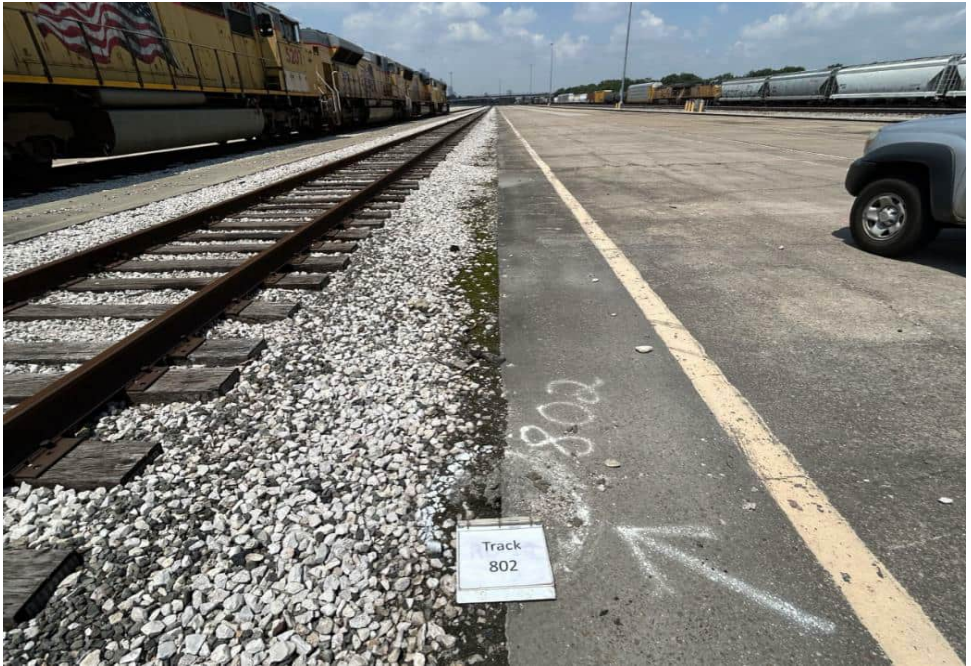
| <b>Photo No.</b><br><b>38</b> | <b>Inspection Date:</b><br>6/12/2024 | | |

| <b>Description:</b><br><br>2 cubic inches of NAPL found at Track 802.<br><br><br>Lat: 29.784947<br>Long: -95.321214 | | | |

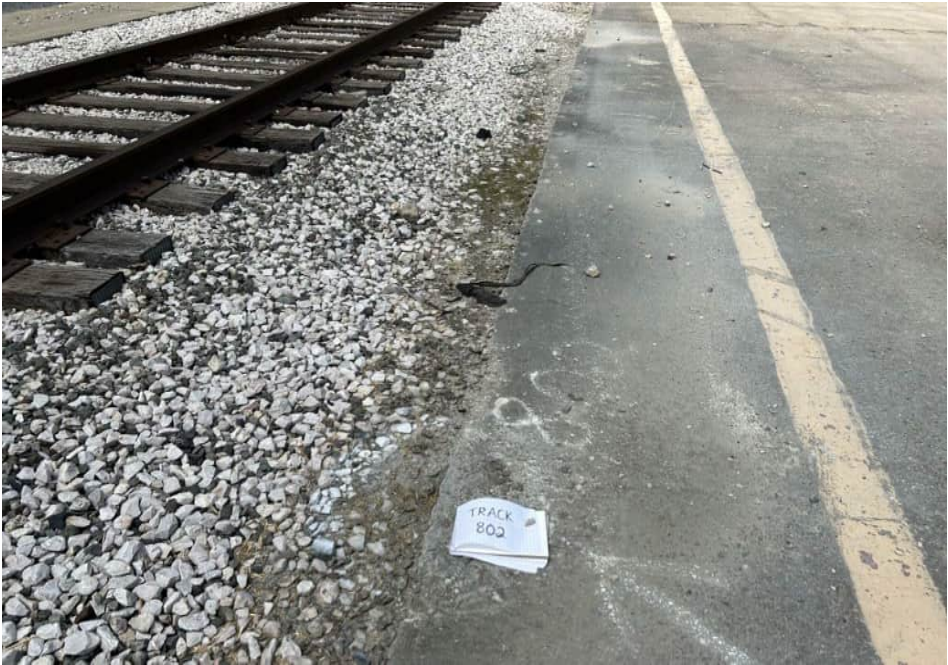
| <b>Photo No.</b><br><b>39</b> | <b>Inspection Date:</b><br>6/26/2024 | | |

| <b>Description:</b><br><br>0.5 cubic inches of NAPL found at Track 802.<br><br><br>Lat: 29.784947<br>Long: -95.321214 | | | |
