July 11, 2024

Project No. 31406585.016

**Re: MONTHLY STATUS UPDATE – ENGLEWOOD INTERMODAL YARD – NAPL COLLECTION  
SYSTEM/CONCRETE CAP REPAIRS AND REVISED INTERIM MEASURES WORK PLAN  
CONSTRUCTION ACTIVITIES  
UNION PACIFIC RAILROAD HOUSTON WOOD PRESERVING WORKS FACILITY  
4910 LIBERTY ROAD FACILITY, HOUSTON, TEXAS  
POST-CLOSURE CARE PERMIT NO. HW-50343; INDUSTRIAL SWR NO. 31547**

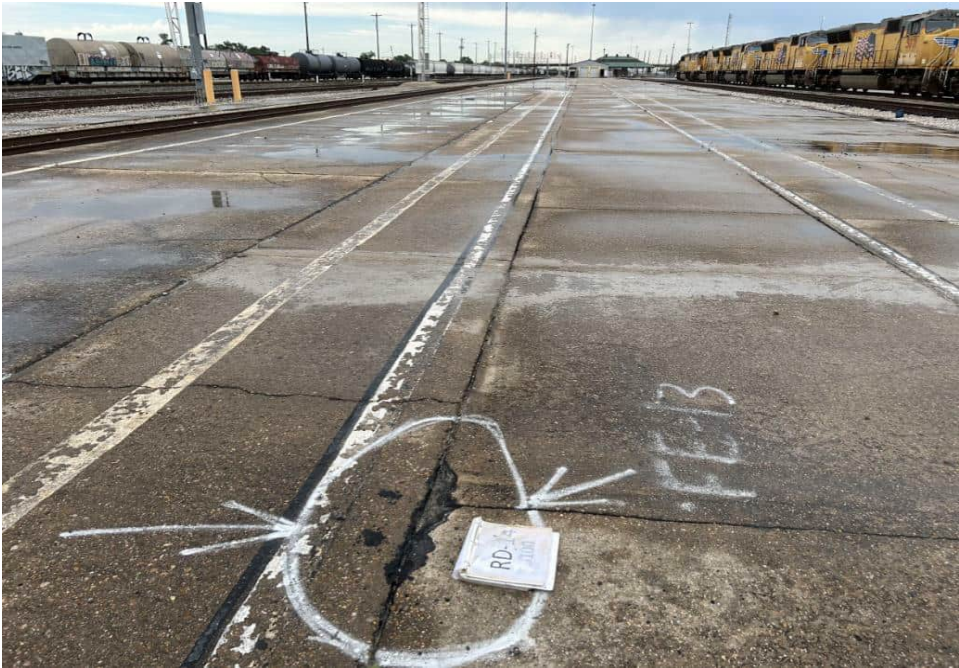
| <b>Photo No.</b><br><b>40</b> | <b>Inspection Date:</b><br>6/5/2024 | | |

| <b>Description:</b><br><br>1.5 cubic inches of NAPL found at RD-14.<br><br><br>Lat: 29.785064<br>Long: -95.321219 | | | |

- Tar-like material observed during the weekly inspection events was removed and recovered using a hand tool to scrap up the material. The number of tar-like material seeps observed, and total volume of material recovered during the month of June was significantly less than during the May inspections. The collection volume reduced from 0.19 gallons to 0.08 gallons due to the quantity of excavations at the seep locations. The material recovered was placed in a drum staged at the CSA for disposal.
- During the June 2024 inspections, no NAPL seeps were observed at the seven July 2020 test pit locations (stalls A010, A021, A098, B013, B057, B096 and B108) or three other stall numbers B042, B056, and B102 Joint.
- As of the end of June 2024, seeps A010, A022, B042, B056, B057, B096, B100, B102, B105, and RD-14 have been excavated.

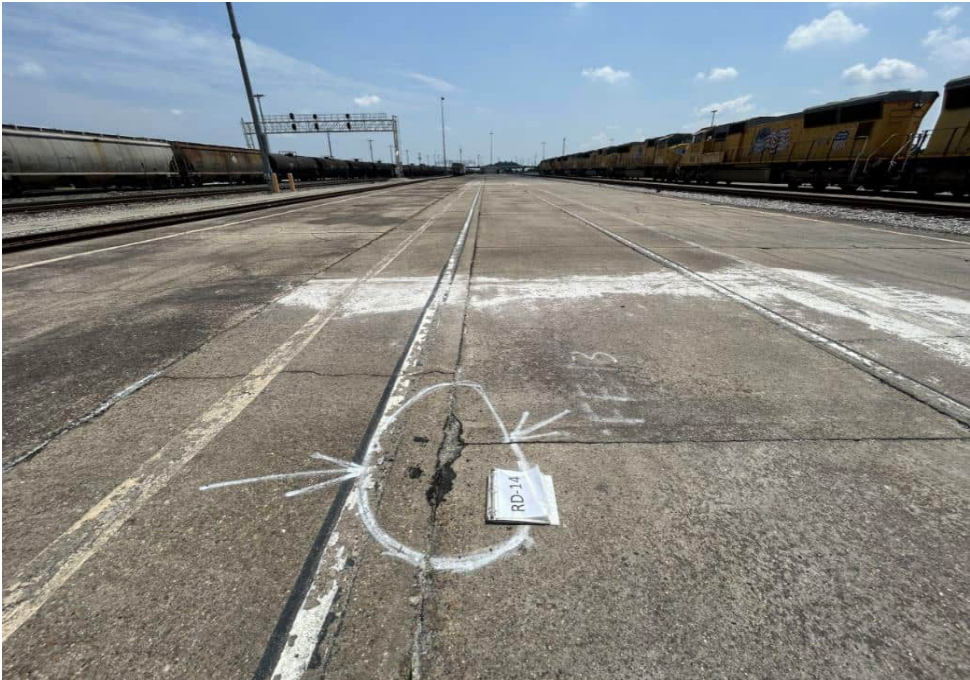
| <b>Photo No.</b><br><b>41</b> | <b>Inspection Date:</b><br>6/12/2024 | | |

| <b>Description:</b><br><br>1 cubic inches of NAPL found at RD-14.<br><br><br>Lat: 29.785064<br>Long: -95.321219 | | | |
