August 15, 2024

Project No. 31406585.016

**Re: MONTHLY STATUS UPDATE – ENGLEWOOD INTERMODAL YARD – NAPL COLLECTION  
SYSTEM/CONCRETE CAP REPAIRS AND REVISED INTERIM MEASURES WORK PLAN  
CONSTRUCTION ACTIVITIES  
UNION PACIFIC RAILROAD HOUSTON WOOD PRESERVING WORKS FACILITY  
4910 LIBERTY ROAD FACILITY, HOUSTON, TEXAS  
POST-CLOSURE CARE PERMIT NO. HW-50343; INDUSTRIAL SWR NO. 31547**

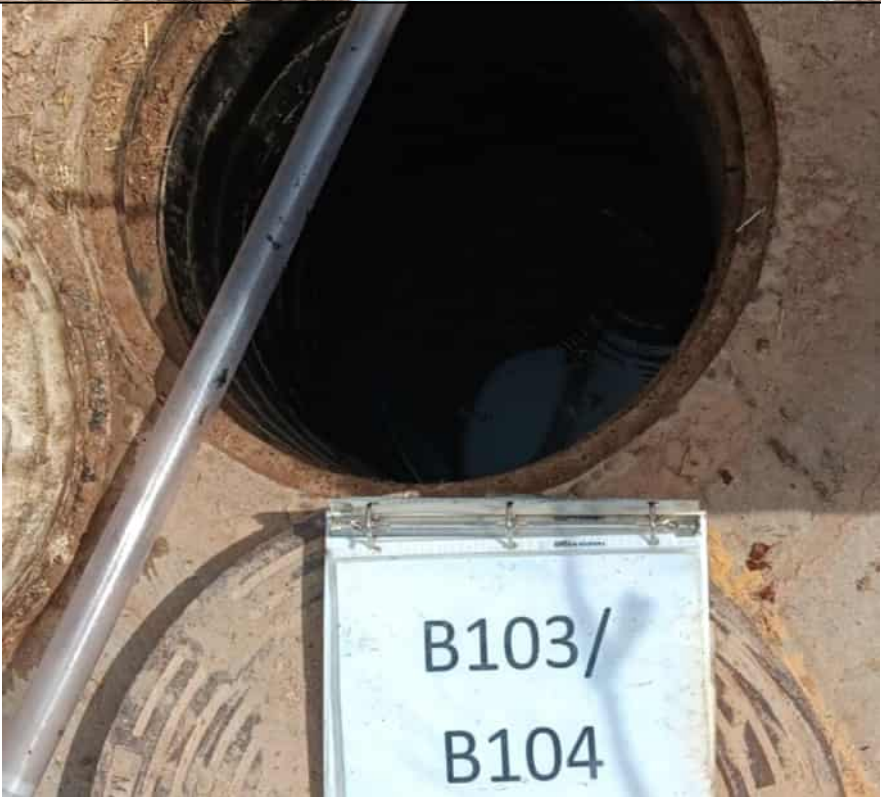
<b>Photo No.</b> 18	<b>Inspection Date:</b> 7/3/2024

<b>Description:</b>  Sump 2 (B103/B104), 43 inches of freeboard in sump. No odor or sheen was observed, and water color was noted as brown.  Lat: 29.7842861 Long: -95.3208611

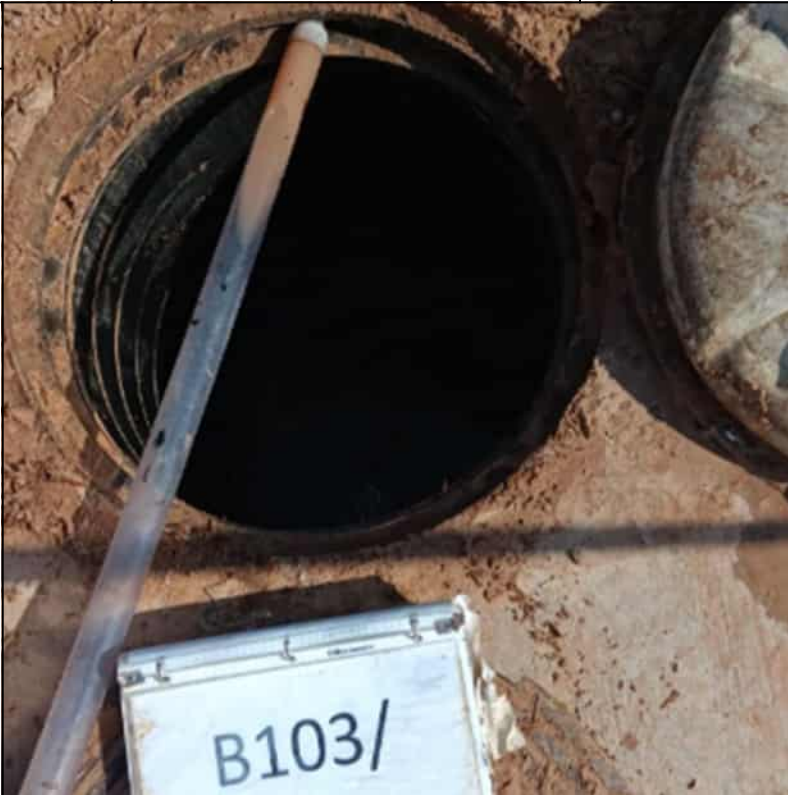
<b>PHOTOGRAPHIC LOG</b>	
<b>Client Name:</b> Union Pacific Railroad		<b>Site Location:</b> Englewood Intermodal Yard, Houston, Texas	<b>Project No.</b> 31406585.016
<b>Photo No.</b> <b>21</b>	<b>Inspection Date:</b> 7/10/2024

<b>Description:</b>  Sump 2 (B103/B104), 35 inches of freeboard in sump. No odor or sheen was observed, and water color was noted as brown.  Lat: 29.7842861 Long: -95.3208611			
<b>Photo No.</b> <b>22</b>	<b>Inspection Date:</b> 7/10/2024

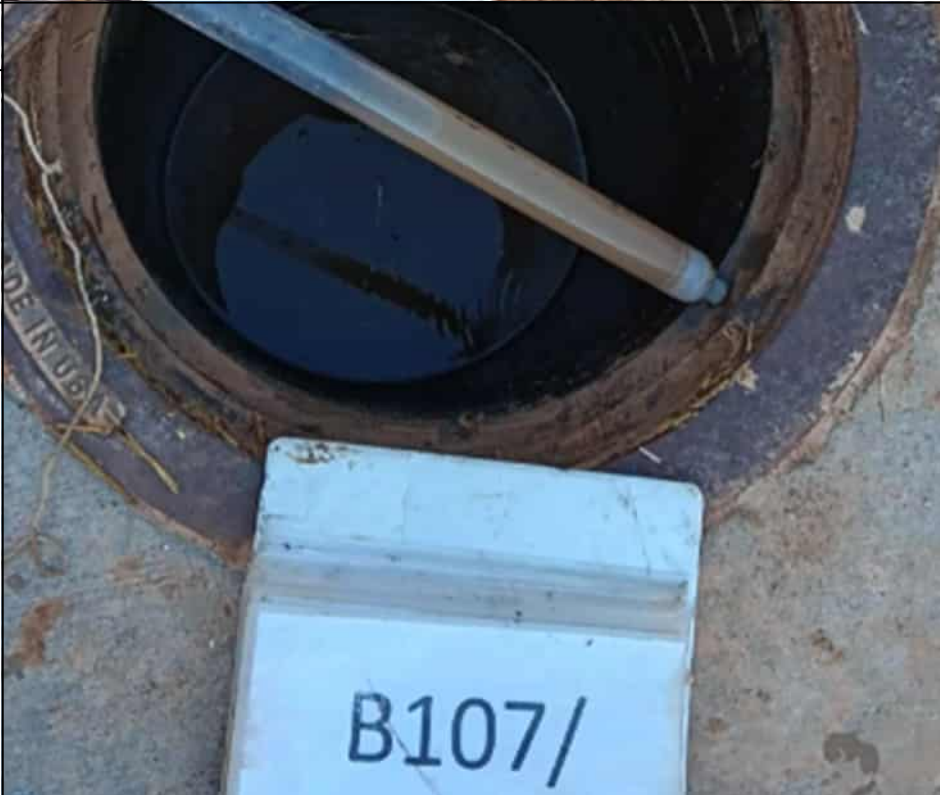
<b>Description:</b>  Sump 3 (B107/B108), 34 inches of freeboard in sump. No odor or sheen was observed, and water color was noted as brown.  Lat: 29.7844000 Long: -95.3205861

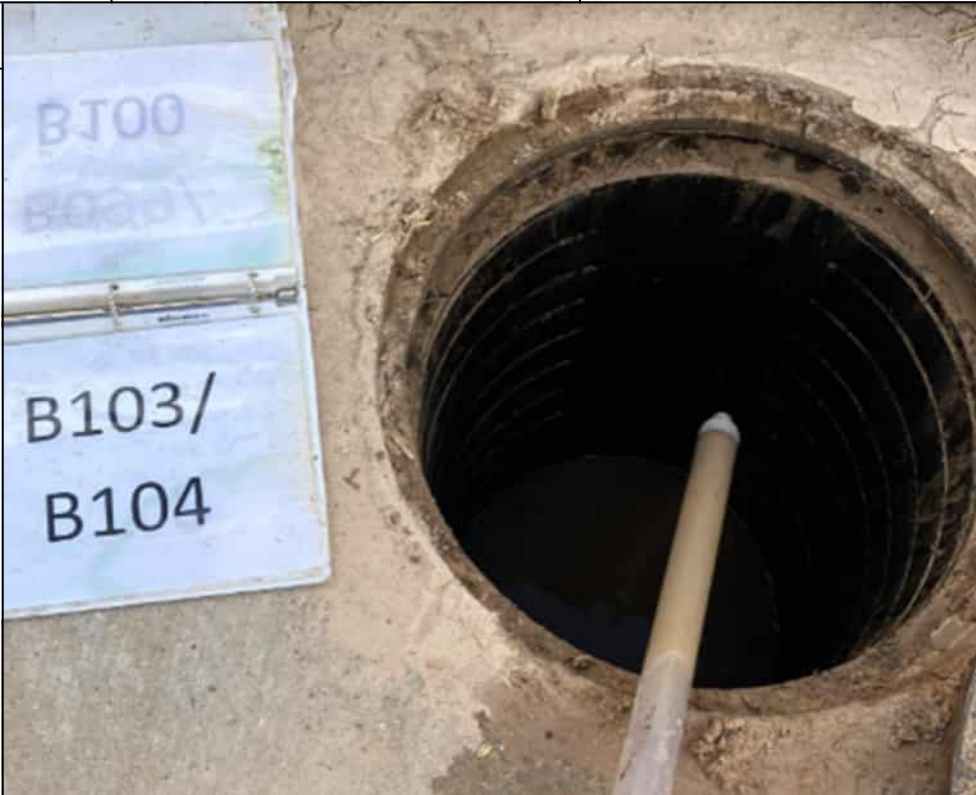
<b>PHOTOGRAPHIC LOG</b>	
<b>Client Name:</b> Union Pacific Railroad		<b>Site Location:</b> Englewood Intermodal Yard, Houston, Texas	<b>Project No.</b> 31406585.016
<b>Photo No.</b> <b>25</b>	<b>Inspection Date:</b> 7/17/2024

<b>Description:</b>  Sump 2 (B103/B104), 39 inches of freeboard in sump. No odor or sheen was observed, and water color was noted as light brown.  Lat: 29.7842861 Long: -95.3208611			
<b>Photo No.</b> <b>26</b>	<b>Inspection Date:</b> 7/17/2024

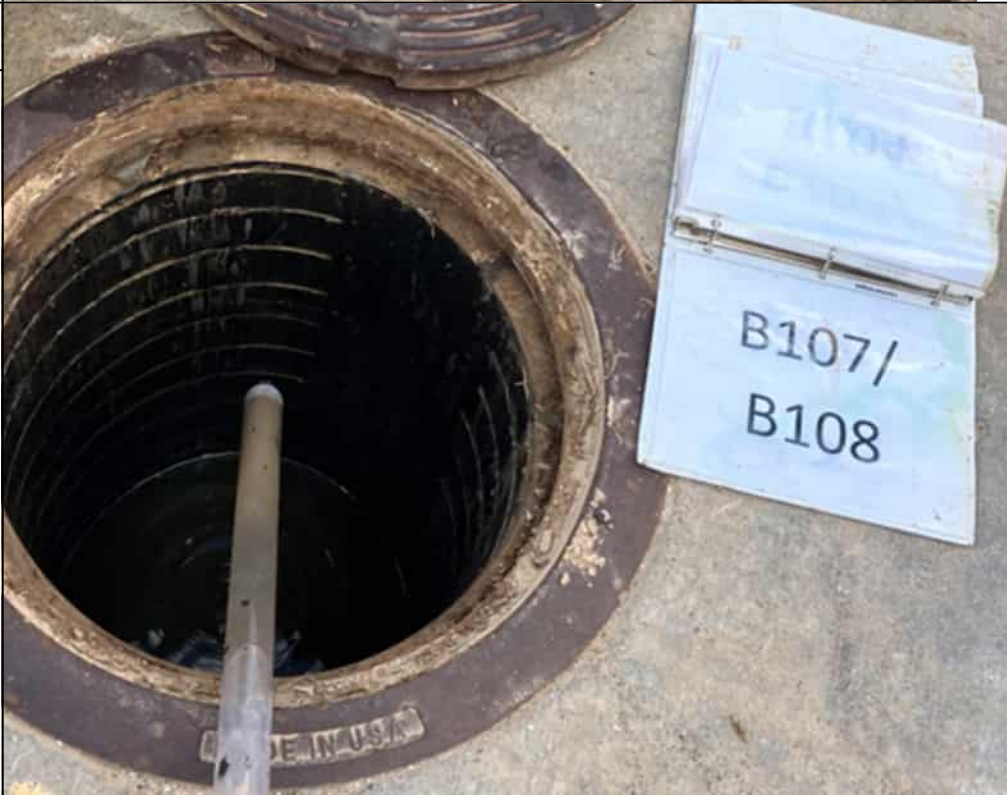
<b>Description:</b>  Sump 3 (B107/B108), 38 inches of freeboard in sump. Sheen was observed, and water color was noted as light brown.  Lat: 29.7844000 Long: -95.3205861

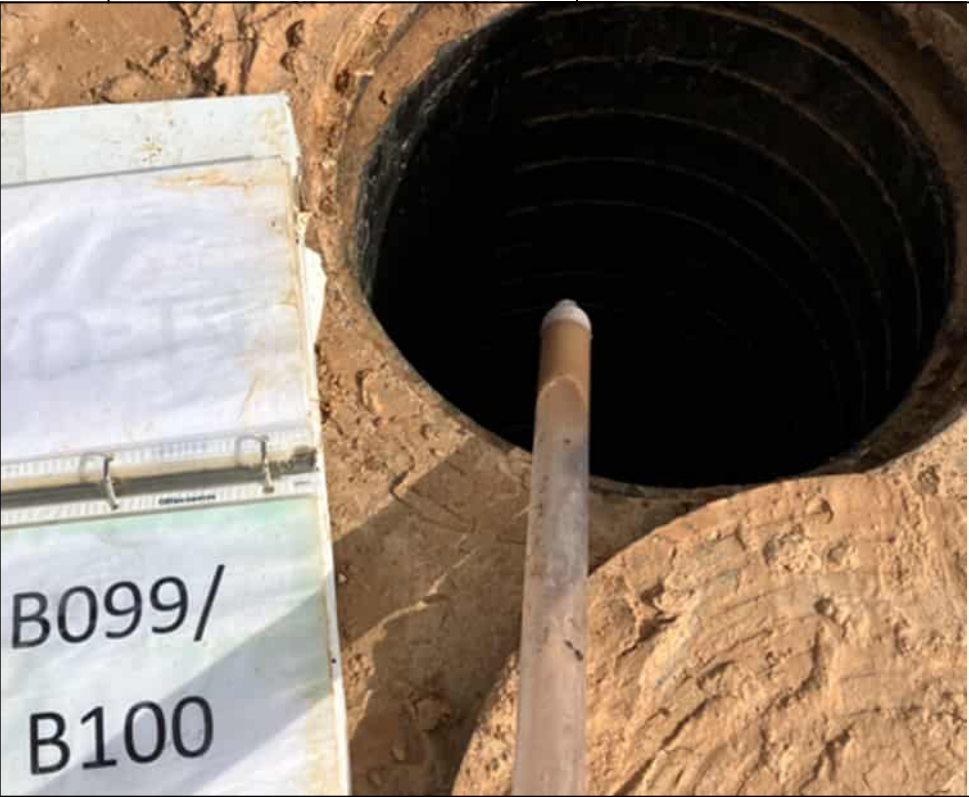
<b>PHOTOGRAPHIC LOG</b>	
<b>Client Name:</b> Union Pacific Railroad		<b>Site Location:</b> Englewood Intermodal Yard, Houston, Texas	<b>Project No.</b> 31406585.016
<b>Photo No.</b> <b>31</b>	<b>Inspection Date:</b> 7/31/2024

- July 31<sup>st</sup> – at 45, 45, and 45 inches (Photo 31, 32, and 33)
- During the July 2024 inspections, the water in Sump 1 was observed to range from dark brown to light brown to brown in color, and the water in Sump 2 and Sump 3 were observed to be brown or light brown. A sheen was observed at Sump 1 during the July 3, 10, 17, and 31, 2024 inspections and Sump 3 during the July 3, 2024 inspection. No odors were reported during the July inspections.

<b>Description:</b>  Sump 1 (B099/B100), 45 inches of freeboard in sump. Sheen was observed, and water color was noted as brown.  Lat: 29.7844000 Long: -95.3205861			
<b>Photo No.</b> <b>32</b>	<b>Inspection Date:</b> 7/31/2024

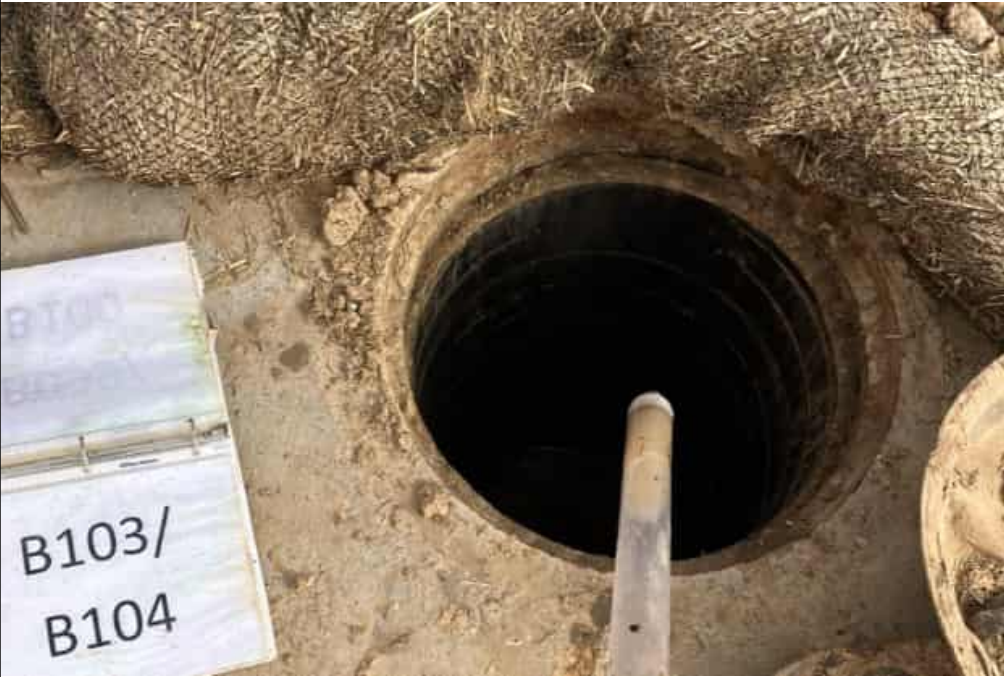
<b>Description:</b>  Sump 2 (B103/B104), 45 inches of freeboard in sump. No odor or sheen was observed, and water color was noted as light brown.  Lat: 29.7842861 Long: -95.3208611

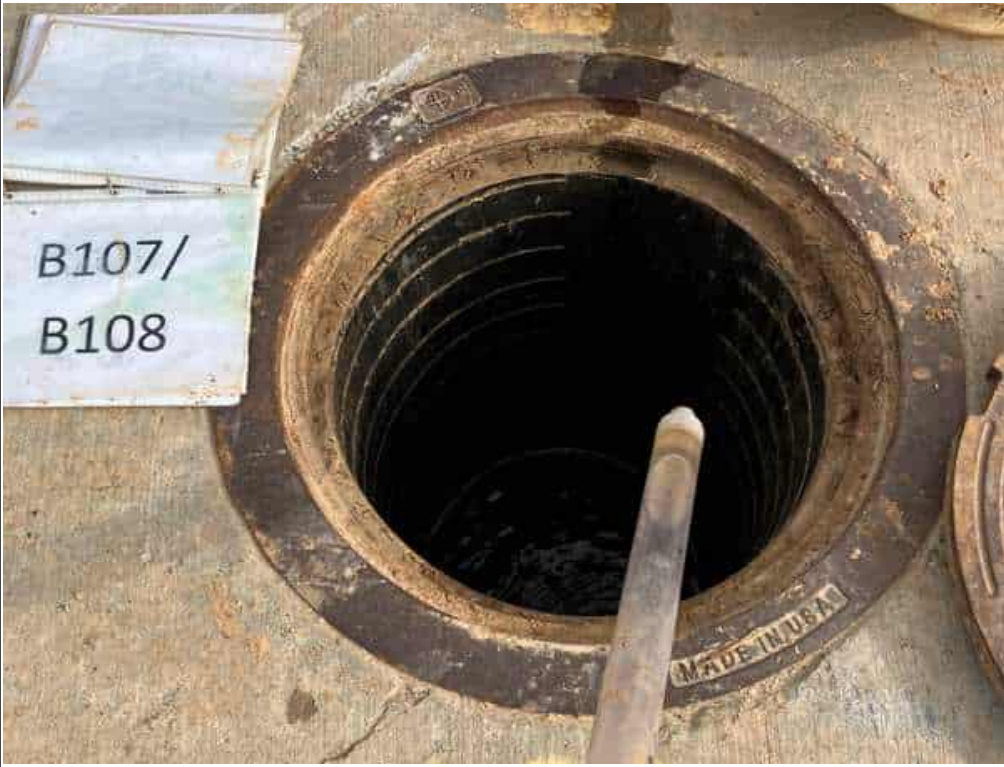
<b>PHOTOGRAPHIC LOG</b>	
<b>Client Name:</b> Union Pacific Railroad		<b>Site Location:</b> Englewood Intermodal Yard, Houston, Texas	<b>Project No.</b> 31406585.016
<b>Photo No.</b> <b>33</b>	<b>Inspection Date:</b> 7/31/2024

<b>Description:</b>  Sump 3 (B107/B108), 45 inches of freeboard in sump. No odor or sheen was observed, and water color was noted as light brown.  Lat: 29.7844000 Long: -95.3205861			
<b>Photo No.</b> <b>34</b>	<b>Inspection Date:</b> 7/3/2024

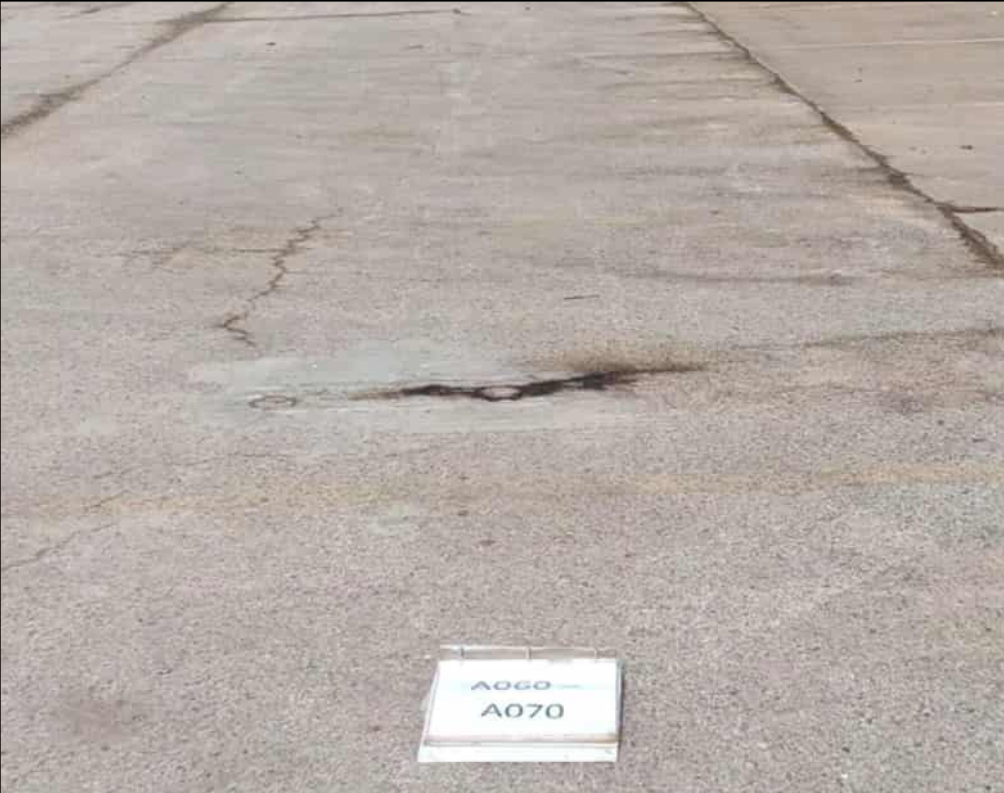
<b>Description:</b>  Stall A060. Small cracks in pavement with staining.  Lat: 29.784858 Long: -95.319733

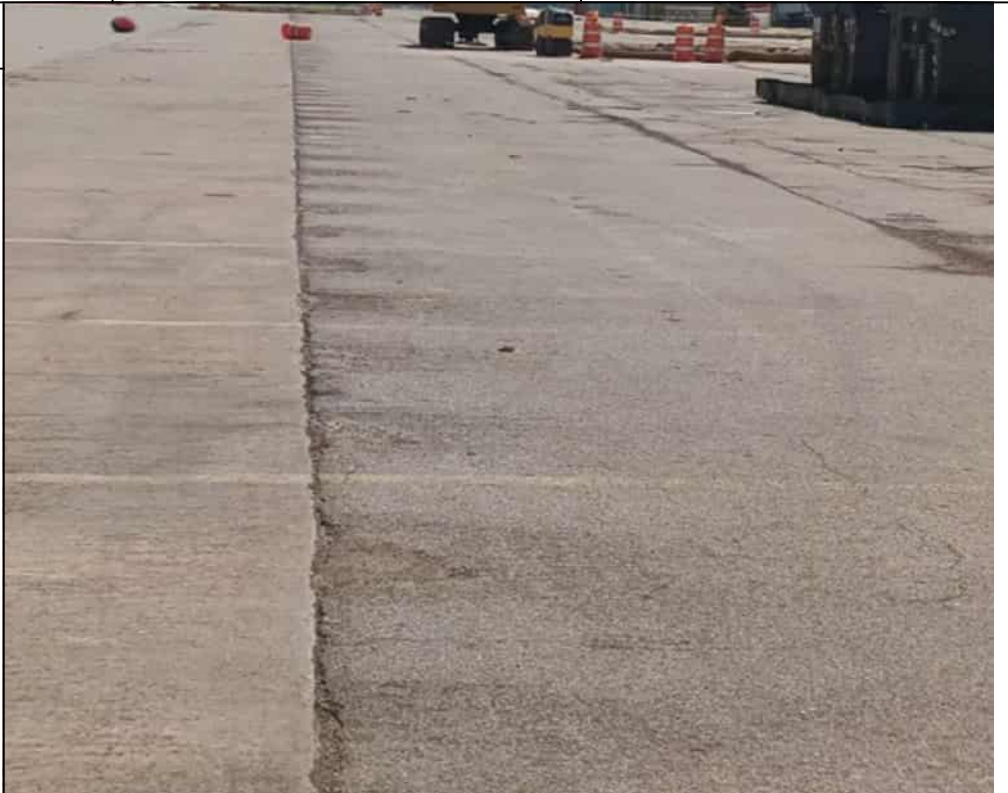
<b>Photo No.</b> <b>38</b>	<b>Inspection Date:</b> 7/17/2024
<b>Description:</b>  Stall A060. Small cracks in pavement without staining.	
Lat: 29.784858 Long: -95.319733

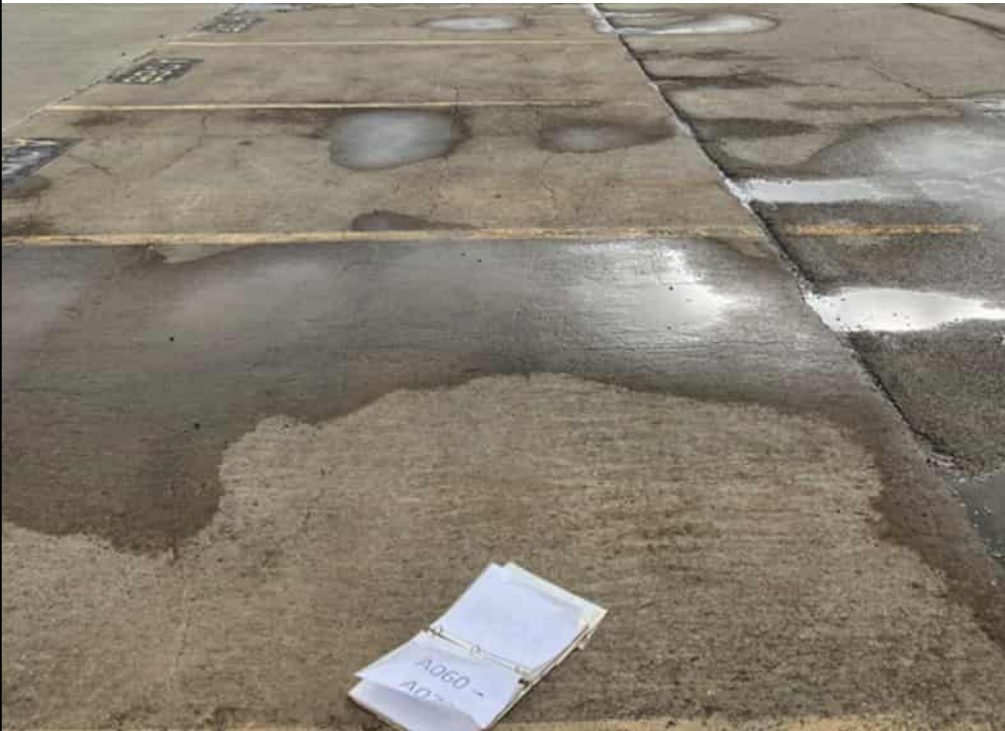
<b>PHOTOGRAPHIC LOG</b>	
<b>Client Name:</b> Union Pacific Railroad		<b>Site Location:</b> Englewood Intermodal Yard, Houston, Texas	<b>Project No.</b> 31406585.016
<b>Photo No.</b> <b>41</b>	<b>Inspection Date:</b> 7/24/2024

<b>Description:</b>  Stall A070. Cracks in pavement with rainwater.      Lat: 29.784858 Long: -95.319733			
<b>Photo No.</b> <b>42</b>	<b>Inspection Date:</b> 7/31/2024

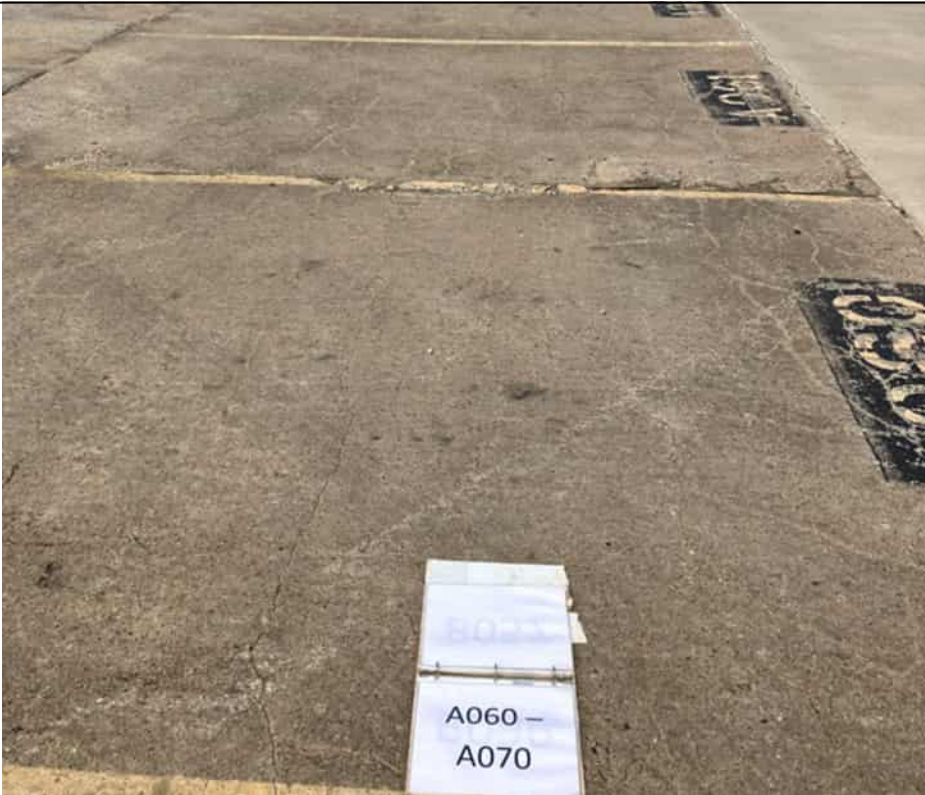
<b>Description:</b>  Stall A060. Small cracks in pavement.      Lat: 29.784858 Long: -95.319733

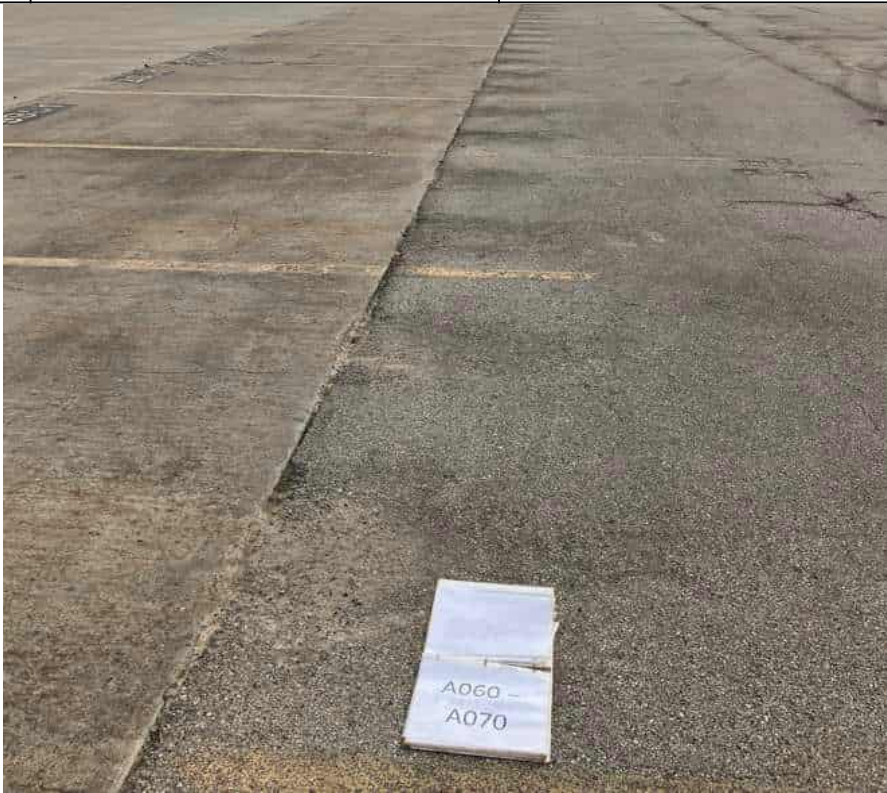
<b>PHOTOGRAPHIC LOG</b>	
<b>Client Name:</b> Union Pacific Railroad		<b>Site Location:</b> Englewood Intermodal Yard, Houston, Texas	<b>Project No.</b> 31406585.016
<b>Photo No.</b> <b>43</b>	<b>Inspection Date:</b> 7/31/2024

<b>Description:</b>  Stall A070. Cracks in pavement with minor staining.   Lat: 29.784858 Long: -95.319733			
<b>Photo No.</b> <b>44</b>	<b>Inspection Date:</b> 7/3/2024

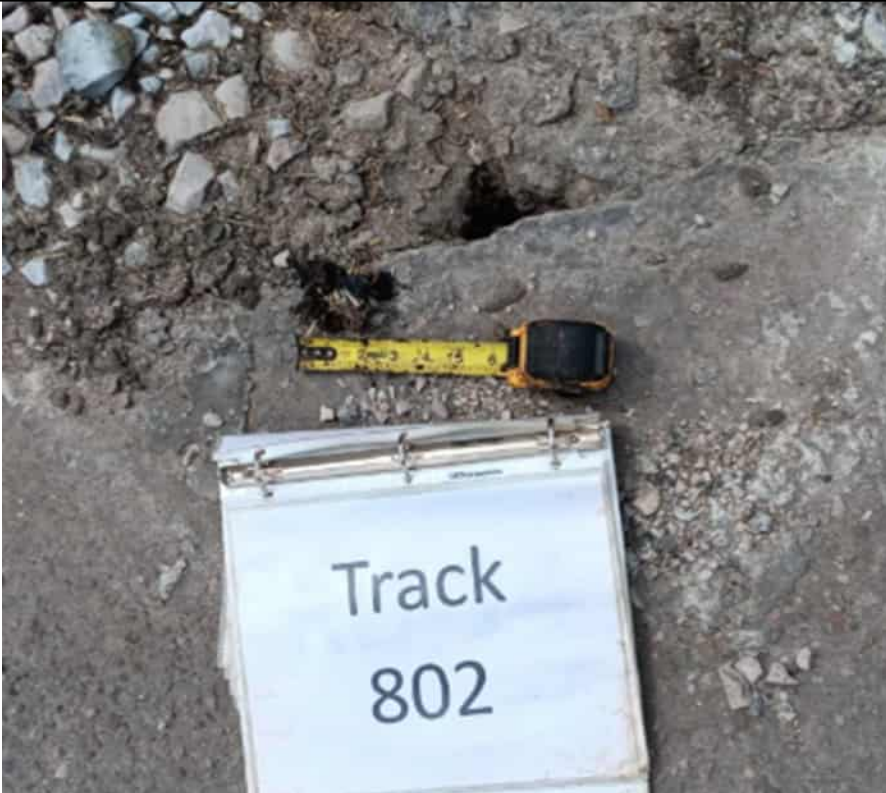
<b>Description:</b>  NAPL seep at Track 802; 2 in <sup>3</sup> of tar was removed.   Lat: 29.784947 Long: -95.321214

- Tar-like material observed during the weekly inspection events was removed and recovered using a hand tool to scrape up the material. The number of tar-like material seeps observed, and total volume of material recovered during the month of July was less than during the June inspections. The collection volume reduced from 0.08 gallons over 4 inspections to 0.07 gallons over 5 inspections due to the on-going focused excavations at the previous seep locations. The material recovered was placed in a drum staged at the CSA for disposal.

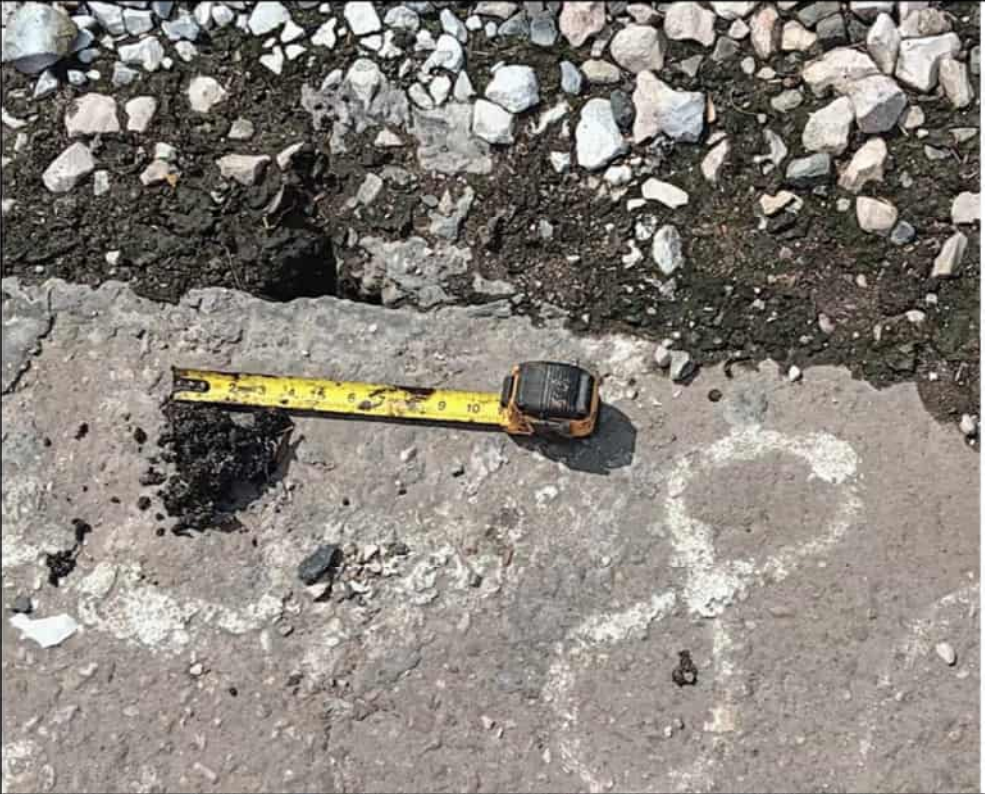
Client Name: Union Pacific Railroad		Site Location: Englewood Intermodal Yard, Houston, Texas	Project No. 31406585.016
Photo No. 45	Inspection Date: 7/10/2024

Description:  NAPL seep at Track 802; 4 in <sup>3</sup> of tar was removed.  Lat: 29.784947 Long: -95.321214			
Photo No. 46	Inspection Date: 7/17/2024

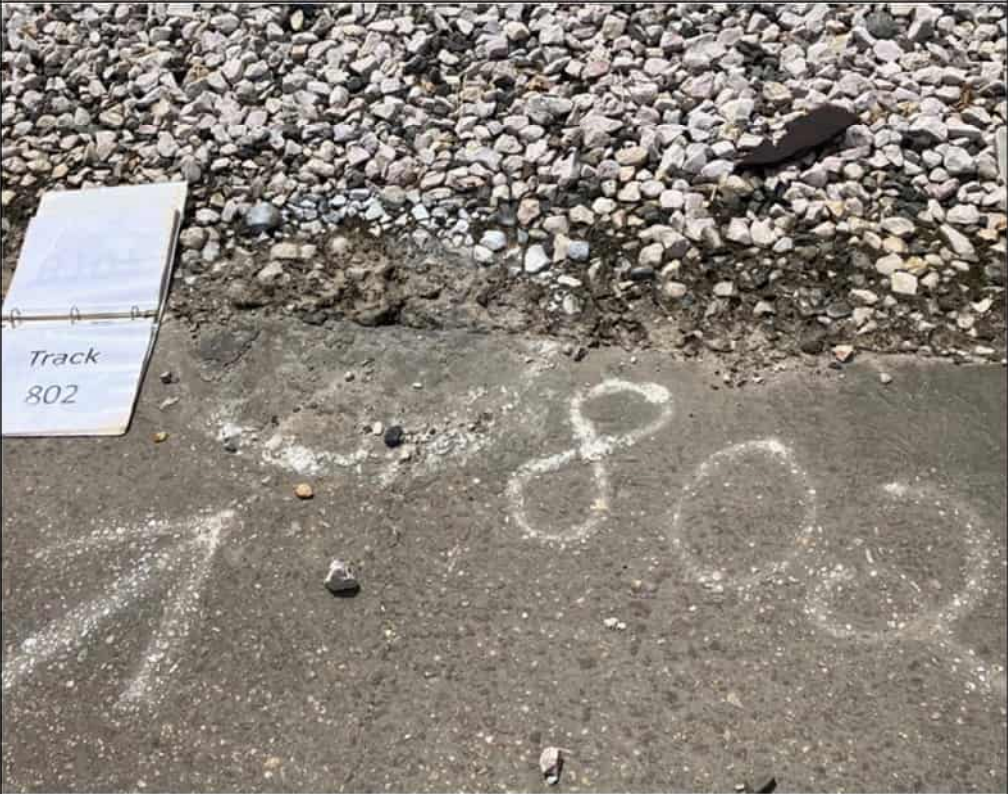
Description:  Ongoing NAPL seep at Track 802; no recoverable tar.  Lat: 29.784947 Long: -95.321214

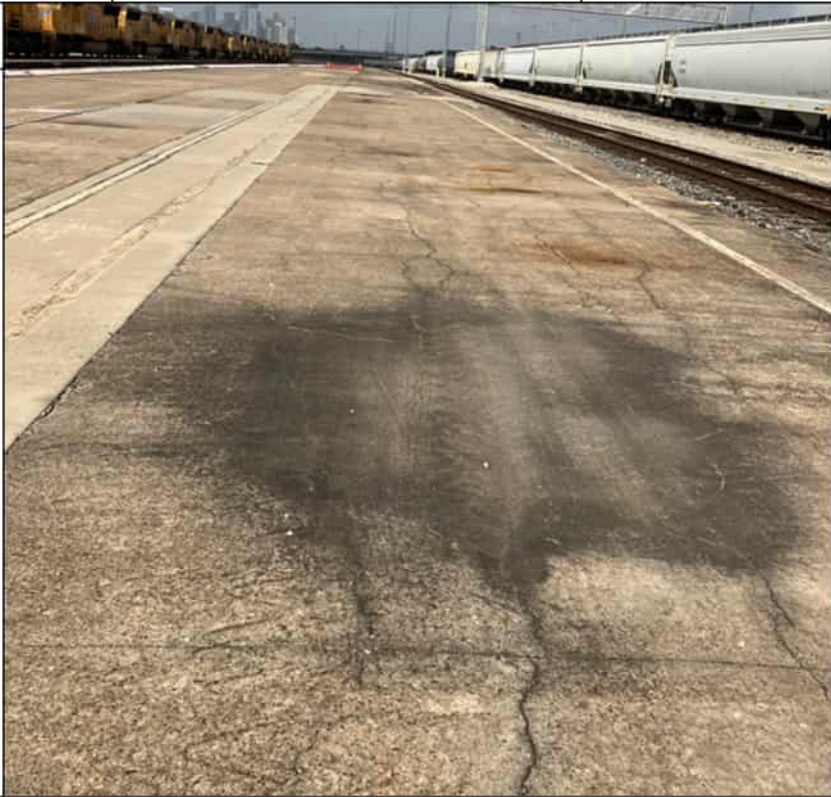
- There was slight staining between the train tracks near FE-13 (Photo 49).

Staining in area between train tracks near FE-13.
