October 15, 2024

Project No. 31406585.016

Re: **MONTHLY STATUS UPDATE – ENGLEWOOD INTERMODAL YARD – NAPL COLLECTION  
SYSTEM/CONCRETE CAP REPAIRS AND REVISED INTERIM MEASURES WORK PLAN  
CONSTRUCTION ACTIVITIES  
UNION PACIFIC RAILROAD HOUSTON WOOD PRESERVING WORKS FACILITY  
4910 LIBERTY ROAD FACILITY, HOUSTON, TEXAS  
POST-CLOSURE CARE PERMIT NO. HW-50343; INDUSTRIAL SWR NO. 31547**

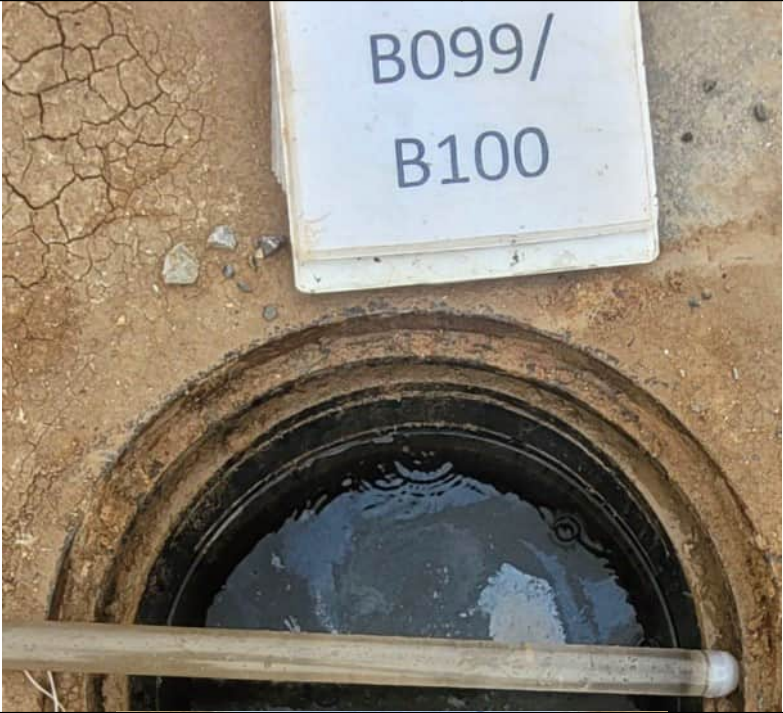
| <b>Photo No.</b><br><b>23</b> | <b>Inspection Date:</b><br>9/4/2024 | | |

| <b>Description:</b><br>Sump 1 (B99/B100), 8 inches of freeboard in sump. Color is tan, and no odor observed. Sheen observed on the surface.<br><br>Lat: 29.784275<br>Long: -95.320844 | | | |

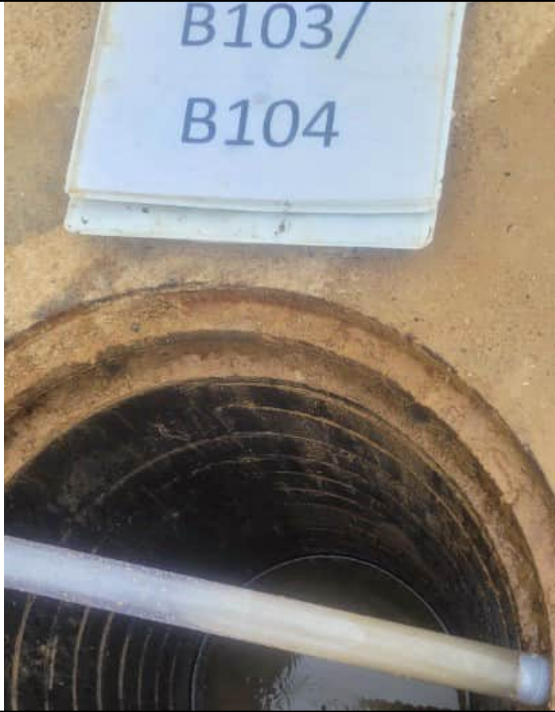
| <b>Photo No.</b><br><b>24</b> | <b>Inspection Date:</b><br>9/4/2024 | | |

| <b>Description:</b><br>Sump 2 (B103/B104), 41 inches of freeboard in sump. Color is tan, and no sheen or odor observed.<br><br>Lat: 29.784202<br>Long: -95.320939 | | | |
