**RE: POST-RESPONSE ACTION COMPLETION REPORT – 2024
UNION PACIFIC RAILROAD HOUSTON WOOD PRESERVING WORKS, HOUSTON, TEXAS
4910 LIBERTY ROAD, HOUSTON, HARRIS COUNTY, TEXAS
TCEQ SWR NO. 31547; TCEQ PERMIT/COMPLIANCE PLAN NO. 50343 EPA ID NO. TXD000820266
CUSTOMER NO. CN600131098; REGULATED ENTITY NO. RN100674613**

Cover Page

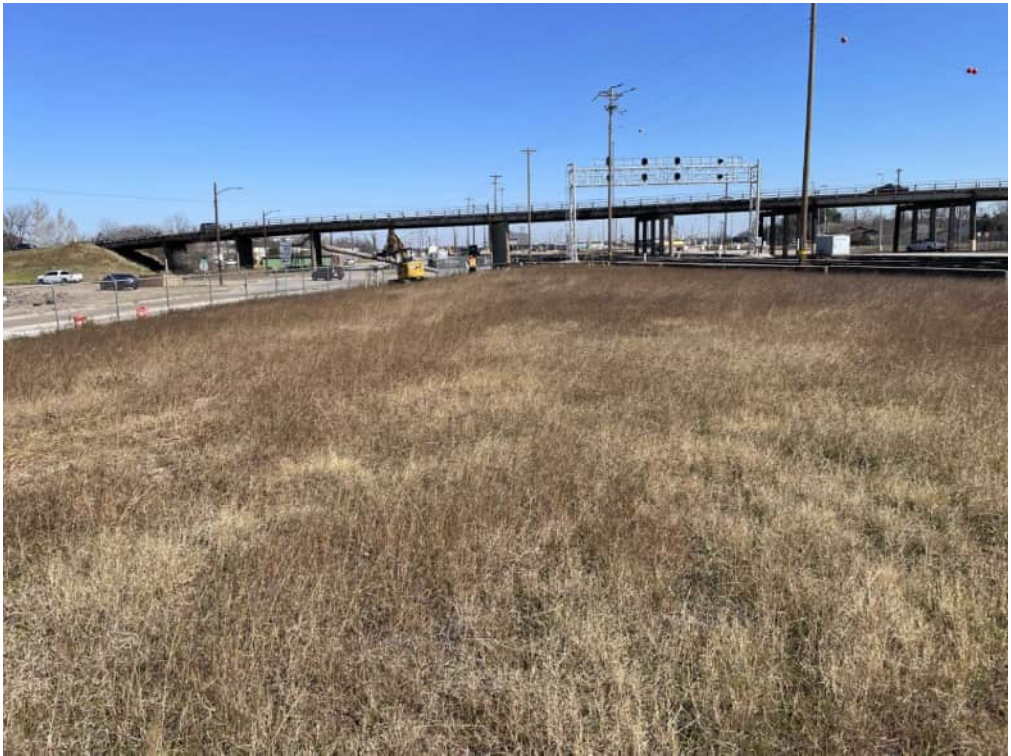
Client Name: Union Pacific Railroad		Site Location: Englewood Intermodal Yard, Houston, Texas	Project No. US0039040.4227
Photo No. 3	Date: 01/19/2024

Description: <u>HWPW Yard Area and Soil Cap:</u> Soil cap well-vegetated in most areas. No major erosion or ruts observed during inspection. Minor stress on vegetation due to the hard freeze cold season. Facing northeast. Lat: 29.787447 Long: -95.317292			
Photo No. 4	Date: 01/19/2024

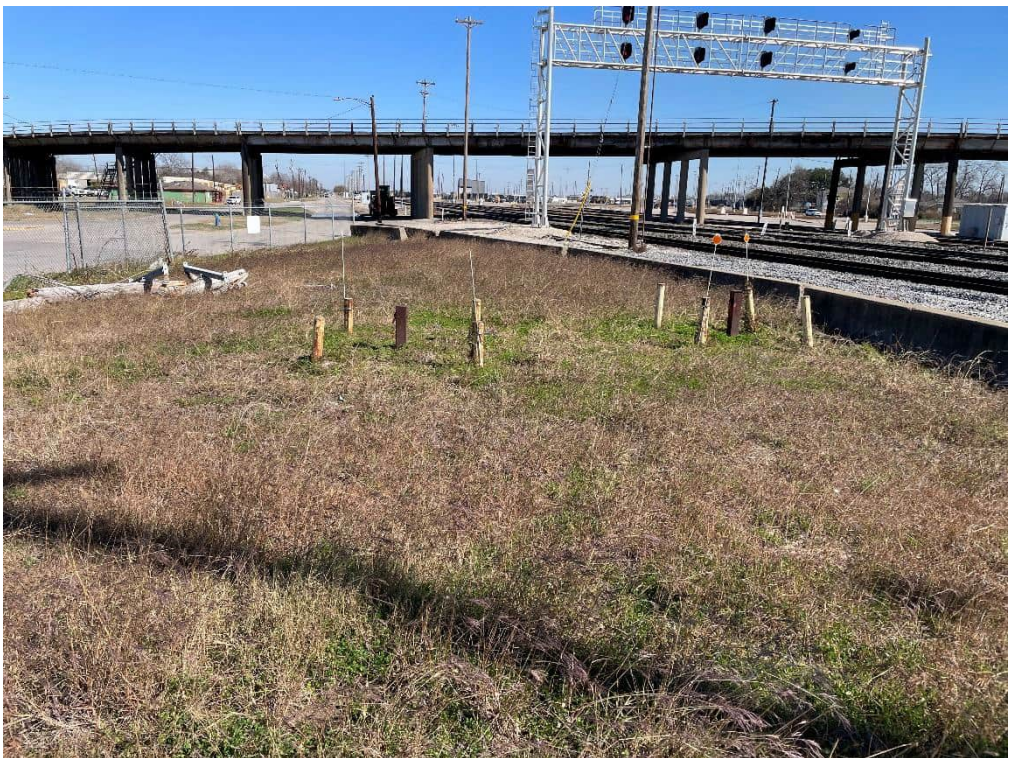
Description: <u>HWPW Yard Area and Soil Cap:</u> Soil cap is well-vegetated in most areas. The electric pole fell on the soil cap. Facing east. Lat: 29.787514 Long: -95.316794

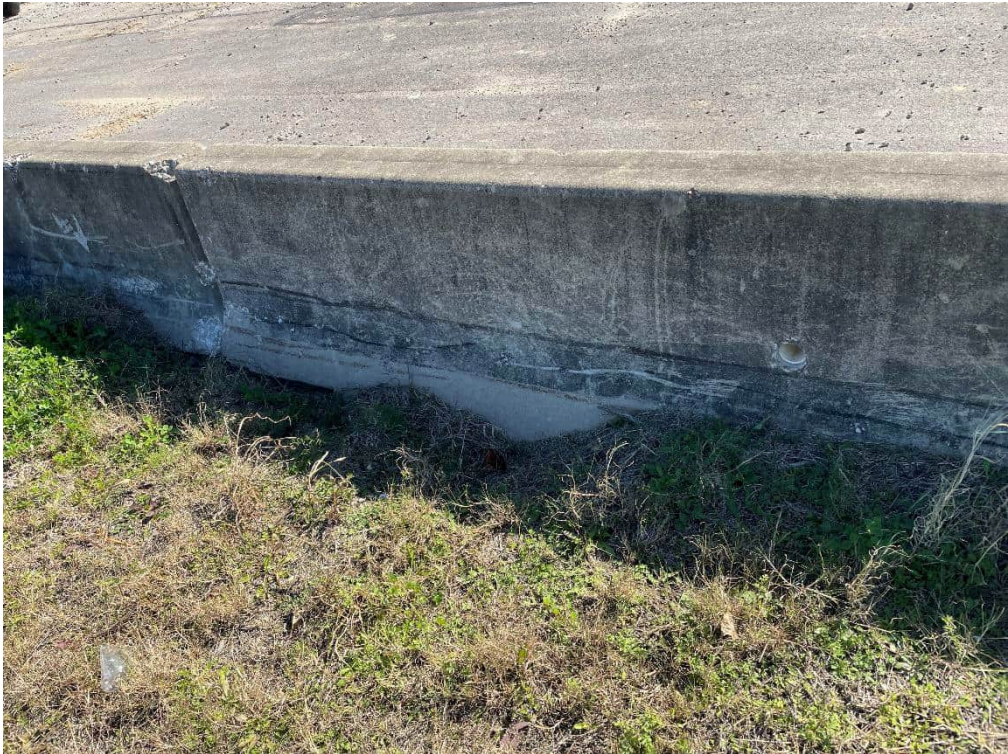
Client Name: Union Pacific Railroad		Site Location: Englewood Intermodal Yard, Houston, Texas	Project No. US0039040.4227
Photo No. 7	Date: 01/19/2024

Description: <u>HWPW Yard Area and Soil Cap:</u> Erosion of soil from joints of concrete jersey at west signal bridge bumpout. Observed near east, central, and west signal bridge bumpouts. Facing south. Lat: 29.785911 Long: -95.320494			
Photo No. 8	Date: 01/19/2024

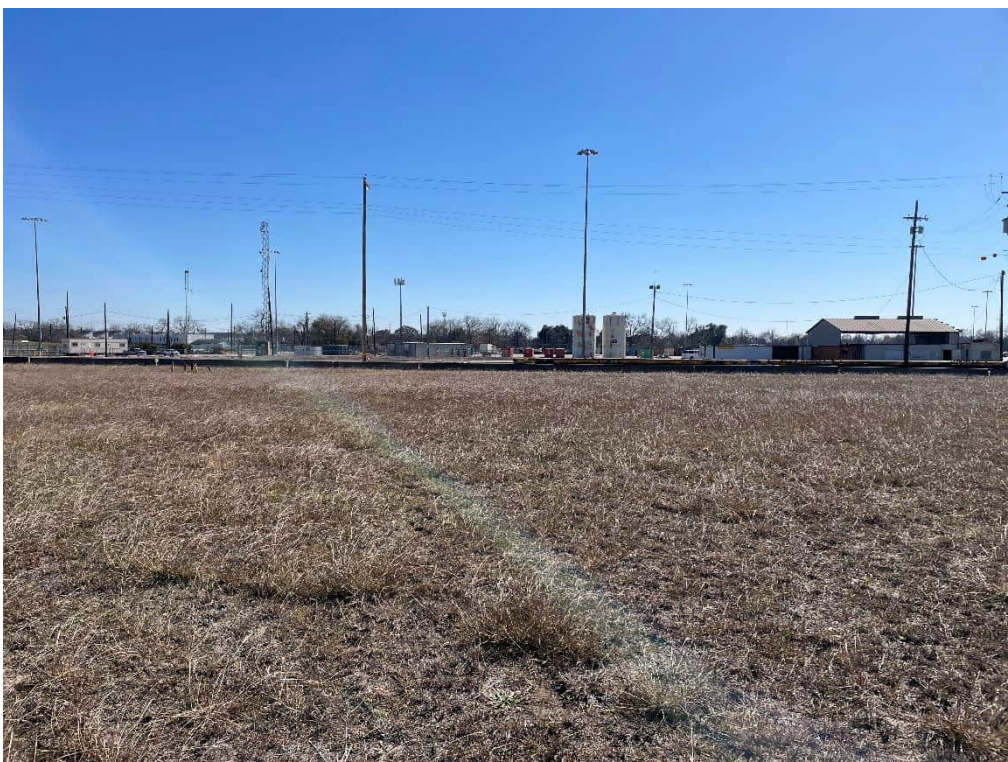
Description: <u>HWPW Yard Area and Soil Cap:</u> Soil cap well-vegetated in most areas. Minor stress on vegetation due to the hard freeze cold season. Facing south. Lat: 29.787189 Long: -95.318650

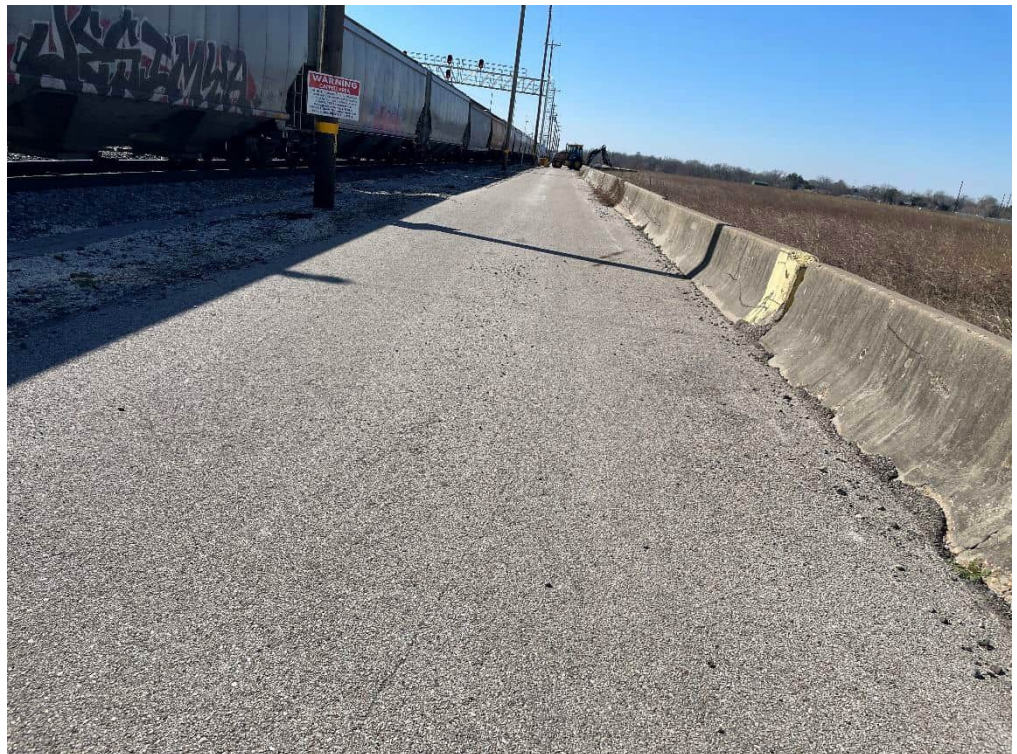
Client Name: Union Pacific Railroad		Site Location: Englewood Intermodal Yard, Houston, Texas	Project No. US0039040.4227
Photo No. 9	Date: 01/19/2024

Description: <u>Asphalt Road Cap and Railroad Ballast Cap:</u> Asphalt roadway and ballast cap in good condition. Vegetation not observed between Asphalt roadway and Ballast Cap. Facing west. Lat: 29.787475 Long: -95.316708			
Photo No. 10	Date: 01/19/2024	 	
Description: <u>Asphalt Road Cap and Railroad Ballast Cap:</u> Asphalt roadway and ballast cap in good condition. Facing east. Lat: 29.786586 Long: -95.318669

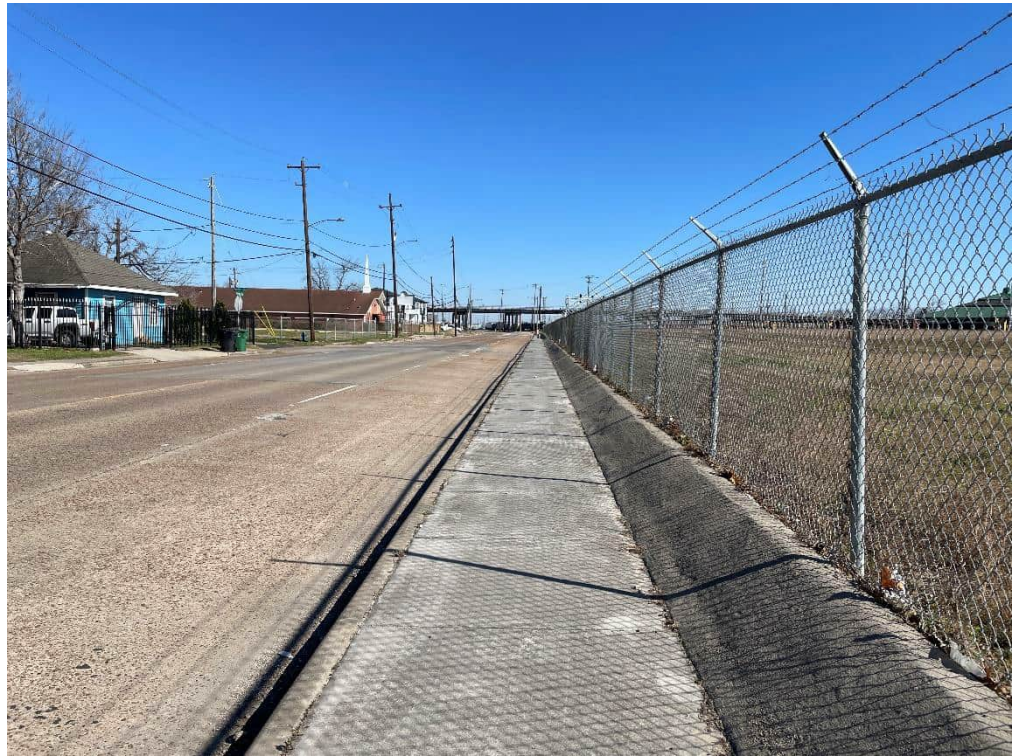
Sidewalk outside security fence in good condition. Facing east.

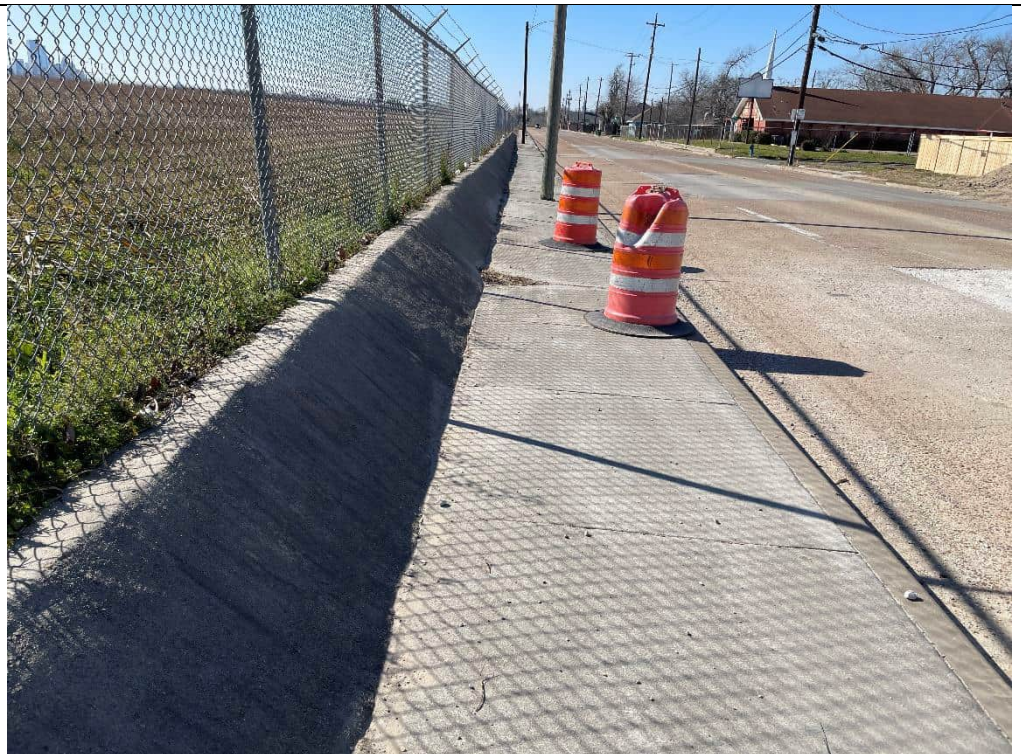
Photo No.
14

Sidewalk outside security fence in good condition. Facing west.

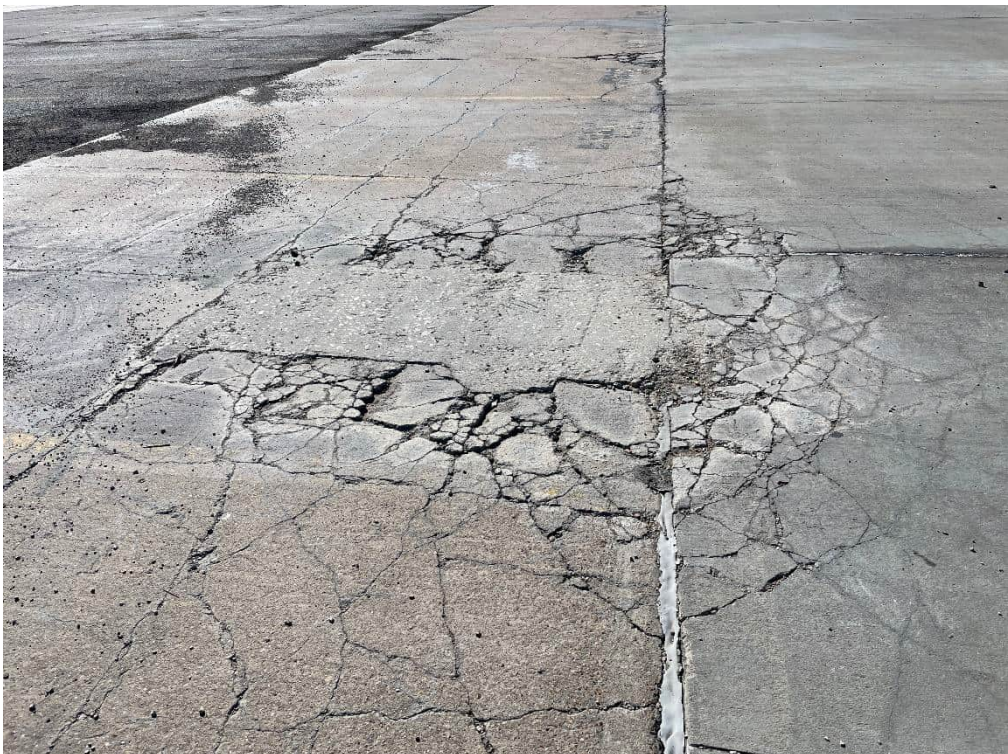
Client Name: Union Pacific Railroad		Site Location: Englewood Intermodal Yard, Houston, Texas	Project No. US0039040.4227
Photo No. 17	Date: 01/19/2024

Description: <u>Concrete Cap</u> <u>(Englewood Intermodal Yard):</u> Cracking in concrete in stalls A010 and A011, at former test pit (TP-07) location. Facing west. Lat: 29.785531 Long: -95.318378			
Photo No. 18	Date: 01/19/2024

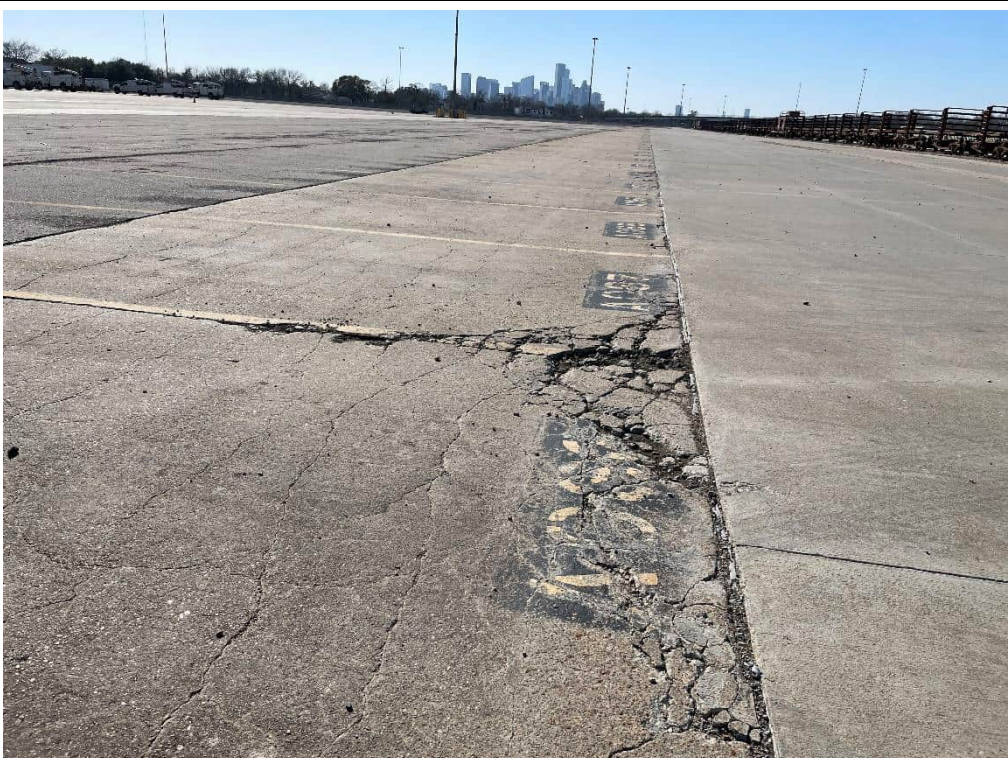
Description: <u>Concrete Cap</u> <u>(Englewood Intermodal Yard):</u> Cracking in concrete in stalls A066 and A067. Facing west. Lat: 29.784861 Long: -95.319939

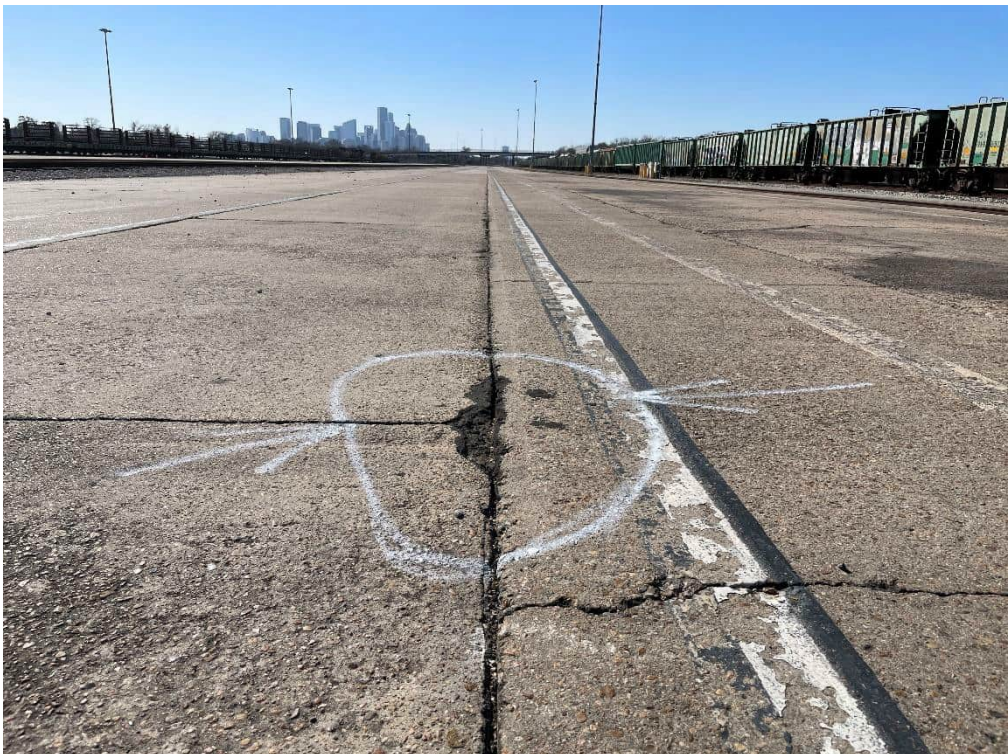
Client Name: Union Pacific Railroad		Site Location: Englewood Intermodal Yard, Houston, Texas	Project No. US0039040.4227
Photo No. 21	Date: 01/19/2024

Description: <u>Concrete Cap</u> <u>(Englewood Intermodal Yard):</u> Black tar visible on the concrete pavement surface between railway lines. Facing west. Lat: 29.785044 Long: -95.321258			
Photo No. 22	Date: 01/19/2024

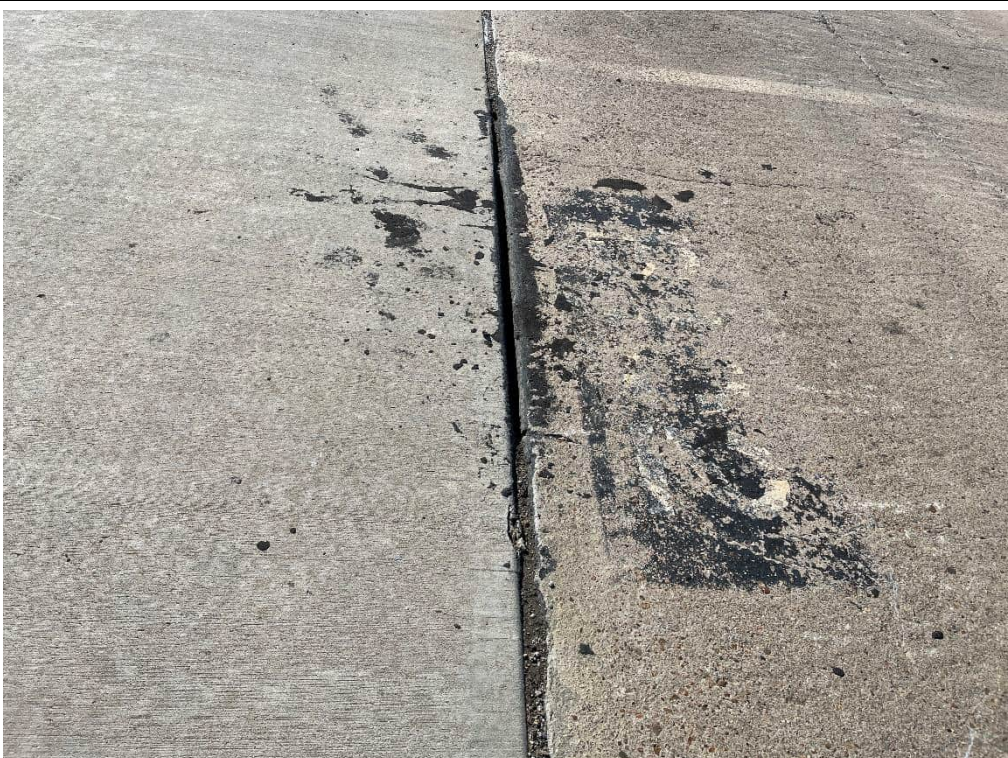
Description: <u>Concrete Cap</u> <u>(Englewood Intermodal Yard):</u> Black tar seepage in concrete pavement joint at stall B102. Facing west. Lat: 29.784203 Long: -95.320844

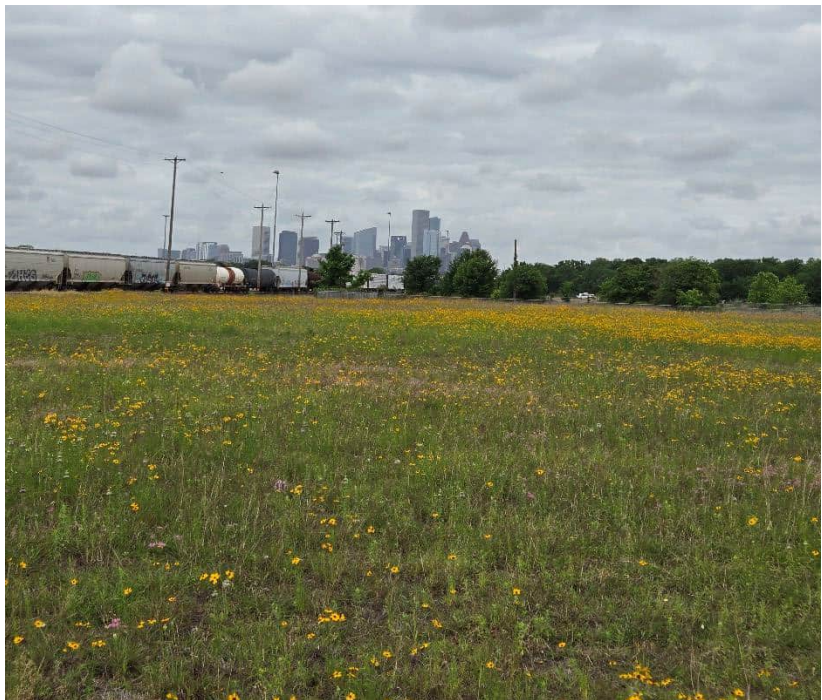
Client Name: Union Pacific Railroad		Site Location: Englewood Intermodal Yard, Houston, Texas	Project No. US0039040.4227
Photo No. 1	Date: 04/24/2024

Description: <u>HWPW Yard Area and Soil Cap:</u> Soil cap is well-vegetated in most areas. No major erosion or ruts were observed during the inspection. Facing West. Lat: 29.786667 Long: -95.319167			
Photo No. 2	Date: 04/24/2024

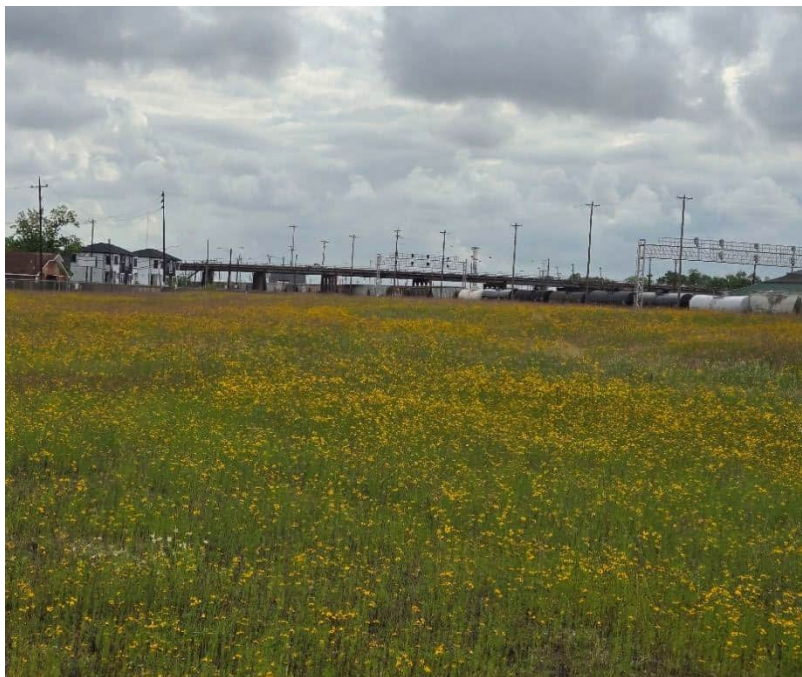
Description: <u>HWPW Yard Area and Soil Cap:</u> Soil cap is well-vegetated in most areas. No major erosion or ruts were observed during the inspection. Grass needs to be trimmed. Facing East. Lat: 29.786667 Long: -95.318889

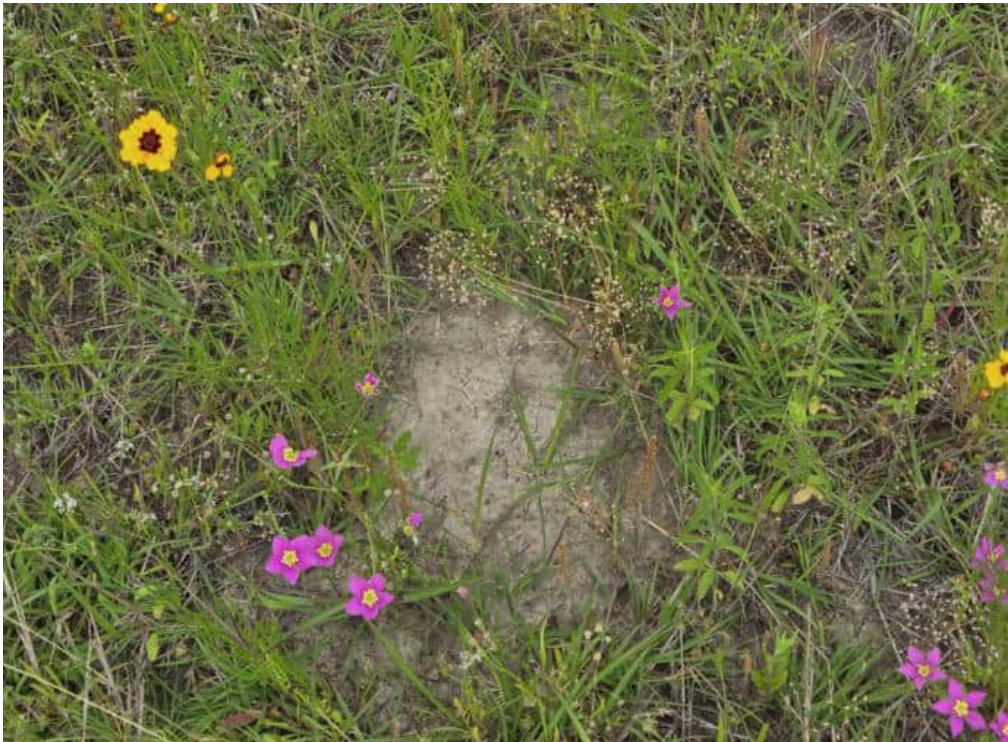
Client Name: Union Pacific Railroad		Site Location: Englewood Intermodal Yard, Houston, Texas	Project No. US0039040.4227
Photo No. 3	Date: 04/24/2024

Description: <u>HWPW Yard Area and Soil Cap:</u> Minor insect burrows in the soil cap. Good coverage of pollinator plants. Lat: 29.786667 Long: -95.320000			
Photo No. 4	Date: 04/24/2024

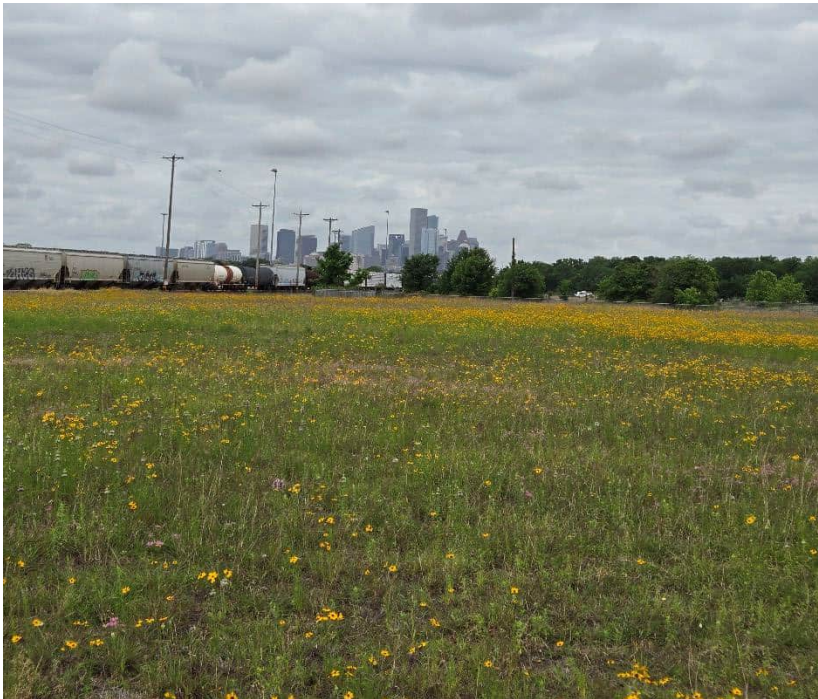
Description: <u>HWPW Yard Area and Soil Cap:</u> Soil cap is well-vegetated in most areas. Facing West. Lat: 29.786667 Long: -95.319167

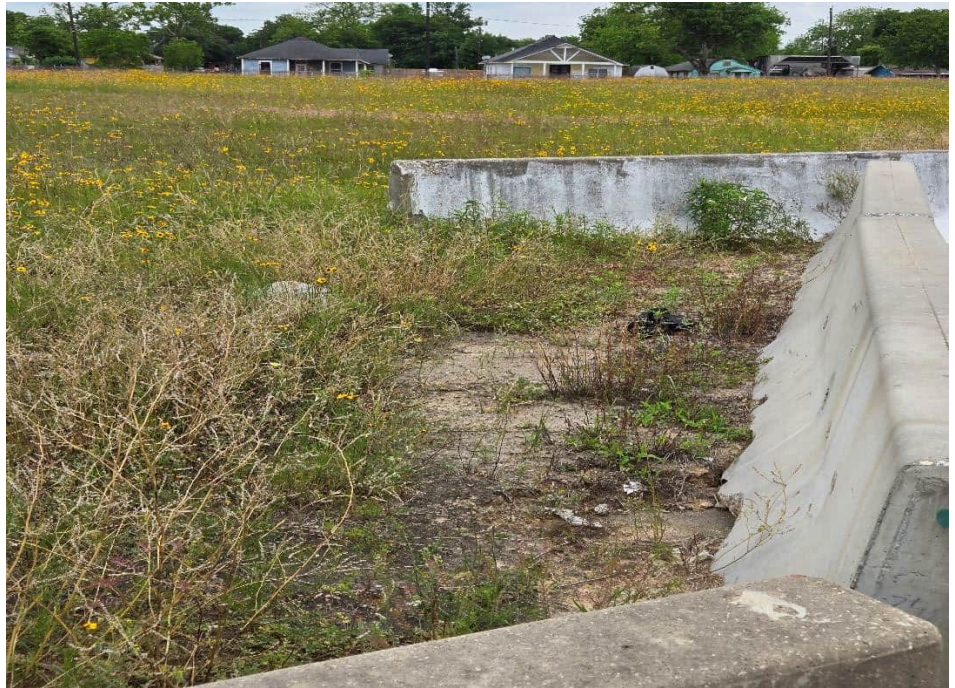
Client Name: Union Pacific Railroad		Site Location: Englewood Intermodal Yard, Houston, Texas	Project No. US0039040.4227
Photo No. 5	Date: 04/24/2024

Description: <u>HWPW Yard Area and Soil Cap:</u> Signal bridge bump-outs (from North By-Pass Project) are in good condition. Minor trash was seen. Facing Northeast. Lat: 29.785833 Long: -95.320556			
Photo No. 6	Date: 04/24/2024

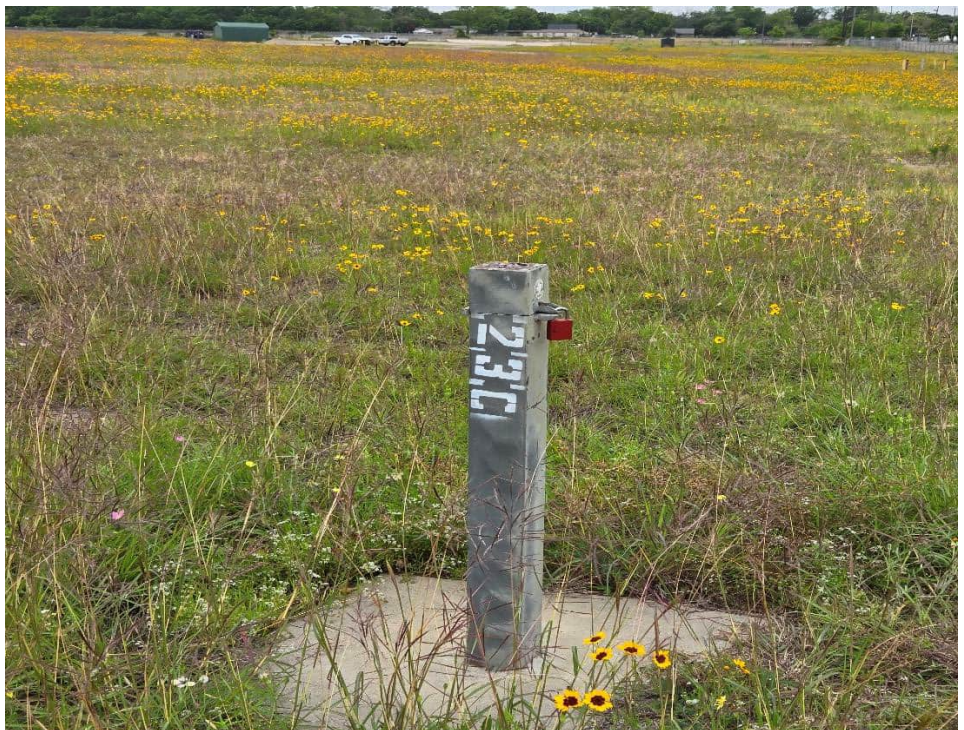
Description: <u>HWPW Yard Area and Soil Cap:</u> Soil cap well vegetated. MW 23C is in good condition and locked. Facing West. Lat: 29.786944 Long: -95.319167

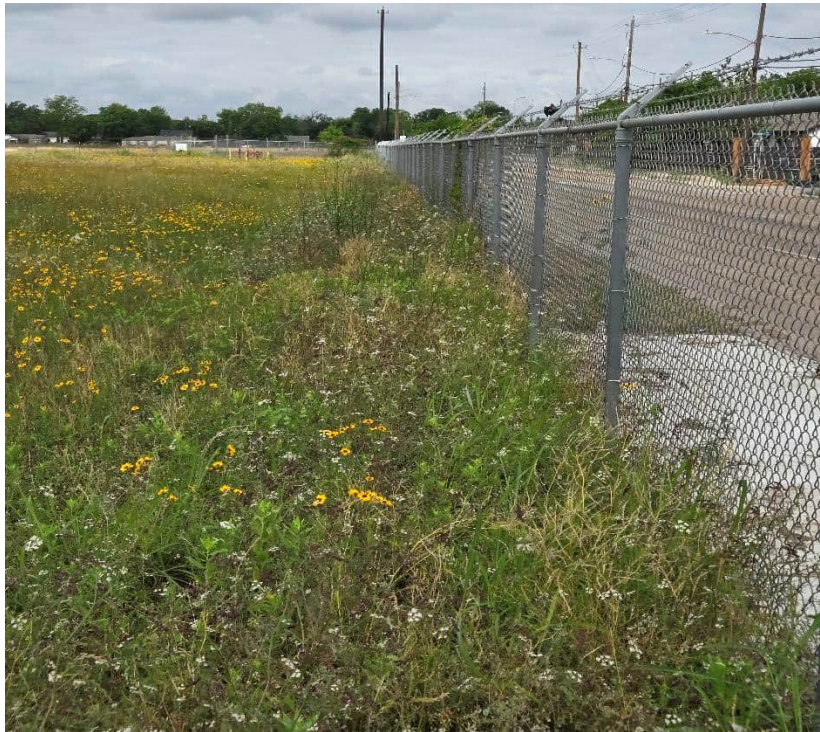
Client Name: Union Pacific Railroad		Site Location: Englewood Intermodal Yard, Houston, Texas	Project No. US0039040.4227
Photo No. 7	Date: 04/24/2024

Description: <u>HWPW Yard Area and Soil Cap:</u> Inside of perimeter fence facing West. Vegetation along fence line needs to be cut. Lat: 29.785833 Long: -95.320556			
Photo No. 8	Date: 04/24/2024

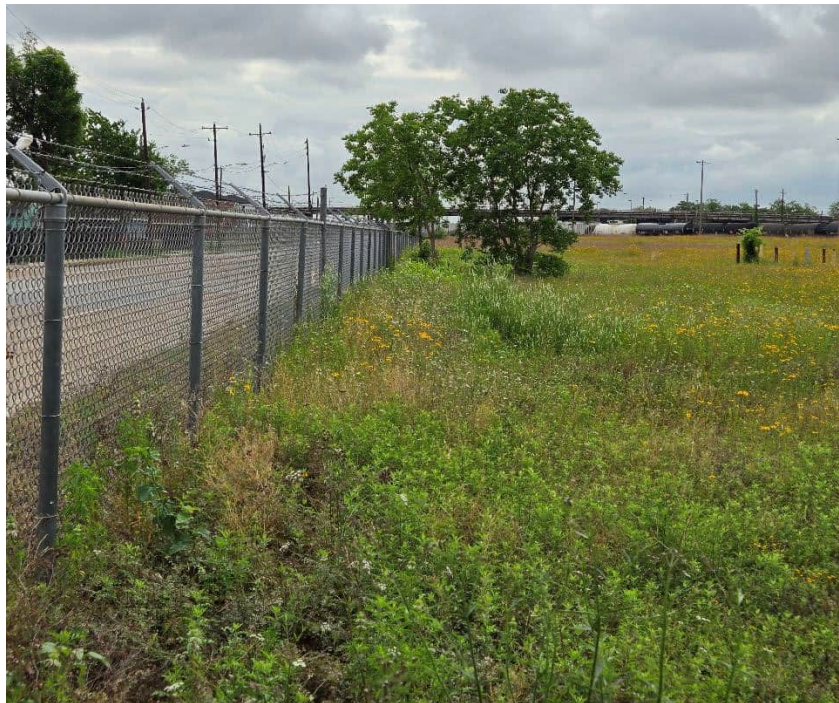
Description: <u>HWPW Yard Area and Soil Cap:</u> Inside of perimeter fence facing East. Vegetation along fence line needs to be cut. Lat: 29.785833 Long: -95.320556

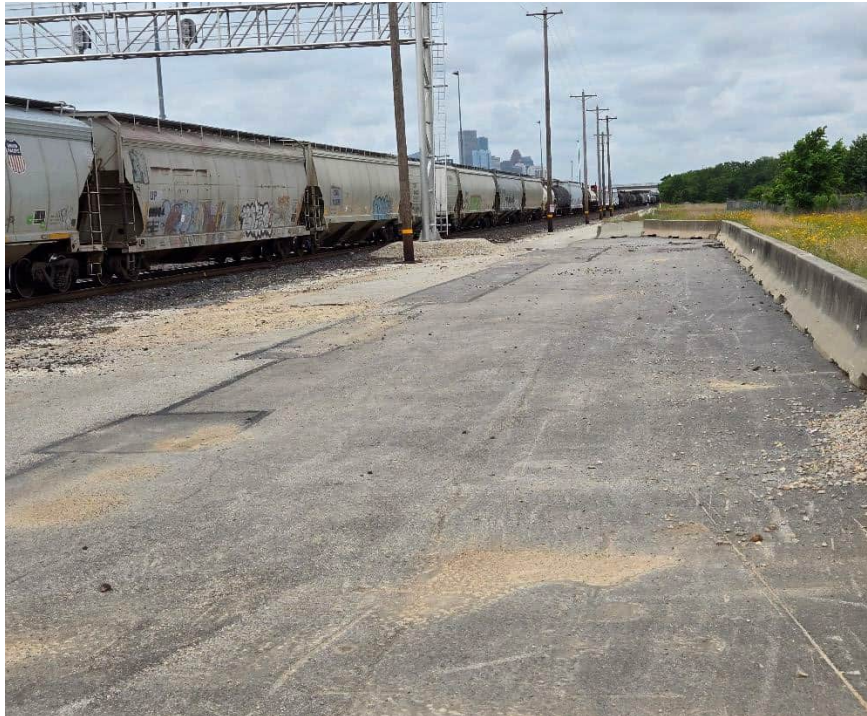
Client Name: Union Pacific Railroad		Site Location: Englewood Intermodal Yard, Houston, Texas	Project No. US0039040.4227
Photo No. 9	Date: 04/24/2024

Description: <u>Asphalt Roadway and Ballast Cap:</u> Asphalt roadway in good condition at the signal bridge bump-out area, free of major cracking/damage. Vegetation not observed between asphalt roadway and ballast Cap. Facing West. Lat: 29.787500 Long: -95.316667			
Photo No. 10	Date: 04/24/2024

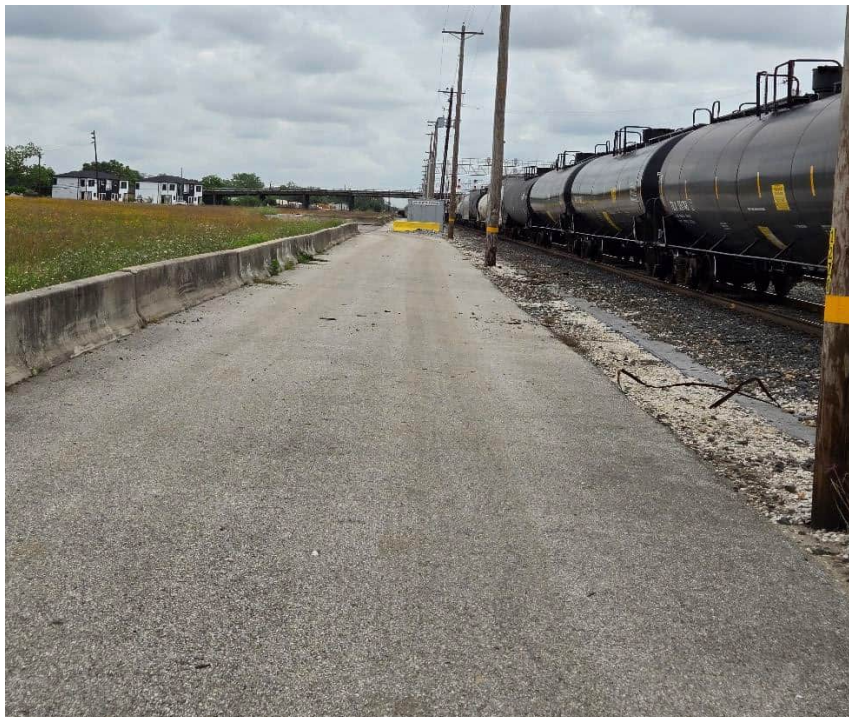
Description: <u>Asphalt Roadway and Ballast Cap:</u> Asphalt roadway and ballast in good condition. Facing East. Lat: 29.786667 Long: -95.318611

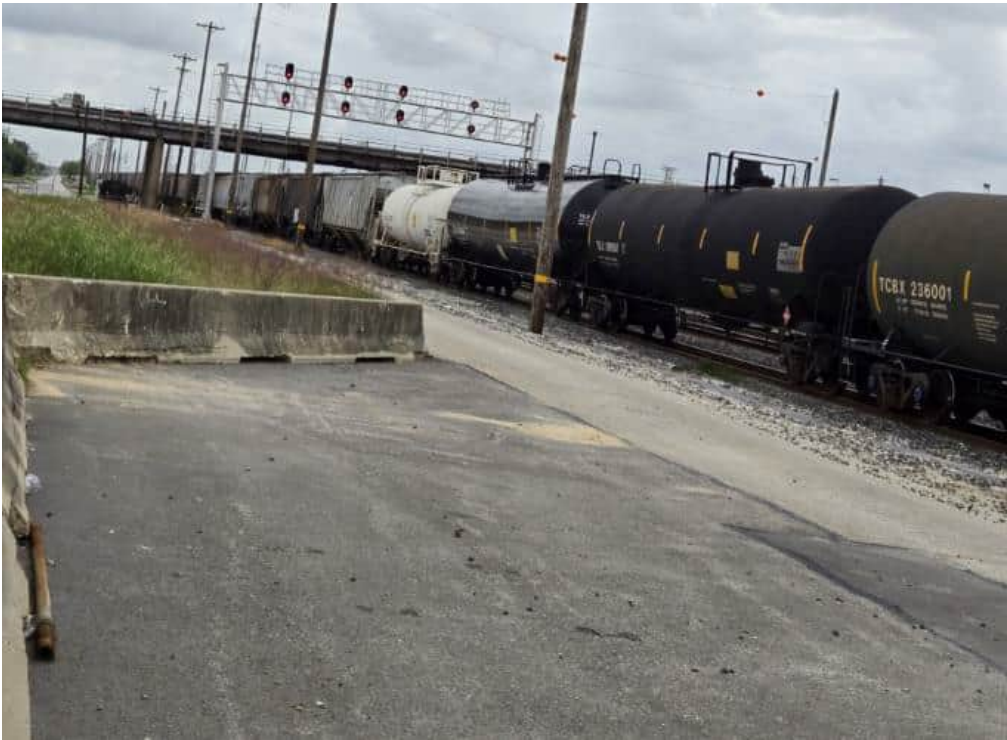
Client Name: Union Pacific Railroad		Site Location: Englewood Intermodal Yard, Houston, Texas	Project No. US0039040.4227
Photo No. 11	Date: 04/24/2024

Description: <u>Asphalt Roadway and Ballast Cap:</u> Asphalt roadway at signal bridge bump out and ballast in good condition. Facing southeast. Lat: 29.786550 Long: -95.318984			
Photo No. 12	Date: 04/24/2024

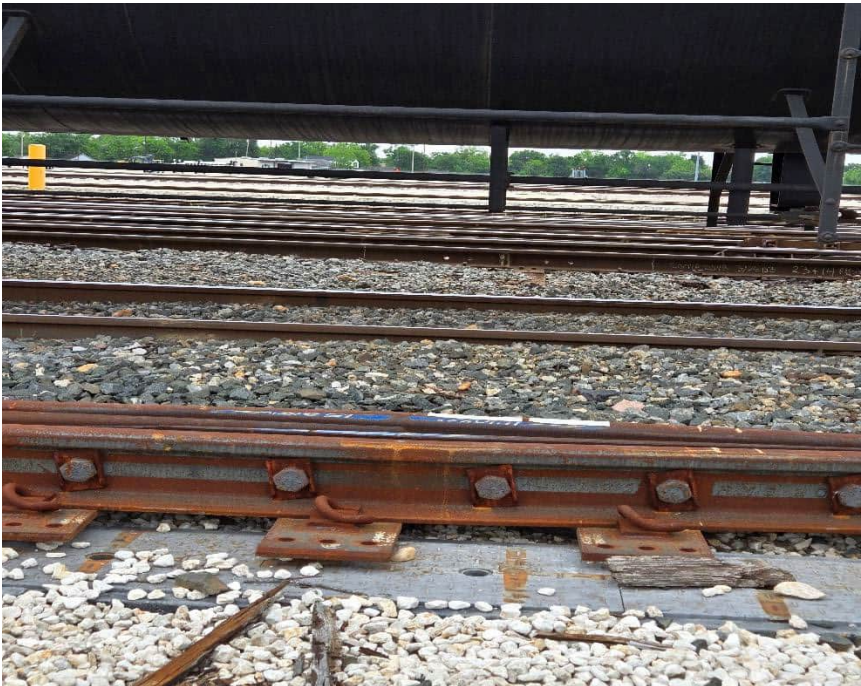
Description: <u>Asphalt Roadway and Ballast Cap:</u> Railroad Ballast Cap in good condition. Facing South. Lat: 29.784444 Long: -95.323611

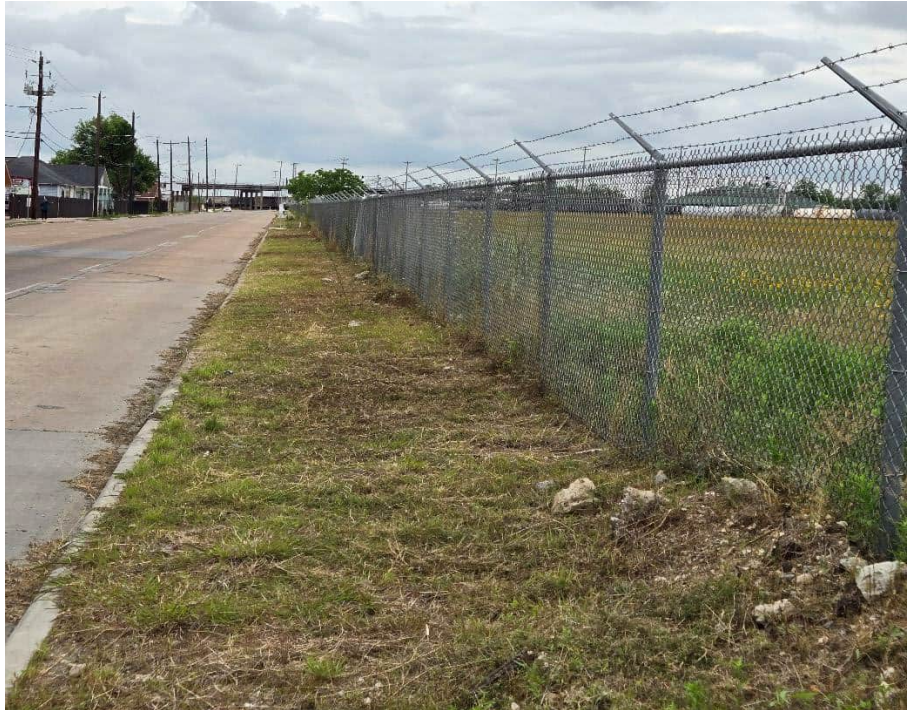
Client Name: Union Pacific Railroad		Site Location: Englewood Intermodal Yard, Houston, Texas	Project No. US0039040.4227
Photo No. 13	Date: 04/24/2024

Description: <u>Perimeter Fence:</u> Security fence in good condition. Facing east. Lat: 29.787500 Long: -95.318889			
Photo No. 14	Date: 04/24/2024

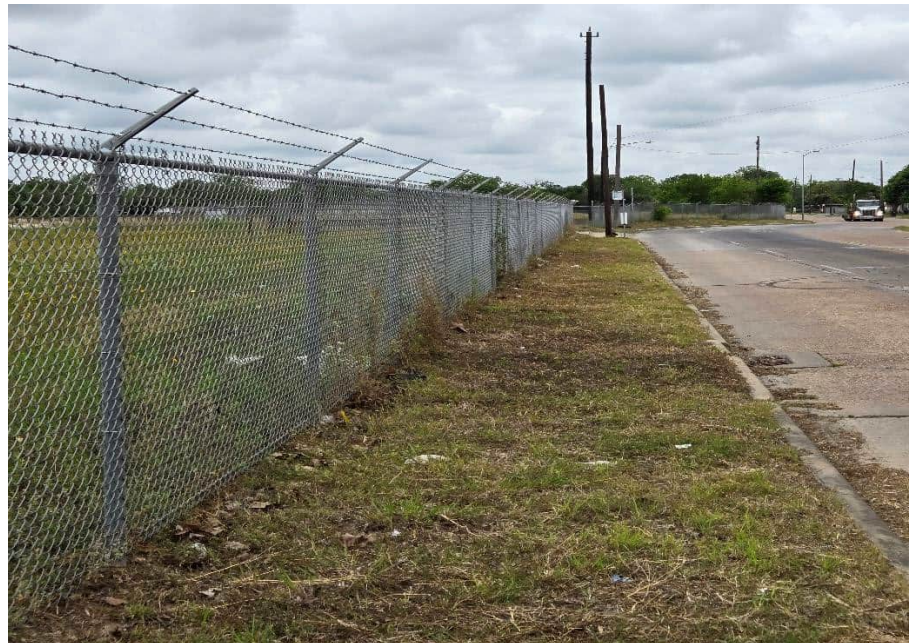
Description: <u>Perimeter Fence:</u> Security fence in good condition. Facing west. Lat: 29.787500 Long: -95.316944

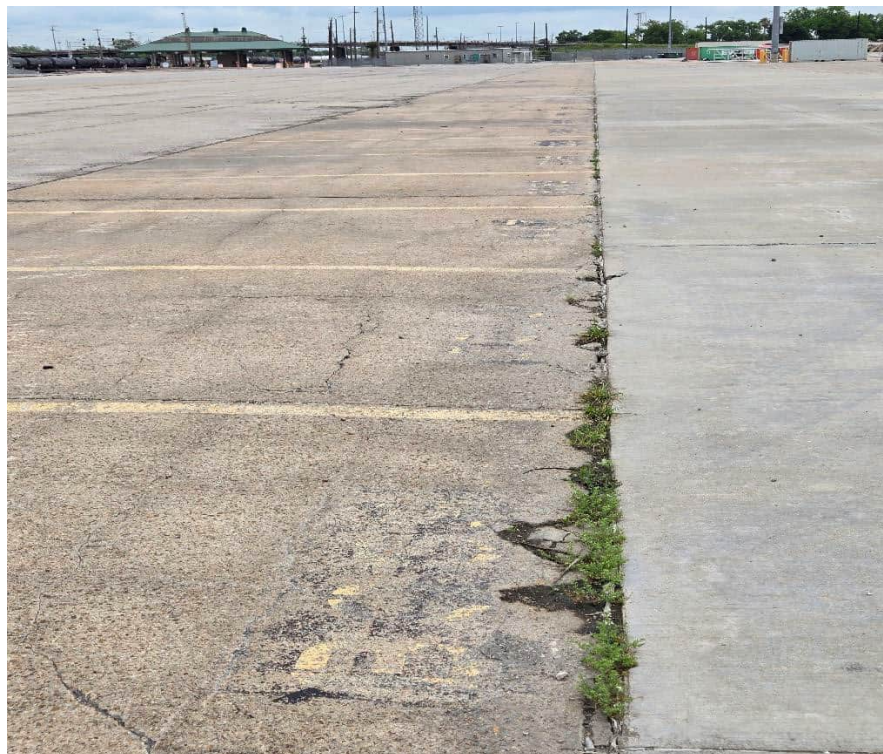
Description: <u>Concrete Cap Area</u> <u>(Englewood Yard):</u> Vegetation along joints along stall B60 to B70. Facing East. Lat: 29.784167 Long: -95.321111

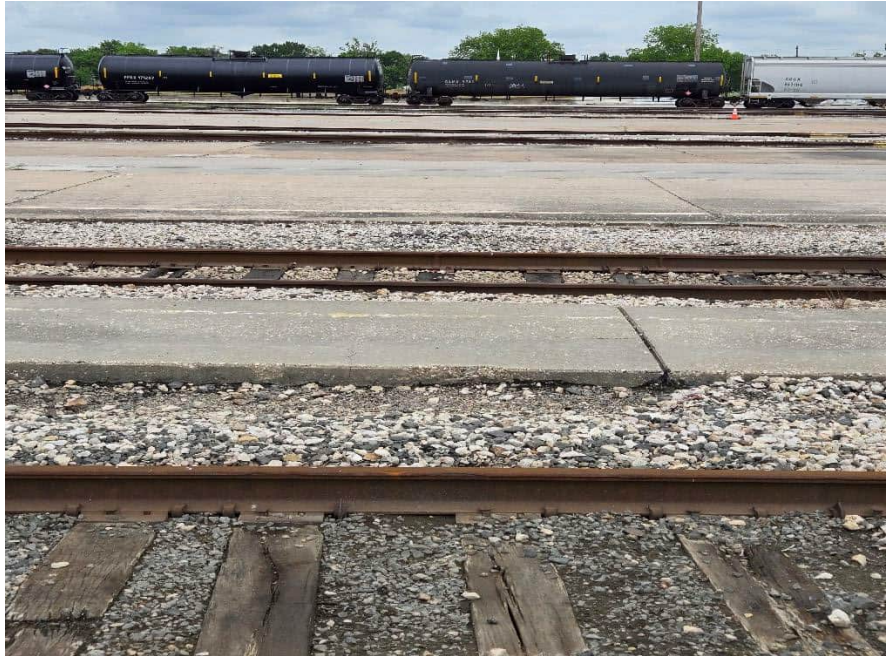
Client Name: Union Pacific Railroad		Site Location: Englewood Intermodal Yard, Houston, Texas	Project No. US0039040.4227
Photo No. 21	Date: 04/24/2024

Description: <u>Concrete Cap Area (Englewood Yard):</u> Ballast cover around the rail tracks are in good condition. No visible intrusion of grass. Facing Southwest. Lat: 29.785000 Long: -95.321111			
Photo No. 22	Date: 04/24/2024

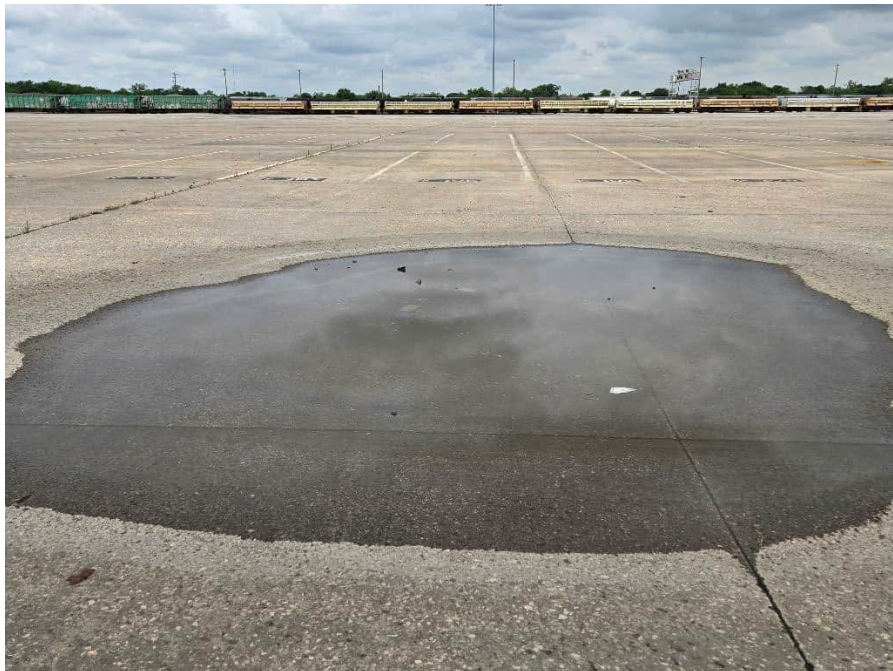
Description: <u>Concrete Cap Area (Englewood Yard):</u> Puddle of water in low lying area in the middle of Row F and Row G, that does not drain. Facing North. Lat: 29.784167 Long: -95.320833

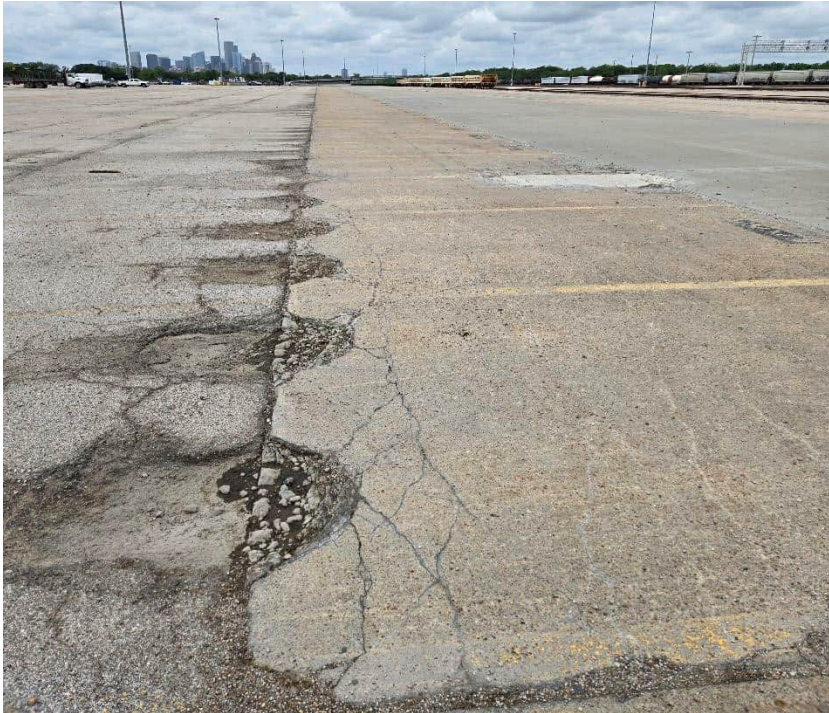
Client Name: Union Pacific Railroad		Site Location: Englewood Intermodal Yard, Houston, Texas	Project No. US0039040.4227
Photo No. 23	Date: 04/24/2024

Description: <u>Concrete Cap Area</u> <u>(Englewood Yard):</u> Joint crack on the concrete pavement along A19 to A23. Facing West. Lat: 29.783333 Long: -95.321111

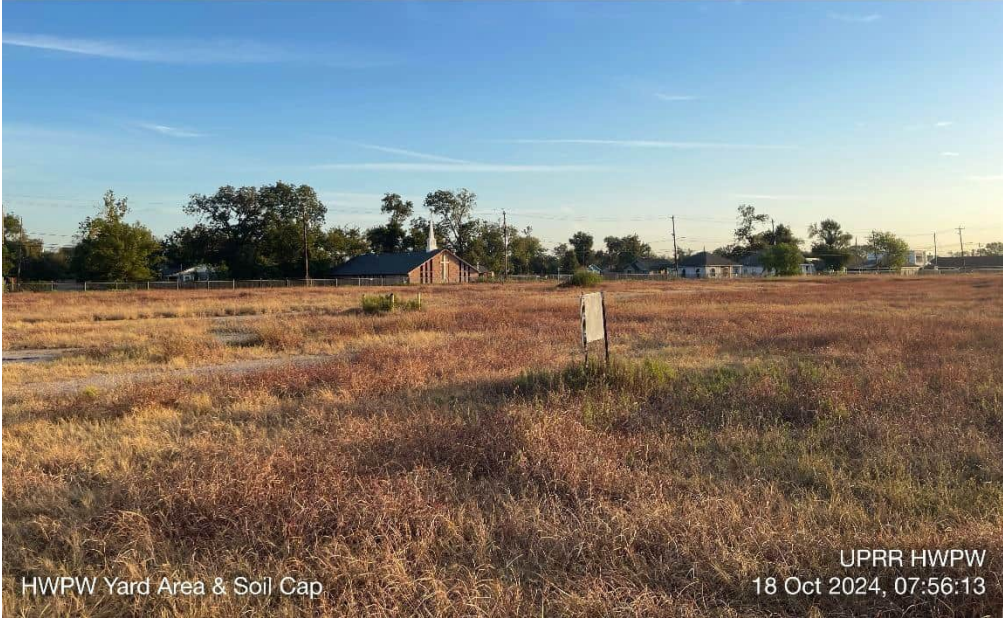
<div>HWPW Yard Area & Soil Cap UPRR HWPW 18 Oct 2024, 07:56:13</div></div>	
Description: <u>HWPW Yard Area and Soil Cap:</u> Soil cap is well-vegetated in most areas. No major erosion or ruts were observed during the inspection. Lat: 29.786667 Long: -95.320278			
Photo No. 2	Date: 10/18/2024	<div><div>SE S SW W NW</div><div>150 180 210 240 270 300</div><div>☀ 226°SW (T) 🌑 29°47'12"N, 95°19'13"W ±9ft ▲ 52ft</div>
