**RE: POST-RESPONSE ACTION COMPLETION REPORT – 2024
UNION PACIFIC RAILROAD HOUSTON WOOD PRESERVING WORKS, HOUSTON, TEXAS
4910 LIBERTY ROAD, HOUSTON, HARRIS COUNTY, TEXAS
TCEQ SWR NO. 31547; TCEQ PERMIT/COMPLIANCE PLAN NO. 50343 EPA ID NO. TXD000820266
CUSTOMER NO. CN600131098; REGULATED ENTITY NO. RN100674613**

Cover Page

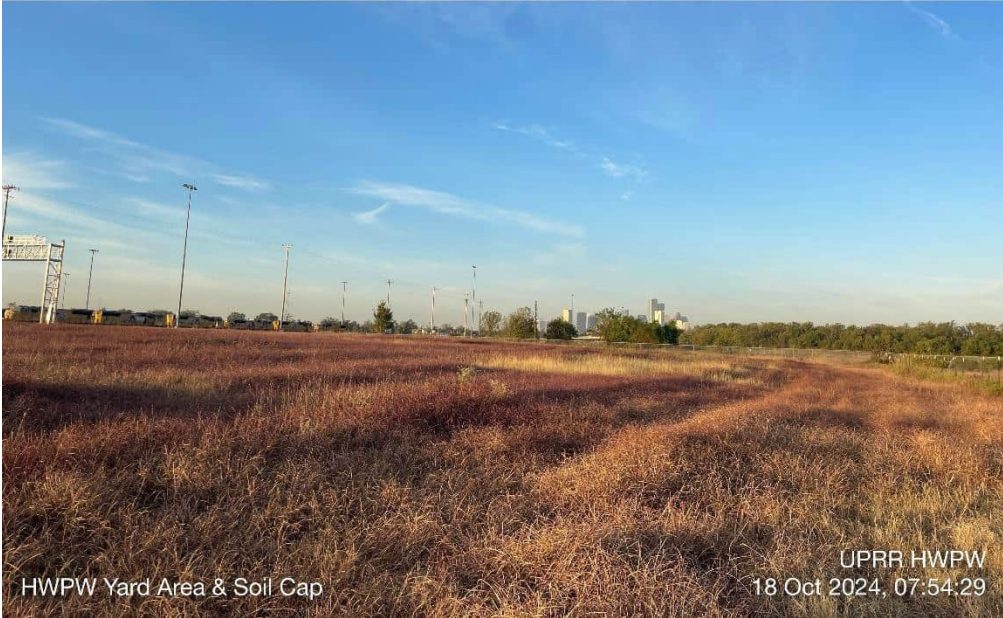
<div>HWPW Yard Area & Soil Cap UPRR HWPW 18 Oct 2024, 07:54:29</div></div>	
Description: <u>HWPW Yard Area and Soil Cap:</u> Soil cap is well-vegetated in most areas. No major erosion or ruts were observed during the inspection. Grass needs to be trimmed. Lat: 29.786667 Long: -95.320278

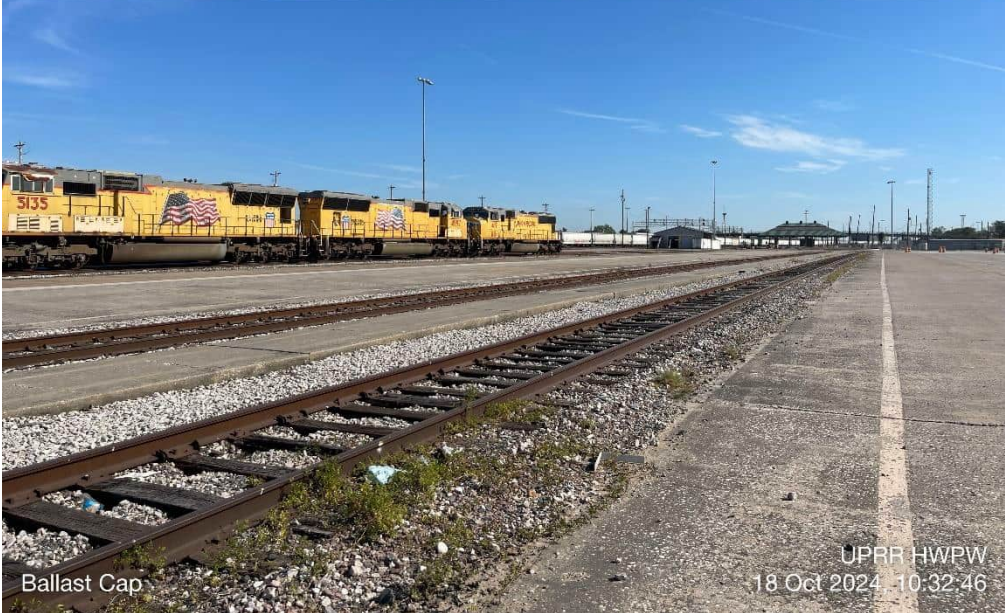
<div> Ballast Cap </div> <div> UPRR HWPW 18 Oct 2024, 10:32:46 </div>	
Description: <u>Asphalt Roadway and Ballast Cap:</u> Some vegetation observed on ballast cap. Lat: 29.784722 Long: -95.320278		<div> <div> N 0 30 60 90 120 150 </div> <div> NE E SE </div> </div> <div> 77°E (T) 29°47'15"N, 95°19'15"W ±29ft ▲ 50ft </div>

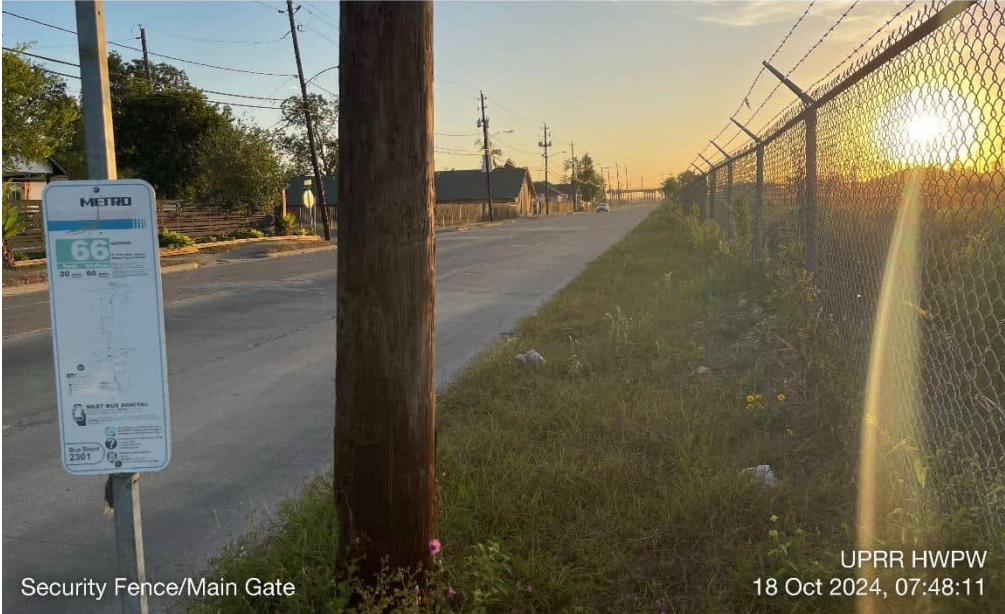
<div> Security Fence/Main Gate </div> <div> UPRR HWPW 18 Oct 2024, 07:48:11 </div>	
Photo No. 14	Date: 10/18/2024	Description: <u>Perimeter Fence:</u> Perimeter fence is in good shape along Liberty Road. Grass needs to be cut near fence line. Some minor trash observed. Lat: 29.787500 Long: -95.320833

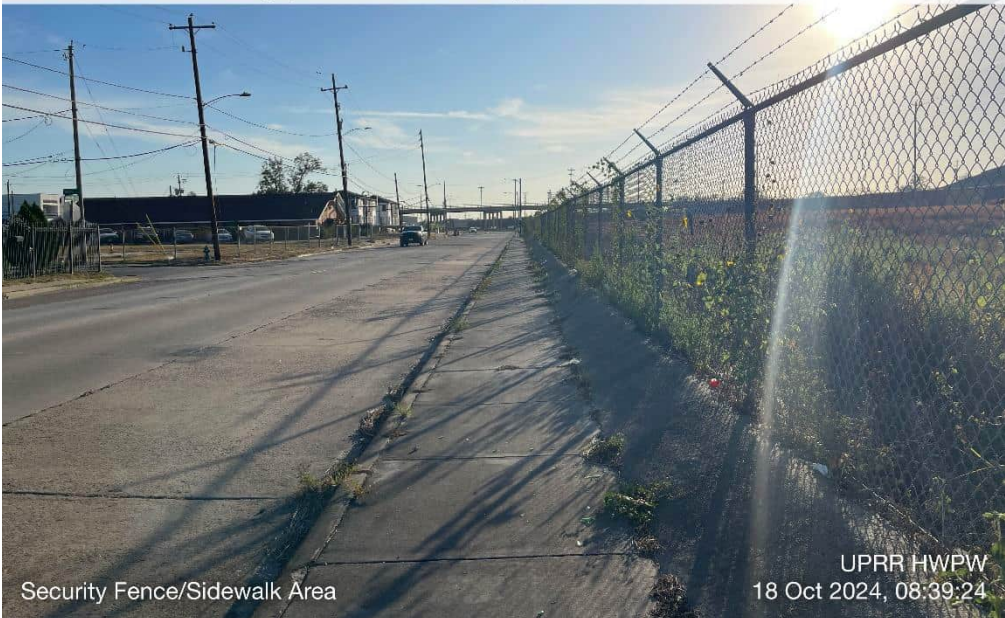
<div> Security Fence/Sidewalk Area </div> <div> UPRR HWPW 18 Oct 2024, 08:39:24 </div> </div>	
Photo No. 16	Date: 10/18/2024	Description: Security Fence/Sidewalk Area: Perimeter fence is in good shape along Liberty Road. Sidewalk area is in good condition. Minor vegetation observed in cracks/joints. Lat: 29.787500 Long: -95.318611

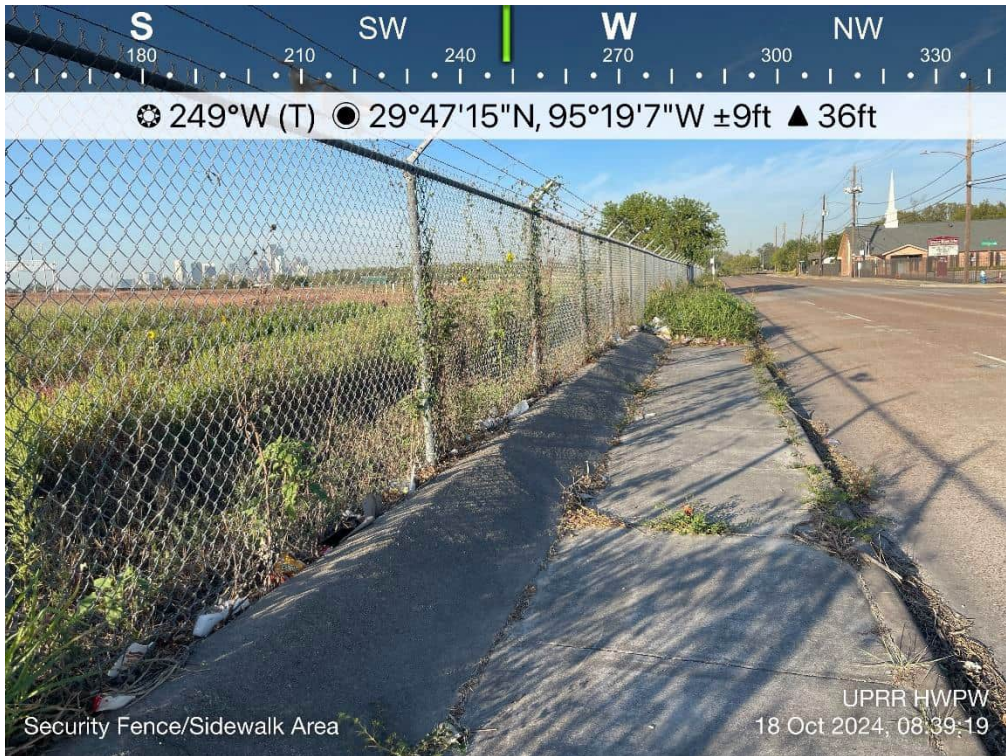
Description: <u>Security Fence/Sidewalk Area:</u> Perimeter fence is in good shape along Liberty Road. Sidewalk area is in good condition. Vegetation observed in cracks/joints. Lat: 29.787500 Long: -95.318611

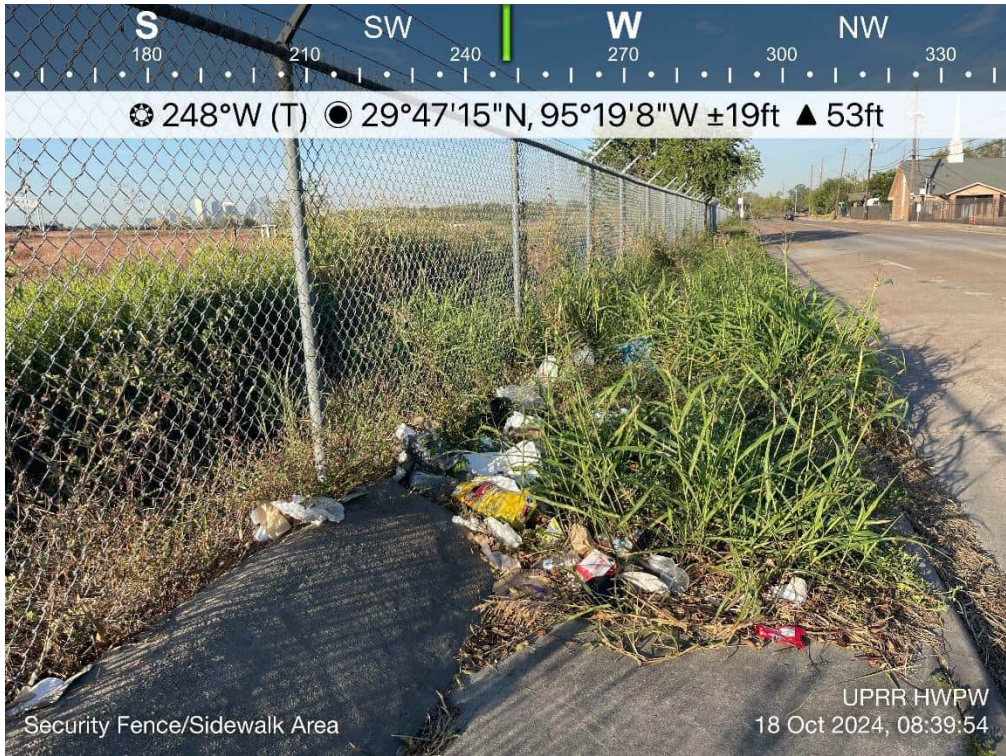
Photo No. 18	Date: 10/18/2024	Description: <u>Security Fence/Sidewalk Area:</u> Perimeter fence is in good shape along Liberty Road. West end of sidewalk area has high amounts of trash in the tall grass. Grass needs to be mowed/trimmed. Lat: 29.787500 Long: -95.318889

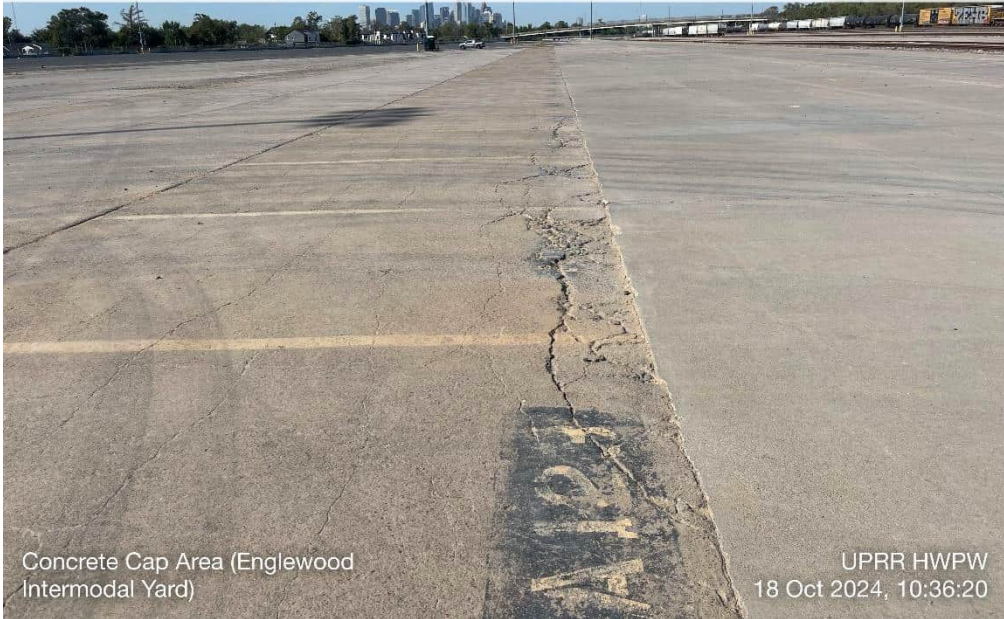
<div>Concrete Cap Area (Englewood Intermodal Yard)UPRR HWPW18 Oct 2024, 10:36:20</div></div></div>	
Description: <u>Concrete Cap Area</u> <u>(Englewood Intermodal Yard):</u> Cracking in concrete in stalls A123 to A127 but no exposed soils observed. Lat: 29.783889 Long: -95.321389			
Photo No. 38	Date: 10/18/2024	<div><div><div>E90SE120150S180SW210240V270</div><div>☼ 175°S (T) ☉ 29°47'5"N, 95°19'11"W ±13ft ▲ 57ft</div> <div>Concrete Cap Area (Englewood Intermodal Yard)UPRR HWPW18 Oct 2024, 10:30:50</div></div></div>	
Description: <u>Concrete Cap Area</u> <u>(Englewood Intermodal Yard):</u> Cracking in concrete in stalls A066 and A067. Lat: 29.784722 Long: -95.319722

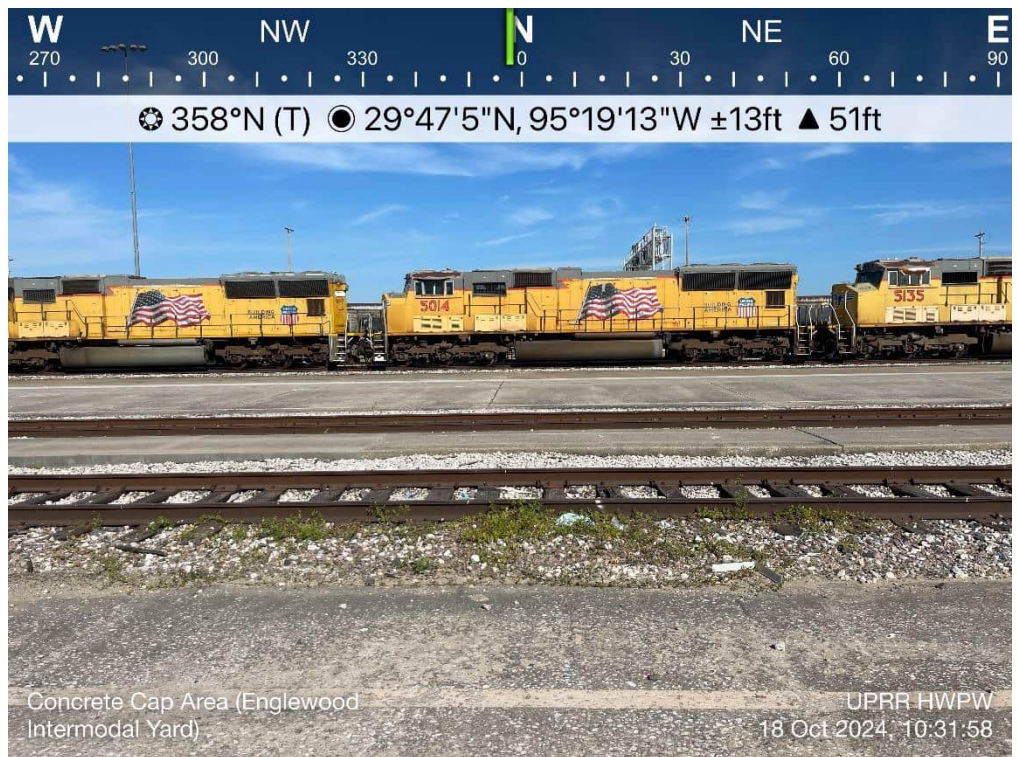
Rail tracks are in good condition.
No visible intrusion of grass in
between ties but did observe
minimal vegetation on sides of
tracks.
