July 15, 2026 Project No. US0039040.3990

Re: **MONTHLY STATUS UPDATE – ENGLEWOOD INTERMODAL YARD – REVISED INTERIM MEASURES WORK PLAN POST-CONSTRUCTION AND NAPL COLLECTION SYSTEM/CONCRETE CAP REPAIR INSPECTIONS**
UNION PACIFIC RAILROAD HOUSTON WOOD PRESERVING WORKS FACILITY
4910 LIBERTY ROAD FACILITY, HOUSTON, TEXAS
POST-CLOSURE CARE PERMIT NO. HW-50343; INDUSTRIAL SWR NO. 31547

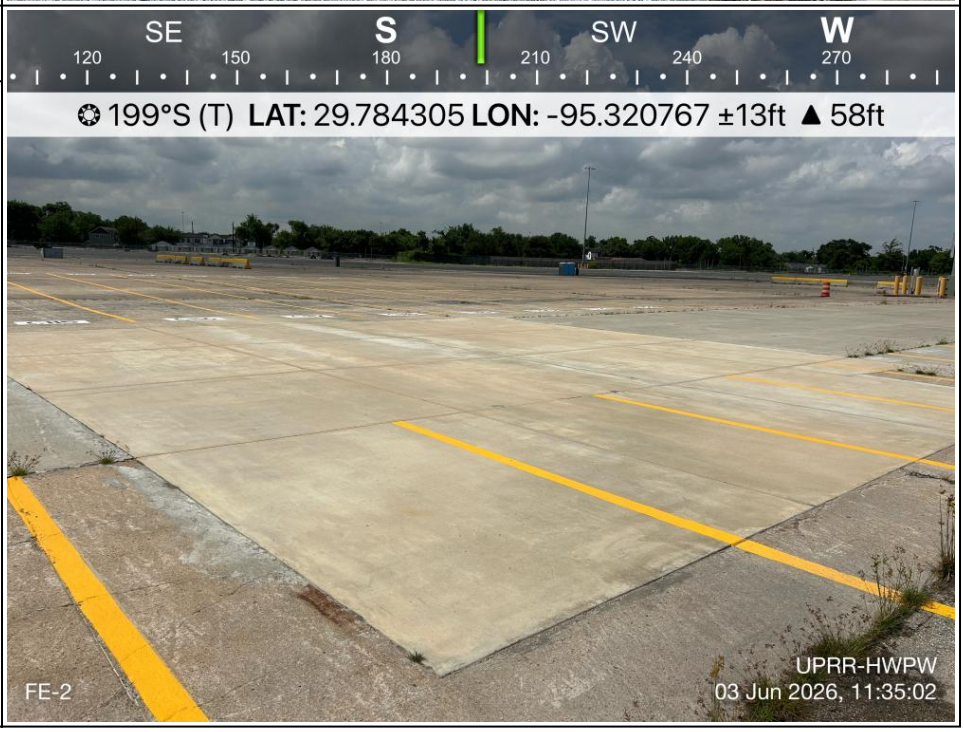
Photo No.	Inspection Date:
4	06/03/2026

Description:
FE-2 weekly inspection of concrete cap. Reconstructed cap in good condition. No NAPL observed at FE location. Facing south.

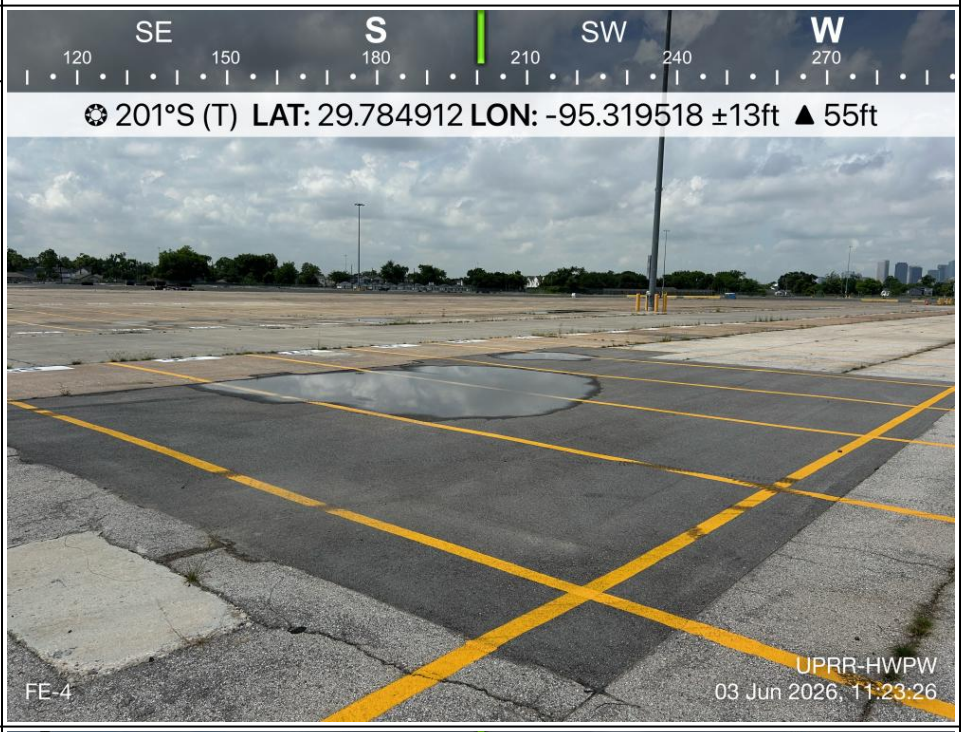
Photo No.	Inspection Date:
5	06/03/2026

FE-4 weekly inspection of asphalt cap. Reconstructed cap in good condition. No NAPL observed at FE location. Standing water from recent rain event. Facing south.

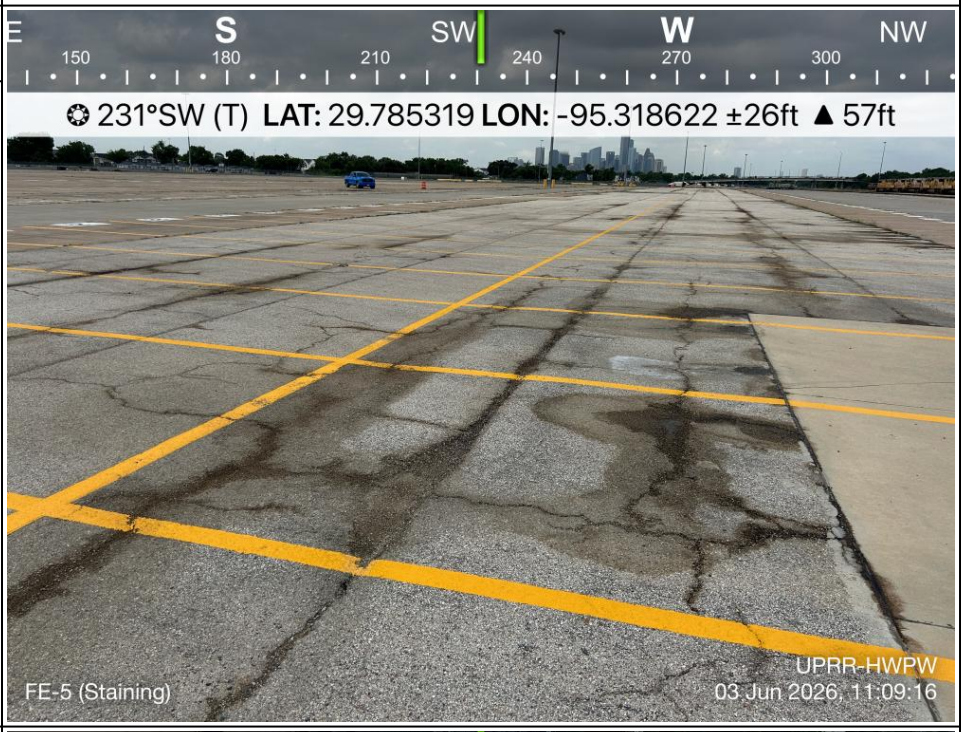
Photo No.	Inspection Date:
7	06/03/2026

- Brown water staining was observed along the southern joint of the reconstructed concrete cap of FE-5 on June 3 (Photo Nos. 7 and 8), June 10 (Photo No. 25), and June 24 (Photo No. 53). The brown water staining was not observed at this location during the June 17th inspection.

FE-5 weekly inspection of concrete cap. Reconstructed cap in good condition. No NAPL observed at FE location. Brown water staining was observed along the southern joint of the reconstructed cap, located with the red arrow in Photo No. 6. Facing southwest.

- On June 19th, UPRR remediation contractor E3 was mobilized to the site to pressure wash areas of brown water staining and recover standing water.

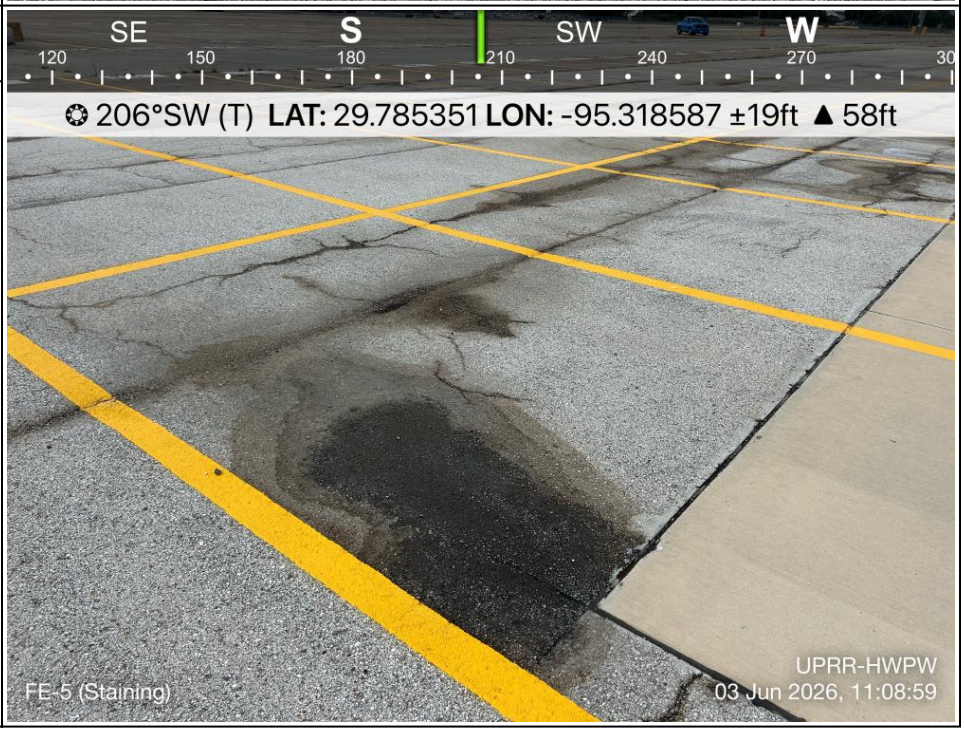
Photo No.	Inspection Date:
8	06/03/2026

FE-5 weekly inspection of concrete cap. Reconstructed cap in good condition. No NAPL observed at FE location. Brown water staining was observed along the southern joint of the reconstructed cap, located with the blue arrow in Photo No. 6. Facing southwest.

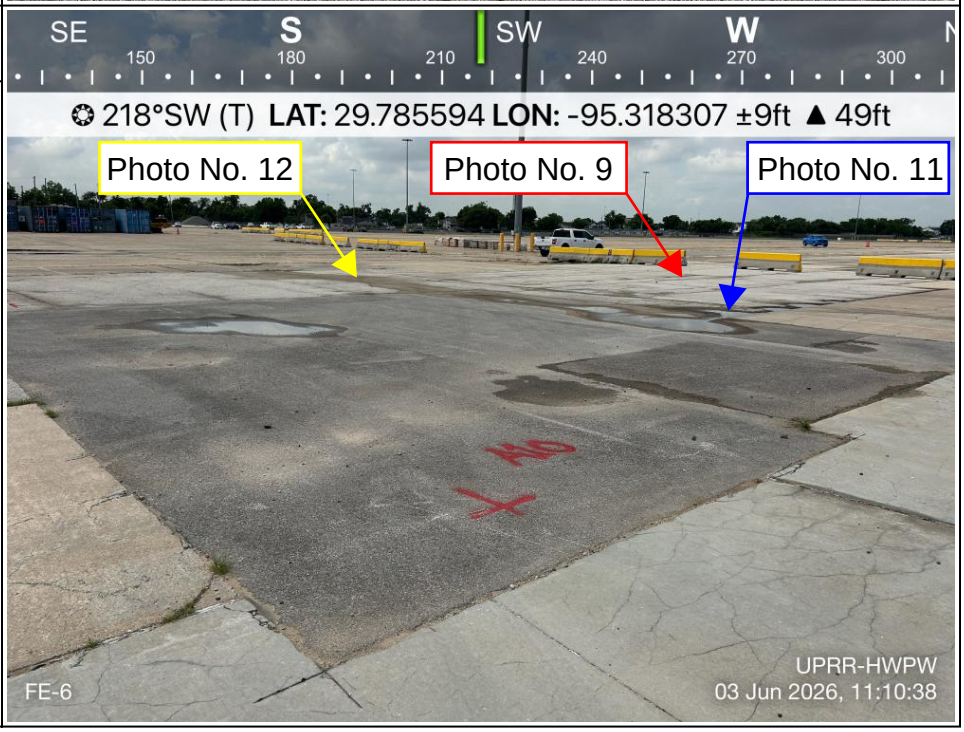
Photo No.	Inspection Date:
10	06/03/2026

- Brown water staining was observed along the western joint perpendicular to the reconstructed asphalt cap of FE-6 and along the southern joint of FE-6 on the following dates: June 3 (Photo Nos. 10 through 12), June 10 (Photo Nos. 26 and 27), June 17 (Photo Nos. 40 through 42), and June 24 (Photo Nos. 54 and 55).

FE-6 weekly inspection of asphalt cap. Reconstructed cap in good condition. No NAPL observed at FE location. Brown water staining and a small amount of standing water were observed along the western joint perpendicular to the reconstructed cap. Brown water staining was observed along the southern joint of the reconstructed cap. Other standing water from recent rain event. Facing southwest.

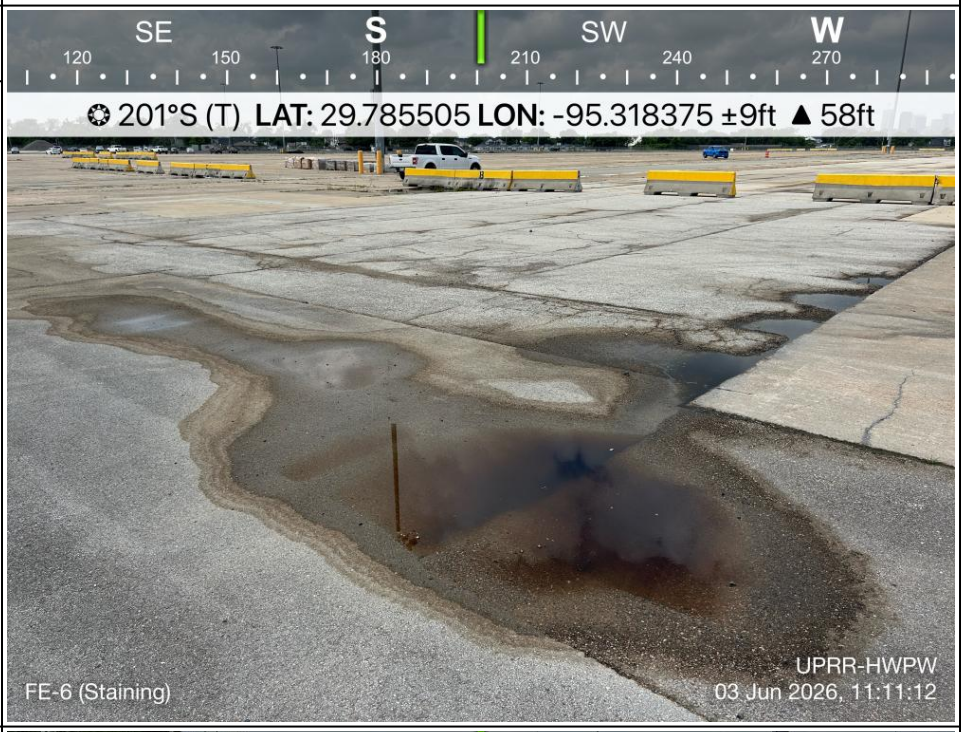
Photo No.	Inspection Date:
11	06/03/2026

FE-6 weekly inspection of asphalt cap. Reconstructed cap in good condition. No NAPL observed at FE location. Brown water staining and a small amount of standing water were observed along the western joint perpendicular to the reconstructed cap, located with the blue arrow in Photo No. 10. Facing south.

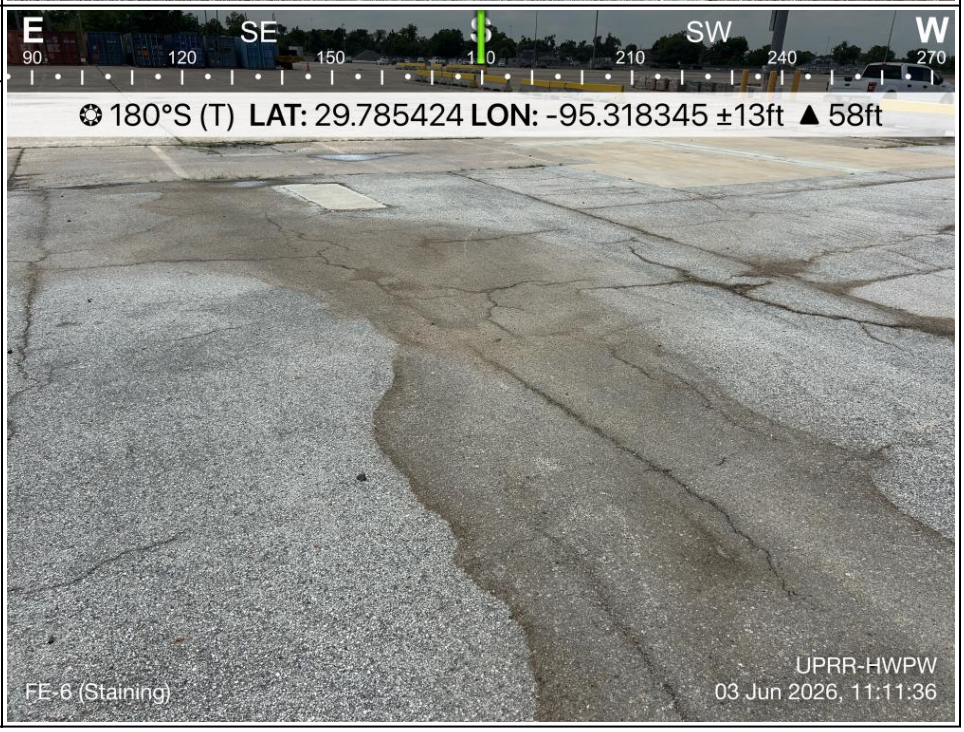
Photo No.	Inspection Date:
12	06/03/2026

FE-6 weekly inspection of asphalt cap. Reconstructed cap in good condition. No NAPL observed at FE location. Brown water staining was observed along the southern joint of the reconstructed cap, located with the yellow arrow in Photo No. 10. Facing south.

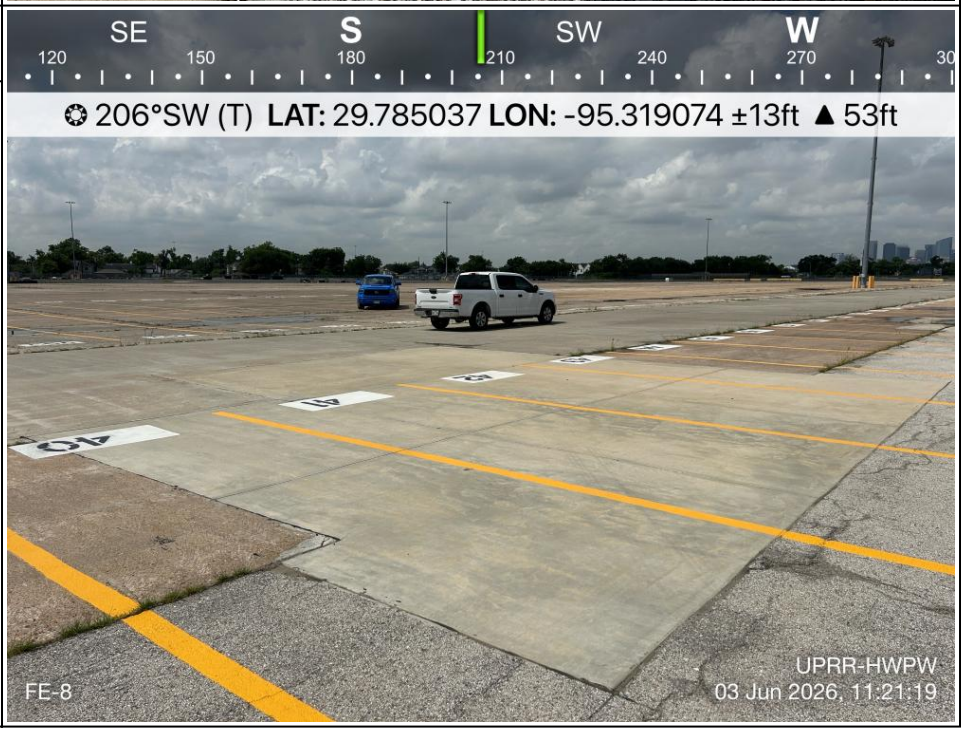
Photo No.	Inspection Date:
14	06/03/2026

FE-8 weekly inspection of concrete cap. Reconstructed cap in good condition. No NAPL observed at FE location. Facing southwest.

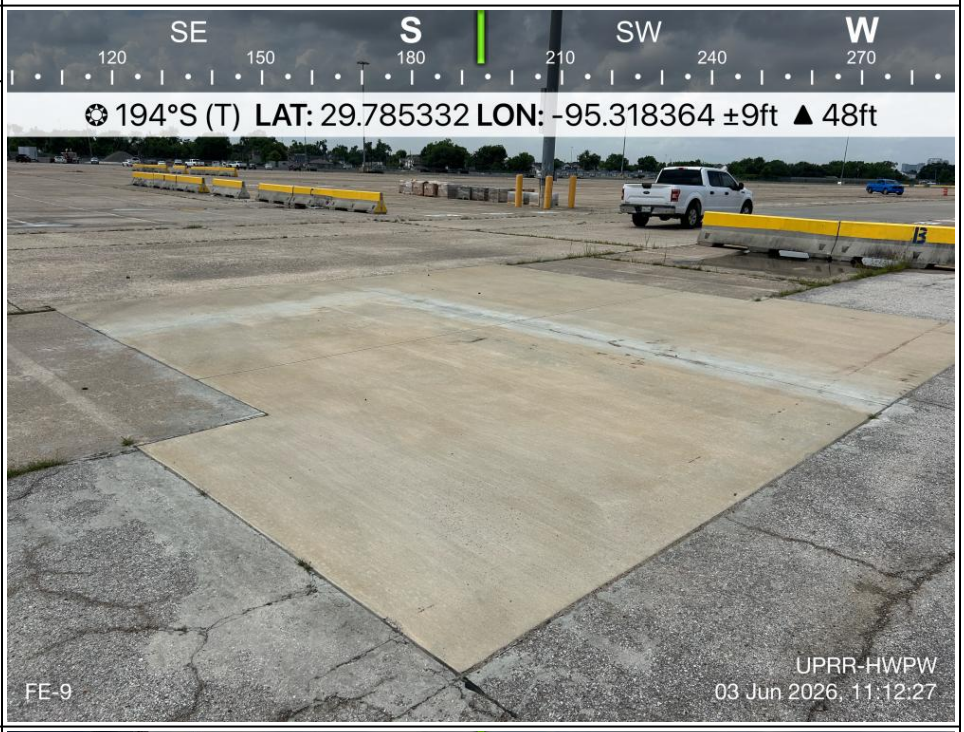
Photo No.	Inspection Date:
15	06/03/2026

FE-9 weekly inspection of concrete cap. Reconstructed cap in good condition. No NAPL observed at FE location. Facing south.

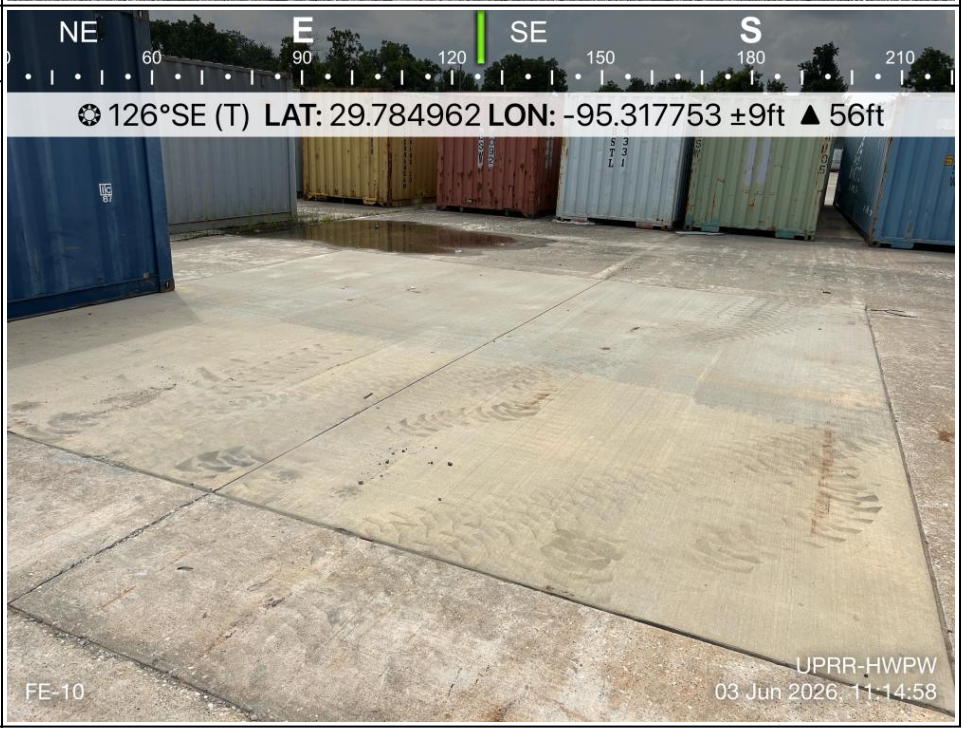
Photo No.	Inspection Date:
16	06/03/2026

FE-10 weekly inspection of concrete cap. Reconstructed cap in good condition. No NAPL observed at FE location. Standing water from recent rain event. Facing southeast.

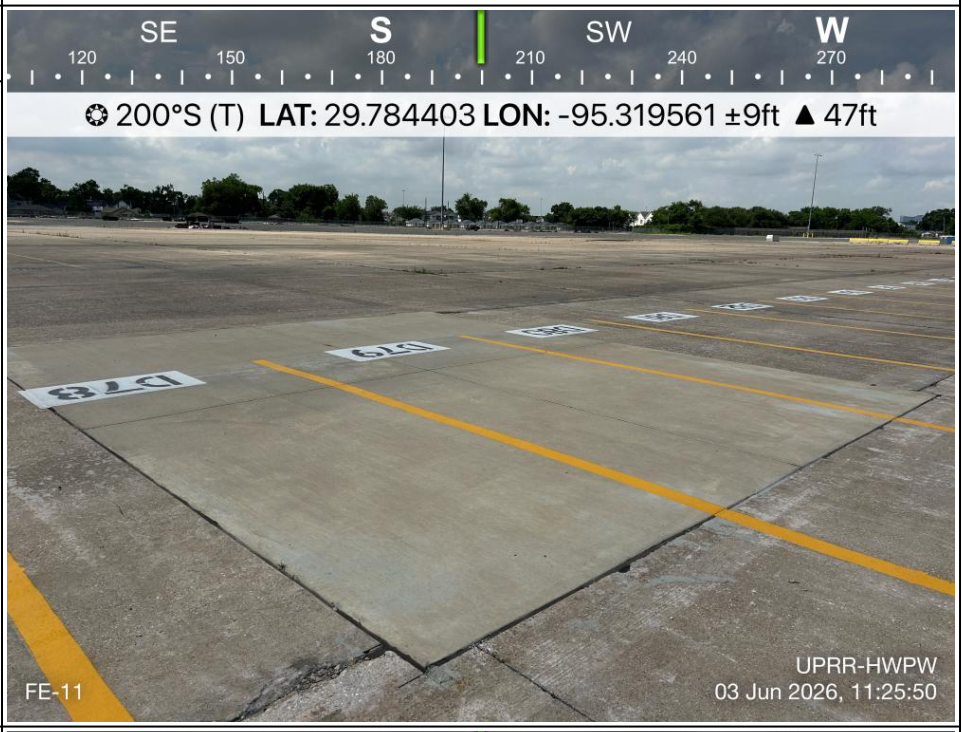
Photo No.	Inspection Date:
17	06/03/2026

FE-11 weekly inspection of concrete cap. Reconstructed cap in good condition. No NAPL observed at FE location. Facing south.

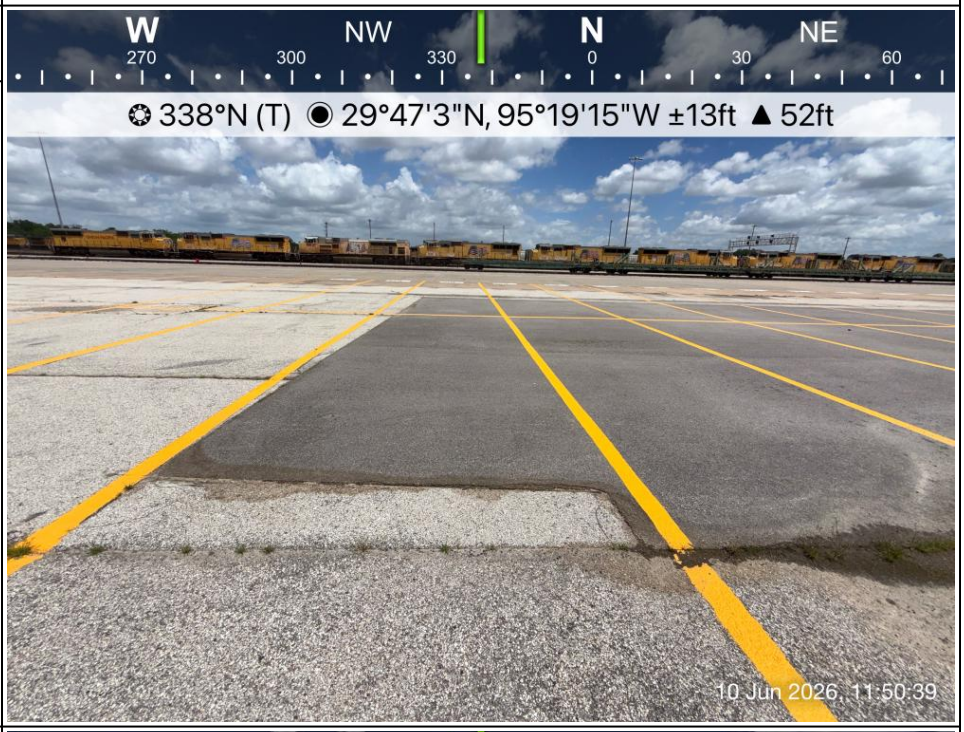
Photo No.	Inspection Date:
21	06/10/2026

- Brown water staining was observed along the southern joint of FE-1&3 on June 10 (Attachment A, Photo No. 21). The brown water staining was not observed at this location during the other June inspections.

FE-1&3 weekly inspection of asphalt cap. Reconstructed cap in good condition. No NAPL observed at FE location. Brown water staining was observed along the southern joint of the reconstructed cap, located with the red arrow in Photo No. 20. Facing north.

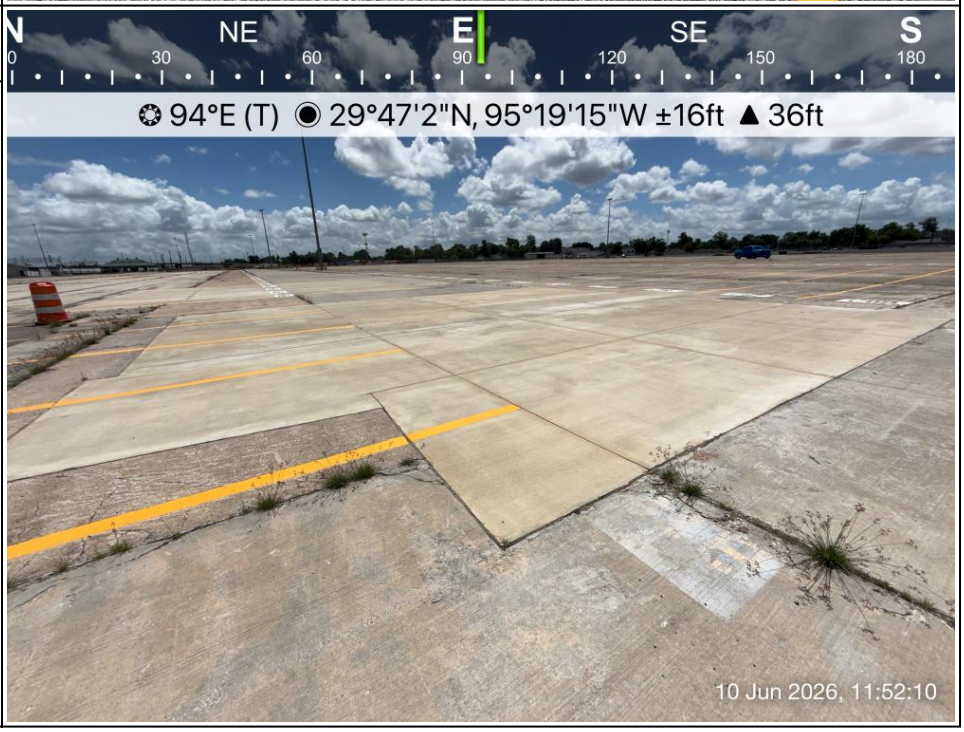
Photo No.	Inspection Date:
22	06/10/2026

FE-2 weekly inspection of concrete cap. Reconstructed cap in good condition. No NAPL observed at FE location. Facing east.

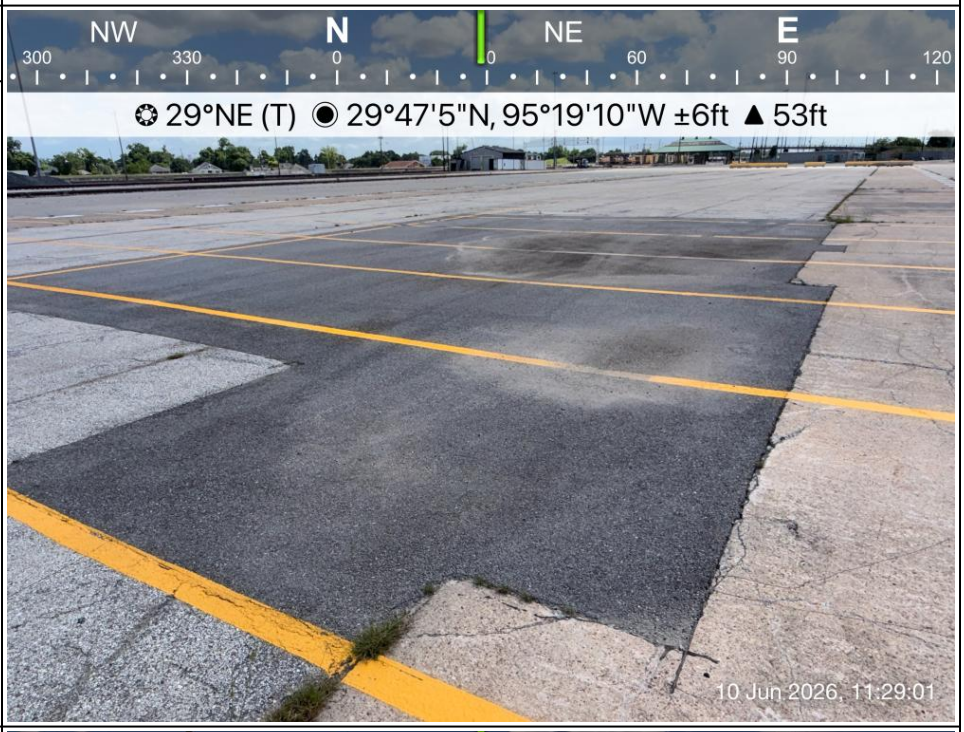
Photo No.	Inspection Date:
23	06/10/2026

FE-4 weekly inspection of asphalt cap. Reconstructed cap in good condition. No NAPL observed at FE location. Facing northeast.

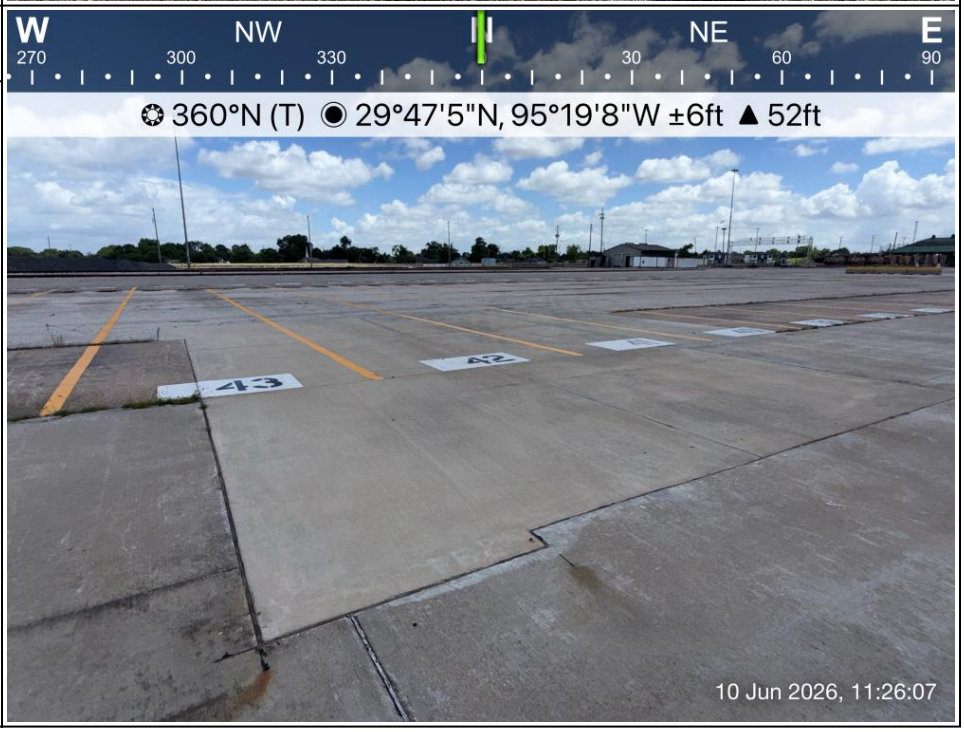
Photo No.	Inspection Date:
30	06/10/2026

FE-8 weekly inspection of concrete cap. Reconstructed cap in good condition. No NAPL observed at FE location. Facing north.

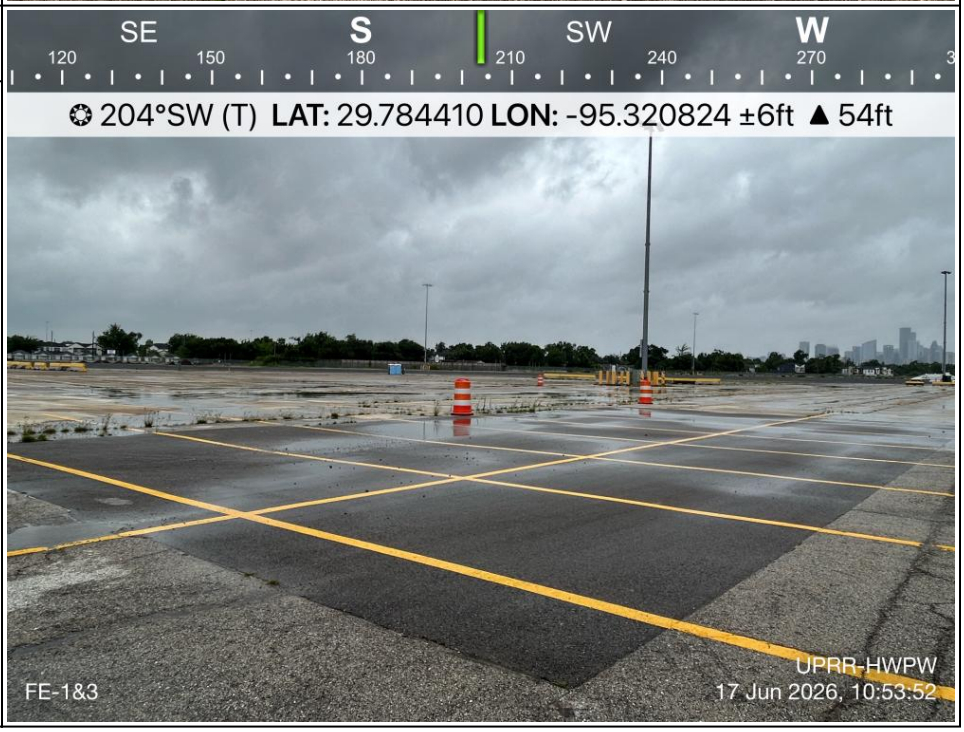
Photo No.	Inspection Date:
36	06/17/2026

FE-1&3 weekly inspection of asphalt cap. Reconstructed cap in good condition. No NAPL observed at FE location. Standing water from recent rain event. Facing southwest.

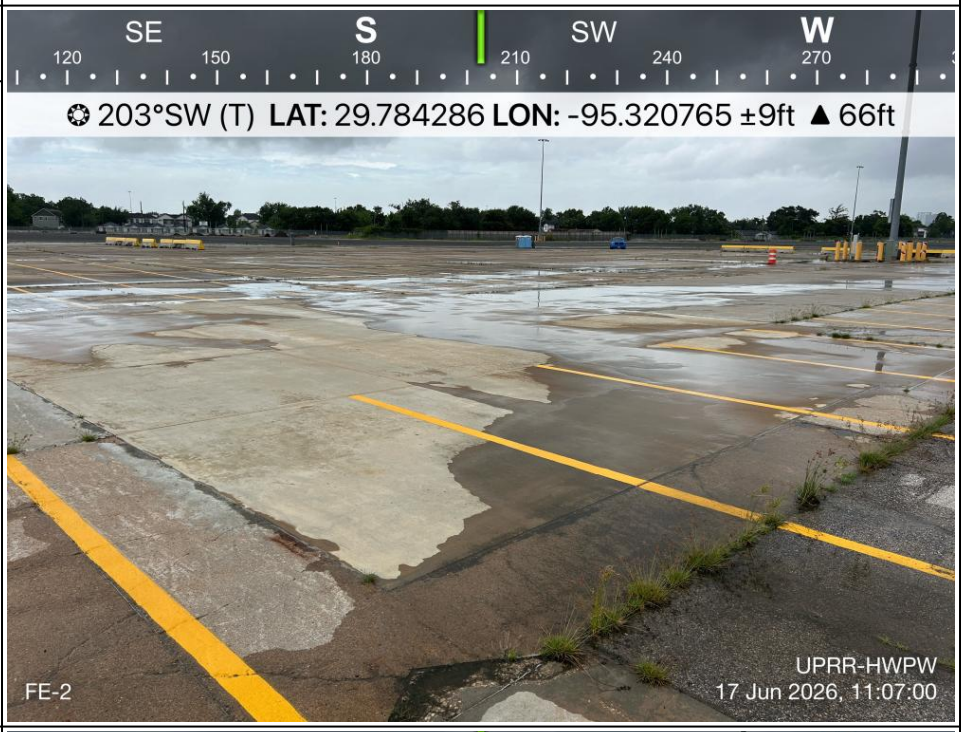
Photo No.	Inspection Date:
37	06/17/2026

FE-2 weekly inspection of concrete cap. Reconstructed cap in good condition. No NAPL observed at FE location. Standing water from recent rain event. Facing southwest.

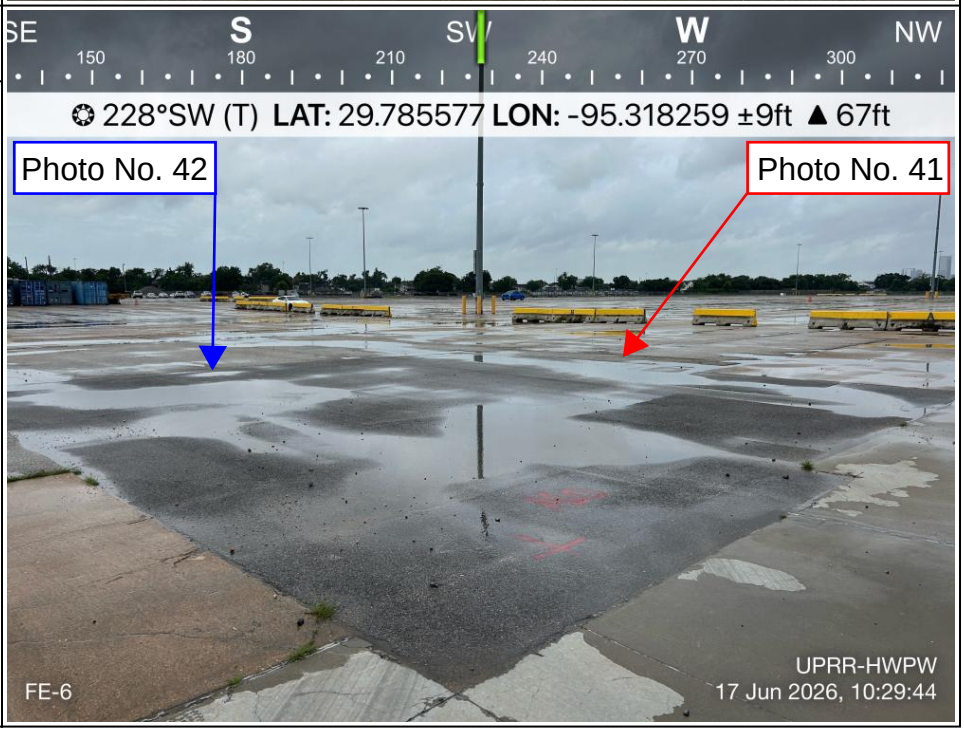
Photo No.	Inspection Date:
40	06/17/2026

FE-6 weekly inspection of asphalt cap. Reconstructed cap in good condition. No NAPL observed at FE location. Brown water staining and a small amount of standing water were observed along the western joint perpendicular to the reconstructed cap. Brown water staining was observed along the southern joint of the reconstructed cap. Other standing water from recent rain event. Facing southwest.

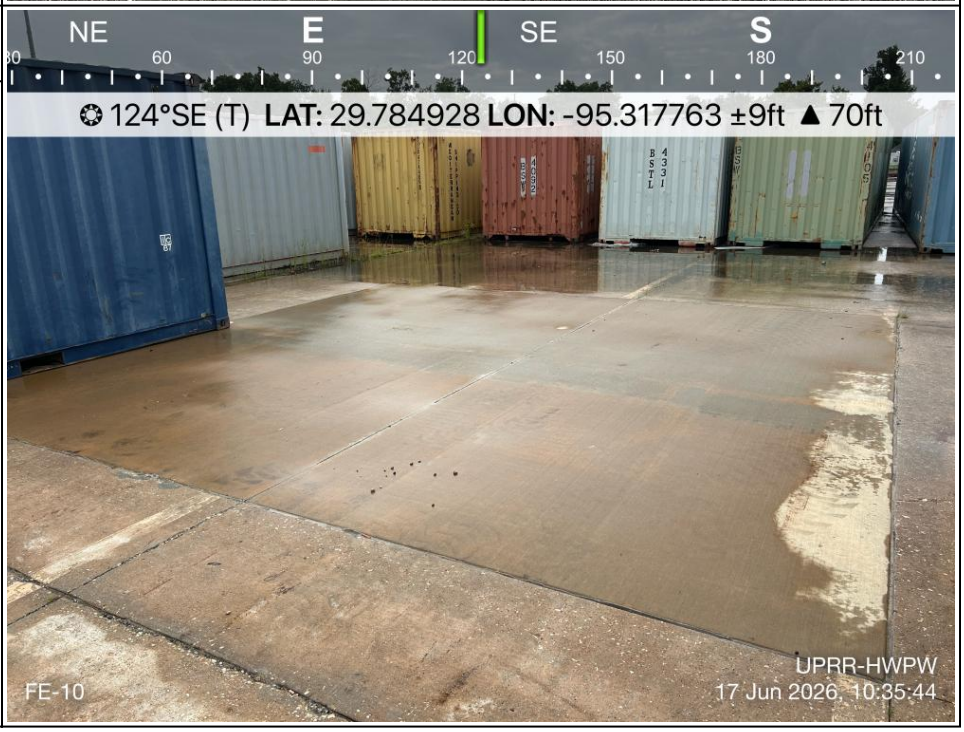
Photo No.	Inspection Date:
46	06/17/2026

FE-10 weekly inspection of concrete cap. Reconstructed cap in good condition. No NAPL observed at FE location. Standing water from recent rain event. Facing southeast.

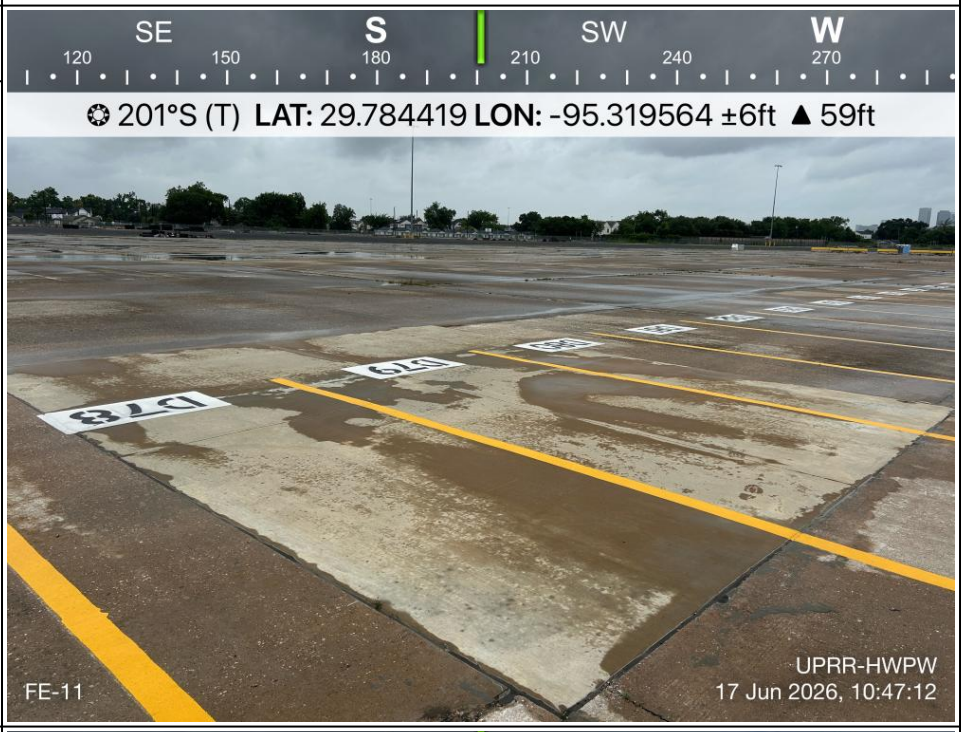
Photo No.	Inspection Date:
47	06/17/2026

FE-11 weekly inspection of concrete cap. Reconstructed cap in good condition. No NAPL observed at FE location. Standing water from recent rain event. Facing south.

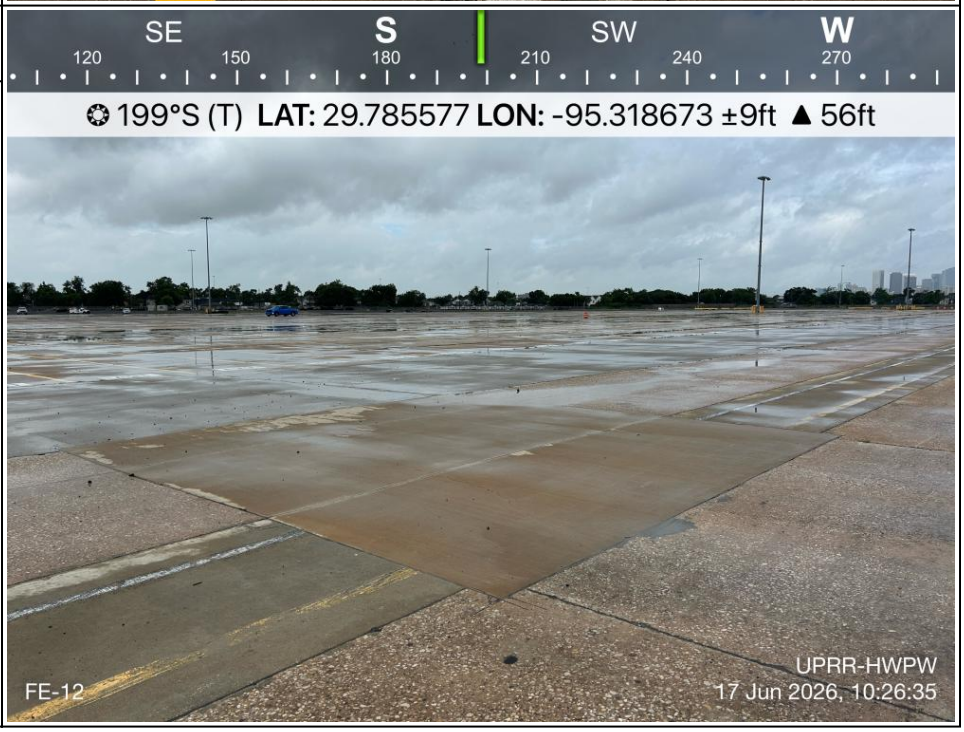
Photo No.	Inspection Date:
48	06/17/2026

FE-12 weekly inspection of concrete cap. Reconstructed cap in good condition. No NAPL observed at FE location. Standing water from recent rain event. Facing south.

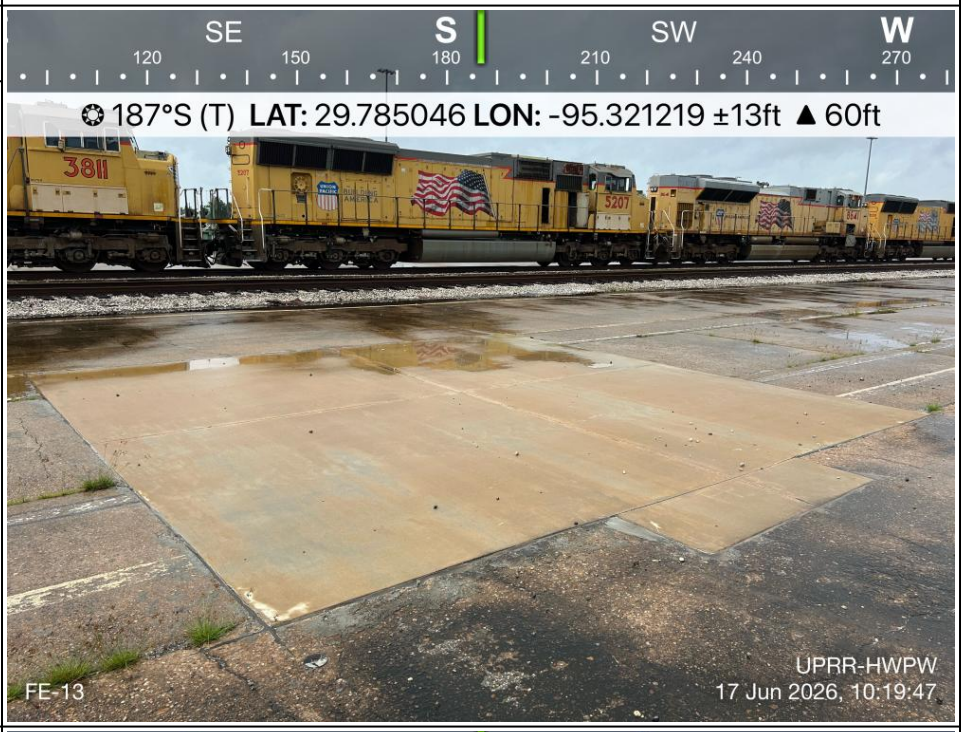
Photo No.	Inspection Date:
49	06/17/2026

FE-13 weekly inspection of concrete cap. Reconstructed cap in good condition. No NAPL observed at FE location. Standing water from recent rain event. Facing south.

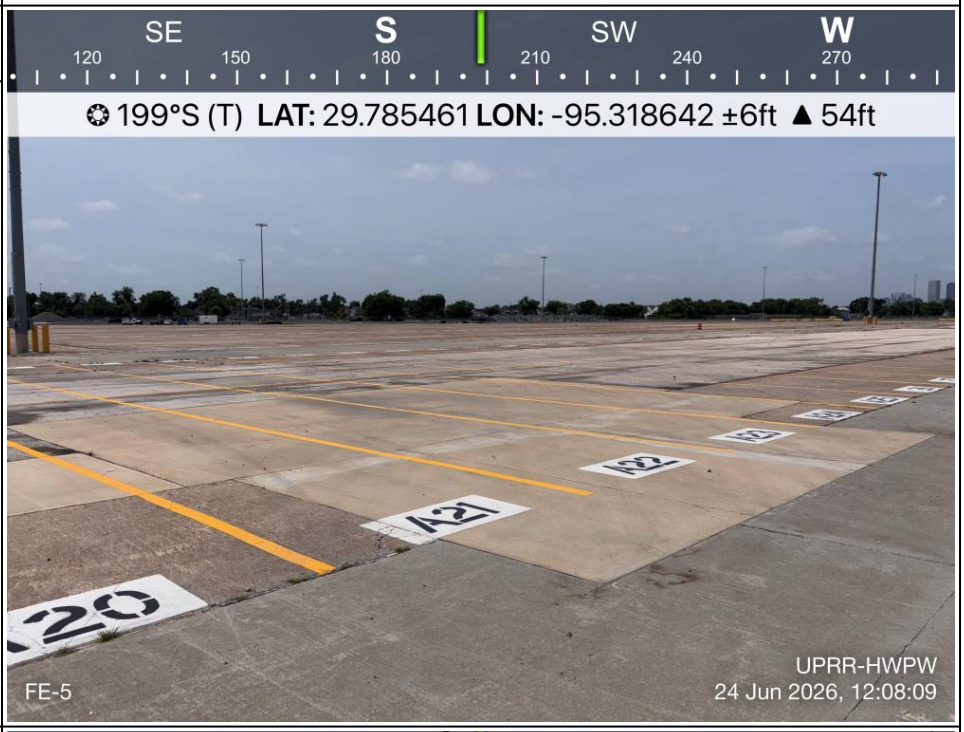
Photo No.	Inspection Date:
53	06/24/2026

FE-5 weekly inspection of concrete cap. Reconstructed cap in good condition. No NAPL observed at FE location. Brown water staining was observed along the southern joint of the reconstructed cap. Facing south.

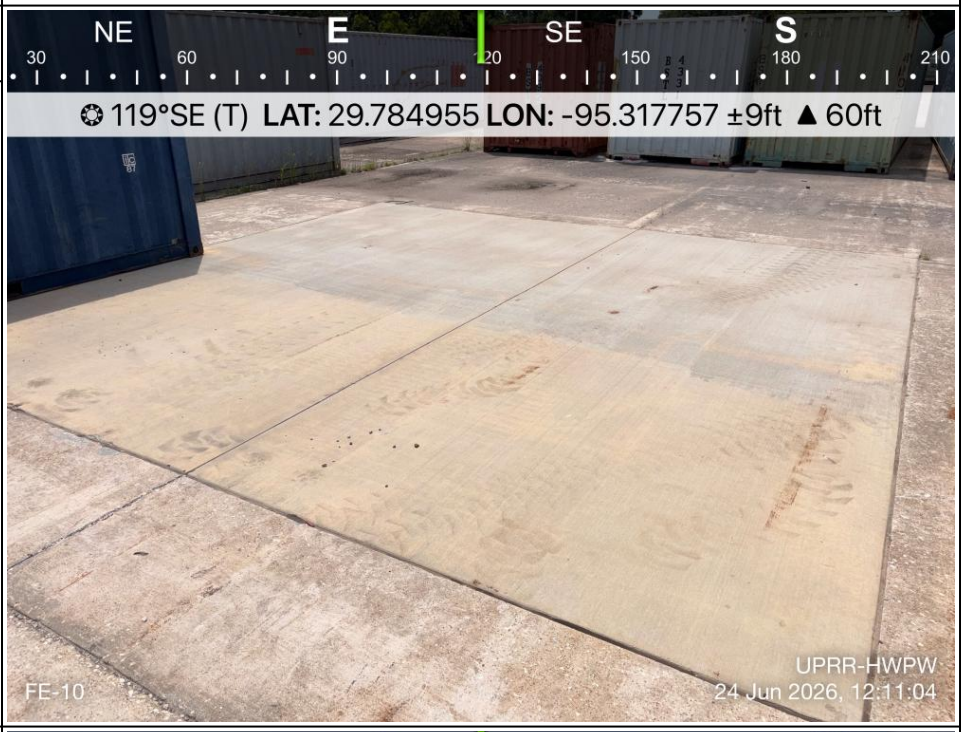
Photo No.	Inspection Date:
59	06/24/2026

FE-10 weekly inspection of concrete cap. Reconstructed cap in good condition. No NAPL observed at FE location. Facing southeast.

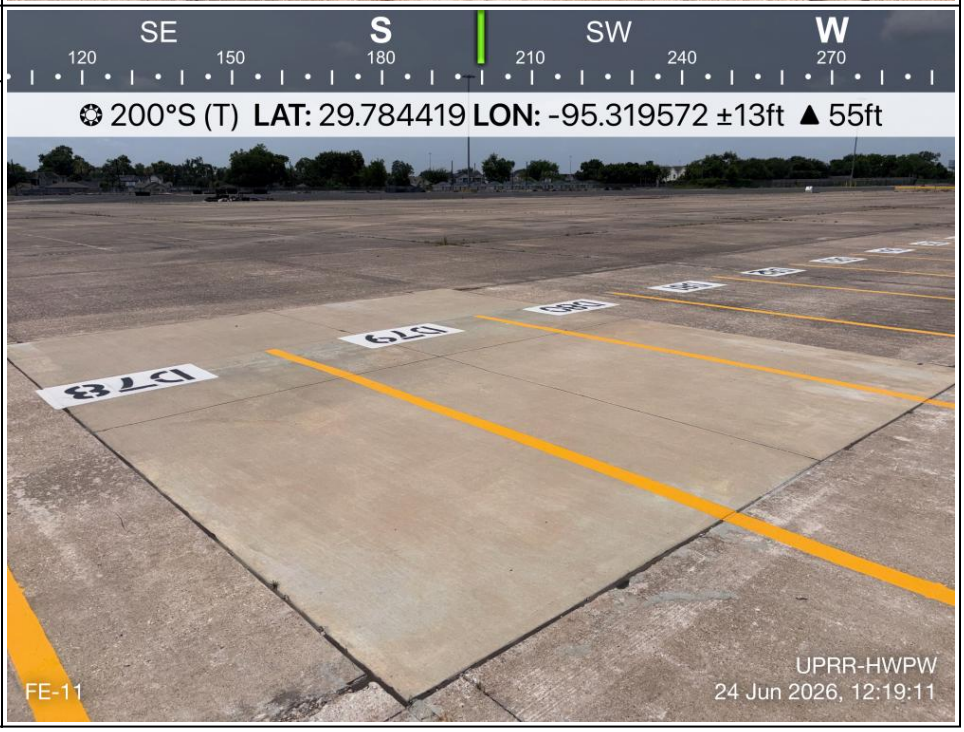
Photo No.	Inspection Date:
60	06/24/2026

FE-11 weekly inspection of concrete cap. Reconstructed cap in good condition. No NAPL observed at FE location. Facing south.

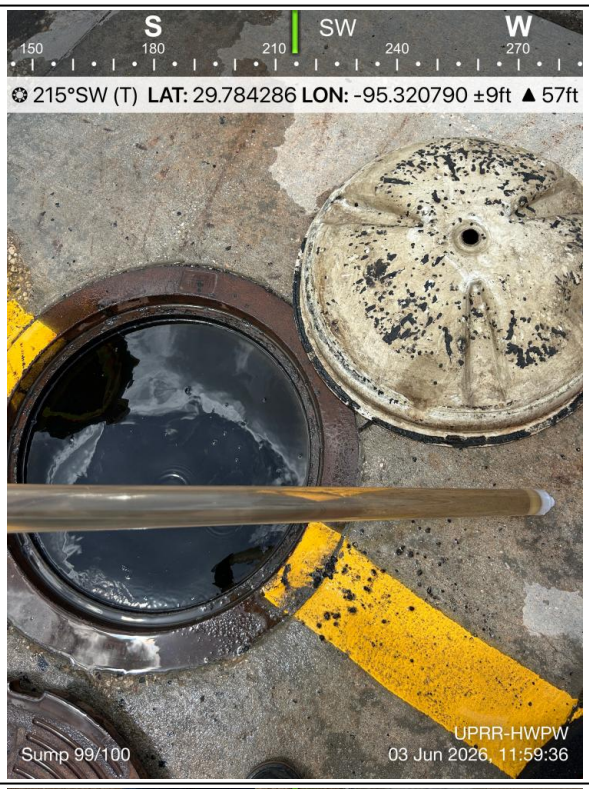
Photo No.	Inspection Date:
63	06/03/2026

- No NAPL was observed or recovered from Sumps 1, 2, and 3 during the June 2026 weekly inspections. During the June inspections, the small amount of NAPL accumulated on the underside of the inflow protector for Sump 1 was similar in appearance to the amount observed in May (Photo No. 63).

Sump 1 (B99/B100), 0.0 inches of freeboard in sump. Color is light brown, and no sheen or odor was reported.

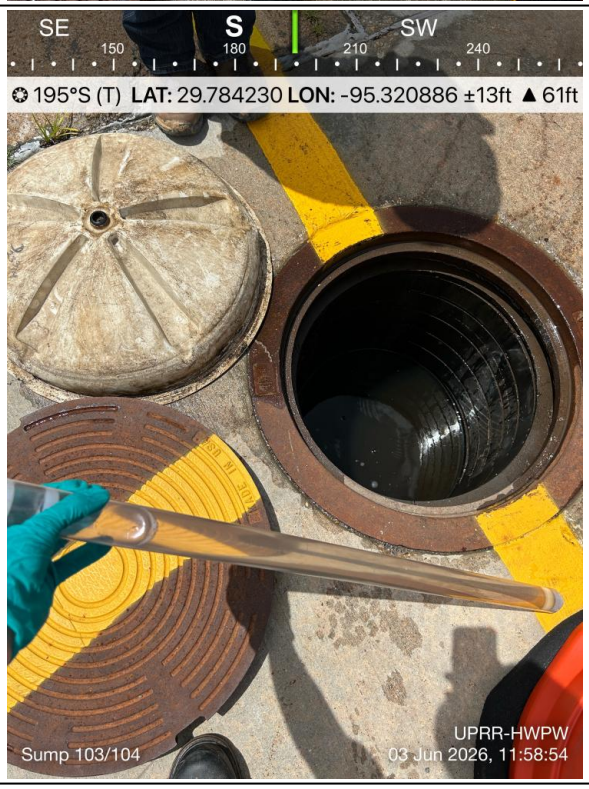
Photo No.	Inspection Date:
64	06/03/2026

Sump 2 (B103/B104), 18.5 inches of freeboard in sump. Color is clear, and no sheen or odor was reported.

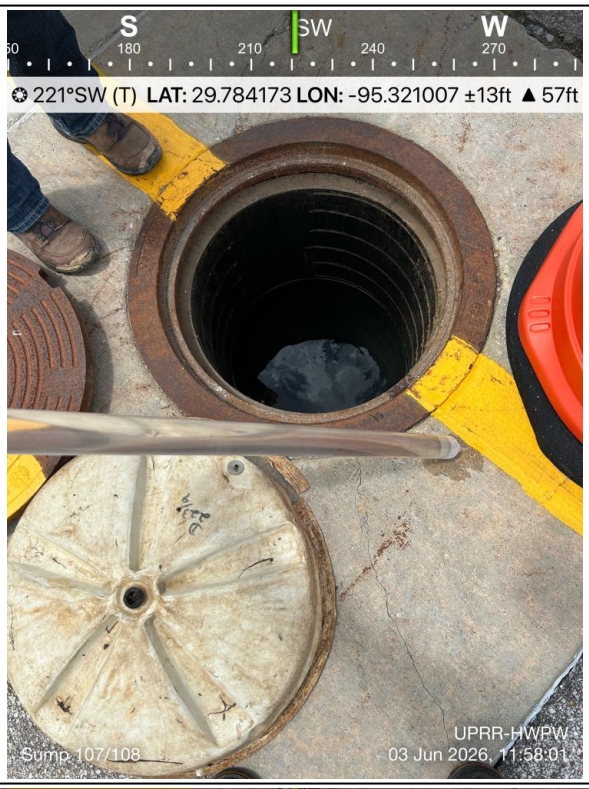
Photo No.	Inspection Date:
65	06/03/2026

Sump 3 (B107/B108), 18.0 inches of freeboard in sump. Color is clear, and no sheen or odor was reported.

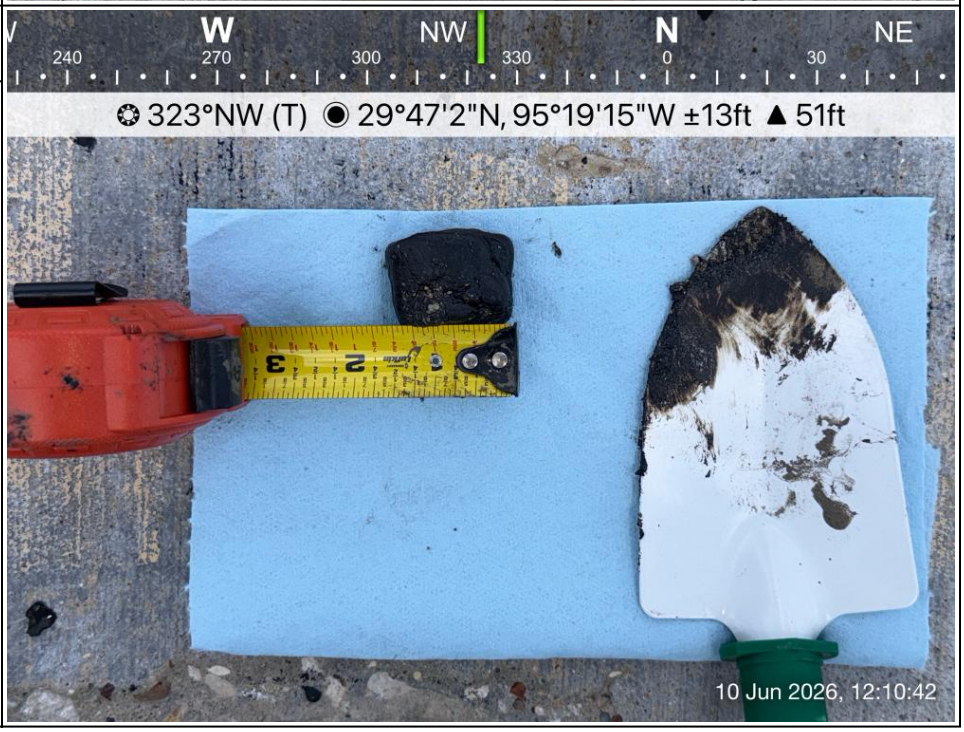
Photo No.	Inspection Date:
78	06/10/2026

- A tar-like material seep was observed at a concrete joint at stall B107 on June 3, June 10, and June 24 immediately adjacent to the NAPL Collection System. Approximately 9.8 cubic inches (approximately 5.4 fluid ounces) of NAPL were recovered. No seep activity was noted at B107 during the June 17th inspection (Photo Nos. 75 through 81). No NAPL seeps were observed along the concrete joints near the NAPL Collection System during the June inspections.

B107 weekly inspection of joint. Surrounding concrete in good condition. Approximately 1.70 cubic inches of NAPL observed at seep location.

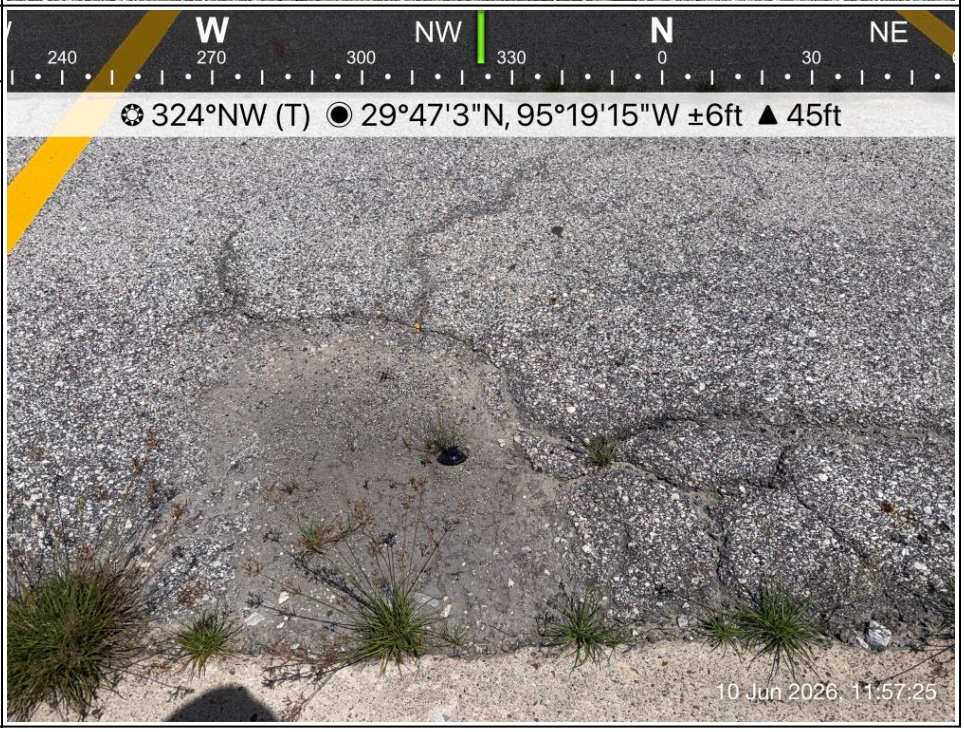
Photo No.	Inspection Date:
90	06/10/2026

- A tar-like material seep was observed in the center of stall B102 on June 10 for the first time since November 5, 2025. A tar-like material seep was also observed in the center of stall B102 on June 24. Approximately 3.4 cubic inches (approximately 1.9 fluid ounces) of NAPL were recovered. No seep activity was noted at stall B102 Center during the other June weekly inspections (Photo Nos. 89 through 94).

B102 Center weekly inspection of previously identified seep. Surrounding asphalt in good condition. Approximately 2.08 cubic inches of NAPL observed at seep location.
