July 15, 2026 Project No. US0039040.3990

Re: **MONTHLY STATUS UPDATE – ENGLEWOOD INTERMODAL YARD – REVISED INTERIM MEASURES WORK PLAN POST-CONSTRUCTION AND NAPL COLLECTION SYSTEM/CONCRETE CAP REPAIR INSPECTIONS**
UNION PACIFIC RAILROAD HOUSTON WOOD PRESERVING WORKS FACILITY
4910 LIBERTY ROAD FACILITY, HOUSTON, TEXAS
POST-CLOSURE CARE PERMIT NO. HW-50343; INDUSTRIAL SWR NO. 31547

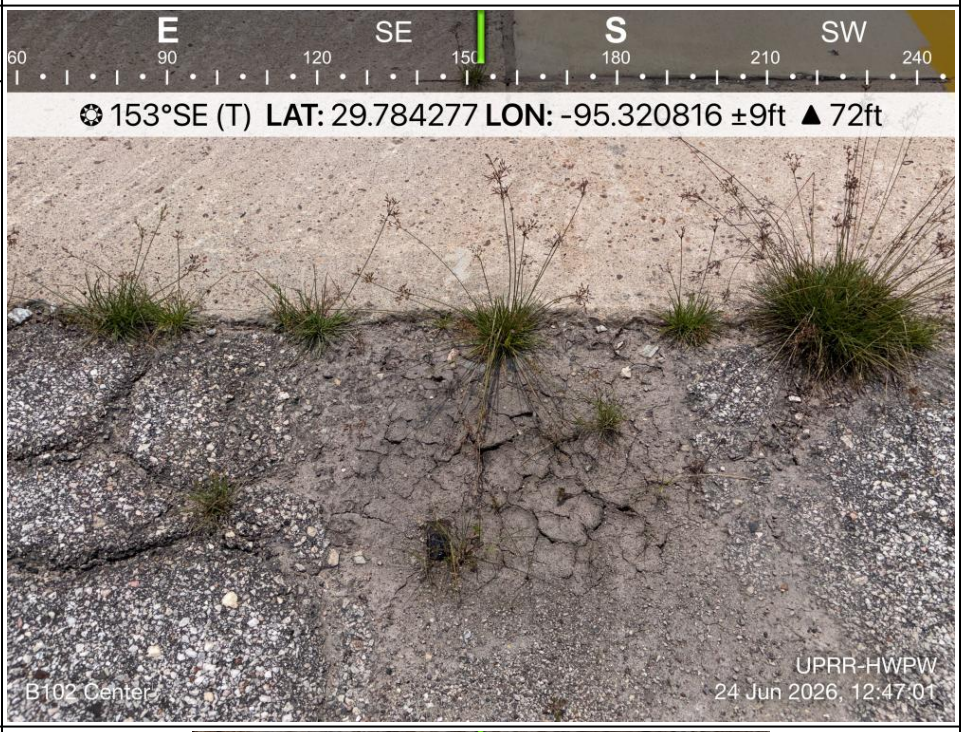
Photo No.	Inspection Date:
93	06/24/2026

- A tar-like material seep was observed in the center of stall B102 on June 10 for the first time since November 5, 2025. A tar-like material seep was also observed in the center of stall B102 on June 24. Approximately 3.4 cubic inches (approximately 1.9 fluid ounces) of NAPL were recovered. No seep activity was noted at stall B102 Center during the other June weekly inspections (Photo Nos. 89 through 94).

B102 Center weekly inspection of previously identified seep. Surrounding asphalt in good condition. Approximately 1.33 cubic inches of NAPL observed at seep location.

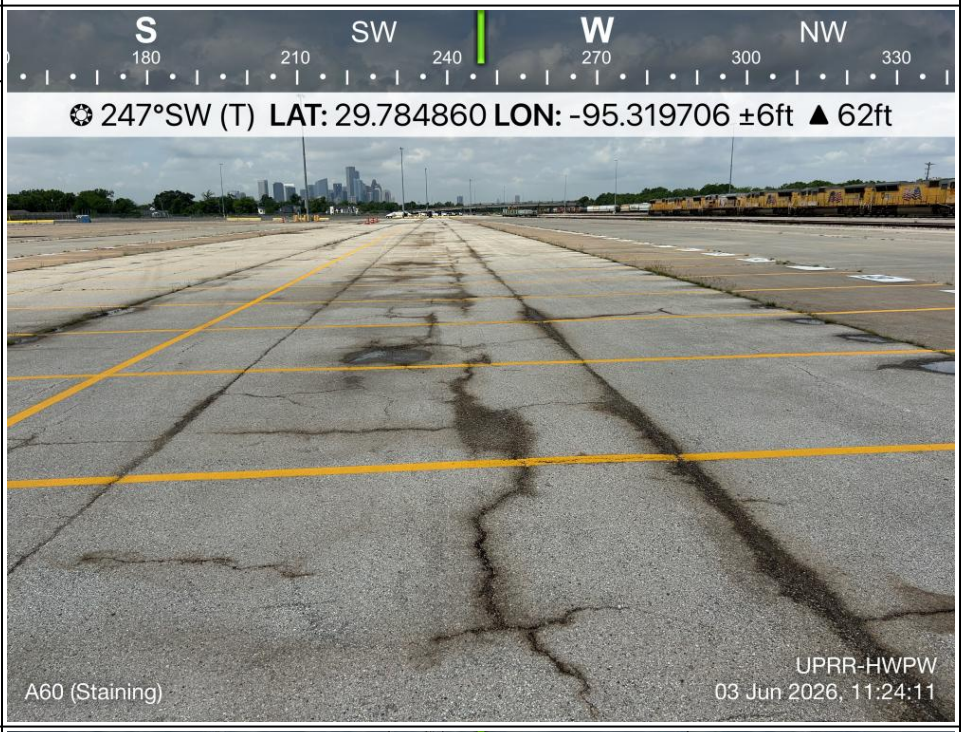
Photo No.	Inspection Date:
95	06/03/2026

- Brown water staining was observed within the EIY along the asphalt joint between stall A060 and A075 on June 3 (Photo No. 95) and June 17 (Photo Nos. 98 and 99), at stall B096 on June 10 (Photo No. 97), and between stall C024 and C031 on June 3 (Photo No. 96). Brown water staining was observed on the pavement north of the reconstructed concrete cap of FE-1&3 on June 3 (Photo Nos. 2 and 3) and June 10 (Photo No. 20).

Brown water staining was observed along the joint that runs through stall A060 west of reconstructed cap FE-4.

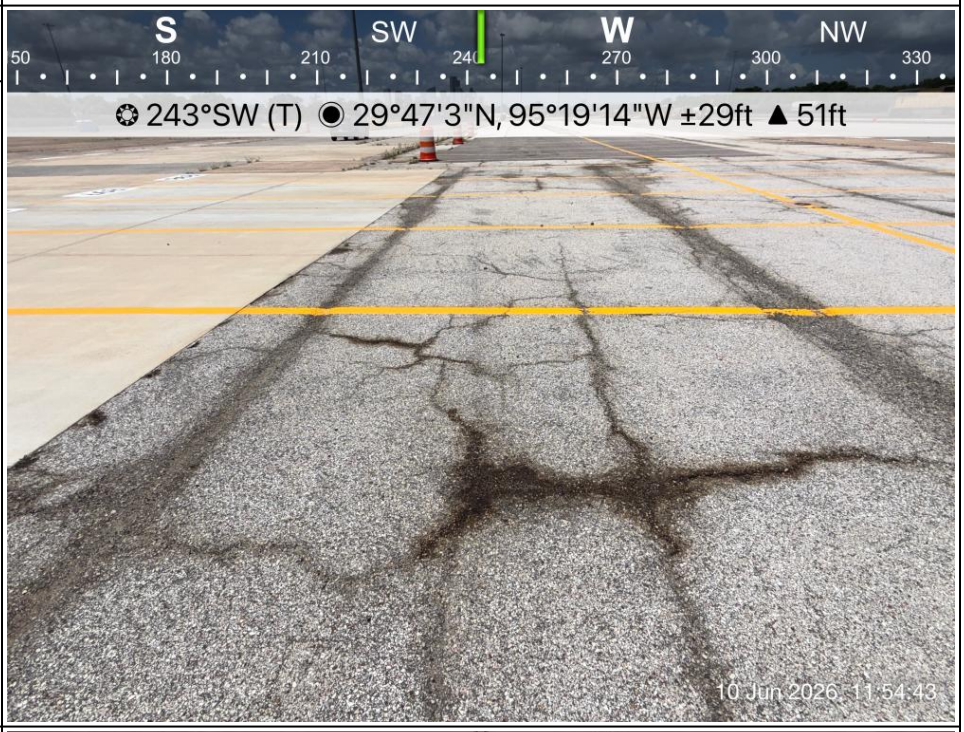
Photo No.	Inspection Date:
97	06/10/2026

Brown water staining was observed along the joint that runs through stall B096.

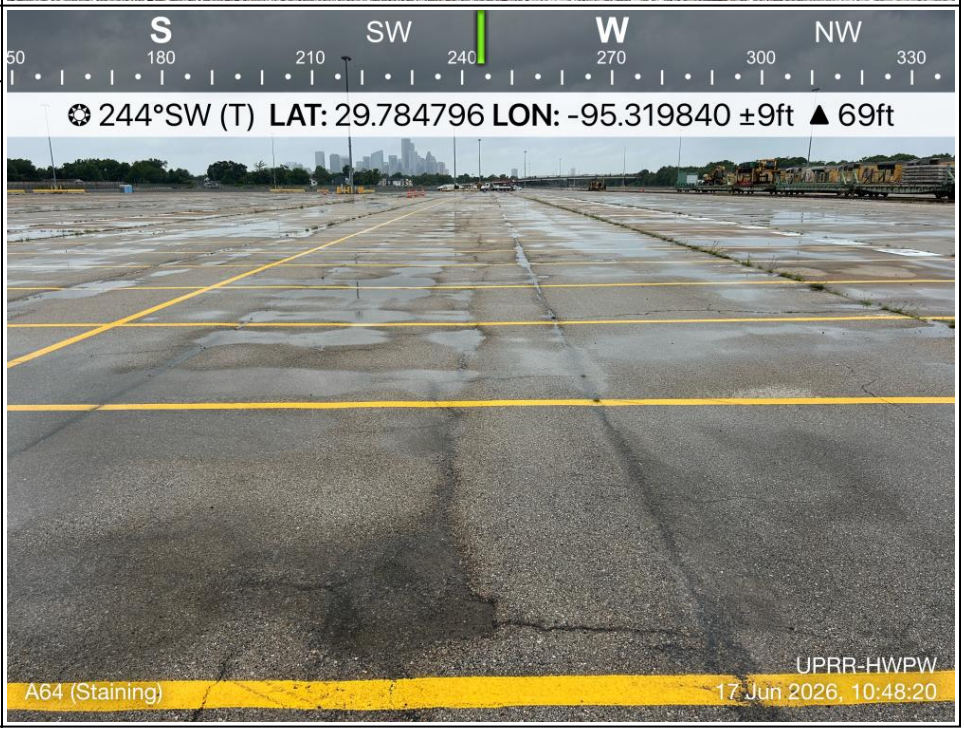
Photo No.	Inspection Date:
98	06/17/2026

Brown water staining was observed along the joint that runs through stall A064.
