Re: Response to Texas Commission on Environmental Quality (TCEQ) Comments on
Post-Response Action Care Report, dated September 29, 2017
Union Pacific Railroad Houston Wood Preserving Works Facility
4910 Liberty Road Facility, Houston, Texas
Post-Closure Care Permit No. HW-50343; Industrial SWR No. 31547
CN600131098; RN100674613

Response to TCEQ Comments on the PRACR dated September 29, 2017
UPRR Houston Wood Preserving Works
4910 Liberty Road, Houston, Texas

POST-HARVEY SOIL CAP INSPECTION RECORD, PHOTOLOG, AND FIGURE

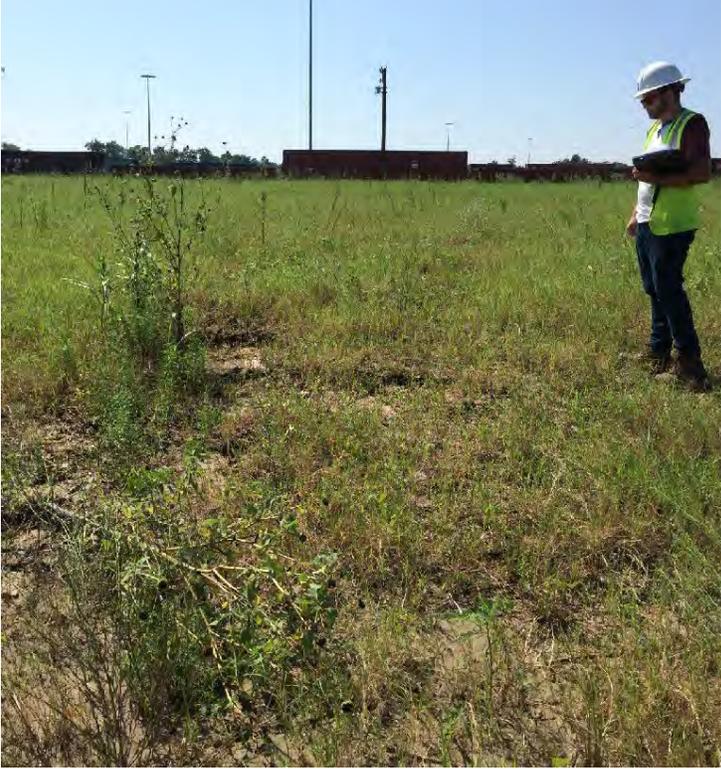
<h1>PBW</h1>		<h2>PHOTOGRAPHIC LOG</h2>	
Client Name: Union Pacific Railroad		Site Location: Houston Wood Preserving Works, 4910 Liberty Road, Houston, Texas	Project No.: 1358-603
Photo No. 1	Date: 8/31/17

Description: Soil Cap Area: Bare patch in vegetation in the Northeastern soil cap area. Lat: 29.78674444 Long: -95.32016111			
Photo No. 2	Date: 8/31/17

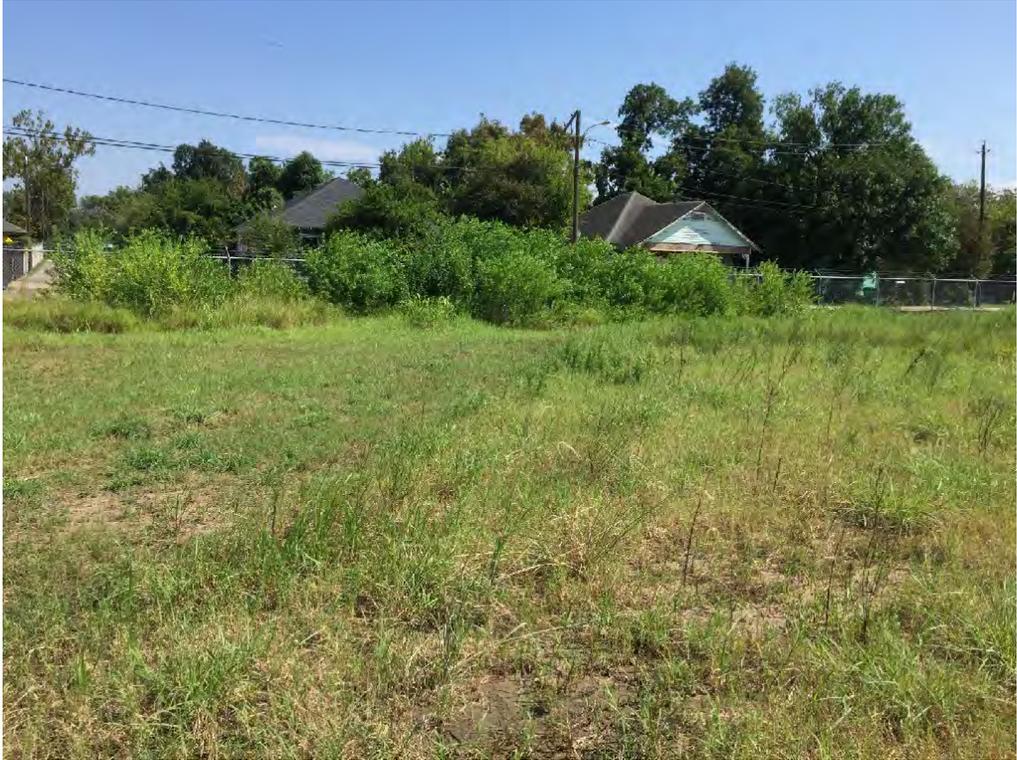
<h1 style="font-size: 2em; margin: 0;">PBW</h1>		<h2 style="font-size: 1.2em; margin: 0;">PHOTOGRAPHIC LOG</h2>
Client Name: Union Pacific Railroad		Site Location: Houston Wood Preserving Works, 4910 Liberty Road, Houston, Texas
Project No. 1358-603		
Photo No. 5	Date: 8/31/17

Description: Soil Cap Area: Heavy vegetation along northern fence. Lat: 29.78730556 Long: -95.31932778		
Photo No. 6	Date: 8/31/17

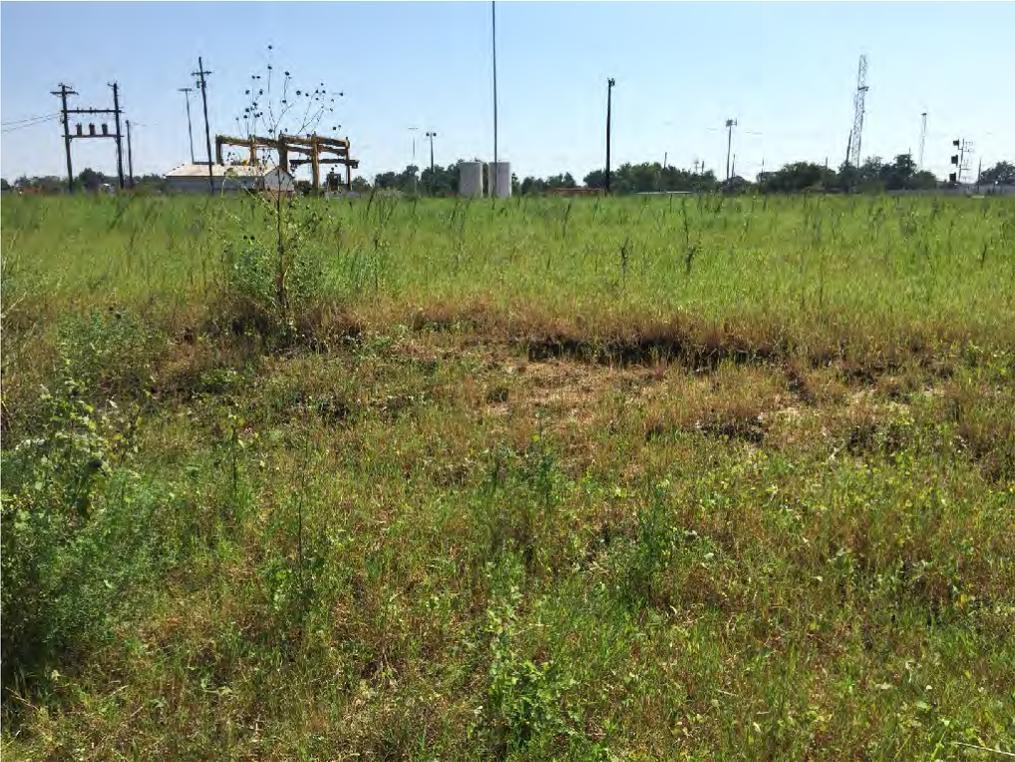
<h1>PBW</h1>		<h2>PHOTOGRAPHIC LOG</h2>	
Client Name: Union Pacific Railroad		Site Location: Houston Wood Preserving Works, 4910 Liberty Road, Houston, Texas	Project No. 1358-603
Photo No. 7	Date: 8/31/17

Description: Soil Cap Area: Small rill and bare patch with very minor amounts of erosion in north-northeastern area of soil cap. Looking south toward the Englewood Yard shop. Lat: 29.78740278 Long: -95.31867222			
Photo No. 8	Date: 8/31/17

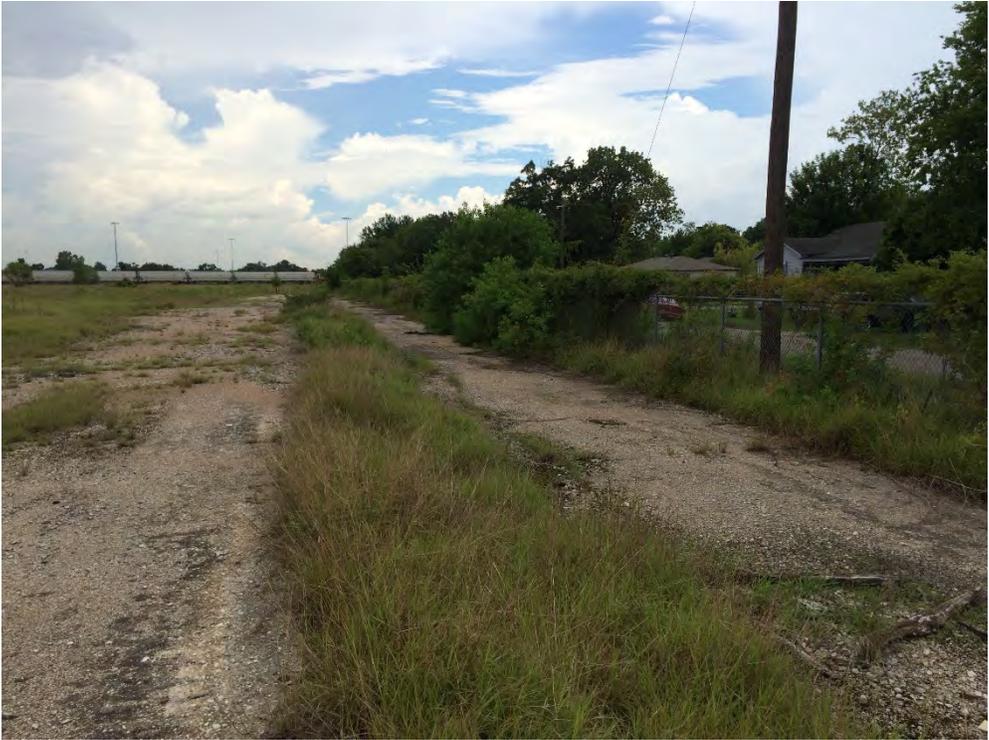
Client Name: Union Pacific Railroad		Site Location: Houston Wood Preserving Works, 4910 Liberty Road, Houston, Texas	Project No. 1358-603
Photo No. 17	Date: 7/17/17

Description: Perimeter Fence: Security fence- significant vegetation on West fence Lat: 29.78749722 Long: -95.32383611			
Photo No. 18	Date: 7/17/17

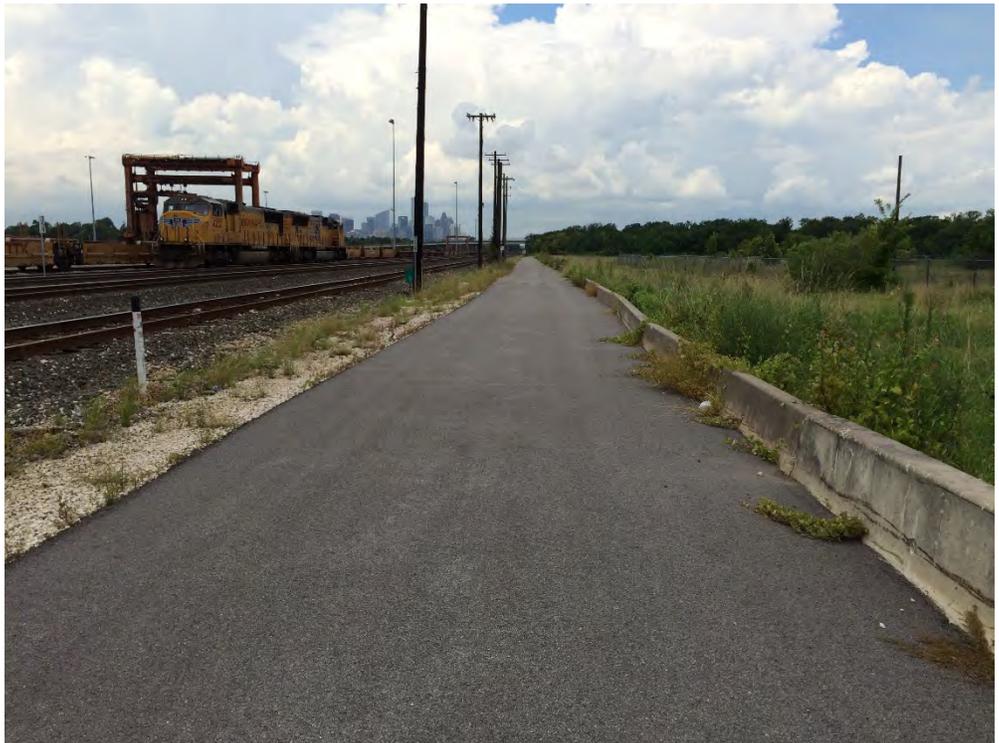
Photo No.
22

**Asphalt Road/Ballast
Cap:**
Concrete Barriers-
Significant vegetative
intrusion underneath
barriers

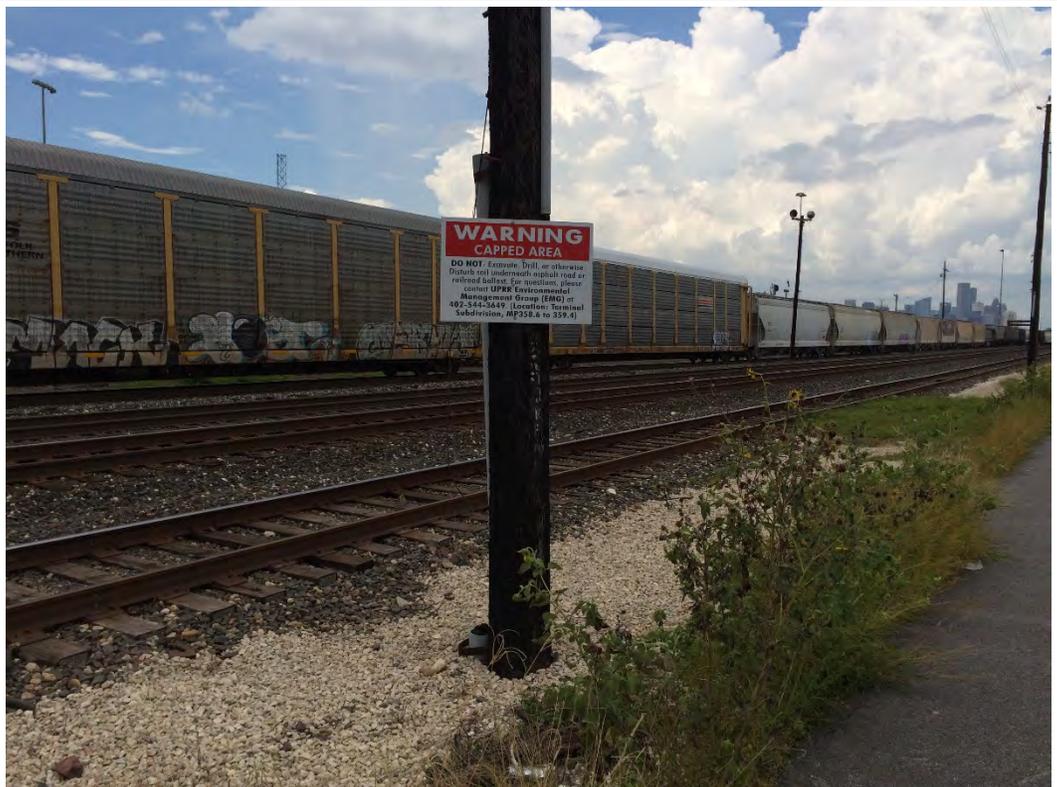
Photo No.
26

Asphalt Road/Ballast
Cap:
 Ballast Cap-Some
 areas of significant
 vegetation, note
 warning sign posted for
 cap area.

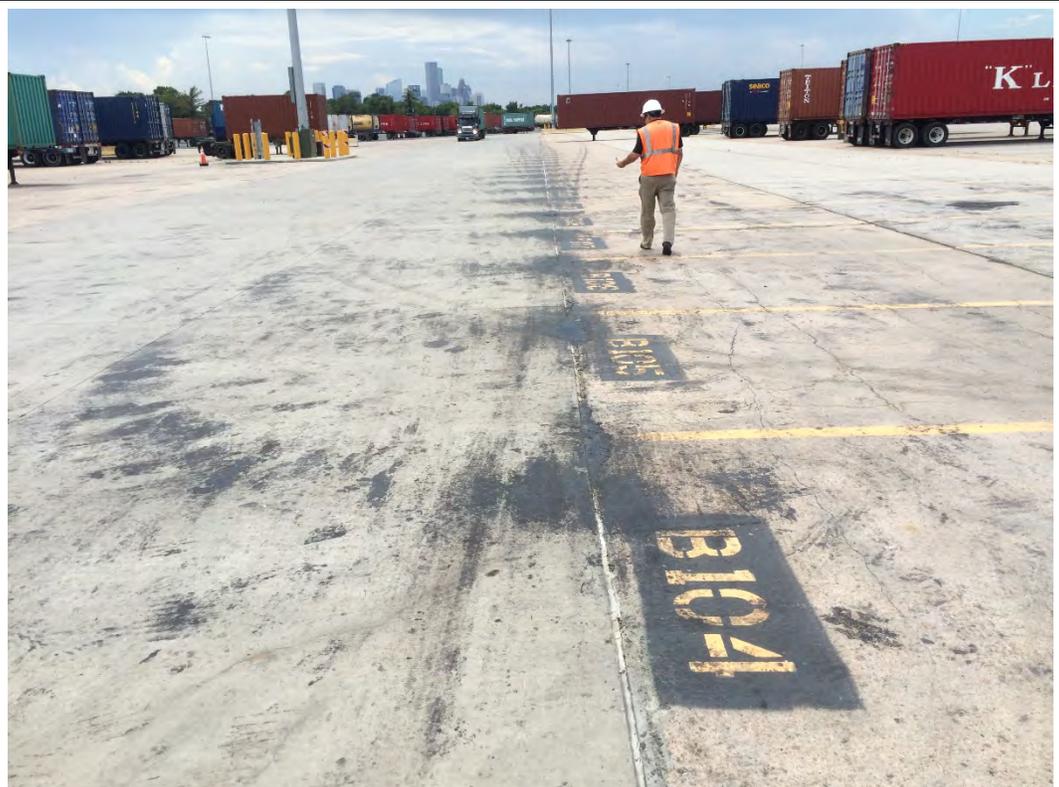
Englewood Intermodal
Yard Concrete Cap
Area – tar-like
substance seeping from
concrete joint.

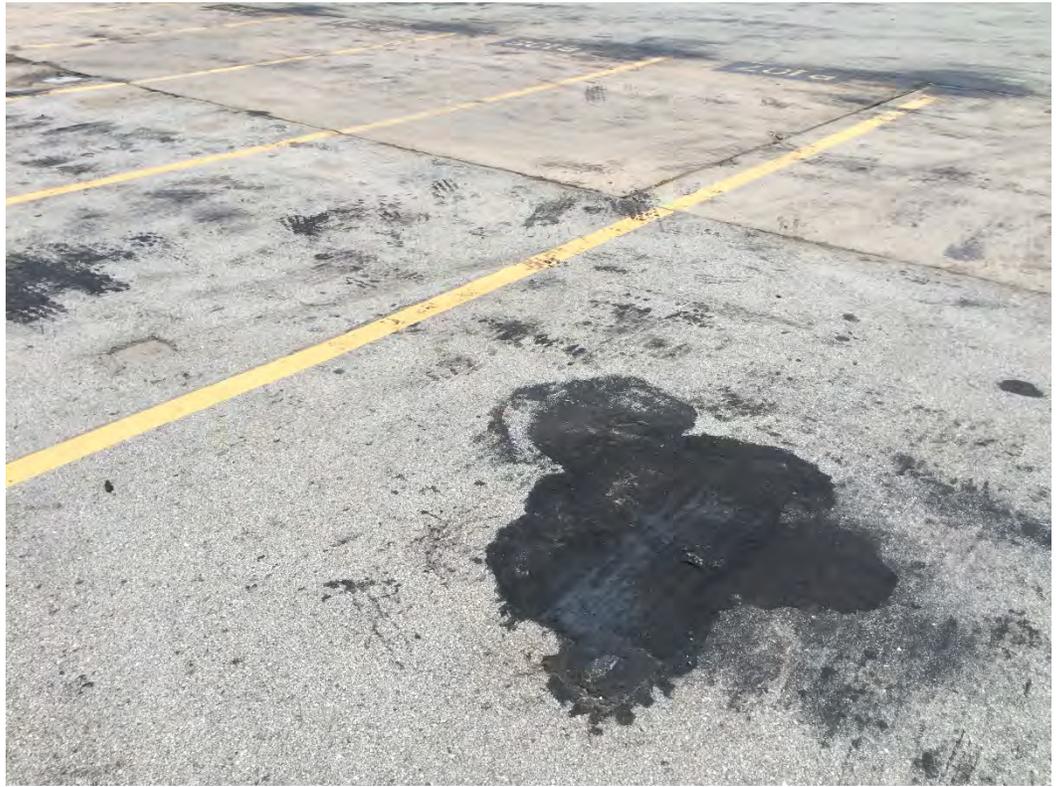
Englewood Intermodal
 Yard Concrete Cap
 Area – tar-like
 substance seeping from
 asphalt area.

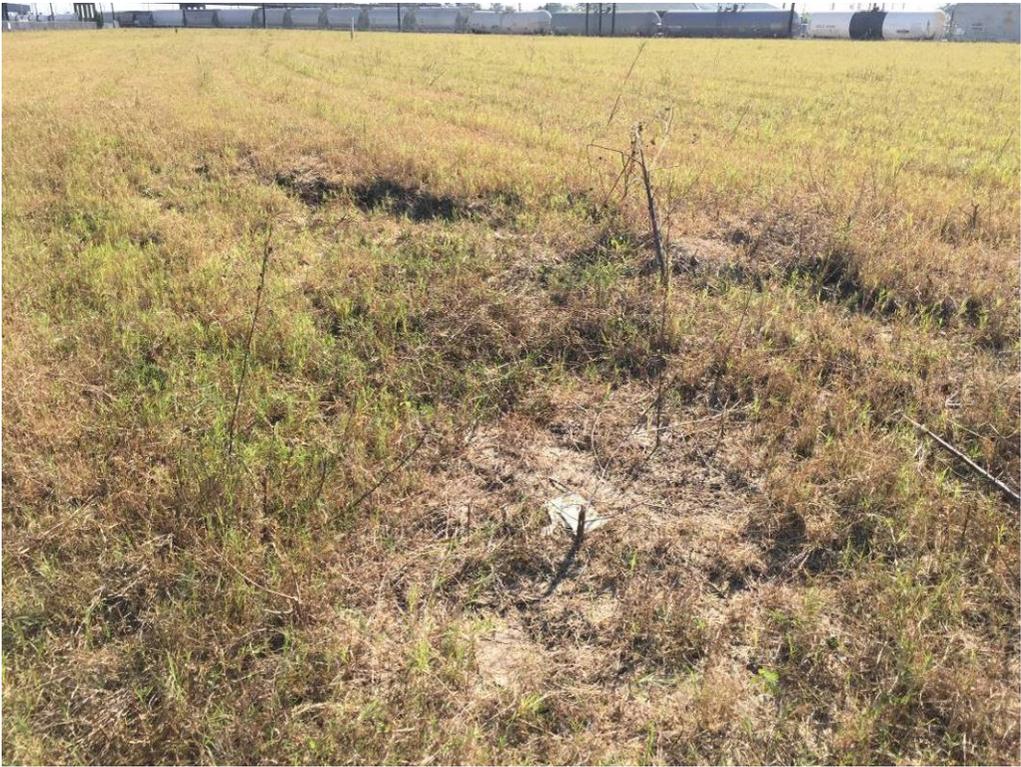
Description: Soil Cap Area: Bare area on northeastern toe of cap, facing south-southeast Lat: 29.78735278, Long: -95.31870278

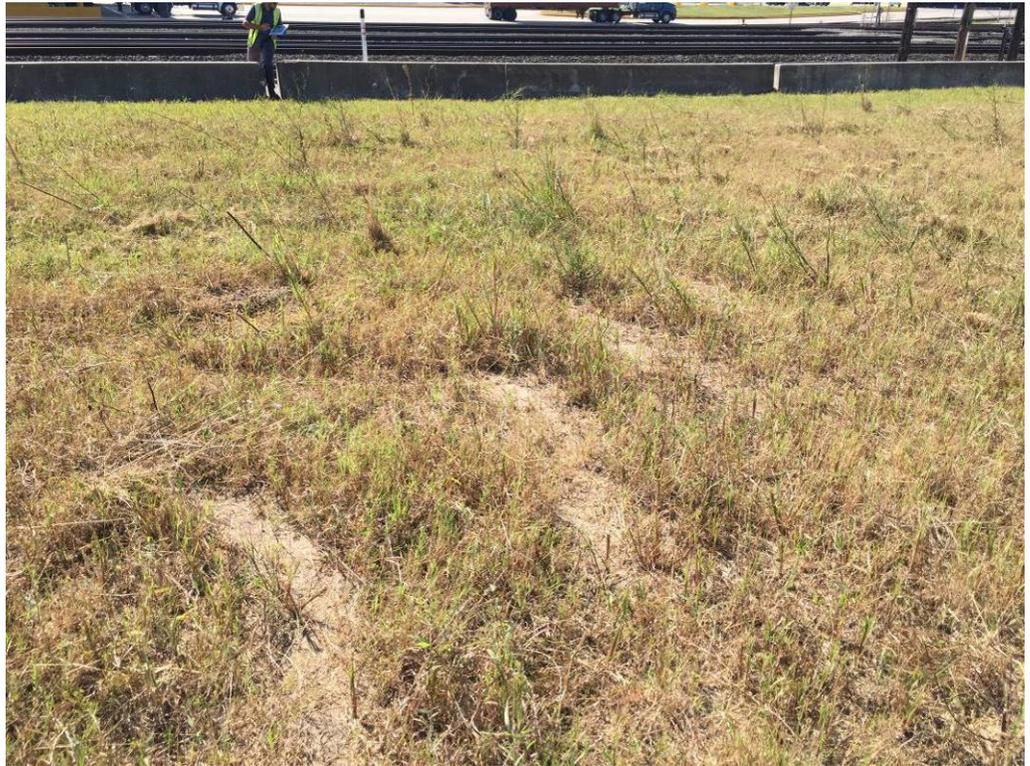
Photo No.
16

Large bare areas in the main body of cap, looking south.

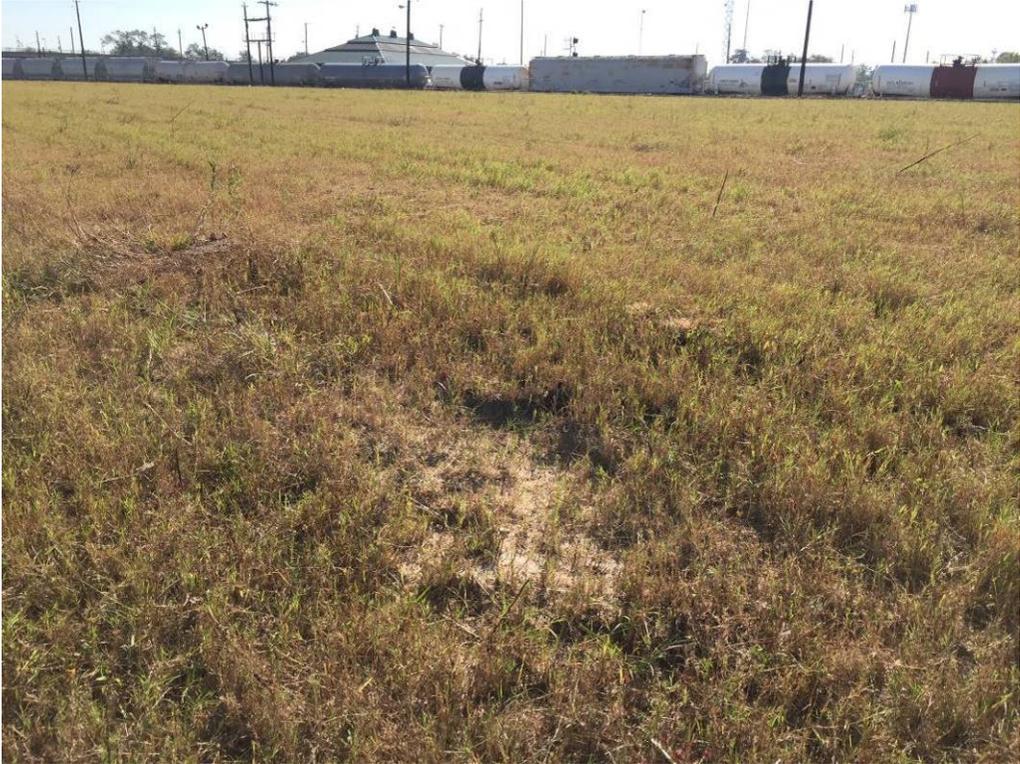
Description: Soil Cap Area: Bare area in main body of soil cap, facing southeast Lat: 29.78728056, Long: -95.3189			
Photo No. 18	Date: 10/18/17

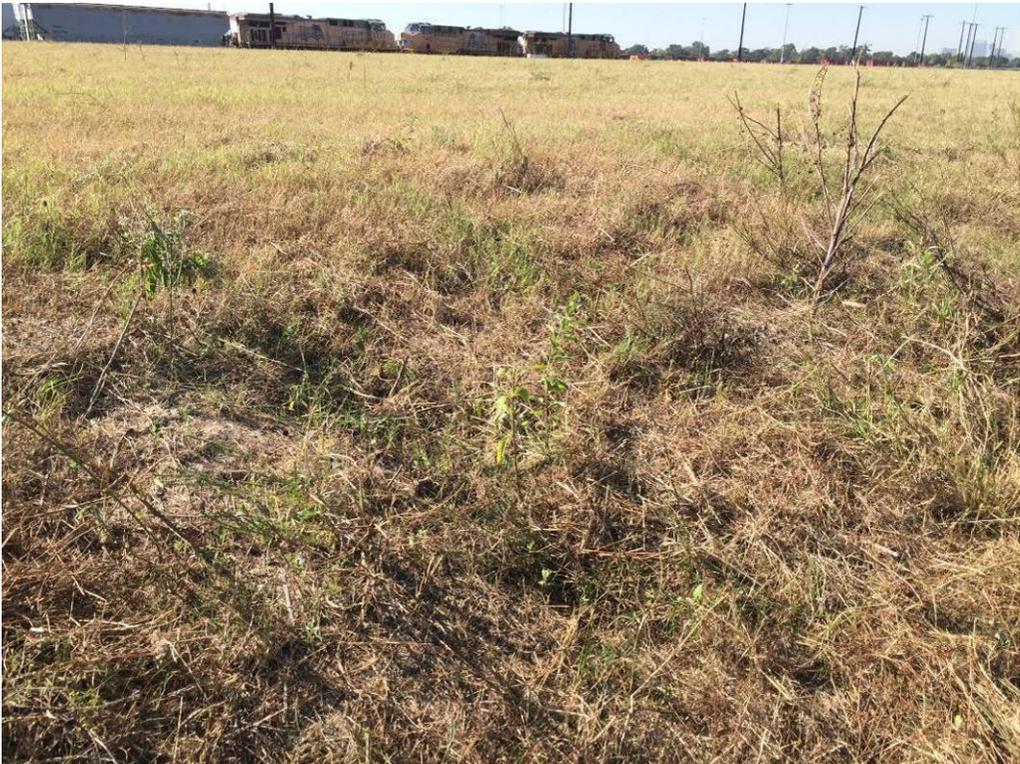
Description: Soil Cap Area: Minor erosion and bare area along northern toe of cap, looking south Lat: 29.78693889, Long: -95.319725

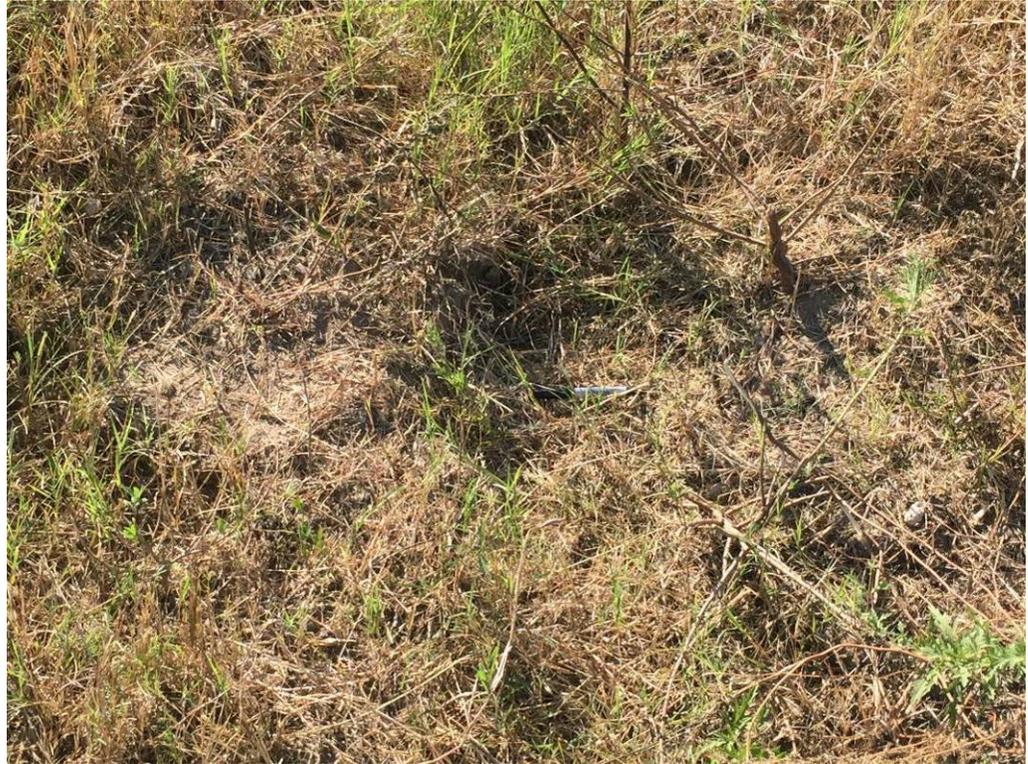
Photo No.
20

Minor bare area and erosion along northern toe of cap. Sharpie for scale

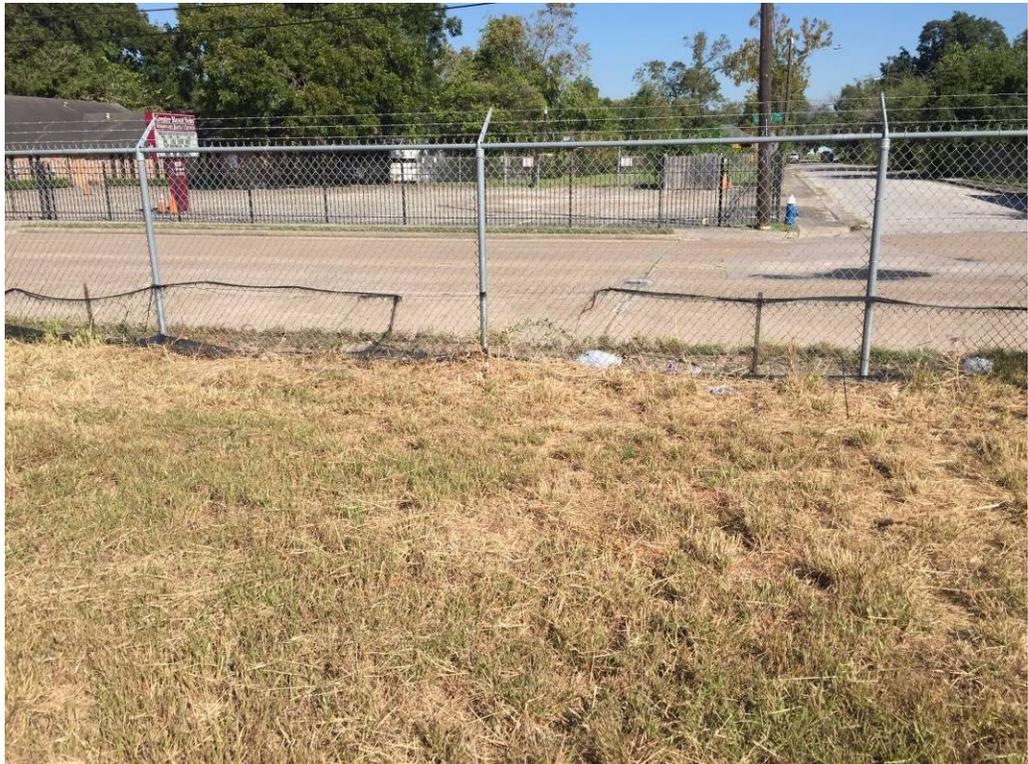
Silt fencing along northern perimeter fence, no longer required with vegetation established, looking north across Liberty Road

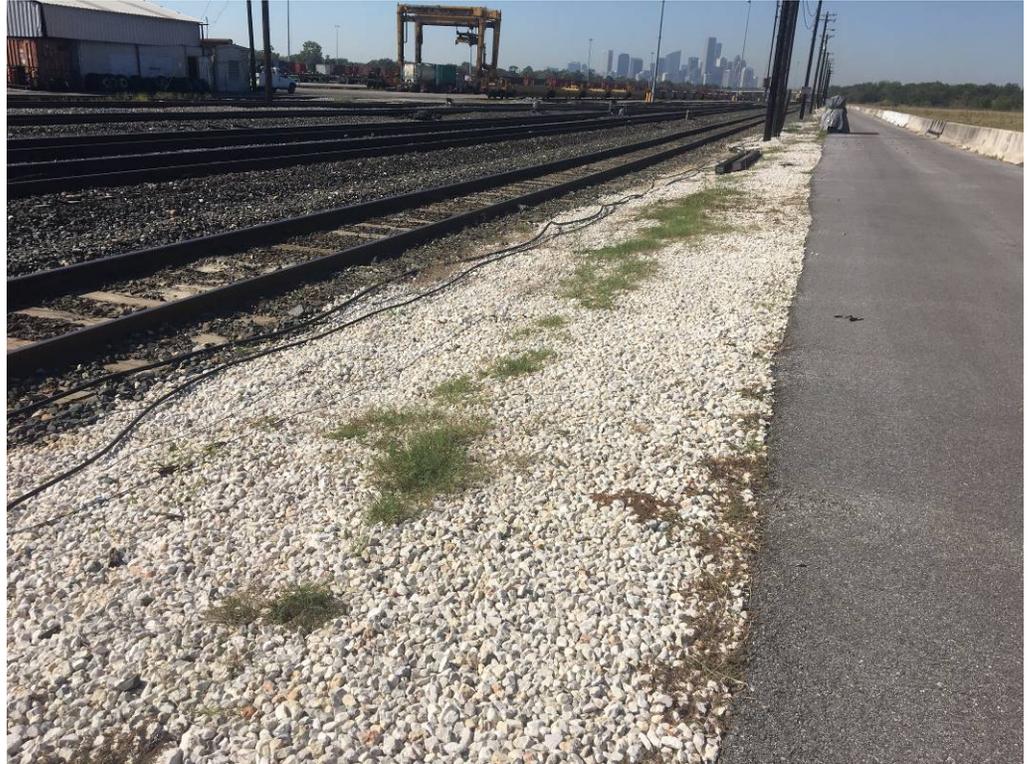
Photo No.
30

Vegetation growing
inside of ballast cap
area.

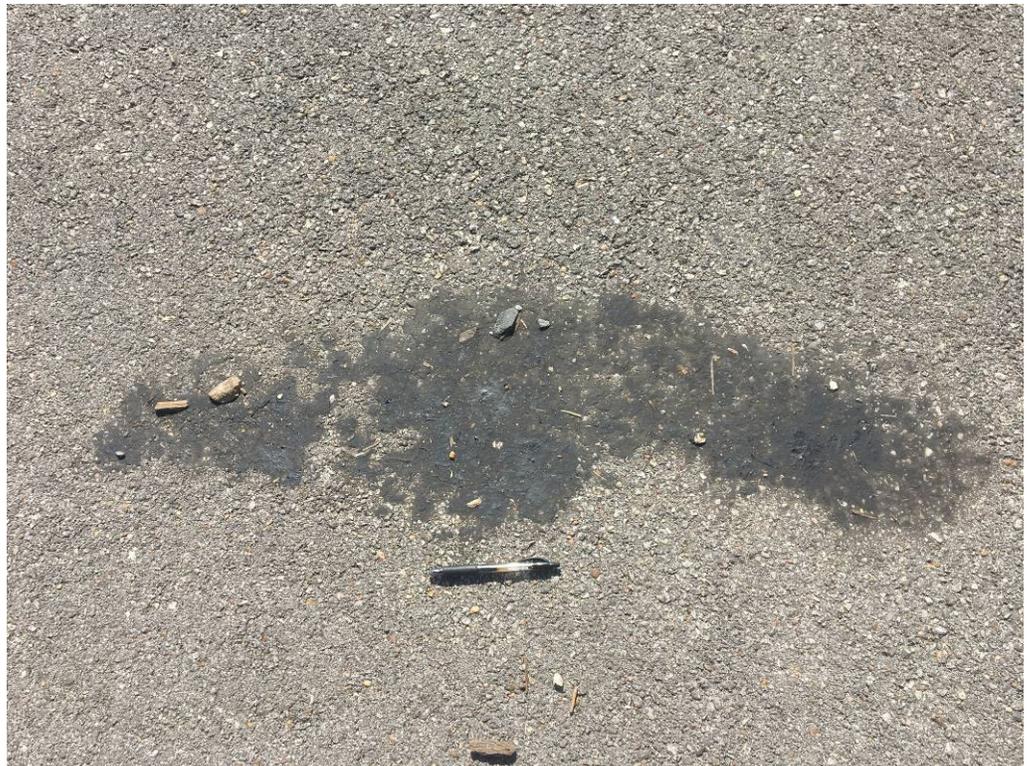
View of asphalt cap
area. Note small oily
stains on pavement
(pen for scale).

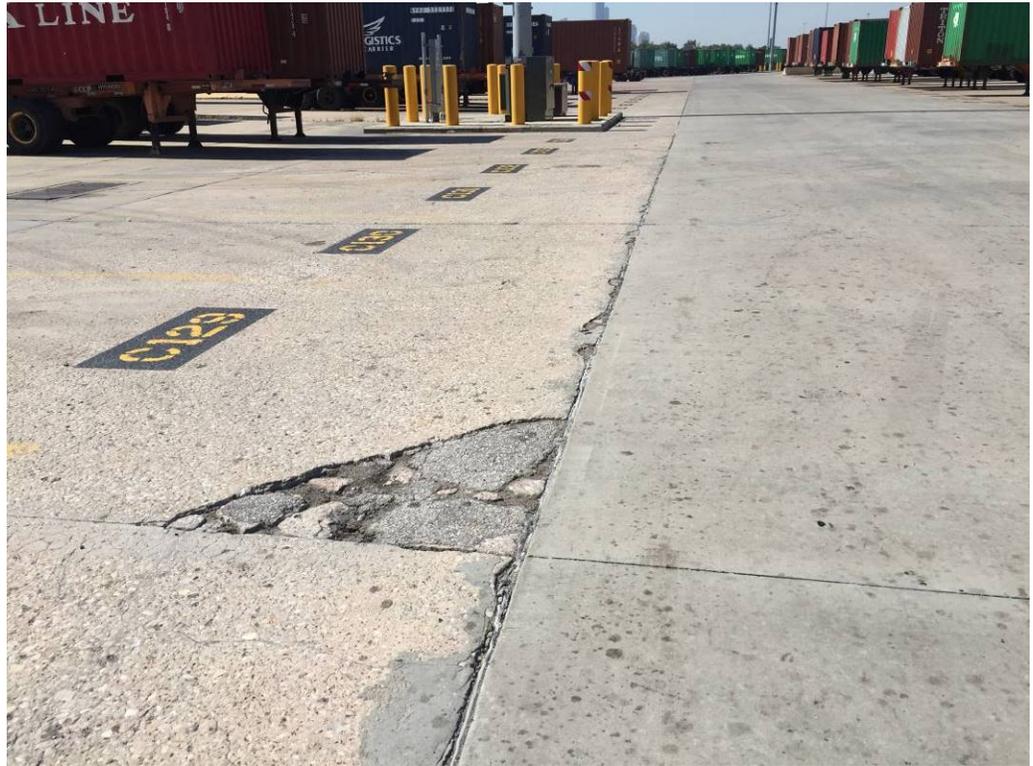
Photo No.
34

Concrete Cap Area:
Concrete cap near parking spot C129, note cracks in concrete but no soil exposed.

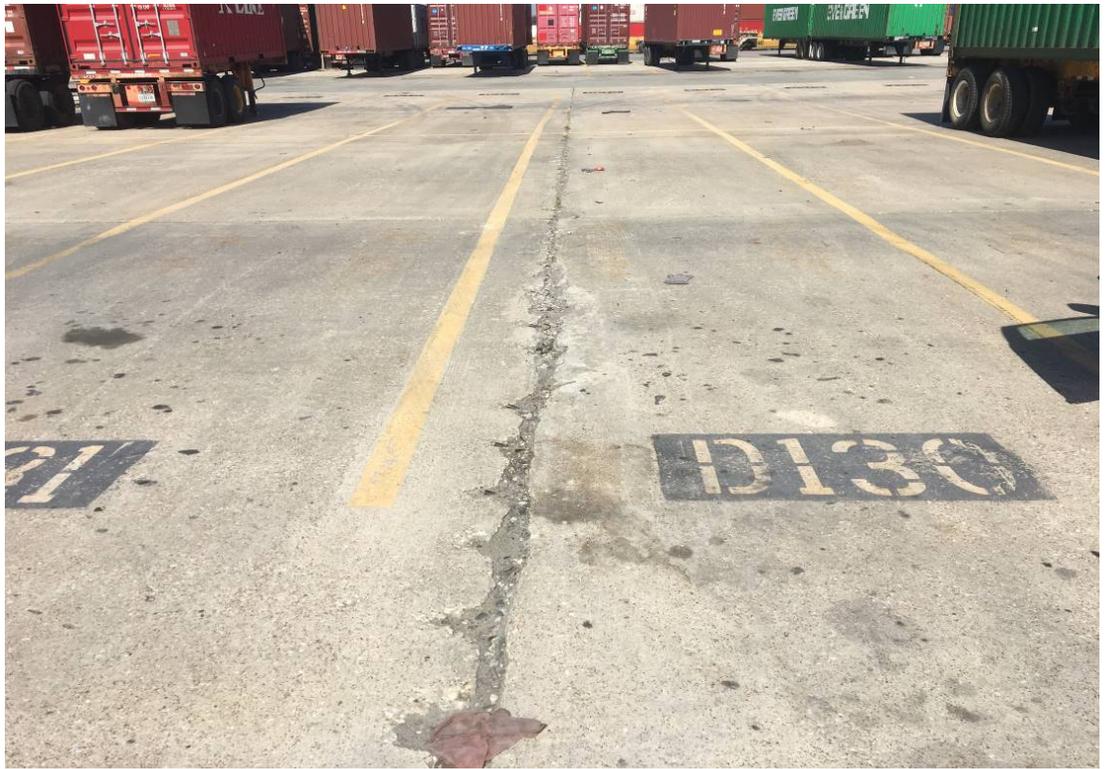
Concrete Cap Area:
Joint damage near D130 but no soil exposed.

Cracking	X		Minor cracking at the west end of the A/B row. See photos
	Joint Damage	X		Some damage along B row and at D130.
Excavated Areas	Surface Damage	X		
	Settlement	X		
	Vegetation Coverage	X		Good vegetation coverage
Container Storage Area	Valve Position (Closed)	X		
	Holding Water	X		No standing water
	Sheen/Floating Solids	X		None

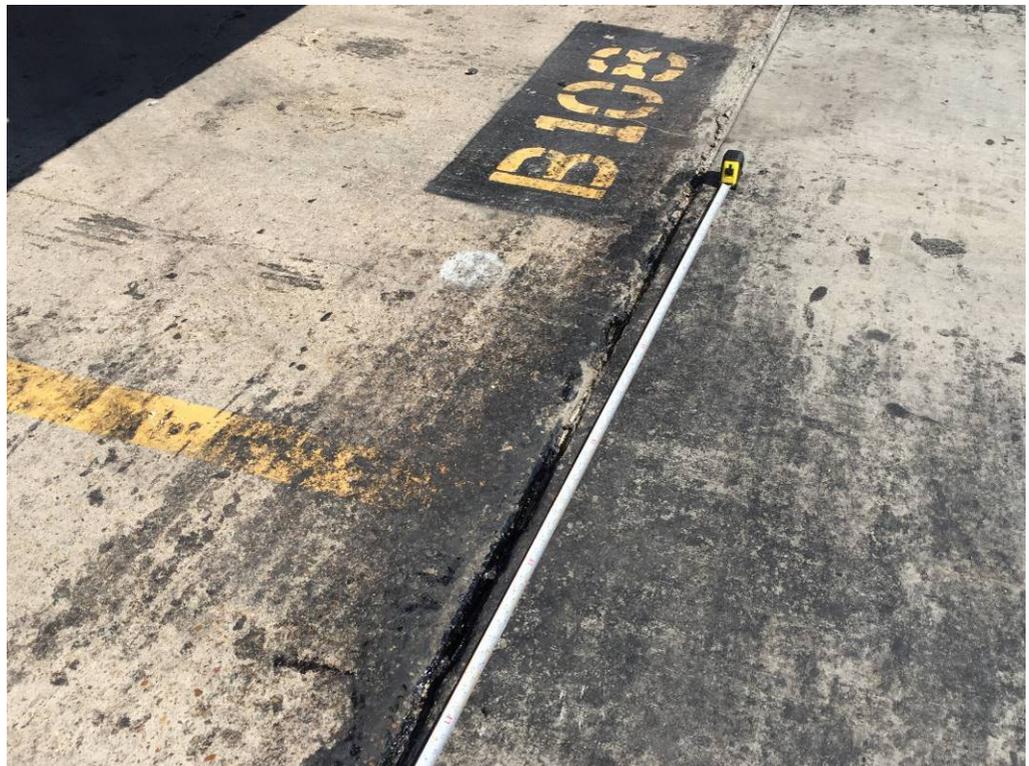
- Concrete Cap (Englewood Intermodal Yard) – Cracks in the pavement were noted, but no soil appeared to be exposed (Photo No. 28 (Lat: 29.78485, Long: -95.31995278)). In the area of parking slots B100 to B109, a tar-like substance was observed surfacing through the joints and cracks in the concrete and asphalt surfaces in the area shown in the attached Figure 1 (Attachment B) (Photo Nos 29 (Lat: 29.78413889, Long: -95.32093056), 30 (Lat: 29.78421667, Long: -95.32085556), and 31(Lat: 29.78422222, Long: -95.32102222)). Since the initial observation of the tar-like substance at the surface, weekly inspections of the affected area have been conducted. The amount of tar which surfaces each week varies. It generally varies in accordance with the ambient temperature (i.e., greater amounts of the tar-like substance surfaces during warm weather). When significant amounts of the tar-like substance surfaces, a remediation contractor (United States Environmental Services (USES)) is notified to mobilize to the Site to remove and properly dispose of the material. To date, USES has conducted four separate removal operations.

Concrete Cap Area:
Tar-like material seeps
near B108, along joint.

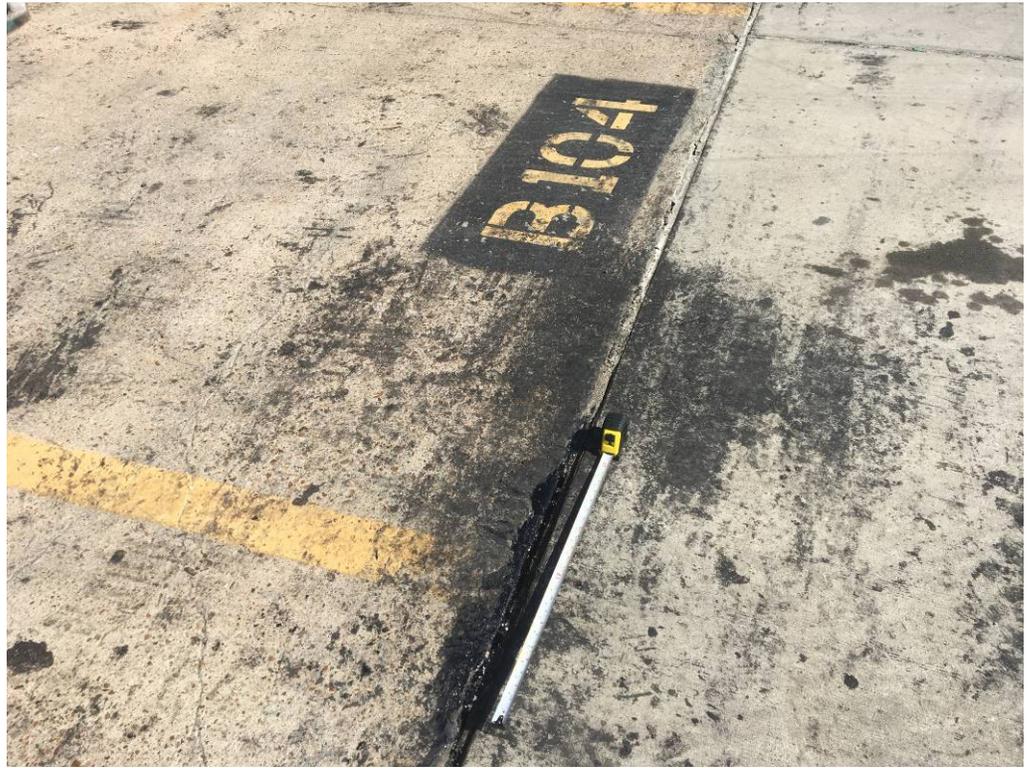
Photo No.
38

Concrete Cap Area:
Tar-like material seeps
near B104, along joint.

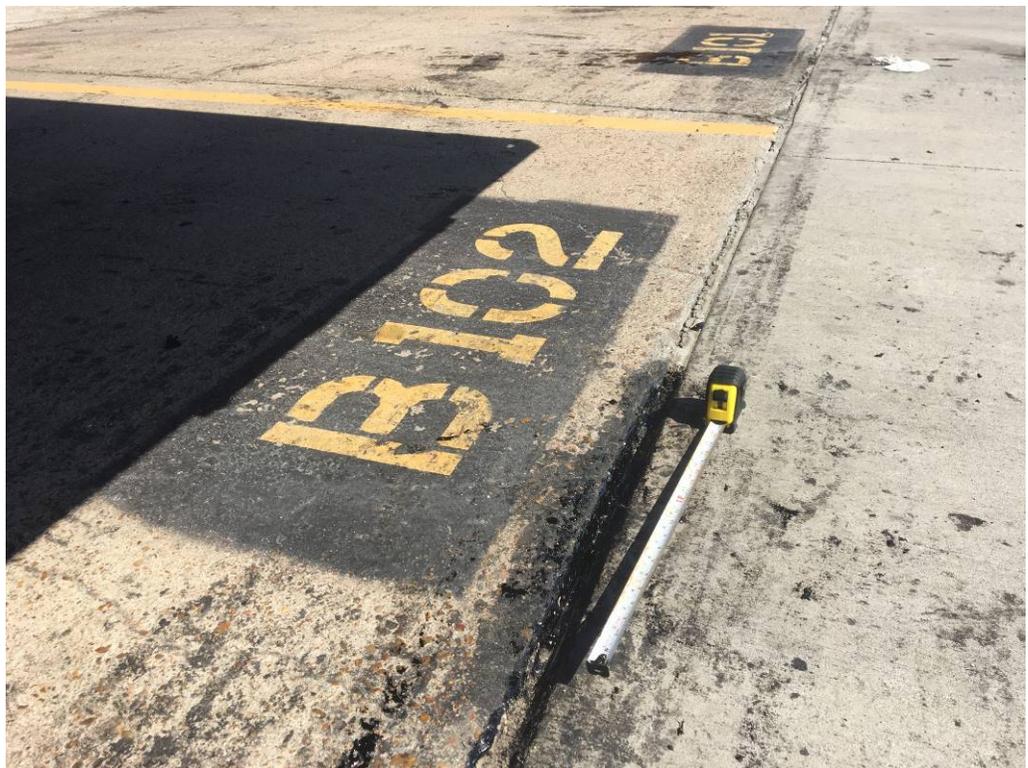
Concrete Cap Area:
Tar-like material seeps
near B102, along joint.

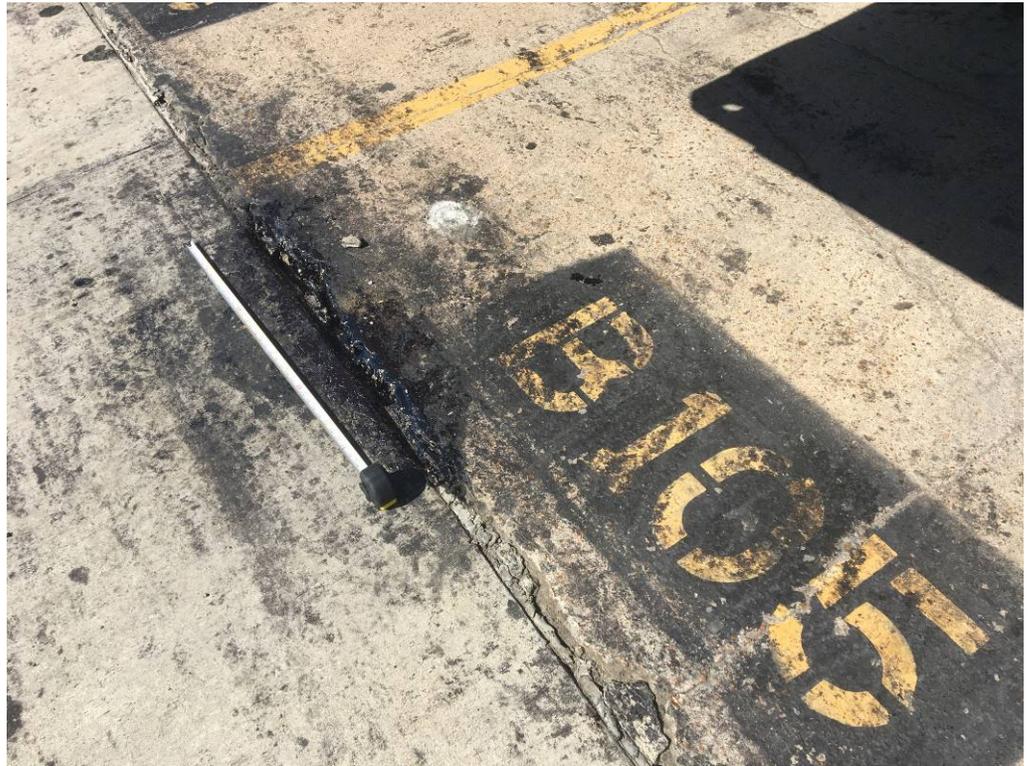
Photo No.
40

Concrete Cap Area:
 Tar-like material seeps
 near B105, along joint.

AREA	ITEM	CONDITIONS		COMMENTS, CORRECTIVE ACTIONS NEEDED, COORECTIVE ACTIONS IMPLEMENTED (WITH DATE)
		Normal	Abnormal	
Soil Cap	Erosion	X		Some erosion at northern the northern toe of the cap, see photos.
	Settlement	X		
	Animal Damage	X		
	Intrusive Shrubs/Trees	X		
	Vegetation Coverage	X		Good overall coverage, some minor bare areas. Prominent bare areas along southern concrete barriers.
	Stressed Vegetation	X		Signs of little recent rainfall.
	Monitoring Wells Condition	X		
Security Fence	Damaged Posts or Wire		X	Two missing posts approximately 150' west of the main entrance.
	Functioning Properly	X		
Asphalt Roadway	Surface Damage	X		
	Settlement	X		
Concrete Sidewalk Cap	Surface Damage	X		
	Cracking	X		
Ballast Cap	Surface Damage	X		
	Signs of Soils	X		
	Intrusive Vegetation		X	Grass and weeds growing through the ballast, see photos.
Concrete Cap (Intermodal Yard)	Surface Damage		X	Tar seeps near B100 - B109 slots, USES called out to scrape up material, see photos.
