September 15, 2022

Project No. 19119232

Re: **MONTHLY STATUS UPDATE – ENGLEWOOD INTERMODAL YARD – NAPL COLLECTION SYSTEM/CONCRETE CAP REPAIRS  
UNION PACIFIC RAILROAD HOUSTON WOOD PRESERVING WORKS FACILITY  
4910 LIBERTY ROAD FACILITY, HOUSTON, TEXAS  
POST-CLOSURE CARE PERMIT NO. HW-50343; INDUSTRIAL SWR NO. 31547**

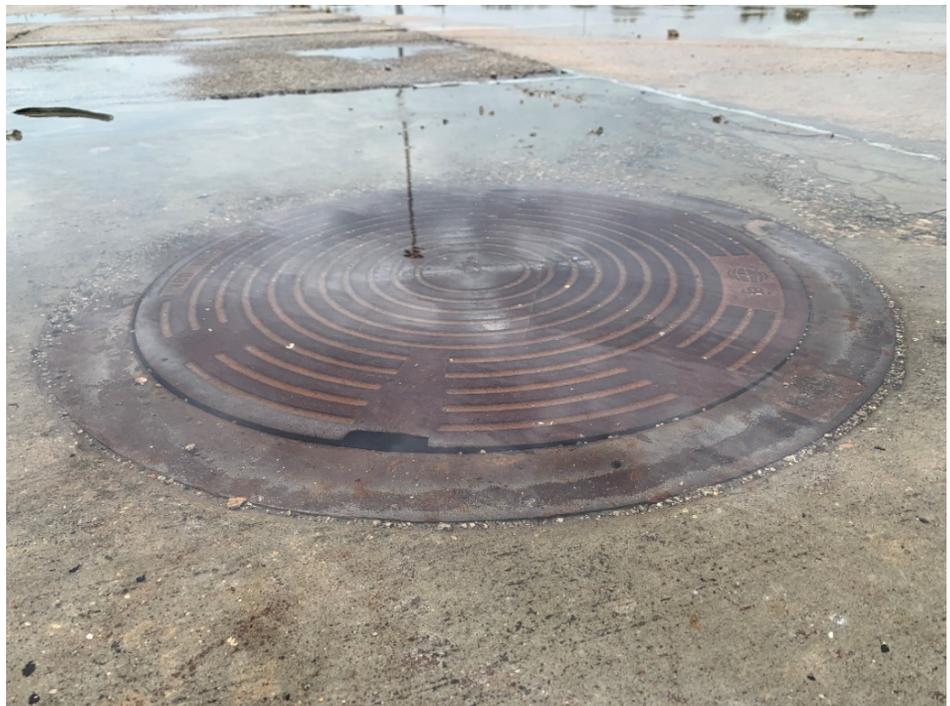
<b>Photo No.</b> <b>29</b>	<b>Inspection Date:</b> 08/24/2022
-------------------------------	---------------------------------------

Sump 1 (B099/B100), 0 inches of freeboard in sump, sump was not opened as it was submerged in water from ongoing rain event.

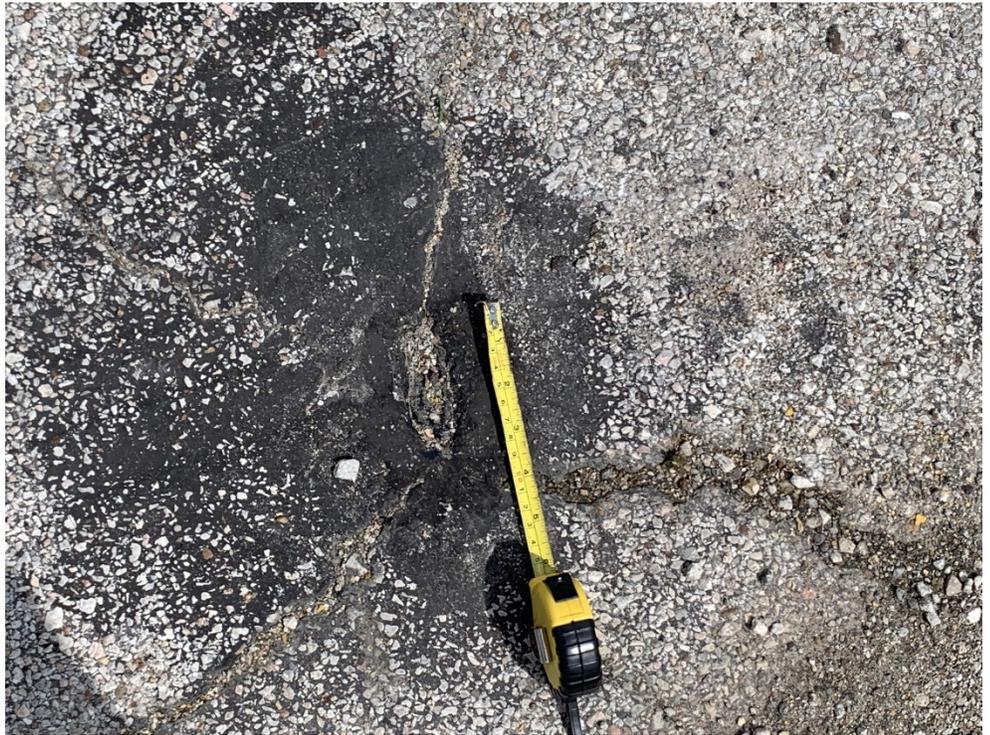
<b>Photo No.</b> <b>36</b>	<b>Inspection Date:</b> 08/31/2022
-------------------------------	---------------------------------------

Stall B105, a very small amount of tar-like material in pavement area, material was removed.
