July 14, 2023

Project No. 31406585.016

**Re: MONTHLY STATUS UPDATE – ENGLEWOOD INTERMODAL YARD – NAPL COLLECTION
SYSTEM/CONCRETE CAP REPAIRS
UNION PACIFIC RAILROAD HOUSTON WOOD PRESERVING WORKS FACILITY
4910 LIBERTY ROAD FACILITY, HOUSTON, TEXAS
POST-CLOSURE CARE PERMIT NO. HW-50343; INDUSTRIAL SWR NO. 31547**

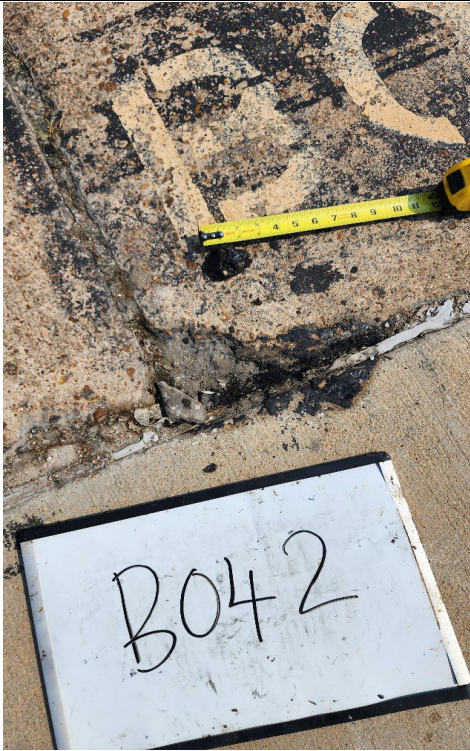
PHOTOGRAPHIC LOG	
Client Name: Union Pacific Railroad		Site Location: Englewood Intermodal Yard, Houston, Texas	Project No. 31406585.016
Photo No. 39	Inspection Date: 6/21/2023	<div> <div> Description: Slot B042, small amount of tar-like material seeping at joint. material was removed. </div> <div> Lat: 29.784926 Long: - 95.319124 </div> </div>
