September 15, 2023

Project No. 31406585.016

**Re: MONTHLY STATUS UPDATE – ENGLEWOOD INTERMODAL YARD – NAPL COLLECTION
SYSTEM/CONCRETE CAP REPAIRS
UNION PACIFIC RAILROAD HOUSTON WOOD PRESERVING WORKS FACILITY
4910 LIBERTY ROAD FACILITY, HOUSTON, TEXAS
POST-CLOSURE CARE PERMIT NO. HW-50343; INDUSTRIAL SWR NO. 31547**

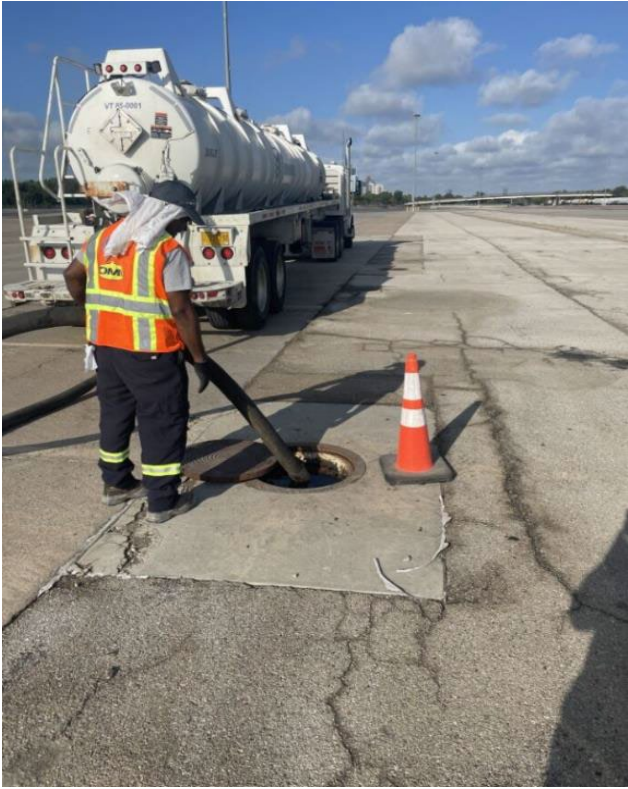
PHOTOGRAPHIC LOG	
Client Name: Union Pacific Railroad		Site Location: Englewood Intermodal Yard, Houston, Texas	
Project No. 31406585.016			
Photo No. 15	Inspection Date: 8/4/2023

Description: OMI environmental cleanup contractor pumping down excess water from sump systems. Lat: 29.784172 Long: -95.320998			
Photo No. 16	Inspection Date: 8/9/2023
