February 14, 2024

Project No. 31406585.016

**Re: MONTHLY STATUS UPDATE – ENGLEWOOD INTERMODAL YARD – NAPL COLLECTION
SYSTEM/CONCRETE CAP REPAIRS
UNION PACIFIC RAILROAD HOUSTON WOOD PRESERVING WORKS FACILITY
4910 LIBERTY ROAD FACILITY, HOUSTON, TEXAS
POST-CLOSURE CARE PERMIT NO. HW-50343; INDUSTRIAL SWR NO. 31547**

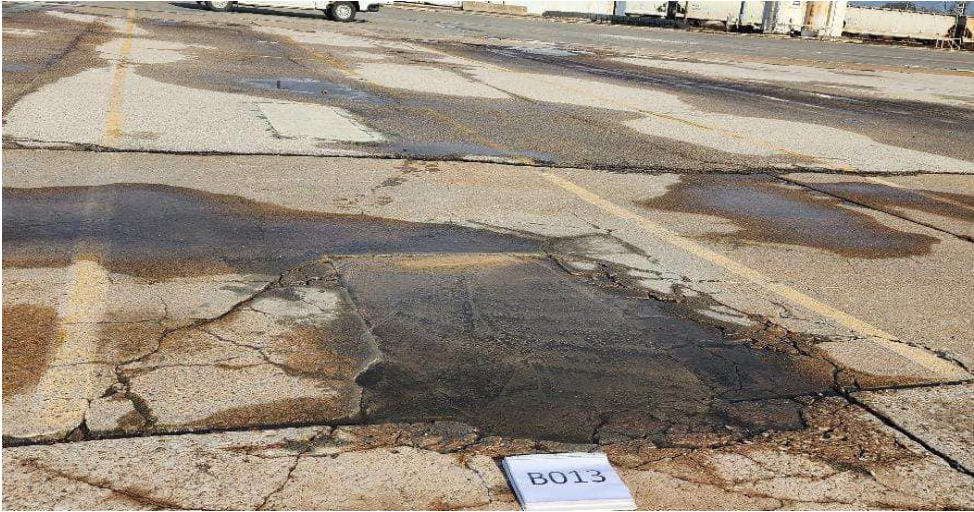
Description: Stall B013. No tar-like material seeps observed at Test Pit B013. Lat: 29.78532 Long:-95.31833			
Photo No. 4	Inspection Date: 1/3/2024

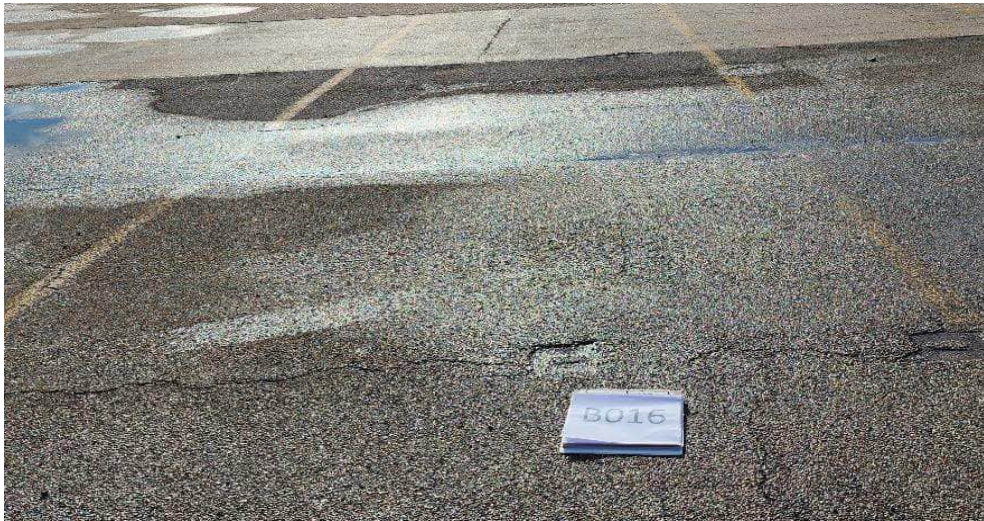
Description: Stall B016. No tar-like material observed at historical seep location along asphalt crack. Lat: 29.785271 Long:-95.31841

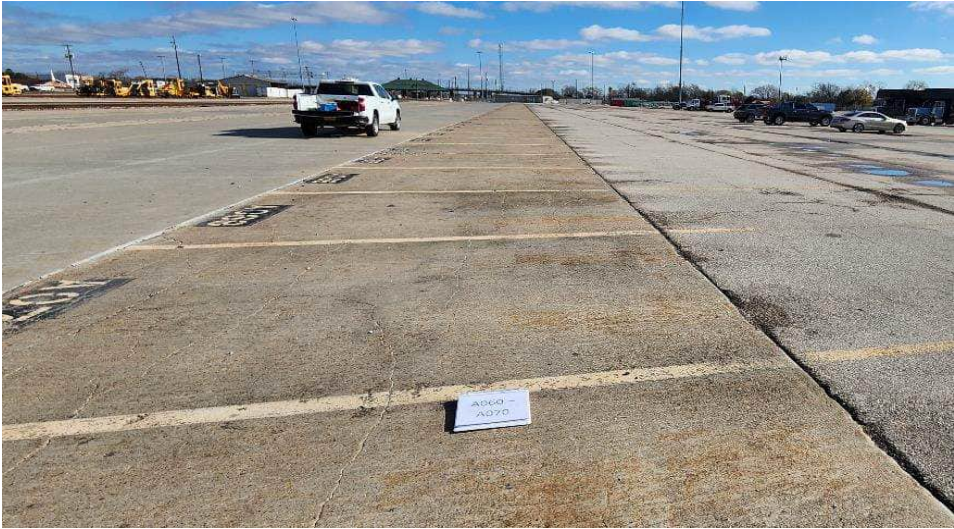
Description: Stalls A060 - A070. Looking southwest. No residual staining observed along cracks in asphalt. Lat: 29.784858 Long: -95.319733

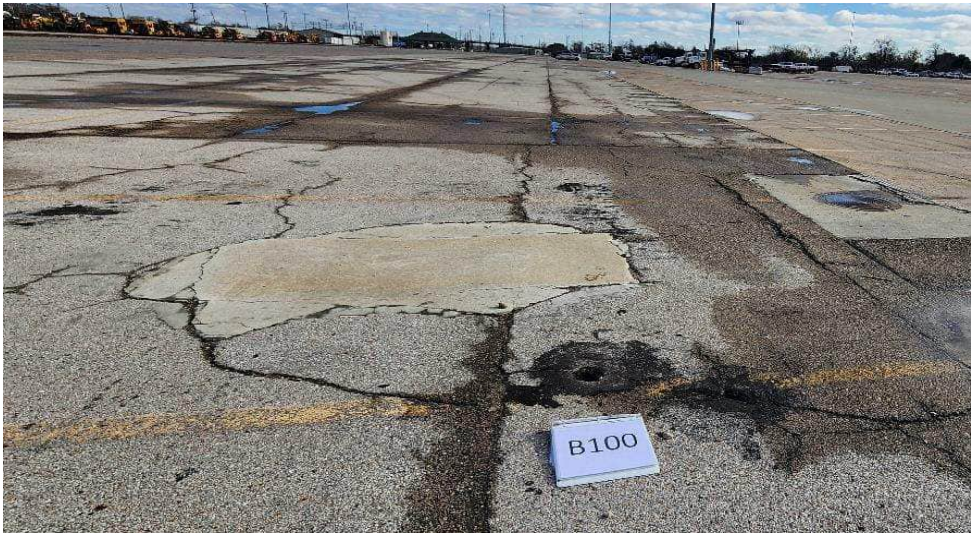
Description: Stall B100, no new tar-like material observed on concrete crack/hole in concrete. Lat: 29.784236 Long: -95.320786

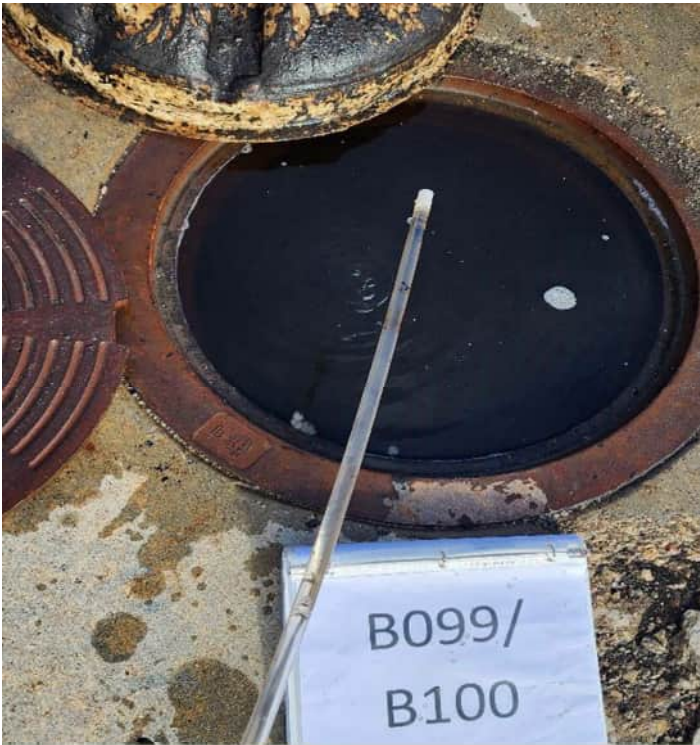
Description: Sump 1 (B099/B100), 0 inches of freeboard in sump, no odor noted, no sheen observed, water color noted as light brown. Lat: 29.7844000 Long: - 95.3205861			
Photo No. 18	Inspection Date: 1/3/2024

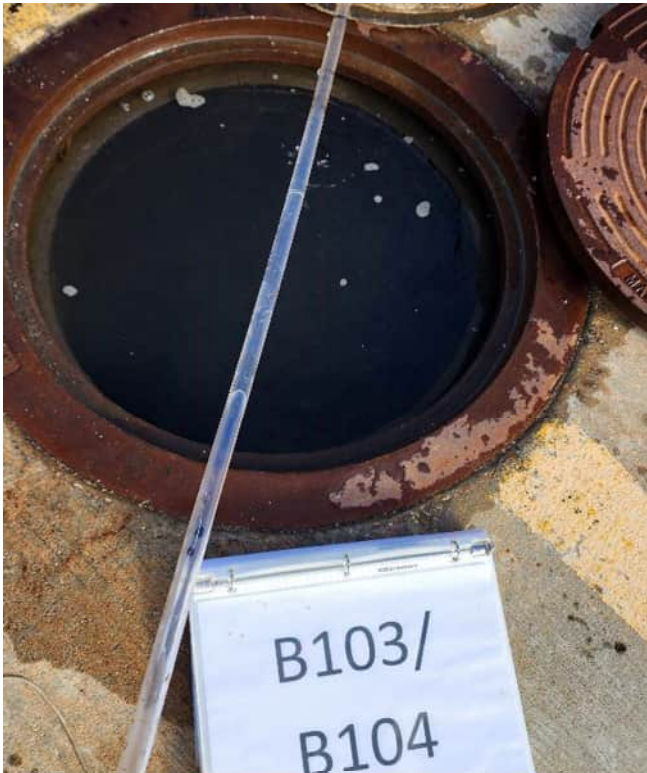
Description: Sump 2 (B103/B104), 0 inches of freeboard in sump. No odor or sheen observed, color noted as clear. Lat: 29.7842861 Long: - 95.3208611

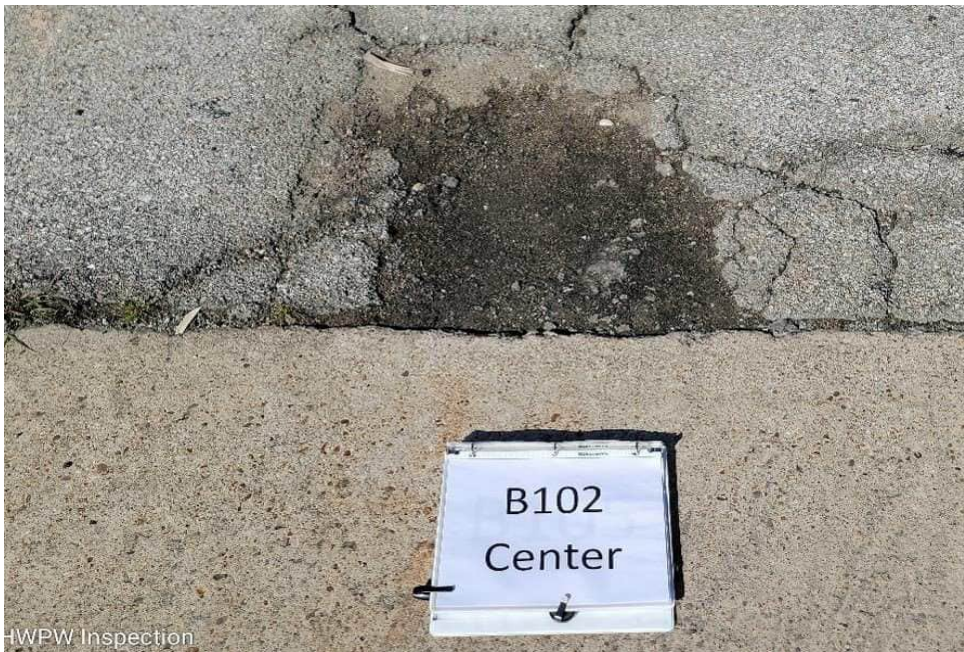
Photo No. 38	Inspection Date: 1/10/2024
Description: Stall B102 (center), no tar-like material observed at seep location along cracks in pavement. Lat: 29.784233 Long: -95.320847

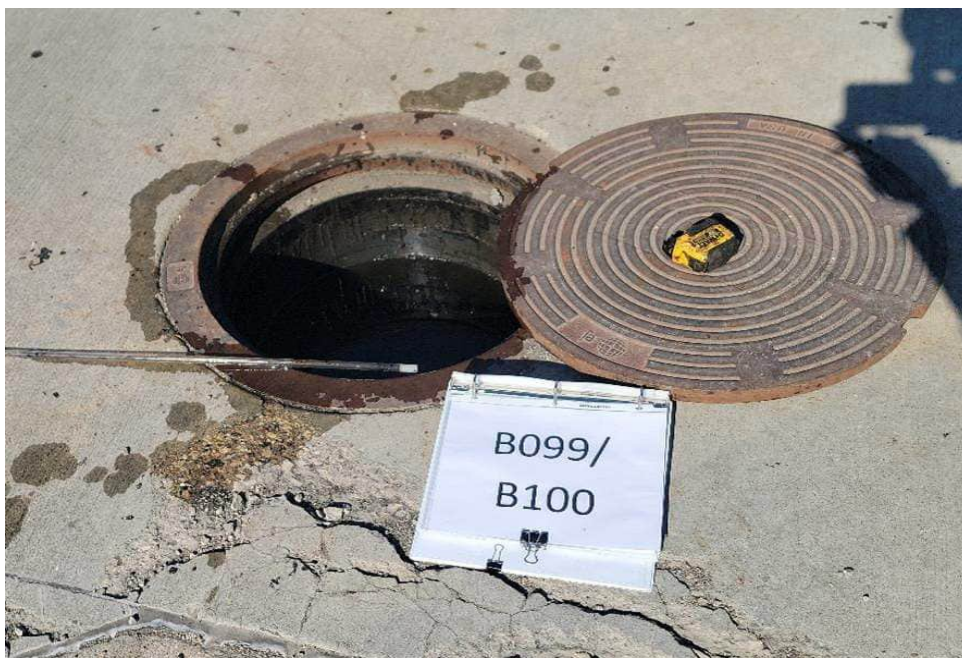
Sump 1 (B099/B100), 12 inches of freeboard in sump, no sheen observed, water color noted as light brown.

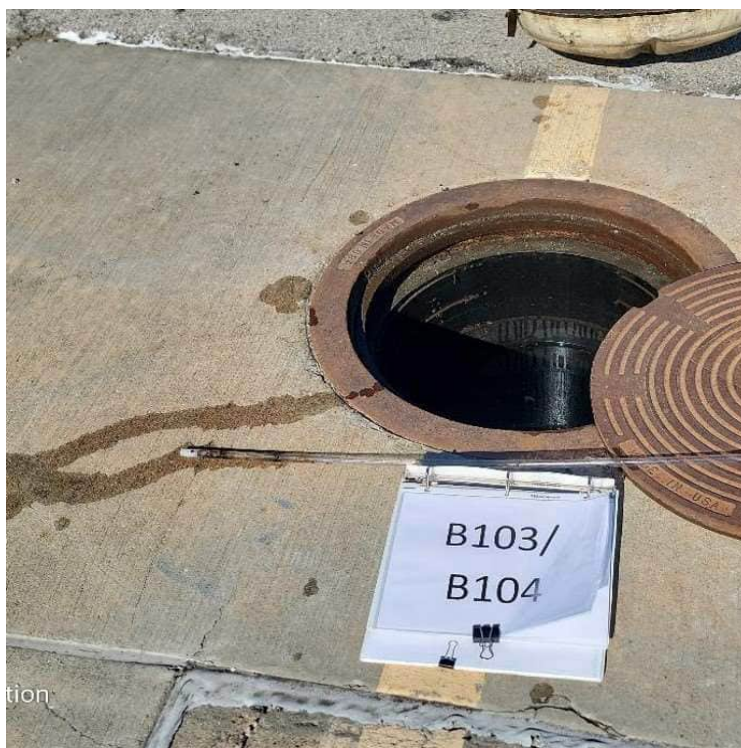
Sump 2 (B103/B104), 15.5 inches of freeboard in sump. No odor or sheen observed, color noted as clear.

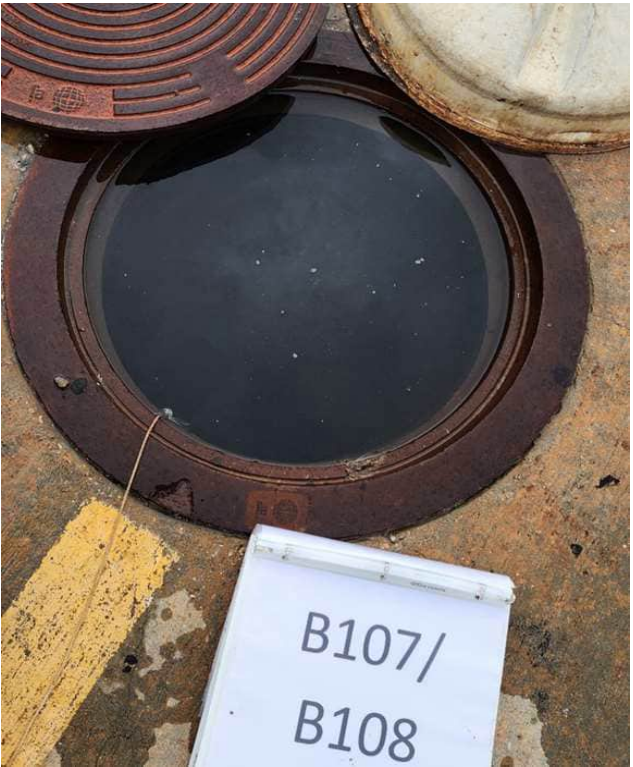
Description: Sump 3 (B107/B108), 0 inches of freeboard in sump, no sheen observed, water color noted as clear. Lat: 29.7844000 Long: - 95.3205861

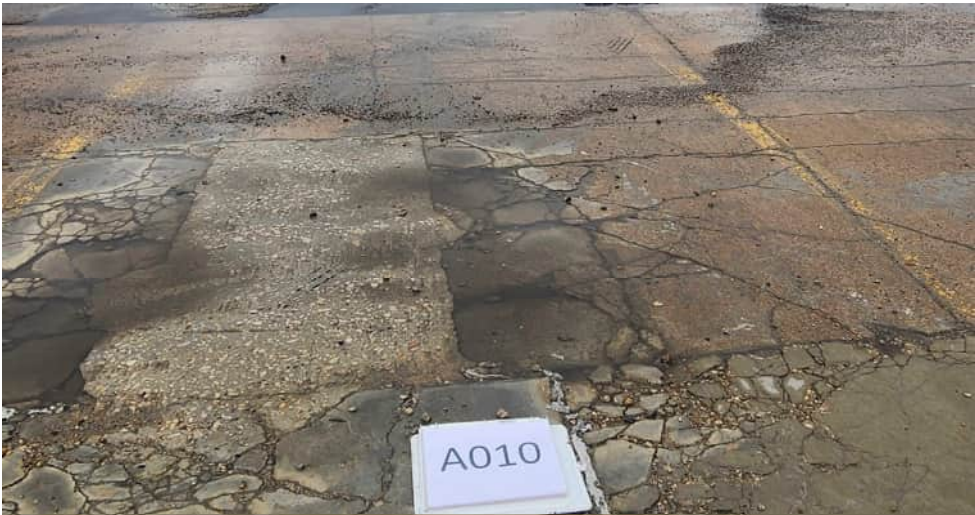
Description: Stall A010. No seeps noted at Test Pit A010. Lat: 29.785517 Long: -95.31834

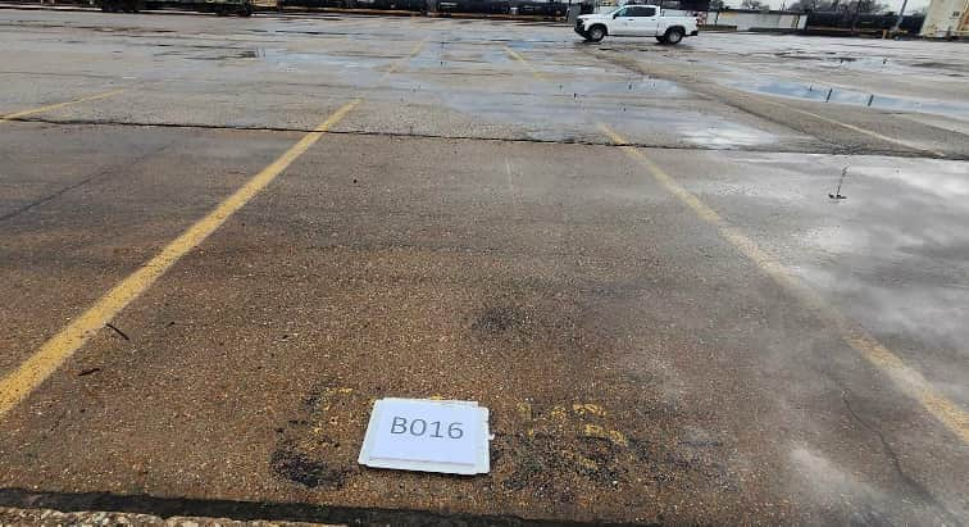
Description: Stall B016. No tar-like material observed at historical seep location along asphalt crack. Lat: 29.785271 Long: -95.31841			
Photo No. 70	Inspection Date: 1/24/2024	 	
Description: Stall A022, no new tar-like material observed at the seep location along the edge. Lat: 29.785381 Long: - 95.318619

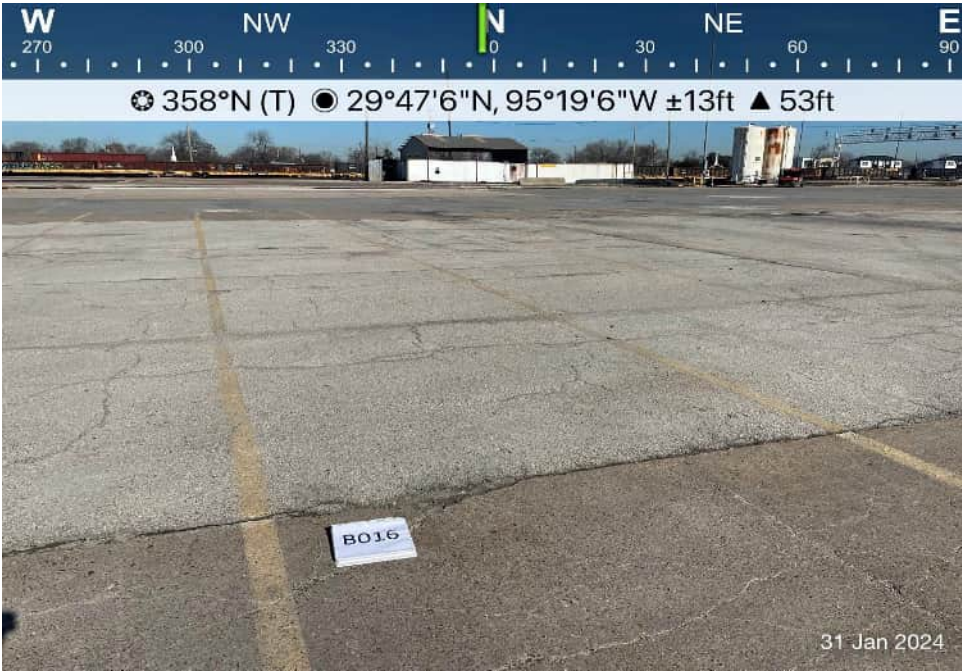
<div style="position: absolute; top: 524px; left: 351px; width: 100%; background-color: black; color: white; padding: 5px;"> <div style="display: flex; justify-content: space-between; font-weight: bold;"> W 270 NW 300 N 330 0 NE 30 E 60 90 </div> <div style="text-align: center; margin-top: 5px;"> ⊗ 358°N (T) ● 29°47'6"N, 95°19'6"W ±13ft ▲ 53ft </div> </div> <div style="position: absolute; bottom: 10px; right: 10px; font-size: small;"> 31 Jan 2024 </div>	
Description: Stall B016. No tar-like material observed at historical seep location along asphalt crack. Lat: 29.785271 Long: -95.31841
