December 16, 2024

Project No. 31406585.016

Re: **MONTHLY STATUS UPDATE – ENGLEWOOD INTERMODAL YARD – NAPL COLLECTION
SYSTEM/CONCRETE CAP REPAIRS AND REVISED INTERIM MEASURES WORK PLAN
CONSTRUCTION ACTIVITIES
UNION PACIFIC RAILROAD HOUSTON WOOD PRESERVING WORKS FACILITY
4910 LIBERTY ROAD FACILITY, HOUSTON, TEXAS
POST-CLOSURE CARE PERMIT NO. HW-50343; INDUSTRIAL SWR NO. 31547**

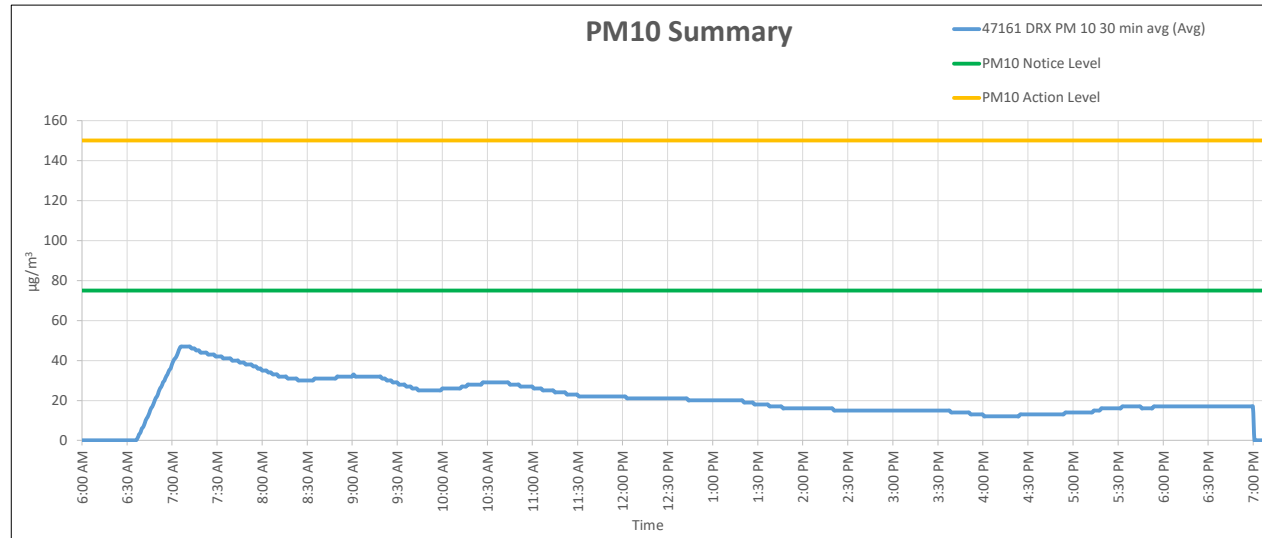
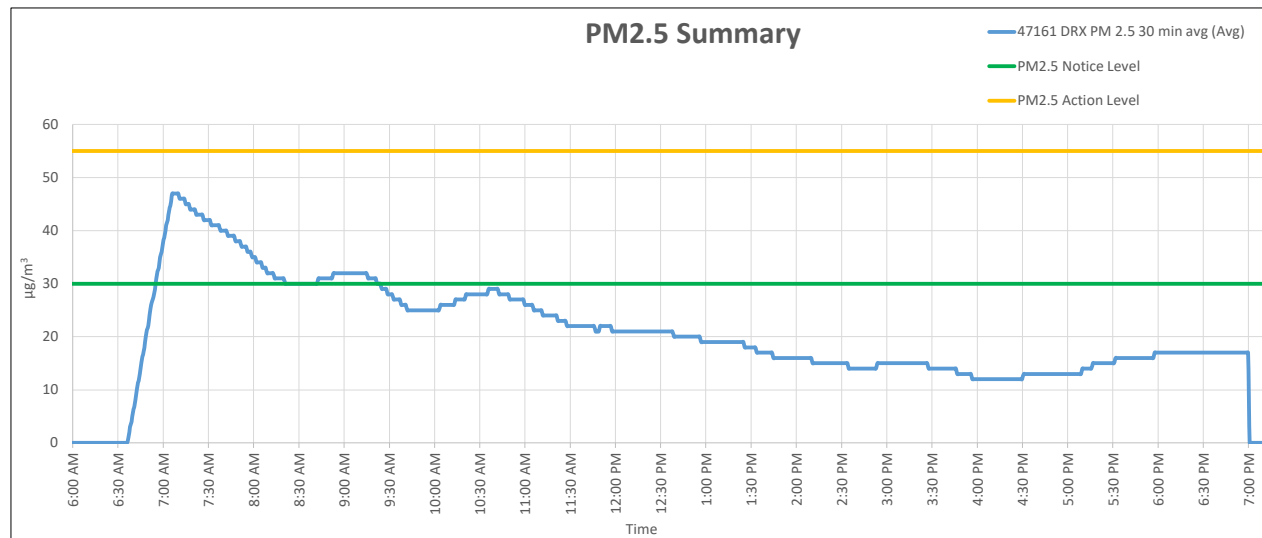
Union Pacific Railroad
Houston Wood Preserving Works Site
Houston Texas
Air Monitoring Values
Monday, November 11, 2024

Monitor Number	Start	Stop	Daily PM ₁₀ Average ($\mu\text{g}/\text{m}^3$)	Daily PM ₁₀ Maximum ($\mu\text{g}/\text{m}^3$)	Daily PM _{2.5} Average ($\mu\text{g}/\text{m}^3$)	Daily PM _{2.5} Maximum ($\mu\text{g}/\text{m}^3$)
47161	6:37 AM	7:00 PM	22.17	47.00	21.85	47.00

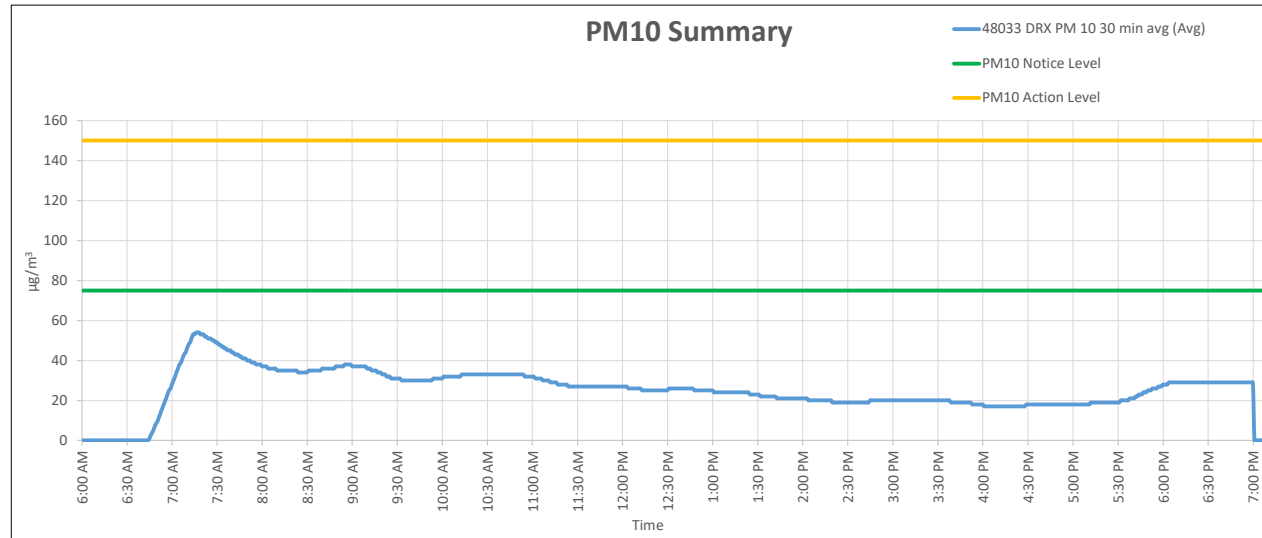
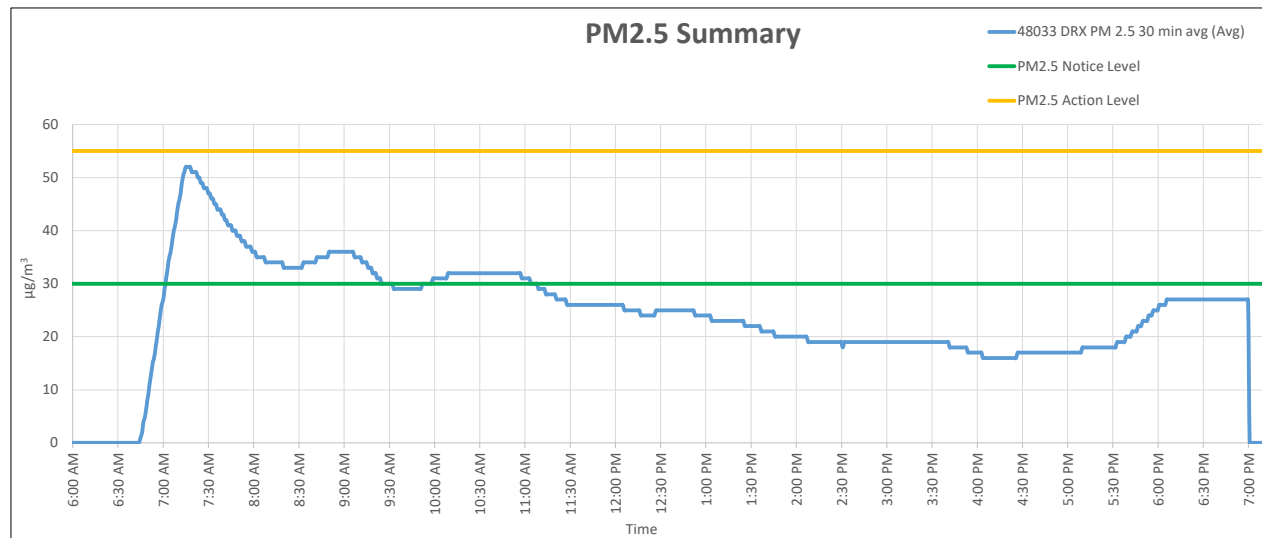
Union Pacific Railroad
Houston Wood Preserving Works Site
Houston Texas
Air Monitoring Values
Monday, November 11, 2024

Monitor Number	Start	Stop	Daily PM ₁₀ Average ($\mu\text{g}/\text{m}^3$)	Daily PM ₁₀ Maximum ($\mu\text{g}/\text{m}^3$)	Daily PM _{2.5} Average ($\mu\text{g}/\text{m}^3$)	Daily PM _{2.5} Maximum ($\mu\text{g}/\text{m}^3$)
48033	6:45 AM	7:00 PM	27.06	54.00	26.00	52.00

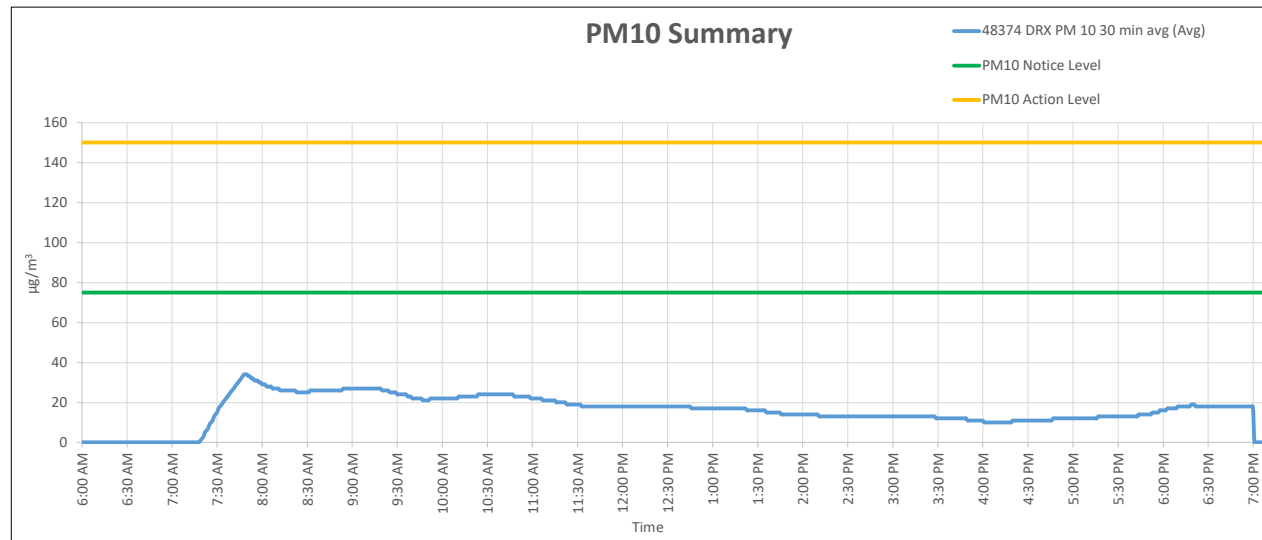
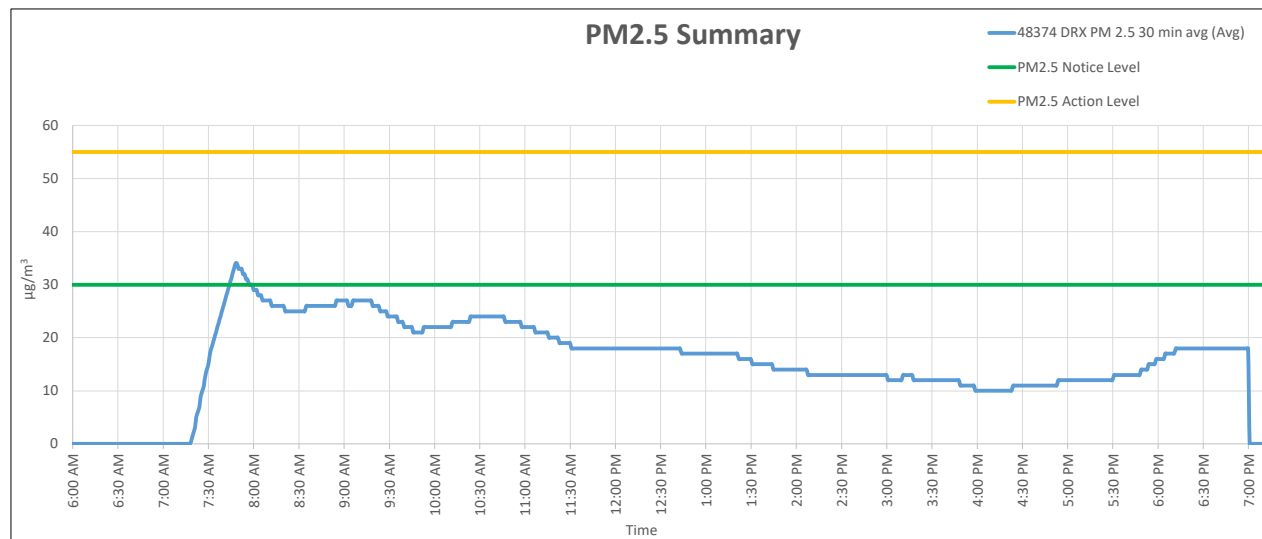
Union Pacific Railroad
Houston Wood Preserving Works Site
Houston Texas
Air Monitoring Values
Monday, November 11, 2024

Monitor Number	Start	Stop	Daily PM ₁₀ Average ($\mu\text{g}/\text{m}^3$)	Daily PM ₁₀ Maximum ($\mu\text{g}/\text{m}^3$)	Daily PM _{2.5} Average ($\mu\text{g}/\text{m}^3$)	Daily PM _{2.5} Maximum ($\mu\text{g}/\text{m}^3$)
48374	7:19 AM	7:00 PM	17.91	34.00	17.77	34.00

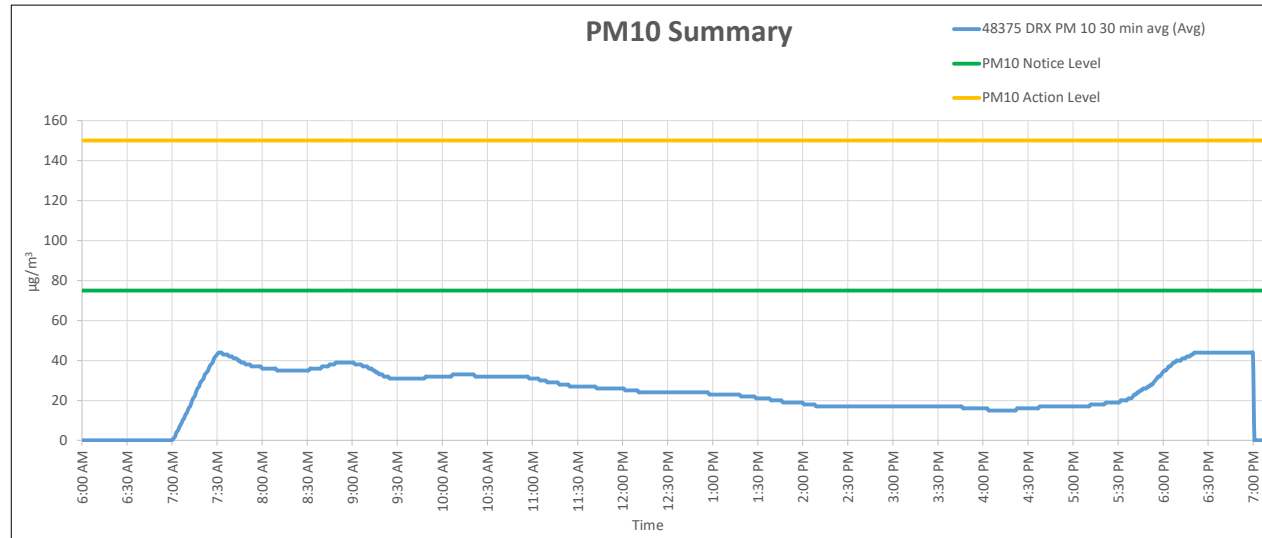
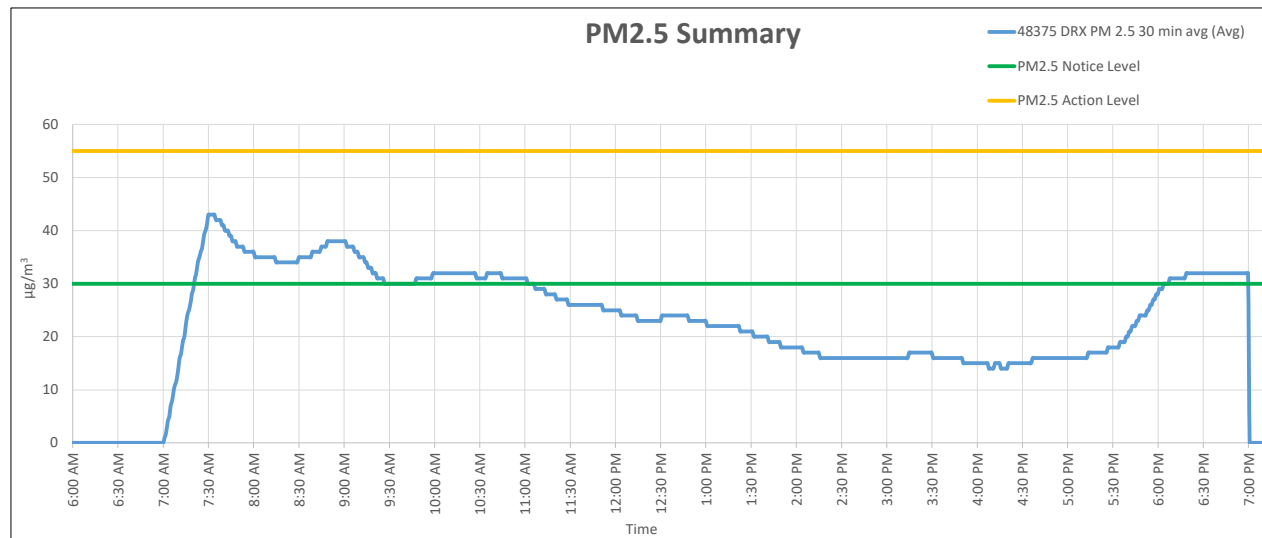
Union Pacific Railroad
Houston Wood Preserving Works Site
Houston Texas
Air Monitoring Values
Monday, November 11, 2024

Monitor Number	Start	Stop	Daily PM ₁₀ Average ($\mu\text{g}/\text{m}^3$)	Daily PM ₁₀ Maximum ($\mu\text{g}/\text{m}^3$)	Daily PM _{2.5} Average ($\mu\text{g}/\text{m}^3$)	Daily PM _{2.5} Maximum ($\mu\text{g}/\text{m}^3$)
48375	7:01 AM	7:00 PM	26.65	44.00	24.97	43.00

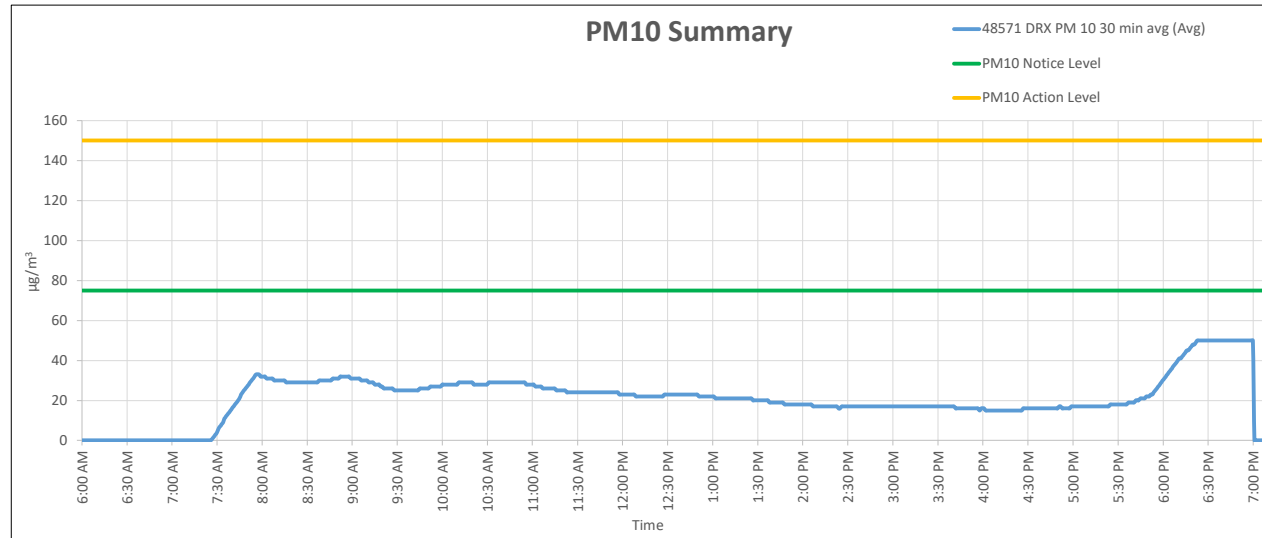
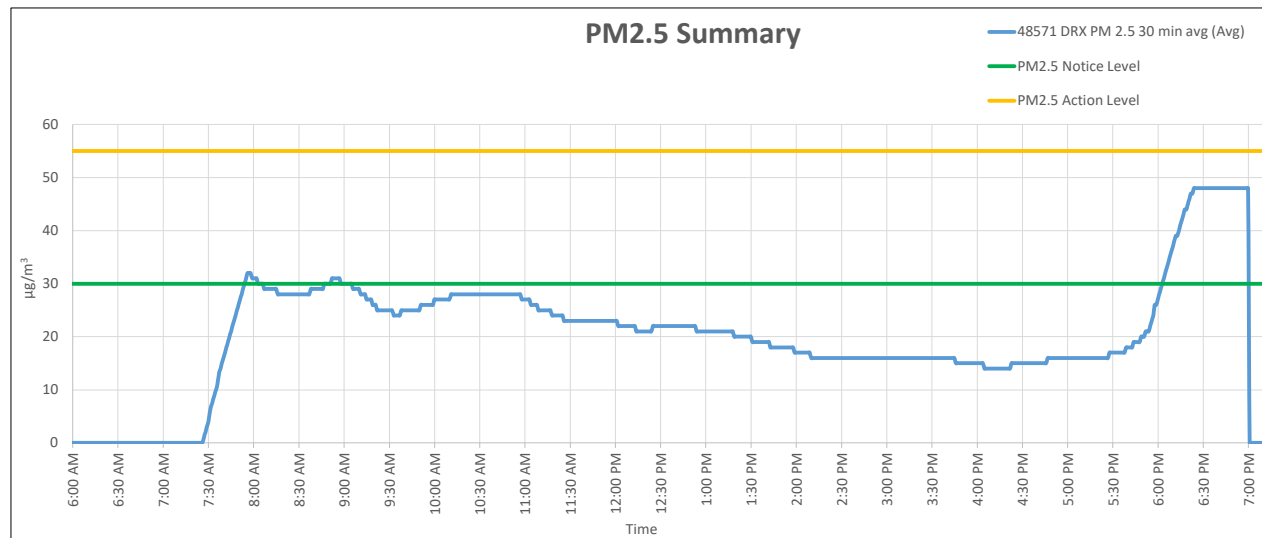
Union Pacific Railroad
Houston Wood Preserving Works Site
Houston Texas
Air Monitoring Values
Monday, November 11, 2024

Monitor Number	Start	Stop	Daily PM ₁₀ Average ($\mu\text{g}/\text{m}^3$)	Daily PM ₁₀ Maximum ($\mu\text{g}/\text{m}^3$)	Daily PM _{2.5} Average ($\mu\text{g}/\text{m}^3$)	Daily PM _{2.5} Maximum ($\mu\text{g}/\text{m}^3$)
48571	7:27 AM	7:00 PM	24.12	50.00	23.15	48.00

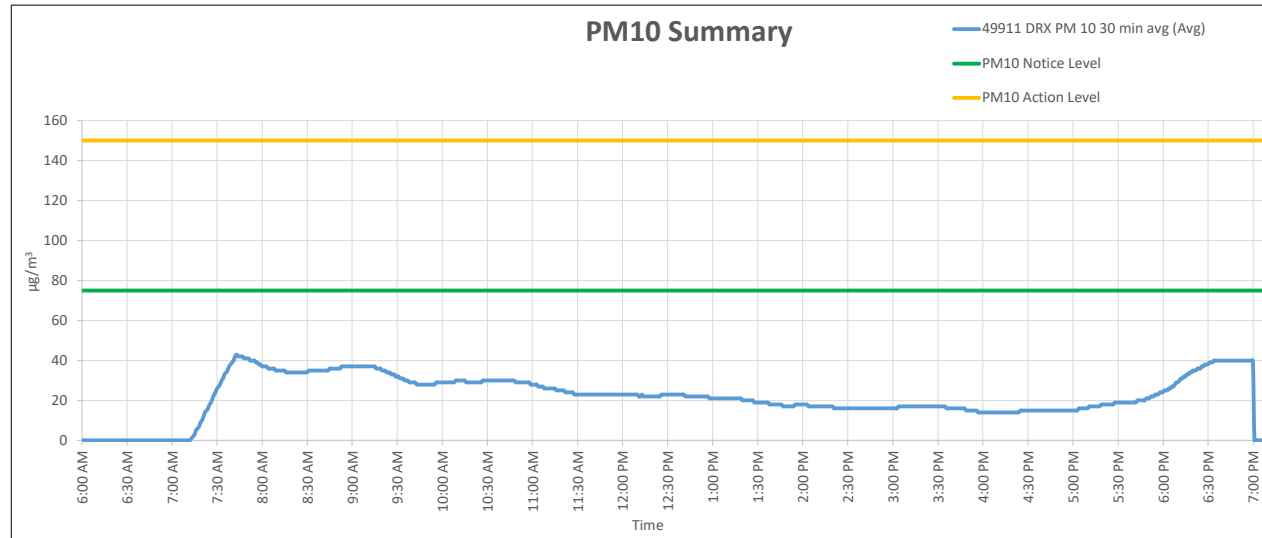
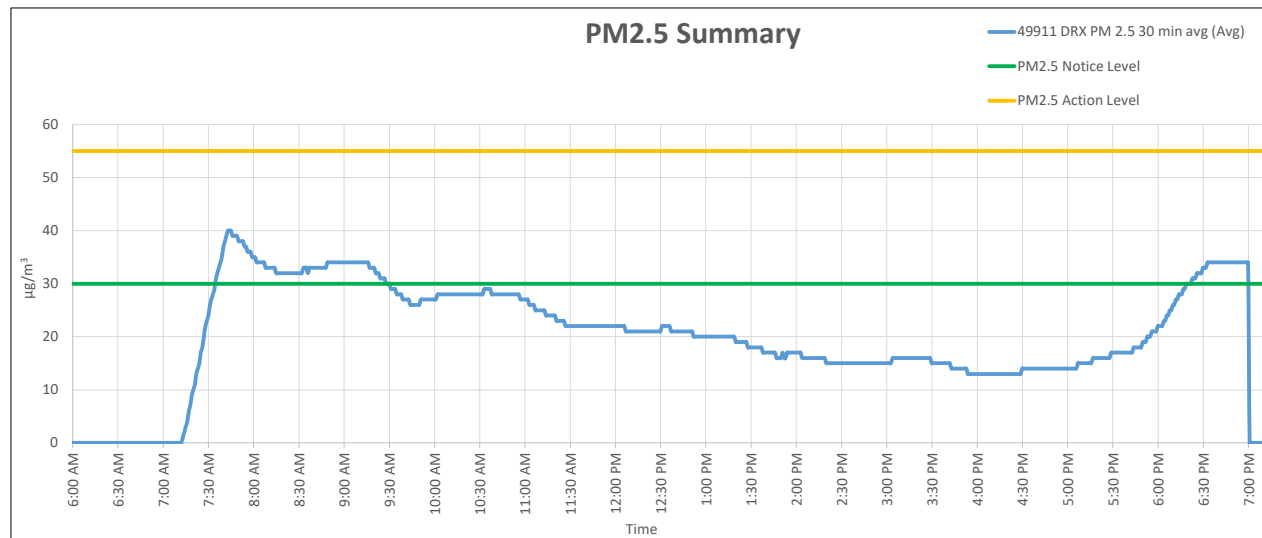
Union Pacific Railroad
Houston Wood Preserving Works Site
Houston Texas
Air Monitoring Values
Monday, November 11, 2024

Monitor Number	Start	Stop	Daily PM ₁₀ Average ($\mu\text{g}/\text{m}^3$)	Daily PM ₁₀ Maximum ($\mu\text{g}/\text{m}^3$)	Daily PM _{2.5} Average ($\mu\text{g}/\text{m}^3$)	Daily PM _{2.5} Maximum ($\mu\text{g}/\text{m}^3$)
49911	7:13 AM	7:00 PM	24.39	43.00	22.59	40.00
