January 15, 2025

Project No. 31406585.016

Re: MONTHLY STATUS UPDATE – ENGLEWOOD INTERMODAL YARD – NAPL COLLECTION SYSTEM/CONCRETE CAP REPAIRS AND REVISED INTERIM MEASURES WORK PLAN CONSTRUCTION ACTIVITIES UNION PACIFIC RAILROAD HOUSTON WOOD PRESERVING WORKS FACILITY 4910 LIBERTY ROAD FACILITY, HOUSTON, TEXAS POST-CLOSURE CARE PERMIT NO. HW-50343; INDUSTRIAL SWR NO. 31547

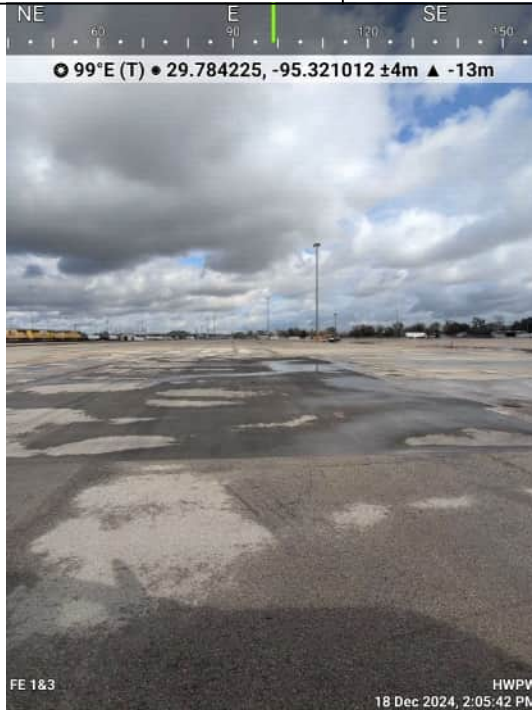
Photo No. 29	Inspection Date: 12/18/2024
Description: FE-1&3 weekly inspection of asphalt cap. No NAPL observed at joints.	
Lat: 29.784225 Long: -95.321012

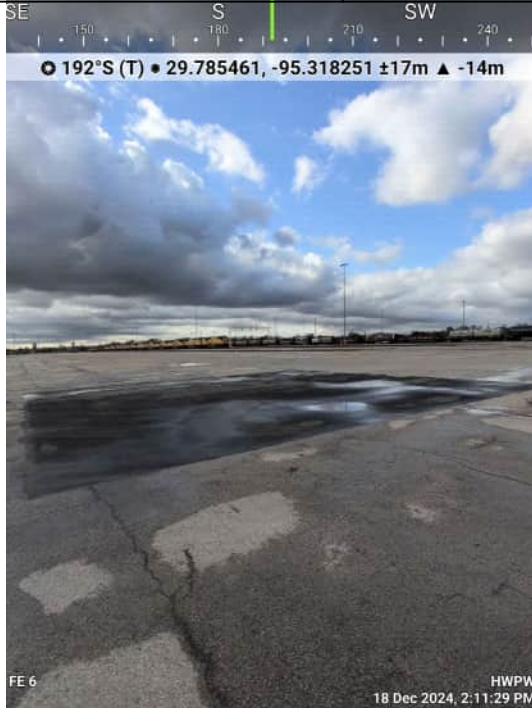
Photo No. 33	Inspection Date: 12/18/2024
Description: FE-6 weekly inspection of asphalt cap. No NAPL observed at joints.	
Lat: 29.785461 Long: -95.318251

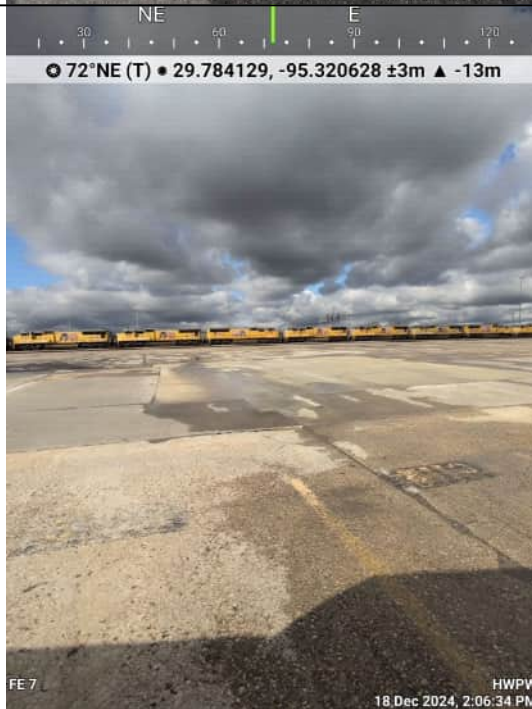
Photo No. 34	Inspection Date: 12/18/2024
Description: FE-7 weekly inspection of concrete cap. No NAPL observed at joints.	
Lat: 29.784129 Long: -95.320628

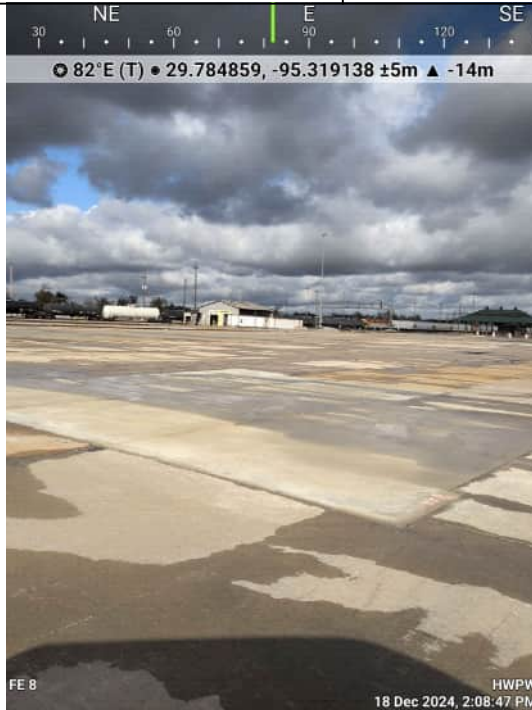
Photo No. 35	Inspection Date: 12/18/2024
Description: FE-8 weekly inspection of concrete cap. No NAPL observed at joints.	
Lat: 29.784859 Long: -95.319138

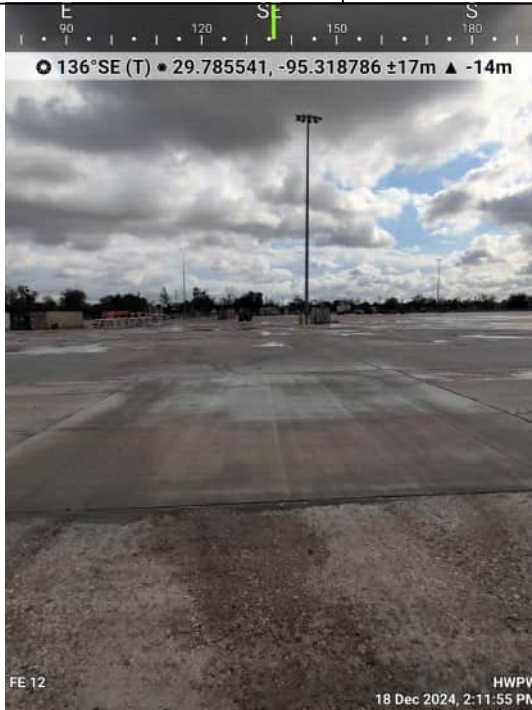
Photo No. 39	Inspection Date: 12/18/2024
Description: FE-12 weekly inspection of concrete cap. No NAPL observed at joints. Lat: 29.785541 Long: -95.318786

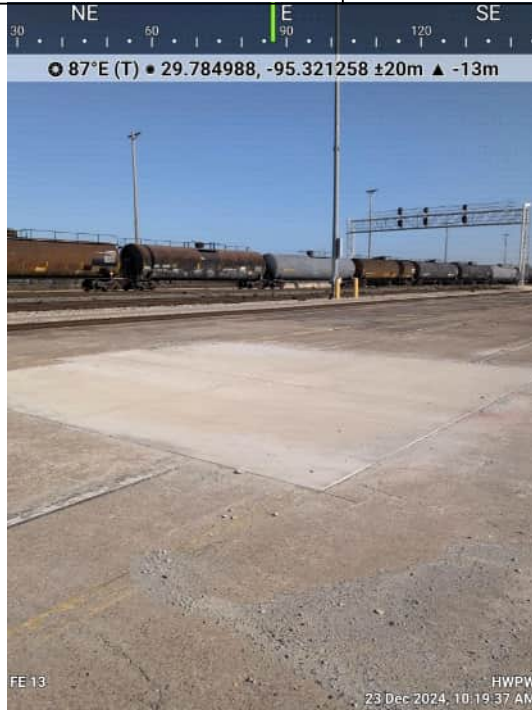
Description:
FE-13 weekly inspection of concrete cap. No NAPL observed at joints.

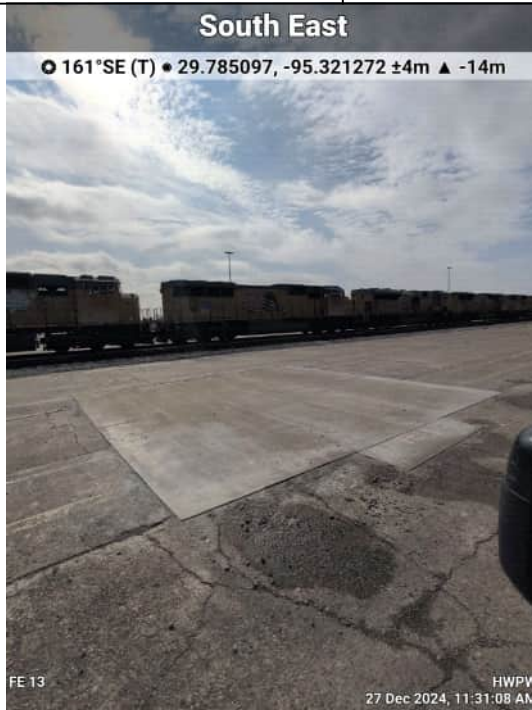
Description:
FE-13 weekly inspection of concrete cap. No NAPL observed at joints.

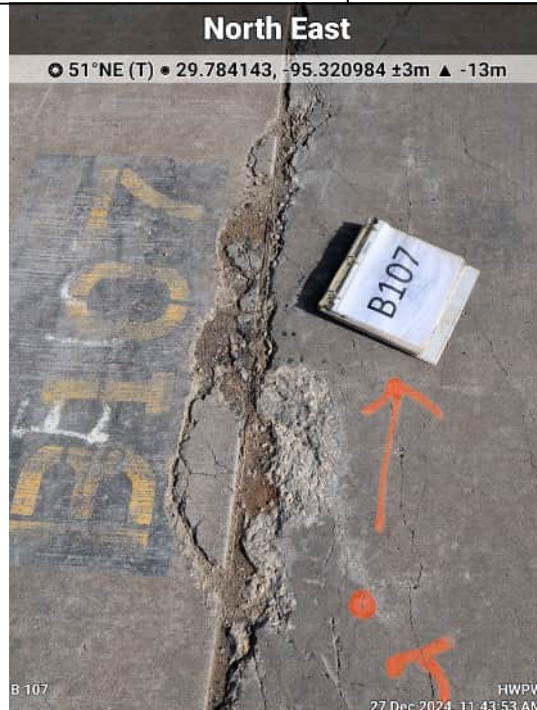
Joint B-107 weekly inspection. No NAPL observed at joints.

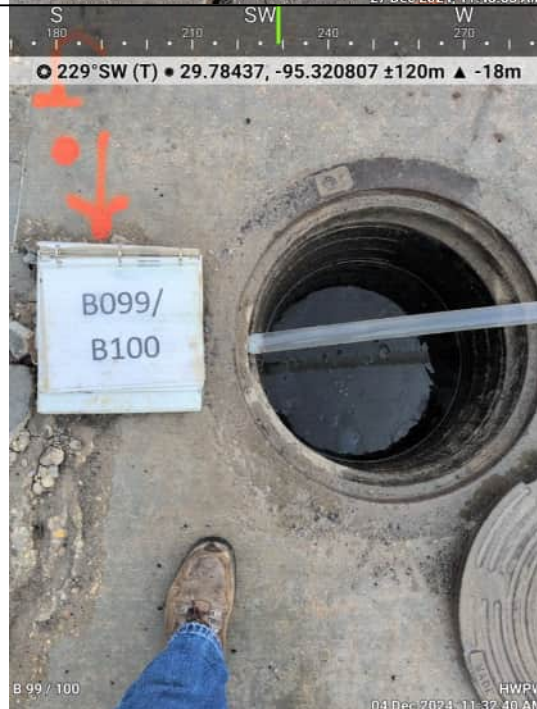
70

Sump 1 (B99/B100), 10.0 inches of freeboard in sump. Color is clear, and no odor observed. Sheen observed on the surface.

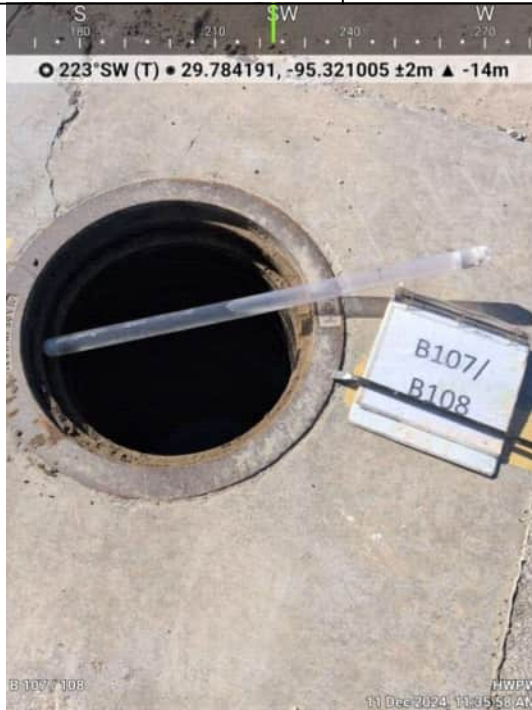
Description:
Sump 3 (B107/B108), 26.0 inches of freeboard in sump. Color is clear, and no sheen or odor observed.

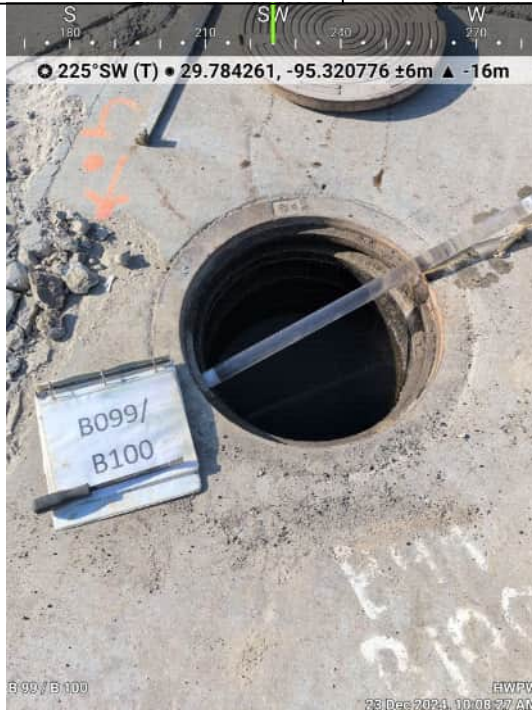
Photo No. 79	Inspection Date: 12/23/2024
Description: Sump 1 (B99/B100), 4.5 inches of freeboard in sump. Color is clear, and no sheen or odor observed. Lat: 29.784261 Long: -95.320776

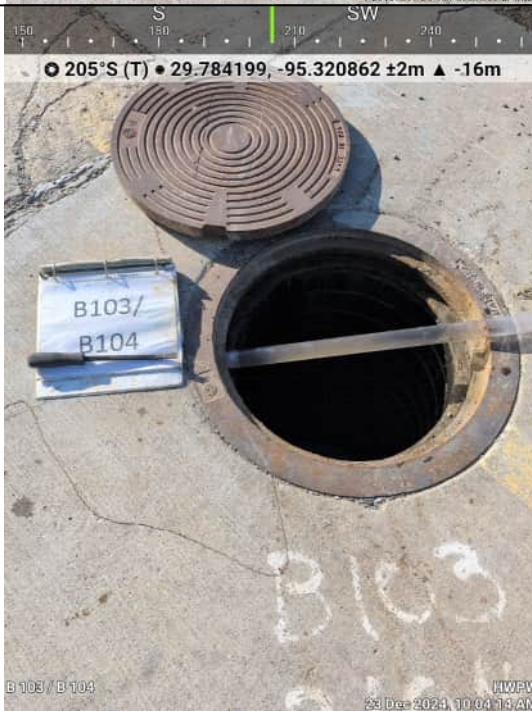
Photo No. 80	Inspection Date: 12/23/2024
Description: Sump 2 (B103/B104), 23.5 inches of freeboard in sump. Color is clear, and no sheen or odor observed. Lat: 29.784199 Long: -95.320862

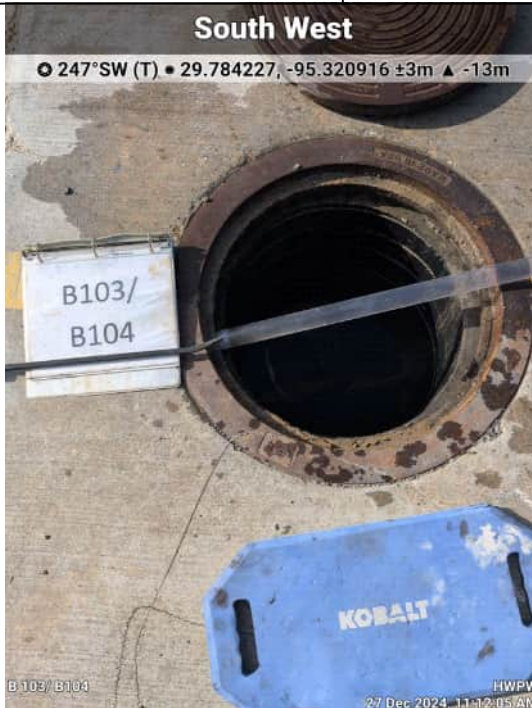
Photo No. 83	Inspection Date: 12/27/2024
Description: Sump 2 (B103/B104), 12.0 inches of freeboard in sump. Color is clear, and no sheen or odor observed. Lat: 29.784227 Long: -95.320916

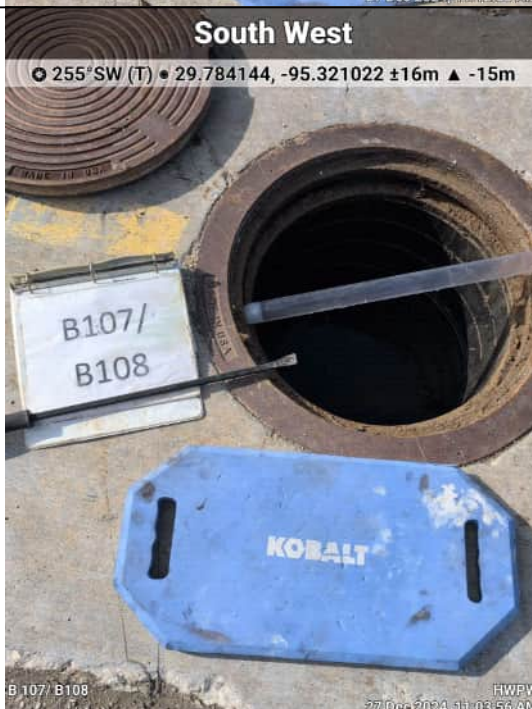
Photo No. 84	Inspection Date: 12/27/2024
Description: Sump 3 (B107/B108), 11.5 inches of freeboard in sump. Color is clear, and no sheen or odor observed. Lat: 29.784144 Long: -95.321022
