February 15, 2025

Project No. US0039040.4227

**Re: MONTHLY STATUS UPDATE – ENGLEWOOD INTERMODAL YARD – NAPL COLLECTION
SYSTEM/CONCRETE CAP REPAIRS AND REVISED INTERIM MEASURES WORK PLAN
CONSTRUCTION ACTIVITIES
UNION PACIFIC RAILROAD HOUSTON WOOD PRESERVING WORKS FACILITY
4910 LIBERTY ROAD FACILITY, HOUSTON, TEXAS
POST-CLOSURE CARE PERMIT NO. HW-50343; INDUSTRIAL SWR NO. 31547**

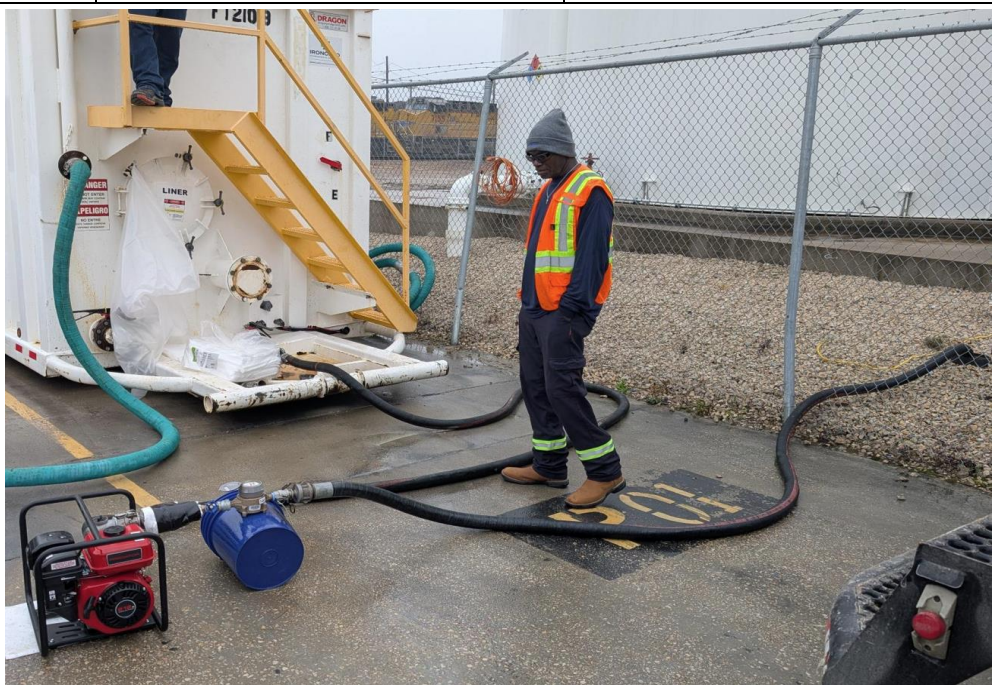
Photo No. 1	Inspection Date: 1/29/2025
Description: Stormwater discharge set up with hoses connecting from the frac tank to the pump through a totalizing flow meter to the drain at the UPRR Settegast Industrial Wastewater Treatment Plant (IWTP). Lat: 29.824028 Long: -95.291417

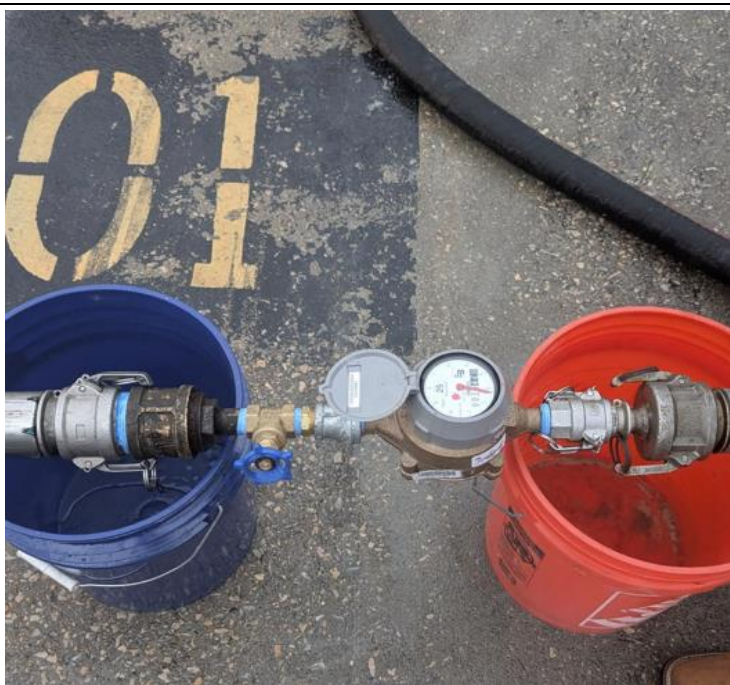
Photo No. 2	Inspection Date: 1/29/2025
Description: Totalizing flow meter set up. Lat: 29.823956 Long: -95.291433

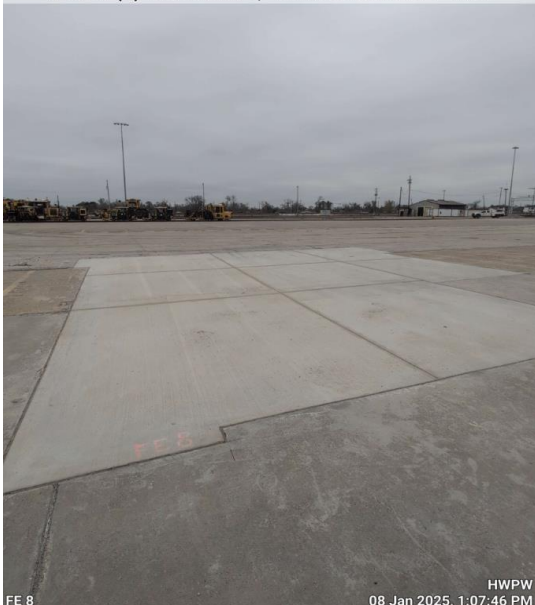
<div> FE 8 <div> HWPW 08 Jan 2025, 1:07:46 PM </div> </div> </div>	
Description: FE-8 weekly inspection of concrete cap. Reconstructed cap in good conditions. No NAPL observed at FE location. Lat: 29.784894 Long: -95.319113

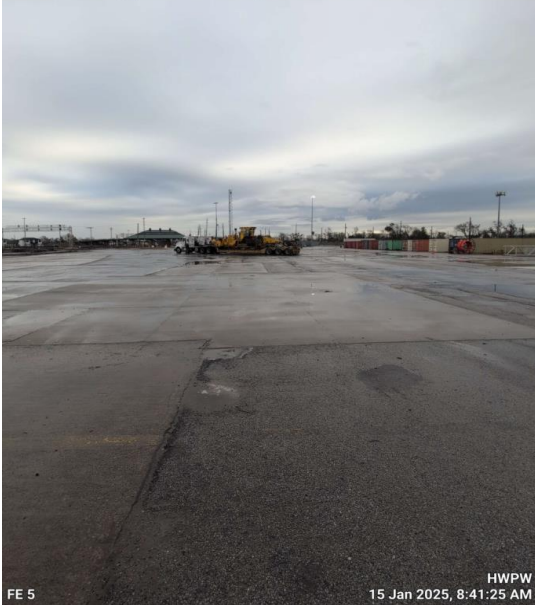
<div> FE 5 <div> HWPW 15 Jan 2025, 8:41:25 AM </div> </div> </div>	
Description: FE-5 weekly inspection of concrete cap. Reconstructed cap in good conditions. No NAPL observed at FE location. Lat: 29.785249 Long: -95.318778			
Photo No. 36	Inspection Date: 1/15/2025	<div> <div>North Elevation</div> <div> 92°E (T) • 29.785354, -95.318293 ±6m ▲ -18m </div>

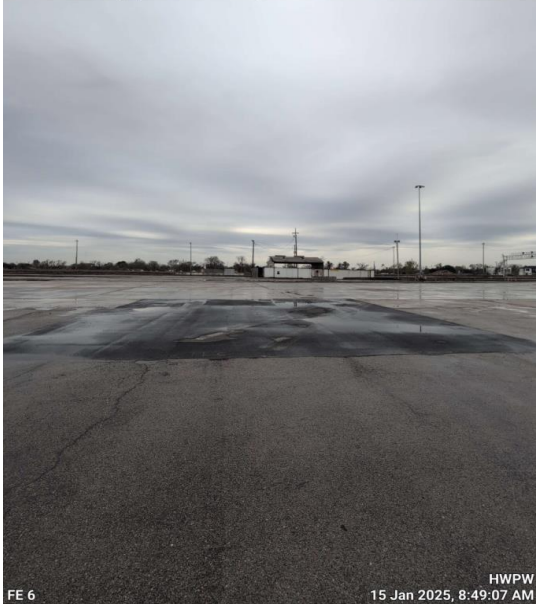
<div> FE 6 <div> HWPW 15 Jan 2025, 8:49:07 AM </div> </div> </div>	
Description: FE-6 weekly inspection of asphalt cap. Reconstructed cap in good conditions. No NAPL observed at FE location. Lat: 29.785354 Long: -95.318293

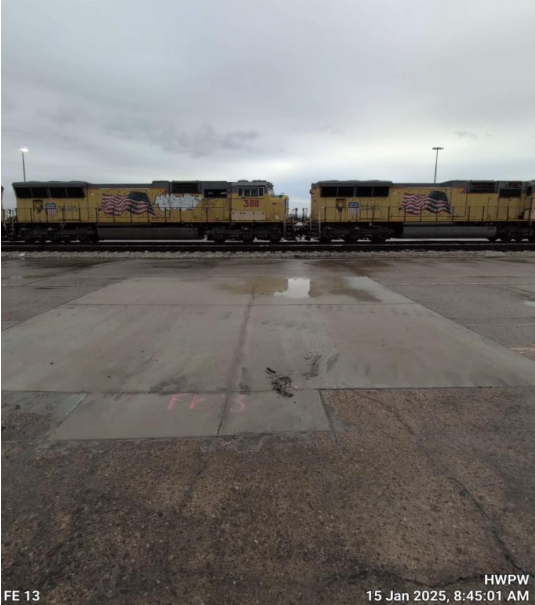
<div> FE 13 </div> <div> HWPW 15 Jan 2025, 8:45:01 AM </div> </div>	
Description: FE-13 weekly inspection of concrete cap. Reconstructed cap in good conditions. No NAPL observed at FE location. Lat: 29.785068 Long: -95.321290			
Photo No. 44	Inspection Date: 1/15/2025	<div> <div> North Elevation </div> <div> 179°S (T) • 29.784918, -95.321214 ±3m ▲ -16m </div>

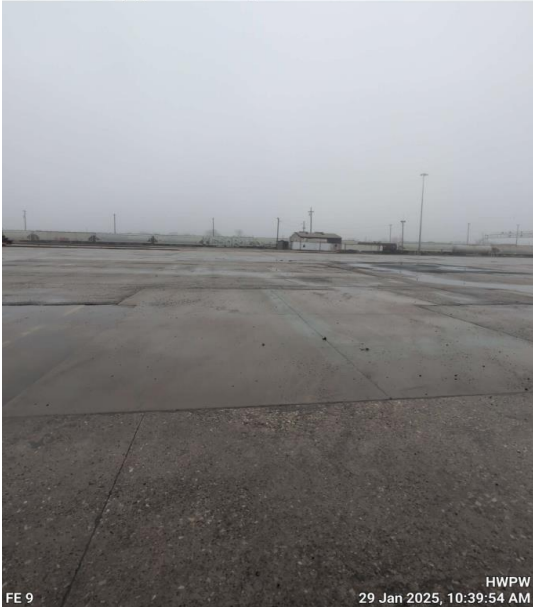
<div> FE 9 HWPW 29 Jan 2025, 10:39:54 AM </div> </div>	
Description: FE-9 weekly inspection of concrete cap. Reconstructed cap in good conditions. No NAPL observed at FE location. Lat: 29.785190 Long: -95.318395			
Photo No. 68	Inspection Date: 1/29/2025	<div> <div> South Elevation </div> <div> ☉ 309°NW (T) • 29.784888, -95.317651 ±4m ▲ -12m </div>

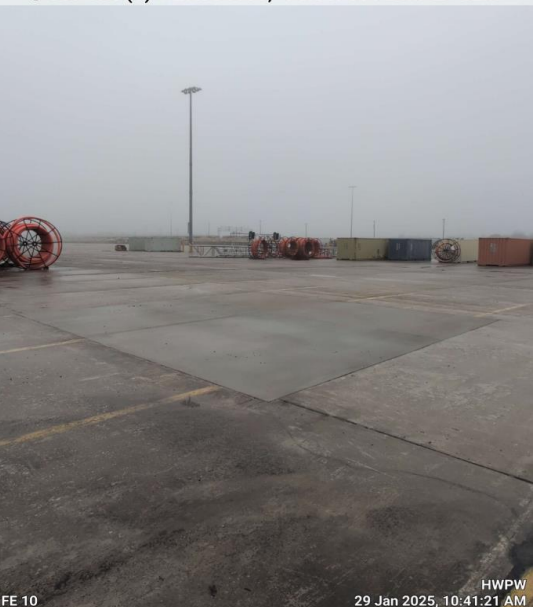
<div> FE 10 HWPW 29 Jan 2025, 10:41:21 AM </div> </div>	
Description: FE-10 weekly inspection of concrete cap. Reconstructed cap in good conditions. No NAPL observed at FE location. Lat: 29.784888 Long: -95.317651

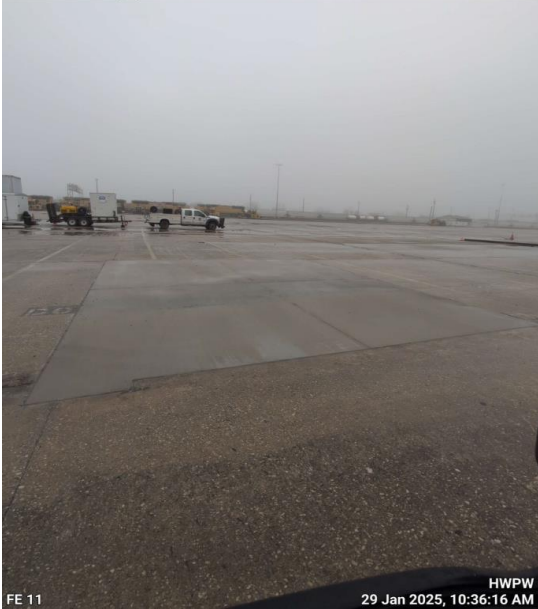
<div> FE 11 <div>HWPW 29 Jan 2025, 10:36:16 AM</div> </div> </div>	
Description: FE-11 weekly inspection of concrete cap. Reconstructed cap in good conditions. No NAPL observed at FE location. Lat: 29.784303 Long: -95.319579			
Photo No. 70	Inspection Date: 1/29/2025	<div> <div>North Elevation</div> <div> 94°E (T) • 29.785454, -95.318684 ±6m ▲ -12m </div>

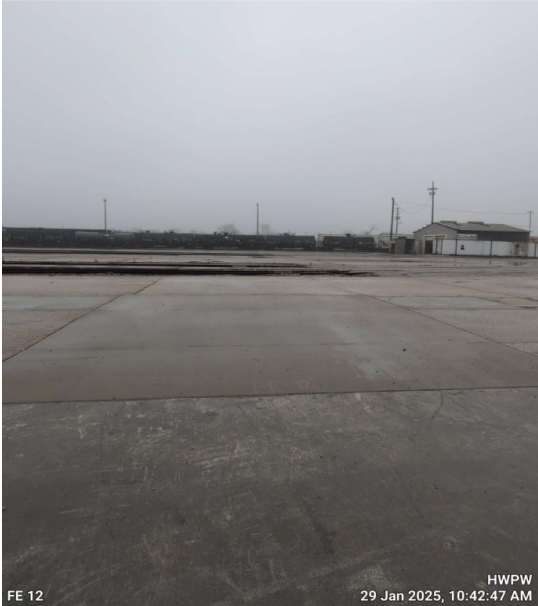
<div> FE 12 <div>HWPW 29 Jan 2025, 10:42:47 AM</div> </div> </div>	
Description: FE-12 weekly inspection of concrete cap. Reconstructed cap in good conditions. No NAPL observed at FE location. Lat: 29.785454 Long: -95.318684

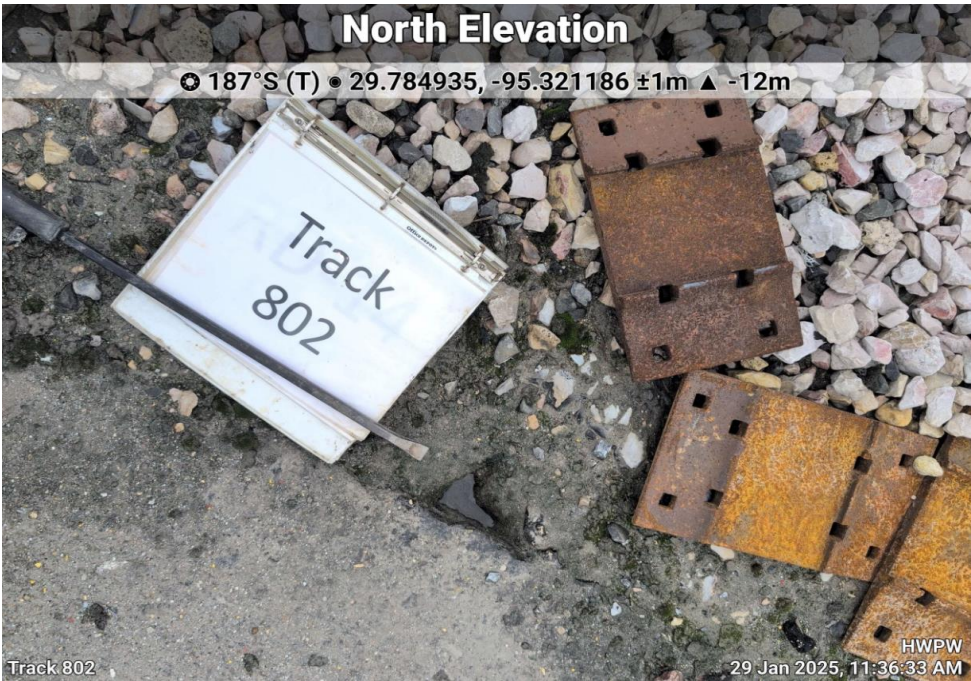
<div> Track 802 HWPW 29 Jan 2025, 11:36:33 AM </div> </div>	
Description: Track 802 weekly inspection of track. Surrounding concrete in good conditions. No NAPL observed at location. Lat: 29.784935 Long: -95.321186

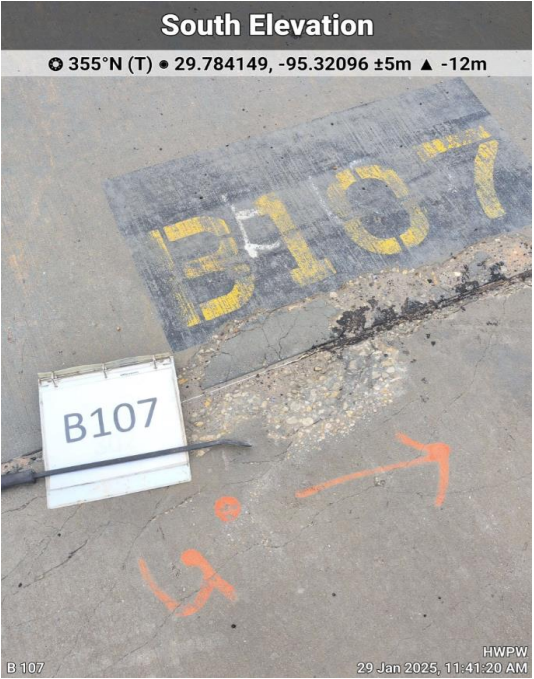
<div> B 107 HWPW 29 Jan 2025, 11:41:20 AM </div> </div>	
Description: B107 weekly inspection of joint. Surrounding concrete in good conditions. No NAPL observed along joint. Lat: 29.784149 Long: -95.320960			
Photo No. 74	Inspection Date: 1/3/2025	<div> <div> East Elevation 253°SW (T) • 29.784307, -95.320662 ±15m ▲ -13m </div>

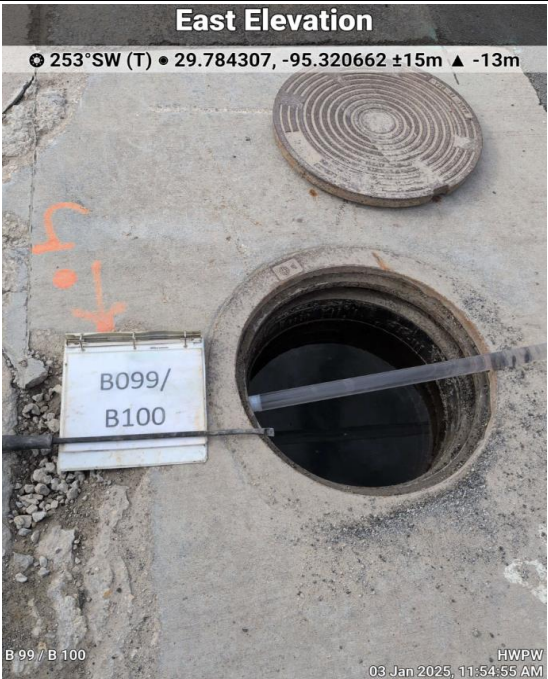
- During the January 2025 inspections, the water in Sump 1, Sump 2, and Sump 3 were observed to be clear in color. A sheen was observed at Sump 1 during the January 3rd, 8th, and 29th inspections (Photos 74, 77, and 86). Additionally, a sheen was observed at Sump 3 during the January 29th inspection (Photo 88). No odors were reported during the January inspections.
- Tar material/NAPL seeps were not observed along the concrete joints along the NAPL Collection System (including Slot B107) during the January inspections.

<div> B 99 / B 100 HWPW 03 Jan 2025, 11:54:55 AM </div> </div>	
Description: Sump 1 (B99/B100), 4.5 inches of freeboard in sump. Color is clear, and no odor observed. Sheen observed on the surface. Lat: 29.784307 Long: -95.320662

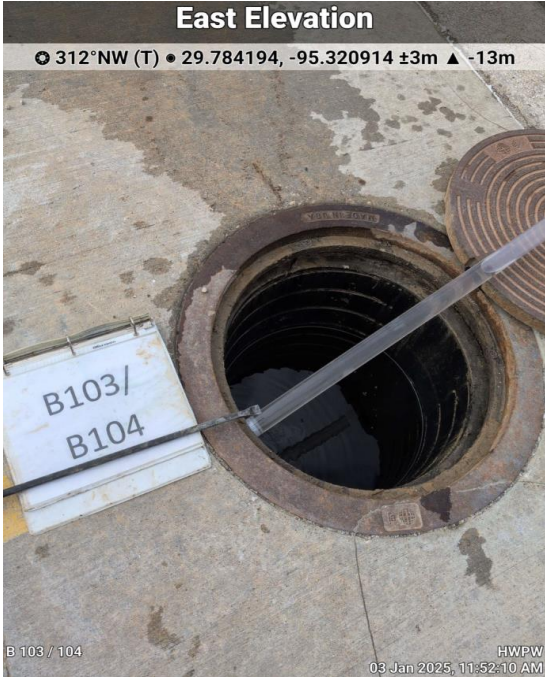
<div> B 103 / 104 HWPW 03 Jan 2025, 11:52:10 AM </div> </div>	
Description: Sump 2 (B103/B104), 12.0 inches of freeboard in sump. Color is clear, and no sheen or odor observed. Lat: 29.784194 Long: -95.320914			
Photo No. 76	Inspection Date: 1/3/2025	<div> <div> East Elevation </div> <div> 257°SW (T) • 29.784194, -95.320968 ±16m ▲ -11m </div>

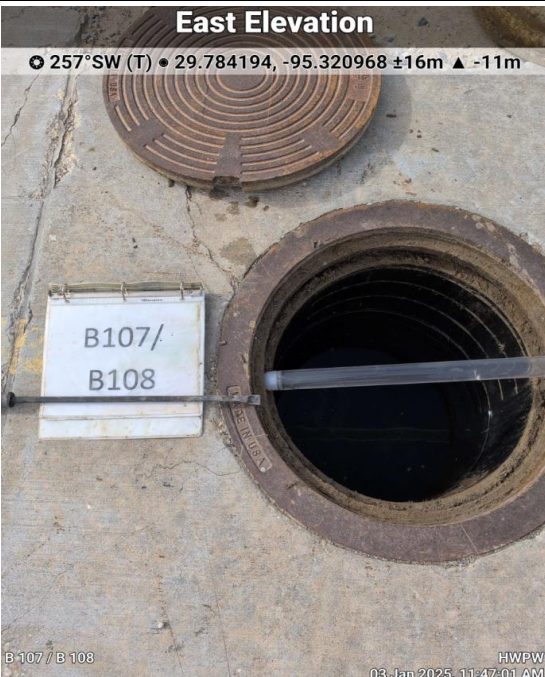
<div> B 107 / B 108 HWPW 03 Jan 2025, 11:47:01 AM </div> </div>	
Description: Sump 3 (B107/B108), 12.0 inches of freeboard in sump. Color is clear, and no sheen or odor observed. Lat: 29.784194 Long: -95.320968

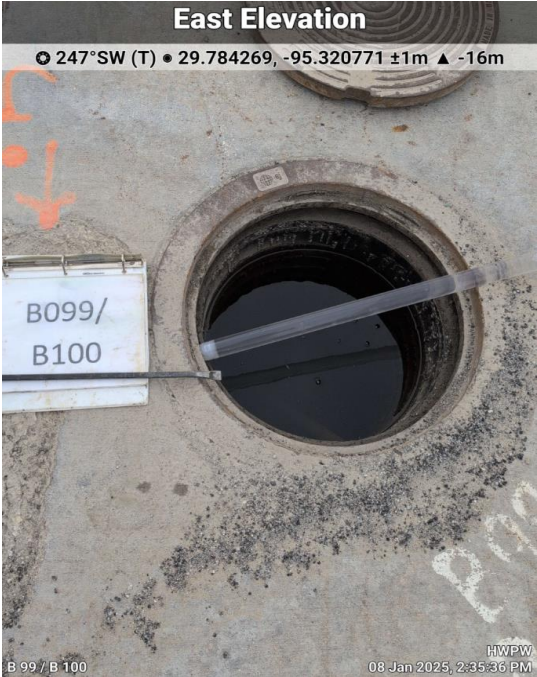
<div> B 99 / B 100 </div> <div> HWPW 08 Jan 2025, 2:35:36 PM </div> </div>	
Description: Sump 1 (B99/B100), 6.0 inches of freeboard in sump. Color is clear, and no odor observed. Sheen observed on the surface.			
Lat: 29.784269 Long: -95.320771			
Photo No. 78	Inspection Date: 1/8/2025	<div> <div> East Elevation </div> <div> 258°SW (T) • 29.784215, -95.320896 ±0m ▲ -31m </div>

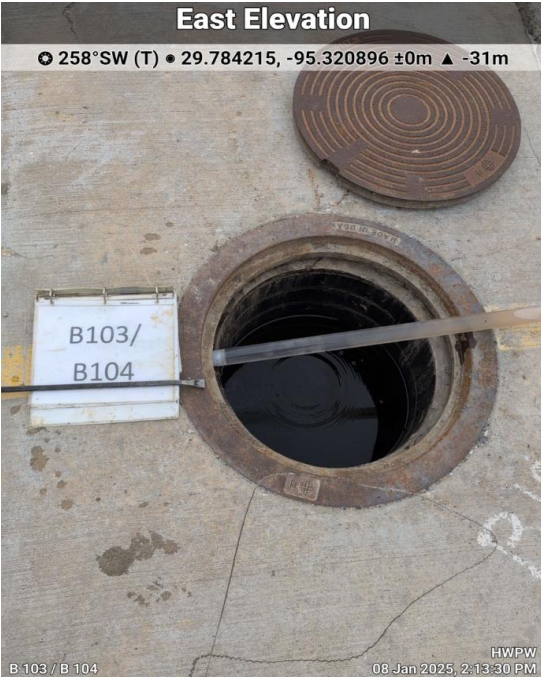
<div> B 103 / B 104 </div> <div> HWPW 08 Jan 2025, 2:13:30 PM </div> </div>	
Description: Sump 2 (B103/B104), 10.5 inches of freeboard in sump. Color is clear, and no sheen or odor observed.			
Lat: 29.784215 Long: -95.320896

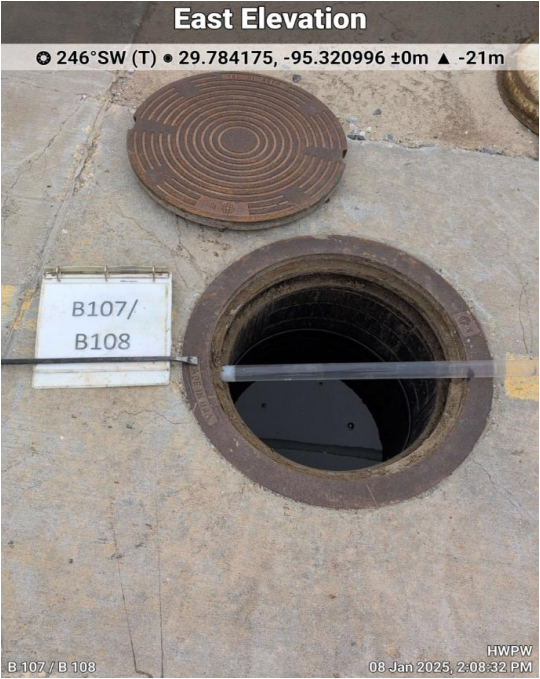
<div> B 107 / B 108 HWPW 08 Jan 2025, 2:08:32 PM </div> </div>	
Description: Sump 3 (B107/B108), 11.0 inches of freeboard in sump. Color is clear, and no sheen or odor observed. Lat: 29.784175 Long: -95.320996			
Photo No. 80	Inspection Date: 1/15/2025	<div> <div> North Elevation </div> <div> 211°S (T) • 29.784297, -95.320782 ±2m ▲ -18m </div>

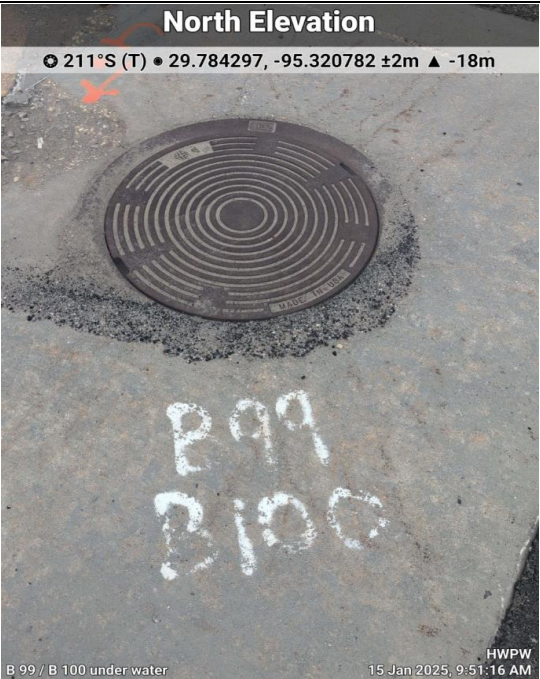
<div> B 99 / B 100 under water HWPW 15 Jan 2025, 9:51:16 AM </div> </div>	
Description: Sump 1 (B99/B100), 0.0 inches of freeboard in sump. Color is clear, and no sheen or odor observed. Lat: 29.784297 Long: -95.320782

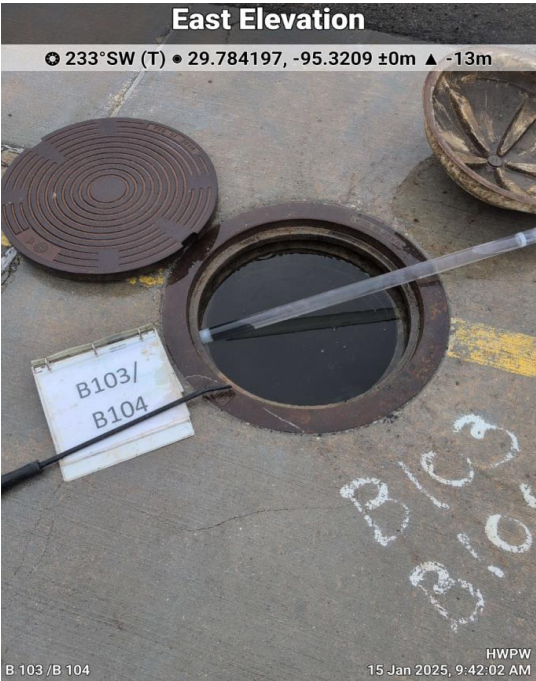
<div> B. 103 /B 104 </div> <div> HWPW 15 Jan 2025, 9:42:02 AM </div> </div>	
Description: Sump 2 (B103/B104), 0.0 inches of freeboard in sump. Color is clear, and no sheen or odor observed. Lat: 29.784197 Long: -95.320900			
Photo No. 82	Inspection Date: 1/15/2025	<div> <div> East Elevation </div> <div> 263°W (T) • 29.784169, -95.321025 ±2m ▲ -16m </div>

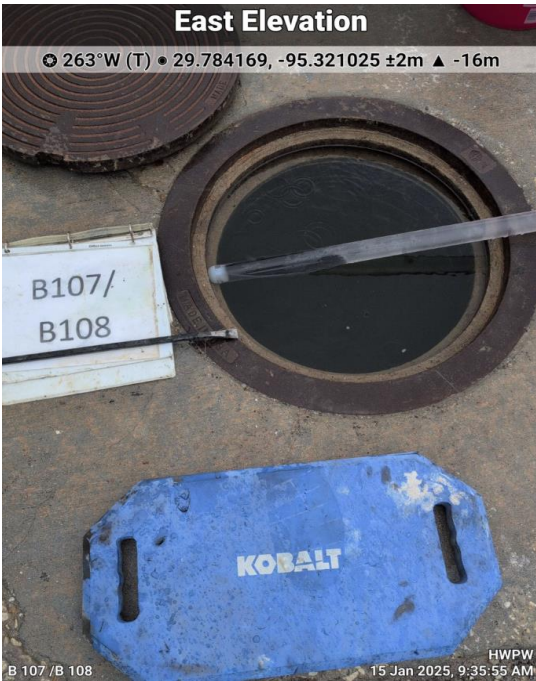
<div> B 107 /B 108 </div> <div> HWPW 15 Jan 2025, 9:35:55 AM </div> </div>	
Description: Sump 3 (B107/B108), 0.0 inches of freeboard in sump. Color is clear, and no sheen or odor observed. Lat: 29.784169 Long: -95.321025

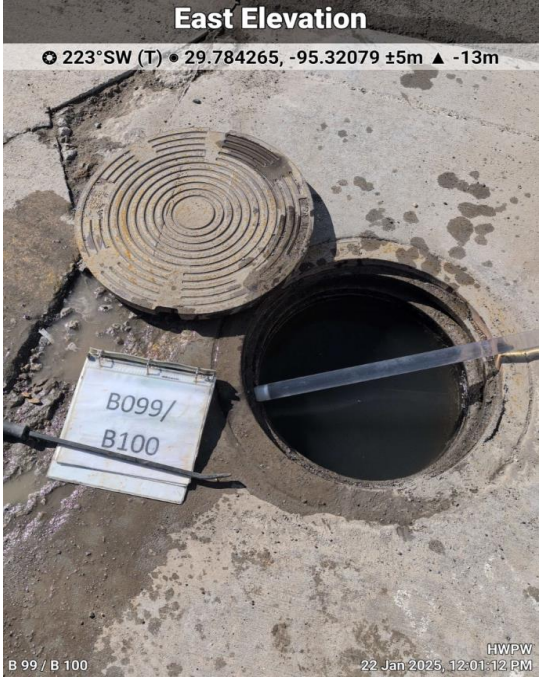
<div> B 99 / B 100 </div> <div> HWPW 22 Jan 2025, 12:01:12 PM </div> </div>	
Description: Sump 1 (B99/B100), 1.5 inches of freeboard in sump. Color is clear, and no sheen or odor observed. Lat: 29.784265 Long: -95.320790			
Photo No. 84	Inspection Date: 1/22/2025	<div> <div> East Elevation </div> <div> 277°W (T) • 29.784199, -95.320871 ±3m ▲ -12m </div>

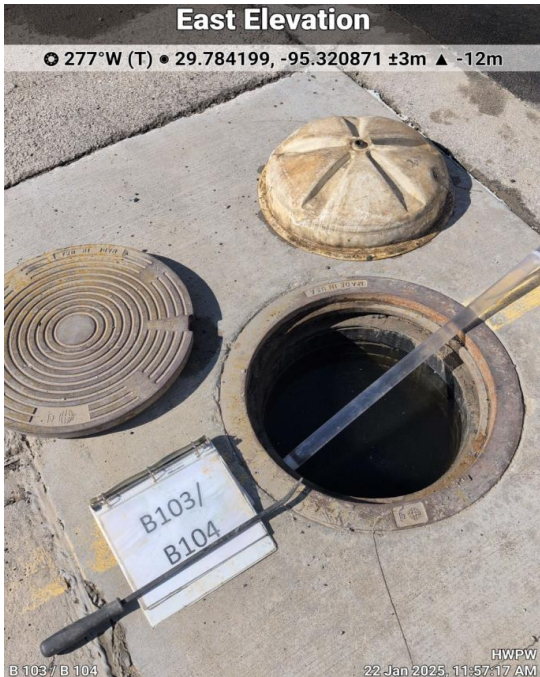
<div> B 103 / B 104 </div> <div> HWPW 22 Jan 2025, 11:57:17 AM </div> </div>	
Description: Sump 2 (B103/B104), 4.0 inches of freeboard in sump. Color is clear, and no sheen or odor observed. Lat: 29.784199 Long: -95.320871

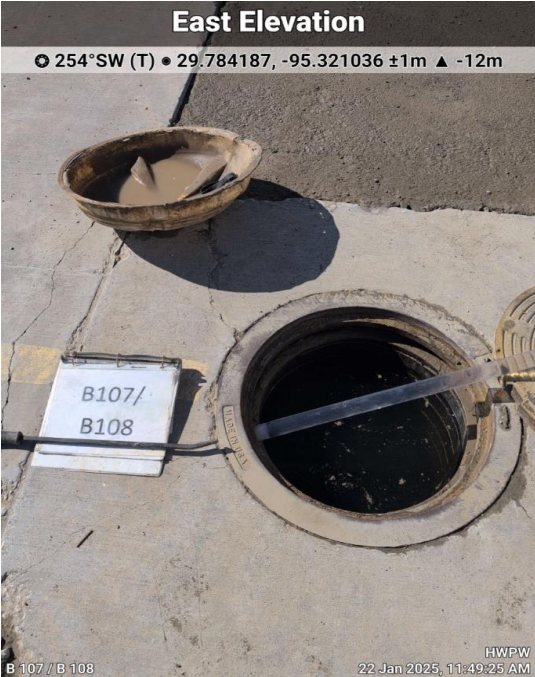
<div> B 107 / B 108 </div> <div> HWPW 22 Jan 2025, 11:49:25 AM </div> </div>	
Description: Sump 3 (B107/B108), 3.5 inches of freeboard in sump. Color is clear, and no sheen or odor observed.			
Lat: 29.784187 Long: -95.321036			
Photo No. 86	Inspection Date: 1/29/2025	<div> <div> East Elevation </div> <div> 277°W (T) • 29.784318, -95.320758 ±12m ▲ -5m </div>

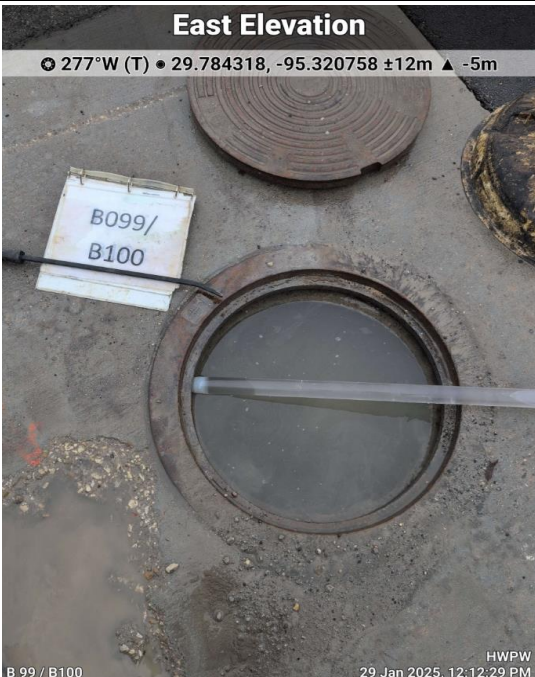
<div> B 99 / B 100 </div> <div> HWPW 29 Jan 2025, 12:12:29 PM </div> </div>	
Description: Sump 1 (B99/B100), 0.0 inches of freeboard in sump. Color is clear, and no odor observed. Sheen observed on the surface.			
Lat: 29.784318 Long: -95.320758

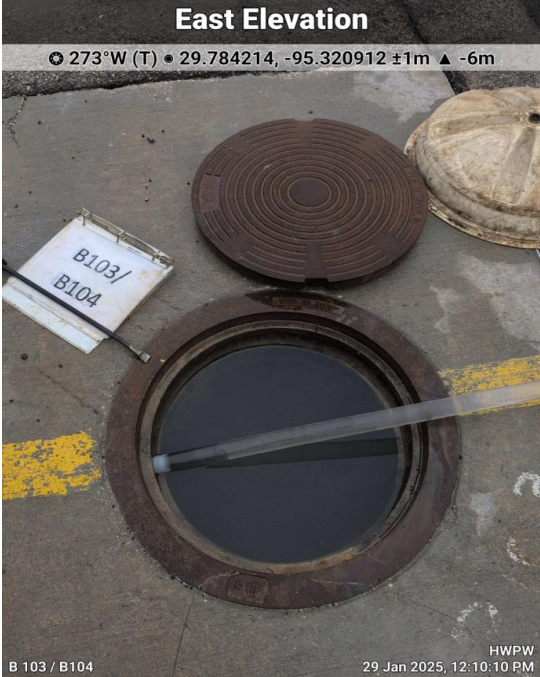
<div> B 103 / B104 HWPW 29 Jan 2025, 12:10:10 PM </div> </div>	
Description: Sump 2 (B103/B104), 0.0 inches of freeboard in sump. Color is clear, and no sheen or odor observed.			
Lat: 29.784214 Long: -95.320912			
Photo No. 88	Inspection Date: 1/29/2025	<div> <div> East Elevation </div> <div> 257°SW (T) • 29.784181, -95.320996 ±3m ▲ -7m </div>

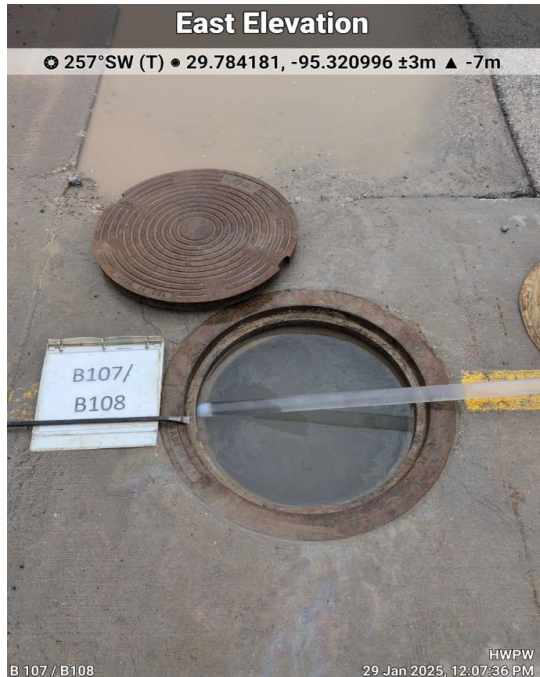
<div> B 107 / B108 HWPW 29 Jan 2025, 12:07:36 PM </div> </div>	
Description: Sump 3 (B107/B108), 0.0 inches of freeboard in sump. Color is clear, and no odor observed. Sheen observed on the surface.			
Lat: 29.784181 Long: -95.320996
