Re: **MONTHLY STATUS UPDATE – ENGLEWOOD INTERMODAL YARD – NAPL COLLECTION
SYSTEM/CONCRETE CAP REPAIRS AND REVISED INTERIM MEASURES WORK PLAN POST-
CONSTRUCTION ACTIVITIES
UNION PACIFIC RAILROAD HOUSTON WOOD PRESERVING WORKS FACILITY
4910 LIBERTY ROAD FACILITY, HOUSTON, TEXAS
POST-CLOSURE CARE PERMIT NO. HW-50343; INDUSTRIAL SWR NO. 31547**

WSP USA Inc. (WSP), on behalf of Union Pacific Railroad Company (UPRR), is pleased to provide this monthly status update for February 2025 summarizing the weekly inspections being conducted at the Englewood Intermodal Yard (EIY) concrete cap area within the UPRR Houston Wood Preserving Works Facility (the Site). The weekly inspections are being conducted to evaluate the post-construction Focused Excavations as detailed in the *Revised Interim Measures Work Plan – Englewood Intermodal Yard (EIY)*, (Revised IMWP) dated October 20, 2023. In addition, a summary of the weekly NAPL Collection System and concrete cap area inspections conducted at the EIY is provided as requested by the TCEQ in a letter dated March 20, 2018. Below is a summary of the weekly Focused Excavation and EIY inspections for February 2025.

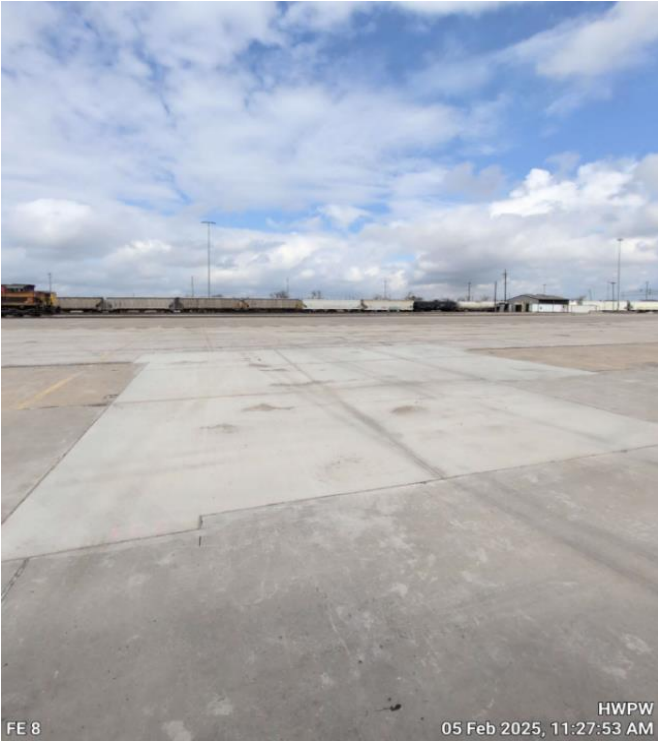
PHOTOGRAPH LOG	
Client Name: Union Pacific Railroad		Site Location: Englewood Intermodal Yard, Houston, Texas	Project No. US0039040.4227
Photo No. 7	Inspection Date: 2/5/2025	<div> <div> Description: FE-8 weekly inspection of concrete cap. Reconstructed cap in good condition. No NAPL observed at FE location. Facing northwest. </div> <div> Lat: 29.784862 Long: -95.319113 </div> </div>

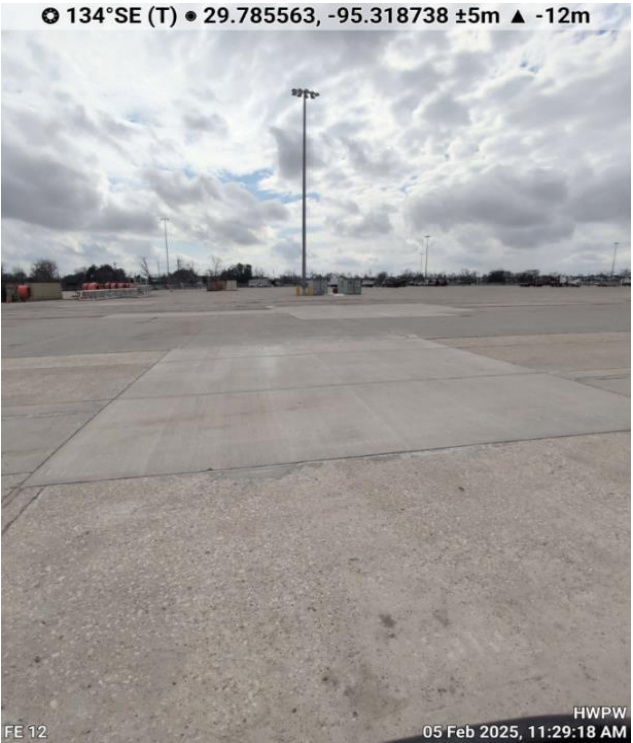
<div> <div>FE 12</div> <div> HWPW 05 Feb 2025, 11:29:18 AM </div> </div> </div>	
Description: FE-12 weekly inspection of concrete cap. Reconstructed cap in good condition. No NAPL observed at FE location. Facing southeast.			
Lat: 29.785563 Long: -95.318738			
Photo No. 12	Inspection Date: 2/5/2025	<div> <div> 162°SE (T) • 29.785096, -95.321254 ±1m ▲ -12m </div>

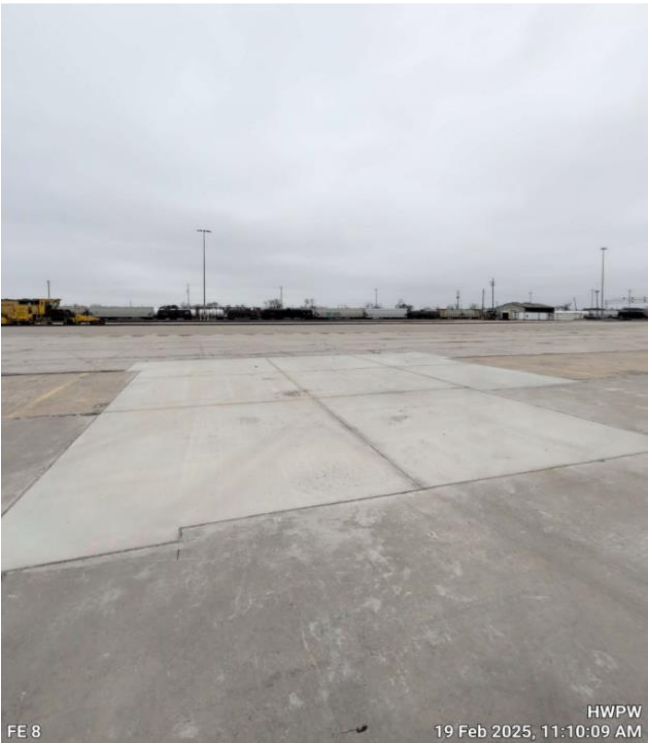
PHOTOGRAPH LOG	
Client Name: Union Pacific Railroad		Site Location: Englewood Intermodal Yard, Houston, Texas	Project No. US0039040.4227
Photo No. 37	Inspection Date: 2/19/2025	<div> <div> Description: FE-8 weekly inspection of concrete cap. Reconstructed cap in good condition. No NAPL observed at FE location. Facing northwest. </div> <div> Lat: 29.784873 Long: -95.319102 </div> </div>

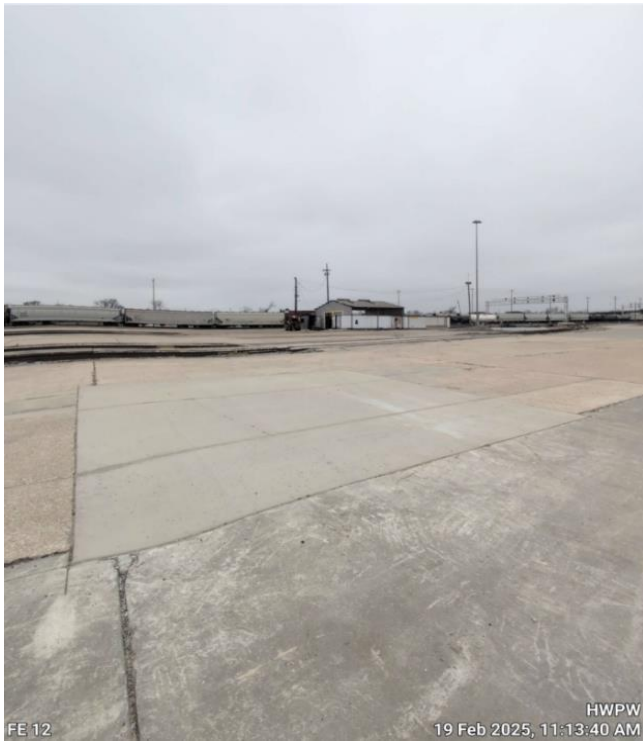
PHOTOGRAPH LOG	
Client Name: Union Pacific Railroad		Site Location: Englewood Intermodal Yard, Houston, Texas	Project No. US0039040.4227
Photo No. 41	Inspection Date: 2/19/2025	<div> <div> Description: FE-12 weekly inspection of concrete cap. Reconstructed cap in good condition. No NAPL observed at FE location. Facing north. </div> <div> Lat: 29.785458 Long: -95.318703 </div> </div>

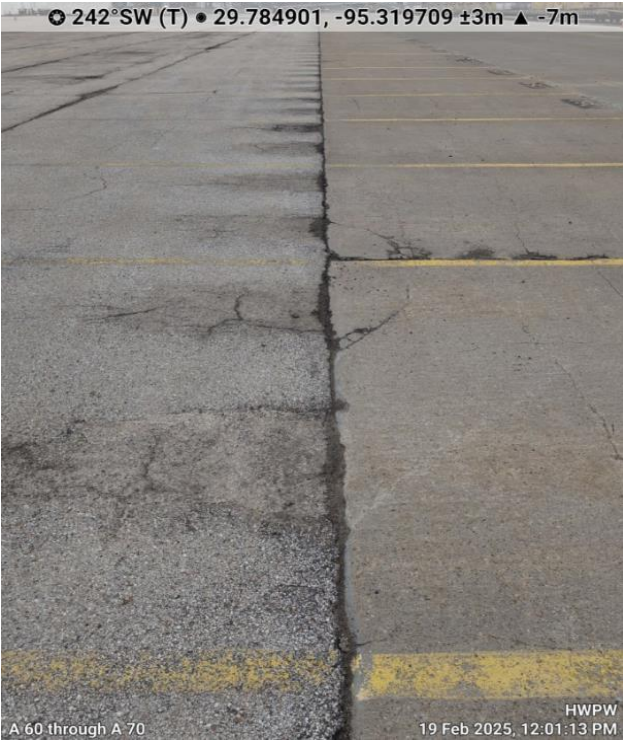
PHOTOGRAPH LOG	
Client Name: Union Pacific Railroad		Site Location: Englewood Intermodal Yard, Houston, Texas	
Project No. US0039040.4227			
Photo No. 45	Inspection Date: 2/19/2025	<div> <div> Description: A060 - A070 weekly inspection of joint. Surrounding asphalt and concrete in good condition. No brown staining observed along joint. Facing southwest. Lat: 29.784901 Long: -95.319709 </div> <div>

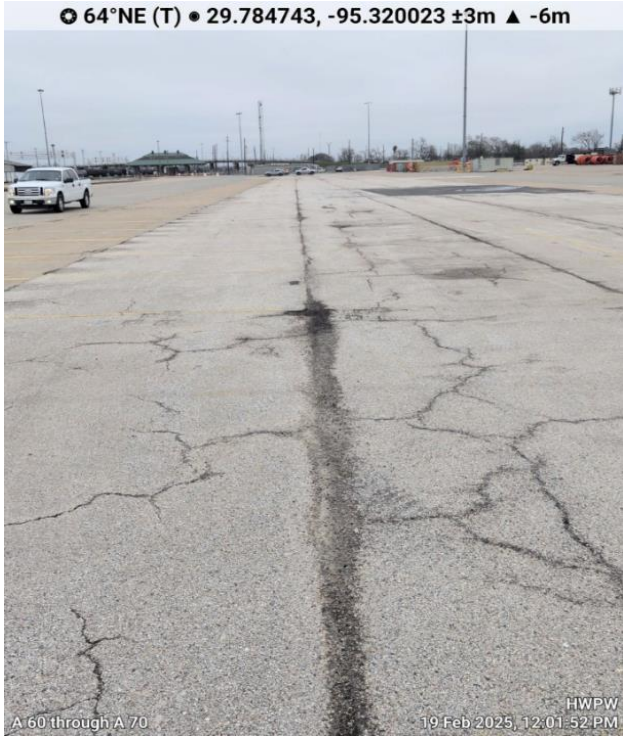
<p> 242°SW (T) • 29.784901, -95.319709 ±3m ▲ -7m A 60 through A 70 HWPW 19 Feb 2025, 12:01:13 PM </p> </div> </div>	
Photo No. 46	Inspection Date: 2/19/2025	<div> <div> Description: A060 - A070 weekly inspection of joint. Surrounding asphalt and concrete in good condition. No brown staining observed along joint. Facing northeast. Lat: 29.784743 Long: -95.320023 </div> <div>

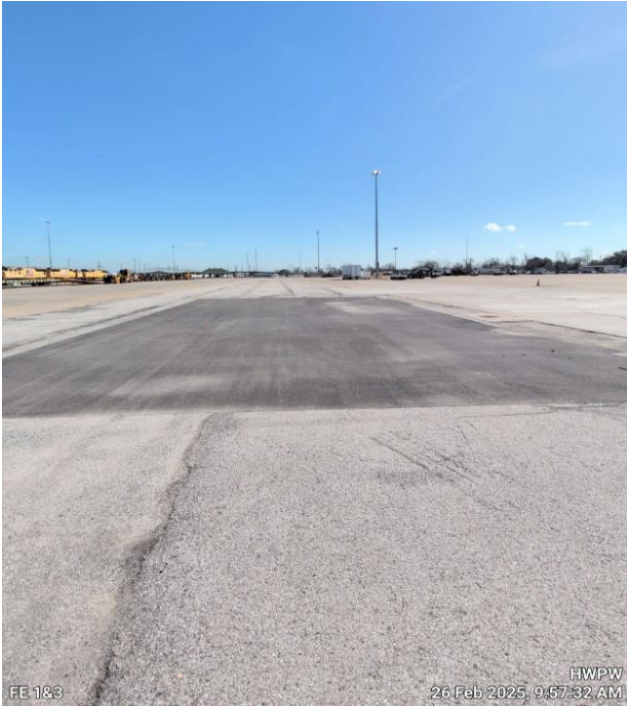
PHOTOGRAPH LOG	
Client Name: Union Pacific Railroad		Site Location: Englewood Intermodal Yard, Houston, Texas	Project No. US0039040.4227
Photo No. 47	Inspection Date: 2/26/2025	<div> <div> Description: FE-1&3 weekly inspection of asphalt cap. Reconstructed cap in good condition. No NAPL observed at FE location. Facing northeast. </div> <div> Lat: 29.784237 Long: -95.321050 </div> </div>

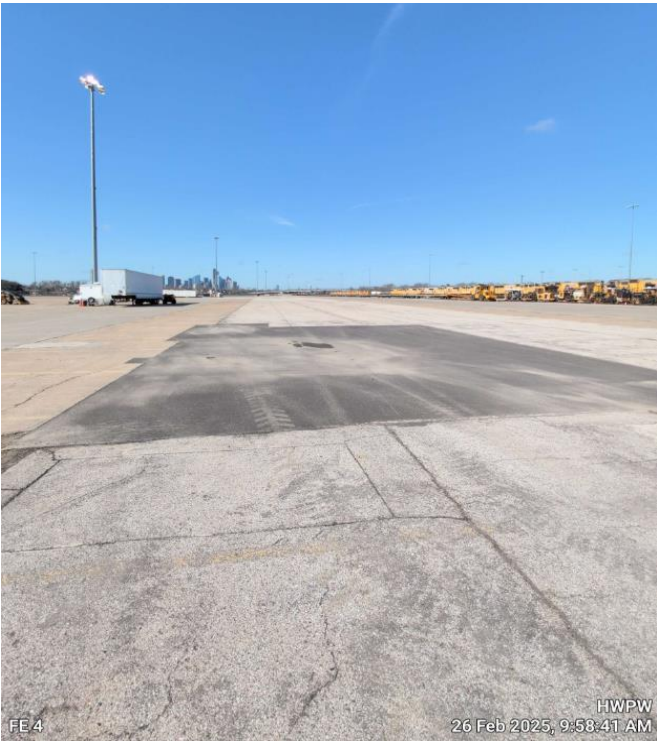
PHOTOGRAPH LOG	
Client Name: Union Pacific Railroad		Site Location: Englewood Intermodal Yard, Houston, Texas	
		Project No. US0039040.4227	
Photo No. 49	Inspection Date: 2/26/2025	<div> <div> Description: FE-4 weekly inspection of asphalt cap. Reconstructed cap in good condition. No NAPL observed at FE location. Facing southwest. </div> <div> Lat: 29.784851 Long: -95.319466 </div> </div>

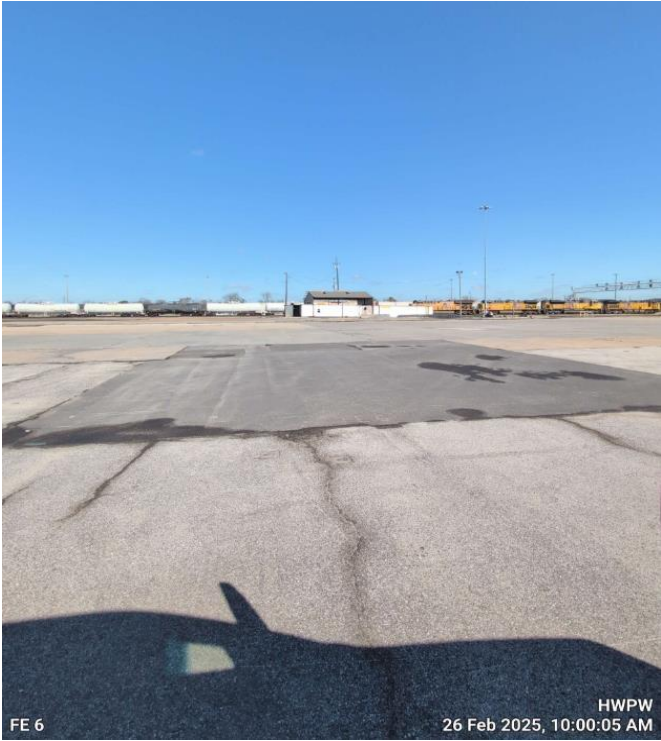
PHOTOGRAPH LOG	
Client Name: Union Pacific Railroad		Site Location: Englewood Intermodal Yard, Houston, Texas	Project No. US0039040.4227
Photo No. 51	Inspection Date: 2/26/2025	<div> <div> Description: FE-6 weekly inspection of asphalt cap. Reconstructed cap in good condition. No NAPL observed at FE location. Facing northwest. Lat: 29.785375 Long: -95.318334 </div> <div>

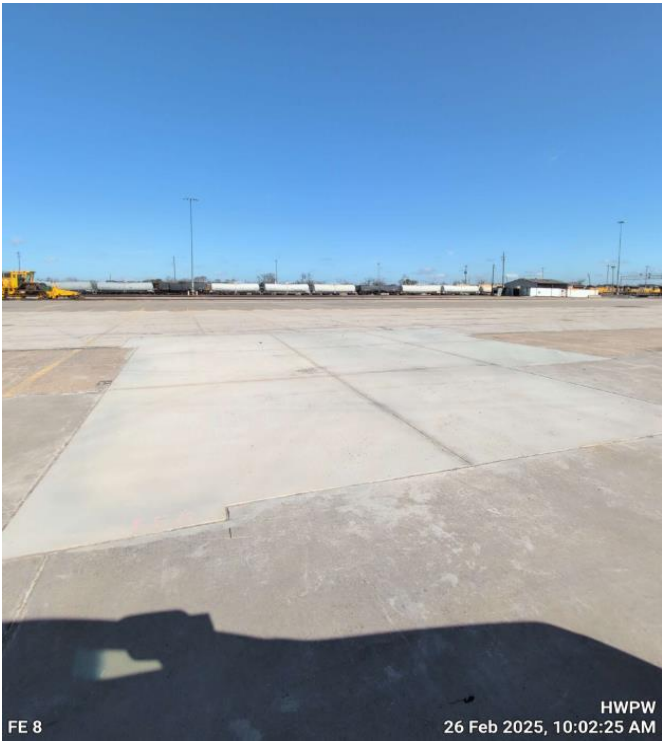
PHOTOGRAPH LOG	
Client Name: Union Pacific Railroad		Site Location: Englewood Intermodal Yard, Houston, Texas	Project No. US0039040.4227
Photo No. 53	Inspection Date: 2/26/2025	<div> <div> Description: FE-8 weekly inspection of concrete cap. Reconstructed cap in good condition. No NAPL observed at FE location. Facing northwest. </div> <div> Lat: 29.784859 Long: -95.319098 </div> </div> <div>

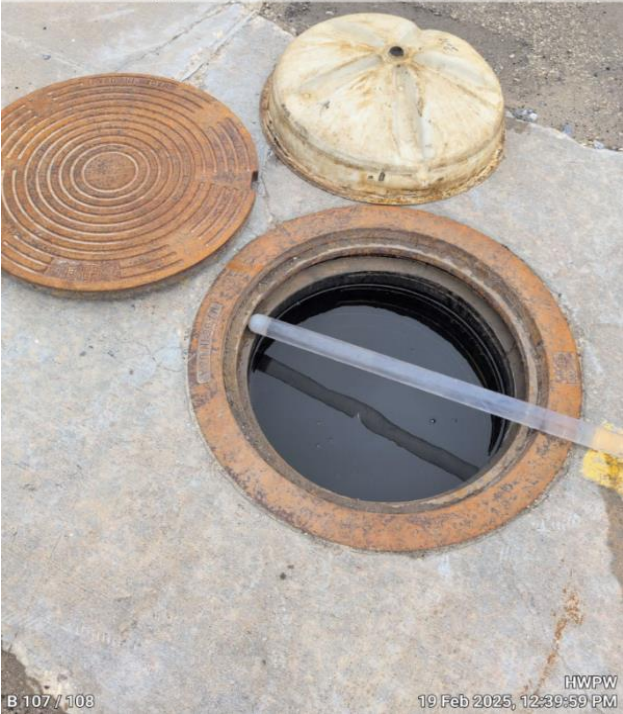
PHOTOGRAPH LOG	
Client Name: Union Pacific Railroad		Site Location: Englewood Intermodal Yard, Houston, Texas	
Project No. US0039040.4227			
Photo No. 71	Inspection Date: 2/19/2025	Coordinates: 243°SW (T) • 29.784161, -95.320965 ±2m ▲ -13m	
Description: Sump 3 (B107/B108), 2.5 inches of freeboard in sump. Color is clear, and no sheen or odor observed.
