April 15, 2025

Project No. US0039040.4227

Re: **MONTHLY STATUS UPDATE – ENGLEWOOD INTERMODAL YARD – NAPL COLLECTION  
SYSTEM/CONCRETE CAP REPAIRS AND REVISED INTERIM MEASURES WORK PLAN POST-  
CONSTRUCTION ACTIVITIES  
UNION PACIFIC RAILROAD HOUSTON WOOD PRESERVING WORKS FACILITY  
4910 LIBERTY ROAD FACILITY, HOUSTON, TEXAS  
POST-CLOSURE CARE PERMIT NO. HW-50343; INDUSTRIAL SWR NO. 31547**

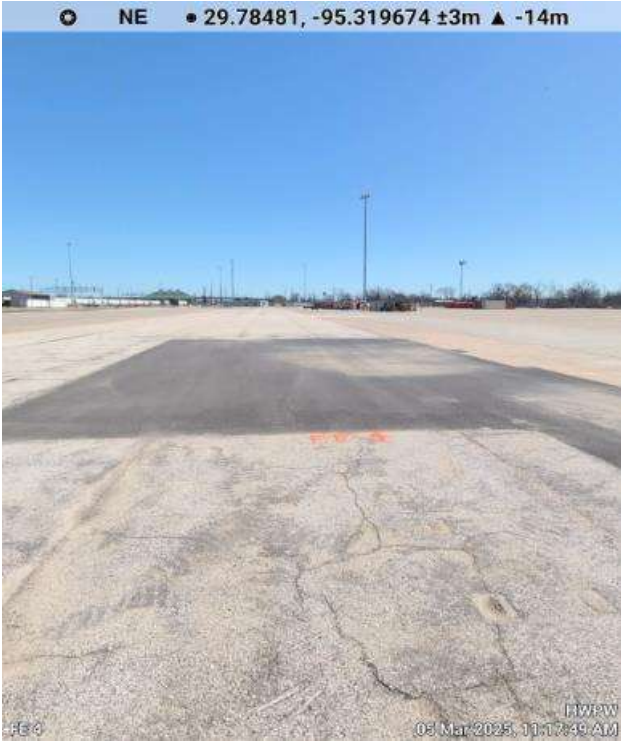
<div> <small>FE4</small> <small>HWPW</small>  <small>05 Mar 2025, 11:17:49 AM</small> </div> </div>	
<b>Description:</b> FE-4 weekly inspection of asphalt cap. Reconstructed cap in good condition. No NAPL observed at FE location. Facing northeast.			
Lat: 29.784810 Long: -95.319674			
<b>Photo No.</b> <b>4</b>	<b>Inspection Date:</b> 3/5/2025	<div>

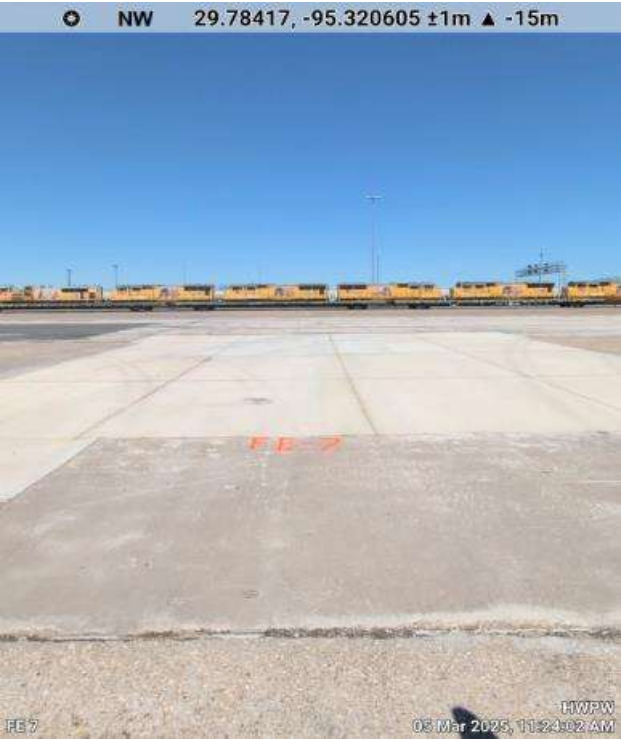
<div> FE 7 05 Mar 2025, 11:24:02 AM HWPW </div> </div>	
<b>Description:</b> FE-7 weekly inspection of concrete cap. Reconstructed cap in good condition. No NAPL observed at FE location. Facing northwest.  Lat: 29.784170 Long: -95.320605

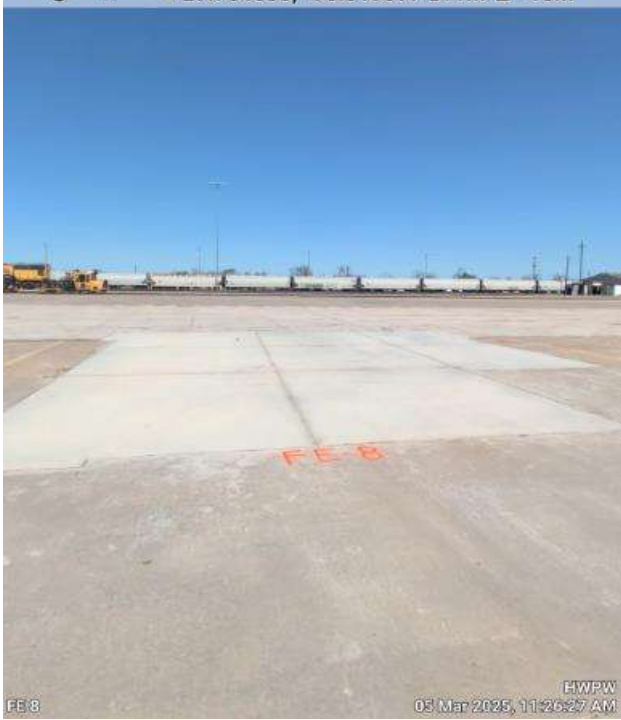
<div>             FE 8             <span style="float: right;">HWPW 05 Mar 2025, 11:26:27 AM</span> </div> </div>	
<b>Description:</b> FE-8 weekly inspection of concrete cap. Reconstructed cap in good condition. No NAPL observed at FE location. Facing north.			
Lat: 29.784888 Long: -95.319097			
<b>Photo No.</b> <b>8</b>	<b>Inspection Date:</b> 3/5/2025	<div>

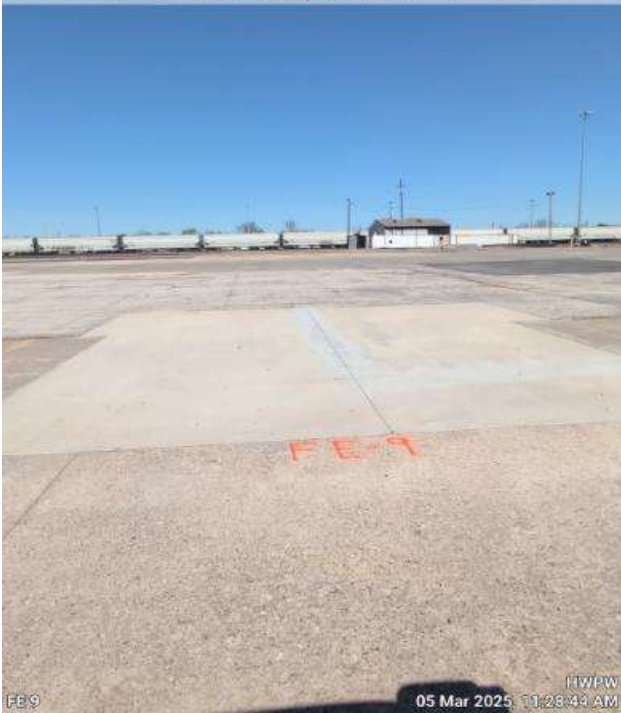
<div>             FE 9             <span style="float: right;">HWPW 05 Mar 2025, 11:28:44 AM</span> </div> </div>	
<b>Description:</b> FE-9 weekly inspection of concrete cap. Reconstructed cap in good condition. No NAPL observed at FE location. Facing northwest.			
Lat: 29.785224 Long: -95.318368

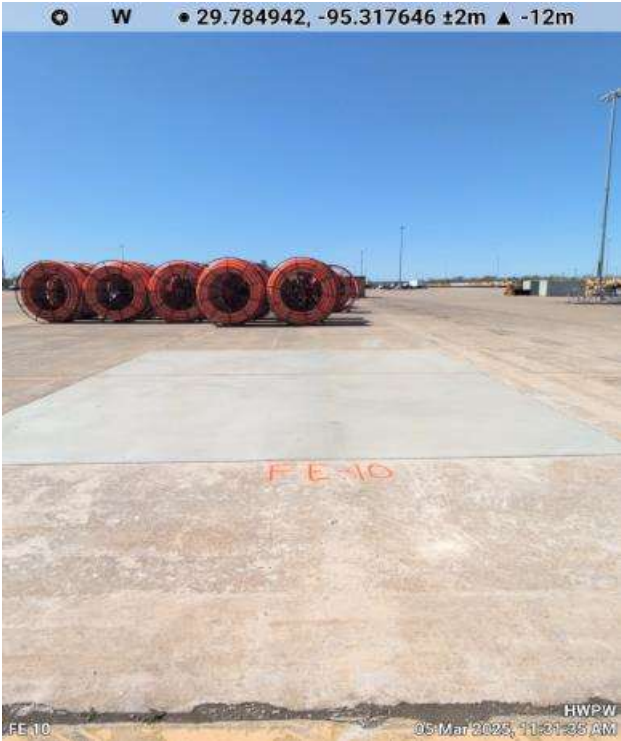
<p>W • 29.784942, -95.317646 ±2m ▲ -12m</p> <p>FE-10</p> <p>HWPW 05 Mar 2025, 11:21:38 AM</p>	
<b>Description:</b> FE-10 weekly inspection of concrete cap. Reconstructed cap in good condition. No NAPL observed at FE location. Facing west.			
Lat: 29.784942 Long: -95.317646			
Photo No. 10	Inspection Date: 3/5/2025

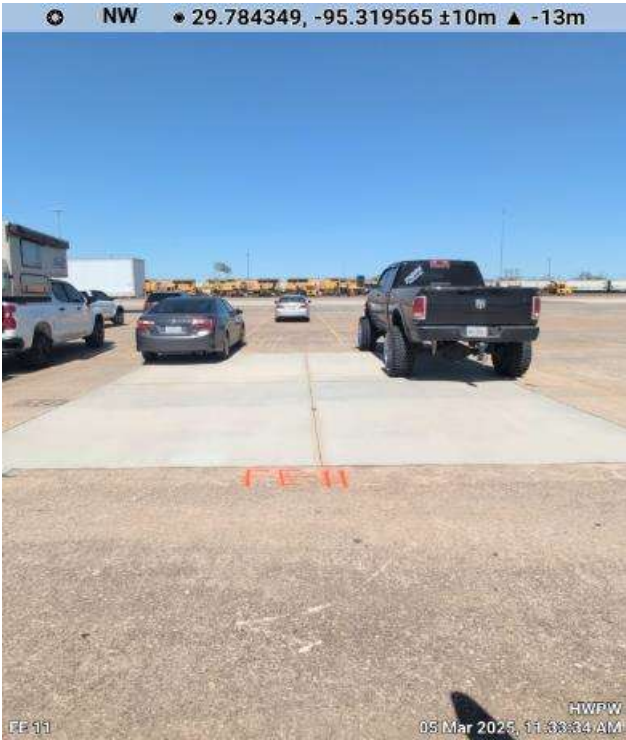
<p>NW • 29.784349, -95.319565 ±10m ▲ -13m</p> <p>FE-11</p> <p>HWPW 05 Mar 2025, 11:38:34 AM</p>	
<b>Description:</b> FE-11 weekly inspection of concrete cap. Reconstructed cap in good condition. No NAPL observed at FE location. Facing northwest.			
Lat: 29.784349 Long: -95.319565

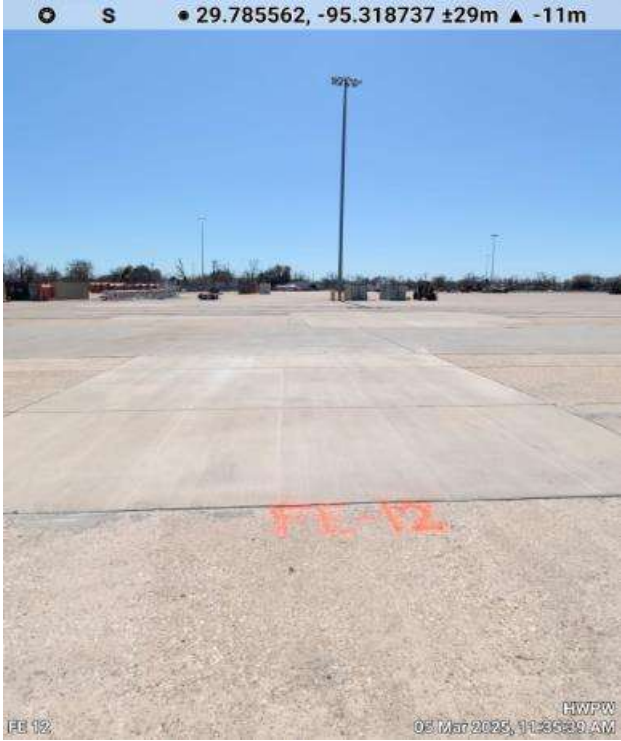
<div> <span>FE 12</span> <span>HWPW 05 Mar 2025, 11:36:29 AM</span> </div>	
<b>Description:</b> FE-12 weekly inspection of concrete cap. Reconstructed cap in good condition. No NAPL observed at FE location. Facing south.		Lat: 29.785562 Long: -95.318737	
<b>Photo No.</b> <b>12</b>	<b>Inspection Date:</b> 3/5/2025	<div>

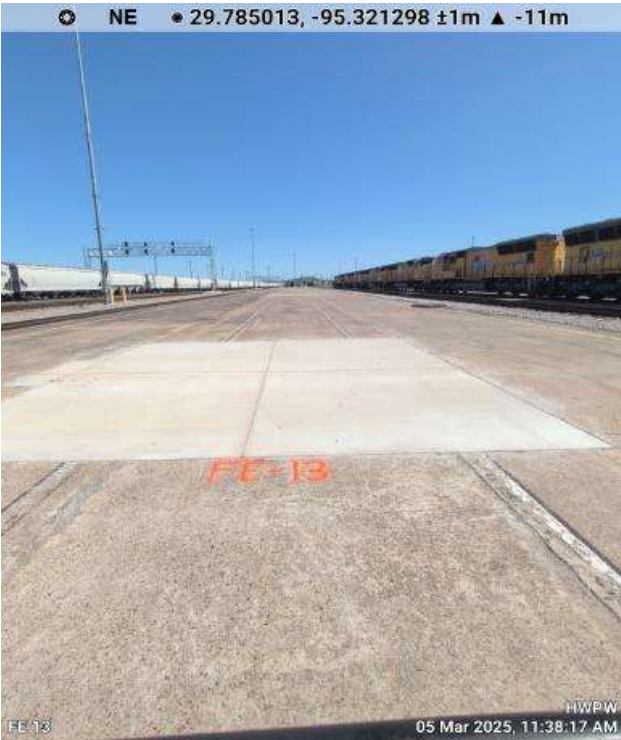
<div> <span>FE 13</span> <span>HWPW 05 Mar 2025, 11:38:17 AM</span> </div>	
<b>Description:</b> FE-13 weekly inspection of concrete cap. Reconstructed cap in good condition. No NAPL observed at FE location. Facing northeast.		Lat: 29.785013 Long: -95.321298

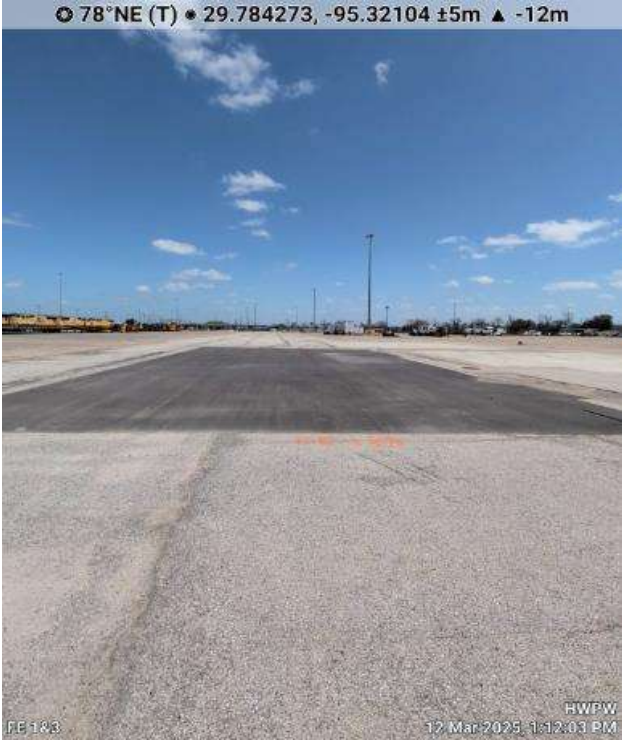
<div> FE1&amp;3 <div>HWPW 12 Mar 2025 1:12:03 PM</div> </div> </div>	
<b>Description:</b> FE-1&3 weekly inspection of asphalt cap. Reconstructed cap in good condition. No NAPL observed at FE location. Facing northeast.			
Lat: 29.784273 Long: -95.321040			
<b>Photo No.</b> <b>14</b>	<b>Inspection Date:</b> 3/12/2025	<div> <div> 312°NW (T) • 29.784082, -95.32076 ±4m ▲ -12m </div>

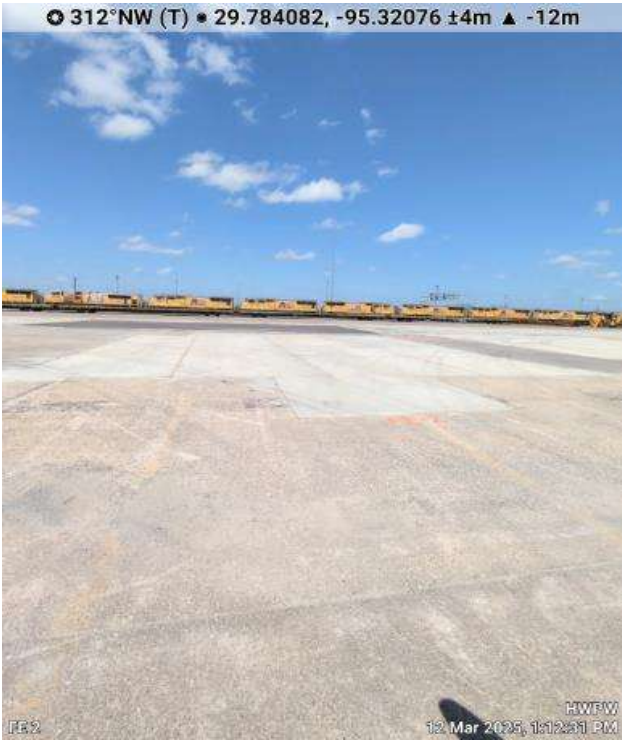
<div> FE2 <div>HWPW 12 Mar 2025 1:12:31 PM</div> </div> </div>	
<b>Description:</b> FE-2 weekly inspection of concrete cap. Reconstructed cap in good condition. No NAPL observed at FE location. Facing northwest.

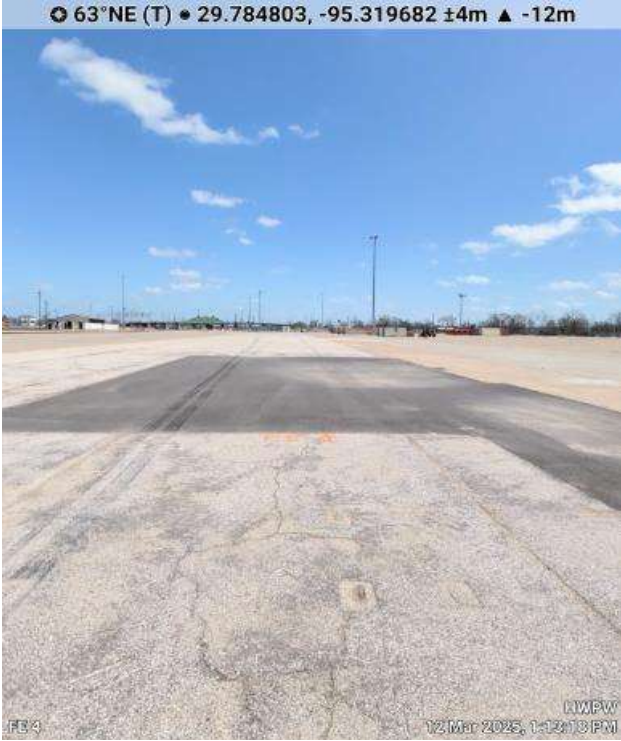
<div>         FE 4          HWPW          12 Mar 2025, 1:12:08 PM       </div> </div>	
<b>Description:</b> FE-4 weekly inspection of asphalt cap. Reconstructed cap in good condition. No NAPL observed at FE location. Facing northeast.			
Lat: 29.784803 Long: -95.319682			
<b>Photo No.</b> <b>16</b>	<b>Inspection Date:</b> 3/12/2025	<div> <div>         262°W (T) • 29.785434, -95.318496 ±4m ▲ -13m       </div>

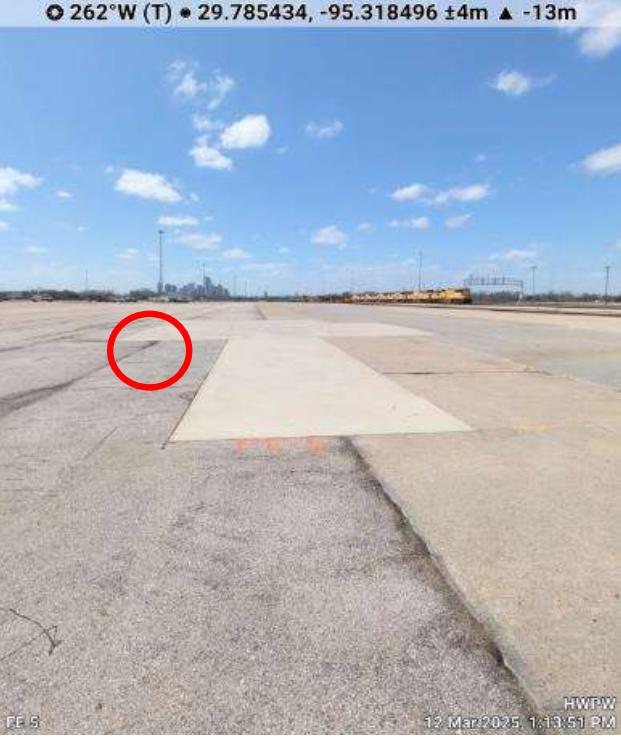
<div>         FE 5          HWPW          12 Mar 2025, 1:13:51 PM       </div> </div>	
<b>Description:</b> FE-5 weekly inspection of concrete cap. Reconstructed cap in good condition. No NAPL observed at FE location. Brown water staining at asphalt joint and at the southeastern corner adjacent to FE-5 observed. Facing west.

<p>Seepage at FE 5</p> <p>HWPW 12 Mar 2025 1:25:43 PM</p>	
<p><b>Description:</b> FE-5 brown water staining observed where the asphalt joint meets the reconstructed concrete cap, located within the red circle on Photo 16.</p> <p>Lat: 29.785372 Long: -95.318601</p>			
Photo No. 18	Inspection Date: 3/12/2025	<p>☉ 320°NW (T) • 29.785411, -95.318294 ±4m ▲ -13m</p>

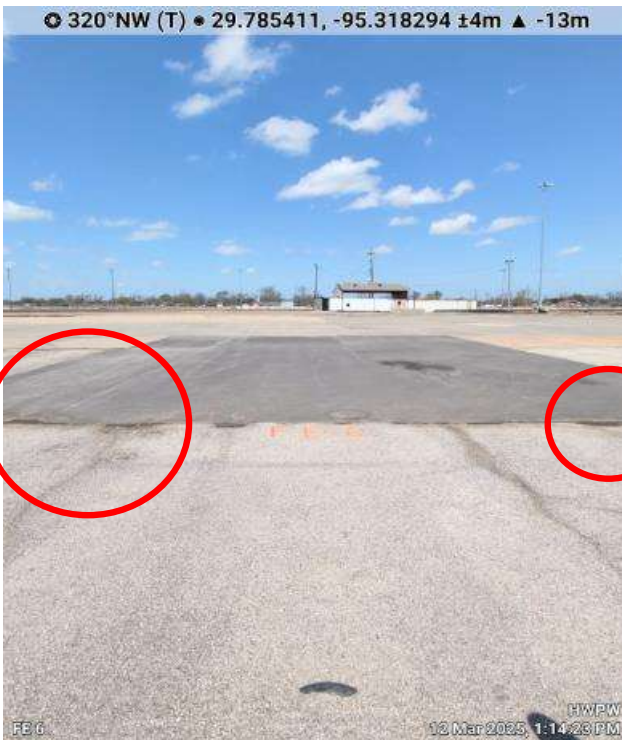
<p>FE 6</p> <p>HWPW 12 Mar 2025 1:14:29 PM</p>	
<p><b>Description:</b> FE-6 weekly inspection of asphalt cap. Reconstructed cap in good condition. No NAPL observed at FE location. Minimal brown water staining along the edges of the FE cap observed. Facing northwest.</p> <p>Lat: 29.785411 Long: -95.318294</p>

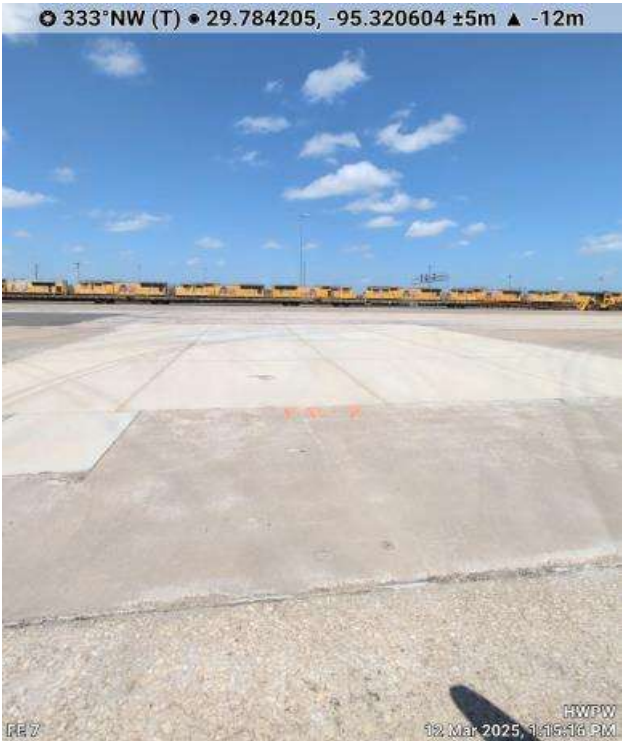
<div> <div>FE 7</div> <div>           HWPW            12 Mar 2025 1:16:16 PM         </div> </div> </div>	
<b>Description:</b> FE-7 weekly inspection of concrete cap. Reconstructed cap in good condition. No NAPL observed at FE location. Facing northwest.  Lat: 29.784205 Long: -95.320604			
<b>Photo No.</b> <b>20</b>	<b>Inspection Date:</b> 3/12/2025	<div> <div> <b>349°N (T) • 29.784903, -95.319097 ±5m ▲ -13m</b> </div>

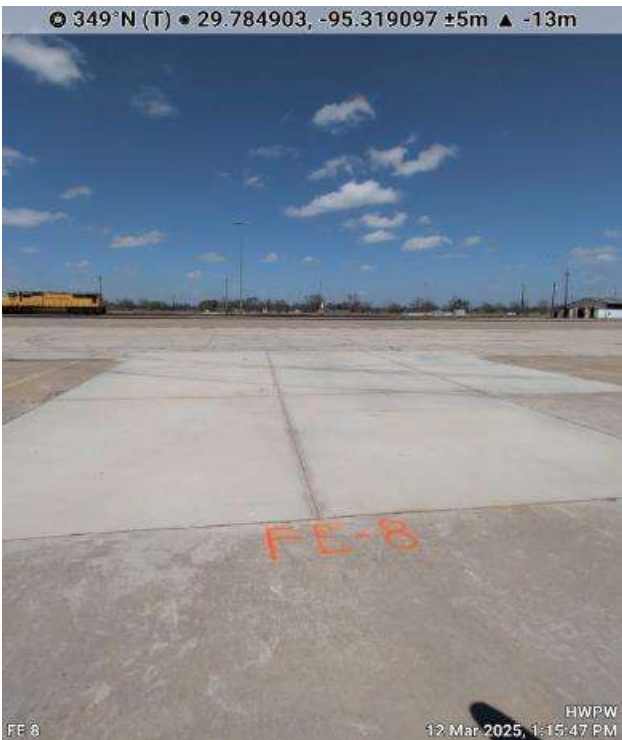
<div> <div>FE 8</div> <div>           HWPW            12 Mar 2025 1:15:47 PM         </div> </div> </div>	
<b>Description:</b> FE-8 weekly inspection of concrete cap. Reconstructed cap in good condition. No NAPL observed at FE location. Facing north.  Lat: 29.784903 Long: -95.319097

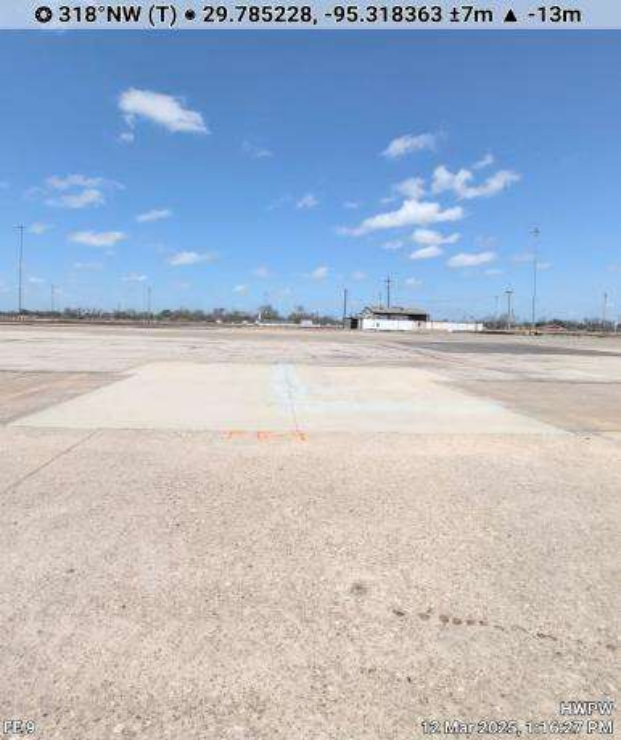
<div> <b>FE 9</b> </div> <div> <b>HWPW</b>          12 Mar 2025, 1:16:27 PM       </div> </div>	
<b>Description:</b> FE-9 weekly inspection of concrete cap. Reconstructed cap in good condition. No NAPL observed at FE location. Facing northwest.		Lat: 29.785228 Long: -95.318363	
<b>Photo No.</b> <b>22</b>	<b>Inspection Date:</b> 3/12/2025	<div> <div> <b>270°W (T) • 29.784967, -95.317647 ±5m ▲ -13m</b> </div>

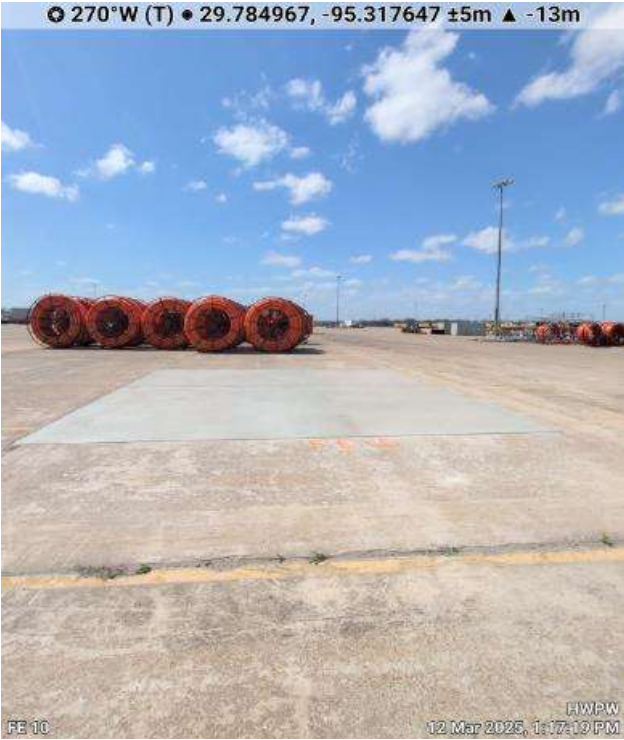
<div> <b>FE 10</b> </div> <div> <b>HWPW</b>          12 Mar 2025, 1:17:19 PM       </div> </div>	
<b>Description:</b> FE-10 weekly inspection of concrete cap. Reconstructed cap in good condition. No NAPL observed at FE location. Facing west.		Lat: 29.784967 Long: -95.317647

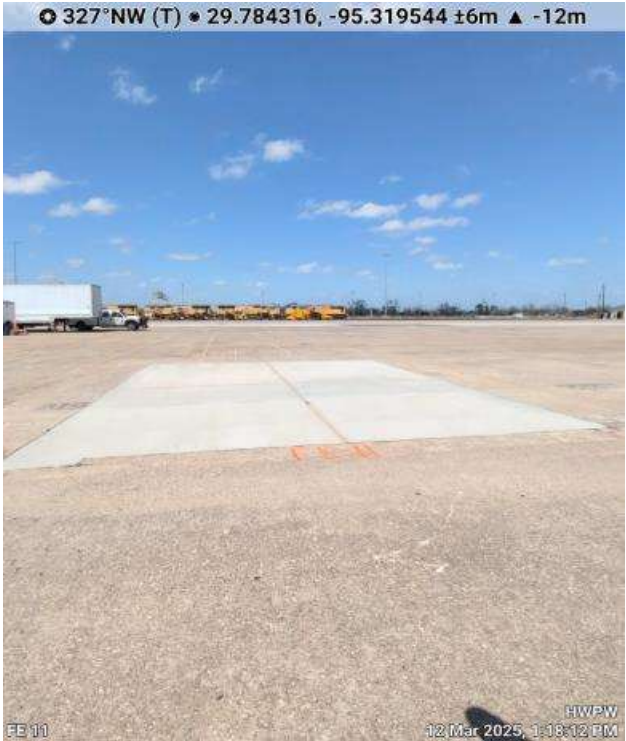
<div> FE 11 <div> HWPW 12 Mar 2025, 1:18:12 PM </div> </div> </div>	
<b>Description:</b> FE-11 weekly inspection of concrete cap. Reconstructed cap in good condition. No NAPL observed at FE location. Facing northwest.			
Lat: 29.784316 Long: -95.319544			
<b>Photo No.</b> <b>24</b>	<b>Inspection Date:</b> 3/12/2025	<div> <div> 173°S (T) • 29.785581, -95.318732 ±3m ▲ -12m </div>

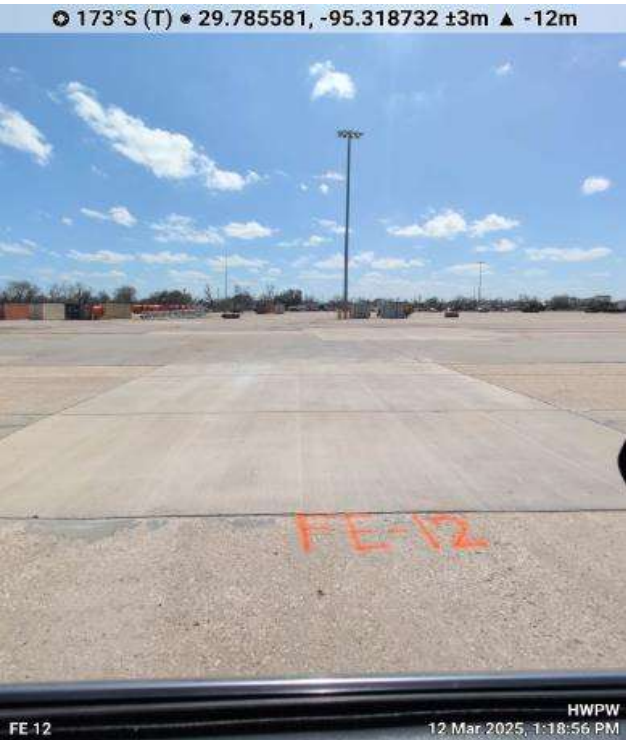
<div> FE 12 <div> HWPW 12 Mar 2025, 1:18:56 PM </div> </div> </div>	
<b>Description:</b> FE-12 weekly inspection of concrete cap. Reconstructed cap in good condition. No NAPL observed at FE location. Facing south.

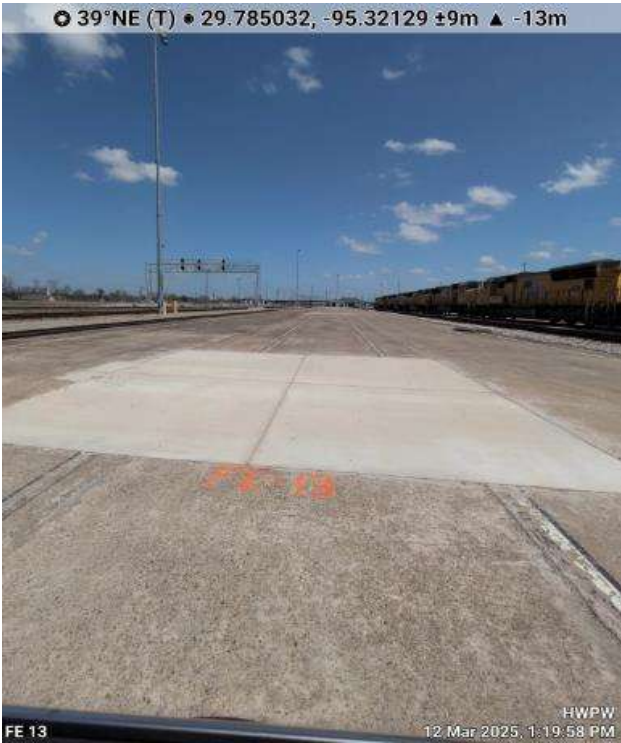
<div> FE 13 <div> HWPW  12 Mar 2025, 1:19:58 PM </div> </div> </div>	
<b>Description:</b> FE-13 weekly inspection of concrete cap. Reconstructed cap in good condition. No NAPL observed at FE location. Facing northeast.			
Lat: 29.785032 Long: -95.321290			
<b>Photo No.</b> <b>26</b>	<b>Inspection Date:</b> 3/19/2025	<div> <div> NE • 29.784282, -95.321069 ±12m ▲ -12m </div>

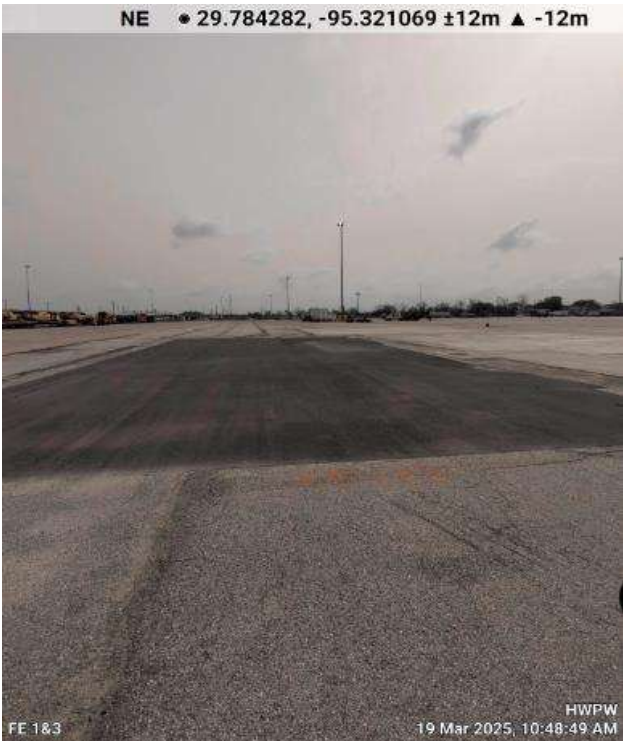
<div> FE 1&amp;3 <div> HWPW  19 Mar 2025, 10:48:49 AM </div> </div> </div>	
<b>Description:</b> FE-1&3 weekly inspection of asphalt cap. Reconstructed cap in good condition. No NAPL observed at FE location. Facing northeast.

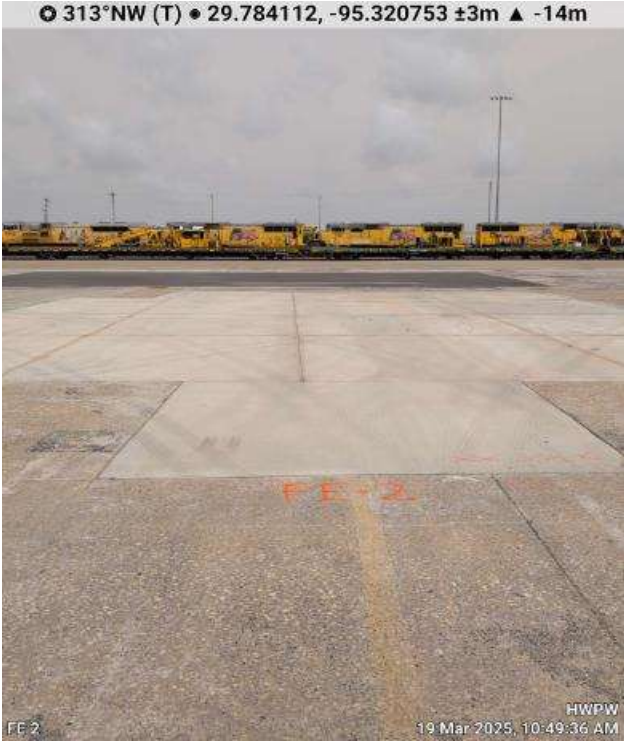
<div> <div>FE 2</div> <div> HWPW  19 Mar 2025, 10:49:36 AM </div> </div> </div>	
<b>Description:</b> FE-2 weekly inspection of concrete cap. Reconstructed cap in good condition. No NAPL observed at FE location. Facing northwest.  Lat: 29.784112 Long: -95.320753			
<b>Photo No.</b> <b>28</b>	<b>Inspection Date:</b> 3/19/2025	<div> <div> <b>47°NE (T) • 29.784812, -95.319724 ±6m ▲ -13m</b> </div>

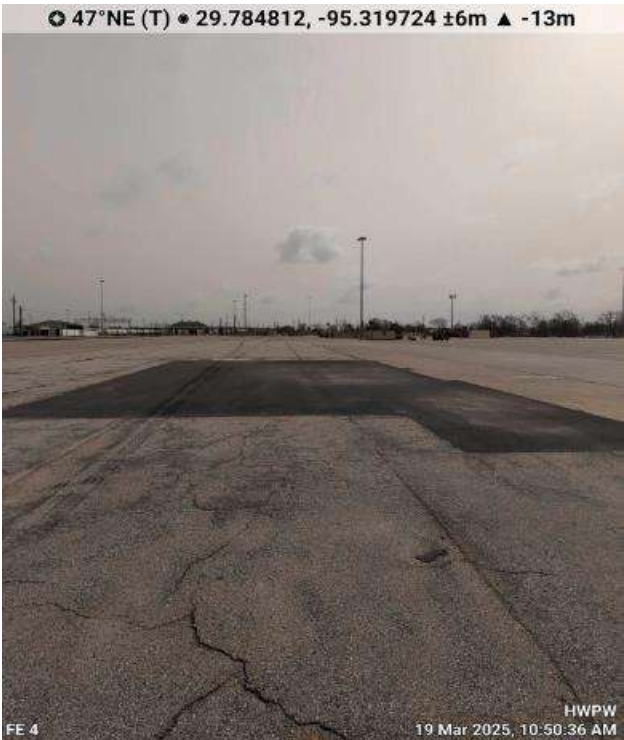
<div> <div>FE 4</div> <div> HWPW  19 Mar 2025, 10:50:36 AM </div> </div> </div>	
<b>Description:</b> FE-4 weekly inspection of asphalt cap. Reconstructed cap in good condition. No NAPL observed at FE location. Facing northeast.  Lat: 29.784812 Long: -95.319724

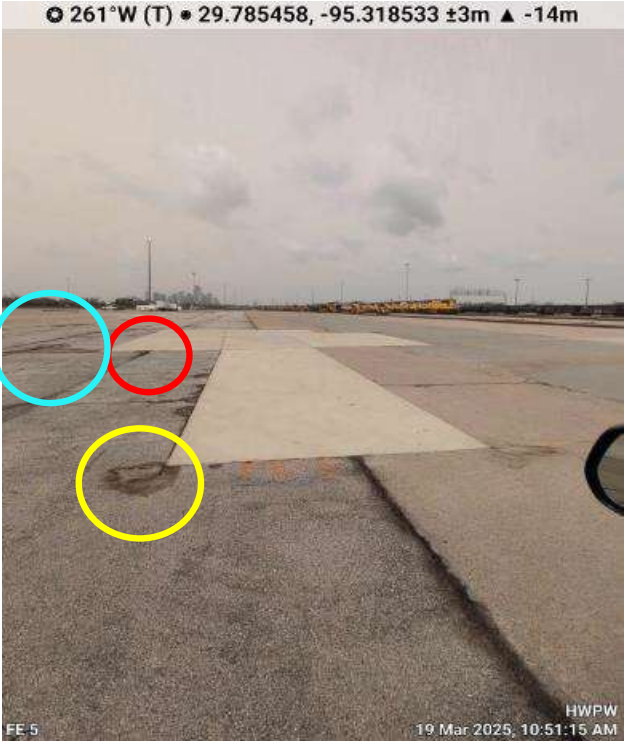
<div> <b>FE 5</b> </div> <div> <b>HWPW</b>  <b>19 Mar 2025, 10:51:15 AM</b> </div> </div>	
<b>Description:</b> FE-5 weekly inspection of concrete cap. Reconstructed cap in good condition. No NAPL observed at FE location. Brown water staining at asphalt joint, southern corner and southeastern corner adjacent to FE-5 observed. Facing west.  Lat: 29.785458 Long: -95.318533			
<b>Photo No.</b> <b>30</b>	<b>Inspection Date:</b> 3/19/2025	<div> <div> <b>226°SW (T) • 29.785372, -95.31863 ±7m ▲ -12m</b> </div>

<b>Description:</b> FE-5 brown water staining observed where the asphalt joint meets the reconstructed FE-5 concrete cap, located within the red circle on Photo 29.  Lat: 29.785372 Long: -95.318630

<div> <b>FE 5 staining</b> </div> <div> <b>HWPW</b>  <b>19 Mar 2025 11:10:19 AM</b> </div> </div>	
<b>Description:</b> FE-5 brown water staining observed at the southeastern corner of the FE reconstructed cap, located within the yellow circle on Photo 29.			
Lat: 29.785422 Long: -95.318541			
<b>Photo No.</b> <b>32</b>	<b>Inspection Date:</b> 3/19/2025	<div> <div> <b>171°S (T) • 29.78536, -95.318628 ±2m ▲ -11m</b> </div>

<div> <b>FE 5 water seep</b> </div> <div> <b>HWPW</b>  <b>19 Mar 2025 11:11:10 AM</b> </div> </div>	
<b>Description:</b> FE-5 brown water staining observed at the southern corner of the FE reconstructed cap, located within the blue circle on Photo 29.

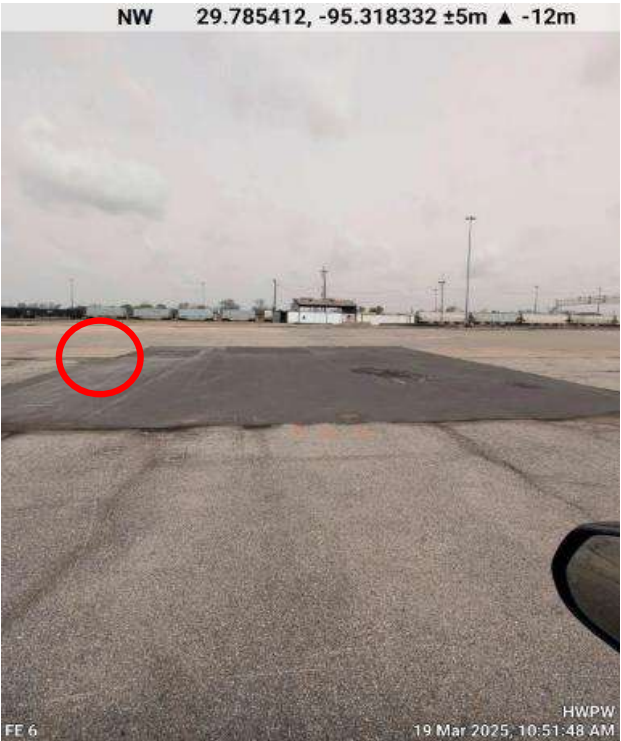
<div> FE 6 HWPW 19 Mar 2025, 10:51:48 AM </div> </div>	
<b>Description:</b> FE-6 weekly inspection of asphalt cap. Reconstructed cap in good condition. No NAPL observed at FE location. Brown water staining along the edges of the FE cap observed. Facing northwest.  Lat: 29.785412 Long: -95.318332			
<b>Photo No.</b> <b>34</b>	<b>Inspection Date:</b> 3/19/2025	<div> <div> 342°NW (T) • 29.785497, -95.318462 ±3m ▲ -11m </div>

<div> N/W area of FE 6 HWPW 19 Mar 2025, 11:09:29 AM </div> </div>	
<b>Description:</b> FE-6 brown water staining observed at the edges of the northwestern corner of the asphalt cap, located within the red circle on Photo 33.  Lat: 29.785497 Long: -95.318462

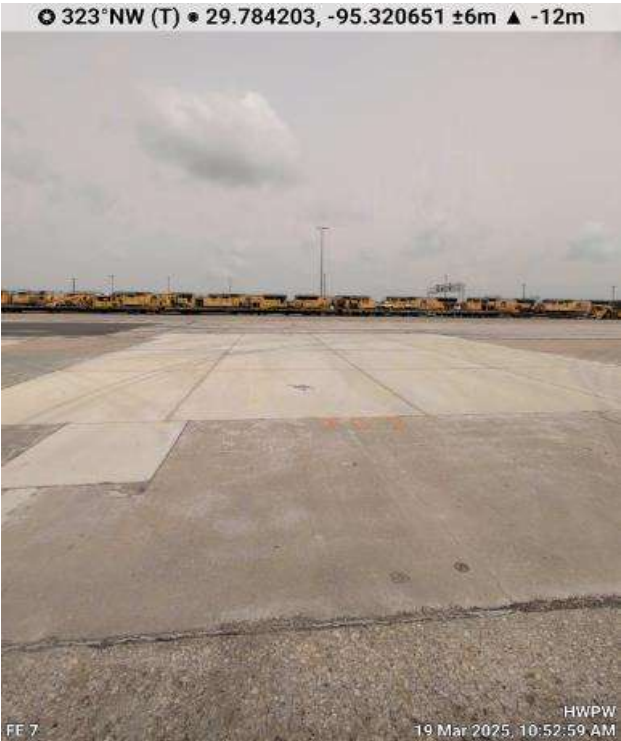
<div> <b>FE 7</b> </div> <div> <b>HWPW</b>  <b>19 Mar 2025, 10:52:59 AM</b> </div> </div>	
<b>Description:</b> FE-7 weekly inspection of concrete cap. Reconstructed cap in good condition. No NAPL observed at FE location. Facing northwest.			
Lat: 29.784203 Long: -95.320651			
<b>Photo No.</b> <b>36</b>	<b>Inspection Date:</b> 3/19/2025	<div> <div> <b>1°N (T) • 29.784907, -95.319133 ±3m ▲ -13m</b> </div>

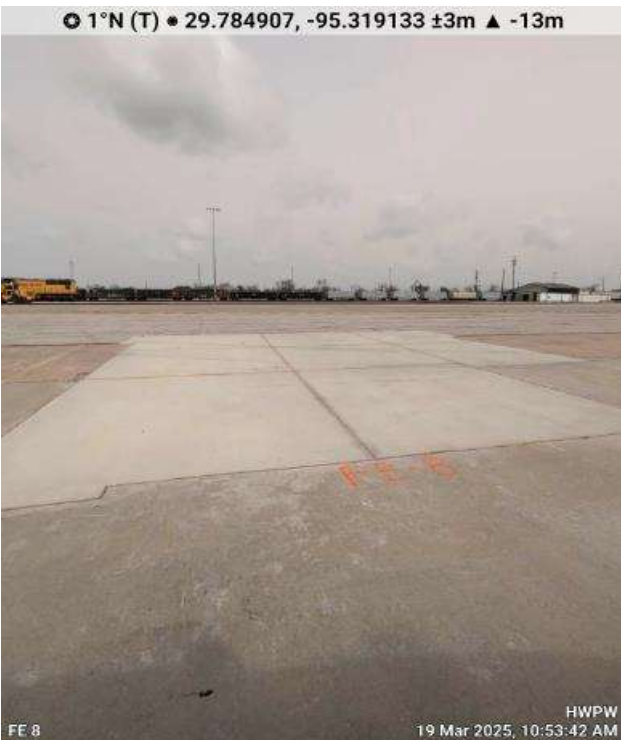
<div> <b>FE 8</b> </div> <div> <b>HWPW</b>  <b>19 Mar 2025, 10:53:42 AM</b> </div> </div>	
<b>Description:</b> FE-8 weekly inspection of concrete cap. Reconstructed cap in good condition. No NAPL observed at FE location. Facing north.

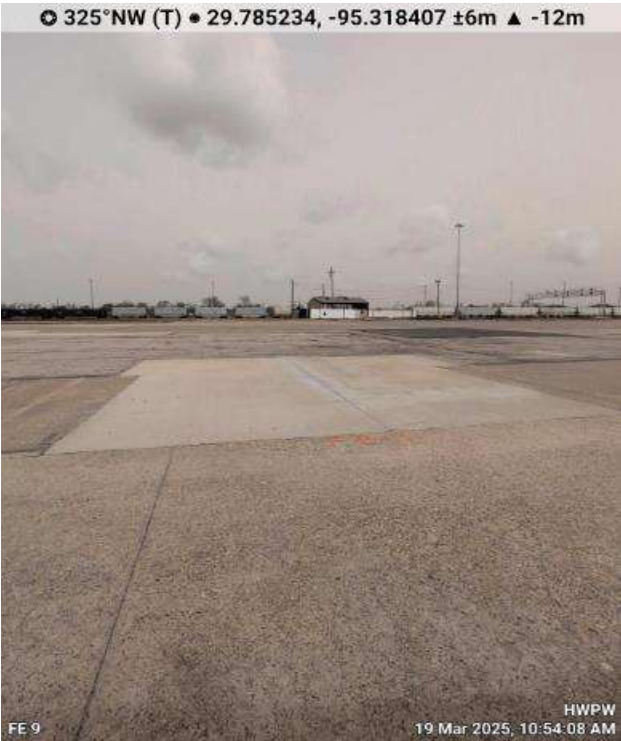
<div> <b>FE 9</b> <span style="float: right;"><b>HWPW</b> 19 Mar 2025, 10:54:08 AM</span> </div> </div>	
<b>Description:</b> FE-9 weekly inspection of concrete cap. Reconstructed cap in good condition. No NAPL observed at FE location. Facing northwest.			
Lat: 29.785234 Long: -95.318407			
<b>Photo No.</b> <b>38</b>	<b>Inspection Date:</b> 3/19/2025	<div> <div> <b>W 29.784982, -95.317687 ±6m ▲ -13m</b> </div>

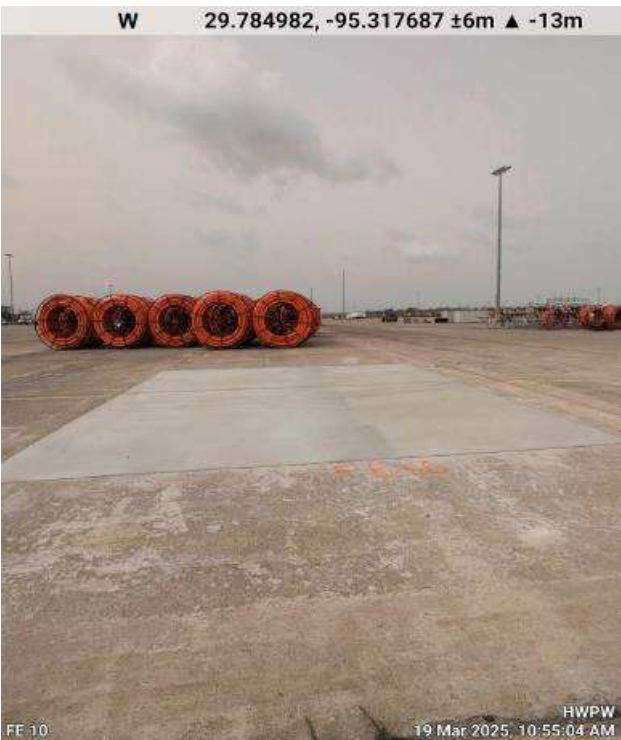
<div> <b>FE 10</b> <span style="float: right;"><b>HWPW</b> 19 Mar 2025, 10:55:04 AM</span> </div> </div>	
<b>Description:</b> FE-10 weekly inspection of concrete cap. Reconstructed cap in good condition. No NAPL observed at FE location. Facing west.

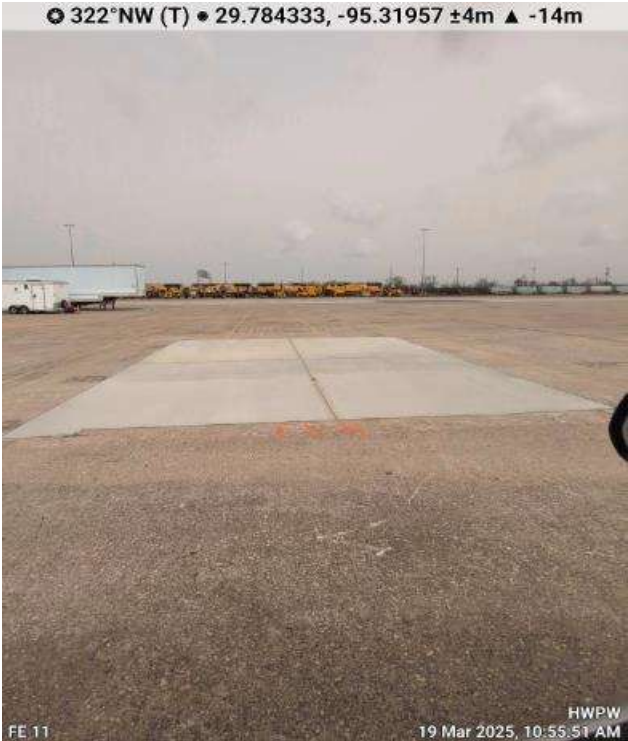
<div> <b>FE 11</b> <span style="float: right;">HWPW 19 Mar 2025, 10:55:51 AM</span> </div> </div>	
<b>Description:</b> FE-11 weekly inspection of concrete cap. Reconstructed cap in good condition. No NAPL observed at FE location. Facing northwest.		Lat: 29.784333 Long: -95.319570	
<b>Photo No.</b> <b>40</b>	<b>Inspection Date:</b> 3/19/2025	<div> <div> <b>S 29.785592, -95.318761 ±7m ▲ -12m</b> </div>

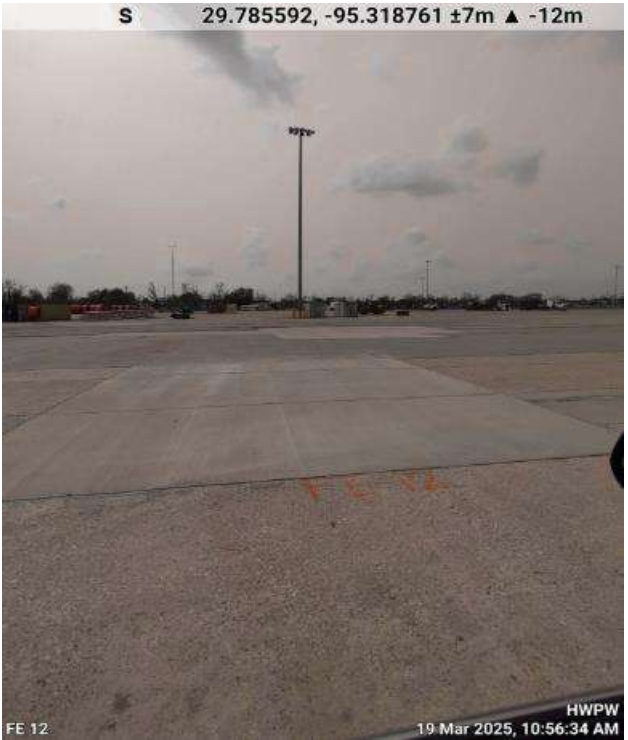
<div> <b>FE 12</b> <span style="float: right;">HWPW 19 Mar 2025, 10:56:34 AM</span> </div> </div>	
<b>Description:</b> FE-12 weekly inspection of concrete cap. Reconstructed cap in good condition. No NAPL observed at FE location. Facing south.		Lat: 29.785592 Long: -95.318761

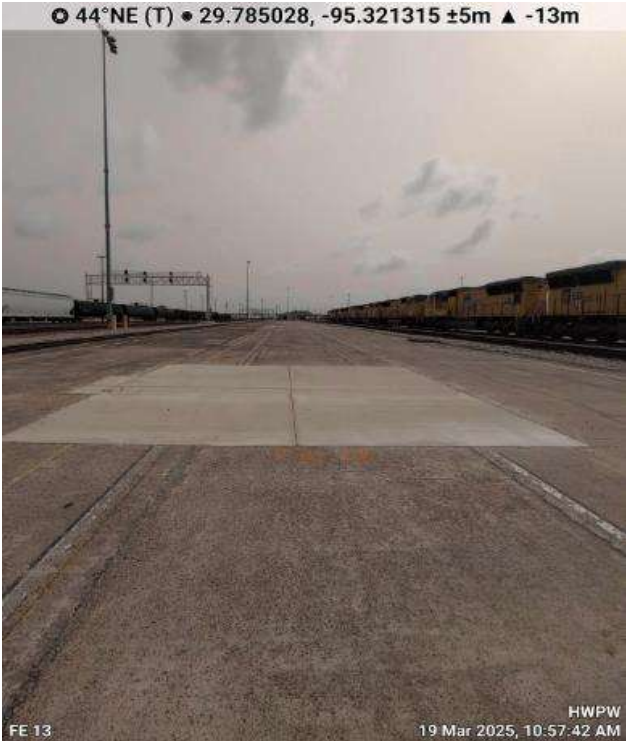
<div> <b>FE 13</b> <span style="float: right;"><b>HWPW</b> 19 Mar 2025, 10:57:42 AM</span> </div> </div>	
<b>Description:</b> FE-13 weekly inspection of concrete cap. Reconstructed cap in good condition. No NAPL observed at FE location. Facing northeast.			
Lat: 29.785028 Long: -95.321315			
<b>Photo No.</b> <b>42</b>	<b>Inspection Date:</b> 3/26/2025	<div> <div> <b>NE ● 29.784277, -95.321029 ±13m ▲ -12m</b> </div>

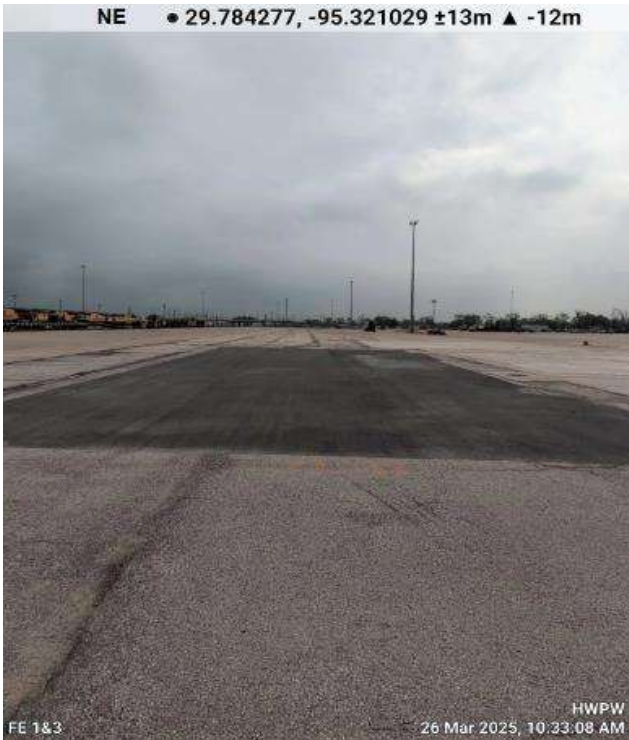
<div> <b>FE 1&amp;3</b> <span style="float: right;"><b>HWPW</b> 26 Mar 2025, 10:33:08 AM</span> </div> </div>	
<b>Description:</b> FE-1&3 weekly inspection of asphalt cap. Reconstructed cap in good condition. No NAPL observed at FE location. Facing northeast.

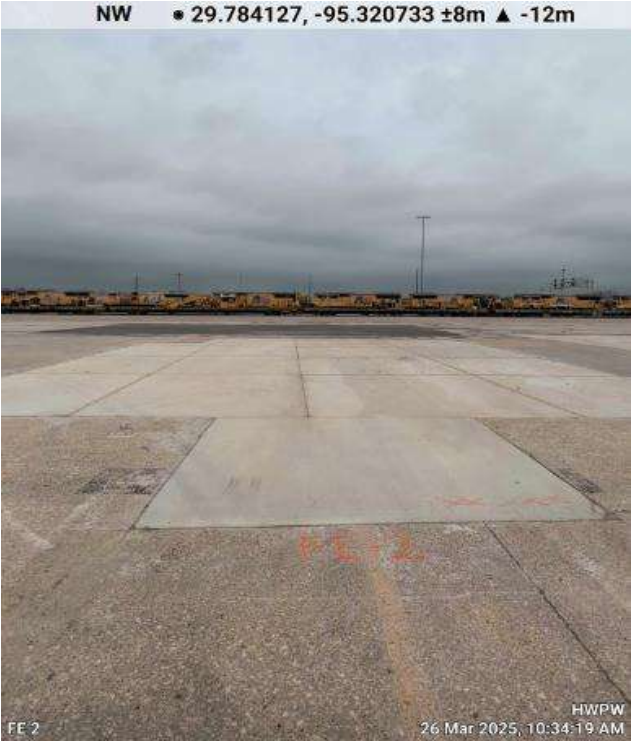
<div> FE 2 HWPW 26 Mar 2025, 10:34:19 AM </div>	
<b>Description:</b> FE-2 weekly inspection of concrete cap. Reconstructed cap in good condition. No NAPL observed at FE location. Facing northwest.			
Lat: 29.784127 Long: -95.320733			
<b>Photo No.</b> <b>44</b>	<b>Inspection Date:</b> 3/26/2025	<div> NE • 29.784826, -95.319675 ±8m ▲ -12m </div>

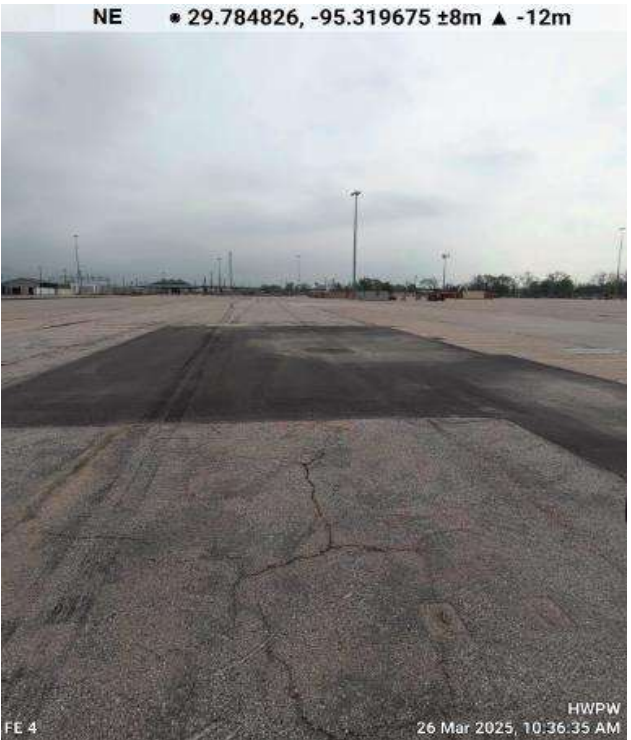
<div> FE 4 HWPW 26 Mar 2025, 10:36:35 AM </div>	
<b>Description:</b> FE-4 weekly inspection of asphalt cap. Reconstructed cap in good condition. No NAPL observed at FE location. Facing northeast.			
Lat: 29.784826 Long: -95.319675

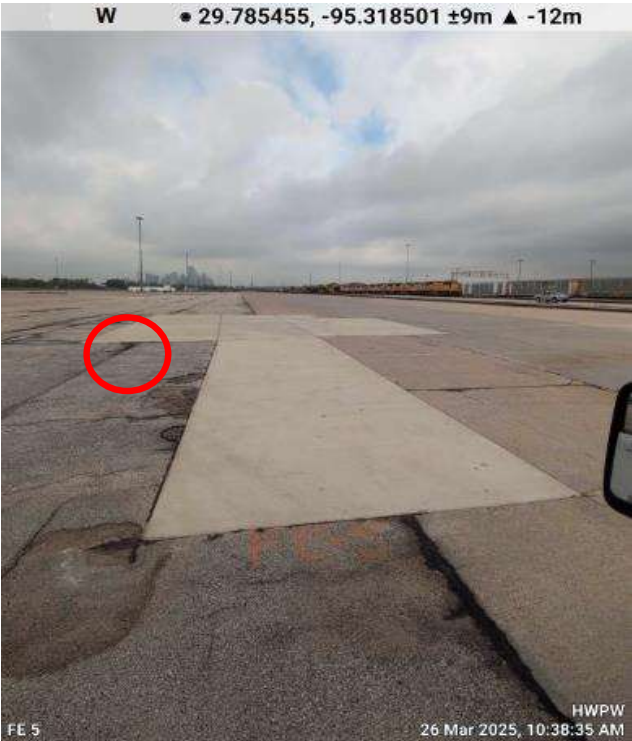
<div> FE 5 HWPW 26 Mar 2025, 10:38:35 AM </div> </div>	
<b>Description:</b> FE-5 weekly inspection of concrete cap. Reconstructed cap in good condition. No NAPL observed at FE location. Brown water staining at asphalt joint and along the southern edges of the FE cap observed. Facing west.			
Lat: 29.785455 Long: -95.318501			
<b>Photo No.</b> <b>46</b>	<b>Inspection Date:</b> 3/26/2025	<div> <div> 247°SW (T) • 29.785368, -95.318586 ±3m ▲ -12m </div>

<div> FE 5, south We 26 Mar 2025, 11:13:43 AM </div> </div>	
<b>Description:</b> FE-5 brown water staining observed where the asphalt joint meets the concrete cap, located within the red circle on Photo 45.

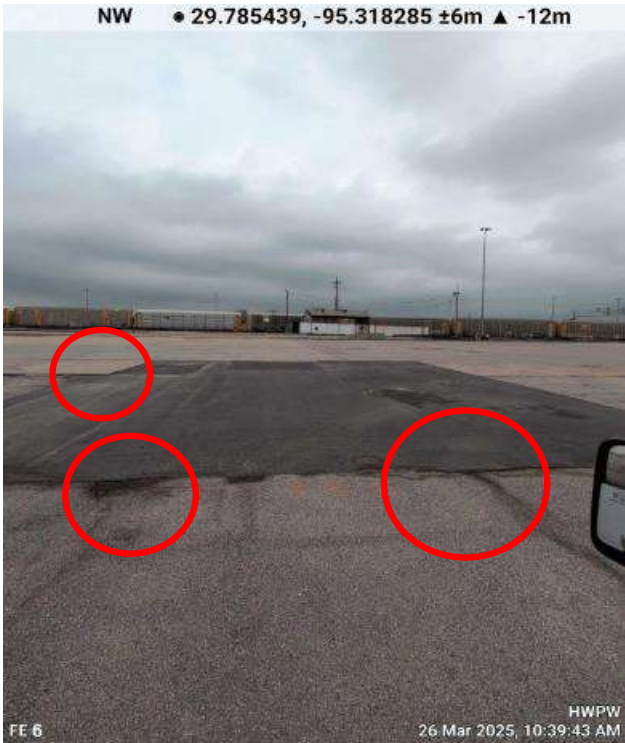
<div> FE 6 <div> HWPW  26 Mar 2025, 10:39:43 AM </div> </div> </div>	
<b>Description:</b> FE-6 weekly inspection of asphalt cap. Reconstructed cap in good condition. No NAPL observed at FE location. Brown water staining along the edges of the FE cap observed. Facing northwest.			
Lat: 29.785439 Long: -95.318285			
<b>Photo No.</b> <b>48</b>	<b>Inspection Date:</b> 3/26/2025	<div> <div> 332°NW (T) • 29.785413, -95.318224 ±3m ▲ -12m </div>

<div> FE 6 south <div> We  26 Mar 2025, 11:08:12 AM </div> </div> </div>	
<b>Description:</b> FE-6 brown water staining observed along the asphalt joint that intersects the asphalt FE cap. Directly east and out of frame in Photo 47.

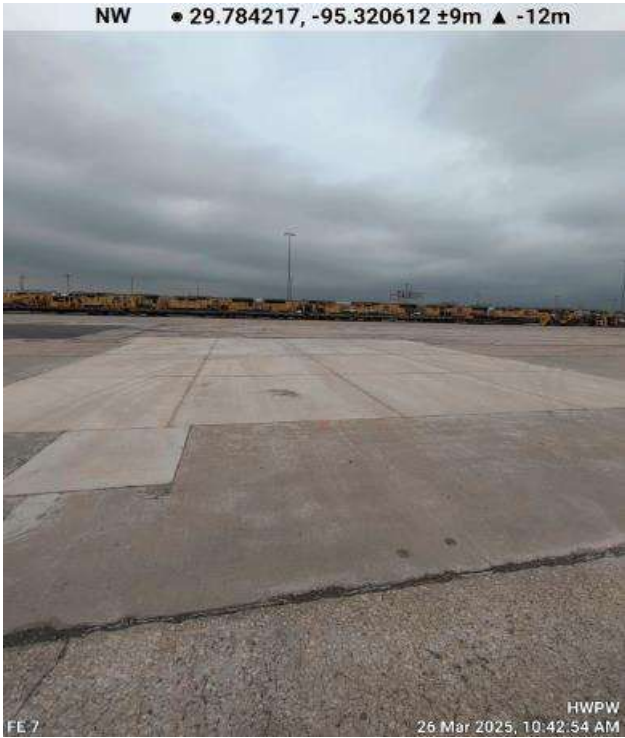
</div> <p> <b>Description:</b>            FE-7 weekly inspection of concrete cap. Reconstructed cap in good condition. No NAPL observed at FE location. Facing northwest.         </p> <p>           Lat: 29.784217            Long: -95.320612         </p>

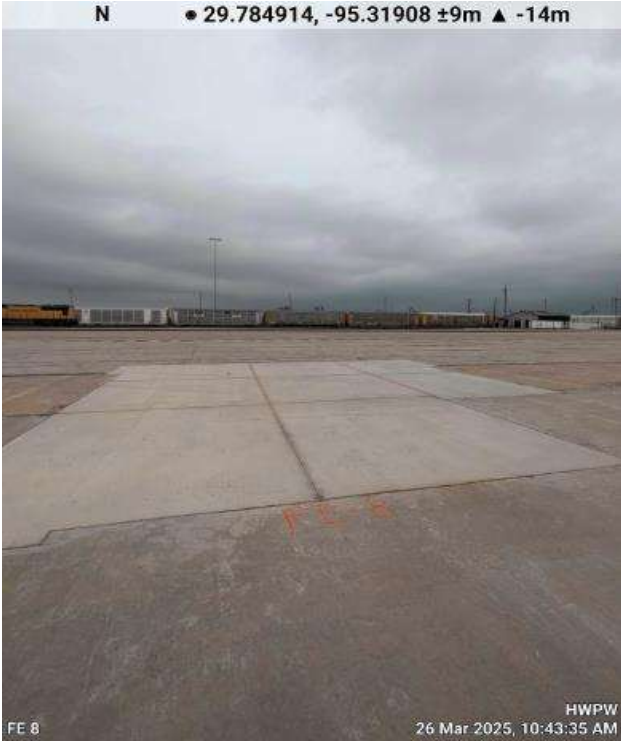
<div> <b>FE 8</b> <span>HWPW 26 Mar 2025, 10:43:35 AM</span> </div> </div>	
<b>Description:</b> FE-8 weekly inspection of concrete cap. Reconstructed cap in good condition. No NAPL observed at FE location. Facing north.			
Lat: 29.784914 Long: -95.319080			
<b>Photo No.</b> <b>52</b>	<b>Inspection Date:</b> 3/26/2025	<div> <div> <b>N</b> <span>• 29.785246, -95.31838 ±9m ▲ -14m</span> </div>

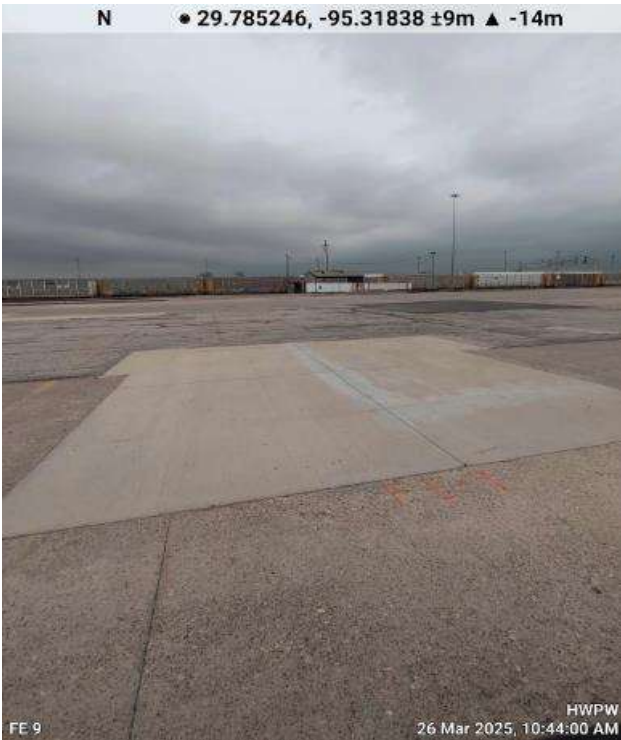
<div> <b>FE 9</b> <span>HWPW 26 Mar 2025, 10:44:00 AM</span> </div> </div>	
<b>Description:</b> FE-9 weekly inspection of concrete cap. Reconstructed cap in good condition. No NAPL observed at FE location. Facing north.
