April 15, 2025

Project No. US0039040.4227

Re: **MONTHLY STATUS UPDATE – ENGLEWOOD INTERMODAL YARD – NAPL COLLECTION  
SYSTEM/CONCRETE CAP REPAIRS AND REVISED INTERIM MEASURES WORK PLAN POST-  
CONSTRUCTION ACTIVITIES  
UNION PACIFIC RAILROAD HOUSTON WOOD PRESERVING WORKS FACILITY  
4910 LIBERTY ROAD FACILITY, HOUSTON, TEXAS  
POST-CLOSURE CARE PERMIT NO. HW-50343; INDUSTRIAL SWR NO. 31547**

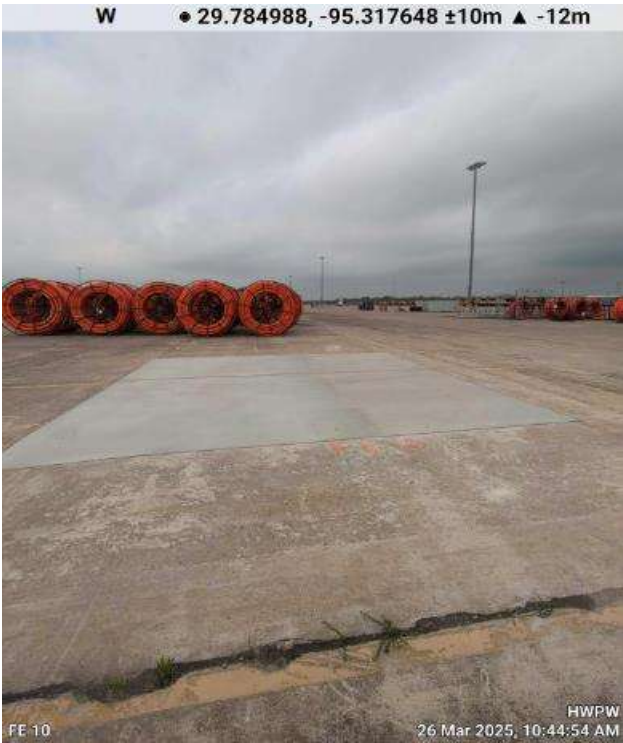
<div> <b>FE 10</b> <span style="float: right;">HWPW 26 Mar 2025, 10:44:54 AM</span> </div> </div>	
<b>Description:</b> FE-10 weekly inspection of concrete cap. Reconstructed cap in good condition. No NAPL observed at FE location. Facing west.			
Lat: 29.784988 Long: -95.317648			
<b>Photo No.</b> <b>54</b>	<b>Inspection Date:</b> 3/26/2025	<div> <div> <b>NW</b> • 29.784341, -95.319527 ±9m ▲ -12m </div>

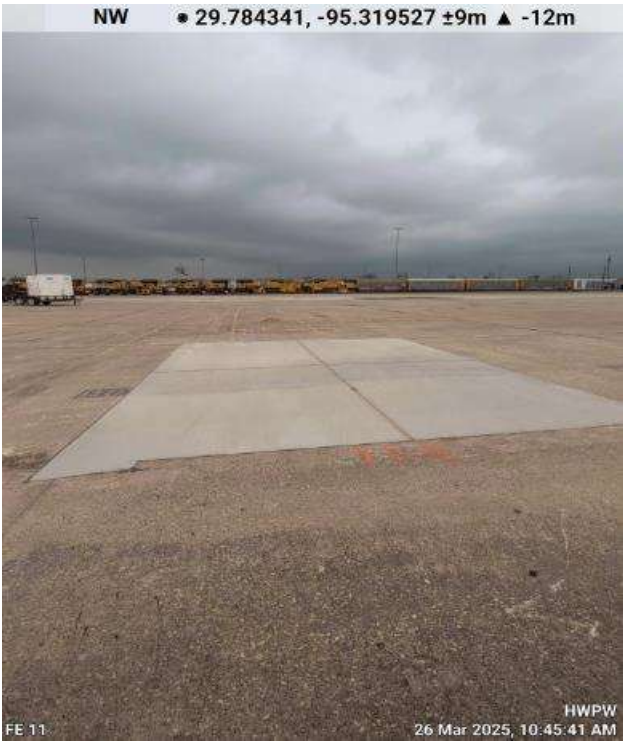
<div> <b>FE 11</b> <span style="float: right;">HWPW 26 Mar 2025, 10:45:41 AM</span> </div> </div>	
<b>Description:</b> FE-11 weekly inspection of concrete cap. Reconstructed cap in good condition. No NAPL observed at FE location. Facing northwest.

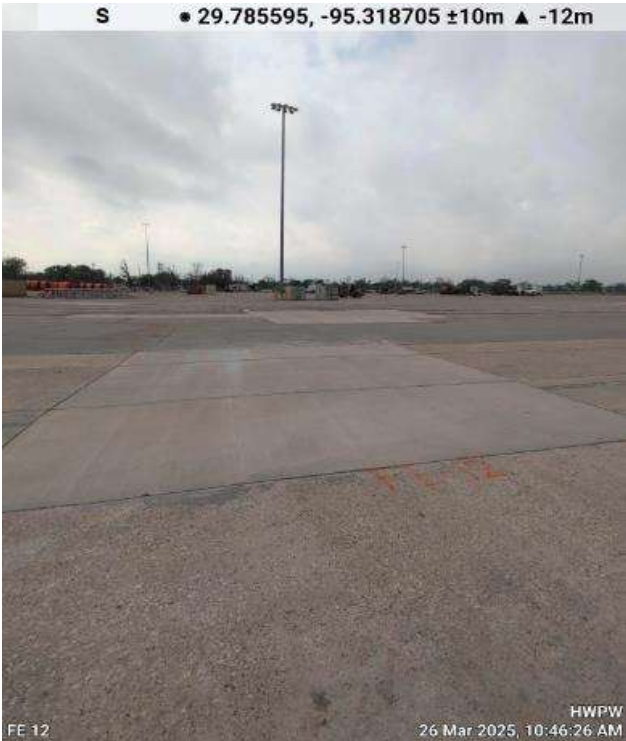
<div> <b>FE 12</b> <span style="float: right;"><b>HWPW</b> 26 Mar 2025, 10:46:26 AM</span> </div> </div>	
<b>Description:</b> FE-12 weekly inspection of concrete cap. Reconstructed cap in good condition. No NAPL observed at FE location. Facing south.			
Lat: 29.785595 Long: -95.318705			
<b>Photo No.</b> <b>56</b>	<b>Inspection Date:</b> 3/26/2025	<div> <div> <b>NE (T)</b> • 29.78502, -95.321302 ±9m ▲ -12m </div>

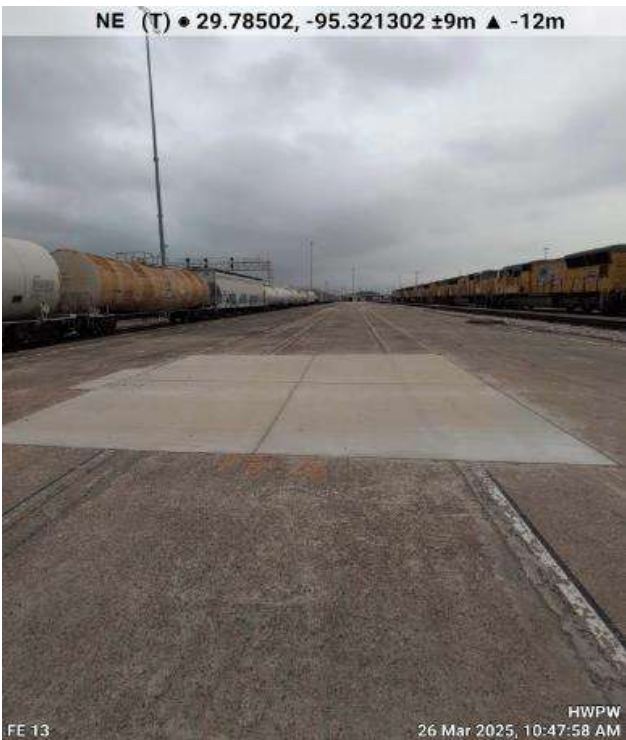
<div> <b>FE 13</b> <span style="float: right;"><b>HWPW</b> 26 Mar 2025, 10:47:58 AM</span> </div> </div>	
<b>Description:</b> FE-13 weekly inspection of concrete cap. Reconstructed cap in good condition. No NAPL observed at FE location. Facing northeast.

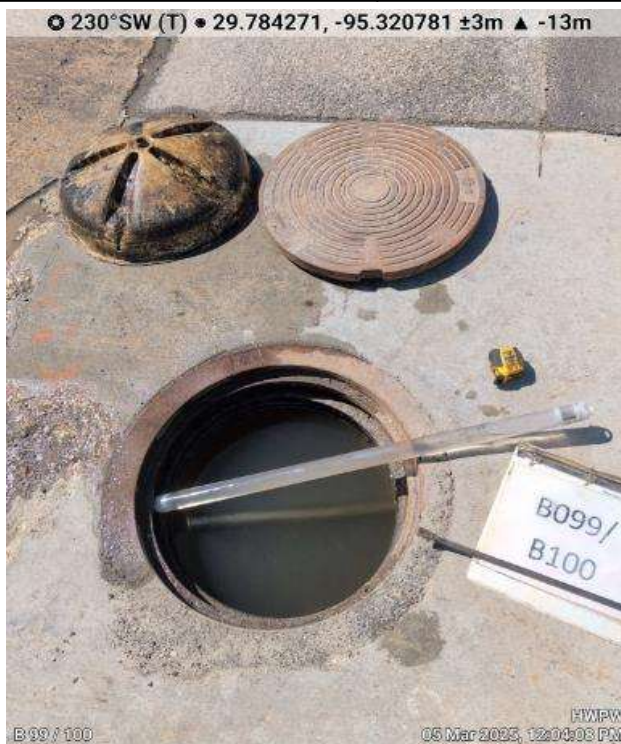
Sump 1 (B99/B100), 1.8 inches of freeboard in sump. Color is tan, and no sheen or odor observed.

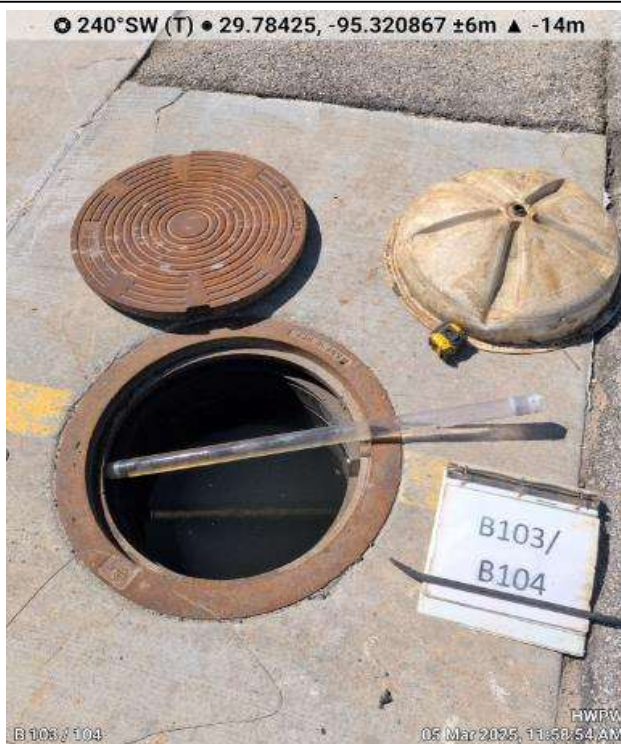
Sump 2 (B103/B104), 4.8 inches of freeboard in sump. Color is tan, and no sheen or odor observed.

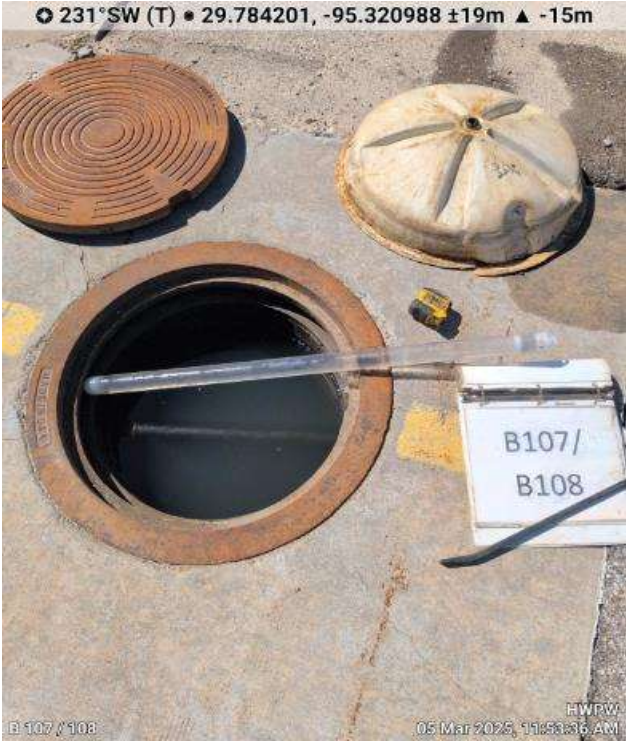
<p> <small>B 107 / 108</small> <small>HWPW</small>  <small>05 Mar 2025, 11:53:36 AM</small> </p> </div>	
<b>Description:</b> Sump 3 (B107/B108), 3.5 inches of freeboard in sump. Color is clear, and no sheen or odor observed.			
Lat: 29.784201 Long: -95.320988			
<b>Photo No.</b> <b>60</b>	<b>Inspection Date:</b> 3/12/2025	<div> <p>           270°W (T) • 29.784295, -95.320767 ±2m ▲ -14m         </p>

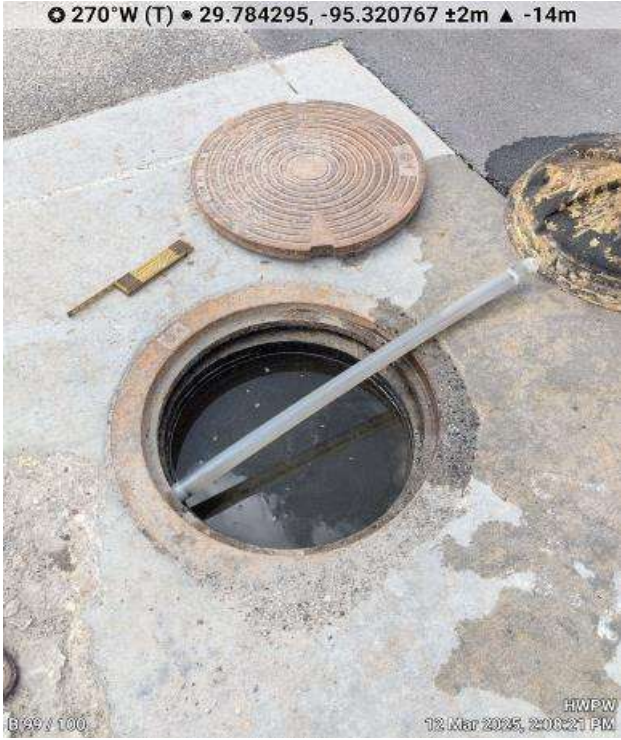
<p> <small>B 99 / 100</small> <small>HWPW</small>  <small>12 Mar 2025, 2:00:21 PM</small> </p> </div>	
<b>Description:</b> Sump 1 (B99/B100), 2.3 inches of freeboard in sump. Color is tan, and no sheen or odor observed.

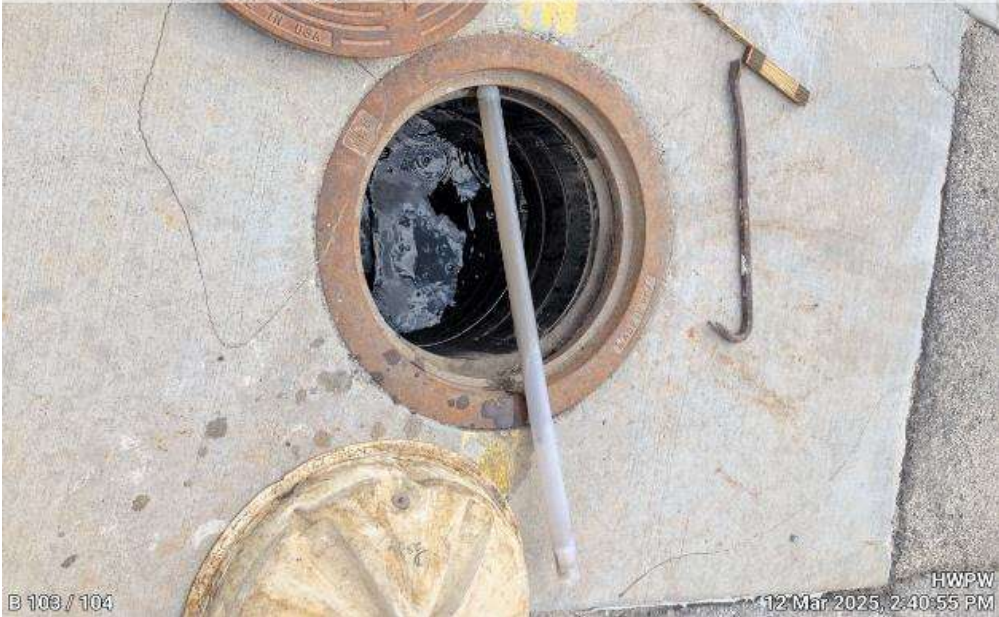
<div> <div>B 103 / 104</div> <div> HWPW  12 Mar 2025, 2:40:55 PM </div> </div> </div>	
<b>Description:</b> Sump 2 (B103/B104), 11.0 inches of freeboard in sump. Color is tan, and no sheen or odor observed.			
Lat: 29.784251 Long: -95.320888			
<b>Photo No.</b> <b>62</b>	<b>Inspection Date:</b> 3/12/2025	<div> <div> <b>287°W (T) • 29.784195, -95.320991 ±3m ▲ -9m</b> </div>

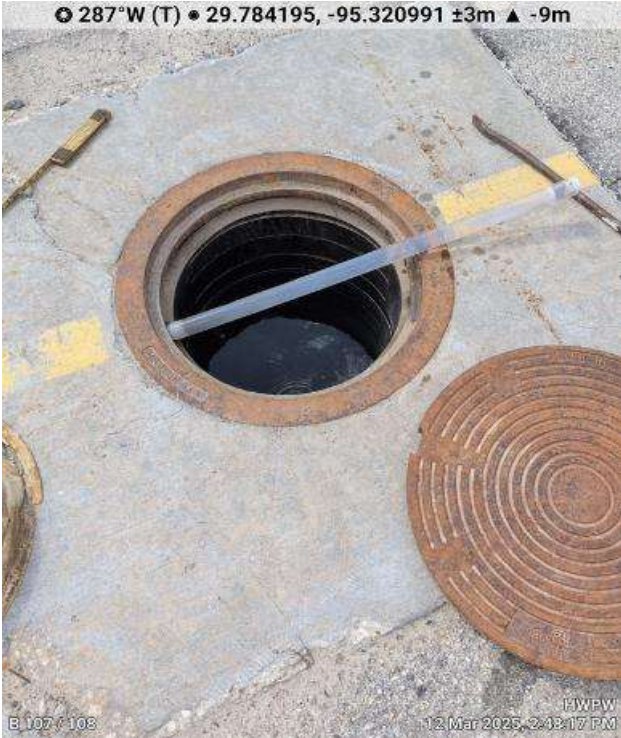
<div> <div>B 107 / 108</div> <div> HWPW  12 Mar 2025, 2:48:17 PM </div> </div> </div>	
<b>Description:</b> Sump 3 (B107/B108), 10.0 inches of freeboard in sump. Color is clear, and no sheen or odor observed.

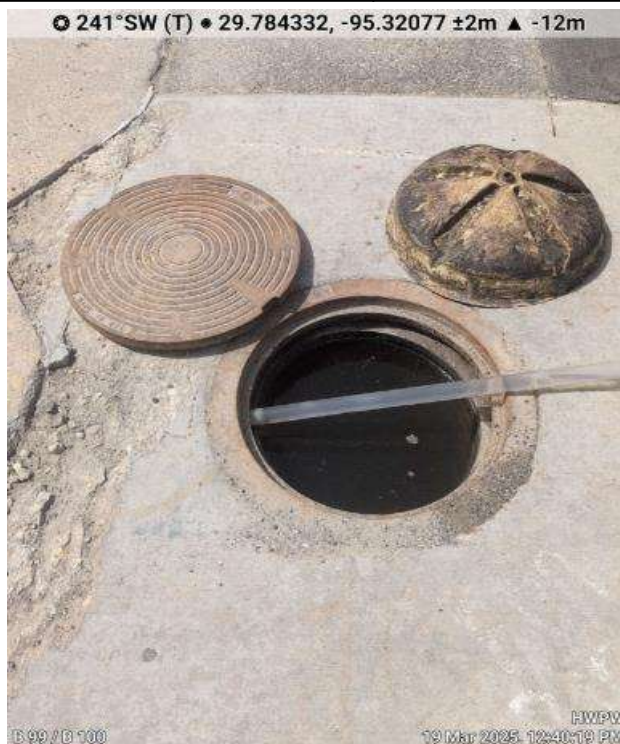
Sump 1 (B99/B100), 1.5 inches of freeboard in sump. Color is clear, and no sheen or odor observed.

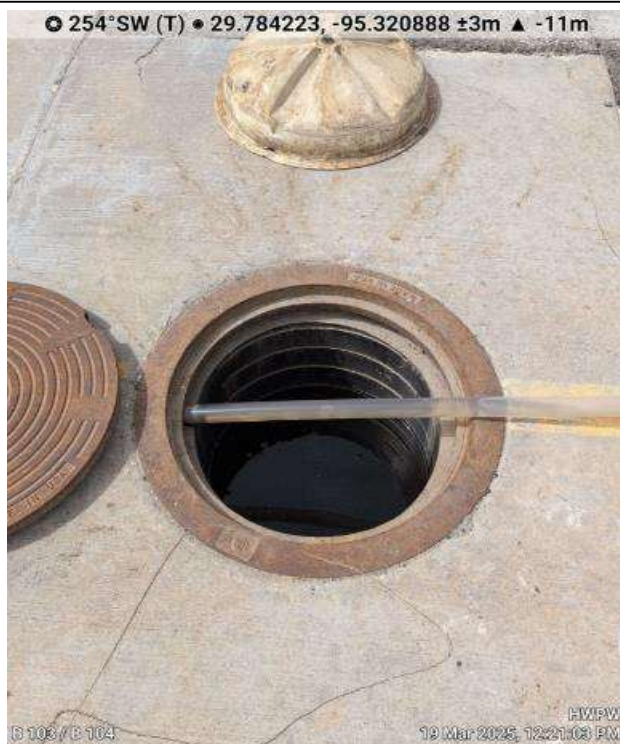
Sump 2 (B103/B104), 9.0 inches of freeboard in sump. Color is tan, and no sheen or odor observed.

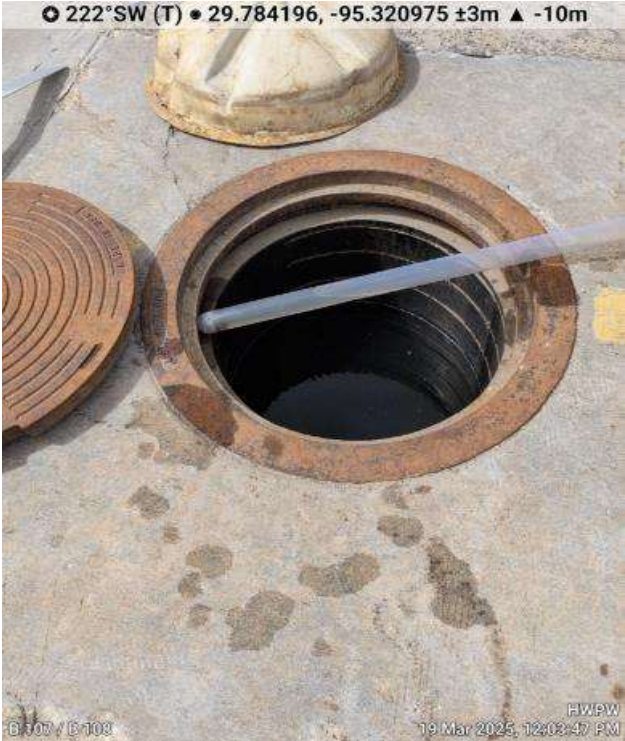
<small>B 107 / B 108 HWPW 19 Mar 2025, 12:03:47 PM</small> </p>	
<p><b>Description:</b> Sump 3 (B107/B108), 10.0 inches of freeboard in sump. Color is clear, and no sheen or odor observed.</p> <p>Lat: 29.784196 Long: -95.320975</p>		<p>           256°SW (T) • 29.784301, -95.32072 ±2m ▲ -12m

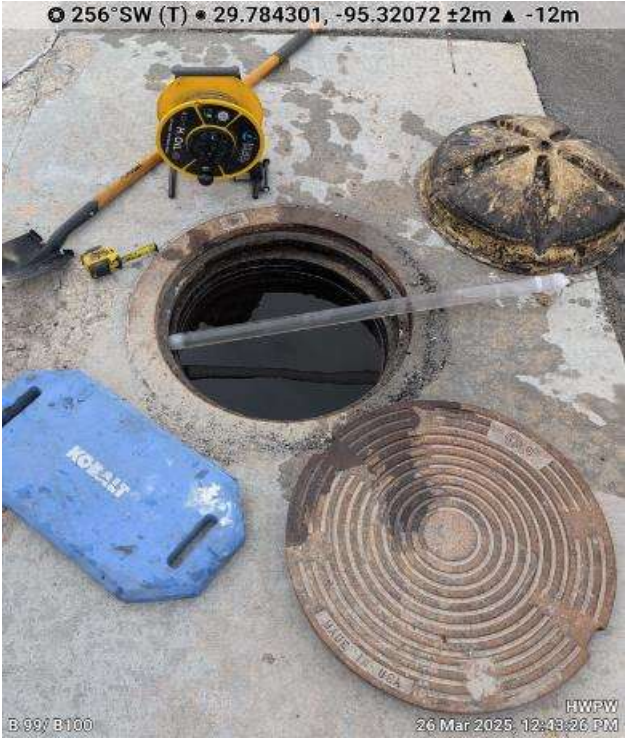
<small>B 99 / B 100 HWPW 26 Mar 2025, 12:43:26 PM</small> </p>	
Photo No. <b>66</b>	Inspection Date: 3/26/2025	<p><b>Description:</b> Sump 1 (B99/B100), 2.0 inches of freeboard in sump. Color is clear, and no sheen or odor observed.</p> <p>Lat: 29.784301 Long: -95.320720</p>

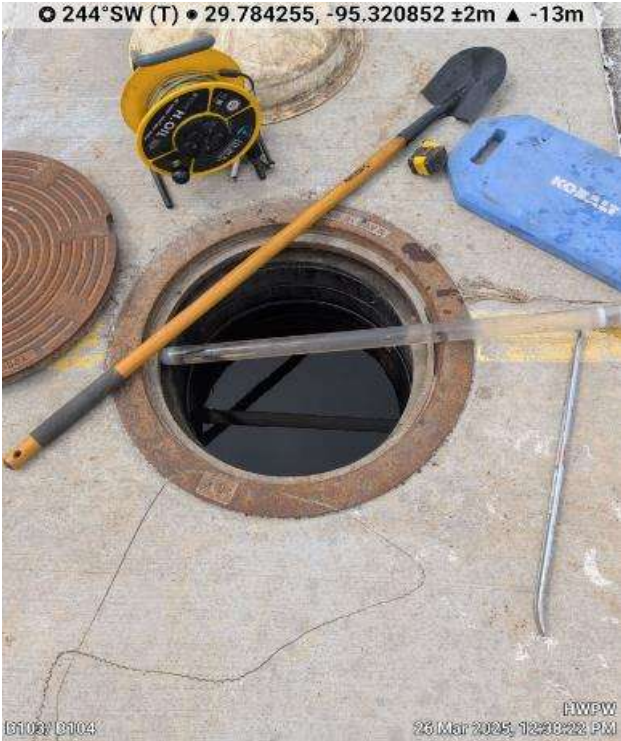
</p> <p>           244°SW (T) • 29.784255, -95.320852 ±2m ▲ -13m            B103/B104            HWPW            26 Mar 2025, 12:22:22 PM         </p>	
<b>Description:</b> Sump 2 (B103/B104), 7.0 inches of freeboard in sump. Color is tan, and no sheen or odor observed.  Lat: 29.784255 Long: -95.320852		<p>

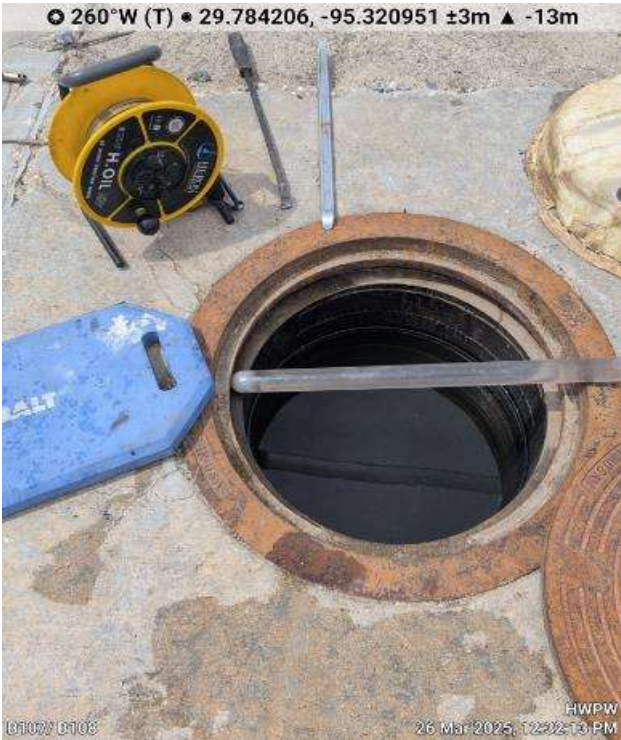
</p> <p>           260°W (T) • 29.784206, -95.320951 ±3m ▲ -13m            B107/B108            HWPW            26 Mar 2025, 12:22:13 PM         </p>	
Photo No. <b>68</b>	Inspection Date: 3/26/2025	<b>Description:</b> Sump 3 (B107/B108), 6.5 inches of freeboard in sump. Color is clear, and no sheen or odor observed.  Lat: 29.784206 Long: -95.320951

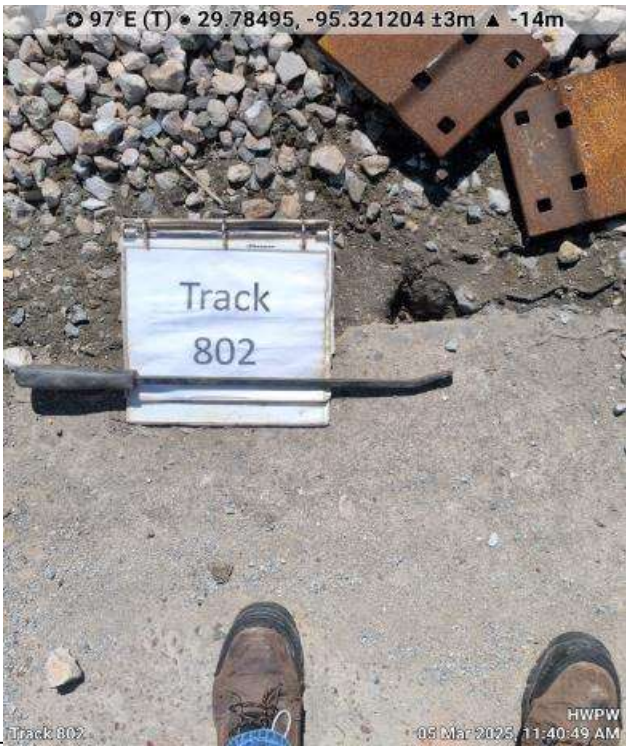
<b>Description:</b> Track 802 weekly inspection of track. Surrounding concrete and ballast in good condition. No NAPL observed at location.  Lat: 29.784950 Long: -95.321204			
<b>Photo No.</b> <b>70</b>	<b>Inspection Date:</b> 3/5/2025

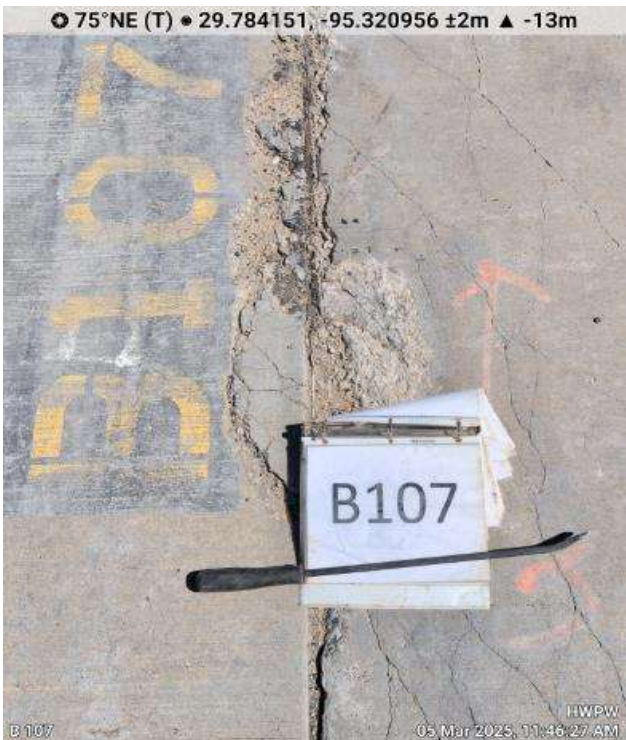
<b>Description:</b> B107 weekly inspection of joint. Surrounding concrete in good condition. No NAPL observed along joint.  Lat: 29.784151 Long: -95.320956

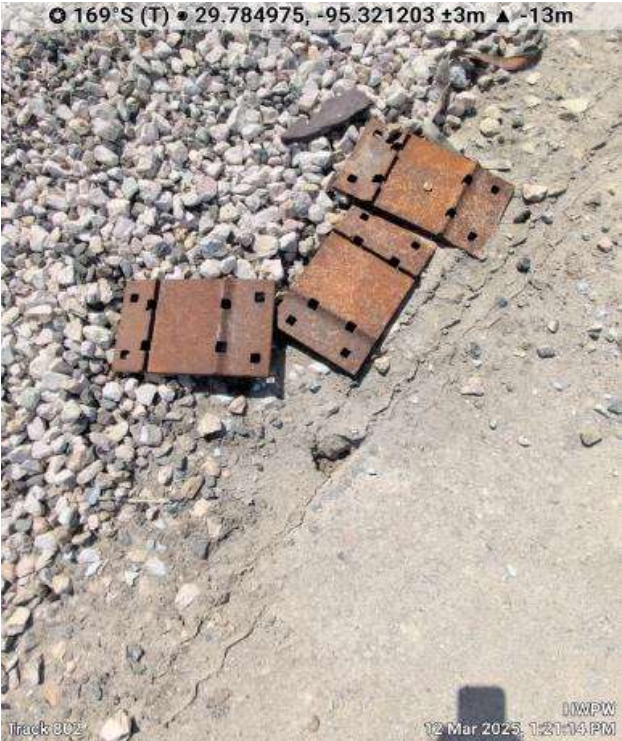
<b>PHOTOGRAPH LOG</b>	
<b>Client Name:</b> <b>Union Pacific Railroad</b>		<b>Site Location:</b> Englewood Intermodal Yard, Houston, Texas	<b>Project No.</b> US0039040.4227
<b>Photo No.</b> <b>71</b>	<b>Inspection Date:</b> 3/12/2025	<div> <div> <b>Description:</b>            Track 802 weekly inspection of track. Surrounding concrete and ballast in good condition. No NAPL observed at location.         </div> <div>           Lat: 29.784975            Long: -95.321203         </div> </div> <div> <div>           169°S (T) • 29.784975, -95.321203 ±3m ▲ -13m         </div>

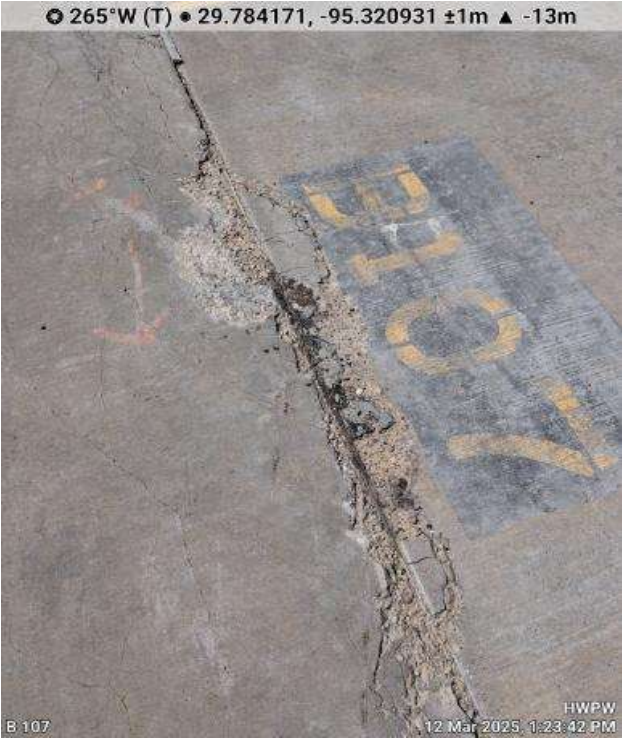
<div>           Track 802           <span style="float: right;">HWPW 12 Mar 2025, 1:21:14 PM</span> </div> </div>	
<b>Photo No.</b> <b>72</b>	<b>Inspection Date:</b> 3/12/2025	<div> <div> <b>Description:</b>            B107 weekly inspection of joint. Surrounding concrete in good condition. No NAPL observed along joint.         </div> <div>           Lat: 29.784171            Long: -95.320931         </div> </div> <div> <div>           265°W (T) • 29.784171, -95.320931 ±1m ▲ -13m         </div>

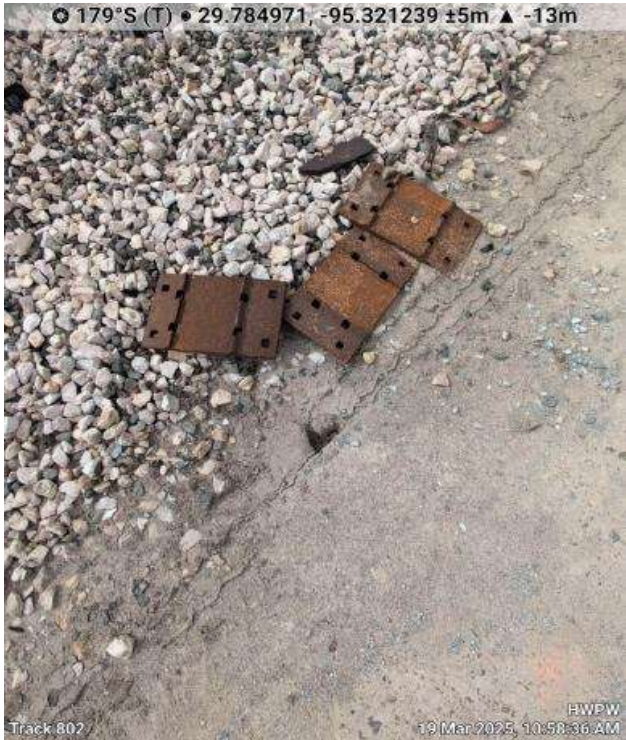
<p>Track 802 weekly inspection of track. Surrounding concrete and ballast in good condition. No NAPL observed at location.</p> <p>Lat: 29.784971 Long: -95.321239</p>	
<b>Photo No.</b> <b>74</b>	<b>Inspection Date:</b> 3/19/2025

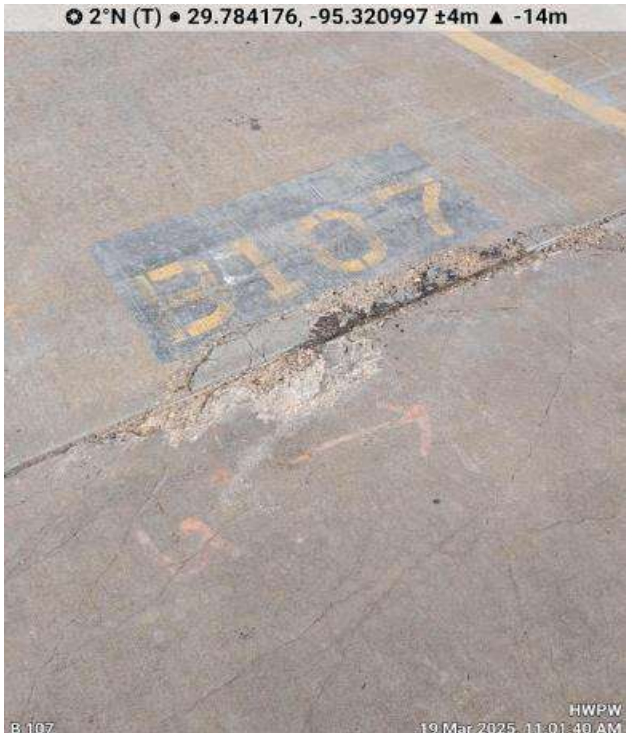
<p>B107 weekly inspection of joint. Surrounding concrete in good condition. No NAPL observed along joint.</p> <p>Lat: 29.784176 Long: -95.320997</p>

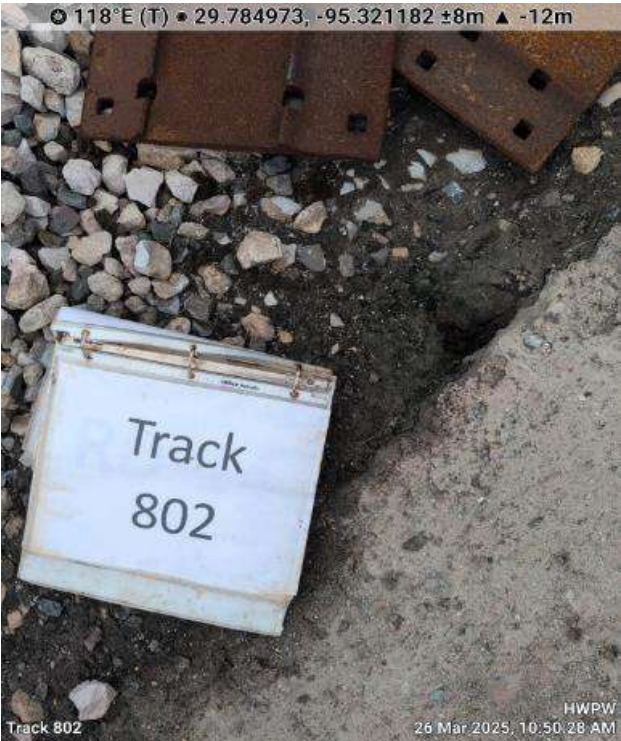
<b>PHOTOGRAPH LOG</b>	
<b>Client Name:</b> <b>Union Pacific Railroad</b>		<b>Site Location:</b> Englewood Intermodal Yard, Houston, Texas	<b>Project No.</b> US0039040.4227
<b>Photo No.</b> <b>75</b>	<b>Inspection Date:</b> 3/26/2025	<div> <div> <b>Description:</b>            Track 802 weekly inspection of track. Surrounding concrete and ballast in good condition. No NAPL observed at location.         </div> <div>           Lat: 29.784973            Long: -95.321182         </div> </div> <div>

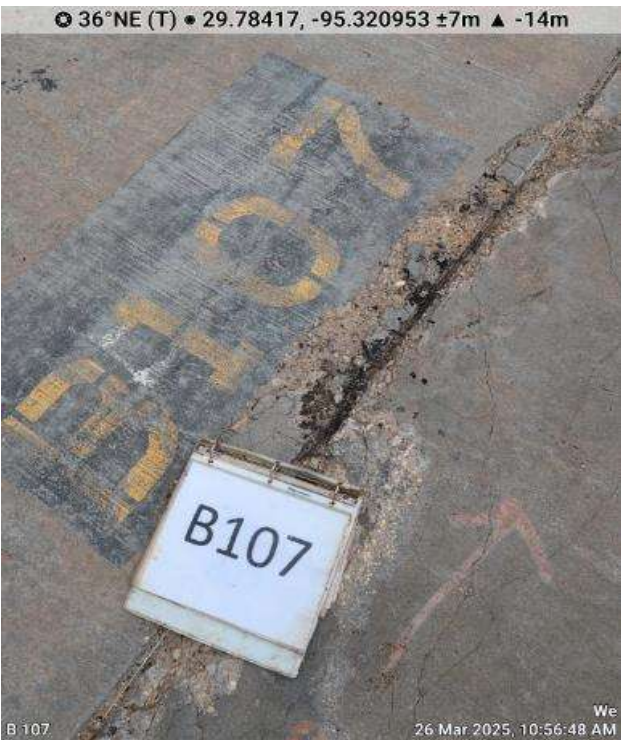
</div>	
<b>Photo No.</b> <b>76</b>	<b>Inspection Date:</b> 3/26/2025	<div> <div> <b>Description:</b>            B107 weekly inspection of joint. Surrounding concrete in good condition. No NAPL observed along joint.         </div> <div>           Lat: 29.784170            Long: -95.320953         </div> </div> <div>

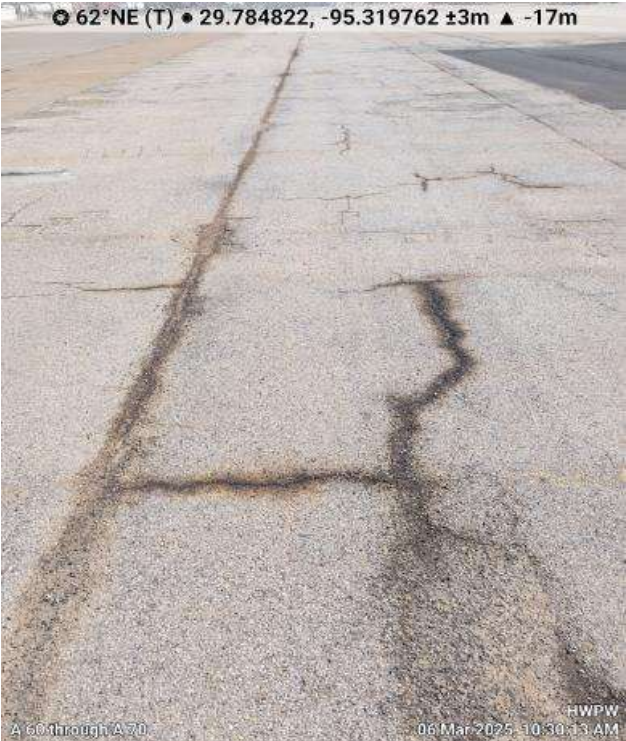
<div>         A 60 through A 70         <span style="float: right;">HWPW 06 Mar 2025 10:30:13 AM</span> </div> </div>	
<b>Description:</b> Minimal brown water staining along the joint that runs from A060 through A070. Facing northeast.			
Lat: 29.784822 Long: -95.319762			
<b>Photo No.</b> <b>78</b>	<b>Inspection Date:</b> 3/12/2025	<div> <div>         ☉ 246°SW (T) • 29.784889, -95.319728 ±3m ▲ -12m       </div>

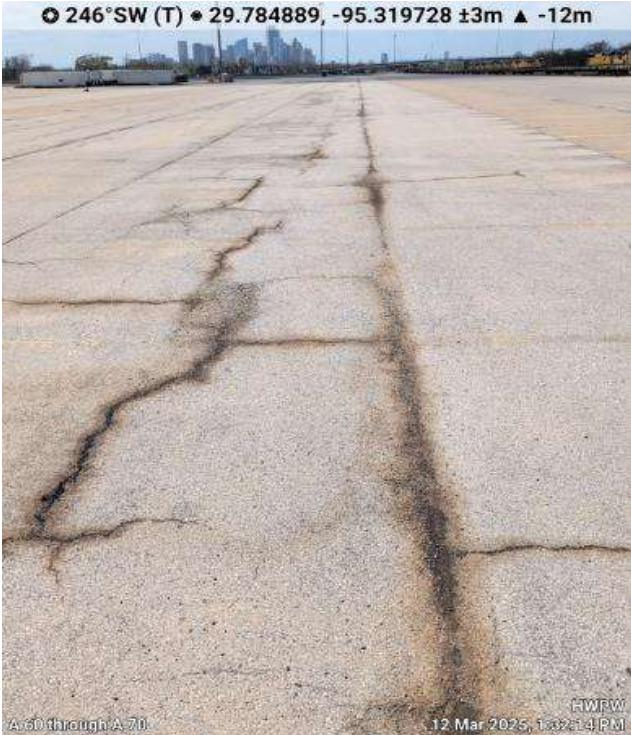
<div>         A 60 through A 70         <span style="float: right;">HWPW 12 Mar 2025 1:02:14 PM</span> </div> </div>	
<b>Description:</b> Brown water staining along the joint that runs from A060 through A070. Facing southwest.

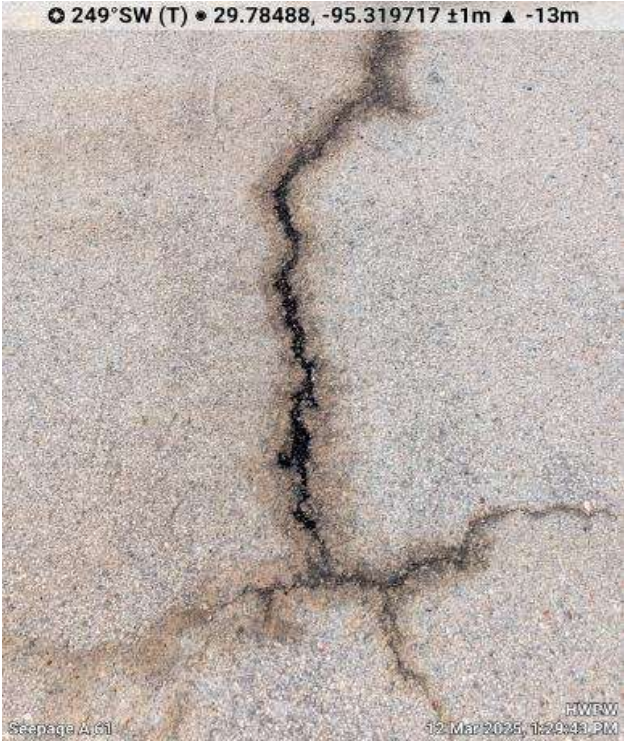
<div>           Seepage Area            HWPW            12 Mar 2025, 1:29:49 PM         </div> </div>	
<b>Description:</b> Brown water staining along crack in asphalt in stall A061.  Lat: 29.784880 Long: -95.319717			
<b>Photo No.</b> <b>80</b>	<b>Inspection Date:</b> 3/19/2025	<div> <div> <b>240°SW (T) • 29.784916, -95.319687 ±2m ▲ -11m</b> </div>

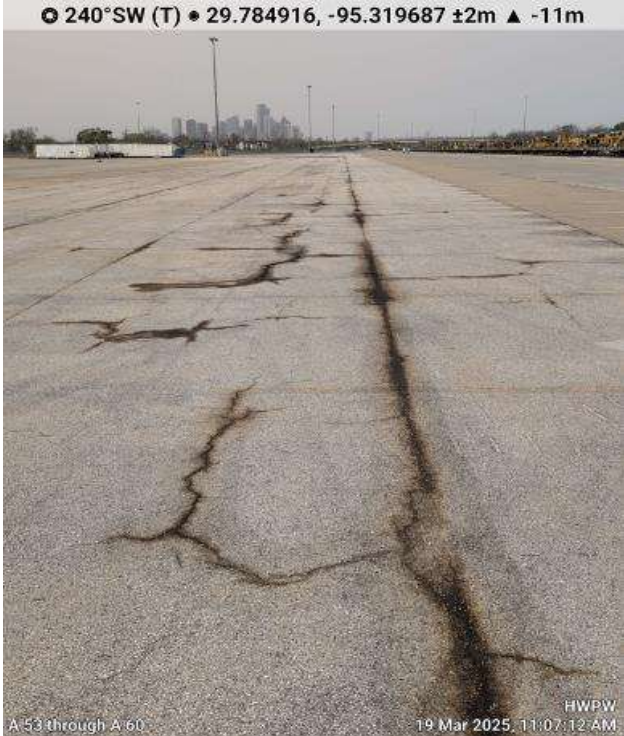
<div>           A 53 through A 60            HWPW            19 Mar 2025, 11:07:12 AM         </div> </div>	
<b>Description:</b> Brown water staining along the joint that runs from A050 through A070. Facing southwest.  Lat: 29.784916 Long: -95.319687

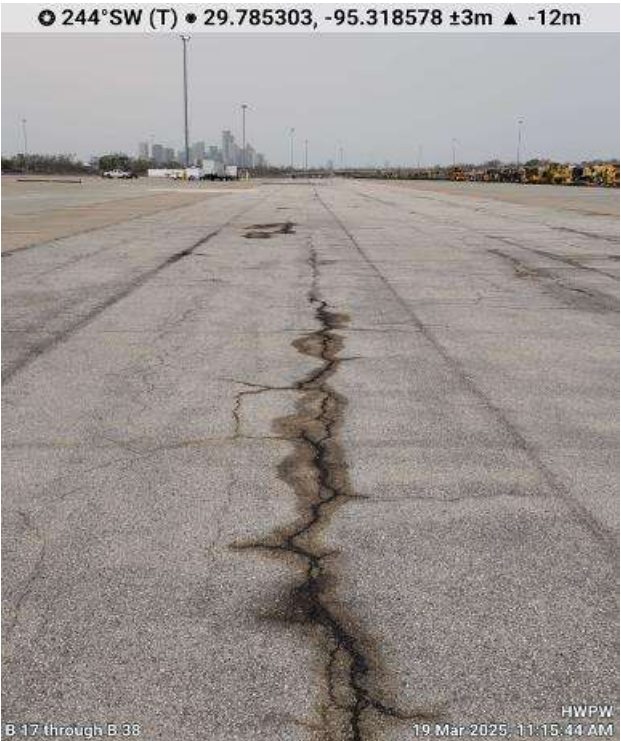
<div>           B 17 through B 38           <span style="float: right;">HWPW 19 Mar 2025, 11:15:44 AM</span> </div> </div>	
<b>Description:</b> Brown water staining along the joint that runs from B017 through B038. Facing southwest.			
Lat: 29.785303 Long: -95.318578			
<b>Photo No.</b> <b>82</b>	<b>Inspection Date:</b> 3/19/2025	<div> <div> <b>242°SW (T) • 29.78523, -95.318725 ±3m ▲ -12m</b> </div>

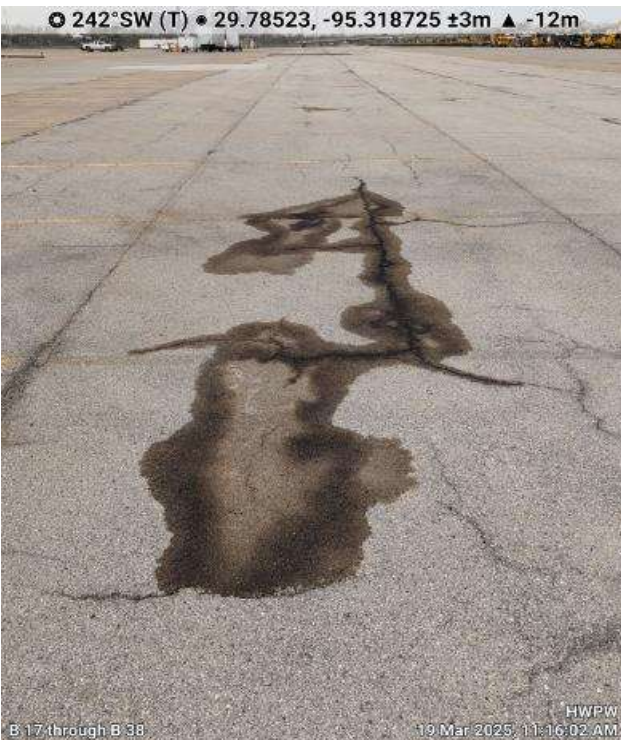
<div>           B 17 through B 38           <span style="float: right;">HWPW 19 Mar 2025, 11:16:02 AM</span> </div> </div>	
<b>Description:</b> Brown water staining along the joint that runs from B017 through B038. Facing southwest.

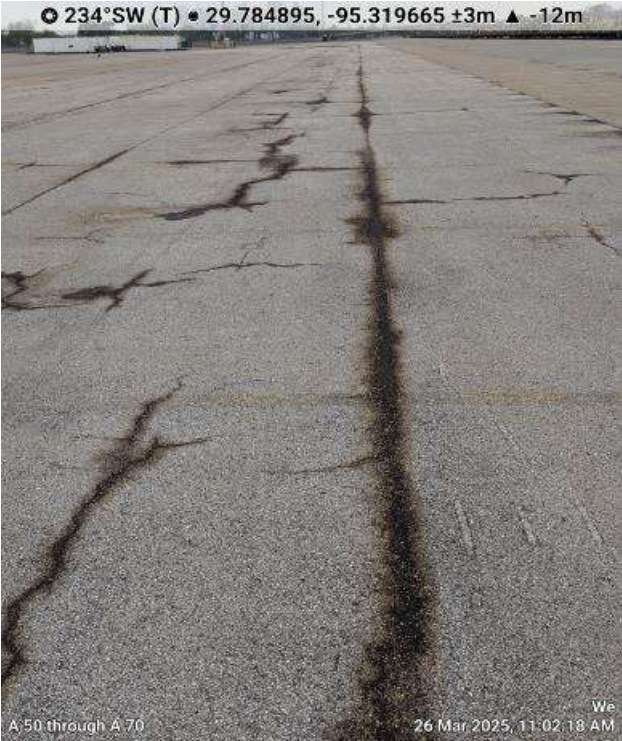
<div>       A 50 through A 70     </div> <div>       We        26 Mar 2025, 11:02:18 AM     </div> </div>	
<b>Description:</b> Brown water staining along the joint that runs from A050 through A070. Facing southwest.			
Lat: 29.784895 Long: -95.319665			
<b>Photo No.</b> <b>84</b>	<b>Inspection Date:</b> 3/26/2025	<div> <div>       236°SW (T) • 29.784848, -95.319802 ±3m ▲ -12m     </div>

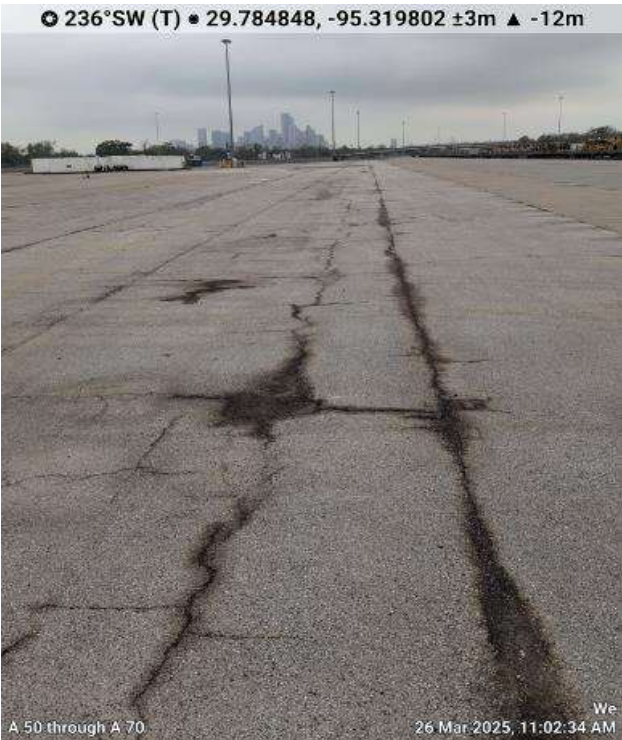
<div>       A 50 through A 70     </div> <div>       We        26 Mar 2025, 11:02:34 AM     </div> </div>	
<b>Description:</b> Brown water staining along the joint that runs from A050 through A070. Facing southwest.

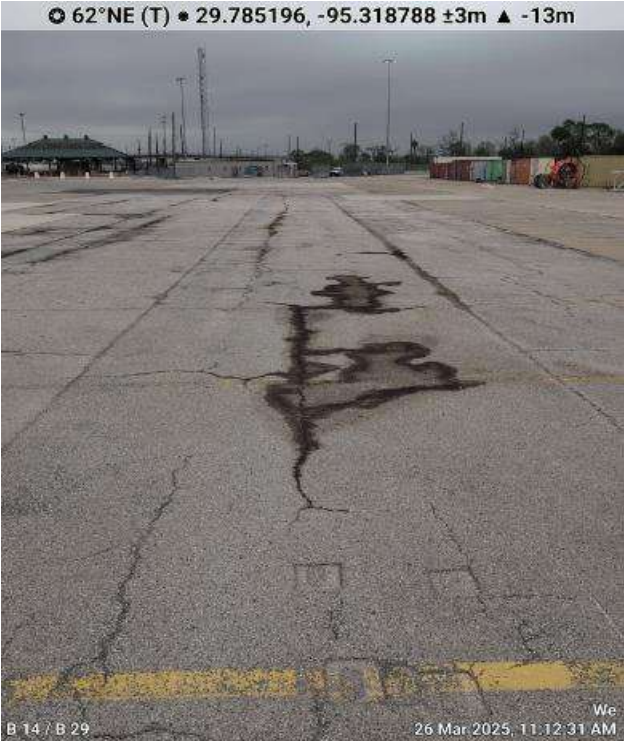
<div>         B 14 / B 29         <span style="float: right;">We 26 Mar 2025, 11:12:31 AM</span> </div> </div>	
<b>Description:</b> Brown water staining along the joint that runs from B014 through B038. Facing northeast.			
Lat: 29.785196 Long: -95.318788			
<b>Photo No.</b> <b>86</b>	<b>Inspection Date:</b> 3/26/2025	<div> <div>         ☉ 242°SW (T) • 29.785349, -95.318533 ±3m ▲ -12m       </div>

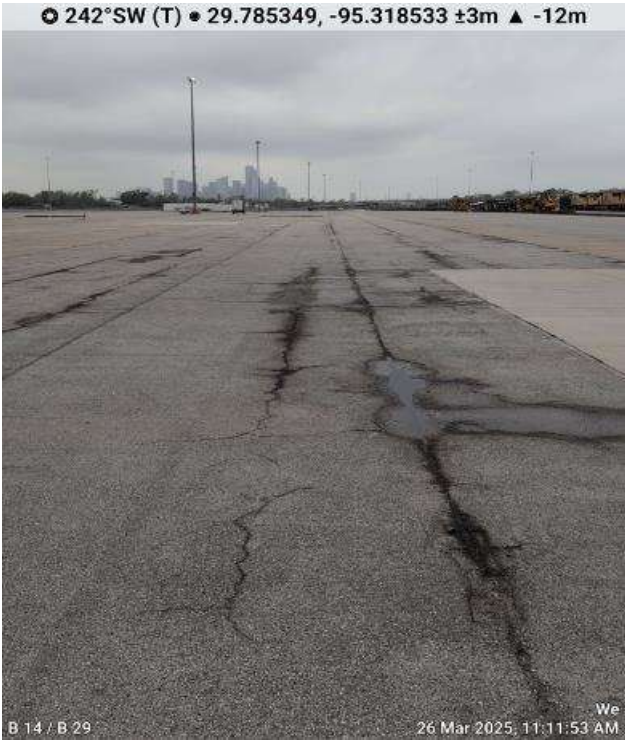
<div>         B 14 / B 29         <span style="float: right;">We 26 Mar 2025, 11:11:53 AM</span> </div> </div>	
<b>Description:</b> Brown water staining along the joint that runs from B014 through B038 directly south of FE-5. A small brown water seep was observed. Facing southwest.
