May 12, 2025

Project No. US0039040.4227

Re: **MONTHLY STATUS UPDATE – ENGLEWOOD INTERMODAL YARD – NAPL COLLECTION
SYSTEM/CONCRETE CAP REPAIRS AND REVISED INTERIM MEASURES WORK PLAN POST-
CONSTRUCTION ACTIVITIES
UNION PACIFIC RAILROAD HOUSTON WOOD PRESERVING WORKS FACILITY
4910 LIBERTY ROAD FACILITY, HOUSTON, TEXAS
POST-CLOSURE CARE PERMIT NO. HW-50343; INDUSTRIAL SWR NO. 31547**

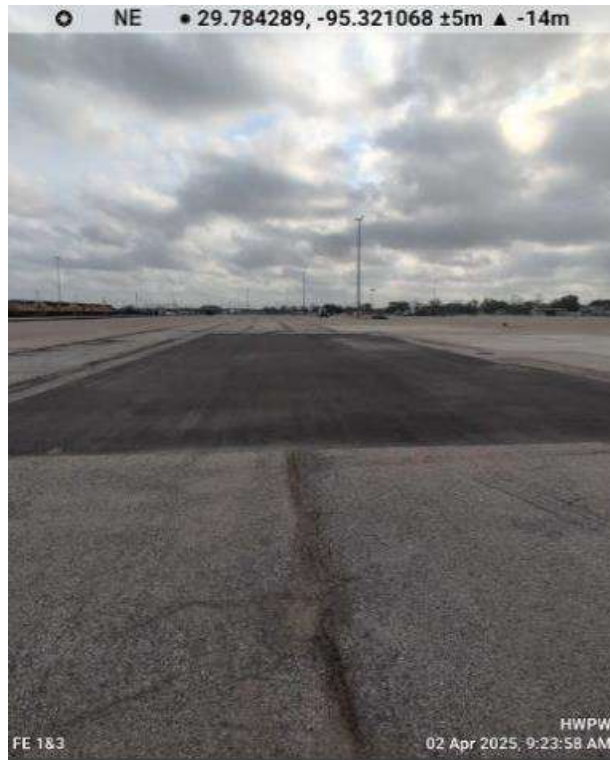
FE-1&3 weekly inspection of asphalt cap.
Reconstructed cap in good condition. No NAPL
observed at FE location. Facing northeast.

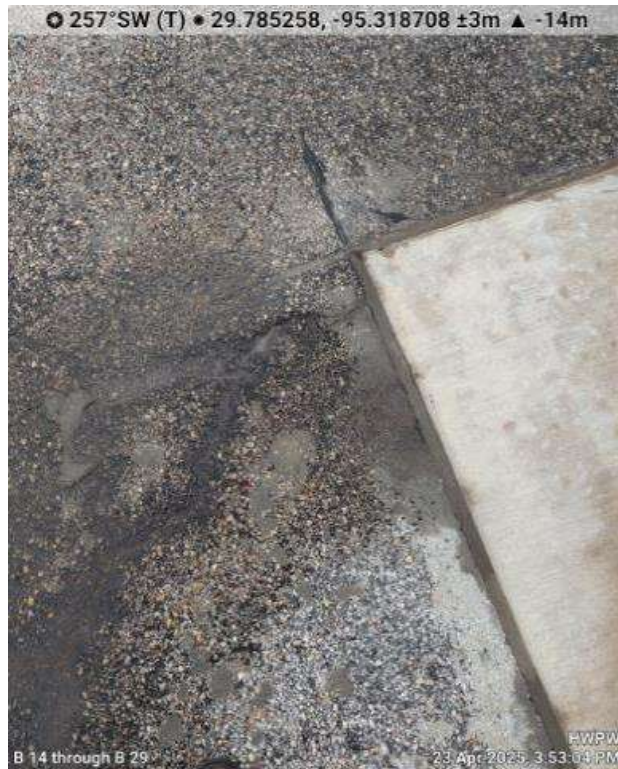
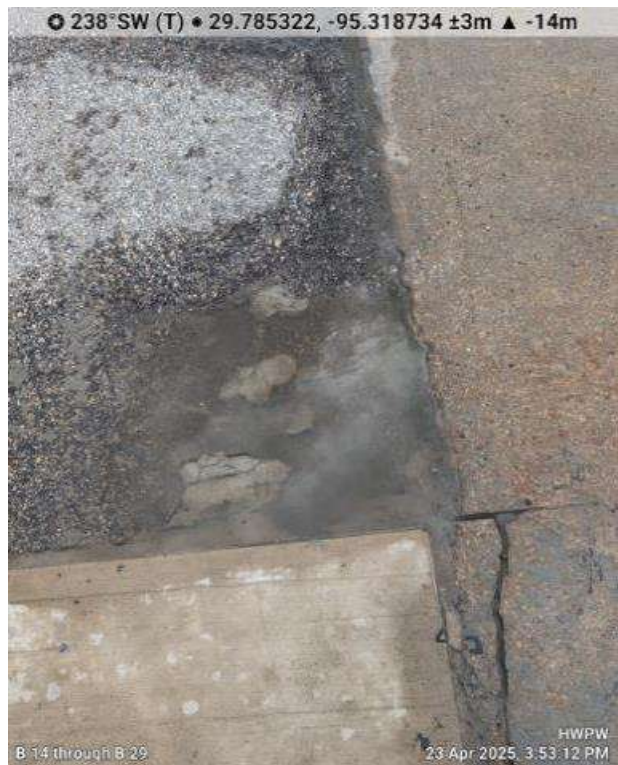
Client Name: Union Pacific Railroad		Site Location: Englewood Intermodal Yard, Houston, Texas	Project No. US0039040.4227
Photo No. 49	Inspection Date: 4/23/2025	<p>Description: FE-5 brown water staining observed at the southern corner of the FE reconstructed cap. Standing water from recent and on-going rain event.</p> <p>Lat: 29.785258 Long: -95.318708</p>	
Photo No. 50		<p>Description: FE-5 brown water staining observed at the joint between the concrete and asphalt pavement and the reconstructed FE-5 concrete cap. Standing water from recent and on-going rain event.</p> <p>Lat: 29.785322 Long: -95.318734</p>

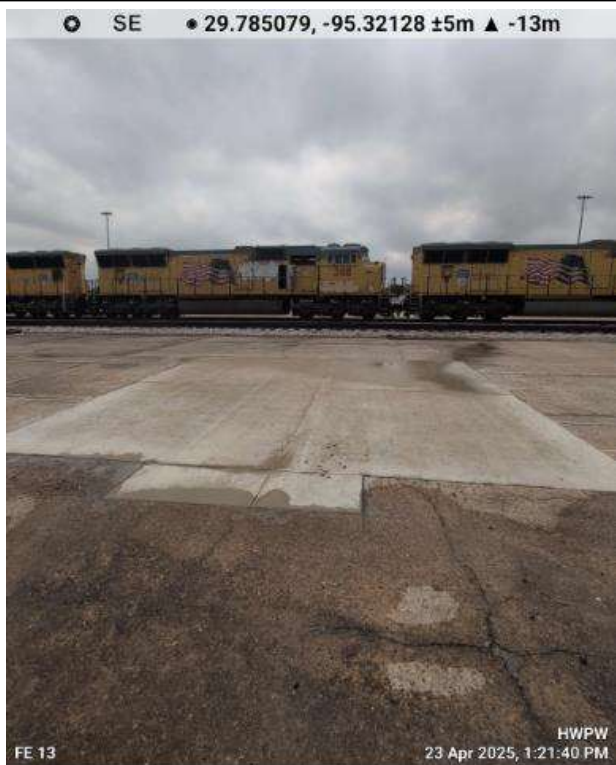
FE-1&3 weekly inspection of asphalt cap.
Reconstructed cap in good condition. No NAPL
observed at FE location. Facing southwest.

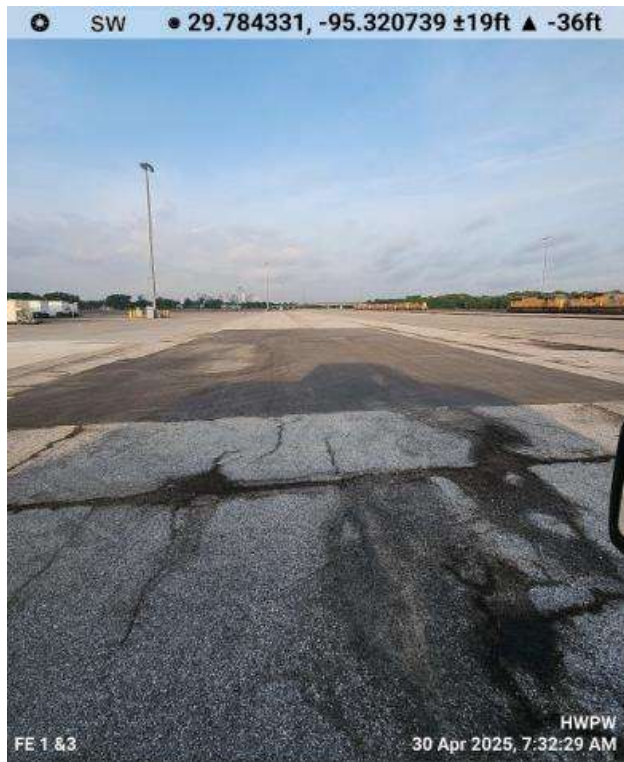
FE-1&3 brown water staining observed northeast
of the FE reconstructed cap. Staining was not
observed on or in the joints of FE-1&3.

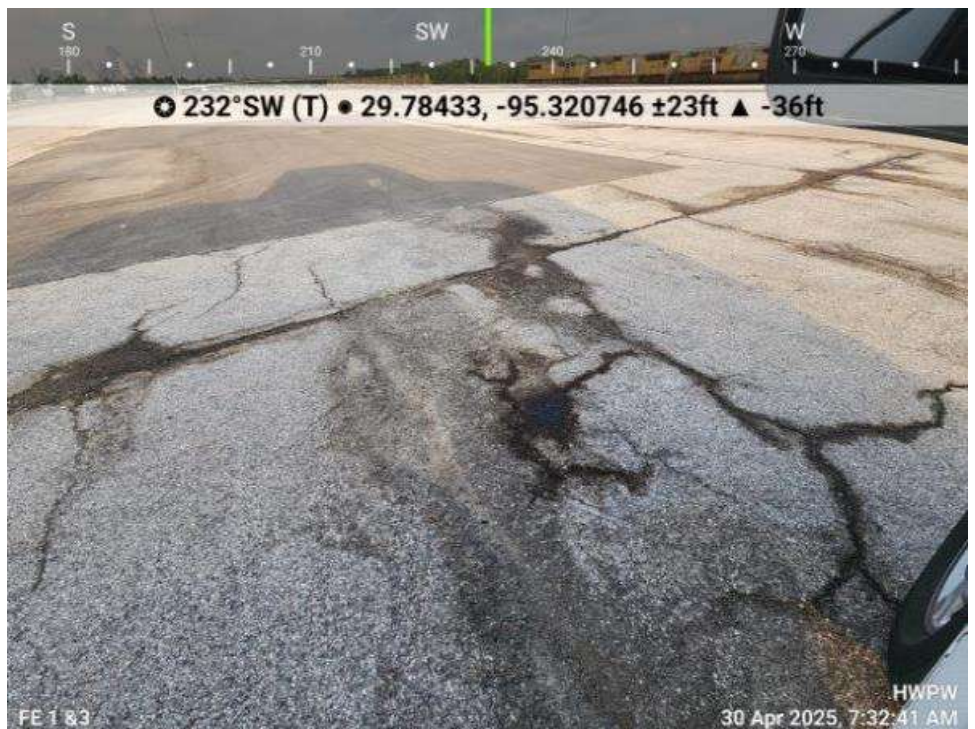
FE-1&3 brown water staining observed north of the FE reconstructed cap. Staining was not observed on or in the joints of FE-1&3.

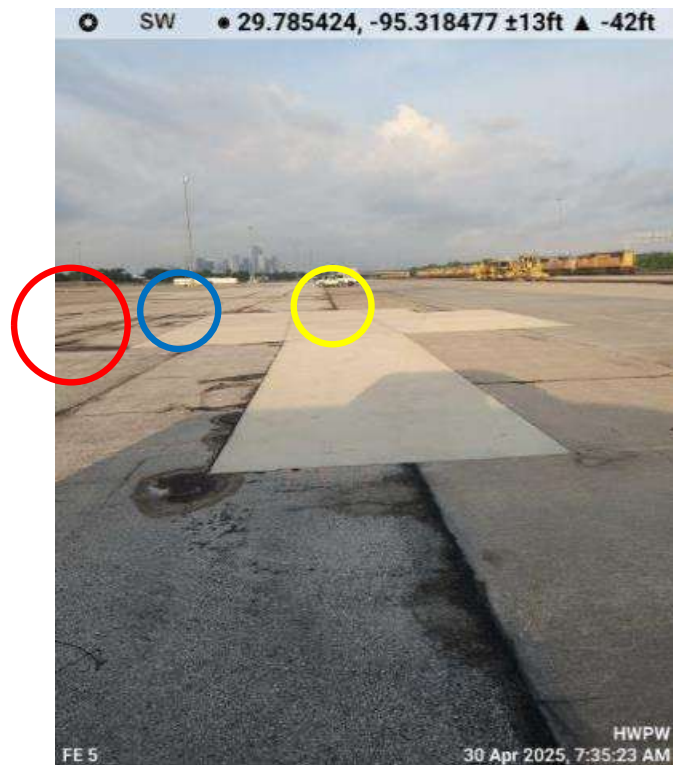
FE-5 brown water staining observed at the southern joint of the FE reconstructed cap, located within the red circle on Photo No. 64.

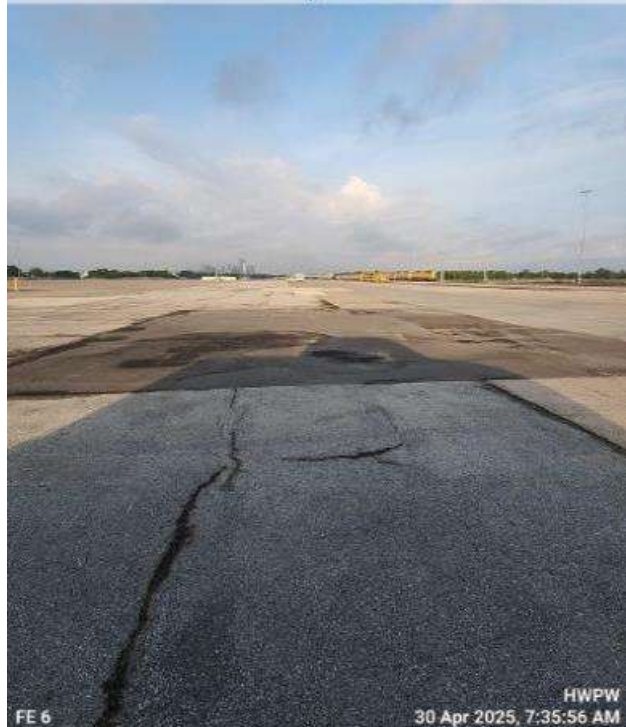
FE-6 brown water staining observed at the southern corner of the FE reconstructed cap.

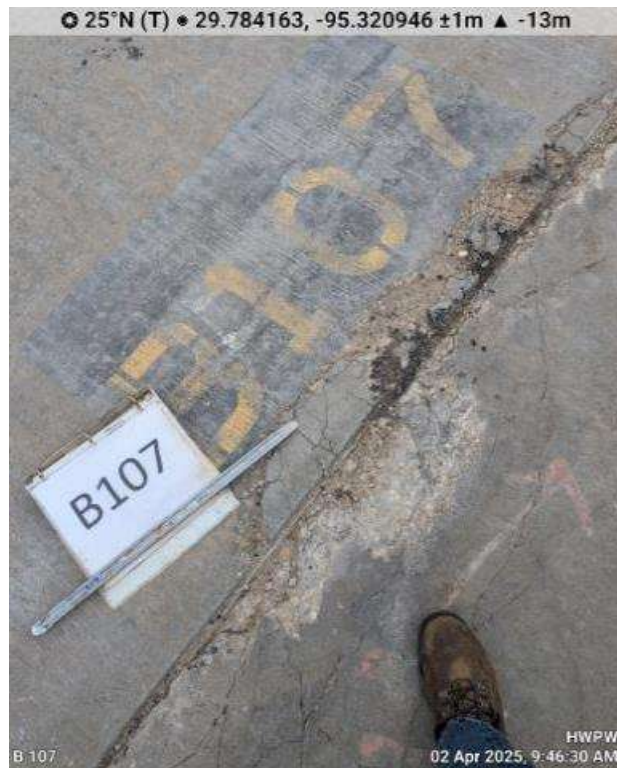
Track 802 weekly inspection of track. Surrounding concrete and ballast in good condition. No NAPL observed at location.

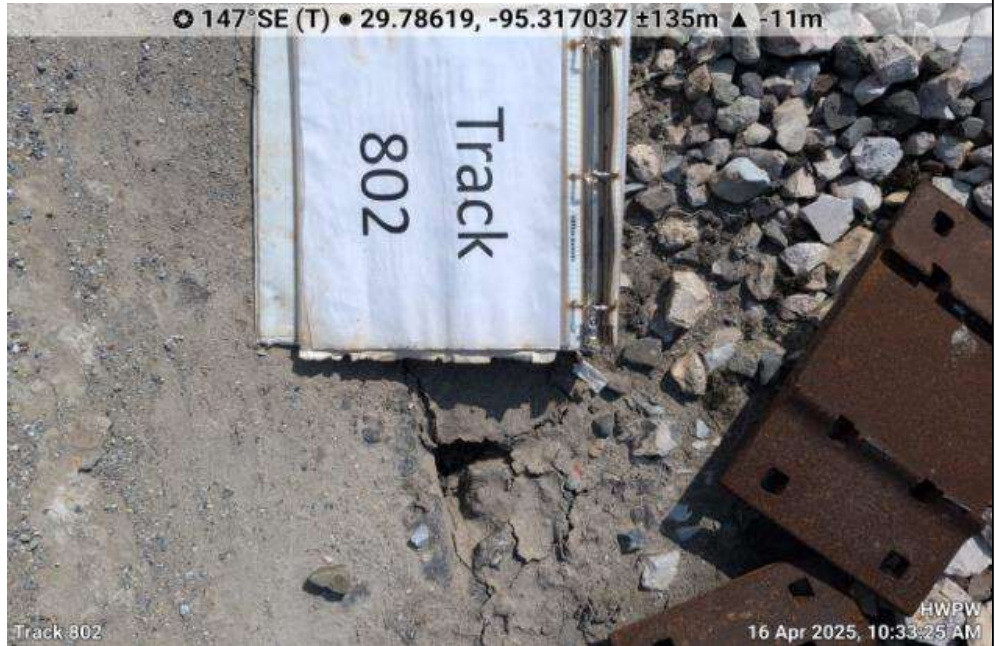
Track 802 weekly inspection of track. Surrounding concrete and ballast in good condition. No NAPL observed at location.

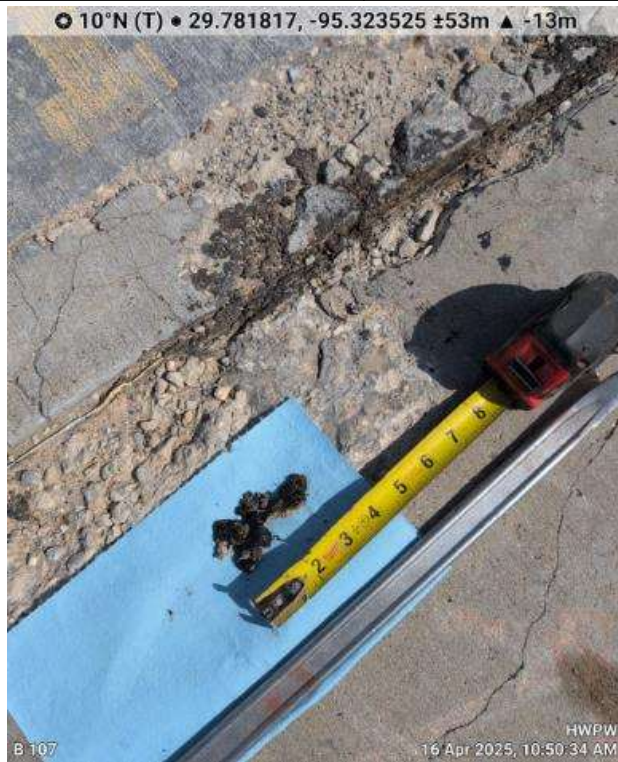
B107 weekly inspection of joint. Surrounding concrete in good condition. Approximately 3 cubic inches of NAPL observed along joint.

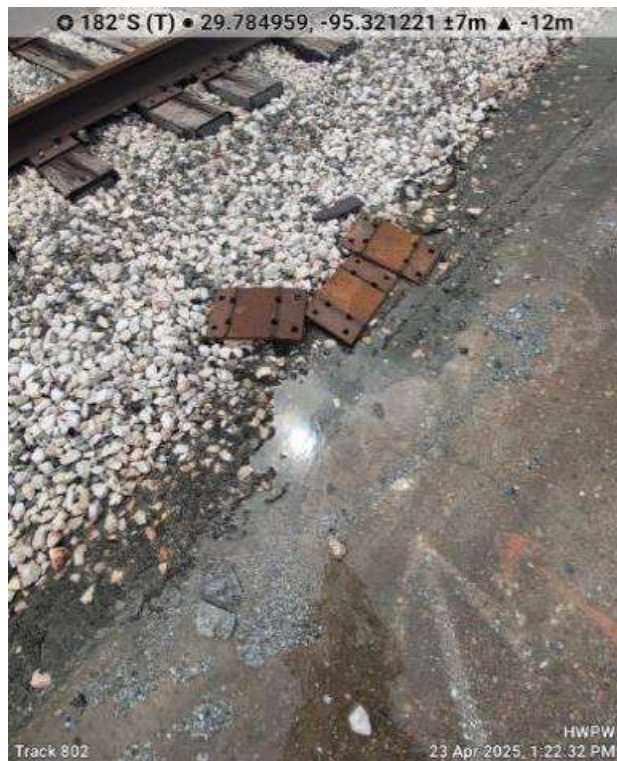
Track 802 weekly inspection of track. Surrounding concrete and ballast in good condition. No NAPL observed at location. Standing water from recent and on-going rain event.

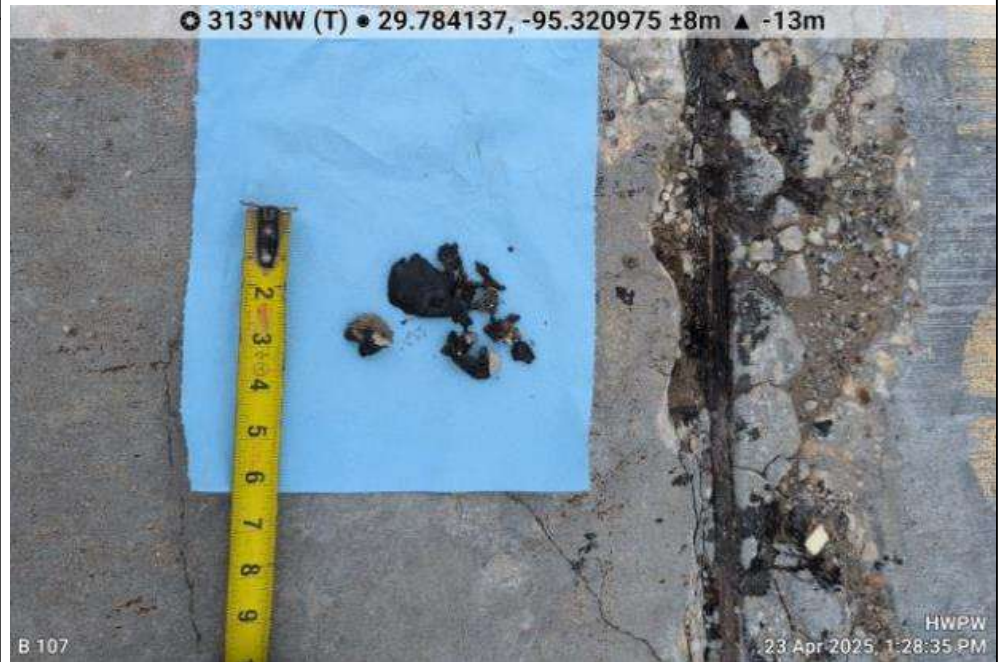
B107 weekly inspection of joint. Surrounding concrete in good condition. Approximately 3 cubic inches of NAPL observed along joint.

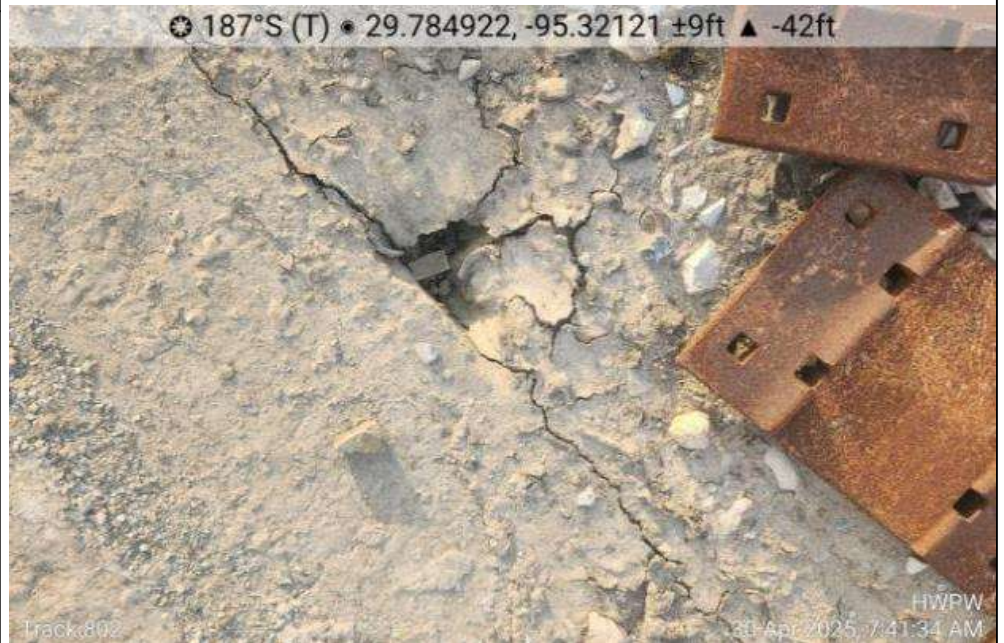
Track 802 weekly inspection of track. Surrounding concrete and ballast in good condition. No NAPL observed at location.

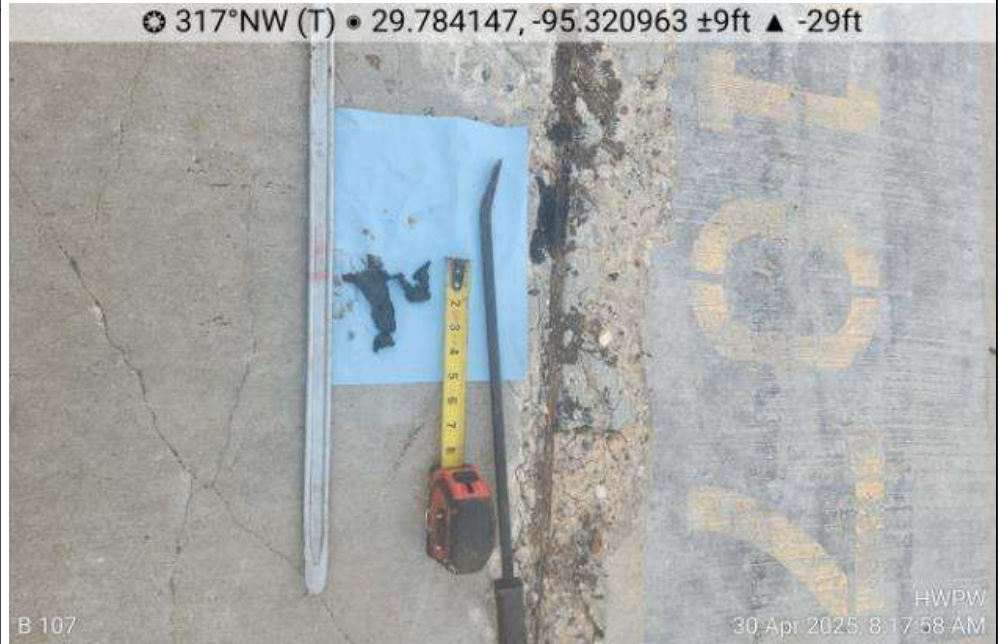
B107 weekly inspection of joint. Surrounding concrete in good condition. Approximately 3 cubic inches of NAPL observed along joint.

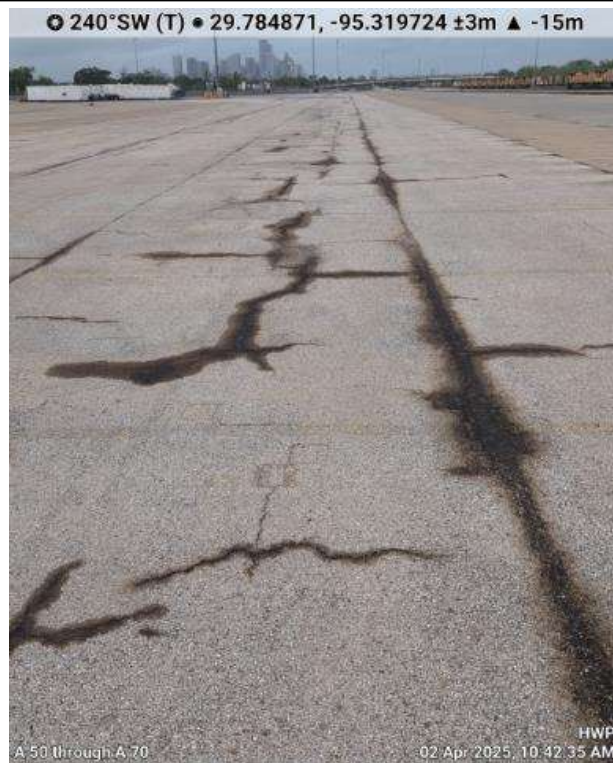
Brown water staining along the joint that runs from A050 through A070. Facing southwest.

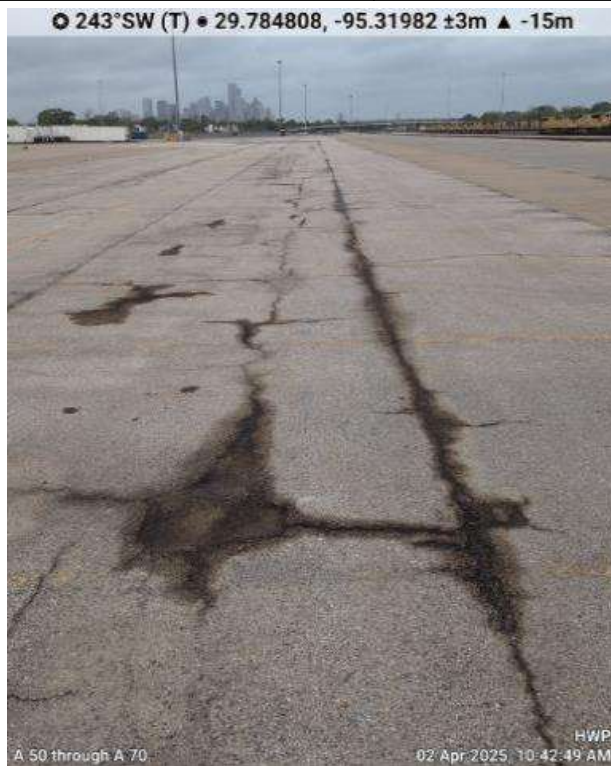
Brown water staining along the joint that runs from A050 through A070. Facing southwest.

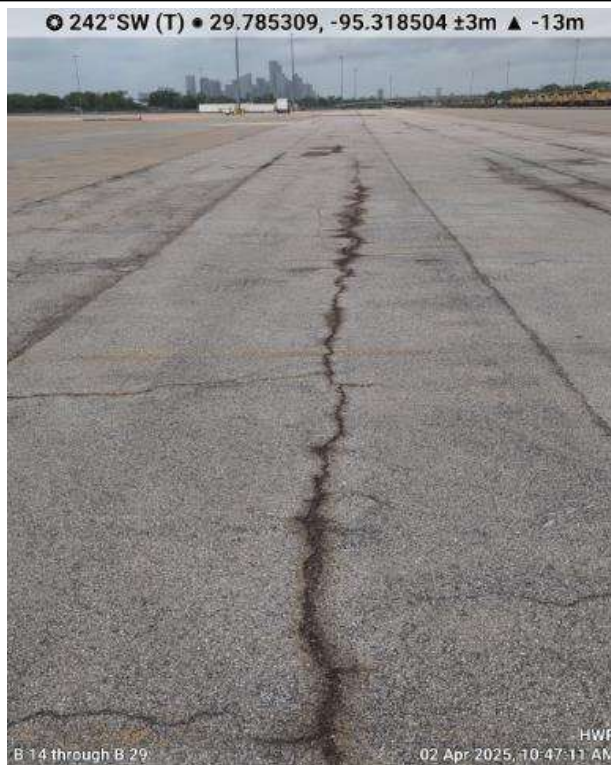
Brown water staining along the joint that runs from B014 through B029. Facing southwest.

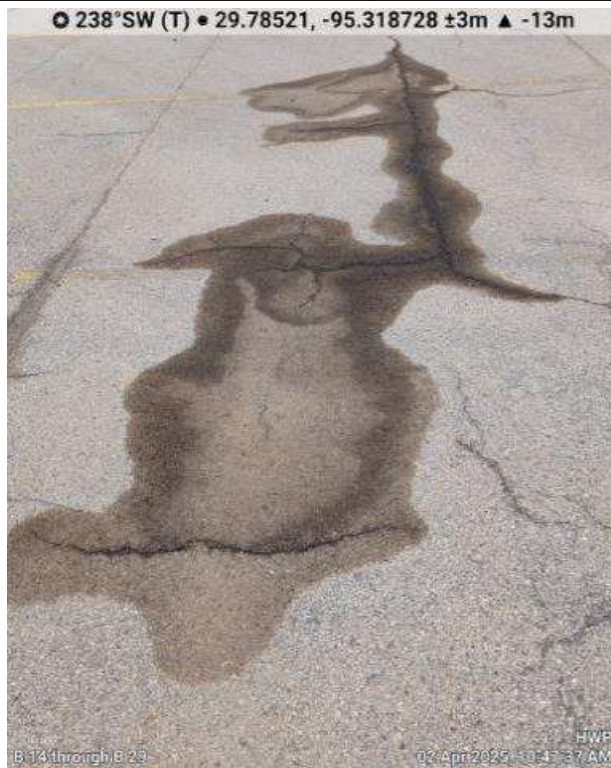
Brown water staining along the joint that runs from B014 through B029. Facing southwest.

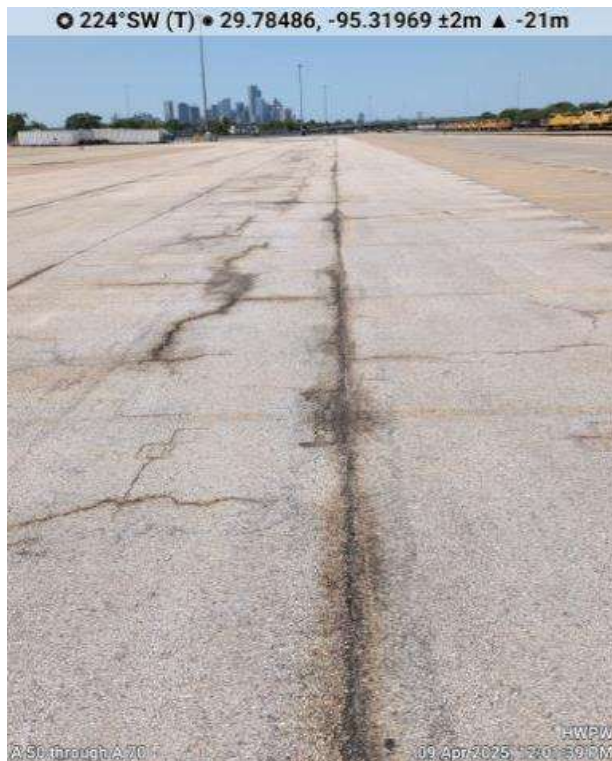
Minimal brown water staining along the joint that runs from A050 through A070 that remained after pressure washing. Facing southwest.

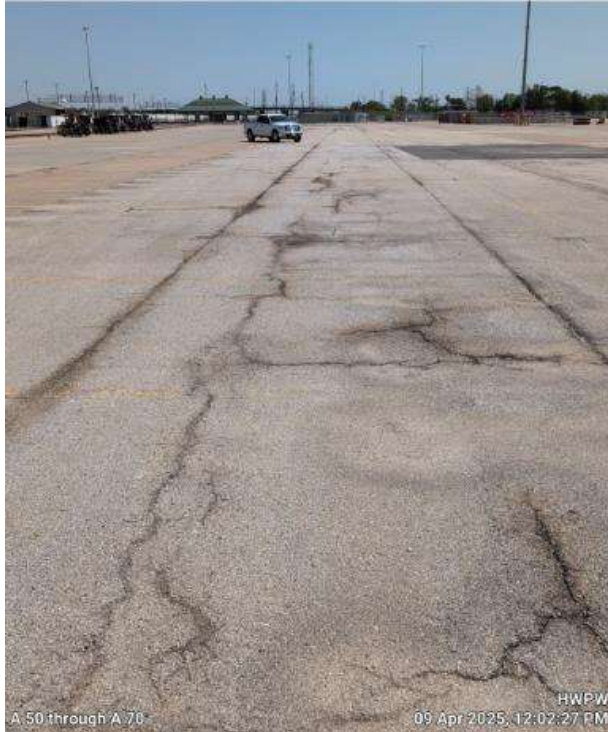
A.50 through A.70

Minimal brown water staining along the joint that runs from A050 through A070 that remained after pressure washing. Facing northeast.

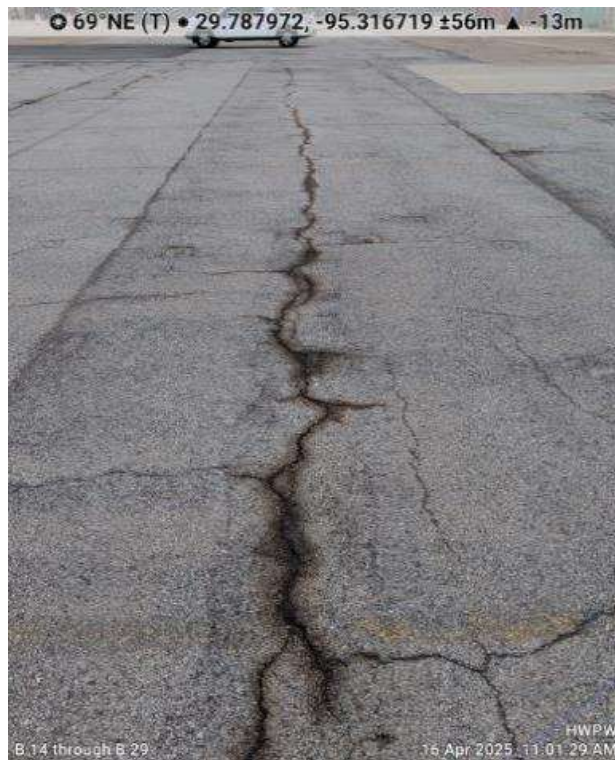
Brown water staining along the joint that runs from B014 through B029. Facing northeast.

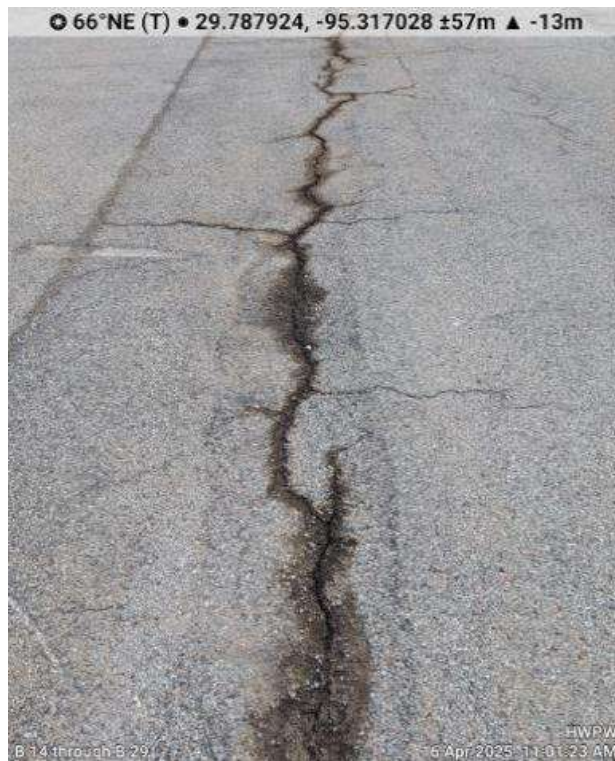
Brown water staining along the joint that runs from B014 through B029. Facing northeast.

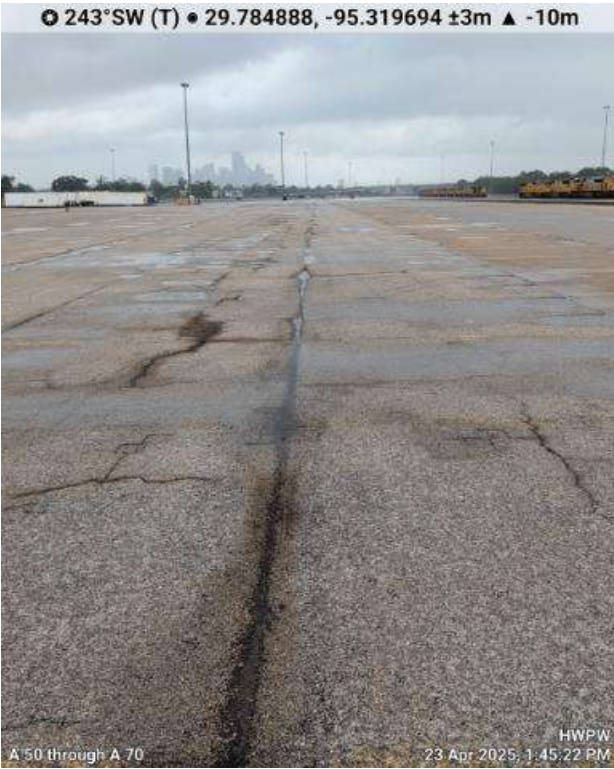
<div> A 50 through A 70 <div> HWPW 23 Apr 2025, 1:45:22 PM </div> </div> </div>	
Description: Brown water staining along the joint that runs from A050 through A070. Facing southwest. Standing water from recent and on-going rain event.			
Lat: 29.784888 Long: -95.319694			
Photo No. 114	Inspection Date: 4/23/2025	<div> <div> 106°E (T) • 29.784829, -95.319896 ±4m ▲ -11m </div>

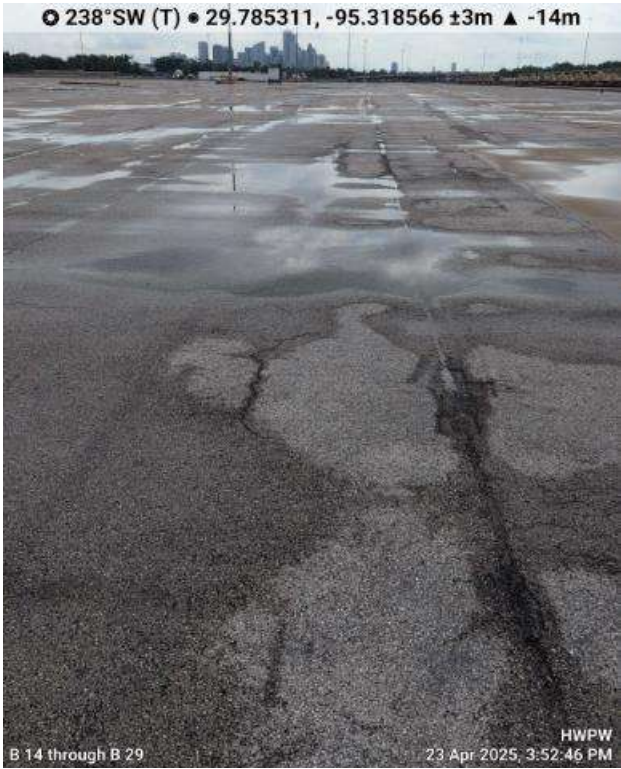
</div> <div> <p> 238°SW (T) • 29.785311, -95.318566 ±3m ▲ -14m </p> <p> B 14 through B 29 </p> <p> HWPW 23 Apr 2025, 3:52:46 PM </p> </div> </div>	
Description: Brown water staining along the joint that runs from B014 through B029. Facing southwest. Standing water from recent and on-going rain event.			
Lat: 29.785311 Long: -95.318566			
Photo No. 116	Inspection Date: 4/30/2025	<div> <div>

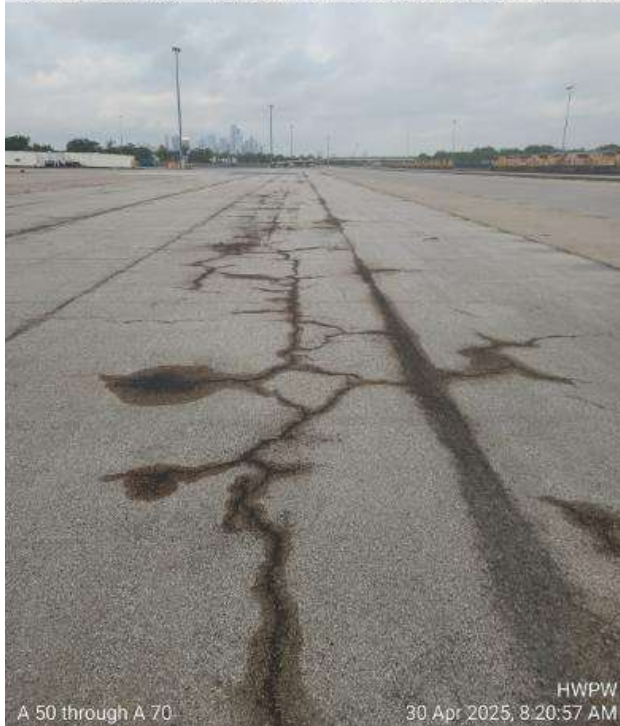
A 50 through A 70

Brown water staining along the joint that runs from A050 through A070. Facing southwest.

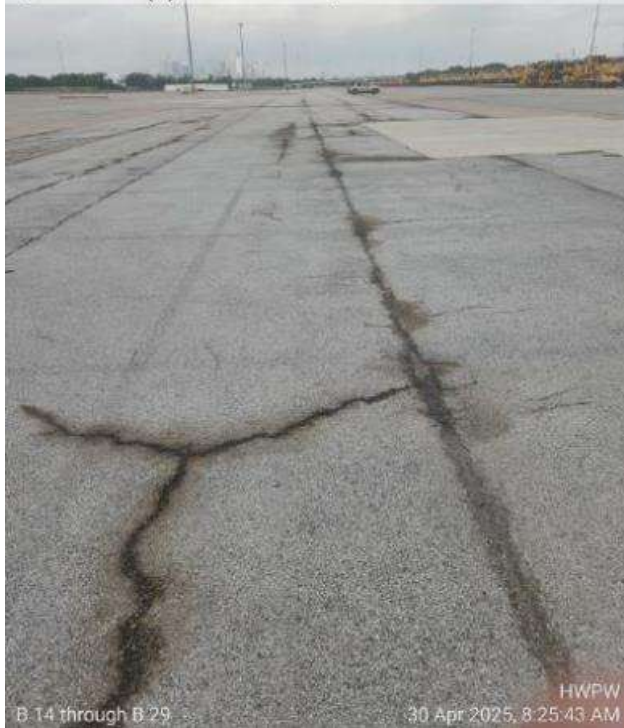
B 14 through B 29

Brown water staining along the joint that runs from B014 through B029. FE-5 in the background. Facing southwest.
