July 15, 2025

Project No. US0039040.4227

Re: **MONTHLY STATUS UPDATE – ENGLEWOOD INTERMODAL YARD – NAPL COLLECTION
SYSTEM/CONCRETE CAP REPAIRS AND REVISED INTERIM MEASURES WORK PLAN POST-
CONSTRUCTION ACTIVITIES
UNION PACIFIC RAILROAD HOUSTON WOOD PRESERVING WORKS FACILITY
4910 LIBERTY ROAD FACILITY, HOUSTON, TEXAS
POST-CLOSURE CARE PERMIT NO. HW-50343; INDUSTRIAL SWR NO. 31547**

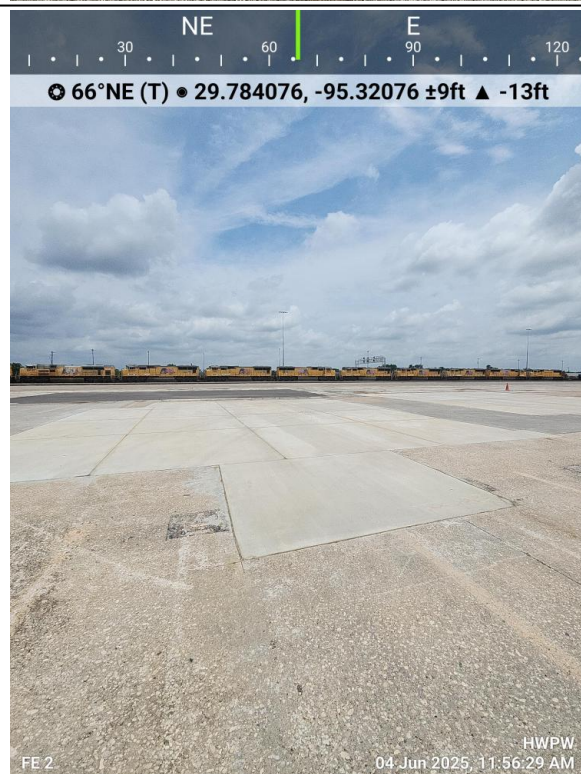
FE-2 weekly inspection of concrete cap.
Reconstructed cap in good condition. No NAPL
observed at FE location. Facing northeast.

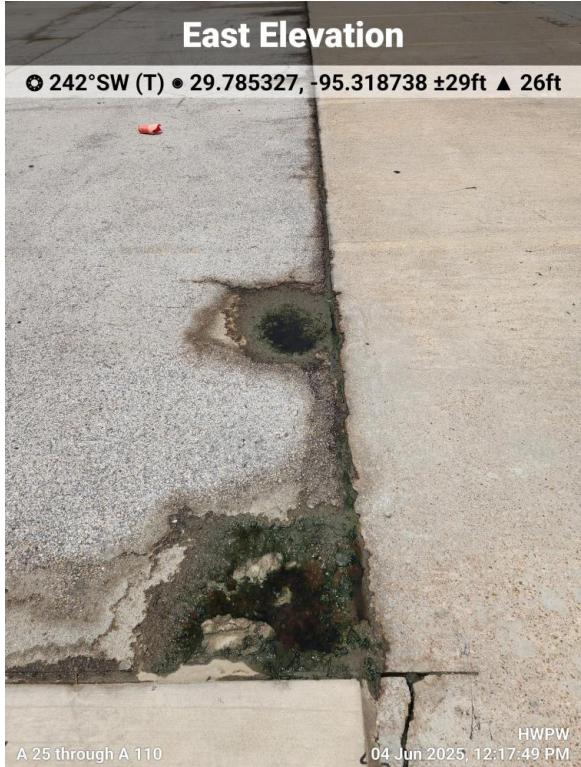
Client Name: Union Pacific Railroad	Site Location: Englewood Intermodal Yard, Houston, Texas	Project No. US0039040.4227
Photo No. 5	Inspection Date: 06/04/2025	<div><p>East Elevation</p><p>☉ 242°SW (T) • 29.785327, -95.318738 ±29ft ▲ 26ft</p>

- Brown water staining was observed at FE-5 during the weekly inspection on June 4th along the southern joint of the reconstructed cap (Photo Nos. 4 through 7). Along the joint perpendicular to the western edge of FE-5, standing brown water was observed (Photo No. 5). The standing brown water was only observed in the concrete joint running west from FE-5 and not within the joints immediately adjacent to FE-5. Brown water staining was not observed during the weekly inspection on June 11th due to a rain event. Minimal brown water staining was noted at FE-5 during the weekly inspection on June 18th and June 25th along the southern joint of the reconstructed cap

FE-5 brown water staining observed along the eastern joint of the FE reconstructed cap. Standing water was solely along the joint perpendicular to eastern edge of FE-5.

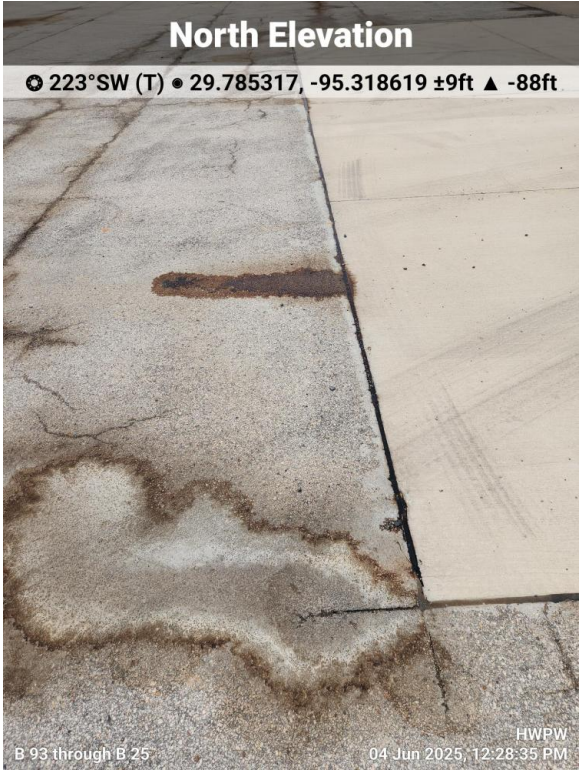
Client Name: Union Pacific Railroad		Site Location: Englewood Intermodal Yard, Houston, Texas	Project No. US0039040.4227
Photo No. 7	Inspection Date: 06/04/2025	<div><div>North Elevation</div><div>☉ 223°SW (T) • 29.785317, -95.318619 ±9ft ▲ -88ft</div>

<div>FE 6HWPW04 Jun 2025, 11:57:59 AM</div></div>	
Description: FE-5 brown water staining observed at the southeastern corner of the FE reconstructed cap. Lat: 29.78532 Long: -95.31862		Description: FE-6 weekly inspection of asphalt cap. Reconstructed cap in good condition. No NAPL observed at FE location. Facing north. Lat: 29.7854 Long: -95.31832

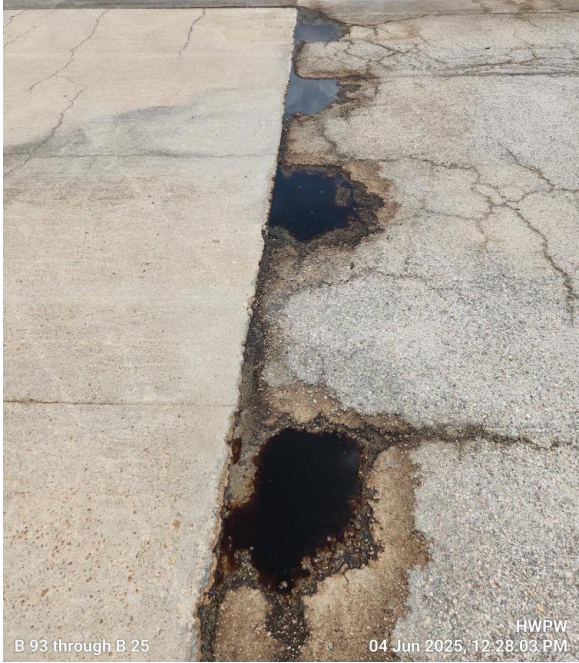
Client Name: Union Pacific Railroad	Site Location: Englewood Intermodal Yard, Houston, Texas	Project No. US0039040.4227
Photo No. 9	Inspection Date: 06/04/2025	<div><p>West Elevation</p><p>☉ 59°NE (T) • 29.785464, -95.318453 ±16ft ▲ -85ft</p>

- Brown water staining was observed at FE-6 during the weekly inspection on June 4th along the western and southern joint of the reconstructed cap (Photo No. 8). Standing brown water was observed approximately 5 feet from FE-6 along the joint perpendicular to the western edge of FE-6 (Photo No. 9). The standing brown water was only observed in the joint running west towards FE-6 and not within the joints immediately adjacent to FE-6. Brown water staining was not observed during the weekly inspection on June 11th due to a rain event. Minimal brown water staining was noted at FE-6 during the weekly inspection on June 18th and June 25th along the western and southern joint of the reconstructed cap.

FE-6 brown water staining observed along the western joint of the FE reconstructed cap. Standing water was solely along the joint perpendicular to western edge of FE-6.

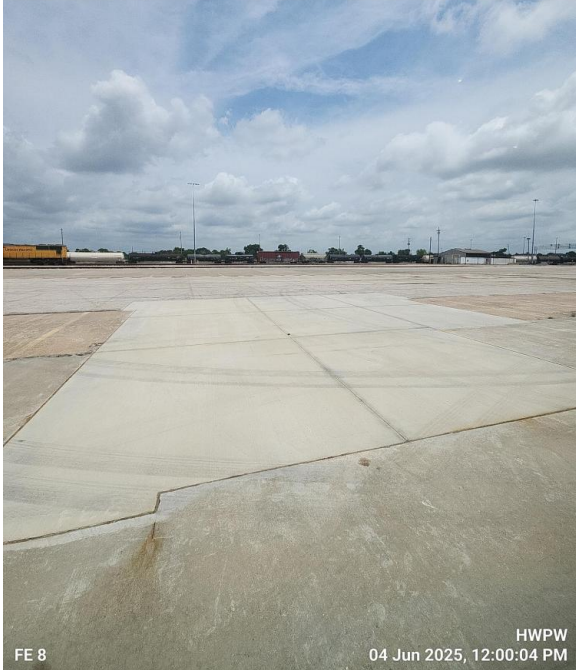
</div><div>FE 9HWPW04 Jun 2025, 12:00:44 PM</div></div>
Description: FE-8 weekly inspection of concrete cap. Reconstructed cap in good condition. No NAPL observed at FE location. Facing north. Lat: 29.78489 Long: -95.3191			
Description: FE-9 weekly inspection of concrete cap. Reconstructed cap in good condition. No NAPL observed at FE location. Facing northeast. Lat: 29.78523 Long: -95.31838

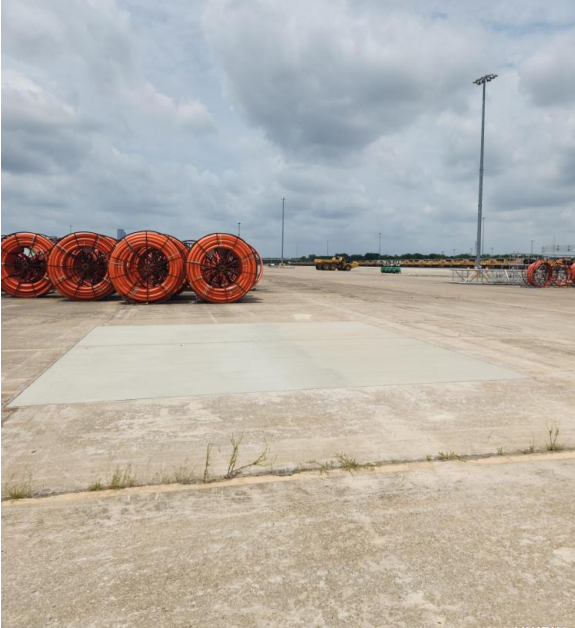
Client Name: Union Pacific Railroad		Site Location: Englewood Intermodal Yard, Houston, Texas	Project No. US0039040.4227
Photo No. 13	Inspection Date: 06/04/2025	<div><div>SWW240270300330</div><div>277°W (T) • 29.784948, -95.317633 ±26ft ▲ -55ft</div>

<div>FE 11HWPW04 Jun 2025, 12:02:14 PM</div></div>	
Description: FE-10 weekly inspection of concrete cap. Reconstructed cap in good condition. No NAPL observed at FE location. Facing west. Lat: 29.78495 Long: -95.31763		Description: FE-11 weekly inspection of concrete cap. Reconstructed cap in good condition. No NAPL observed at FE location. Facing south. Lat: 29.7844 Long: -95.31965

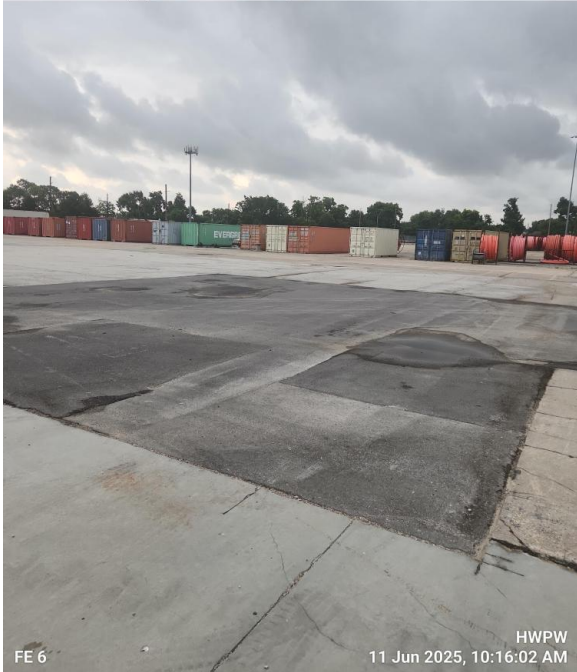
Client Name: Union Pacific Railroad		Site Location: Englewood Intermodal Yard, Houston, Texas	Project No. US0039040.4227
Photo No. 21	Inspection Date: 06/11/2025	<div>West Elevation</div> <div>☉ 106°E (T) • 29.785522, -95.31845 ±26ft ▲ -26ft</div>

<div>FE 7 HWPW 11 Jun 2025, 10:17:29 AM</div>	
Description: FE-6 weekly inspection of asphalt cap. Reconstructed cap in good condition. No NAPL observed at FE location. Facing east. Lat: 29.78552 Long: -95.31845		Description: FE-7 weekly inspection of concrete cap. Reconstructed cap in good condition. No NAPL observed at FE location. Facing northwest. Lat: 29.78417 Long: -95.32064

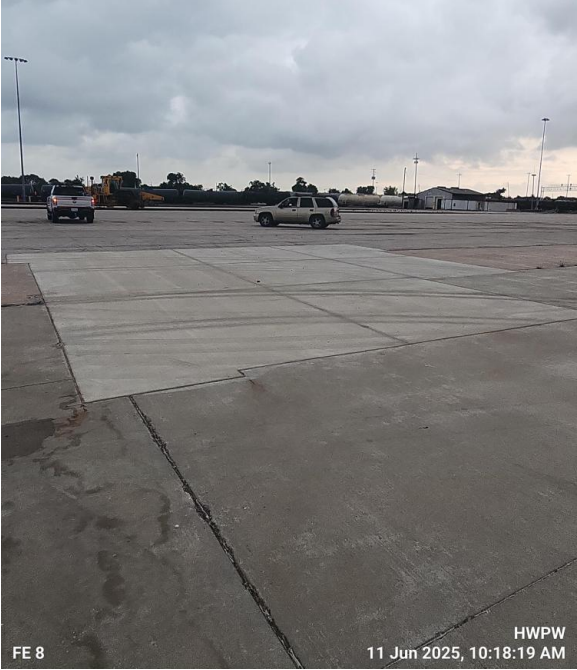
Client Name: Union Pacific Railroad		Site Location: Englewood Intermodal Yard, Houston, Texas	Project No. US0039040.4227
Photo No. 23	Inspection Date: 06/11/2025	<div><div>West Elevation</div><div>☉ 30°N (T) • 29.78487, -95.319124 ±19ft ▲ -42ft</div>

<div>FE 9HWPW 11 Jun 2025, 10:19:00 AM</div></div>	
Description: FE-8 weekly inspection of concrete cap. Reconstructed cap in good condition. No NAPL observed at FE location. Facing north. Lat: 29.78487 Long: -95.31912		Description: FE-9 weekly inspection of concrete cap. Reconstructed cap in good condition. No NAPL observed at FE location. Facing northeast. Lat: 29.78521 Long: -95.31838

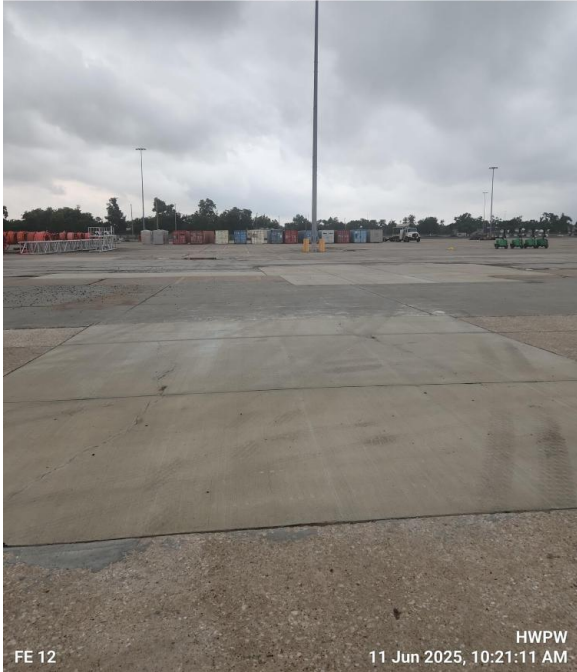
Client Name: Union Pacific Railroad		Site Location: Englewood Intermodal Yard, Houston, Texas	Project No. US0039040.4227
Photo No. 27	Inspection Date: 06/11/2025	<div>North Elevation</div> <div>☉ 161°SE (T) • 29.785565, -95.318728 ±9ft ▲ -68ft</div>

<div>FE 12 HWPW 11 Jun 2025, 10:21:11 AM</div>	
Description: FE-12 weekly inspection of concrete cap. Reconstructed cap in good condition. No NAPL observed at FE location. Facing southeast. Lat: 29.78556 Long: -95.31873			
Photo No. 28	Inspection Date: 06/11/2025	<div>North Elevation</div> <div>☉ 267°W (T) • 29.785089, -95.321237 ±16ft ▲ -49ft</div>

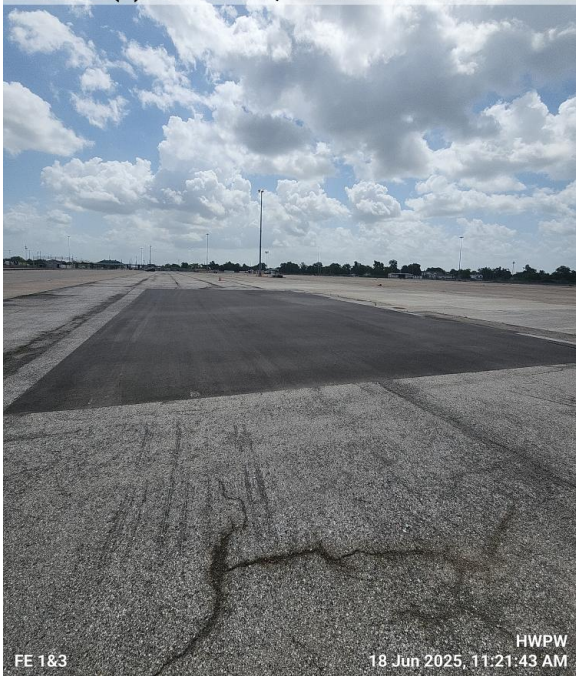
Client Name: Union Pacific Railroad		Site Location: Englewood Intermodal Yard, Houston, Texas	Project No. US0039040.4227
Photo No. 29	Inspection Date: 06/18/2025		<div><div>West Elevation</div><div>☉ 84°E (T) • 29.784266, -95.321046 ±9ft ▲ -190ft</div>

<div>FE 1&3HWPW 18 Jun 2025, 11:21:43 AM</div></div>
Description: FE-1&3 weekly inspection of asphalt cap. Reconstructed cap in good condition. No NAPL observed at FE location. Facing east. Lat: 29.78427 Long: -95.32105			
Photo No. 30	Inspection Date: 06/18/2025		<div><div>West Elevation</div><div>☉ 5°N (T) • 29.784062, -95.320777 ±9ft ▲ -150ft</div>

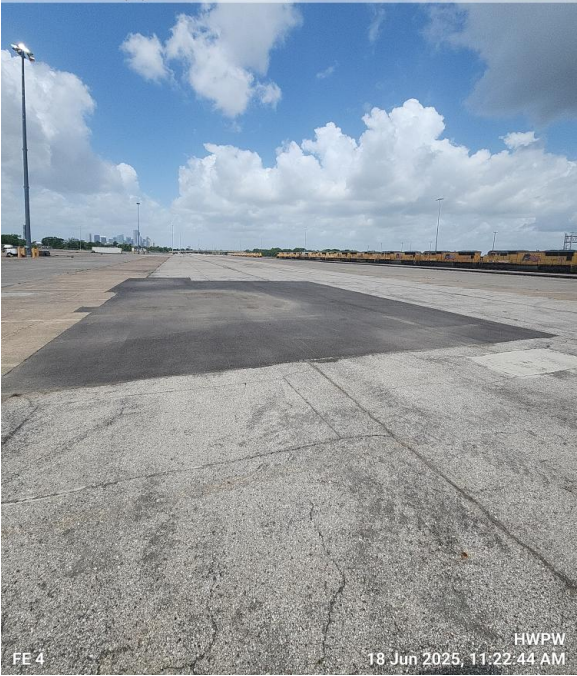
Client Name: Union Pacific Railroad		Site Location: Englewood Intermodal Yard, Houston, Texas	Project No. US0039040.4227
Photo No. 31	Inspection Date: 06/18/2025	<div><div>South Elevation</div><div>☉ 268°W (T) • 29.784868, -95.319425 ±9ft ▲ -180ft</div>

<div>FE 5 HWPW 18 Jun 2025, 11:23:31 AM</div></div>	
Description: FE-4 weekly inspection of asphalt cap. Reconstructed cap in good condition. No NAPL observed at FE location. Facing west. Lat: 29.78487 Long: -95.31942		Description: FE-5 weekly inspection of concrete cap. Reconstructed cap in good condition. No NAPL observed at FE location. Facing southwest. Lat: 29.78542 Long: -95.31849

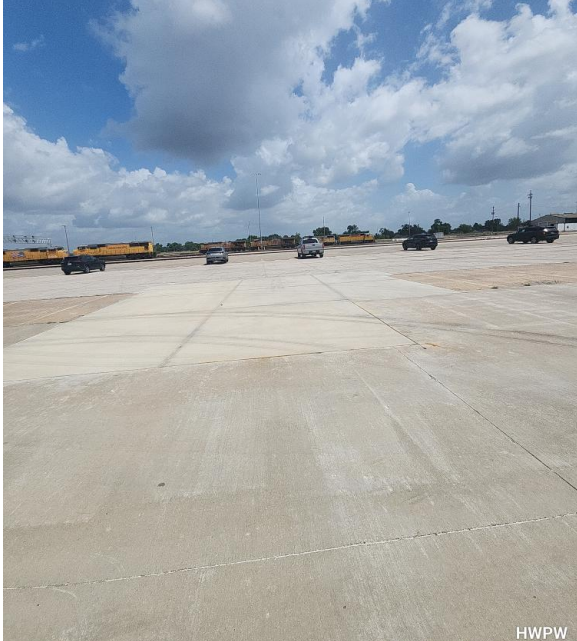
Client Name: Union Pacific Railroad		Site Location: Englewood Intermodal Yard, Houston, Texas	Project No. US0039040.4227
Photo No. 35	Inspection Date: 06/18/2025	<div><div>West Elevation</div><div>☉ 330°NW (T) • 29.78491, -95.31905 ±23ft ▲ -49ft</div>

<div>FE 9HWPW 18 Jun 2025, 11:25:55 AM</div></div>	
Description: FE-8 weekly inspection of concrete cap. Reconstructed cap in good condition. No NAPL observed at FE location. Facing northwest. Lat: 29.78491 Long: -95.31905		Description: FE-9 weekly inspection of concrete cap. Reconstructed cap in good condition. No NAPL observed at FE location. Facing northwest. Lat: 29.7852 Long: -95.31838

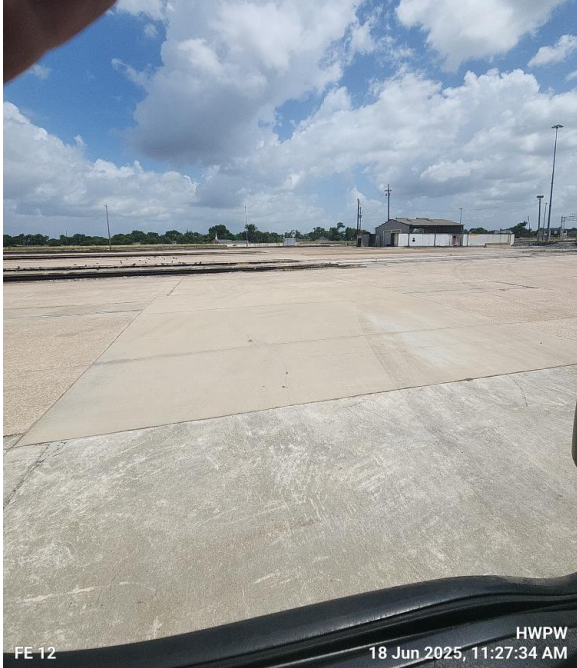
Client Name: Union Pacific Railroad		Site Location: Englewood Intermodal Yard, Houston, Texas	Project No. US0039040.4227
Photo No. 39	Inspection Date: 06/18/2025	<div><div><div>South Elevation</div><div>☉ 332°NW (T) • 29.785469, -95.318674 ±26ft ▲ -42ft</div>

<div>FE 12HWPW 18 Jun 2025, 11:27:34 AM</div></div><div><div>Description:</div><div>FE-12 weekly inspection of concrete cap. Reconstructed cap in good condition. No NAPL observed at FE location. Facing northwest.</div><div>Lat: 29.78547 Long: -95.31867</div></div></div>	
Photo No. 40	Inspection Date: 06/18/2025	<div><div><div>North Elevation</div><div>☉ 159°SE (T) • 29.785107, -95.321252 ±26ft ▲ -29ft</div>

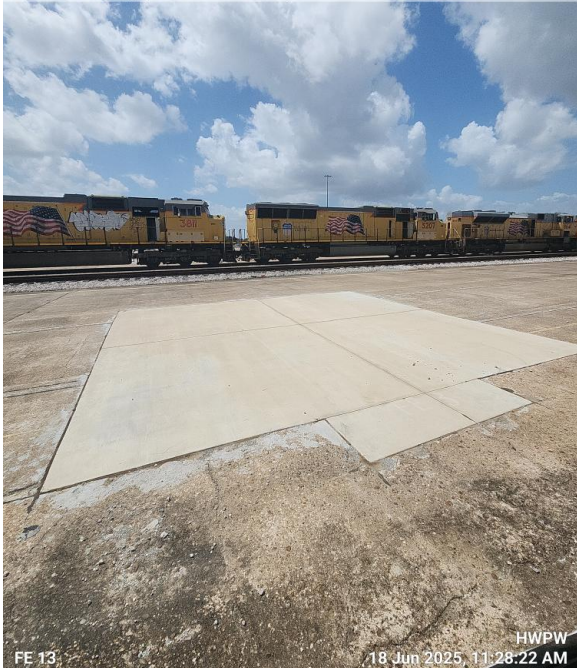
<div>FE 13HWPW 18 Jun 2025, 11:28:22 AM</div></div><div><div>Description:</div><div>FE-13 weekly inspection of concrete cap. Reconstructed cap in good condition. No NAPL observed at FE location. Facing southeast.</div><div>Lat: 29.78511 Long: -95.32125</div></div></div>

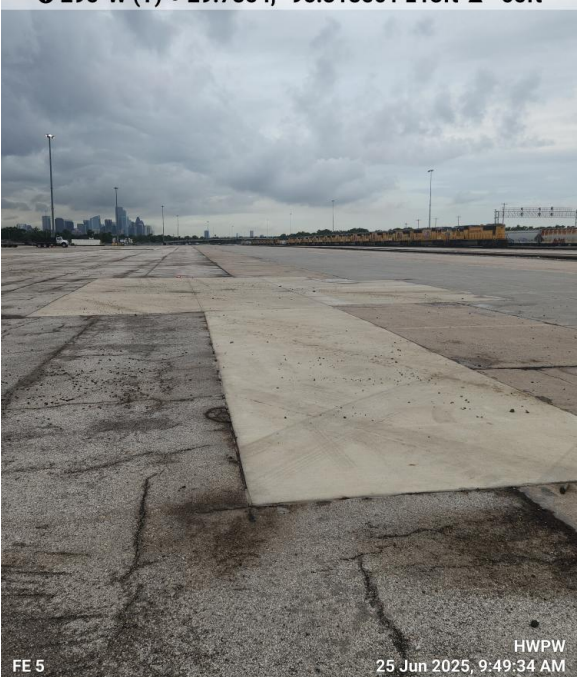
<div>FE 5HWPW 25 Jun 2025, 9:49:34 AM</div></div>	
Description: FE-4 weekly inspection of asphalt cap. Reconstructed cap in good condition. No NAPL observed at FE location. Facing northeast. Lat: 29.7847 Long: -95.31965		Description: FE-5 weekly inspection of concrete cap. Reconstructed cap in good condition. No NAPL observed at FE location. Facing west. Lat: 29.7854 Long: -95.3185

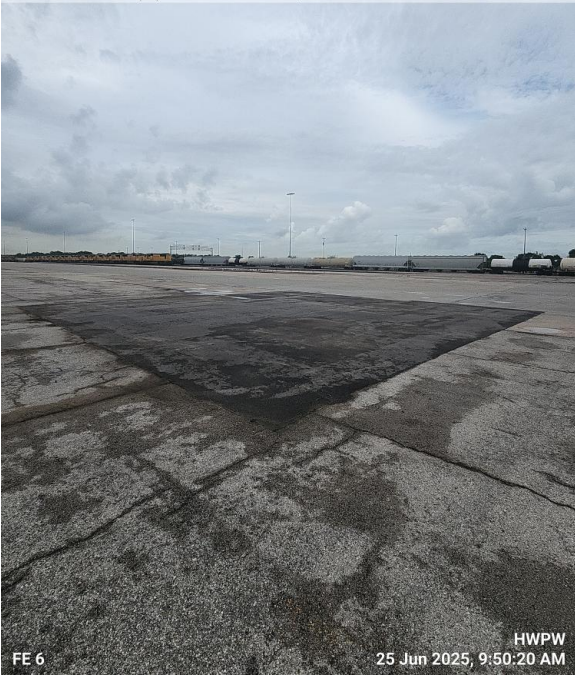
FE-6 weekly inspection of asphalt cap.
Reconstructed cap in good condition. No NAPL
observed at FE location. Facing northwest.

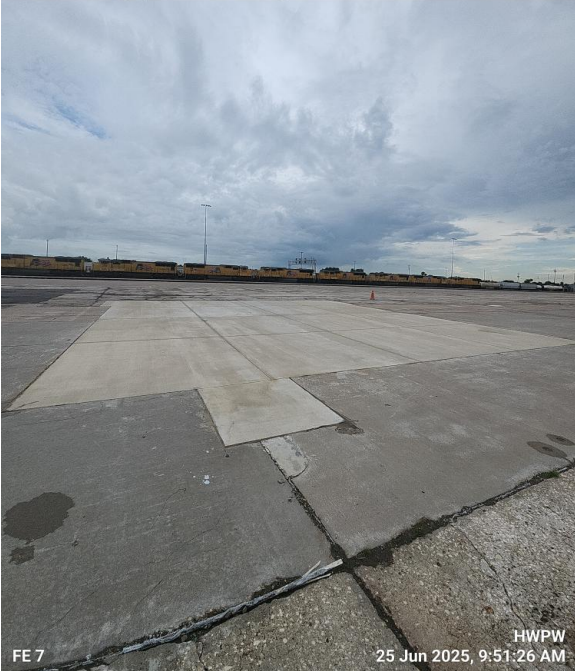
FE-7 weekly inspection of concrete cap.
Reconstructed cap in good condition. No NAPL
observed at FE location. Facing north.

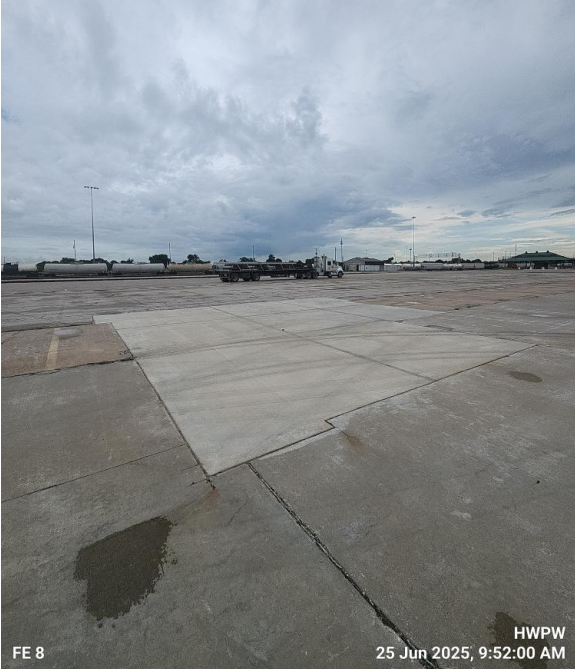
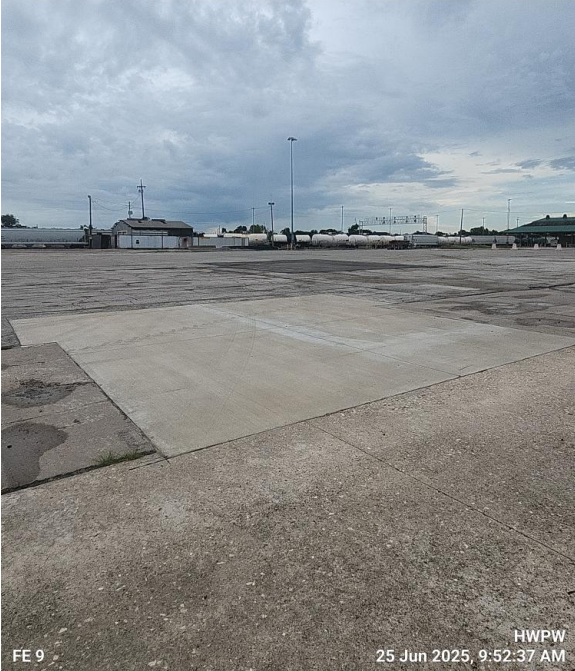
<div>FE 9 HWPW 25 Jun 2025, 9:52:37 AM</div>	
Description: FE-8 weekly inspection of concrete cap. Reconstructed cap in good condition. No NAPL observed at FE location. Facing north. Lat: 29.78486 Long: -95.31914		Description: FE-9 weekly inspection of concrete cap. Reconstructed cap in good condition. No NAPL observed at FE location. Facing northeast. Lat: 29.78521 Long: -95.31842

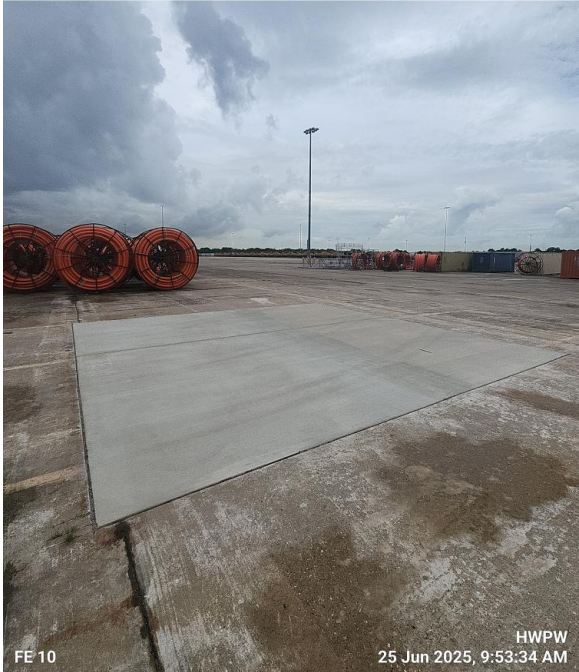
FE-10 weekly inspection of concrete cap.
Reconstructed cap in good condition. No NAPL
observed at FE location. Facing west.

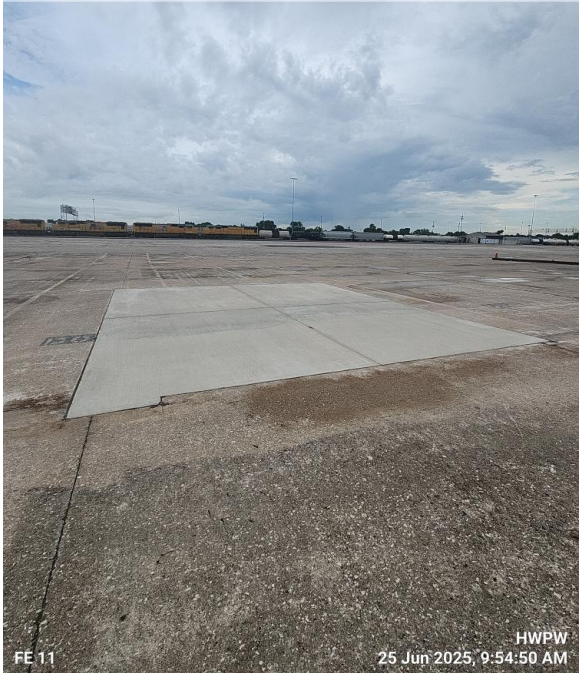
FE-11 weekly inspection of concrete cap.
Reconstructed cap in good condition. No NAPL
observed at FE location. Facing north.

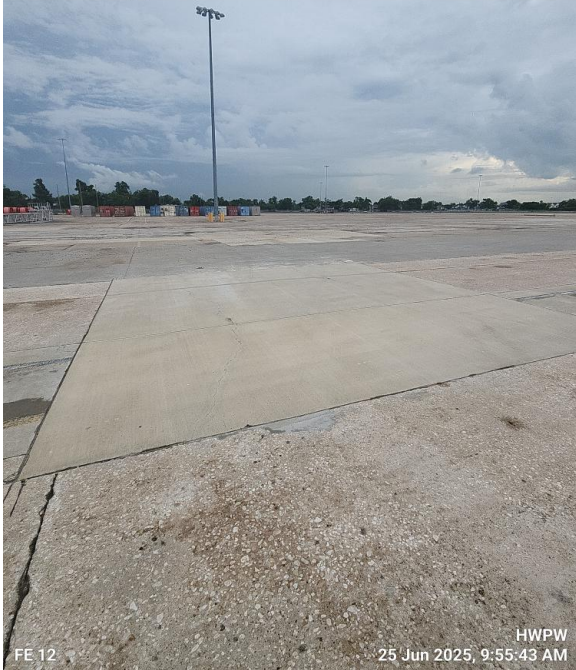
</div> <div>FE 12HWPW 25 Jun 2025, 9:55:43 AM</div>	
Description: FE-12 weekly inspection of concrete cap. Reconstructed cap in good condition. No NAPL observed at FE location. Facing south. Lat: 29.78555 Long: -95.31871			
Photo No. 52	Inspection Date: 06/25/2025	<div>4910 Liberty Rd, Houston, TX 77026, USA</div> <div>☉ 199°S (T) • 29.785081, -95.321225 ±9ft ▲ -42ft</div> <div>

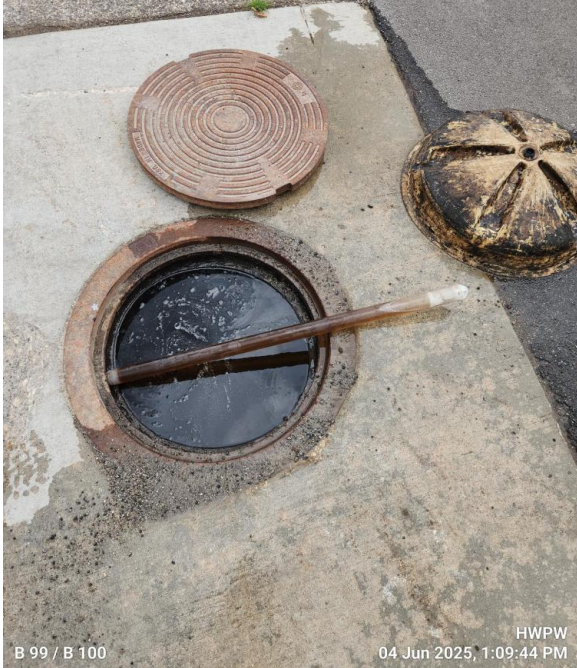
<p>B 99 / B 100</p><p>HWPW 04 Jun 2025, 1:09:44 PM</p></div>
Photo No. 54	Inspection Date: 06/04/2025	<div><p>East Elevation</p><p>☉ 263°W (T) • 29.784249, -95.320885 ±26ft ▲ -52ft</p>

Sump 1 (B99/B100), 0.0 inches of freeboard in sump. Color is dark brown, and no sheen or odor observed.

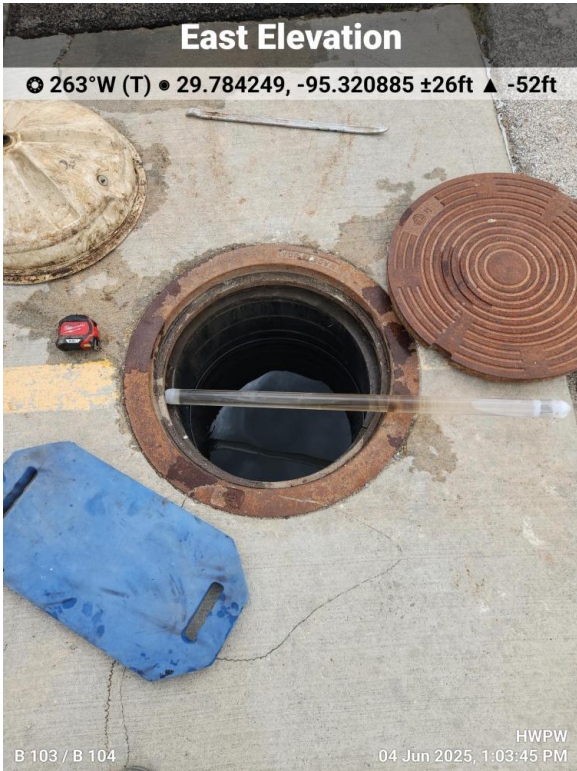
<p>B 103 / B 104</p><p>HWPW 04 Jun 2025, 1:03:45 PM</p></div>

Sump 2 (B103/B104), 9.5 inches of freeboard in sump. Color is tan, and no sheen or odor observed.

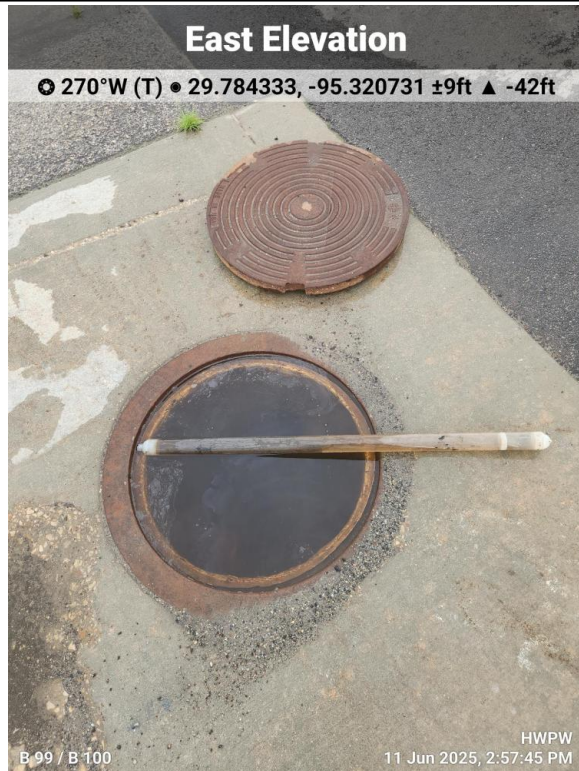
Photo No. 56	Inspection Date: 06/11/2025		
Description: Sump 1 (B99/B100), 0.0 inches of freeboard in sump. Color is dark brown, and no sheen or odor observed. Lat: 29.78433 Long: -95.32073

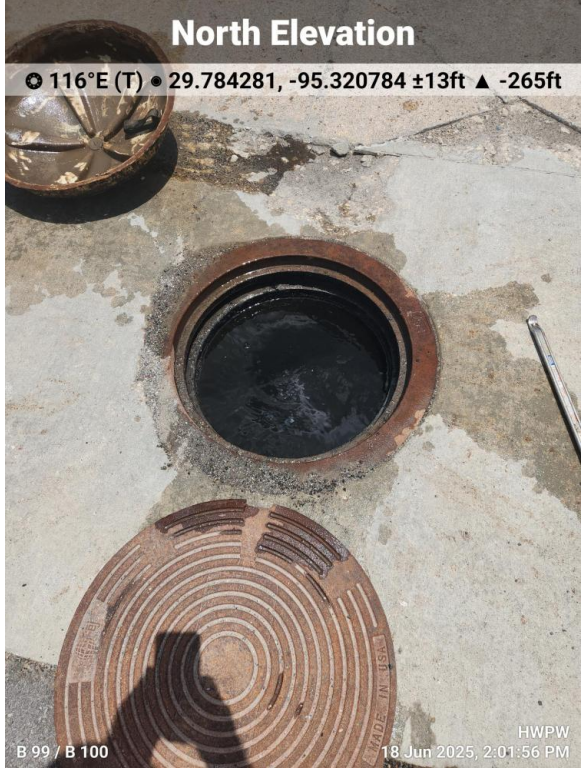
<p>B 99 / B 100 HWPW 18 Jun 2025, 2:01:56 PM</p></div>
Photo No. 60	Inspection Date: 06/18/2025	<div><p>North Elevation</p><p>☉ 291°W (T) • 29.784219, -95.32087 ±9ft ▲ -42ft</p>

Sump 1 (B99/B100), 1.5 inches of freeboard in sump. Color is dark brown, and no sheen or odor observed.

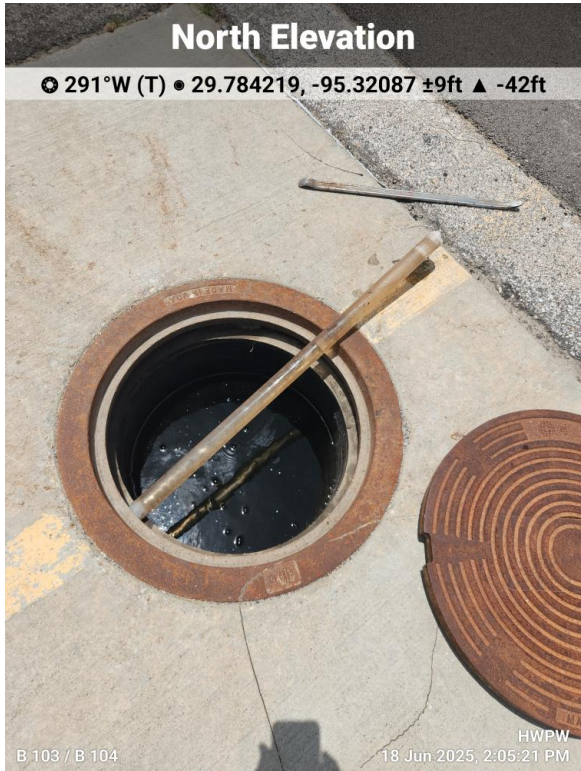
<p>B 103 / B 104 HWPW 18 Jun 2025, 2:05:21 PM</p></div>

Sump 2 (B103/B104), 6.5 inches of freeboard in sump. Color is tan, and no sheen or odor observed.

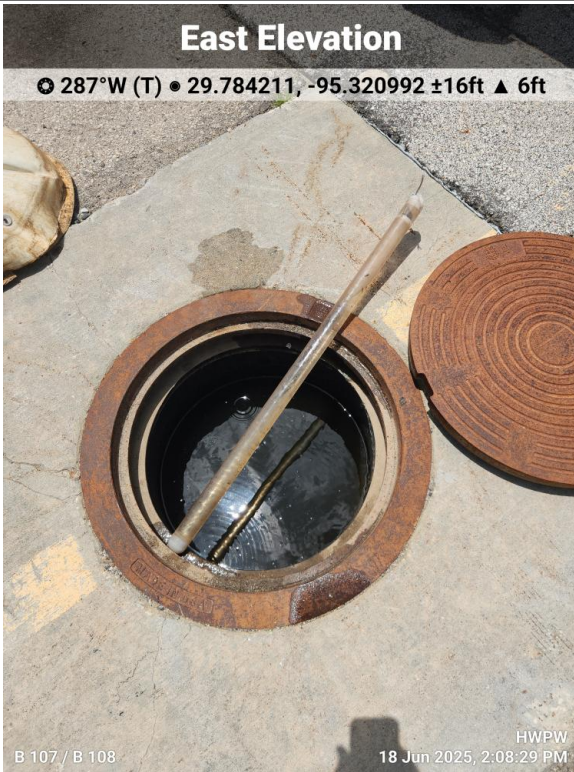
<div>B 107 / B 108</div><div>HWPW 18 Jun 2025, 2:08:29 PM</div></div>
Description: Sump 3 (B107/B108), 6.0 inches of freeboard in sump. Color is tan, and no sheen or odor observed. Lat: 29.78421 Long: -95.32099			
Photo No. 62	Inspection Date: 06/25/2025		<div><div>W W NW</div><div>☉ 284°W (T) • 29.784264, -95.320771 ±26ft ▲ -52ft</div>

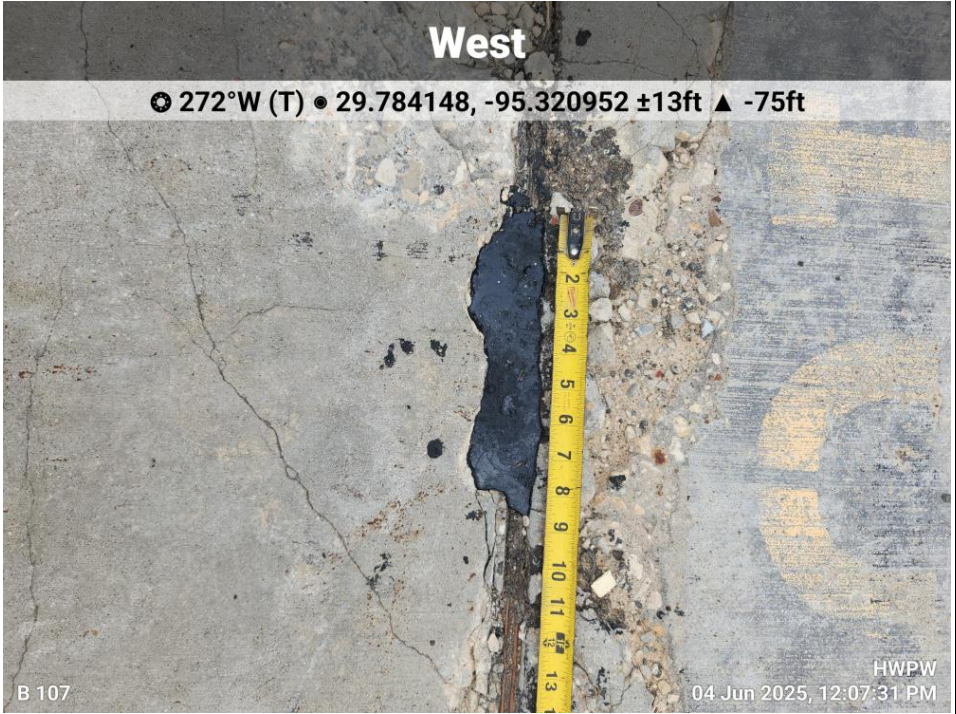
B107 weekly inspection of joint. Surrounding concrete in good condition. Approximately 9 cubic inches of NAPL observed along joint.

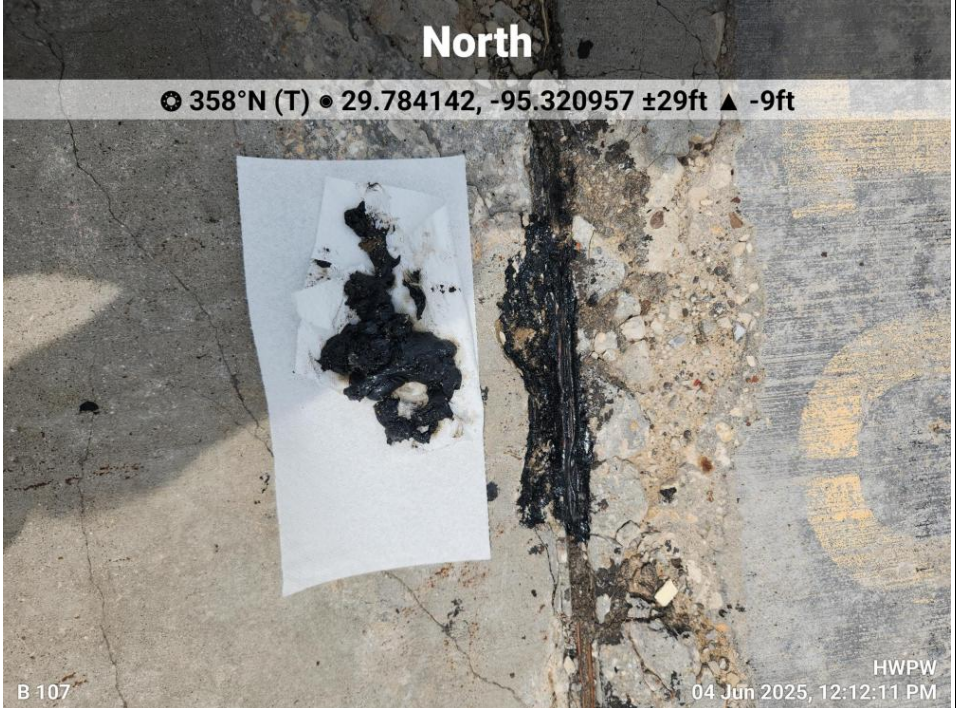
B107 weekly inspection of joint. Surrounding concrete in good condition. Approximately 9 cubic inches of NAPL observed along joint.

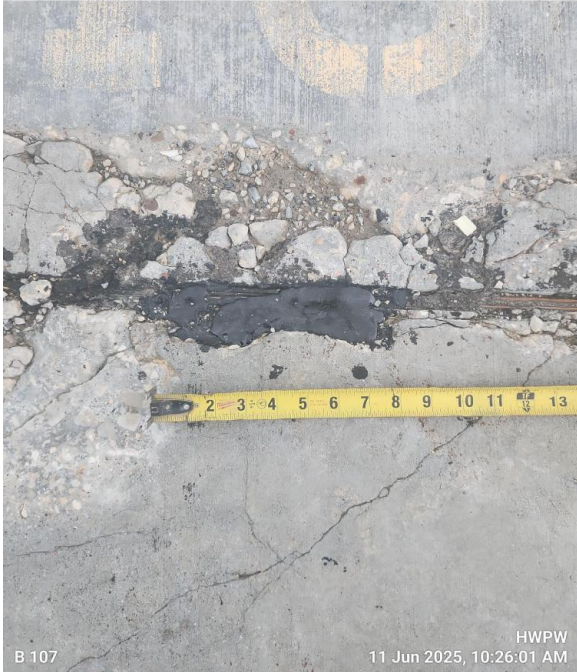
<div>B 107HWPW 11 Jun 2025, 2:41:24 PM</div></div>	
Description: B107 weekly inspection of joint. Surrounding concrete in good condition. Approximately 3 cubic inches of NAPL observed along joint. Lat: 29.78414 Long: -95.3201		Description: B107 weekly inspection of joint. Surrounding concrete in good condition. Approximately 3 cubic inches of NAPL observed along joint. Lat: 29.7842 Long: -95.321

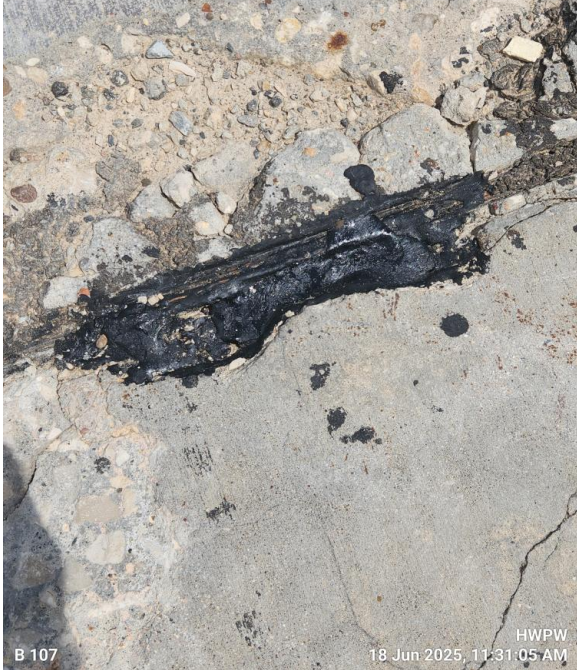
<div>B 107 HWPW 18 Jun 2025, 11:31:05 AM</div></div>
<div>Description: B107 weekly inspection of joint. Surrounding concrete in good condition. Approximately 3 cubic inches of NAPL observed along joint. Lat: 29.78415 Long: -95.32095</div>			
Photo No. 70	Inspection Date: 06/18/2025		<div><div>South Elevation</div><div>☉ 214°SW (T) • 29.78418, -95.321008 ±13ft ▲ -187ft</div>

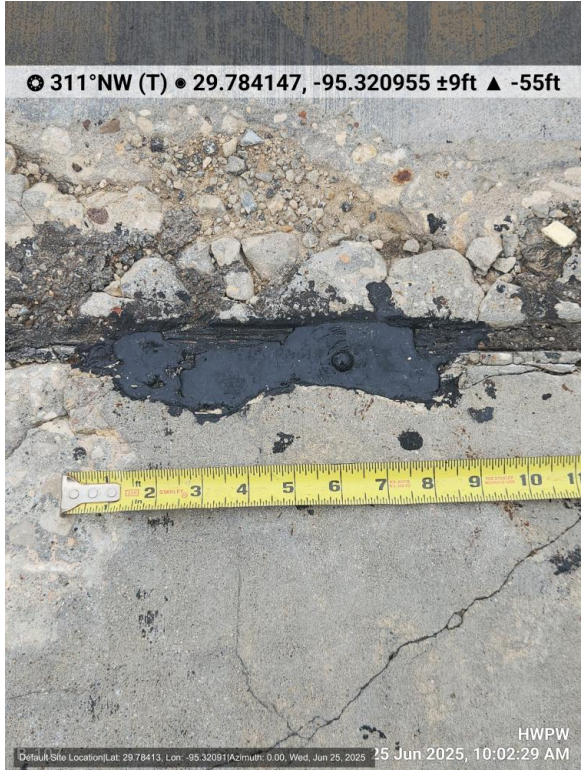
<p>2508 Wipprecht St, Houston, TX 77020, USA</p> <p>⊙ 342°NW (T) • 29.784135, -95.320877 ±36ft ▲ 98ft</p> <p>HWPW B-107 25 Jun 2025, 10:08:06 AM</p>	
Description: B107 weekly inspection of joint. Surrounding concrete in good condition. Approximately 5 cubic inches of NAPL observed along joint.		Description: B107 weekly inspection of joint. Surrounding concrete in good condition. Approximately 5 cubic inches of NAPL observed along joint.	
Lat: 29.78415 Long: -95.32096		Lat: 29.78414 Long: -95.32088

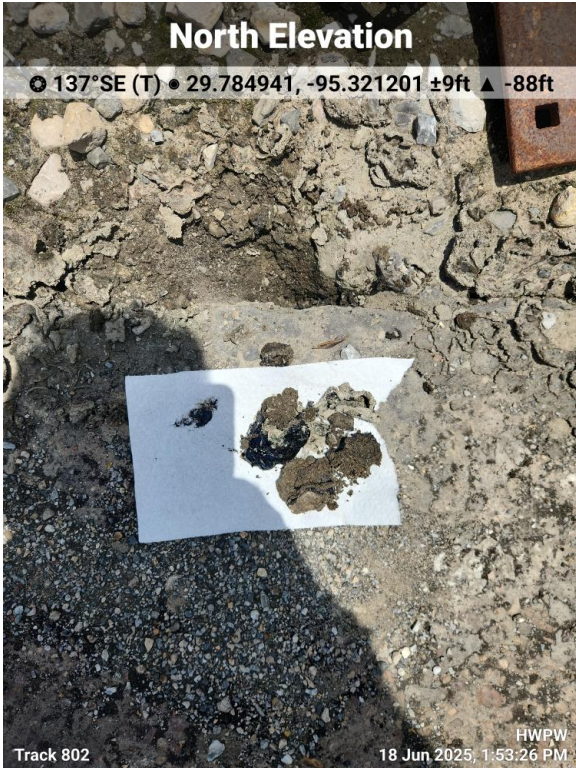
<div>Track 802</div> <div>HWPW 18 Jun 2025, 1:53:26 PM</div>
Description: Track 802 weekly inspection of track. Surrounding concrete and ballast in good condition. Approximately 1 cubic inches of NAPL observed along joint. Lat: 29.78494 Long: -95.3212

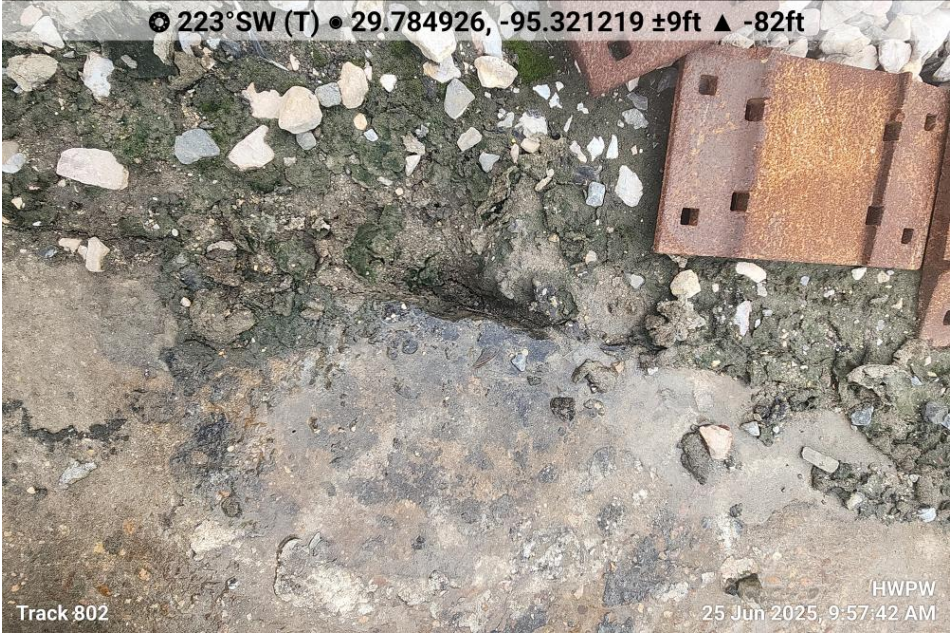
<div>H 20</div> <div>HWPW 04 Jun 2025, 12:30:12 PM</div>	
Description: Track 802 weekly inspection of track. Surrounding concrete and ballast in good condition. No NAPL observed at location. Lat: 29.78493 Long: -95.32122		Description: Remnants of tar-like NAPL material near stall H020. No additional tar-like material accumulated along joint. Lat: 29.78428 Long: -95.31764

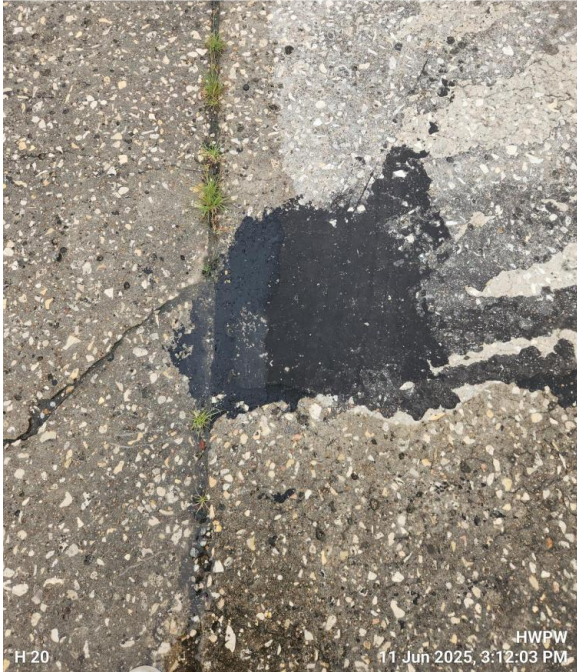
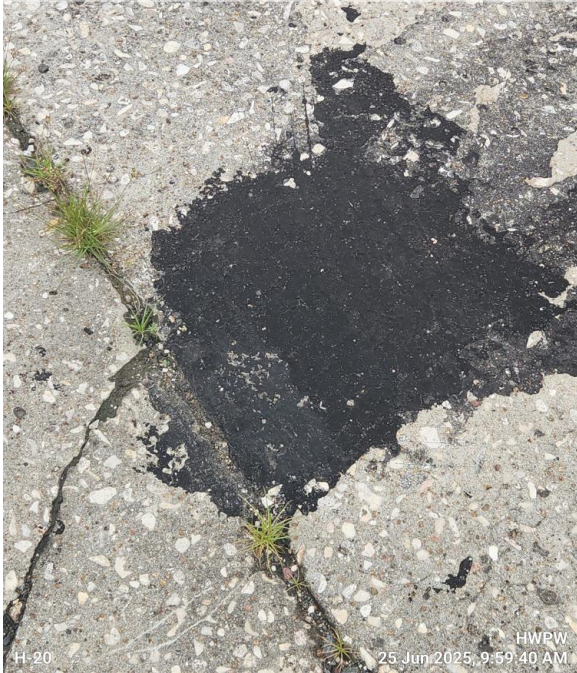
<div>H-20 HWPW 25 Jun 2025, 9:59:40 AM</div>	
Description: Remnants of tar-like NAPL material near stall H020. No additional tar-like material accumulated along joint. Lat: 29.78426 Long: -95.31757		Description: Remnants of tar-like NAPL material near stall H020. No additional tar-like material accumulated along joint. Lat: 29.78426 Long: -95.31764

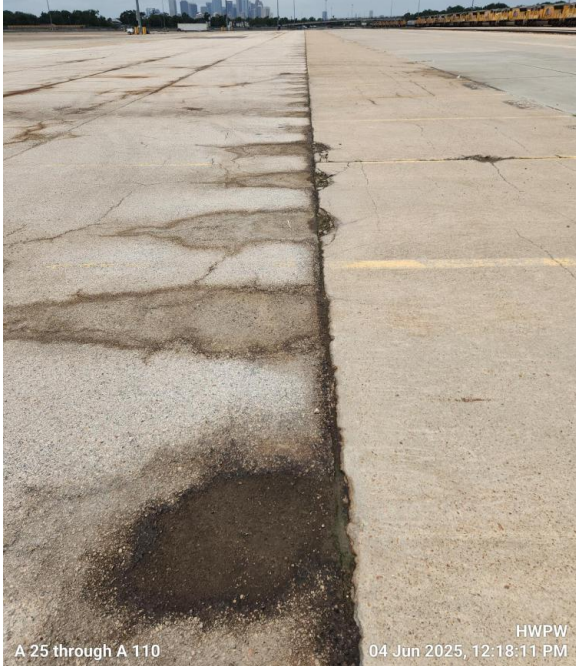
<div>A 25 through A 110HWPW04 Jun 2025, 12:18:11 PM</div></div>
<div>Description: Brown water staining along the joint that runs from A025 through A110. Facing southwest. Lat: 29.7853 Long: -95.31886</div>			
Photo No. 82	Inspection Date: 06/04/2025		<div><div>East Elevation</div><div>☉ 241°SW (T) • 29.784759, -95.319964 ±9ft ▲ -3ft</div>

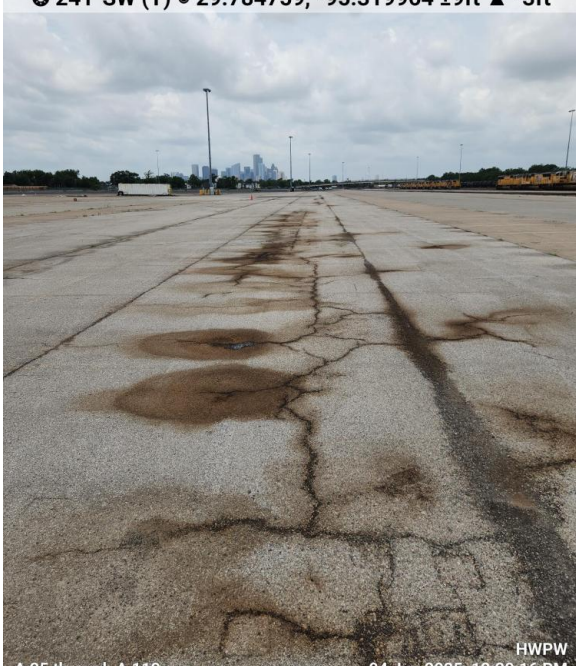
<div>A 25 through A 110HWPW04 Jun 2025, 12:20:16 PM</div></div>
<div>Description: Brown water staining along the joint that runs from A025 through A110. Facing southwest. Lat: 29.78476 Long: -95.31996</div>

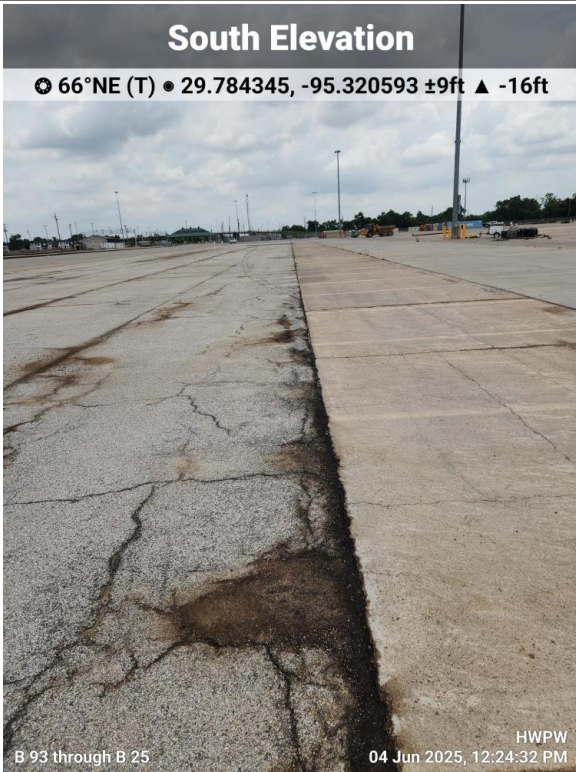
Client Name: Union Pacific Railroad		Site Location: Englewood Intermodal Yard, Houston, Texas	Project No. US0039040.4227
Photo No. 83	Inspection Date: 06/04/2025		
Description: Brown water staining along the joint that runs from B025 through B093. Facing northeast. Lat: 29.78434 Long: -95.32059			<div><div>South Elevation</div><div>☉ 66°NE (T) • 29.784345, -95.320593 ±9ft ▲ -16ft</div>

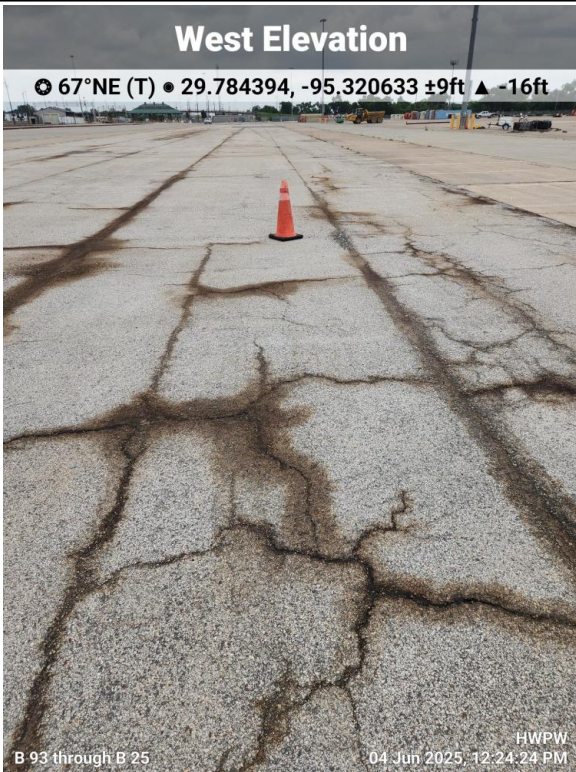
<div>B 93 through B 25HWPW04 Jun 2025, 12:24:32 PM</div></div>
Photo No. 84	Inspection Date: 06/04/2025		
Description: Brown water staining along the joint that runs from B025 through B093. Facing northeast. Lat: 29.78439 Long: -95.32063			<div><div>West Elevation</div><div>☉ 67°NE (T) • 29.784394, -95.320633 ±9ft ▲ -16ft</div>
