Project No. US0039040.4227

**Re: MONTHLY STATUS UPDATE – ENGLEWOOD INTERMODAL YARD – REVISED INTERIM MEASURES
WORK PLAN POST-CONSTRUCTION AND NAPL COLLECTION SYSTEM/CONCRETE CAP REPAIR
INSPECTIONS
UNION PACIFIC RAILROAD HOUSTON WOOD PRESERVING WORKS FACILITY
4910 LIBERTY ROAD FACILITY, HOUSTON, TEXAS
POST-CLOSURE CARE PERMIT NO. HW-50343; INDUSTRIAL SWR NO. 31547**

WSP USA Inc. (WSP), on behalf of Union Pacific Railroad Company (UPRR), is pleased to provide this monthly status update for December 2025 summarizing the weekly inspections being conducted at the Englewood Intermodal Yard (EIY) concrete cap area within the UPRR Houston Wood Preserving Works Facility (the Site). The weekly inspections are being conducted to evaluate the post-construction Focused Excavations as detailed in the *Revised Interim Measures Work Plan – Englewood Intermodal Yard (EIY)*, (Revised IMWP) dated October 20, 2023. In addition, a summary of the weekly Non-Aqueous Phase Liquid (NAPL) Collection System and concrete cap area inspections conducted at the EIY is provided as requested by the Texas Commission on Environmental Quality (TCEQ) in a letter dated March 20, 2018. Below is a summary of the weekly

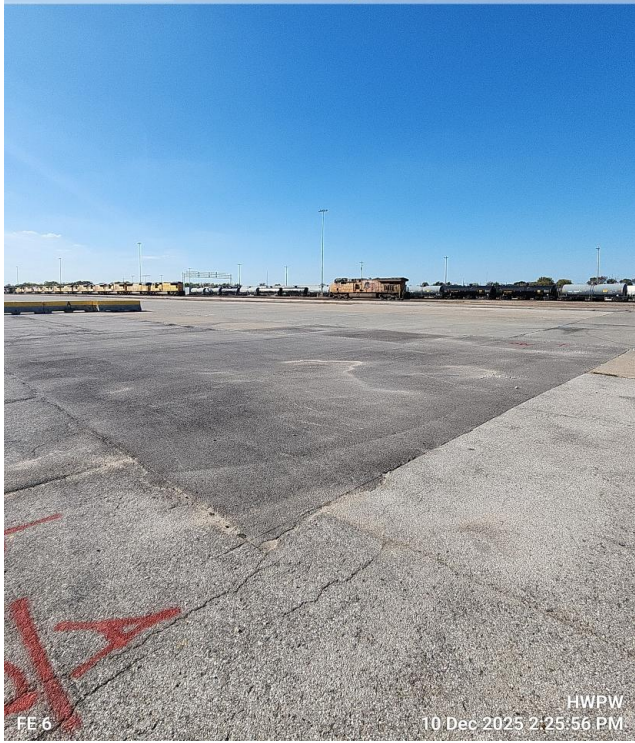
Photo No. 17	Inspection Date: 12/10/2025	<p>POS: 29.785456, -95.318242 ±9ft ALT: -36ft</p>

FE-6 weekly inspection of asphalt cap. Reconstructed cap in good condition. No NAPL observed at FE location. Facing northwest.

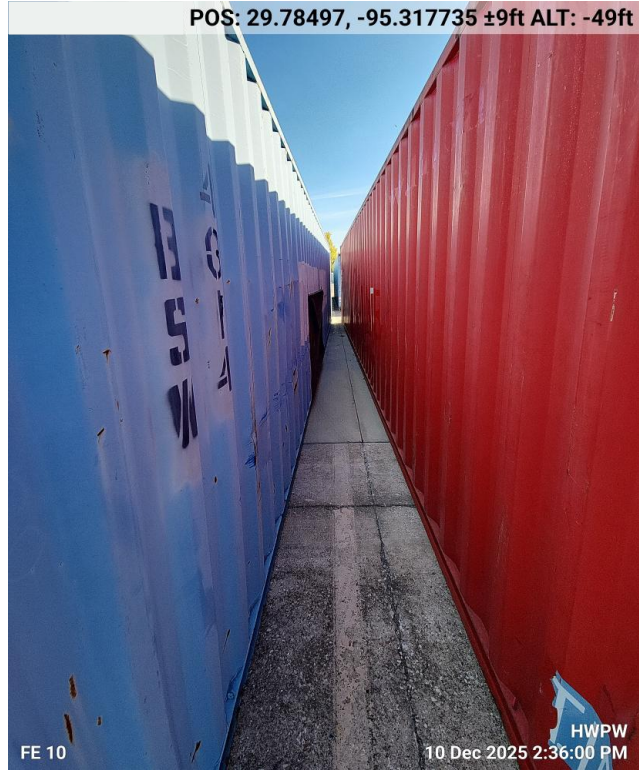
FE-10 weekly inspection of concrete cap. Reconstructed cap in good condition. No NAPL observed at FE location. Facing northwest.

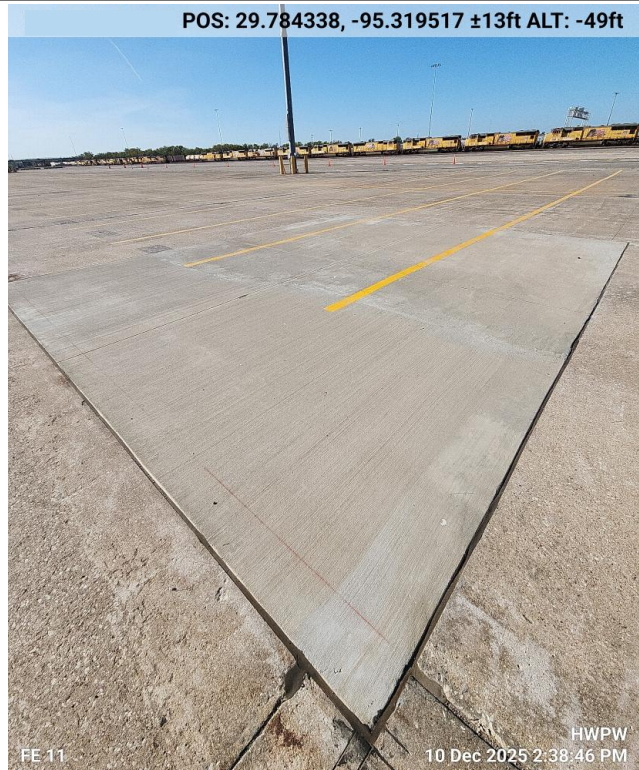
FE-11 weekly inspection of concrete cap. Reconstructed cap in good condition. No NAPL observed at FE location. Facing northwest.

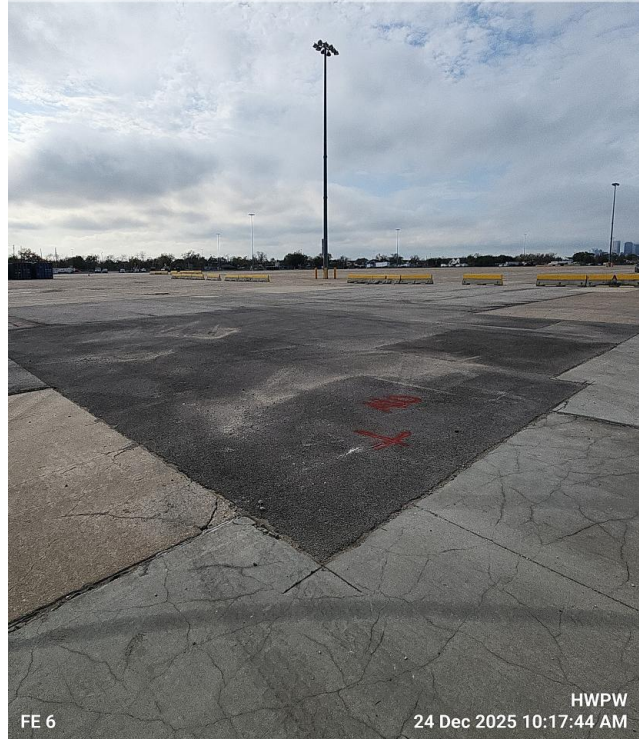
FE-6 weekly inspection of asphalt cap.
Reconstructed cap in good condition. No NAPL observed at FE location. Facing southwest.

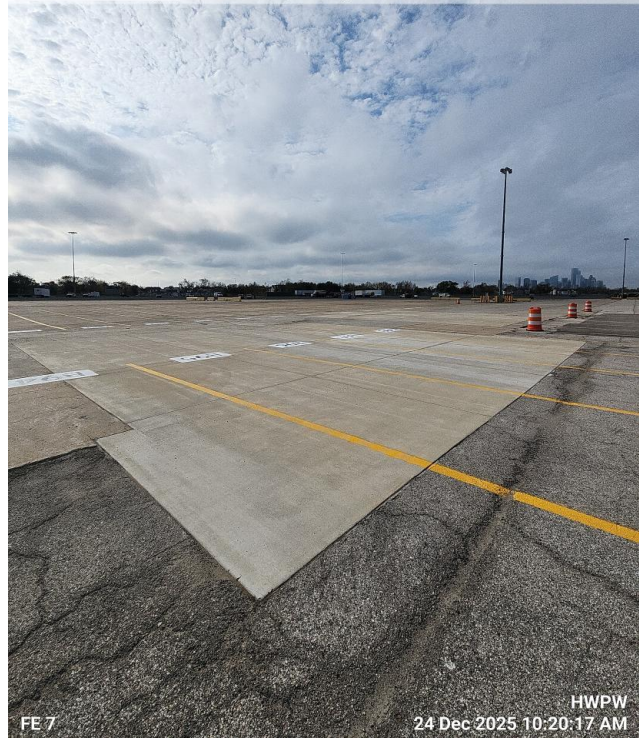
FE-7 weekly inspection of concrete cap.
Reconstructed cap in good condition. No NAPL observed at FE location. Facing southwest.

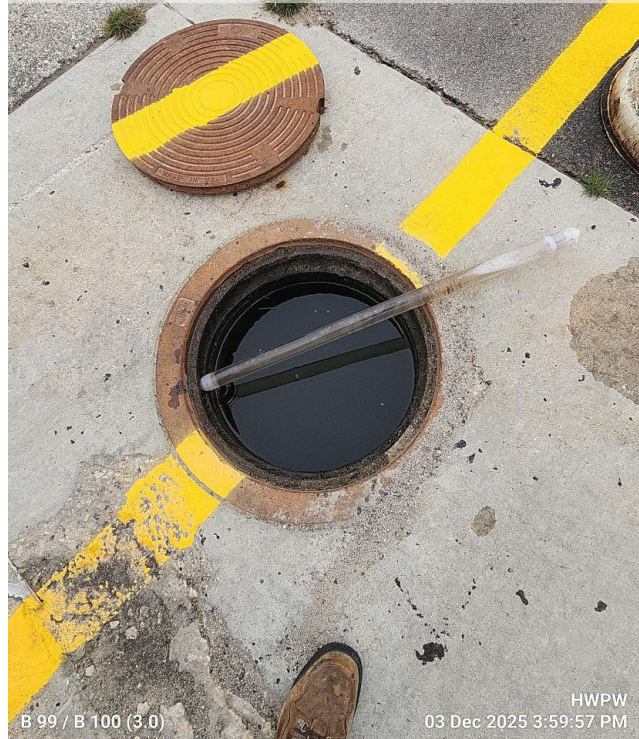
Sump 1 (B99/B100), 3.0 inches of freeboard in sump. Color is clear with a brown tint, and a sheen was observed. No odor was reported.

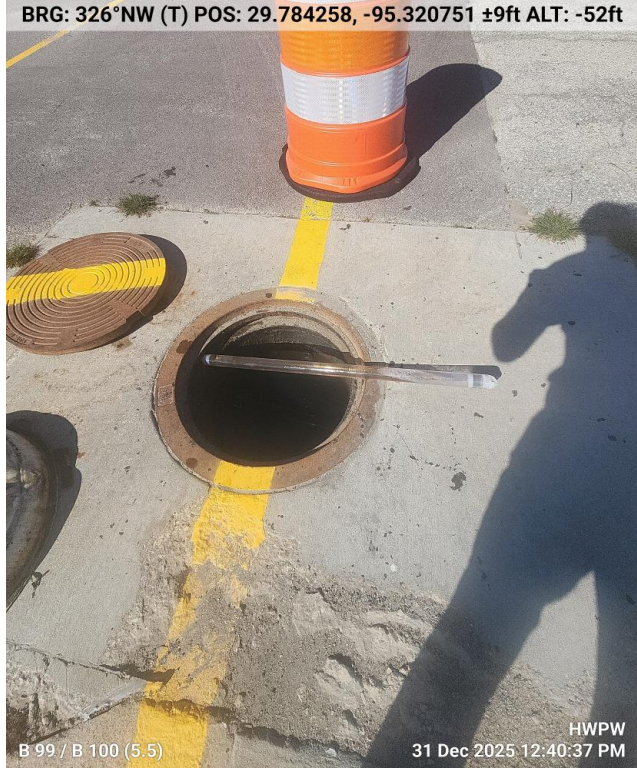
Photo No.
74

Sump 1 (B99/B100), 5.5 inches of freeboard in sump. Color is clear with a brown tint, and no sheen or odor was reported.

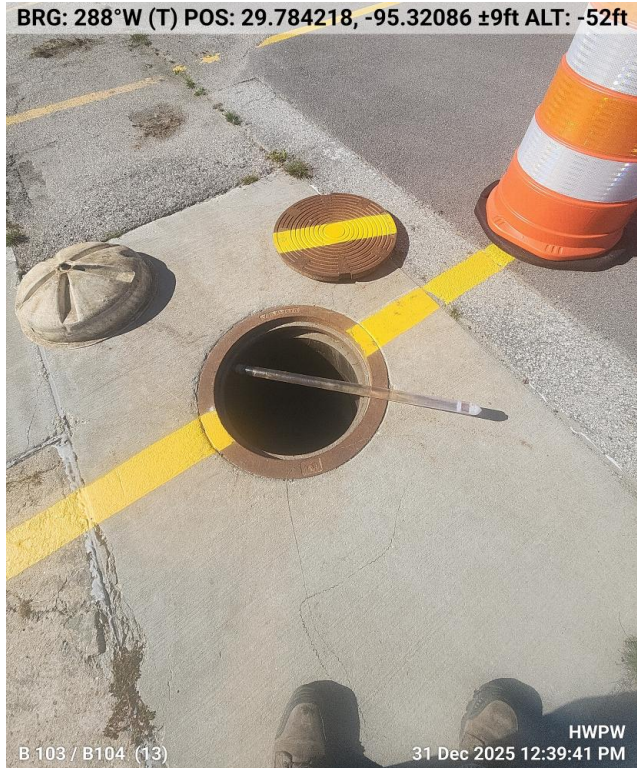
Sump 2 (B103/B104), 13.0 inches of freeboard in sump. Color is clear, and no sheen or odor was reported.

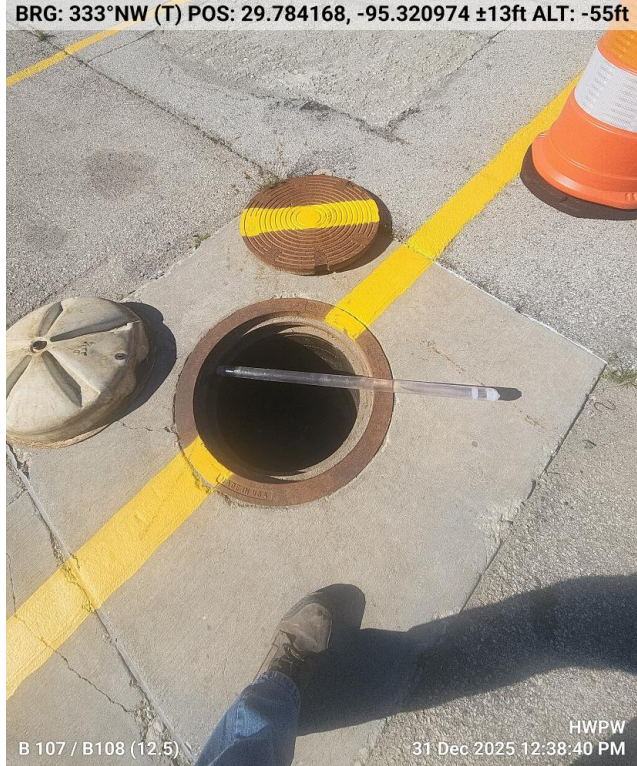
Sump 3 (B107/B108), 12.5 inches of freeboard in sump. Color is clear, and no sheen or odor was reported.

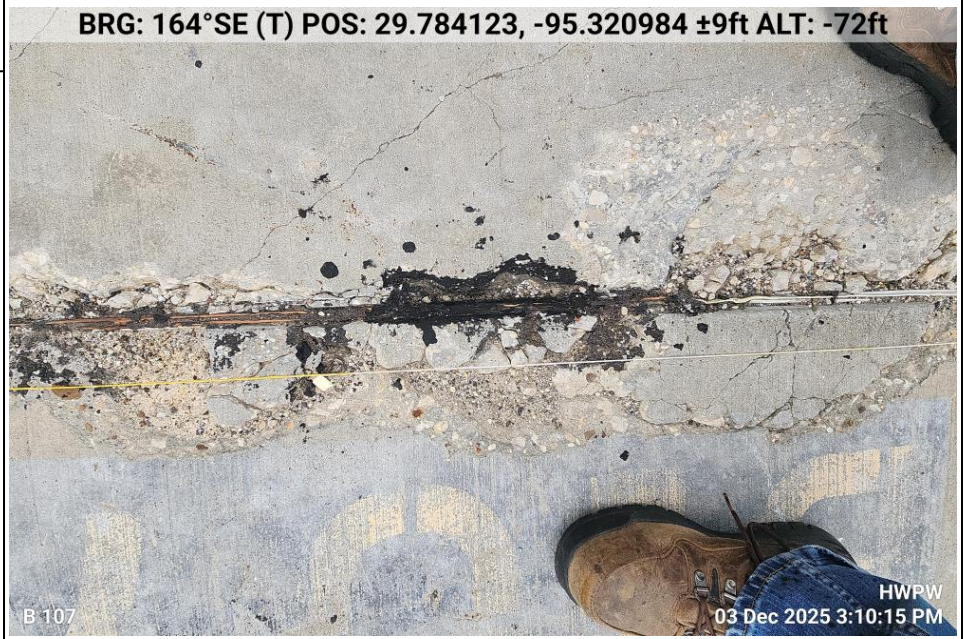
B107 weekly inspection of joint. Surrounding concrete in good condition. No active NAPL seep observed along joint.

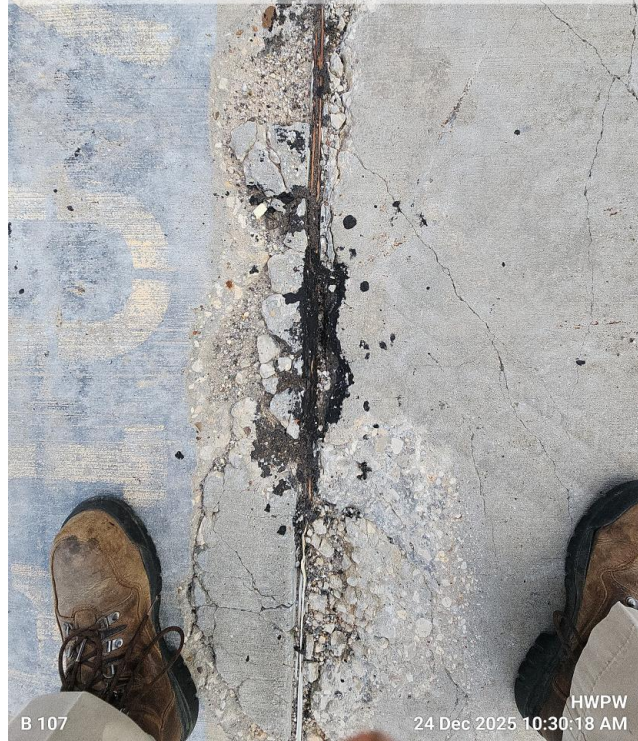
B 107

B107 weekly inspection of joint. Surrounding concrete in good condition. No active NAPL seep observed along joint.

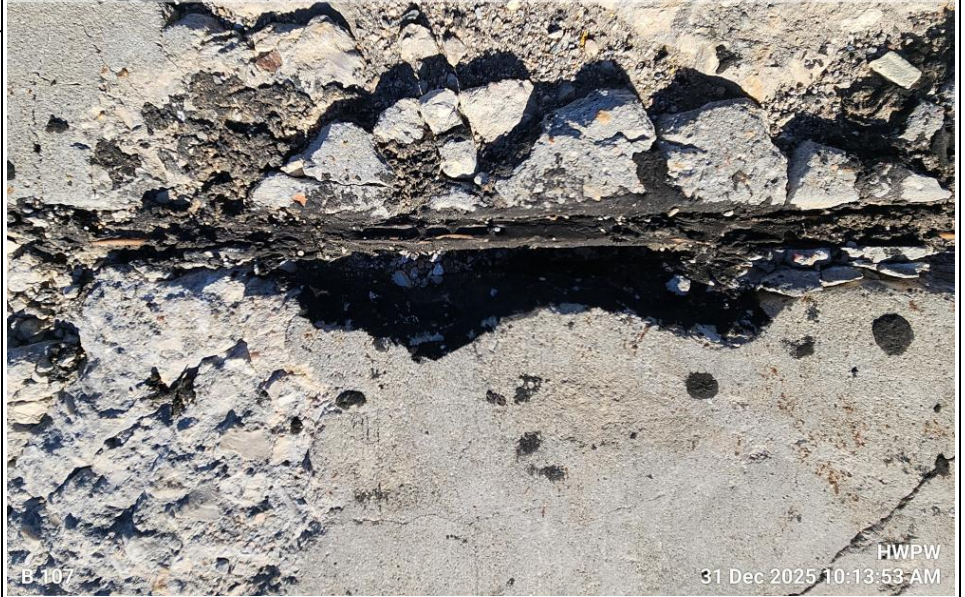
B 107

B107 weekly inspection of joint. Surrounding concrete in good condition. No active NAPL seep observed along joint.

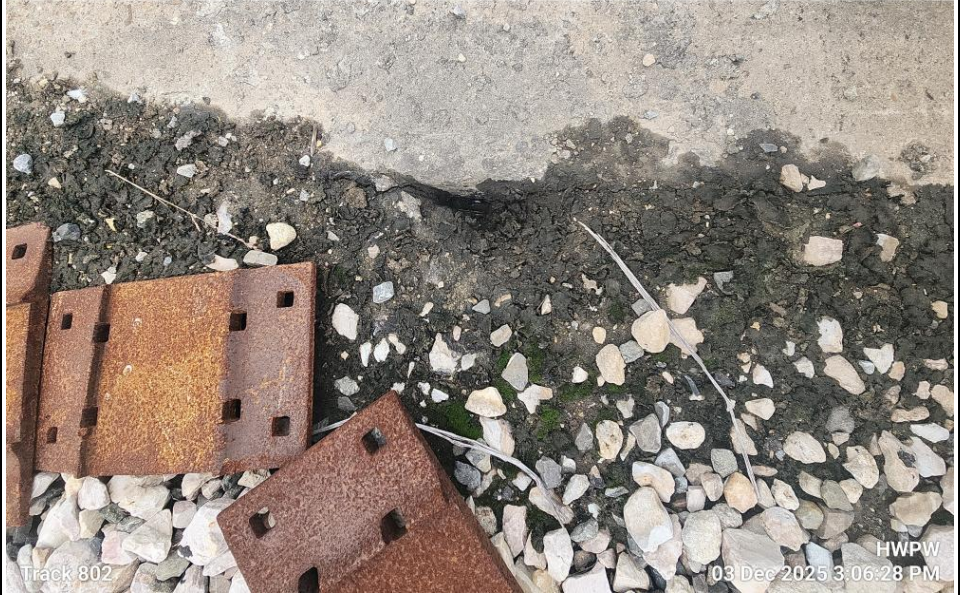
Photo No.
82

Track 802 weekly inspection of track. Surrounding concrete and ballast in good condition. No active NAPL seep observed along joint.

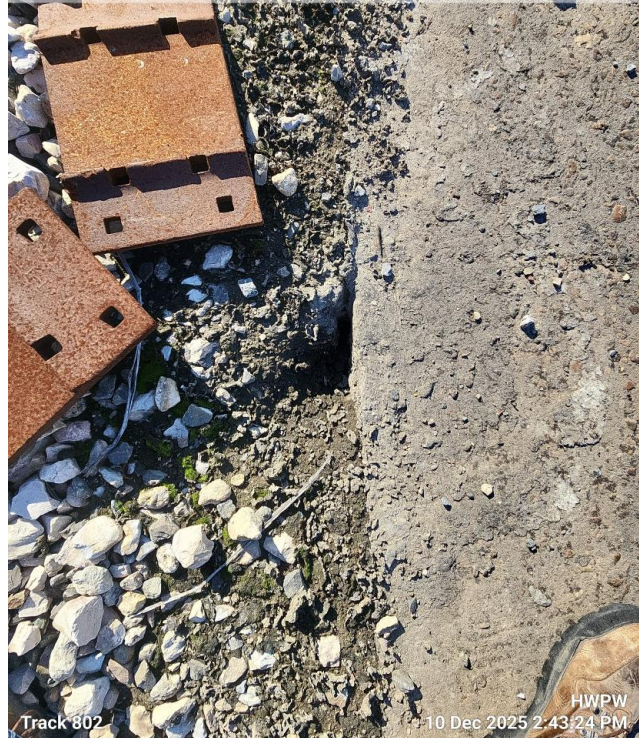
Track 802 weekly inspection of track. Surrounding concrete and ballast in good condition. No active NAPL seep observed along joint.

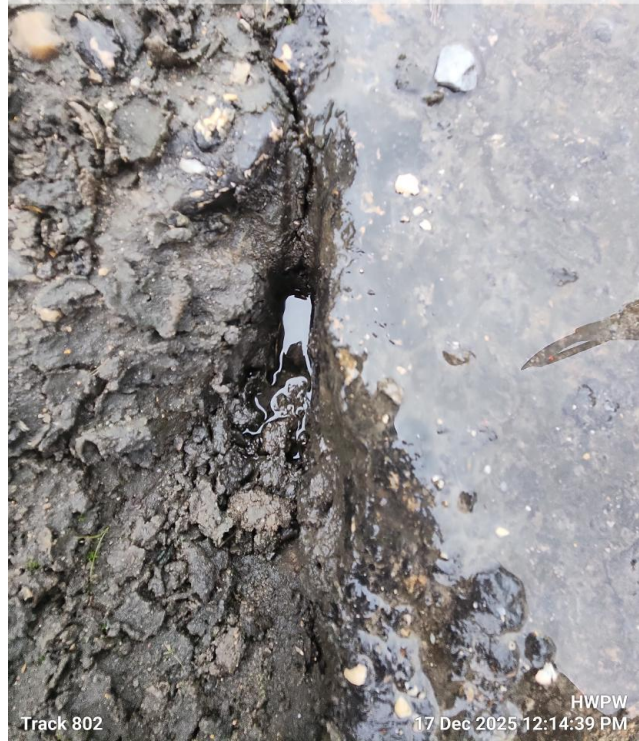
Photo No.
84

Track 802 weekly inspection of track. Surrounding concrete and ballast in good condition. No active NAPL seep observed along joint.

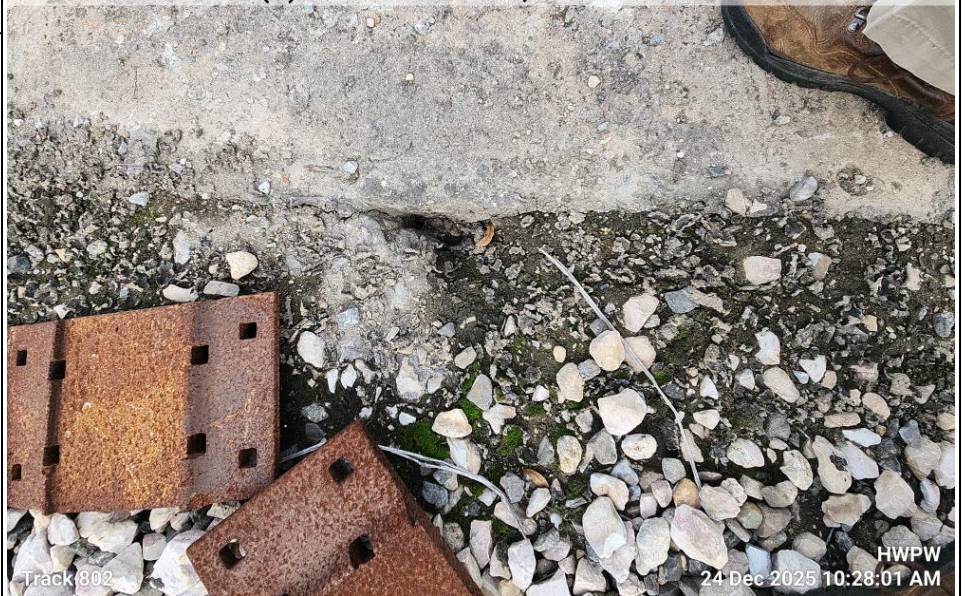
Track 802 weekly inspection of track. Surrounding concrete and ballast in good condition. No active NAPL seep observed along joint.

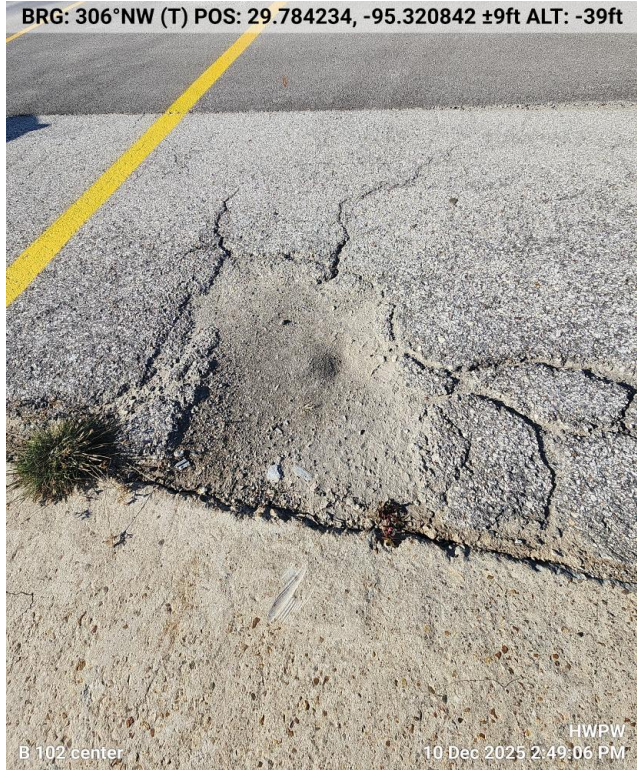
Photo No.
88

B102 Center weekly inspection of previously identified seep. Surrounding asphalt in good condition. No active NAPL seep observed along joint.

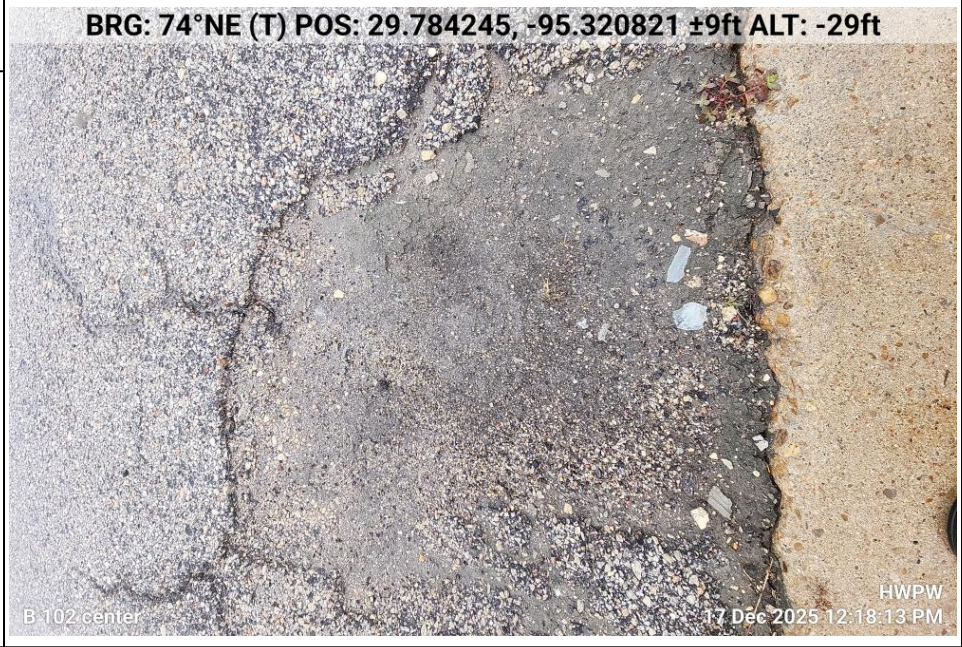
B102 Center weekly inspection of previously identified seep. Surrounding asphalt in good condition. No active NAPL seep observed along joint.
