November 14, 2025

Project No. US0039040.4227

**Re: MONTHLY STATUS UPDATE – ENGLEWOOD INTERMODAL YARD – REVISED INTERIM MEASURES
WORK PLAN POST-CONSTRUCTION AND NAPL COLLECTION SYSTEM/CONCRETE CAP REPAIR
INSPECTIONS
UNION PACIFIC RAILROAD HOUSTON WOOD PRESERVING WORKS FACILITY
4910 LIBERTY ROAD FACILITY, HOUSTON, TEXAS
POST-CLOSURE CARE PERMIT NO. HW-50343; INDUSTRIAL SWR NO. 31547**

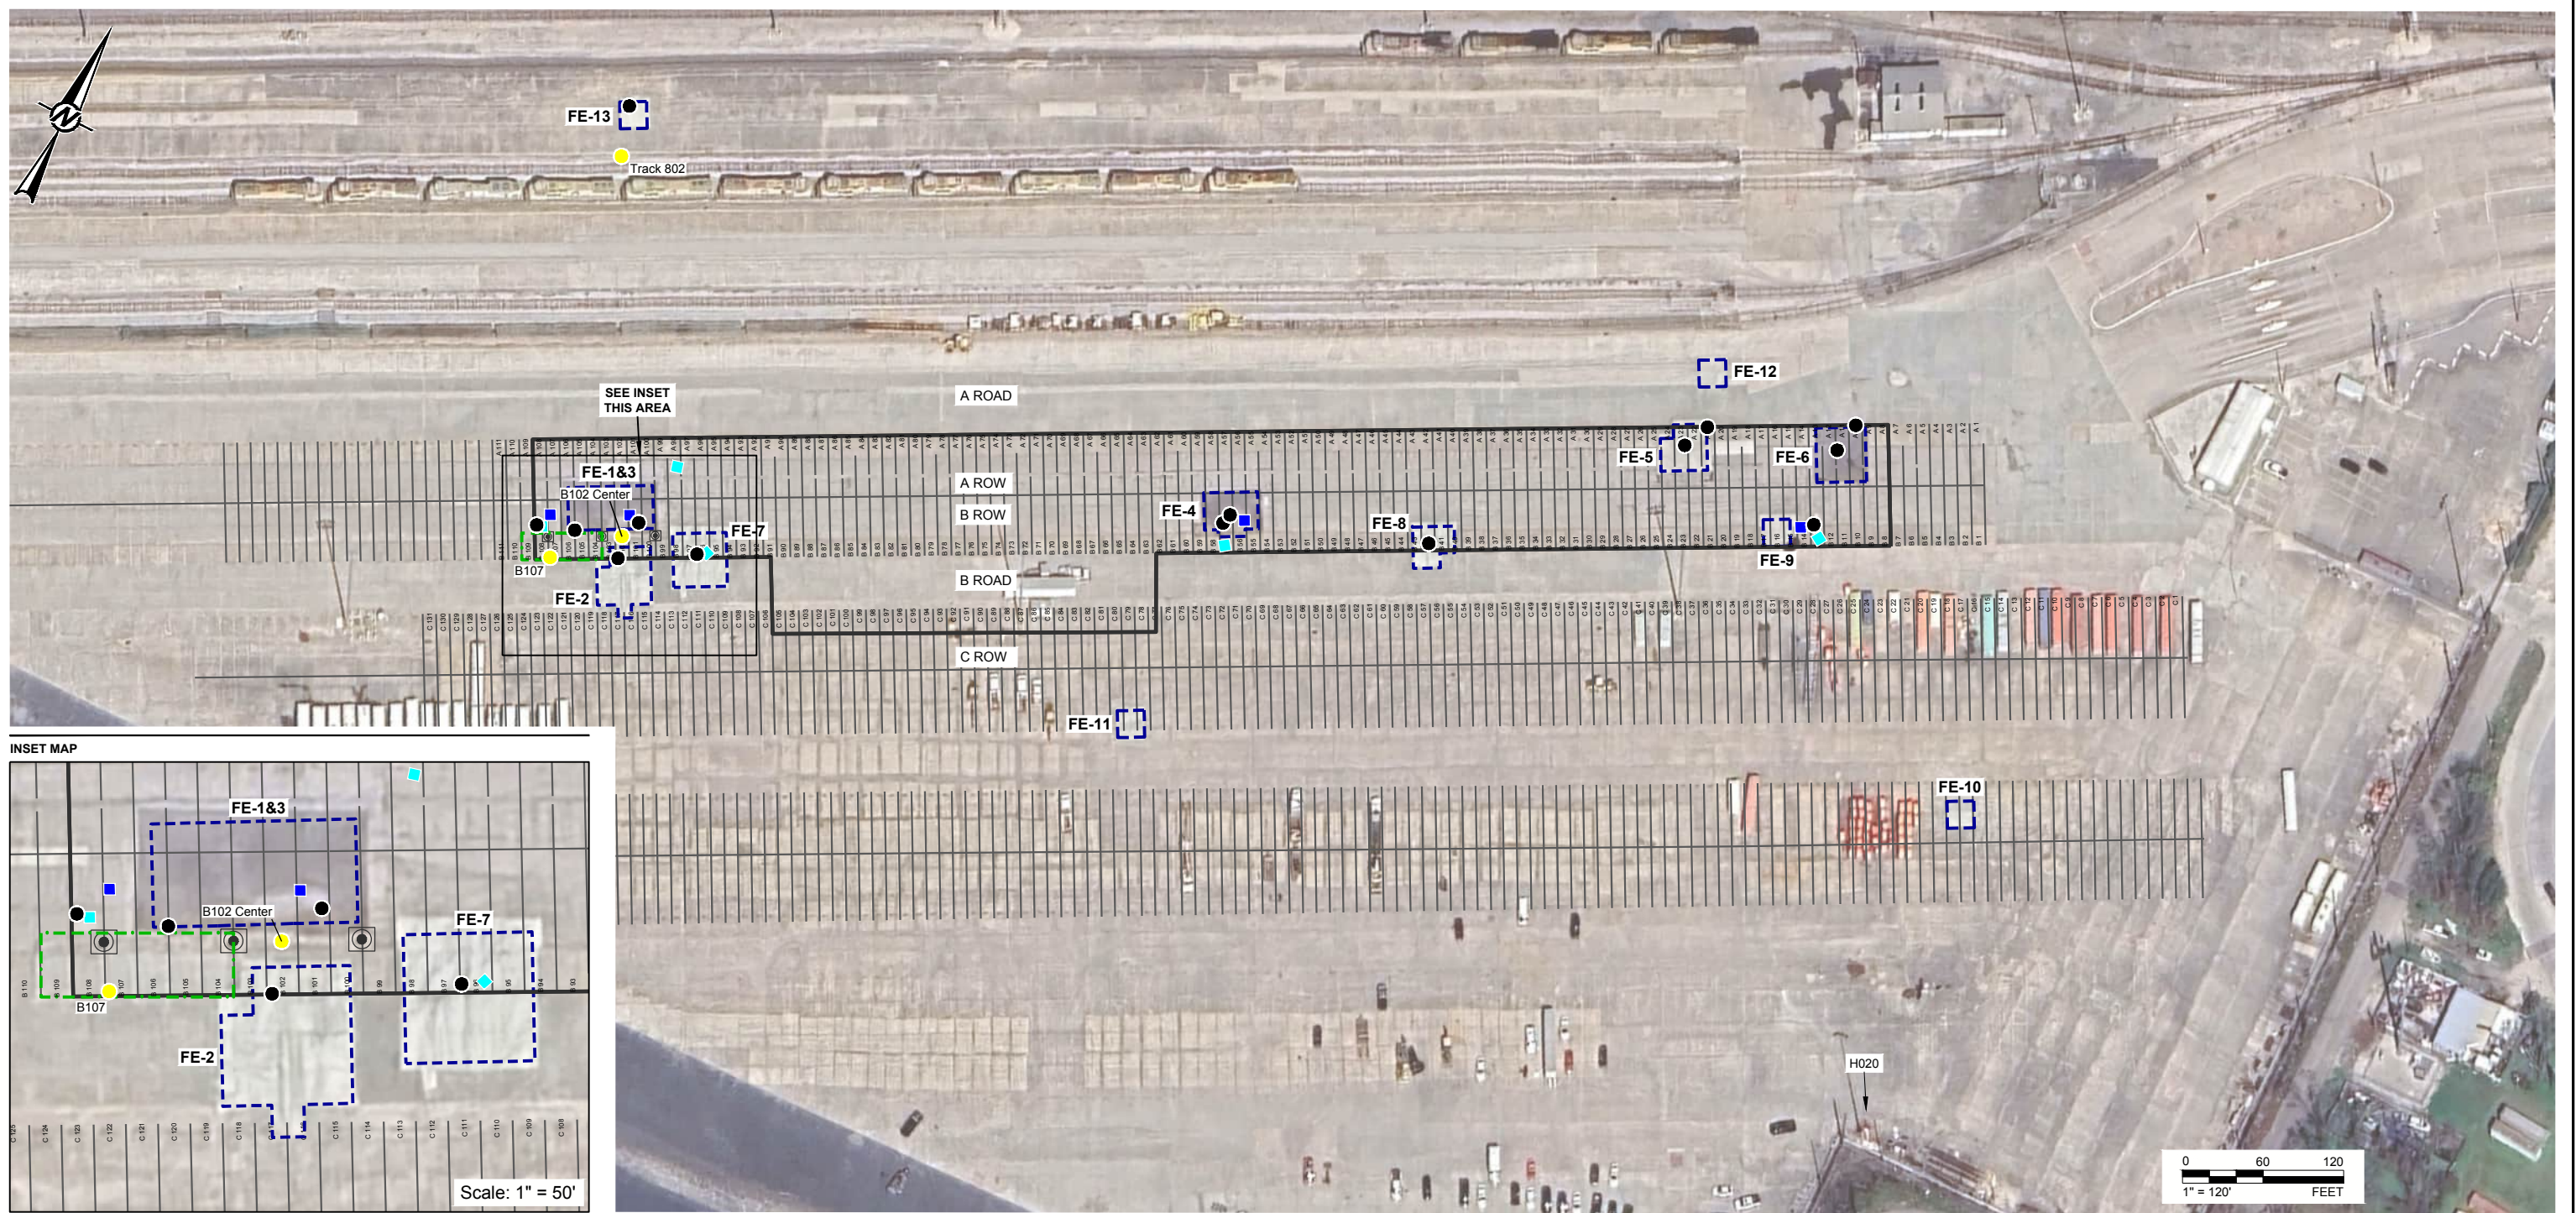
A figure showing the active and historical seep locations is provided on Figure 1.

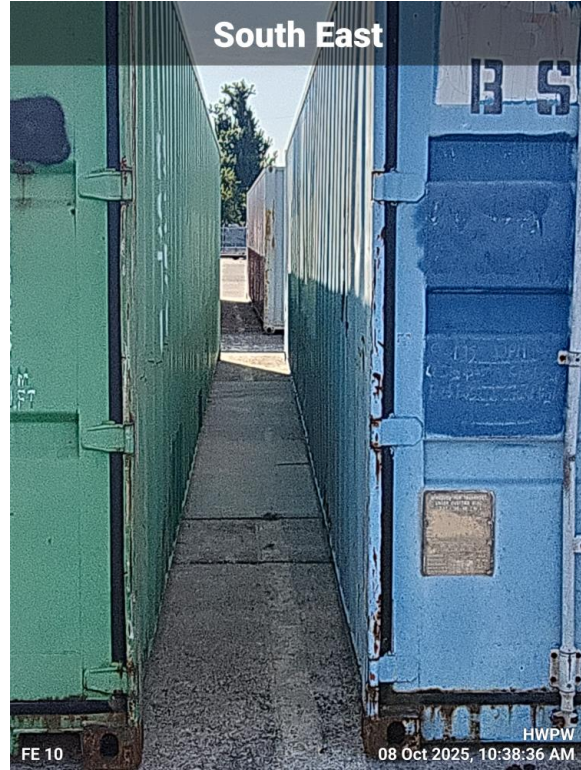
FE-10 weekly inspection of concrete cap.
Reconstructed cap in good condition. No NAPL
observed at FE location. Facing southeast.

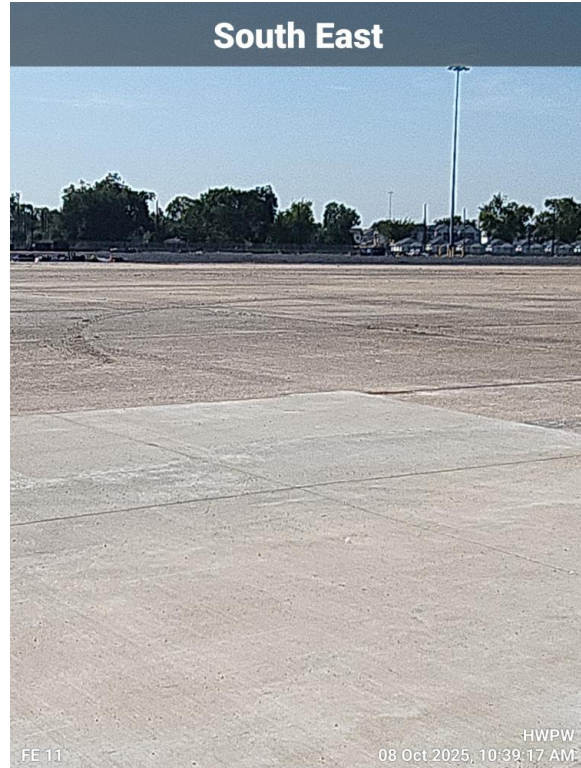
Photo No.
22

FE-11 weekly inspection of concrete cap.
Reconstructed cap in good condition. No NAPL
observed at FE location. Facing southeast.

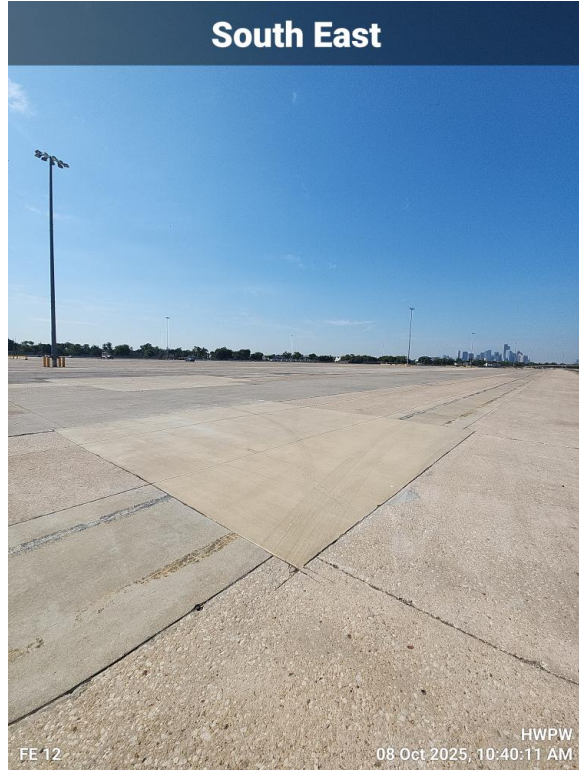
FE-12 weekly inspection of concrete cap.
Reconstructed cap in good condition. No NAPL
observed at FE location. Facing southeast.

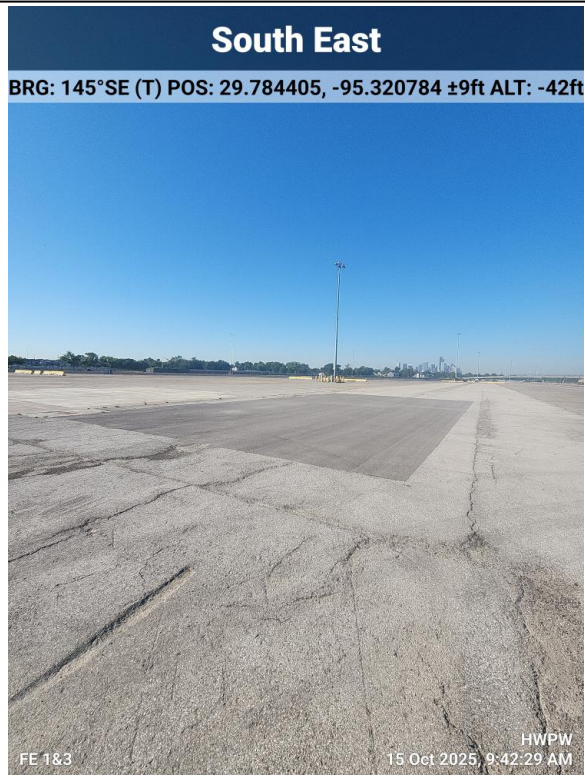
FE-1&3 weekly inspection of asphalt cap. Reconstructed cap in good condition. No NAPL observed at FE location. Facing southeast.

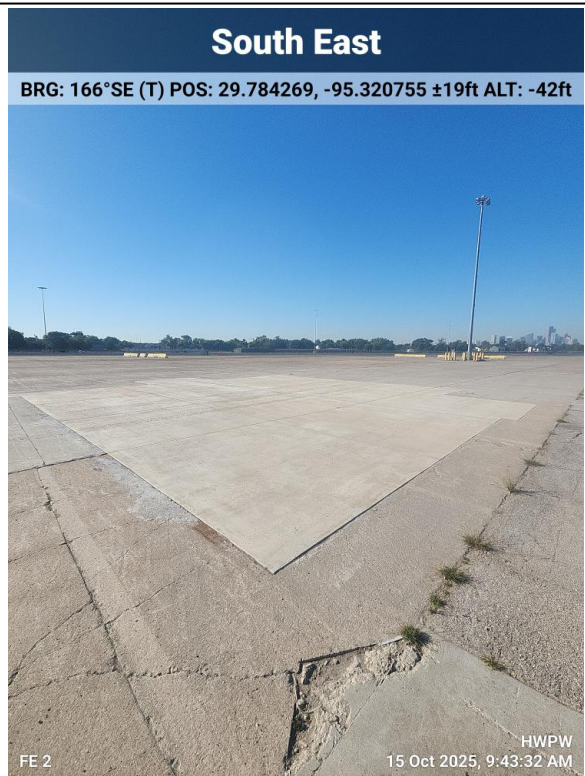
Photo No. 26	Inspection Date: 10/15/2025
------------------------	---------------------------------------

FE-2 weekly inspection of concrete cap. Reconstructed cap in good condition. No NAPL observed at FE location. Facing southeast.

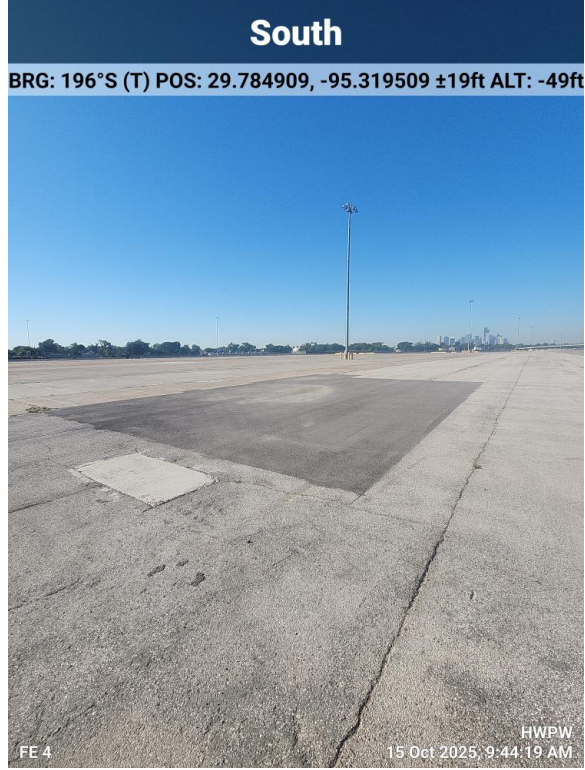
FE-4 weekly inspection of asphalt cap. Reconstructed cap in good condition. No NAPL observed at FE location. Facing south.

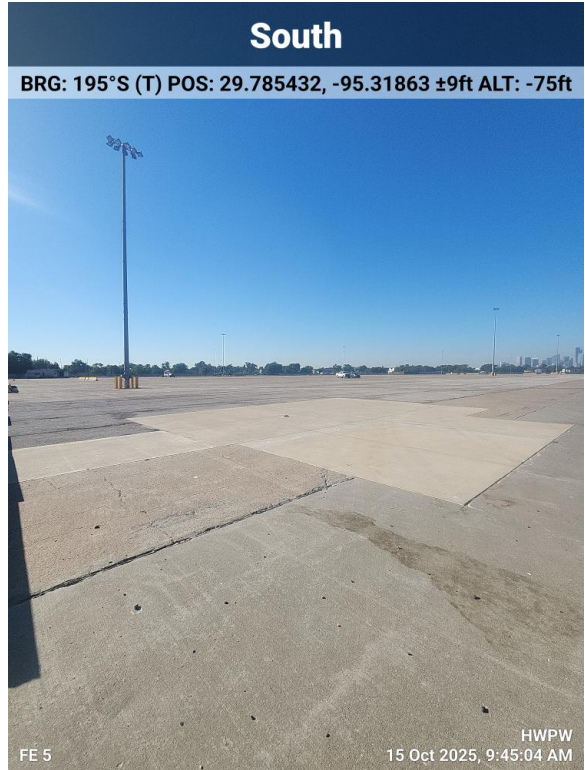
Photo No. 28	Inspection Date: 10/15/2025
------------------------	---------------------------------------

FE-5 weekly inspection of concrete cap. Reconstructed cap in good condition. No NAPL observed at FE location. Facing south.

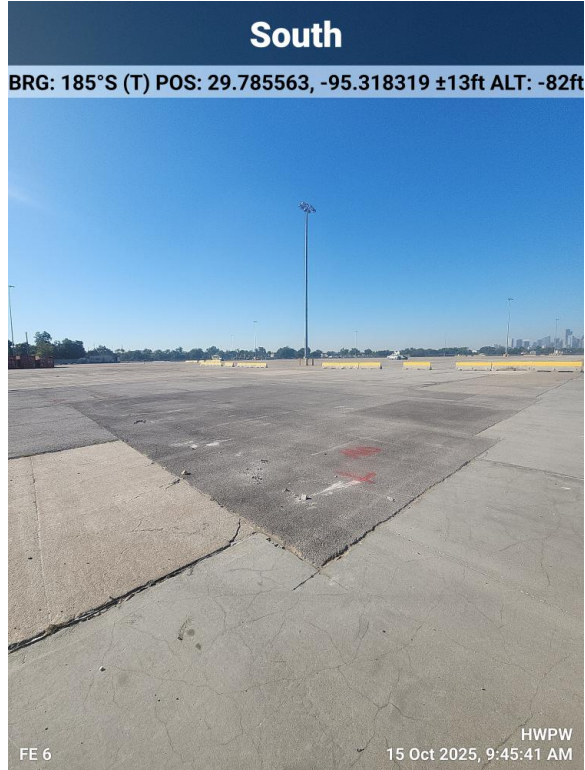
FE-6 weekly inspection of asphalt cap. Reconstructed cap in good condition. No NAPL observed at FE location. Facing south.

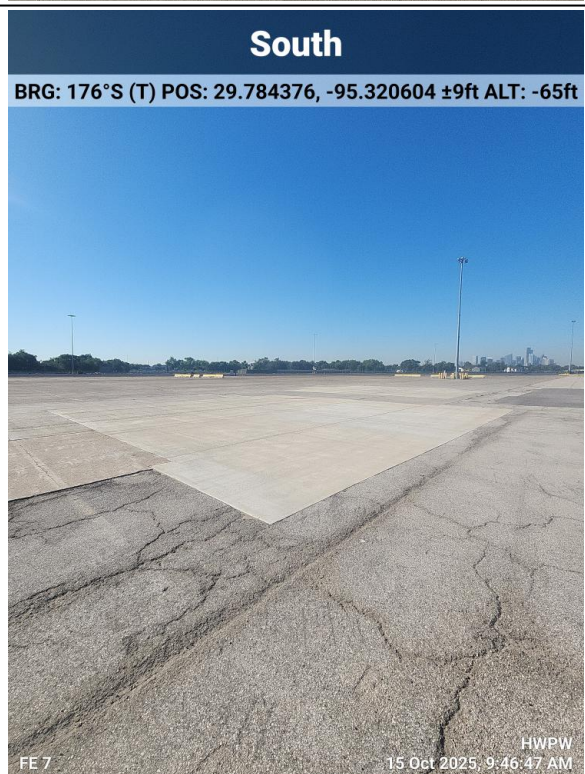
Photo No. 30	Inspection Date: 10/15/2025
------------------------	---------------------------------------

FE-7 weekly inspection of concrete cap. Reconstructed cap in good condition. No NAPL observed at FE location. Facing south.

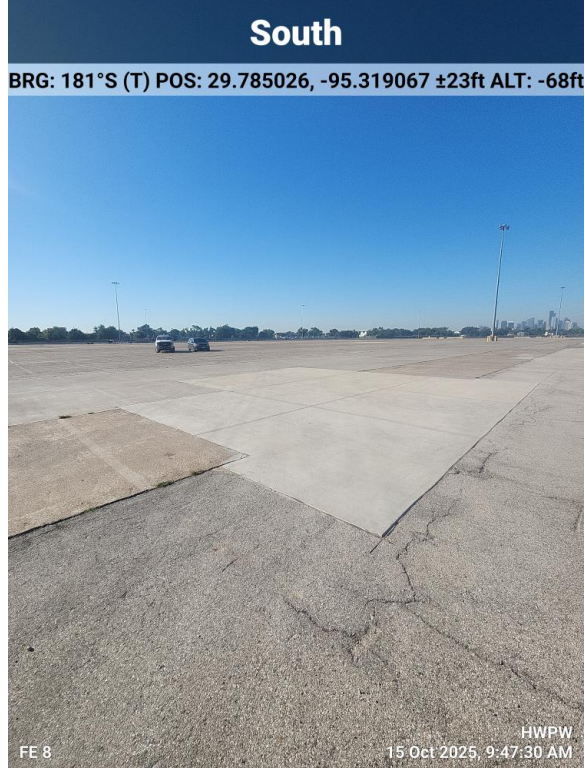
FE-8 weekly inspection of concrete cap. Reconstructed cap in good condition. No NAPL observed at FE location. Facing south.

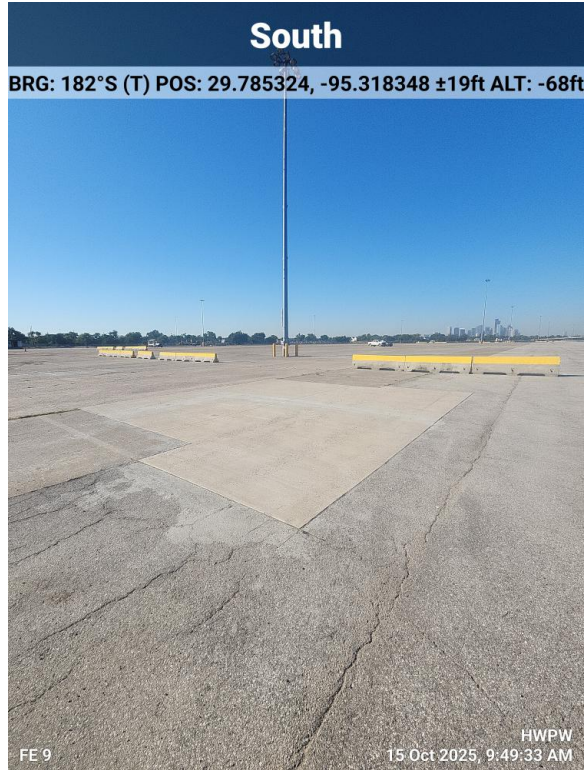
Photo No. 32	Inspection Date: 10/15/2025
------------------------	---------------------------------------

FE-9 weekly inspection of concrete cap. Reconstructed cap in good condition. No NAPL observed at FE location. Facing south.

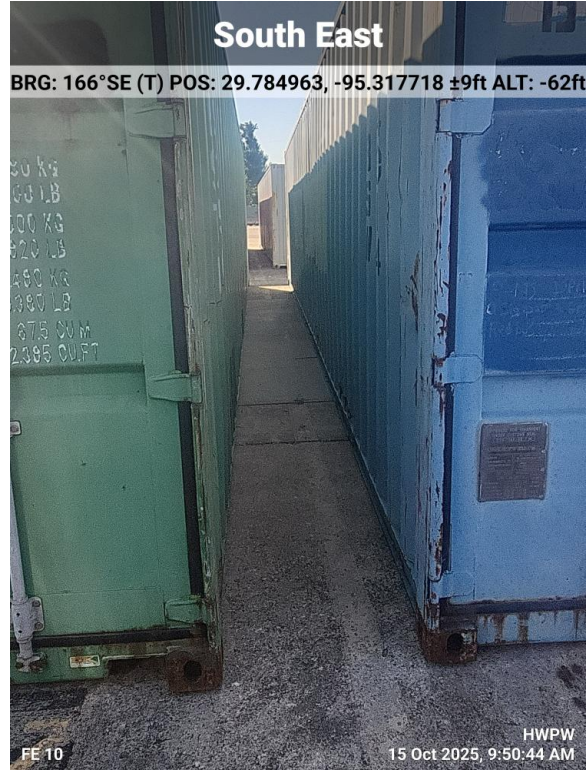
FE-10 weekly inspection of concrete cap.
Reconstructed cap in good condition. No NAPL
observed at FE location. Facing southeast.

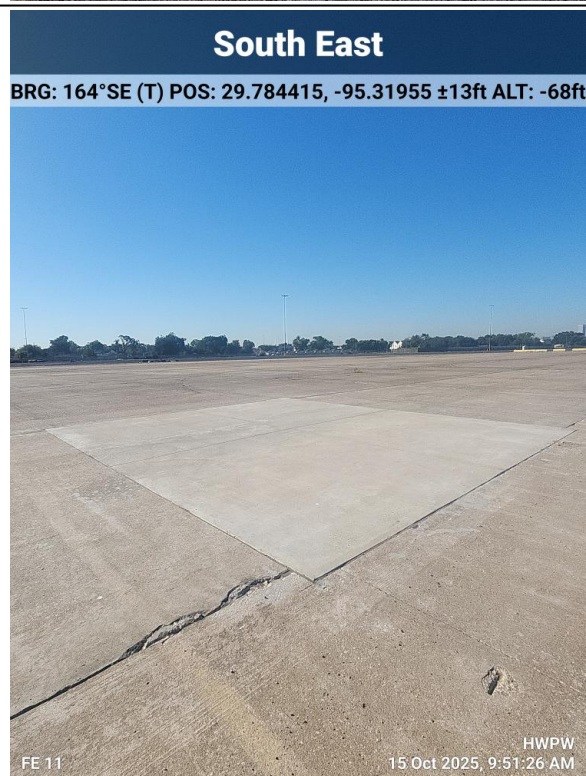
Photo No.
34

FE-11 weekly inspection of concrete cap.
Reconstructed cap in good condition. No NAPL
observed at FE location. Facing southeast.

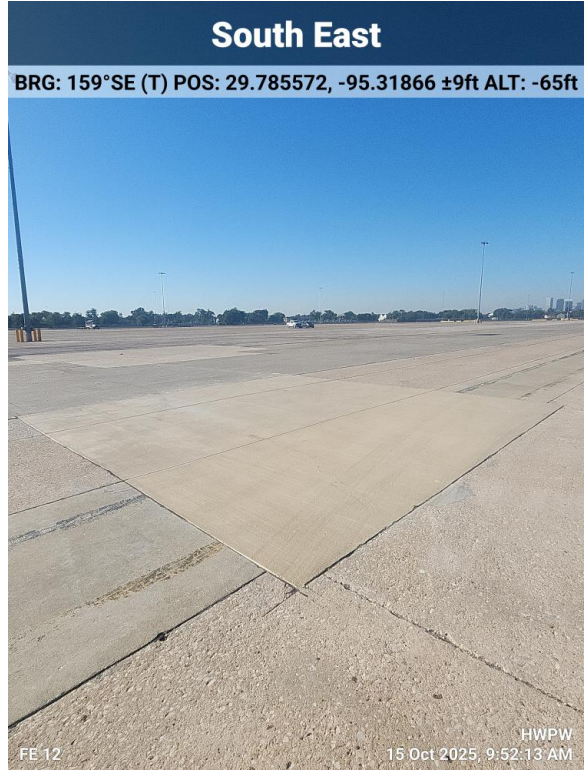
FE-12 weekly inspection of concrete cap.
Reconstructed cap in good condition. No NAPL
observed at FE location. Facing southeast.

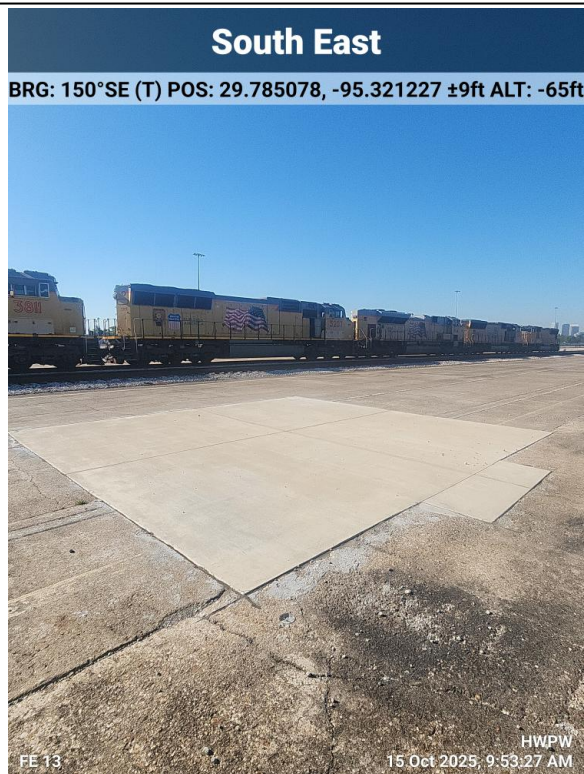
Photo No.
36

FE-13 weekly inspection of concrete cap.
Reconstructed cap in good condition. No NAPL
observed at FE location. Facing southeast.

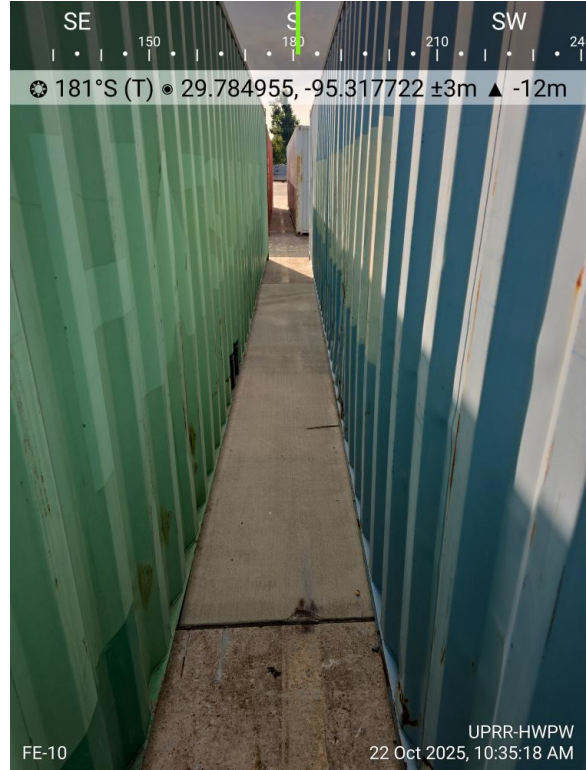
FE-10 weekly inspection of concrete cap.
Reconstructed cap in good condition. No NAPL
observed at FE location. Facing south.

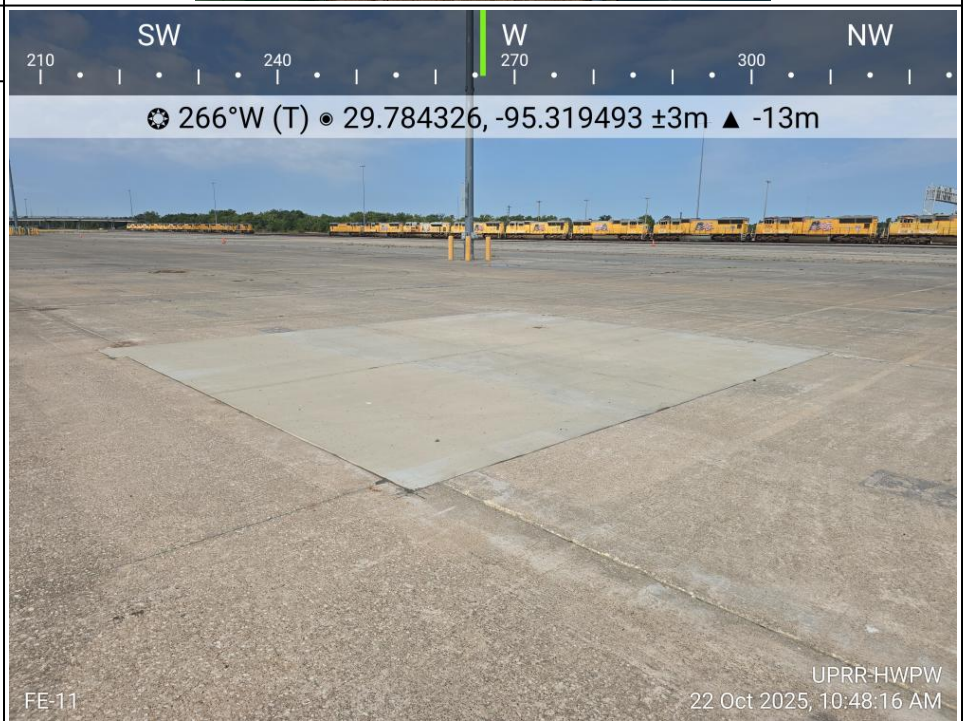
Photo No.
46

FE-11 weekly inspection of concrete cap.
Reconstructed cap in good condition. No NAPL
observed at FE location. Facing west.

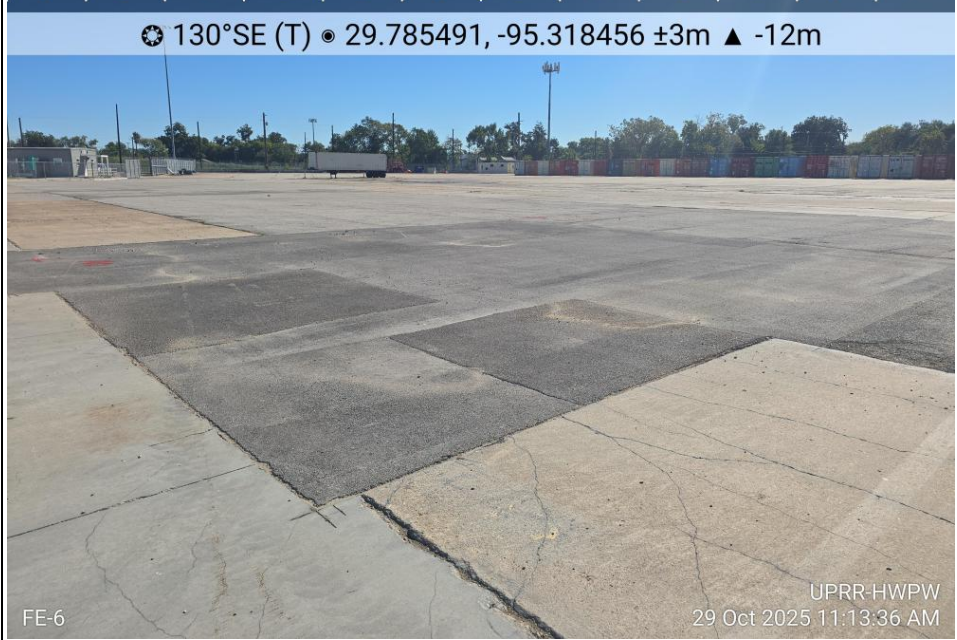
Description:
FE-6 weekly inspection of asphalt cap. Reconstructed cap in good condition. No NAPL observed at FE location. Facing southeast.

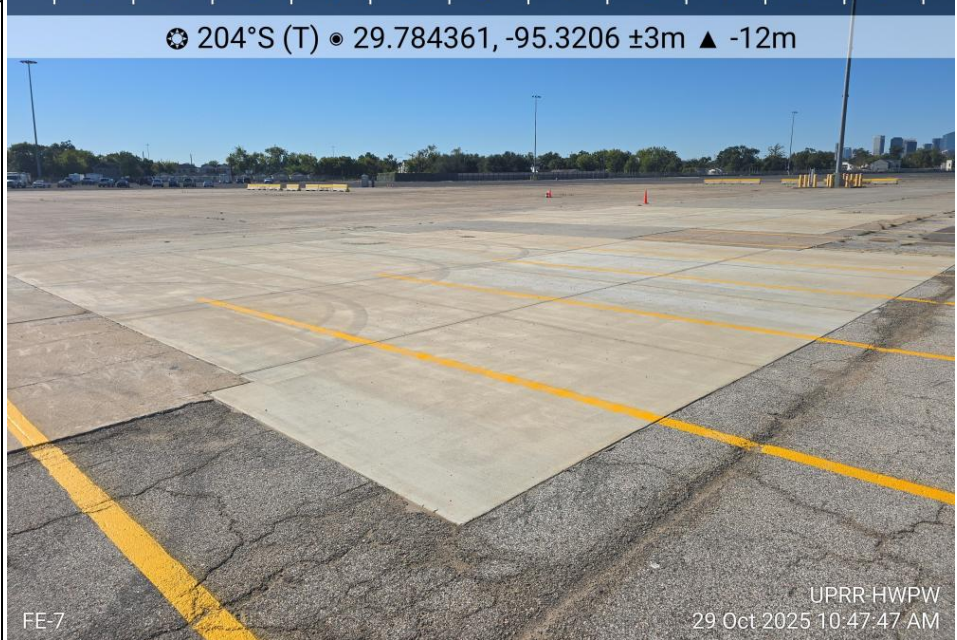
Photo No.
54

Description:
FE-7 weekly inspection of concrete cap. Reconstructed cap in good condition. No NAPL observed at FE location. Facing south.

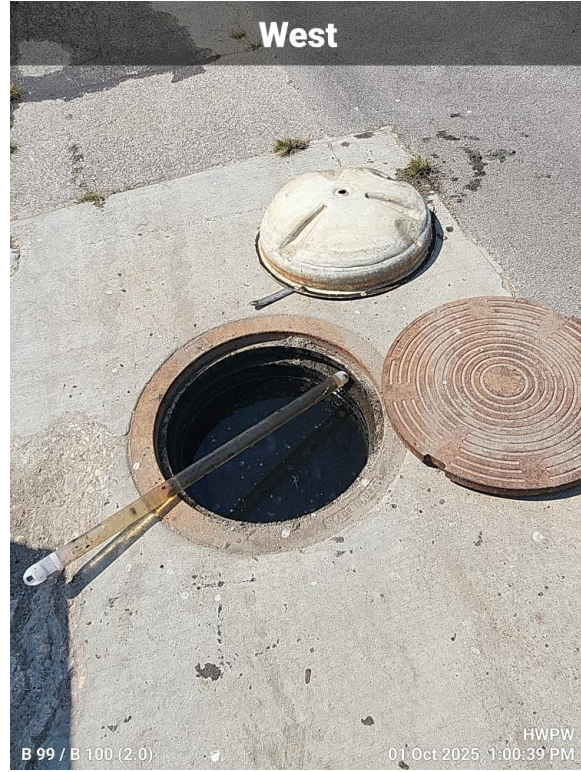
Sump 1 (B99/B100), 2.0 inches of freeboard in sump. Color is brown, and a sheen was observed. No odor was reported.

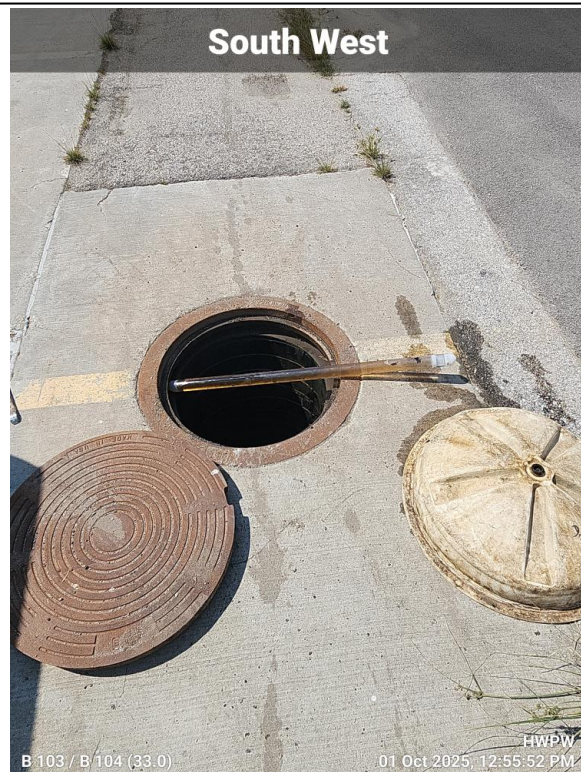
Photo No.
62

Sump 2 (B103/B104), 33.0 inches of freeboard in sump. Color is clear with a brown tint, and no sheen or odor was reported.

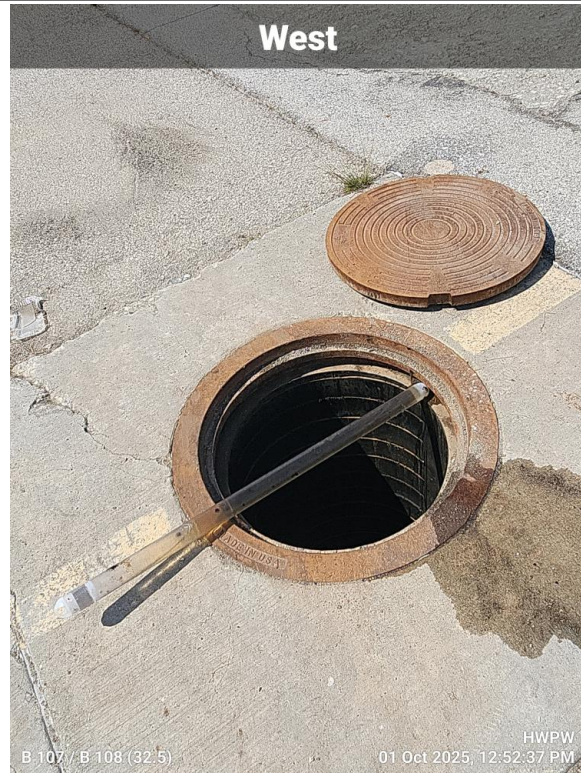
Sump 3 (B107/B108), 32.5 inches of freeboard in sump. Color is clear with a brown tint, and no sheen or odor was reported.

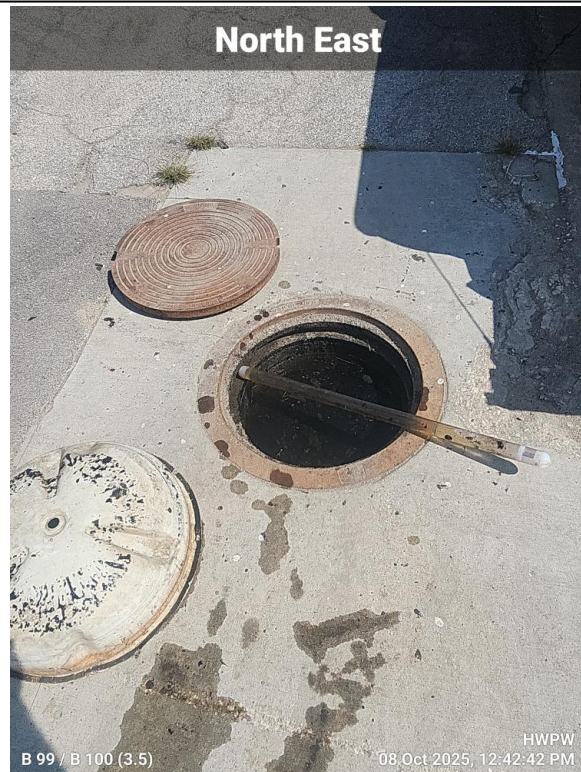
Photo No.
64

Sump 1 (B99/B100), 3.5 inches of freeboard in sump. Color is brown, and a sheen was observed. No odor was reported.

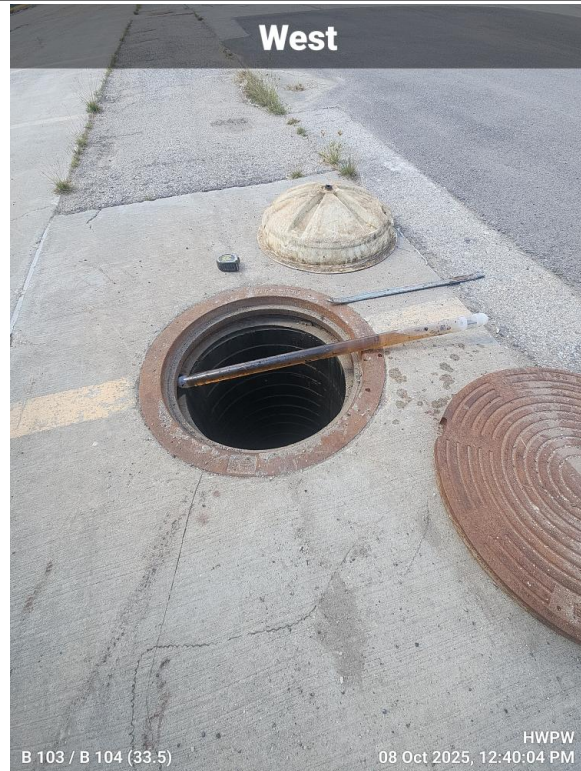
Sump 2 (B103/B104), 33.5 inches of freeboard in sump. Color is clear with a brown tint, and no sheen or odor was reported.

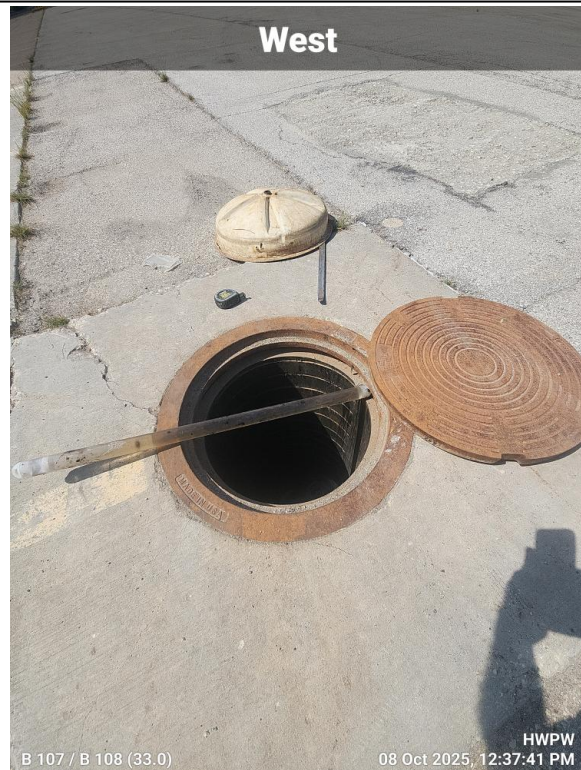
Photo No.
66

Sump 3 (B107/B108), 33.0 inches of freeboard in sump. Color is clear, and no sheen or odor was reported.

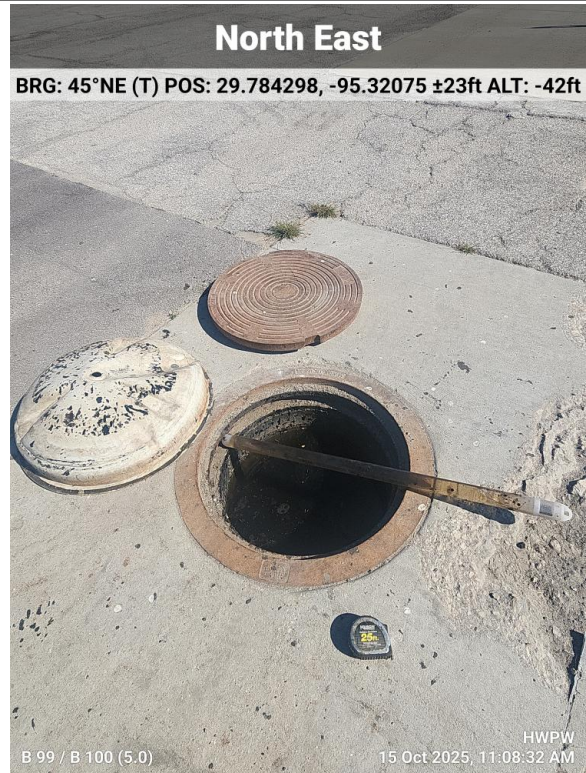
Sump 1 (B99/B100), 5.0 inches of freeboard in sump. Color is brown, and a sheen was observed. No odor was reported.

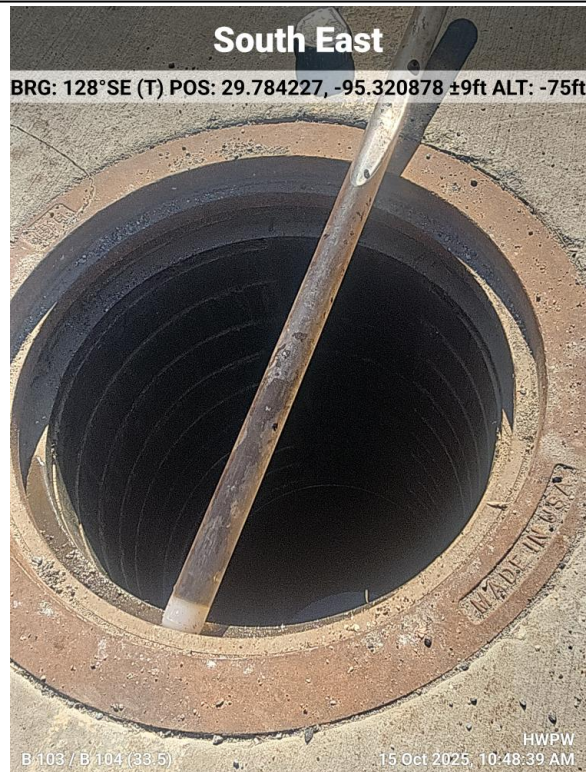
Photo No.
68

Sump 2 (B103/B104), 33.5 inches of freeboard in sump. Color is clear, and no sheen or odor was reported.

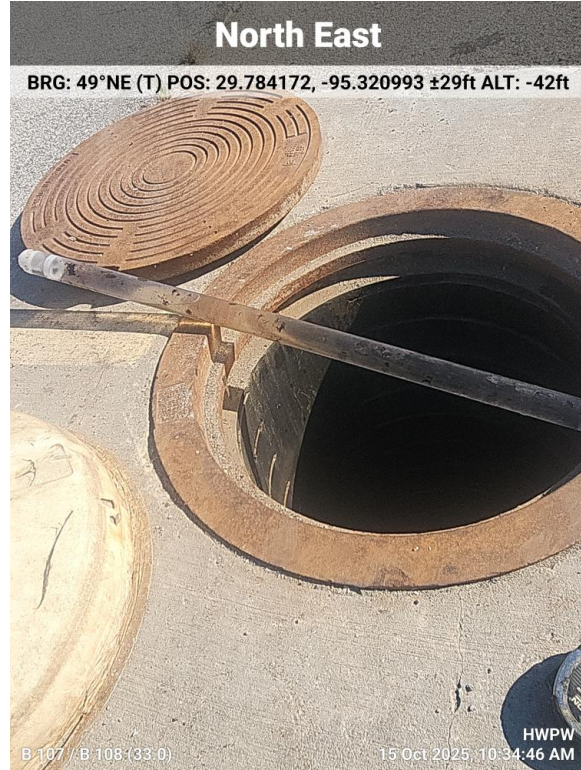
Sump 3 (B107/B108), 33.0 inches of freeboard in sump. Color is clear, and no sheen or odor was reported.

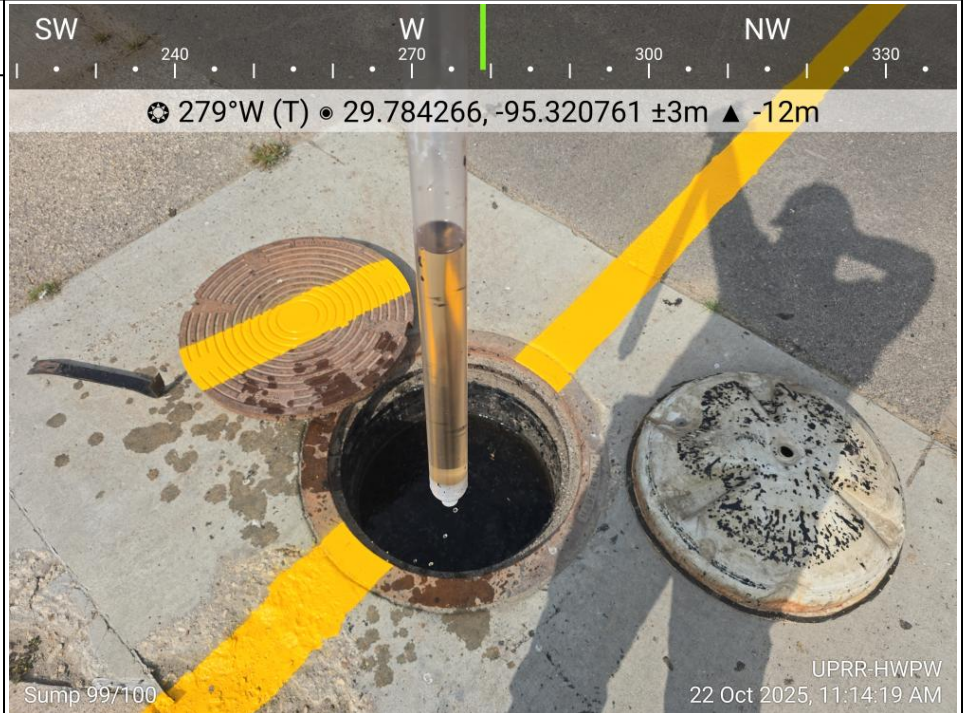
Photo No.
70

Sump 1 (B99/B100), 7.0 inches of freeboard in sump. Color is light brown, and a sheen was observed. No odor was reported.

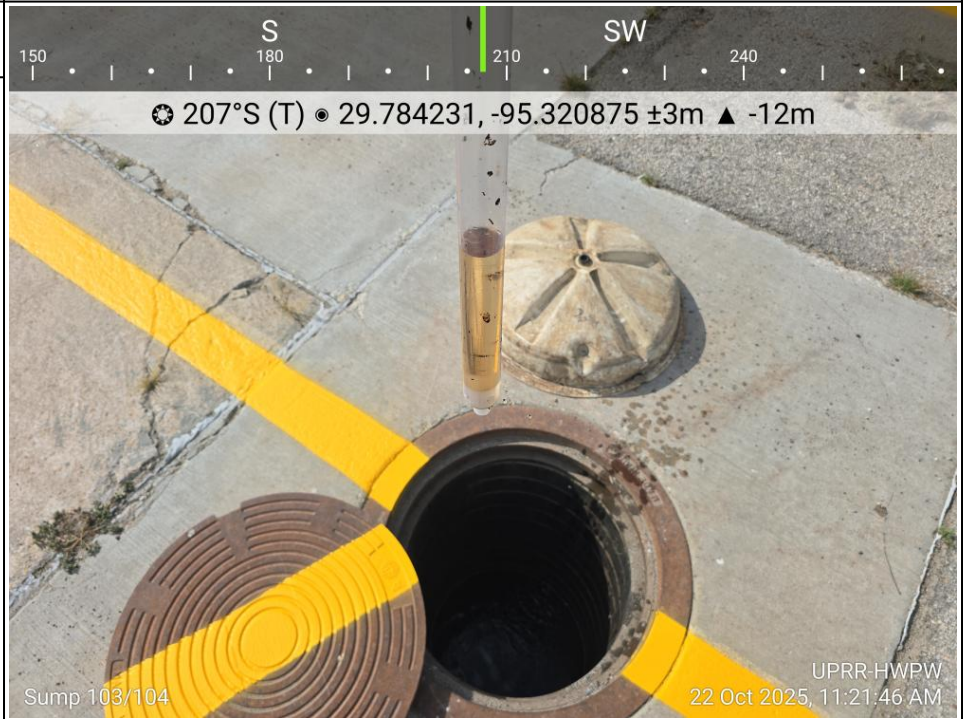
Photo No.
71

Description:
Sump 2 (B103/B104), 34.0 inches of freeboard in sump. Color is light brown, and no sheen or odor was reported.

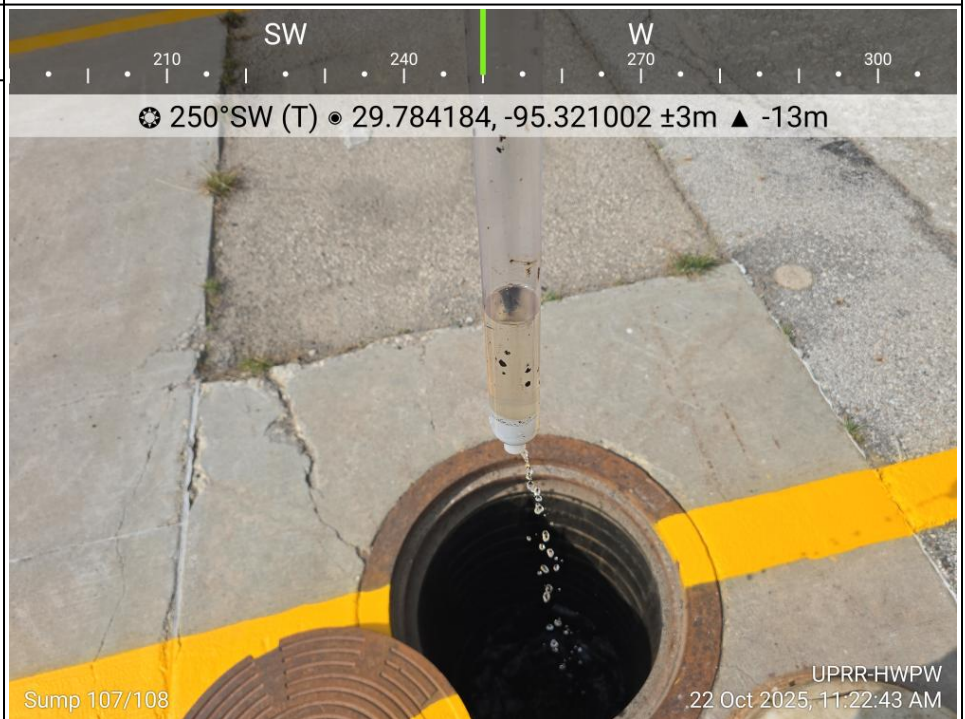
Photo No.
72

Description:
Sump 3 (B107/B108), 33.0 inches of freeboard in sump. Color is clear, and no sheen or odor was reported.

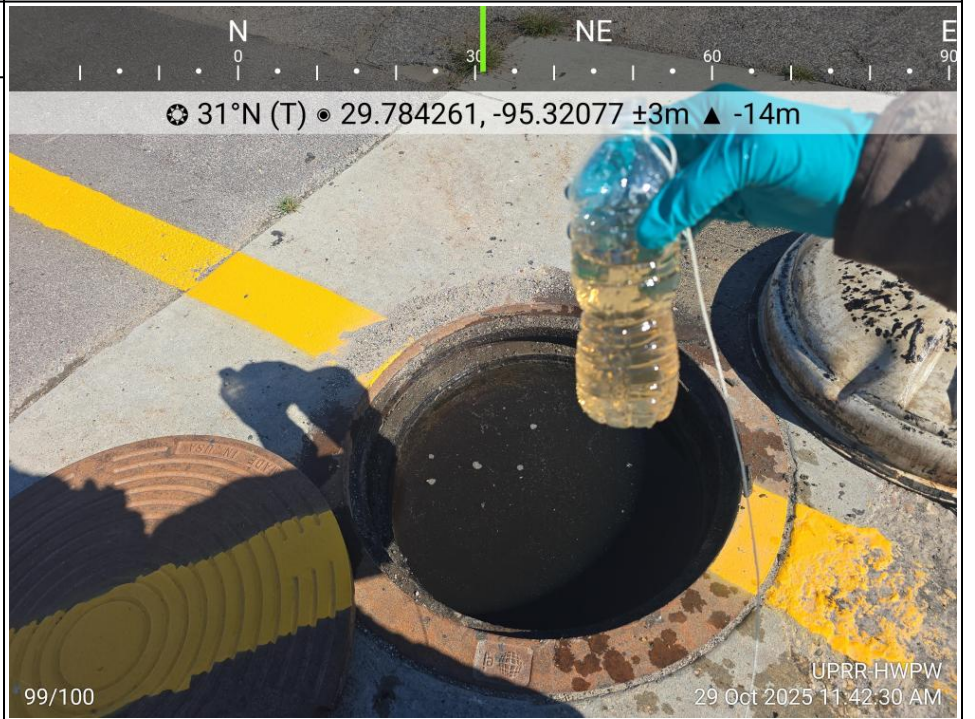
Description:
Sump 1 (B99/B100), 0.0 inches of freeboard in sump. Color is light brown, and a sheen was observed. No odor was reported.

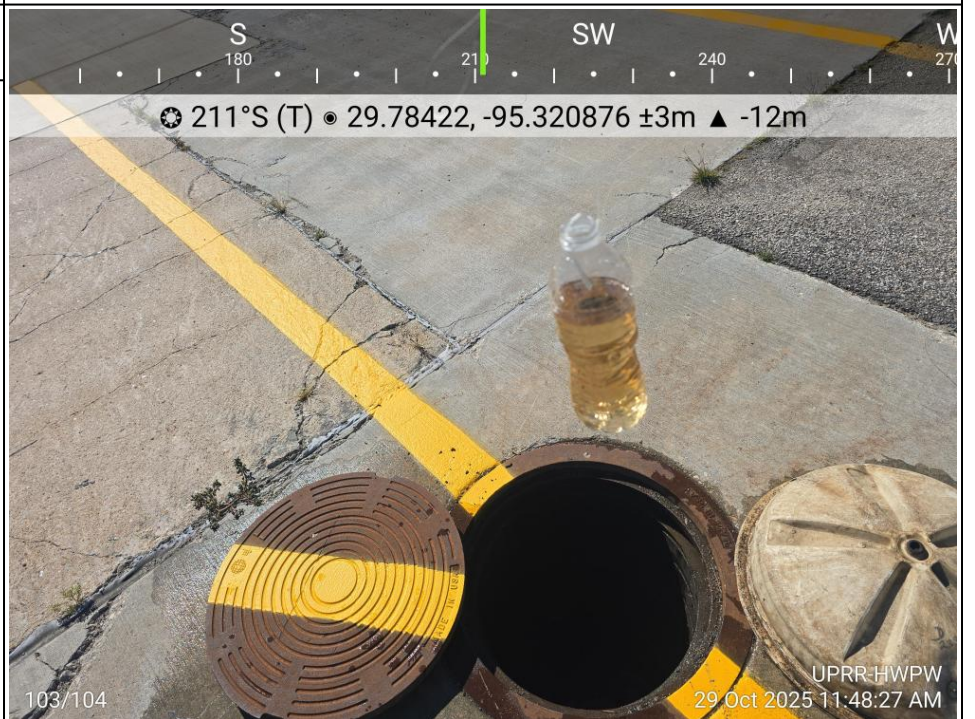
Photo No.
74

Description:
Sump 2 (B103/B104), 29.0 inches of freeboard in sump. Color is light brown, and no sheen or odor was reported.

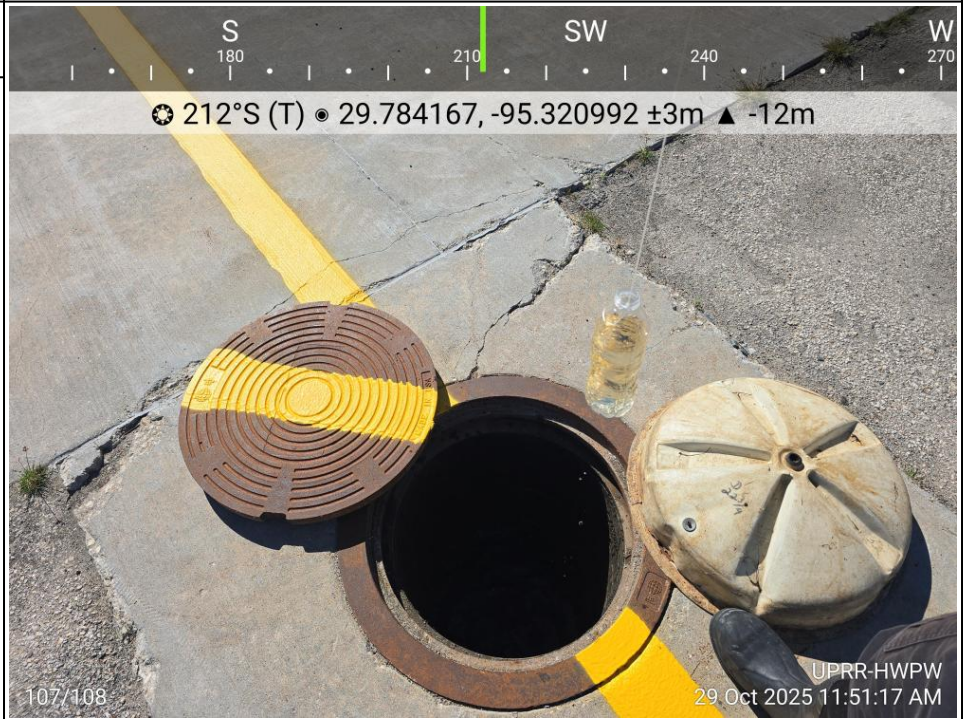
Photo No.
75

Description:
Sump 3 (B107/B108), 29.0 inches of freeboard in sump. Color is clear, and no sheen or odor was reported.

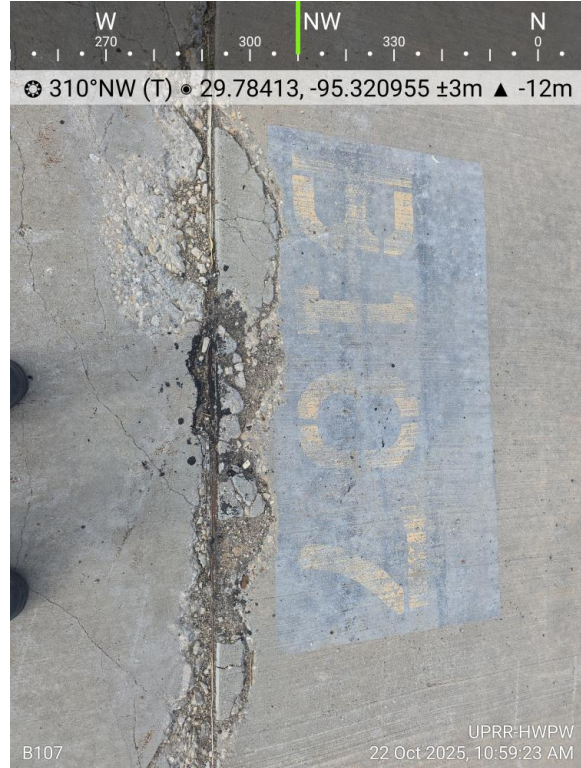
B107 weekly inspection of joint. Surrounding concrete in good condition. No NAPL observed along joint.

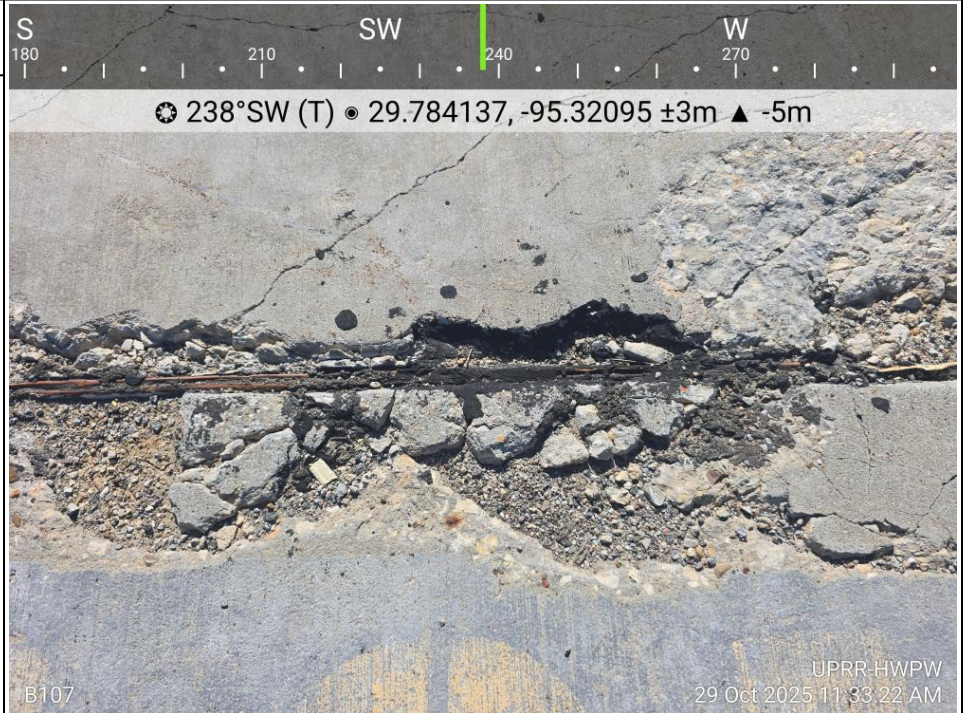
Photo No.
80

B107 weekly inspection of joint. Surrounding concrete in good condition. No NAPL observed along joint.
