November 14, 2025

Project No. US0039040.4227

**Re: MONTHLY STATUS UPDATE – ENGLEWOOD INTERMODAL YARD – REVISED INTERIM MEASURES
WORK PLAN POST-CONSTRUCTION AND NAPL COLLECTION SYSTEM/CONCRETE CAP REPAIR
INSPECTIONS
UNION PACIFIC RAILROAD HOUSTON WOOD PRESERVING WORKS FACILITY
4910 LIBERTY ROAD FACILITY, HOUSTON, TEXAS
POST-CLOSURE CARE PERMIT NO. HW-50343; INDUSTRIAL SWR NO. 31547**

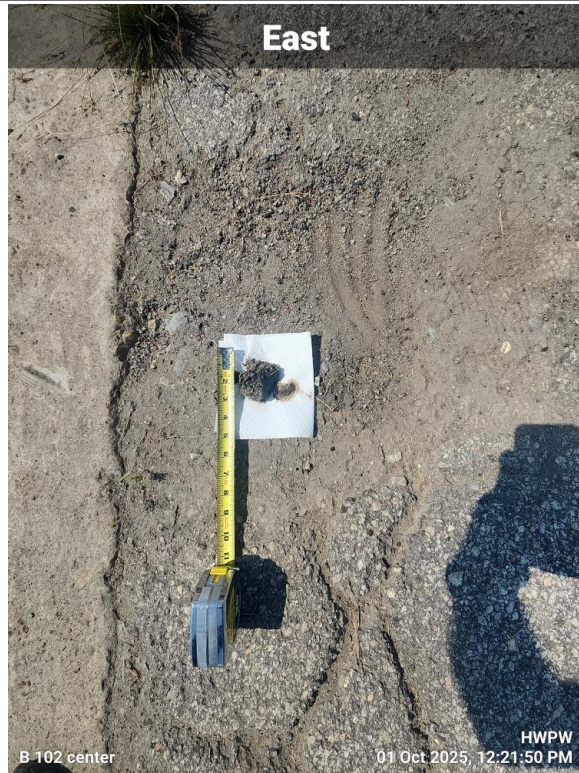
B102 Center weekly inspection of previously identified seep. Surrounding asphalt in good condition. Approximately 3 cubic inches of NAPL observed at seep location.

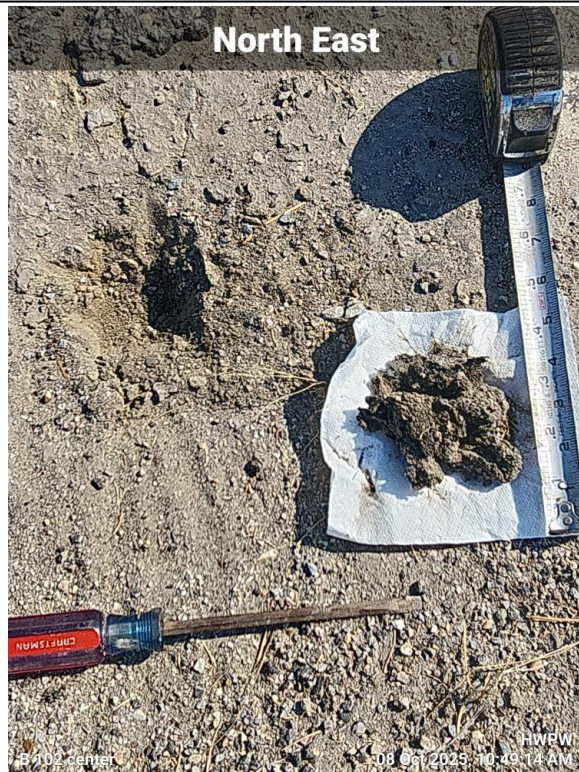
Photo No.
88

B102 Center weekly inspection of previously identified seep. Surrounding asphalt in good condition. Approximately 6 cubic inches of NAPL observed at seep location.

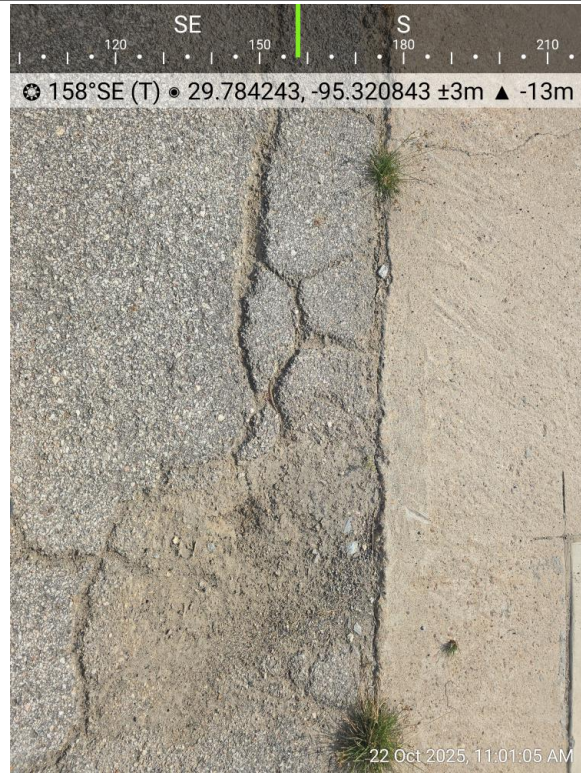
B102 Center weekly inspection of previously identified seep. Surrounding asphalt in good condition. No NAPL observed along joint.

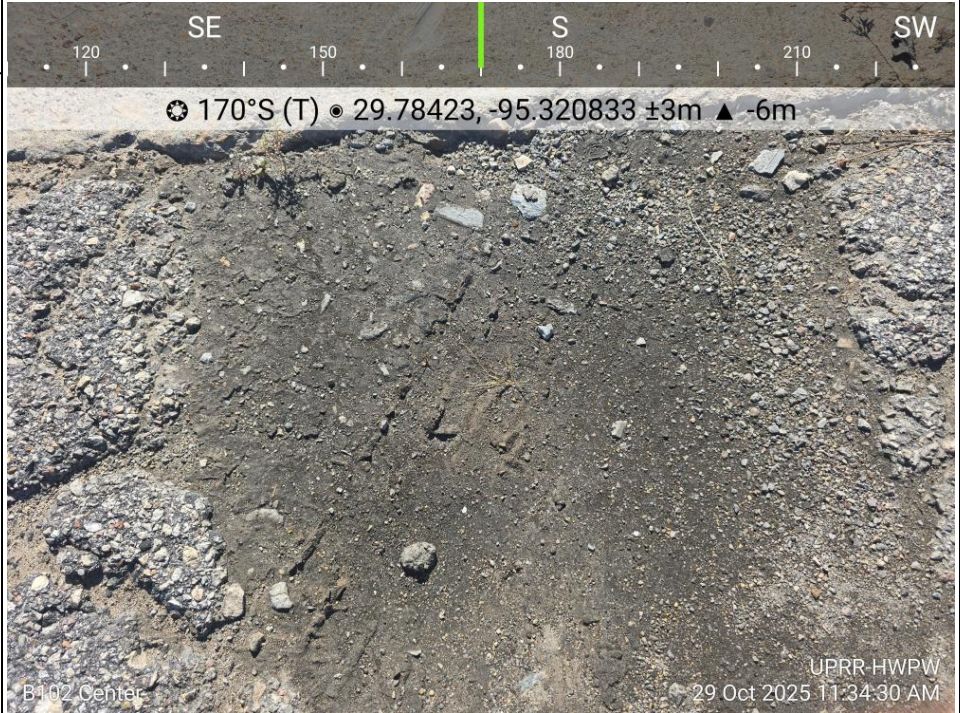
Photo No. 92	Inspection Date: 10/29/2025
------------------------	---------------------------------------

B102 Center weekly inspection of previously identified seep. Surrounding asphalt in good condition. No NAPL observed along joint.
