December 15, 2025

Project No. US0039040.4227

Re: **MONTHLY STATUS UPDATE – ENGLEWOOD INTERMODAL YARD – REVISED INTERIM MEASURES WORK PLAN POST-CONSTRUCTION AND NAPL COLLECTION SYSTEM/CONCRETE CAP REPAIR INSPECTIONS
UNION PACIFIC RAILROAD HOUSTON WOOD PRESERVING WORKS FACILITY
4910 LIBERTY ROAD FACILITY, HOUSTON, TEXAS
POST-CLOSURE CARE PERMIT NO. HW-50343; INDUSTRIAL SWR NO. 31547**

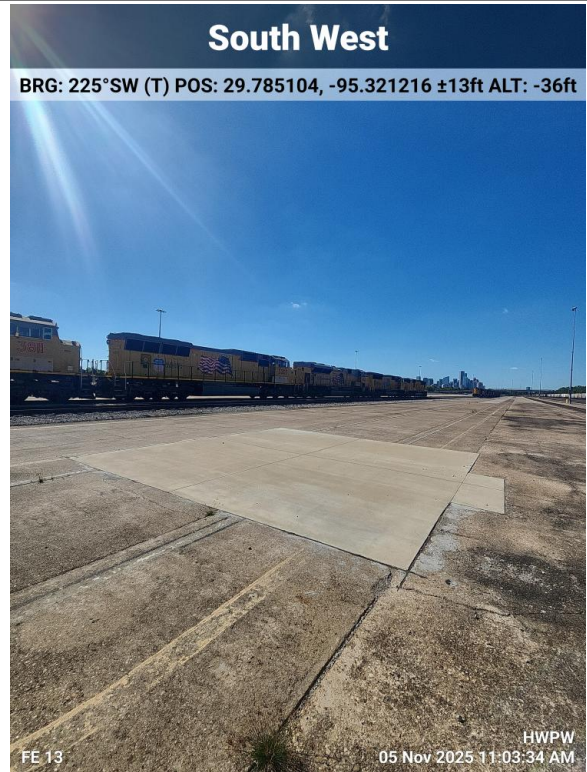
FE-13 weekly inspection of concrete cap. Reconstructed cap in good condition. No NAPL observed at FE location. Facing southwest.

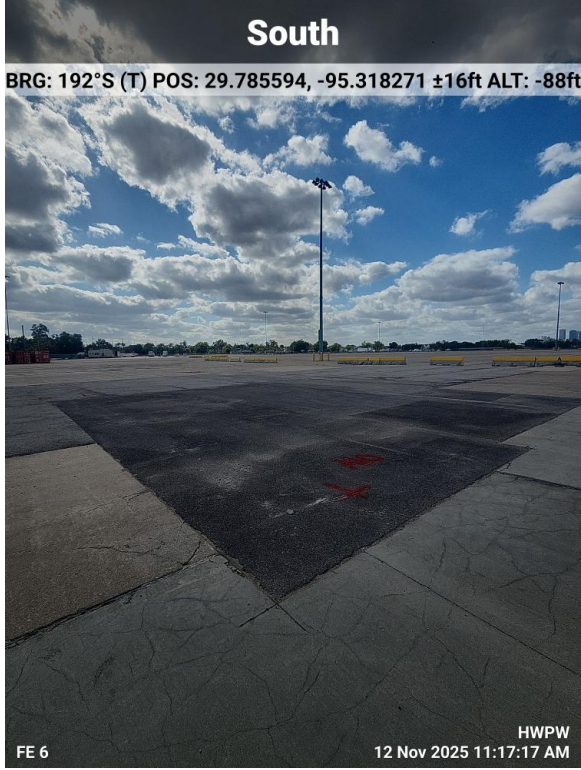
Photo No. 17	Inspection Date: 11/12/2025	<p style="text-align: center;">South</p> <p>BRG: 192°S (T) POS: 29.785594, -95.318271 ±16ft ALT: -88ft</p>

FE-6 weekly inspection of asphalt cap. Reconstructed cap in good condition. No NAPL observed at FE location. Facing south.

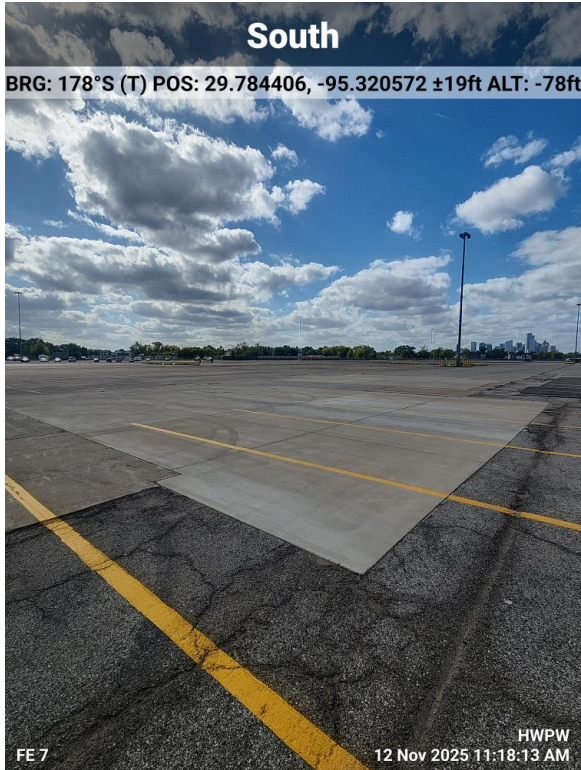
Photo No. 18	Inspection Date: 11/12/2025	<p style="text-align: center;">South</p> <p>BRG: 178°S (T) POS: 29.784406, -95.320572 ±19ft ALT: -78ft</p>

FE-7 weekly inspection of concrete cap. Reconstructed cap in good condition. No NAPL observed at FE location. Facing south.

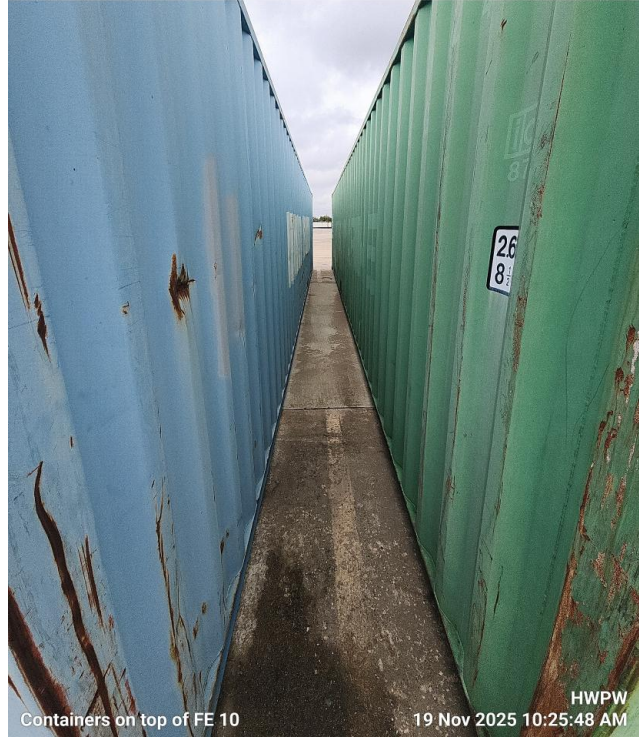
FE-10 weekly inspection of concrete cap.
Reconstructed cap in good condition. No NAPL observed at FE location. Facing northwest.

Containers on top of FE 10

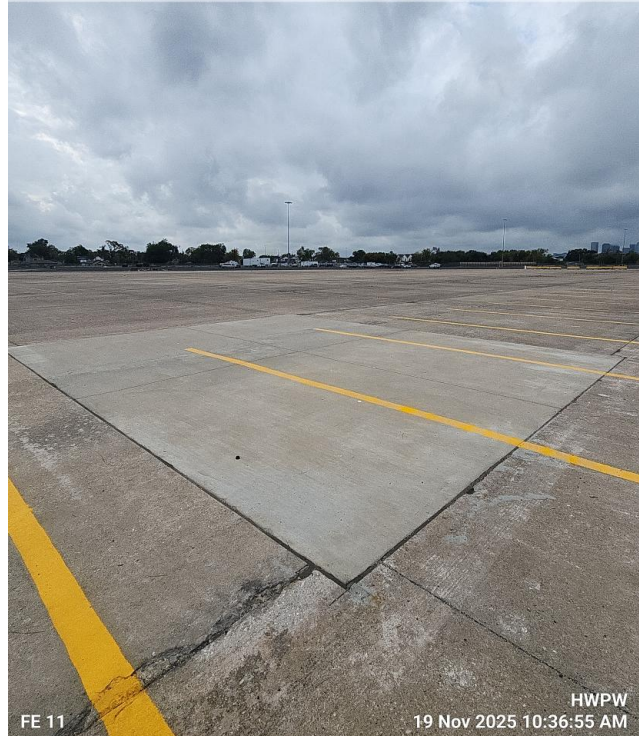
FE 11

FE-11 weekly inspection of concrete cap.
Reconstructed cap in good condition. No NAPL observed at FE location. Facing south.

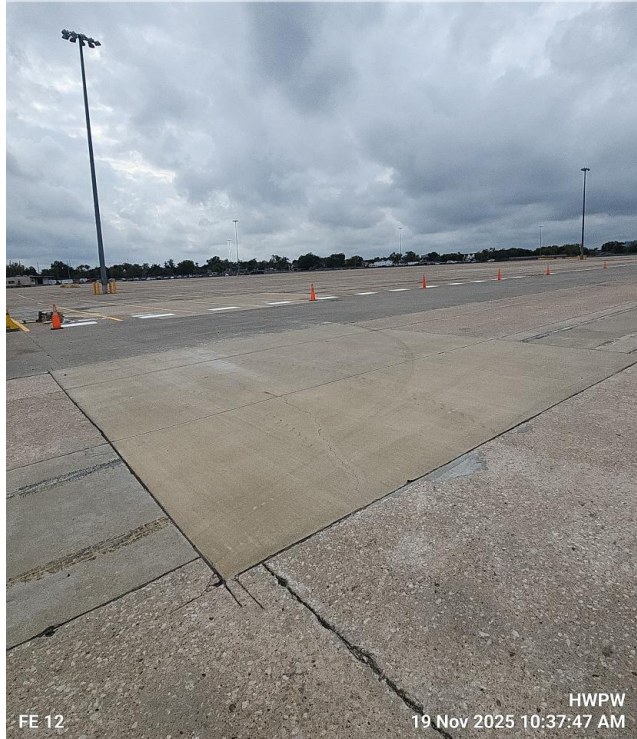
FE 12

FE-12 weekly inspection of concrete cap.
Reconstructed cap in good condition. No NAPL
observed at FE location. Facing southeast.

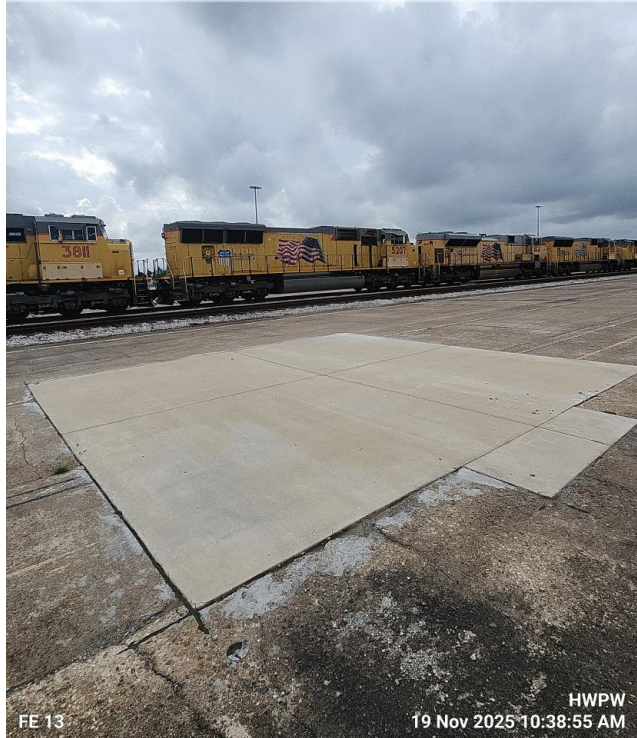
FE 13

FE-13 weekly inspection of concrete cap.
Reconstructed cap in good condition. No NAPL
observed at FE location. Facing southeast.

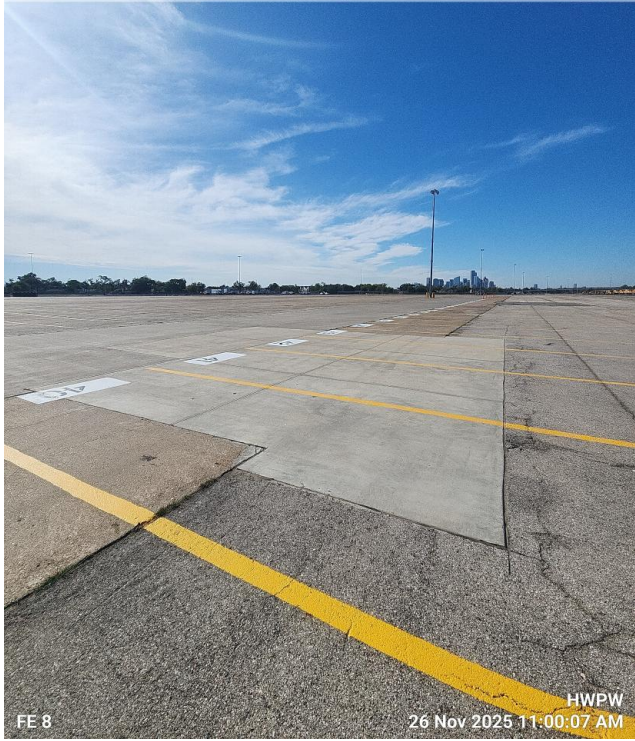
Photo No. 43	Inspection Date: 11/26/2025	BRG: 216°SW (T) POS: 29.785034, -95.319079 ±16ft ALT: -42ft

FE-8 weekly inspection of concrete cap. Reconstructed cap in good condition. No NAPL observed at FE location. Facing southwest.

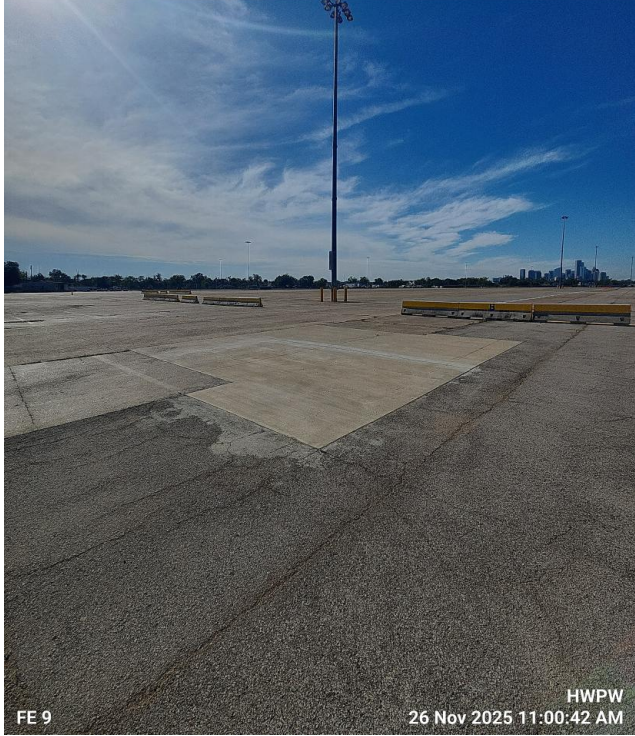
Photo No. 44	Inspection Date: 11/26/2025	BRG: 212°S (T) POS: 29.785356, -95.31836 ±19ft ALT: -42ft

FE-9 weekly inspection of concrete cap. Reconstructed cap in good condition. No NAPL observed at FE location. Facing south.

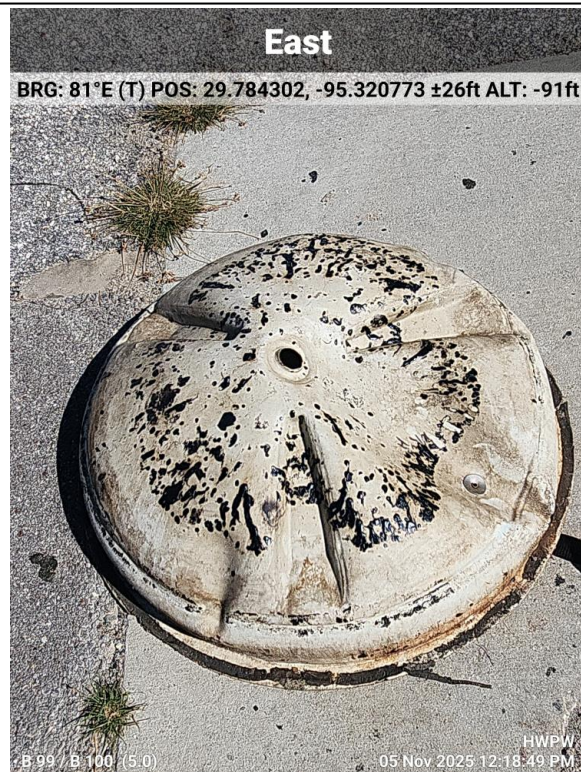
Sump 1 (B99/B100), NAPL accumulated on plastic inflow protector installed on October 1.

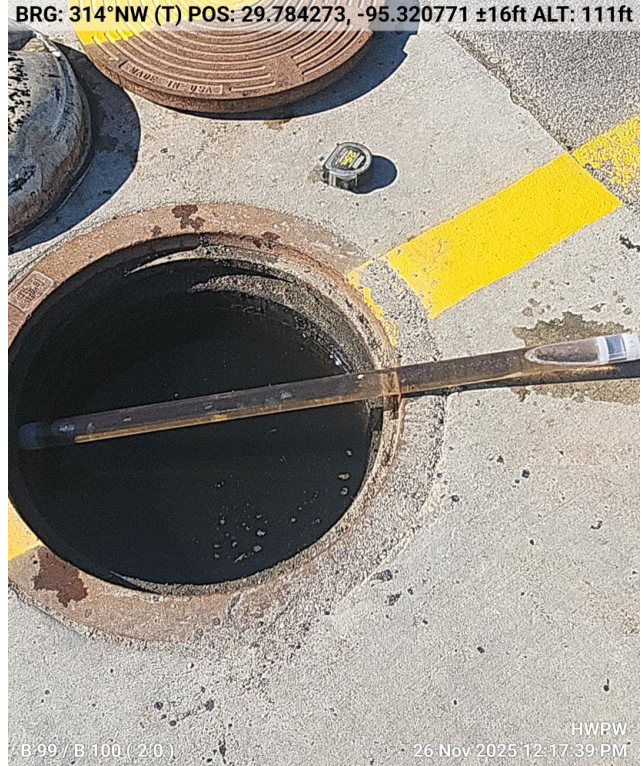
Sump 1 (B99/B100), 2.0 inches of freeboard in sump. Color is clear with a brown tint, and a sheen was observed. No odor was reported.

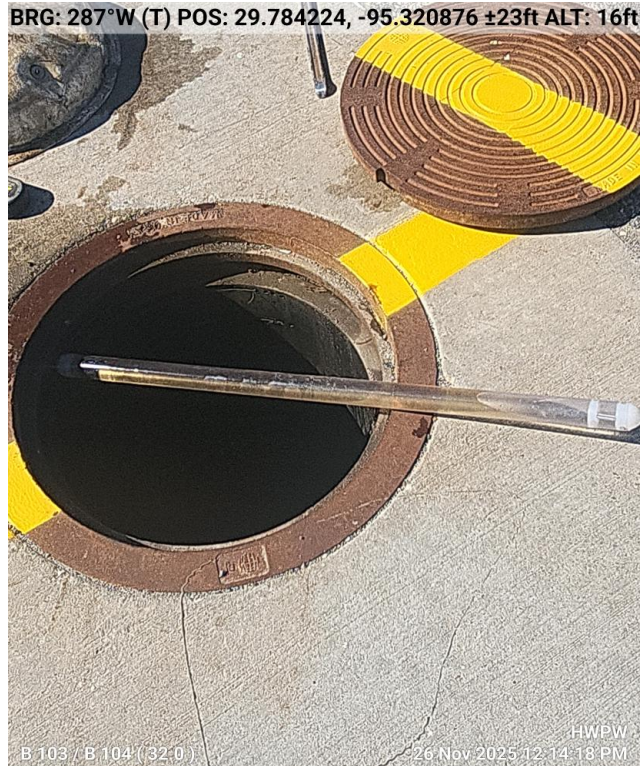
Photo No.
60

Sump 2 (B103/B104), 32.0 inches of freeboard in sump. Color is clear, and no sheen or odor was reported.

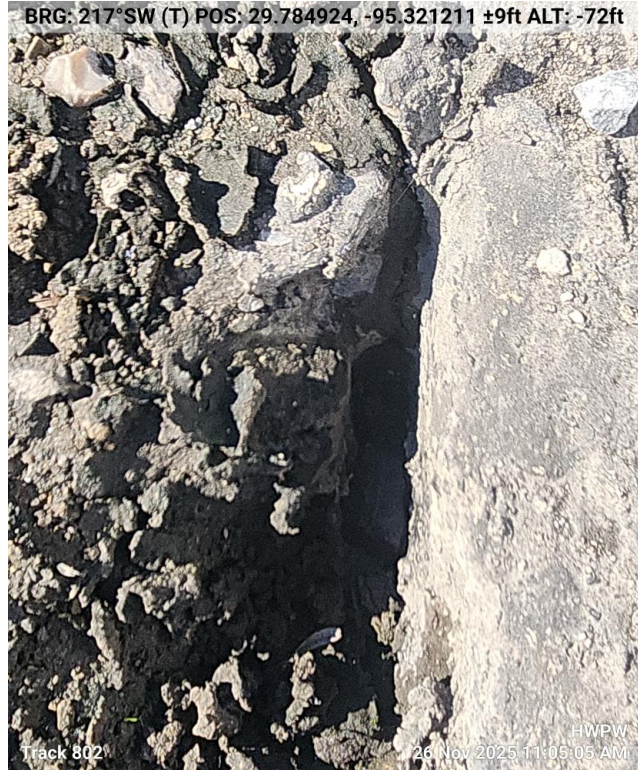
Track 802 weekly inspection of track. Surrounding concrete and ballast in good condition. No NAPL observed along joint.

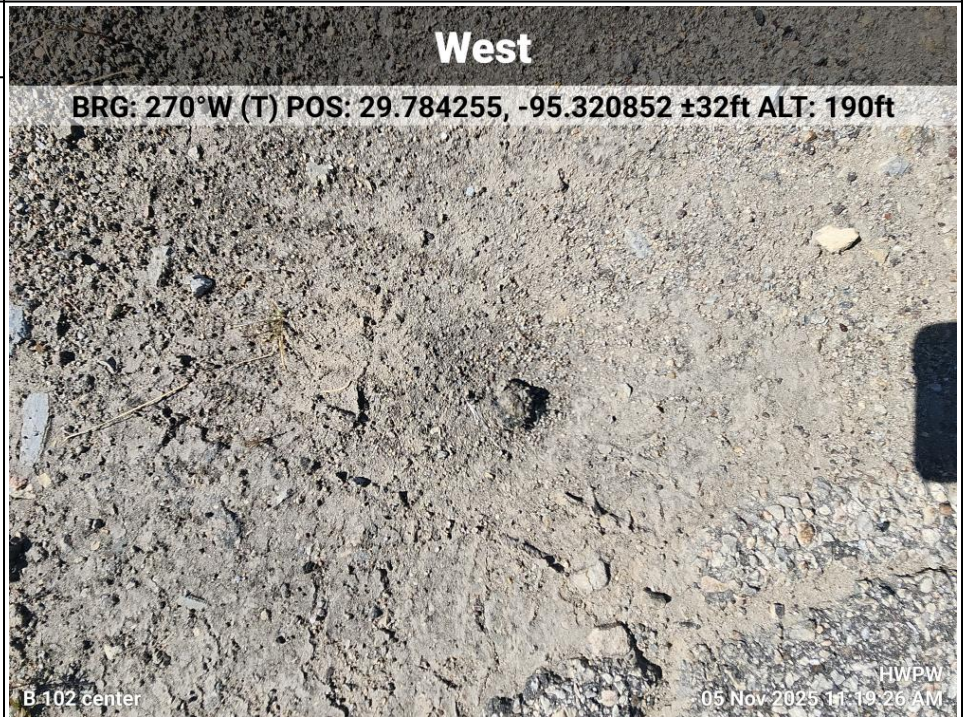
Photo No.
72

B102 Center weekly inspection of previously identified seep. Surrounding asphalt in good condition. Approximately 2 cubic inches of NAPL observed at seep location.

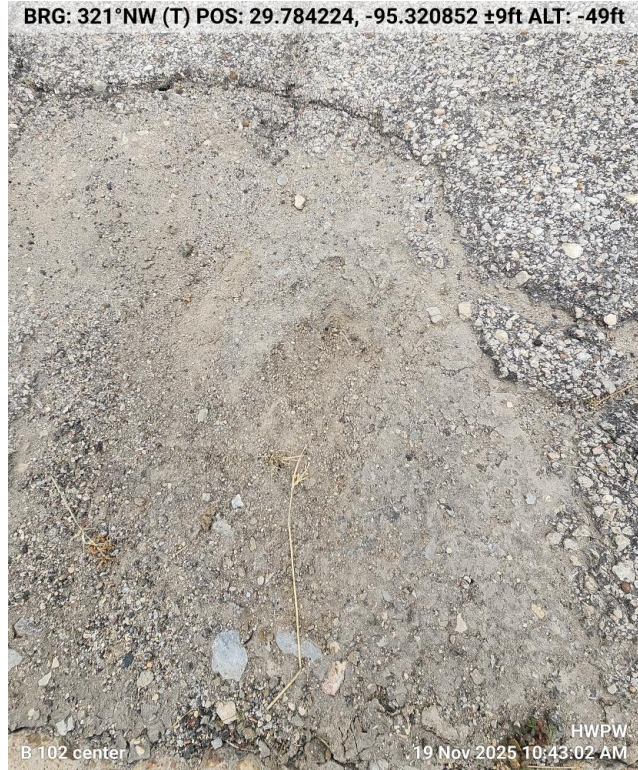
B102 Center weekly inspection of previously identified seep. Surrounding asphalt in good condition. No NAPL observed along joint.

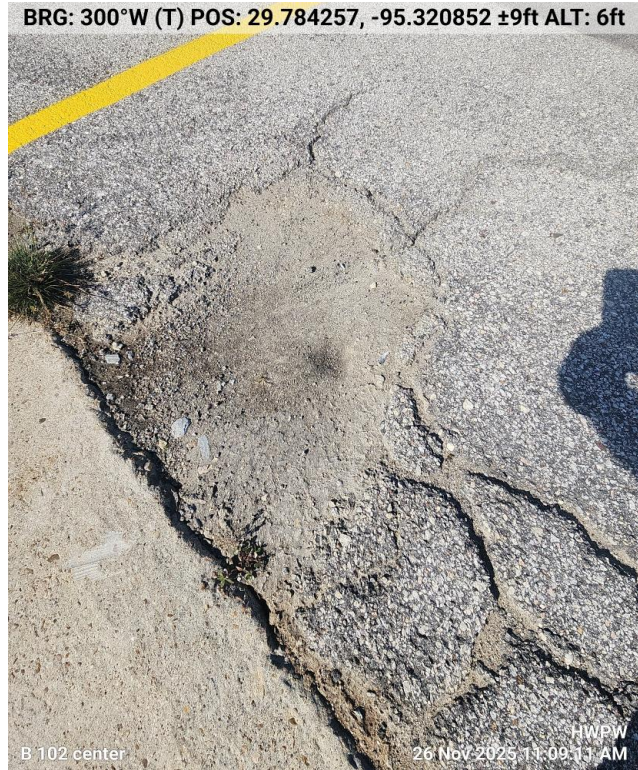
Photo No. 76
Inspection Date: 11/26/2025

B102 Center weekly inspection of previously identified seep. Surrounding asphalt in good condition. No NAPL observed along joint.
