March 16, 2026

Project No. US0039040.3990

Re: **MONTHLY STATUS UPDATE – ENGLEWOOD INTERMODAL YARD – REVISED INTERIM MEASURES WORK PLAN POST-CONSTRUCTION AND NAPL COLLECTION SYSTEM/CONCRETE CAP REPAIR INSPECTIONS  
UNION PACIFIC RAILROAD HOUSTON WOOD PRESERVING WORKS FACILITY  
4910 LIBERTY ROAD FACILITY, HOUSTON, TEXAS  
POST-CLOSURE CARE PERMIT NO. HW-50343; INDUSTRIAL SWR NO. 31547**

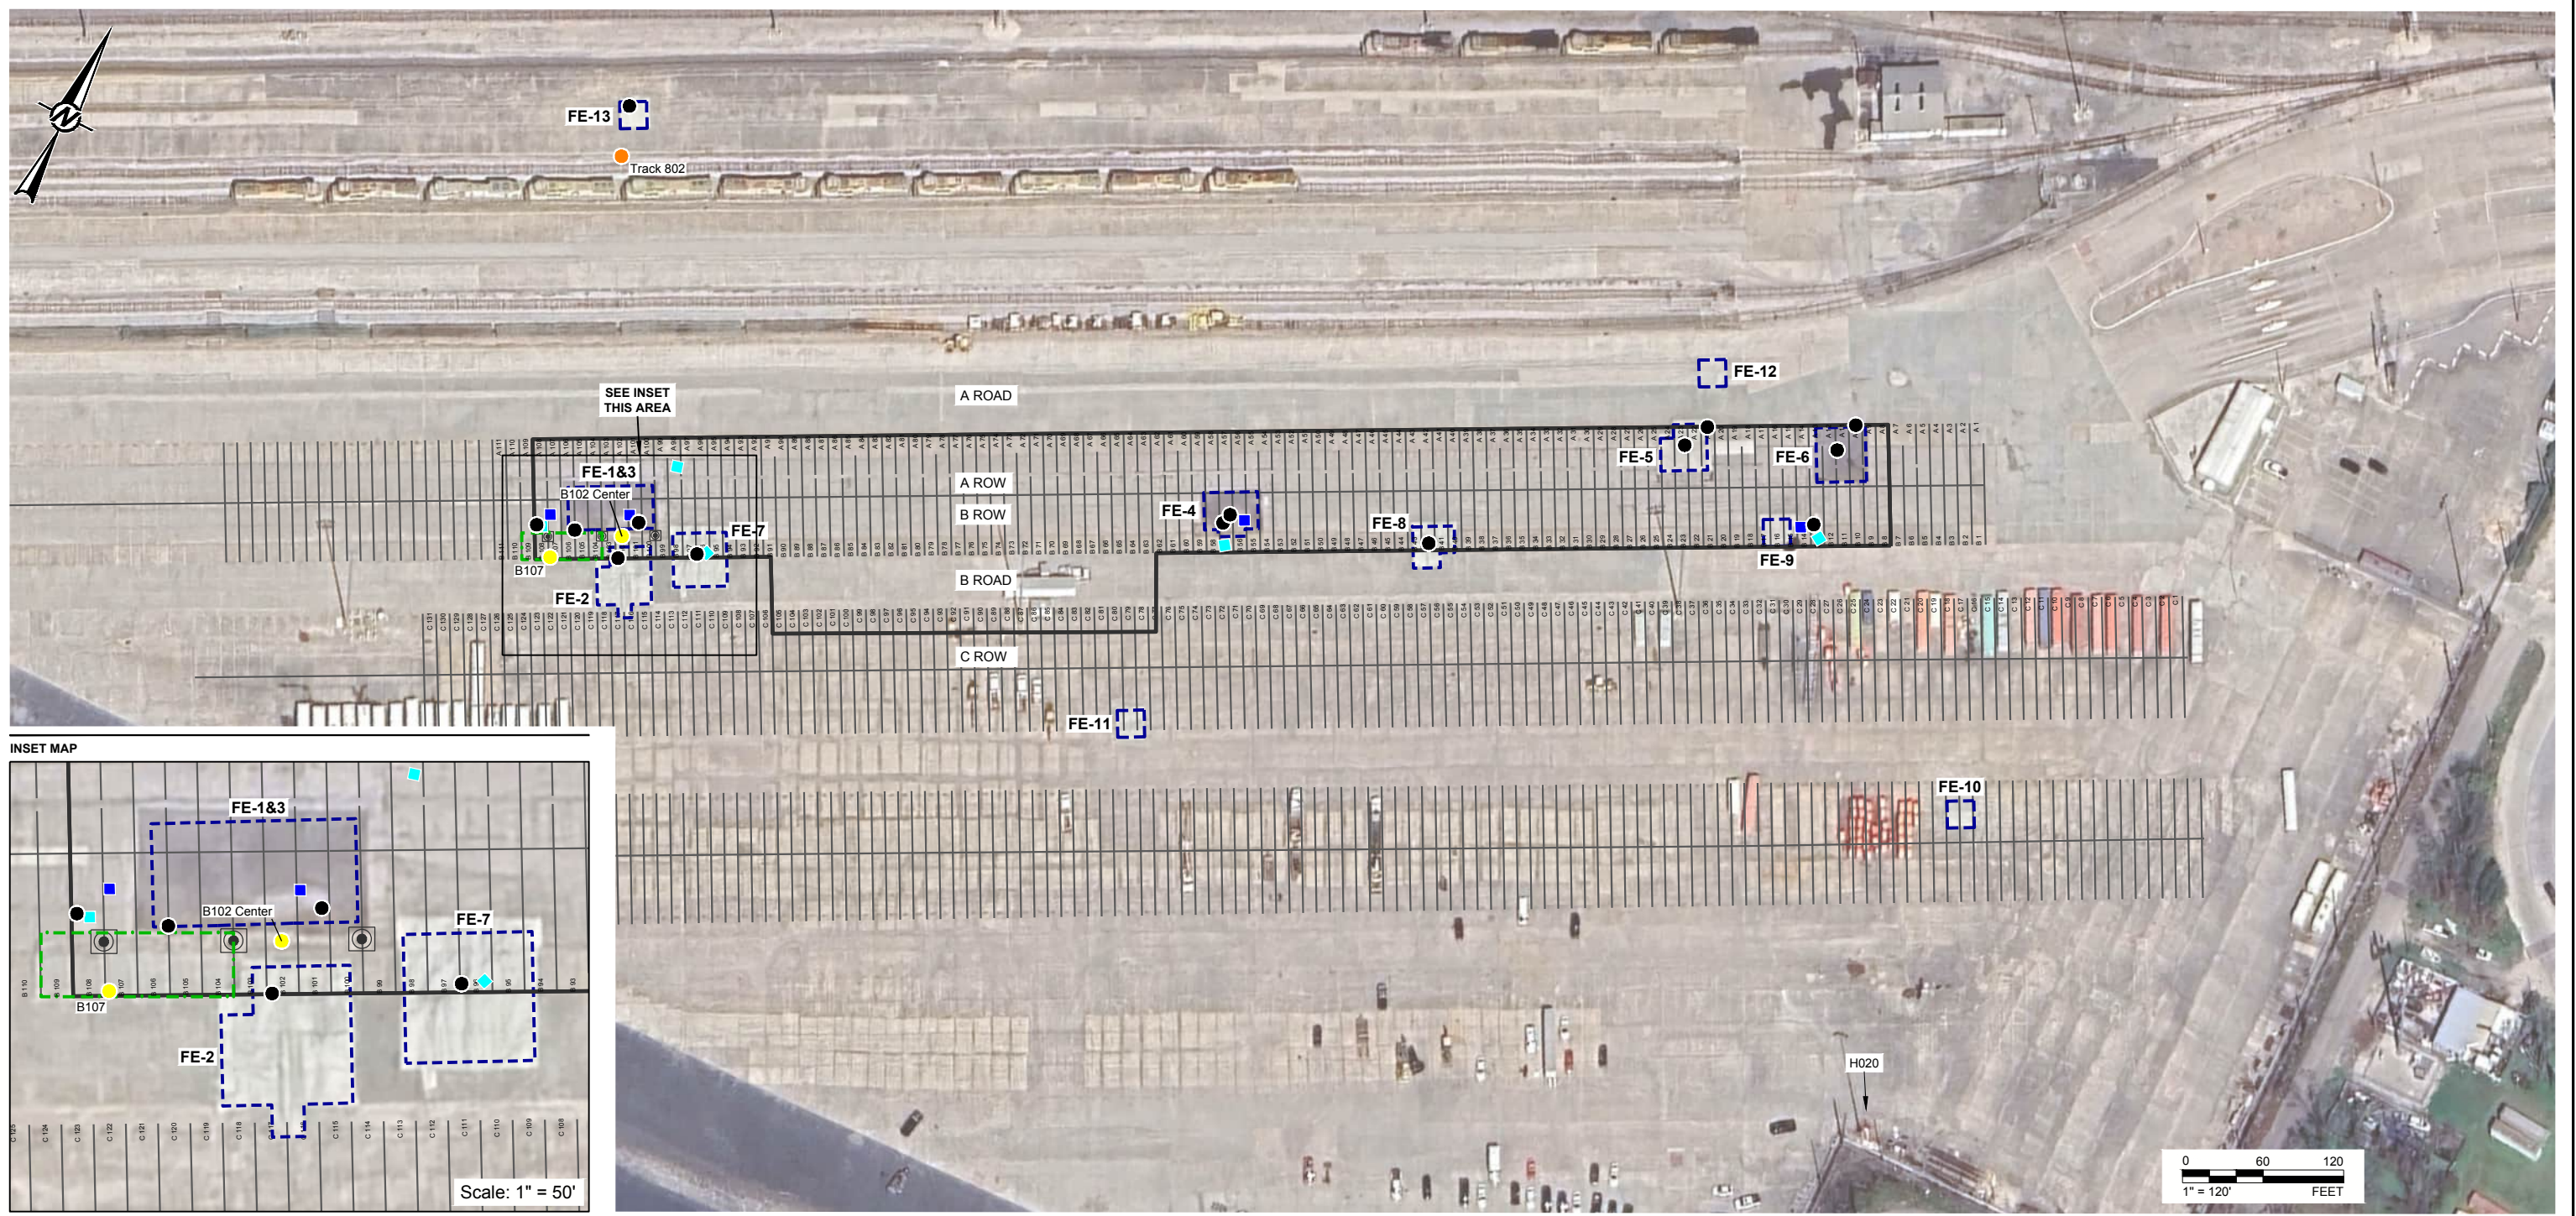
A figure showing the active and historical seep locations is provided on Figure 1.

**NOTE(S)**  
 1. WSP IS CURRENTLY EVALUATING THE ORIGIN OF THE TAR-LIKE NAPL MATERIAL OBSERVED AT H020.  
 2. THE HISTORICAL NAPL SEEP LOCATIONS WITHIN AS-BUILT EXTENT OF FOCUSED EXCAVATION AREAS HAVE BEEN ADDRESSED.

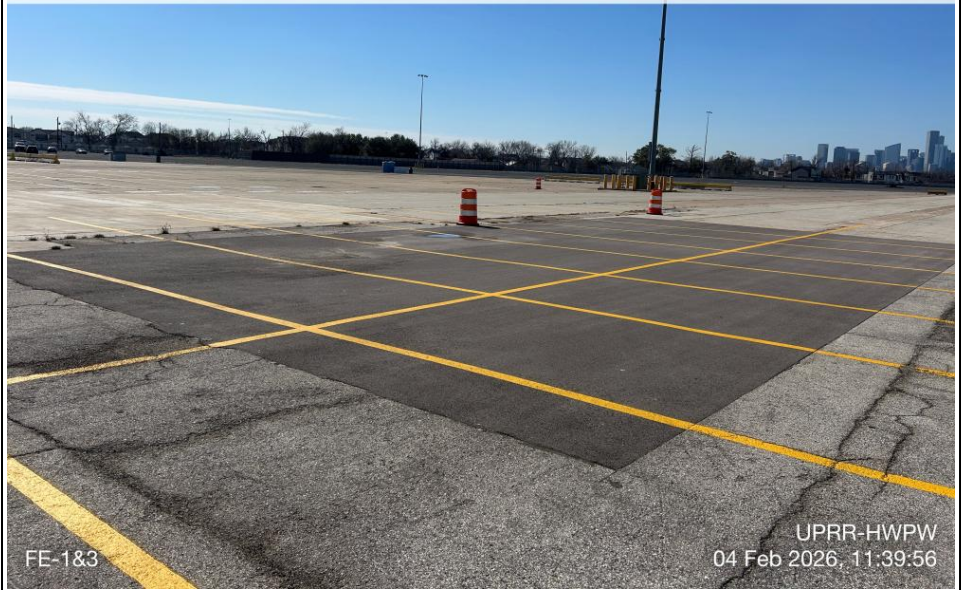
**Description:**  
FE-1&3 weekly inspection of asphalt cap. Reconstructed cap in good condition. No NAPL observed at FE location. Standing water from recent rain event. Facing southwest.

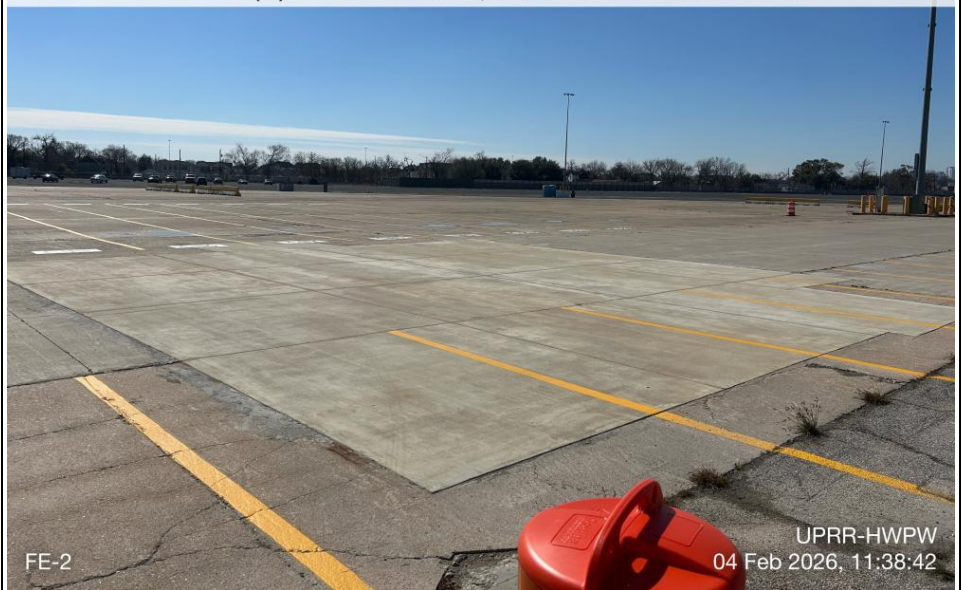
**Photo No.**  
2

**Description:**  
FE-2 weekly inspection of concrete cap. Reconstructed cap in good condition. No NAPL observed at FE location. Facing south.

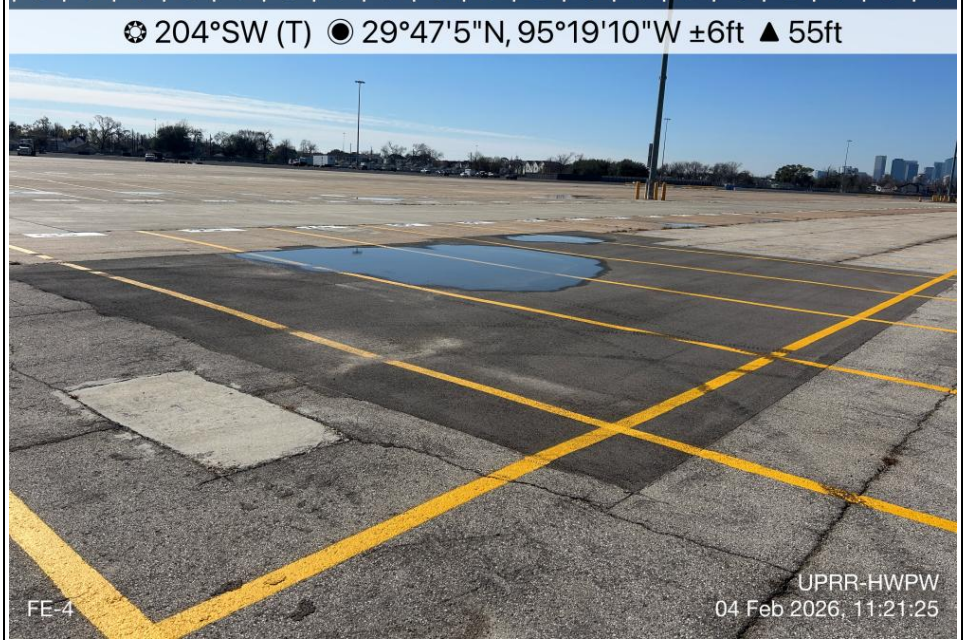
**Description:**  
FE-4 weekly inspection of asphalt cap. Reconstructed cap in good condition. No NAPL observed at FE location. Standing water from recent rain event. Facing southwest.

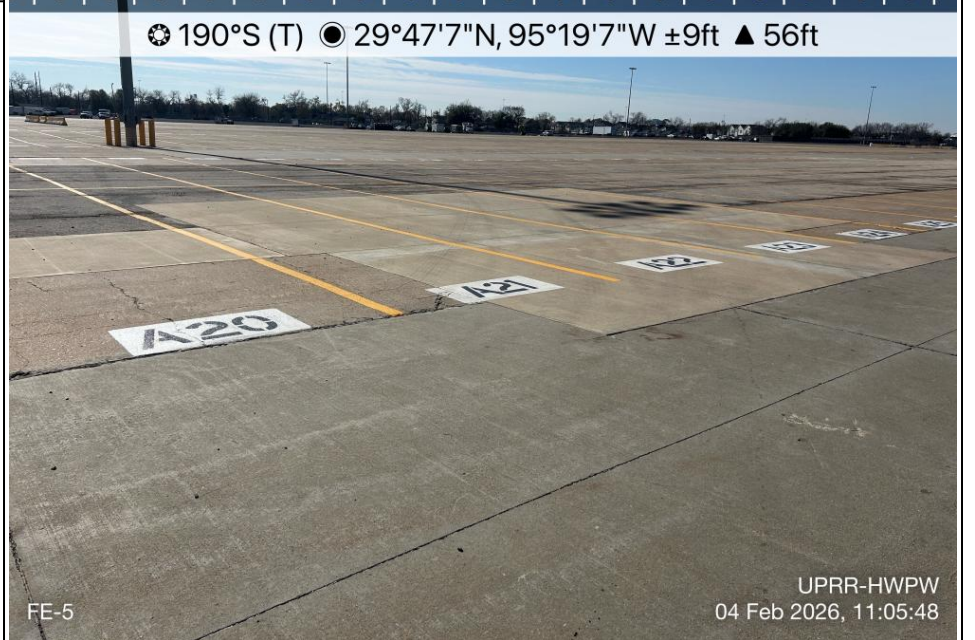
**Photo No.**  
4

**Description:**  
FE-5 weekly inspection of concrete cap. Reconstructed cap in good condition. No NAPL observed at FE location. Facing south.

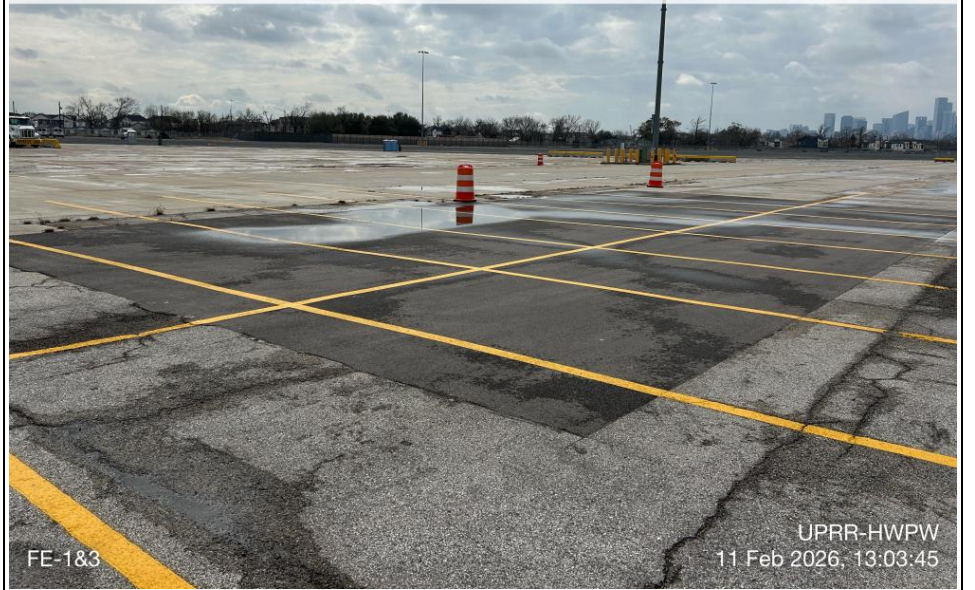
FE-1&3 weekly inspection of asphalt cap. Reconstructed cap in good condition. No NAPL observed at FE location. Standing water from recent rain event. Facing southwest.

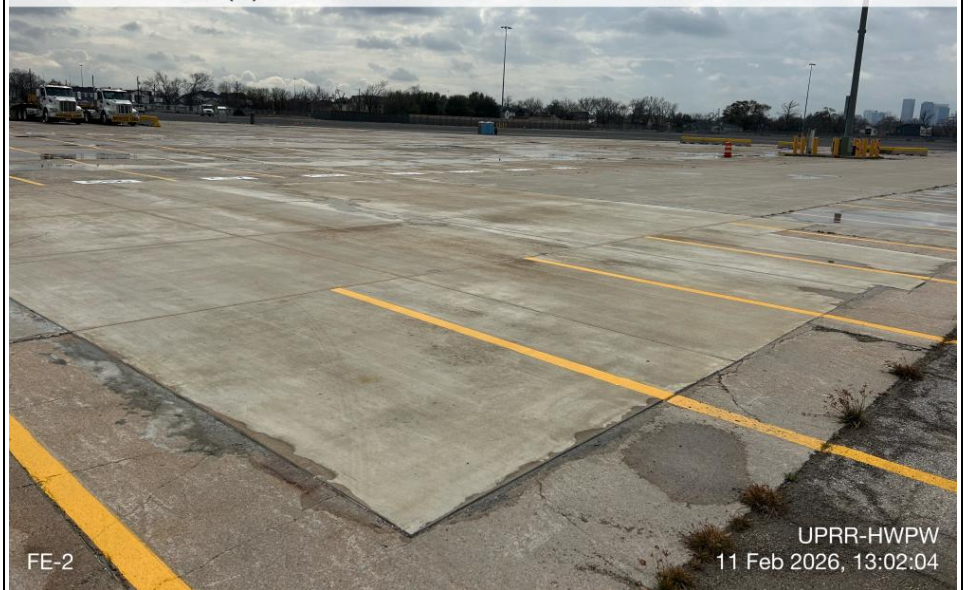
**Photo No.**  
14

FE-2 weekly inspection of concrete cap. Reconstructed cap in good condition. No NAPL observed at FE location. Standing water from recent rain event. Facing southwest.

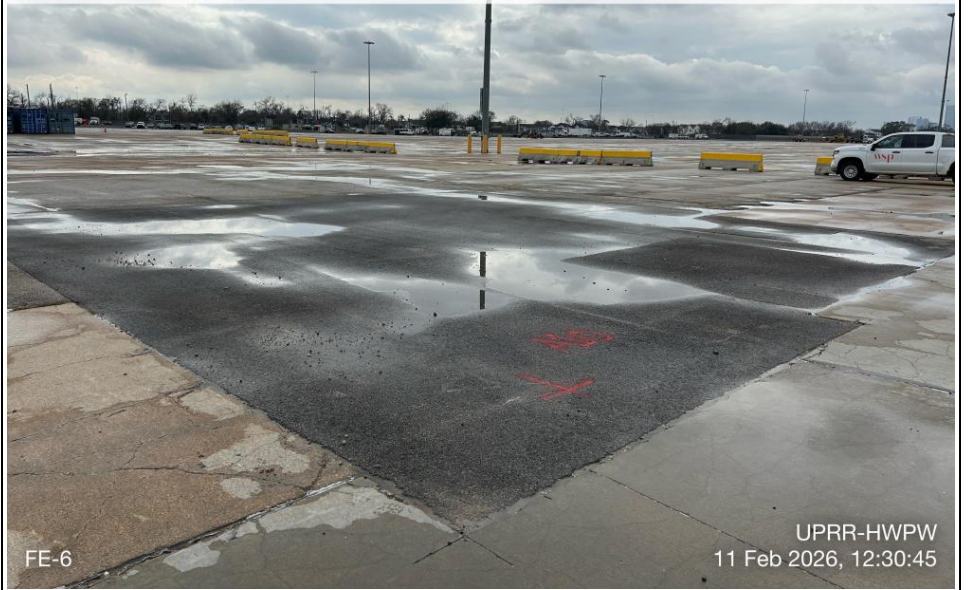
**Description:**  
FE-6 weekly inspection of asphalt cap. Reconstructed cap in good condition. No NAPL observed at FE location. Standing water from recent rain event. Facing south.

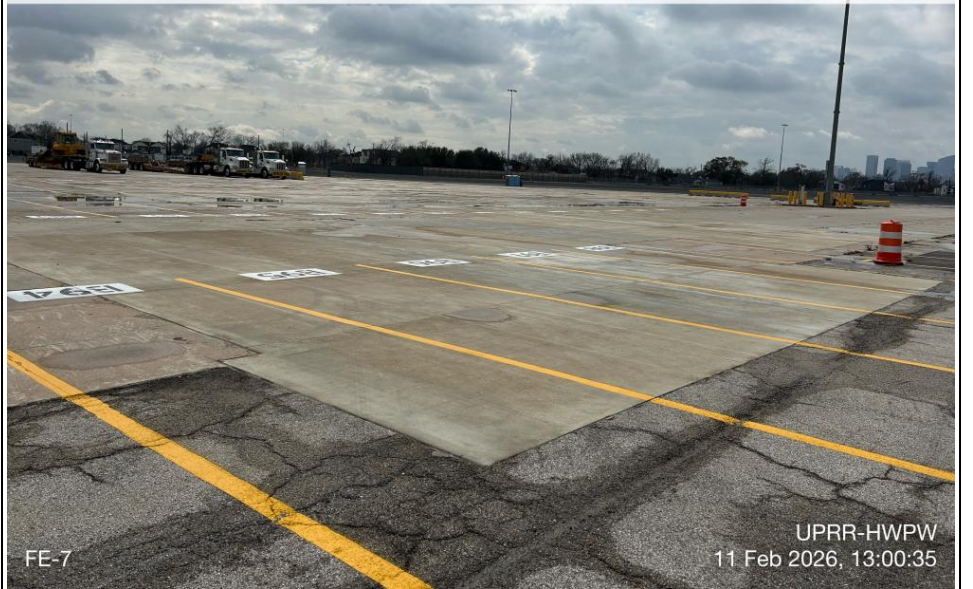
**Photo No.**  
18

**Description:**  
FE-7 weekly inspection of concrete cap. Reconstructed cap in good condition. No NAPL observed at FE location. Standing water from recent rain event. Facing southwest.

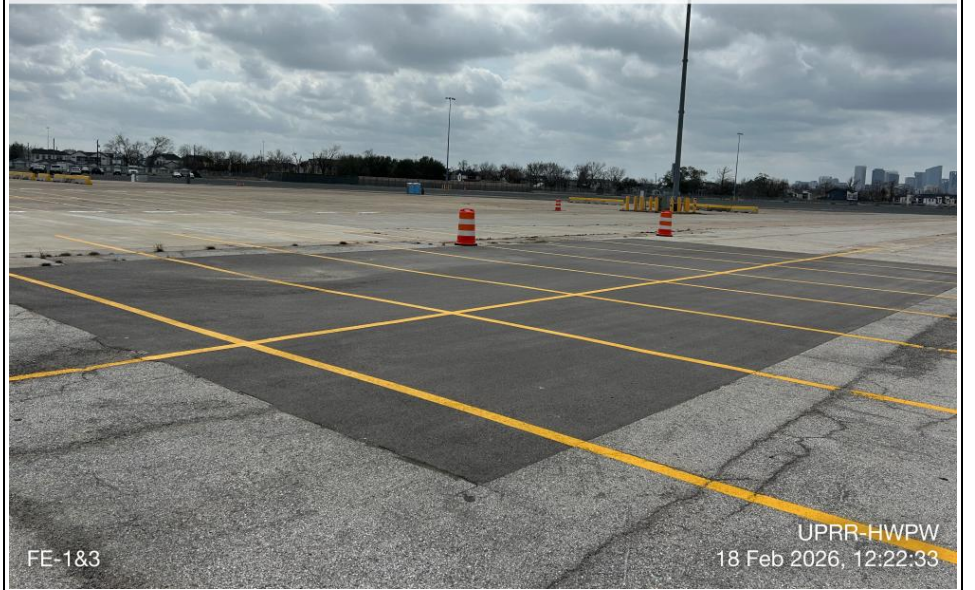
FE-1&3 weekly inspection of asphalt cap. Reconstructed cap in good condition. No NAPL observed at FE location. Facing southwest.

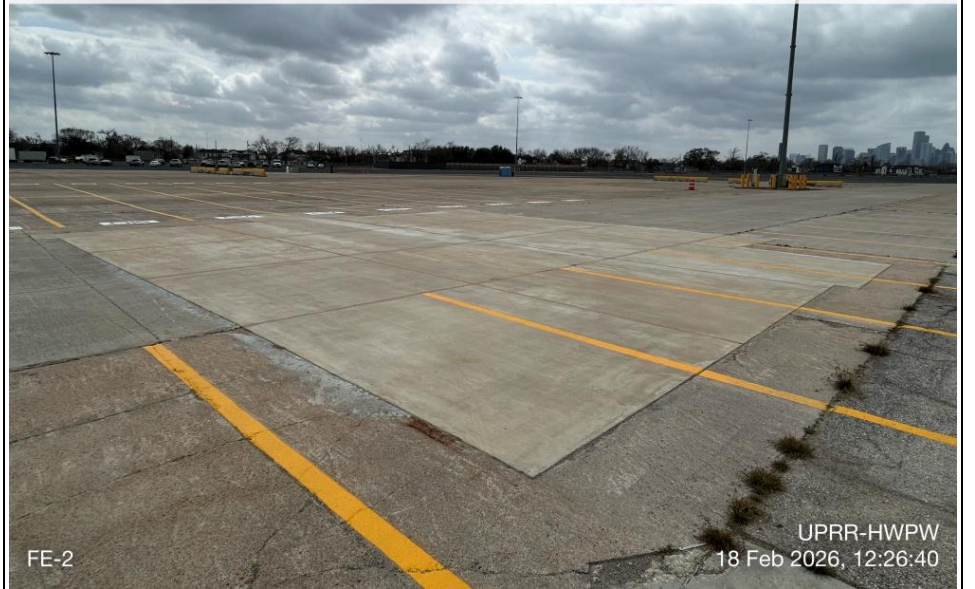
**Photo No.**  
26

FE-2 weekly inspection of concrete cap. Reconstructed cap in good condition. No NAPL observed at FE location. Facing south.

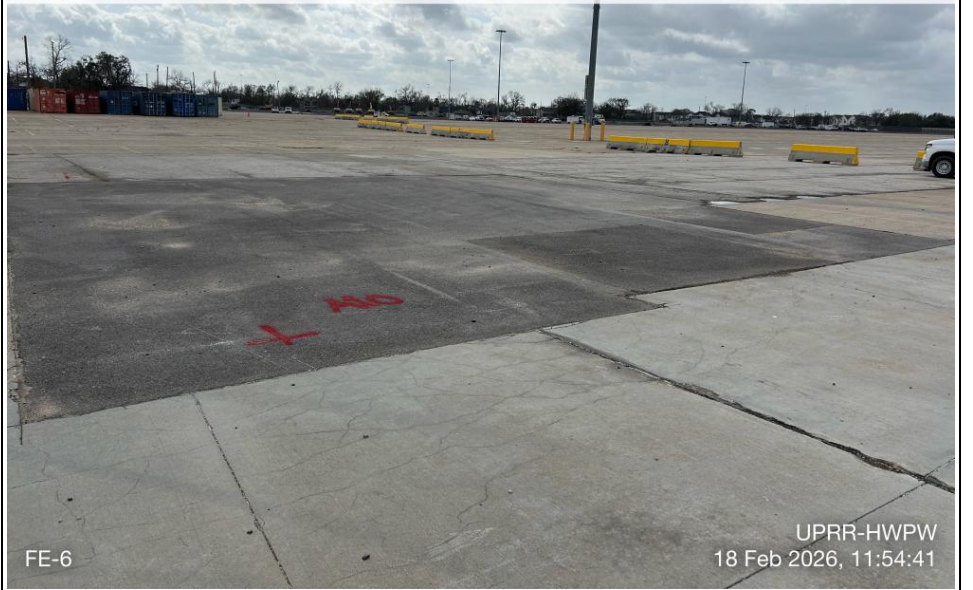
**Description:**  
FE-6 weekly inspection of asphalt cap. Reconstructed cap in good condition. No NAPL observed at FE location. Facing south.

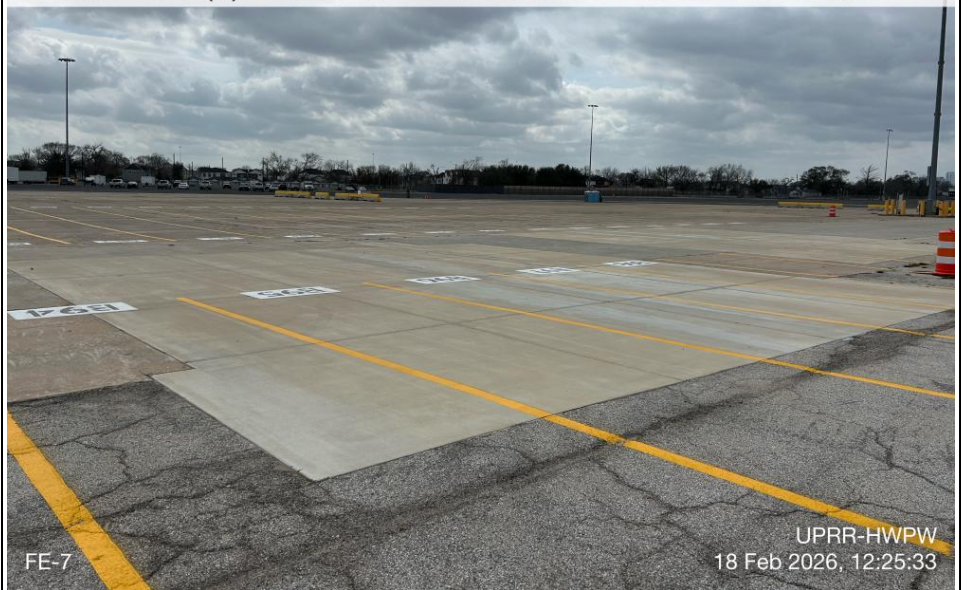
**Photo No.**  
30

**Description:**  
FE-7 weekly inspection of concrete cap. Reconstructed cap in good condition. No NAPL observed at FE location. Facing south.

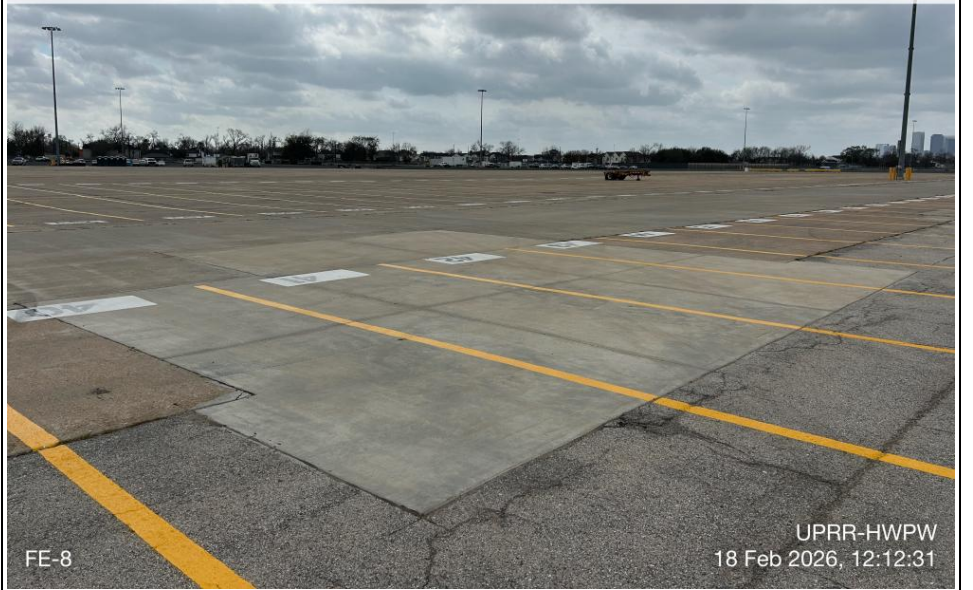
**Description:**  
FE-8 weekly inspection of concrete cap.  
Reconstructed cap in good condition. No NAPL observed at FE location. Facing south.

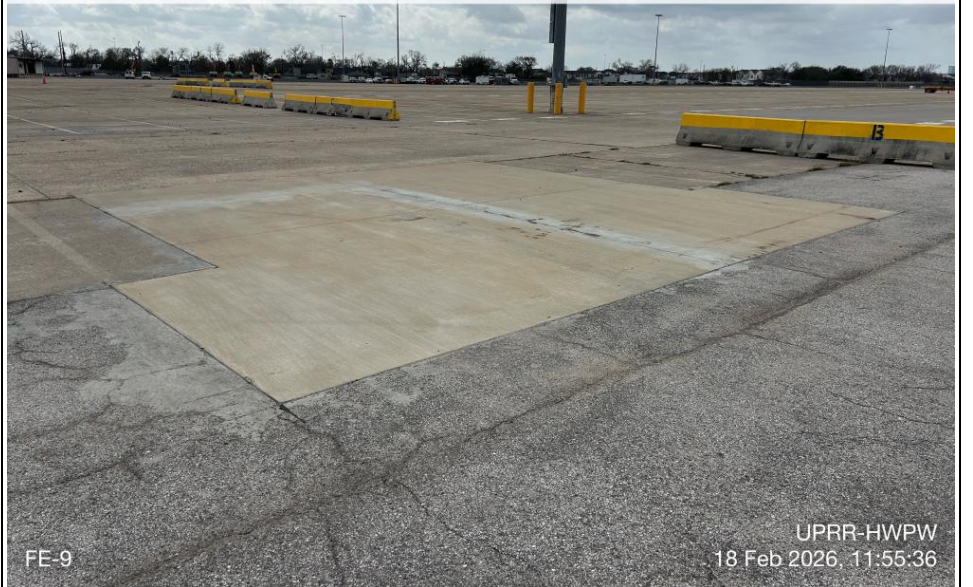
**Photo No.**  
32

**Description:**  
FE-9 weekly inspection of concrete cap.  
Reconstructed cap in good condition. No NAPL observed at FE location. Facing south.

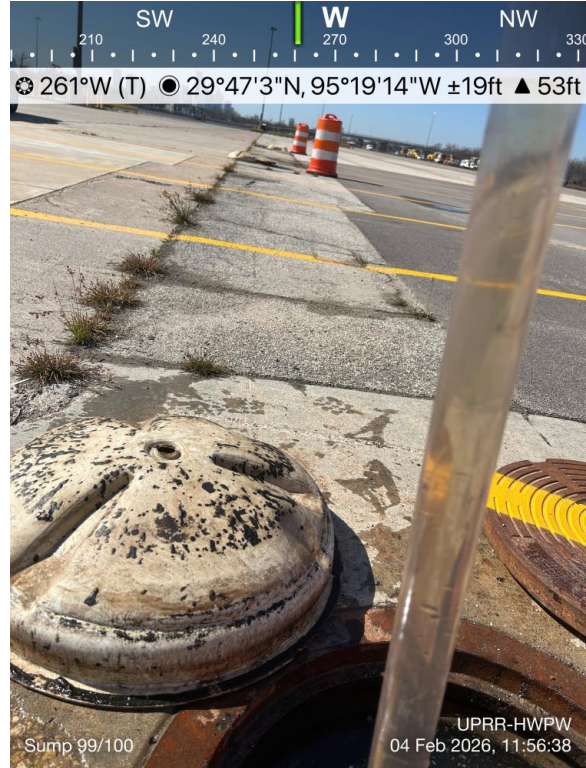
Sump 1 (B99/B100), 0 inches of freeboard in sump. Color is light brown, and no sheen or odor was reported.

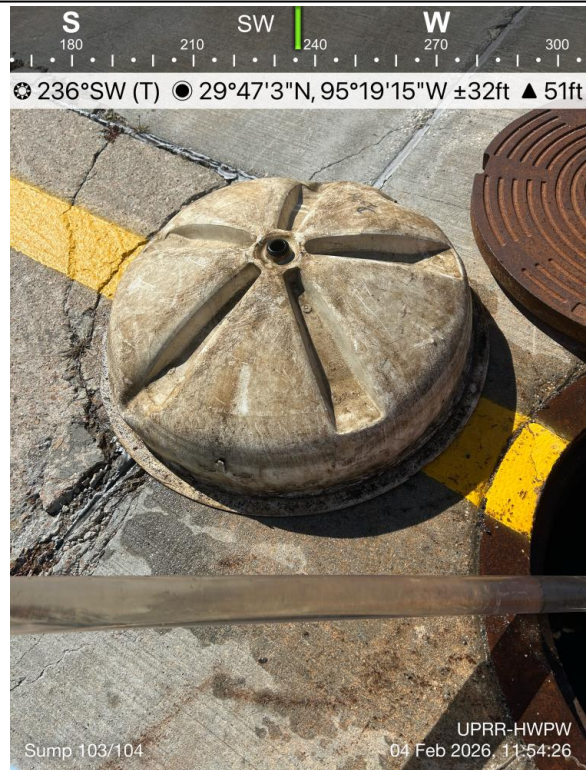
**Photo No.**  
50

Sump 2 (B103/B104), 0.9 inches of freeboard in sump. Color is clear, and no sheen or odor was reported.

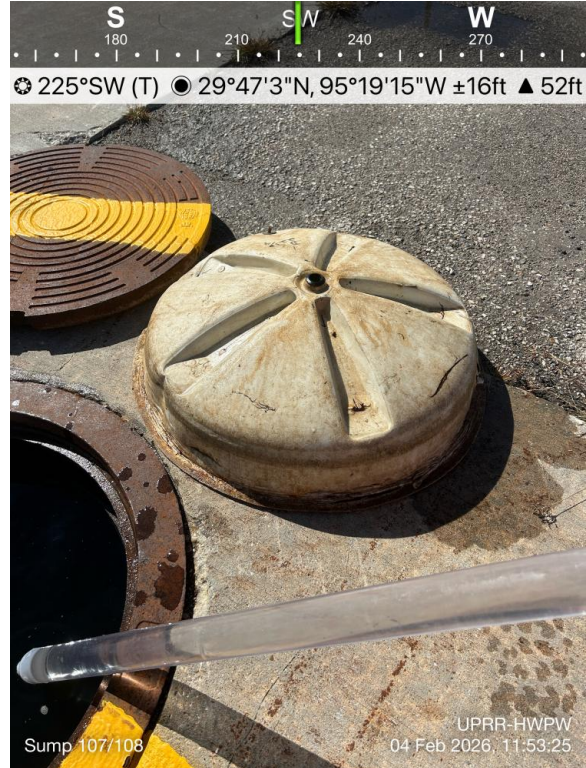
Sump 3 (B107/B108), 0.1 inches of freeboard in sump. Color is clear, and no sheen or odor was reported.

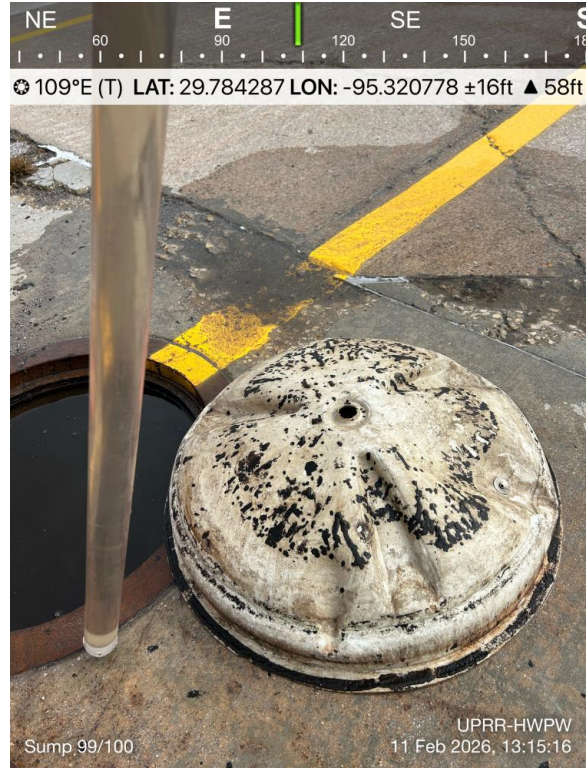
**Photo No.**  
52

Sump 1 (B99/B100), 1.9 inches of freeboard in sump. Color is light brown, and no sheen or odor was reported.

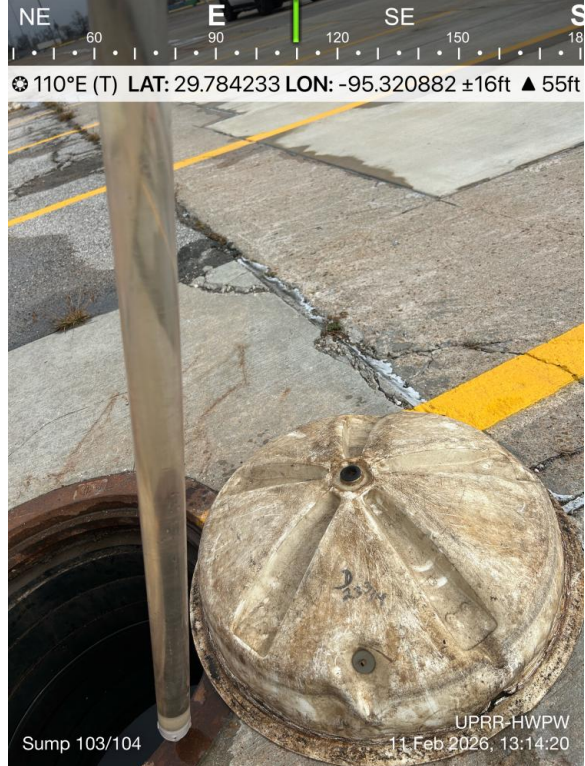
Sump 2 (B103/B104), 10.5 inches of freeboard in sump. Color is light brown, and no sheen or odor was reported.

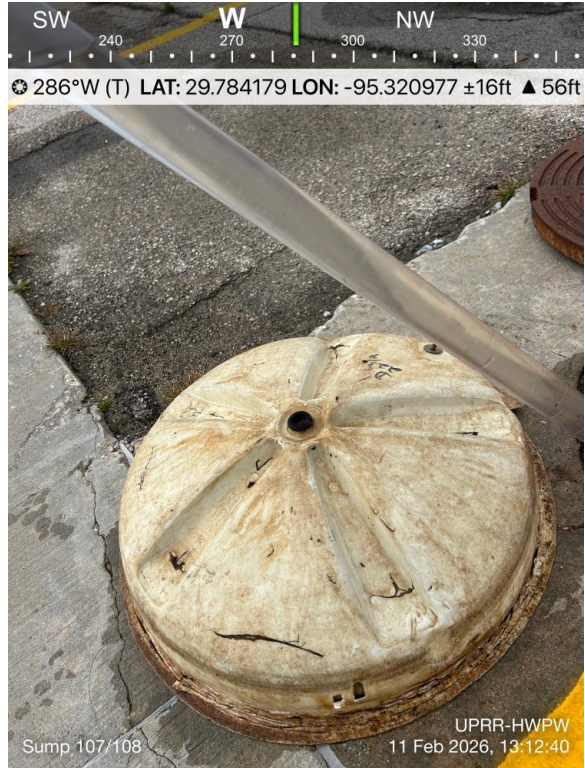
**Photo No.**  
54

Sump 3 (B107/B108), 9.3 inches of freeboard in sump. Color is clear, and no sheen or odor was reported.

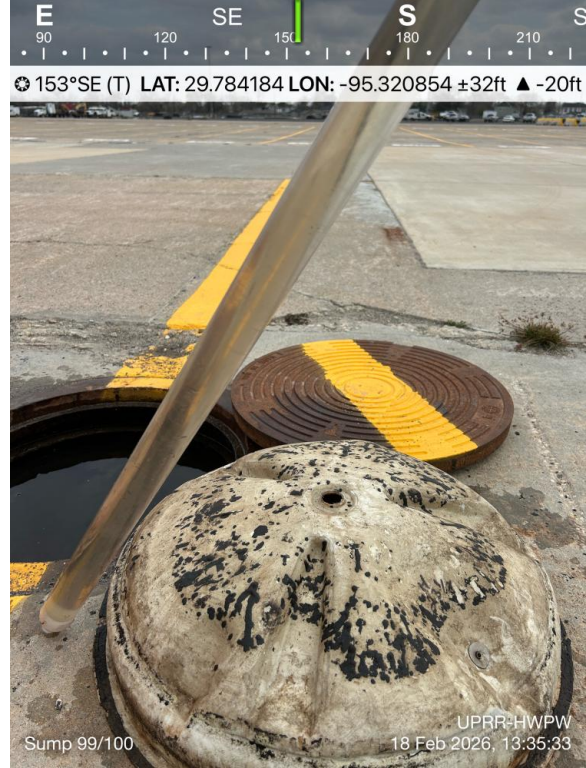
**Description:**  
Sump 1 (B99/B100), 0 inches of freeboard in sump. Color is light brown, and no sheen or odor was reported.

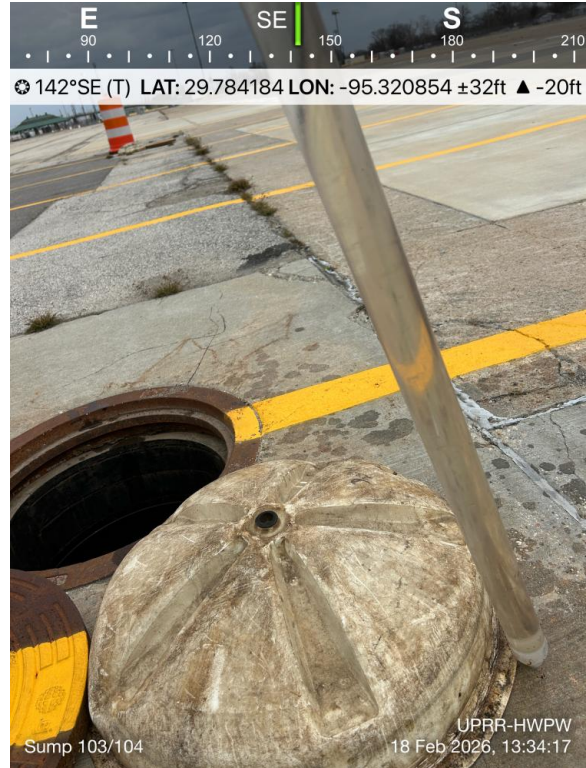
**Photo No.**  
56

**Description:**  
Sump 2 (B103/B104), 8.7 inches of freeboard in sump. Color is clear, and no sheen or odor was reported.

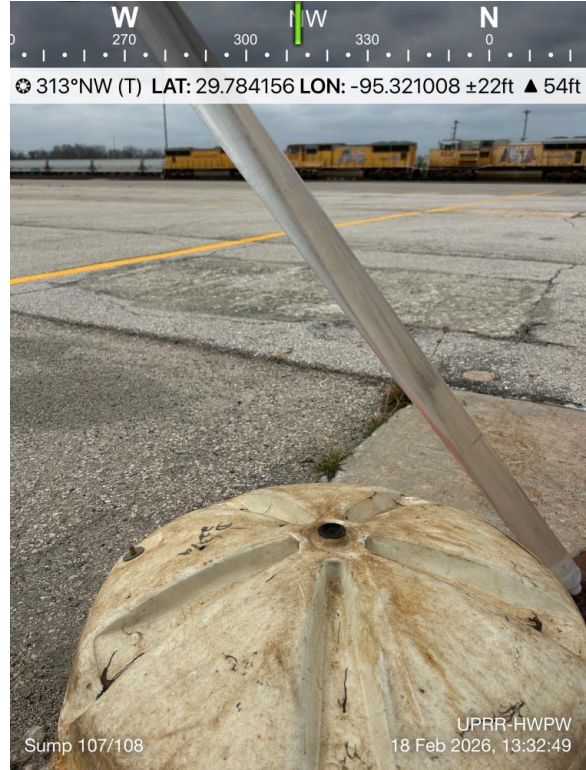
Sump 3 (B107/B108), 7.7 inches of freeboard in sump. Color is clear, and no sheen or odor was reported.

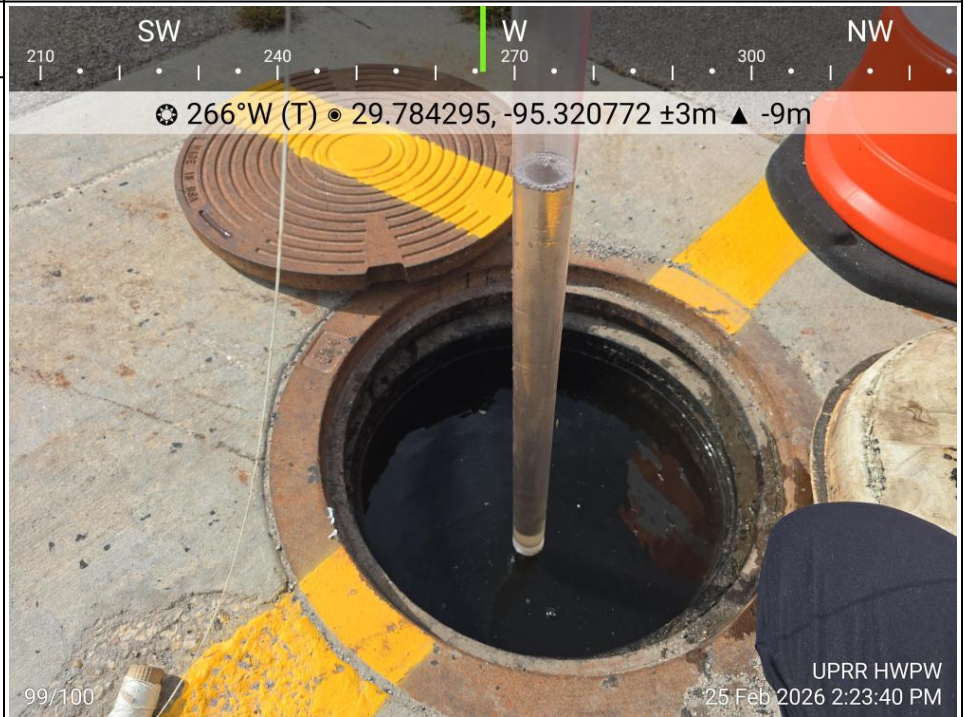
**Photo No.**  
58

Sump 1 (B99/B100), 2 inches of freeboard in sump. Color is light brown, and no sheen or odor was reported.

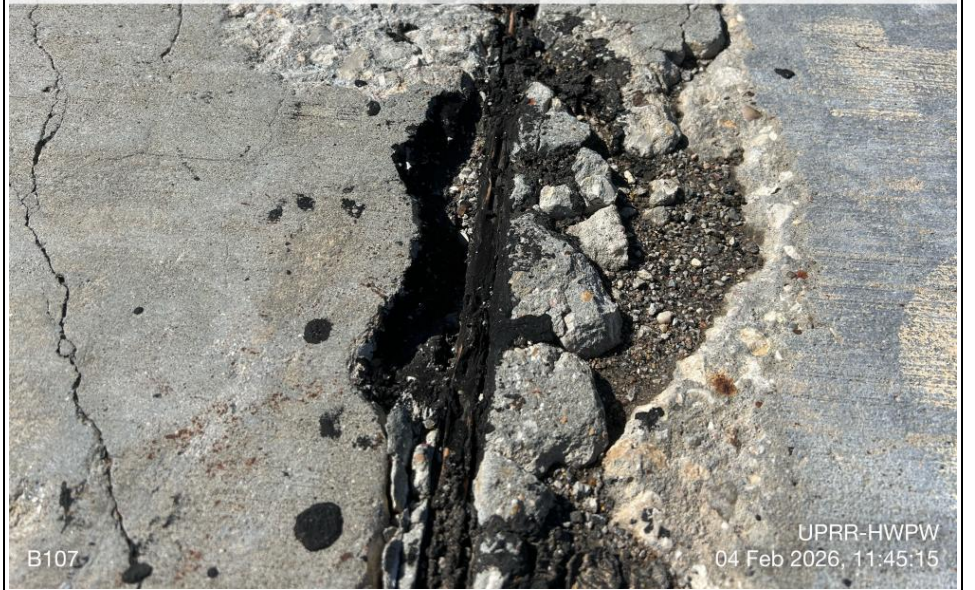
B107 weekly inspection of joint. Surrounding concrete in good condition. No active NAPL seep observed along joint.

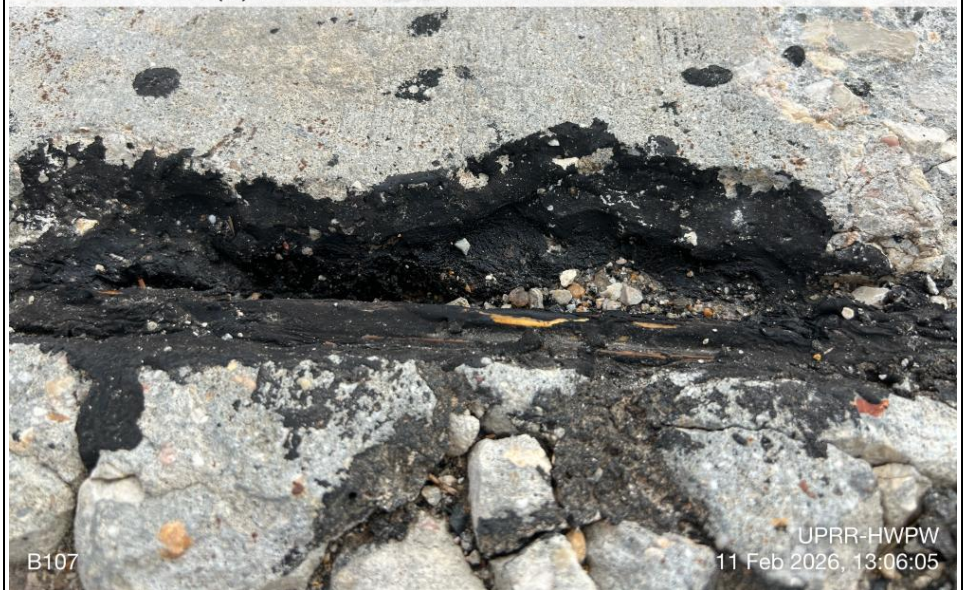
**Photo No.**  
62

B107 weekly inspection of joint. Surrounding concrete in good condition. No active NAPL seep observed along joint.

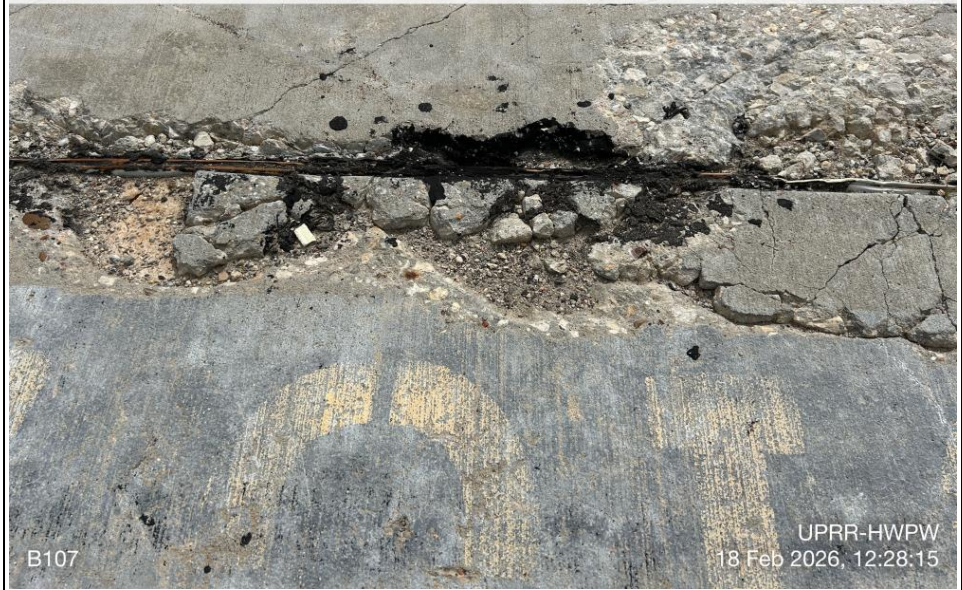
B107 weekly inspection of joint. Surrounding concrete in good condition. No active NAPL seep observed along joint.

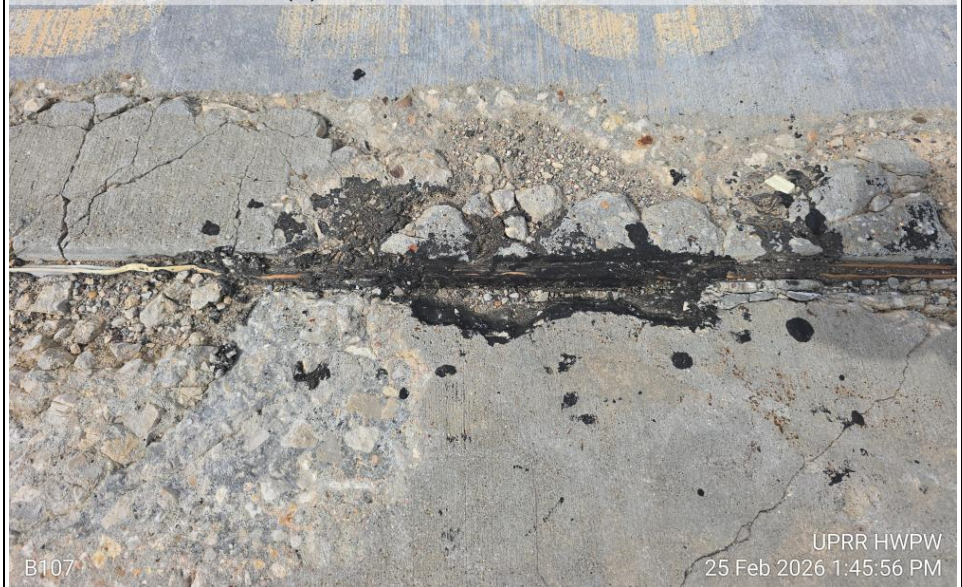
**Photo No.**  
64

B107 weekly inspection of joint. Surrounding concrete in good condition. No active NAPL seep observed along joint.

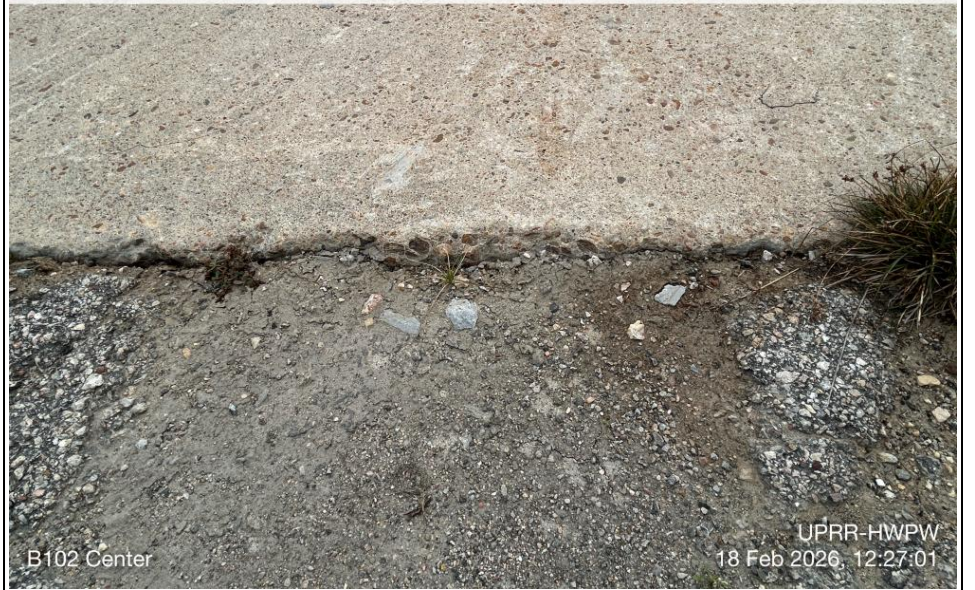
B102 Center weekly inspection of previously identified seep. Surrounding asphalt in good condition. No active NAPL seep observed along joint.

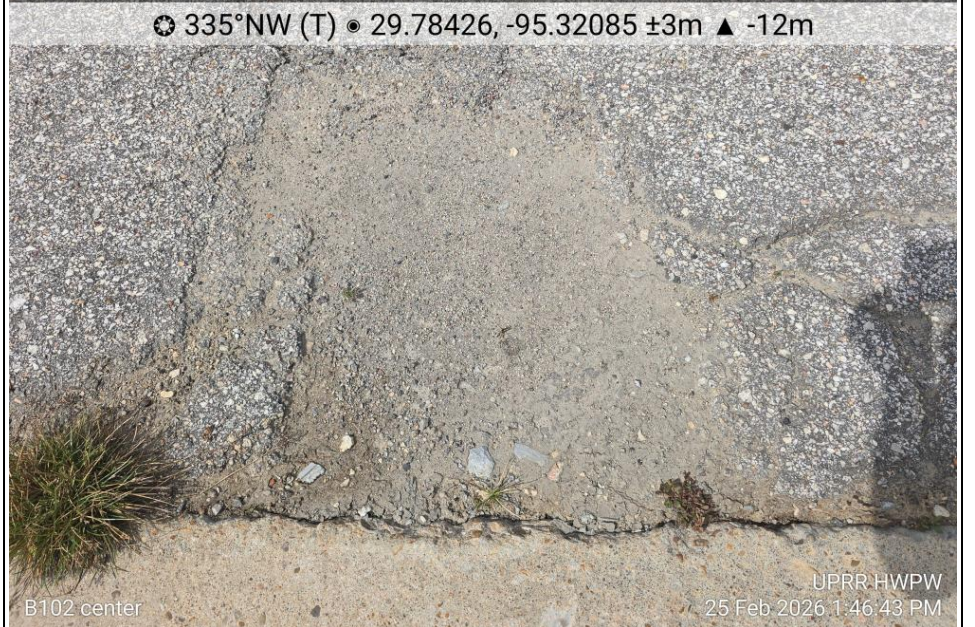
**Photo No.**  
74

B102 Center weekly inspection of previously identified seep. Surrounding asphalt in good condition. No active NAPL seep observed along joint.

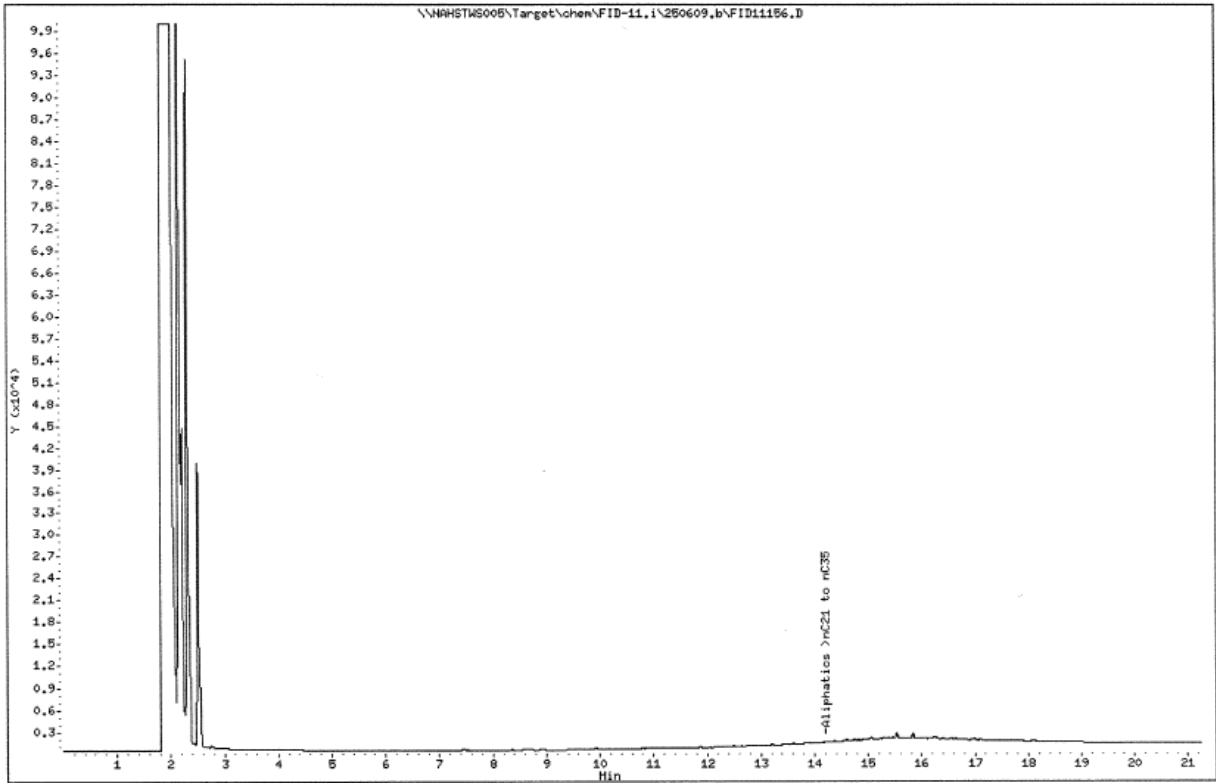
Figure 1 – May 2025 Sample Chromatogram

In addition to the TPH Method 1006 analyses, WSP requested chromatograms from the laboratory from the two analyses and assessed the information provided on those chromatograms. **Figure 1** shows the TPH chromatogram for the May sample event and **Figure 2** shows the expanded chromatogram with the y-axis magnified. The numbers on the x-axis are the times from 1 to 21 minutes and the numbers on the y-axis are the responses of the flame ionization detector to the material entering the detector. The peaks between 1 and 3 minutes are the pentane solvent used to dissolve the sample for gas chromatography; these peaks are not considered in the chromatographic interpretation. The numbers above the peaks in **Figure 2** are the retention times for each peak. Three red lines with circles on **Figure 2** mark the retention times for the markers in the TCEQ TPH method, i.e., n-dodecane (nC12) at 6.8 minutes, n-octacosane (nC28) at 14.8 minutes, and n-pentatriacontane (nC35) at 17.8 minutes.
