March 16, 2026

Project No. US0039040.3990

Re: **MONTHLY STATUS UPDATE – ENGLEWOOD INTERMODAL YARD – REVISED INTERIM MEASURES WORK PLAN POST-CONSTRUCTION AND NAPL COLLECTION SYSTEM/CONCRETE CAP REPAIR INSPECTIONS  
UNION PACIFIC RAILROAD HOUSTON WOOD PRESERVING WORKS FACILITY  
4910 LIBERTY ROAD FACILITY, HOUSTON, TEXAS  
POST-CLOSURE CARE PERMIT NO. HW-50343; INDUSTRIAL SWR NO. 31547**

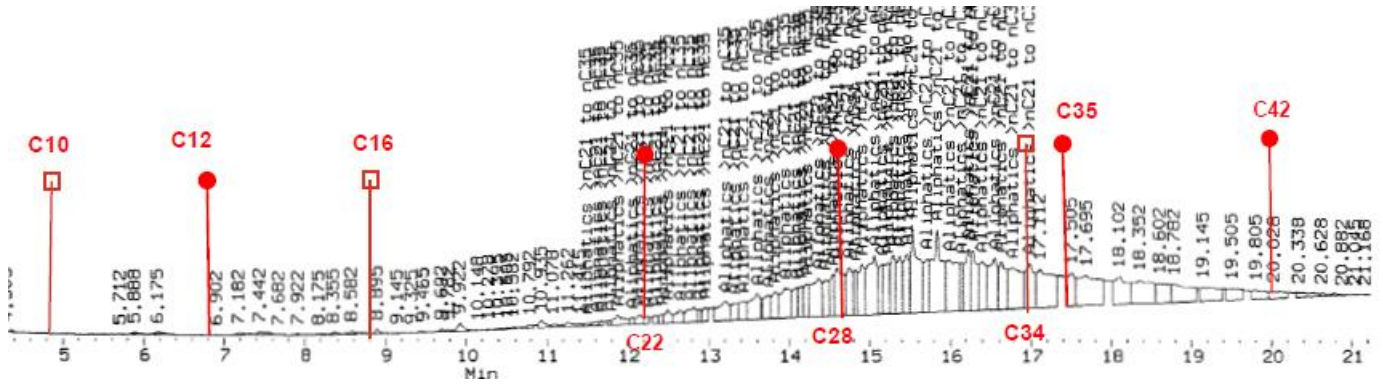
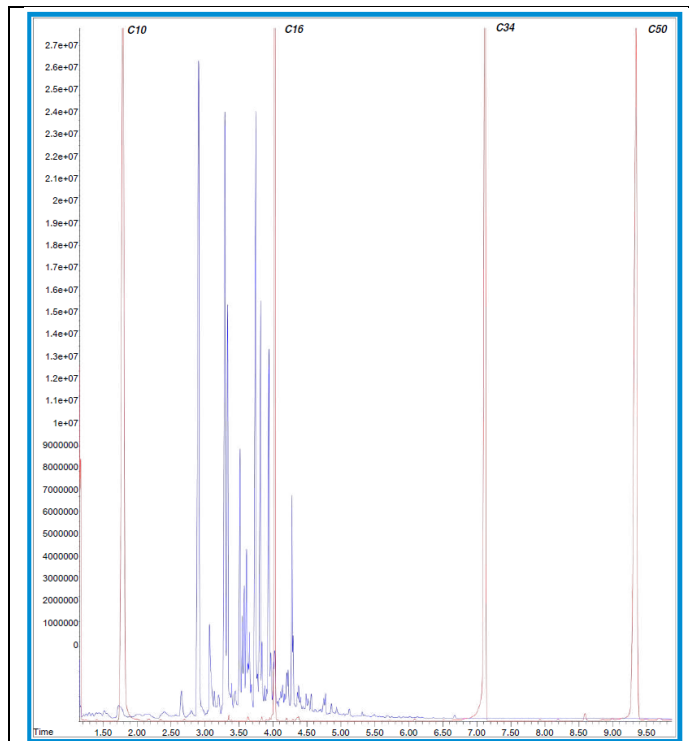
Figure 5 - May 2025 Sample Chromatogram with Retention Time Markers

**Figure 5** shows the area used for interpretation highlighted in yellow. This area corresponds to approximately the C22 to C42 carbon range. Since the known petroleum hydrocarbons encountered at the Site are creosote and No. 6 fuel oil, the sample chromatogram was compared to the reference chromatograms for creosote and No. 6 fuel oil. **Figures 6** and **7** provide the reference chromatograms for creosote and No. 6 fuel oil, respectively (BV, 2025). Comparison of these profiles to the May 2025 sample chromatogram show that the peaks and profiles in creosote and No. 6 fuel oil do not match the sample chromatogram.

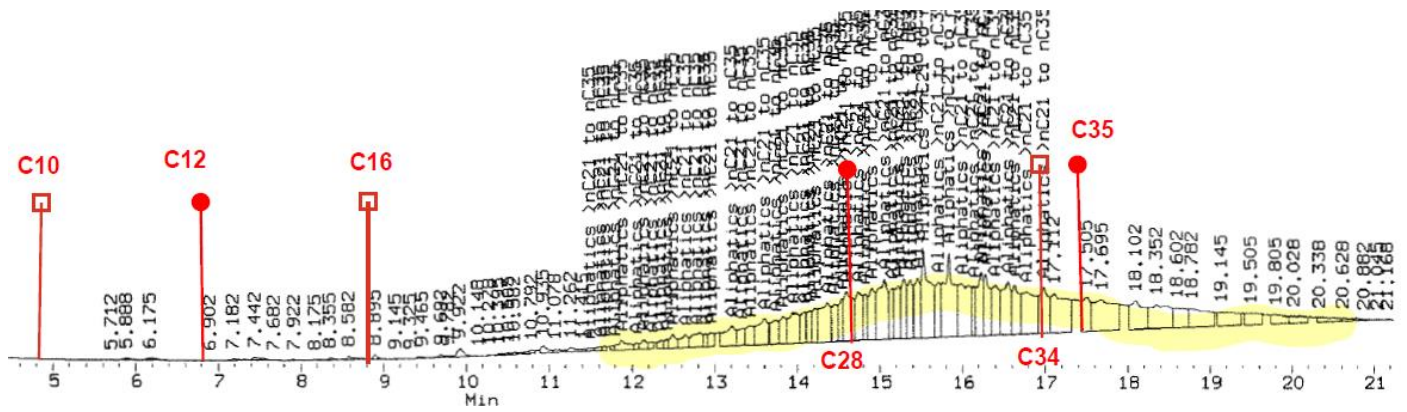
Figure 8 - May 2025 Sample Chromatogram with Retention Time Markers

Since creosote and No. 6 fuel oil were eliminated as the unknown product, reference chromatograms were reviewed for similar chromatographic profiles and carbon ranges. **Figure 8** repeats the sample chromatogram shown in **Figure 5**, **Figure 9** provides the reference chromatograms for motor oils (BV 2025), and **Figure 10** provides a closeup of the motor oil chromatograms between C16 and C50. Comparison of the profiles of the sample chromatogram and motor oils indicates the closest matches are the 10W30 and 15W40 motor oils.
